REPORT NUMBER: TWG-TRC-14-06

**NEW CAR ASSESSMENT PROGRAM (NCAP)**  
**SIDE AIRBAG OUT-OF-POSITION INJURY TESTING**

Mazda Motor Corporation  
2014 Mazda 3 4-Door Sedan

NHTSA NUMBER: M20145405TWG2  
TRC TEST NUMBER: 140529-1

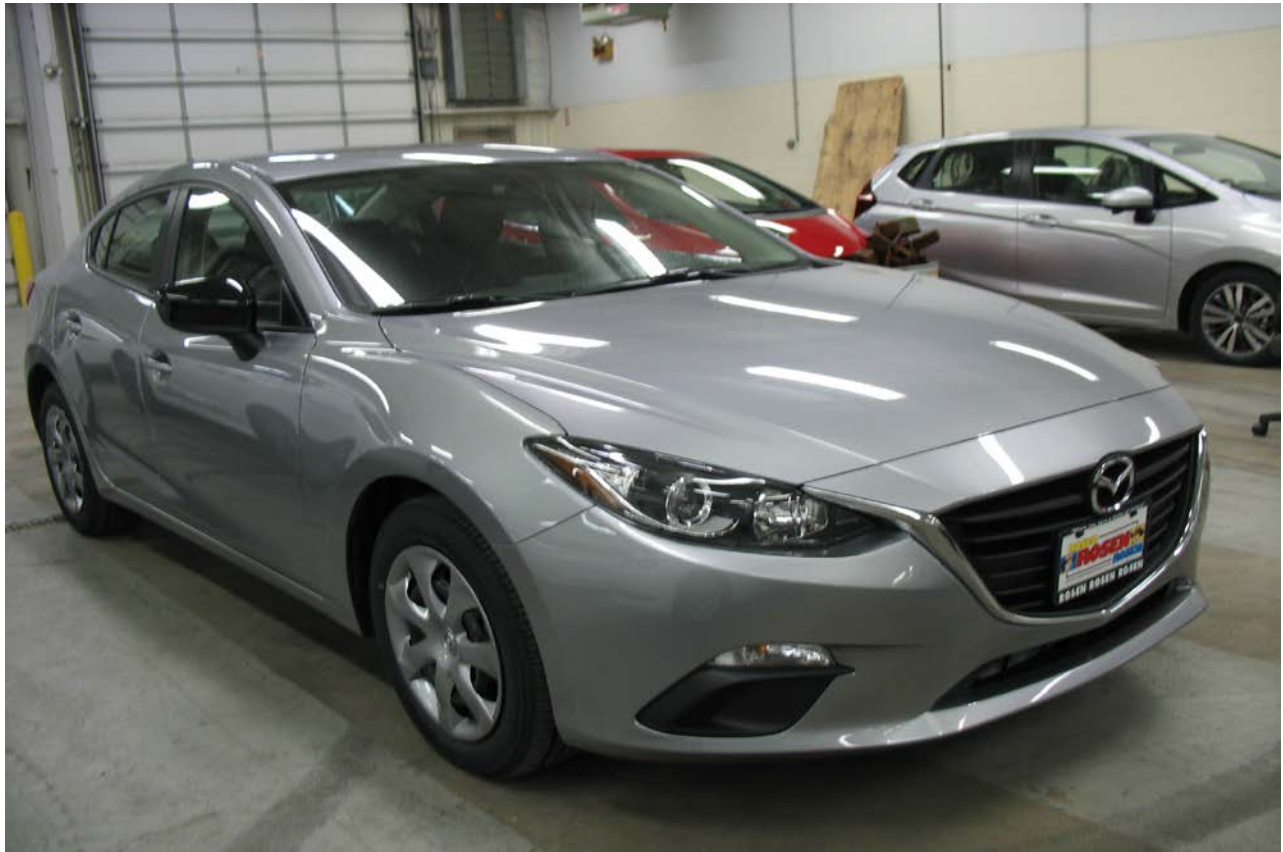
**Figure A-1 Right ¾ Front View, as Received**

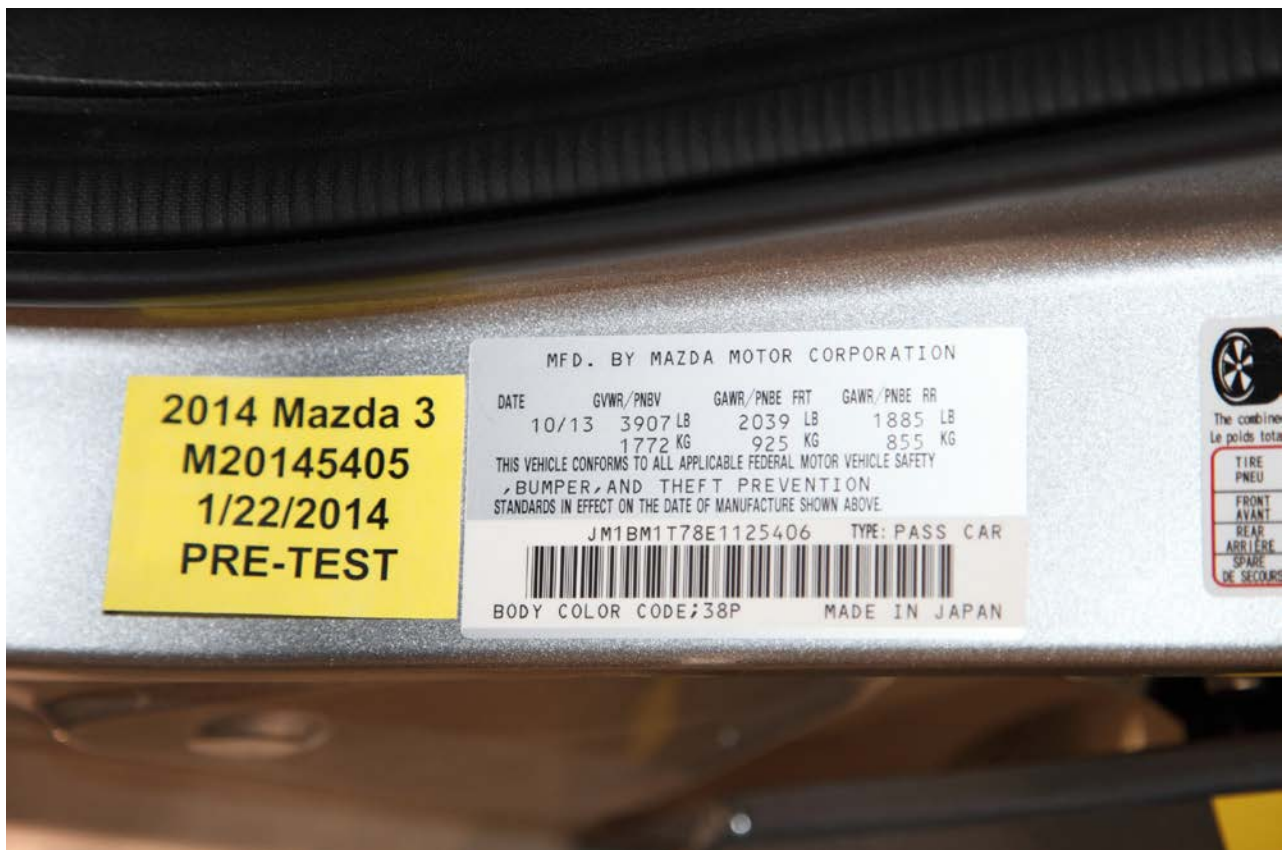
**Figure A-2 Vehicle Certification Label**

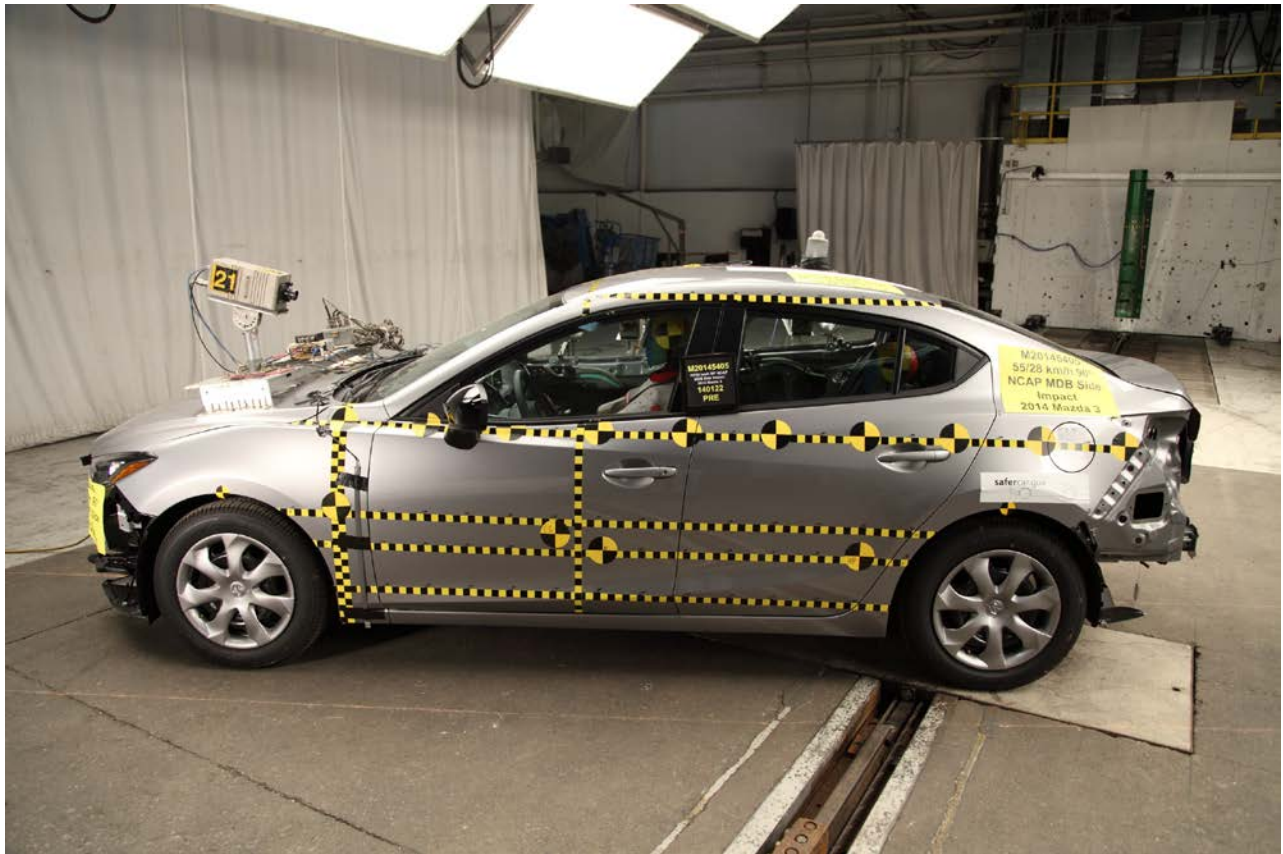
**Figure A-3 Pre-Crash Test Image From NCAP Vehicle**

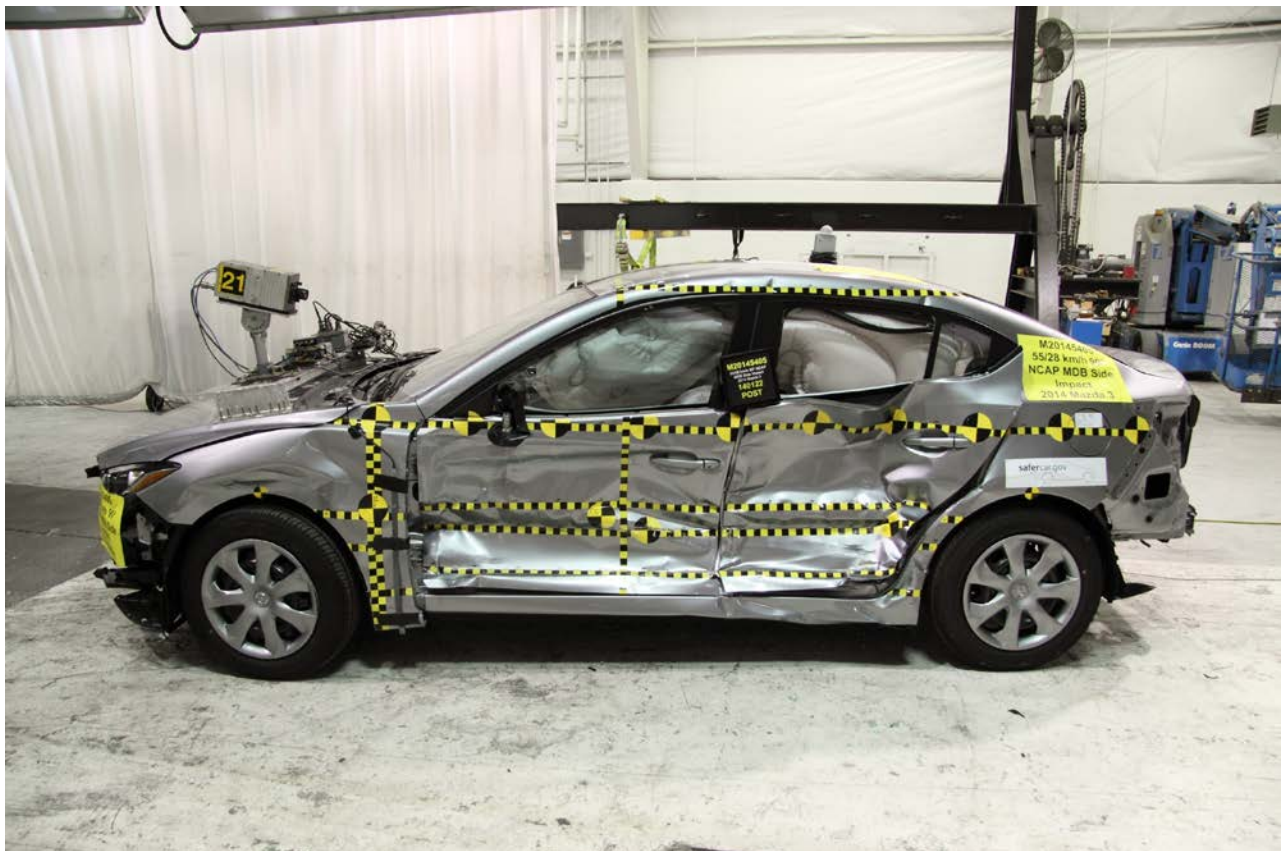
**Figure A-4 Post-Crash Test Image From NCAP Vehicle**

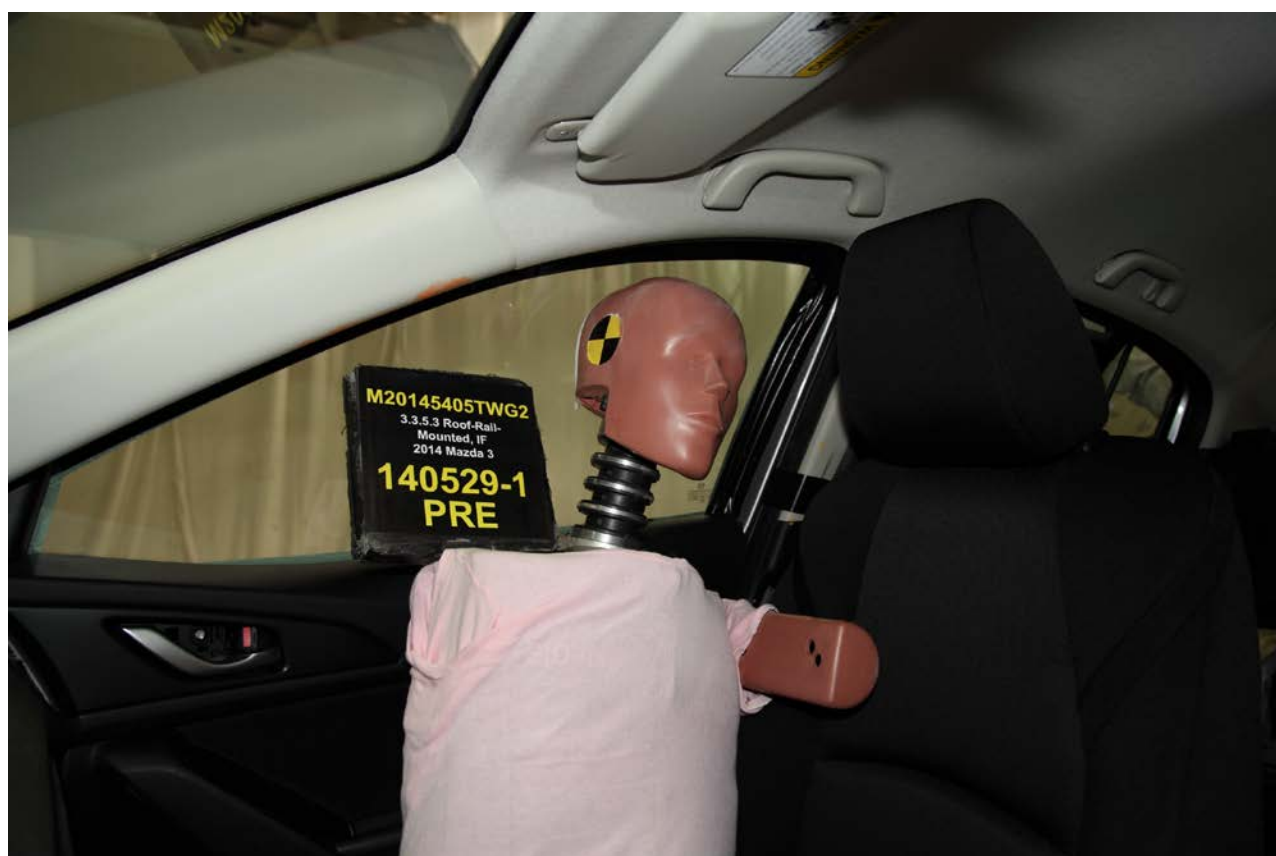
**Figure A-6 Pre-Test Front Right Dummy Position –  $\frac{3}{4}$  View**

The SID-IIs ATD was positioned in the seat dummy facing toward the center of the vehicle with its arm against the seatback. The arm was rotated horizontal in the forward direction with respect to the dummy. The seat was positioned to minimize the vertical distance between the dummy's head and the roof-rail module and to maximize the cushion to head interaction. The seat track test position measurements were not recorded. The head was in a neutral orientation and the pelvis was in contact with the door trim panel. The CG of the head was centered in the deployment trajectory of the airbag. A vertical plane through the centerline of the dummy's rib-stiffener and shoulder bolt was parallel to the centerline of the vehicle. This orientation complies with section 3.3.5.3 of the TWG Recommended Procedures for Evaluating Occupant Injury Risk from Deploying Side Airbags, First Revision dated July, 2003.

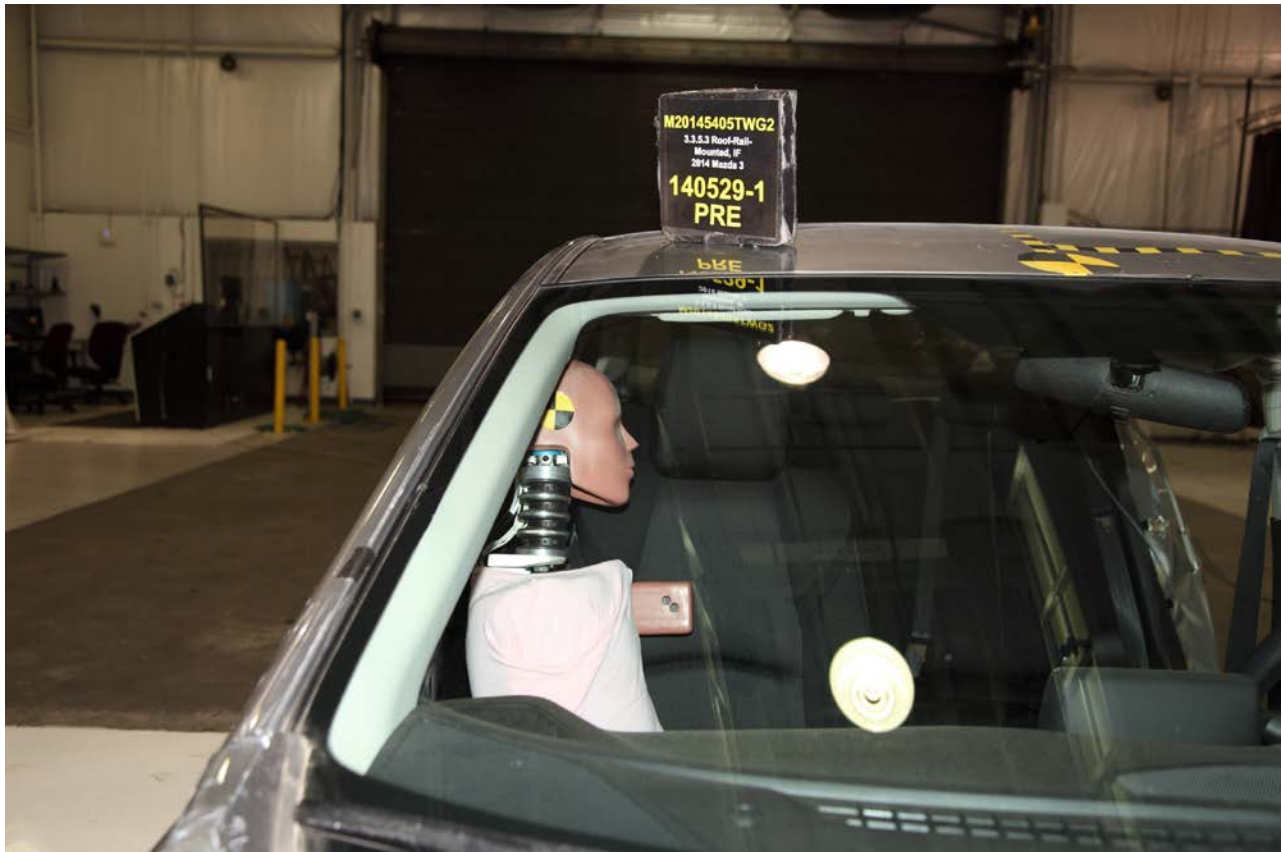
**Figure A-7 Pre-Test Front Right Dummy Position – Front View**

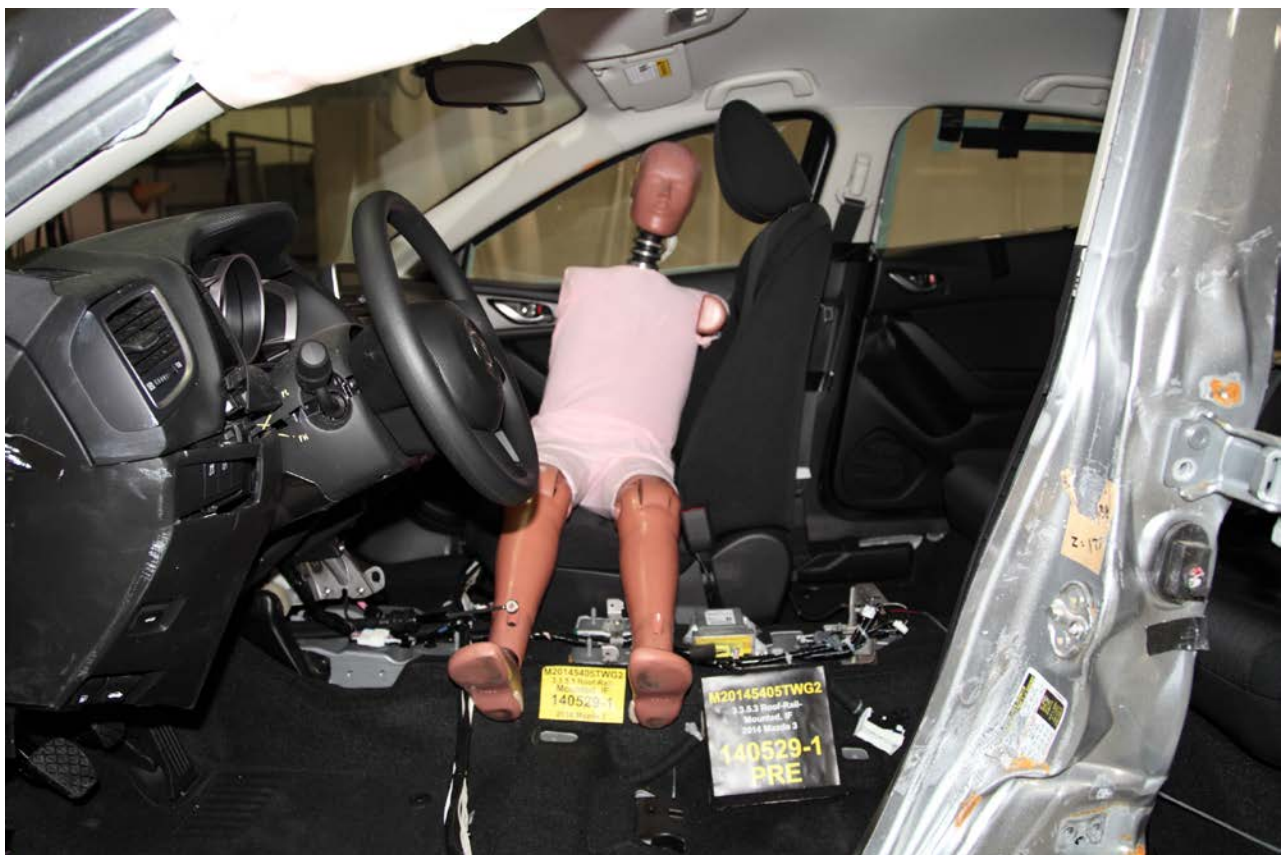
**Figure A-8 Pre-Test Front Right Dummy Positioning – Left Side View**

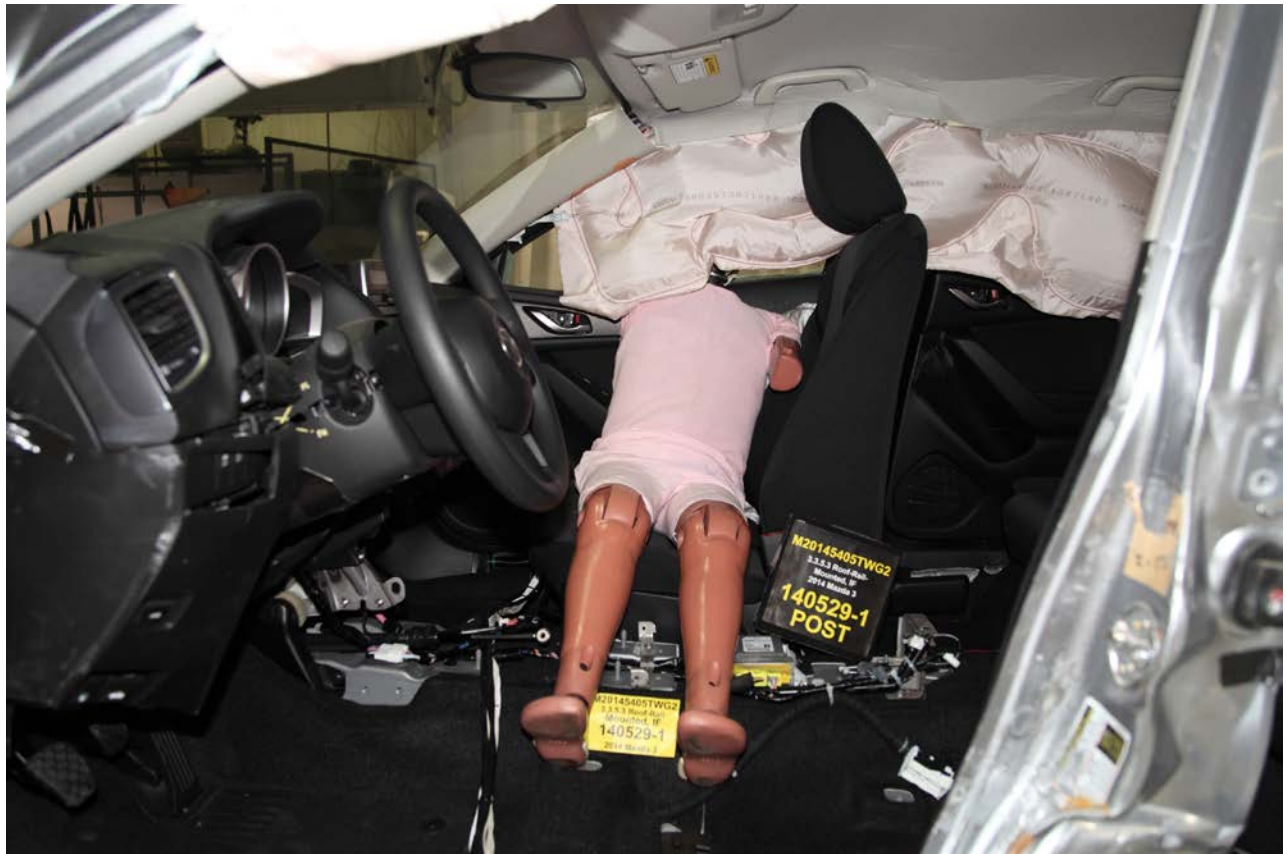
**Figure A-9 Post-Test Front Right Dummy Position – Left Side View**

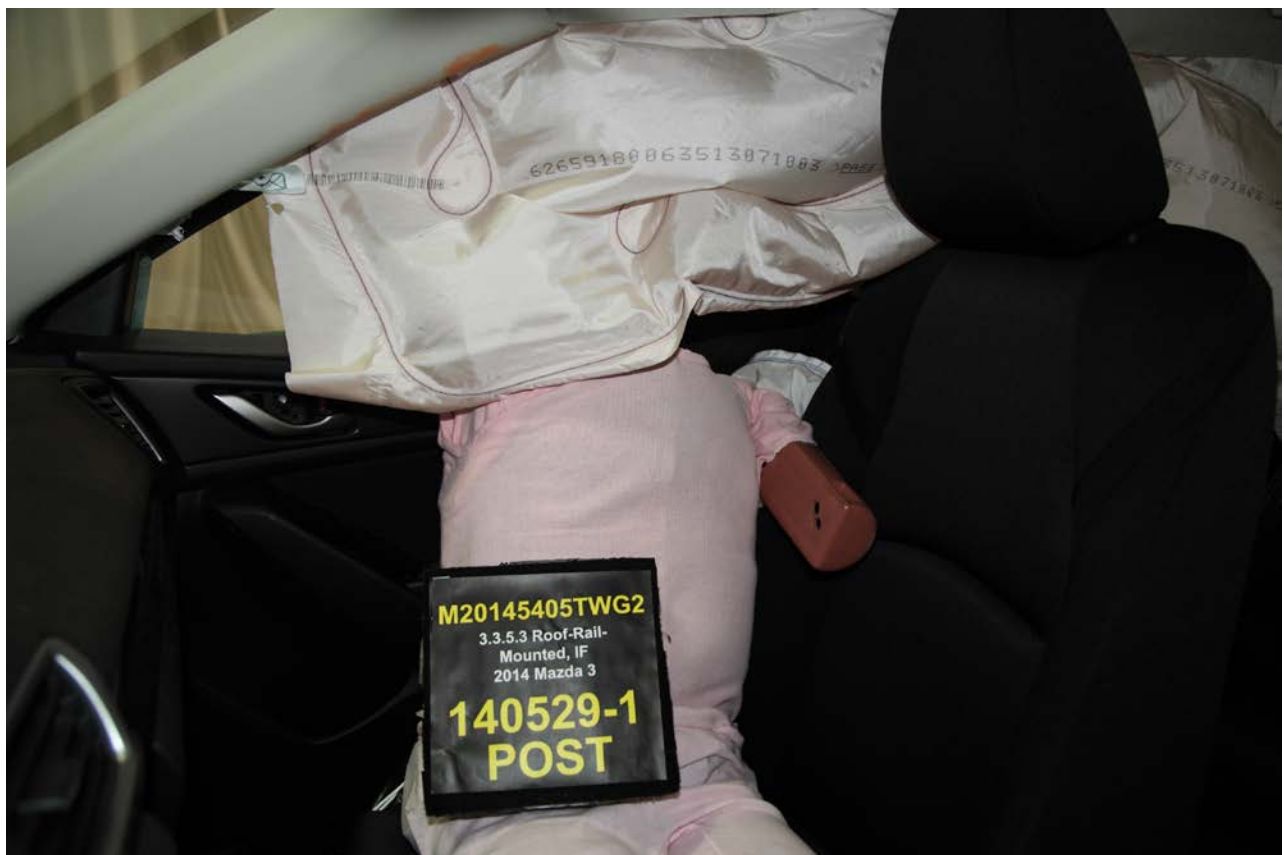
**Figure A-10 Post-Test Front Right Dummy Position – ¾ View**

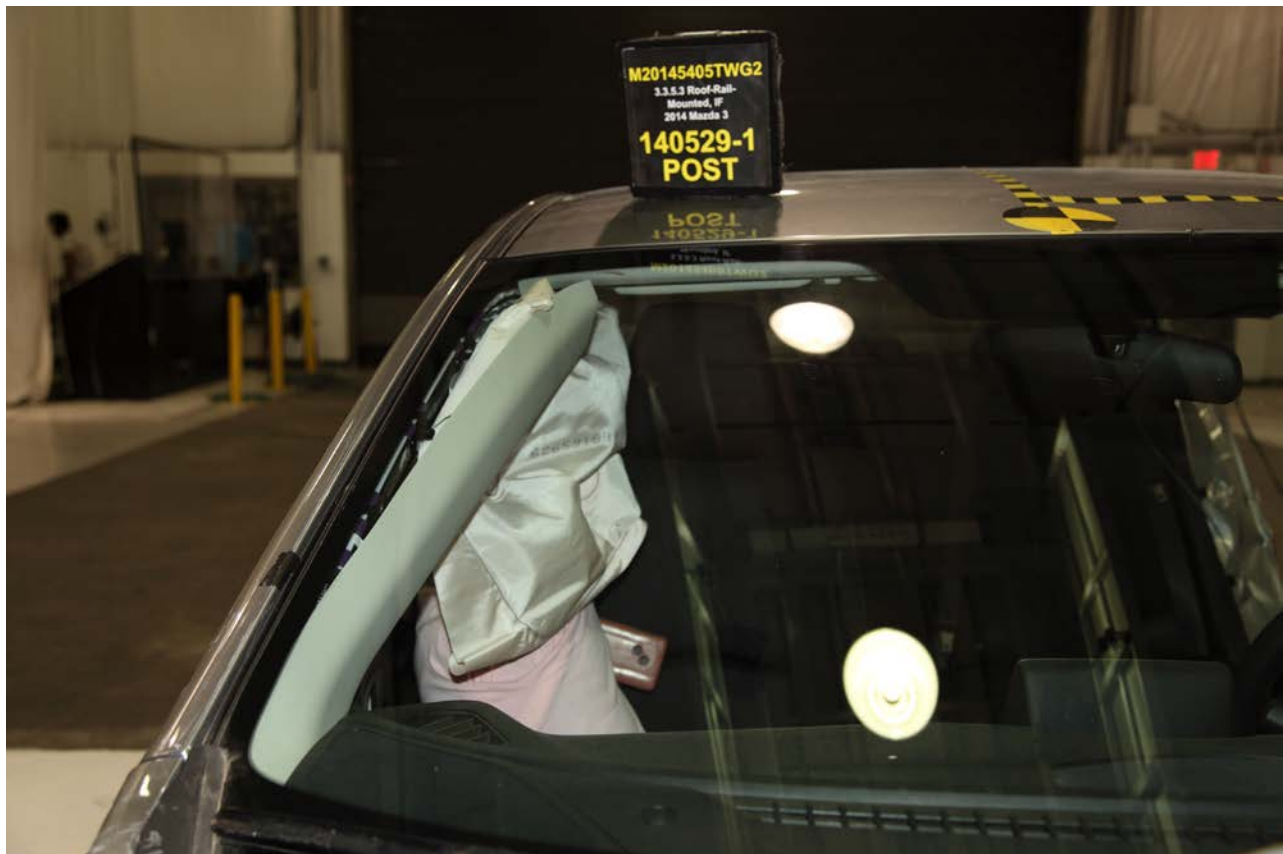
**Figure A-11 Post-Test Front Right Dummy Position – Front View**

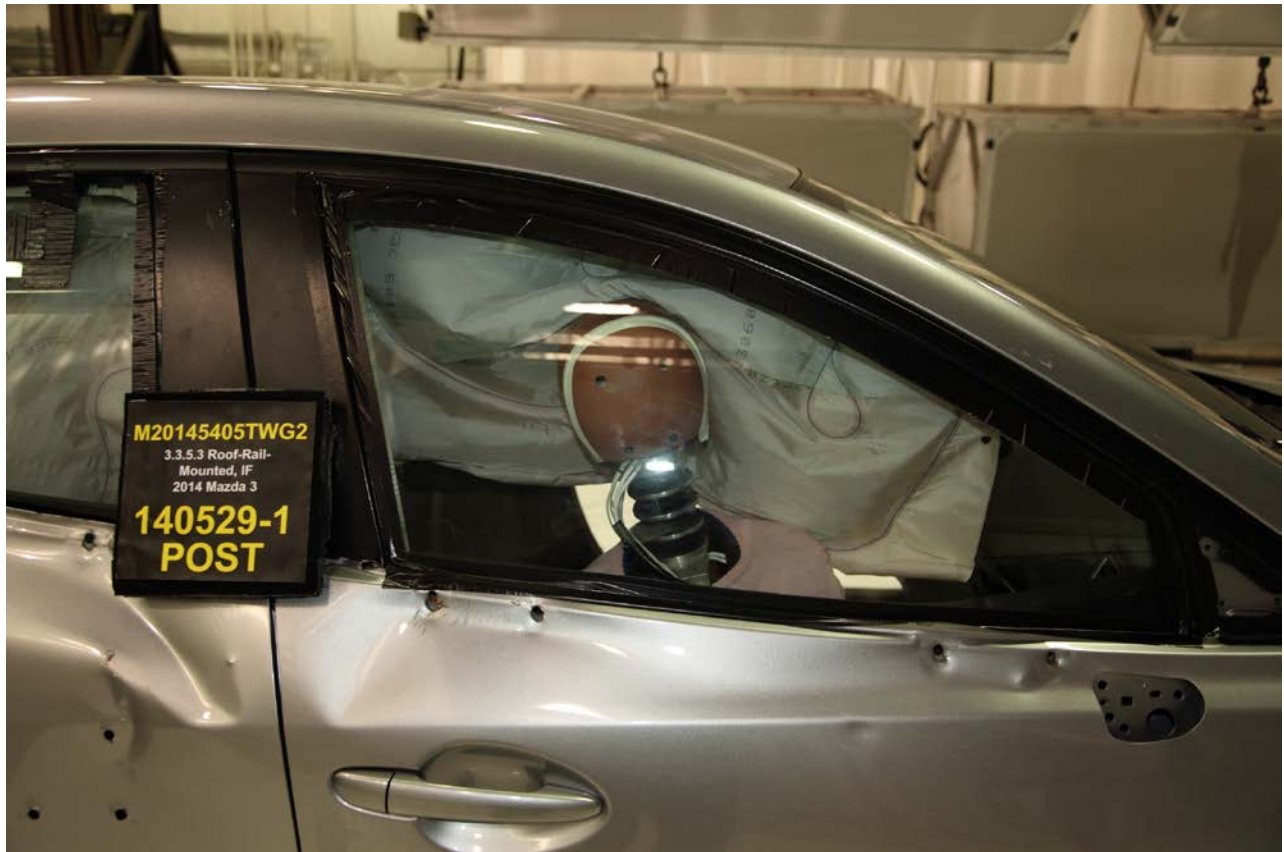
Figure A-13 Post-Test Front Passenger Door – Window View

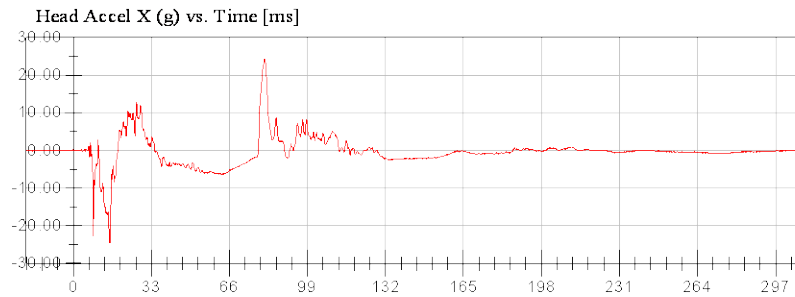
24.36 g at 80.80 ms

-24.74 g at 15.44 ms

| Channel | Max | Time (ms) | Min | Time (ms) |
|---|---|---|---|---|
| Head Ax [g , CFC_1000] | 24.4 | 80.8 | -24.7 | 15.4 |
