**REPORT NUMBER: SPNCAP-KAR-14-020**

**NEW CAR ASSESSMENT PROGRAM (NCAP)  
SIDE IMPACT POLE TEST**

**BAYERISCHE MOTOREN WERKE AG  
2014 MINI COOPER HARDTOP 3-DOOR HATCHBACK**

**FINAL REPORT**

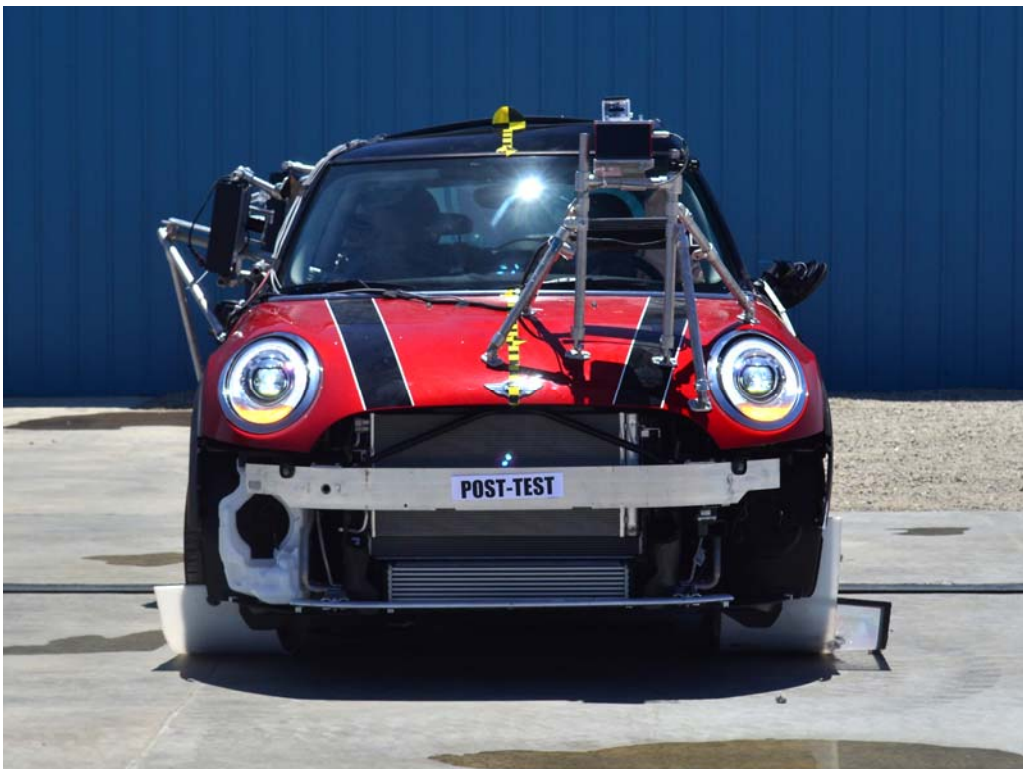
FIGURE 4. Post-Test Frontal View of Test Vehicle

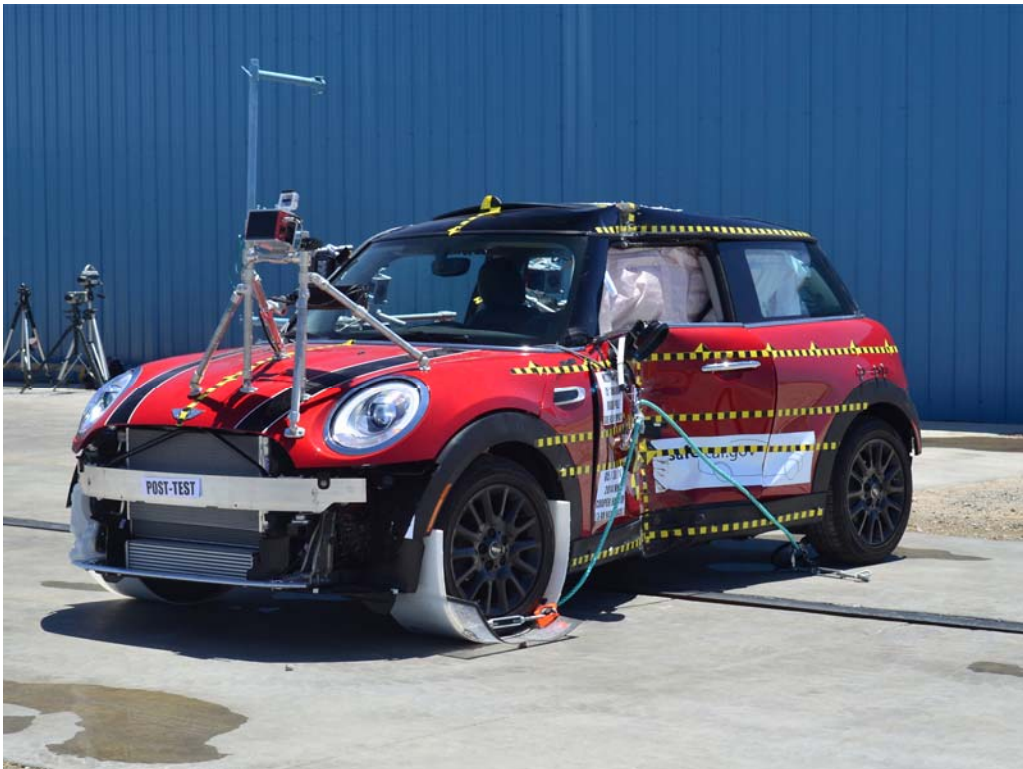
FIGURE 6. Post-Test Left Front  $\frac{3}{4}$  View of Test Vehicle

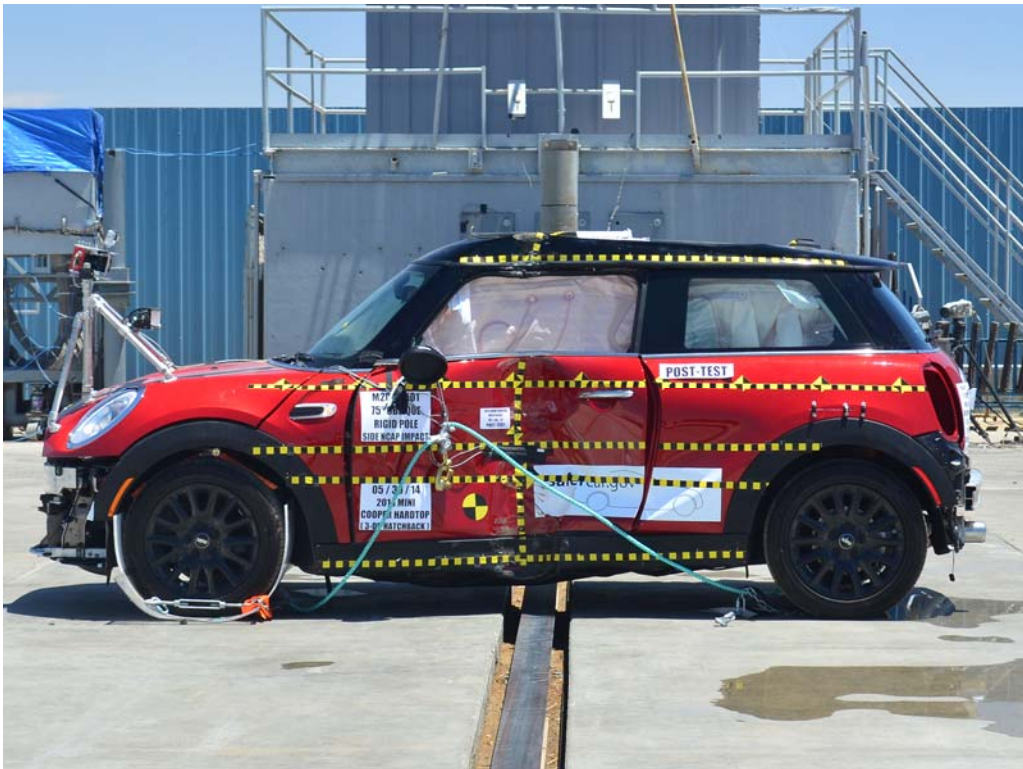
FIGURE 8. Post-Test Left Side View of Test Vehicle

| Critical Areas of Performance | Observations and Conclusions |
|---|---|
| Side Window Damage | Left front window broken |

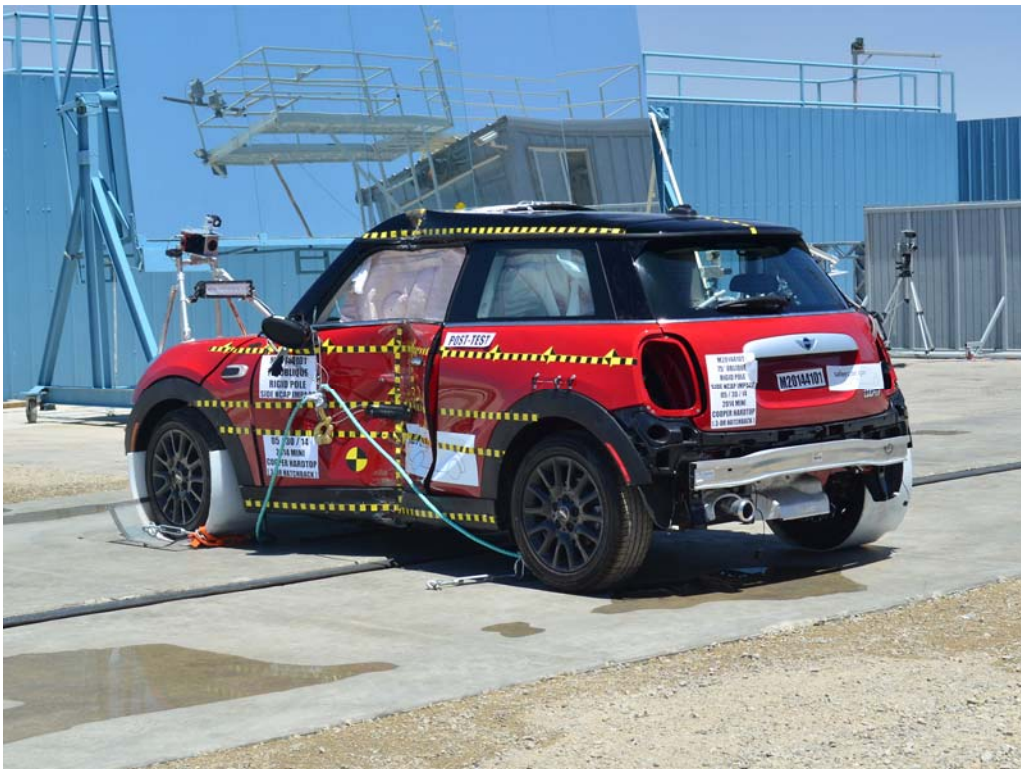
FIGURE 10. Post-Test Left Rear  $\frac{3}{4}$  View of Test Vehicle

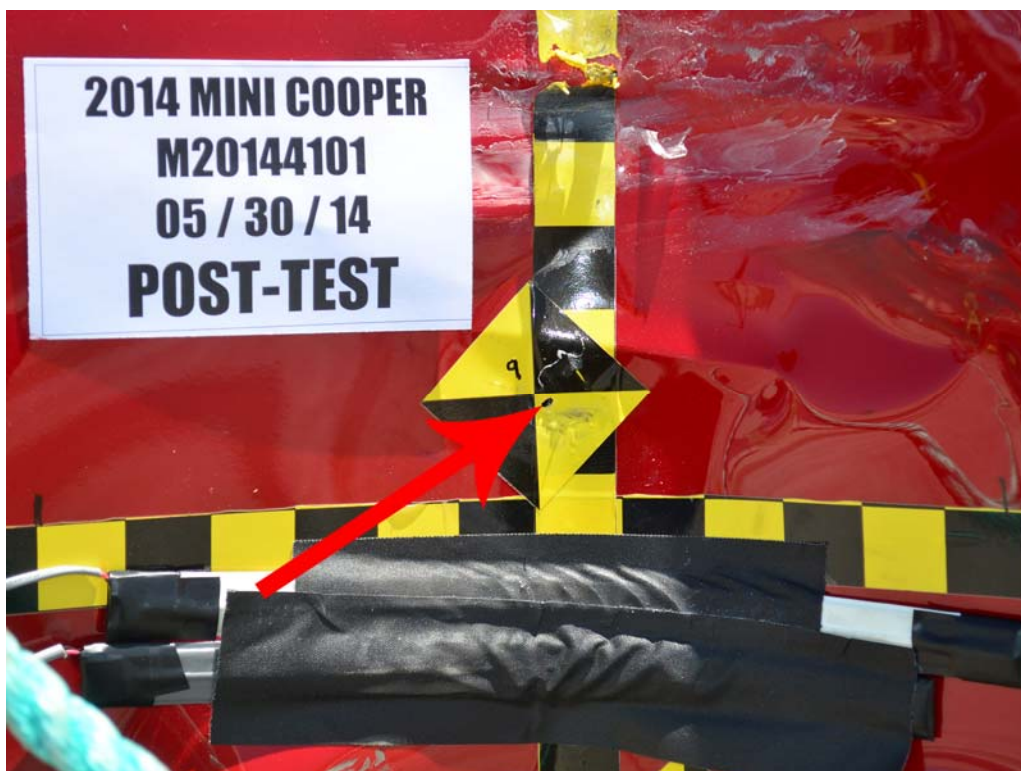
FIGURE 20. Post-Test Close-Up View of Impact Point Target  
Showing Impact Location

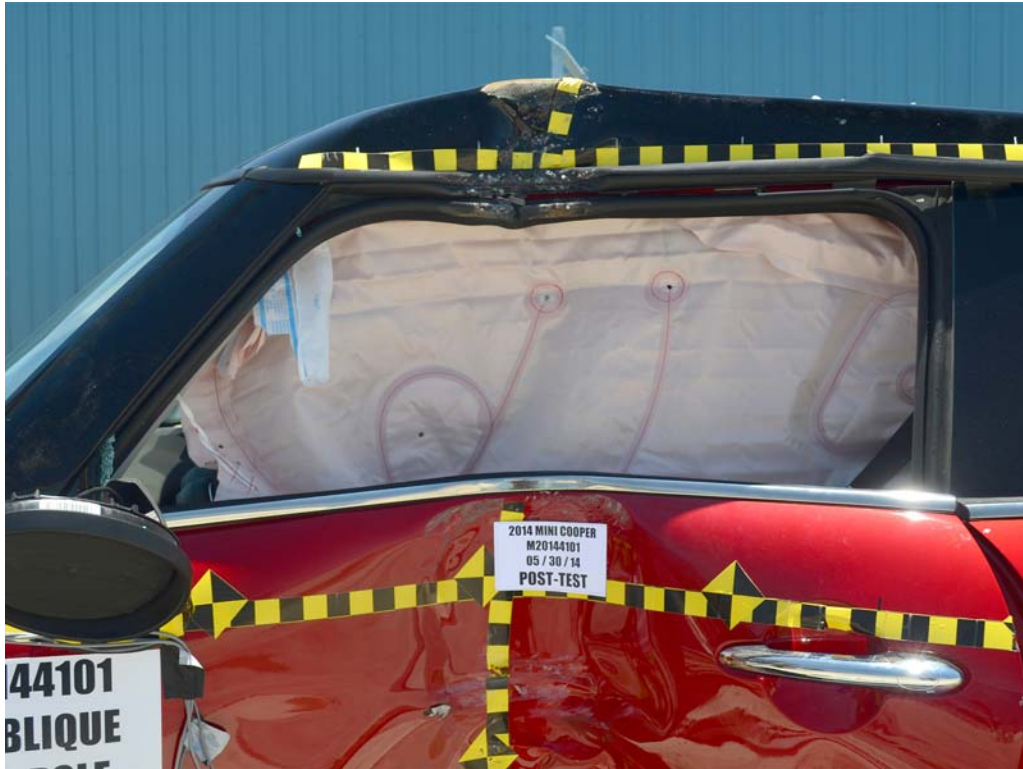
FIGURE 25. Post-Test Left Side View of Dummy Shoulder and Door Top View

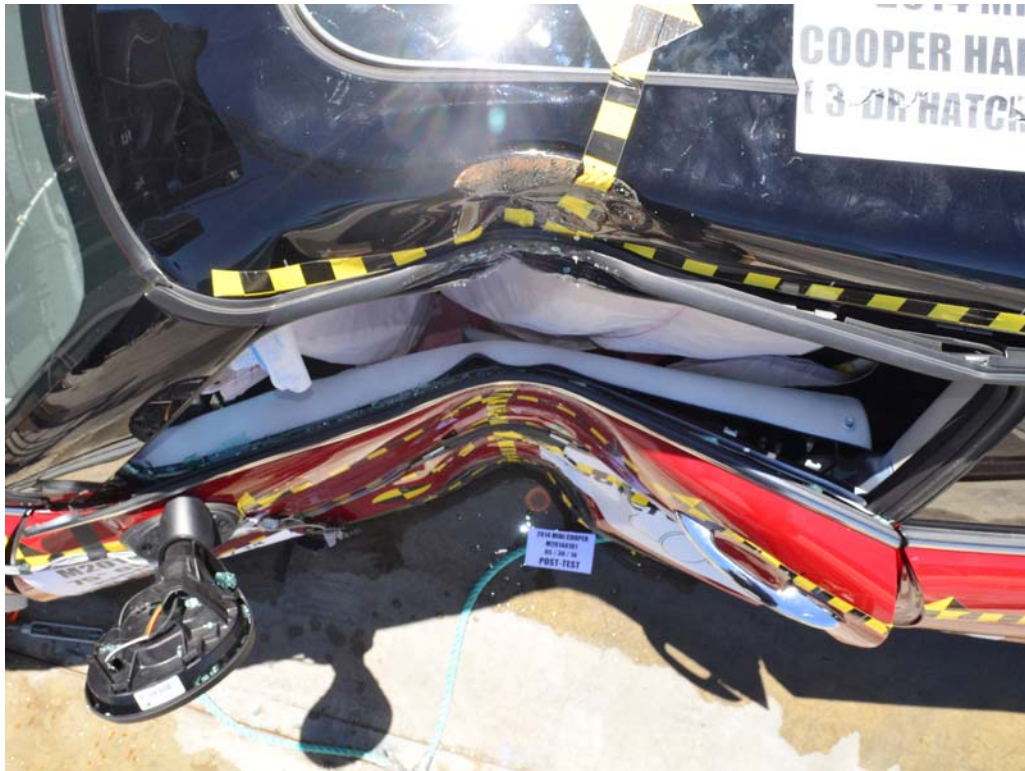
FIGURE 41. Post-Test Dummy and Door Clearance View

The door on the struck side of the vehicle remained closed and latched. There was no separation at the hinges or latch. The door on the non-struck side remained closed and latched. There were no ATD values that exceeded limits.

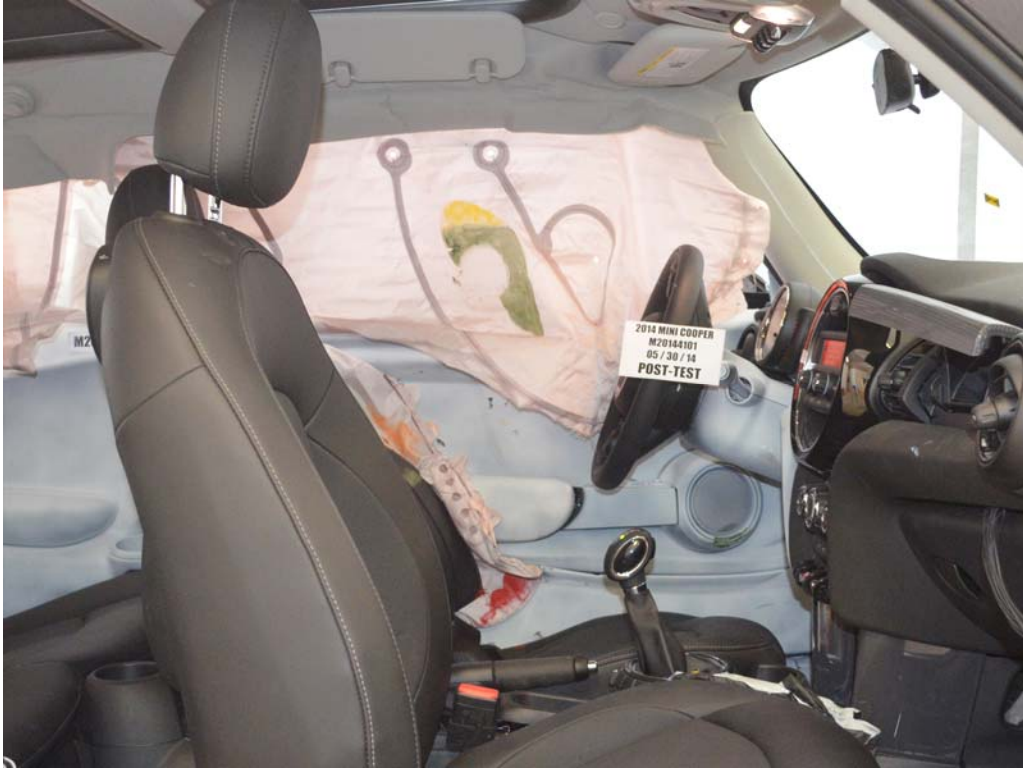
FIGURE 45. Post-Test Inner Door Panel View  
Showing Dummy Contact Locations

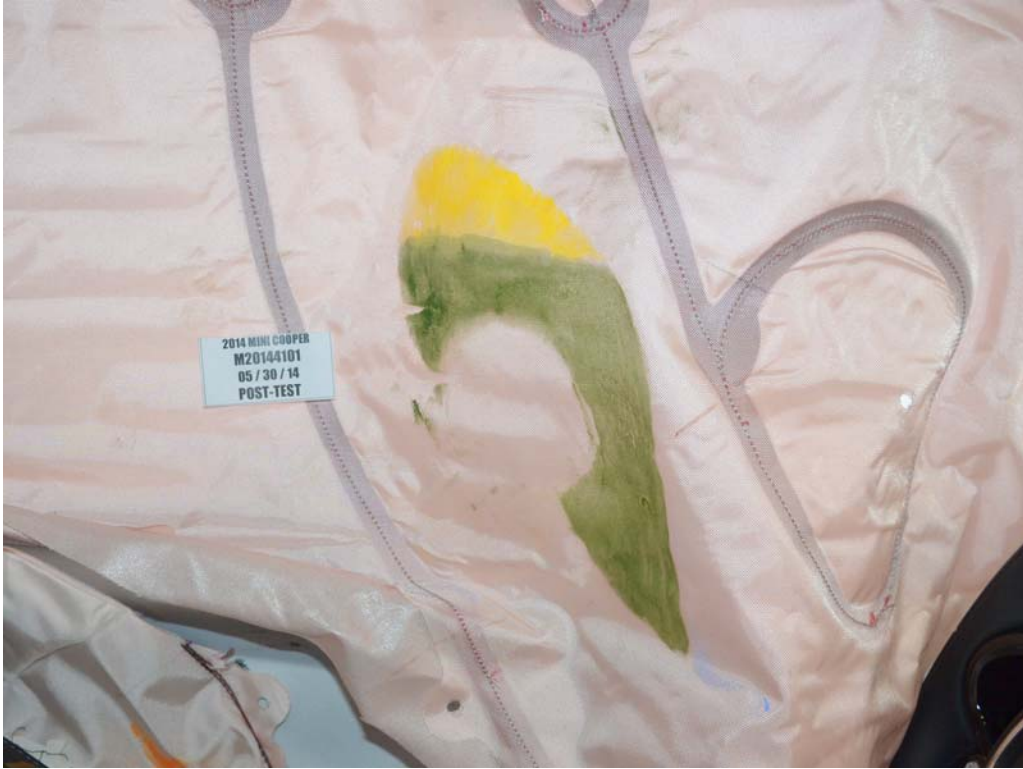
FIGURE 47. Post-Test Dummy Close-Up Head Contact With Side Airbag View

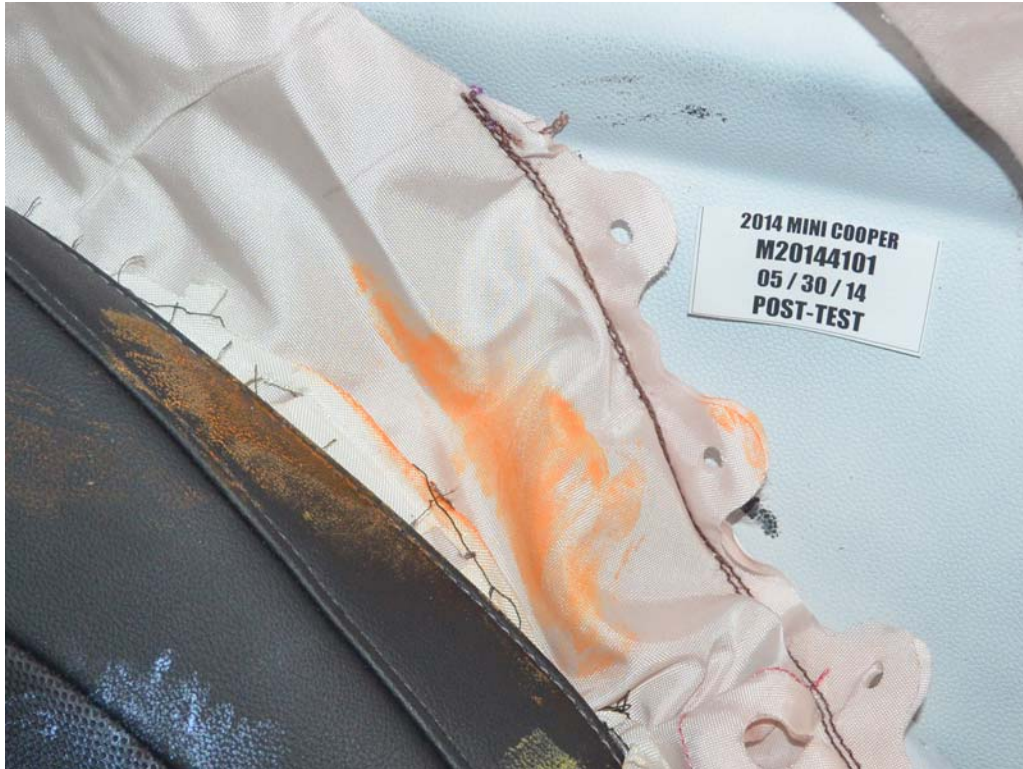
FIGURE 49. Post-Test Dummy Close-Up Torso Contact With Side Airbag View

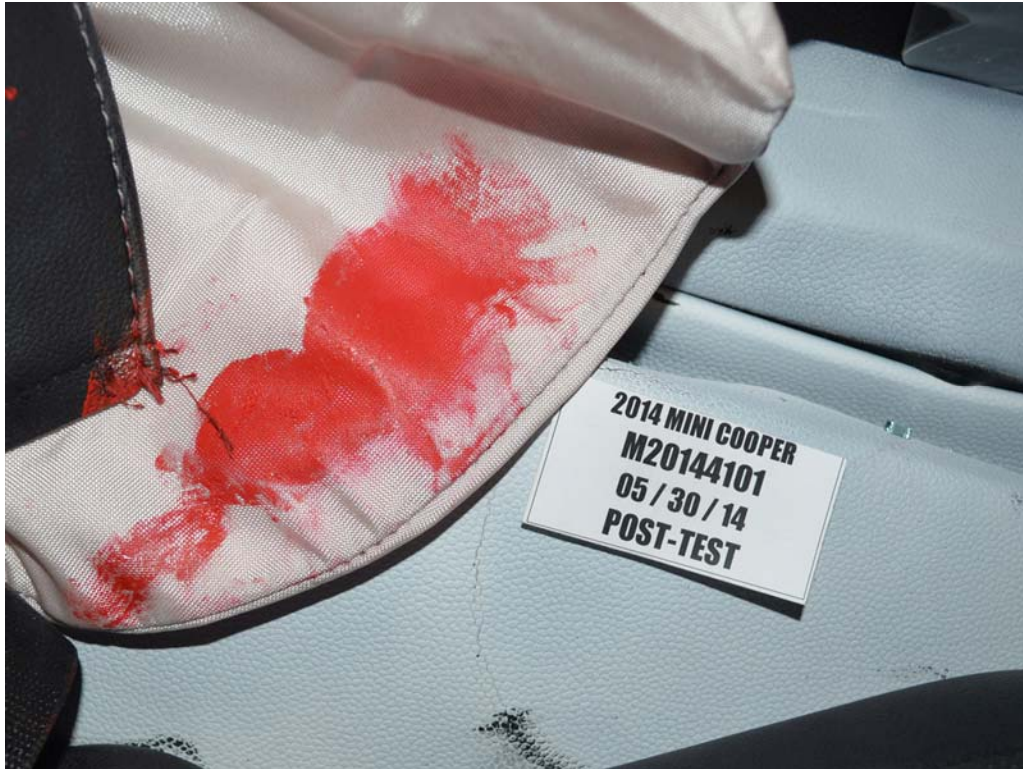
FIGURE 51. Post-Test Dummy Close-Up Pelvis Contact With Side Airbag View

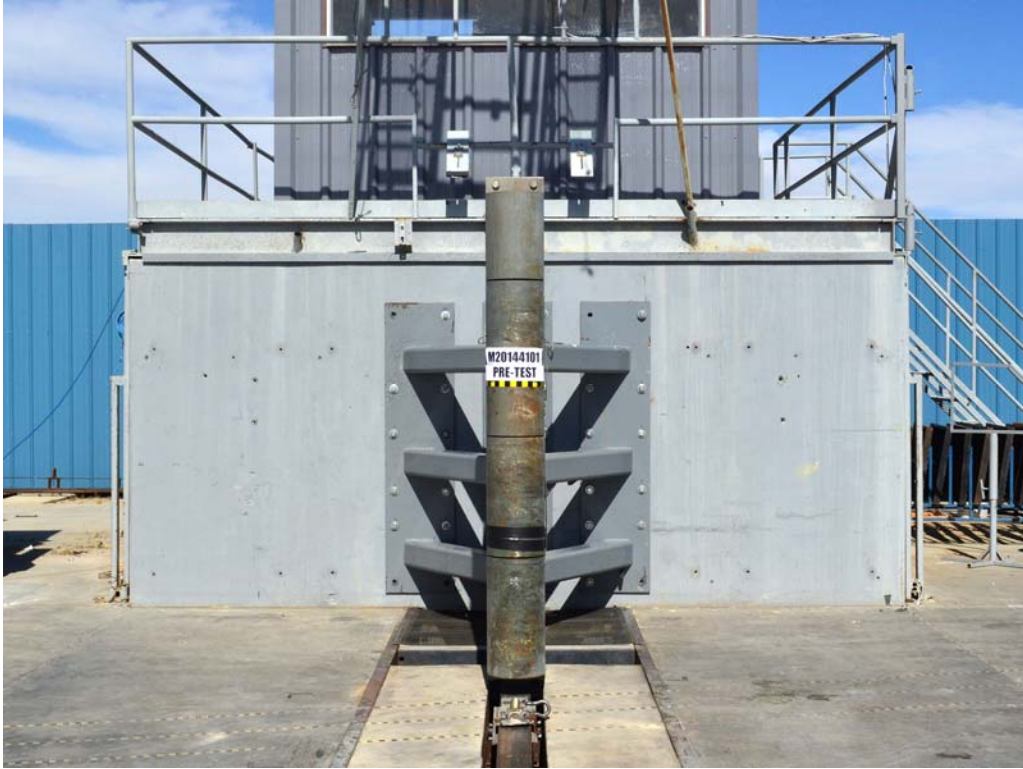
FIGURE 57. Pre-Test Pole Barrier Front View

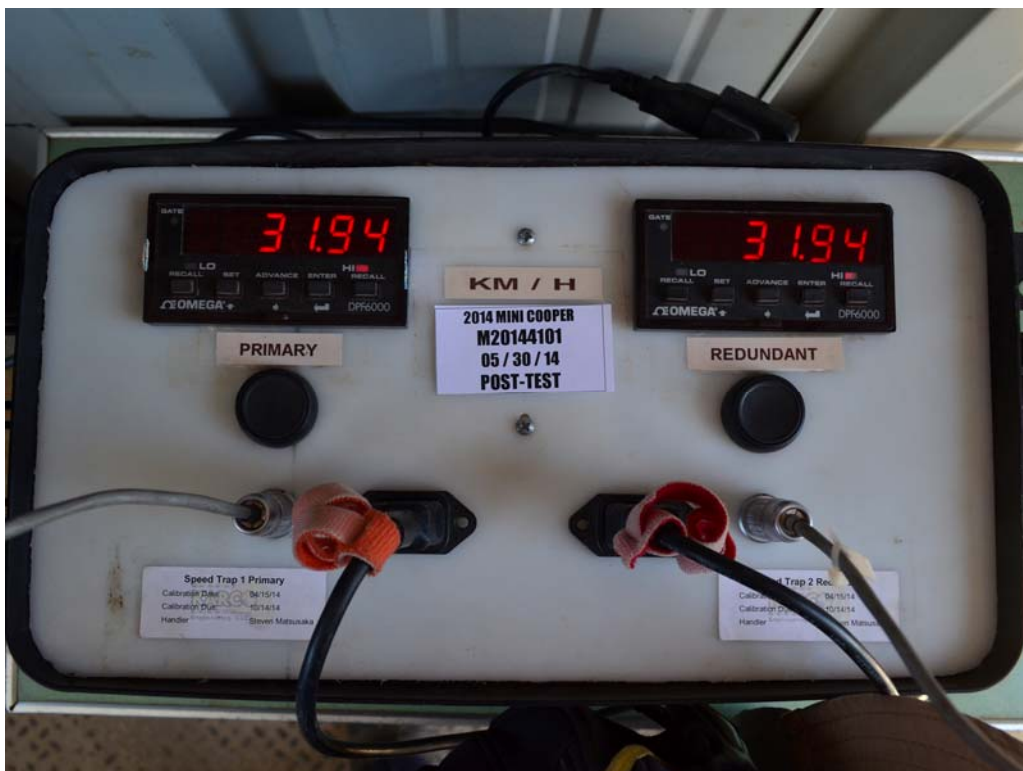
FIGURE 62. Post-Test Primary and Redundant Speed Trap Read-Out

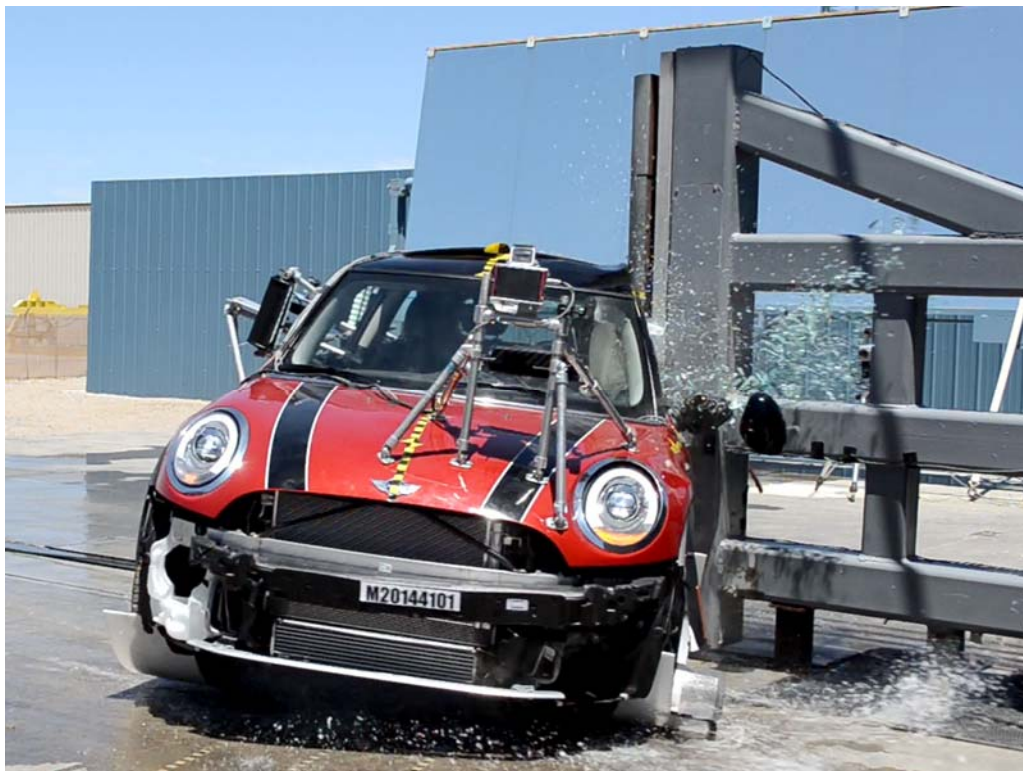
FIGURE 68. Impact Event

A rigid pole side impact test was conducted on a 2014 Mini Cooper Hardtop 3-door hatchback. The subject vehicle was towed into the rigid pole at an angle of 74.9° and a velocity of 31.94 km/h. The test was conducted by KARCO Engineering, LLC. in Adelanto, California on May 30, 2014. Pre- and post-test photographs of the test vehicle and side impact dummy (SID-IIs) are included in Appendix A of this report.
