**REPORT NUMBER: NCAP-MGA-2015-002**

**NEW CAR ASSESSMENT PROGRAM (NCAP)  
Frontal Barrier Impact Test**

**HYUNDAI MOTOR COMPANY  
2015 Hyundai Genesis AWD 4-Dr Sedan  
NHTSA No.: O20154200**

**MGA RESEARCH CORPORATION  
5000 Warren Road  
Burlington, WI 53105**

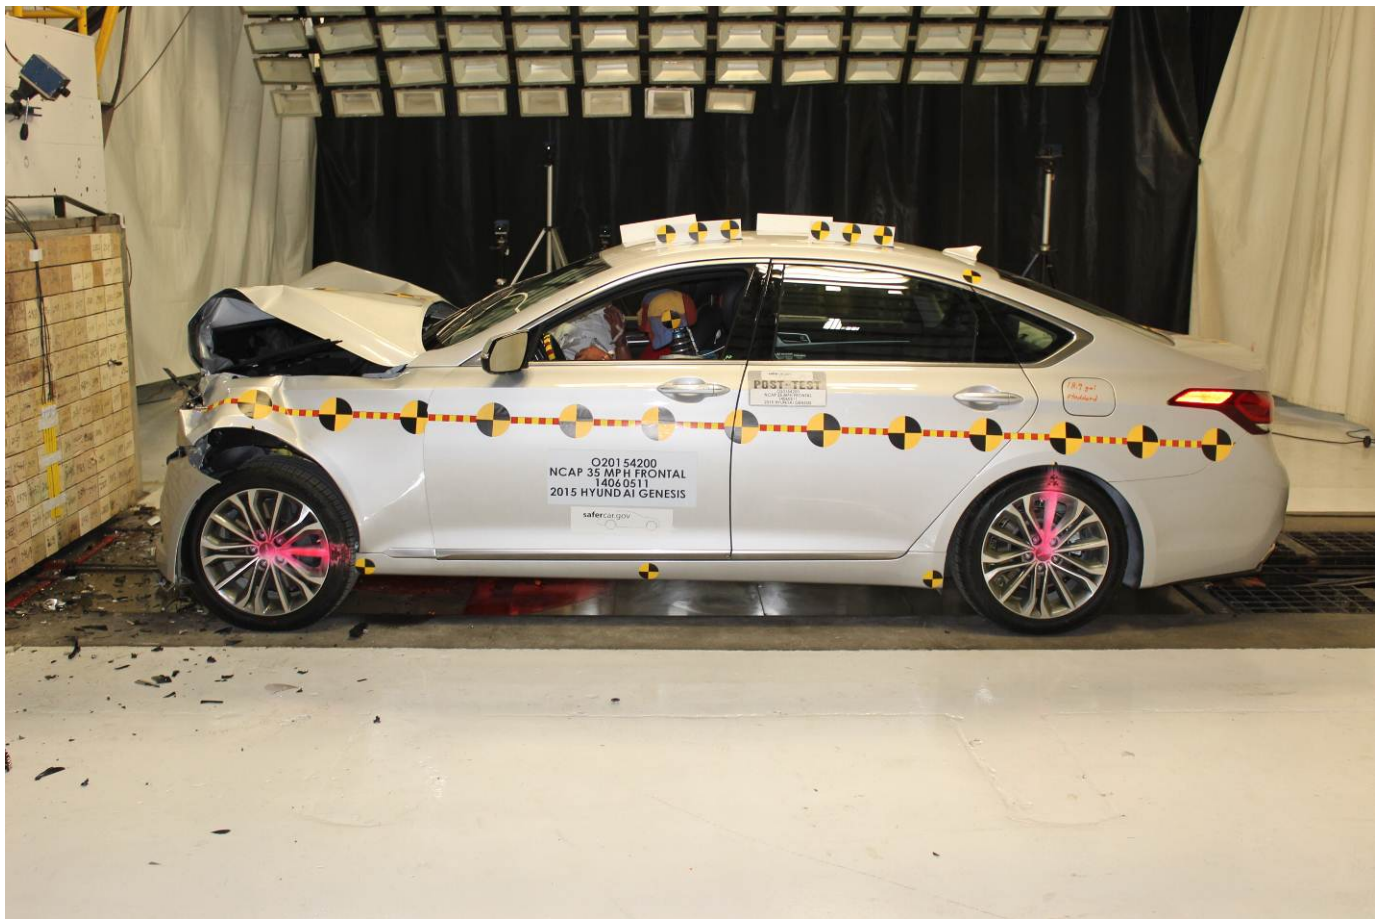
Post-Test Left View of Test Vehicle

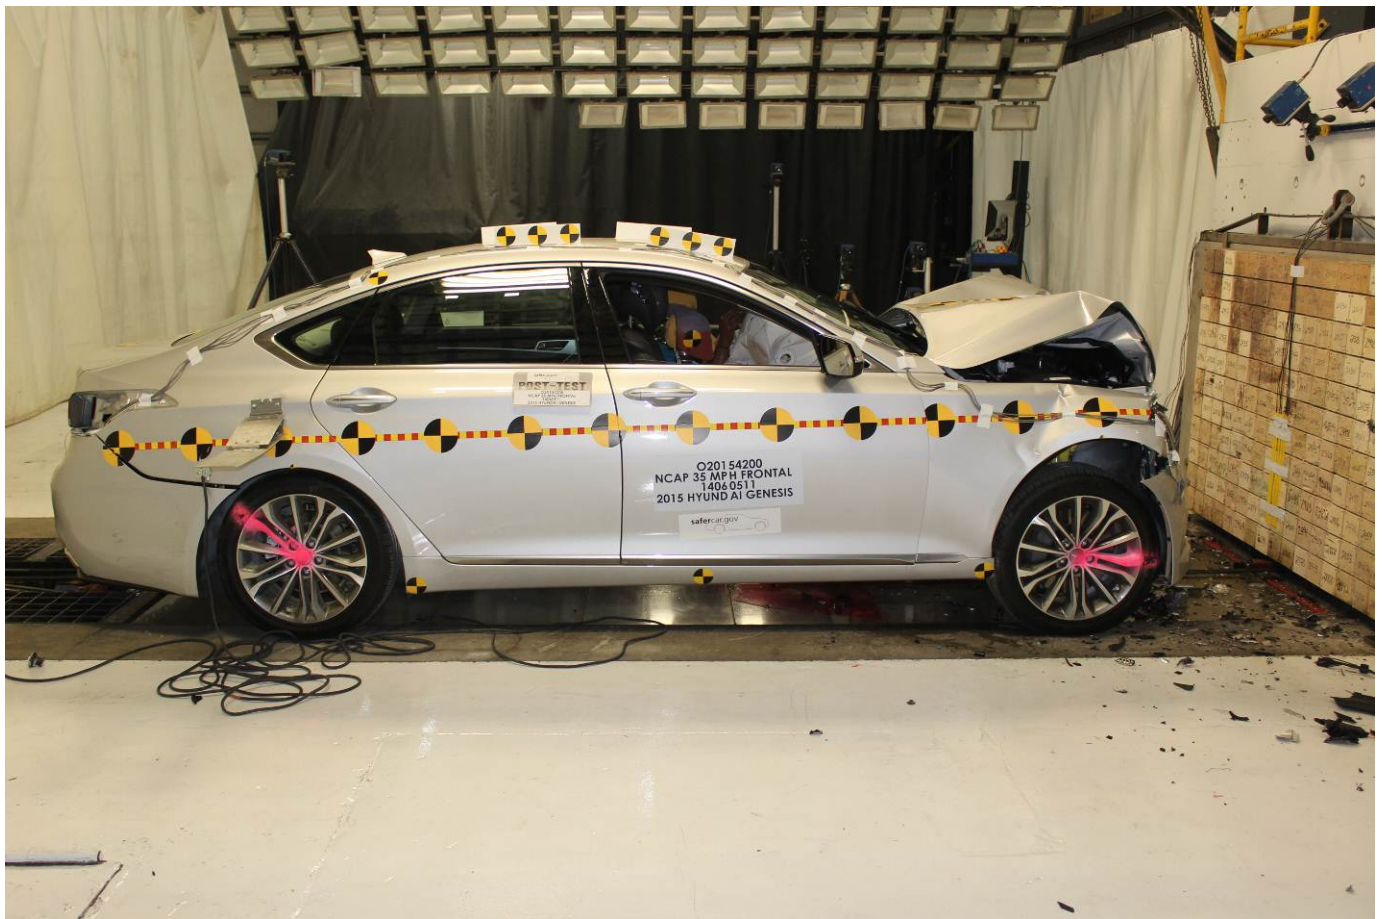
Post-Test Right View of Test Vehicle

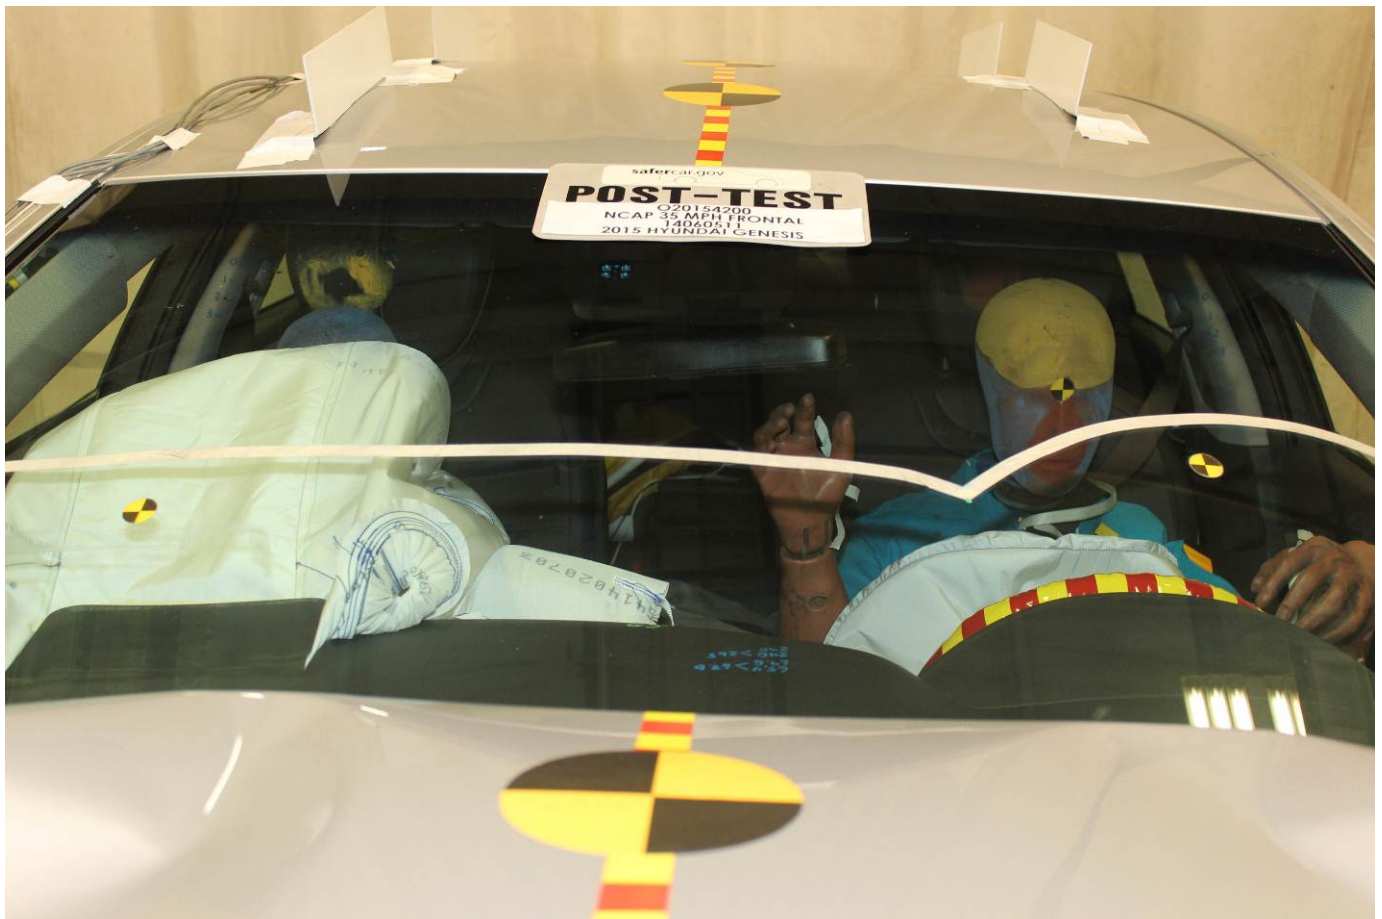
Post-Test Windshield View

There was 100 percent windshield retention and no intrusion into the protected zone of the windshield during the event. There was no Stoddard Solvent leakage after the event or during any phase of the static rollover.

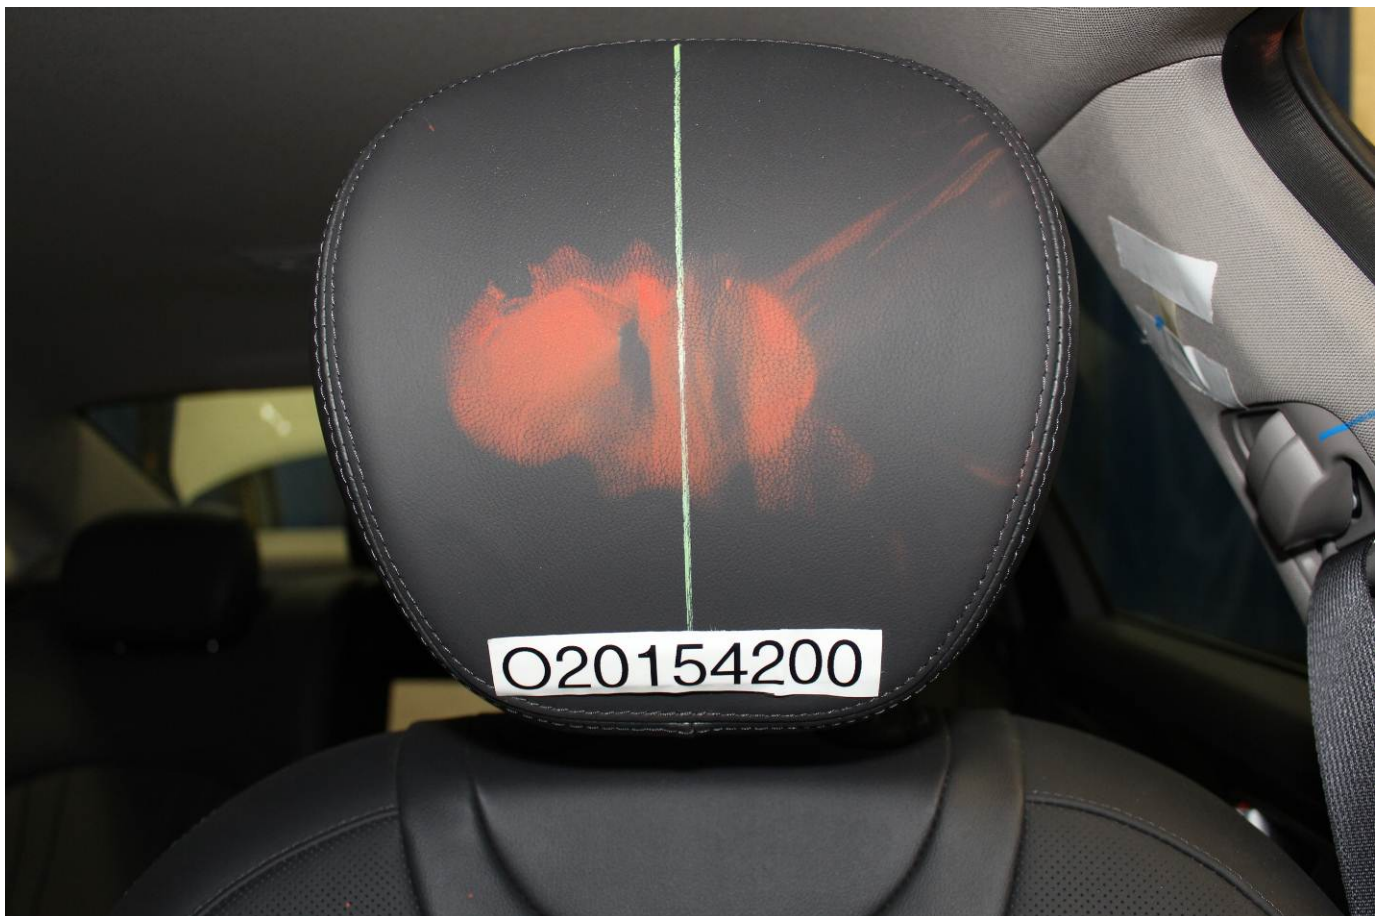
Post-Test Driver Dummy Contact with Headrest

The driver's visible contact points were as follows: The driver's head and chest contacted the airbag. The driver's head also contacted the headrest. The driver's knees contacted the knee airbag. The passenger's visible contact points were as follows: The passenger's head and chest contacted the airbag. The passenger's head also contacted the headrest. The passenger's knees contacted the glovebox.

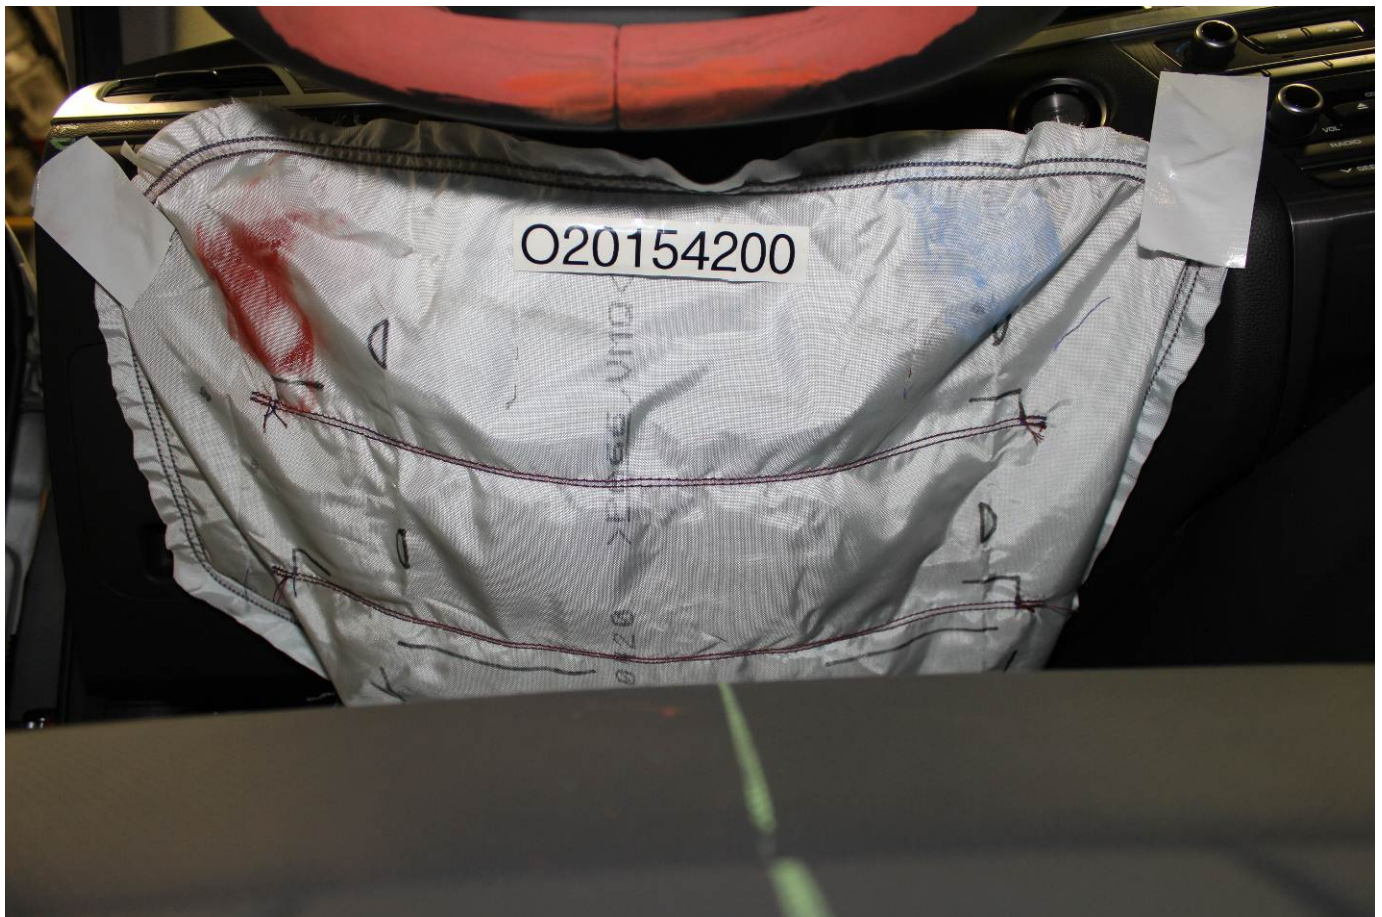
Post-Test Driver Dummy Contact with Knee Airbag

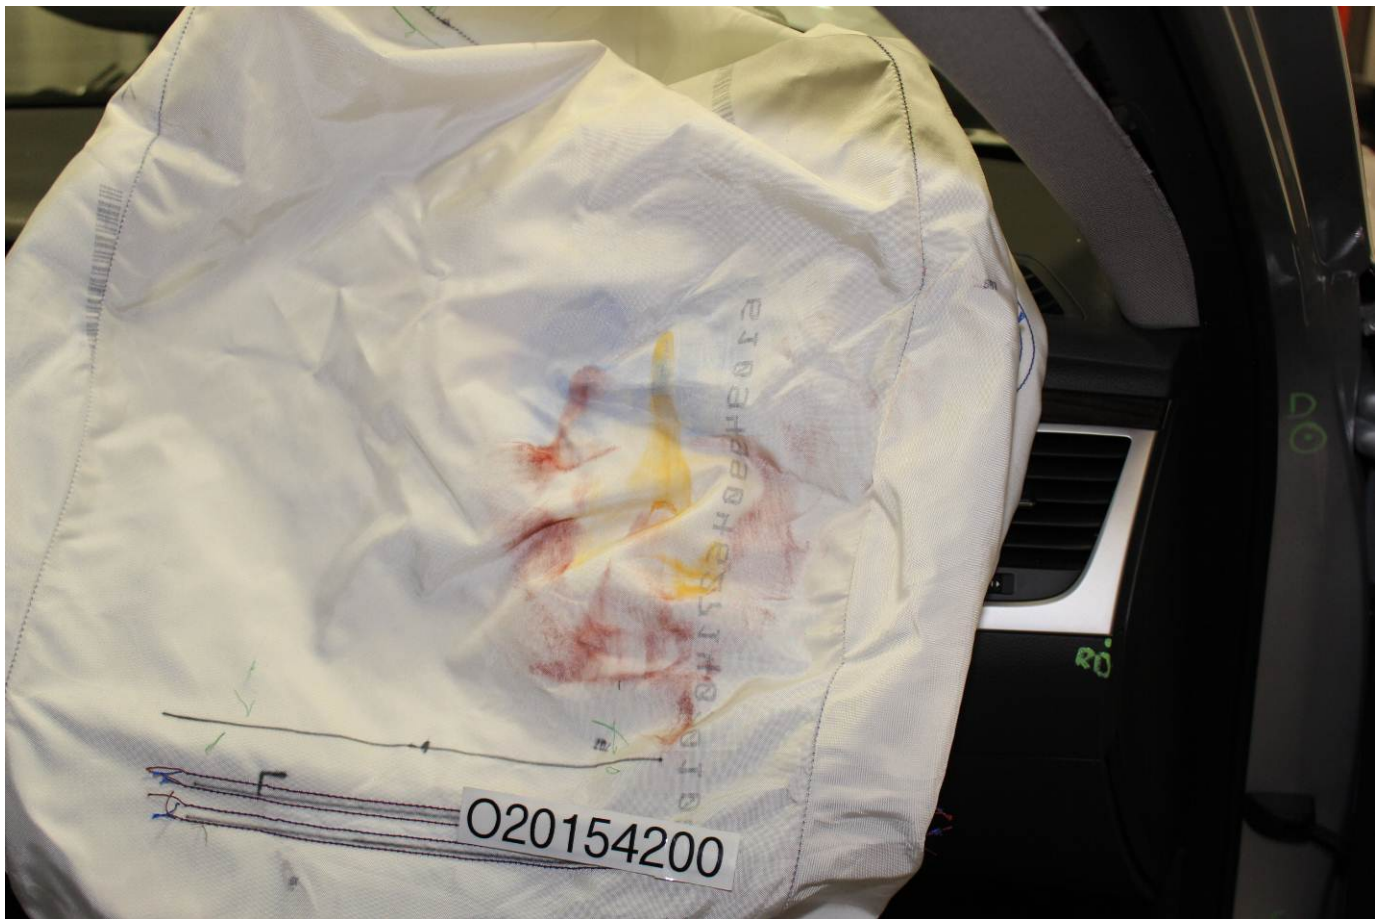
Post-Test Passenger Dummy Contact with Airbag

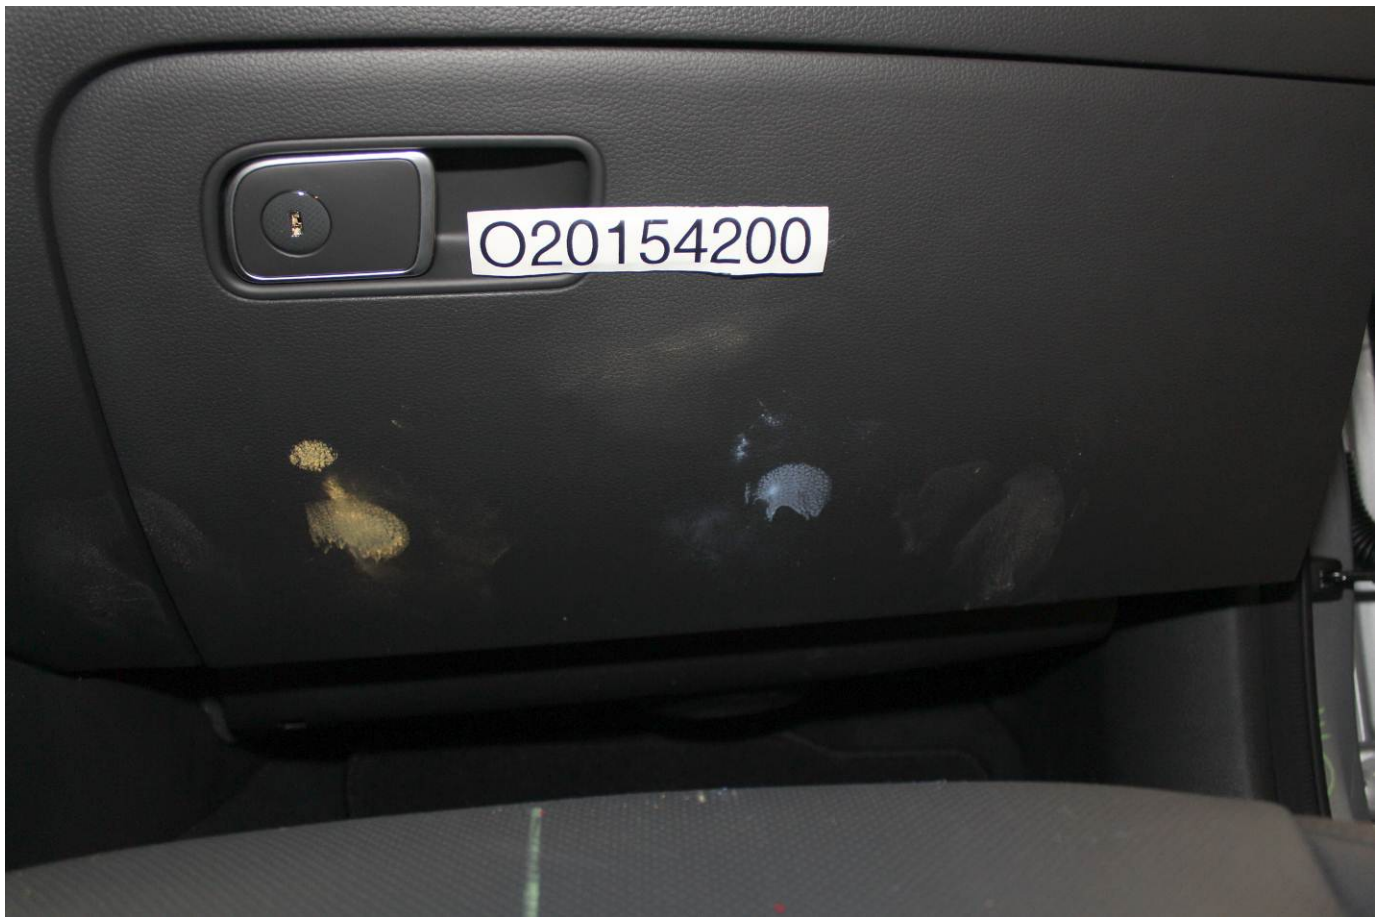
Post-Test Passenger Dummy Contact with Glovebox

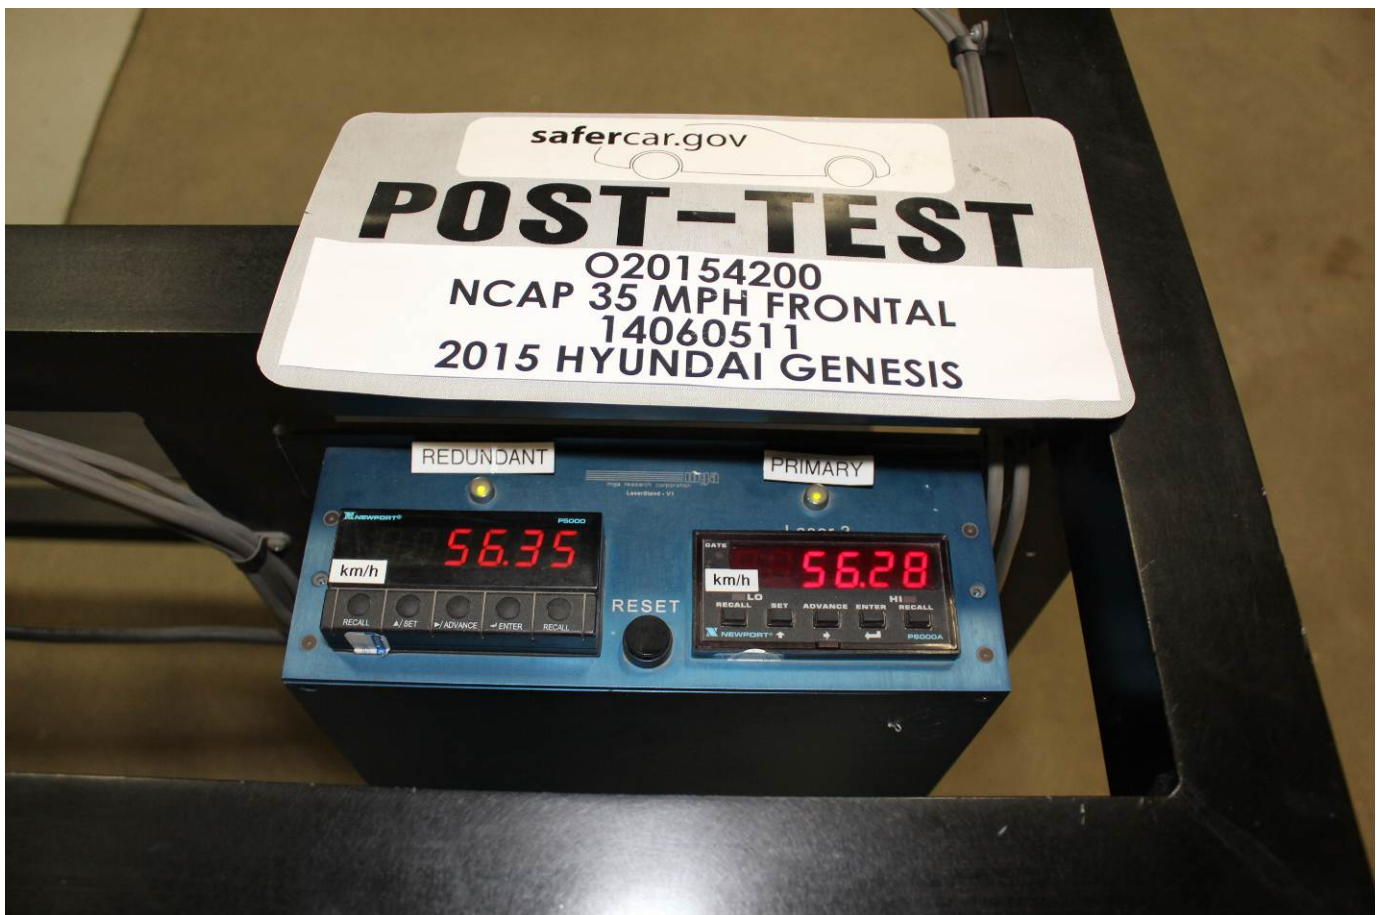
Post-Test Speed Trap Read-Out

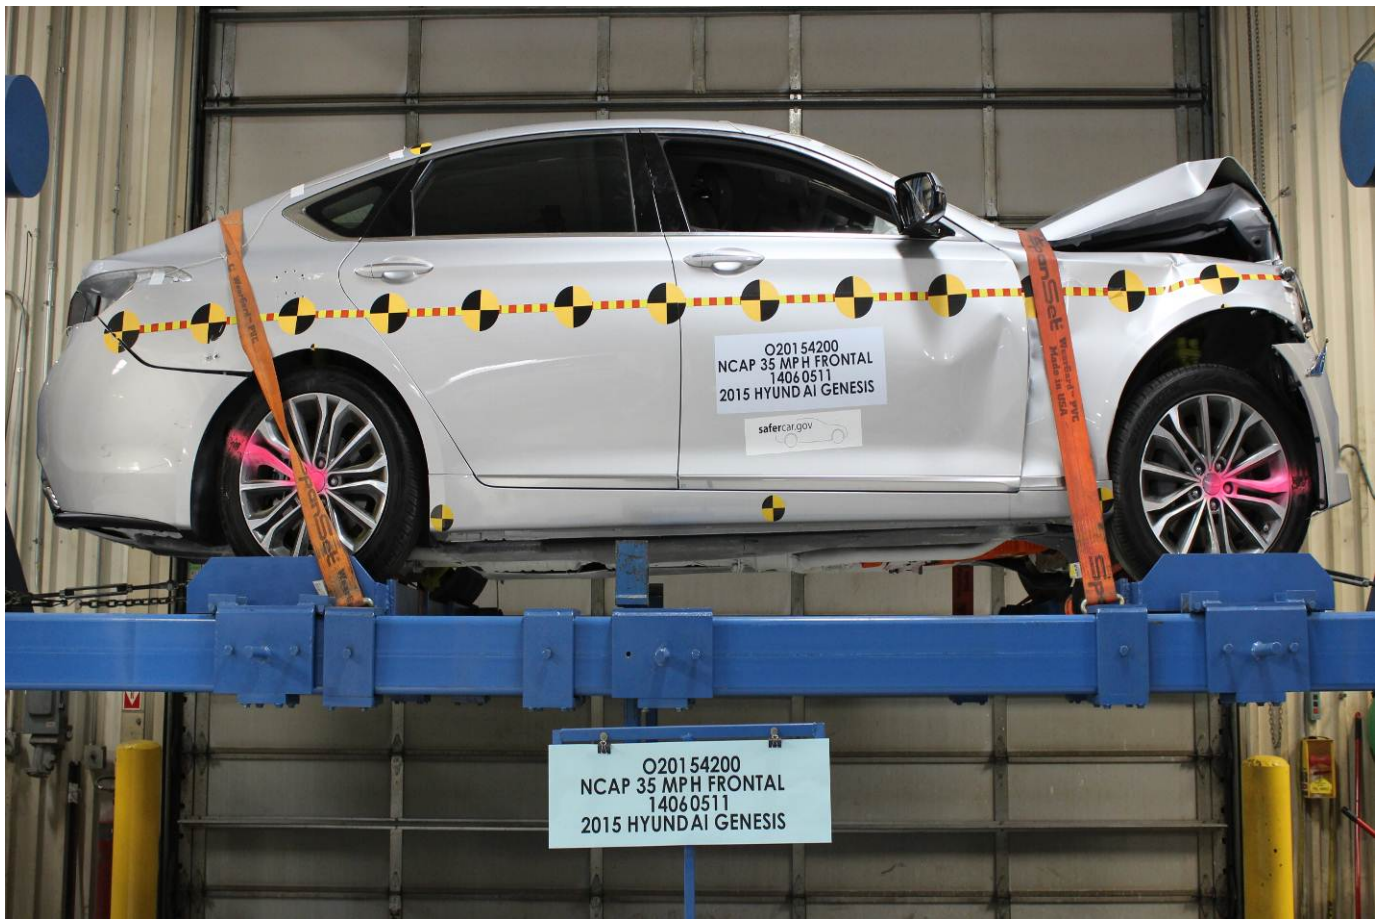
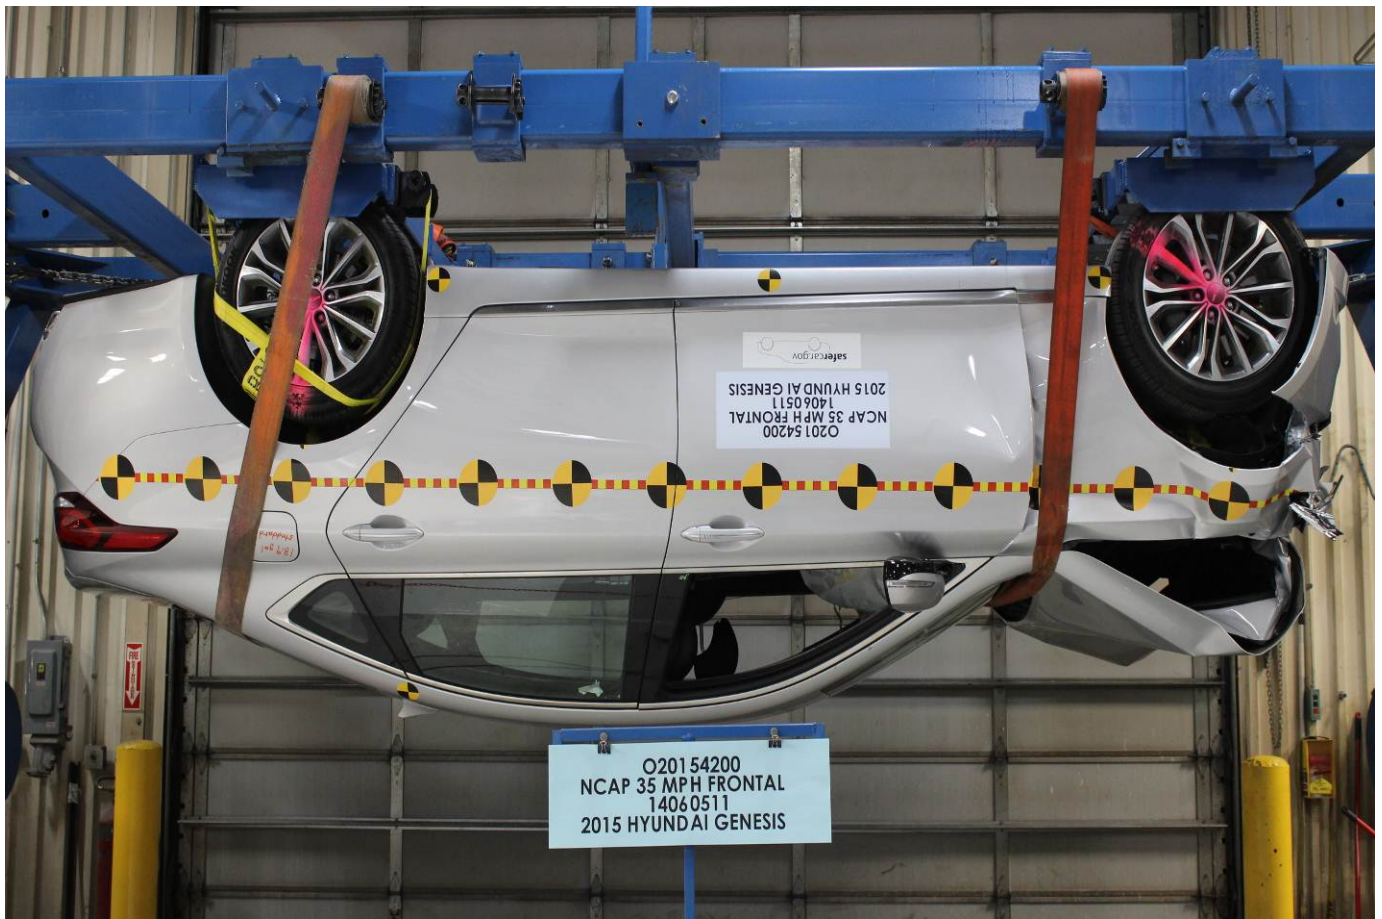
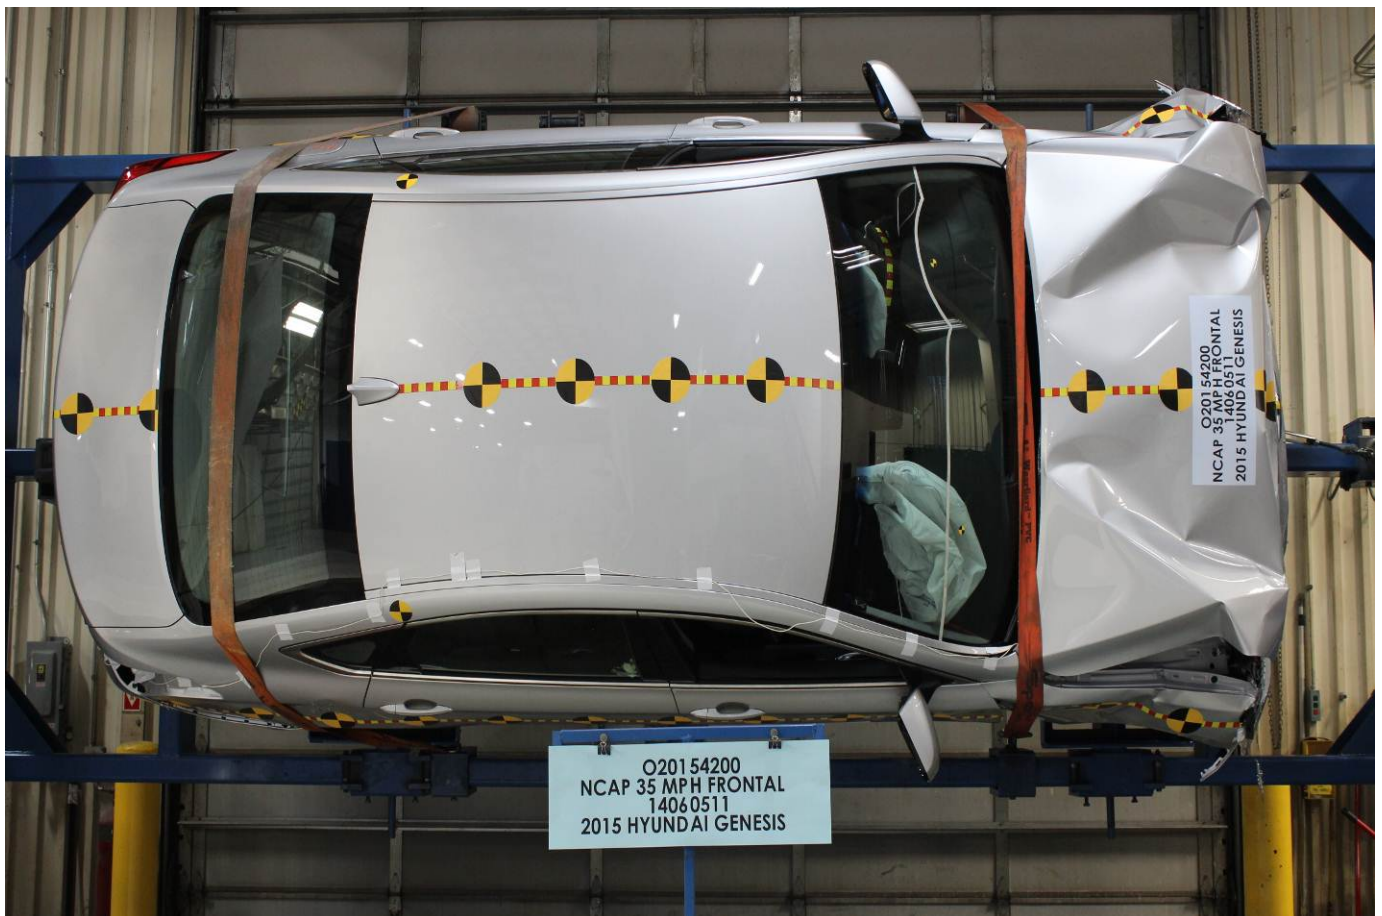
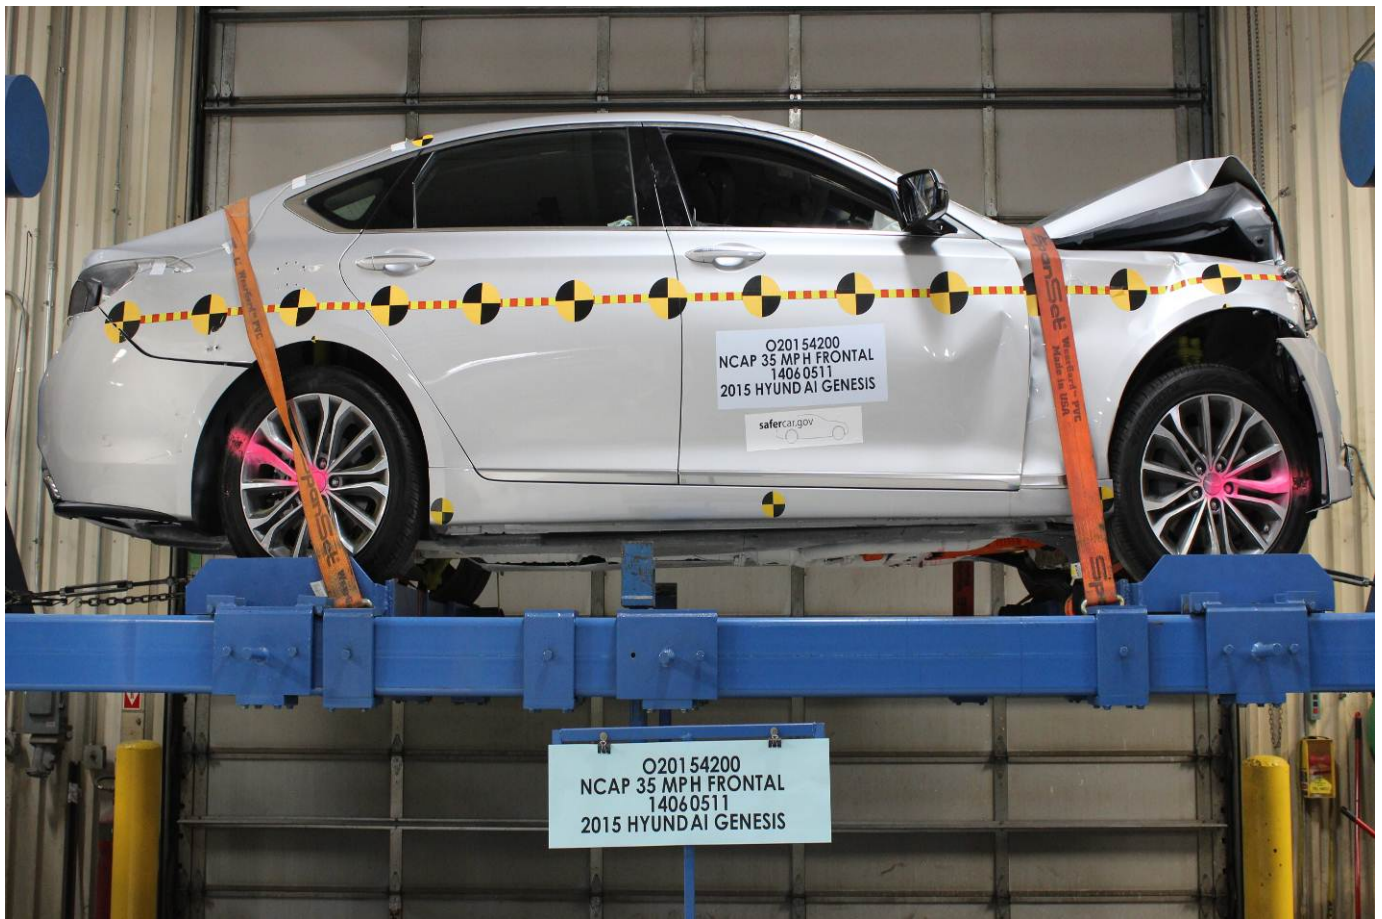
Vehicle at 0 Degree on Static Rollover Device

Vehicle at 90 Degrees on Static Rollover Device

Vehicle at 180 Degrees on Static Rollover Device

Vehicle at 270 Degrees on Static Rollover Device

Vehicle at 360 Degrees on Static Rollover Device
