REPORT NUMBER: SINCAP-MCW-14-014

**NEW CAR ASSESSMENT PROGRAM (NCAP)
MOVING DEFORMABLE BARRIER SIDE IMPACT TEST**

**MITSUBISHI MOTORS NORTH AMERICA, INC.
2014 MITSUBISHI OUTLANDER SPORT 5-DOOR SUV
NHTSA NUMBER: O20145601**

**PREPARED BY:
MEDICAL COLLEGE OF WISCONSIN
5000 WEST NATIONAL AVENUE
RESEARCH 151
MILWAUKEE, WISCONSIN 53295**

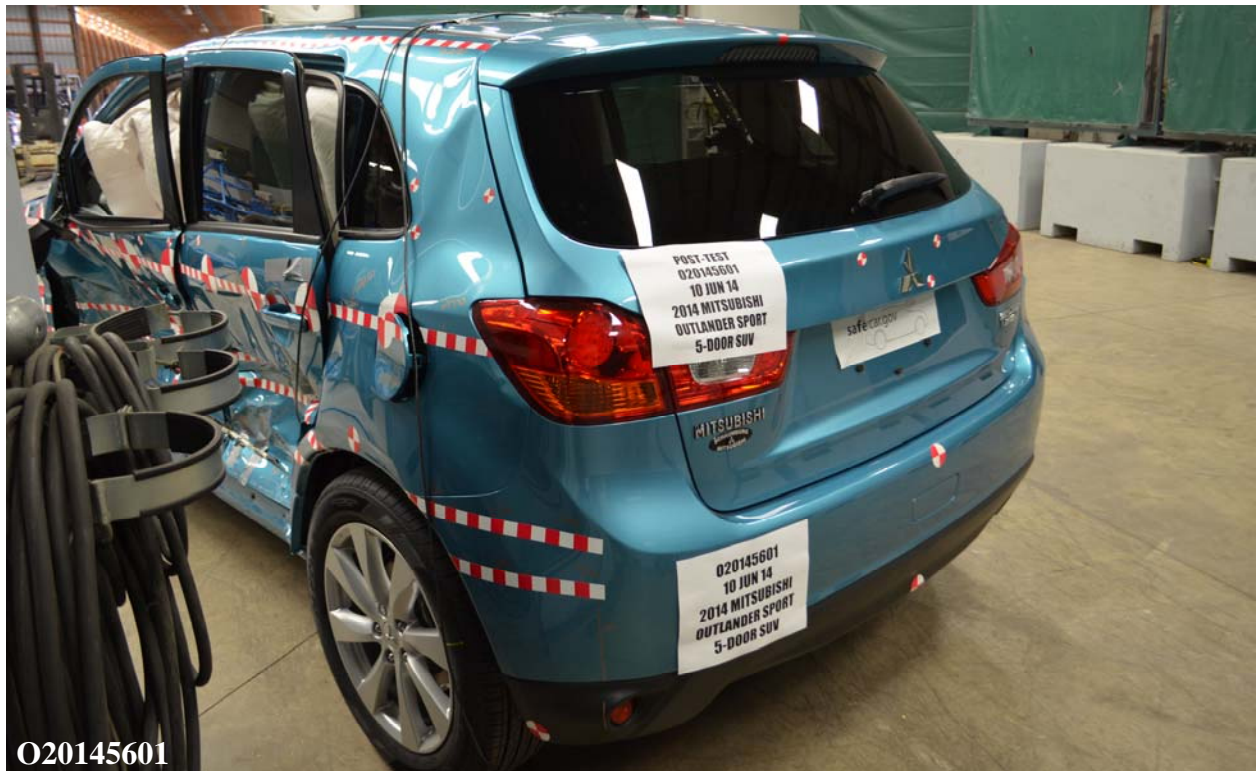
Figure A-10: Post-Test Left Rear 3-4 View of Test Vehicle

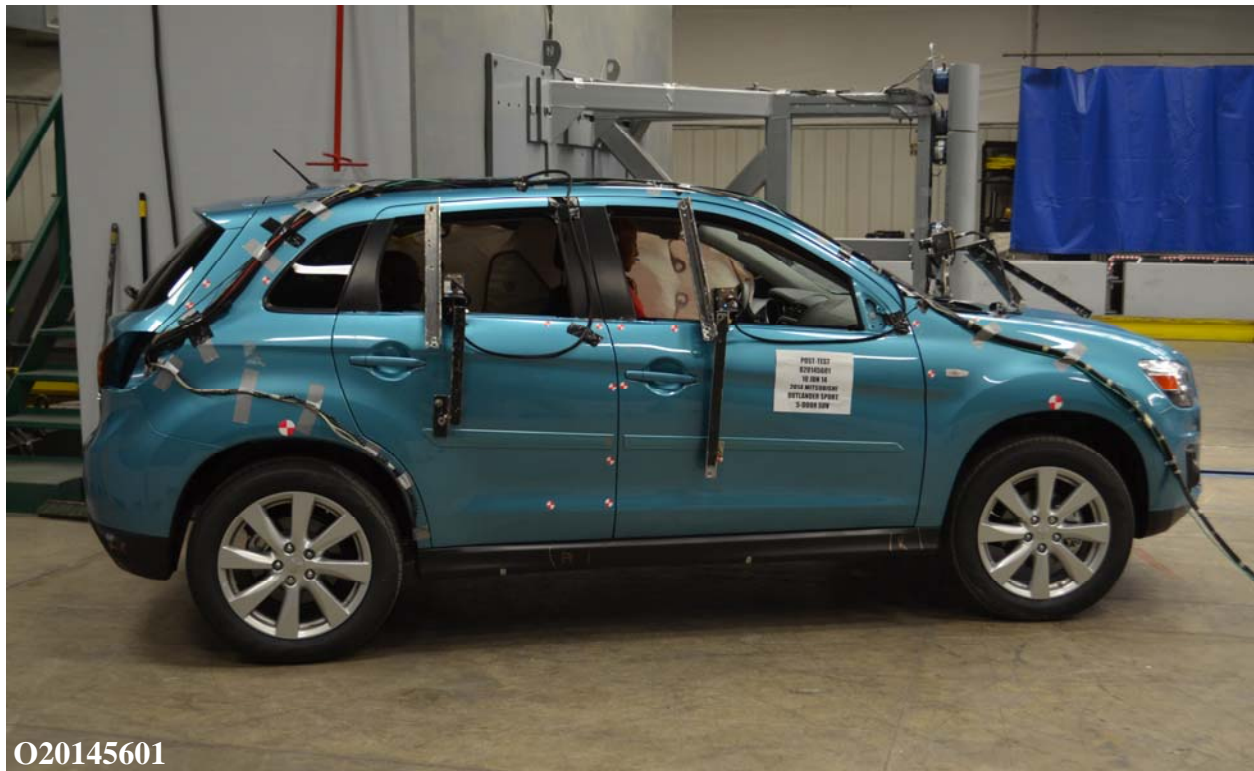
Figure A-14: Post-Test Right Side View of Test Vehicle

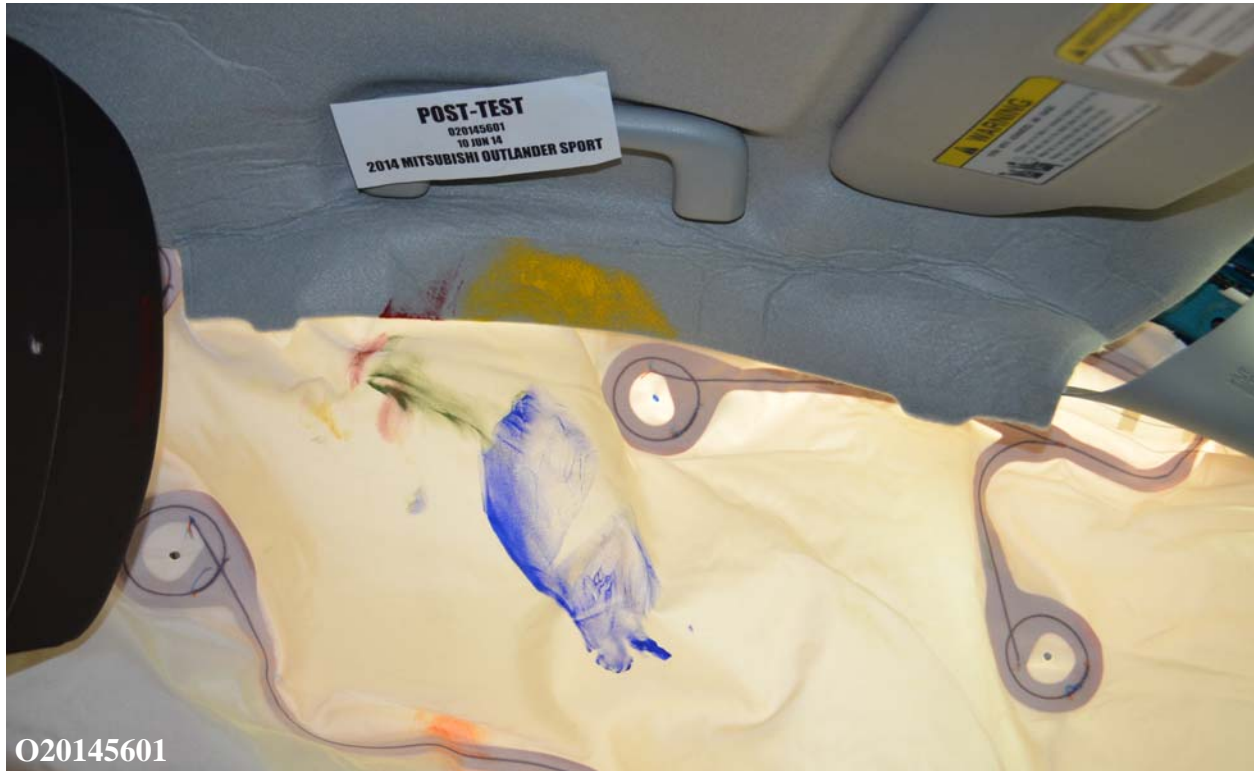
Figure A-49: Post-Test Driver Dummy Close-Up Head Contact with Side Airbag View

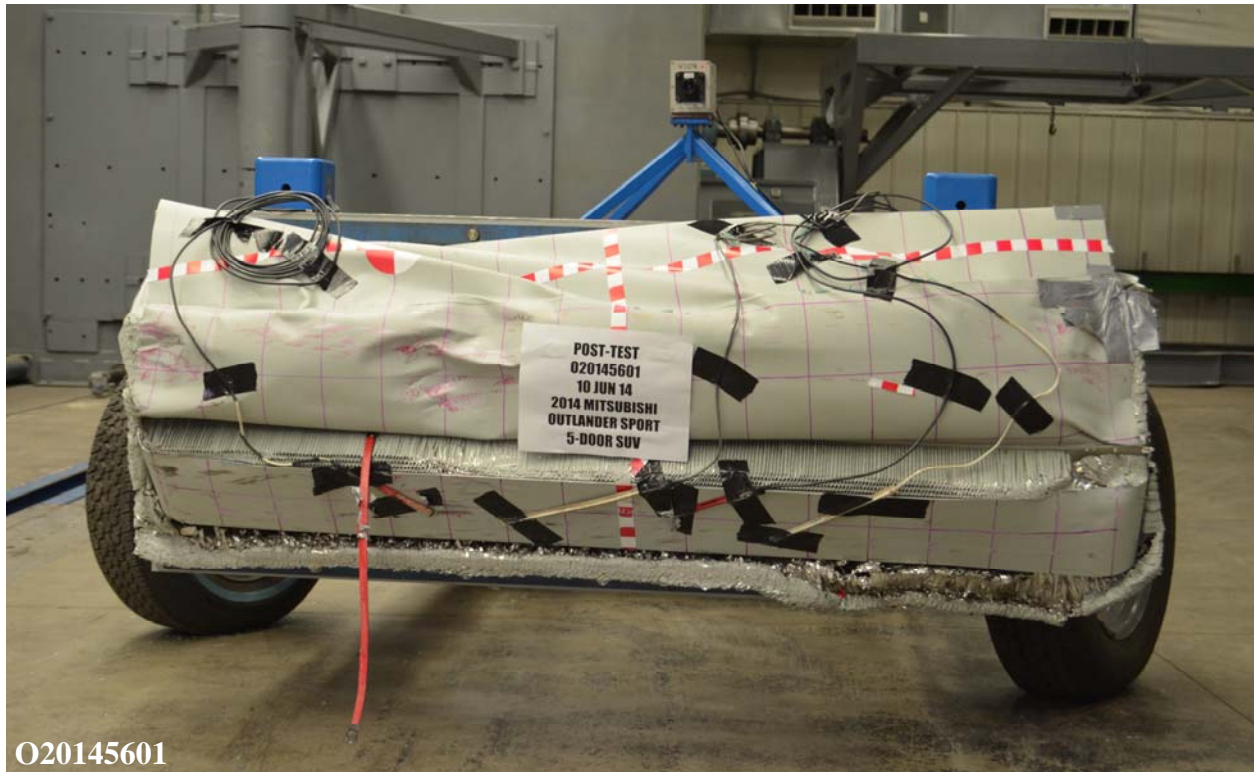
Figure A-85: Post-Test Front View of MDB Impactor Face

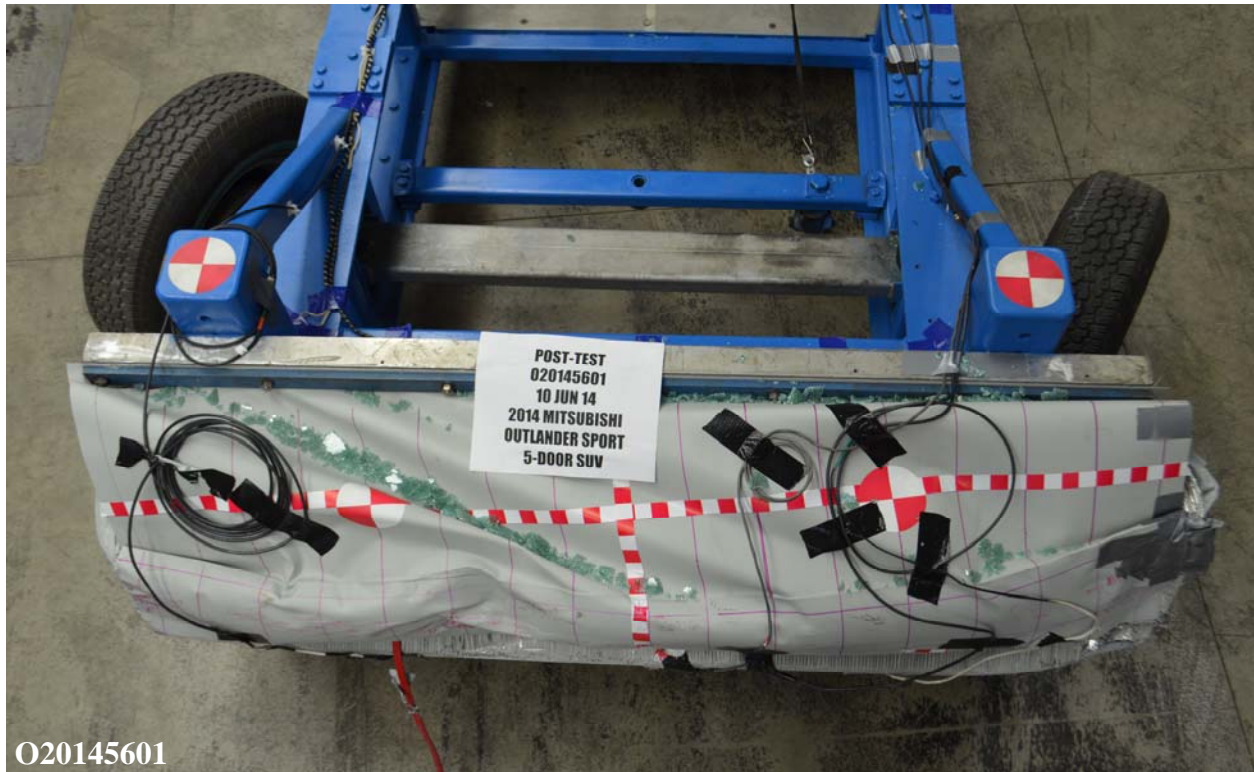
Figure A-87: Post-Test Top View of MDB Impactor Face

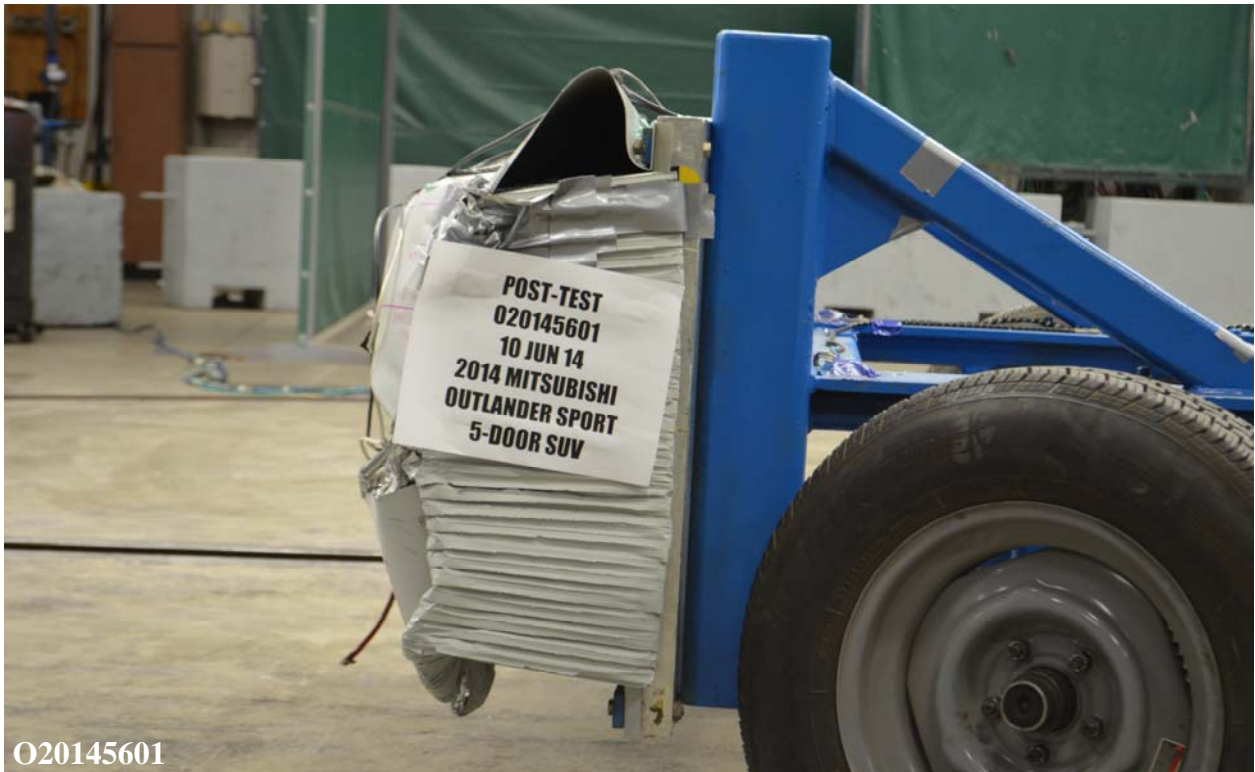
Figure A-89: Post-Test Left Side View of MDB Impactor Face

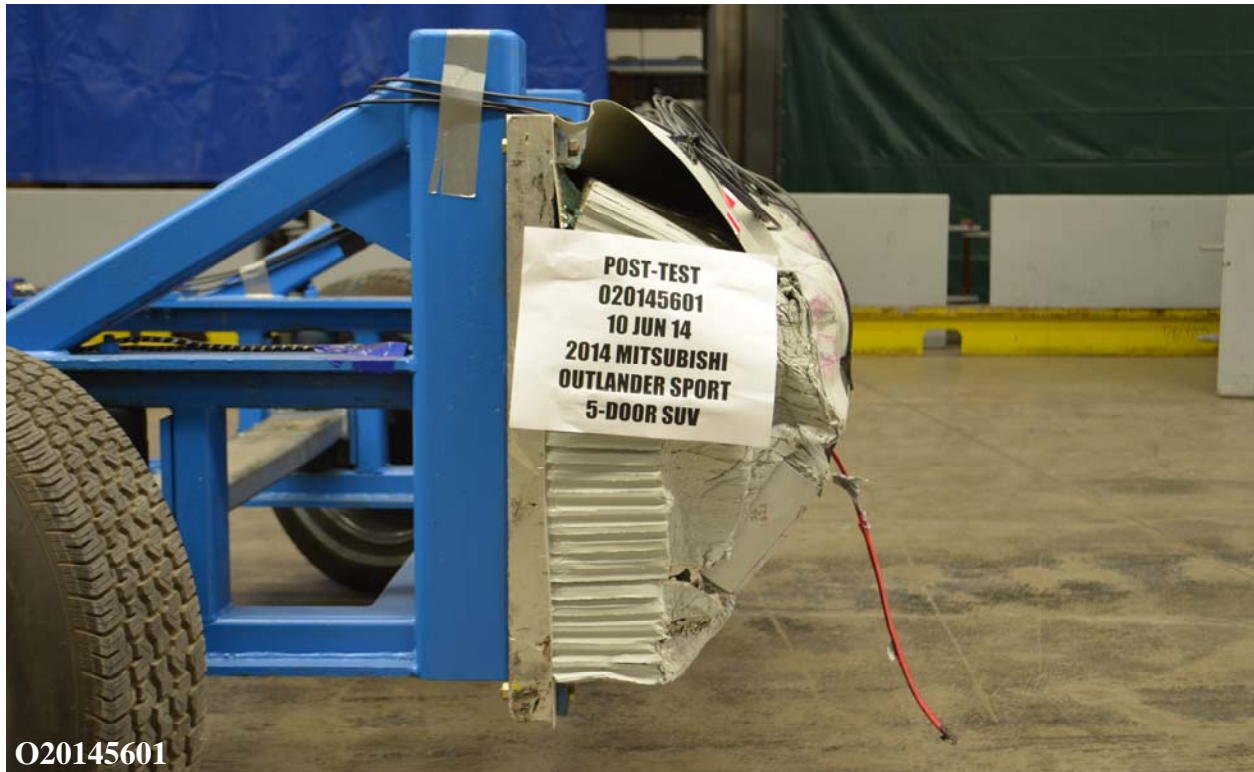
Figure A-91: Post-Test Right Side View of MDB Impactor Face
