REPORT NUMBER: R&D-CAL-14-001

**MOVING BARRIER TO VEHICLE CRASH TEST IN SUPPORT OF NHTSA'S
FRONTAL OBLIQUE OFFSET PROGRAM
RESEARCH MOVING DEFORMABLE BARRIER INTO LEFT FRONT OF A**

2014 Honda Accord

90.1KPH, 15 DEGREE ANGLE, 35% OVERLAP

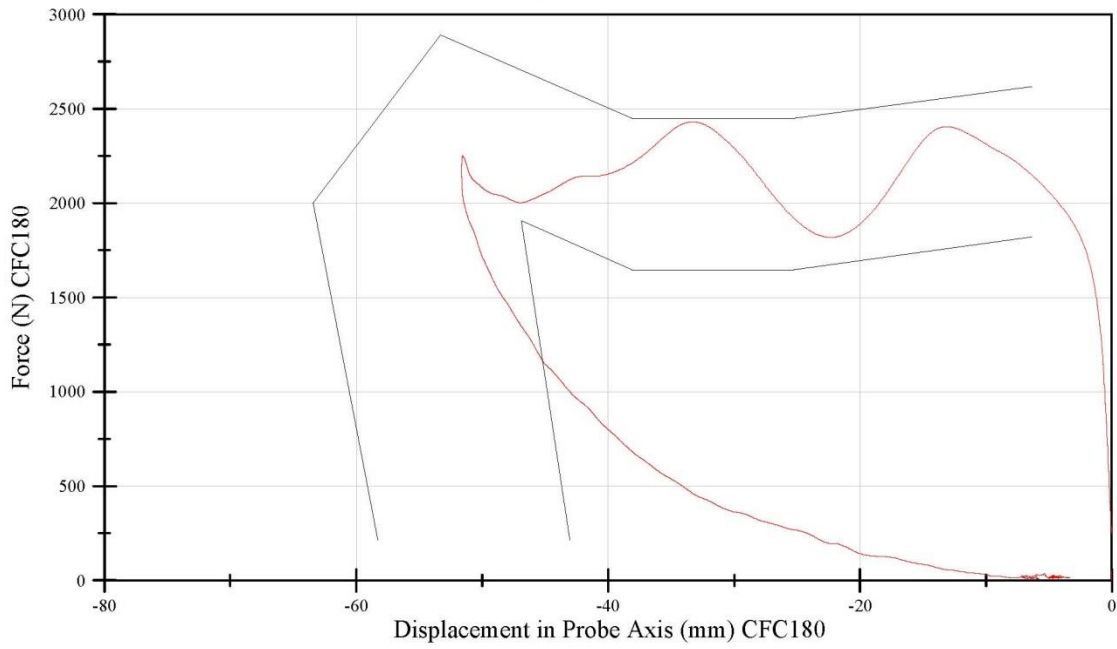
THOR Upper Thorax Certification
Thorax Response With Kroell Corridor
Serial Number: T016

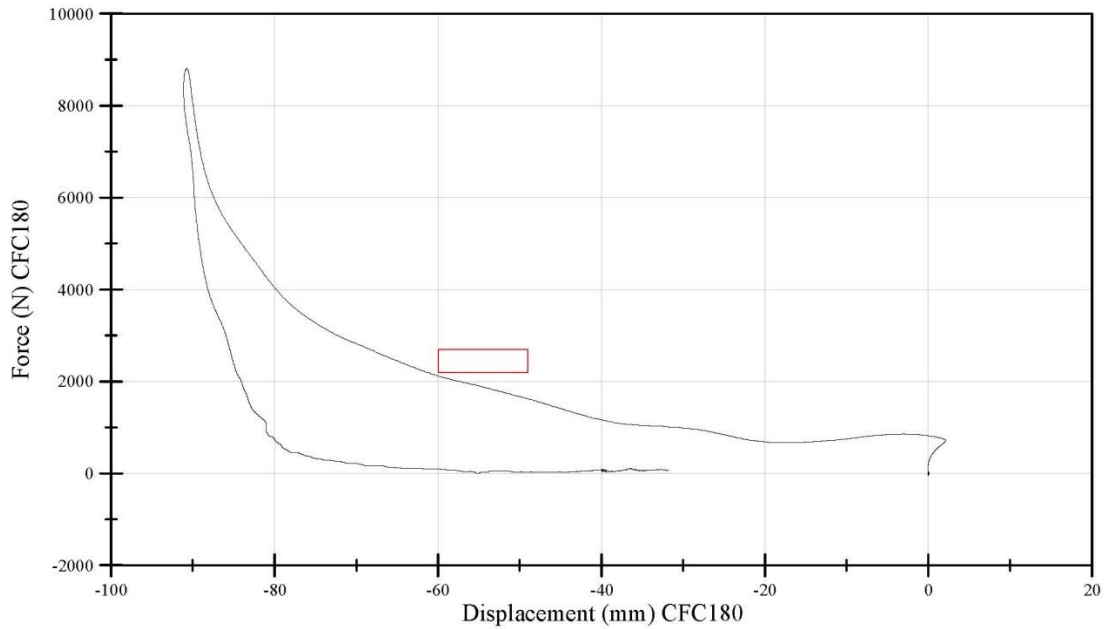
THOR Lower Abdomen Certification
Abdomen Displacement vs. Probe Force
Serial Number: T016

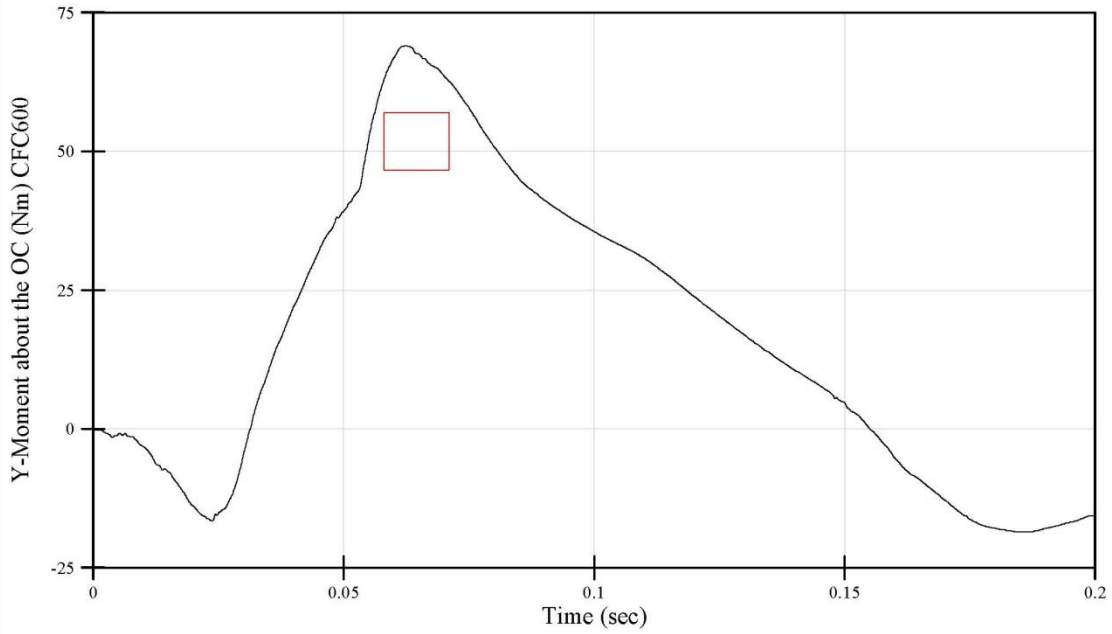
THOR Neck Flexion Certification
Y-Moment
Serial Number: T0016

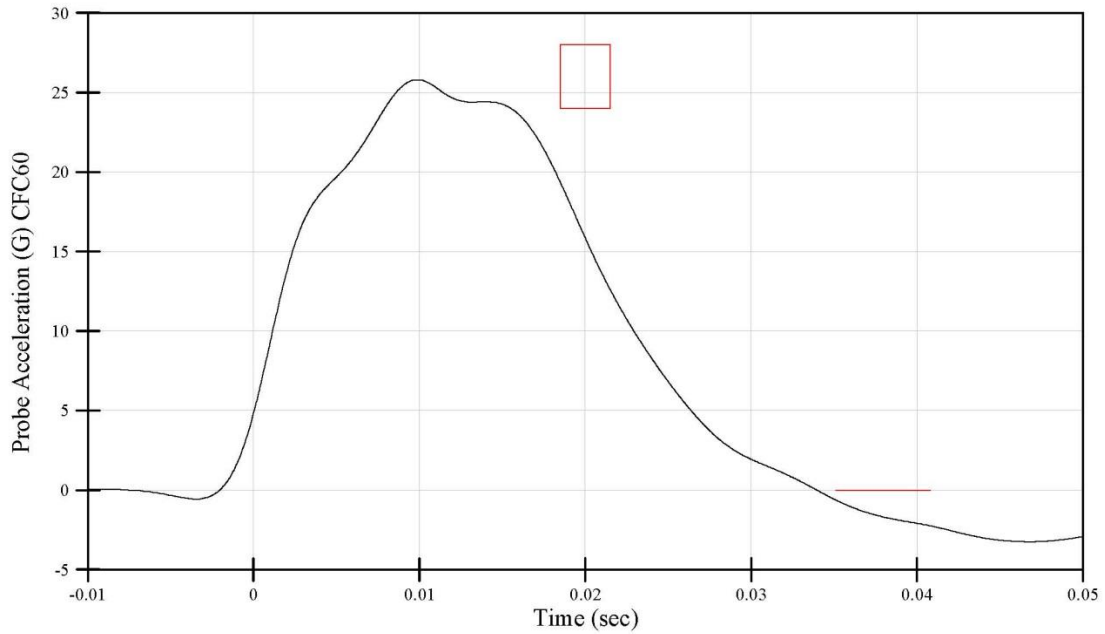
THOR Neck Flexion Certification
Probe Acceleration
Serial Number: T0016

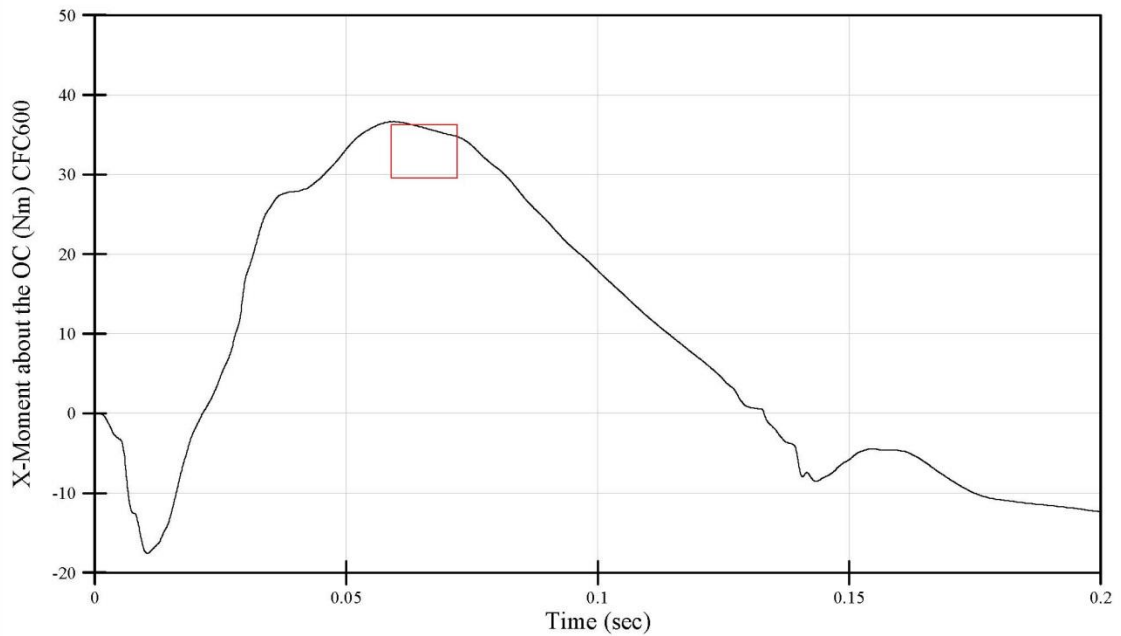
THOR Neck Left Lateral Flexion Certification
X-Moment
Serial Number: T0016

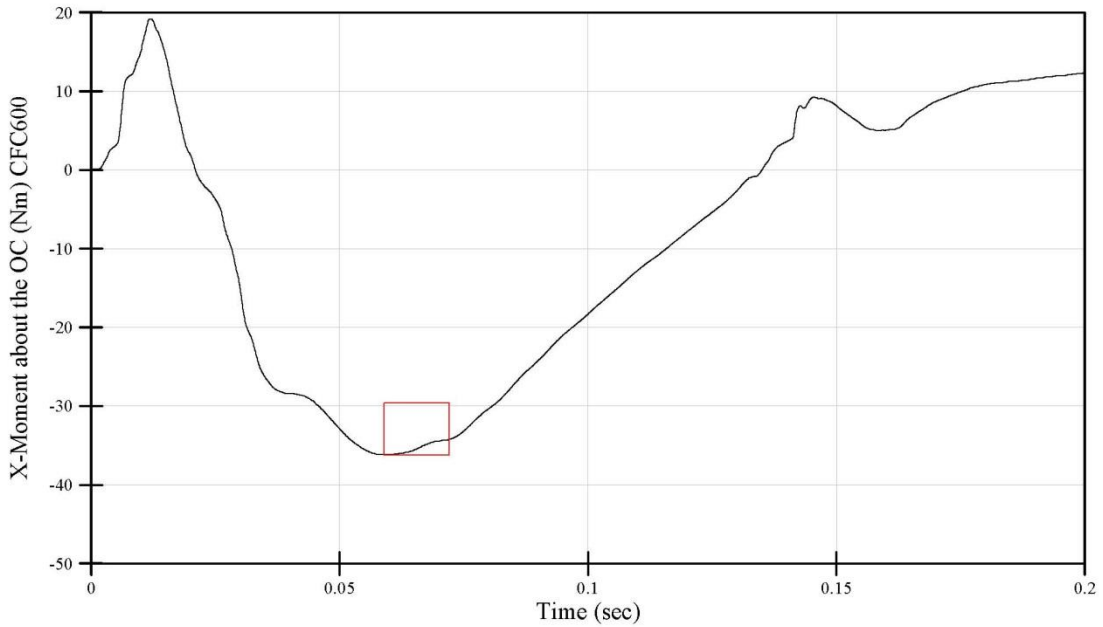
THOR Neck Right Lateral Flexion Certification
X-Moment
Serial Number: T0016

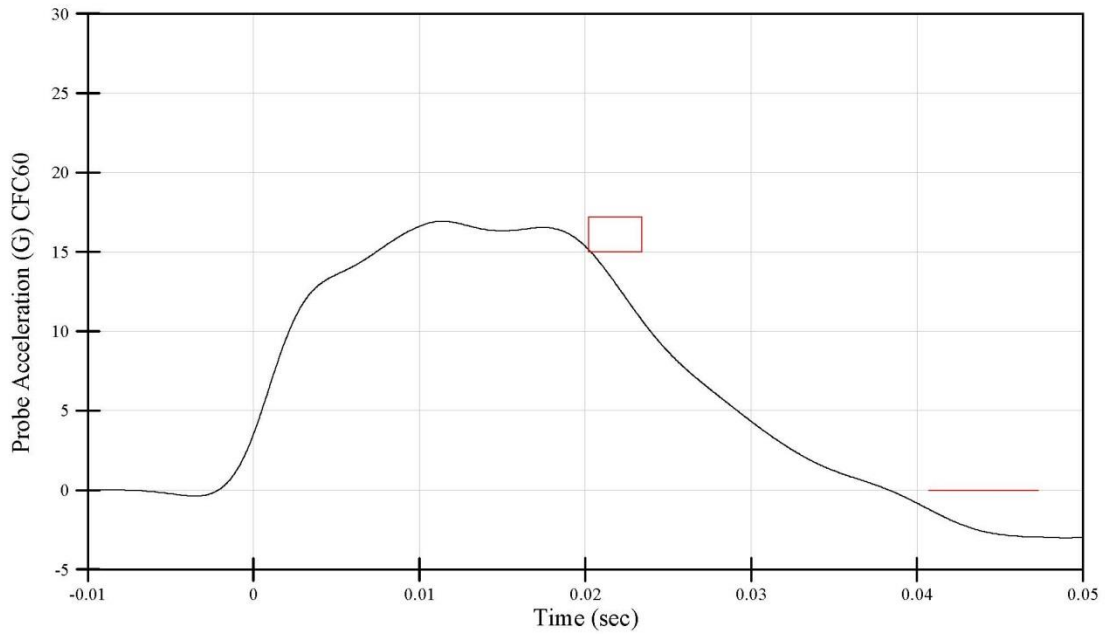
THOR Neck Right Lateral Flexion Certification
Probe Acceleration
Serial Number: T0016

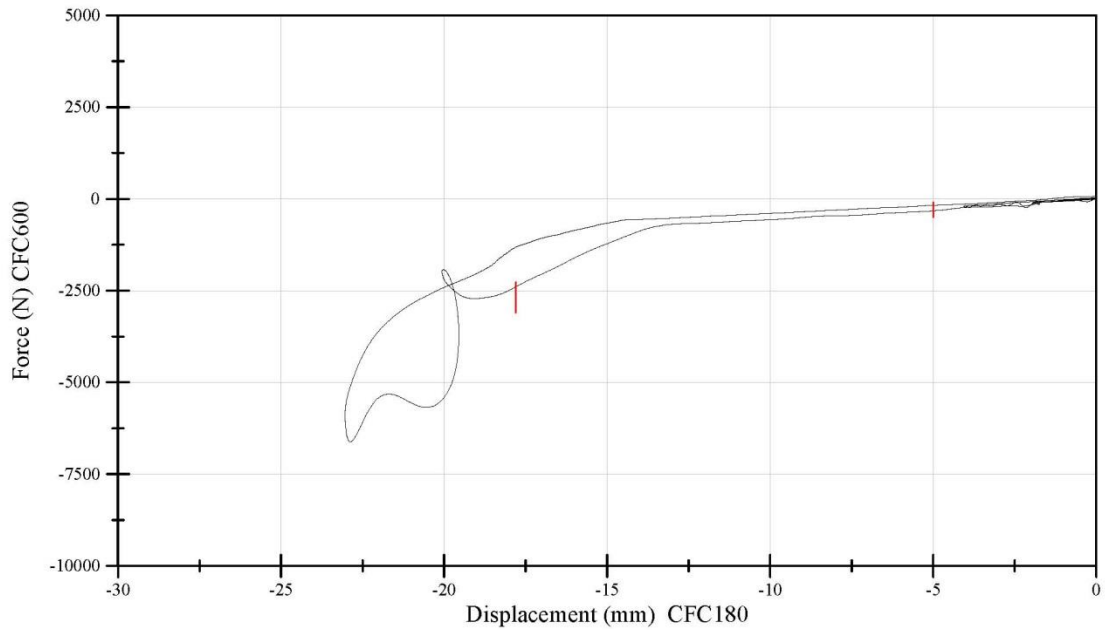
THOR Right Knee Certification
Femur Force vs. Knee Displacement
Serial Number: LX018

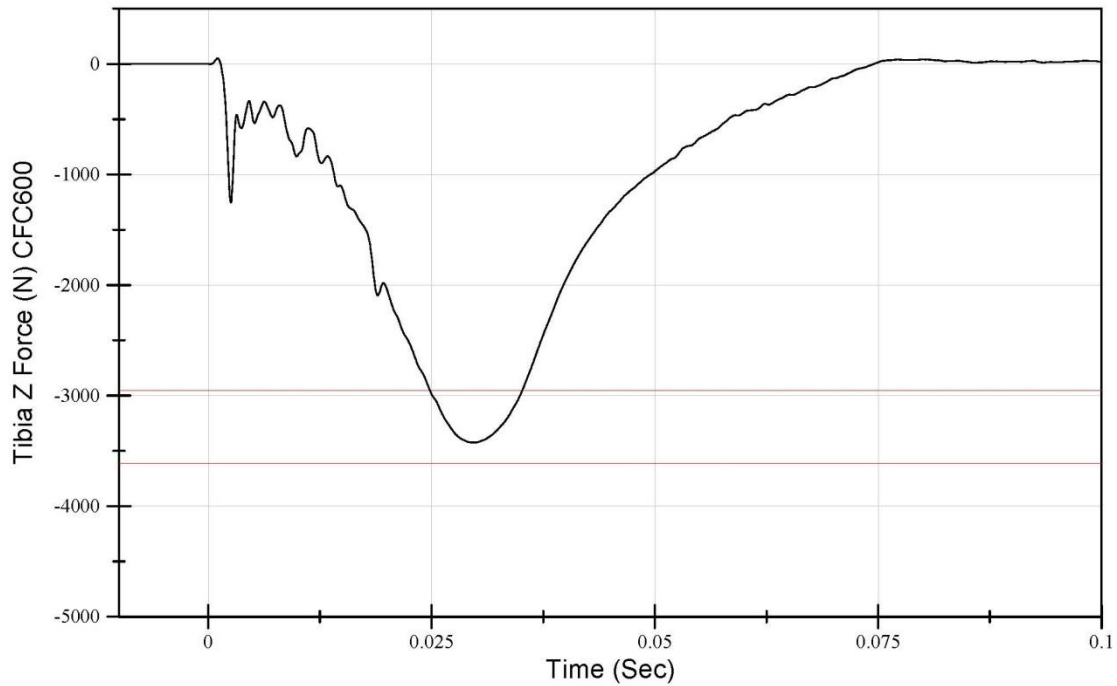
THOR Right Foot Dorsiflexion Certification
Tibia Load
Serial Number: LX0018

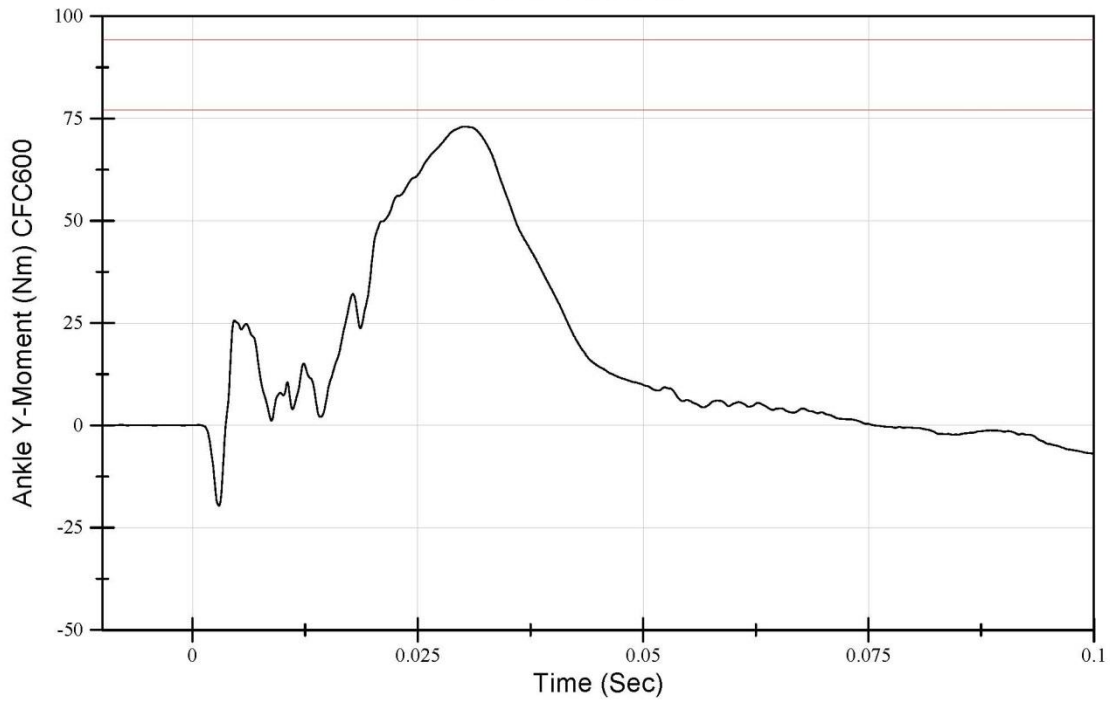
THOR Right Foot Dorsiflexion Certification
Ankle Y-Moment
Serial Number: LX0018

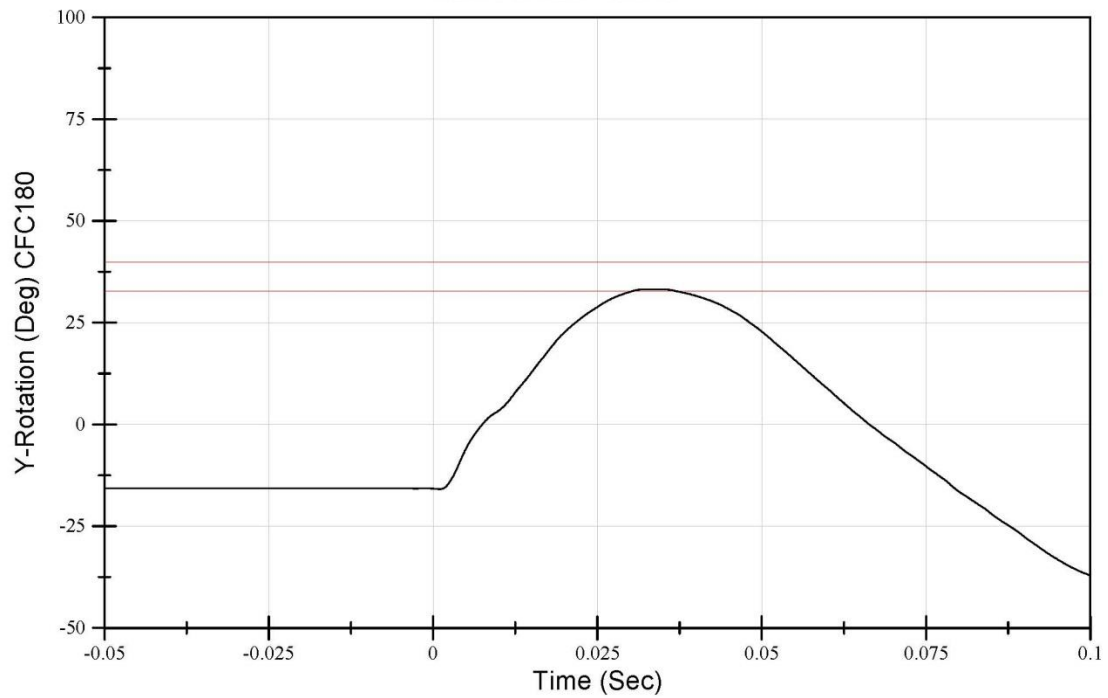
THOR Right Foot Dorsiflexion Certification
Ankle Y-Rotation
Serial Number: LX0018

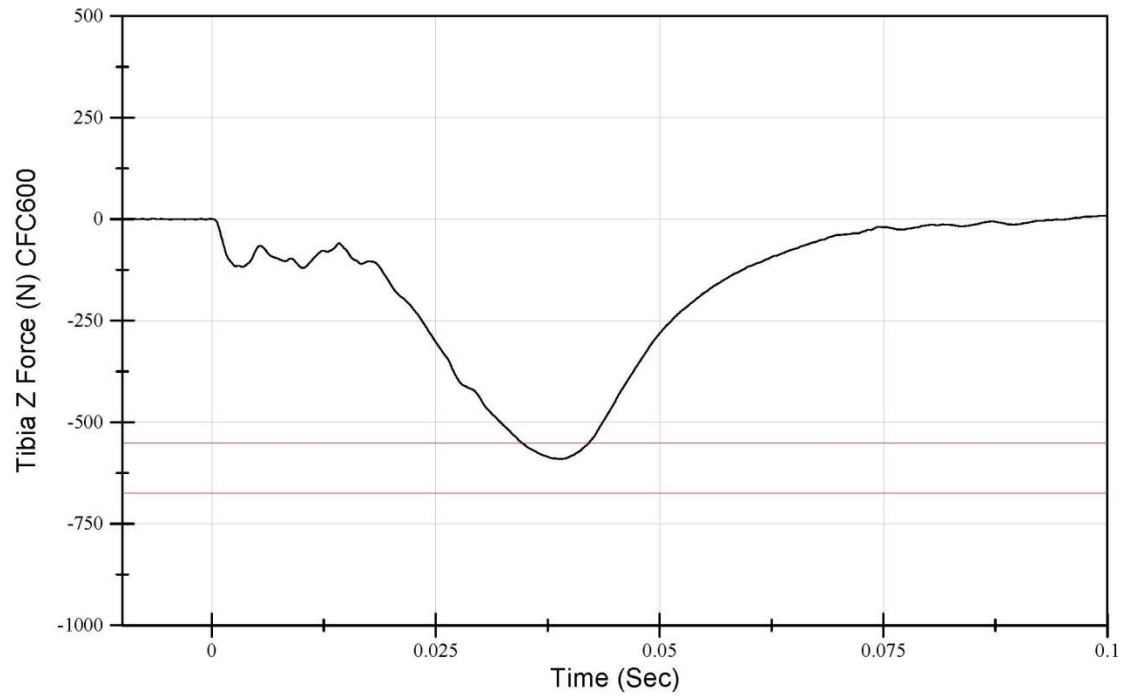
THOR Right Foot Eversion Certification
Tibia Load
Serial Number: LX0018

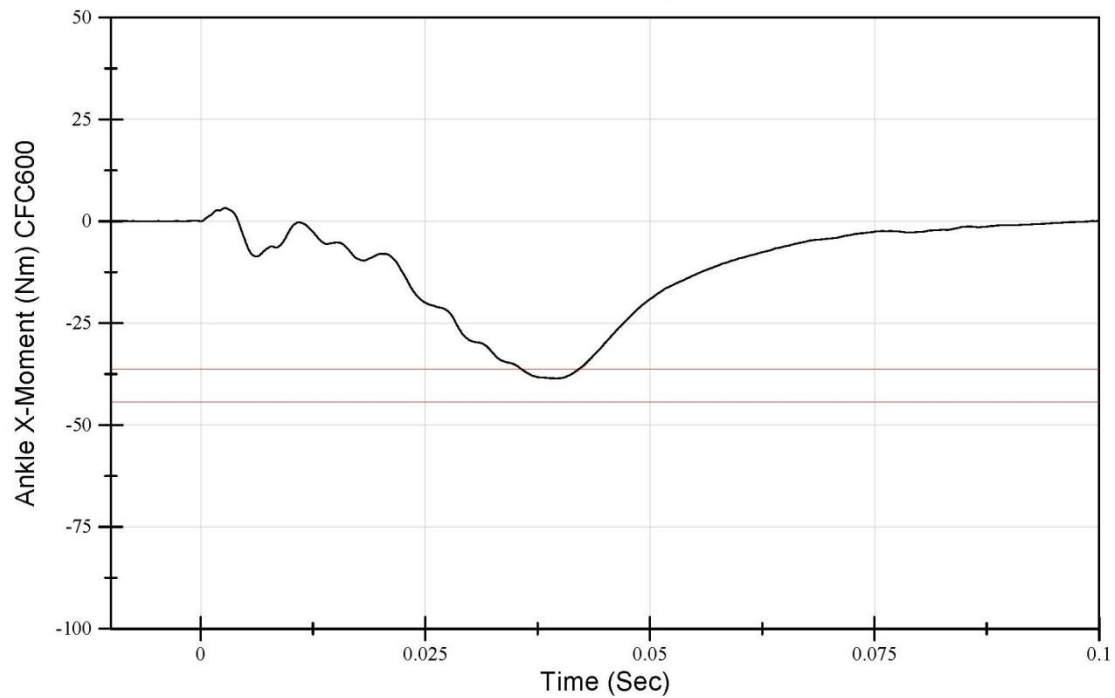
THOR Right Foot Eversion Certification
Ankle Moment
Serial Number: LX0018

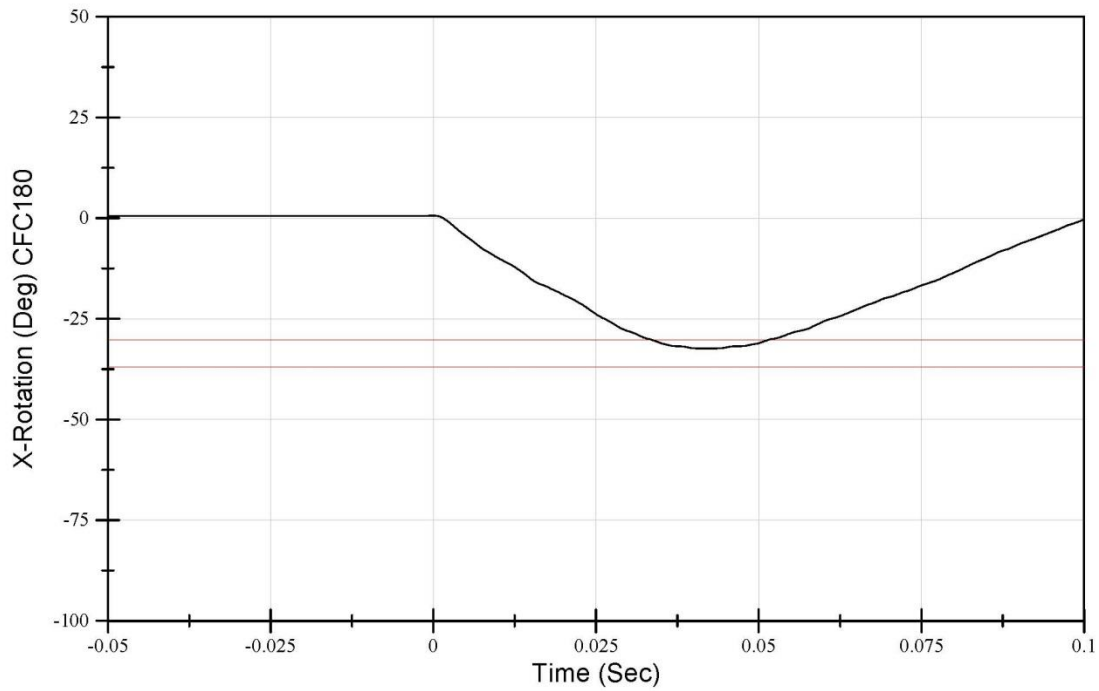
THOR Right Foot Eversion Certification
Ankle X-Rotation
Serial Number: LX0018

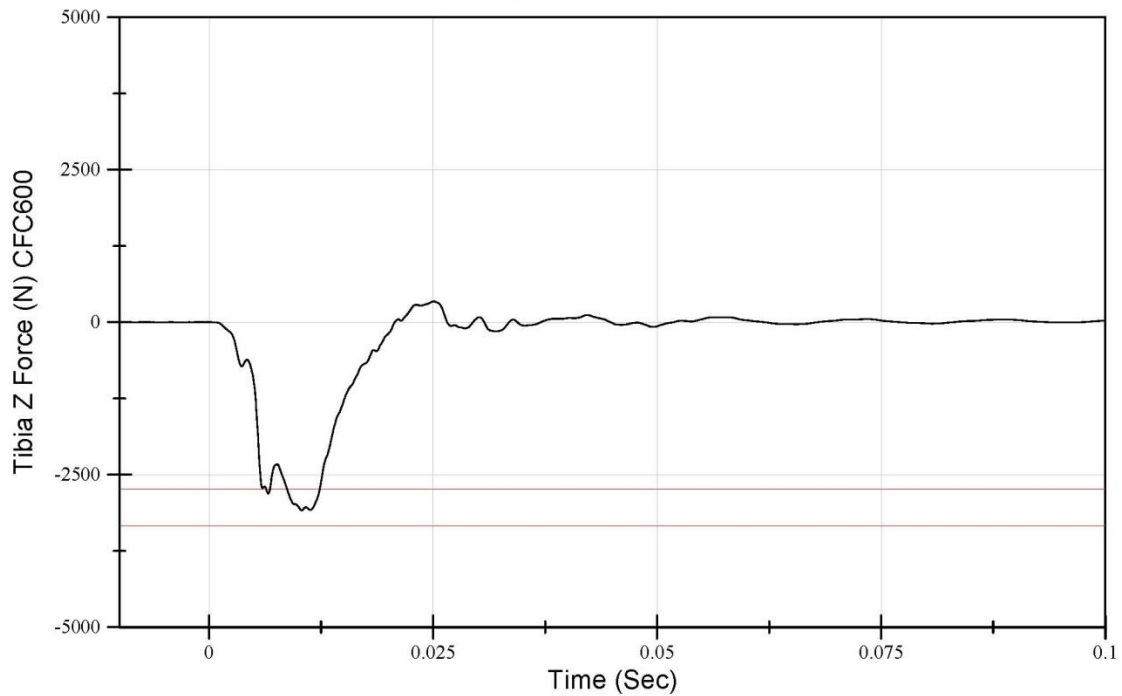
THOR Right Foot Heel Certification
Tibia Load
Serial Number: LX0018

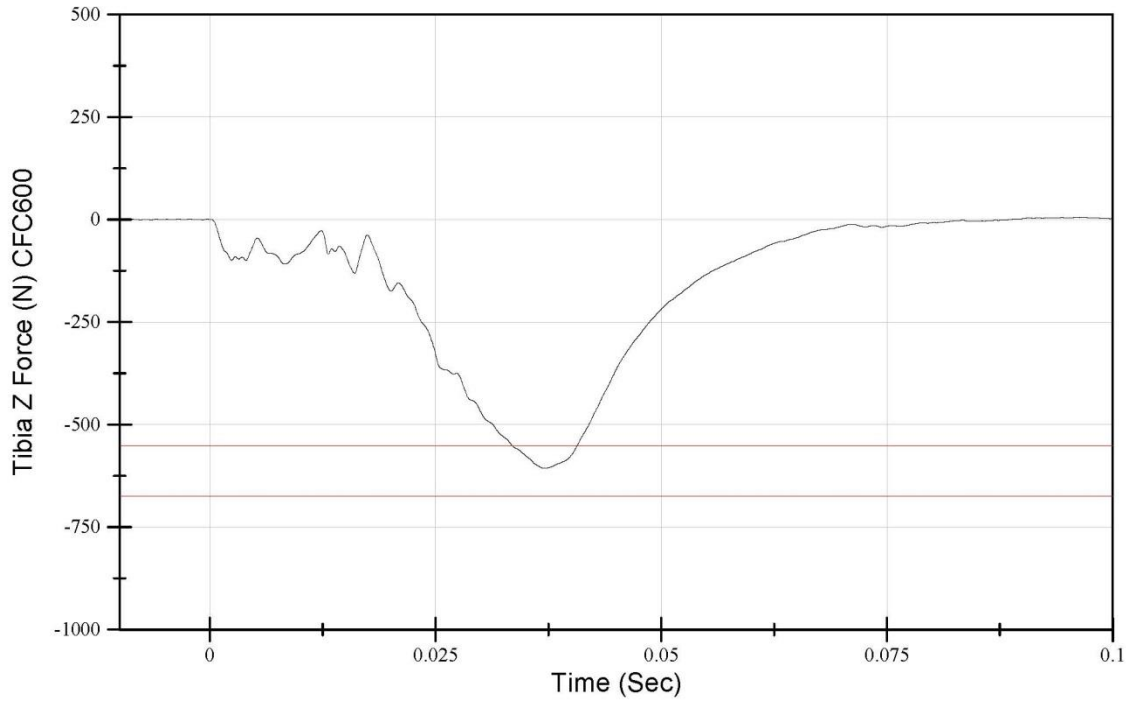
THOR Right Foot Inversion Certification
Tibia Load
Serial Number: LX0018

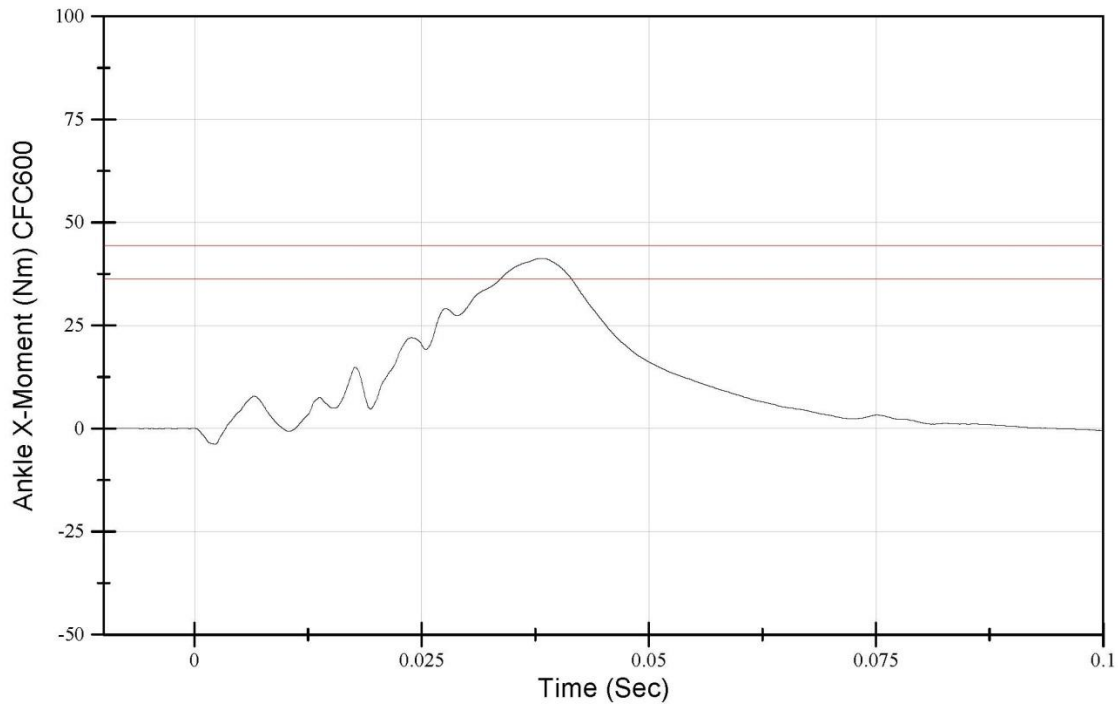
THOR Right Foot Inversion Certification
Ankle Moment
Serial Number: LX0018

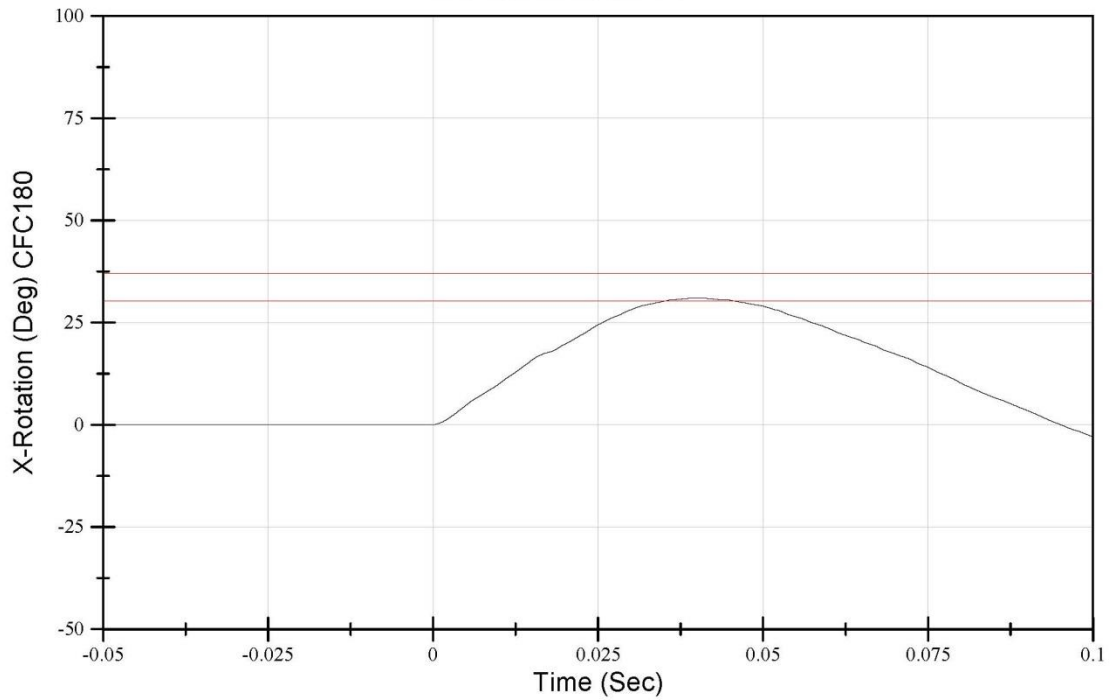
THOR Right Foot Inversion Certification
Ankle X-Rotation
Serial Number: LX0018

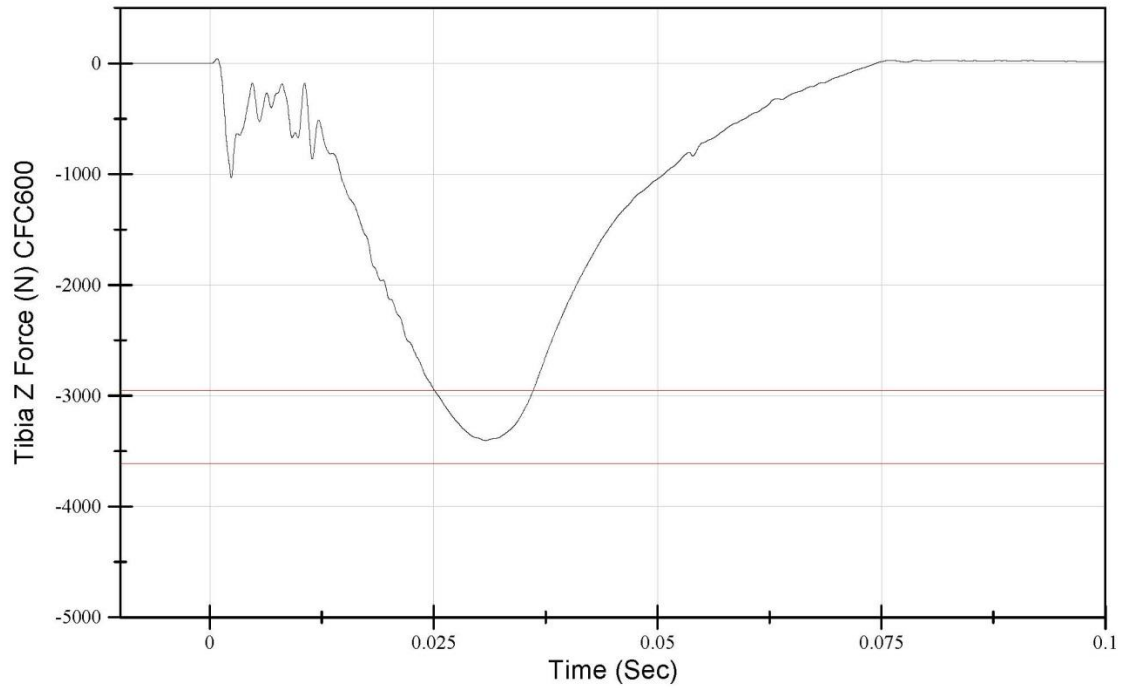
THOR Left Foot Dorsiflexion Certification
Tibia Load
Serial Number: LX0019

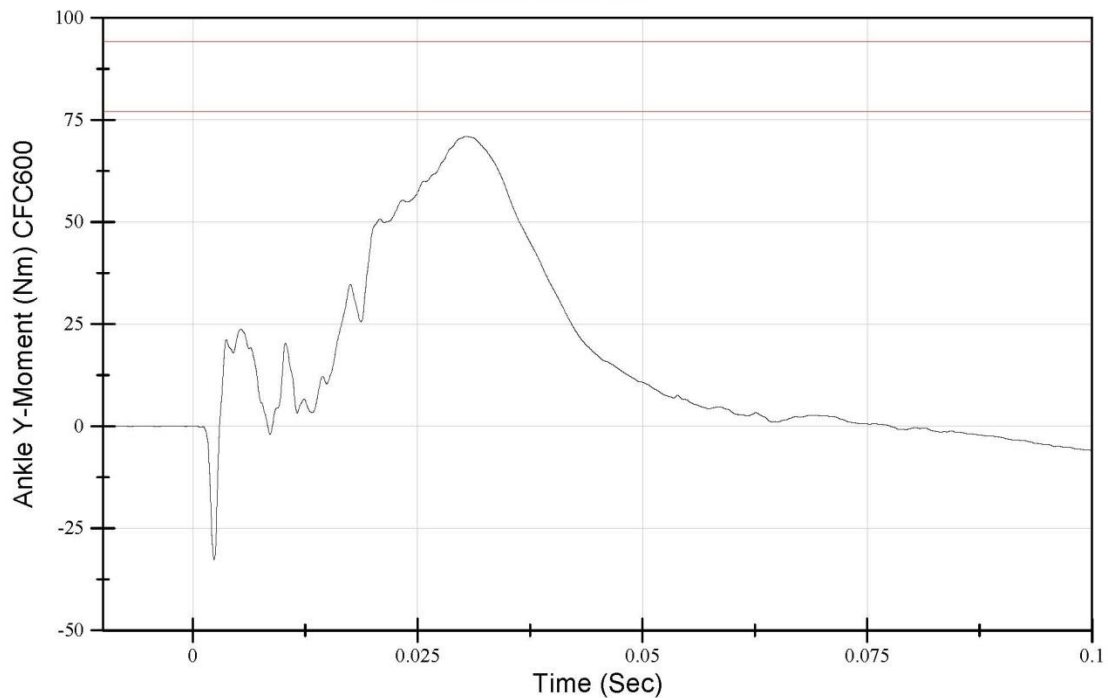
THOR Left Foot Dorsiflexion Certification
Ankle Y-Moment
Serial Number: LX0019

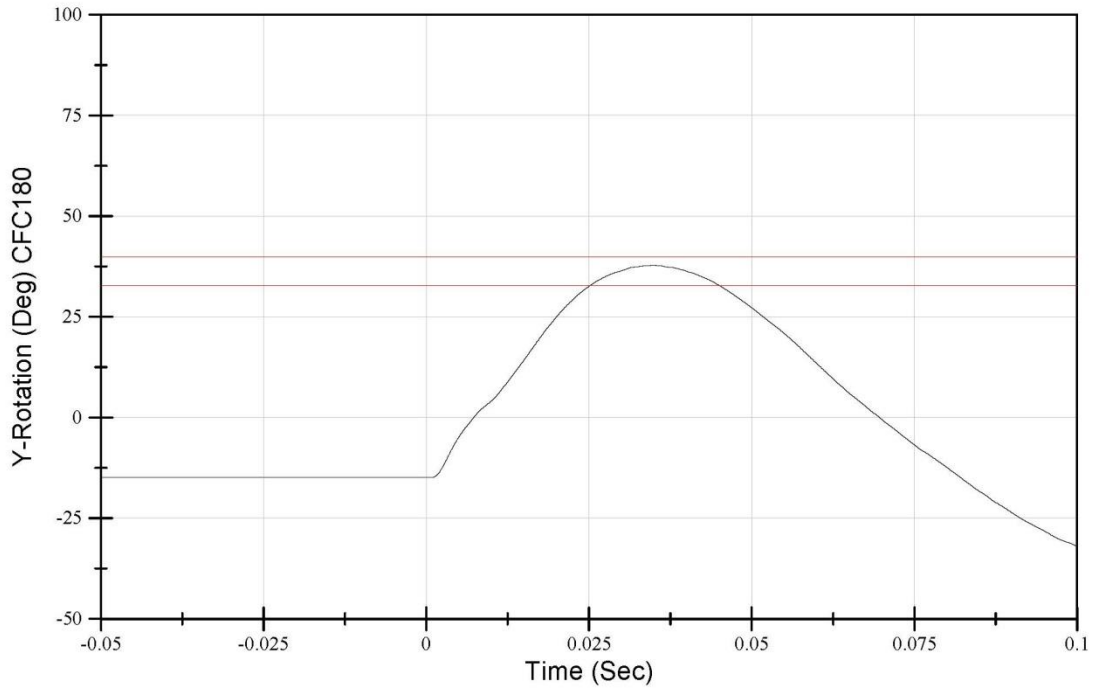
THOR Left Foot Dorsiflexion Certification
Ankle Y-Rotation
Serial Number: LX0019

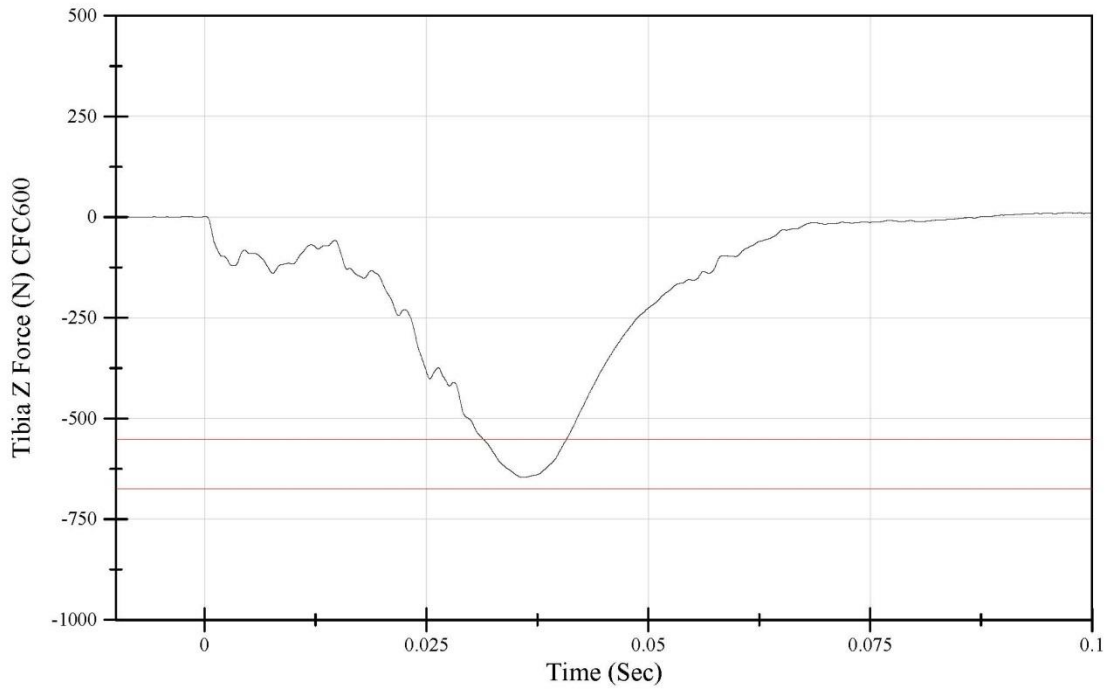
THOR Left Foot Eversion Certification
Tibia Load
Serial Number: LX0019

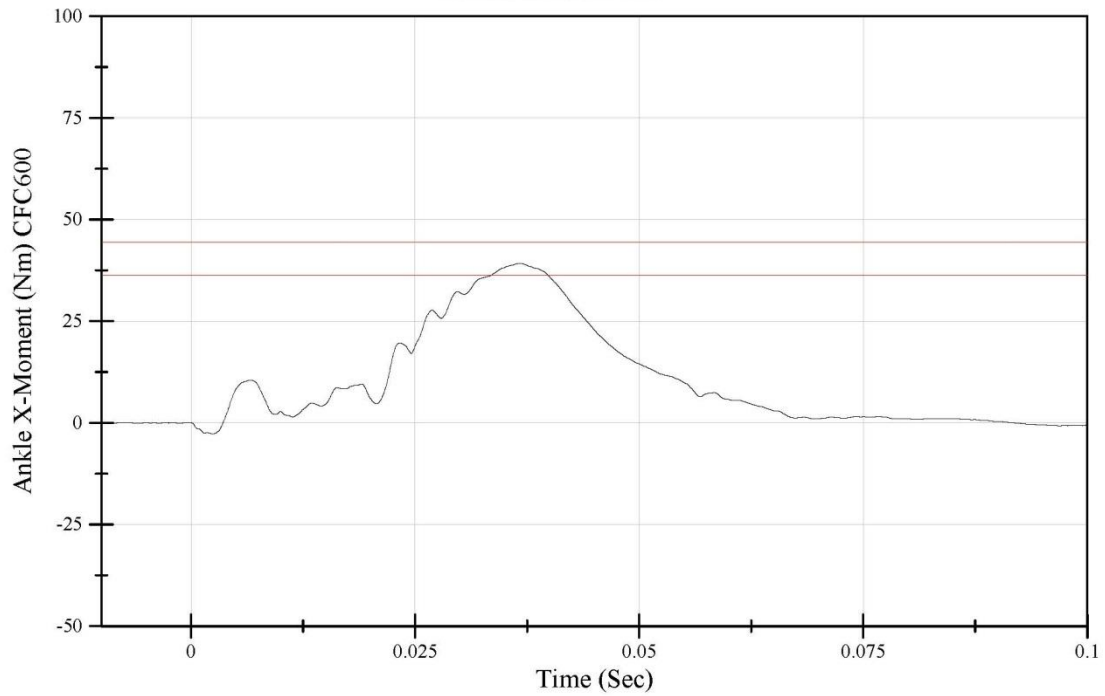
THOR Left Foot Eversion Certification
Ankle Moment
Serial Number: LX0019

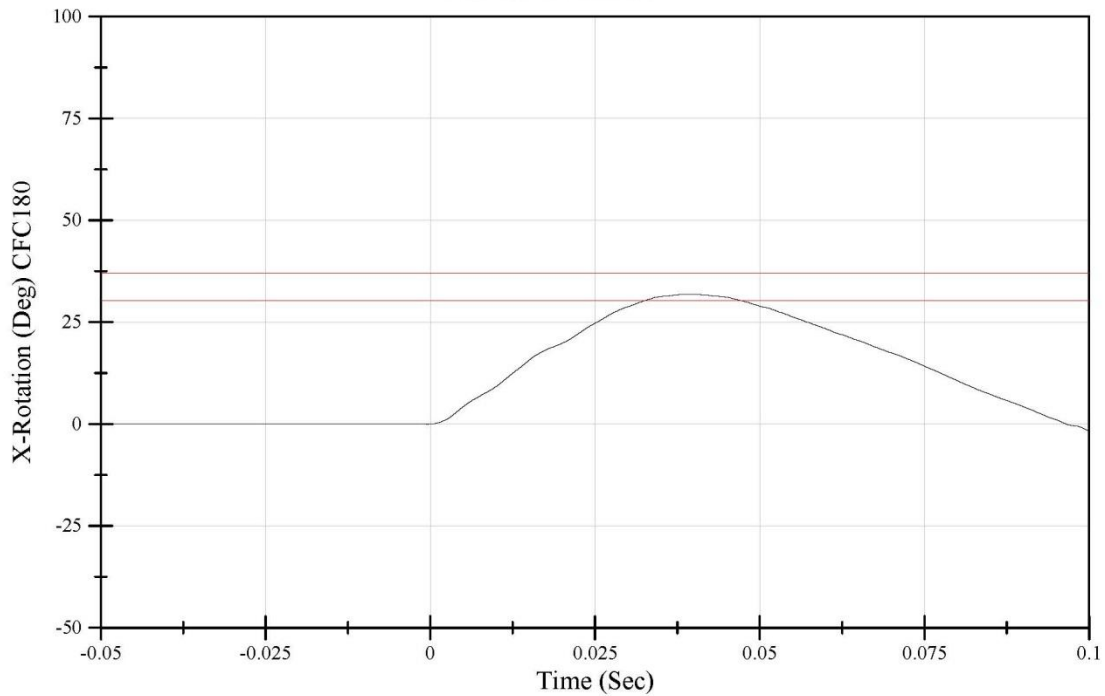
THOR Left Foot Eversion Certification
Ankle X-Rotation
Serial Number: LX0019

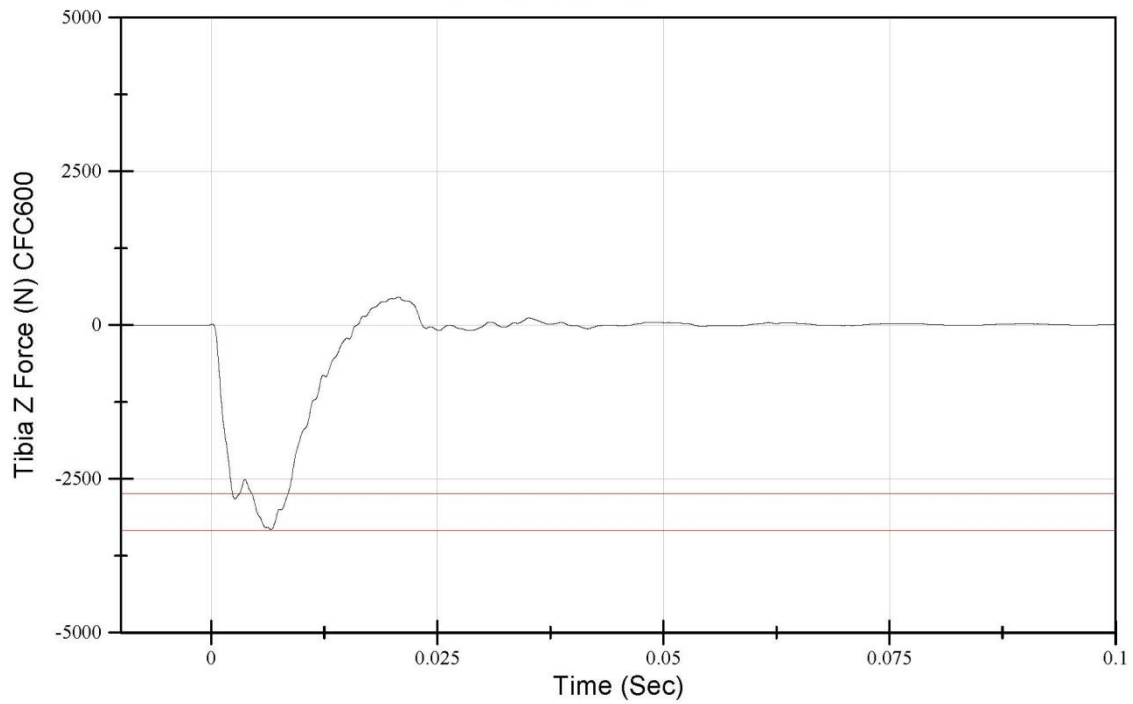
THOR Left Foot Heel Certification
Tibia Load
Serial Number: LX0019

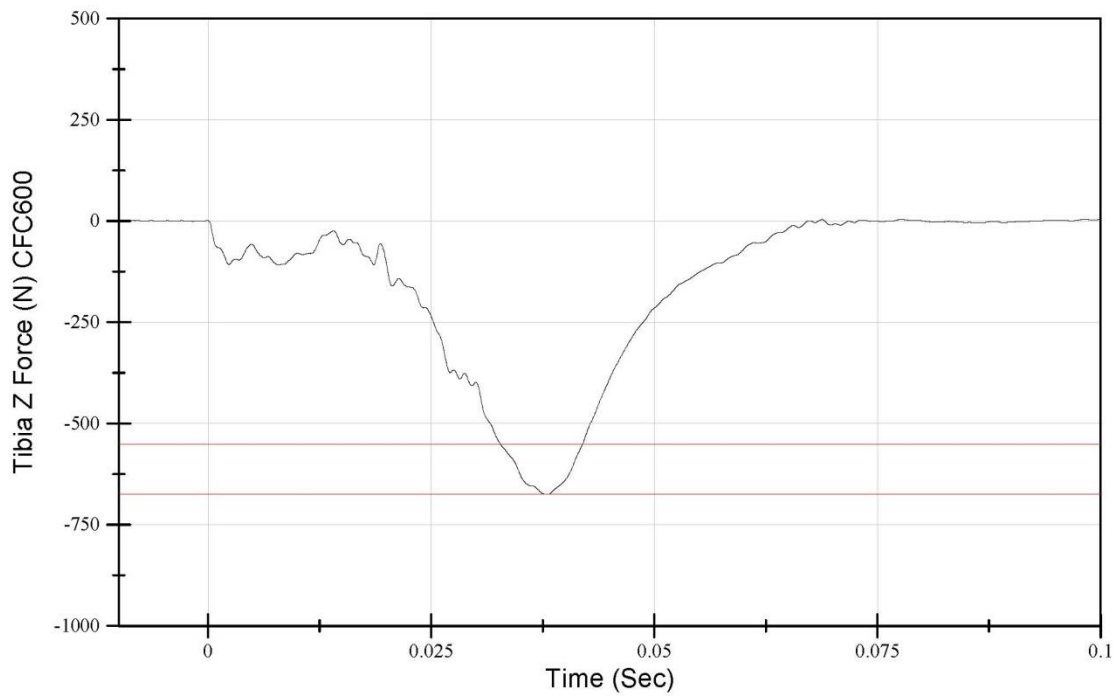
THOR Left Foot Inversion Certification
Tibia Load
Serial Number: LX0019

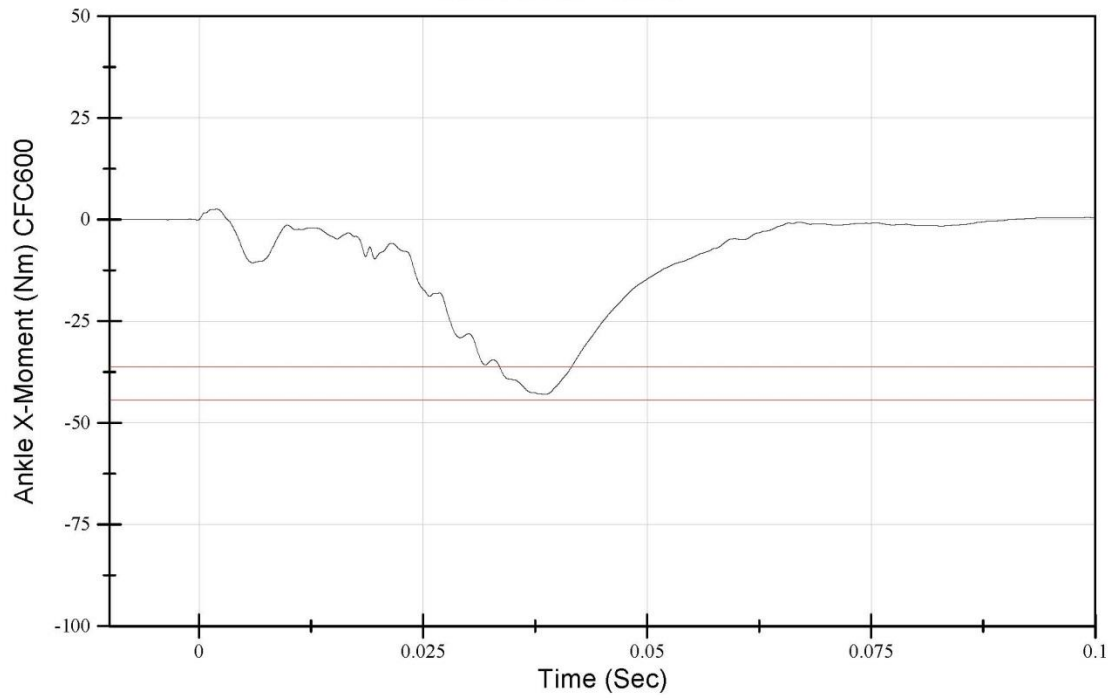
THOR Left Foot Inversion Certification
Ankle Moment
Serial Number: LX0019

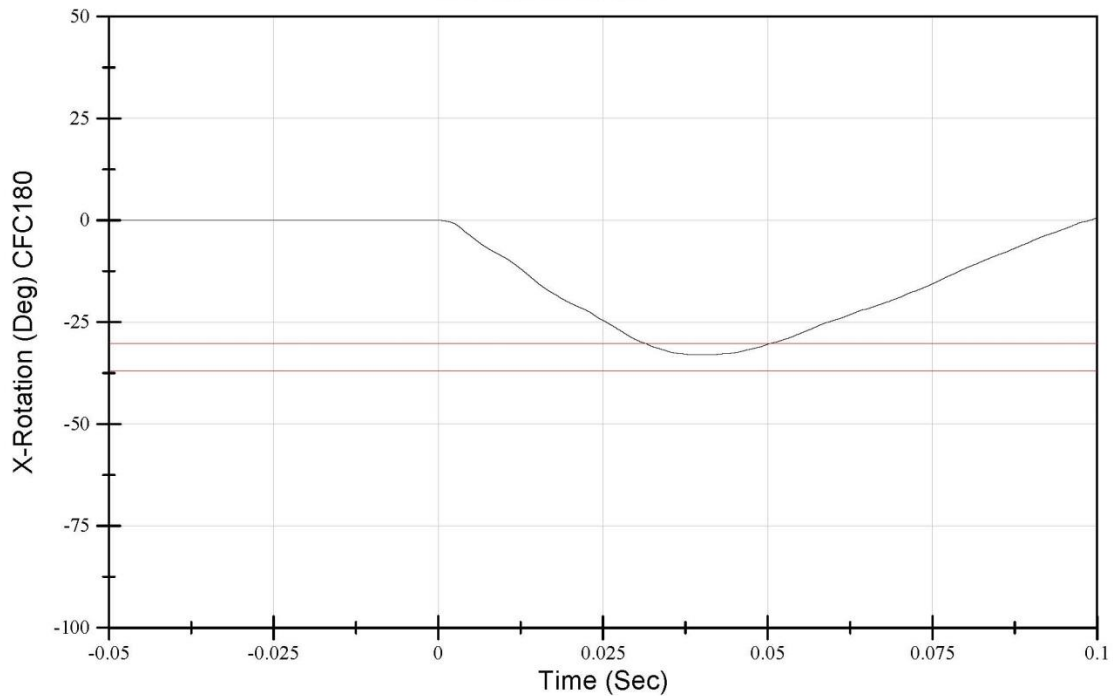
THOR Left Foot Inversion Certification
Ankle X-Rotation
Serial Number: LX0019

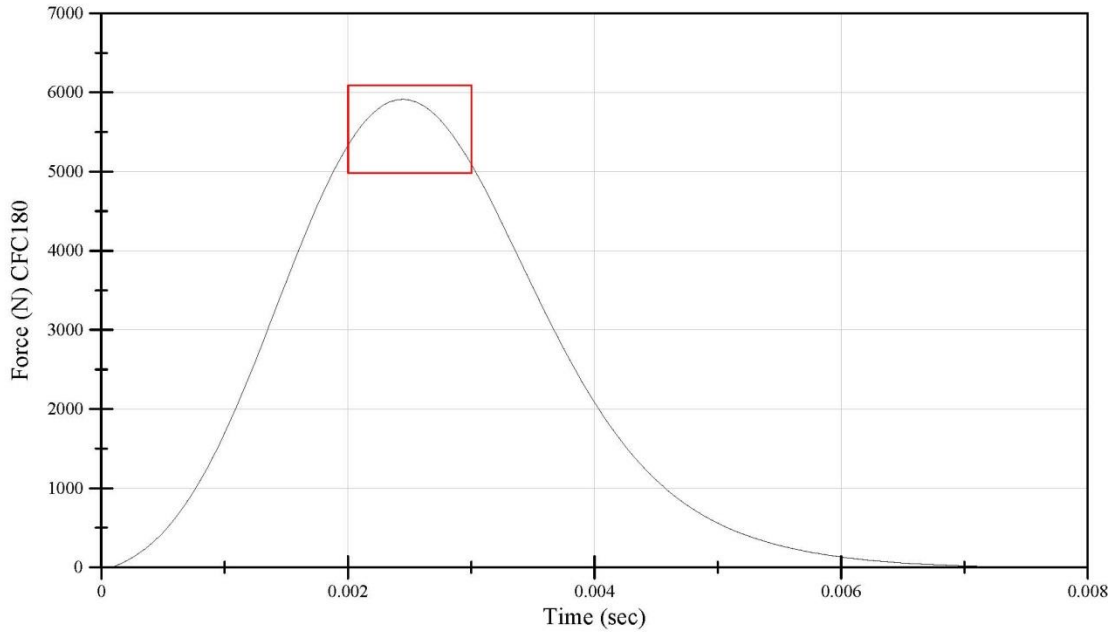
THOR Head Impact Certification
Probe Force
Serial Number: T015

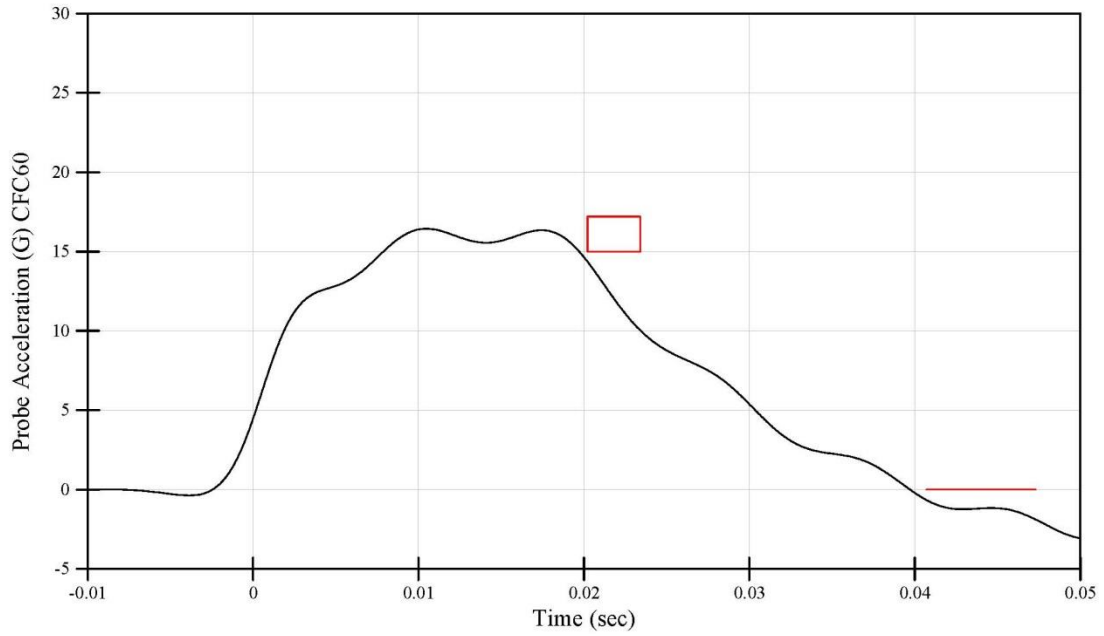
THOR Neck Right Lateral Flexion Certification
Probe Acceleration
Serial Number: T015
