REPORT NUMBER: R&D-CAL-14-001

**MOVING BARRIER TO VEHICLE CRASH TEST IN SUPPORT OF NHTSA'S
FRONTAL OBLIQUE OFFSET PROGRAM
RESEARCH MOVING DEFORMABLE BARRIER INTO LEFT FRONT OF A**

2014 Honda Accord

90.1KPH, 15 DEGREE ANGLE, 35% OVERLAP

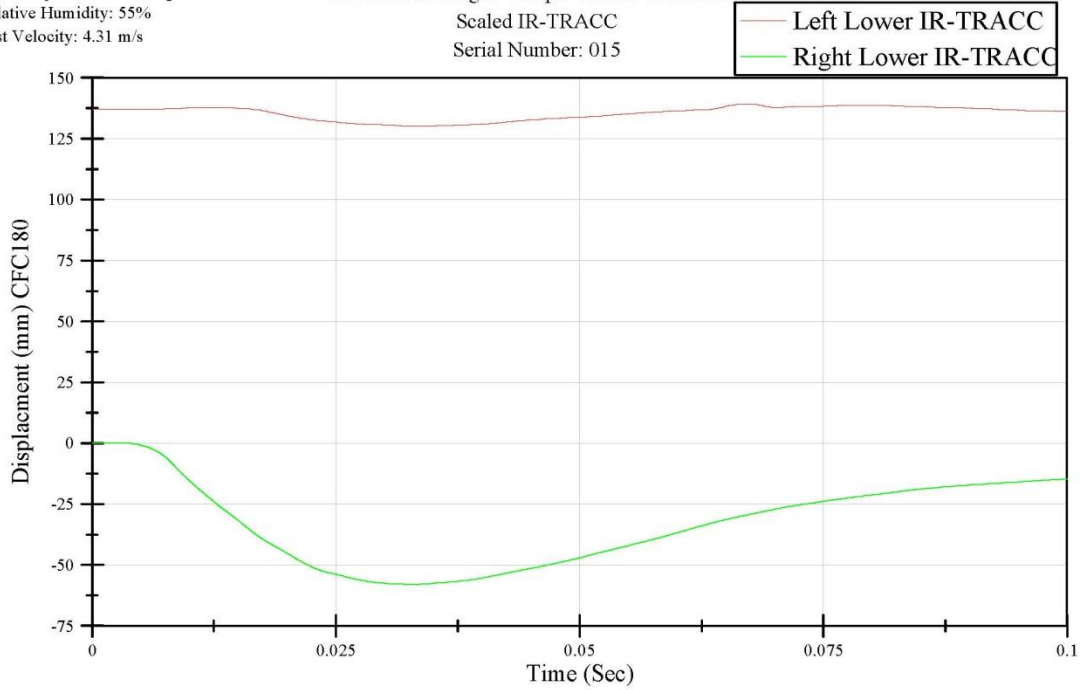
THOR Lower Right Oblique Thorax Certification
Scaled IR-TRACC
Serial Number: 015

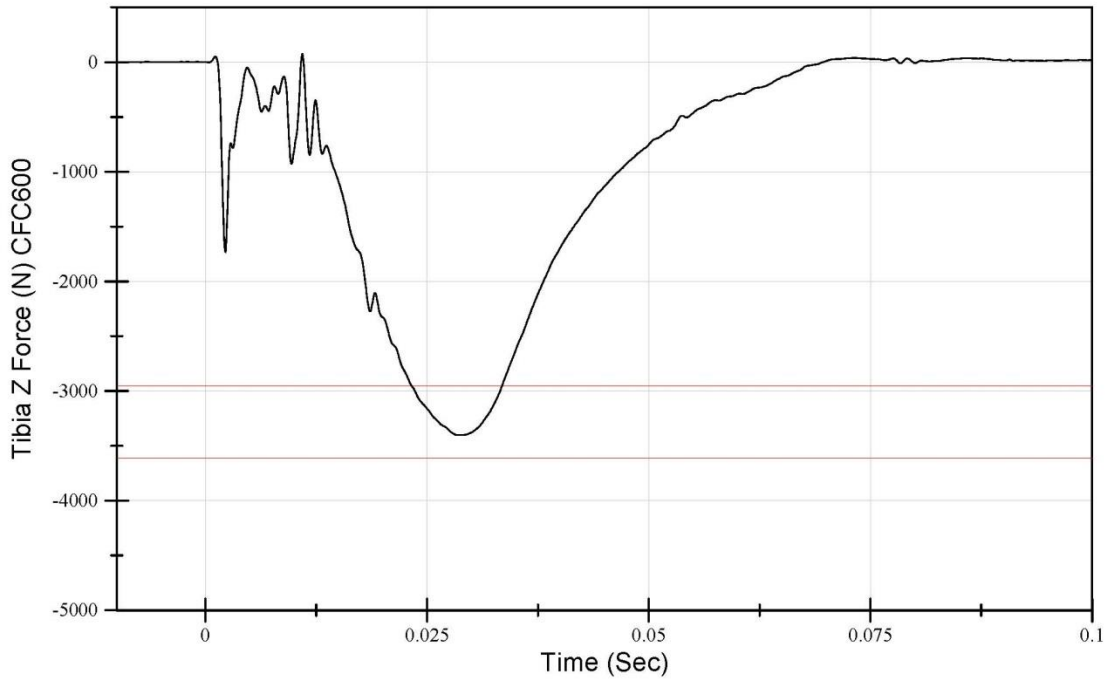
THOR Right Foot Dorsiflexion Certification
Tibia Load
Serial Number: LX0038

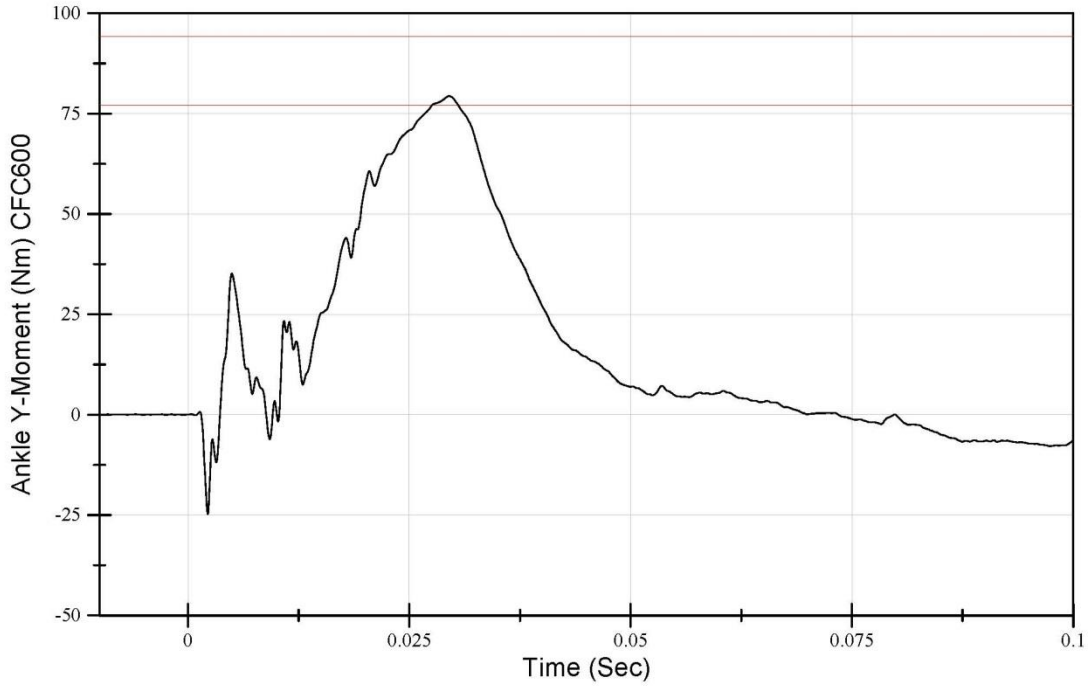
THOR Right Foot Dorsiflexion Certification
Ankle Y-Moment
Serial Number: LX0038

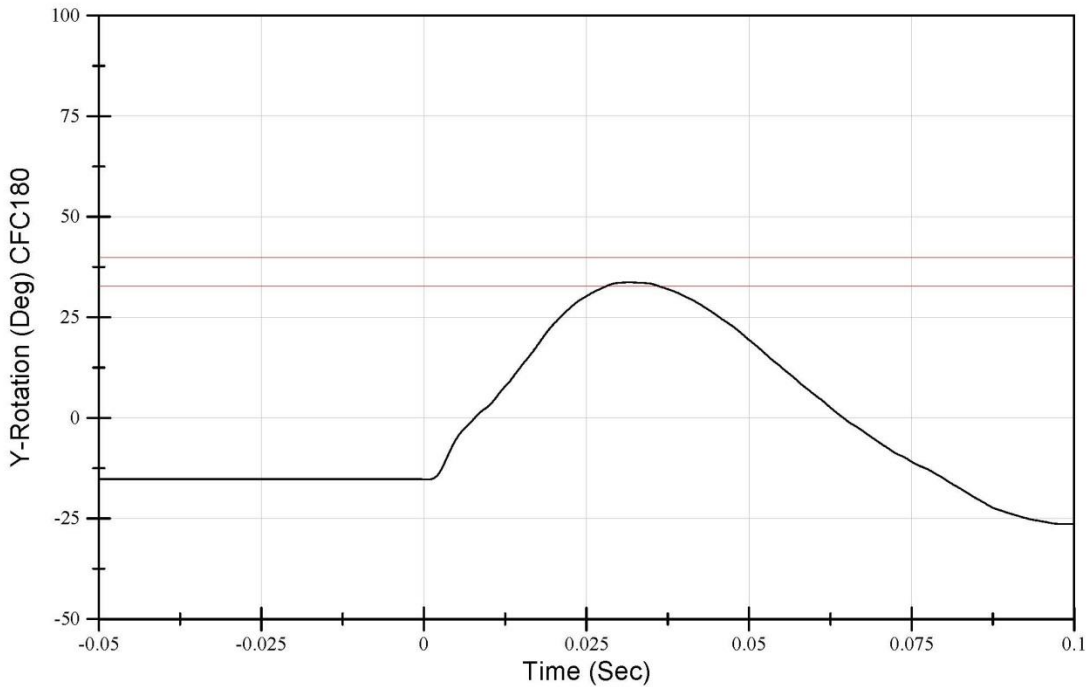
THOR Right Foot Dorsiflexion Certification
Ankle Y-Rotation
Serial Number: LX0038

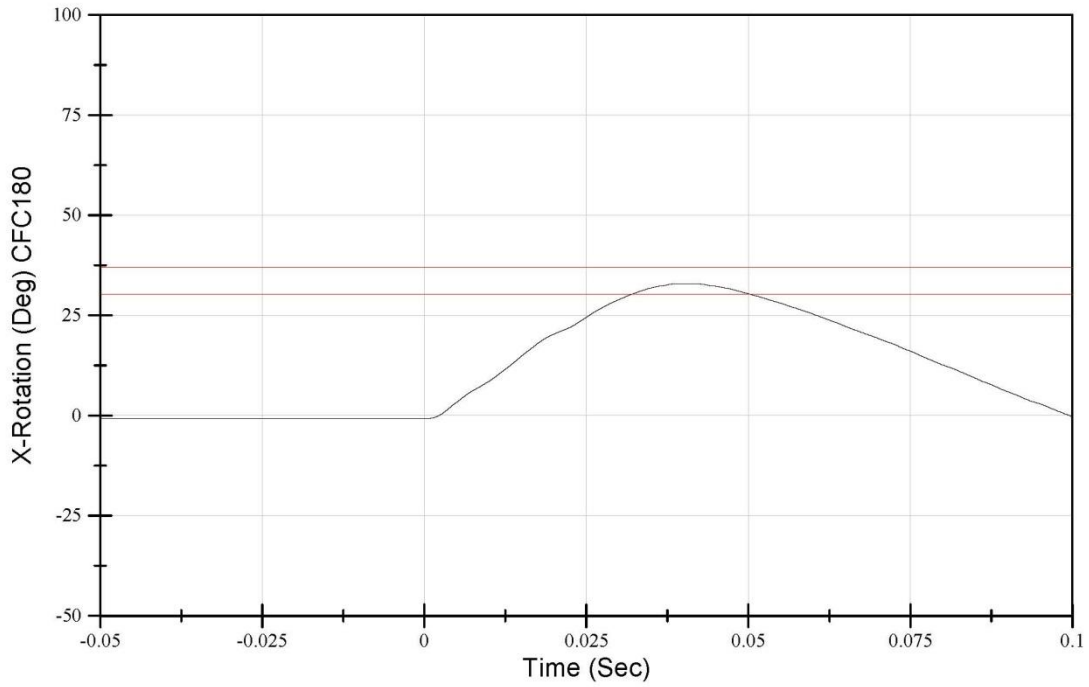
THOR Right Foot Inversion Certification
Ankle X-Rotation
Serial Number: LX0038

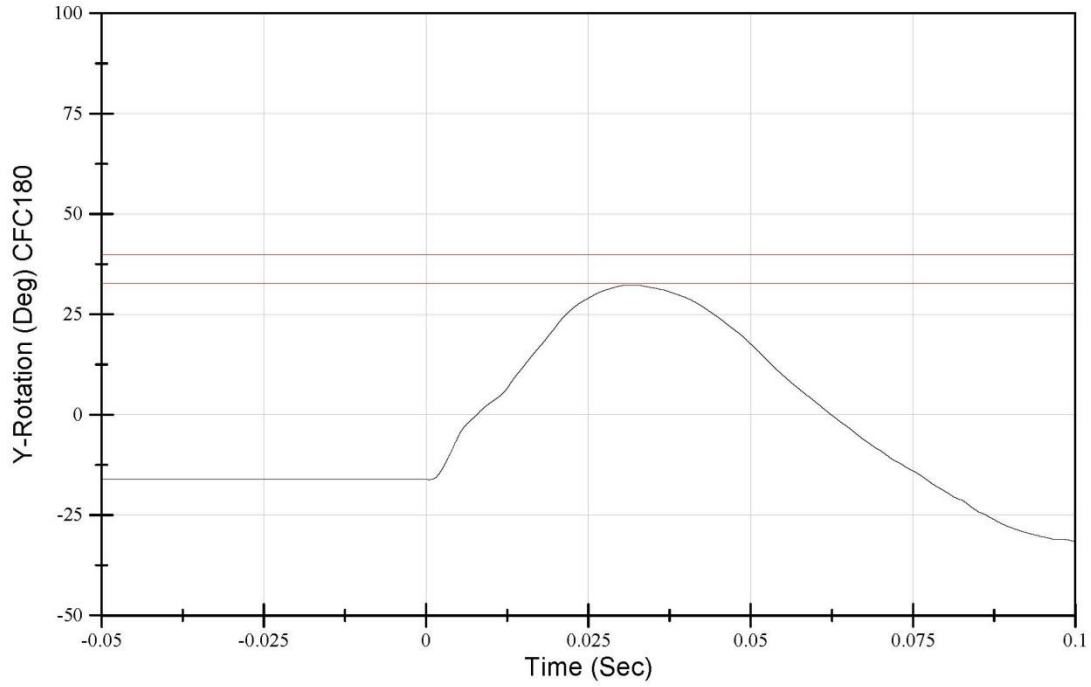
THOR Left Foot Dorsiflexion Certification
Ankle Y-Rotation
Serial Number: LX0039

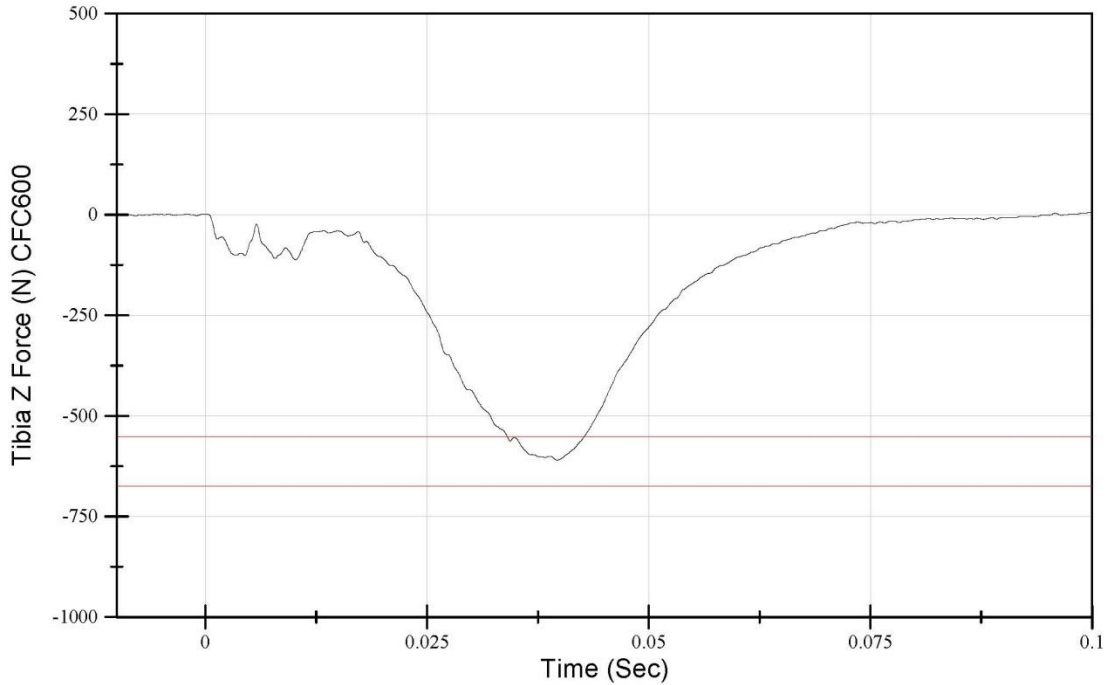
THOR Left Foot Eversion Certification
Tibia Load
Serial Number: LX0039

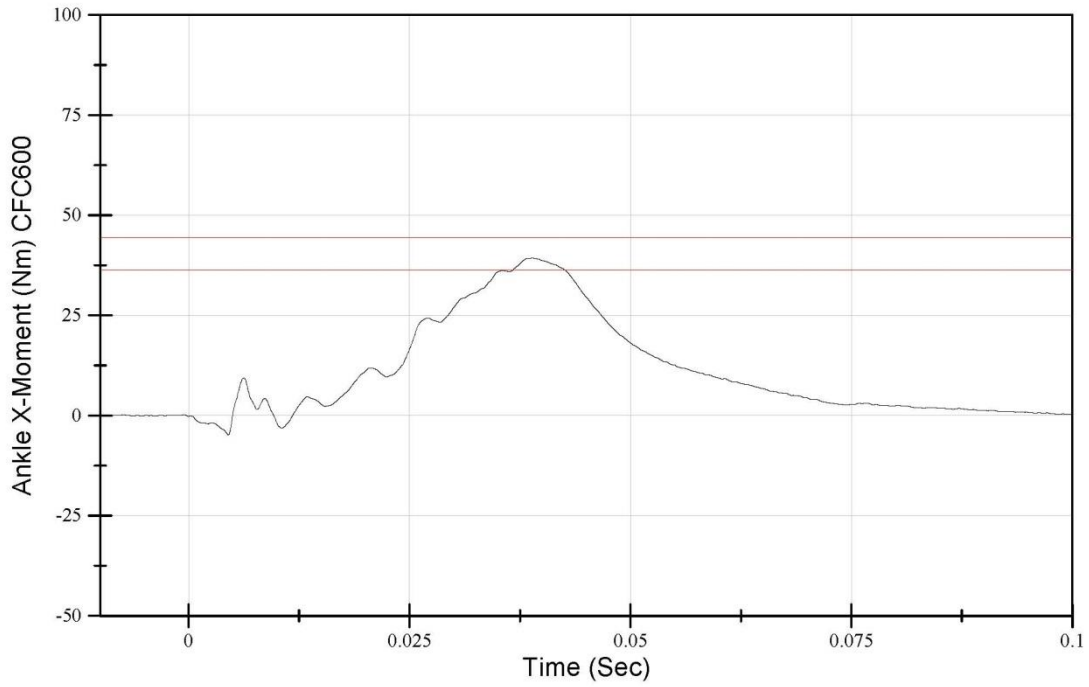
THOR Left Foot Eversion Certification
Ankle Moment
Serial Number: LX0039

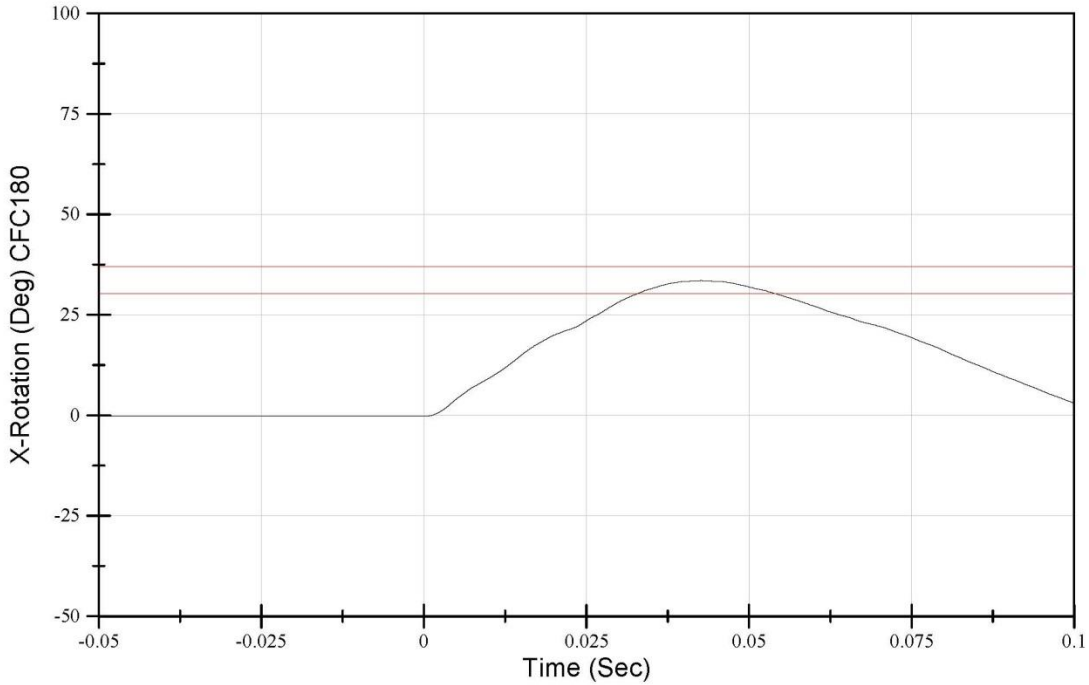
THOR Left Foot Eversion Certification
Ankle X-Rotation
Serial Number: LX0039

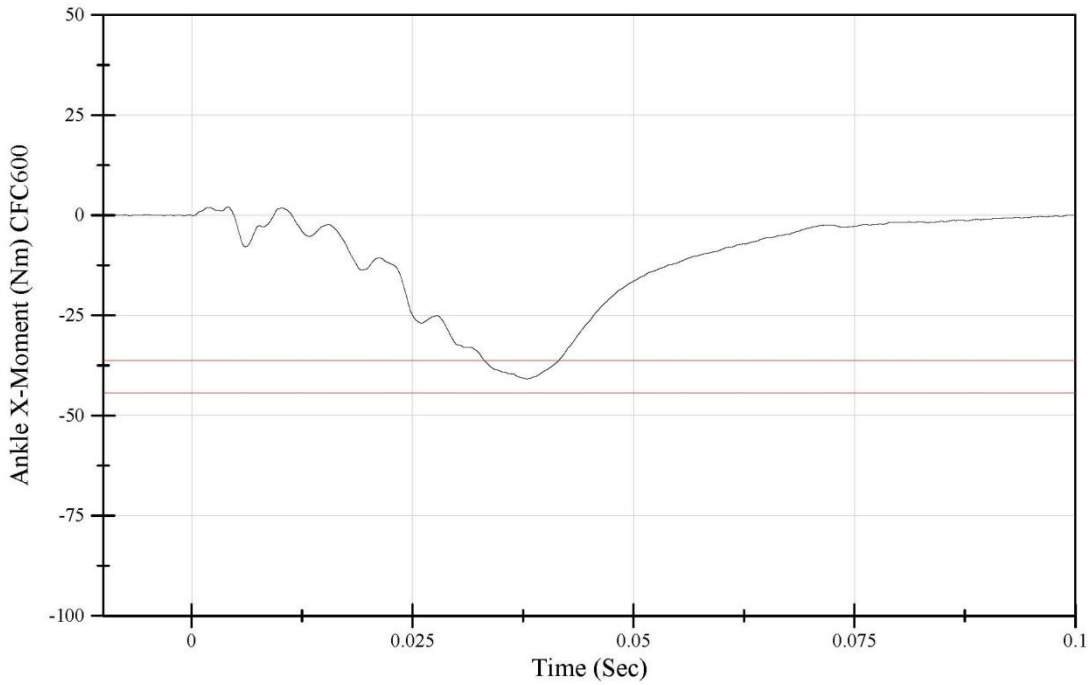
THOR Left Foot Inversion Certification
Ankle Moment
Serial Number: LX0039

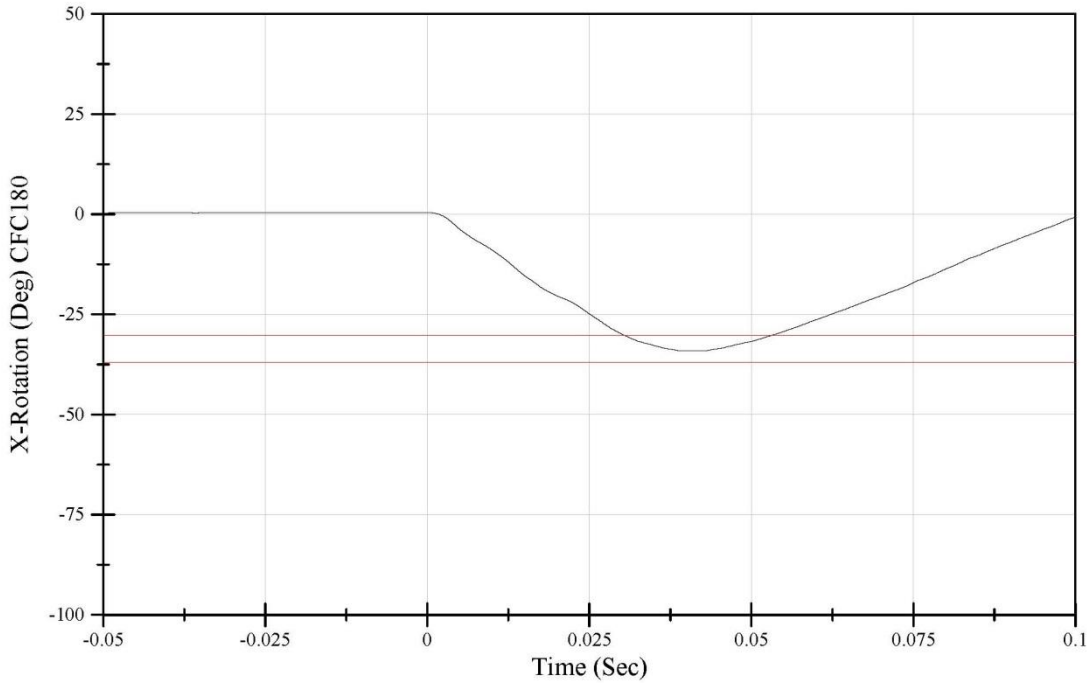
THOR Left Foot Inversion Certification
Ankle X-Rotation
Serial Number: LX0039
