**REPORT NUMBER: R&D-CAL-14-007**

**MOVING BARRIER TO VEHICLE CRASH TEST IN SUPPORT OF NHTSA'S  
FRONTAL OBLIQUE OFFSET PROGRAM  
RESEARCH MOVING DEFORMABLE BARRIER INTO LEFT FRONT OF A**

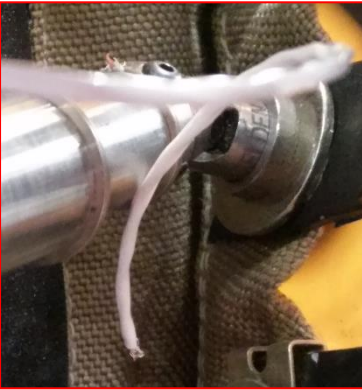
| OTHER | <p><b>Hole in chest damper foam on the left side</b></p> <p><b>Right lower Dx IRTRACC cable broke at front end. Test data (300ms) was not affected. IRTRACC swapped with left lower tube per Dan/James' email approval on 6/26/14.</b></p> <p><b>IRTRACC Replaced and is functional</b></p> |

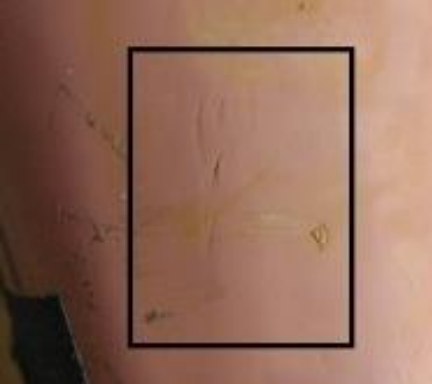
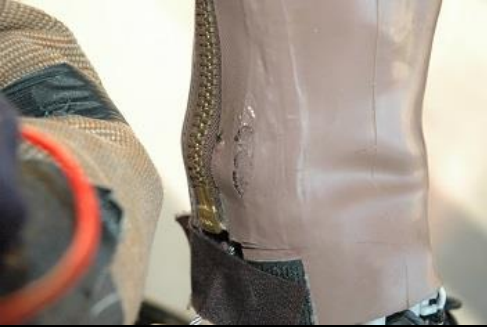
| LOWER EXTREMITY (LX) | |
|---|---|
| Y / N | <p>No cuts, tears, or scuffing of leg flesh</p> <p><b>Right leg flesh is torn at zipper attachment.</b></p> <p><b>Right leg flesh is much more torn after CAL2712. Repair was made with Gaffer's tape.</b></p> <p><b>Right leg scuffing</b></p> <p><b>Right leg flesh has multiple small cuts:</b></p> <p><b>Left leg zipper is pulling away from leg flesh:</b></p> |

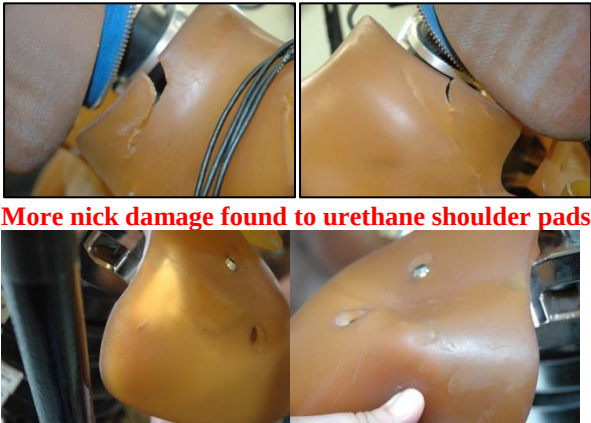
| SHOULDER | |
|---|---|
| Y / N | <p>Urethane shoulder pads show no evidence of contact</p> <p><b>Both shoulder pads are torn. We used Gaffer's tape to prevent further damage.</b></p> <p><b>More nick damage found to urethane shoulder pads</b></p> |

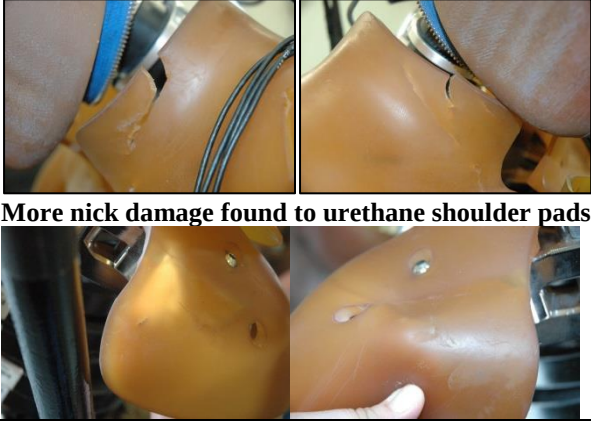
| SHOULDER | |
|---|---|
| Y / N | <p>Urethane shoulder pads show no evidence of contact</p> <p><b>Both shoulder pads are torn. We used Gaffer's tape to prevent further damage.</b></p> <p><b>More nick damage found to urethane shoulder pads</b></p> |

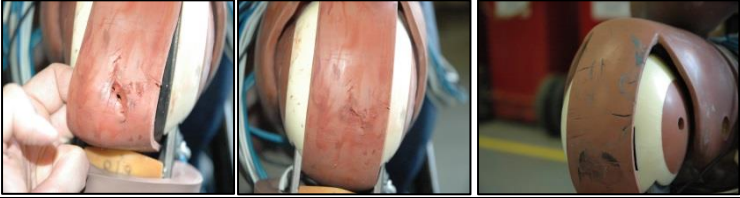
| OTHER | | |
