REPORT NUMBER: NCAP-MGA-2015-006

**NEW CAR ASSESSMENT PROGRAM (NCAP)
Frontal Barrier Impact Test**

**GENERAL MOTORS LLC
2014 Cadillac CTS AWD 4-Dr Sedan
NHTSA No.: O20140102**

**MGA RESEARCH CORPORATION
5000 Warren Road
Burlington, WI 53105**

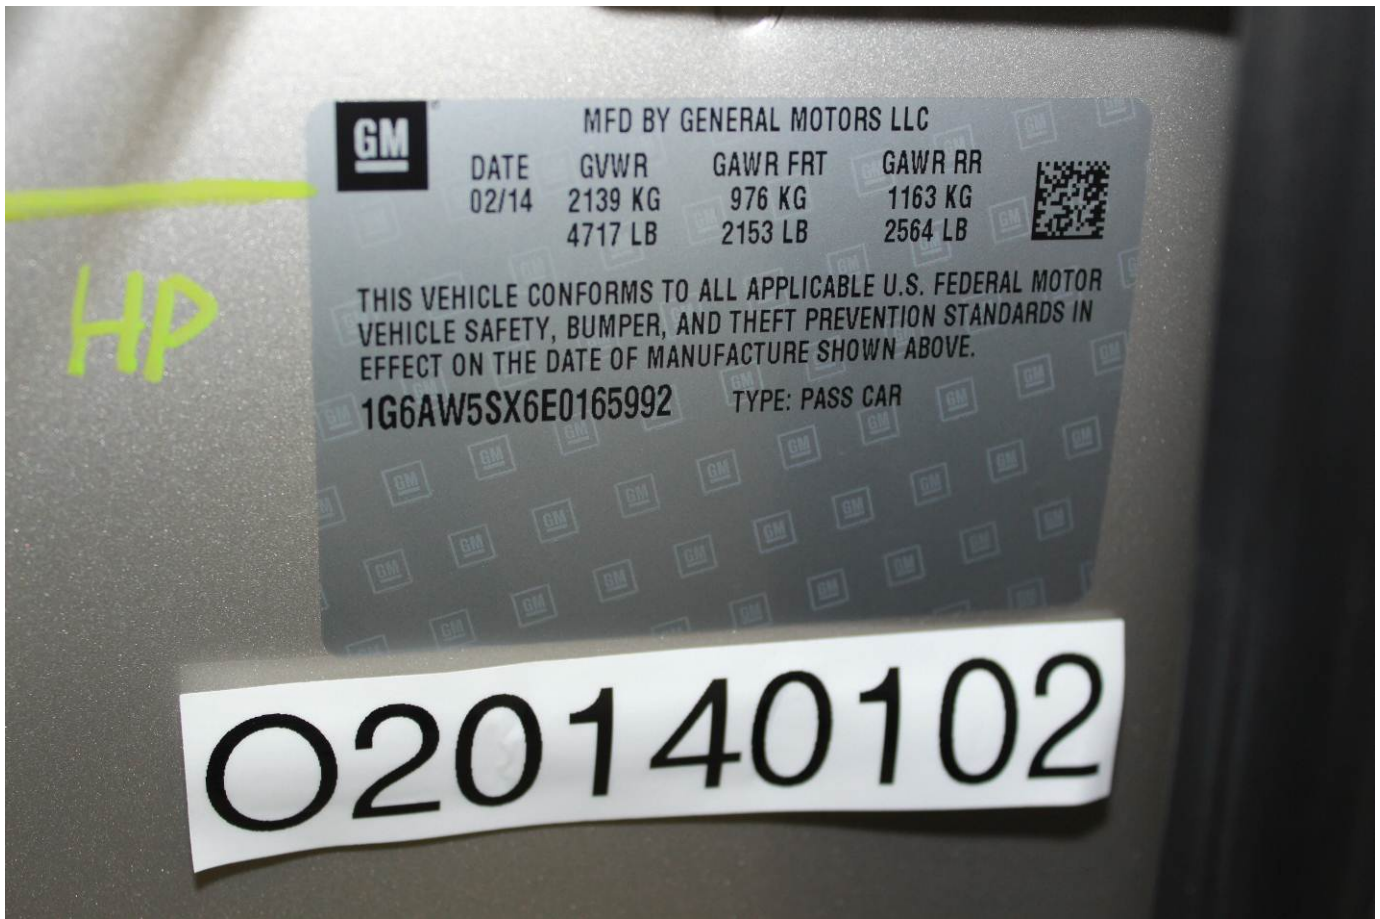
Manufacturer's Label

Manufactured By	General Motors LLC	GVWR (kg)	2139
Date of Manufacture	02/14	GAWR Front (kg)	976
		GAWR Rear (kg)	1163

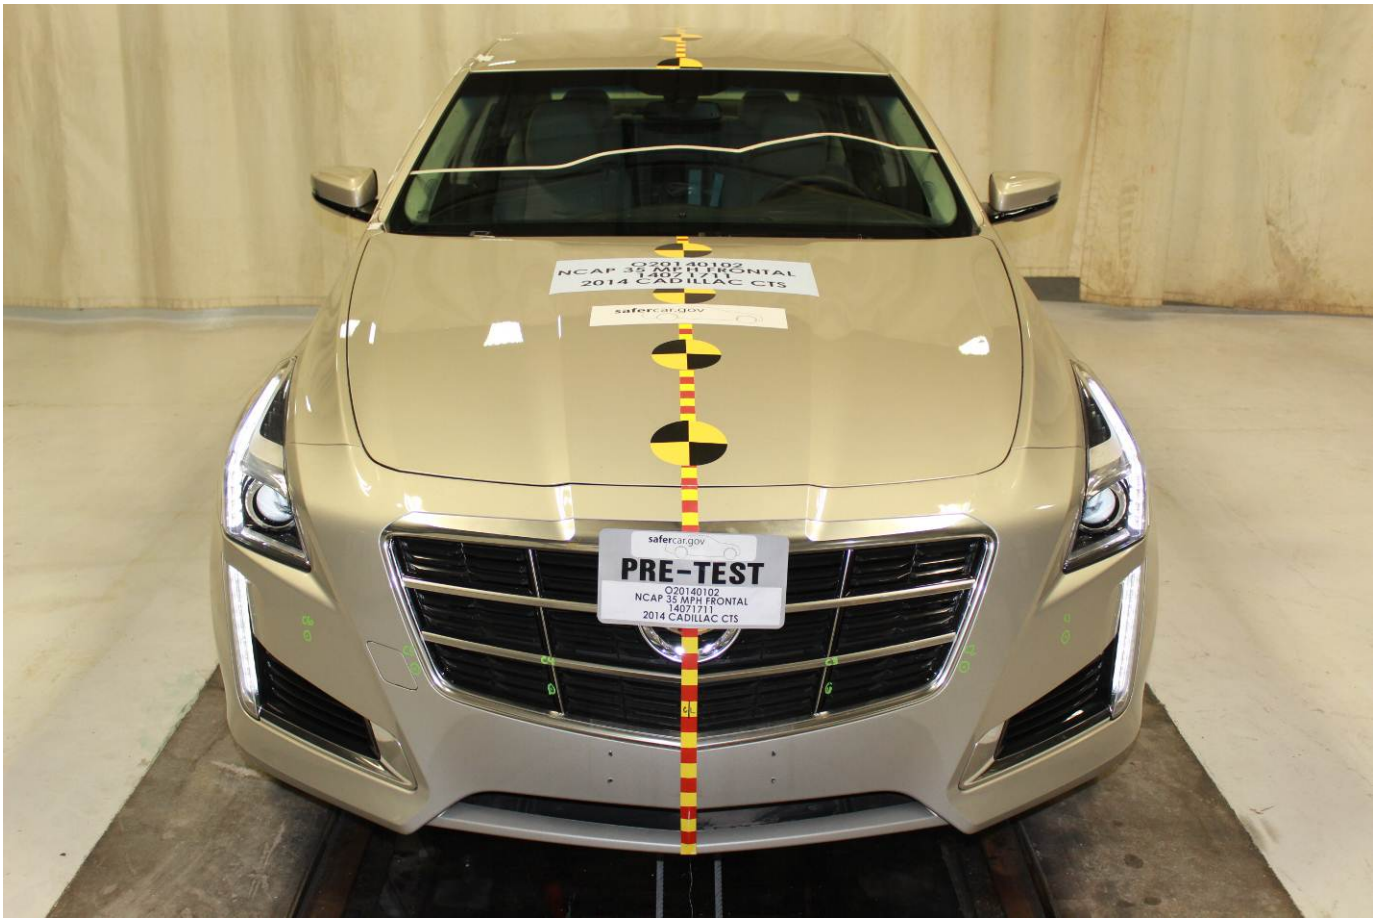
Pre-Test Front View of Test Vehicle

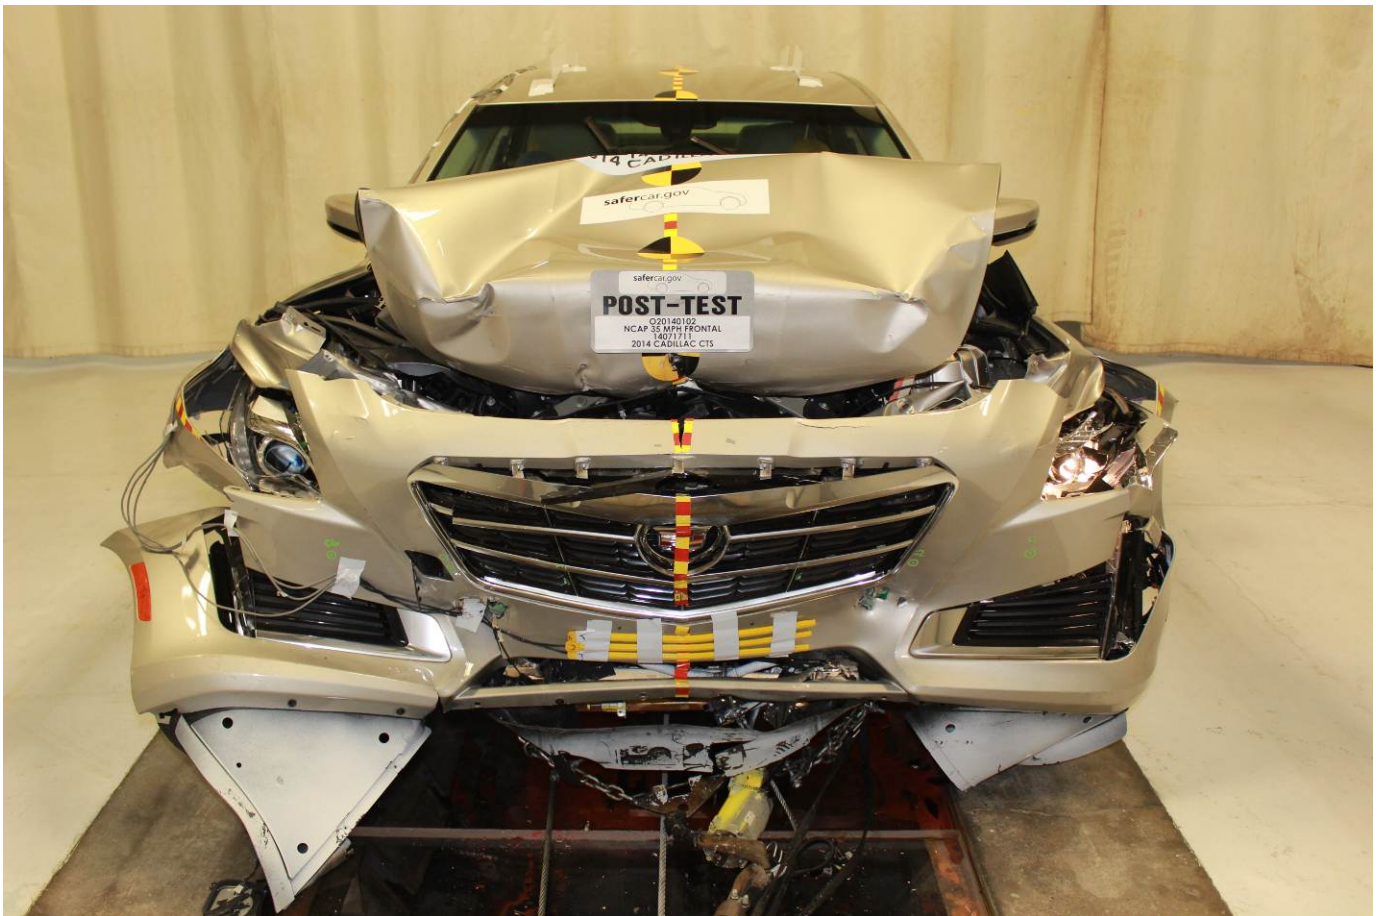
Post-Test Front View of Test Vehicle

The maximum static crush of the vehicle was 521 mm and both the driver and passenger side doors remained closed during the impact event and were operable after the impact.

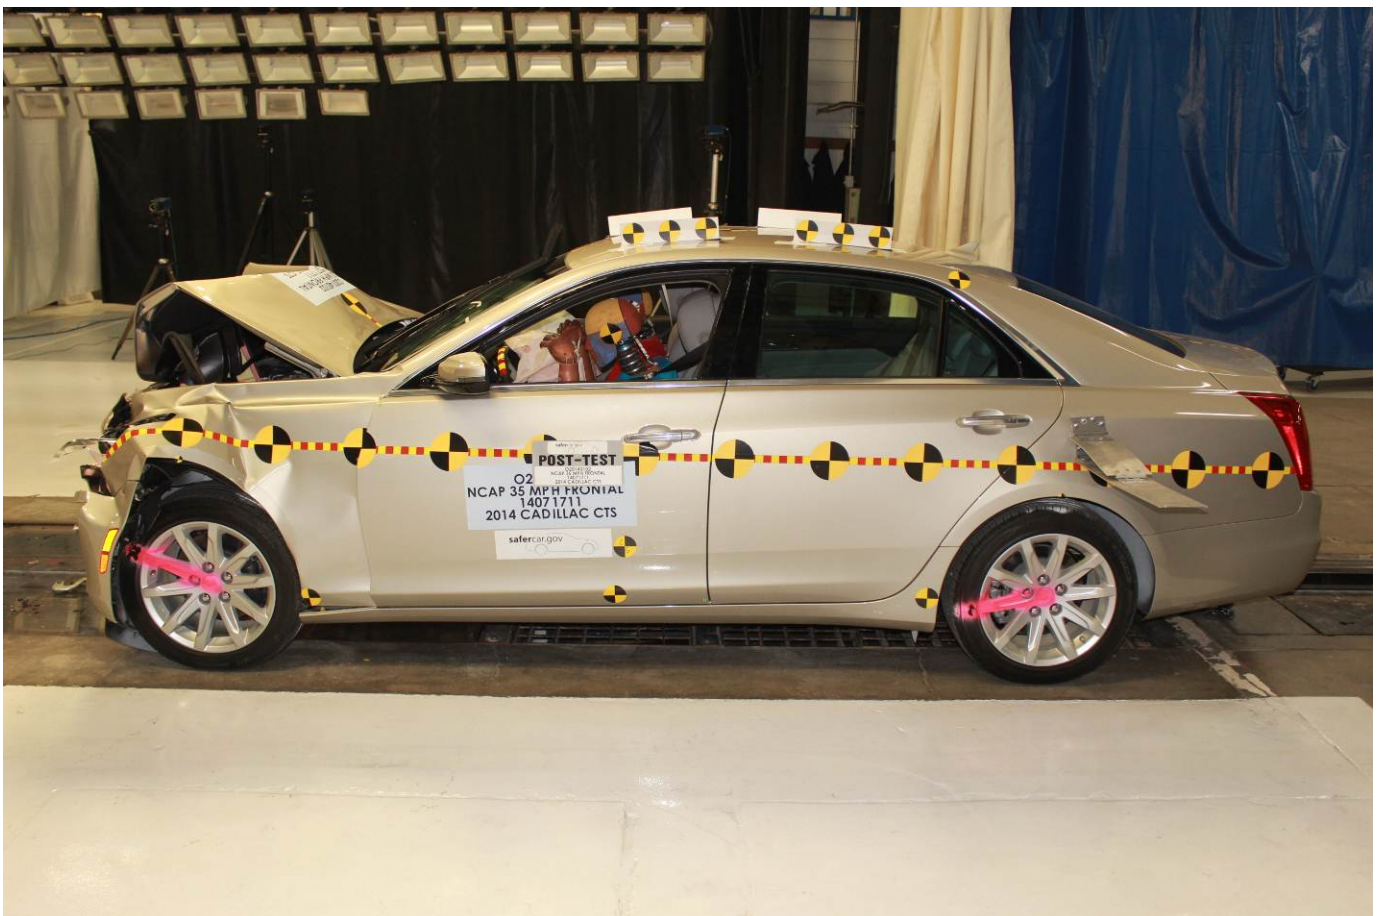
Post-Test Left View of Test Vehicle

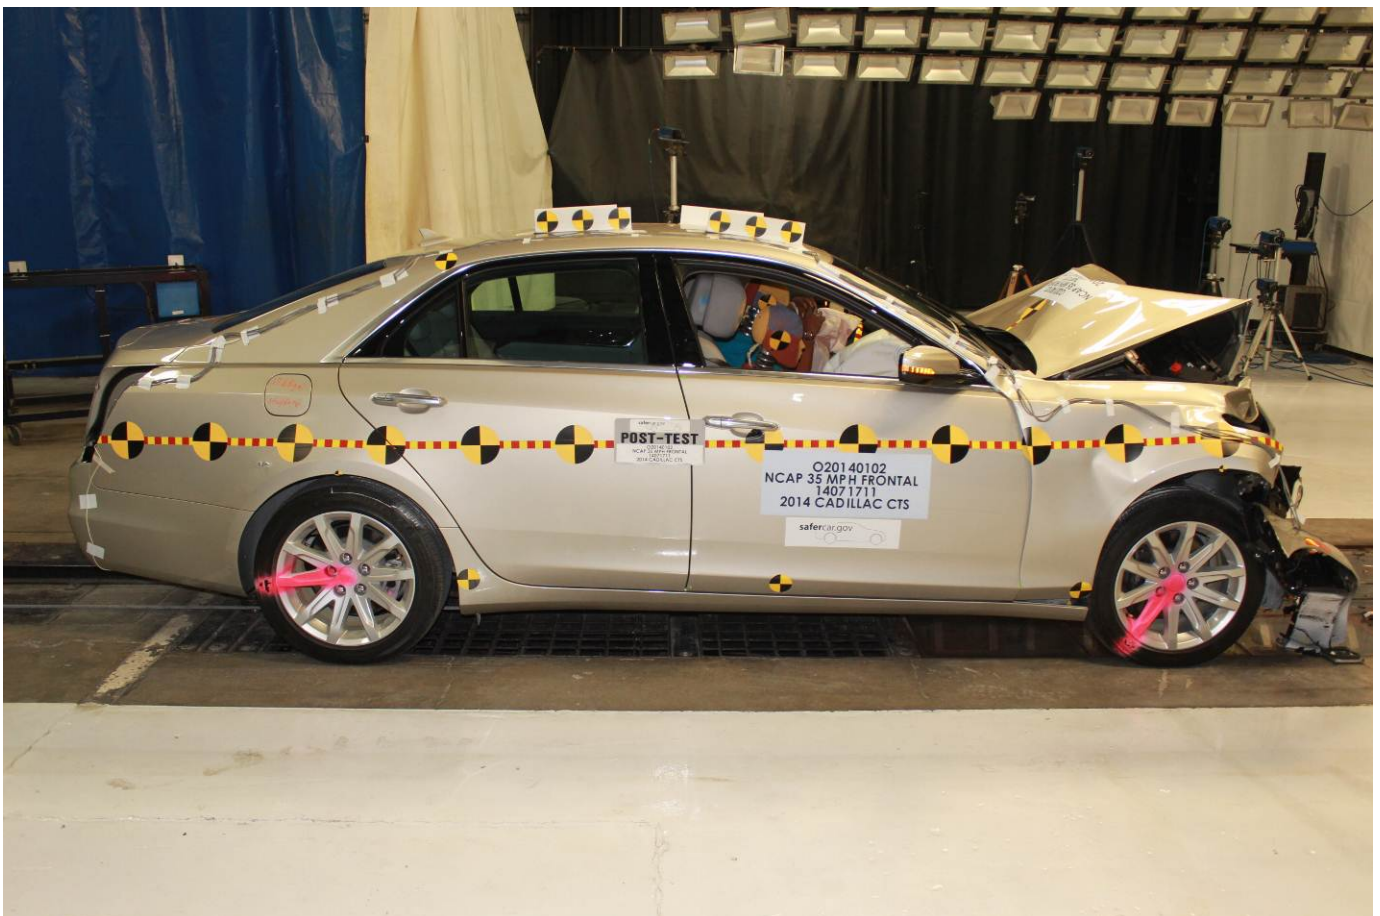
Post-Test Right View of Test Vehicle

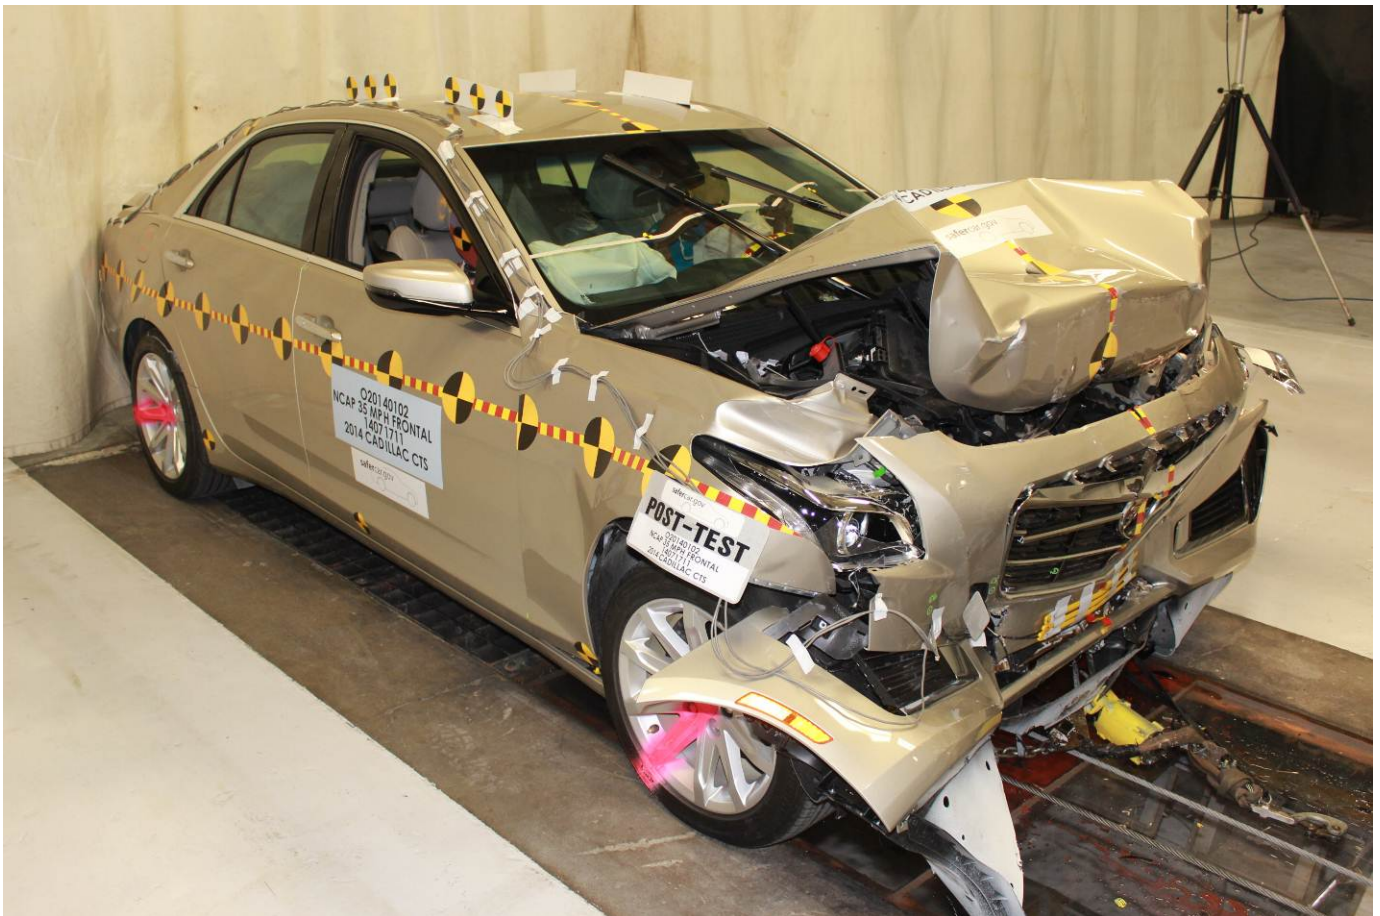
Post-Test Right Front 3-4 View

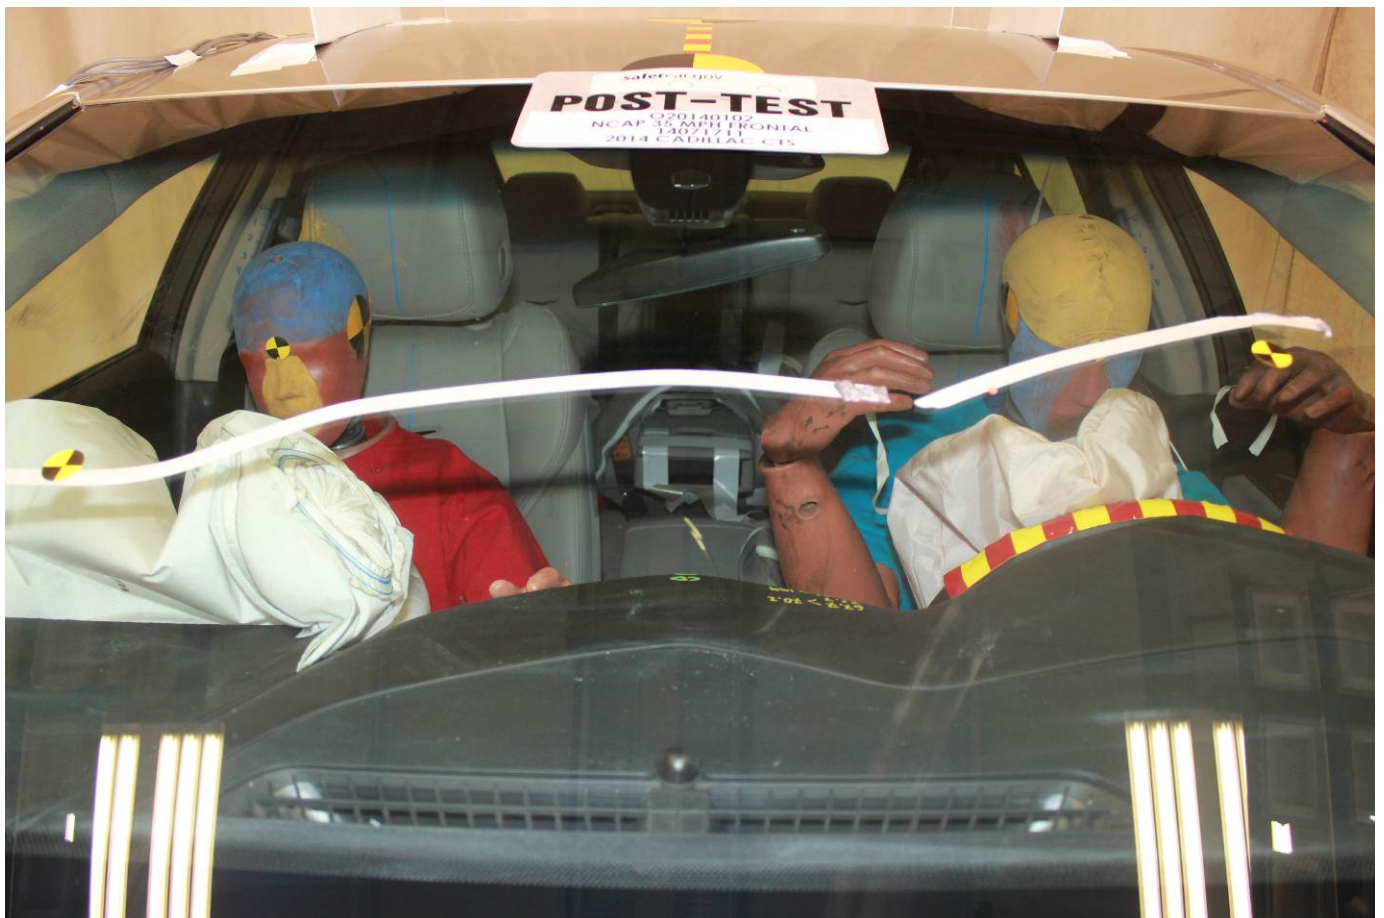
Post-Test Windshield View

There was 100 percent windshield retention and no intrusion into the protected zone of the windshield during the event. There was no Stoddard Solvent leakage after the event or during any phase of the static rollover.

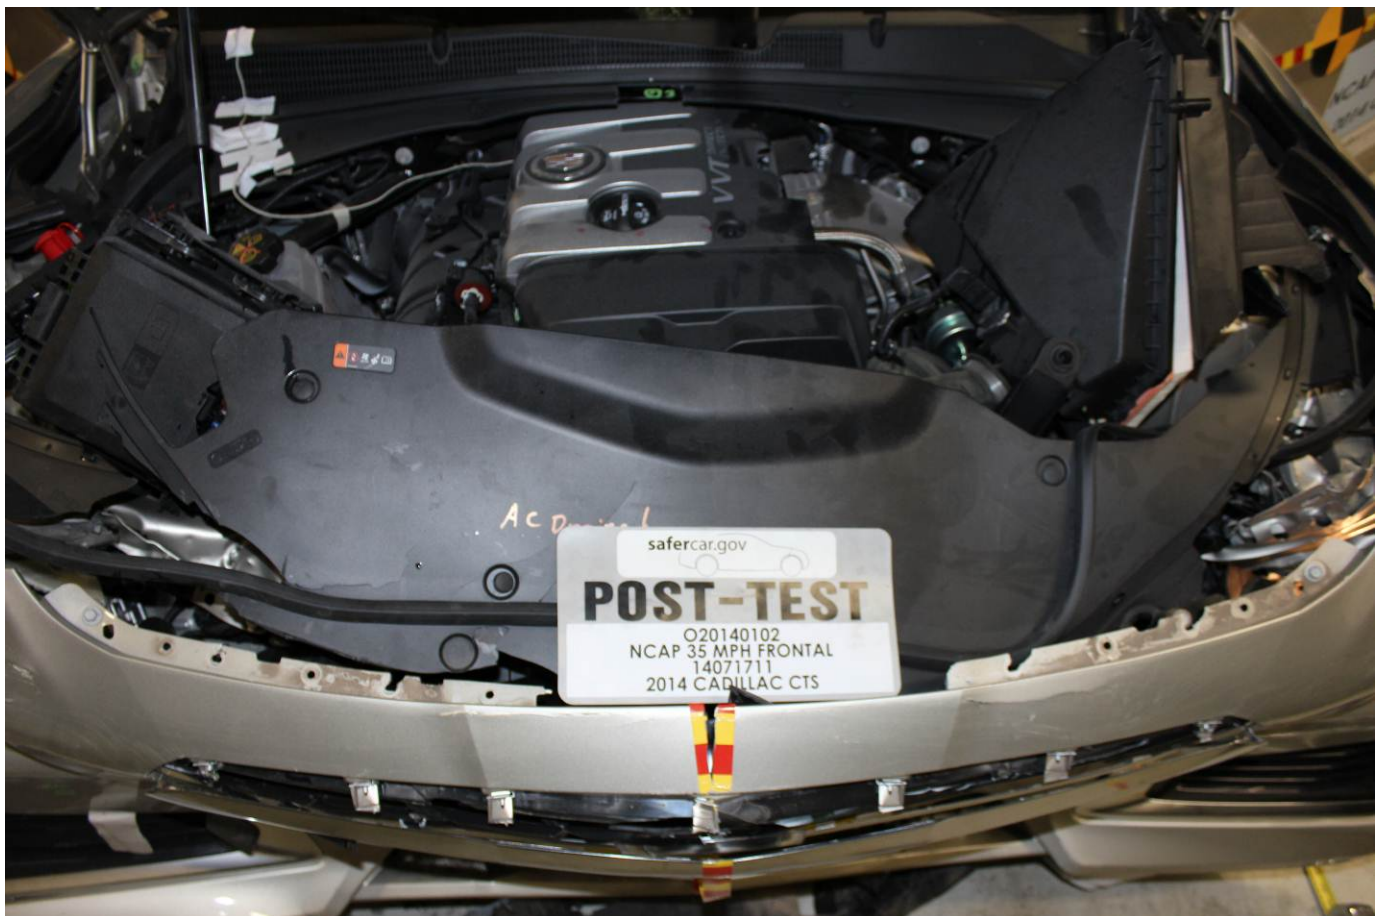
Post-Test Engine Compartment View

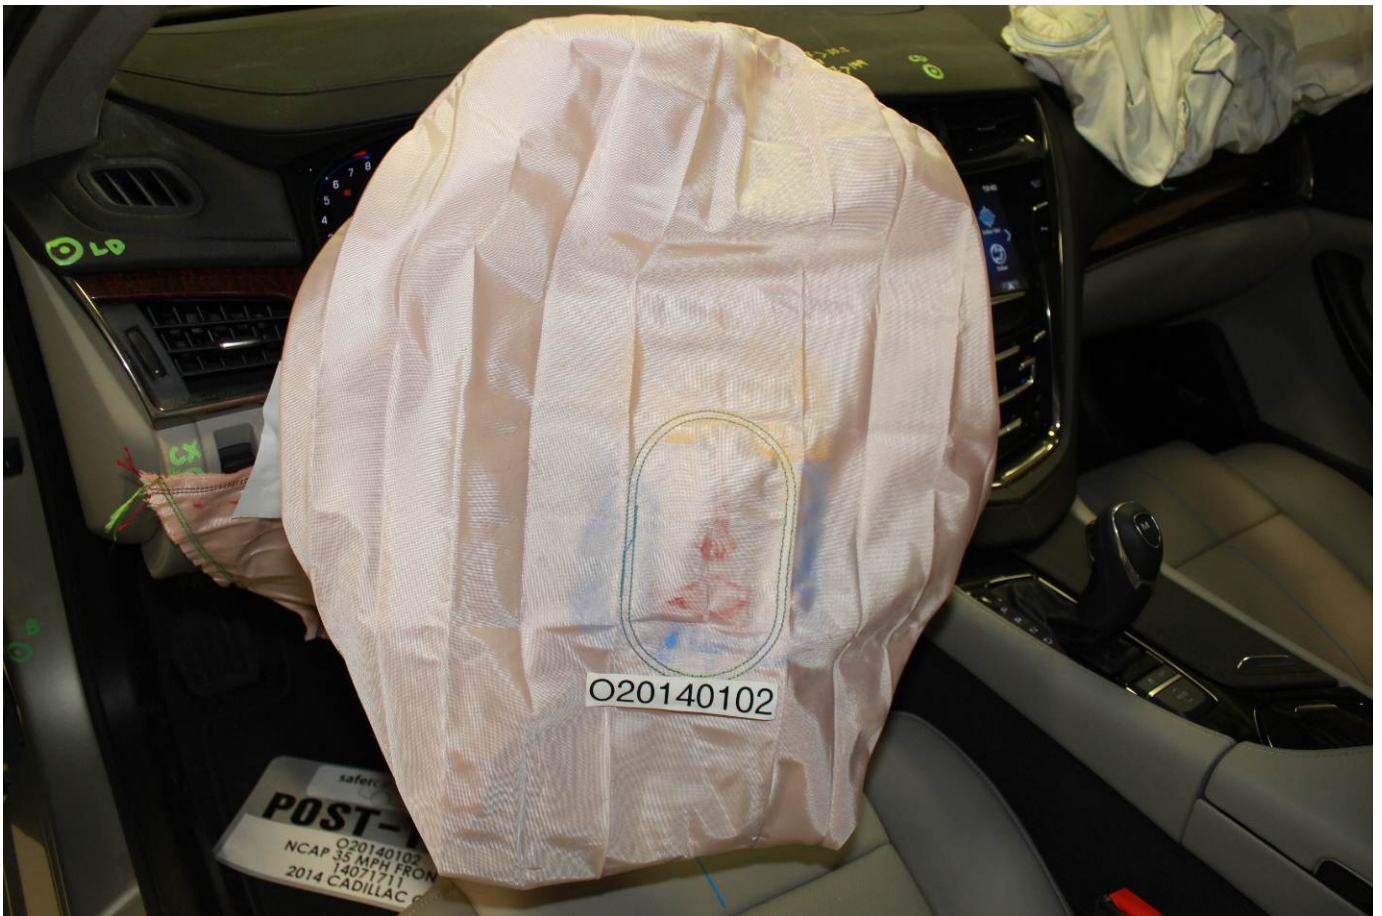
Post-Test Driver Dummy Contact with Airbag

The driver's visible contact points were as follows: The driver's head and chest contacted the airbag. The driver's head also contacted the headrest. The driver's knees contacted the knee airbag. The passenger's visible contact points were as follows: The passenger's head and chest contacted the airbag. The passenger's head also contacted the headrest. The passenger's knees contacted the glovebox.

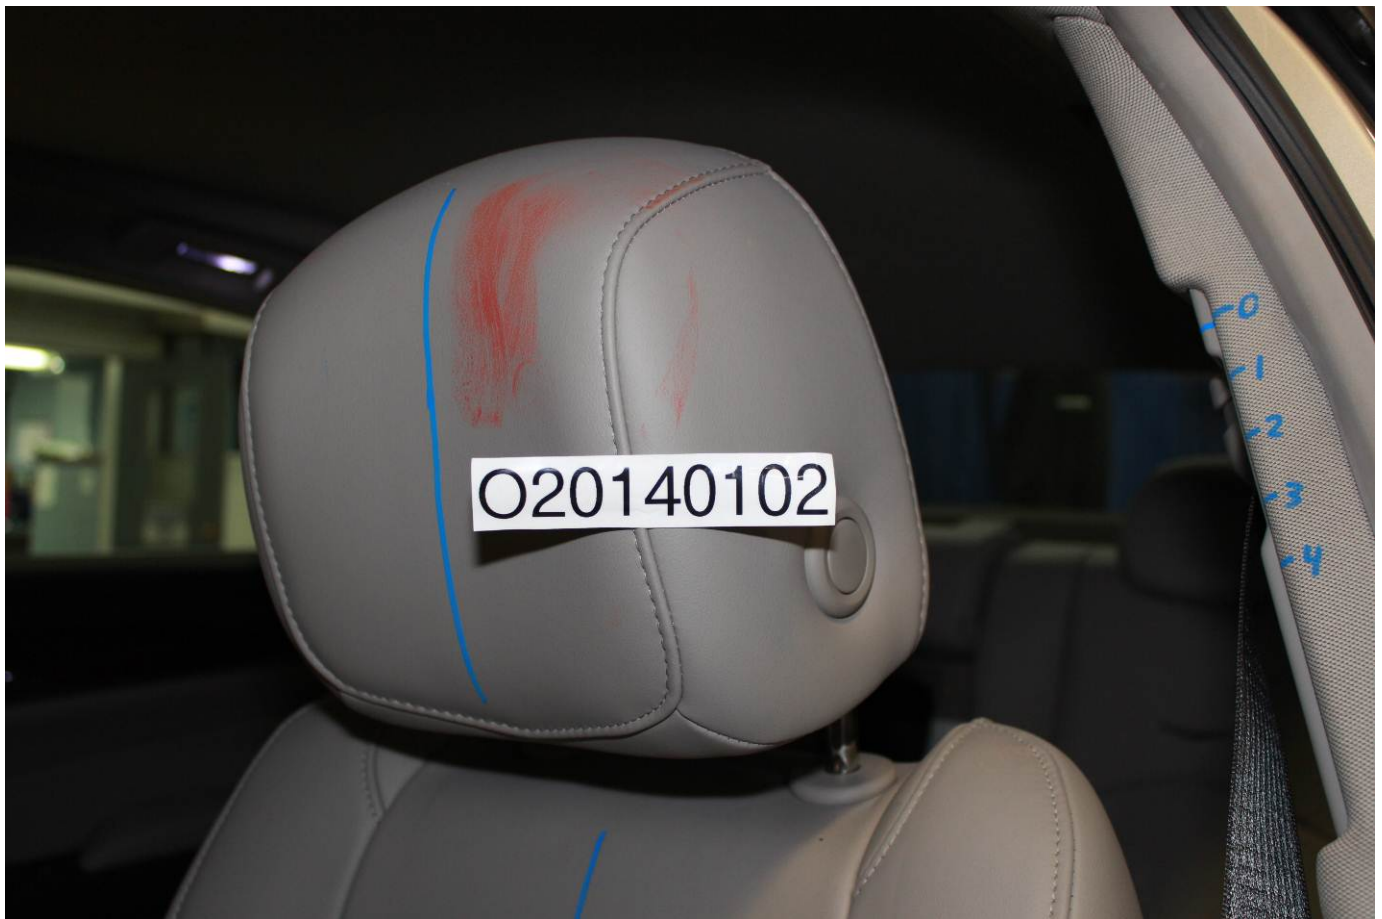
Post-Test Driver Dummy Contact with Headrest

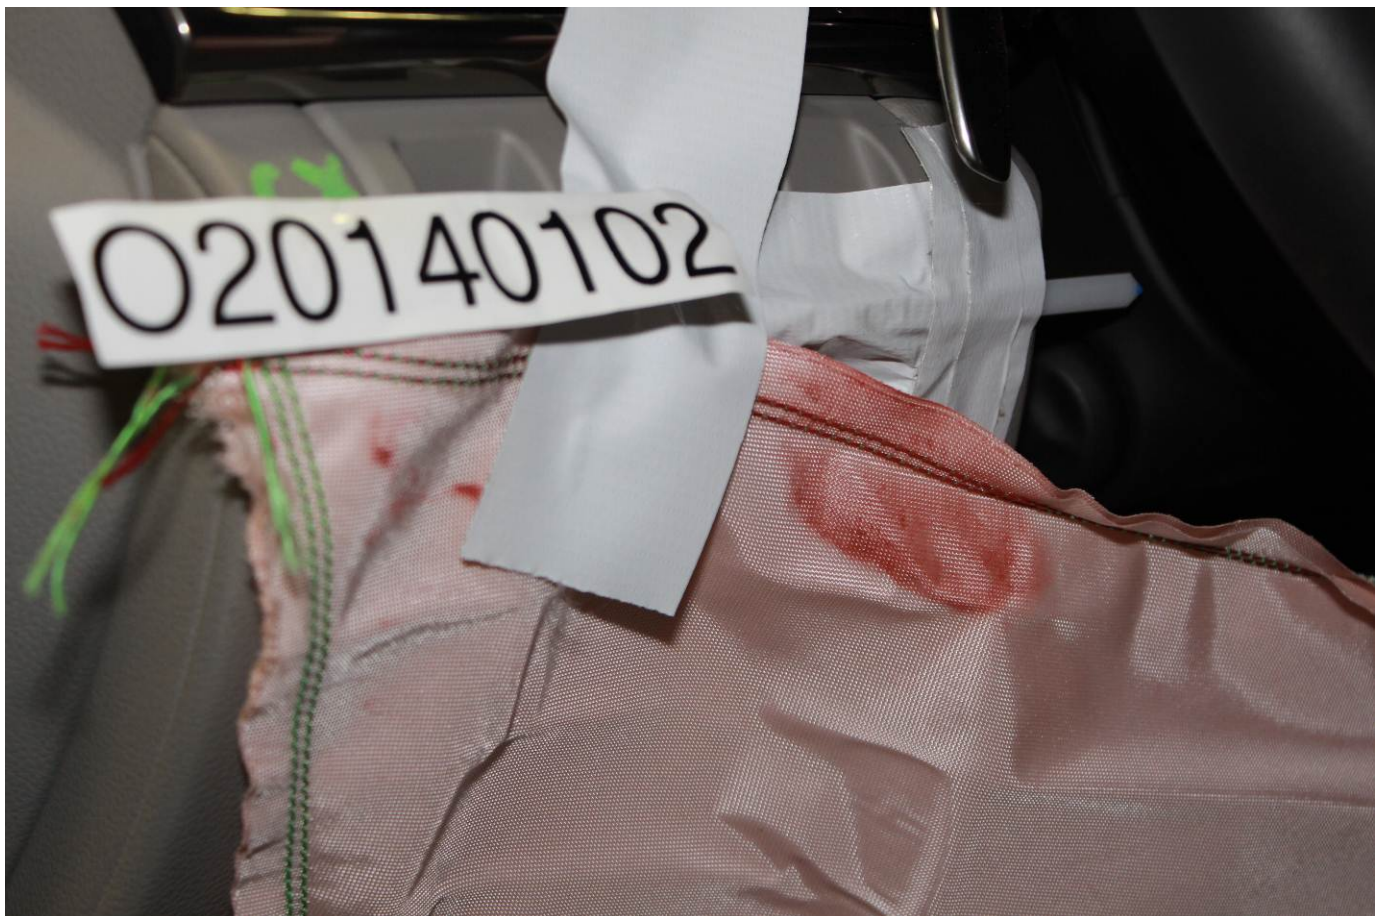
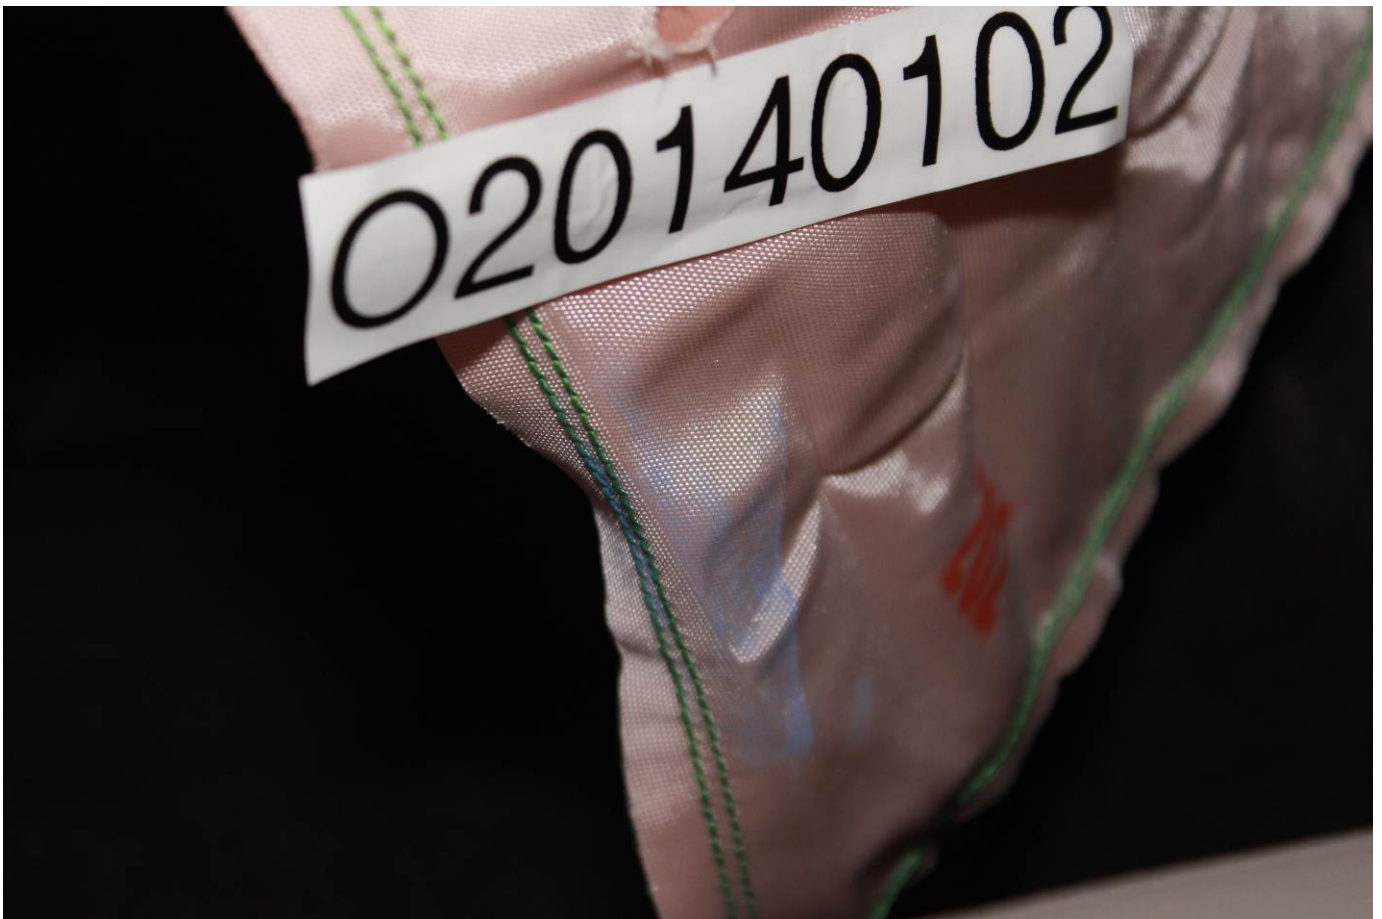
Post-Test Driver Dummy Contact with Knee Airbag

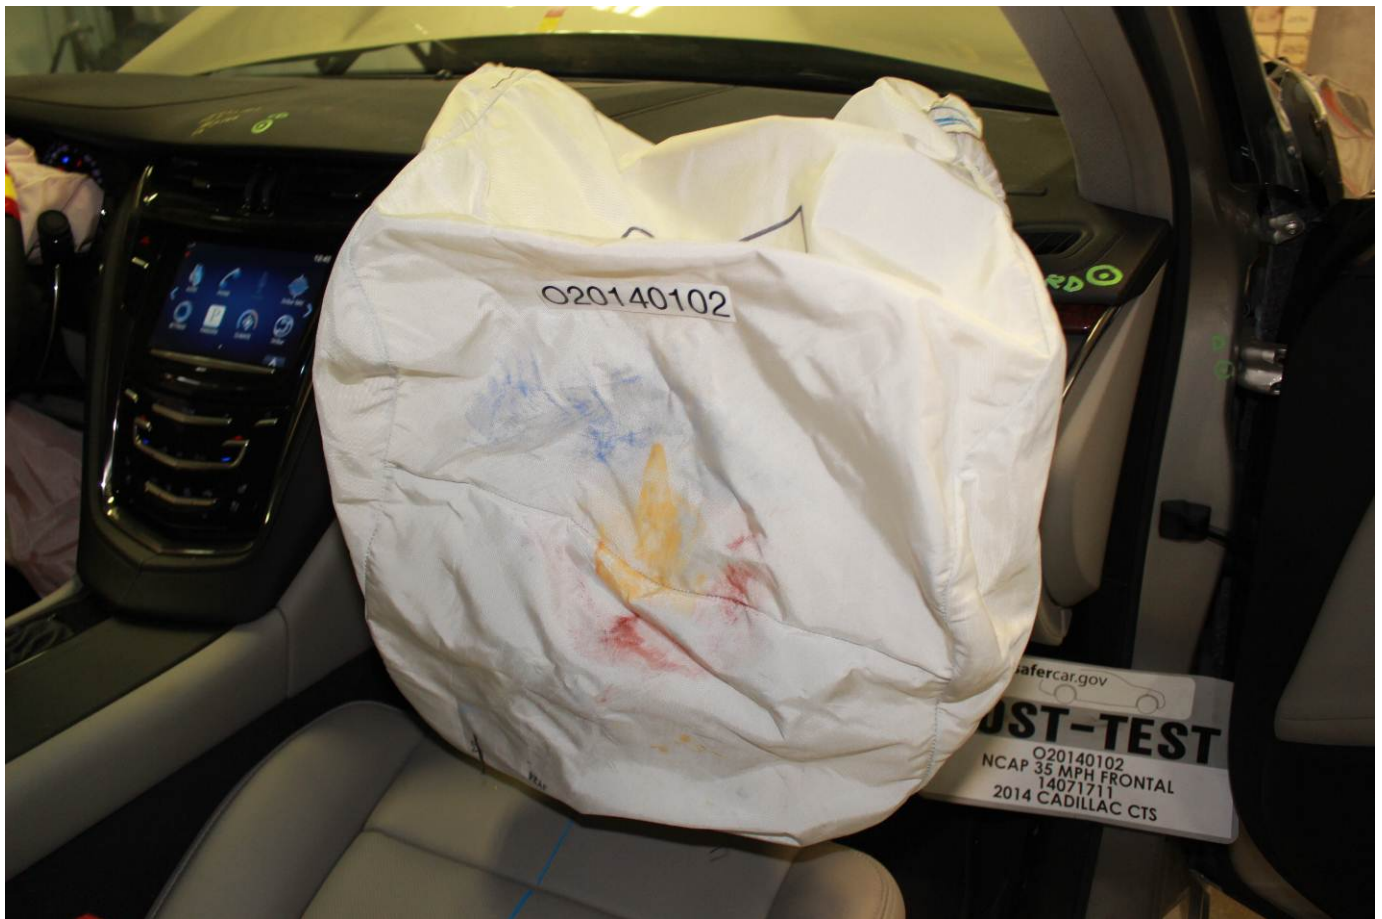
Post-Test Passenger Dummy Contact with Airbag

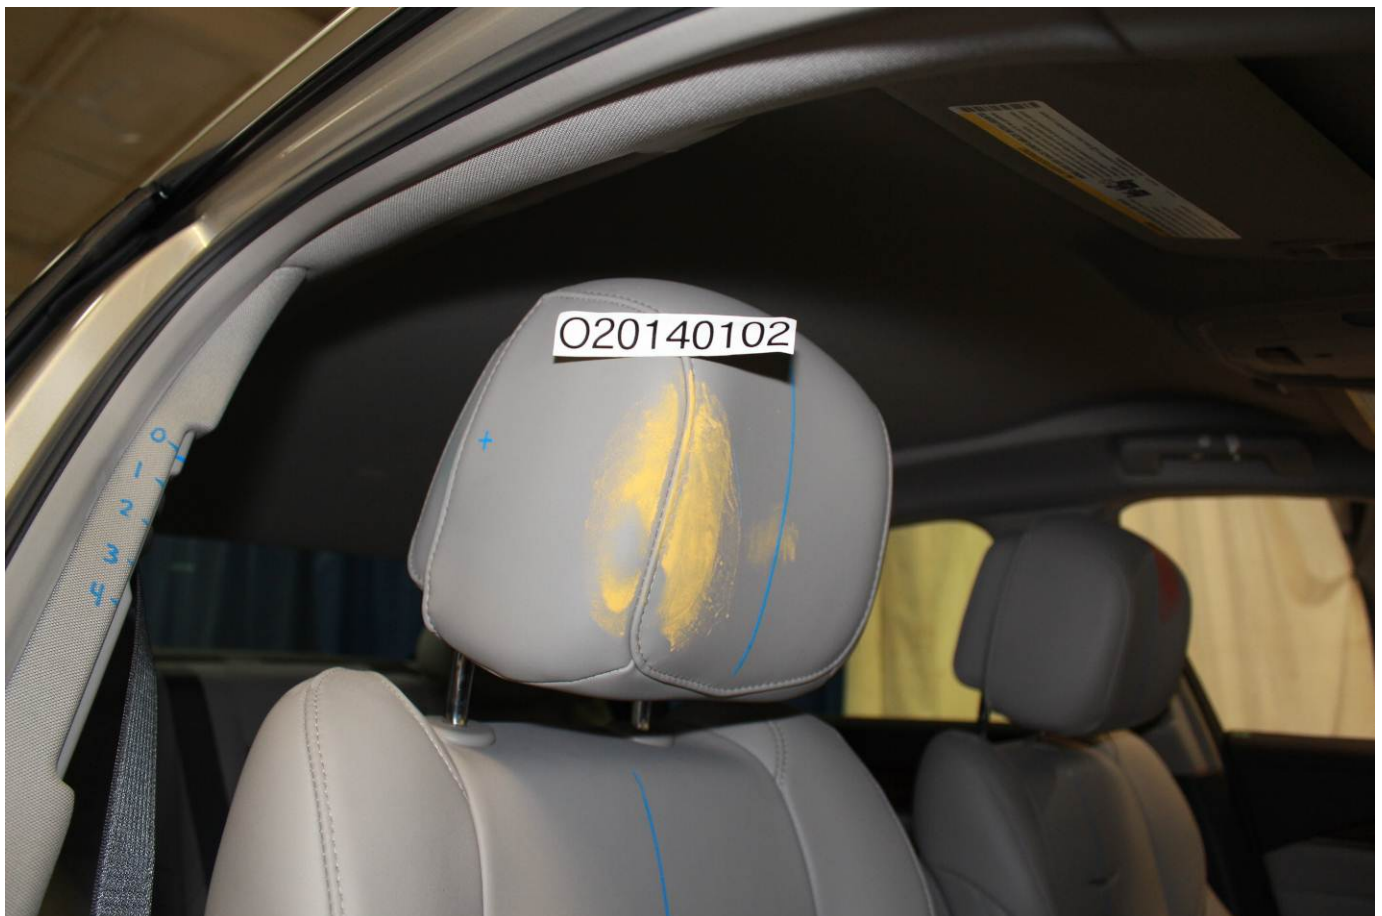
Post-Test Passenger Dummy Contact with Headrest

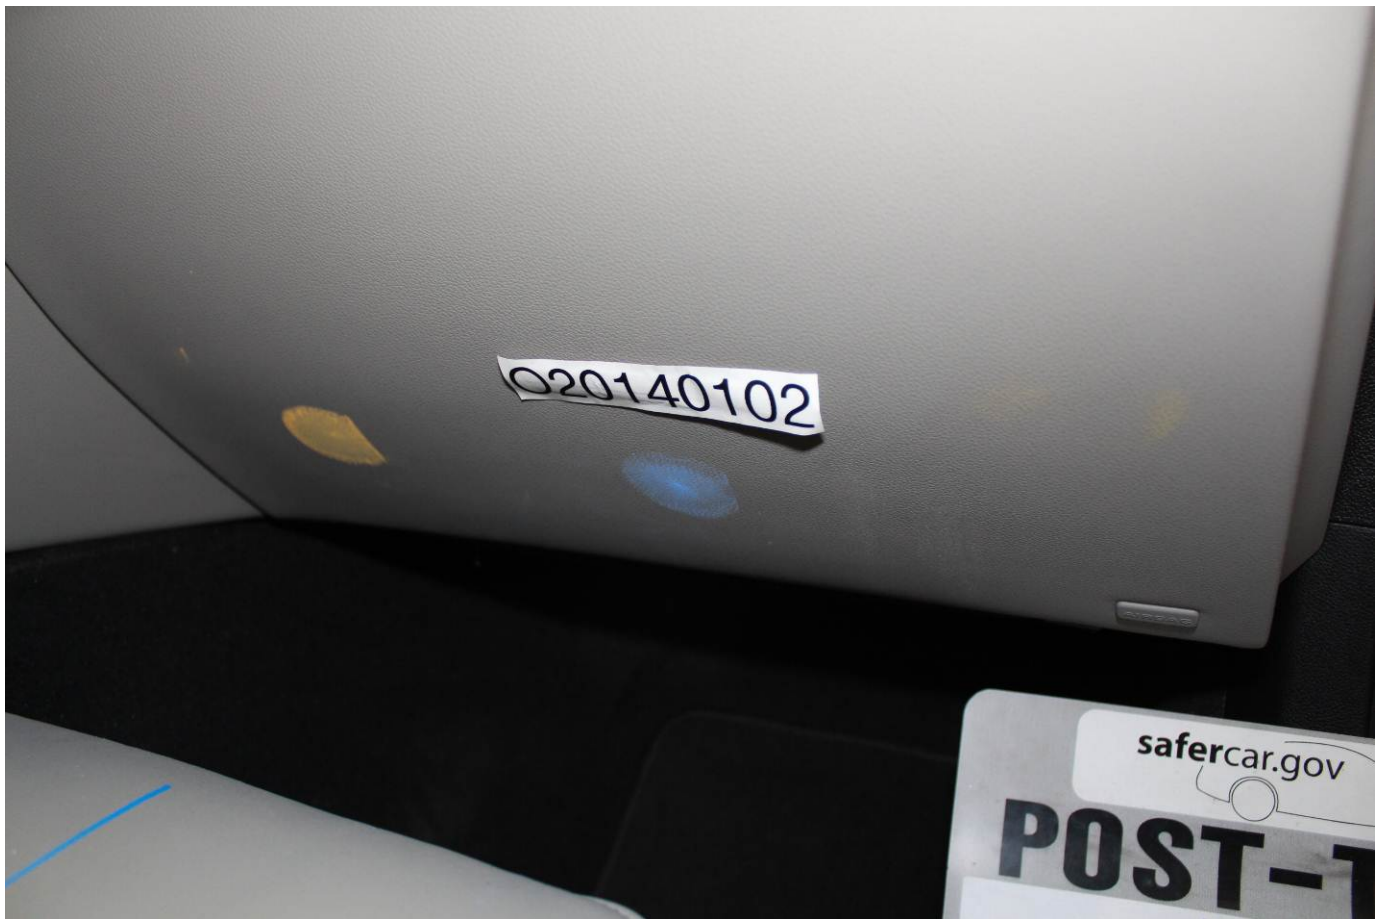
Post-Test Passenger Dummy Contact with Glovebox

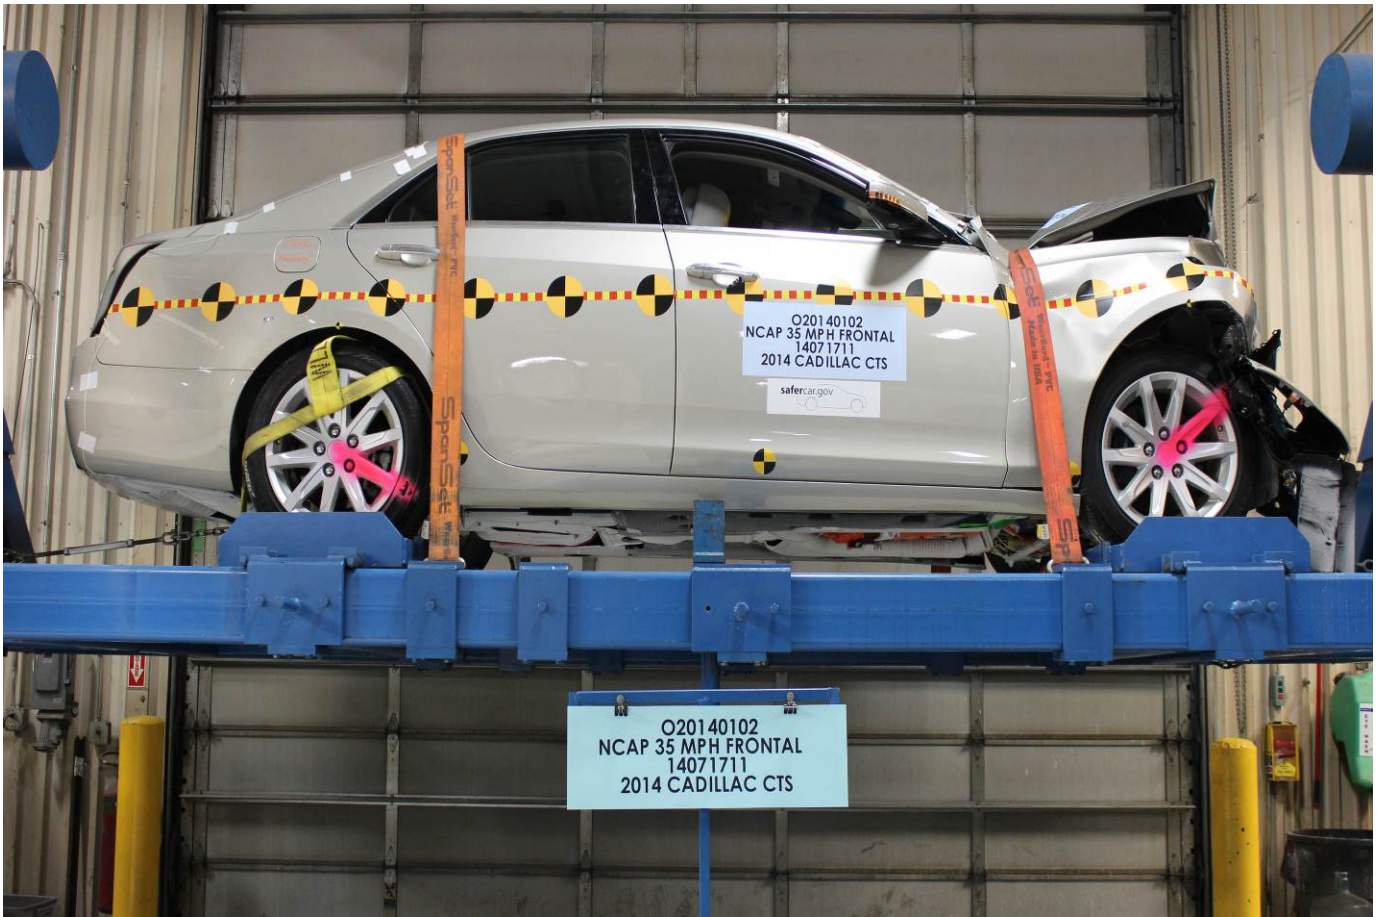
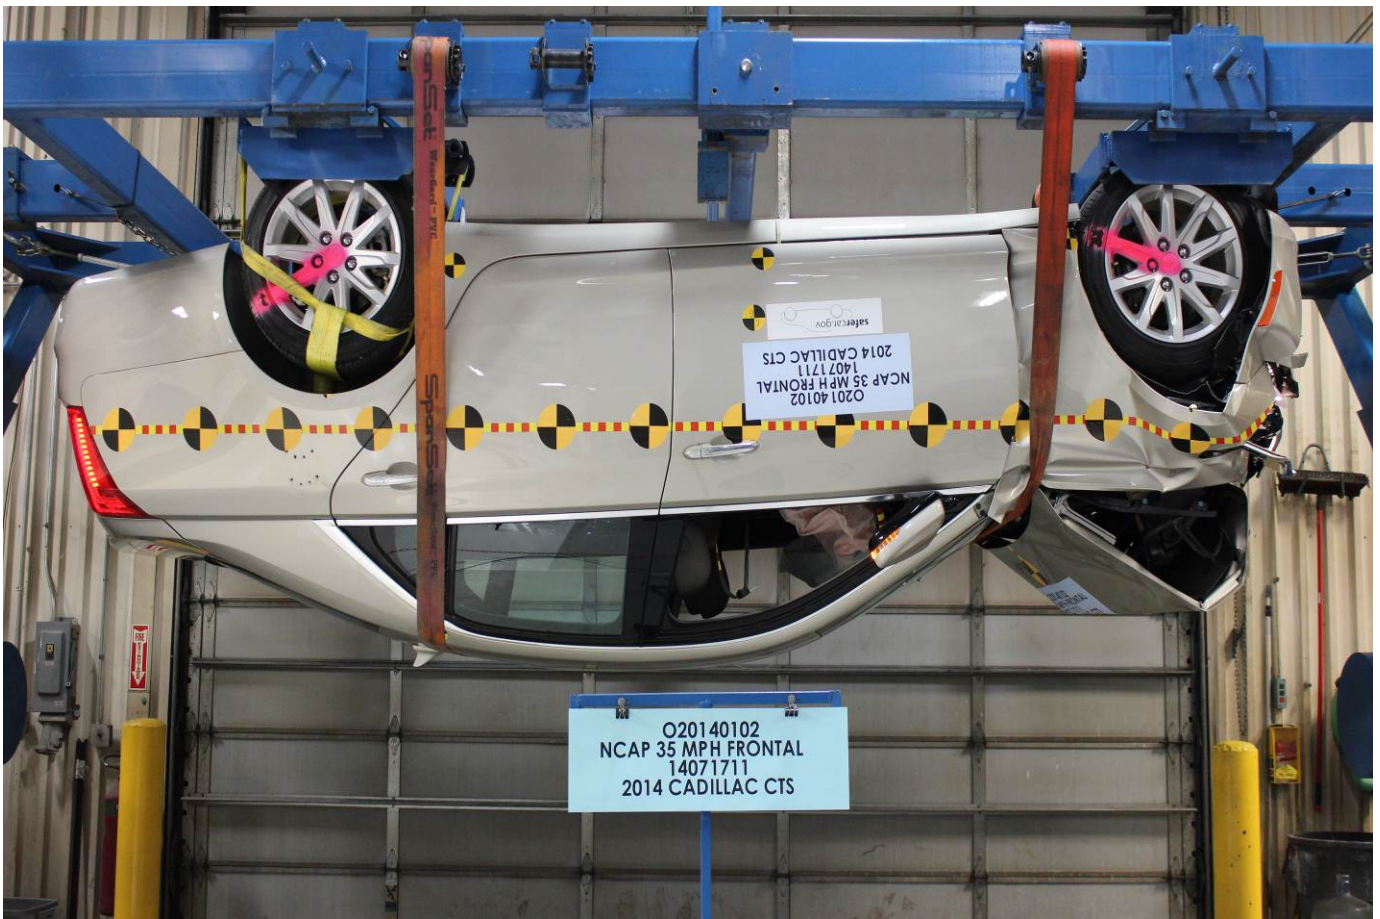
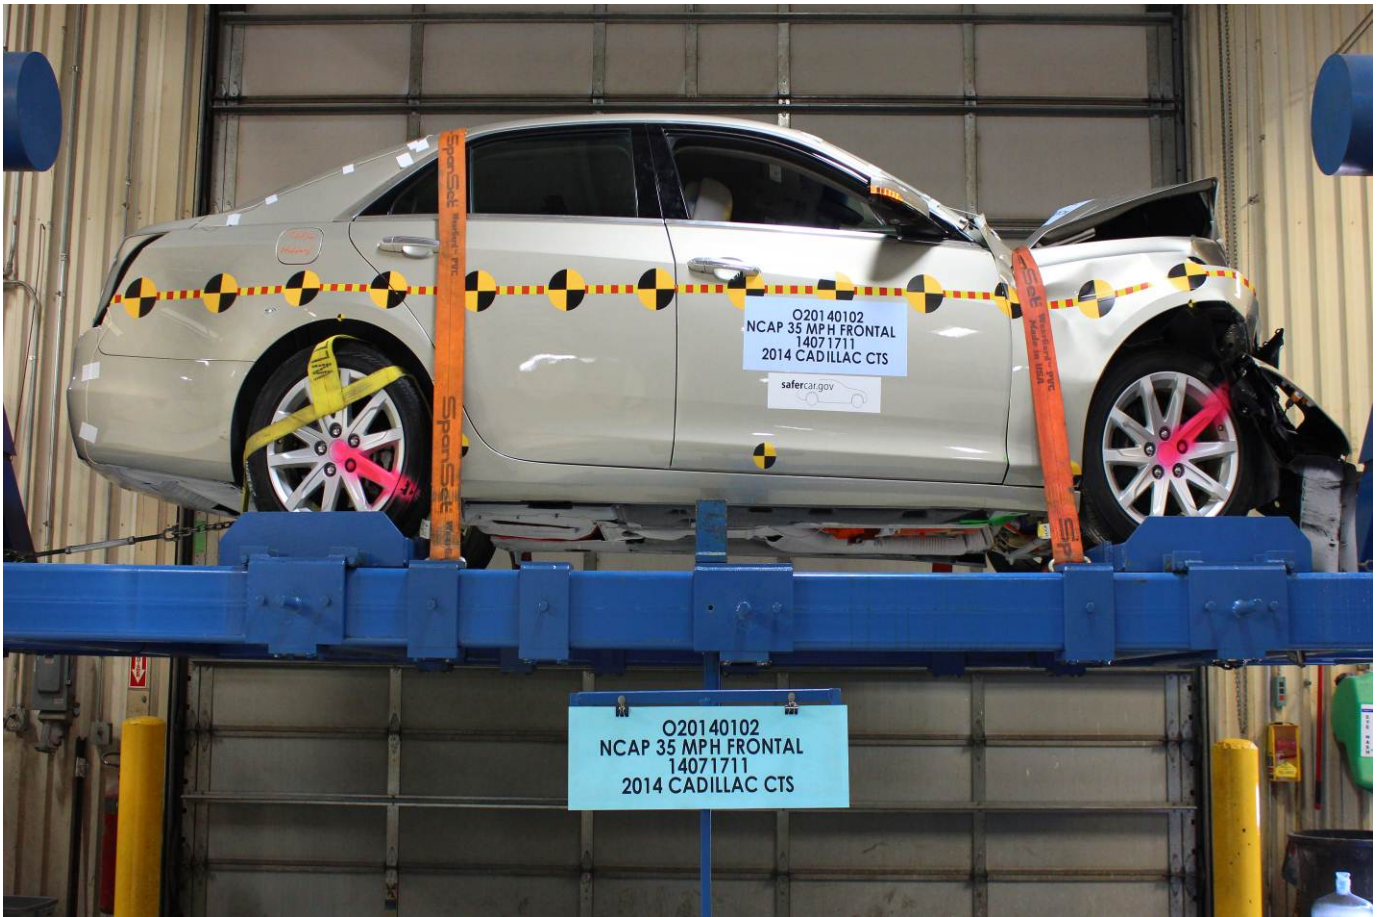
Vehicle at 0 Degree on Static Rollover Device

Vehicle at 180 Degrees on Static Rollover Device

Vehicle at 360 Degrees on Static Rollover Device
