**REPORT NUMBER: SINCAP-MGA-2015-008**

**NEW CAR ASSESSMENT PROGRAM (NCAP)  
Moving Deformable Barrier Side Impact Test**

**HYUNDAI MOTOR MANUFACTURING ALABAMA, LLC  
2015 Hyundai Sonata SE 4-Dr Sedan  
NHTSA No.: O20154205**

**MGA RESEARCH CORPORATION  
5000 Warren Road  
Burlington, WI 53105**

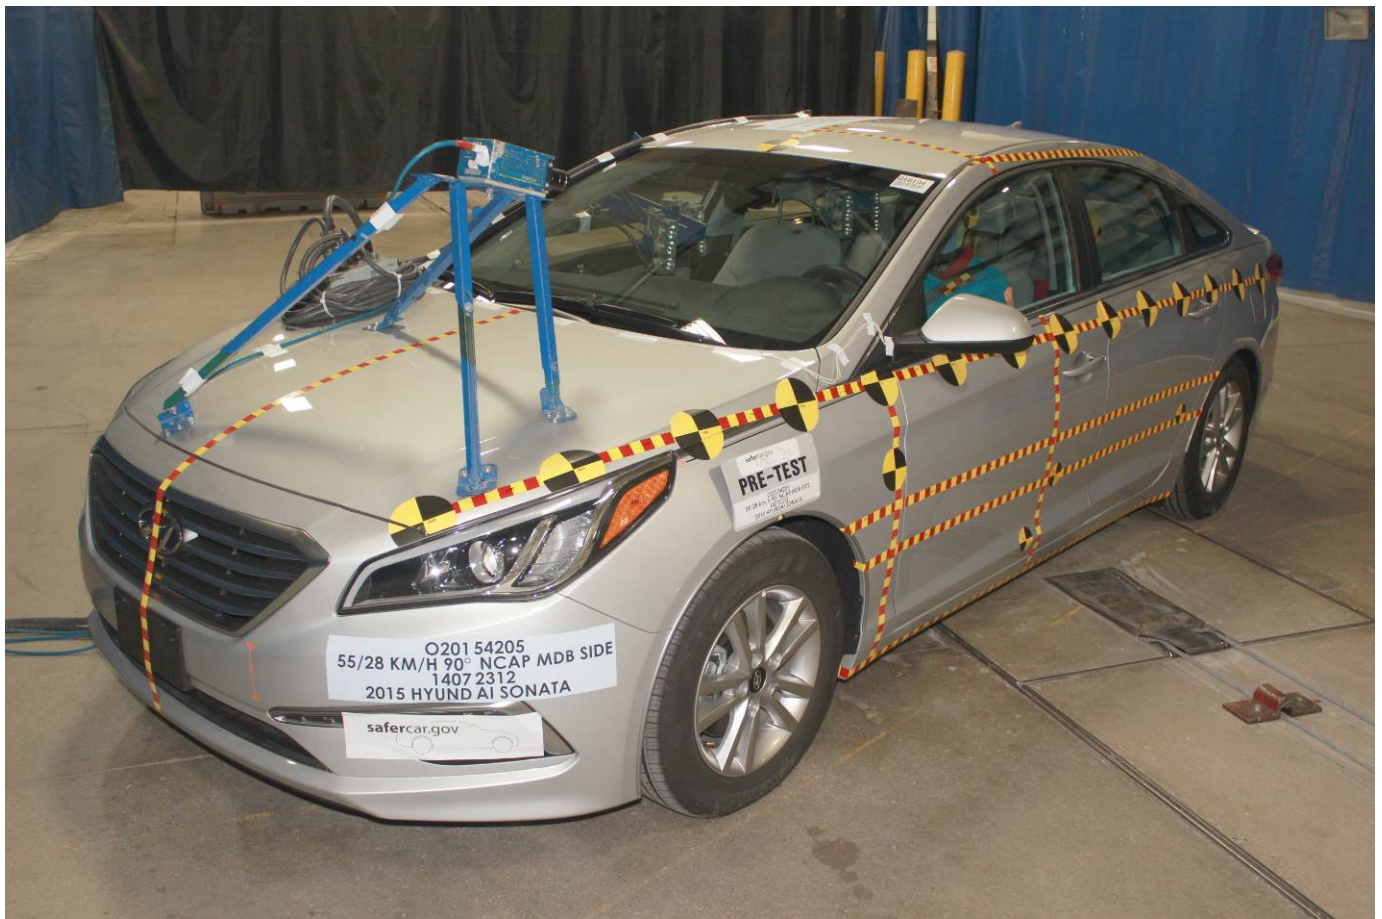
Post-Test Frontal View of Test Vehicle

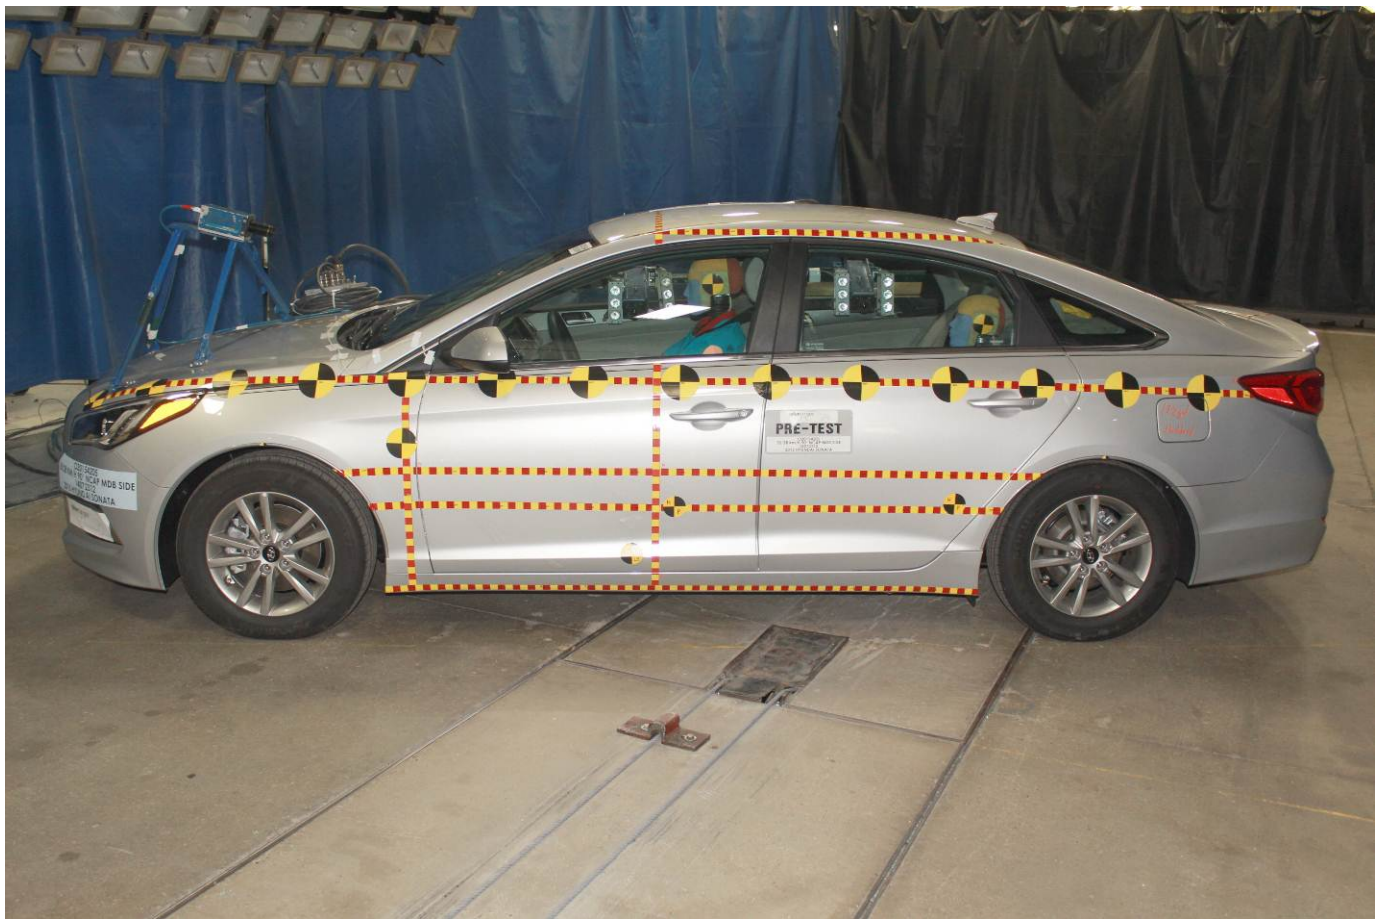
Post-Test Left Front Three-Quarter View of Test Vehicle

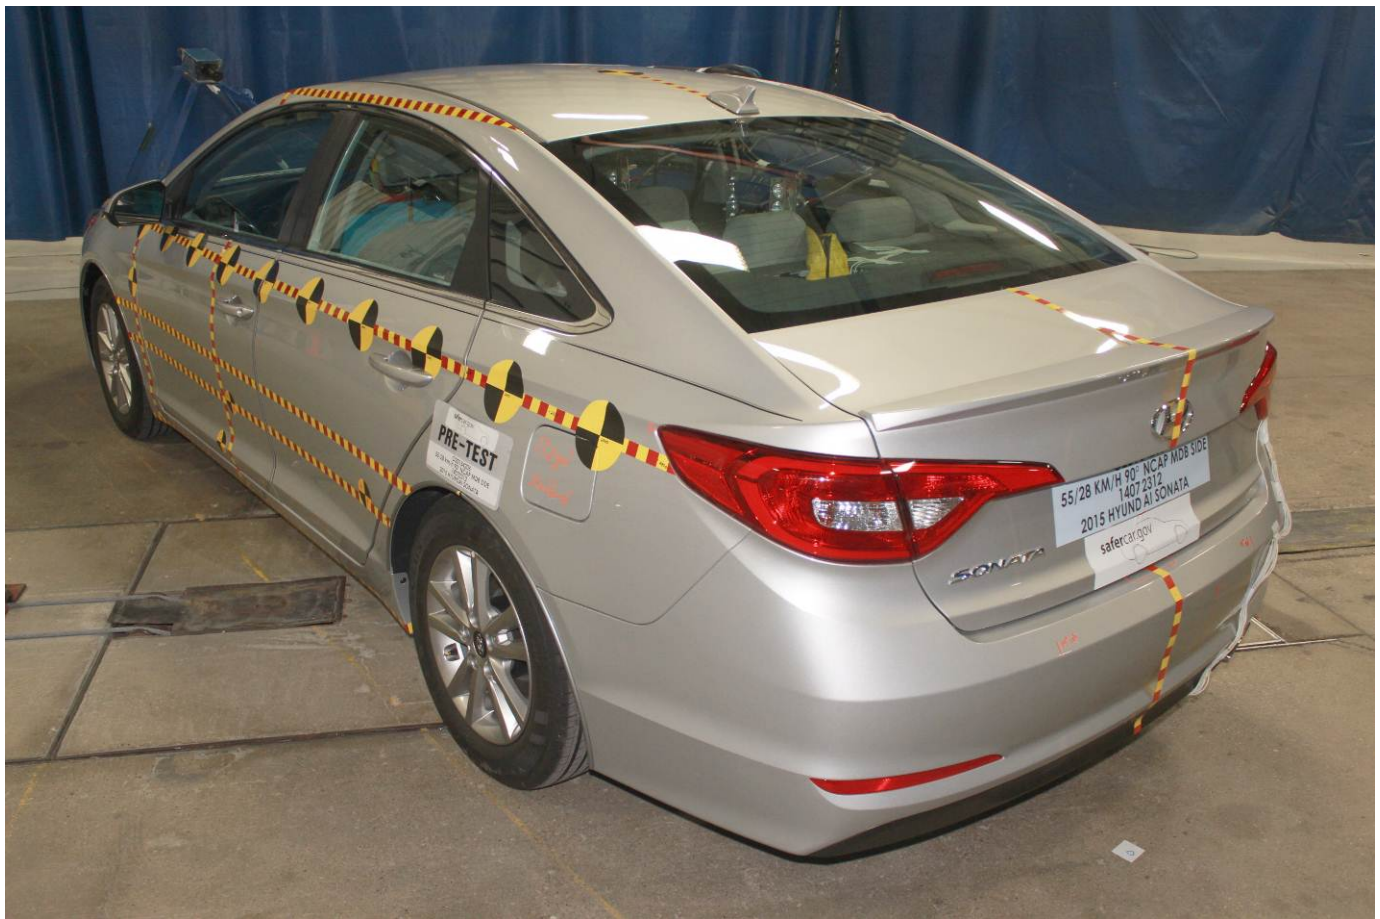
Post-Test Left Side View of Test Vehicle

| Critical Areas of Performance | Observations and Conclusions |
|---|---|
| Side Window Damage | Left Front and Left Rear Windows Broken |

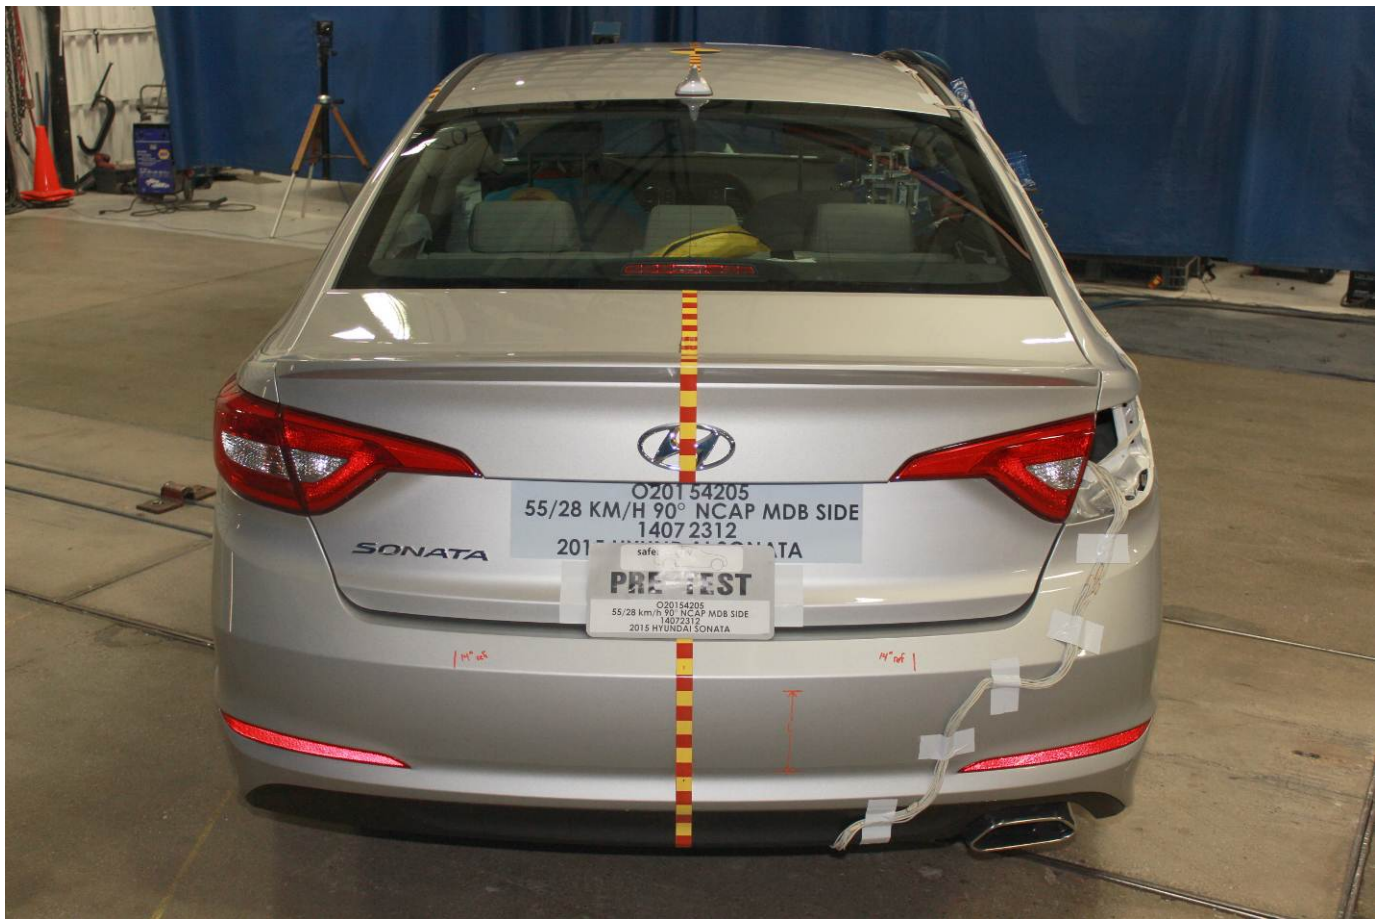
Post-Test Left Three-Quarter Rear View of Test Vehicle

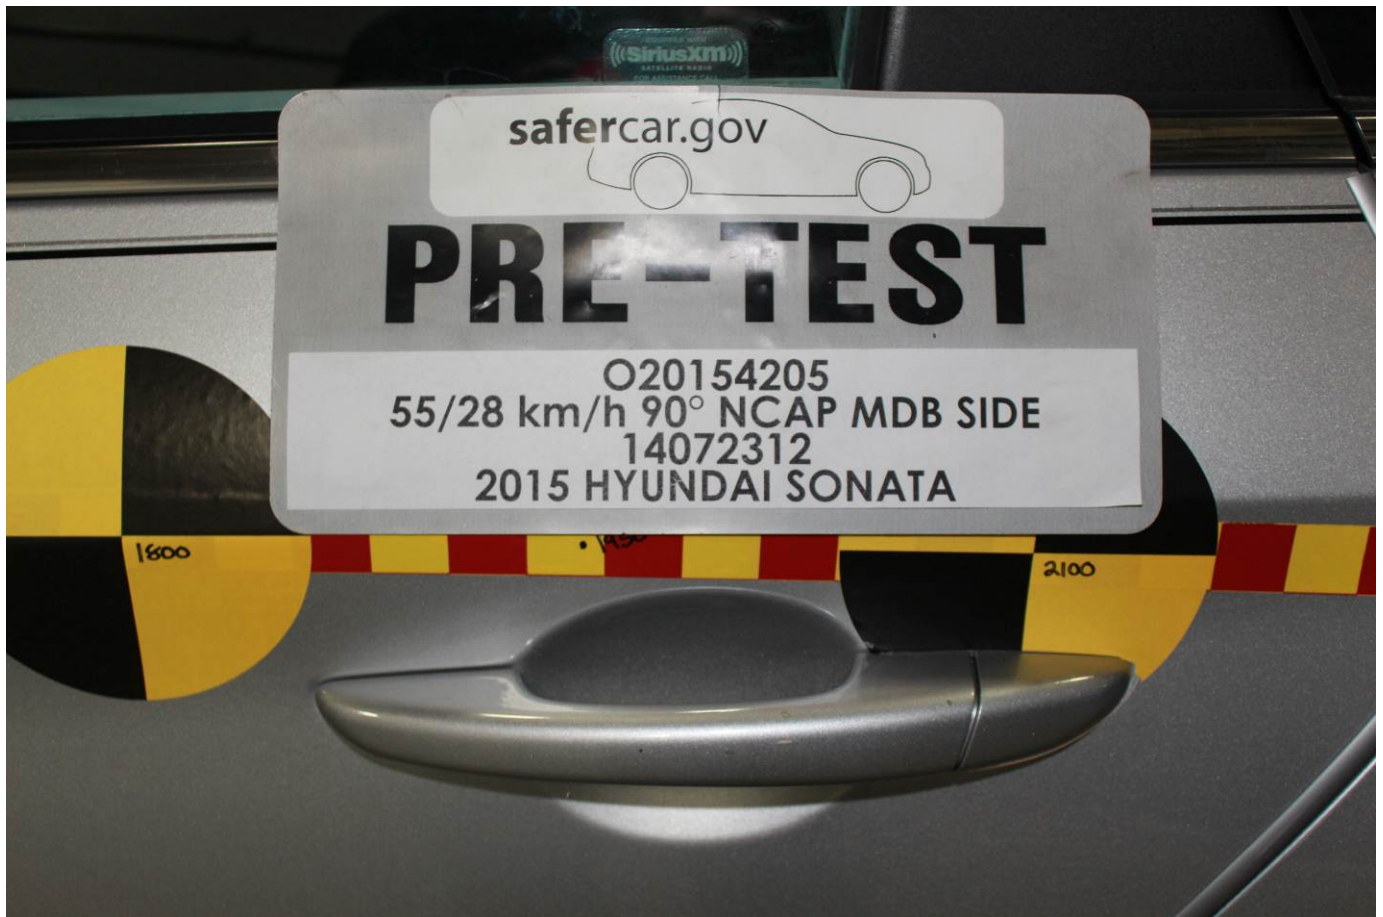
Post-Test Left Front Door Latch Close-Up

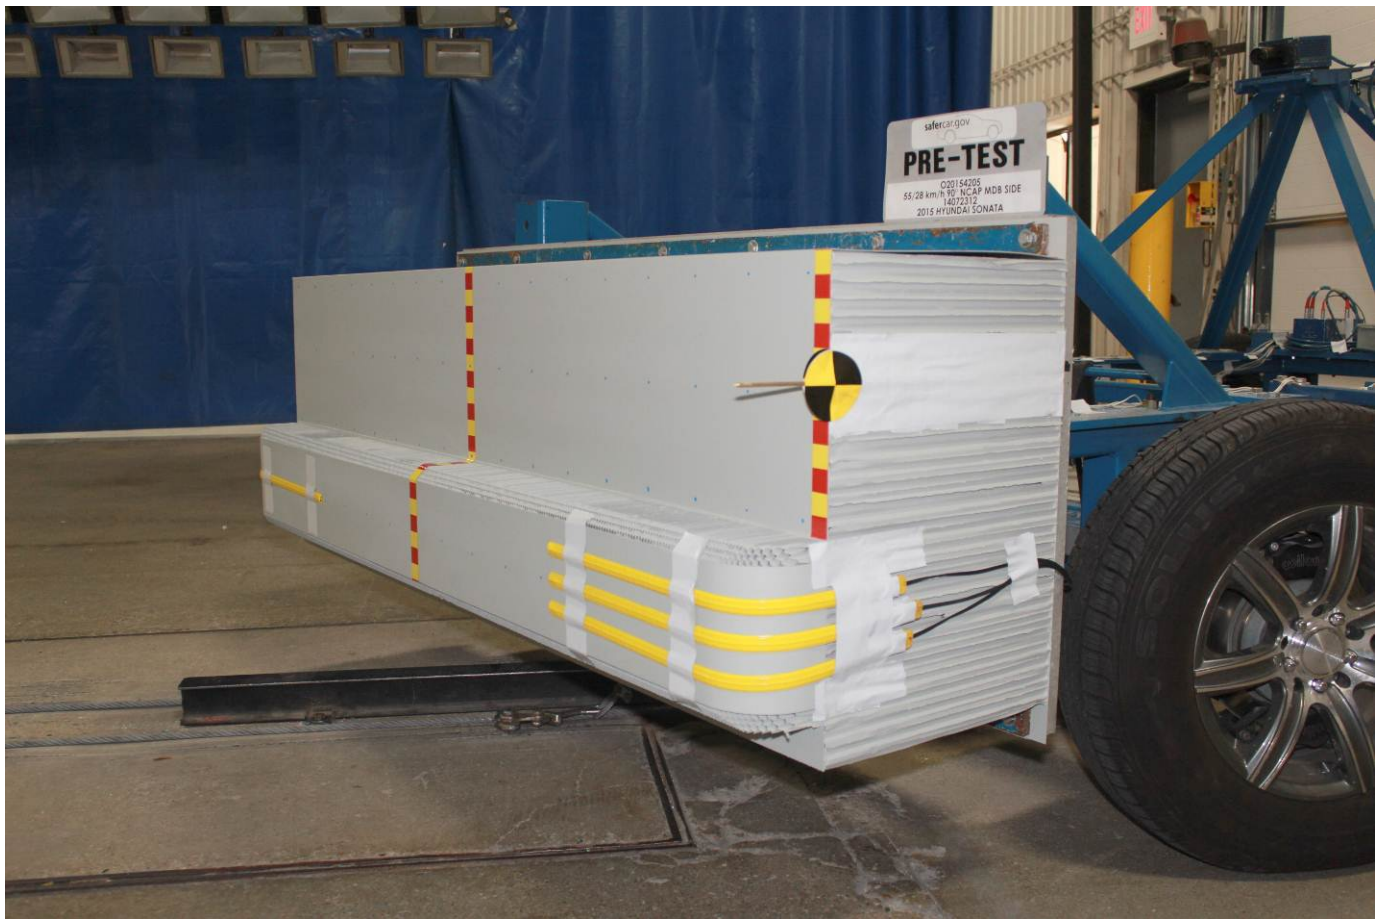
Post-Test Top View of MDB Impactor Face

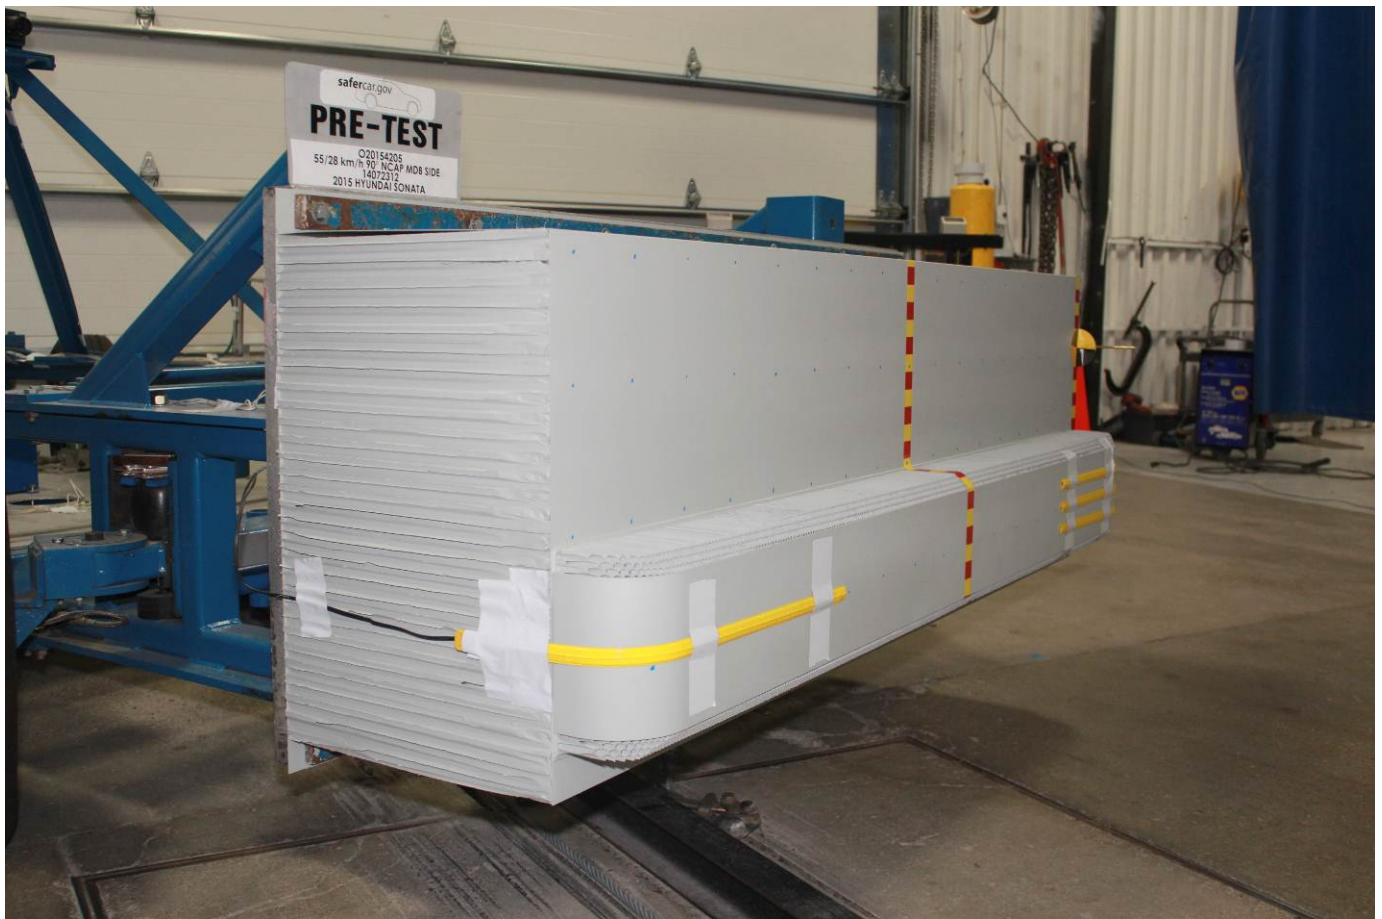
Post-Test Left Side View of MDB Impactor Face
