**REPORT NUMBER: SPNCAP-MGA-2015-009**

**NEW CAR ASSESSMENT PROGRAM (NCAP)  
Side Impact Pole Test**

**HYUNDAI MOTOR MANUFACTURING ALABAMA, LLC  
2015 Hyundai Sonata SE 4-Dr Sedan  
NHTSA No.: O20154204**

**MGA RESEARCH CORPORATION  
5000 Warren Road  
Burlington, WI 53105**

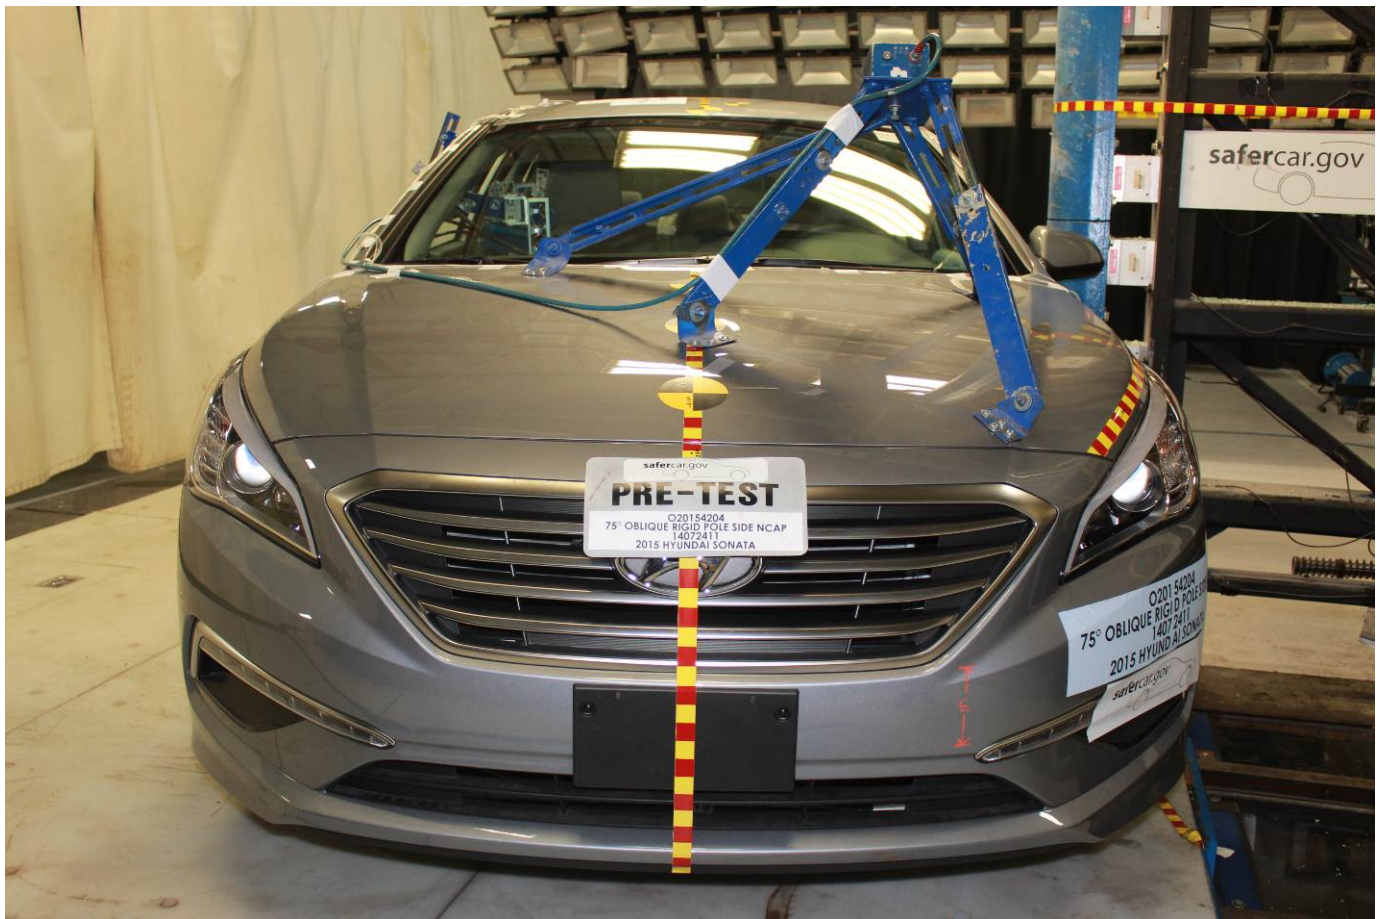
Pre-Test Frontal View of Test Vehicle

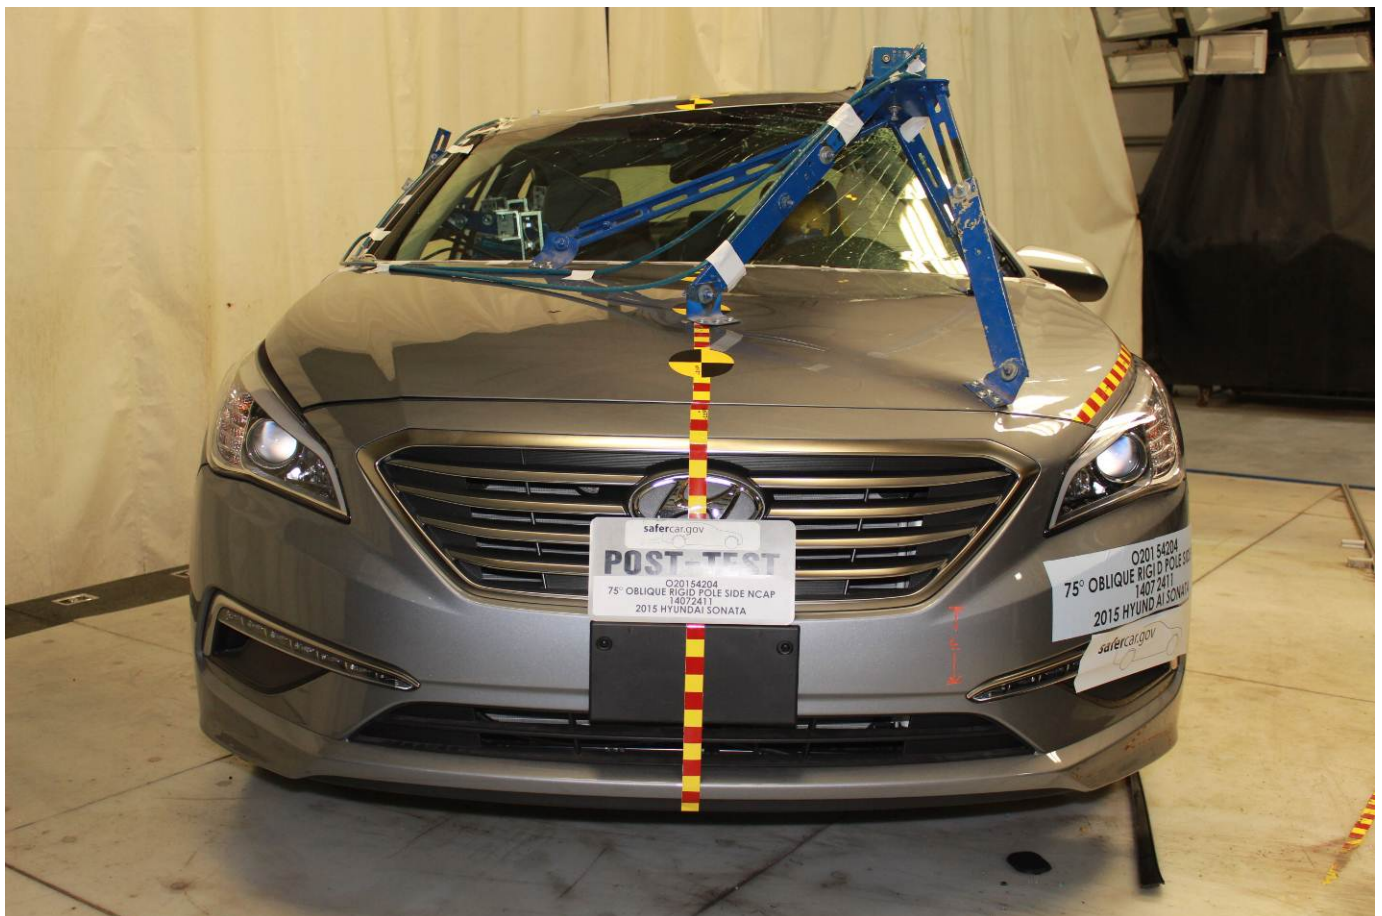
Post-Test Frontal View of Test Vehicle

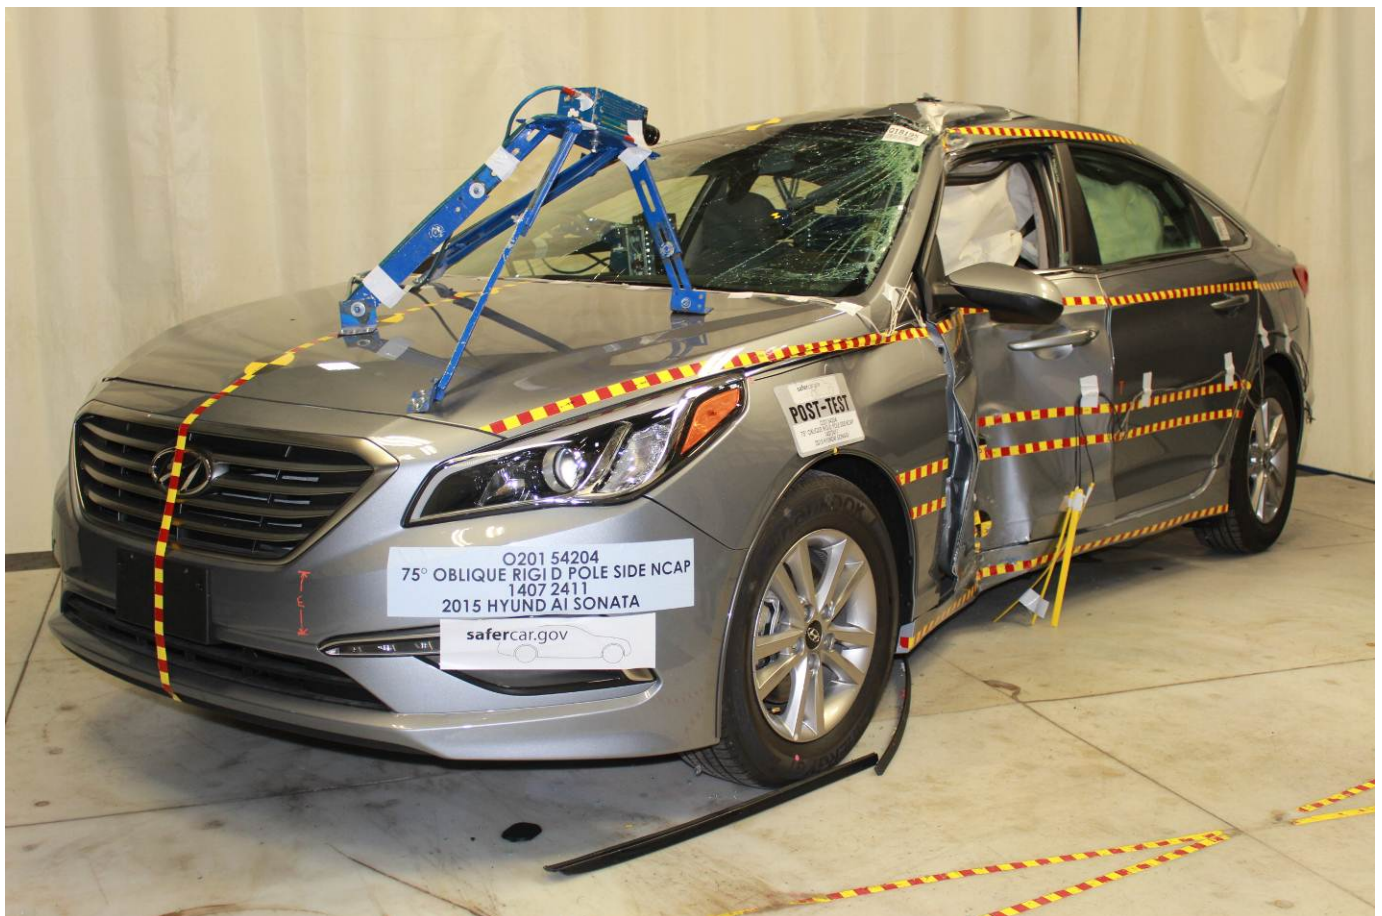
Post-Test Left Front ¾ View of Test Vehicle

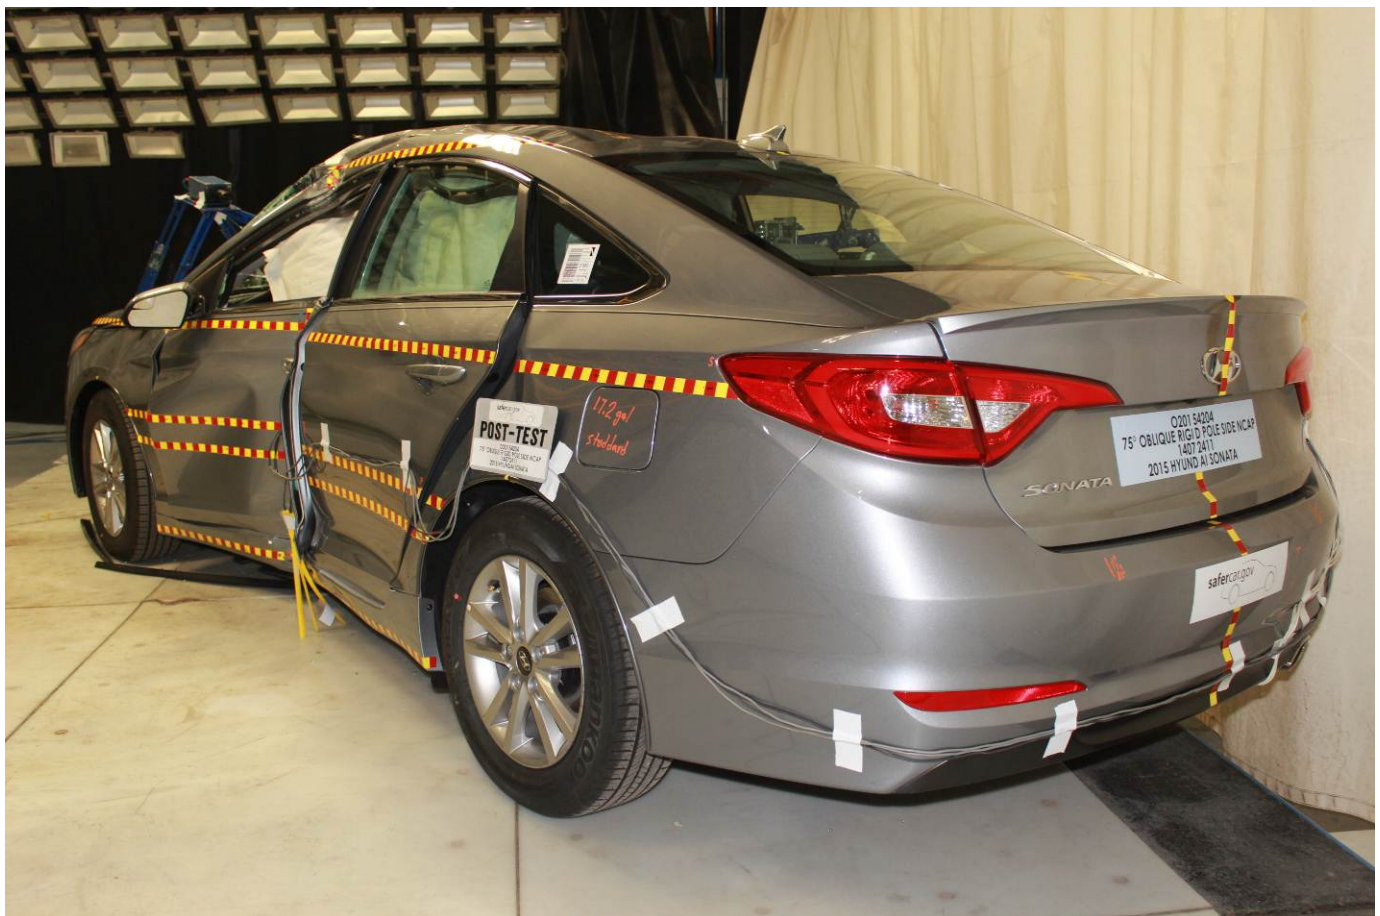
Post-Test Left Rear  $\frac{3}{4}$  View of Test Vehicle

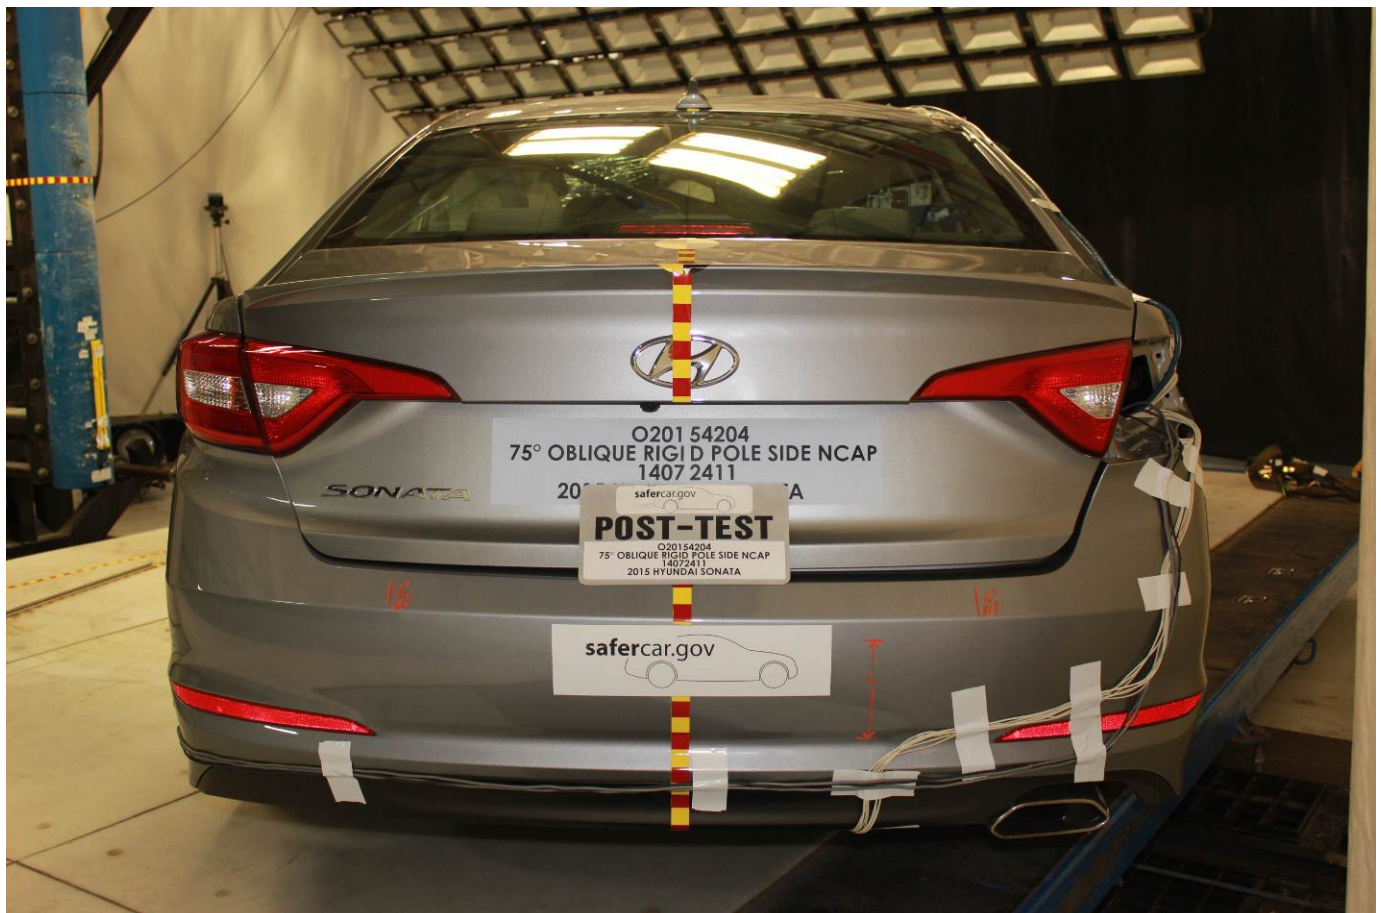
Post-Test Rear View of Test Vehicle

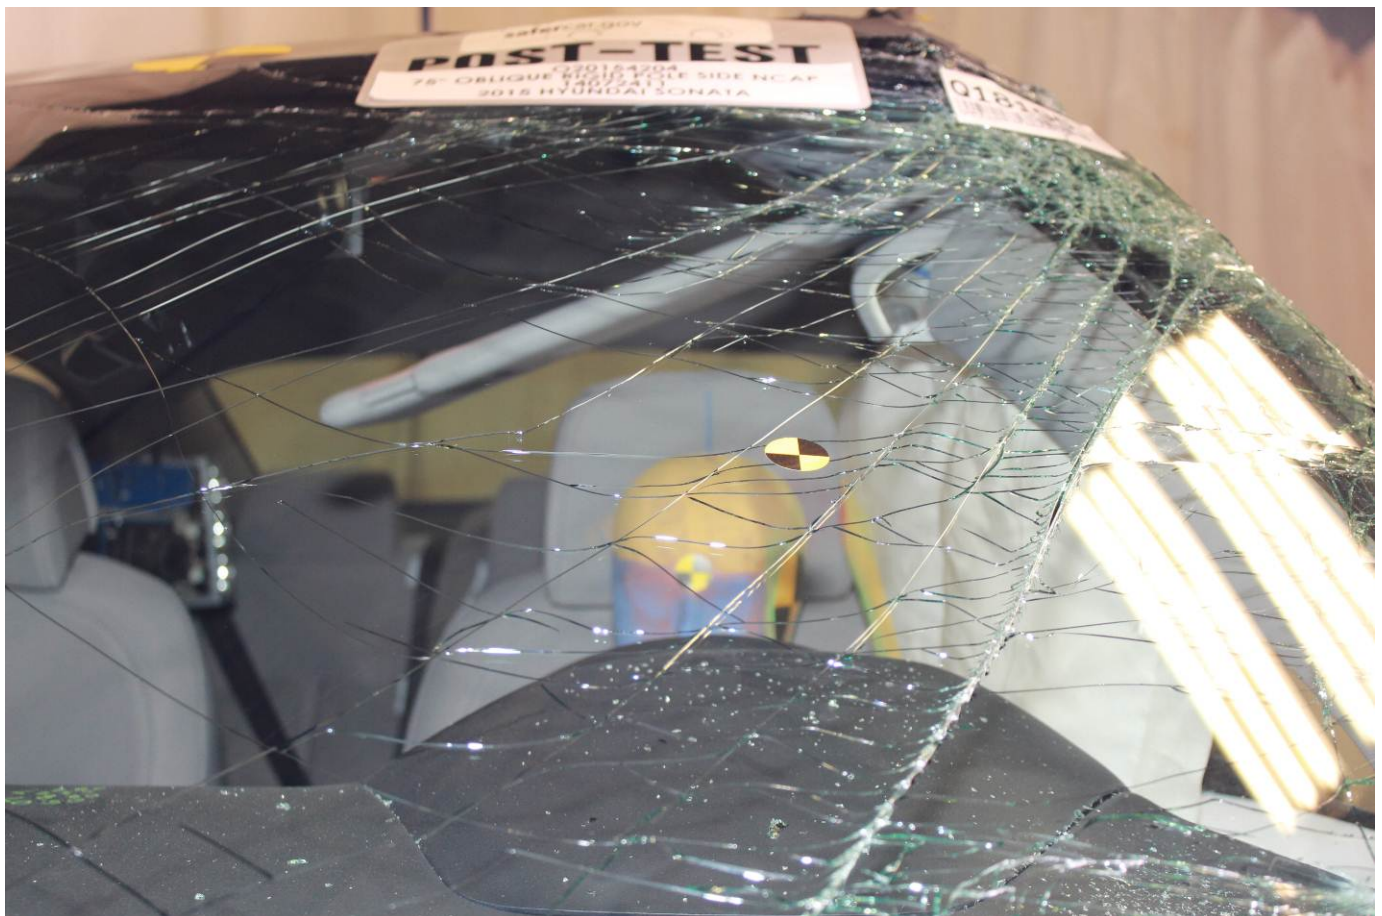
Post-Test Front Close-Up View of Dummy

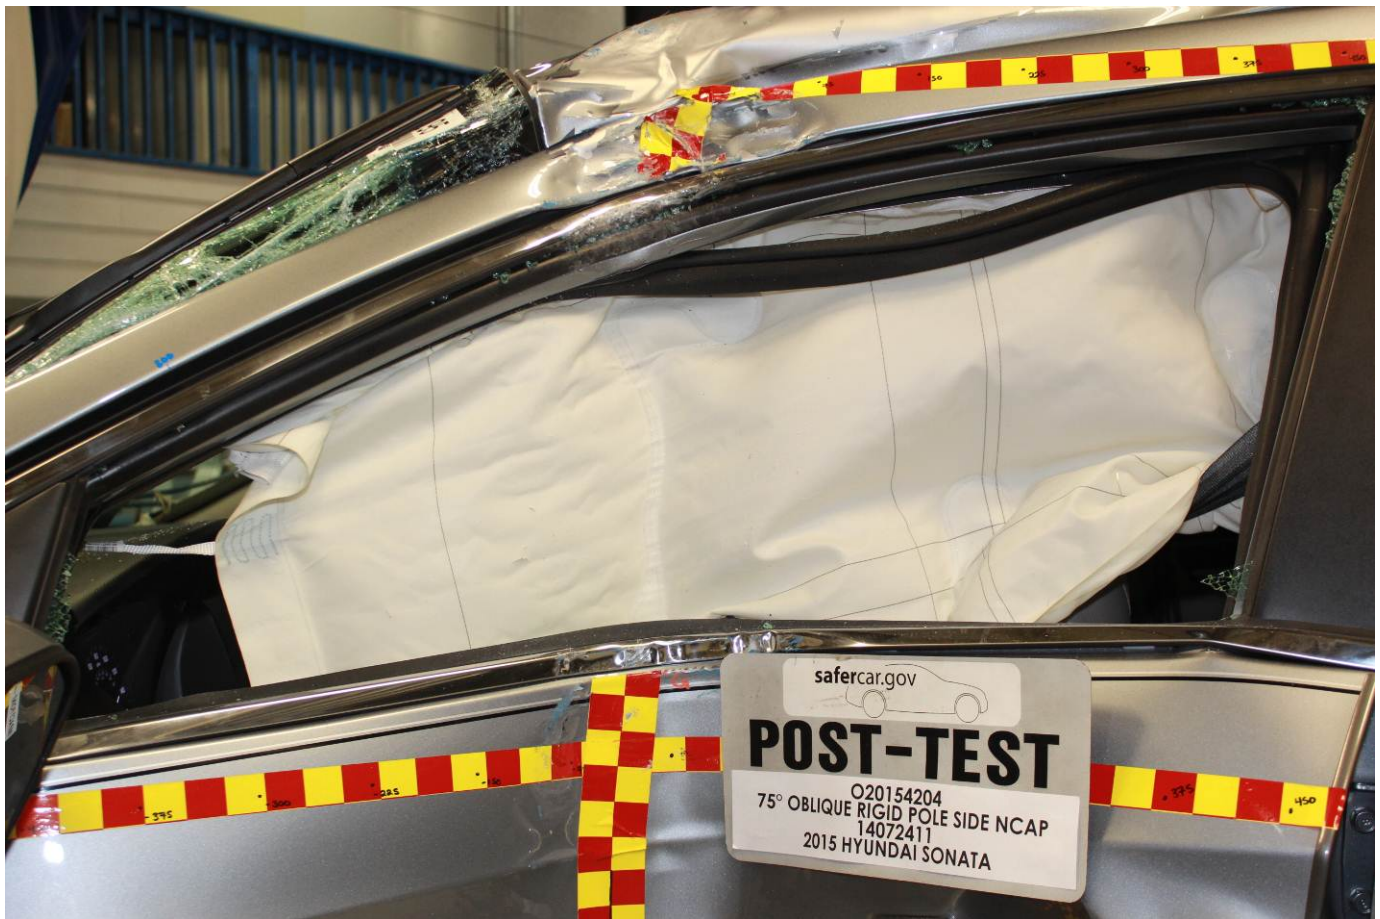
Post-Test Left Side View of Dummy Shoulder and Door Top View

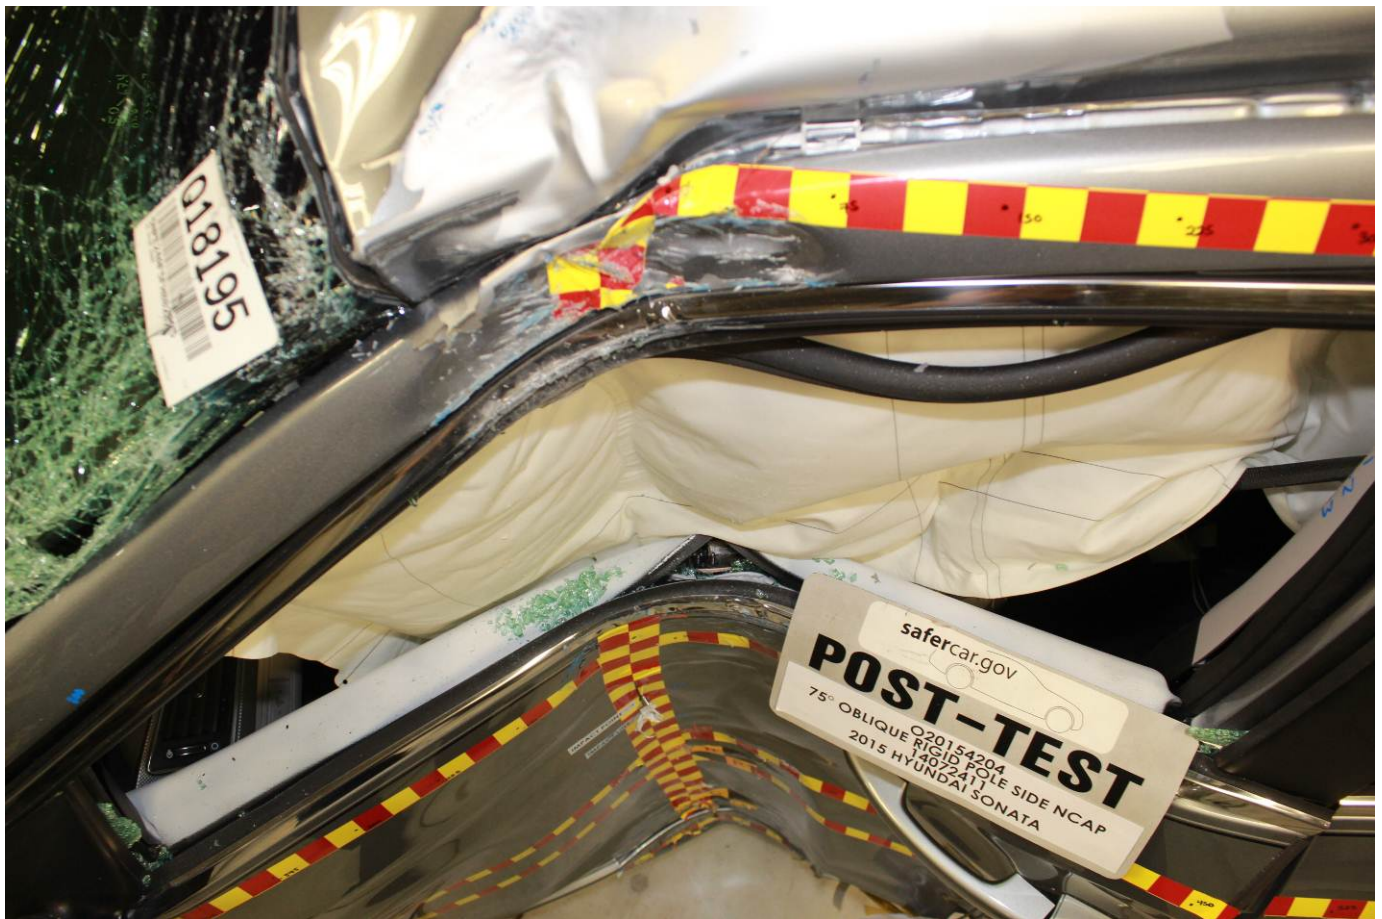
Post-Test Dummy and Door Clearance View

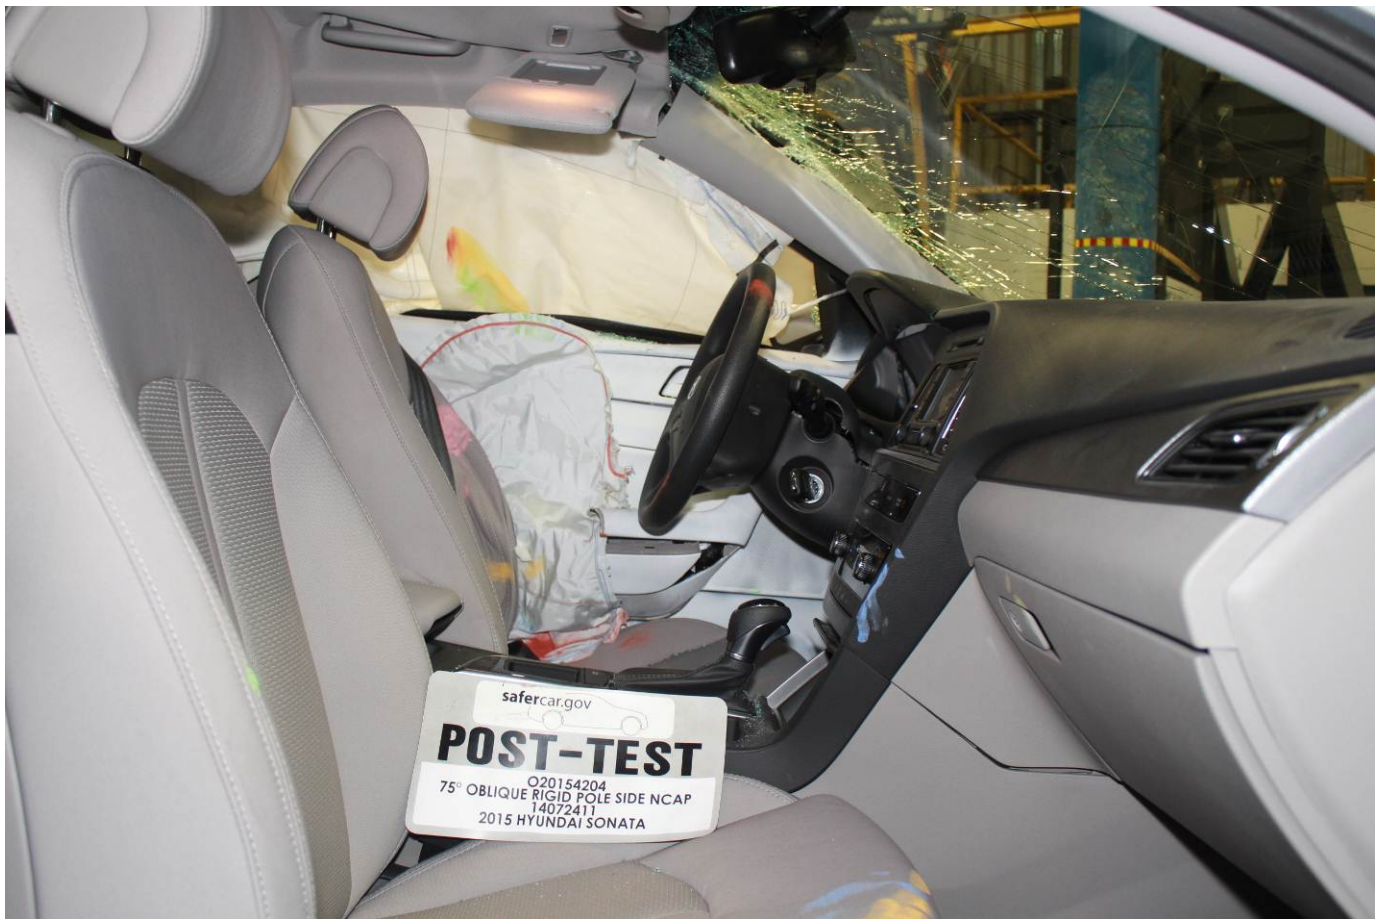
Post-Test Inner Door Panel View Showing Dummy Contact Location

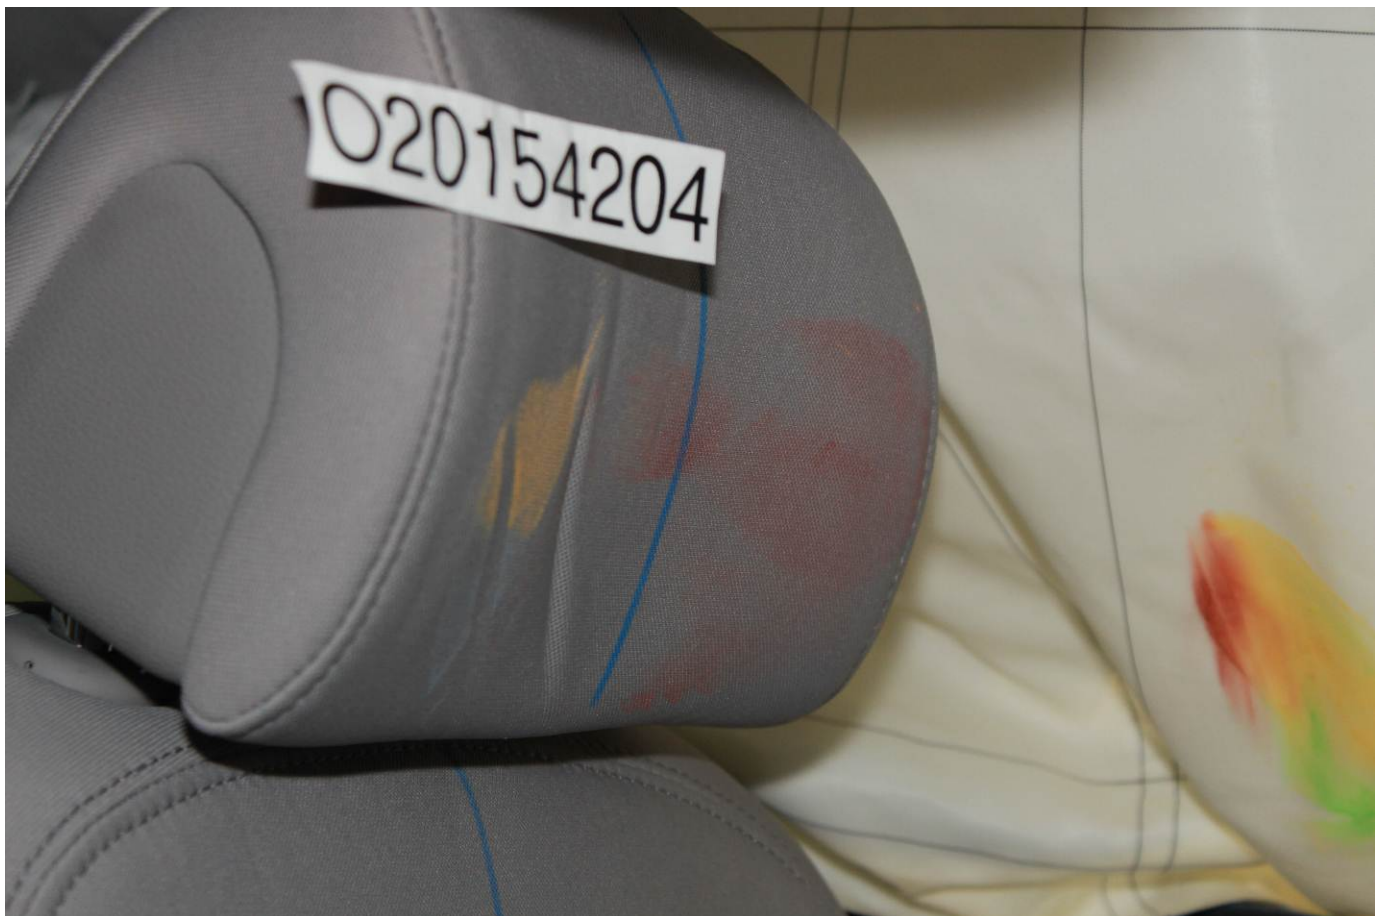
Post-Test Dummy Close-Up Head Contact with Vehicle Interior View

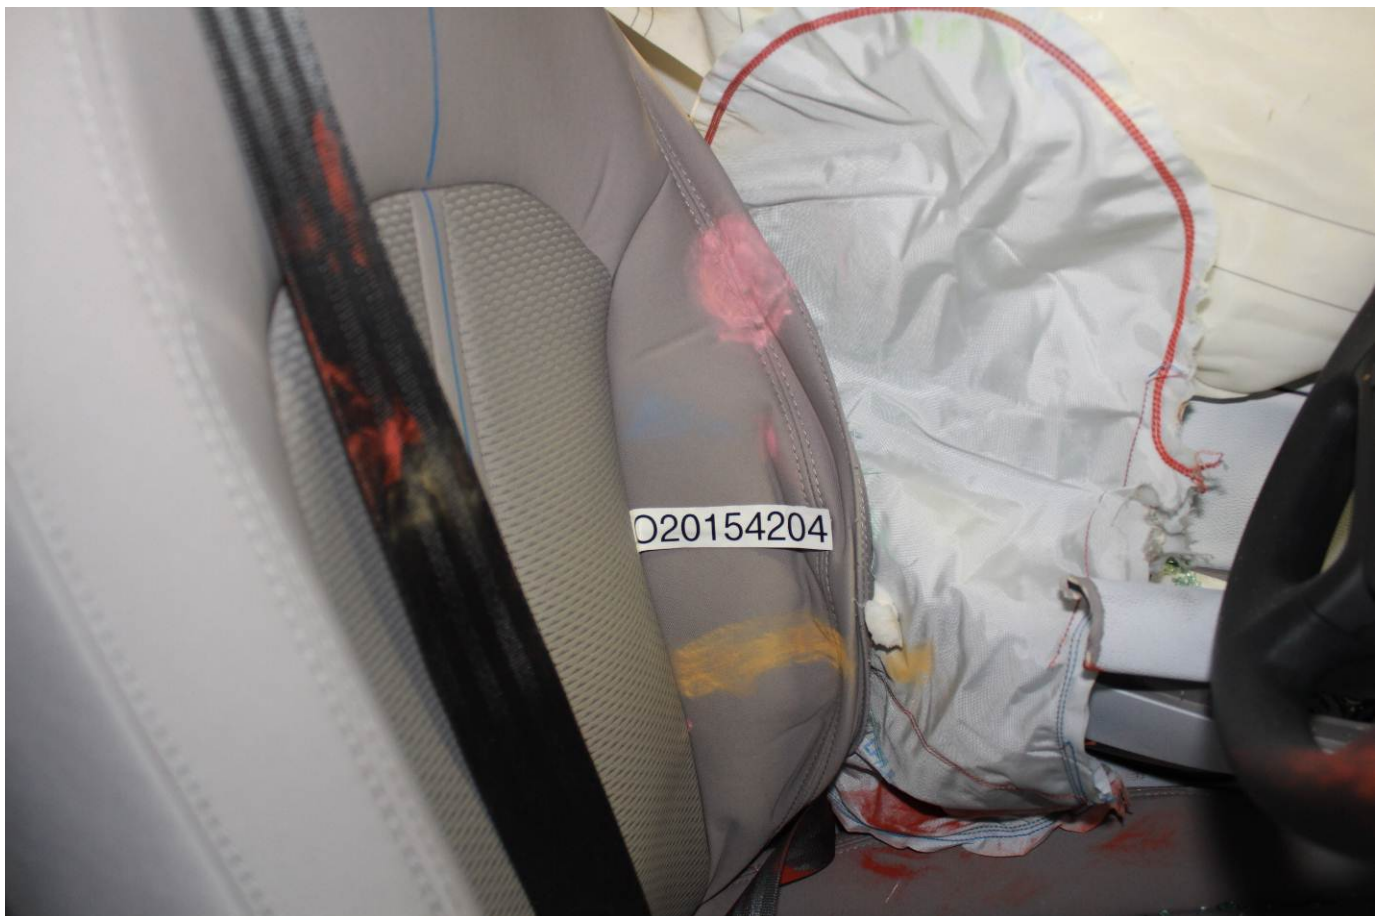
Post-Test Dummy Close-Up Torso Contact with Vehicle Interior View

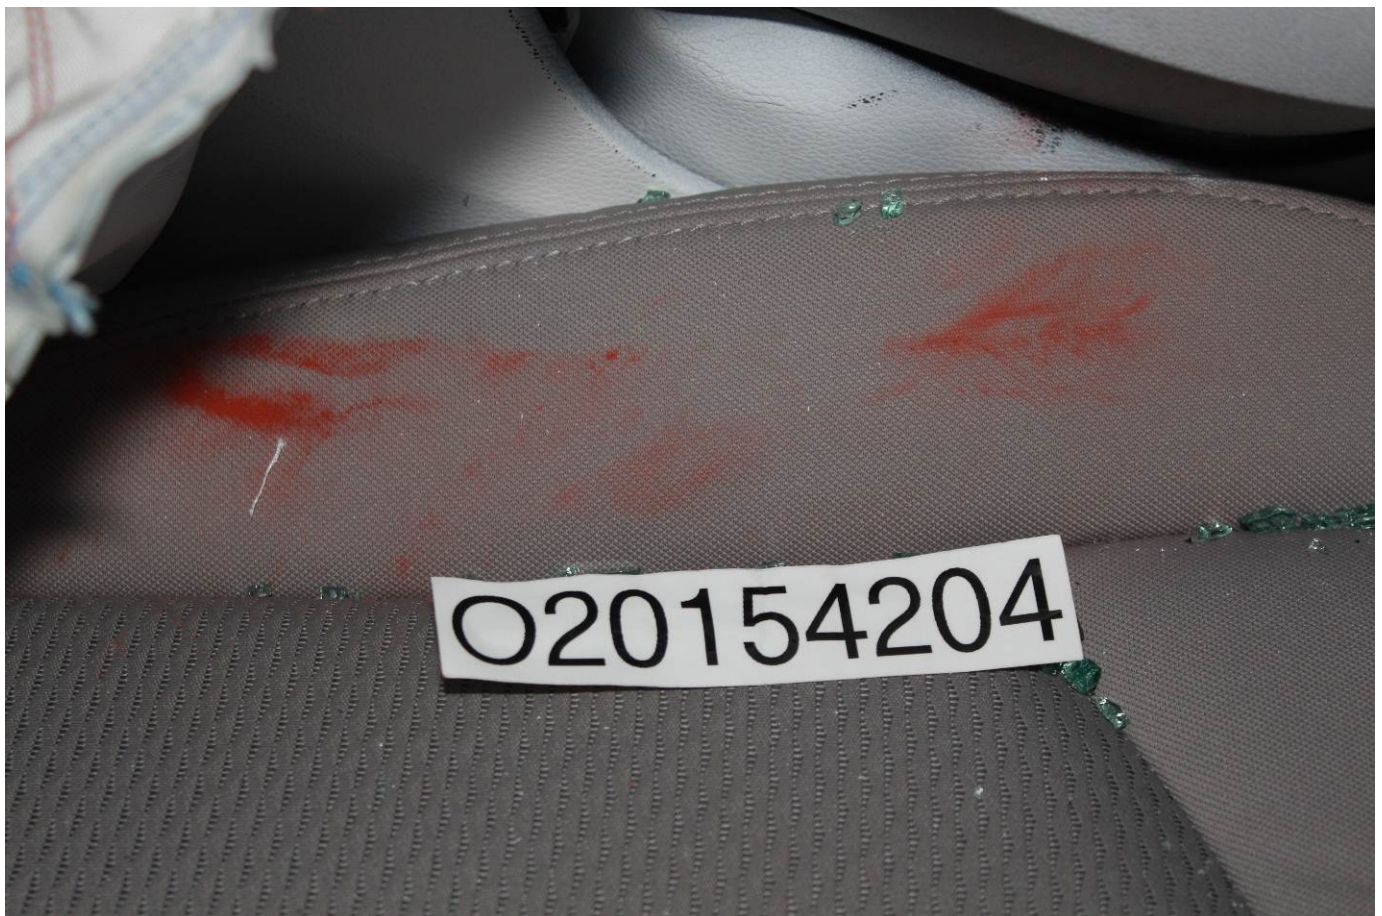
Post-Test Dummy Close-Up Pelvis Contact with Vehicle Interior View

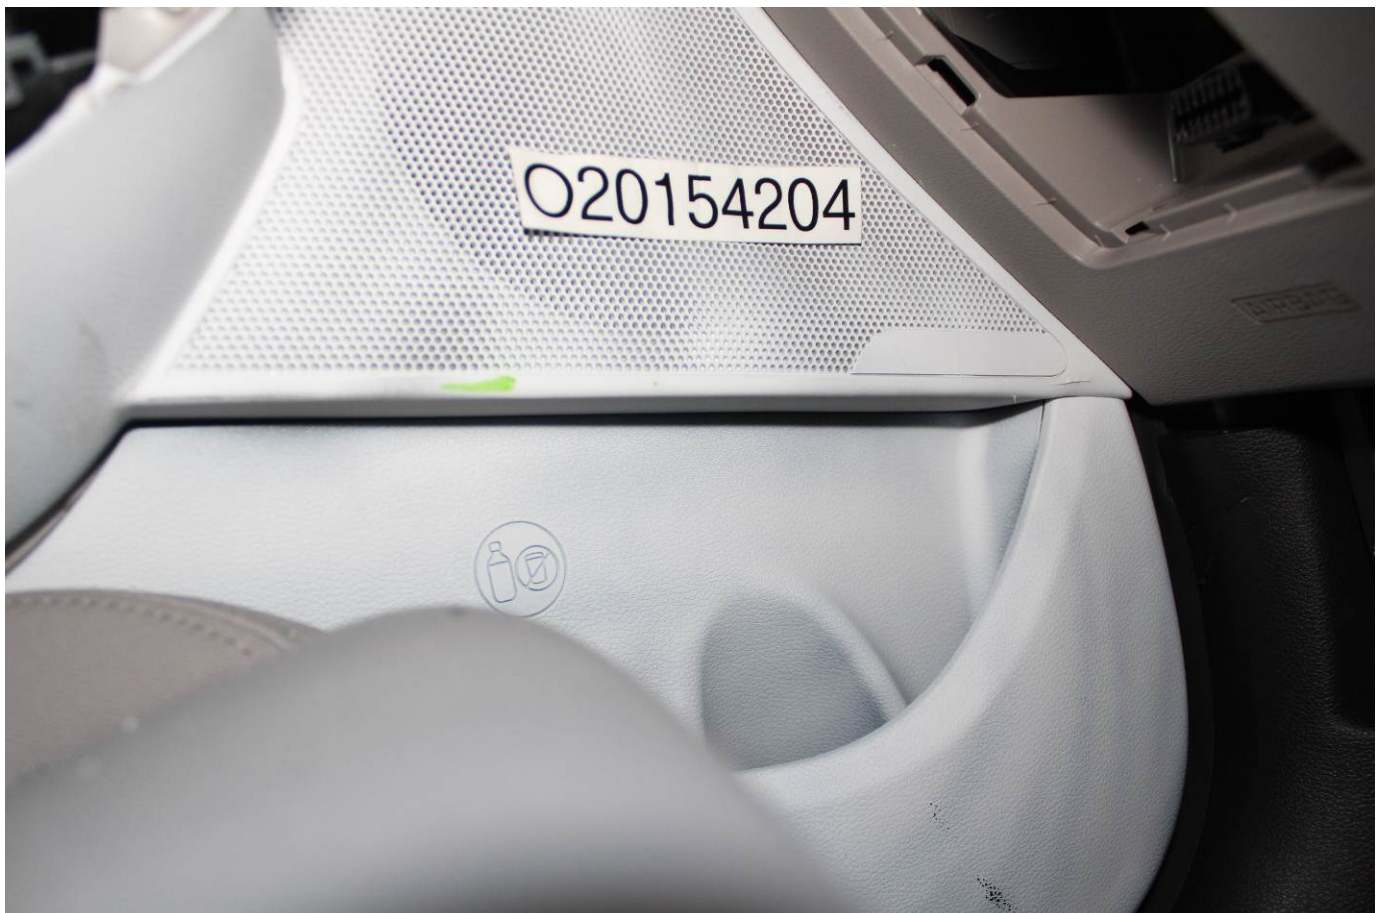
Post-Test Dummy Close-Up Knee Contact with Vehicle Interior View

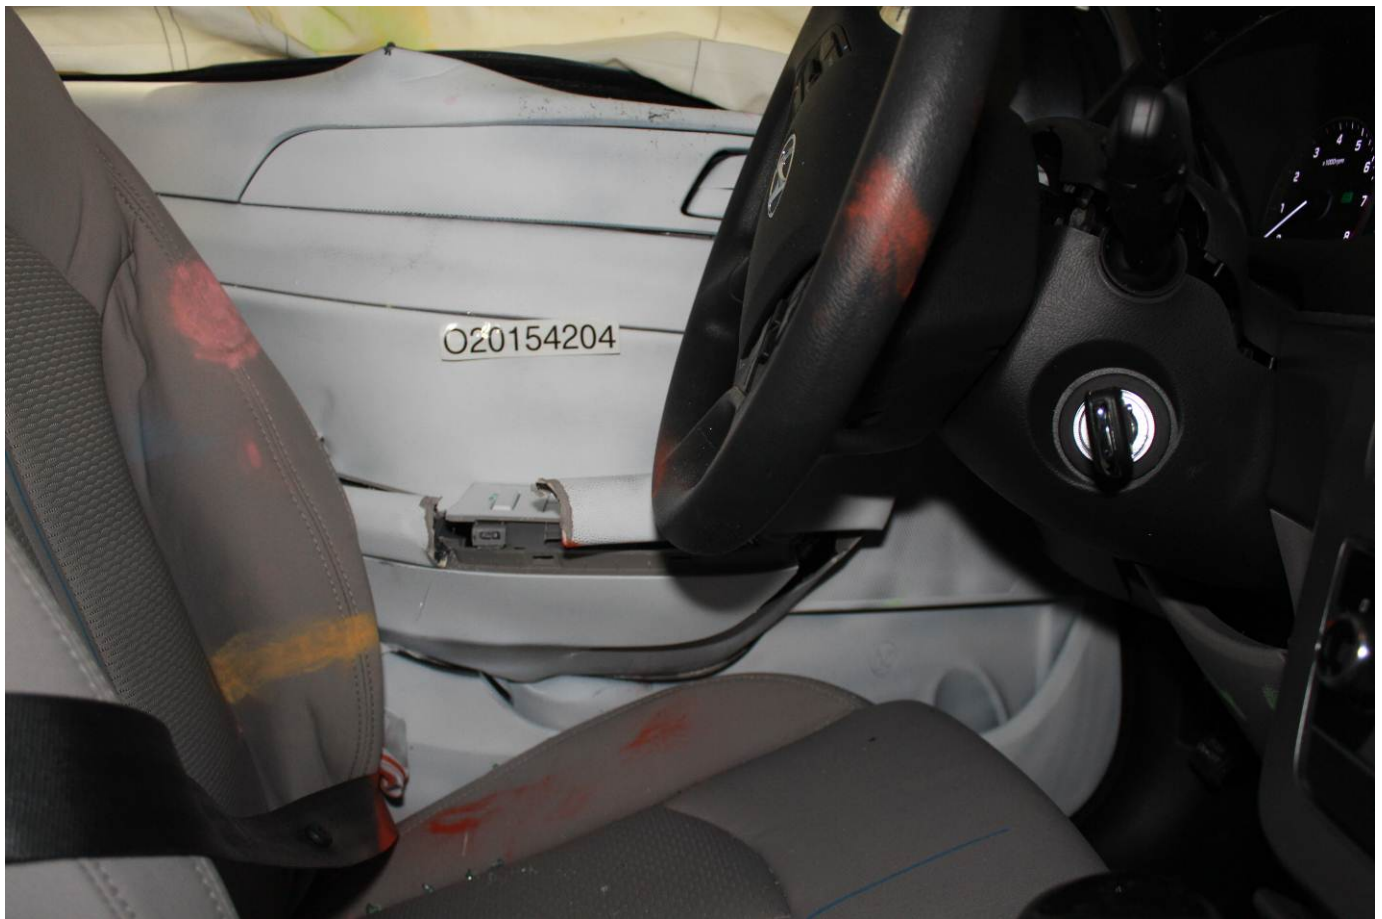
Post-Test View of Shattered Vehicle Inner Door Panel
