**REPORT NUMBER: NCAP-MGA-2015-016**

**NEW CAR ASSESSMENT PROGRAM (NCAP)  
Frontal Barrier Impact Test**

**FORD MOTOR COMPANY  
2015 Lincoln MKC AWD SUV  
NHTSA No.: M20150200**

**MGA RESEARCH CORPORATION  
5000 Warren Road  
Burlington, WI 53105**

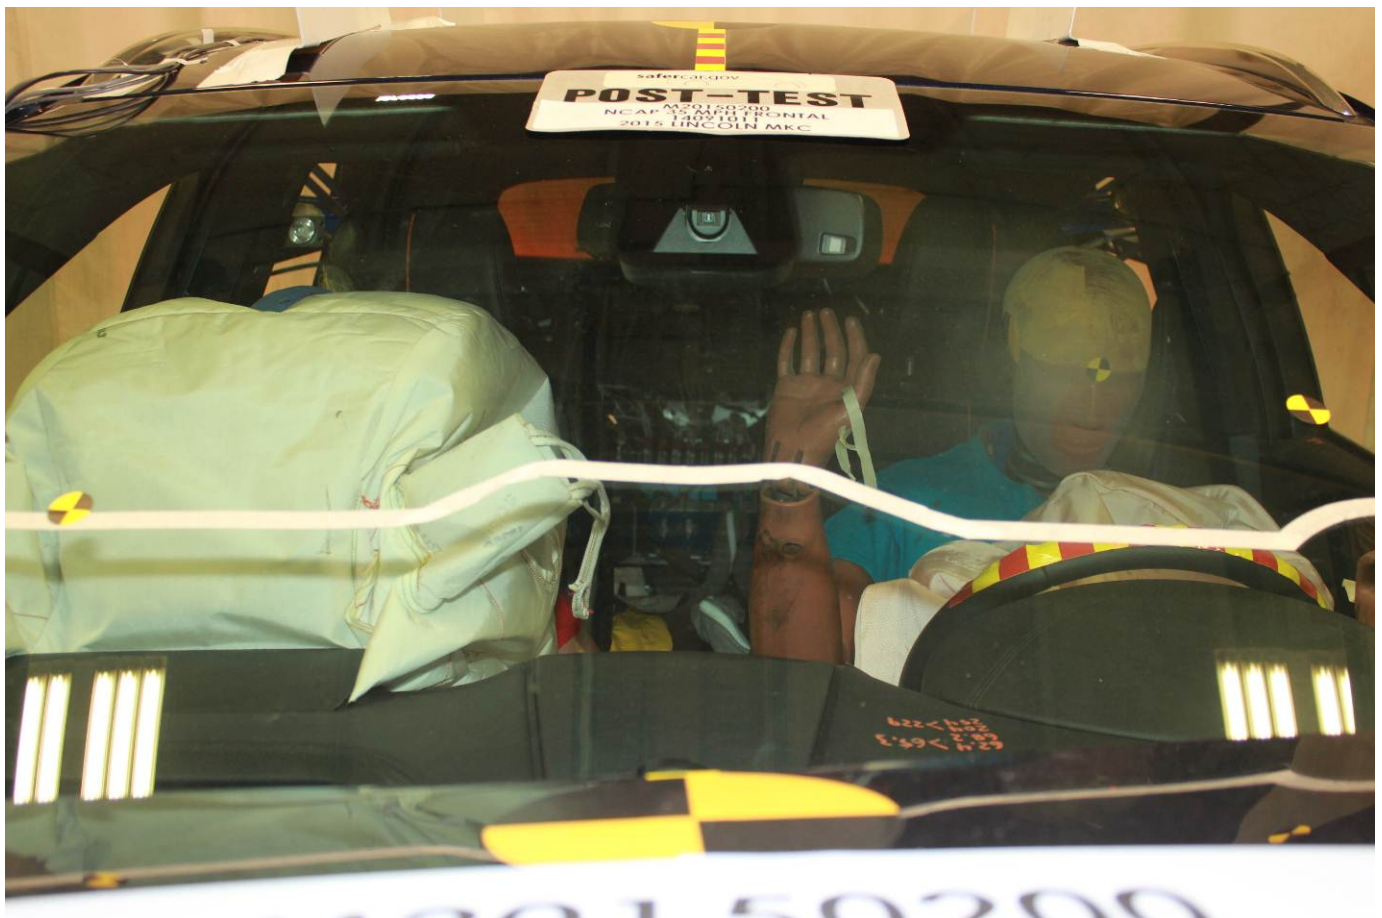
Post-Test Windshield View

There was 100 percent windshield retention and no intrusion into the protected zone of the windshield during the event. There was no Stoddard Solvent leakage after the event or during any phase of the static rollover.

| Critical Areas of Performance | Observations and Conclusions |
|---|---|
| Windshield Damage | Cracked |

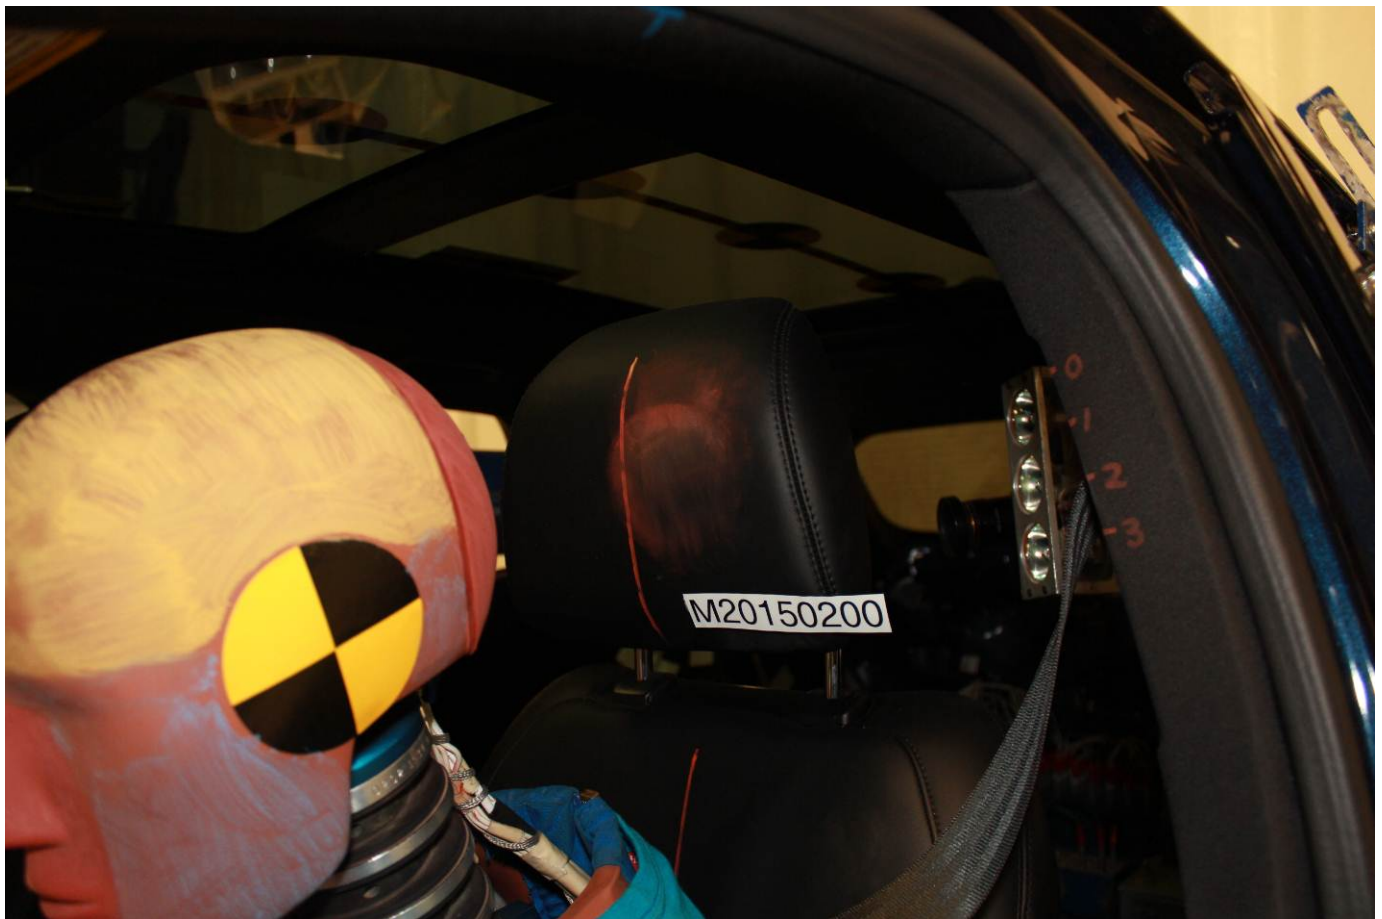
Post-Test Driver Dummy Contact with Headrest

The driver's visible contact points were as follows: The driver's head and chest contacted the airbag. The driver's head also contacted the headrest. The driver's knees contacted the knee airbag. The passenger's visible contact points were as follows: The passenger's head and chest contacted the airbag. The passenger's head also contacted the headrest. The passenger's knees contacted the glovebox.

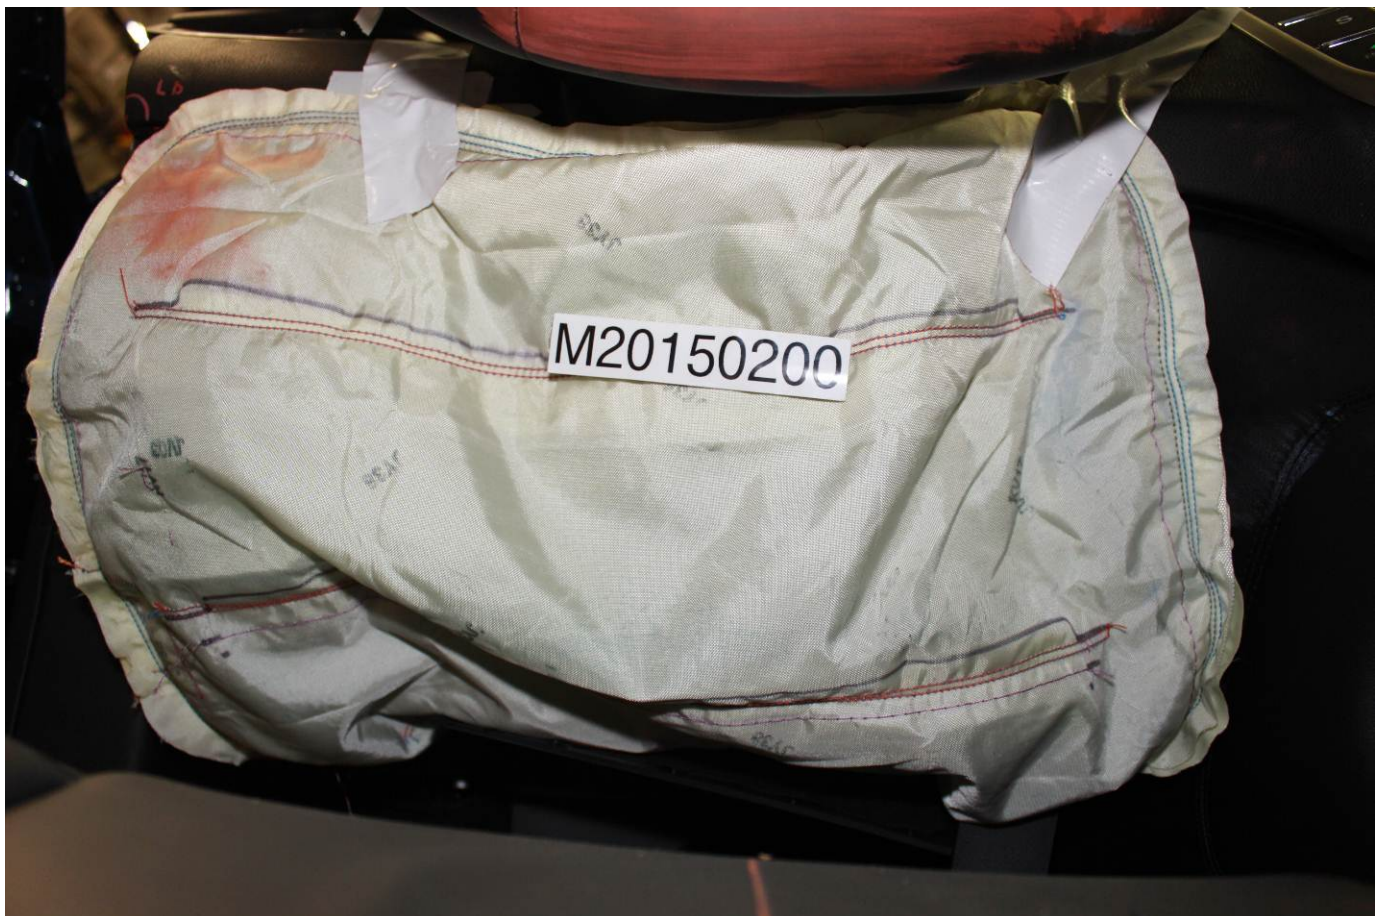
Post-Test Driver Dummy Contact with Knee Airbag

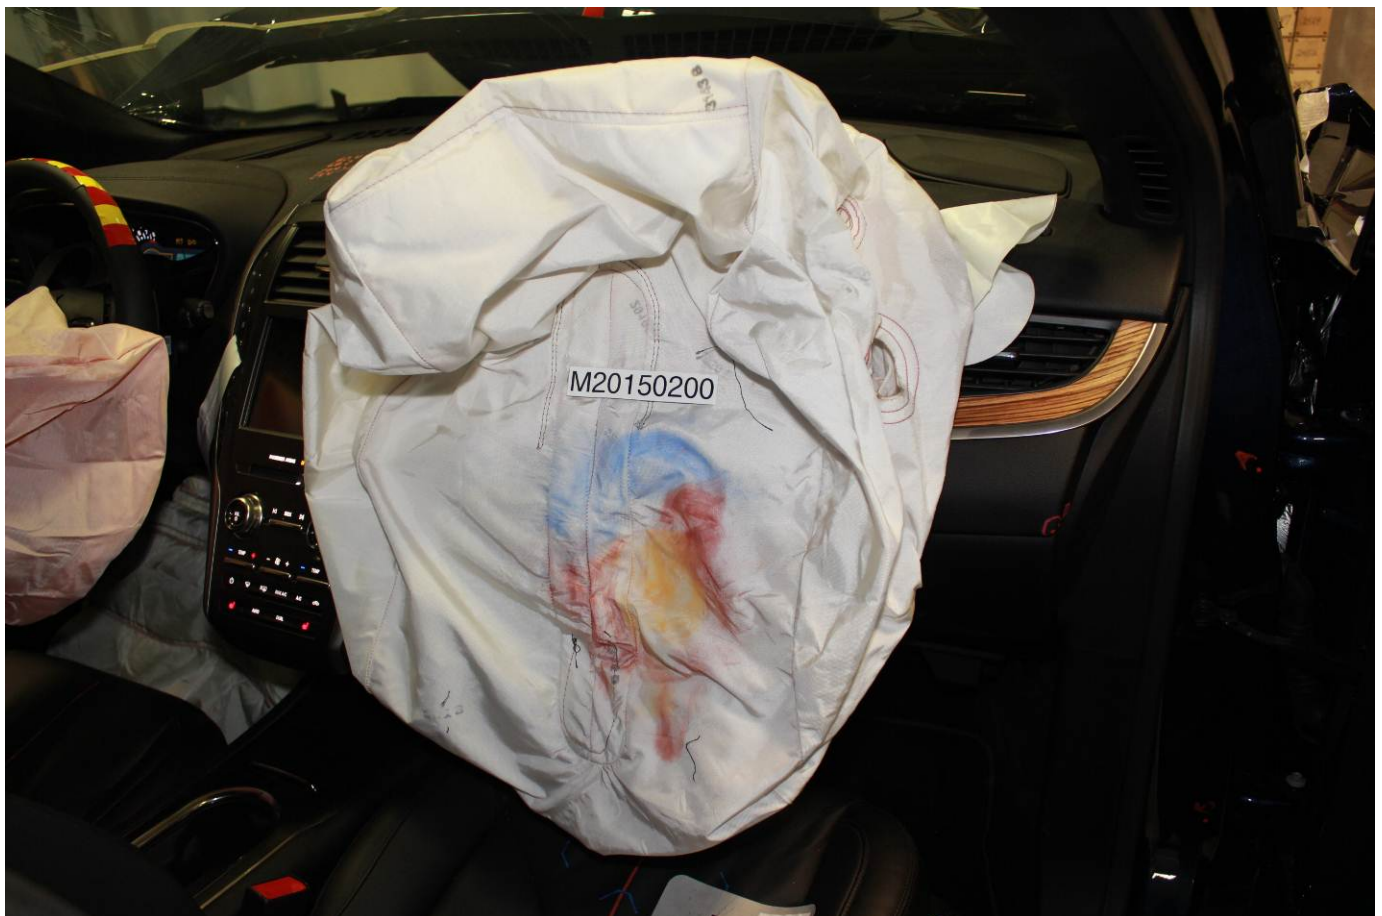
Post-Test Passenger Dummy Contact with Airbag

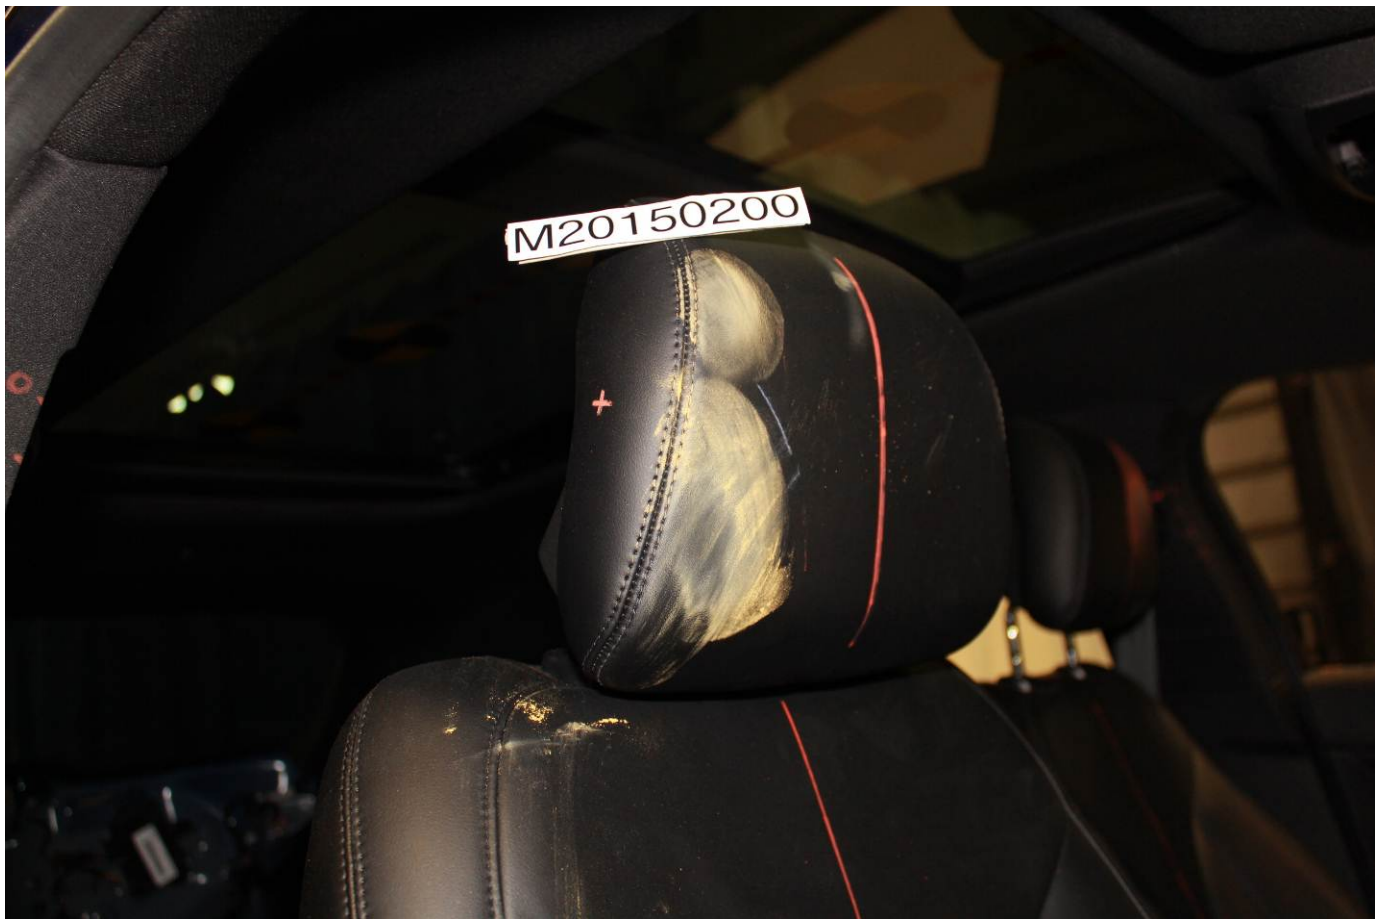
Post-Test Passenger Dummy Contact with Headrest

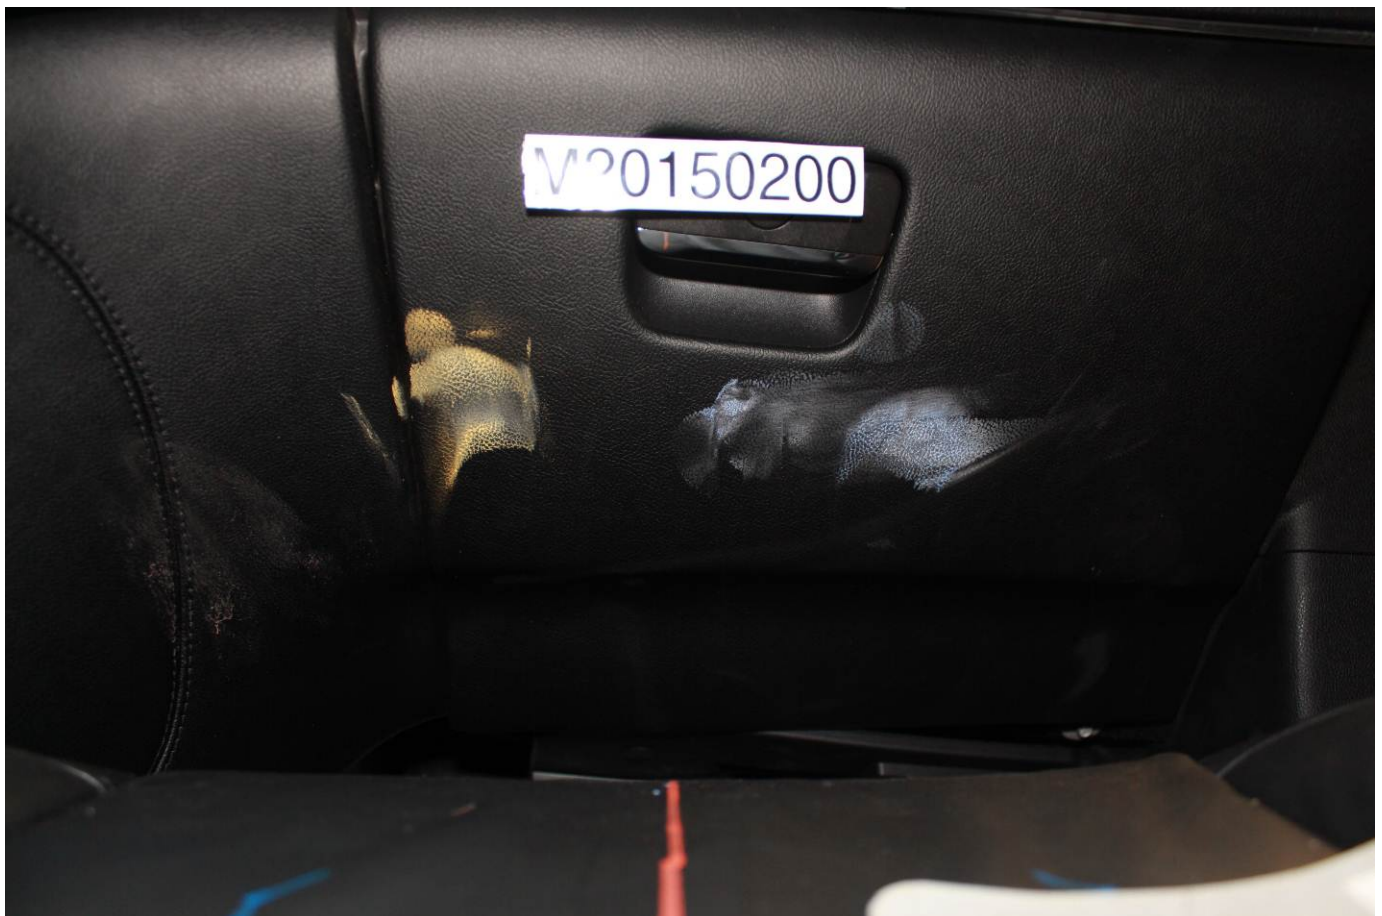
Post-Test Passenger Dummy Contact with Glovebox

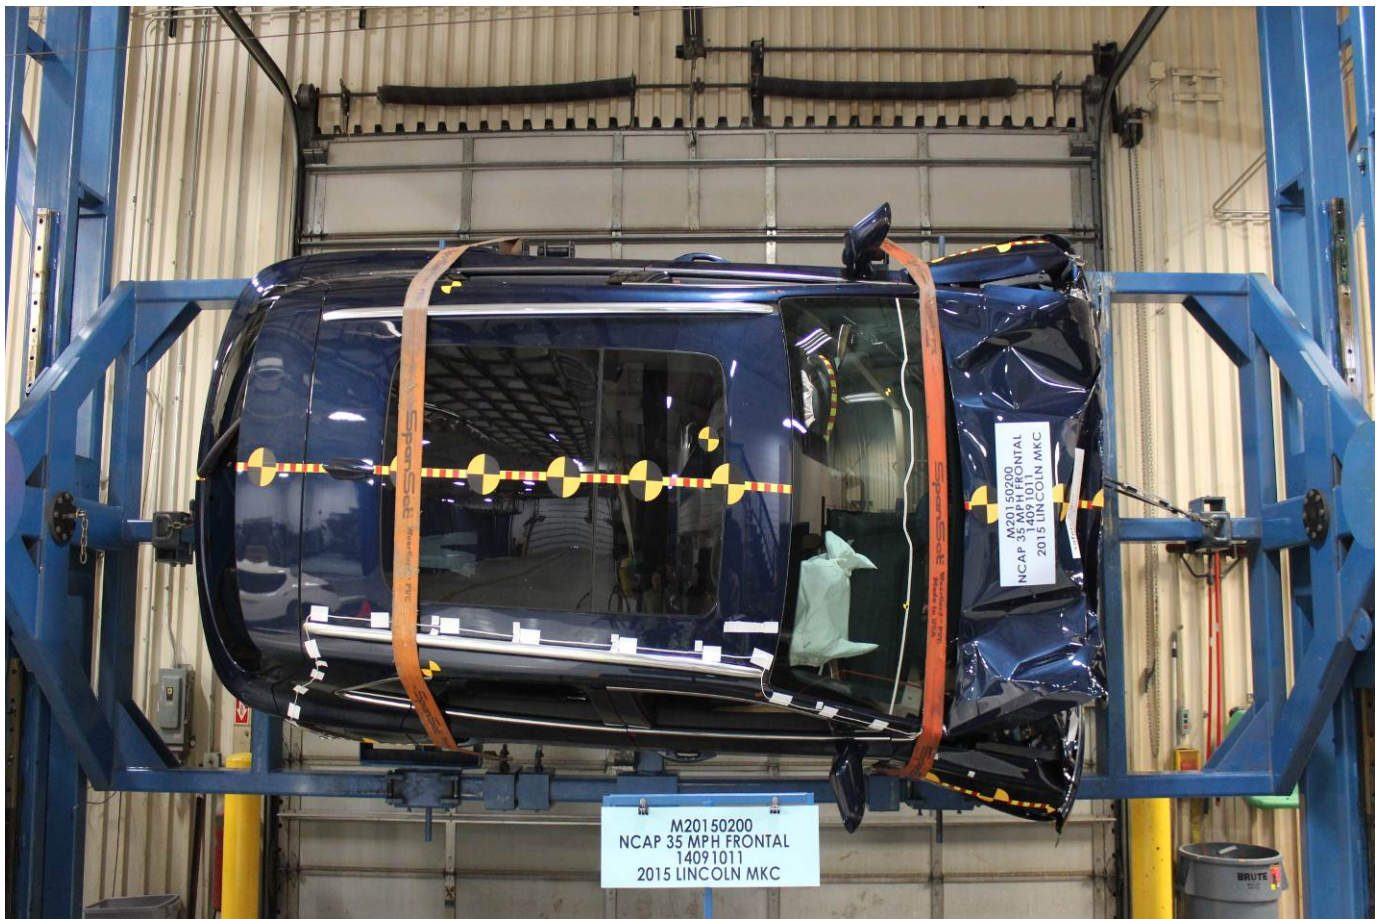
Vehicle at 90 Degrees on Static Rollover Device
