**OCAS-DRI-FCW-13-005**

**NCAP FORWARD COLLISION WARNING CONFIRMATION TEST**

**2013 Buick Encore**

**DYNAMIC RESEARCH, INC.**

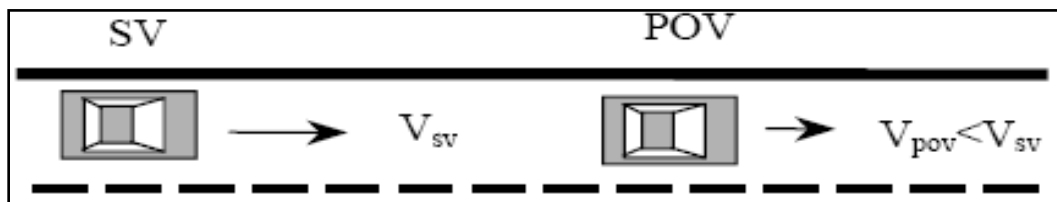
This test examines the ability of the FCW system to recognize a slower lead vehicle being driven with a constant speed and issue a timely alert. As depicted in Figure 3, the scenario was conducted with a closing speed equal to 25.0 mph (40.2 kph).

Figure 3. Depiction of Test 3

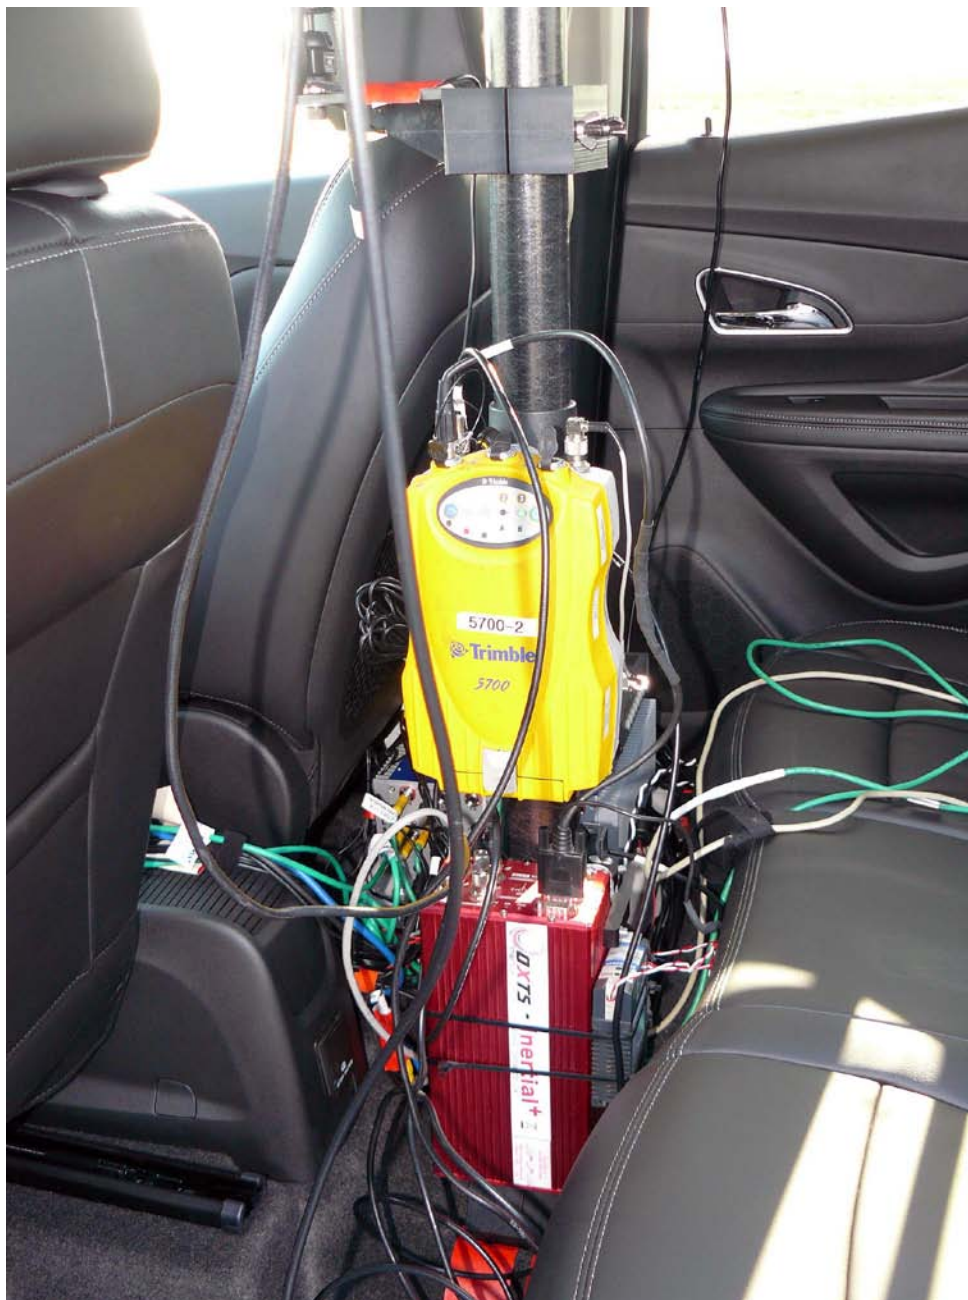
Figure A7. DGPS and Inertial Measurement Unit Installed in Subject Vehicle

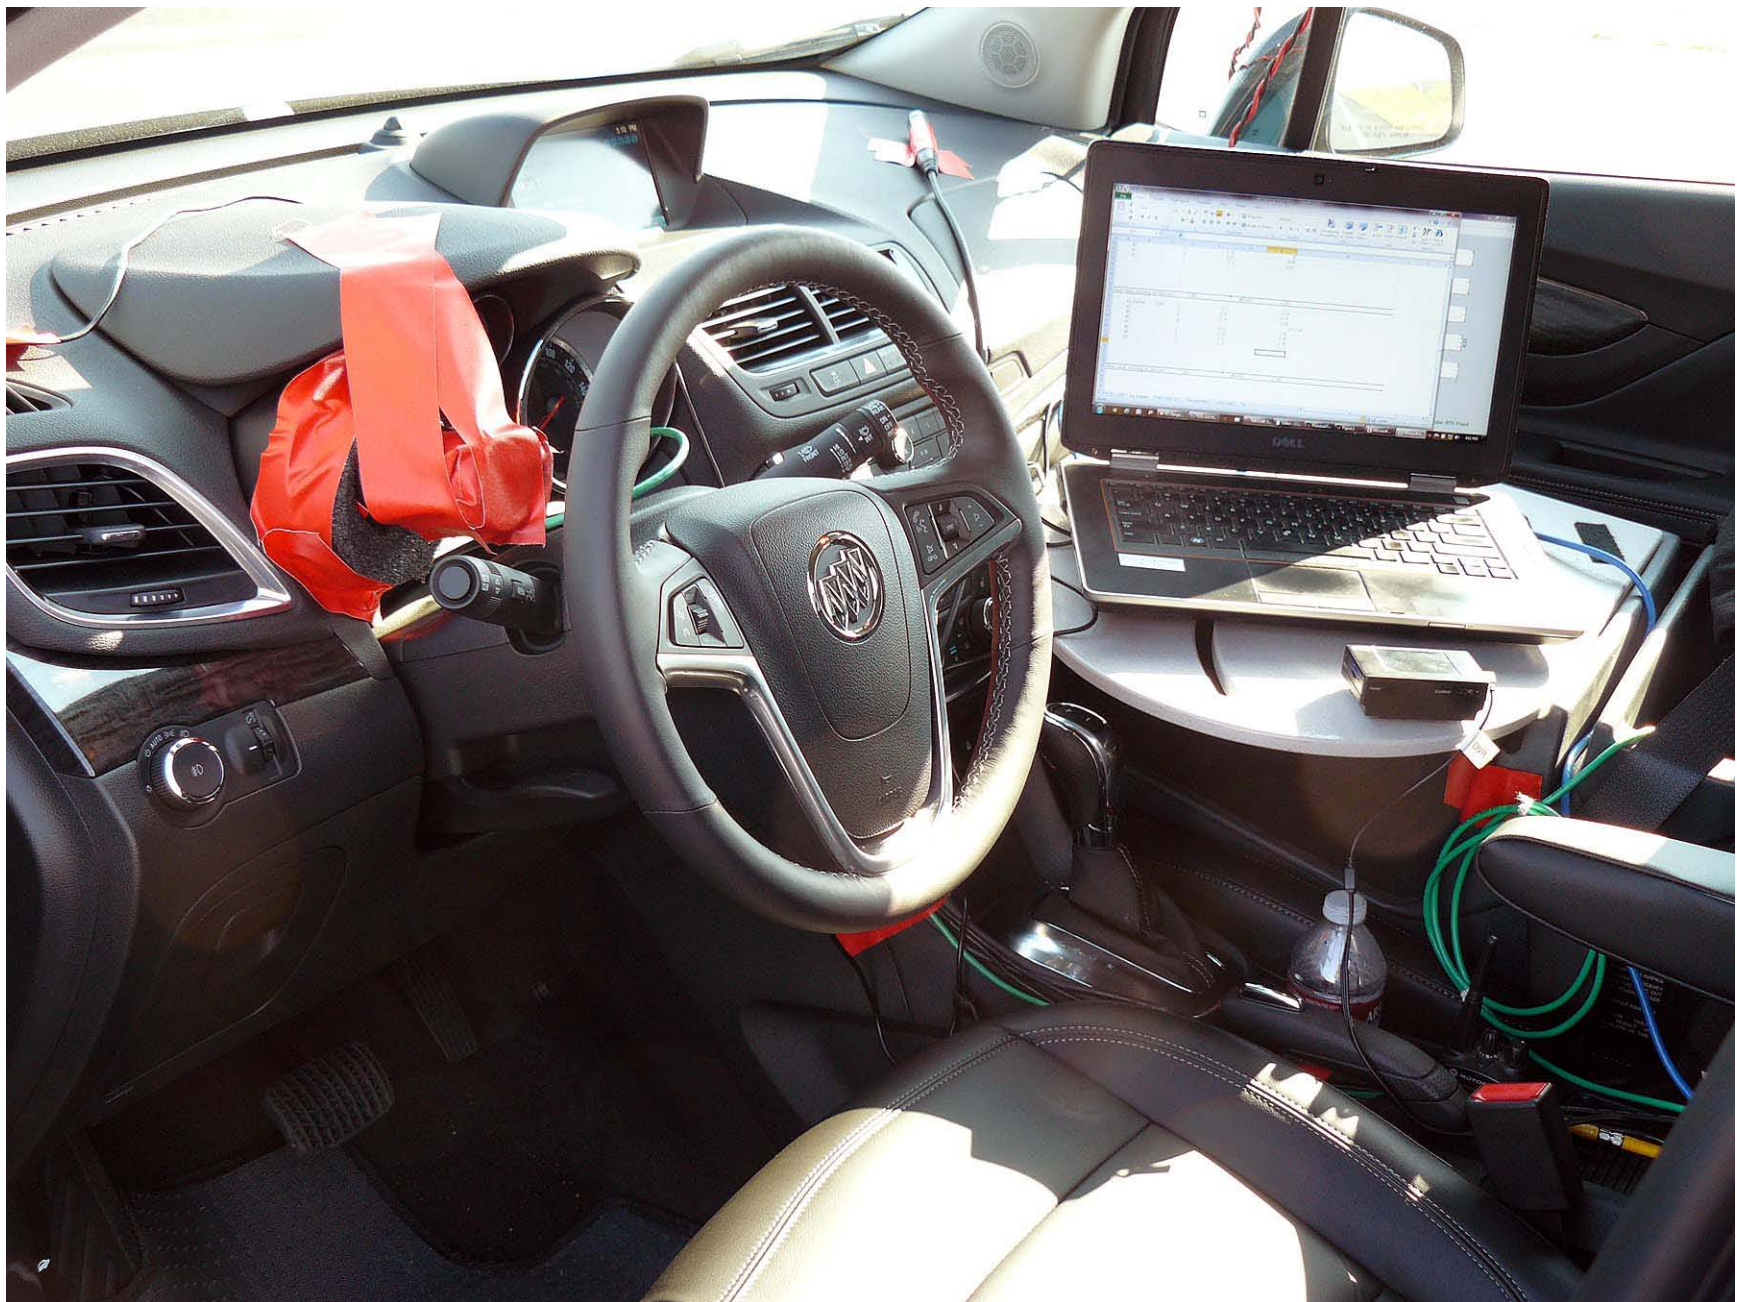
Figure A9. Computer Installed in Subject Vehicle

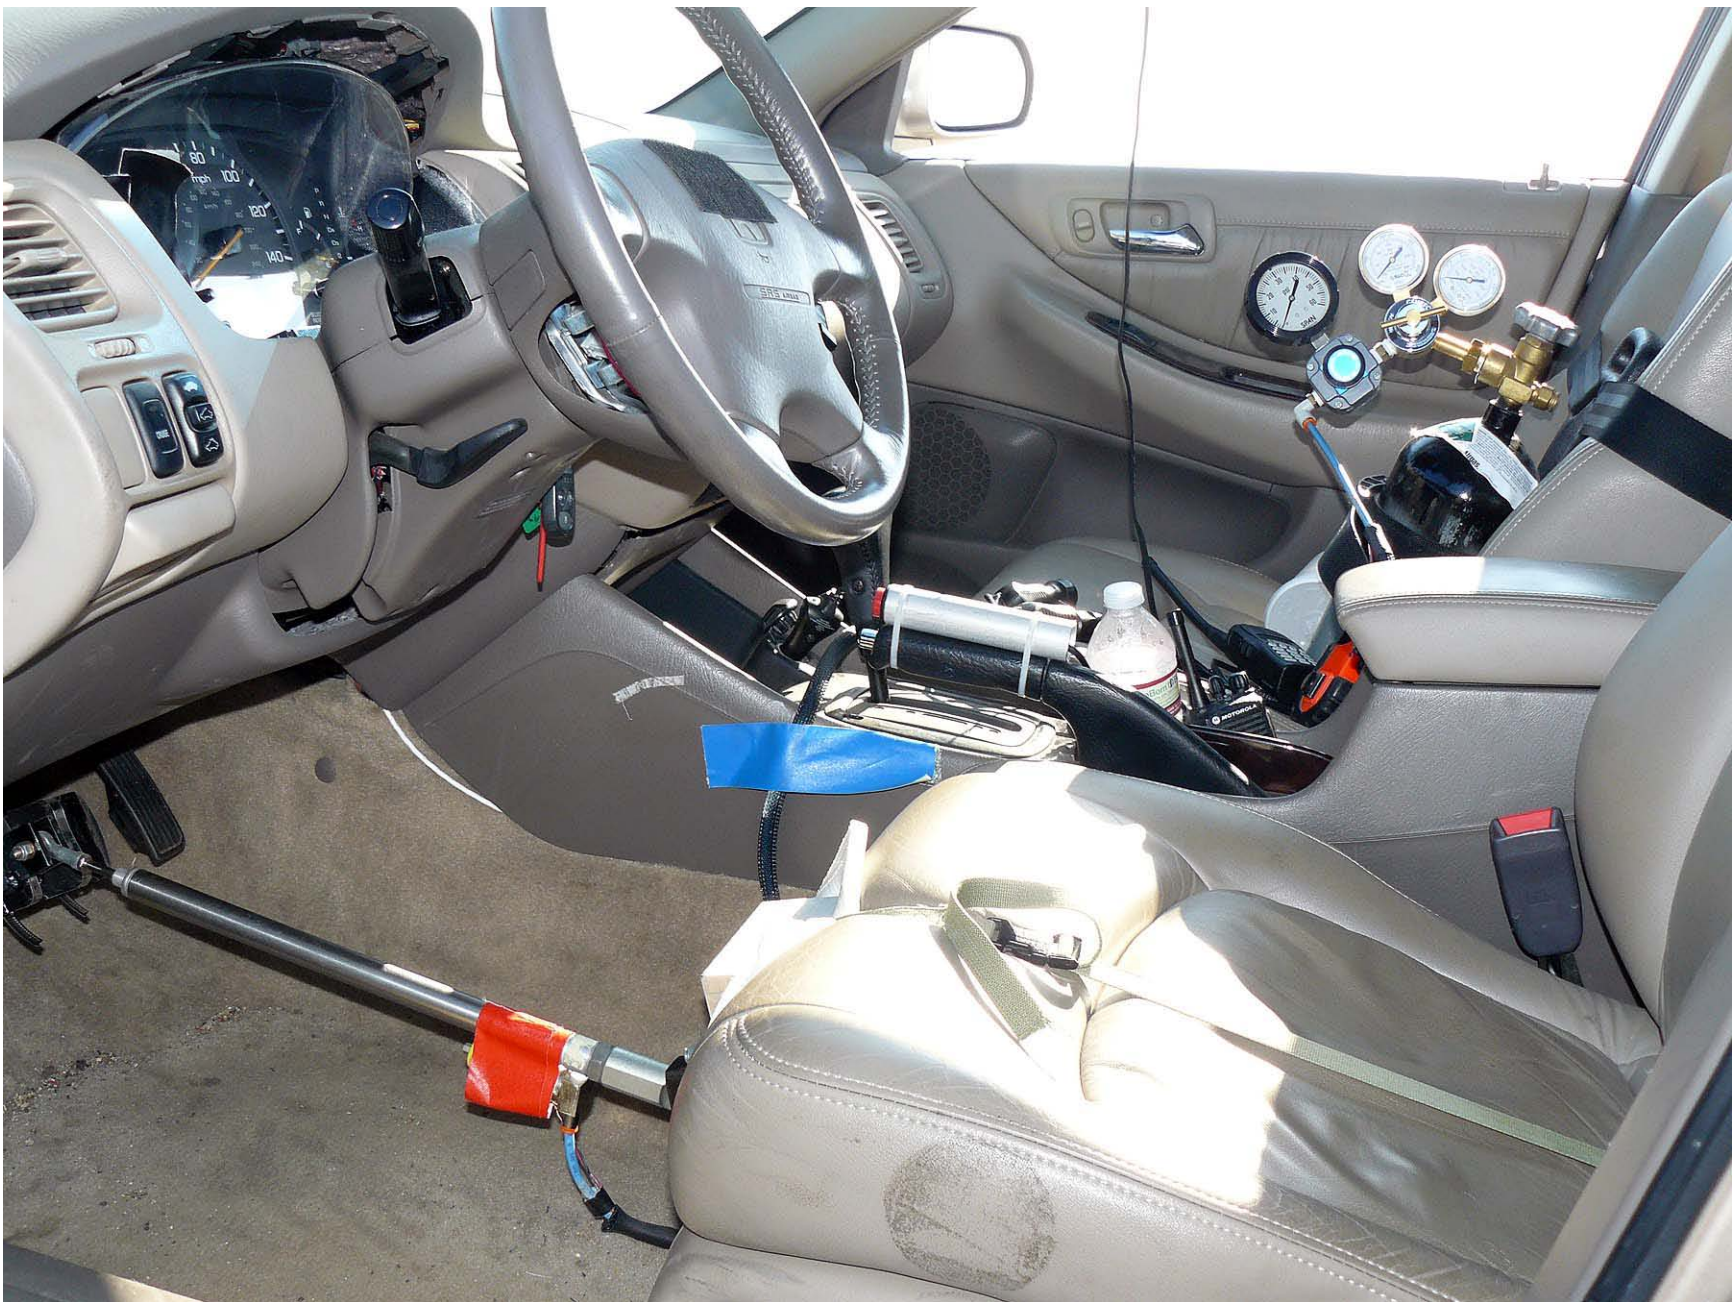
Figure A10. Brake Actuation System Installed in Principal Other Vehicle

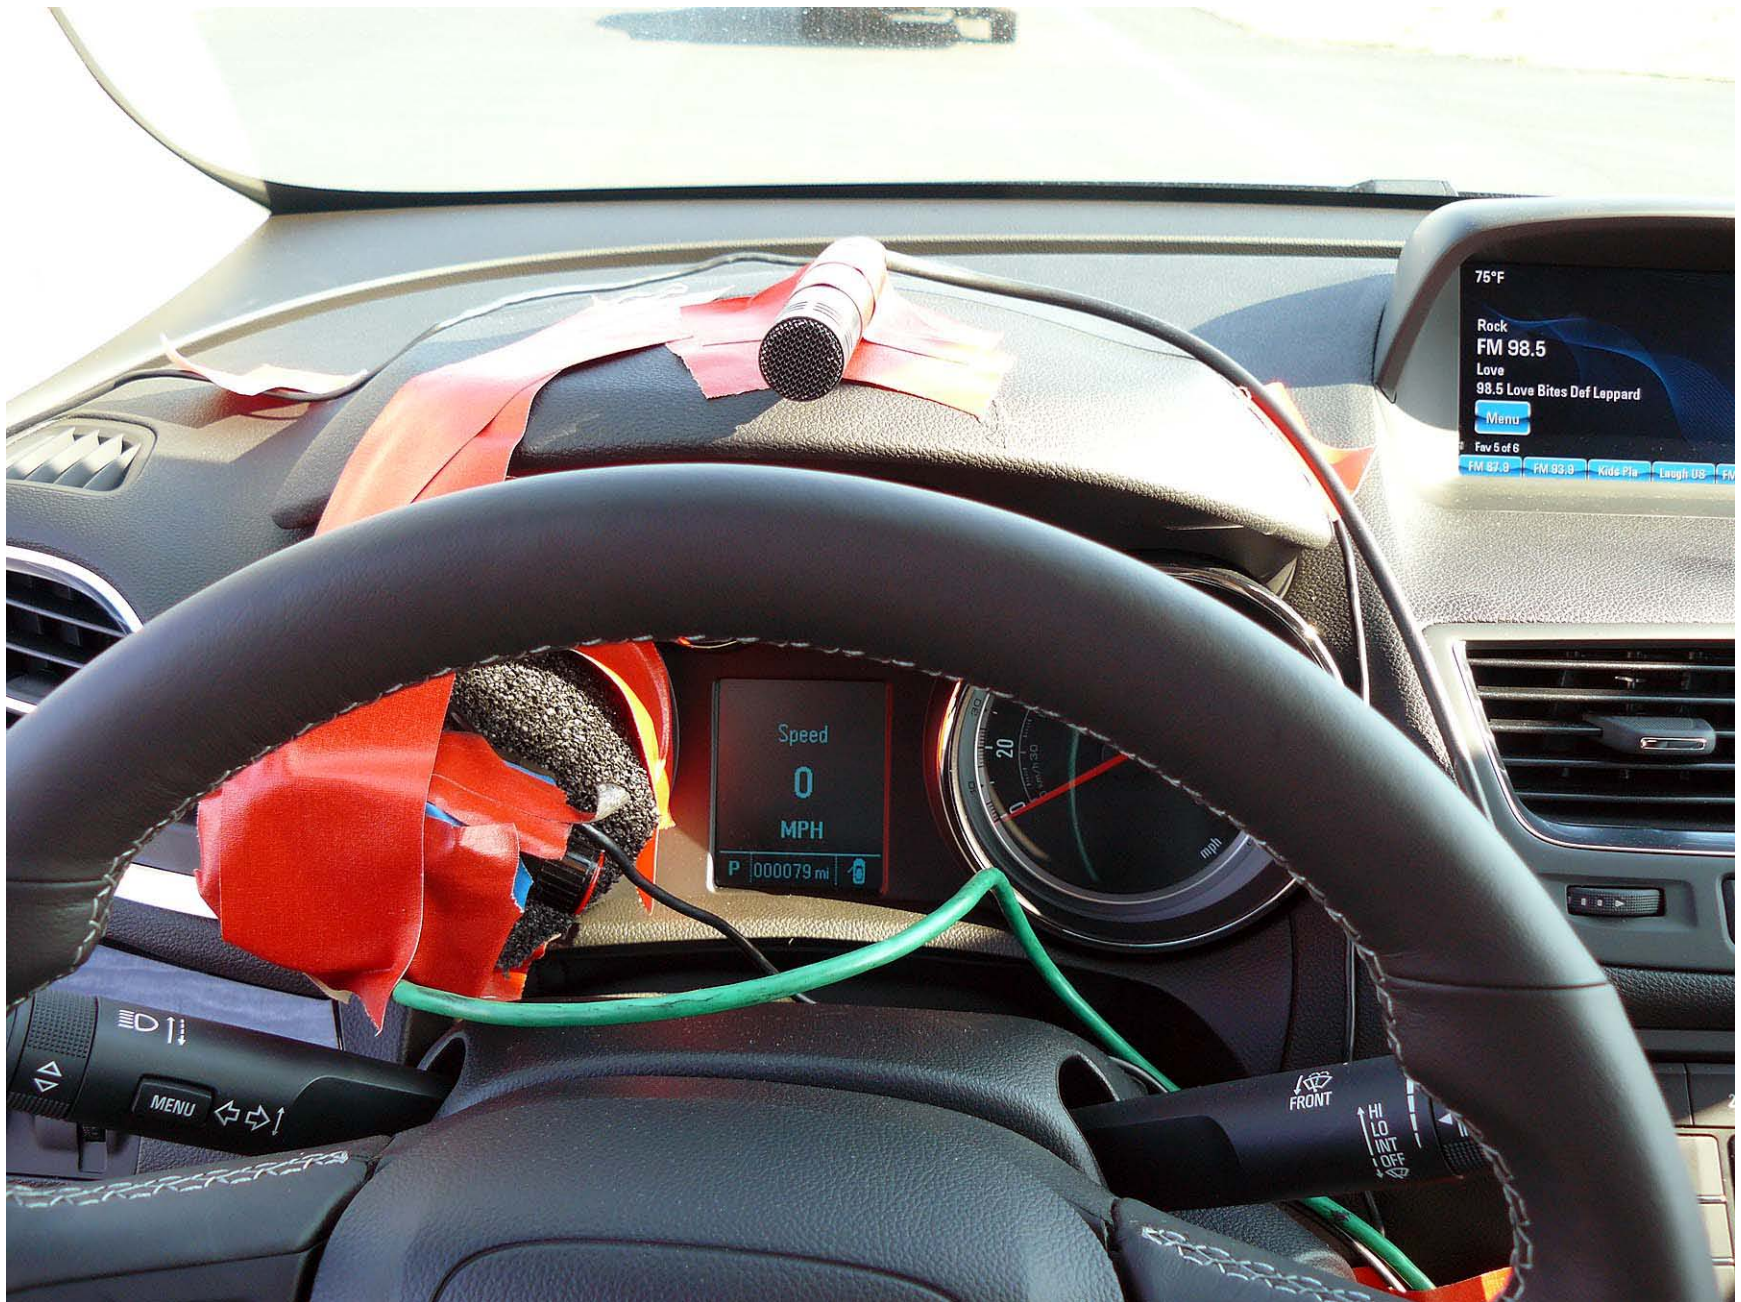
Figure A11. Sensors for Detecting Acoustic and Visual Alerts

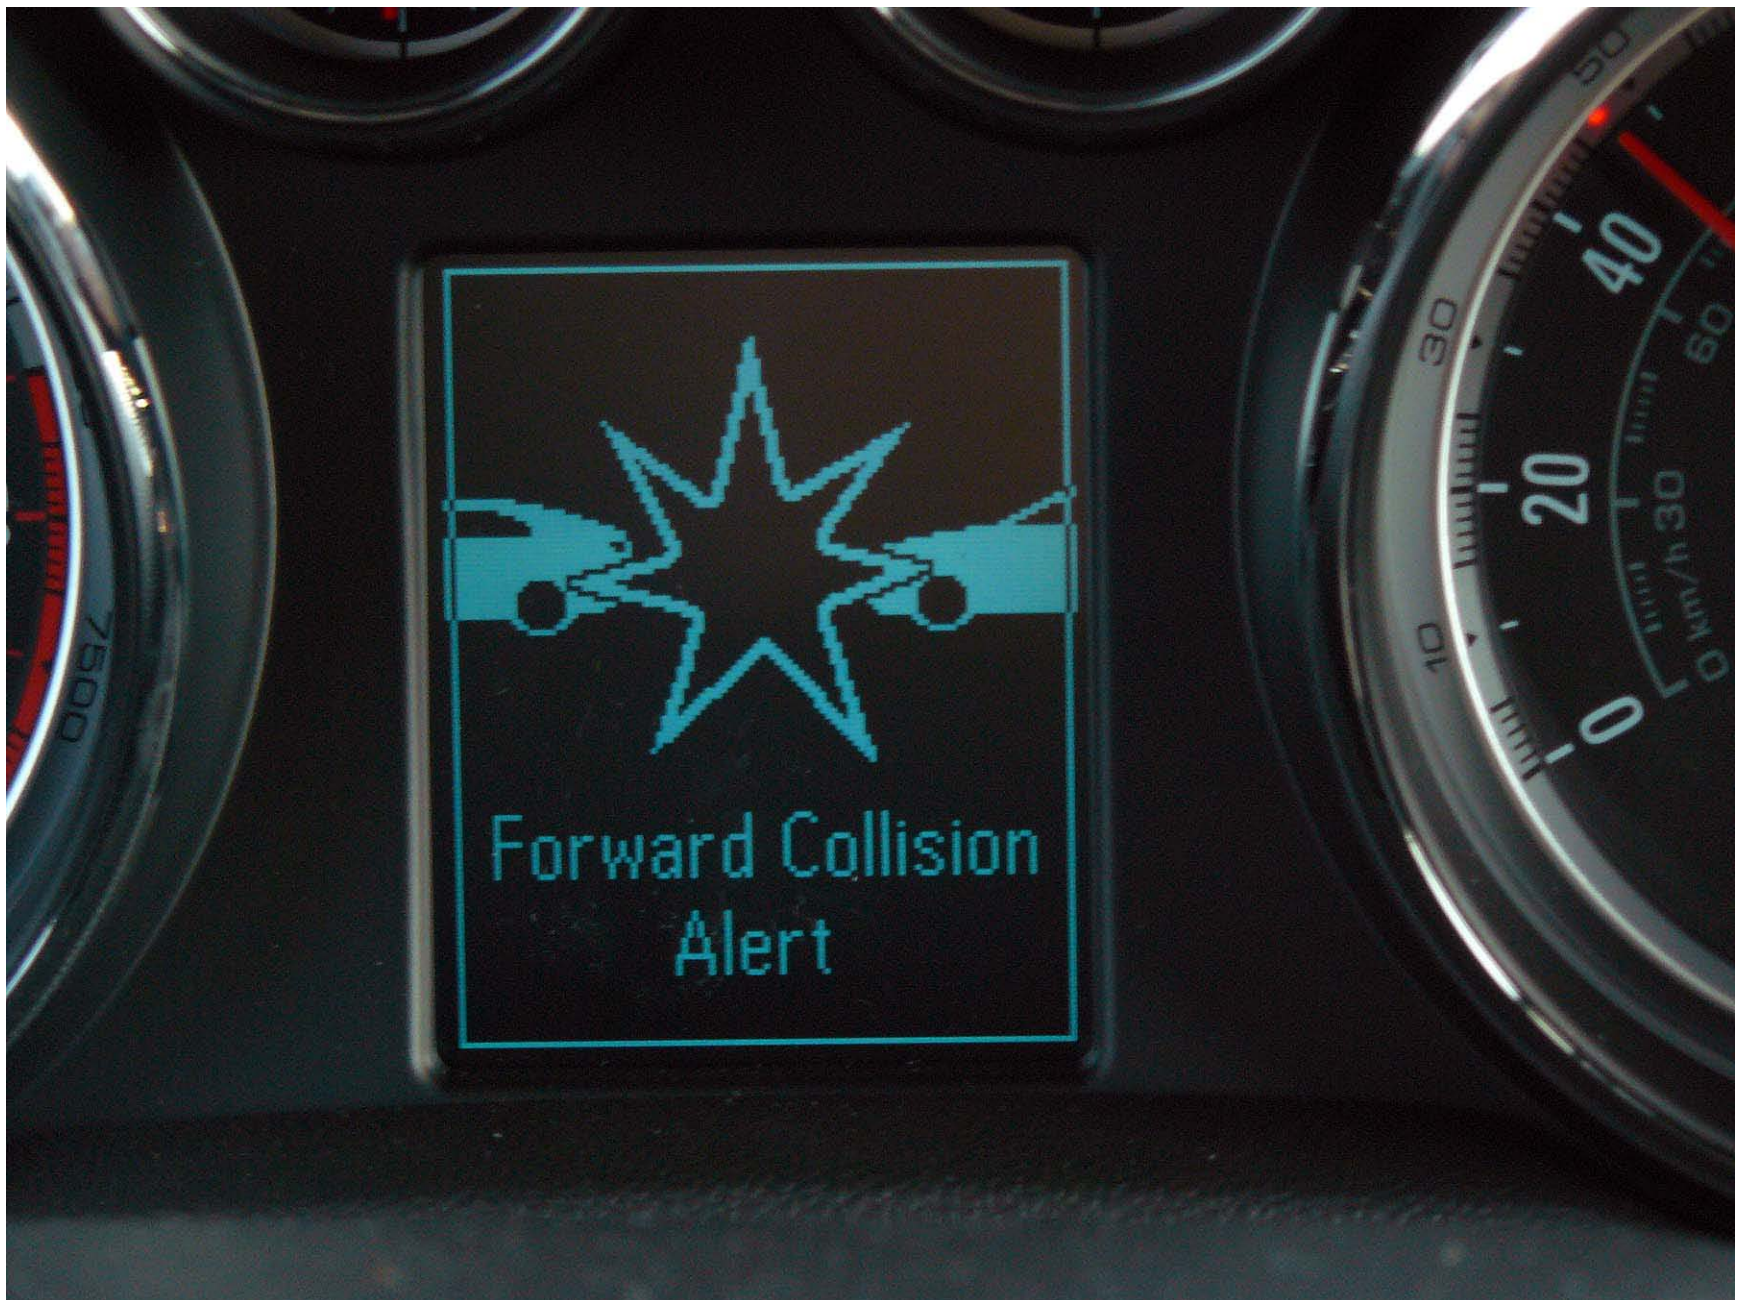
Figure A12. Visual Warning Display

The visual alert consists of an image of two vehicles about to have a rear end collision with a star in between and the words "Forward Collision Alert" below. The image appears in the common display area in the center of the instrument panel. (Figure A.12)

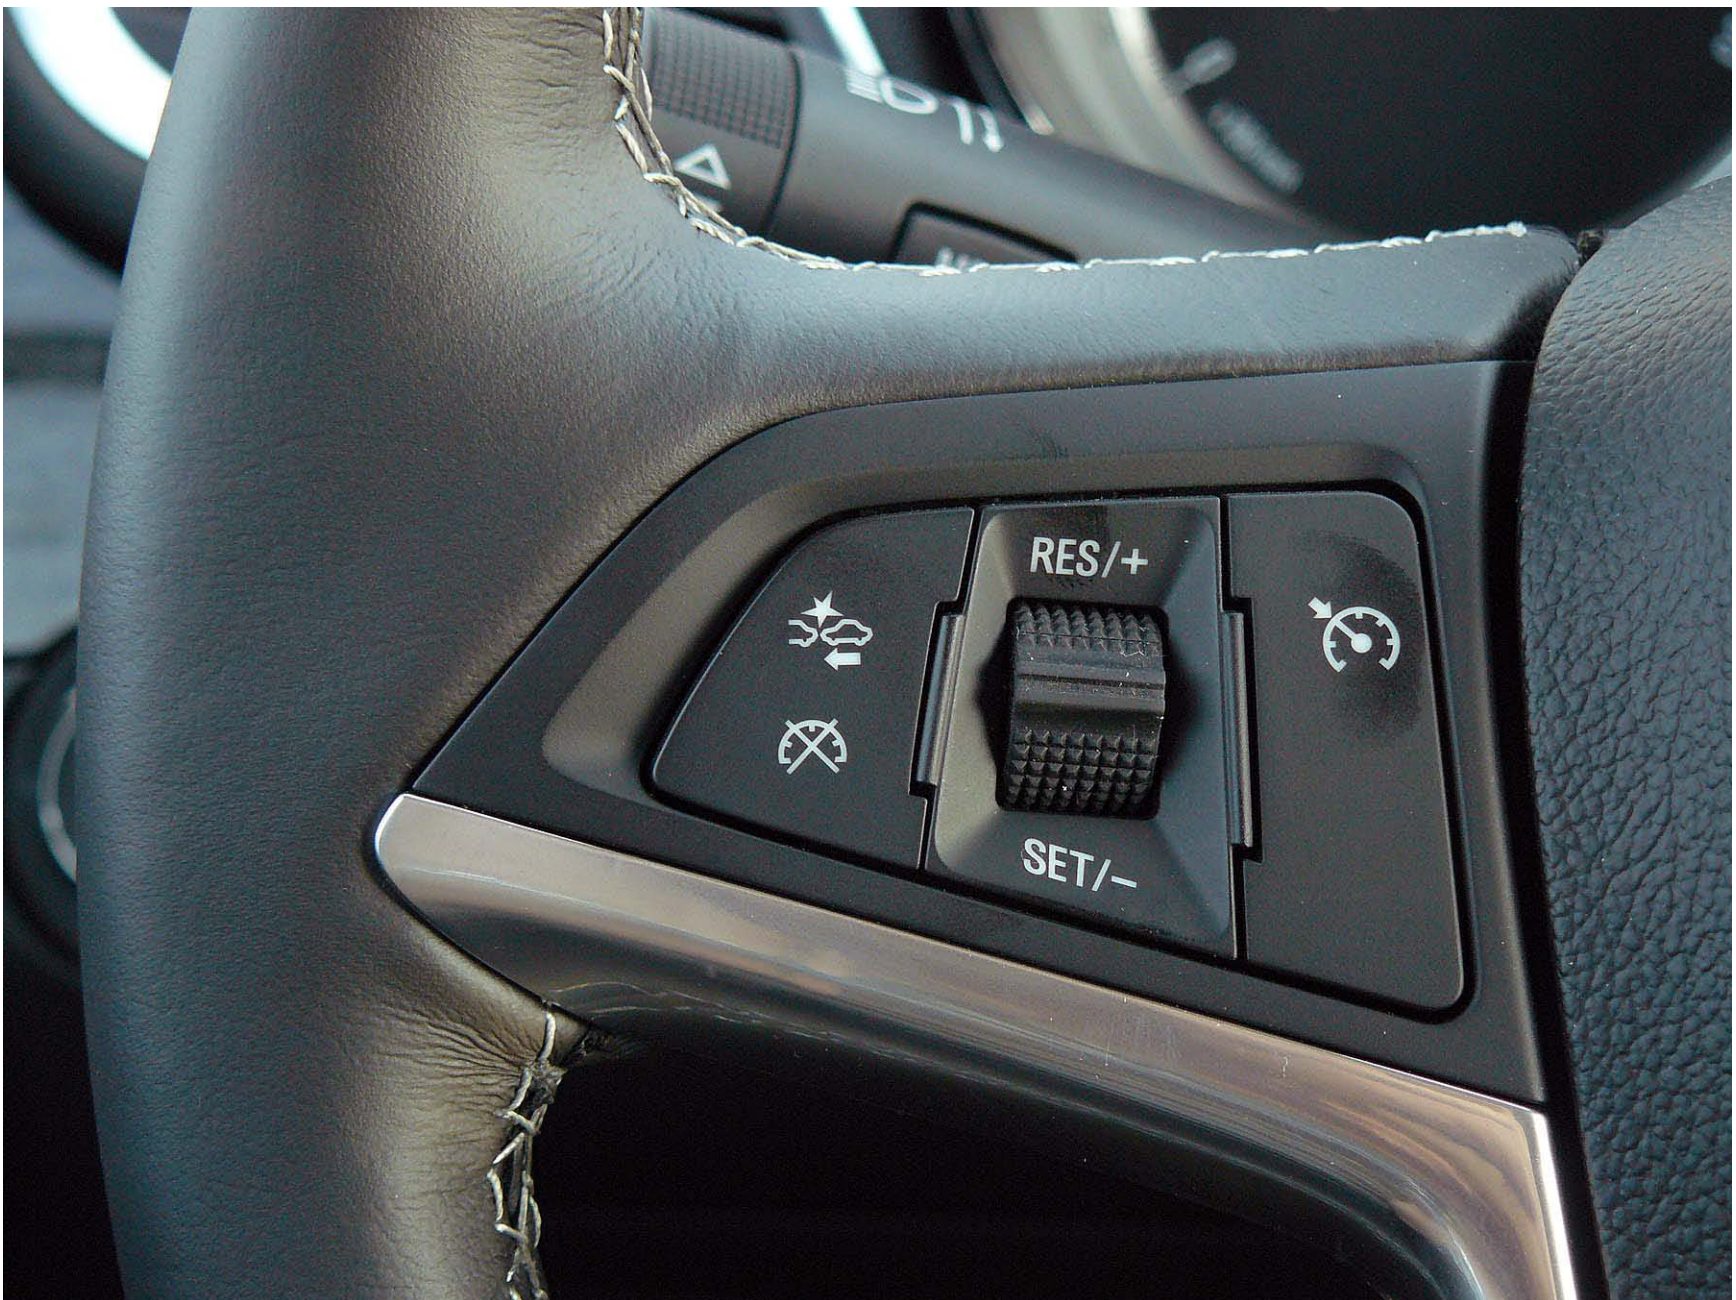
Figure A13. FCW On/Off and Distance Switch

A switch located on the left side of the steering wheel toggles the warning system between "Long", "Medium", "Short", and "Off" modes. The switch has an image of two vehicles about to have a rear end collision with a star above it. (Figure A.13)
