**OCAS-DRI-FCW-13-009**

**NCAP FORWARD COLLISION WARNING CONFIRMATION TEST**

**2013 Ford Explorer**

**DYNAMIC RESEARCH, INC.**

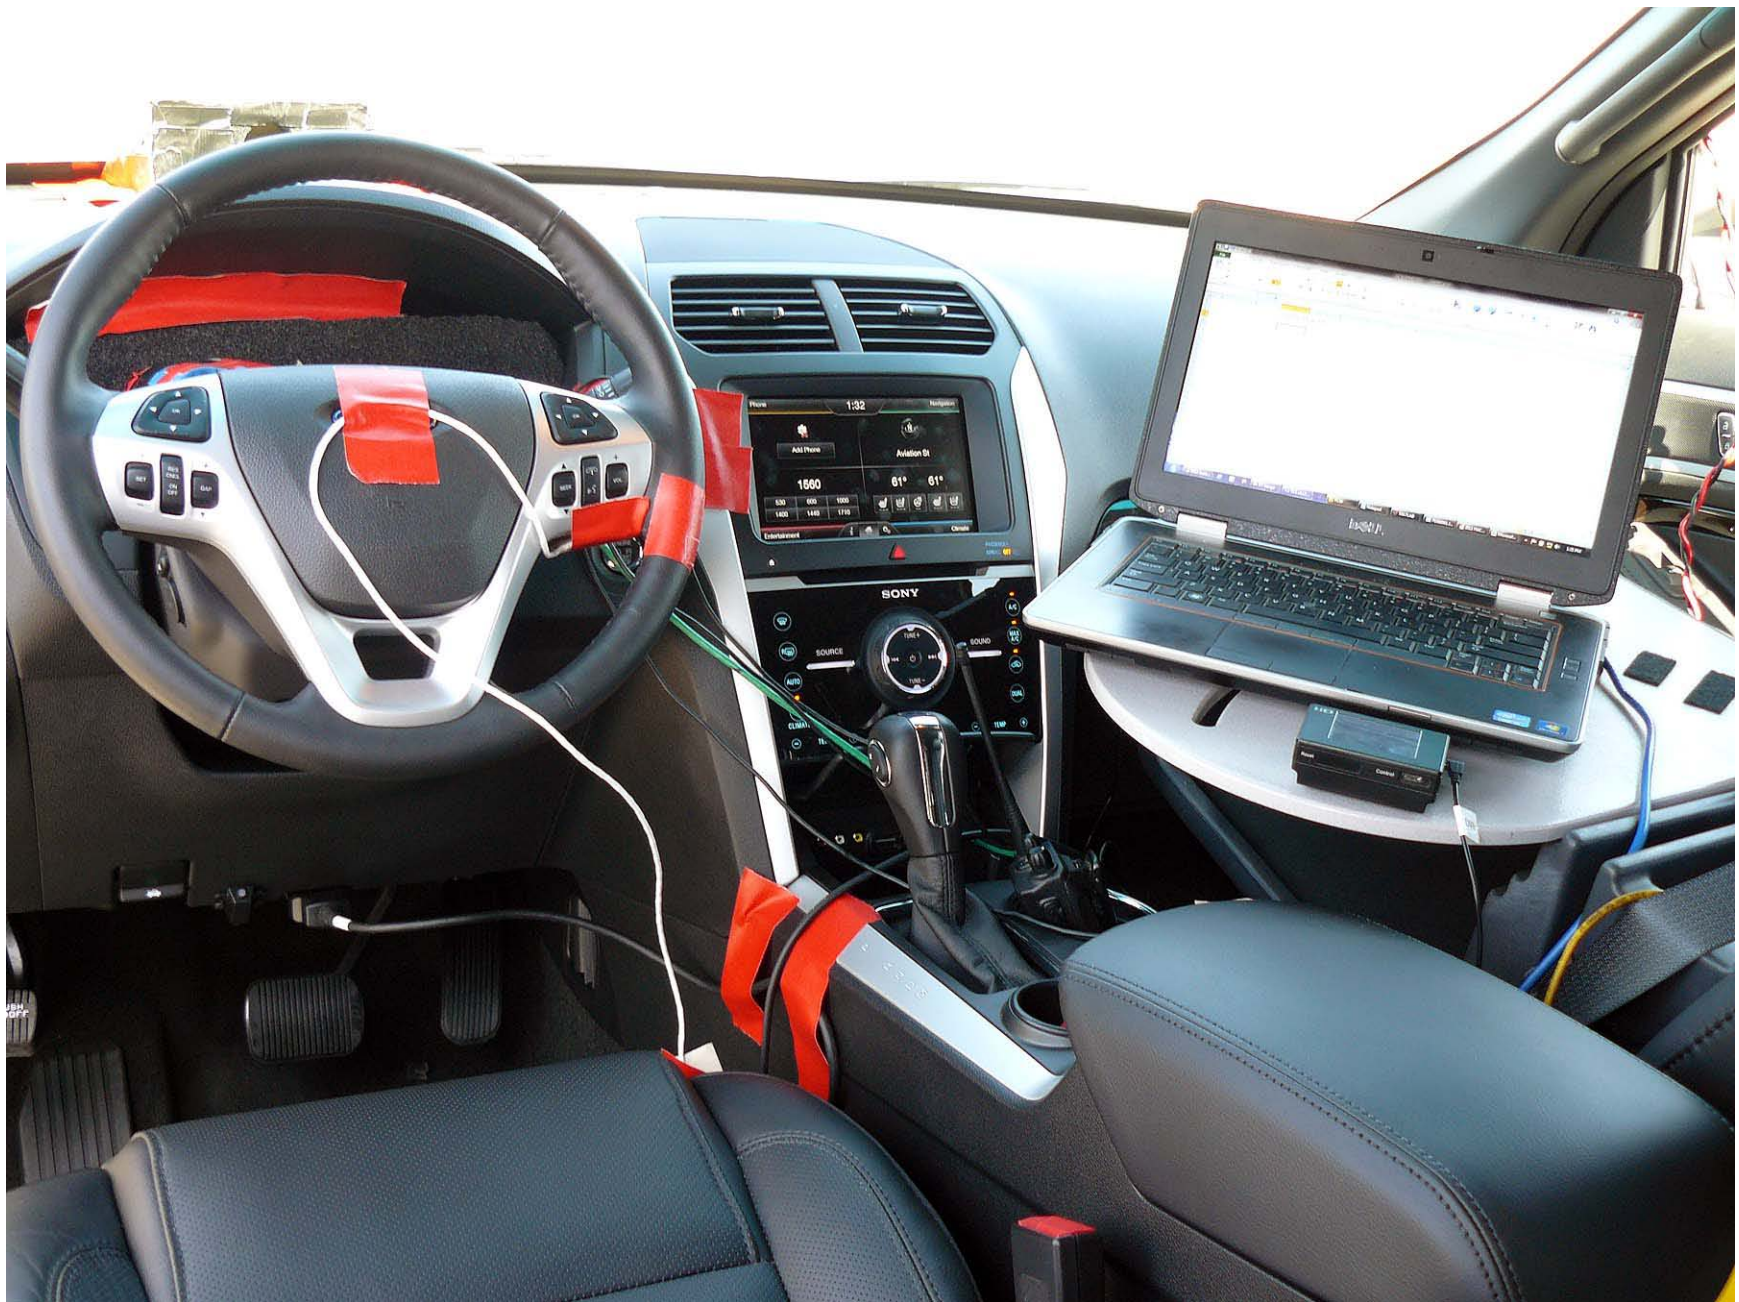
Figure A9. Computer Installed in Subject Vehicle

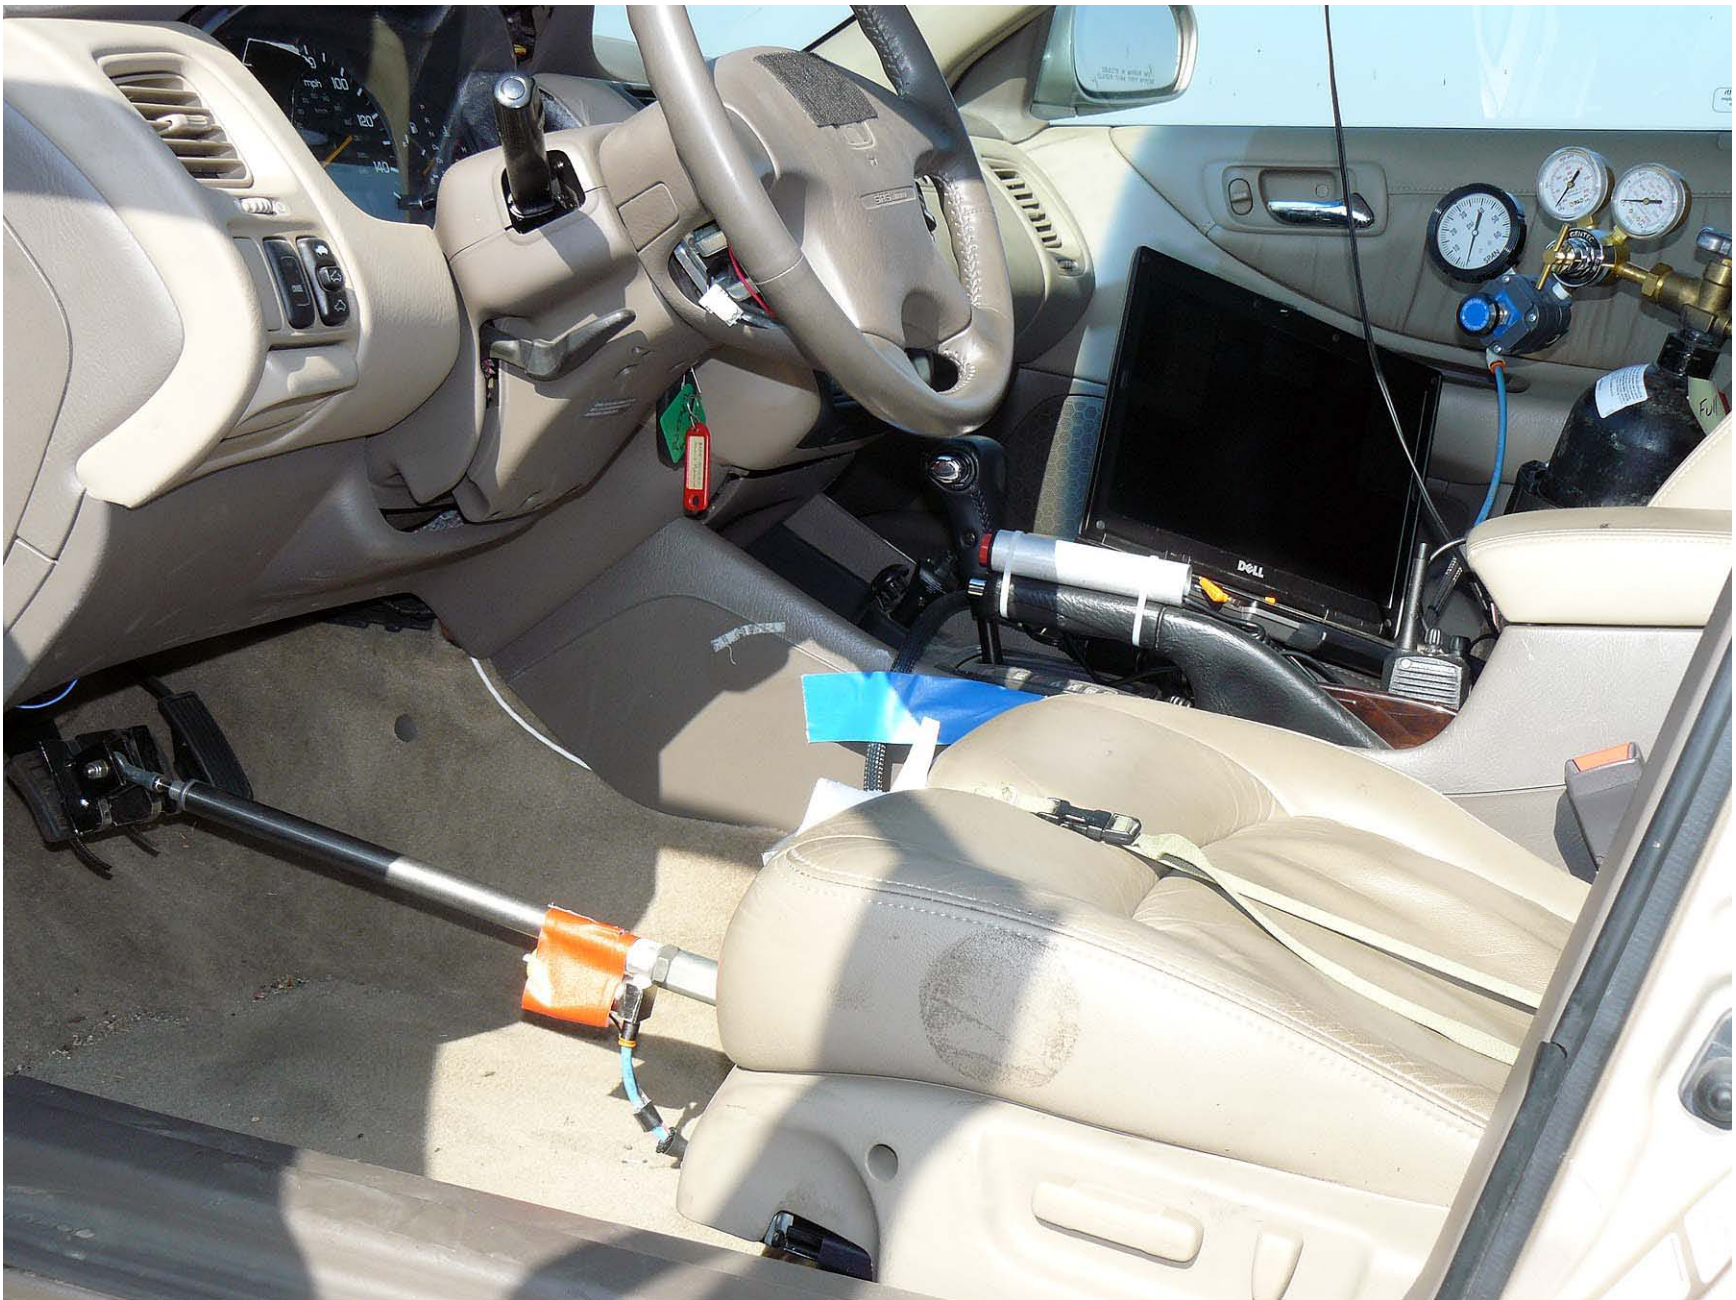
Figure A10. Brake Actuation System Installed in Principal Other Vehicle

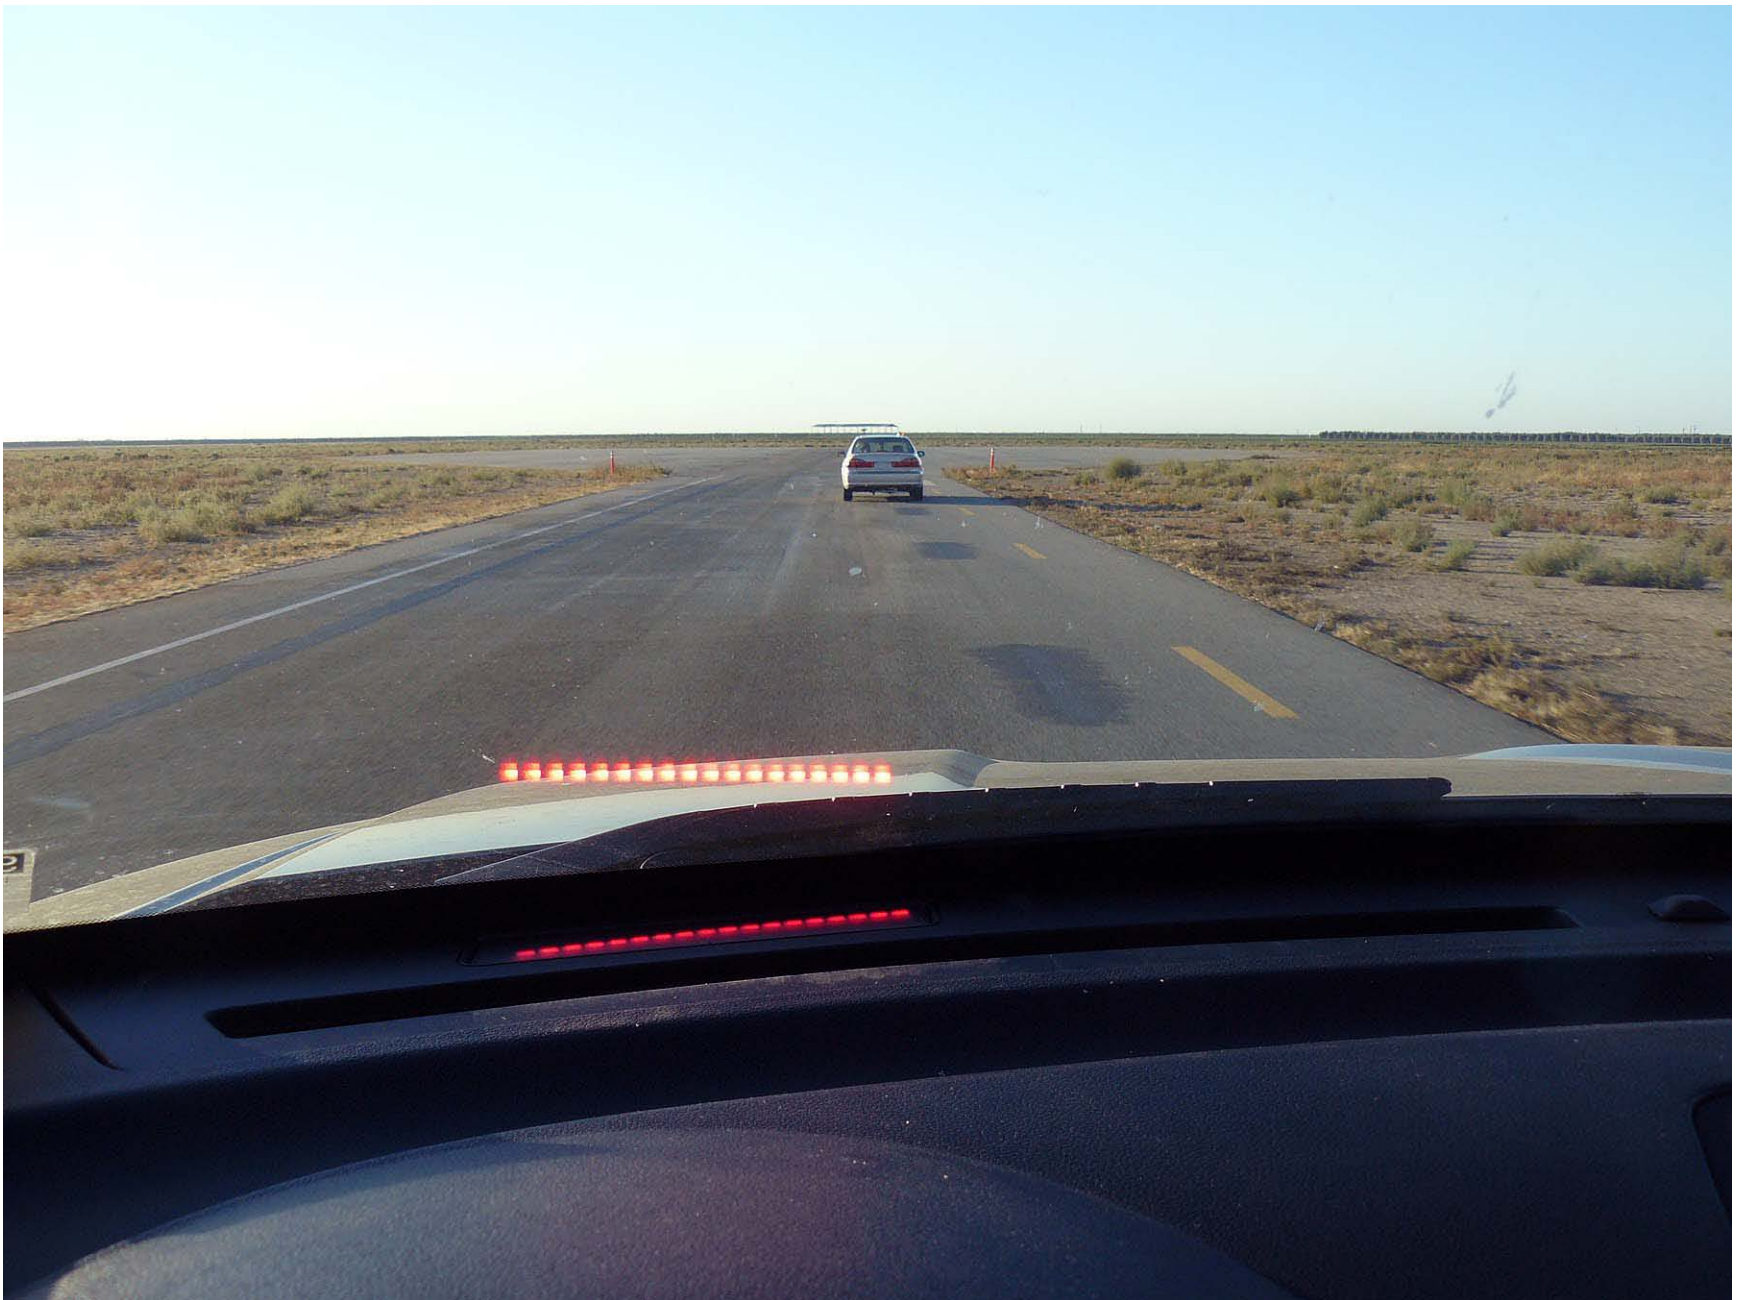
Figure A11. Forward Collision Visual Warning

Warning light is seen in the lower portion of the windshield directly in front of the driver. The audible warning is a repeated tone (3 sets of 4 beeps at 1800 Hz).

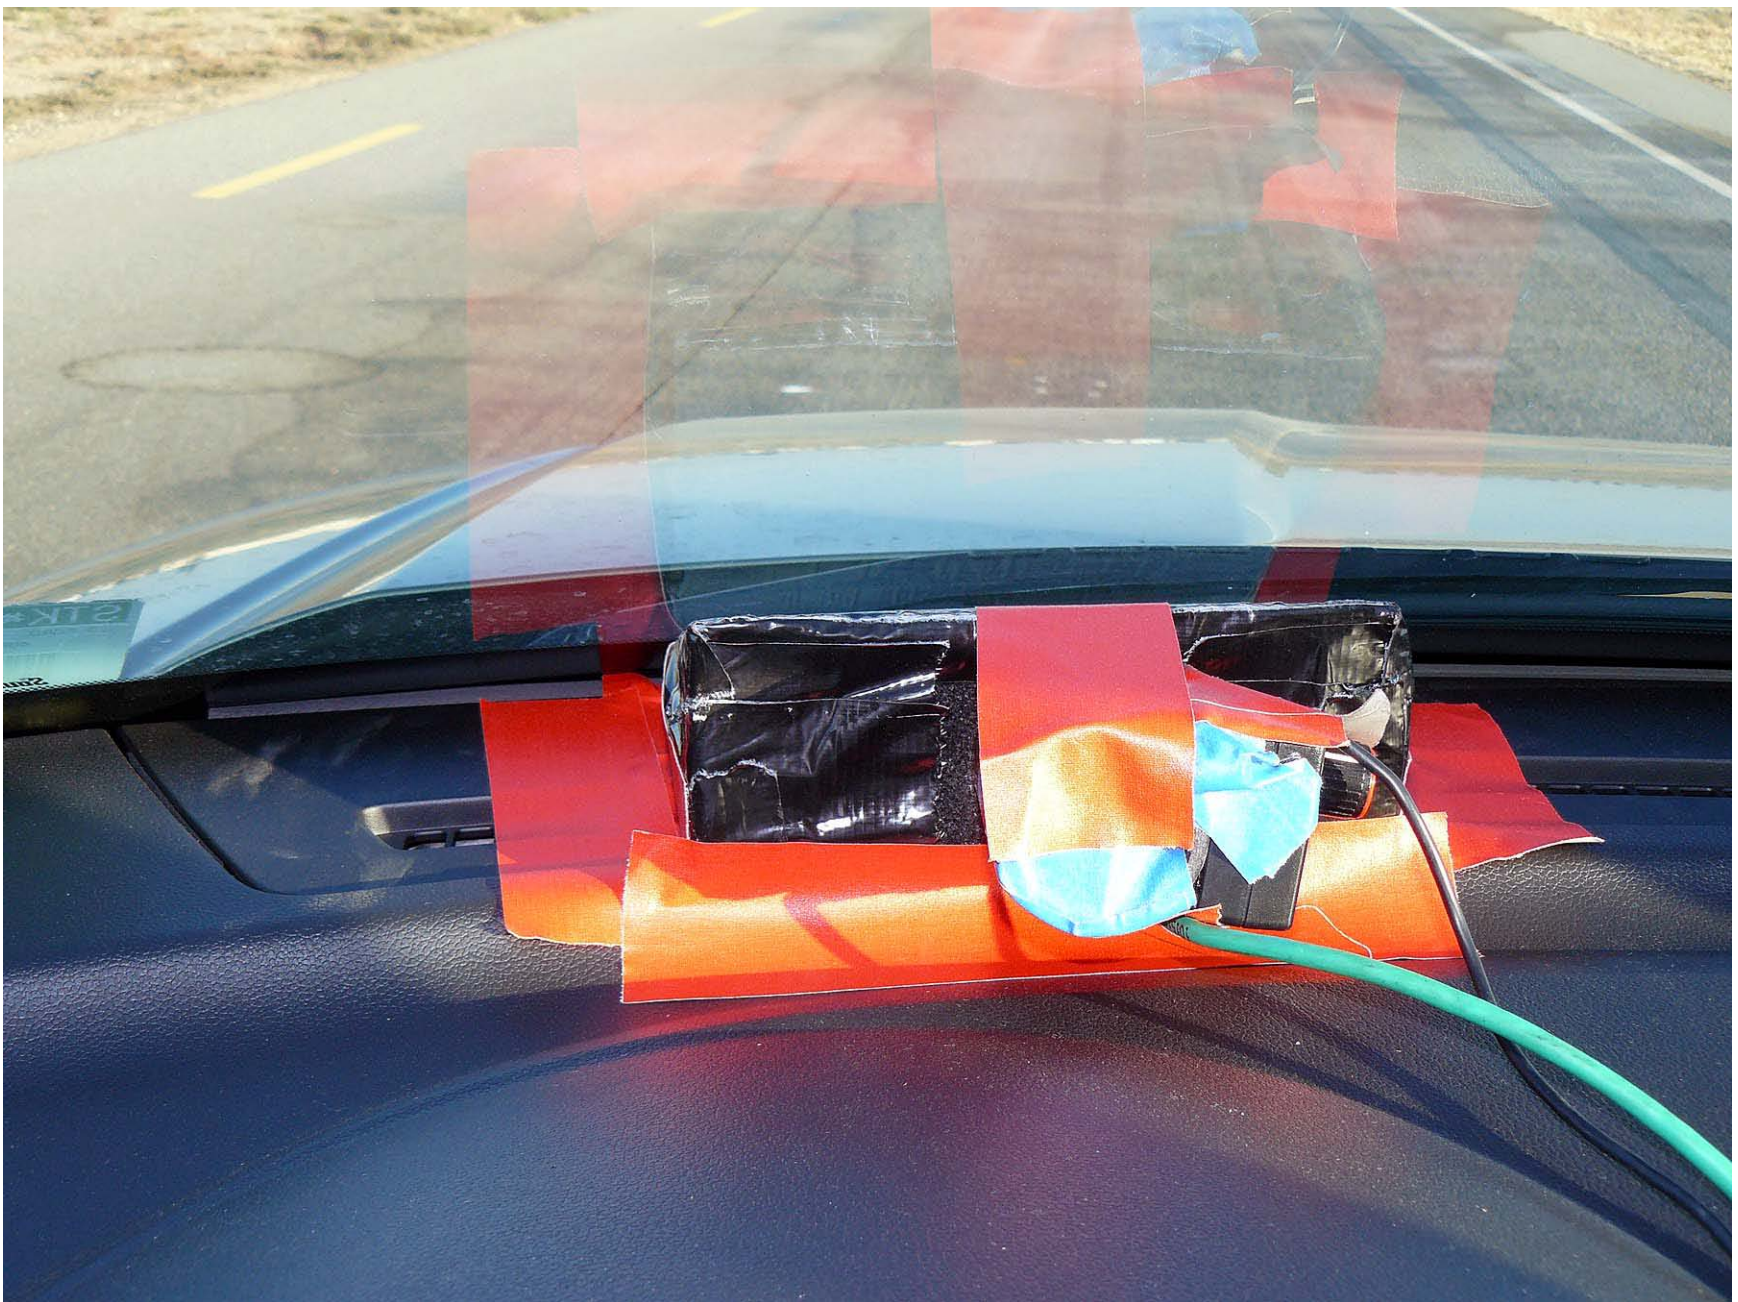
Figure A12. Sensor for Detecting Visual Warning

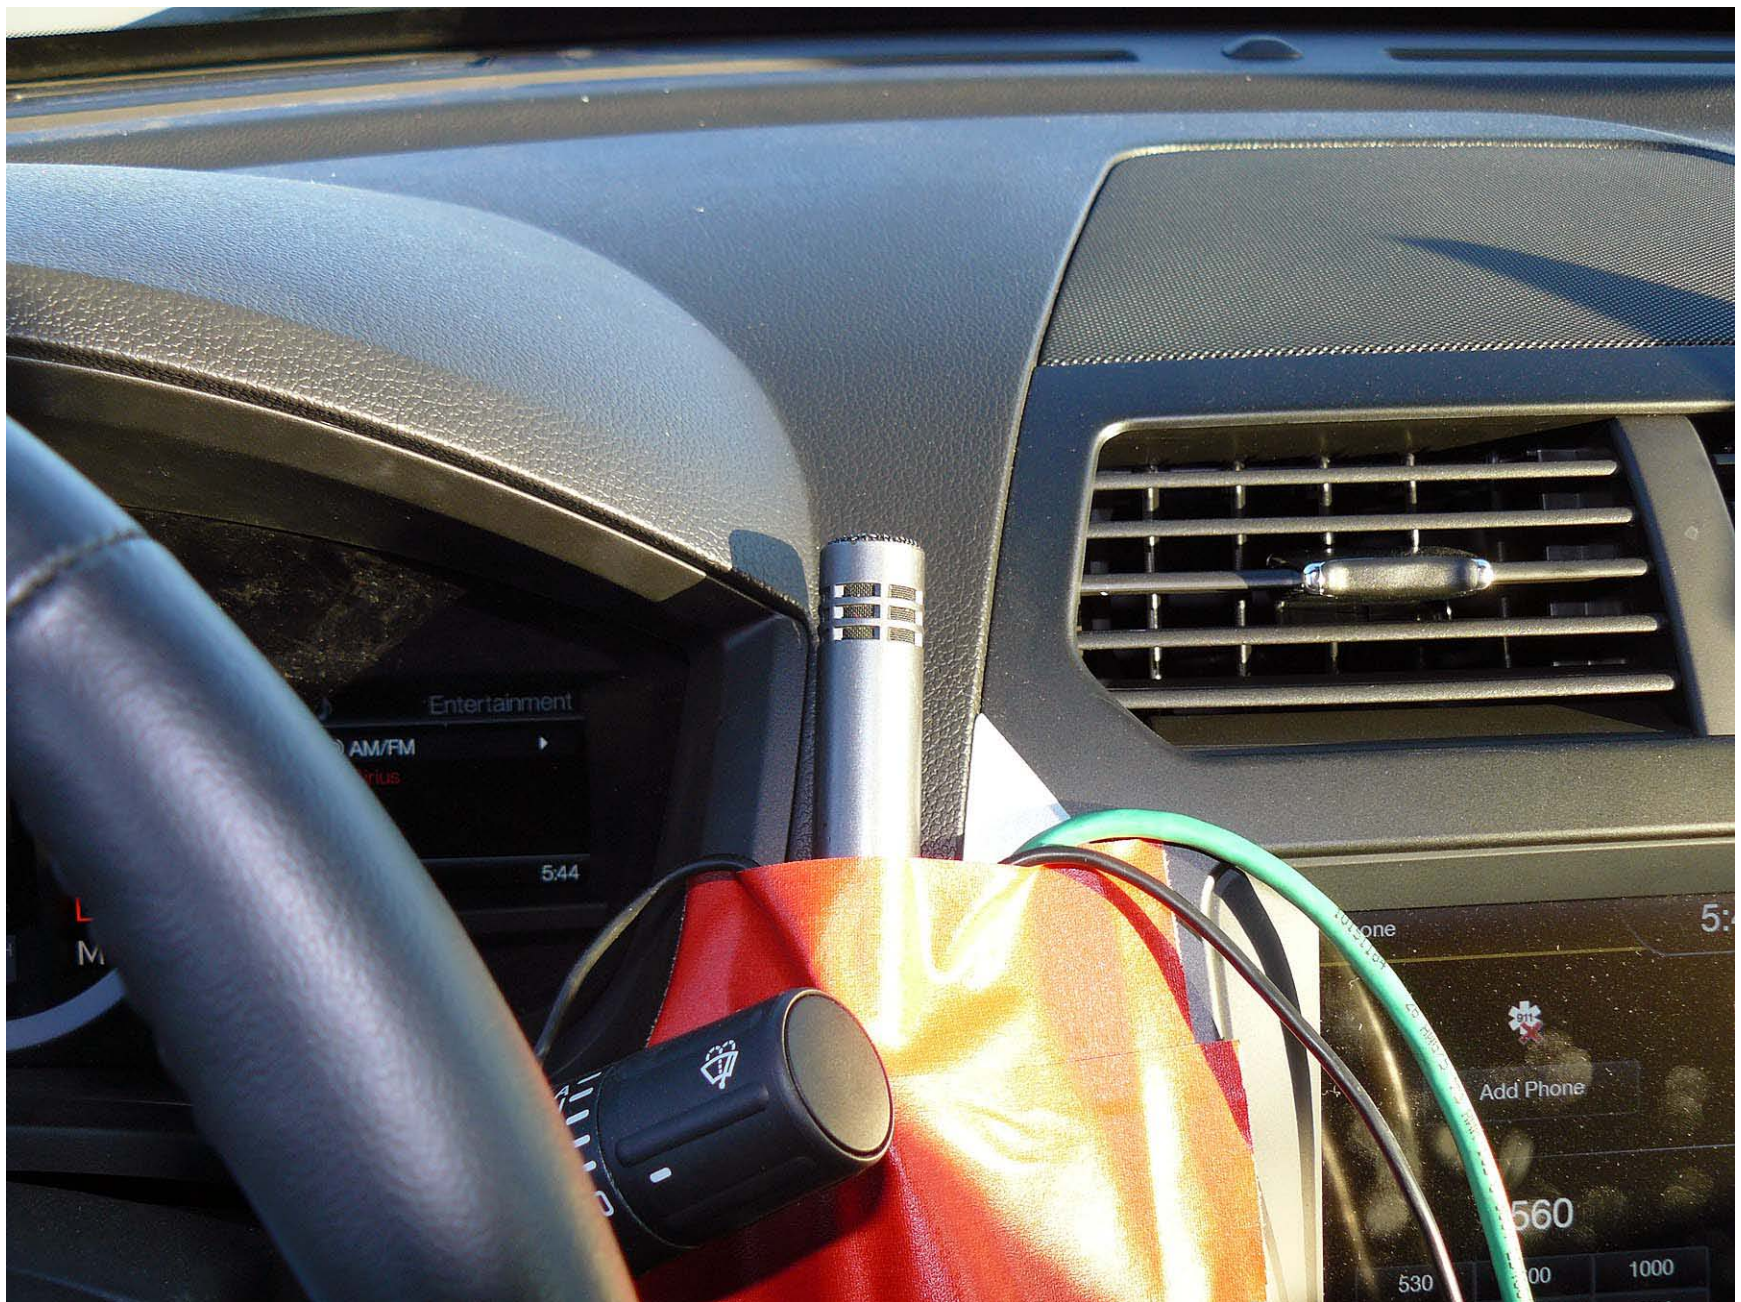
Figure A13. Sensor for Detecting Acoustic Warning

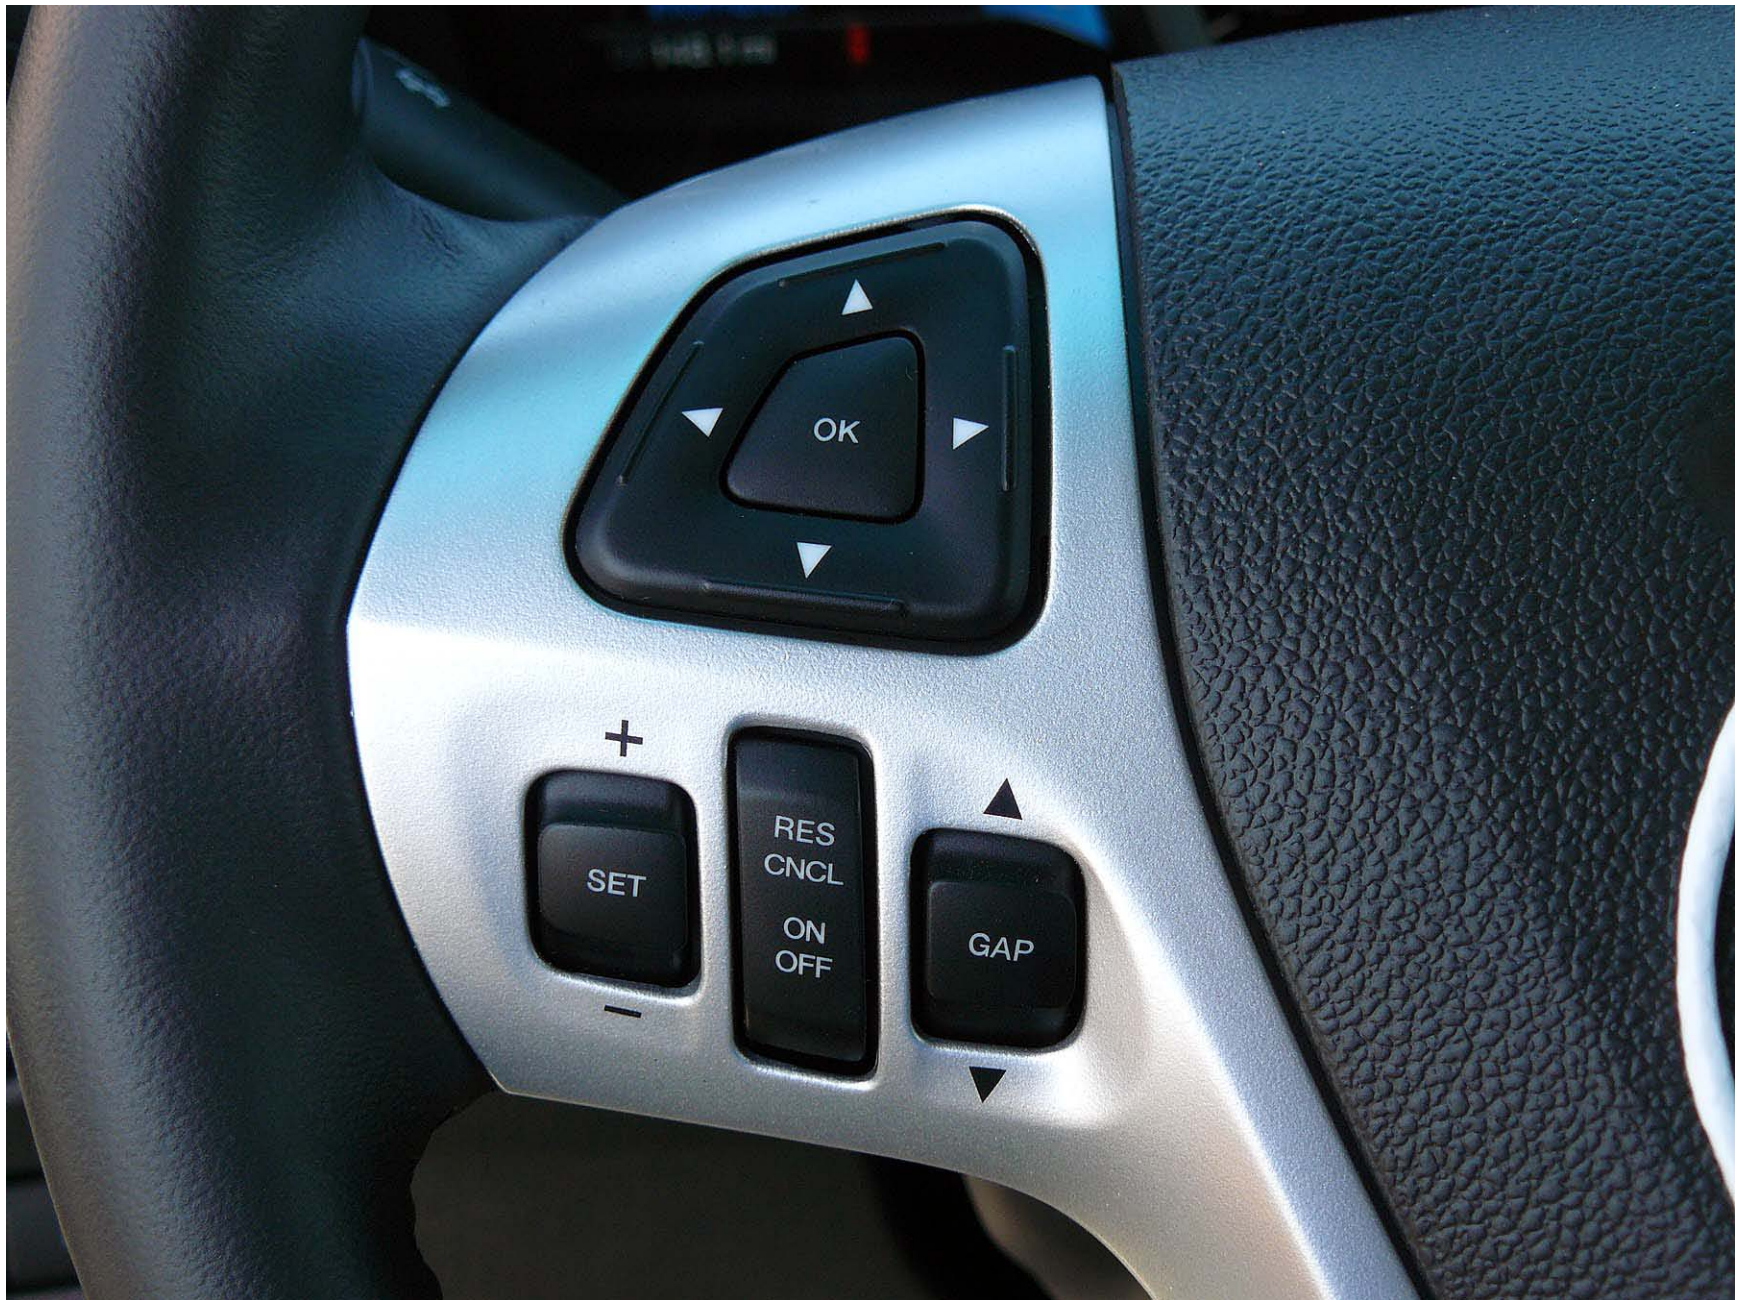
Figure A14. Controls for Adjusting Vehicle Settings

Control on left spoke of the steering wheel operates the information display in the center of the instrument display. Menu path as follows:

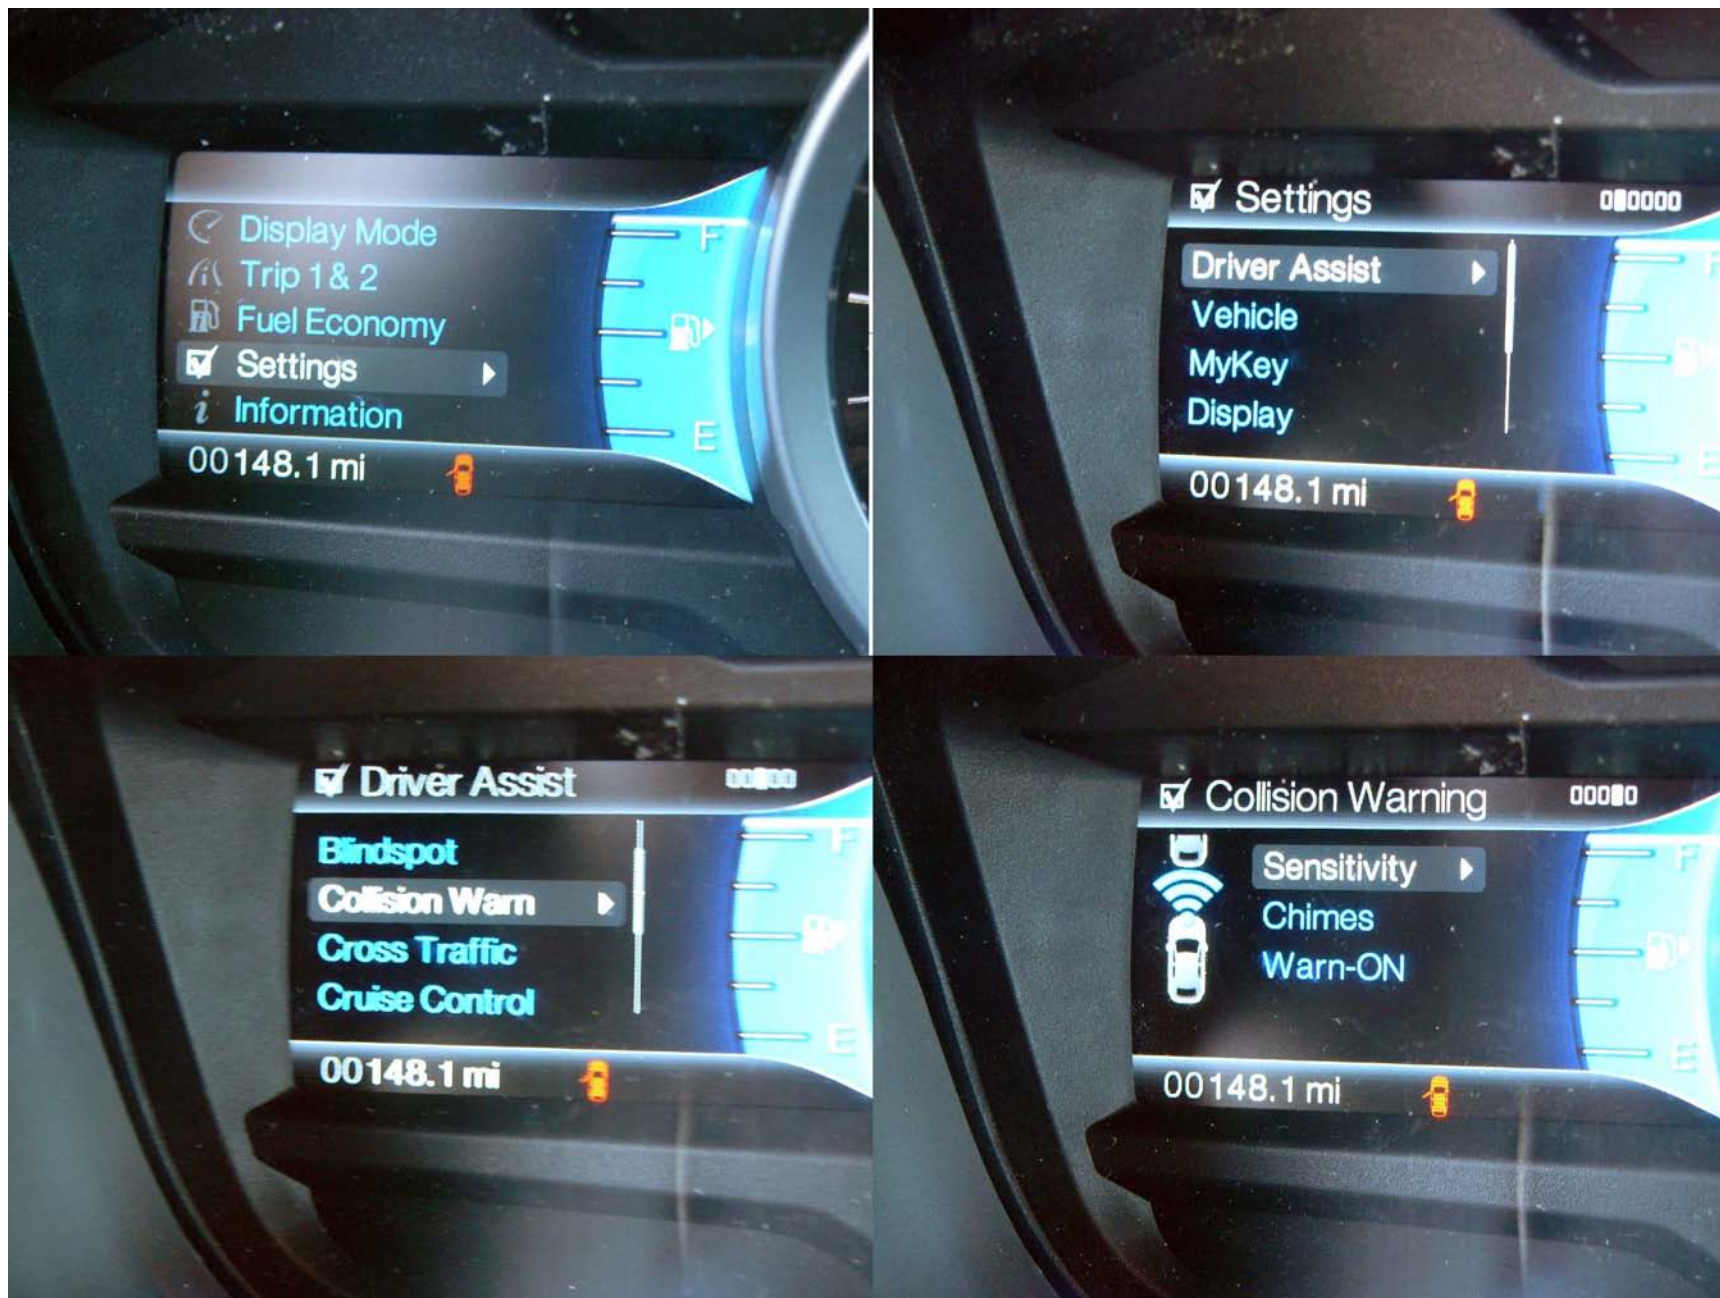
Figure A15. FCW Settings Menu

Control on left spoke of the steering wheel operates the information display in the center of the instrument display. Menu path as follows:
