OCAS-DRI-FCW-13-011

NCAP FORWARD COLLISION WARNING CONFIRMATION TEST

2013 Ford Taurus

Final Report

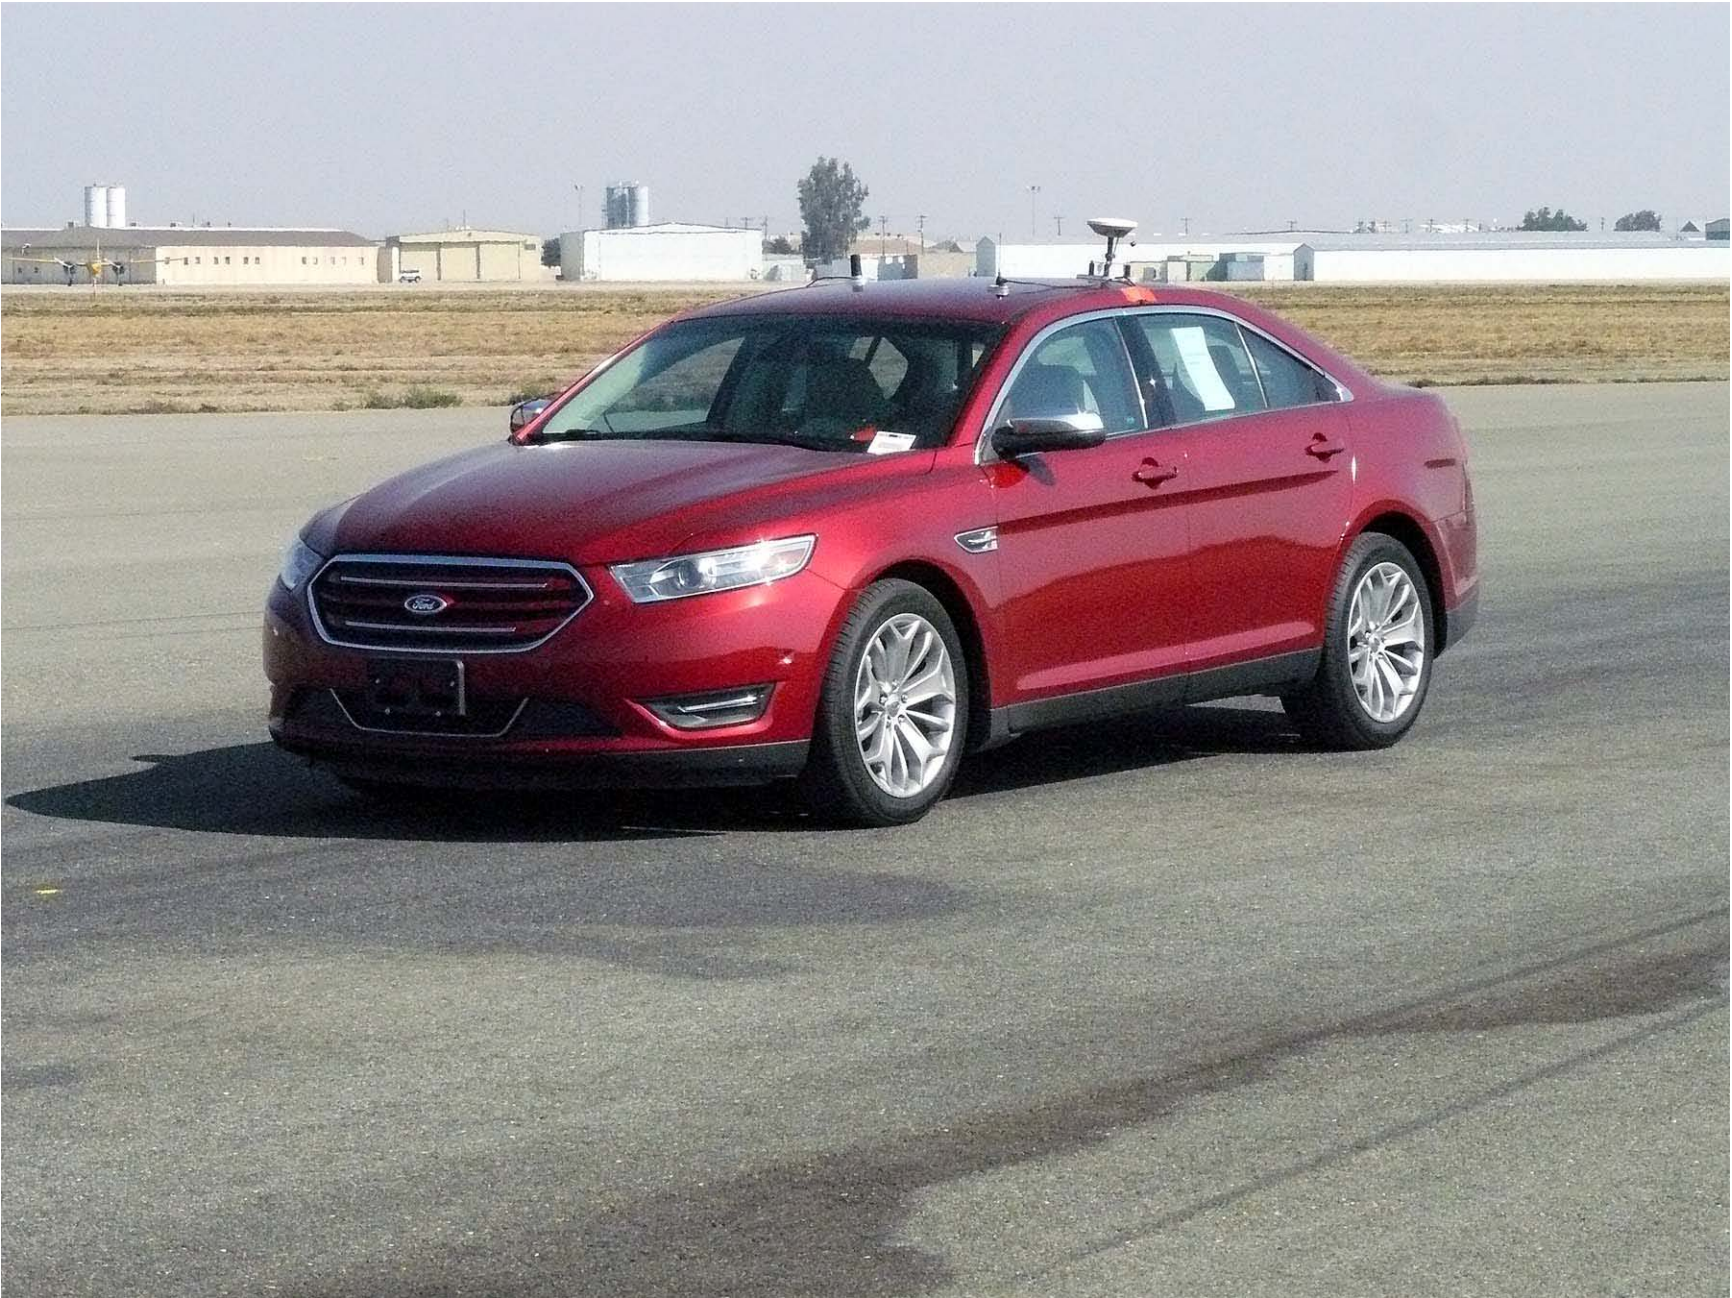
Figure A1. Front View of Subject Vehicle

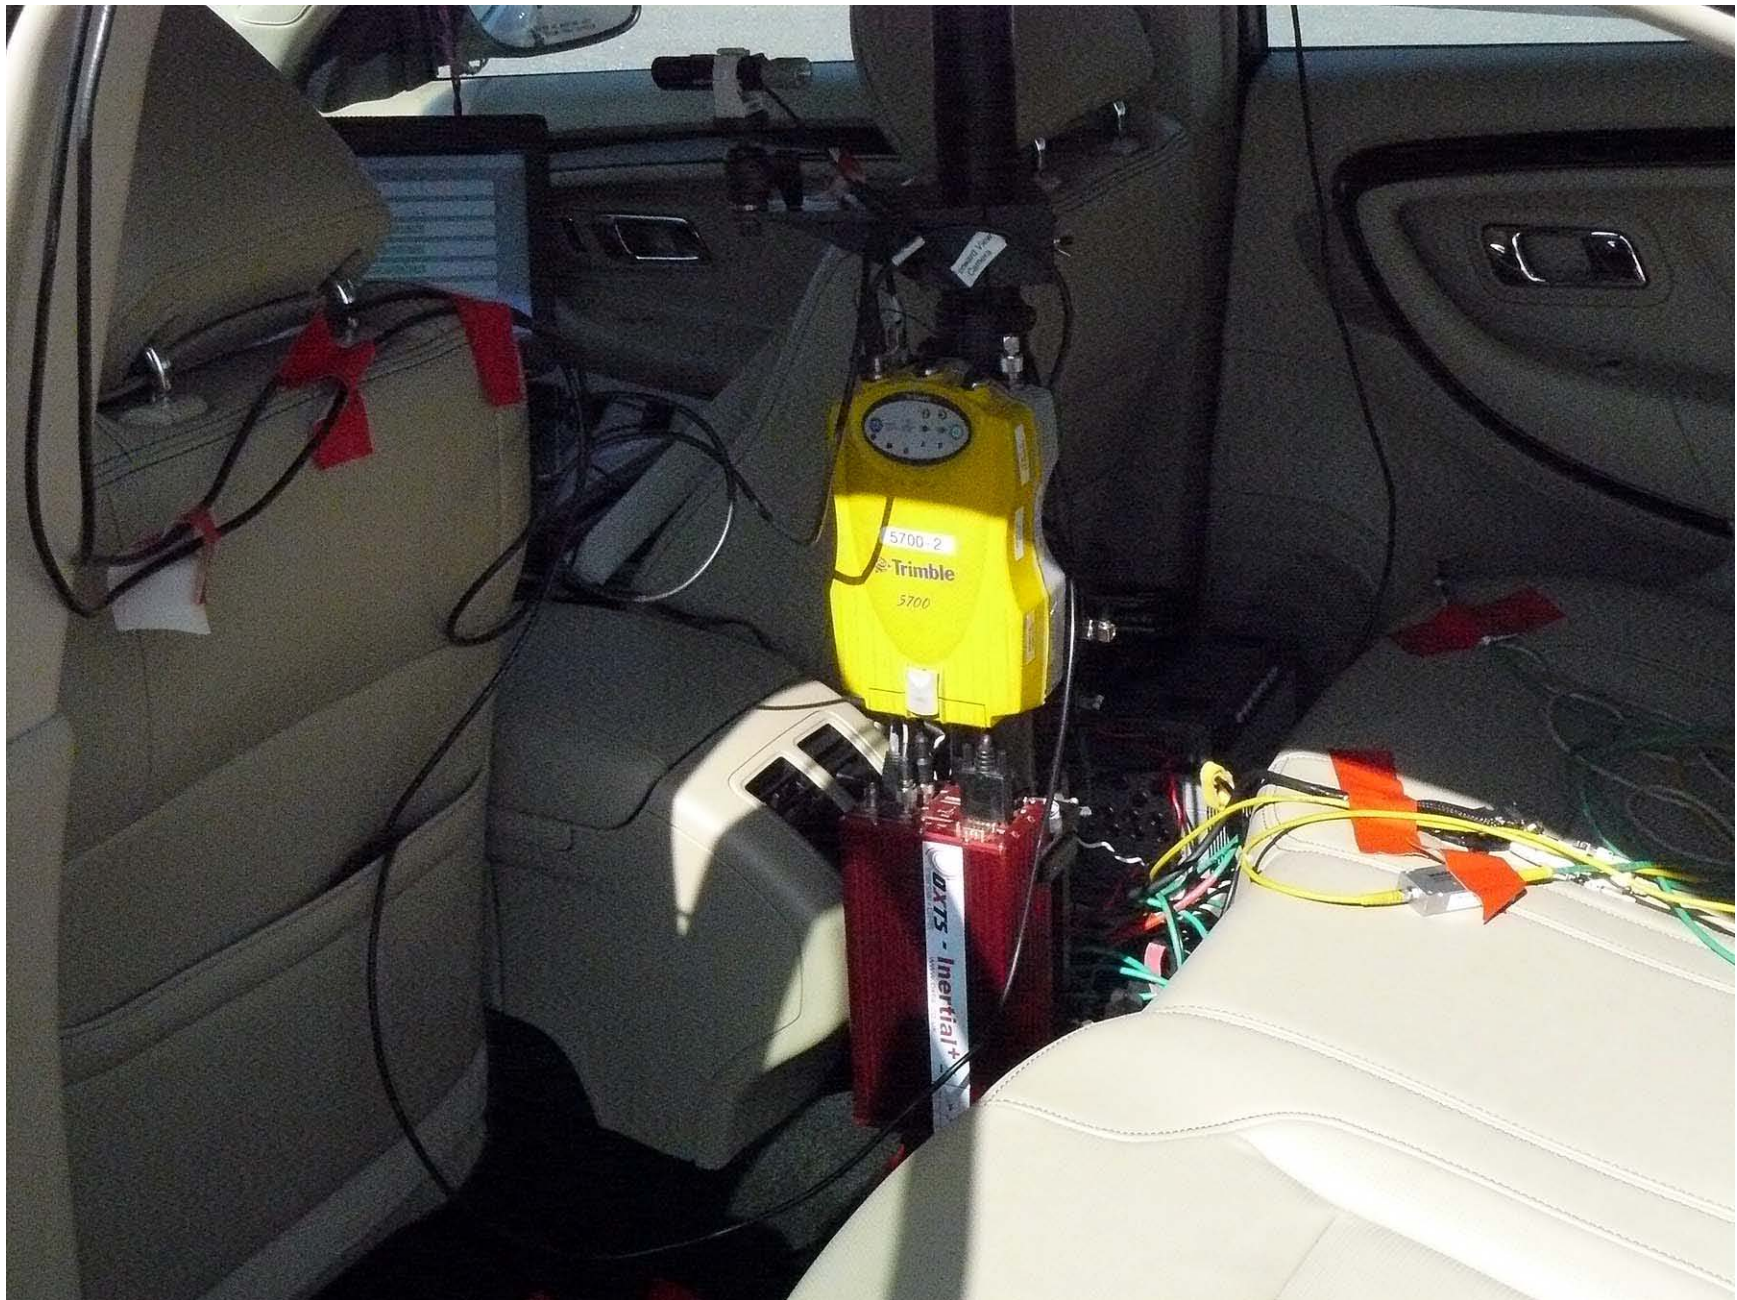
Figure A7. DGPS and Inertial Measurement Unit Installed in Subject Vehicle

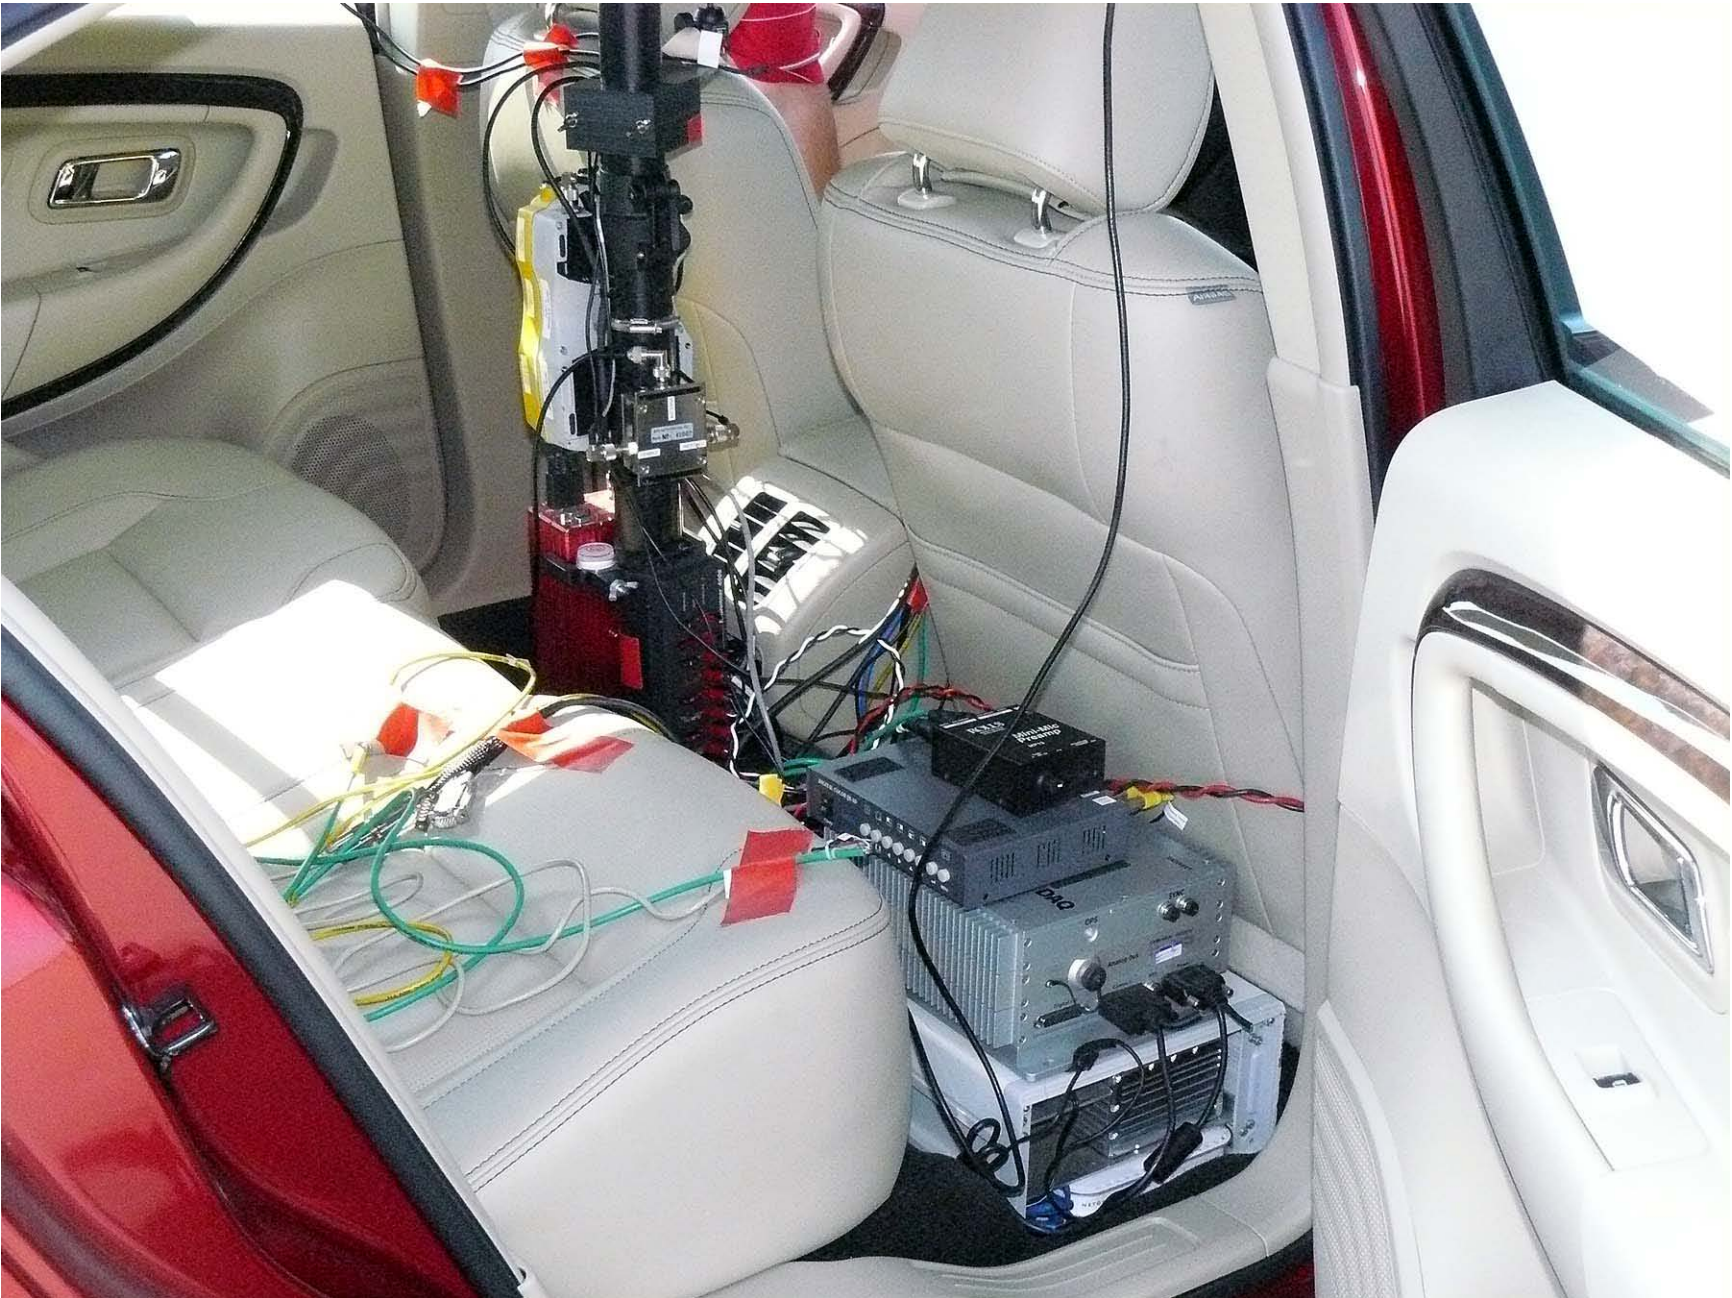
Figure A8. Data Acquisition System Installed in Subject Vehicle

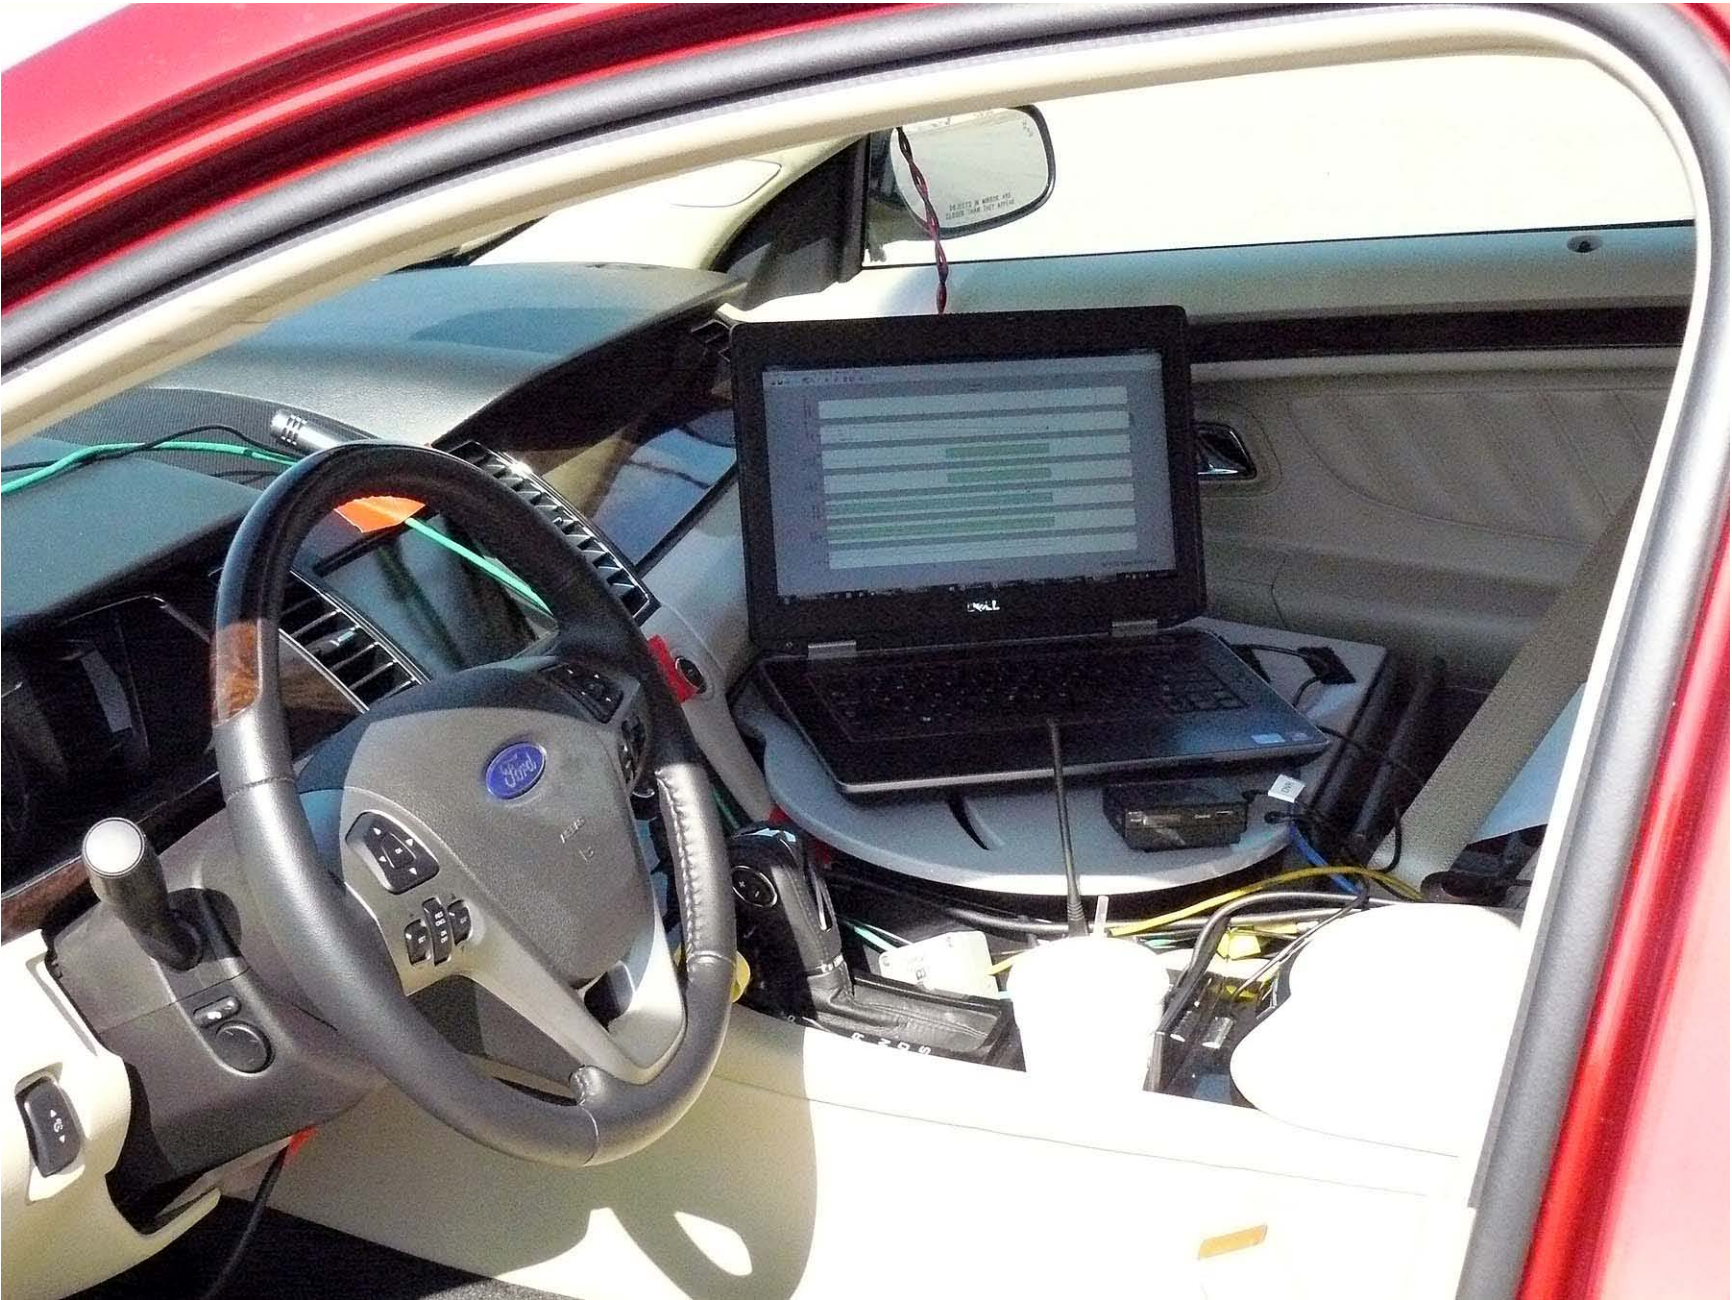
Figure A9. Computer Installed in Subject Vehicle

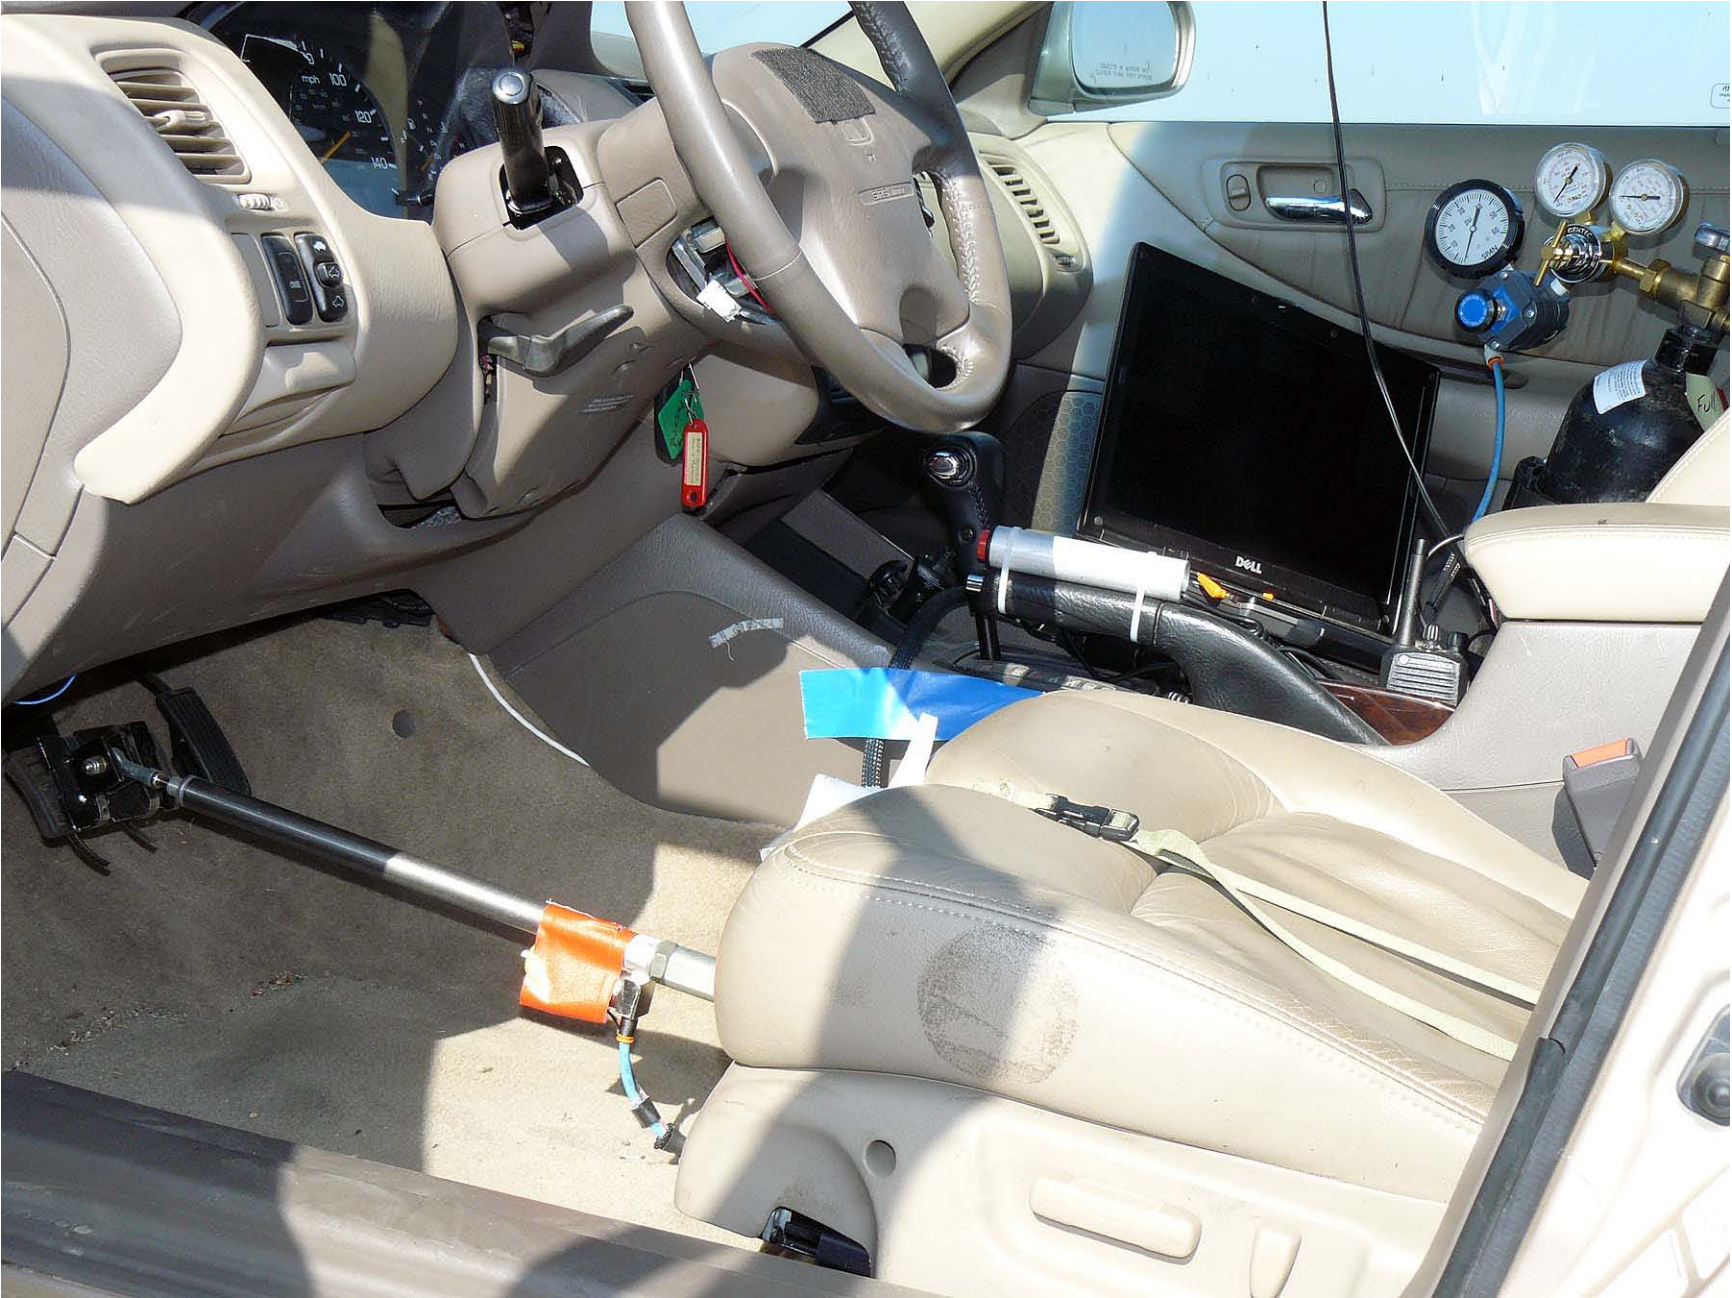
Figure A10. Brake Actuation System Installed in Principal Other Vehicle

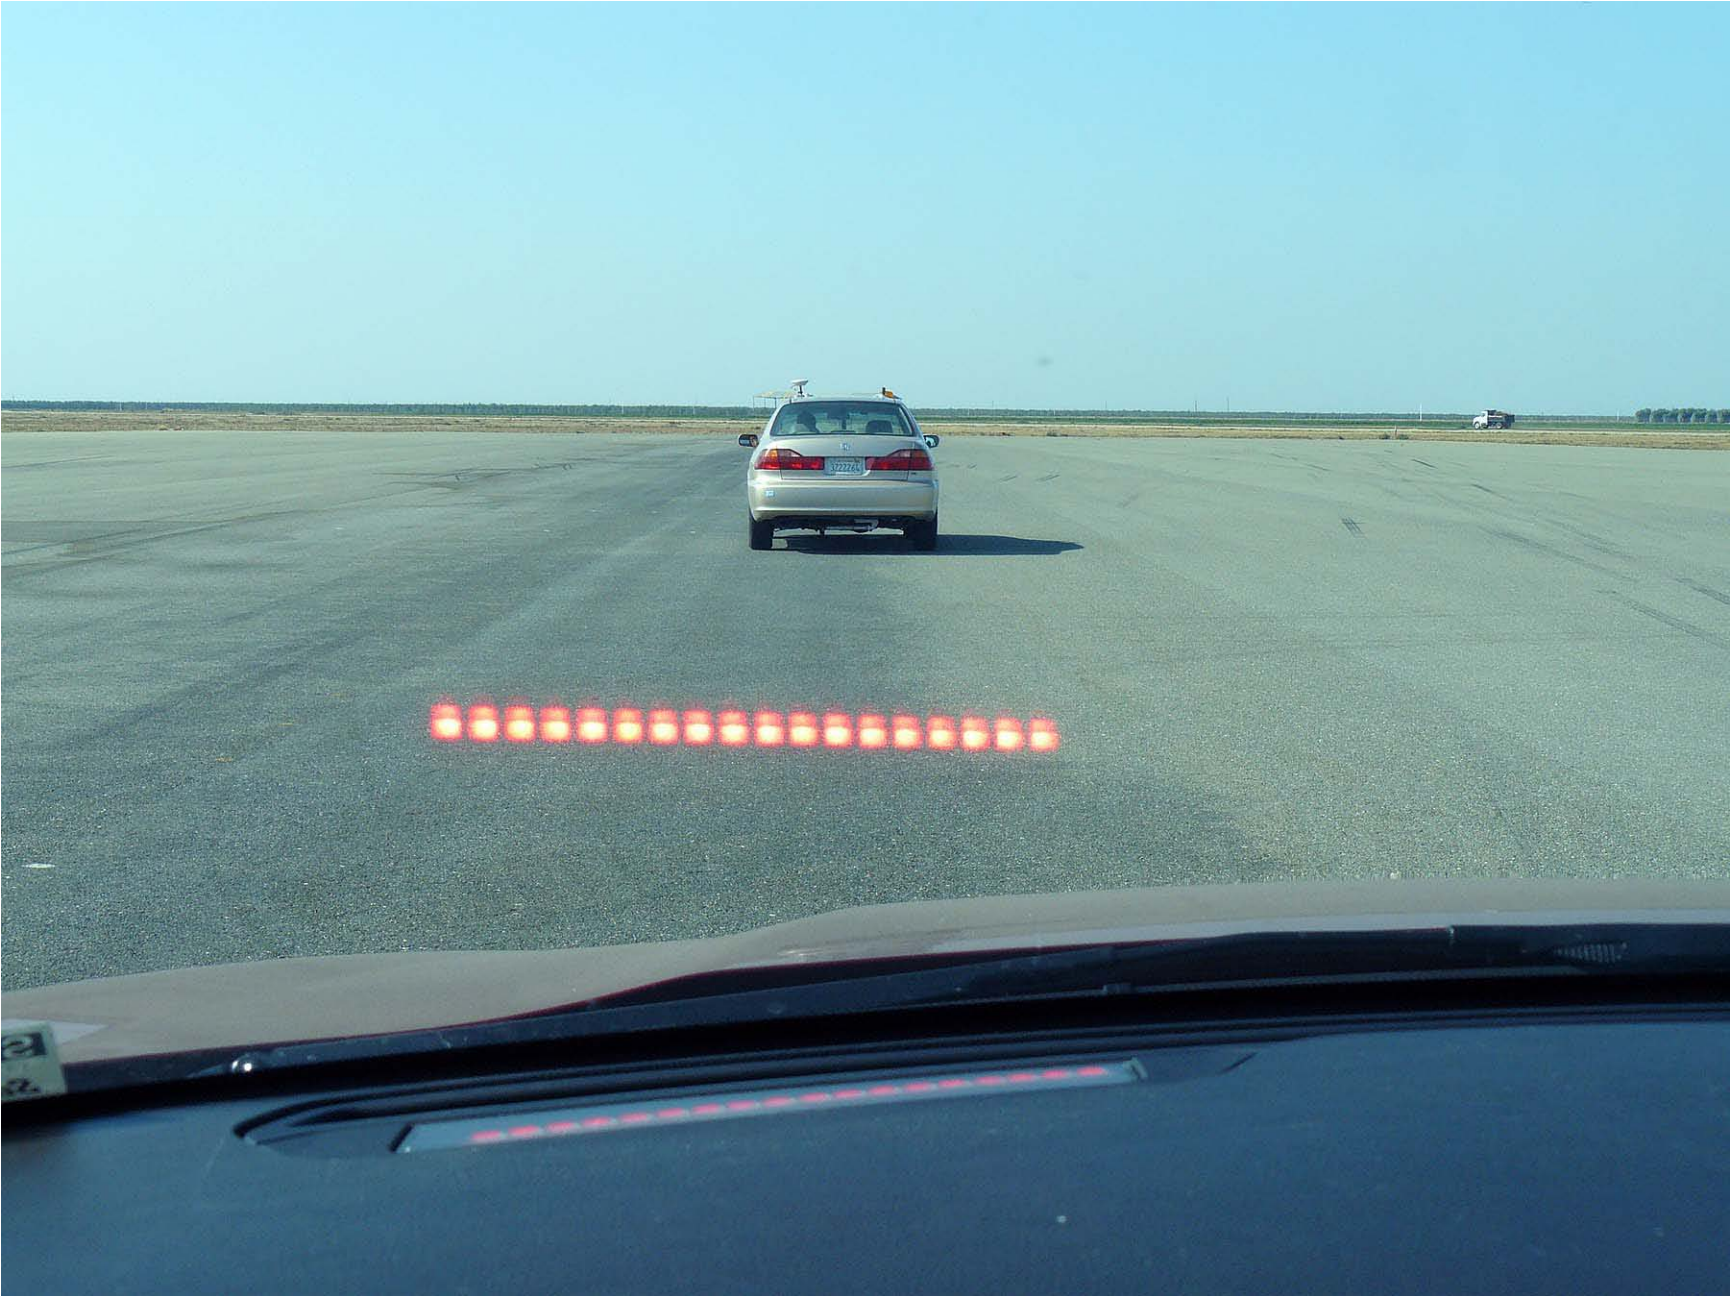
Figure A11. Forward Collision Visual Warning

Warning light is a row of red lights that are reflected onto the windscreen directly ahead of the driver (i.e. HUD). Acoustic alert is three sets of four beeps with a dominant tone at 600 Hz

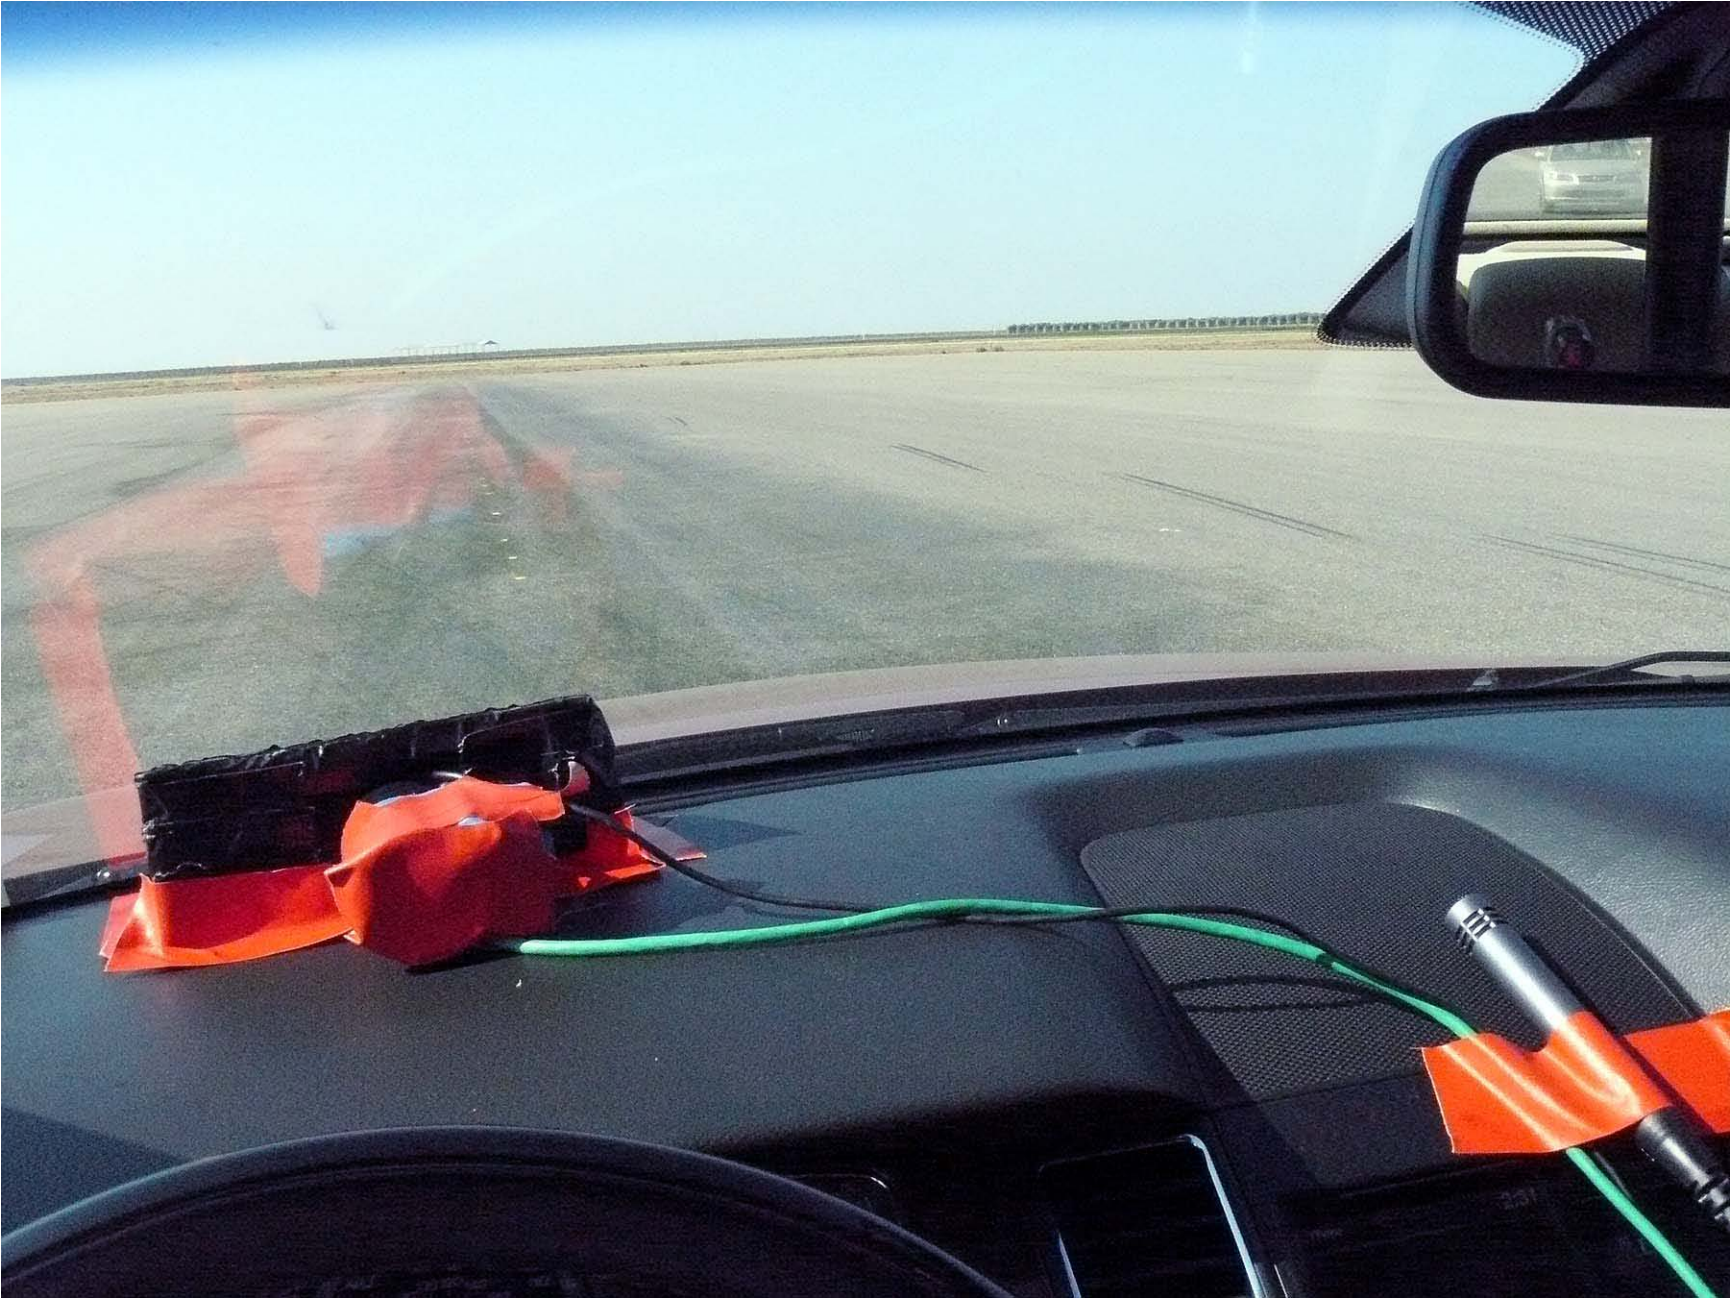
Figure A12. Sensors for Detecting Visual and Aural Warnings

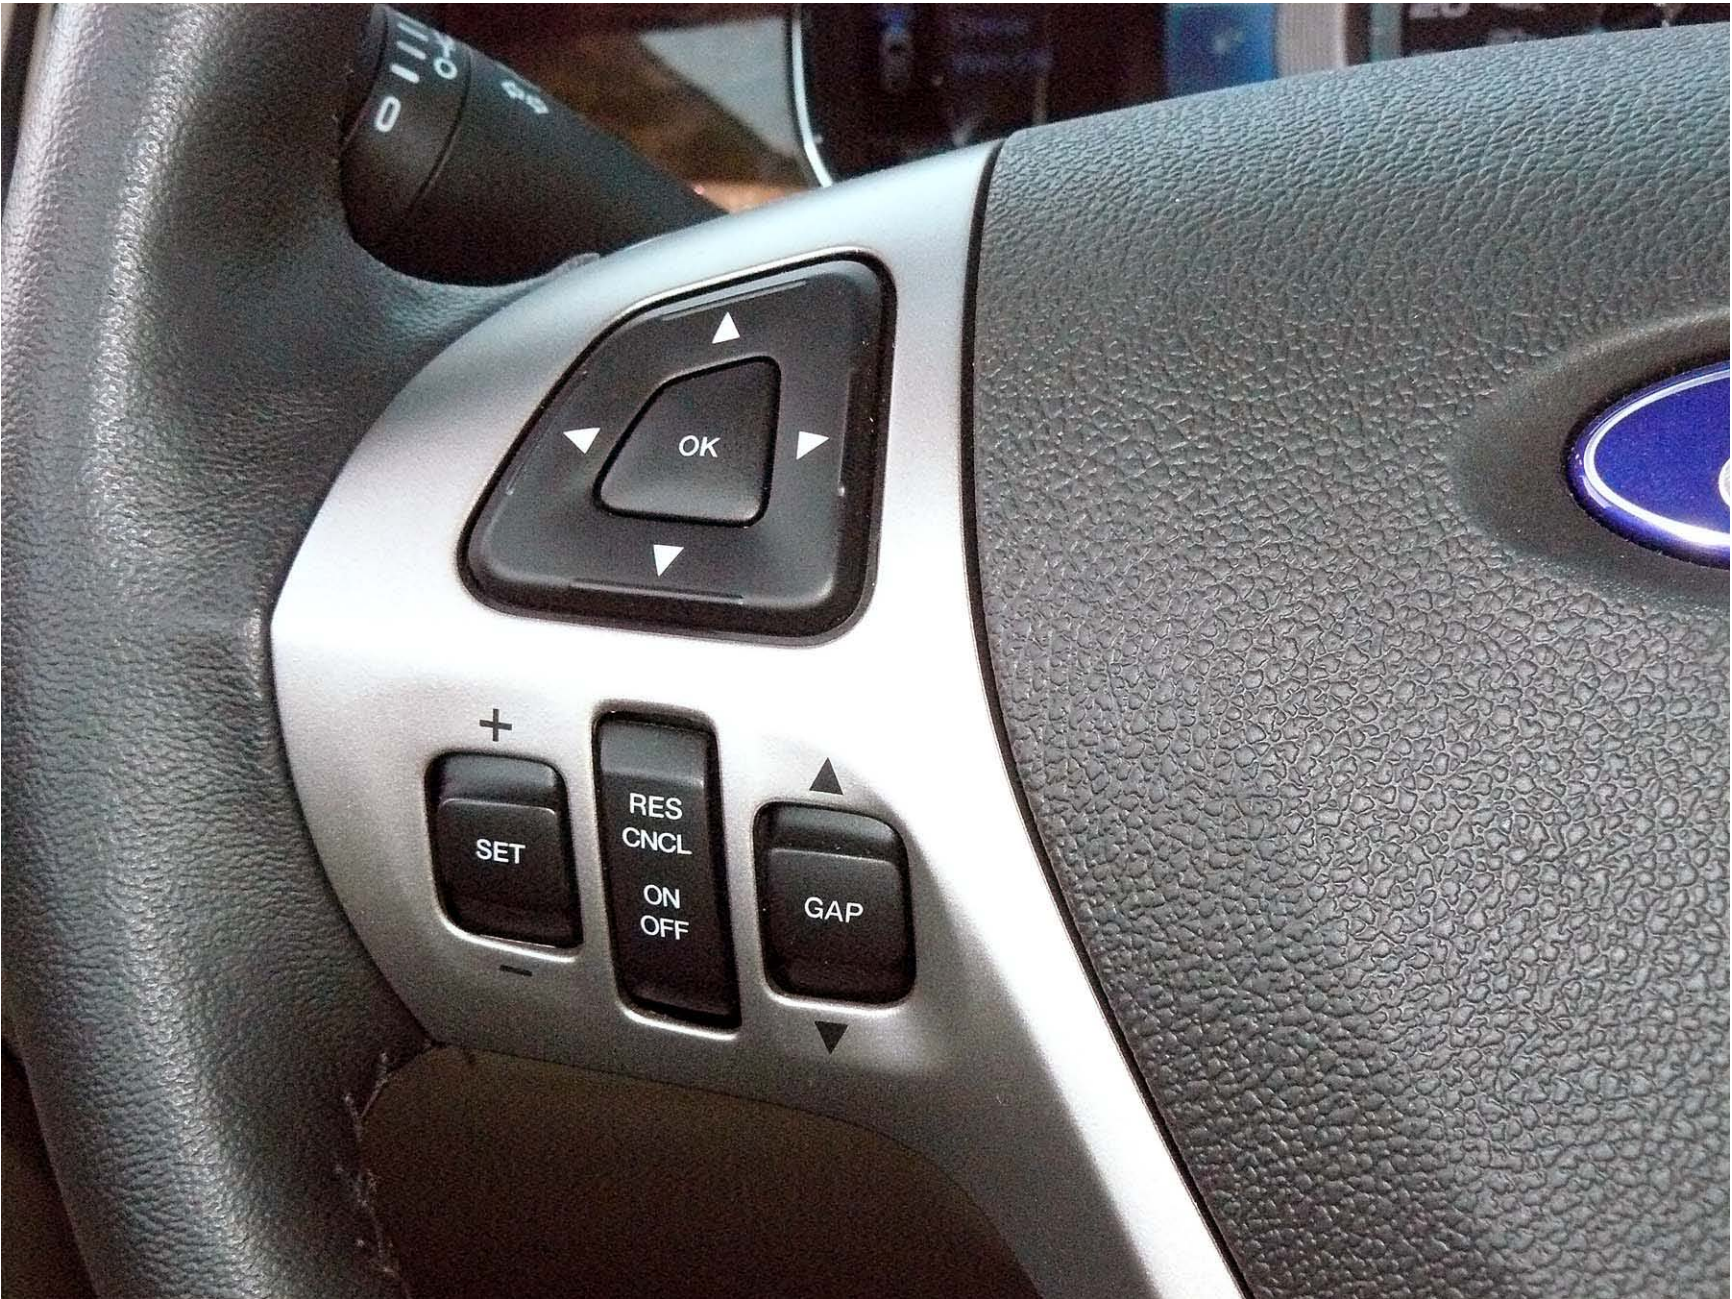
Figure A13. Controls for Adjusting Vehicle Settings

FCW is switched on and off via the menu system on the left side of the instrument panel, via buttons on the left side of the steering wheel.

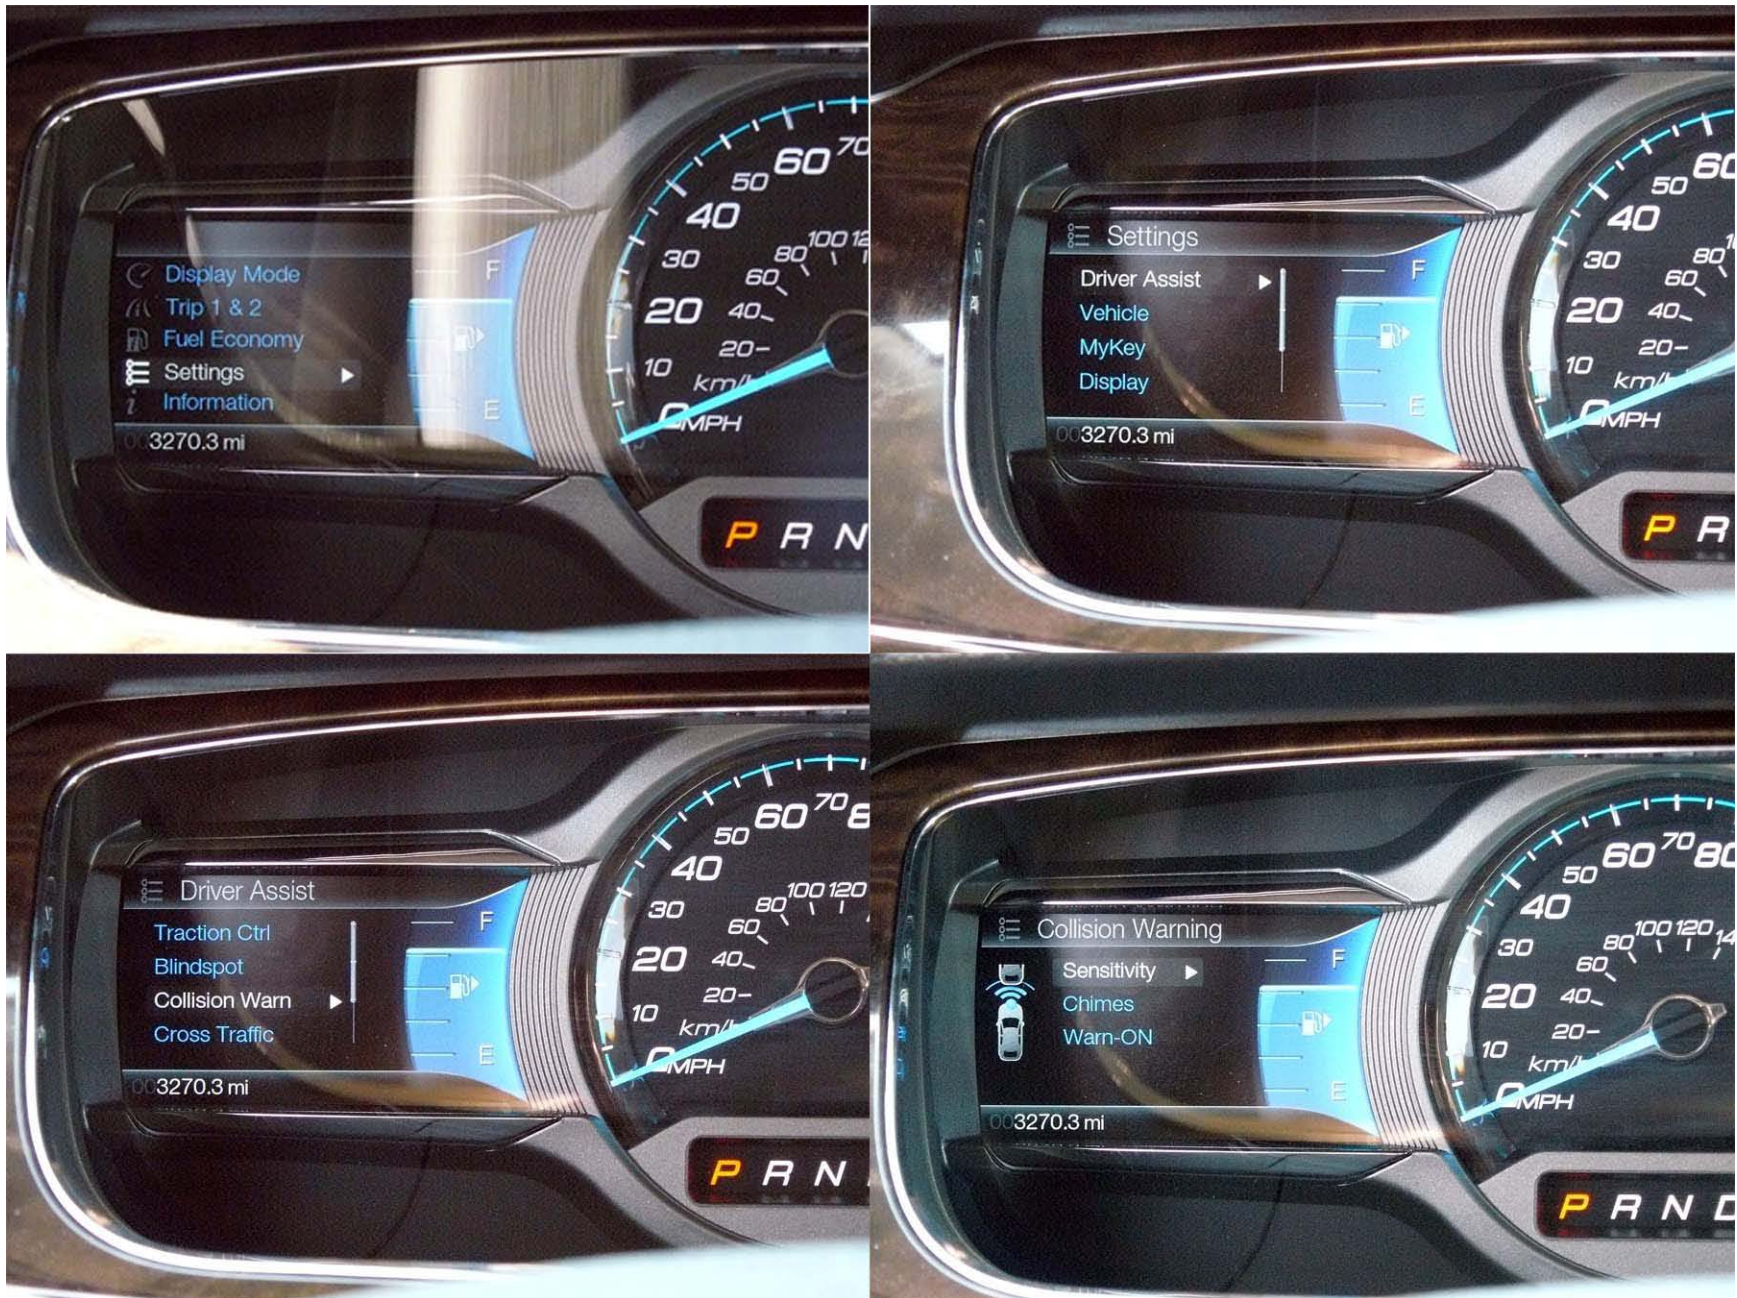
Figure A14. FCW Settings Menu

See Figures a-14 and A-15

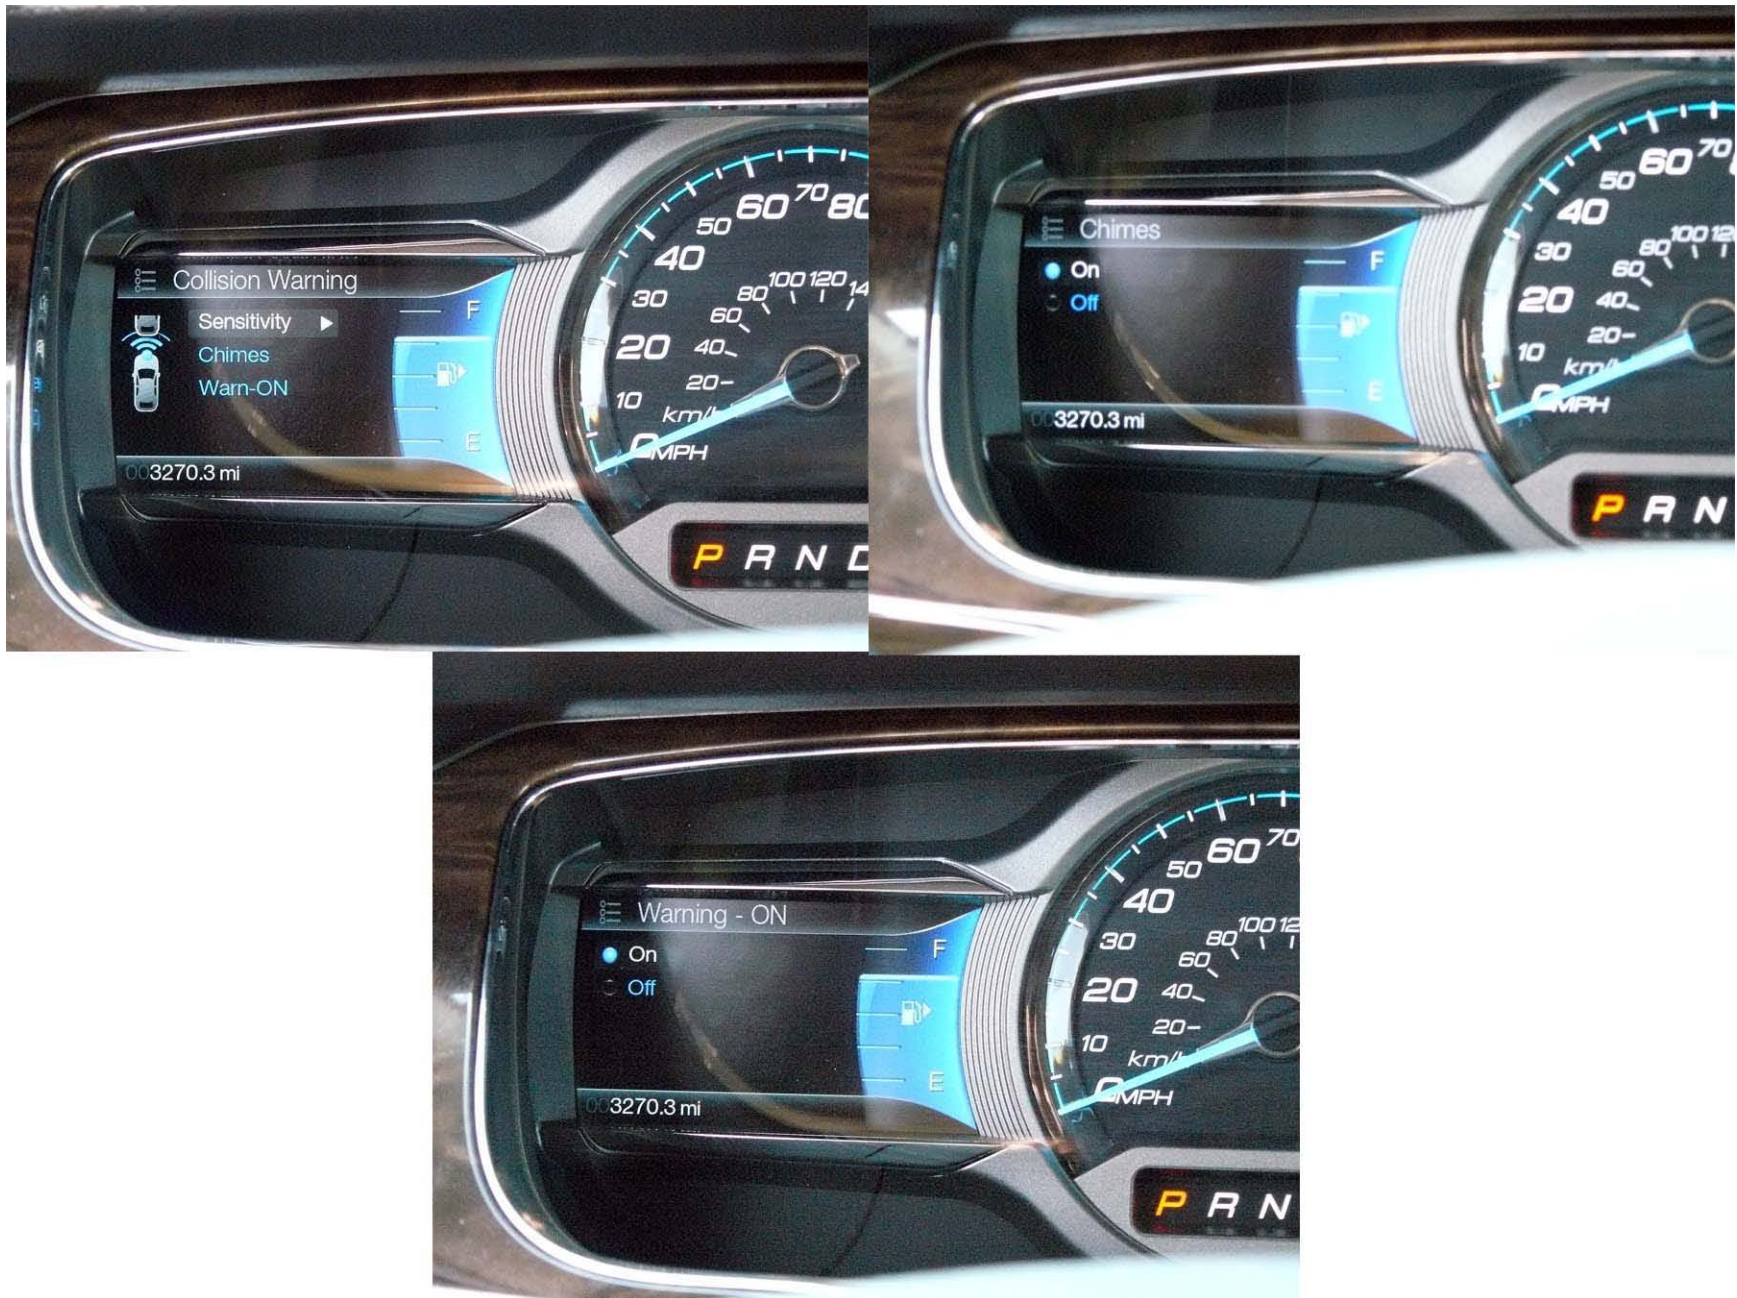
Figure A15. FCW Settings Menu (cont.)

Acoustic alert can be turned on and off using
