OCAS-DRI-FCW-13-011

NCAP FORWARD COLLISION WARNING CONFIRMATION TEST

2013 Ford Taurus

Final Report

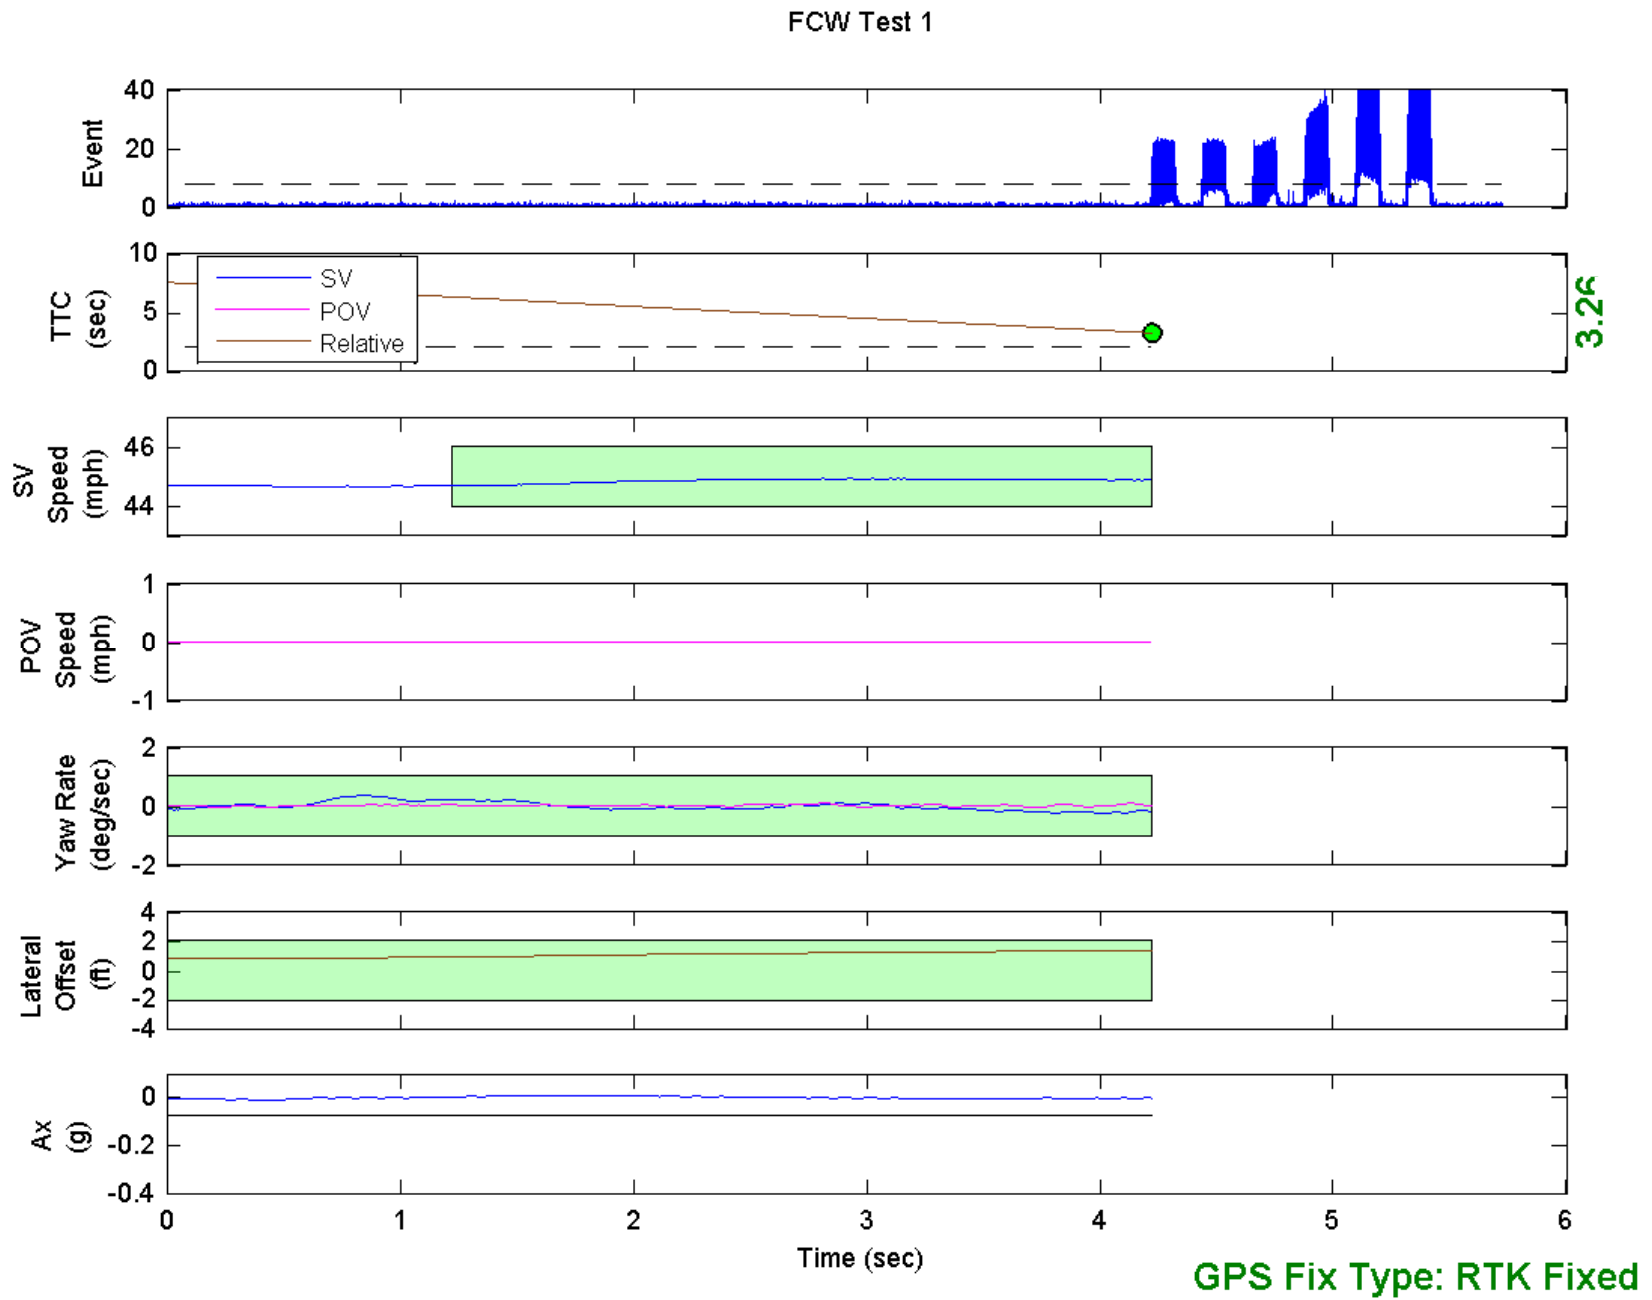
Figure D1. Example Time History for Test Type 1, Passing

Examples of time history plots for each test type (including passing, failing and invalid runs) are shown in Figure D1 through Figure D6. Actual time history data plots for the vehicle under consideration are provided subsequently.

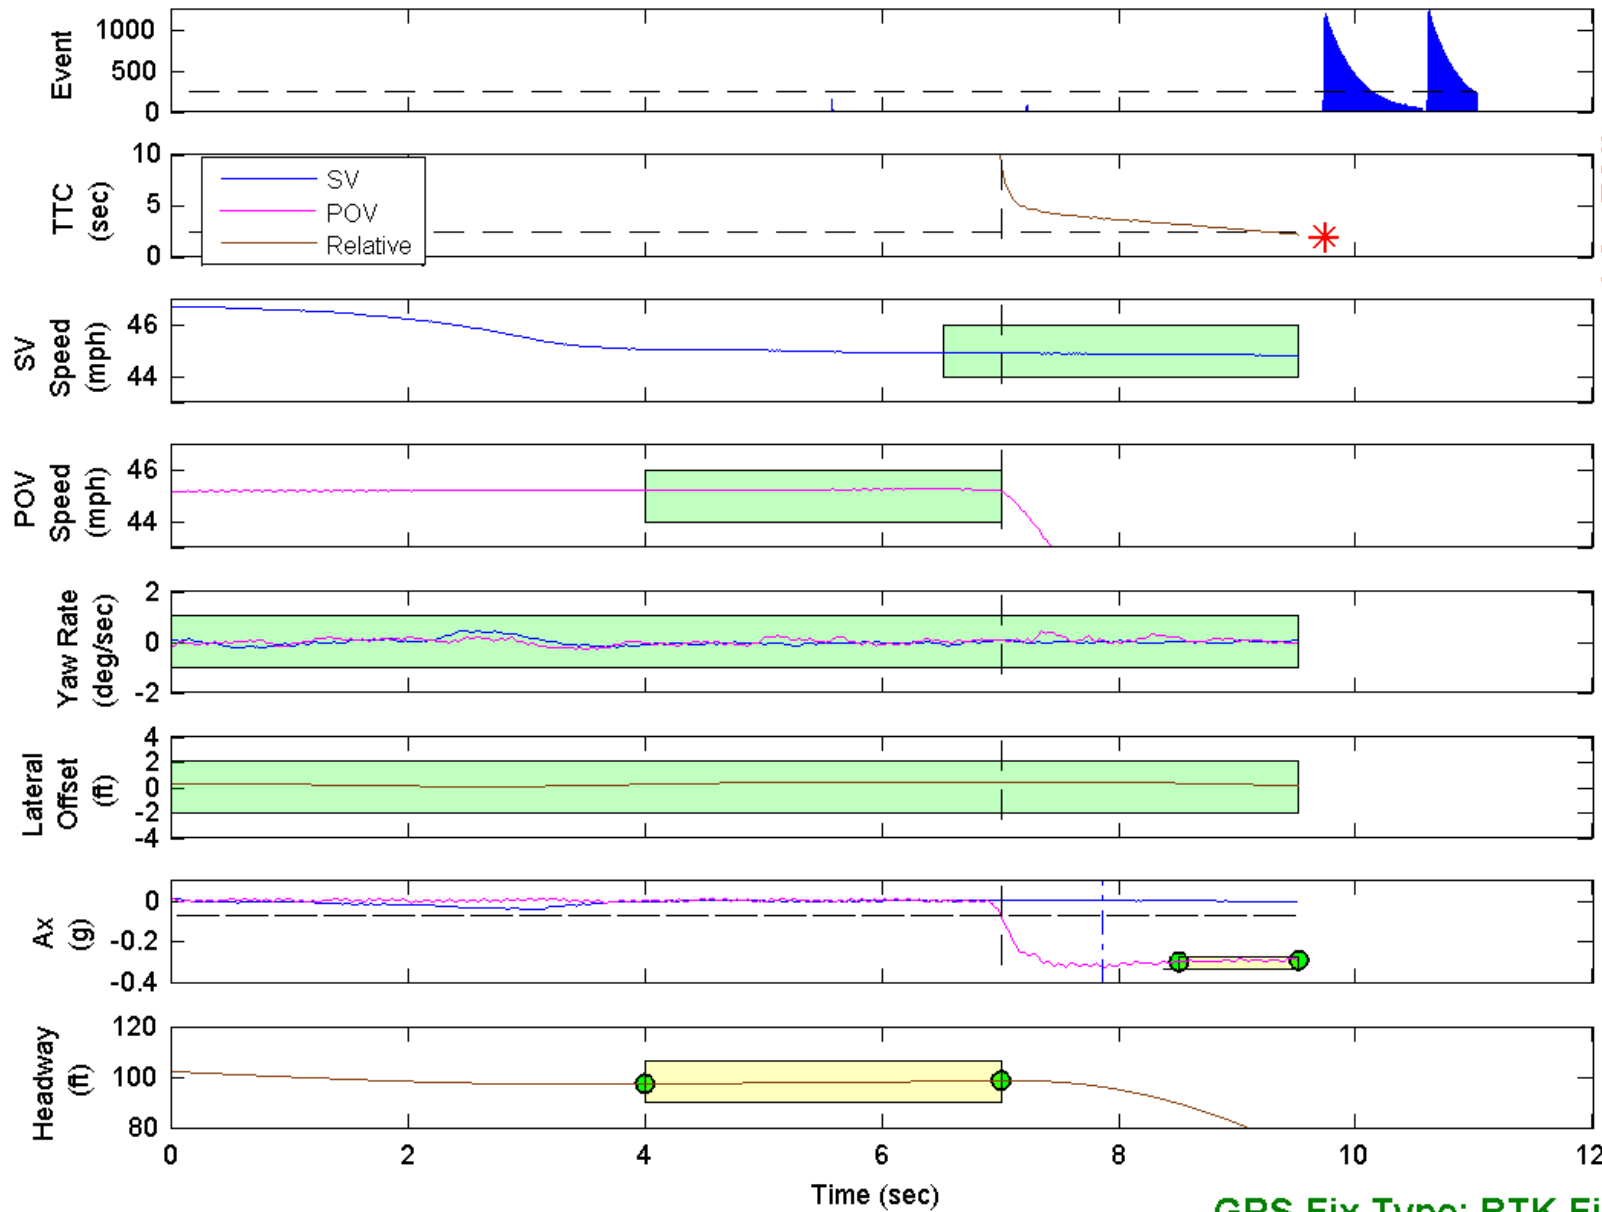
Figure D2. Example Time History for Test Type 2, Failing

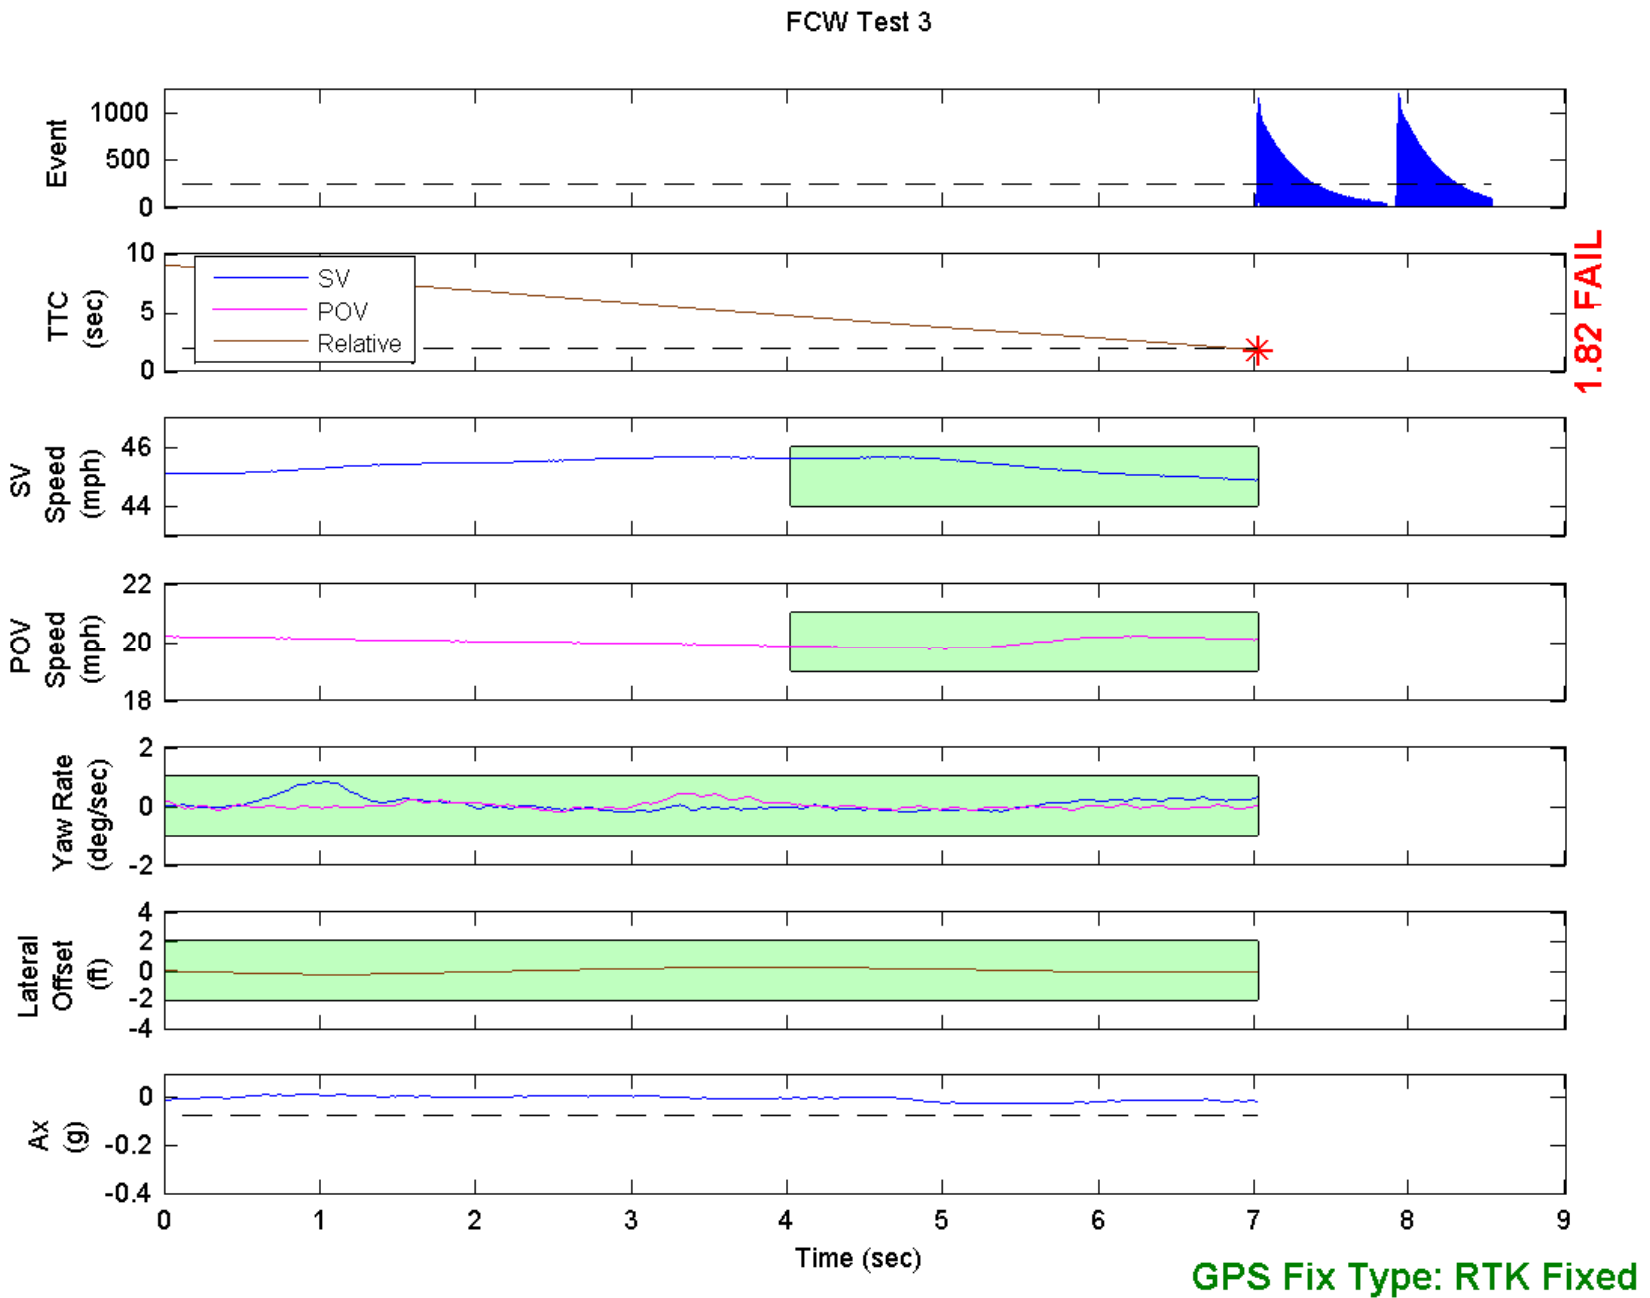
Figure D4. Example Time History for Test Type 3, Failing

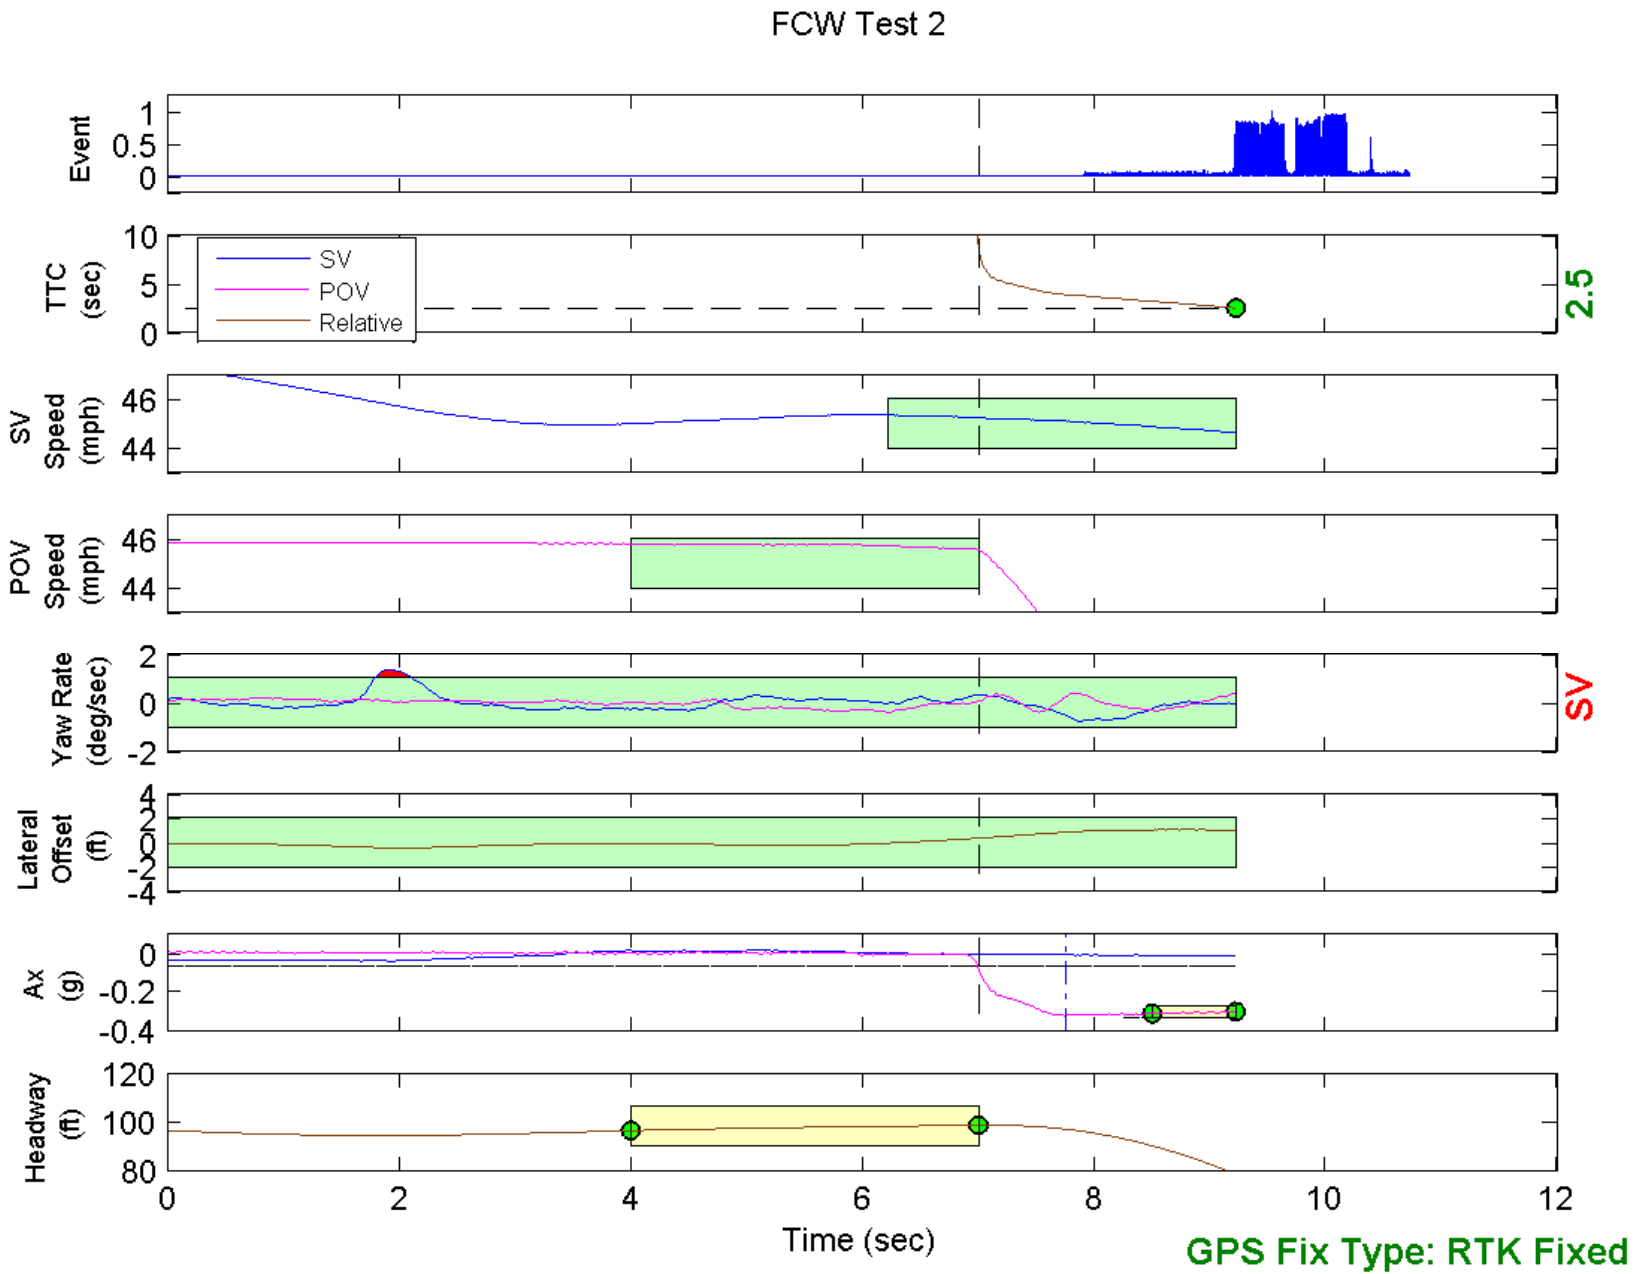
Figure D6. Example Time History for Test Type 2, Invalid Run Due to Subject Vehicle Yaw Rate

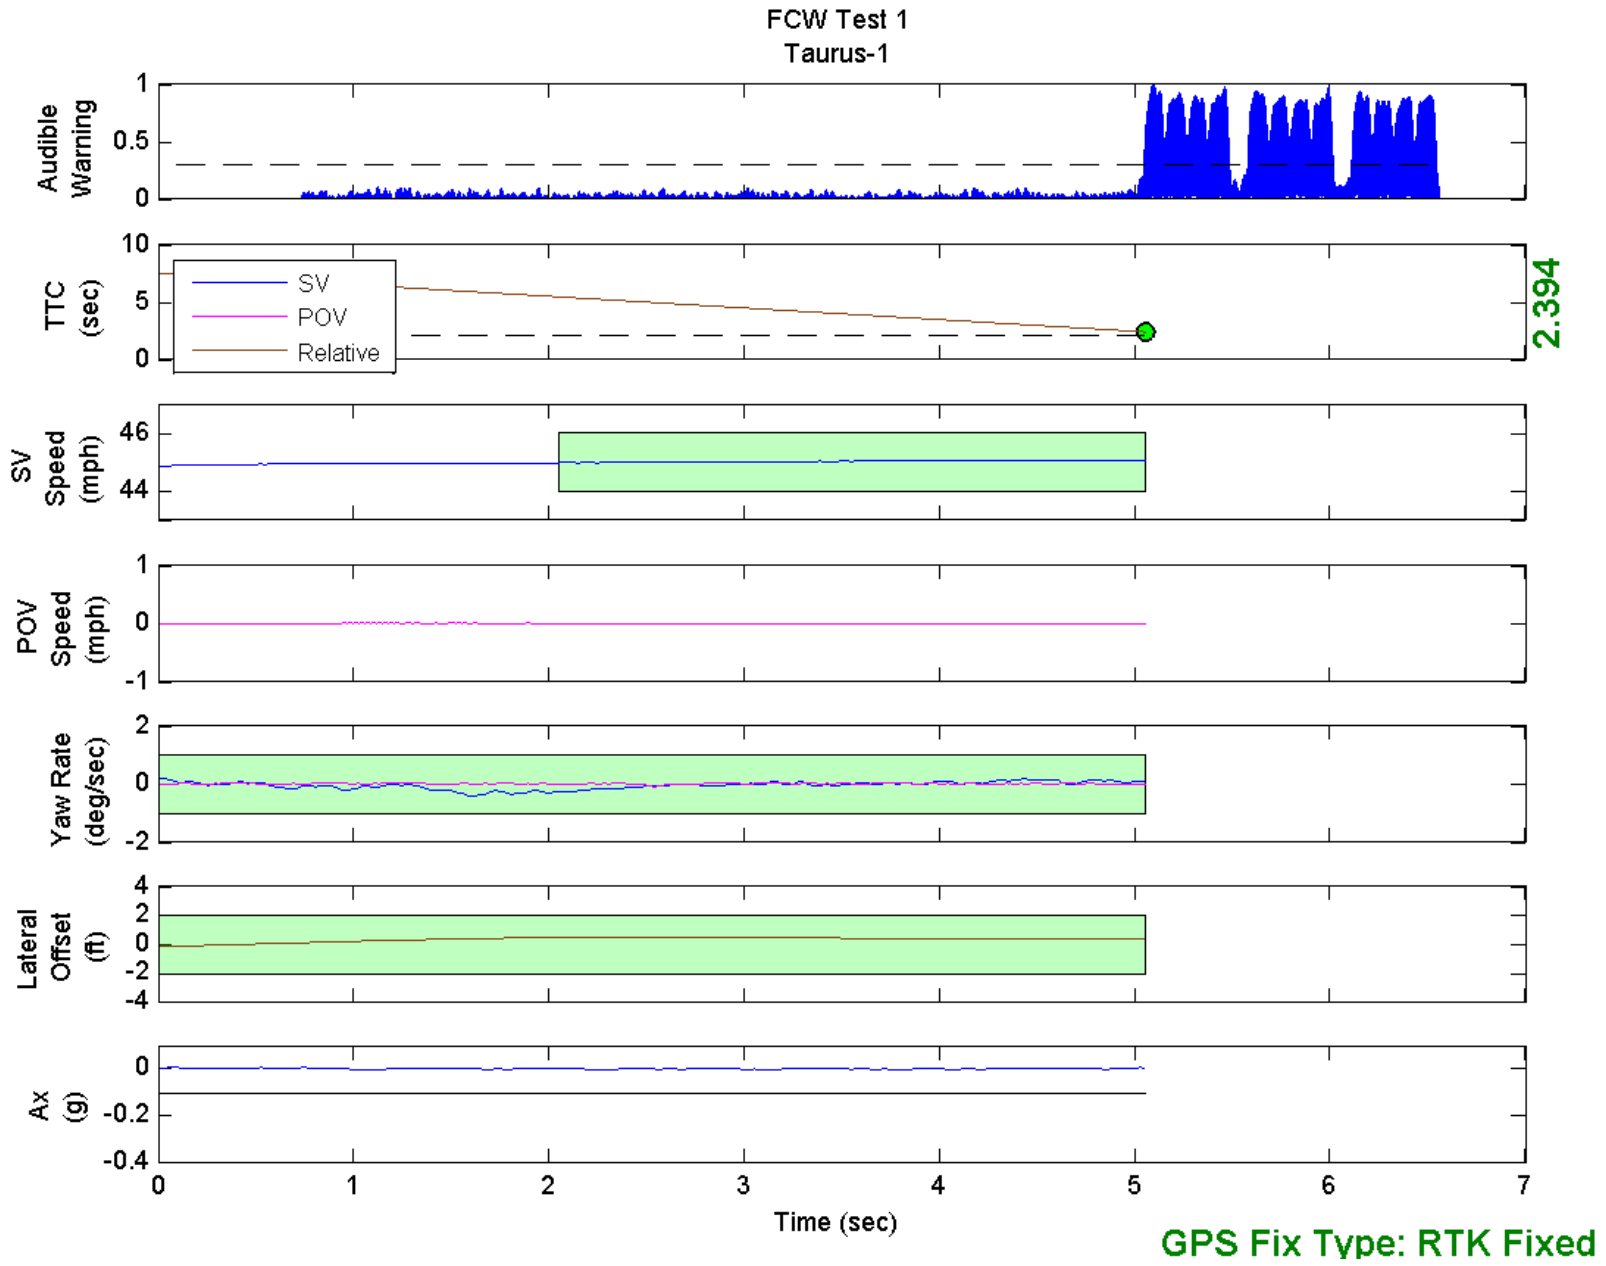
Figure D7. Time History for Run 1, FCW Test 1, Audible Warning

Run	Test Type	Valid Run?	TTCW Sound (sec)	TTCW Light (sec)	TTCW CAN (sec)	TTCW Margin (sec)	Pass/Fail	Notes
1	FCW1 (Stopped)	Y	2.39	2.40	2.41	0.31	Pass	
2		Y	2.39	2.38	2.40	0.30	Pass	
3		Y	2.41	2.41	2.43	0.33	Pass	
4		Y	2.07	2.06	2.08	-0.02	Pass	(All TTCW round to 2.1)
5		Y	2.43	2.42	2.44	0.34	Pass	
6		Y	2.02	2.02	2.04	-0.06	Fail	
7		Y	2.42	2.42	2.44	0.34	Pass	
8	FCW3 (Slower)	Y	2.75	2.75	2.77	0.77	Pass	
9		Y	2.88	2.88	2.91	0.91	Pass	
10		Y	2.70	2.71	2.72	0.72	Pass	
11		Y	2.88	2.88	2.90	0.90	Pass	
12		Y	2.77	2.77	2.79	0.79	Pass	
13		Y	2.79	2.79	2.81	0.81	Pass	
14		N						Data file problem
15		Y	2.57	2.57	2.59	0.59	Pass

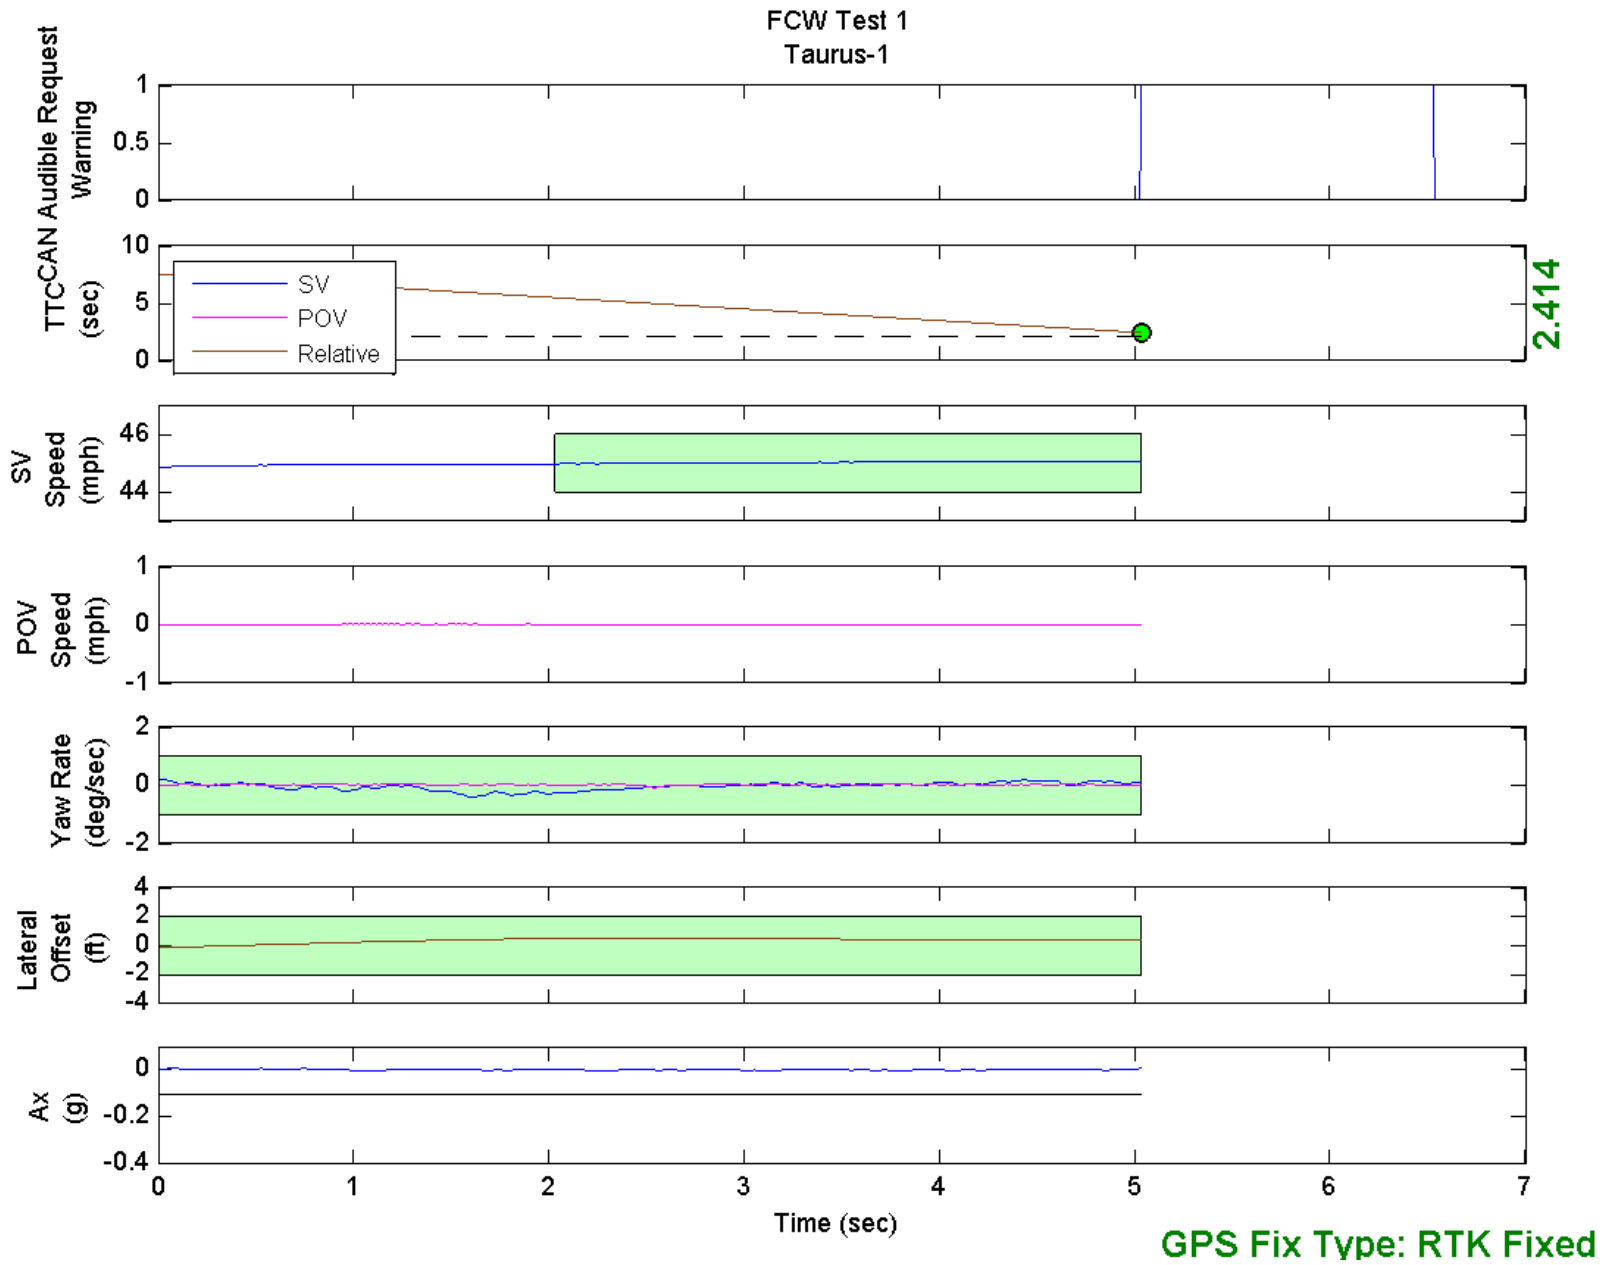
Figure D8. Time History for Run 1, FCW Test 1, CAN Audible Warning Request

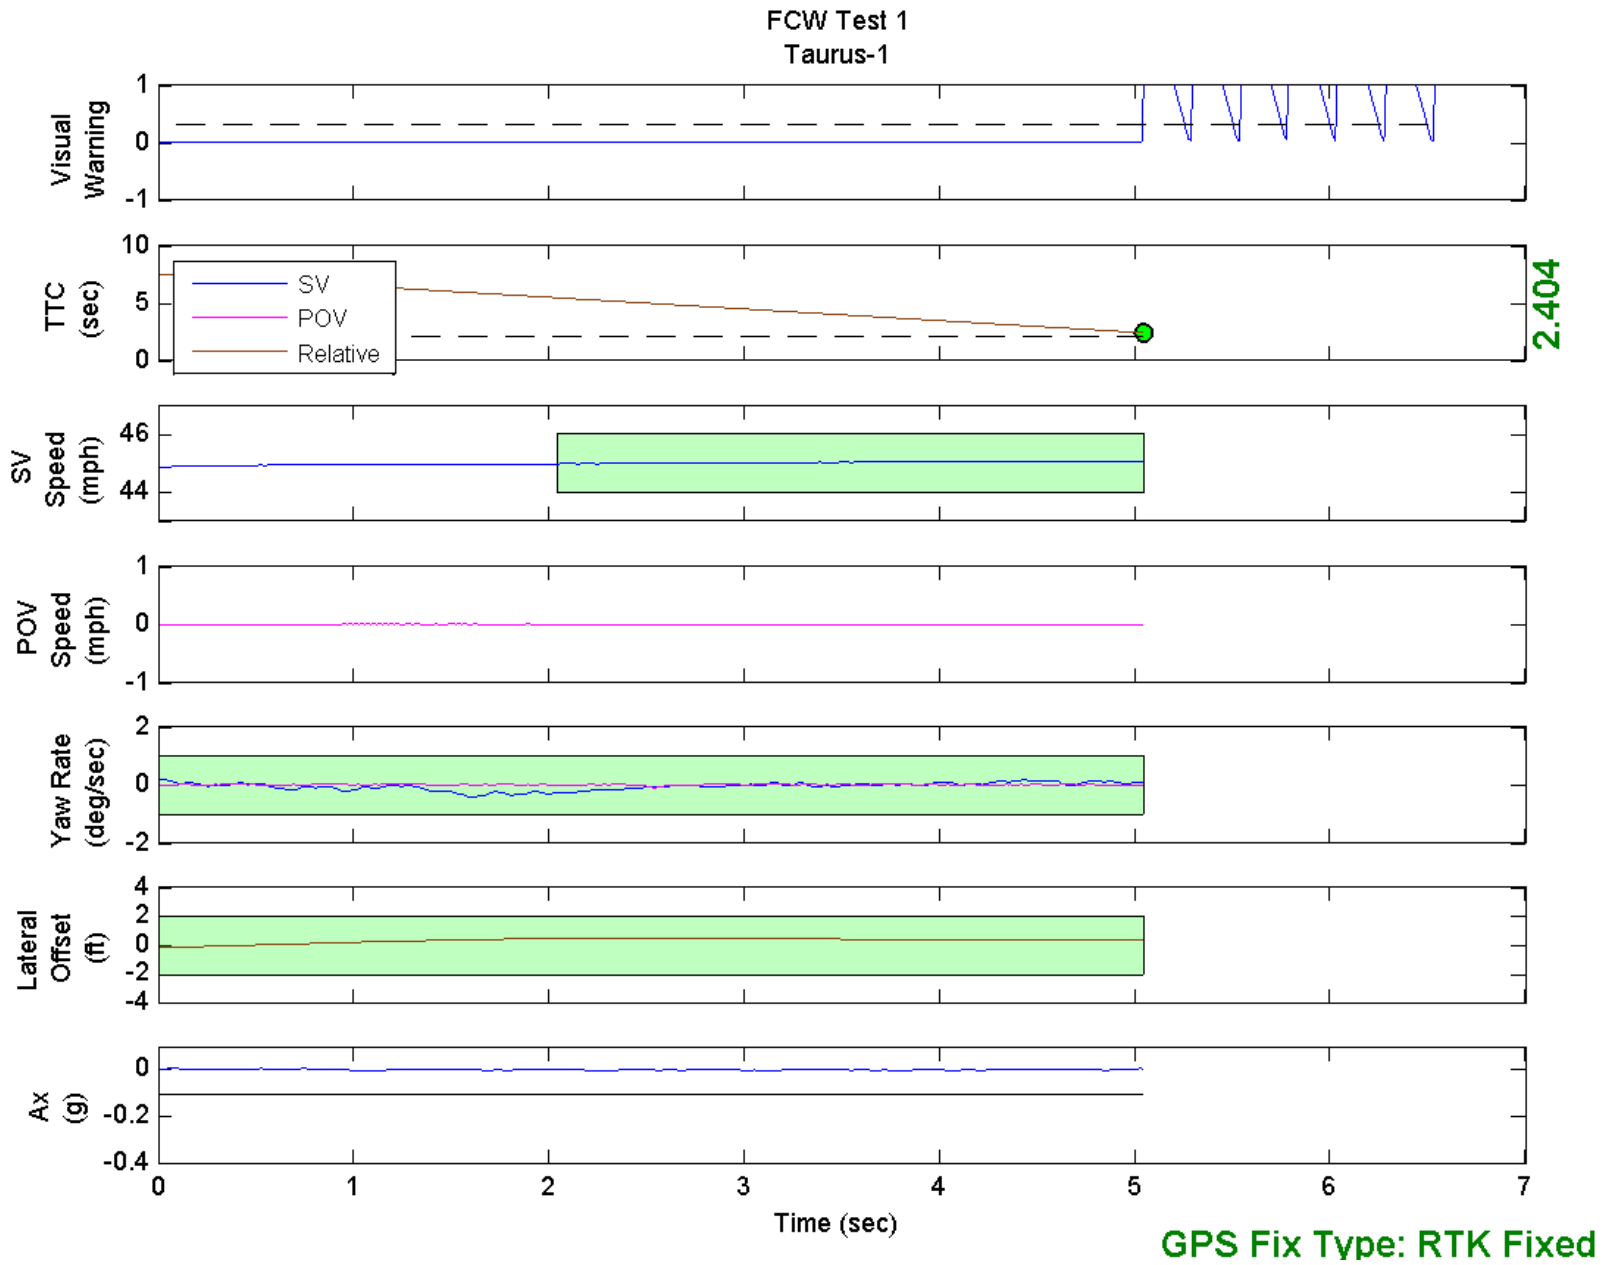
Figure D9. Time History for Run 1, FCW Test 1, Visual Warning

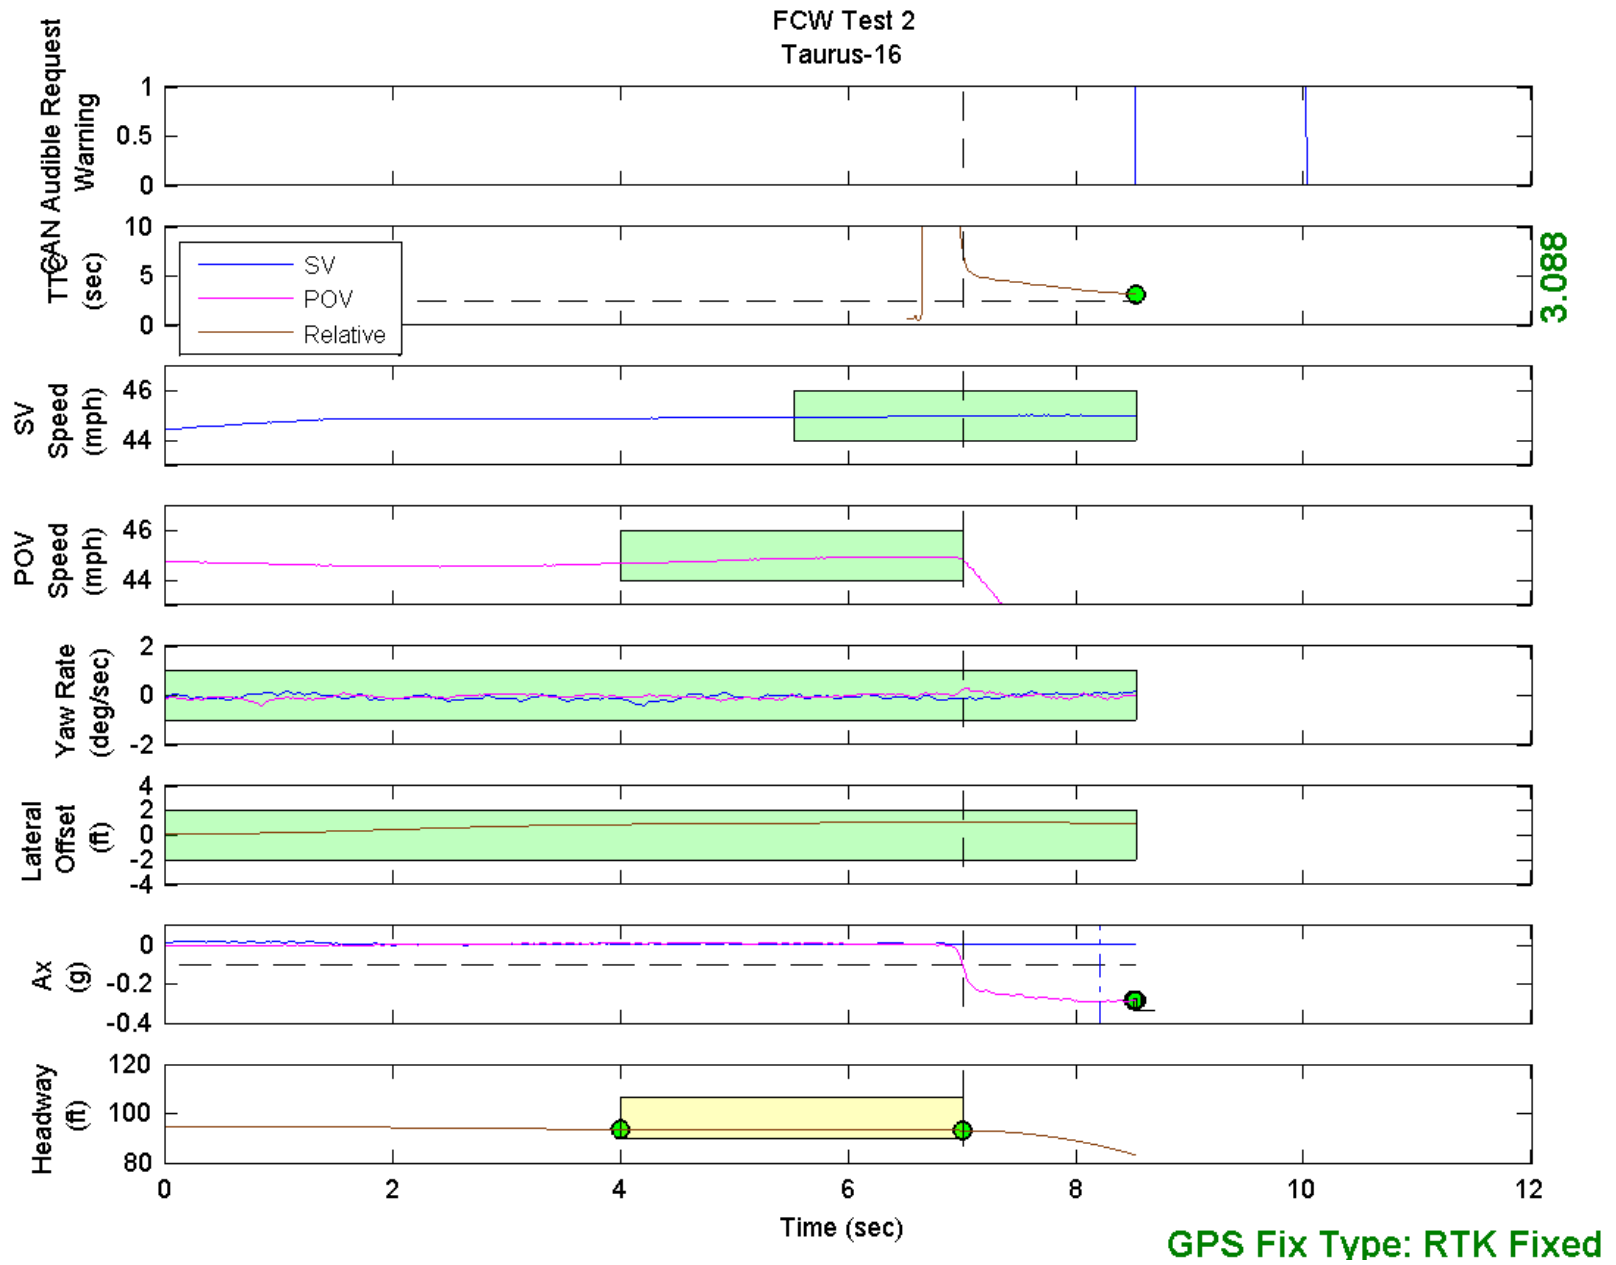
Figure D29. Time History for Run 16, FCW Test 2, CAN Audible Warning Request

Run	Test Type	Valid Run?	TTCW Sound (sec)	TTCW Light (sec)	TTCW CAN (sec)	TTCW Margin (sec)	Pass/Fail	Notes
16	FCW2 (Braking)	Y	3.05	3.07	3.09	0.69	Pass	
17		Y	3.01	3.01	3.04	0.64	Pass	
18		Y	3.11	3.11	3.16	0.76	Pass	
19		Y	3.08	3.08	3.11	0.71	Pass	
20		Y	3.20	3.20	3.21	0.81	Pass	
21		N						Lateral offset high
22		Y	3.14	3.14	3.17	0.77	Pass	
23		Y	3.07	3.10	3.11	0.71	Pass

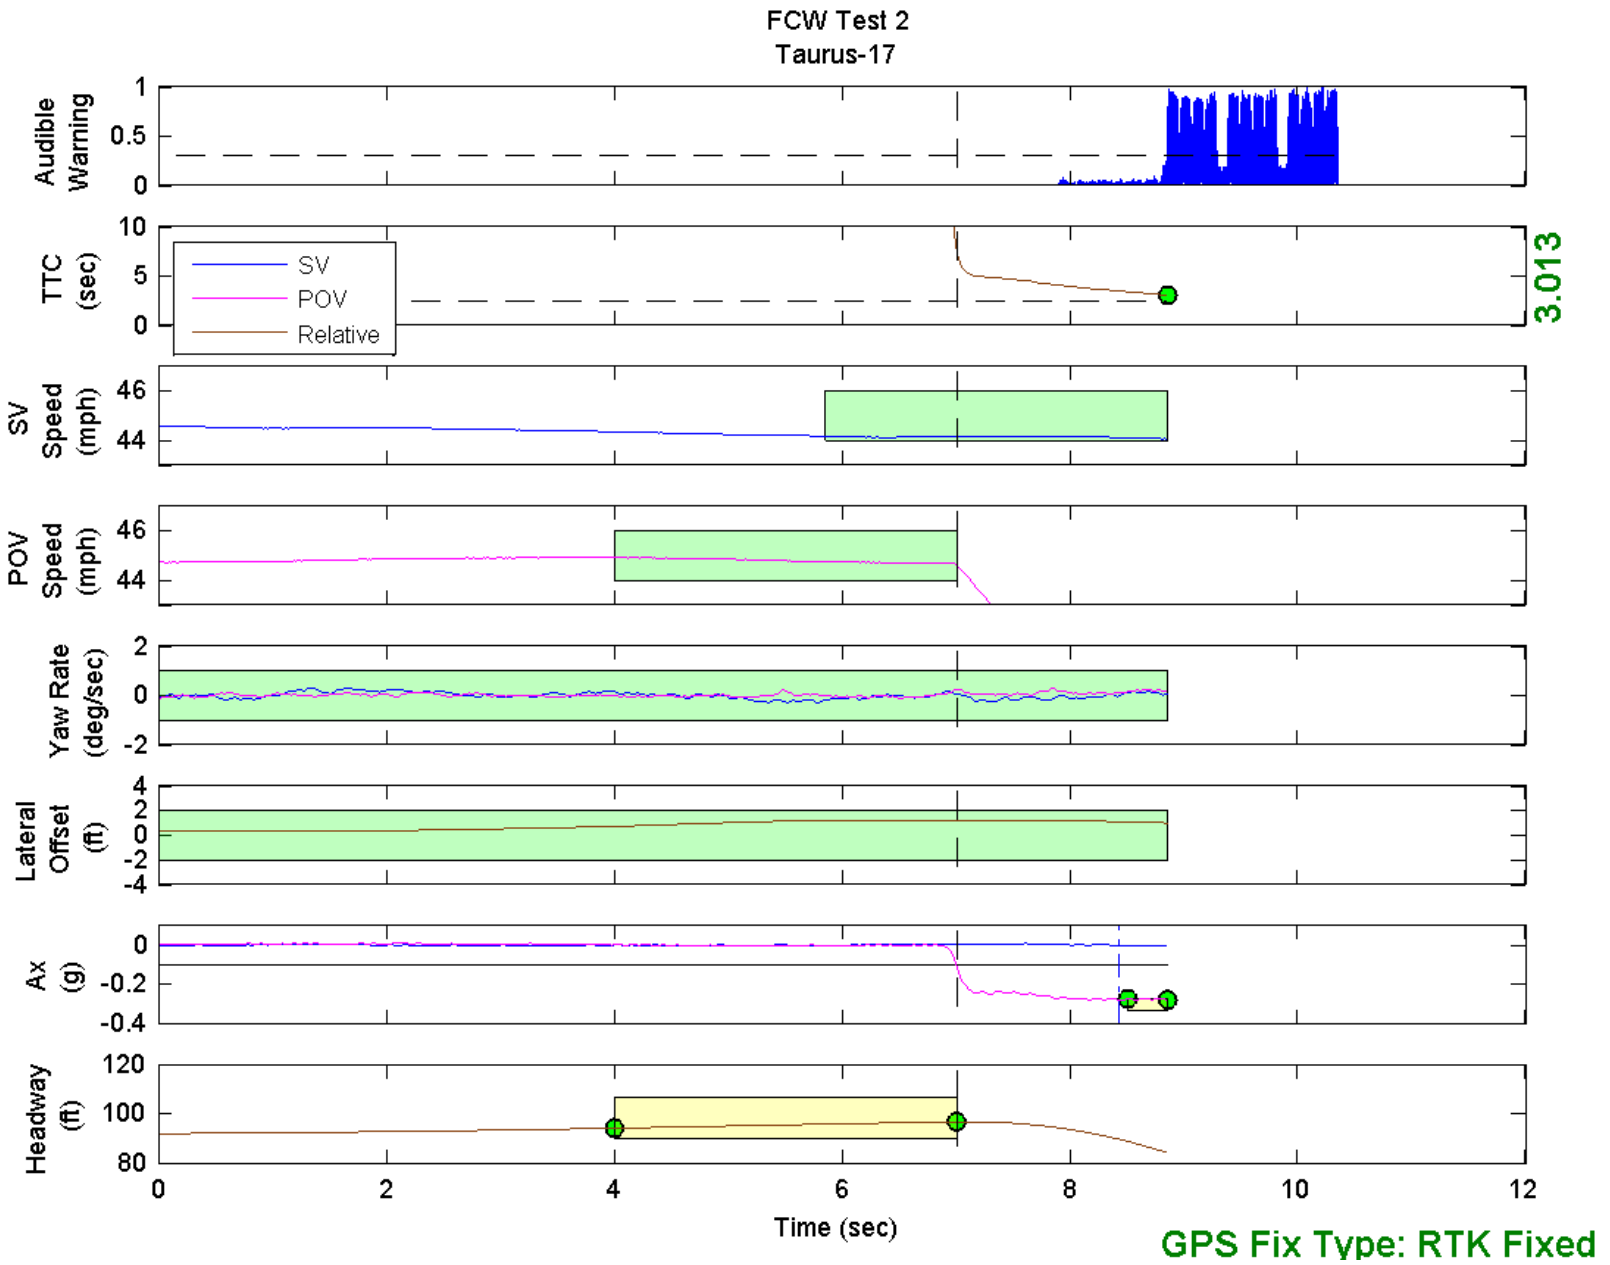
Figure D31. Time History for Run 17, FCW Test 2, Audible Warning
