**REPORT NUMBER: NCAP-KAR-15-005**

**NEW CAR ASSESSMENT PROGRAM (NCAP)  
FRONTAL BARRIER IMPACT TEST**

**FUJI HEAVY INDUSTRIES LTD.  
2015 SUBARU OUTBACK 2.5i 5-DOOR MPV**

**FINAL REPORT**

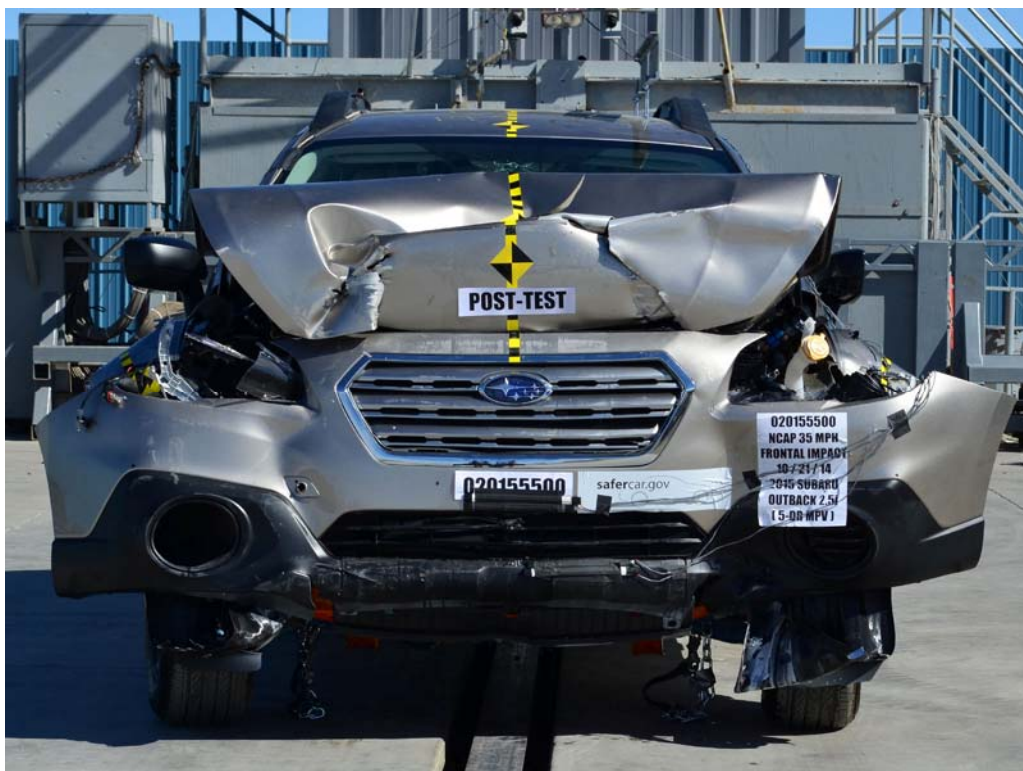
FIGURE 8. Post-Test Front View of Test Vehicle

The maximum static crush of the test vehicle was 480 mm located at DPD 2 to the left of the vehicle's centerline. Both the driver and passenger side doors remained closed during the impact event and were operable after the impact.

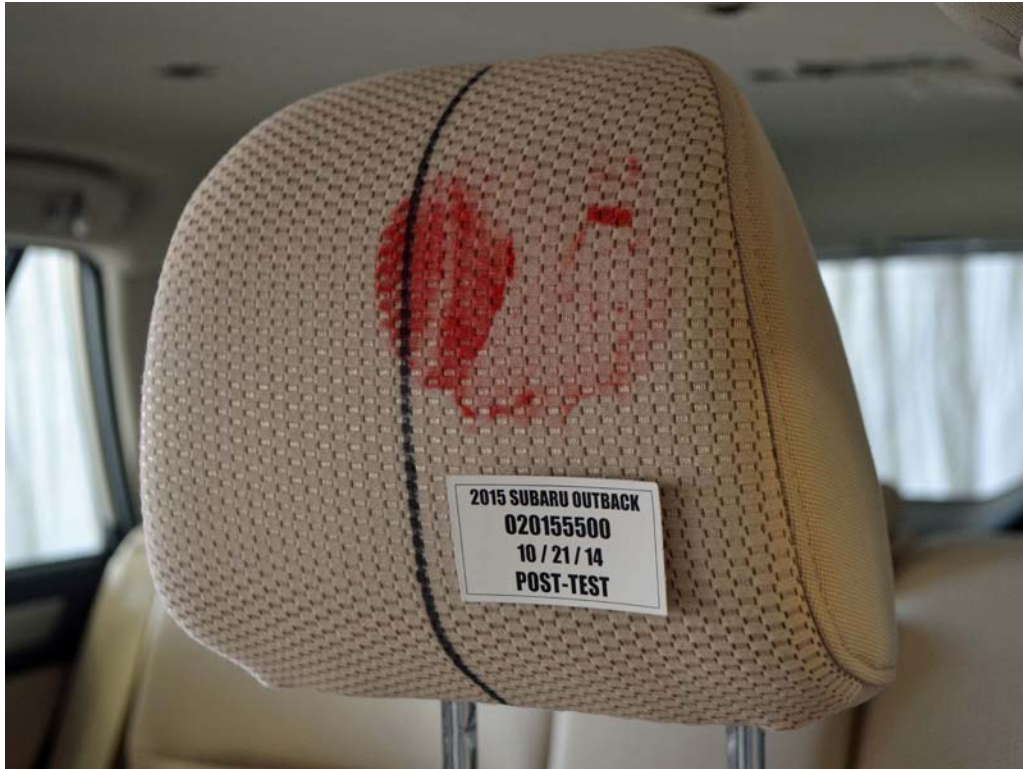
FIGURE 47. Post-Test Driver Dummy Contact with Headrest

The driver's visible contact points were as follows: The driver ATD's head contacted the airbag and headrest. The upper torso contacted the airbag. Both the left and right knees contacted the knee bolster.

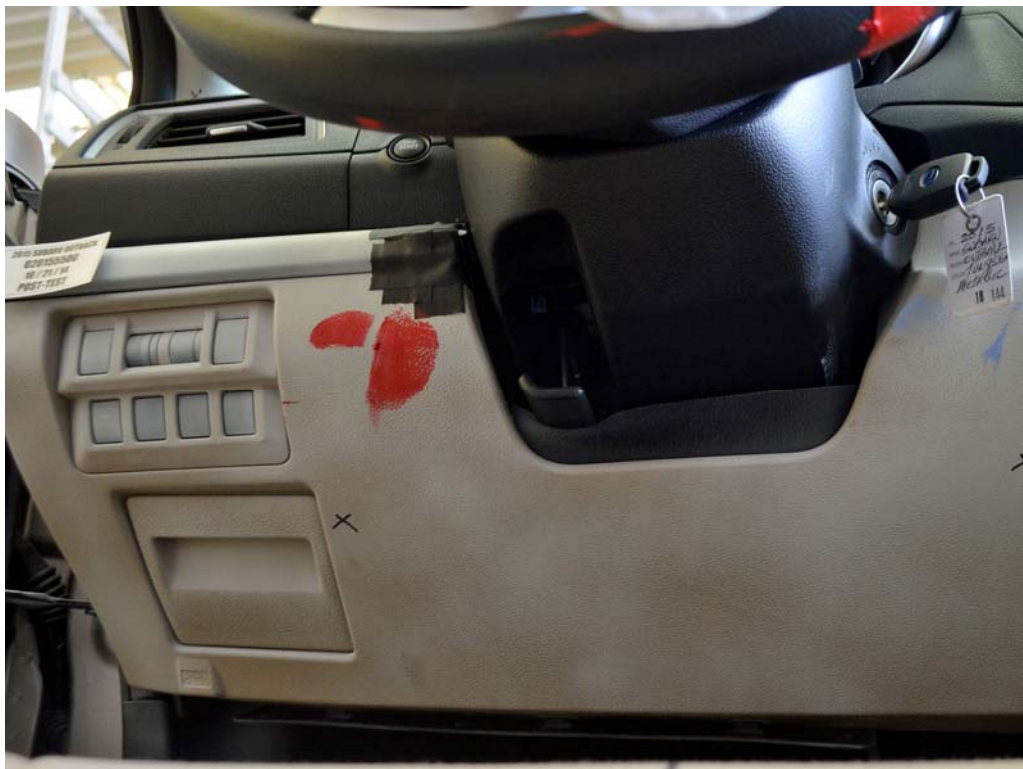
FIGURE 47a. Post-Test Driver Dummy Contact with Knee Bolster

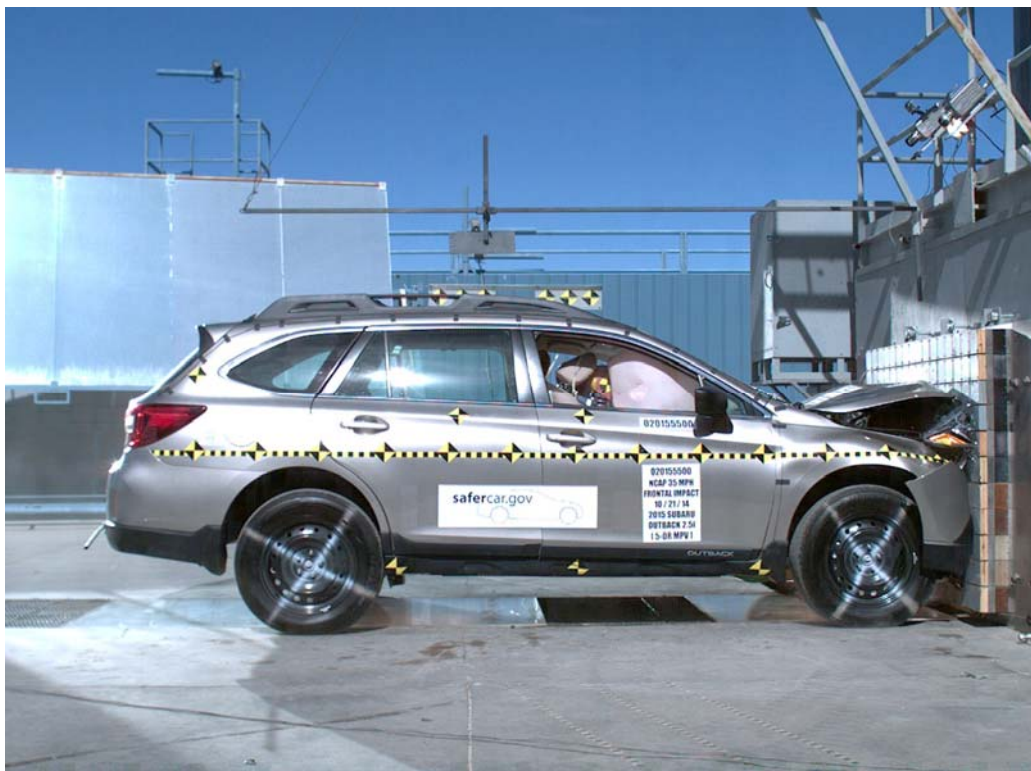
FIGURE 77. 2015 Subaru Outback Frontal Impact Event
