**REPORT NUMBER: SPNCAP-KAR-15-010**

**NEW CAR ASSESSMENT PROGRAM (NCAP)  
SIDE IMPACT POLE TEST**

**TOYOTA MOTOR MANUFACTURING, TEXAS, INC.  
2015 TOYOTA TACOMA ACCESS CAB 2-DOOR TRUCK**

**NHTSA No: M20155304**

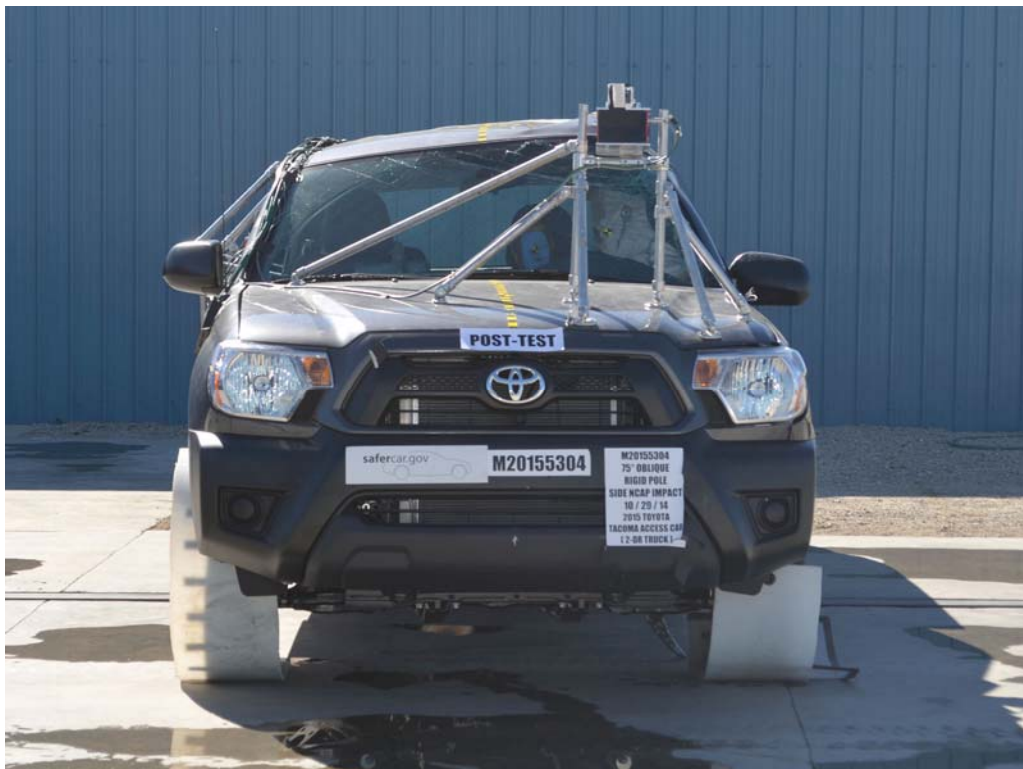
FIGURE 4. Post-Test Frontal View of Test Vehicle

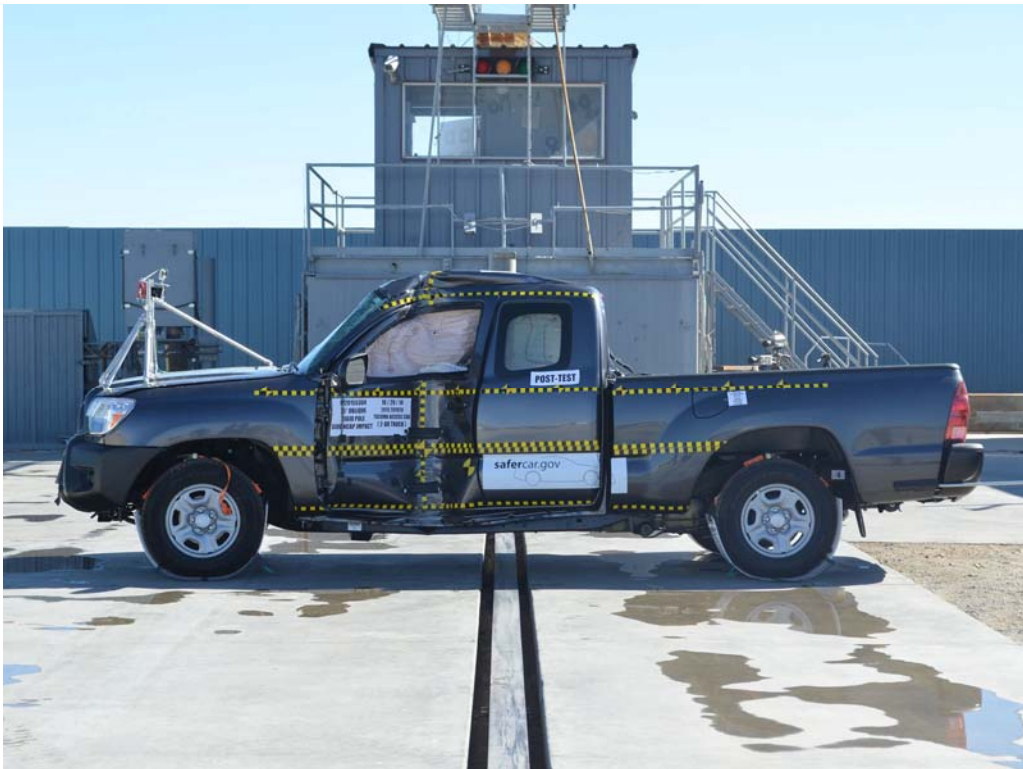
FIGURE 8. Post-Test Left Side View of Test Vehicle

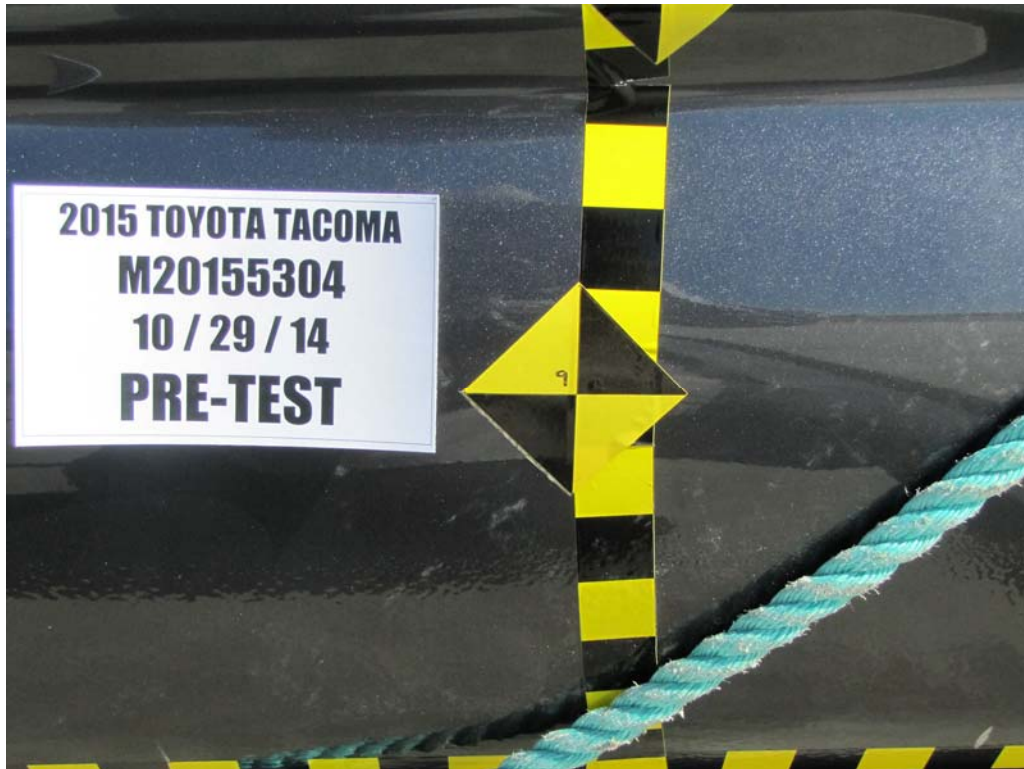
FIGURE 19. Pre-Test Close-Up View of Impact Point Target

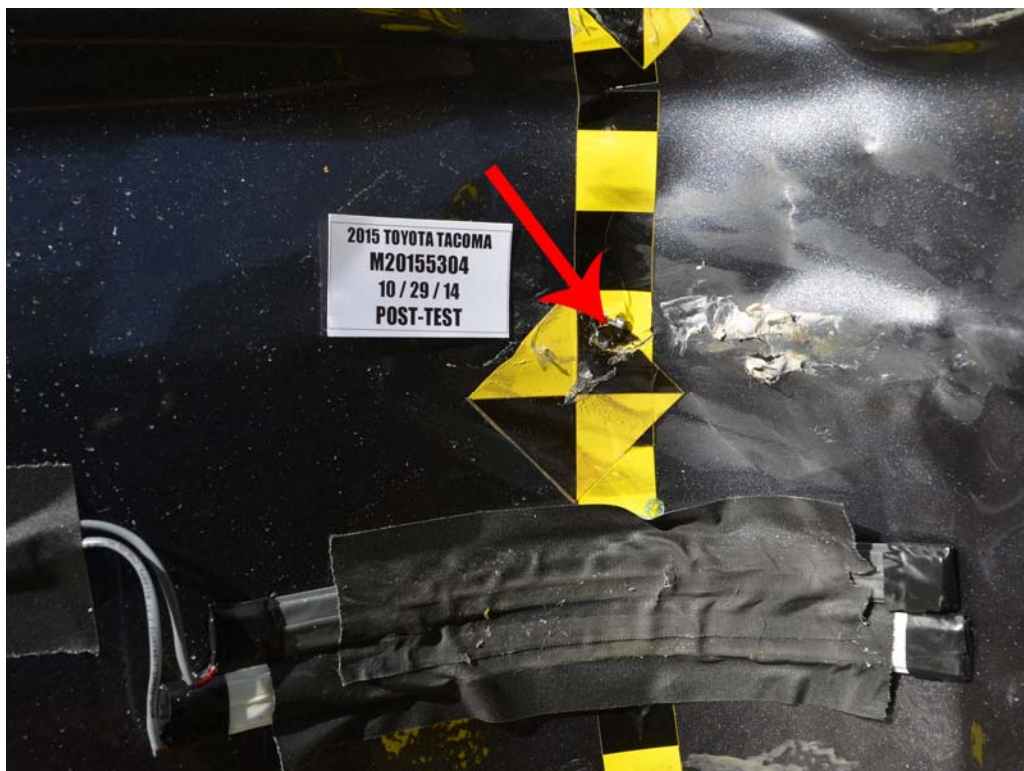
FIGURE 20. Post-Test Close-Up View of Impact Point Target  
Showing Impact Location

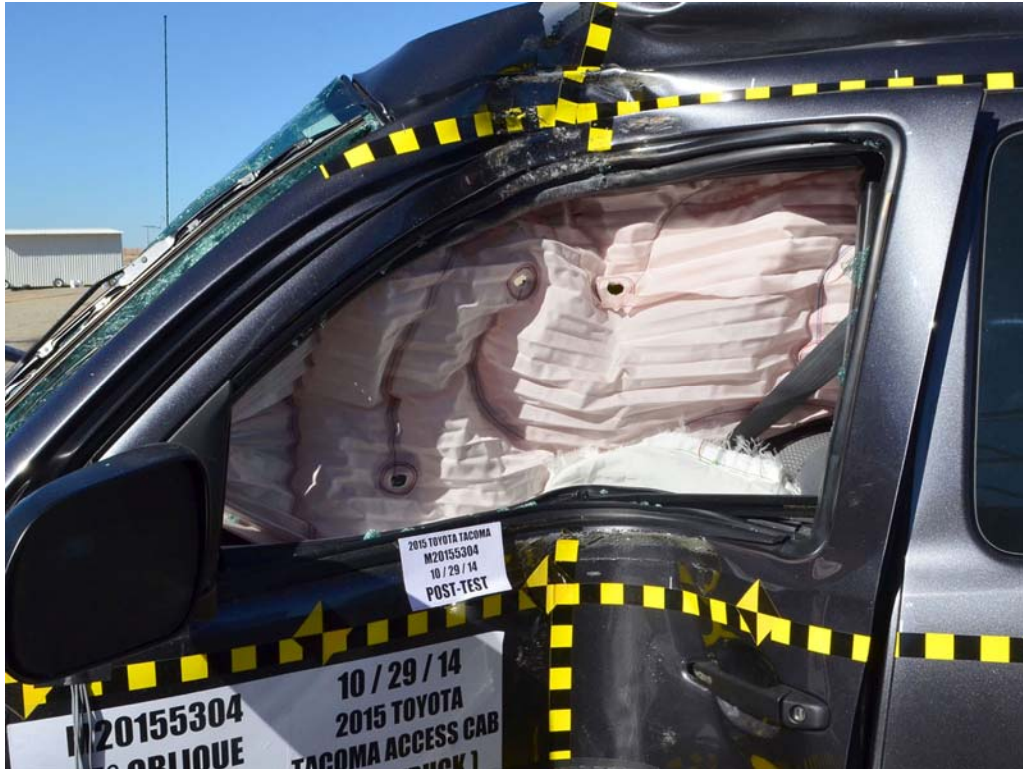
FIGURE 25. Post-Test Left Side View of Dummy Shoulder and Door Top View

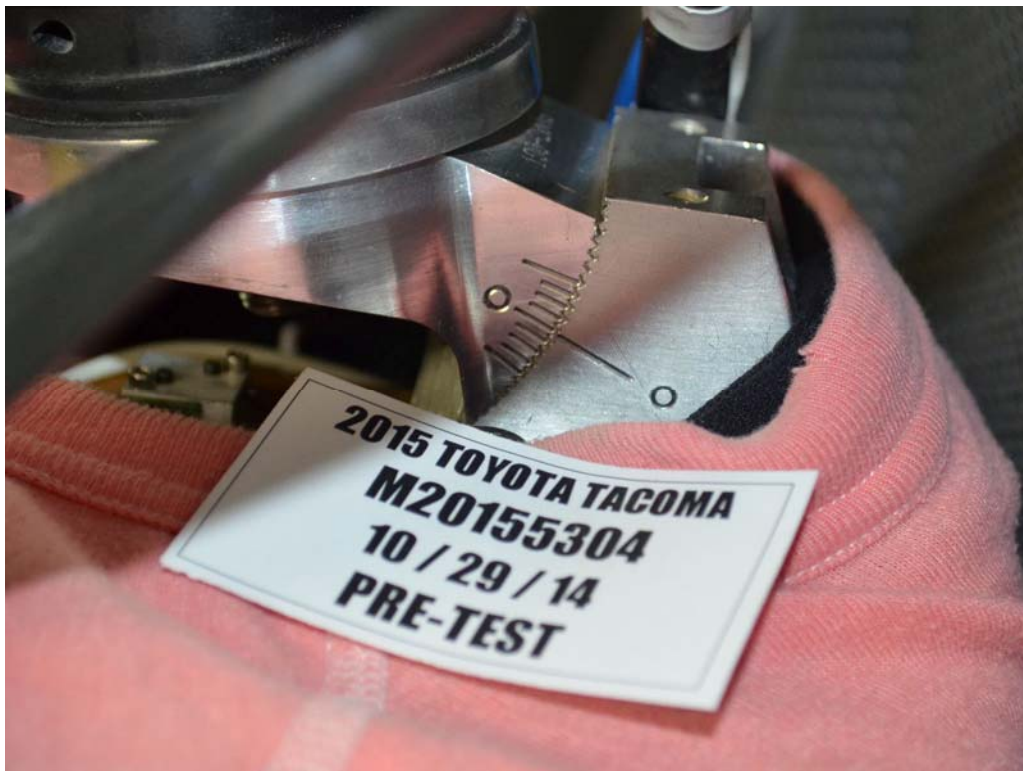
FIGURE 30. Pre-Test Left Side View of Dummy's Neck  
Showing Position of Adjustable Neck Bracket

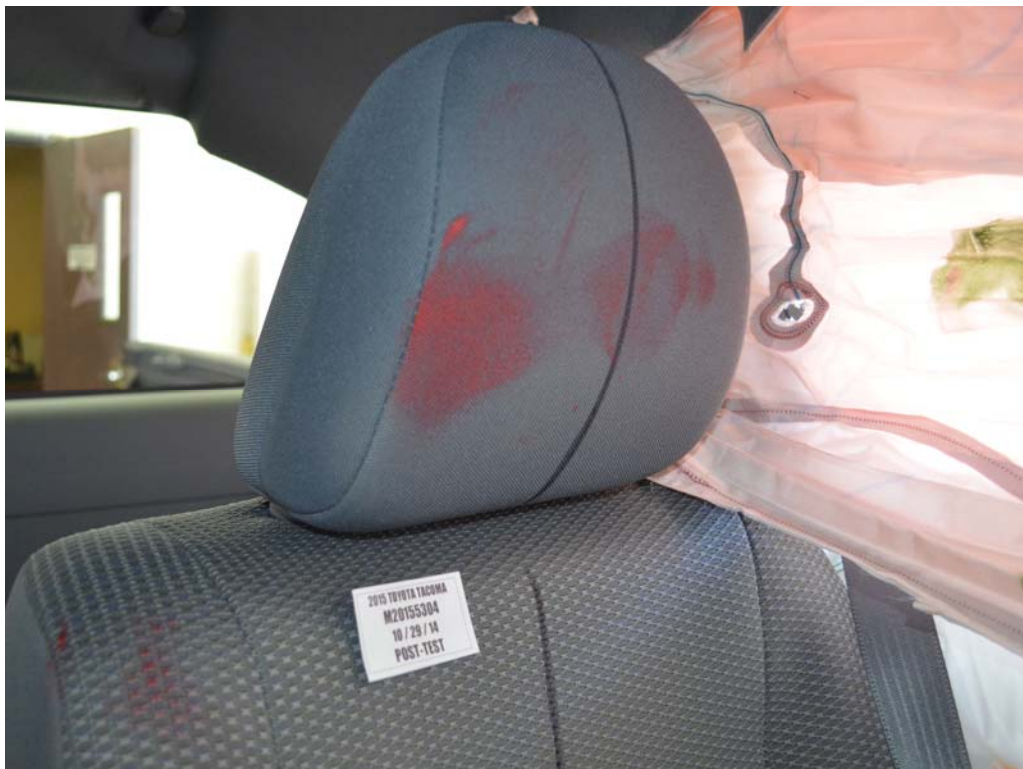
FIGURE 46. Post-Test Dummy Close-Up Head Contact with Vehicle Interior View

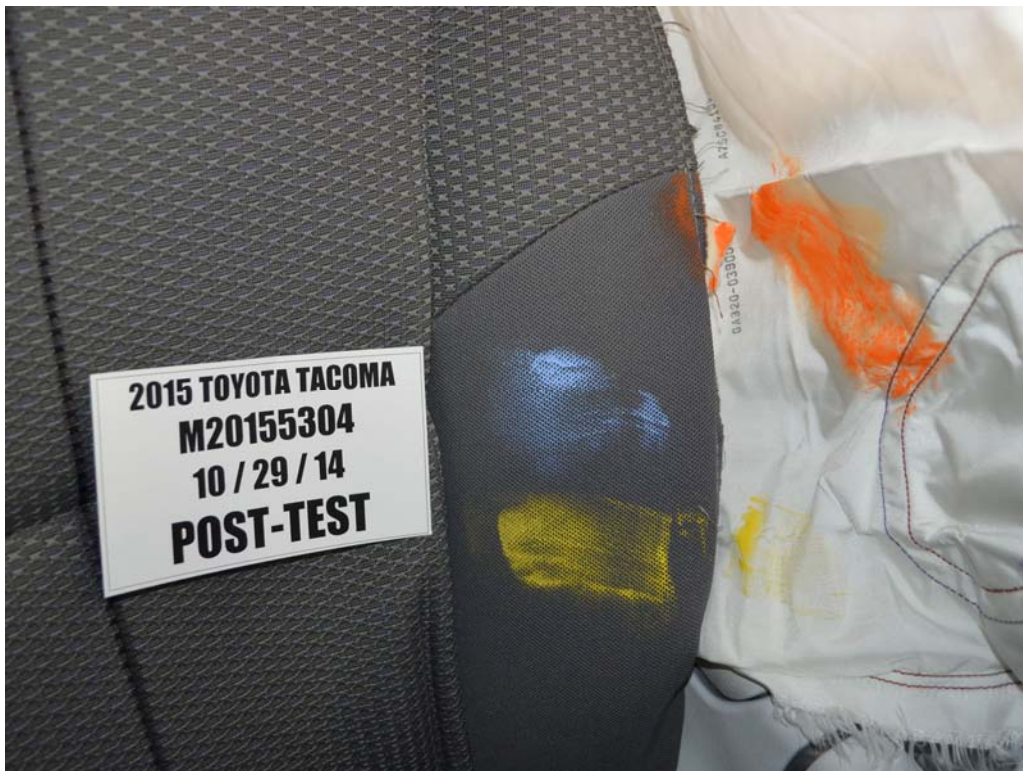
FIGURE 48. Post-Test Dummy Close-Up Torso Contact With Vehicle Interior View

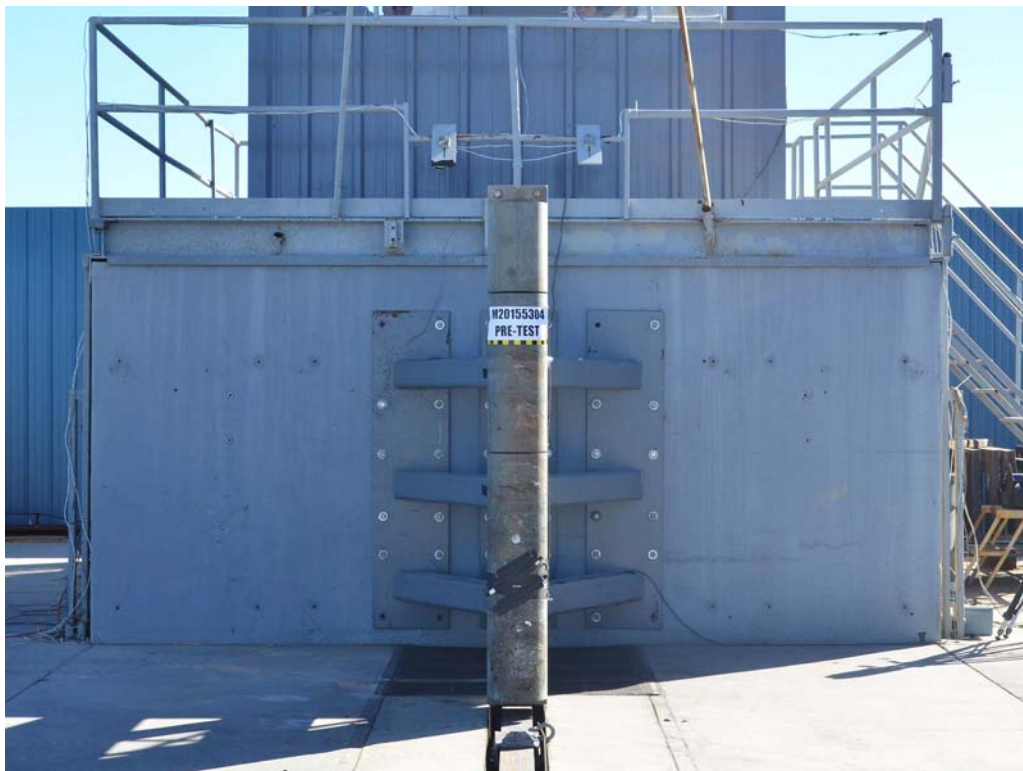
FIGURE 57. Pre-Test Pole Barrier Front View

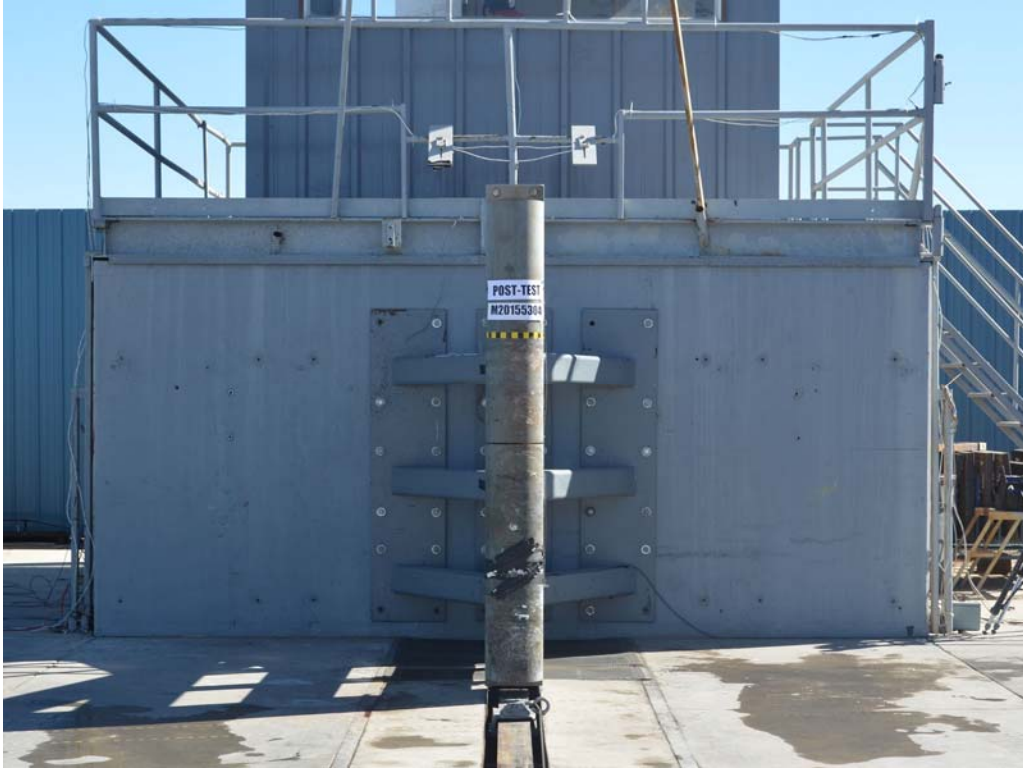
FIGURE 58. Post-Test Pole Barrier Front View
