**REPORT NUMBER: SPNCAP-MGA-2015-024**

**NEW CAR ASSESSMENT PROGRAM (NCAP)  
Side Impact Pole Test**

**FORD MOTOR COMPANY  
2015 Ford Transit 150 LR Wagon XLT  
NHTSA No.: M20150204**

**FINAL REPORT**

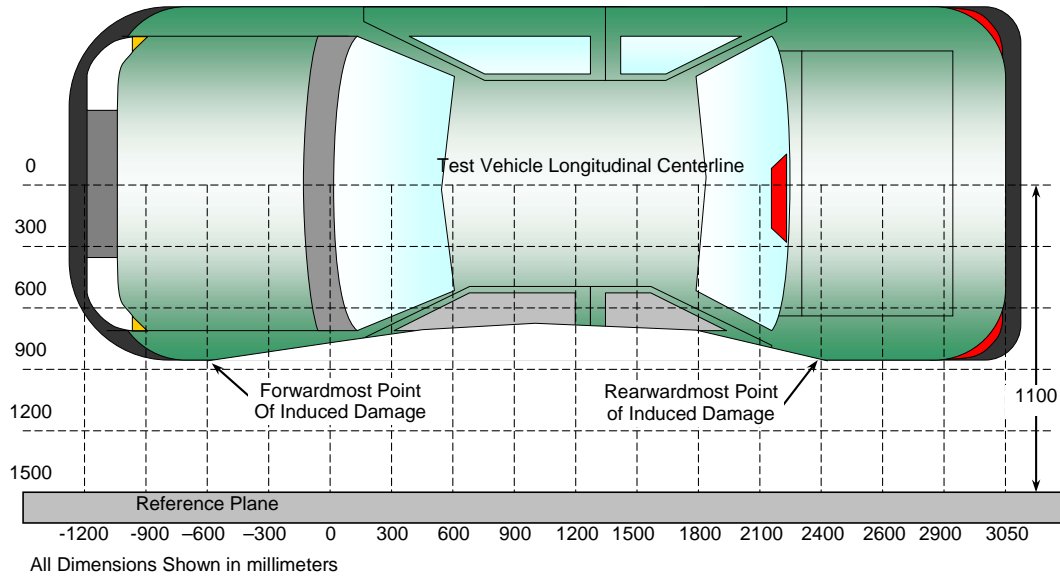
**DATA SHEET NO. 11**  
**VEHICLE DAMAGE PROFILE DISTANCES**

**TOP VIEW**

**DAMAGE PROFILE DISTANCES**

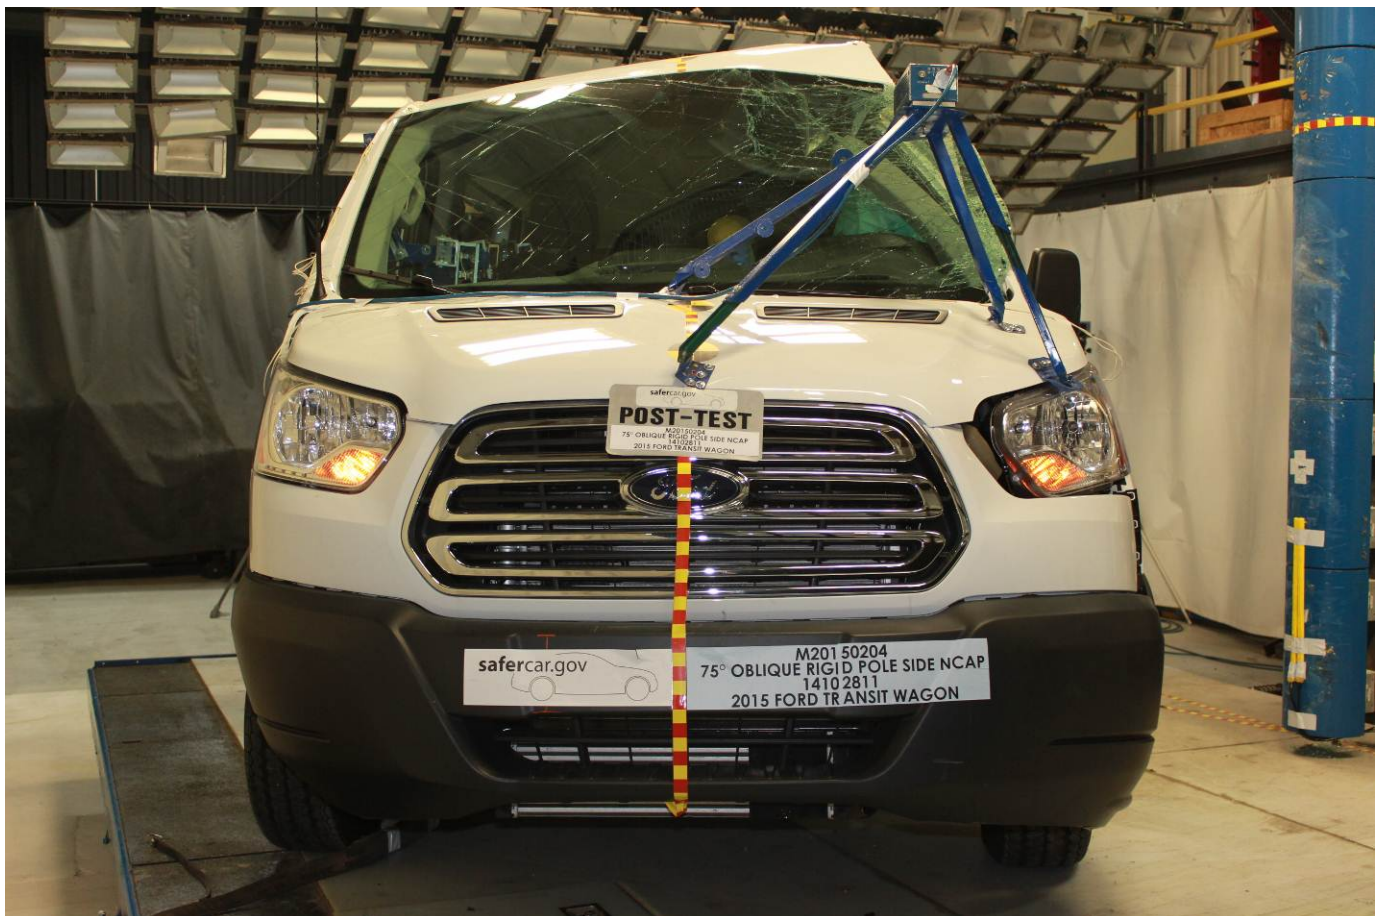
Post-Test Frontal View of Test Vehicle

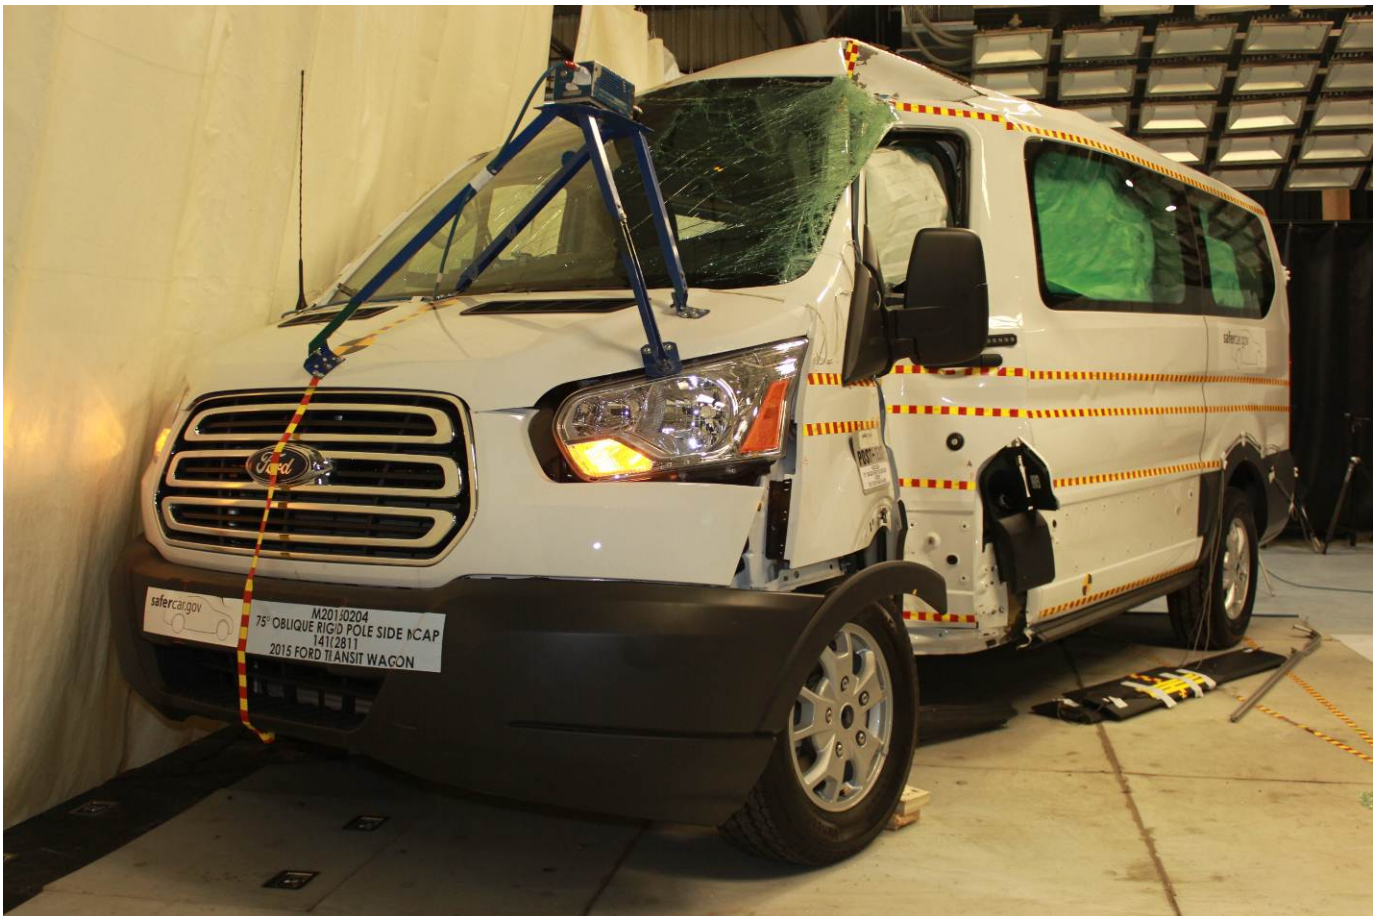
Post-Test Left Front ¾ View of Test Vehicle

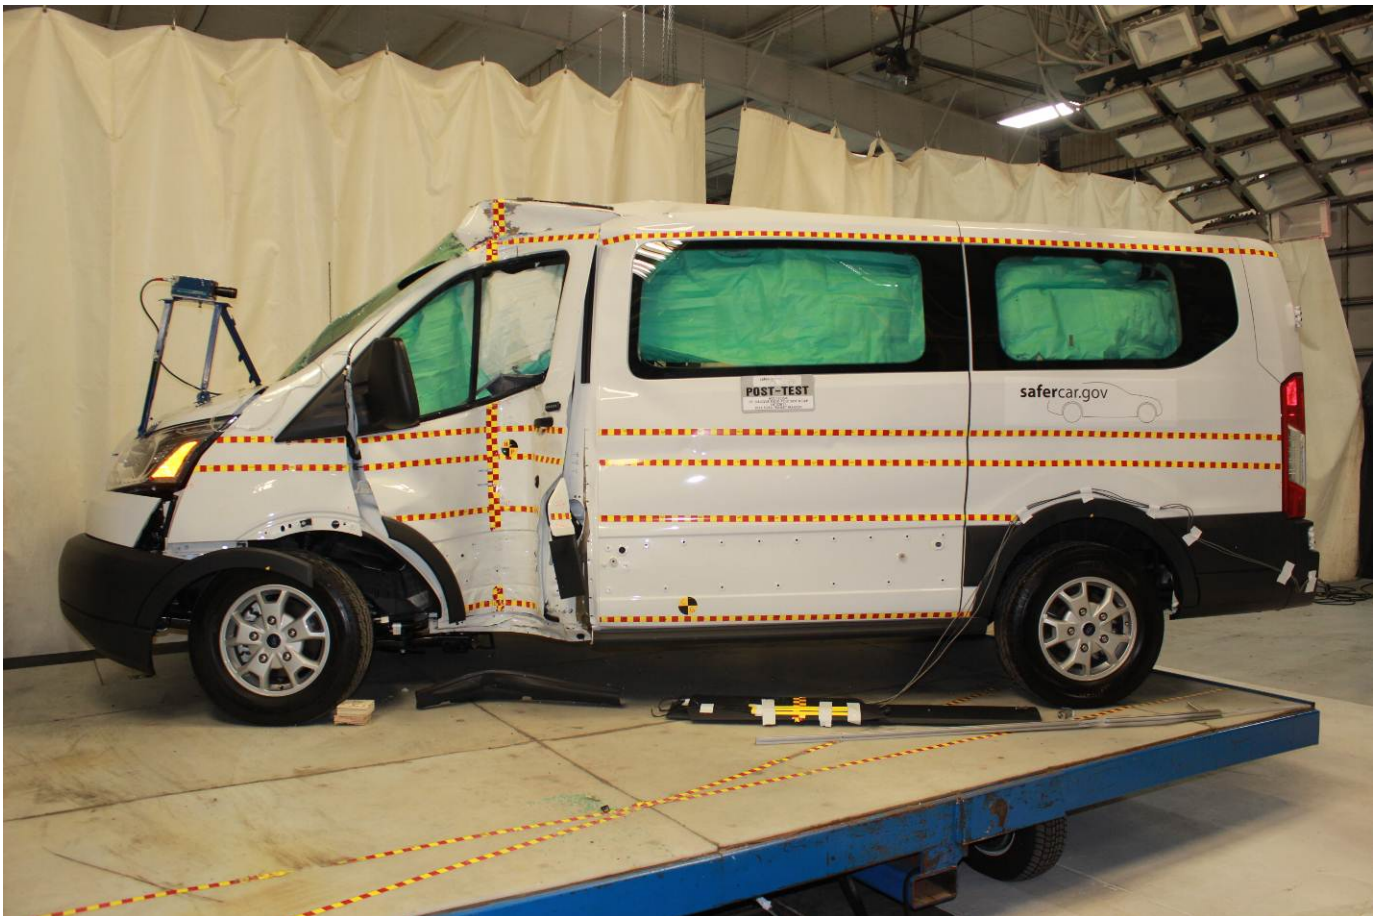
Post-Test Left Side View of Test Vehicle

Critical Areas of Performance	Observations and Conclusions
Pillar Performance	No Separation
Sill Separation	None
Windshield Damage	Cracked
Side Window Damage	Left Front Window Broken
Other Notable Effects	None

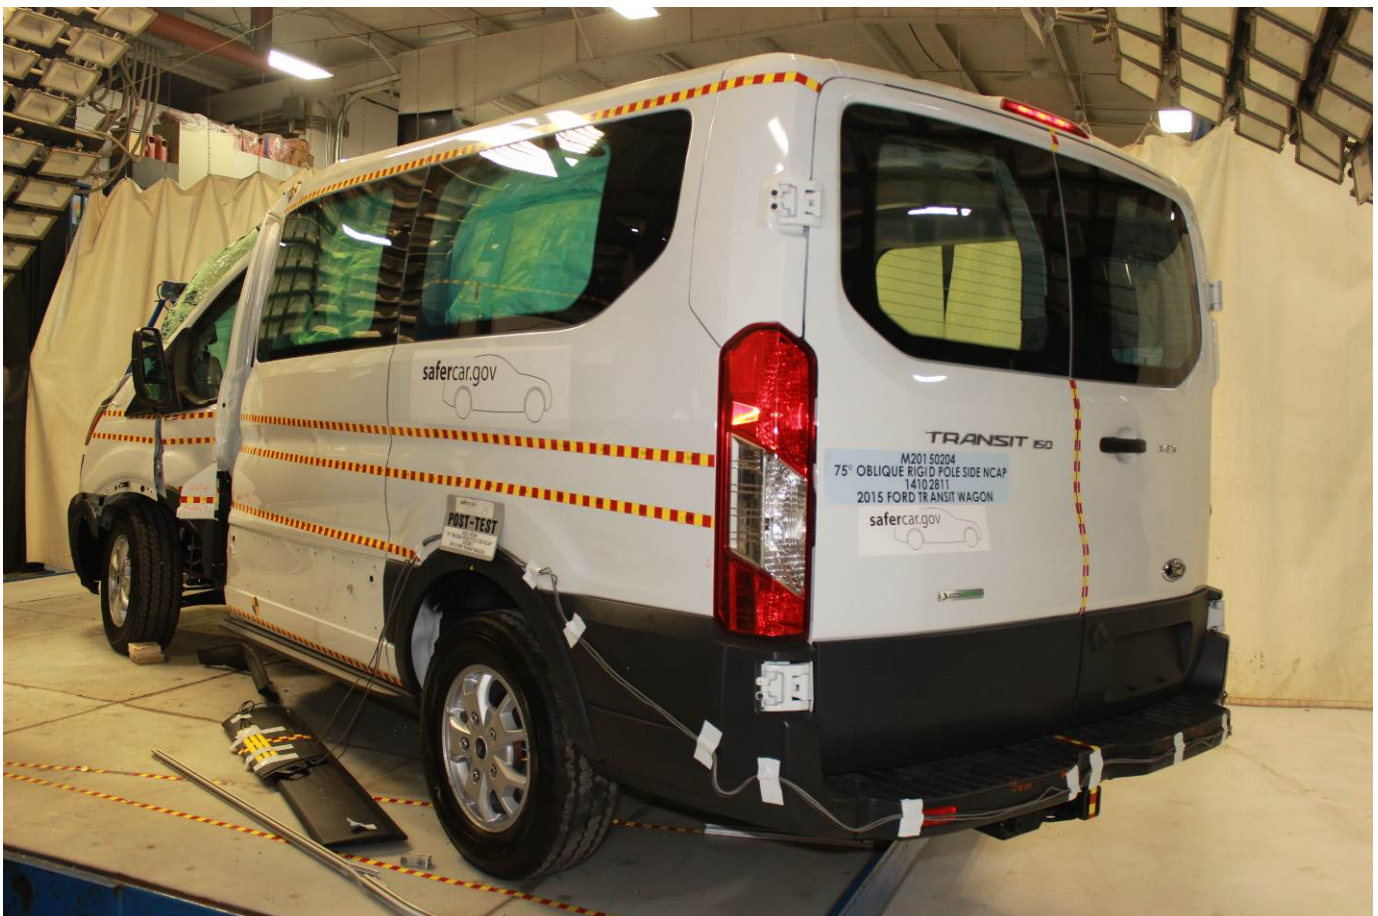
Post-Test Left Rear  $\frac{3}{4}$  View of Test Vehicle

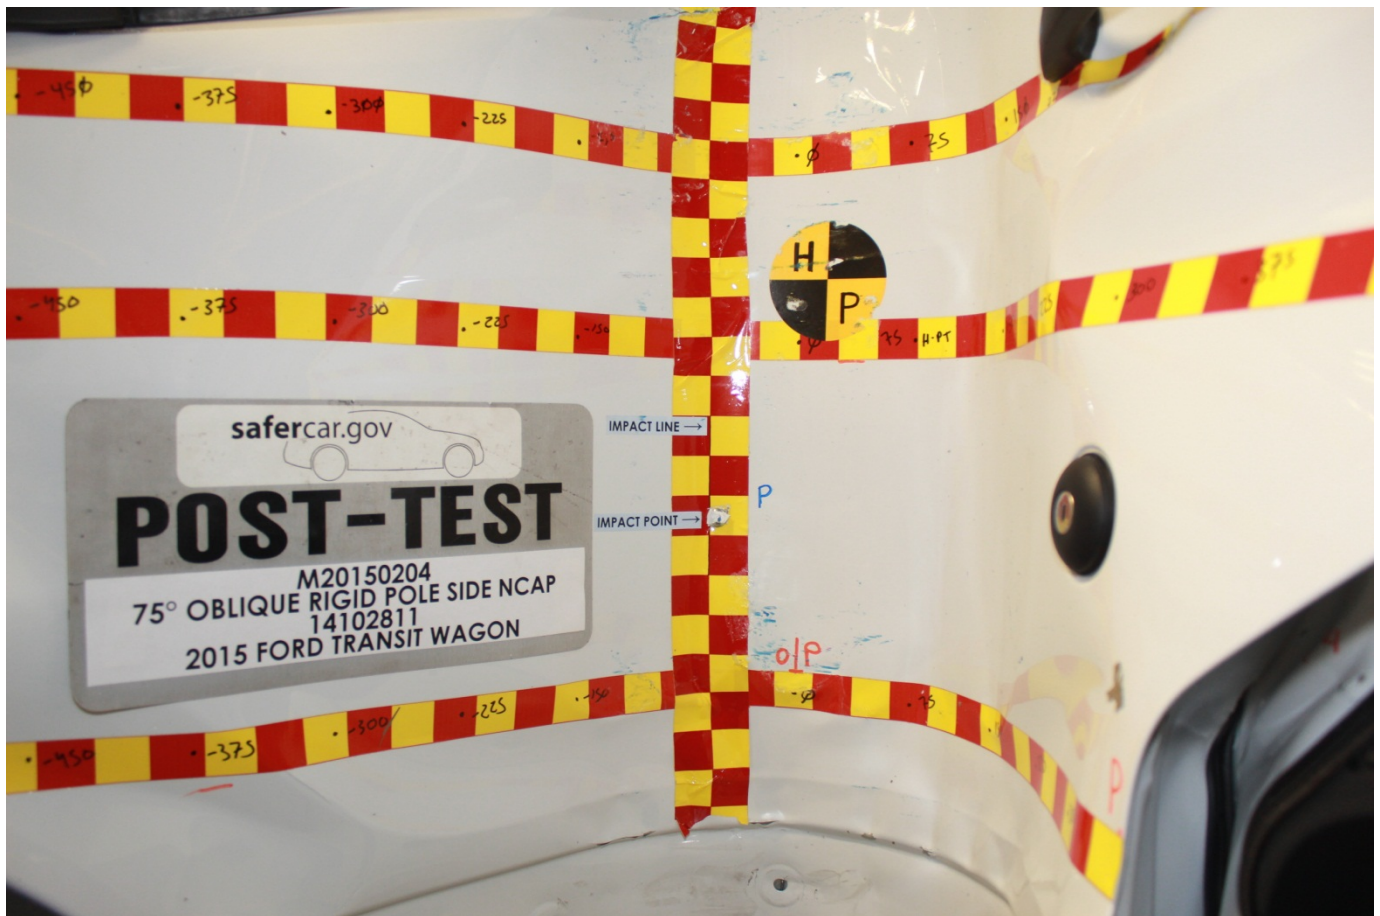
Post-Test Close-Up View of Impact Point Target Showing Impact Location

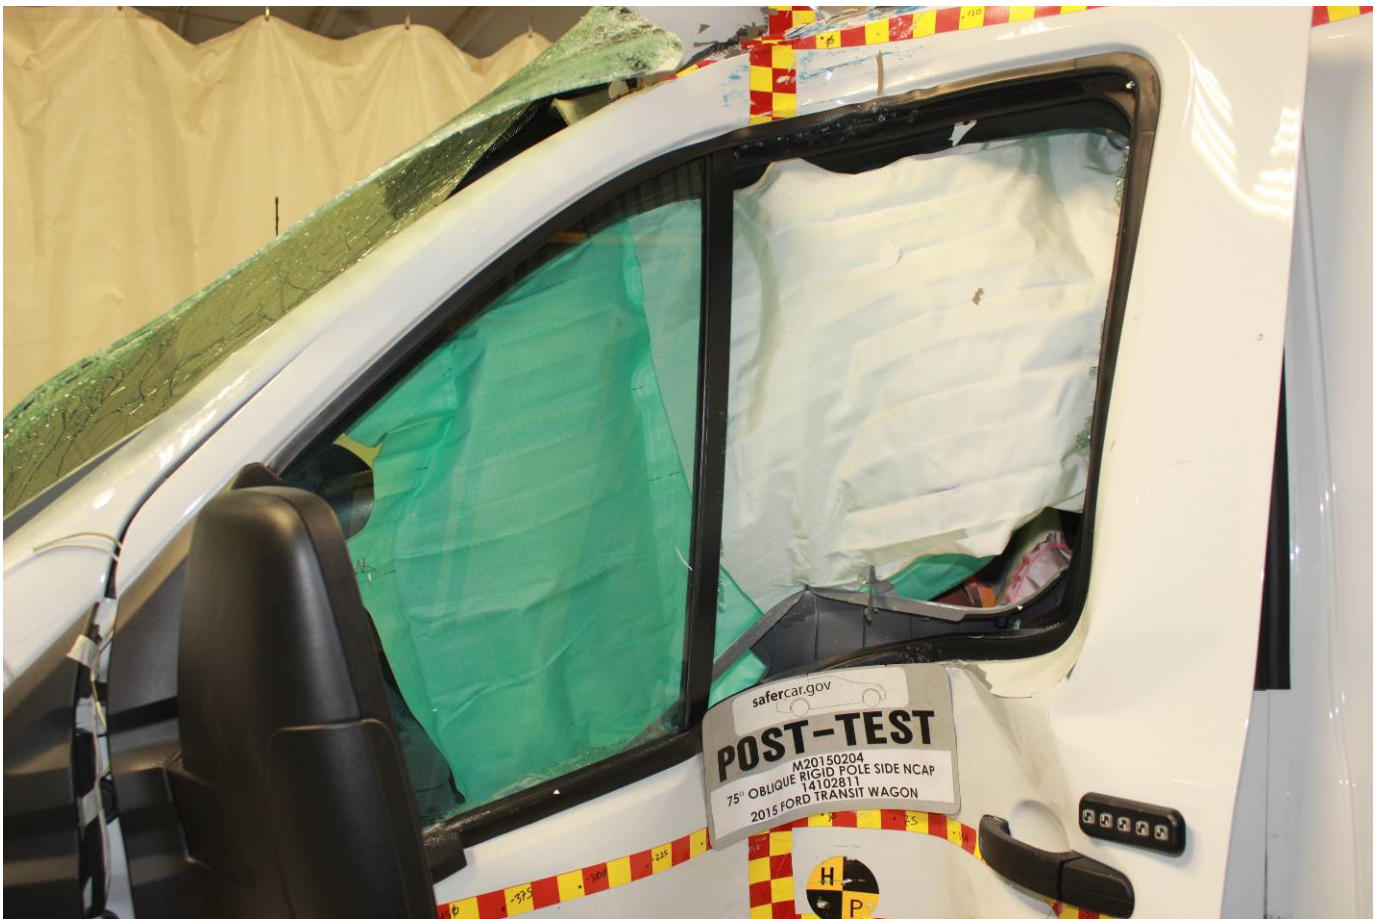
Post-Test Left Side View of Dummy Shoulder and Door Top View

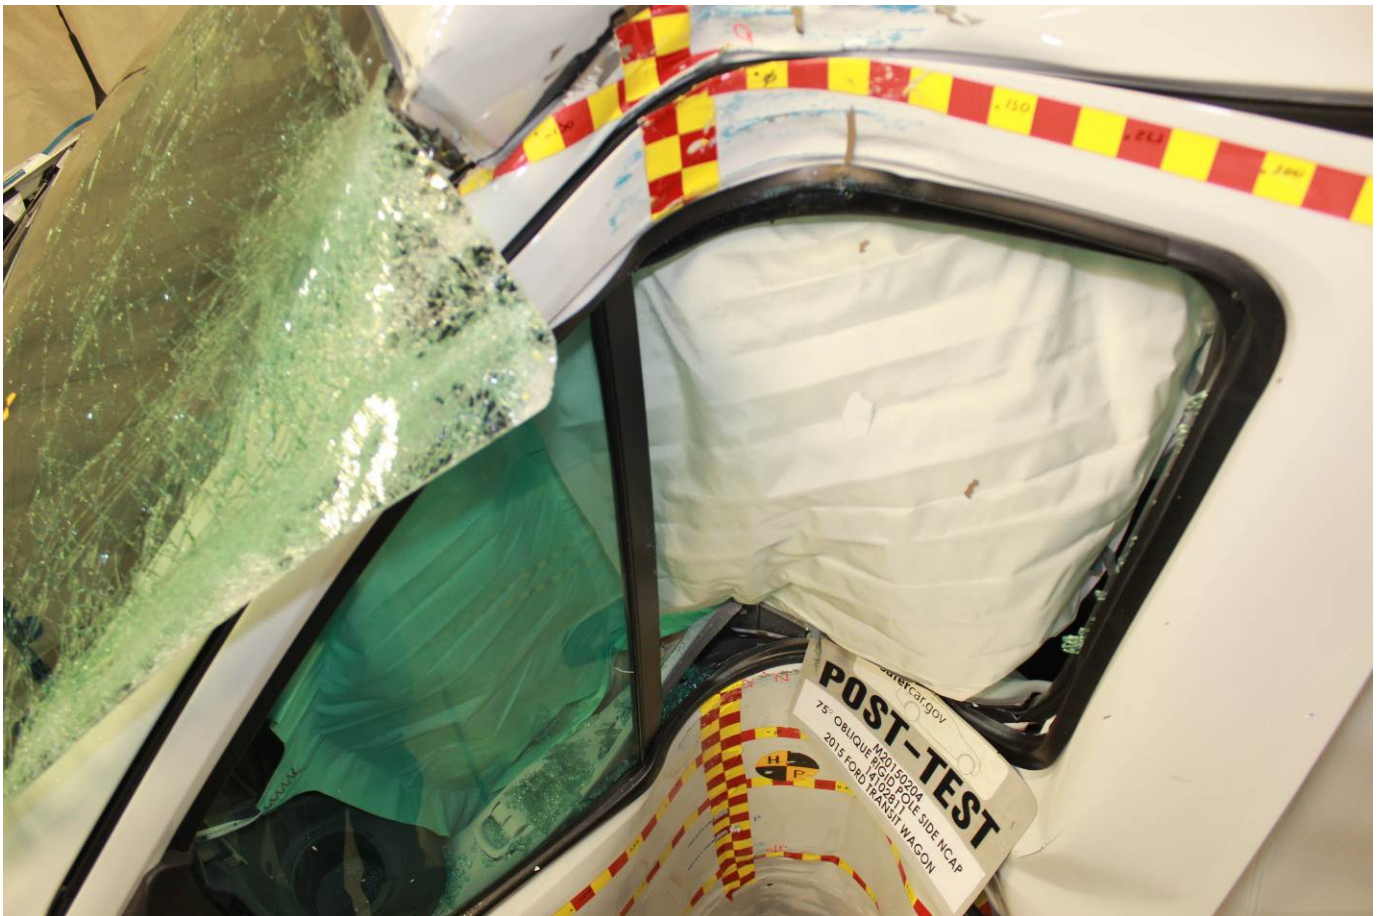
Post-Test Dummy and Door Clearance View

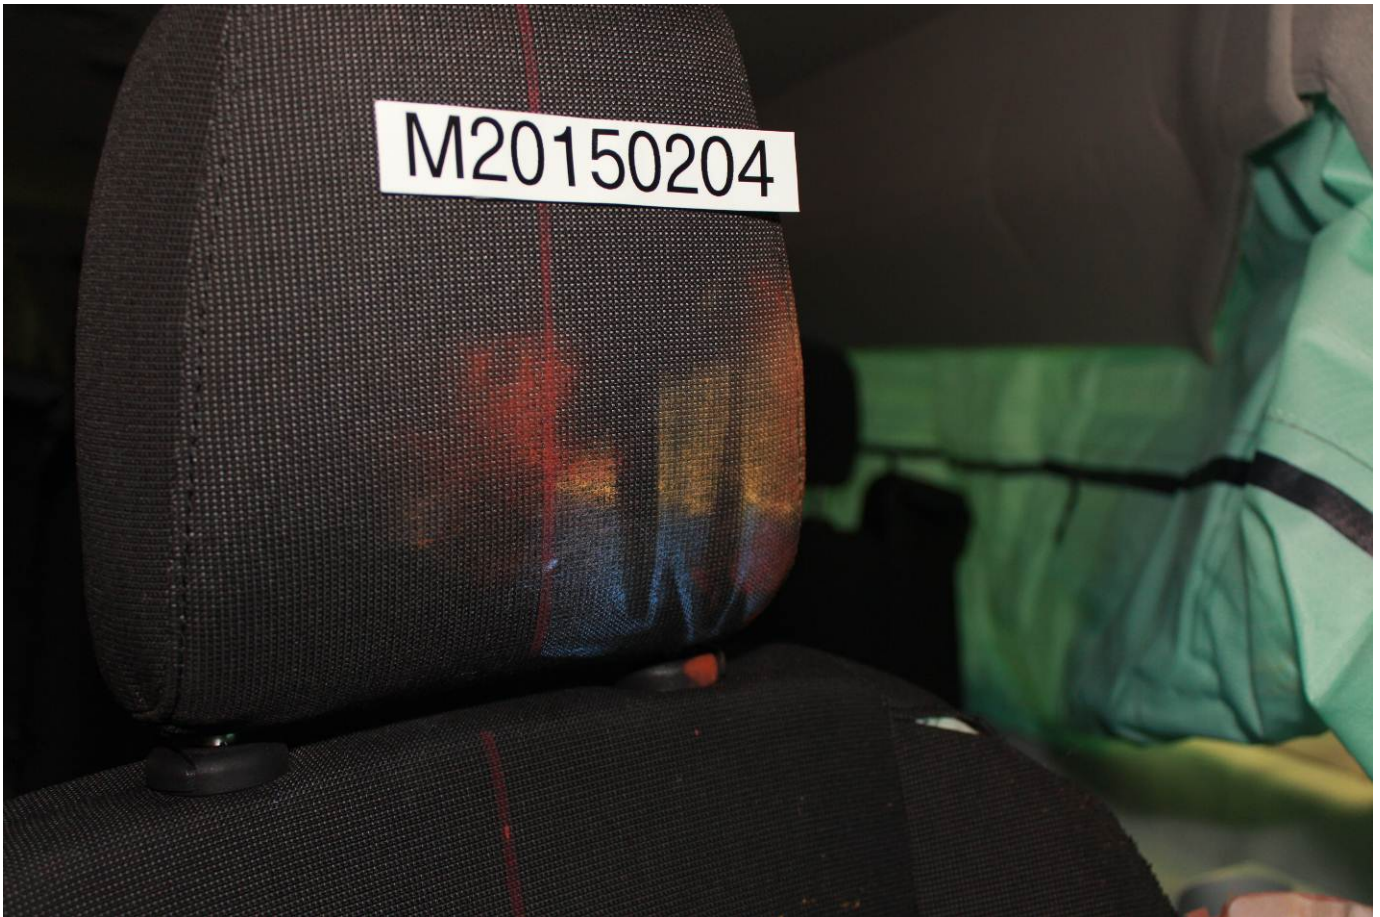
Post-Test Dummy Close-Up Head Contact with Vehicle Interior View

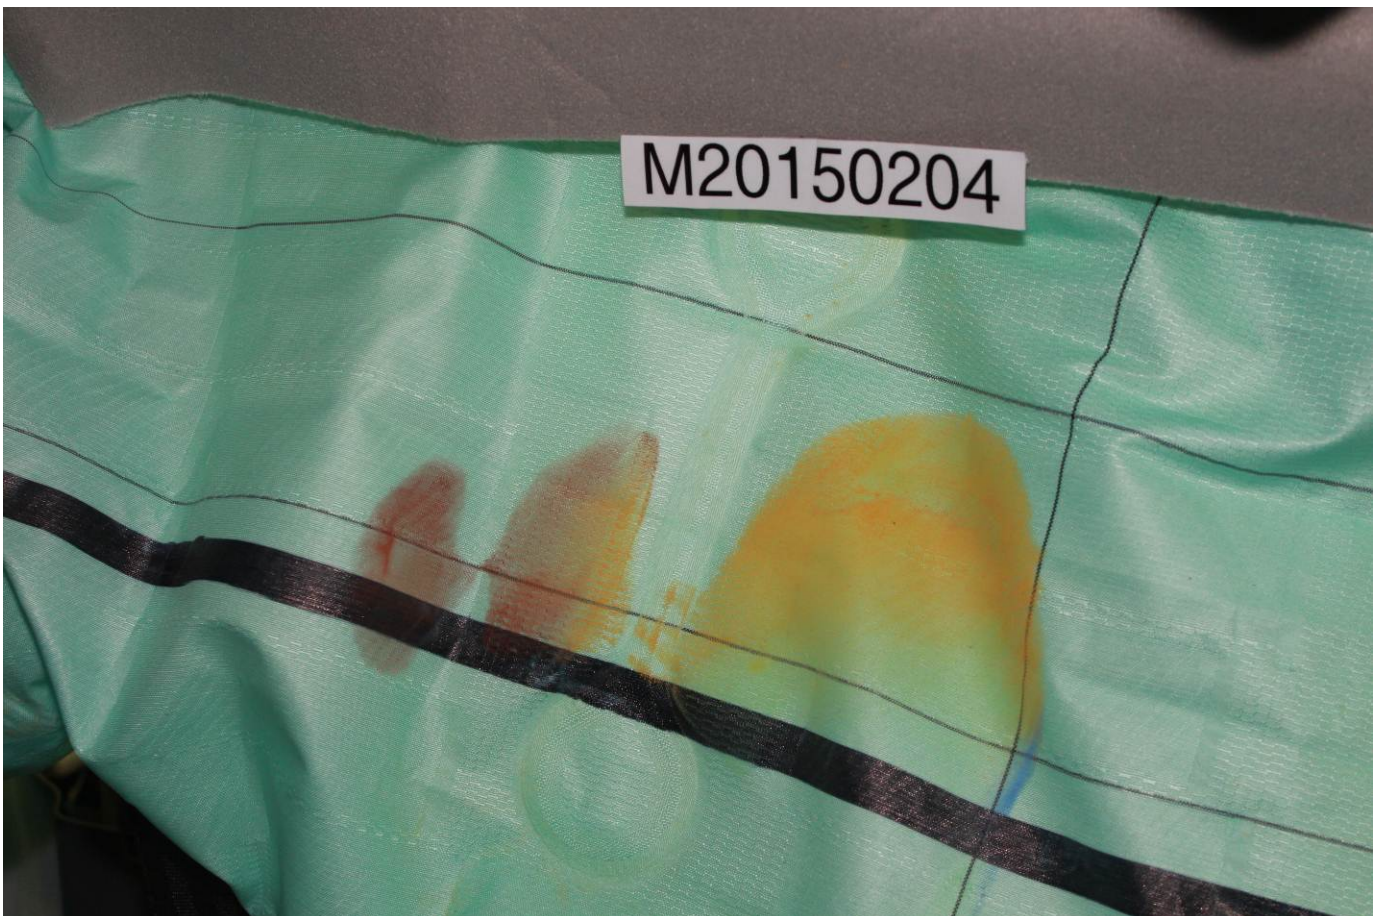
Post-Test Dummy Close-Up Head Contact with Side Air Bag View

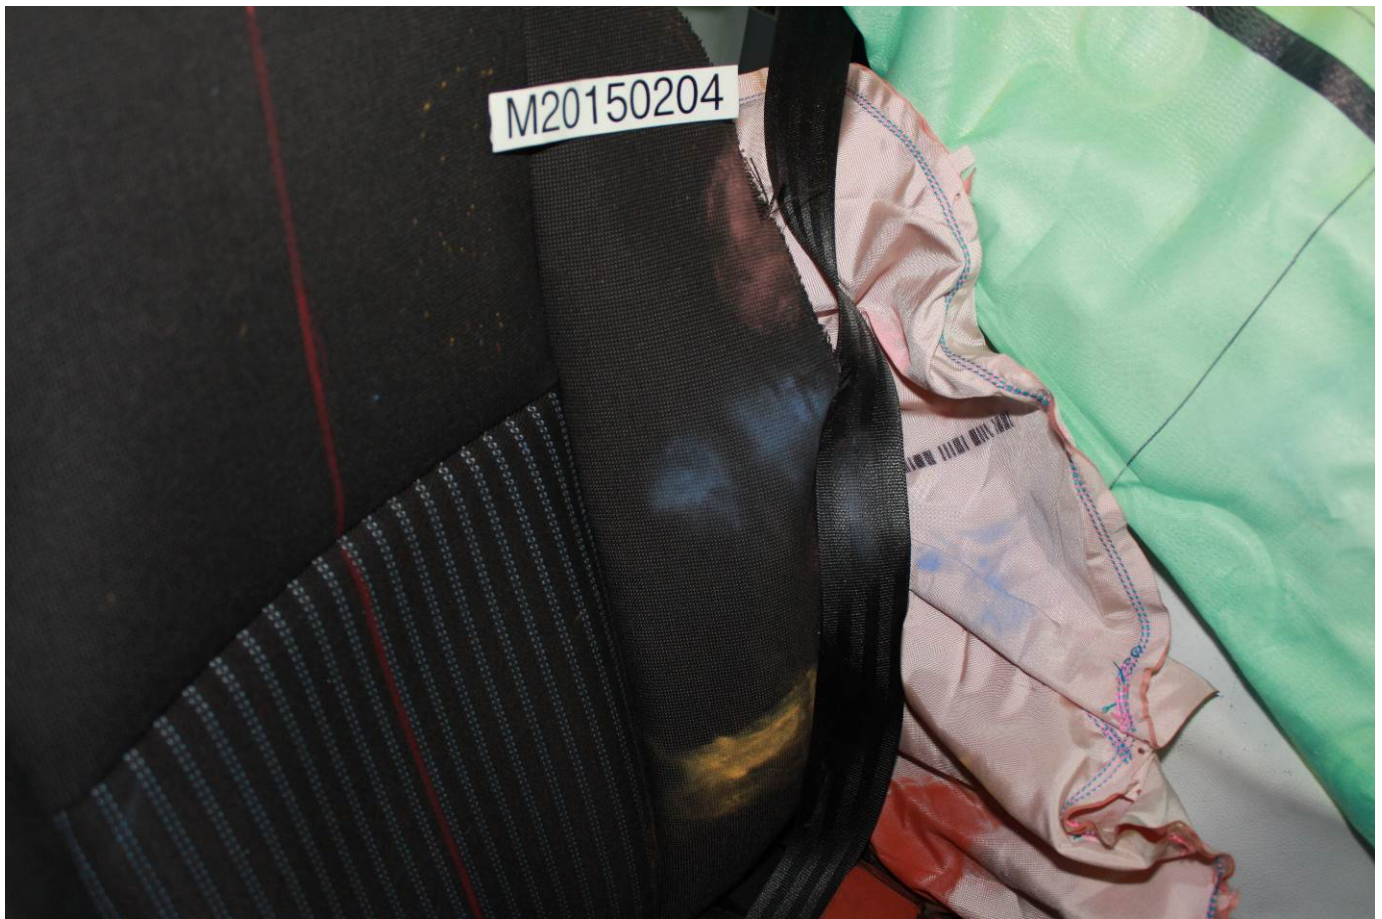
Post-Test Dummy Close-Up Torso Contact with Vehicle Interior View

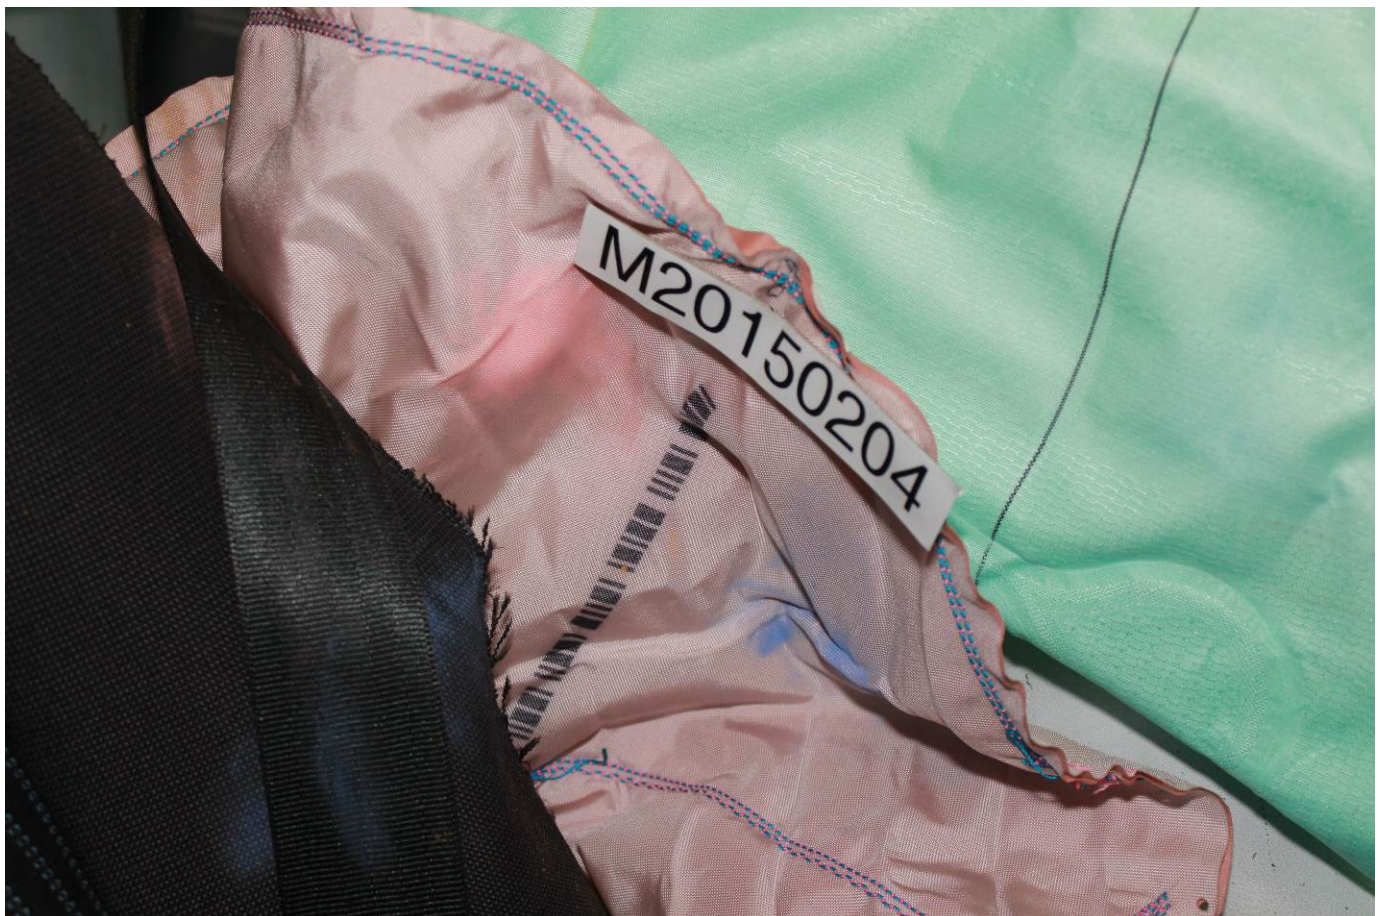
Post-Test Dummy Close-Up Torso Contact with Side Air Bag View

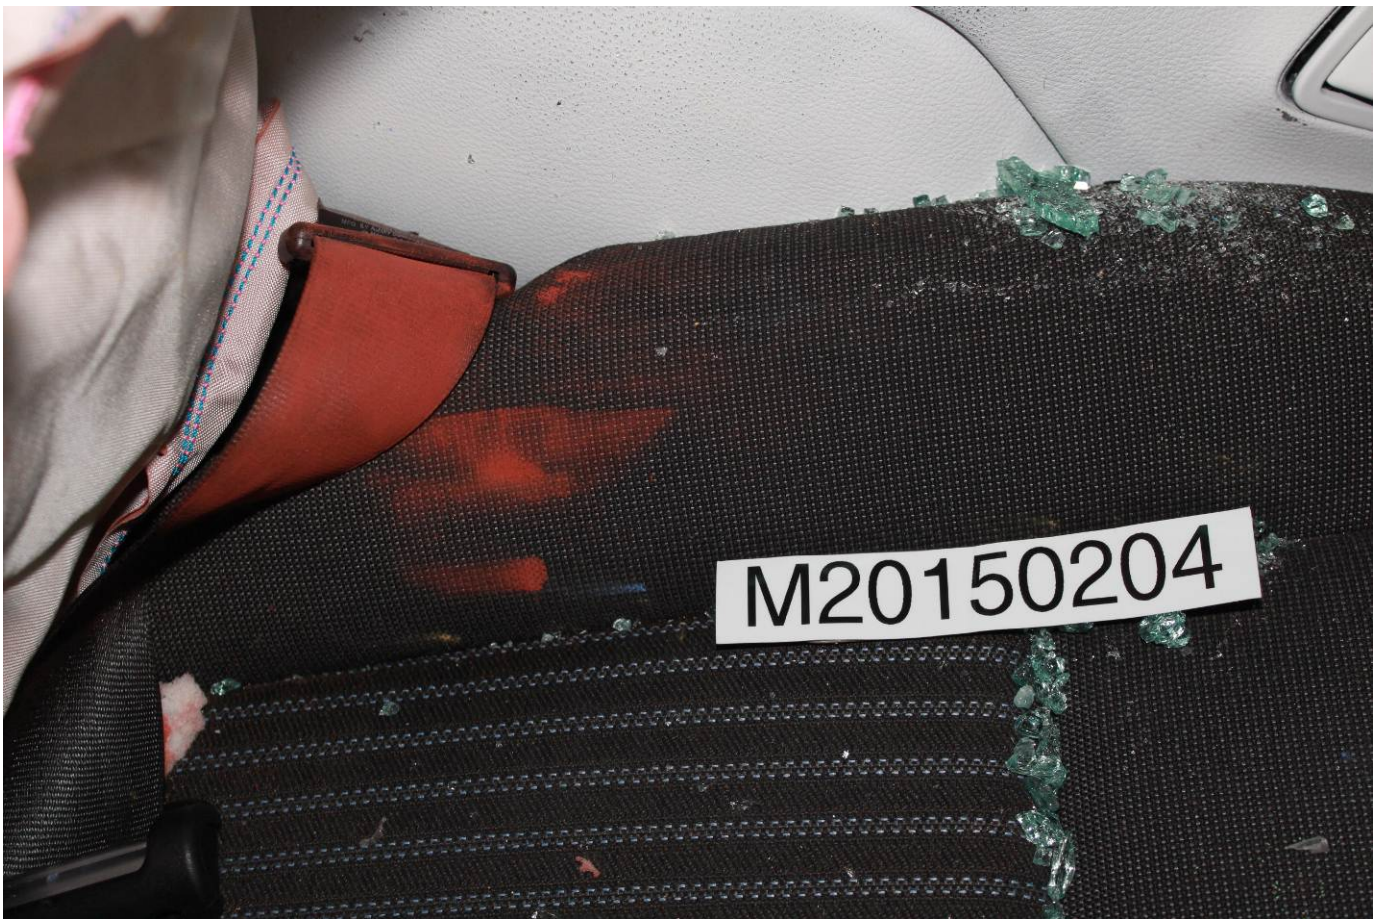
Post-Test Dummy Close-Up Pelvis Contact with Vehicle Interior View

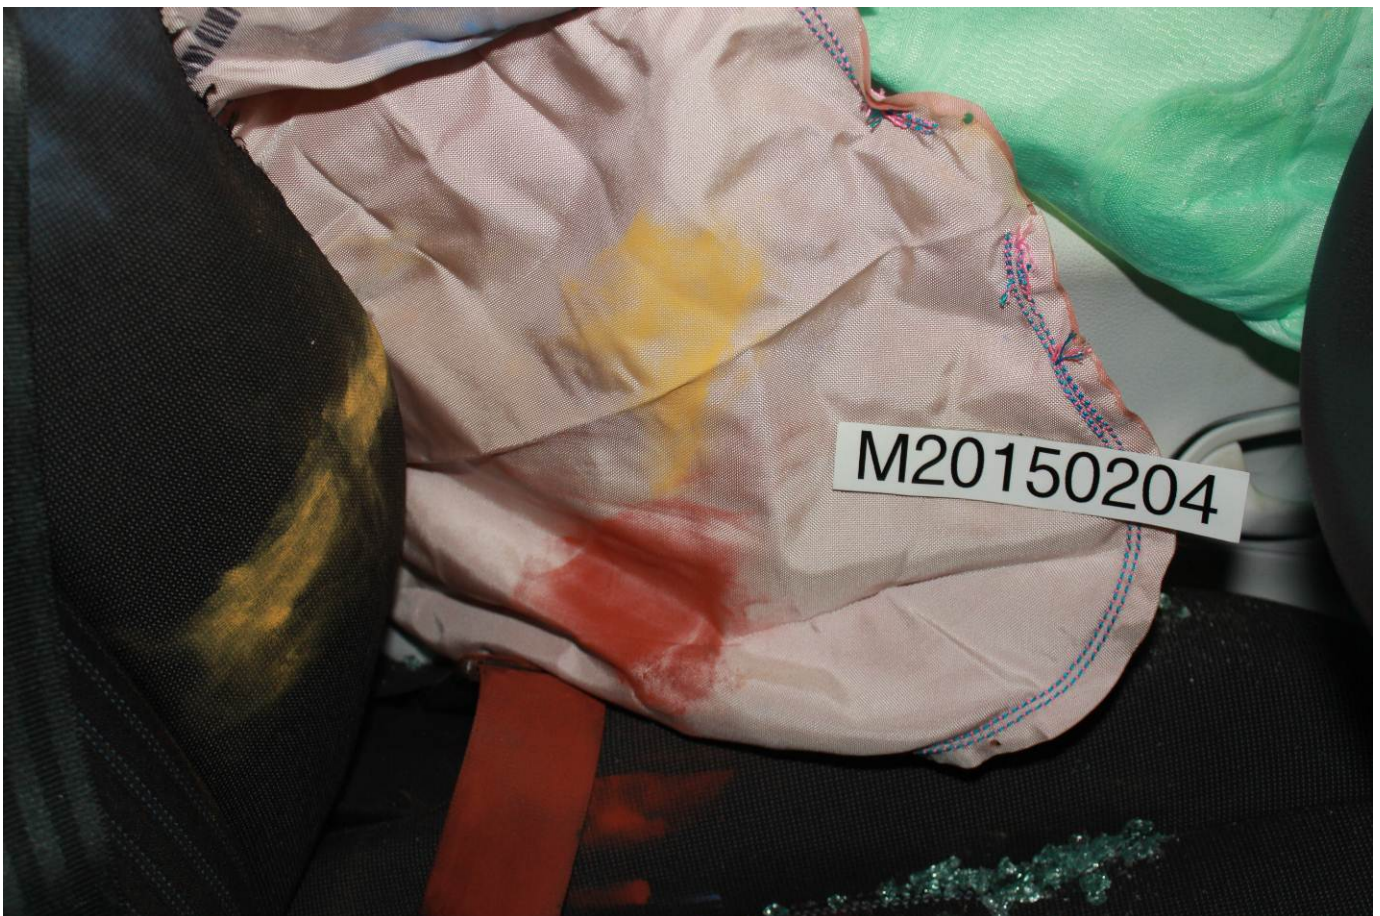
Post-Test Dummy Close-Up Pelvis Contact with Side Air Bag View

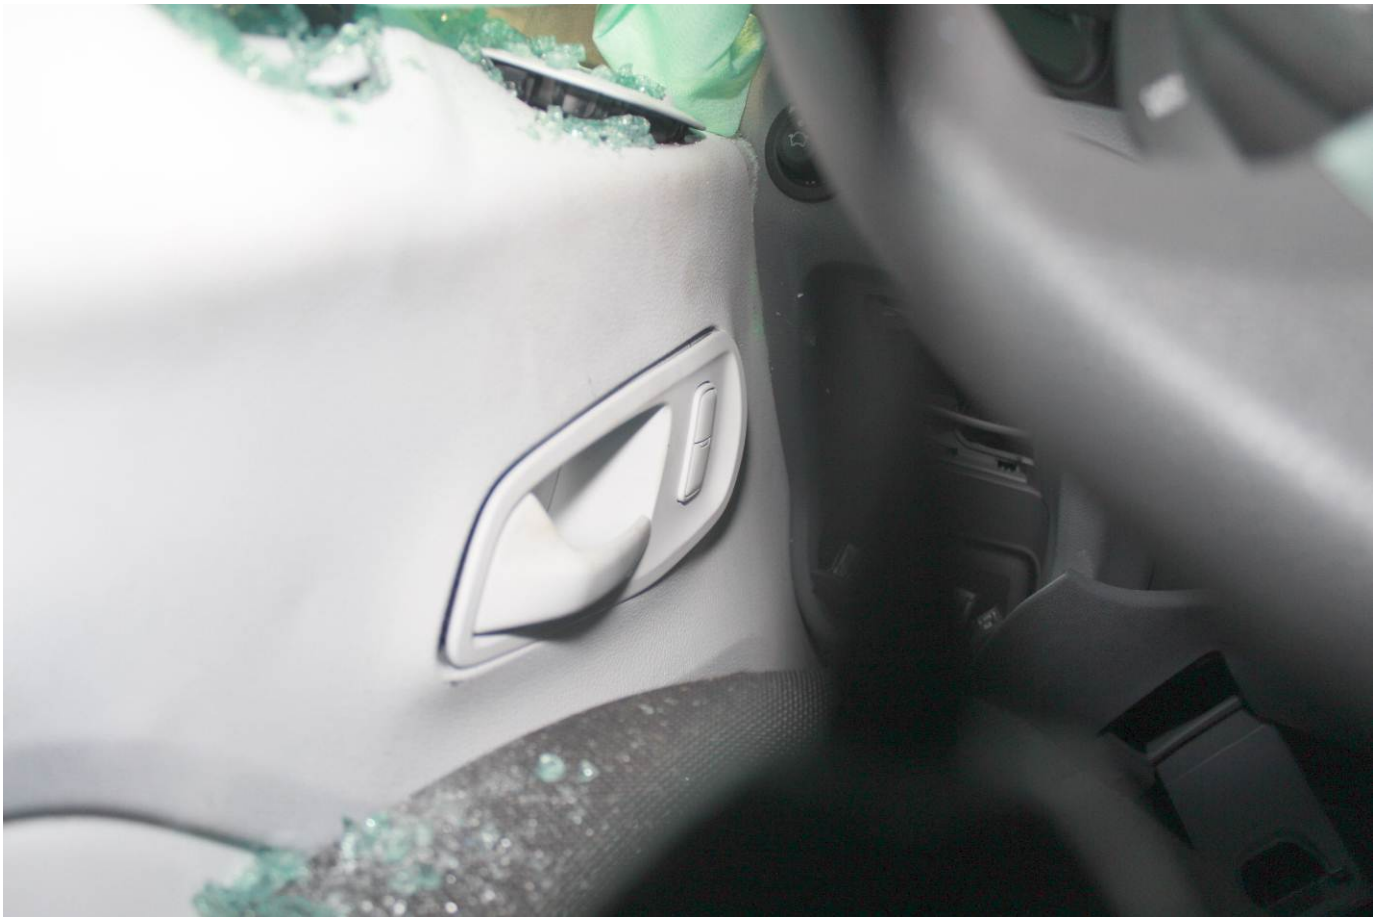
Post-Test Dummy Close-Up Knee Contact with Vehicle Interior View

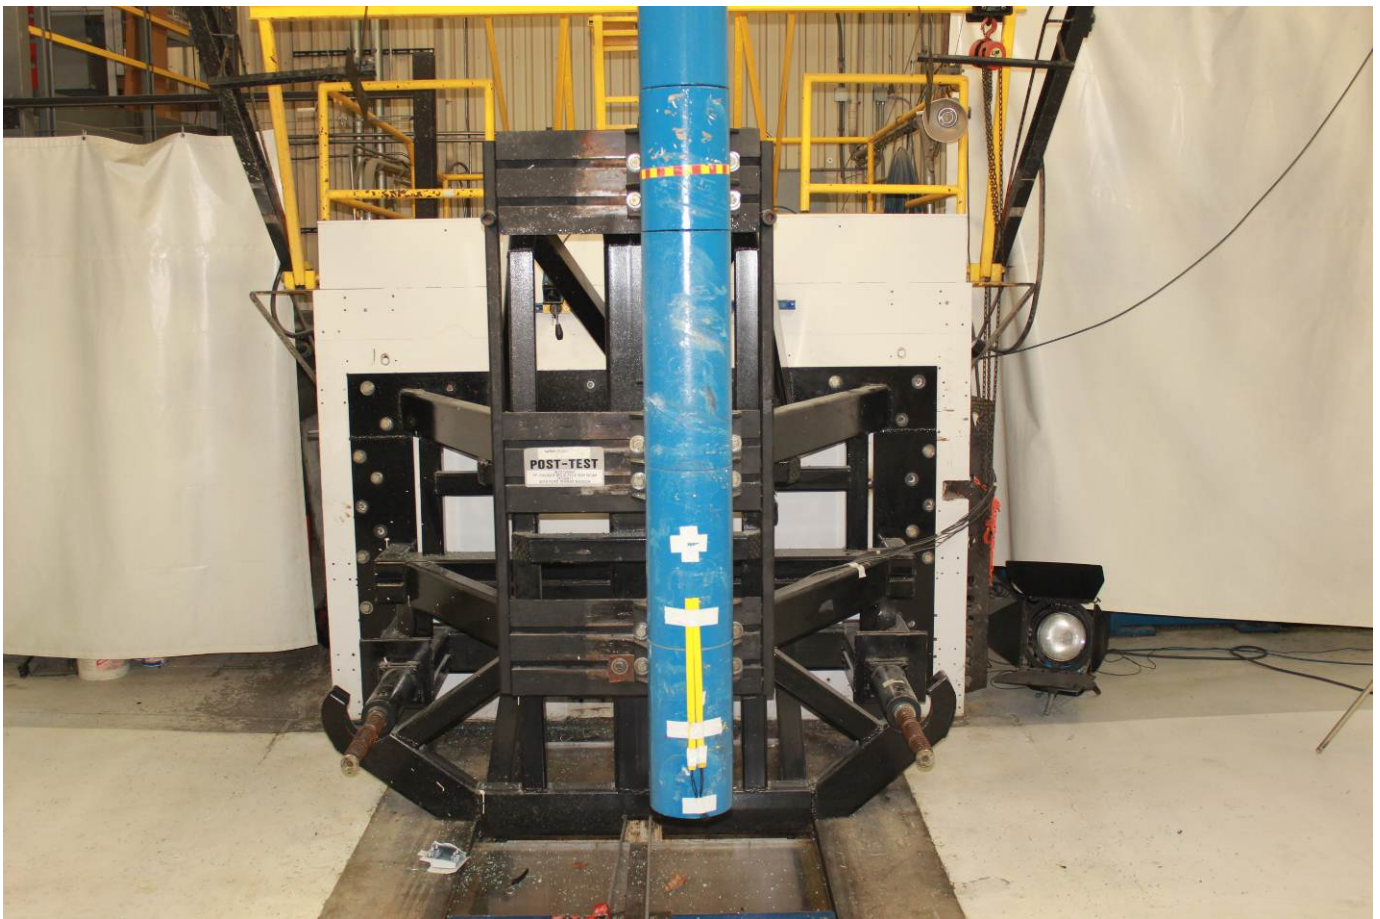
Post-Test Pole Barrier Front View

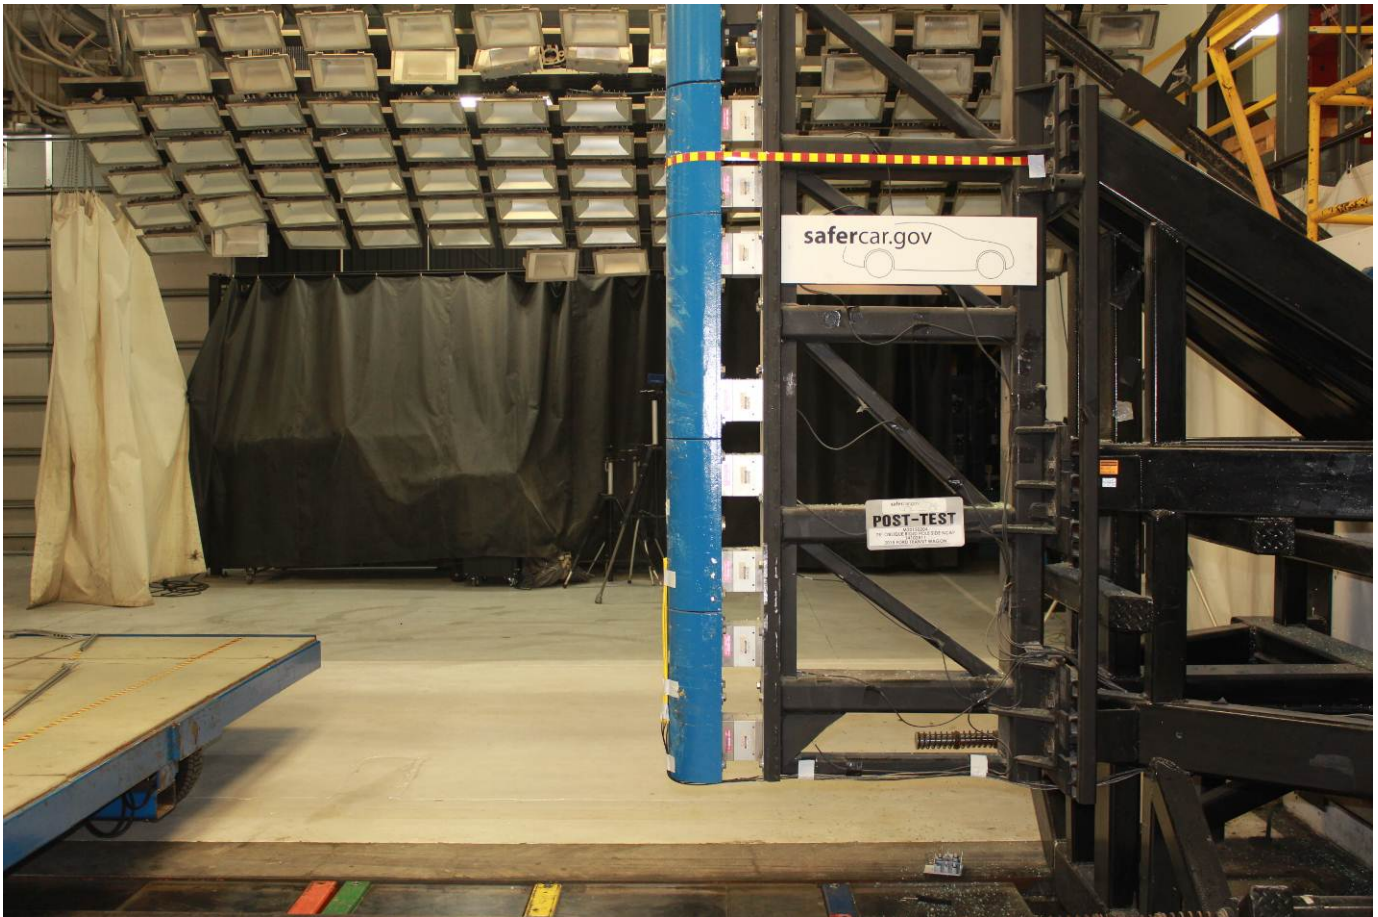
Post-Test Pole Barrier Side View
