**REPORT NUMBER: SPNCAP-KAR-15-011**

**NEW CAR ASSESSMENT PROGRAM (NCAP)  
SIDE IMPACT POLE TEST**

**TOYOTA MOTOR MANUFACTURING, TEXAS, INC.  
2015 TOYOTA TACOMA PRERUNNER DOUBLE CAB 4-DOOR TRUCK**

**PREPARED BY:  
KARCO ENGINEERING, LLC.  
9270 HOLLY ROAD  
ADELANTO, CA 92301**

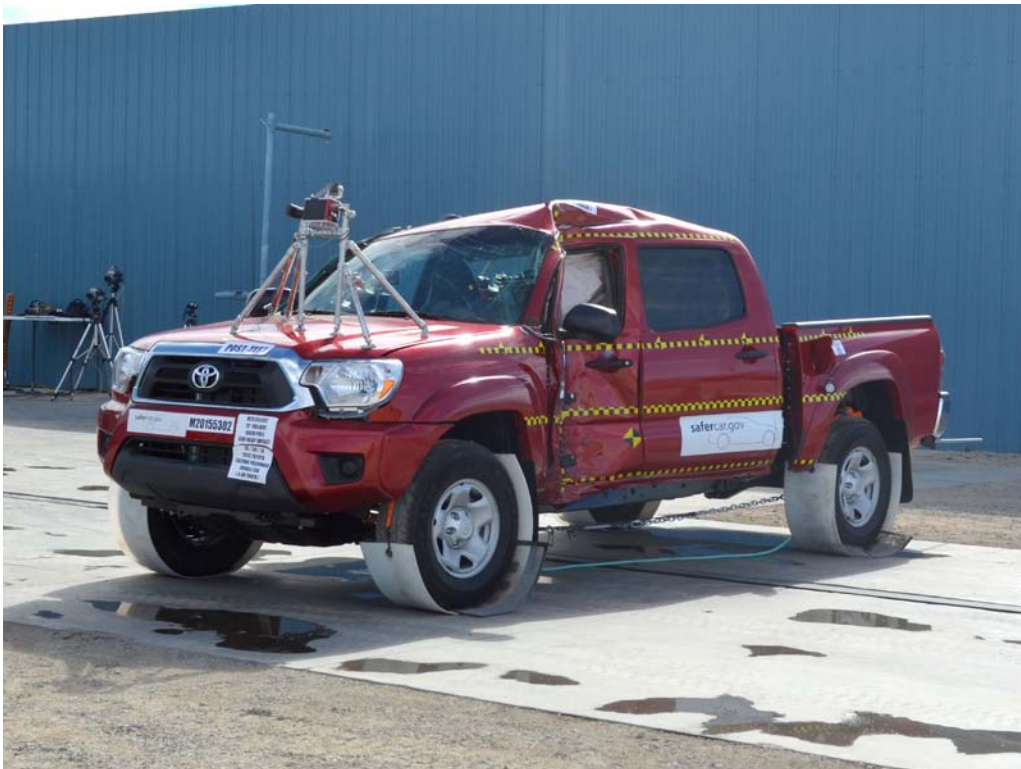
FIGURE 6. Post-Test Left Front  $\frac{3}{4}$  View of Test Vehicle

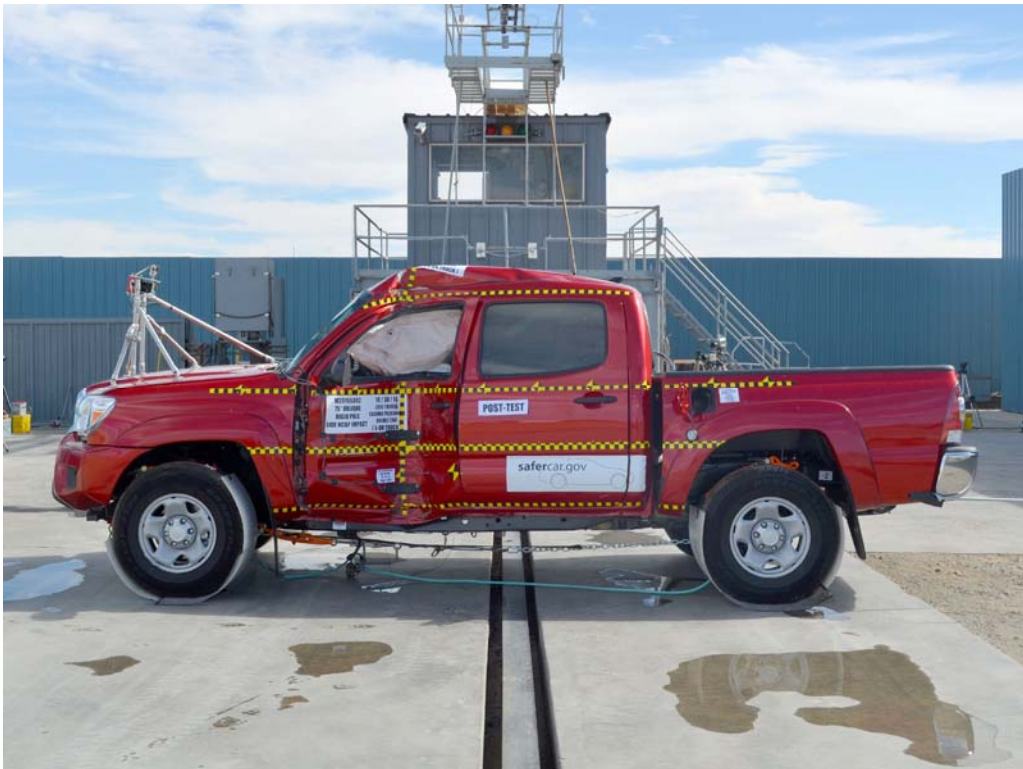
FIGURE 8. Post-Test Left Side View of Test Vehicle

The doors on the struck side of the vehicle remained closed and latched. There was no separation at the hinges or latches. The doors on the non-struck side remained closed and latched. There was no ATD injury value that exceeded its limit.

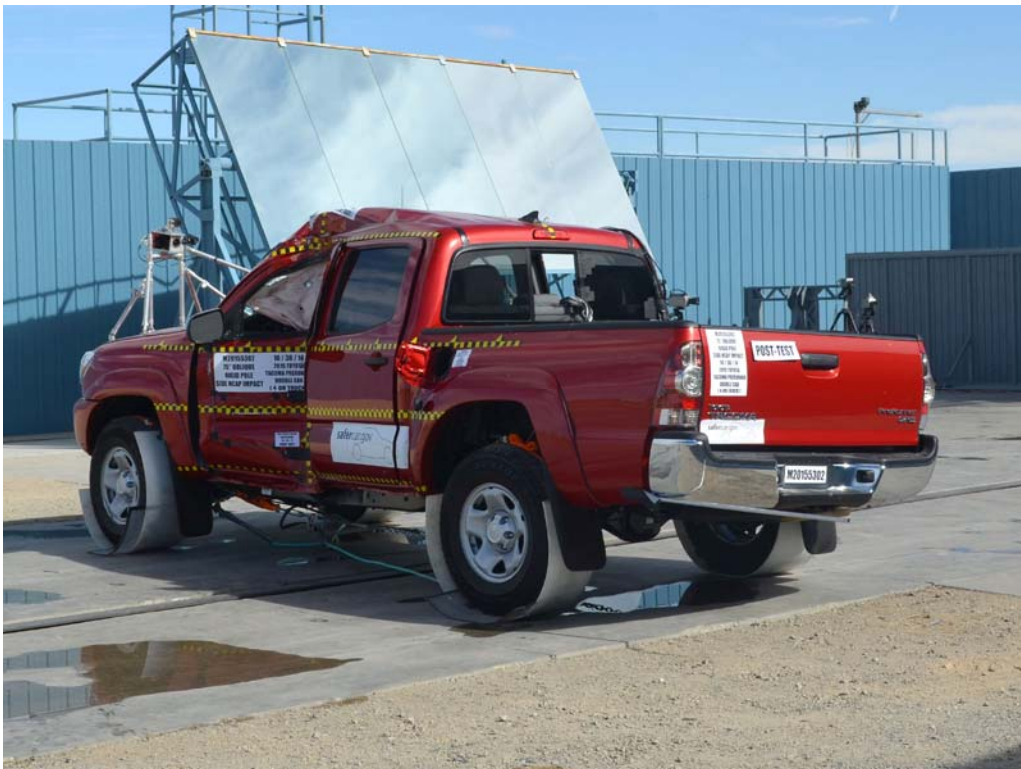
FIGURE 10. Post-Test Left Rear  $\frac{3}{4}$  View of Test Vehicle

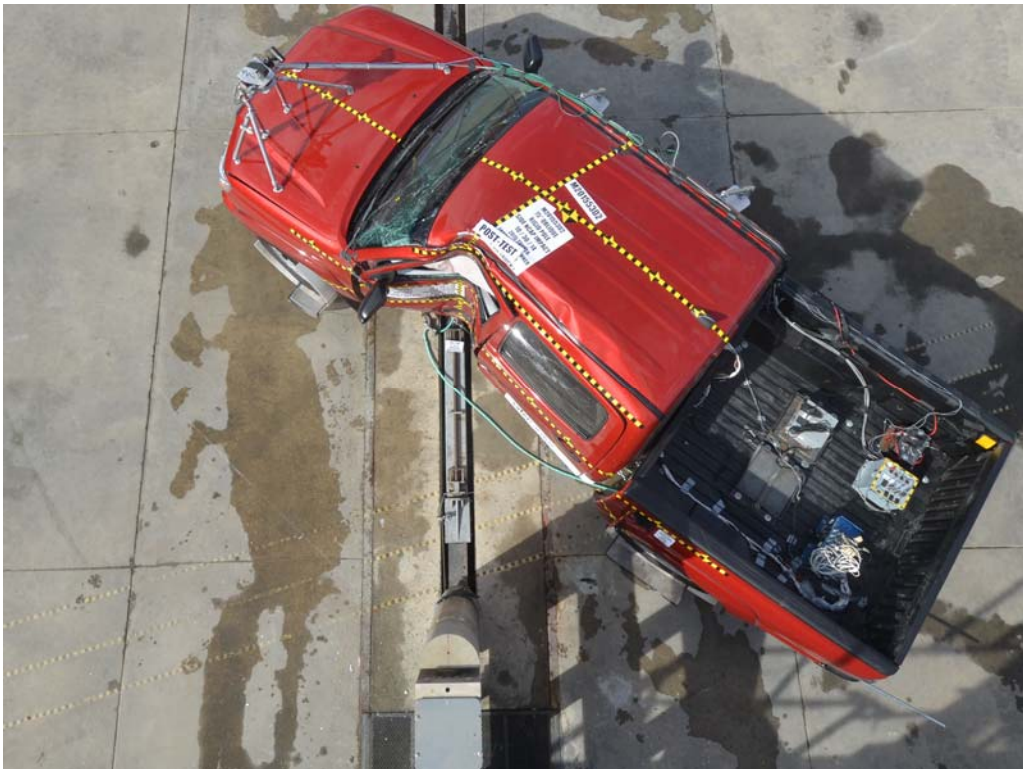
FIGURE 16. Post-Test Overhead View of Test Area

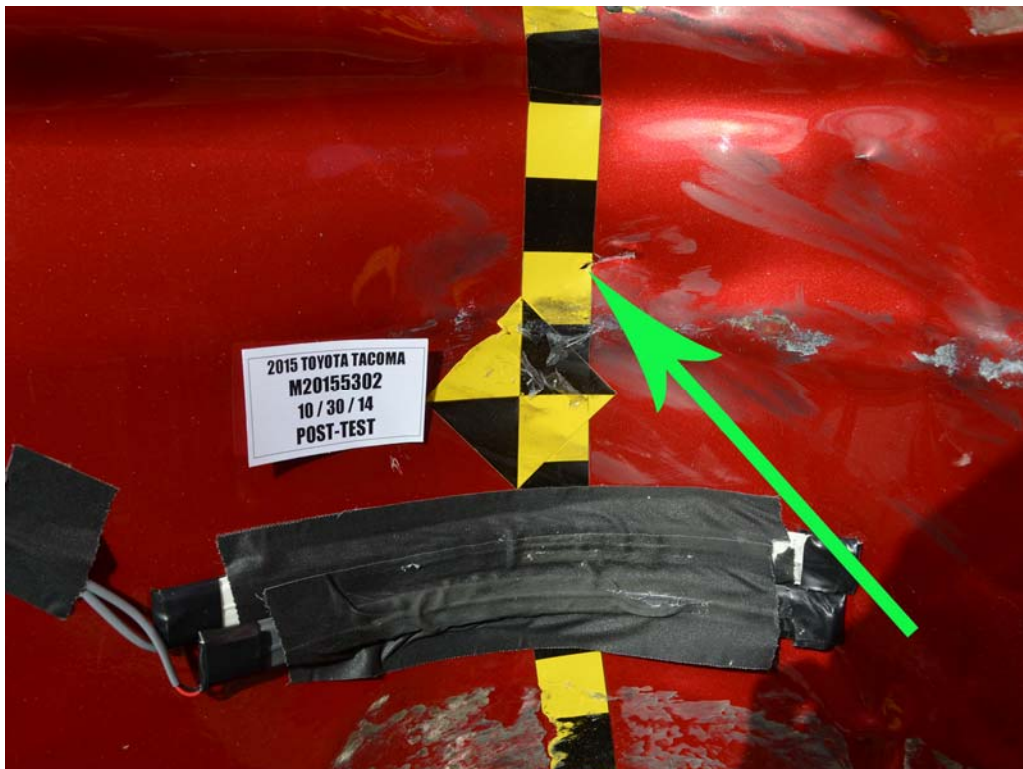
FIGURE 20. Post-Test Close-Up View of Impact Point Target  
Showing Impact Location

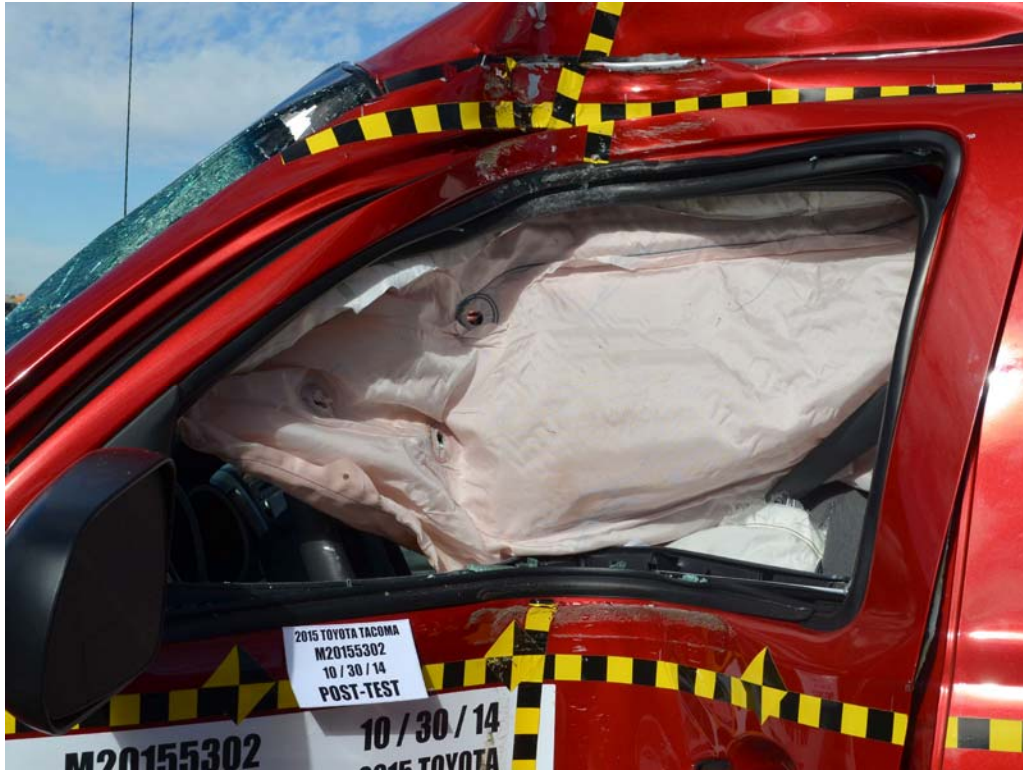
FIGURE 25. Post-Test Left Side View of Dummy Shoulder and Door Top View

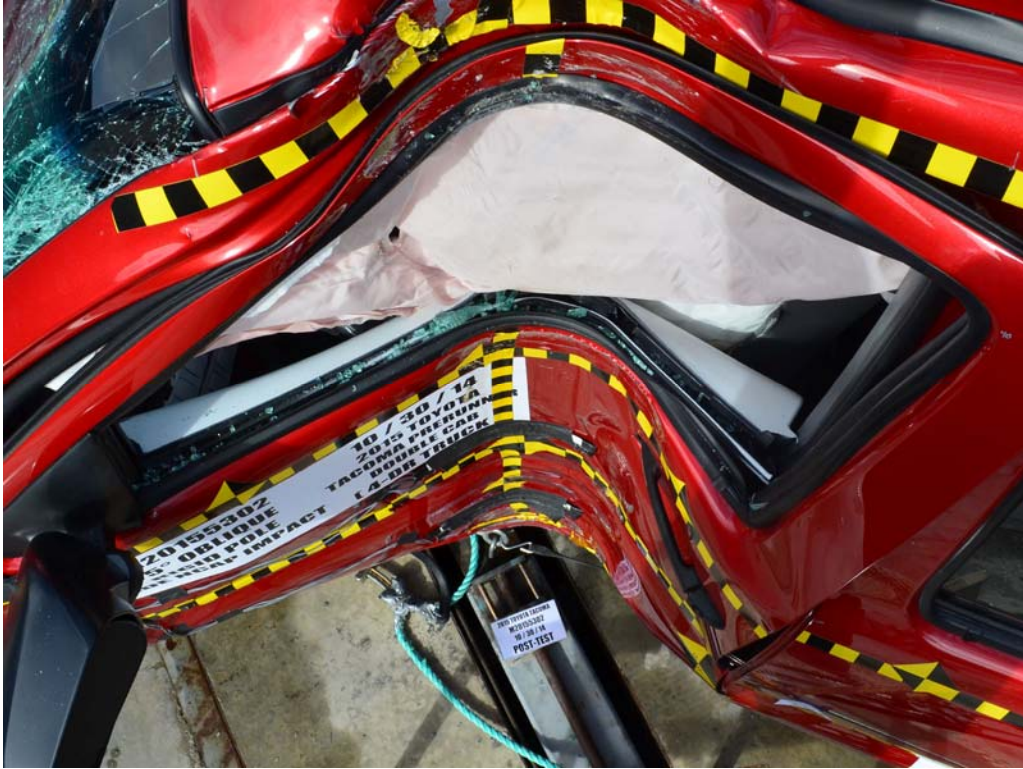
FIGURE 41. Post-Test Dummy and Door Clearance View

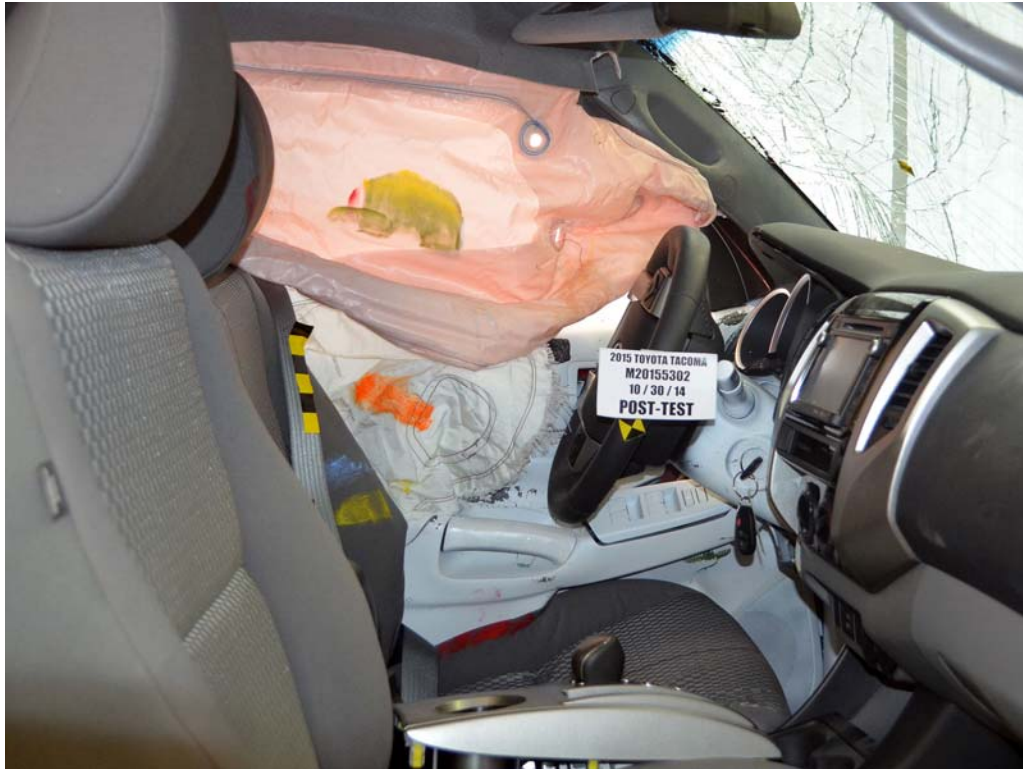
FIGURE 45. Post-Test Inner Door Panel View  
Showing Dummy Contact Locations

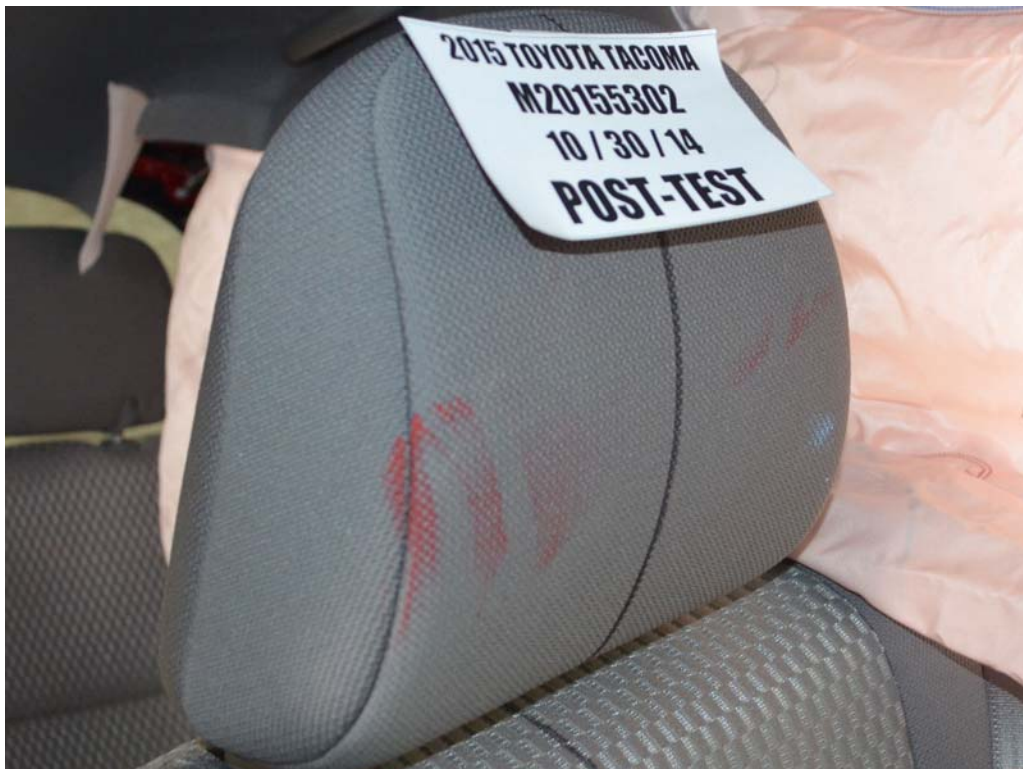
FIGURE 46. Post-Test Dummy Close-Up Head Contact with Vehicle Interior View

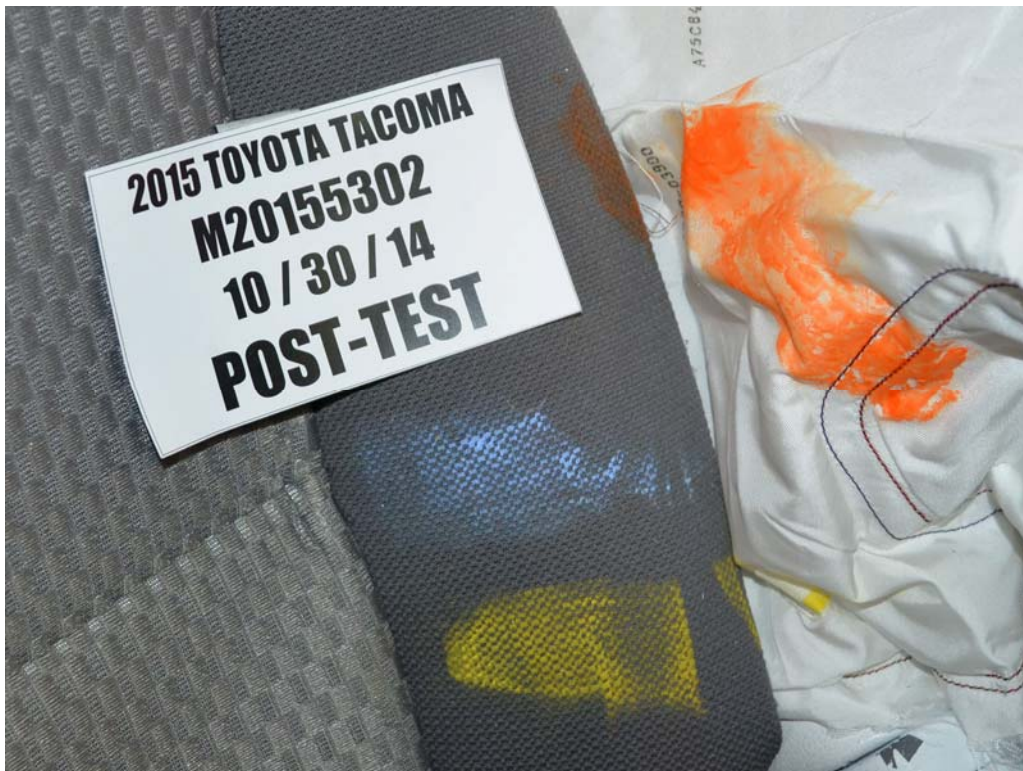
FIGURE 48. Post-Test Dummy Close-Up Torso Contact With Vehicle Interior View

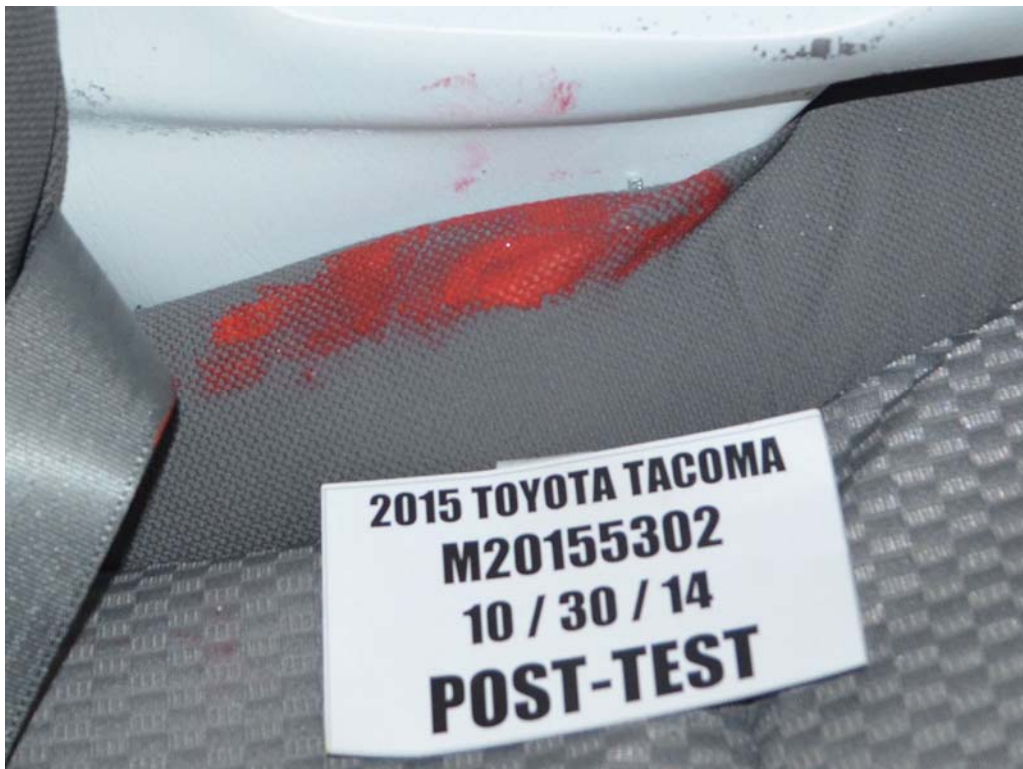
FIGURE 50. Post-Test Dummy Close-Up Pelvis Contact With Vehicle Interior View

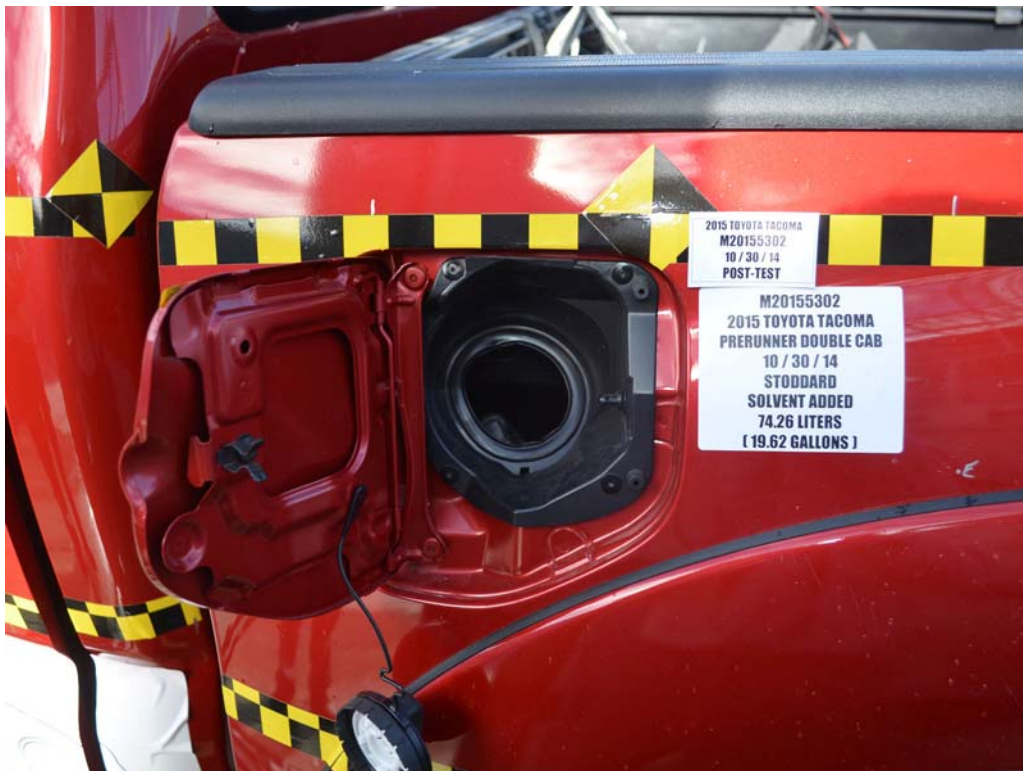
FIGURE 54. Post-Test View of Fuel Filler Cap or Fuel Filler Neck

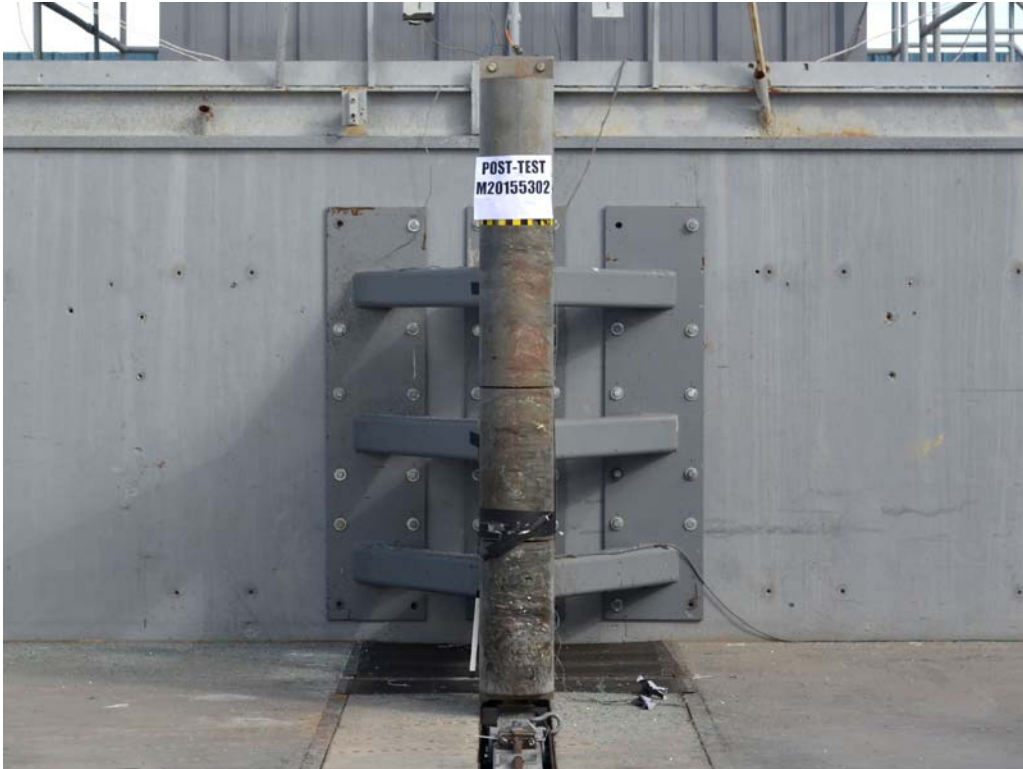
FIGURE 58. Post-Test Pole Barrier Front View

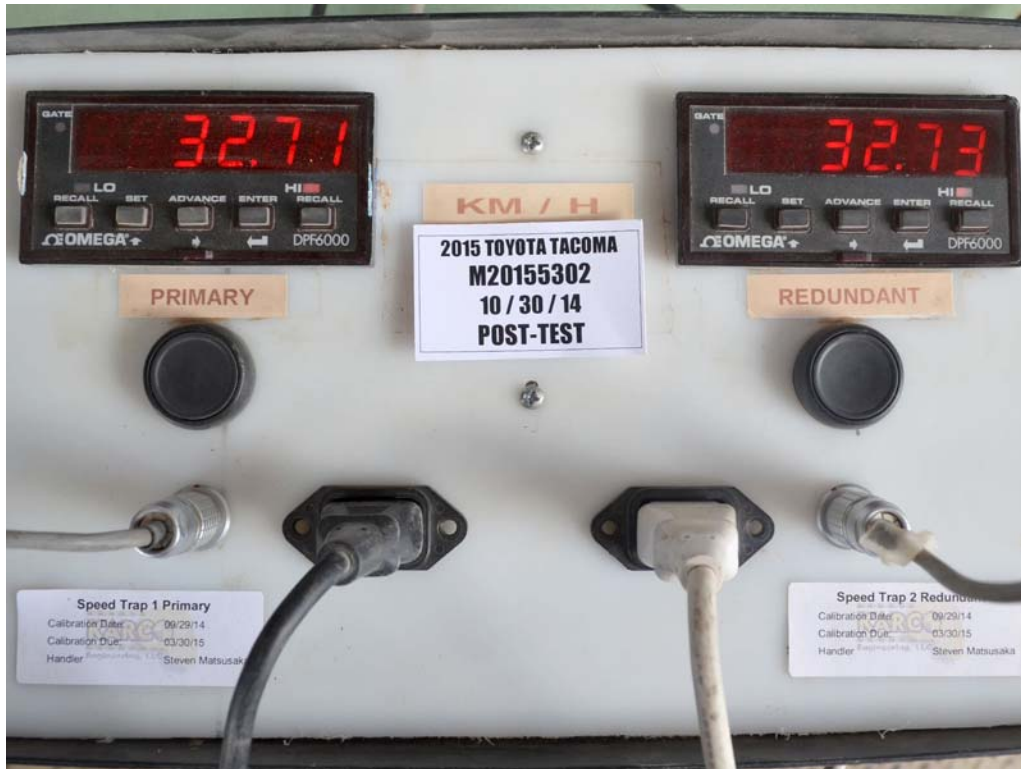
FIGURE 62. Post-Test Primary and Redundant Speed Trap Read-Out

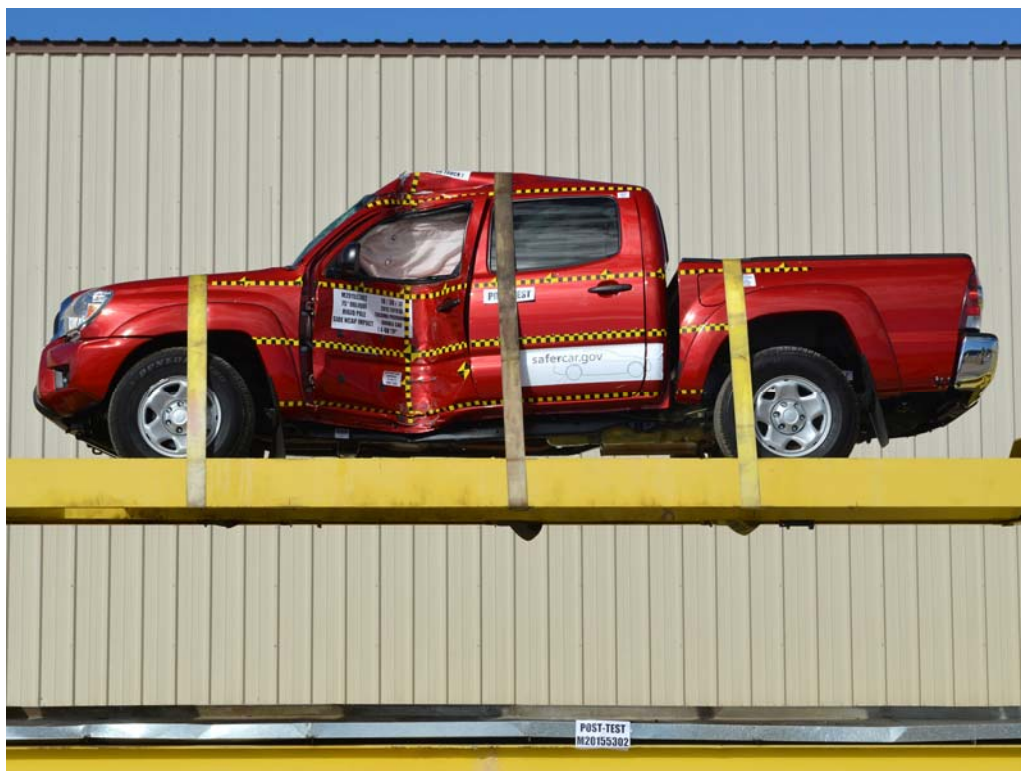
FIGURE 63. FMVSS No. 301 Static Rollover 0 Degrees

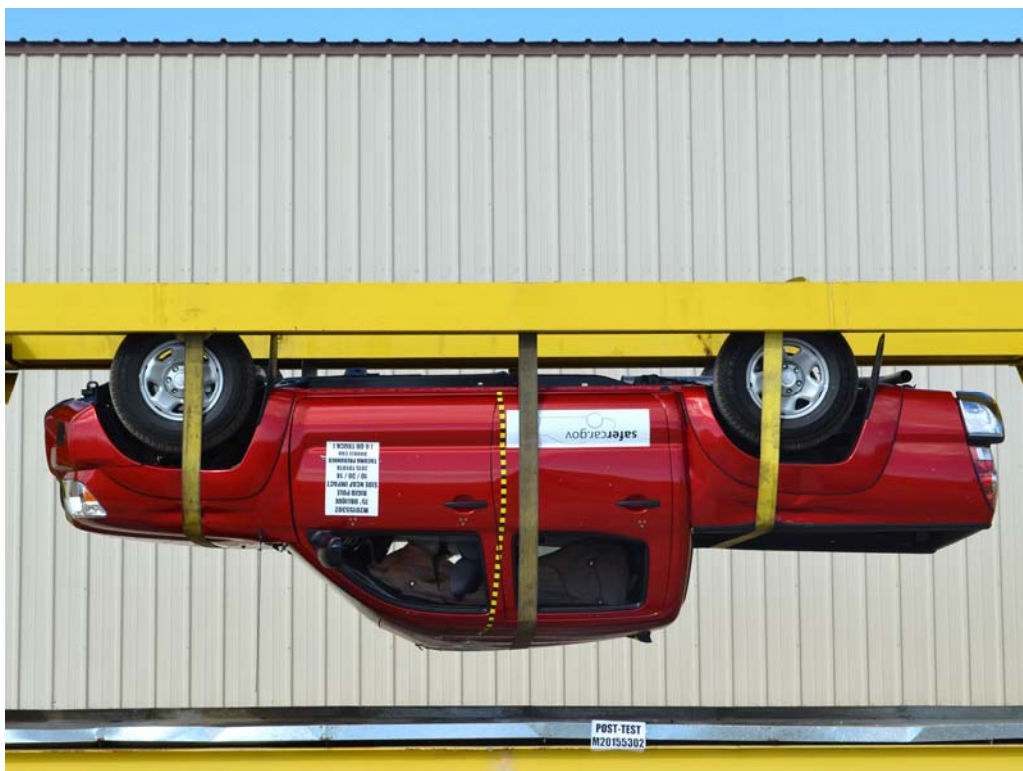
FIGURE 65. FMVSS No. 301 Static Rollover 180 Degrees

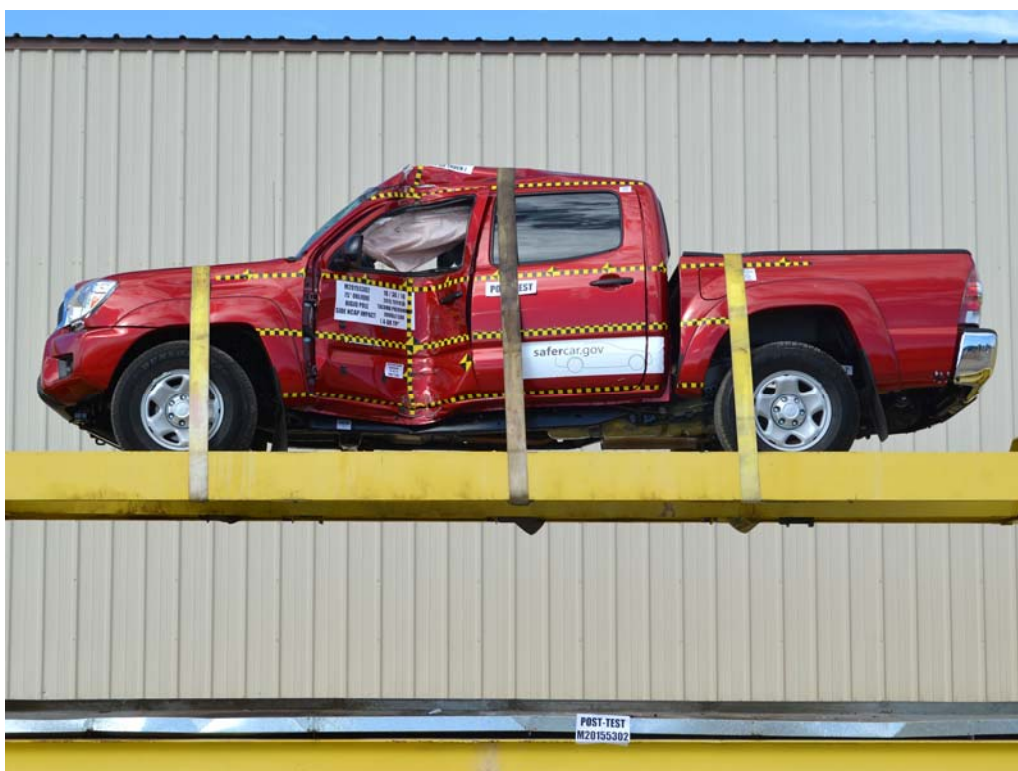
FIGURE 67. FMVSS No. 301 Static Rollover 360 Degrees
