**REPORT NUMBER: R&D-CAL-14-011**

**MOVING BARRIER TO VEHICLE CRASH TEST IN SUPPORT OF NHTSA'S  
FRONTAL OBLIQUE OFFSET PROGRAM  
RESEARCH MOVING DEFORMABLE BARRIER INTO RIGHT FRONT OF A**

**2014 MAZDA CX-5**

**90.1KPH, 15 DEGREE ANGLE, 35% OVERLAP**

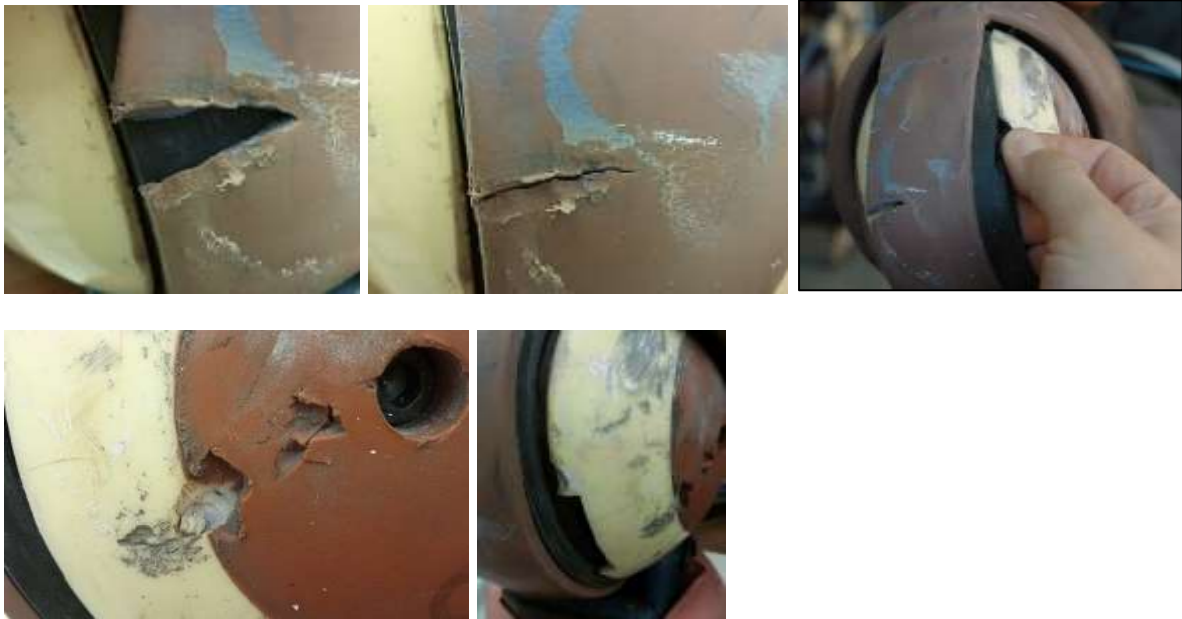
| FEMUR | |
|---|---|
| Y / N | No cuts, tears, or scuffing of knee flesh<br>Both knees are in pretty rough shape: The right knee has a cut that starts at the outside and goes half way through the knee flesh. The inside of the right knee is chipped and pitted, and the insert is also cut all the way through |

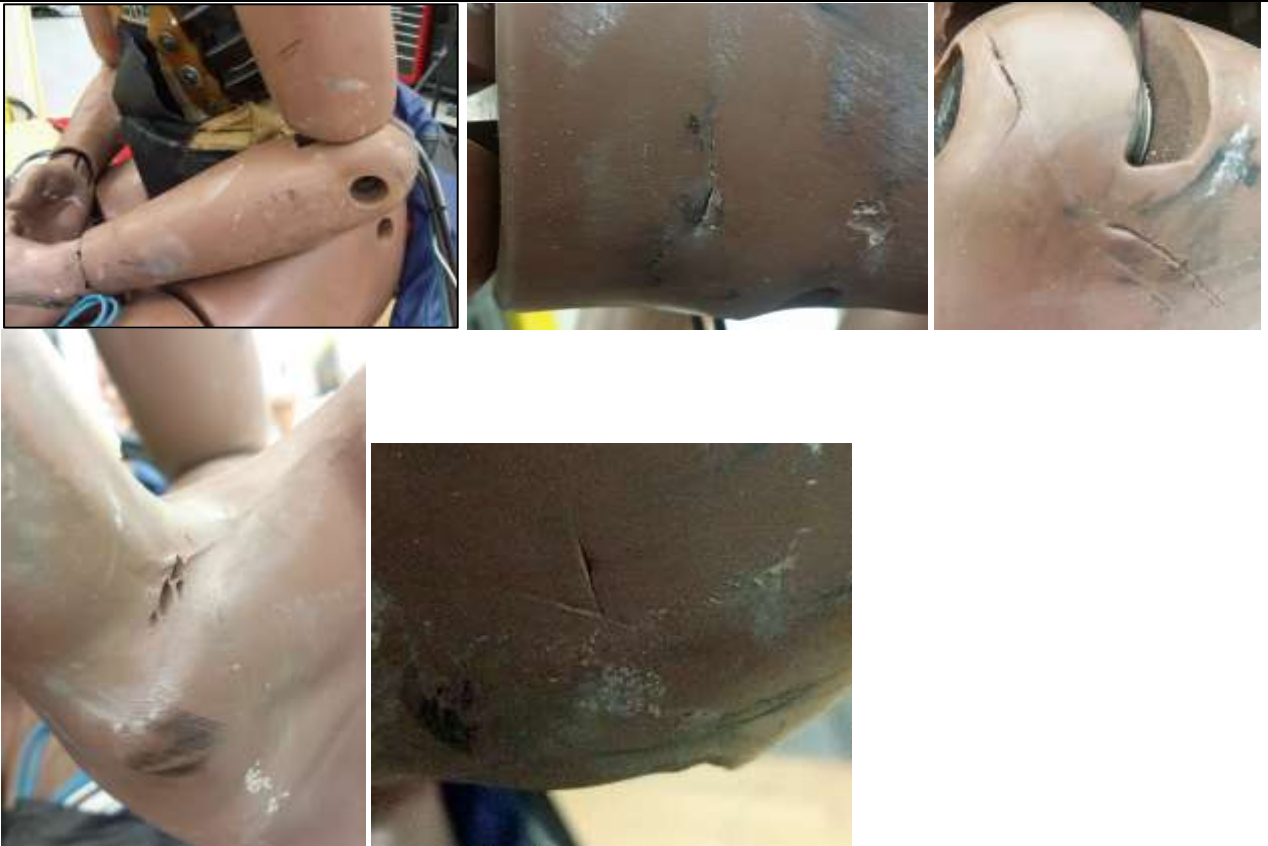
| SHOULDER | |
|---|---|
| OTHER | <p>The left arm and hand has heavy scuffing, cuts on the outside of the wrist, cuts to the outside of the hand near the wrist, a cut where the thumb meets the hand, and a small cut at the elbow.</p> |

The right arm and hand has heavy scuffing, a tear where the thumb meets the hand, and small cuts on the inside of the hand near the thumb.

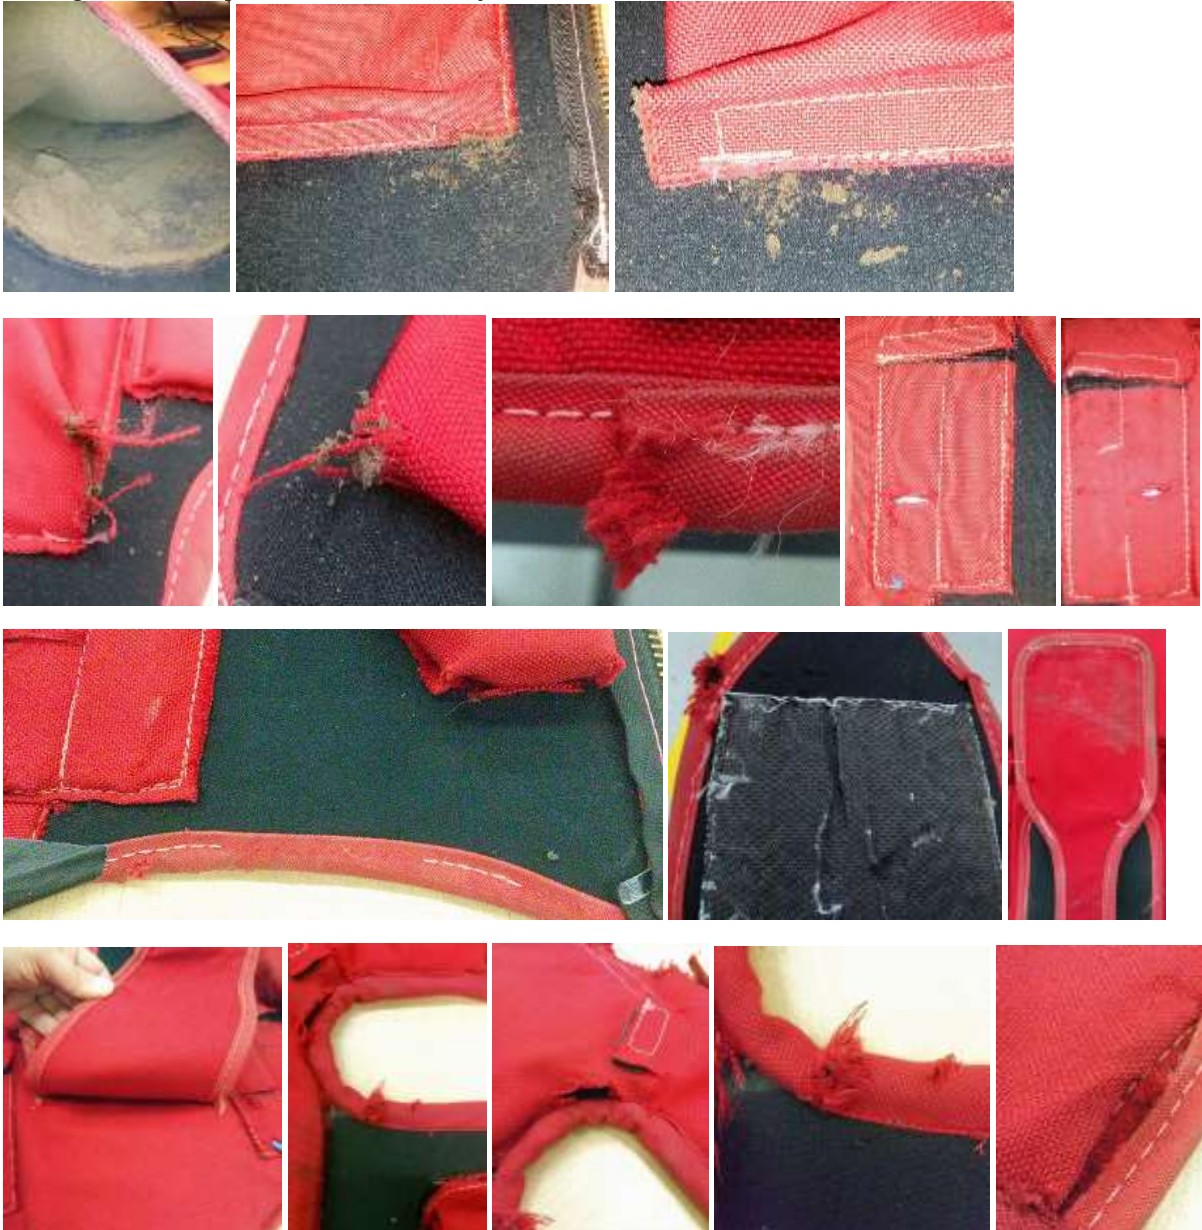
| JACKET | |
|---|---|
| Y / N | <p>No evidence of tears or holes in jacket fabric, Velcro, or zippers<br/>The chest jacket is beginning to fall apart. There are many holes, fraying seams, and the back padding is disintegrating causing it to bunch up and the bottom of the jacket, and fall out.</p> |
