**REPORT NUMBER: R&D-CAL-14-012**

**MOVING BARRIER TO VEHICLE CRASH TEST IN SUPPORT OF NHTSA'S  
FRONTAL OBLIQUE OFFSET PROGRAM  
RESEARCH MOVING DEFORMABLE BARRIER INTO RIGHT FRONT OF A**

**2014 MAZDA 3**

**90.1KPH, 15 DEGREE ANGLE, 35% OVERLAP**

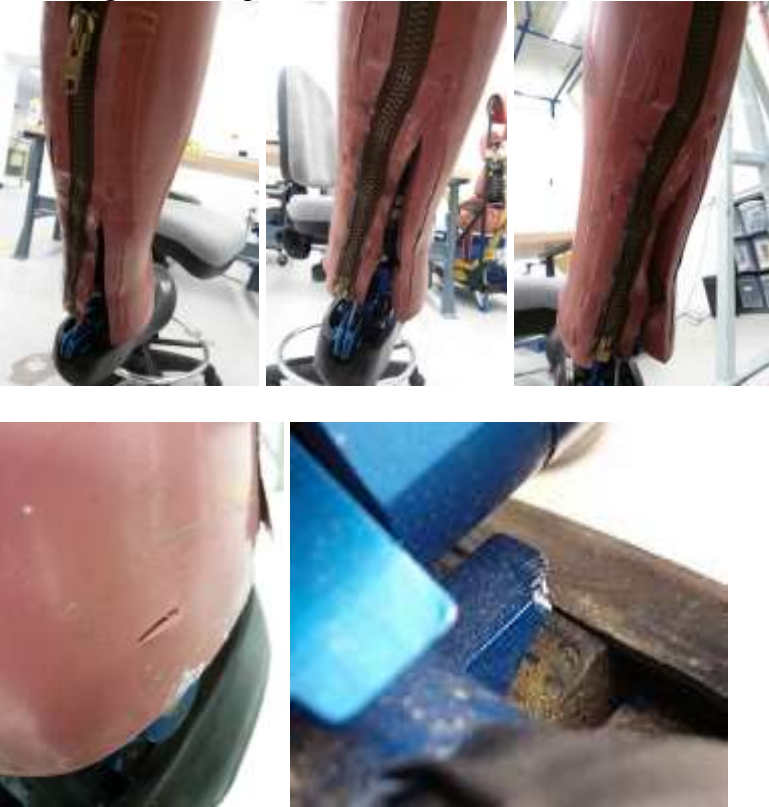
| LOWER EXTREMITY (LX) | |
|---|---|
| Y / N | <p>No cuts, tears, or scuffing of leg flesh<br/> The legs are badly damaged. The right leg flesh is torn badly at the zipper. It is currently being held on with graffer's tape. There is also a cut in the flesh on the inside of the right leg.</p> <p>The left leg flesh is damaged as well. It looks as if the leg flesh has begun to melt due to the friction</p> |

| | <p>against it during testing.</p> |

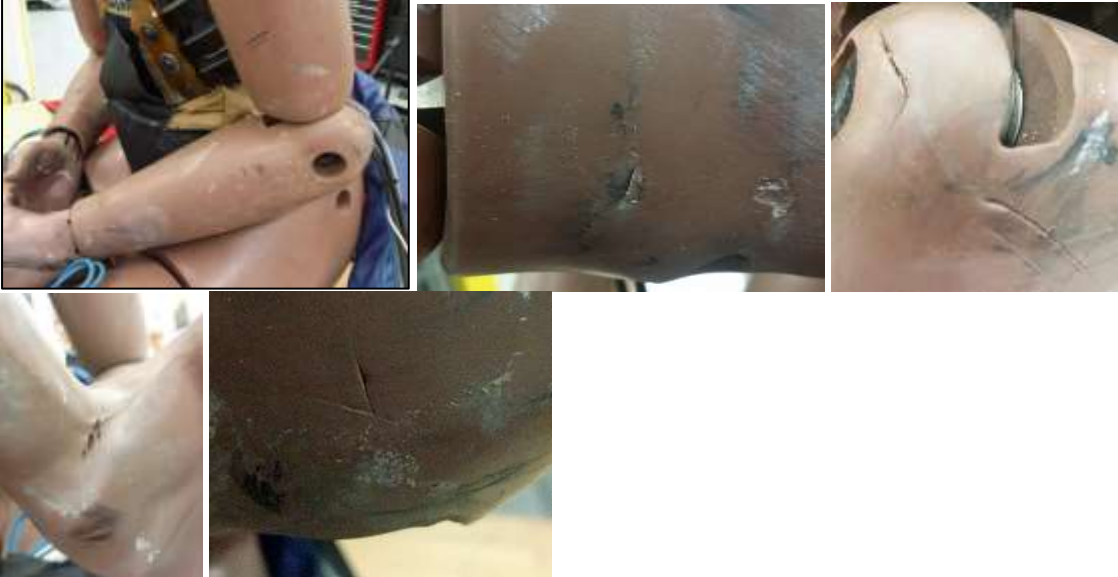
| OTHER | <p>The left arm and hand has heavy scuffing, cuts on the outside of the wrist, cuts to the outside of the hand near the wrist, a cut where the thumb meets the hand, and a small cut at the elbow.</p> |
| | <p>The right arm and hand has heavy scuffing, a tear where the thumb meets the hand, and small cuts on the inside of the hand near the thumb.</p> |

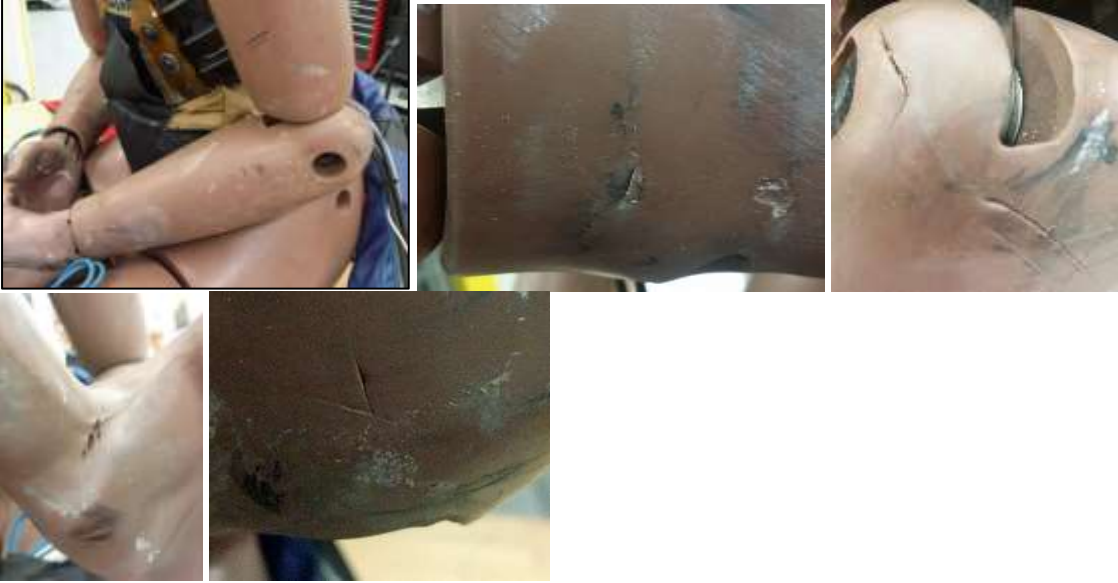
| OTHER | <p>The left arm and hand has heavy scuffing, cuts on the outside of the wrist, cuts to the outside of the hand near the wrist, a cut where the thumb meets the hand, and a small cut at the elbow.</p> <p>The right arm and hand has heavy scuffing, a tear where the thumb meets the hand, and small cuts on the inside of the hand near the thumb.</p> <p>Tear where the thumb meets the hand is deeper</p> |
