**REPORT NUMBER: SINCAP-MGA-2015-026**

**NEW CAR ASSESSMENT PROGRAM (NCAP)  
Moving Deformable Barrier Side Impact Test**

**TOYOTA MOTOR MANUFACTURING, NORTHERN KENTUCKY, INC.  
2015 Toyota Camry LE 4-Dr Sedan  
NHTSA No.: M20155108**

**MGA RESEARCH CORPORATION  
5000 Warren Road  
Burlington, WI 53105**

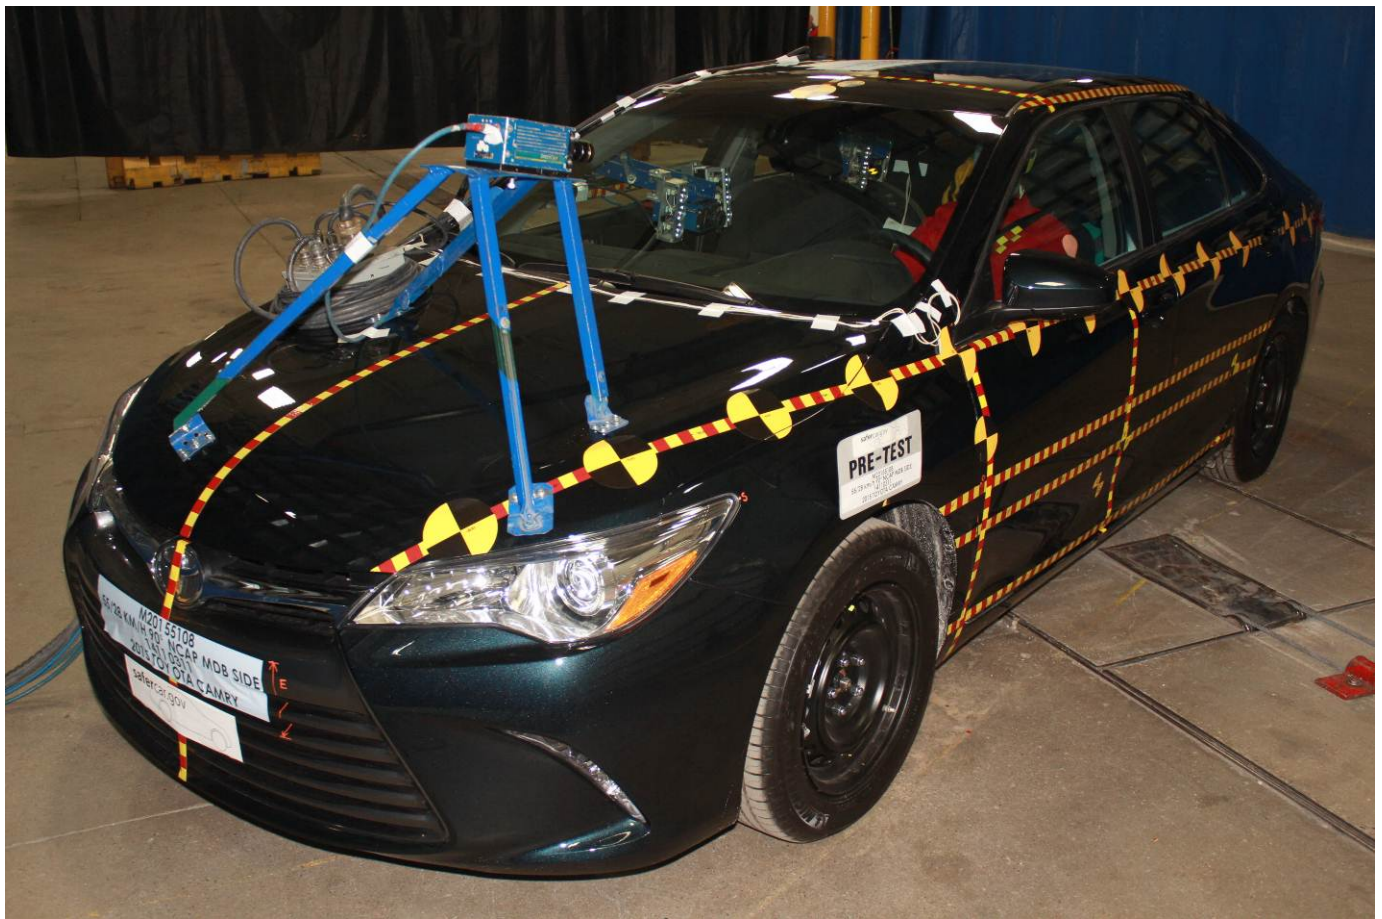
Post-Test Frontal View of Test Vehicle

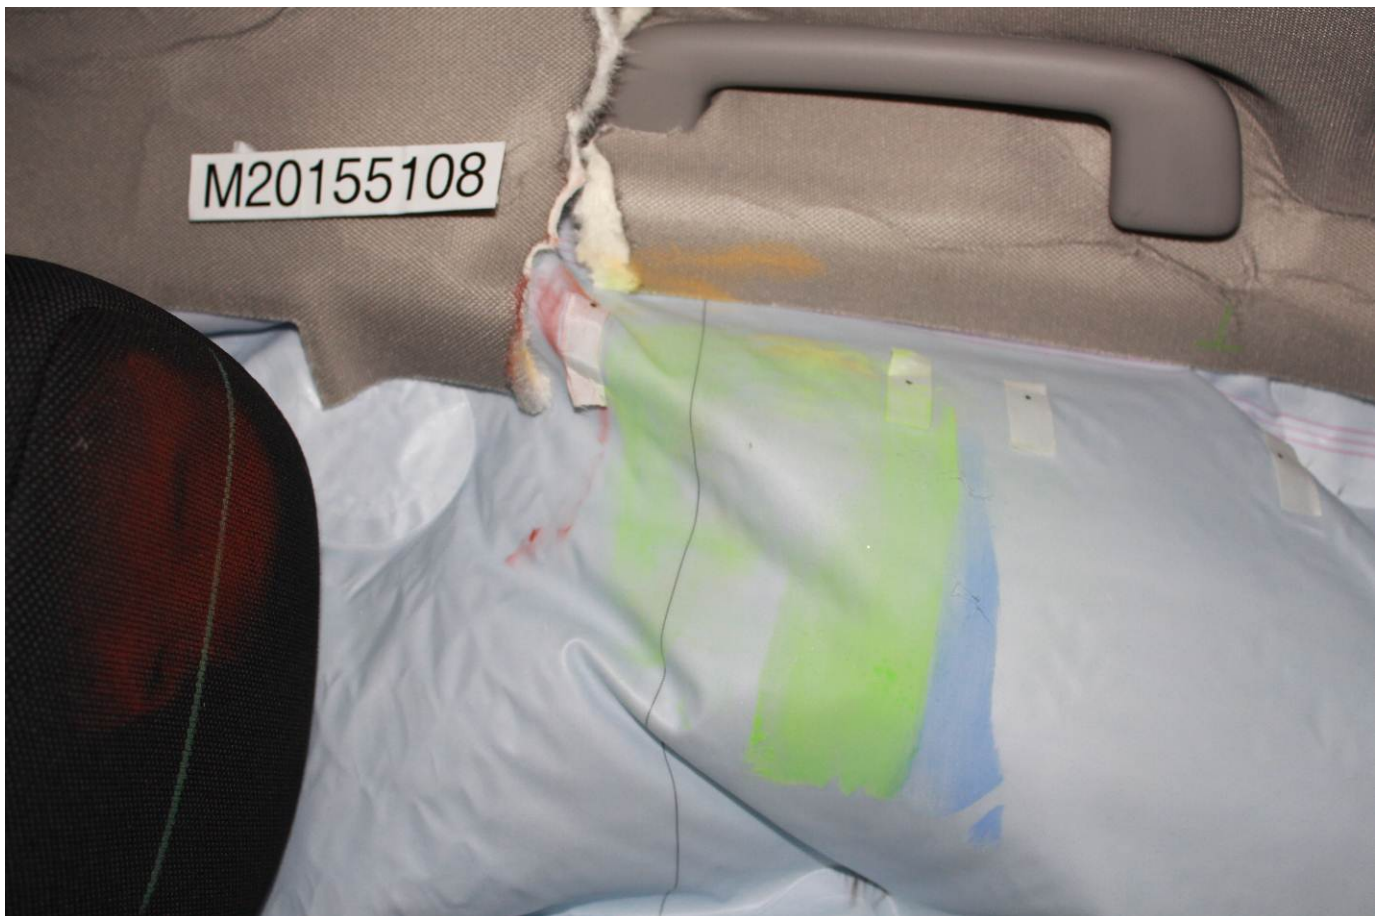
Post-Test Driver Dummy Close-up Head Contact with Vehicle Interior View

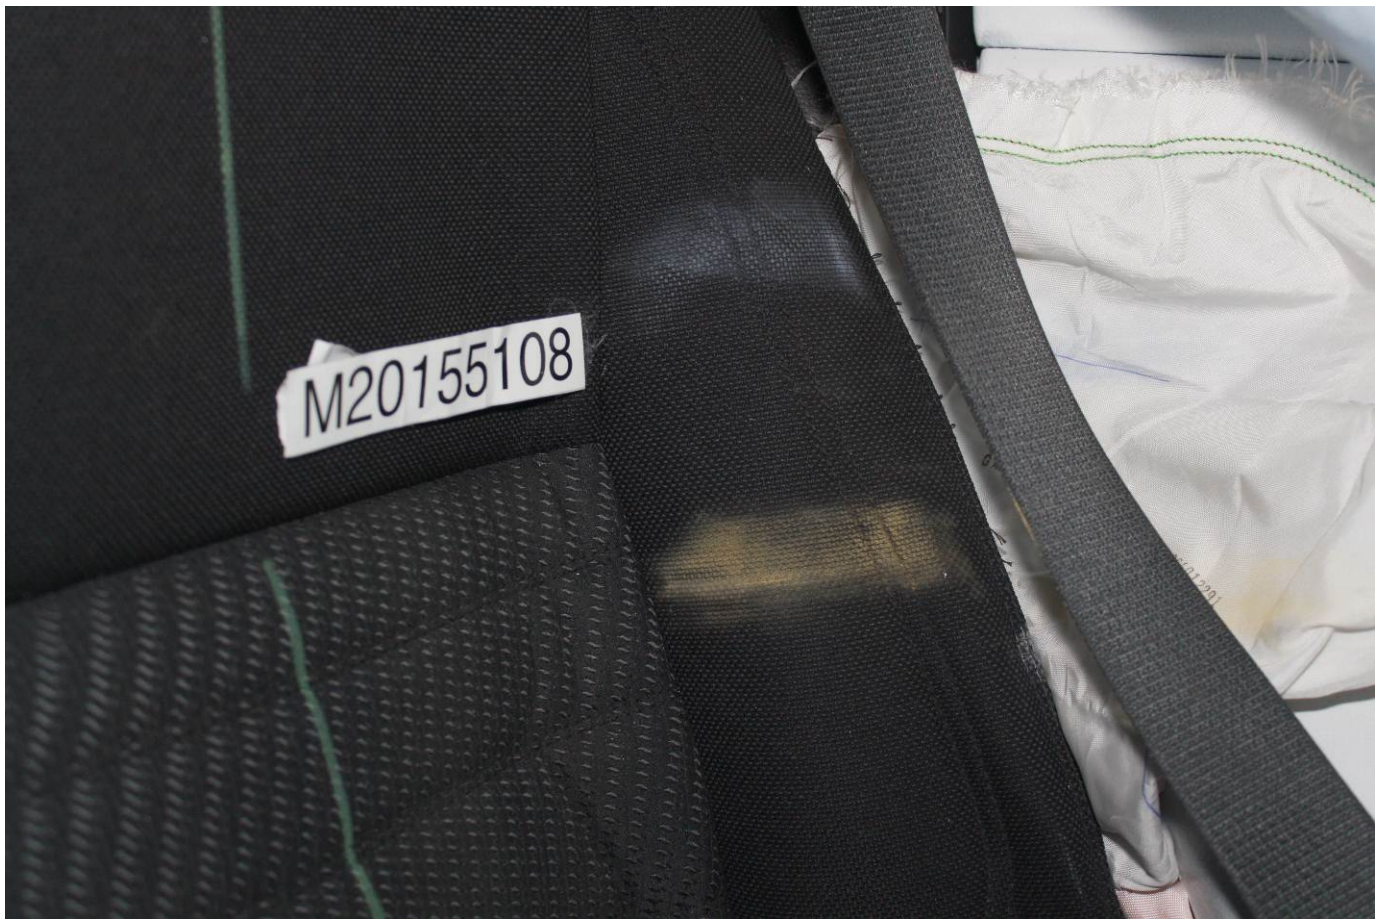
Post-Test Driver Dummy Close-up Head Contact with Side Airbag View
