**REPORT NUMBER: SPNCAP-MGA-2015-027**

**NEW CAR ASSESSMENT PROGRAM (NCAP)  
Side Impact Pole Test**

**TOYOTA MOTOR MANUFACTURING, NORTHERN KENTUCKY INC.  
2015 Toyota Camry LE 4-Dr Sedan  
NHTSA No.: M20155107**

**FINAL REPORT**

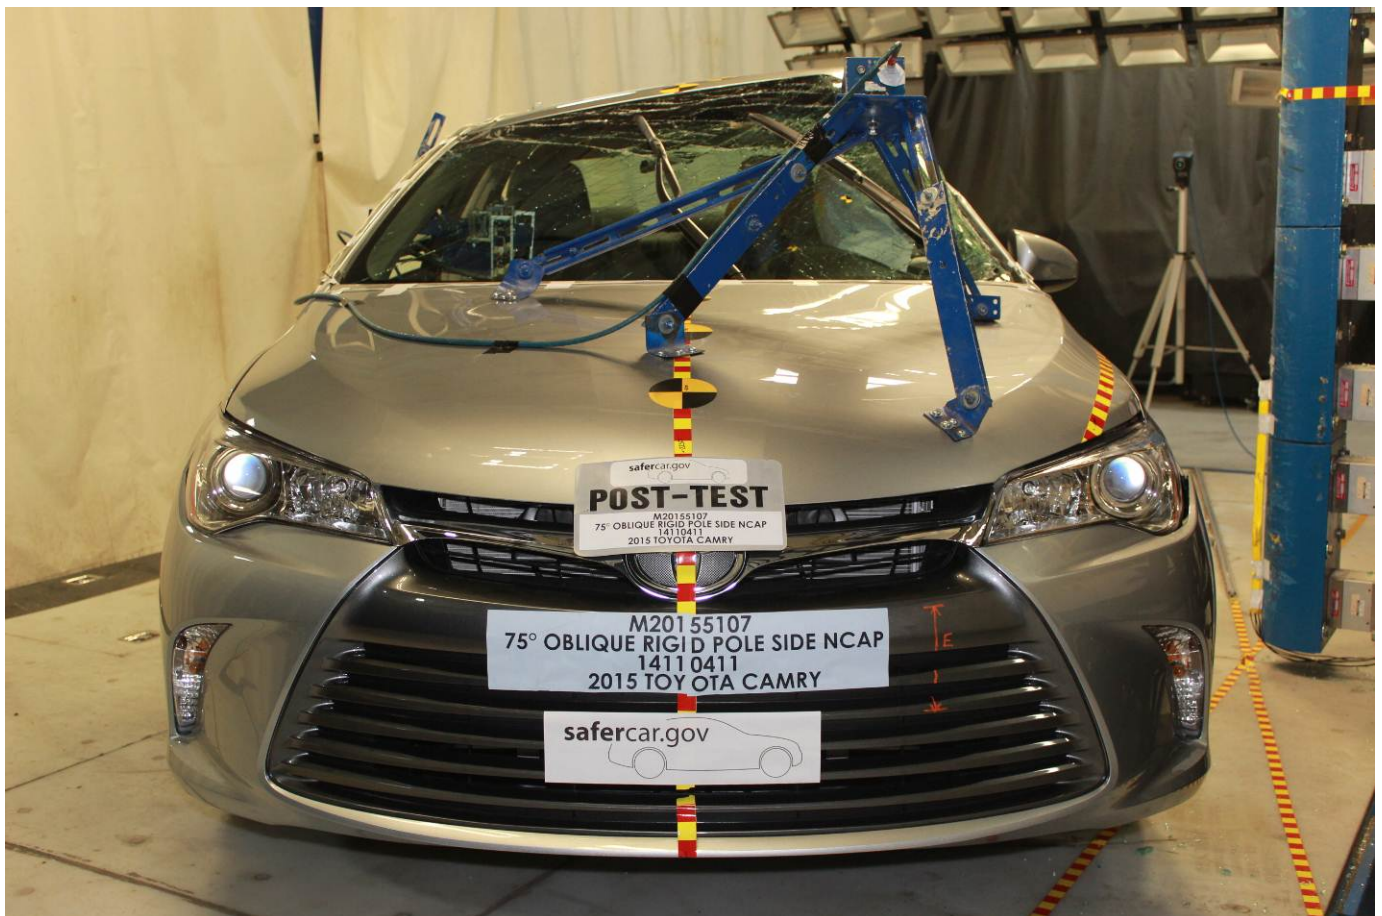
Post-Test Frontal View of Test Vehicle

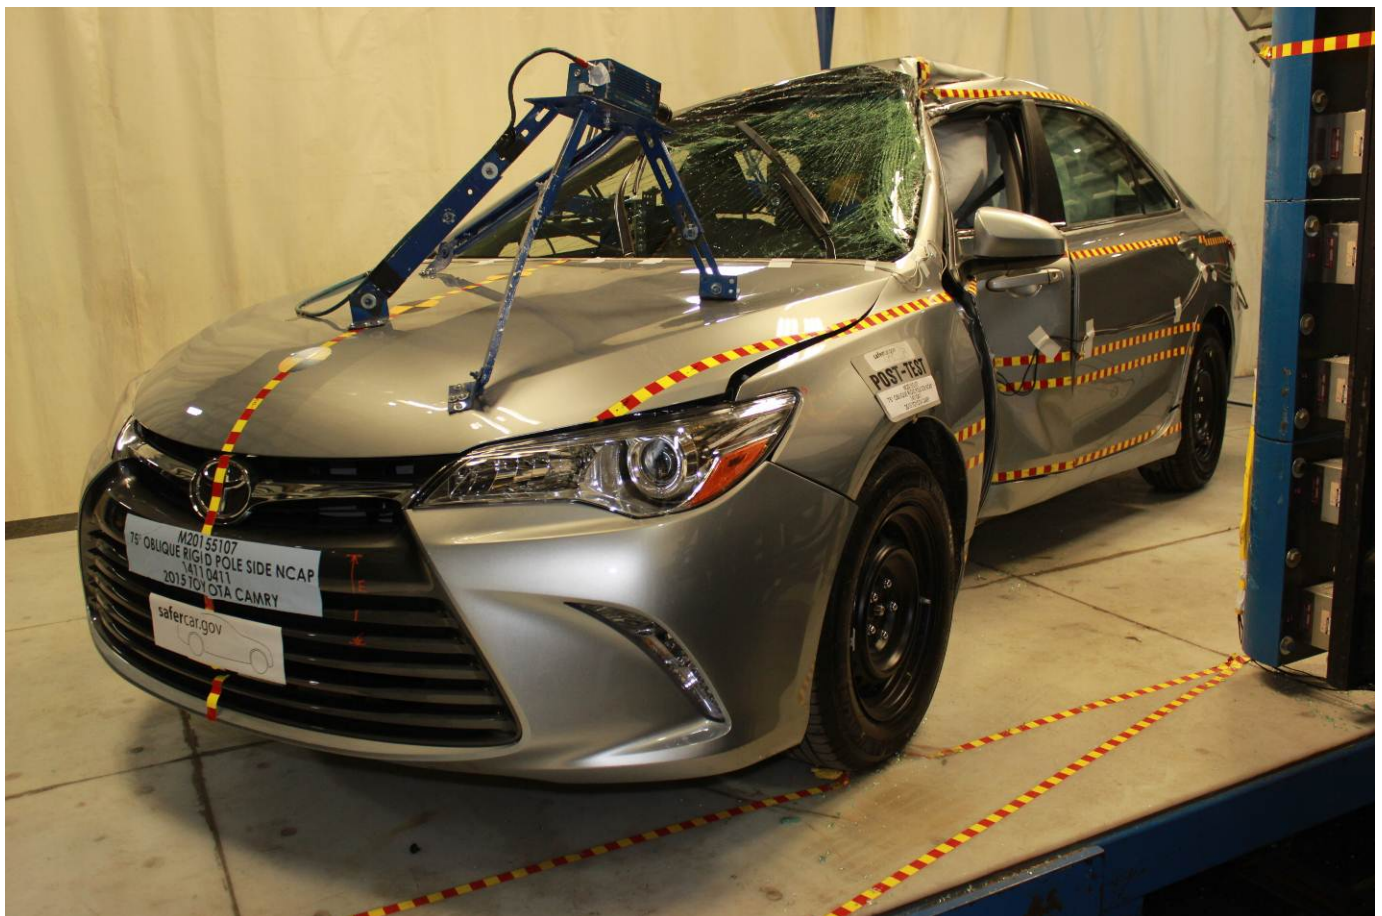
Post-Test Left Front  $\frac{3}{4}$  View of Test Vehicle

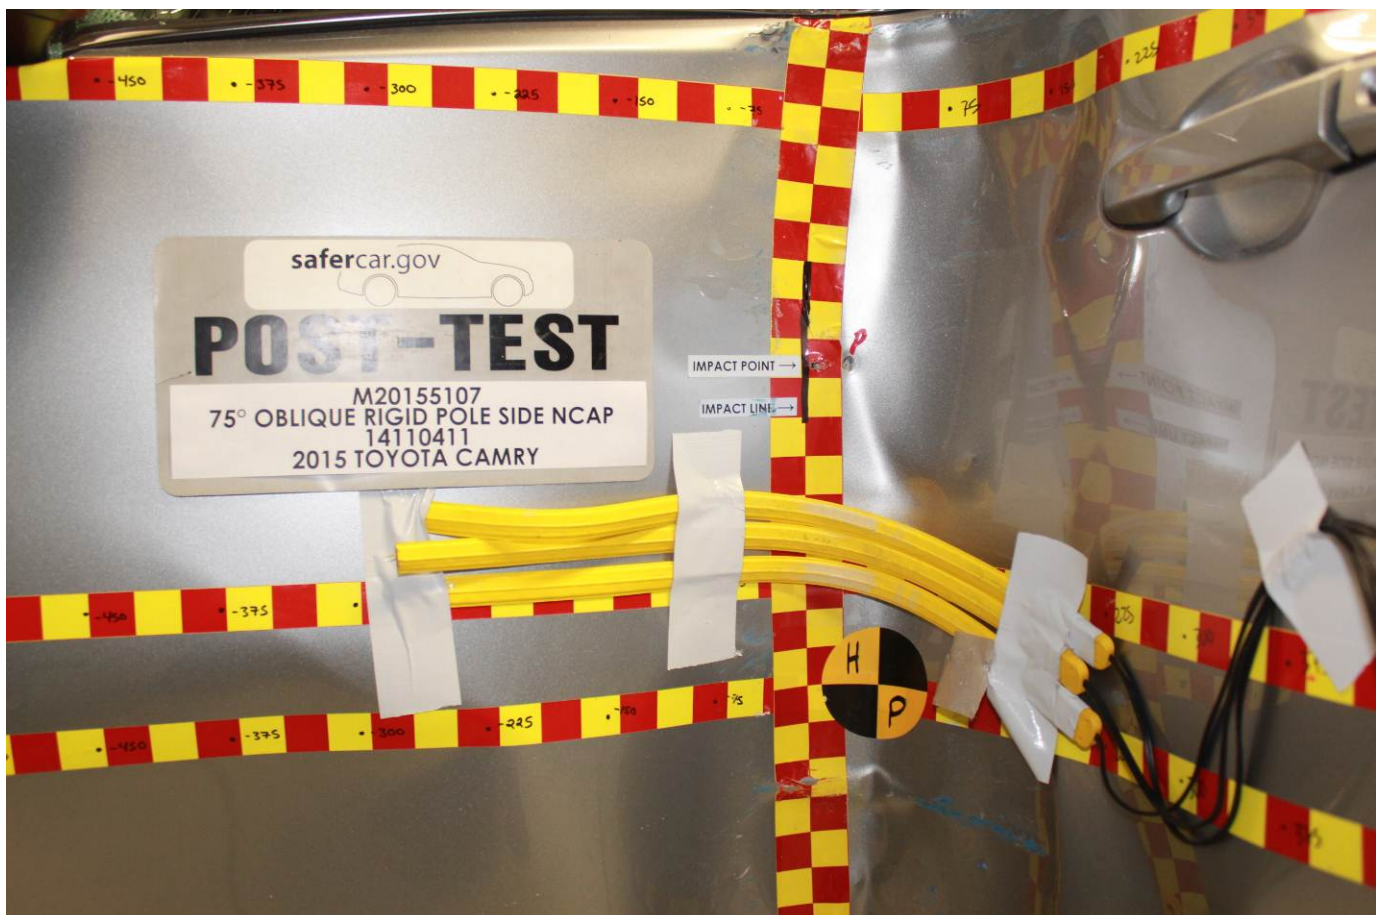
Post-Test Close-Up View of Impact Point Target Showing Impact Location

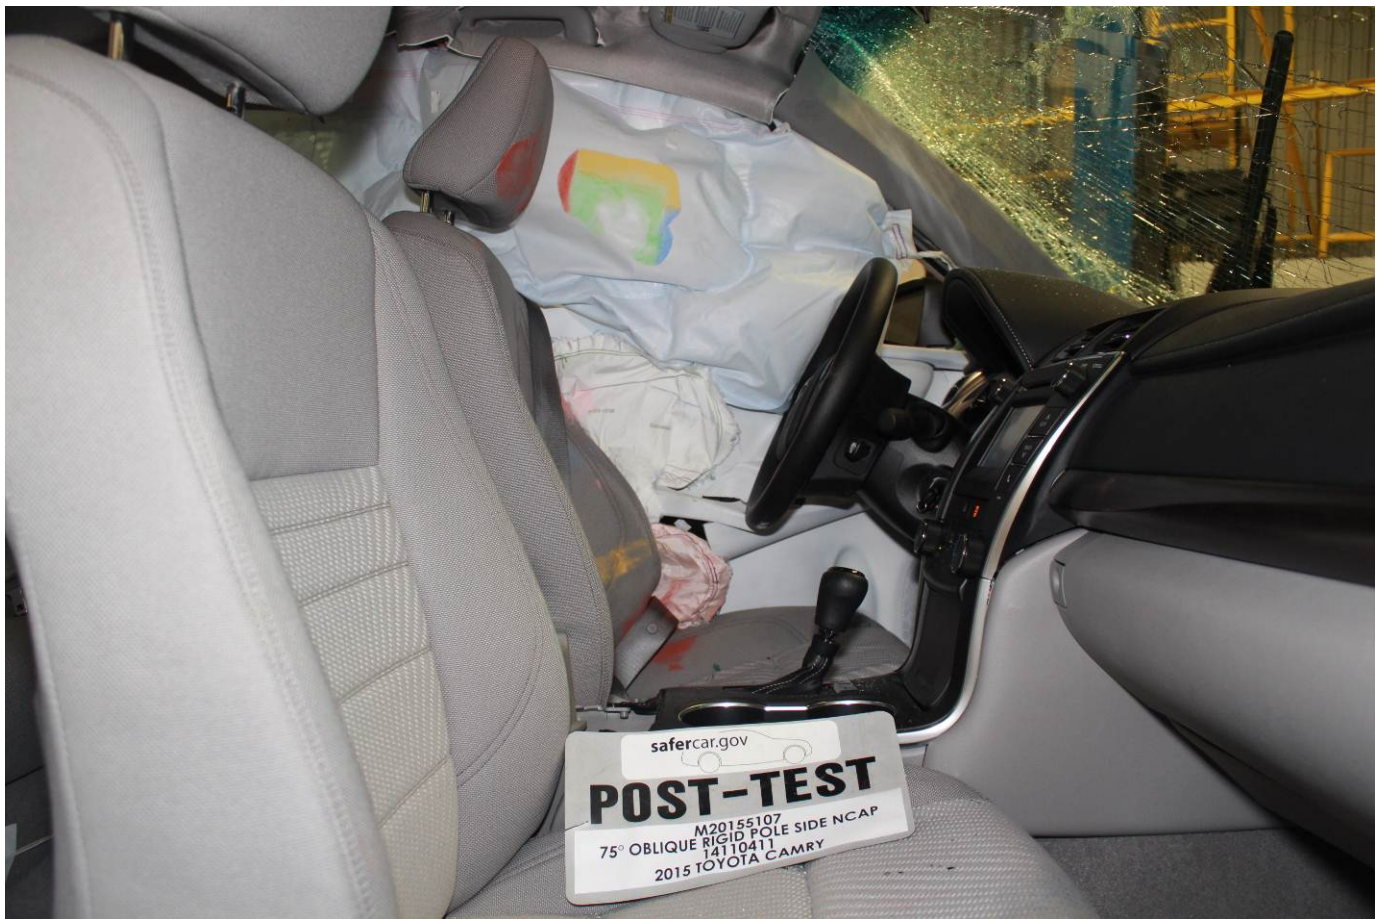
Post-Test Inner Door Panel View Showing Dummy Contact Location

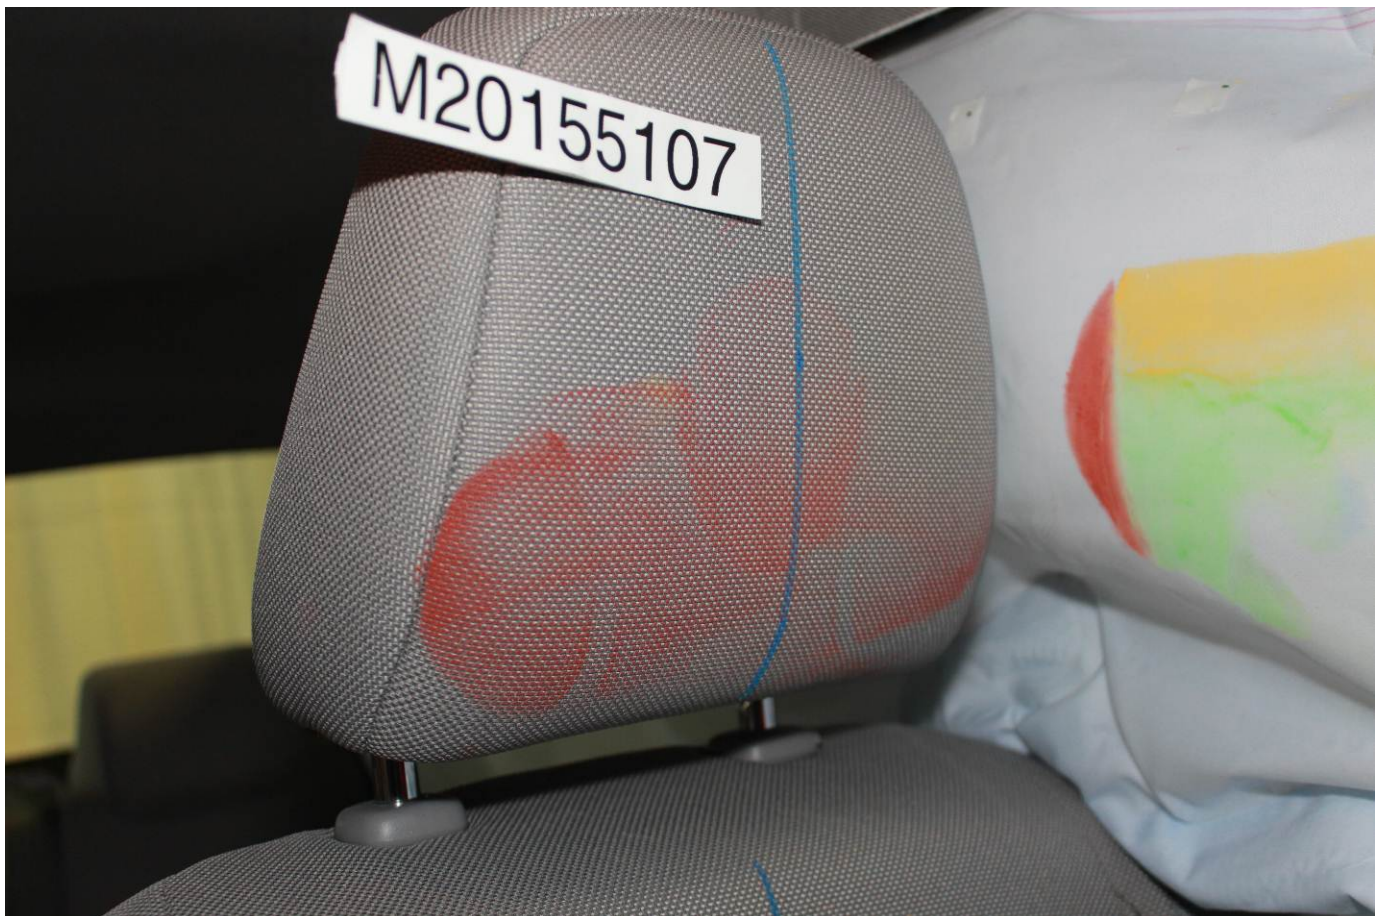
Post-Test Dummy Close-Up Head Contact with Vehicle Interior View

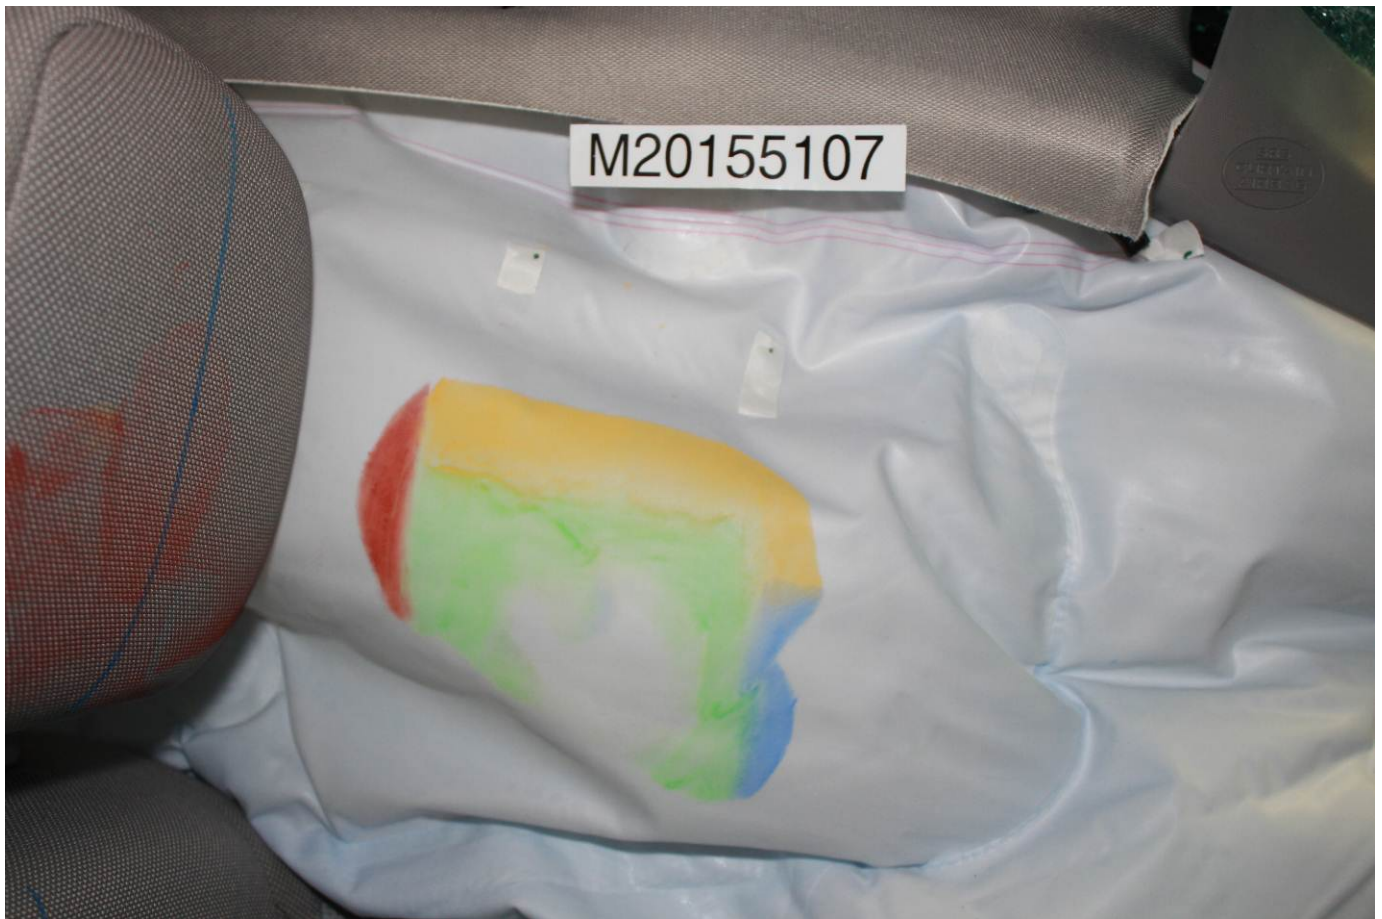
Post-Test Dummy Close-Up Head Contact with Side Air Bag View

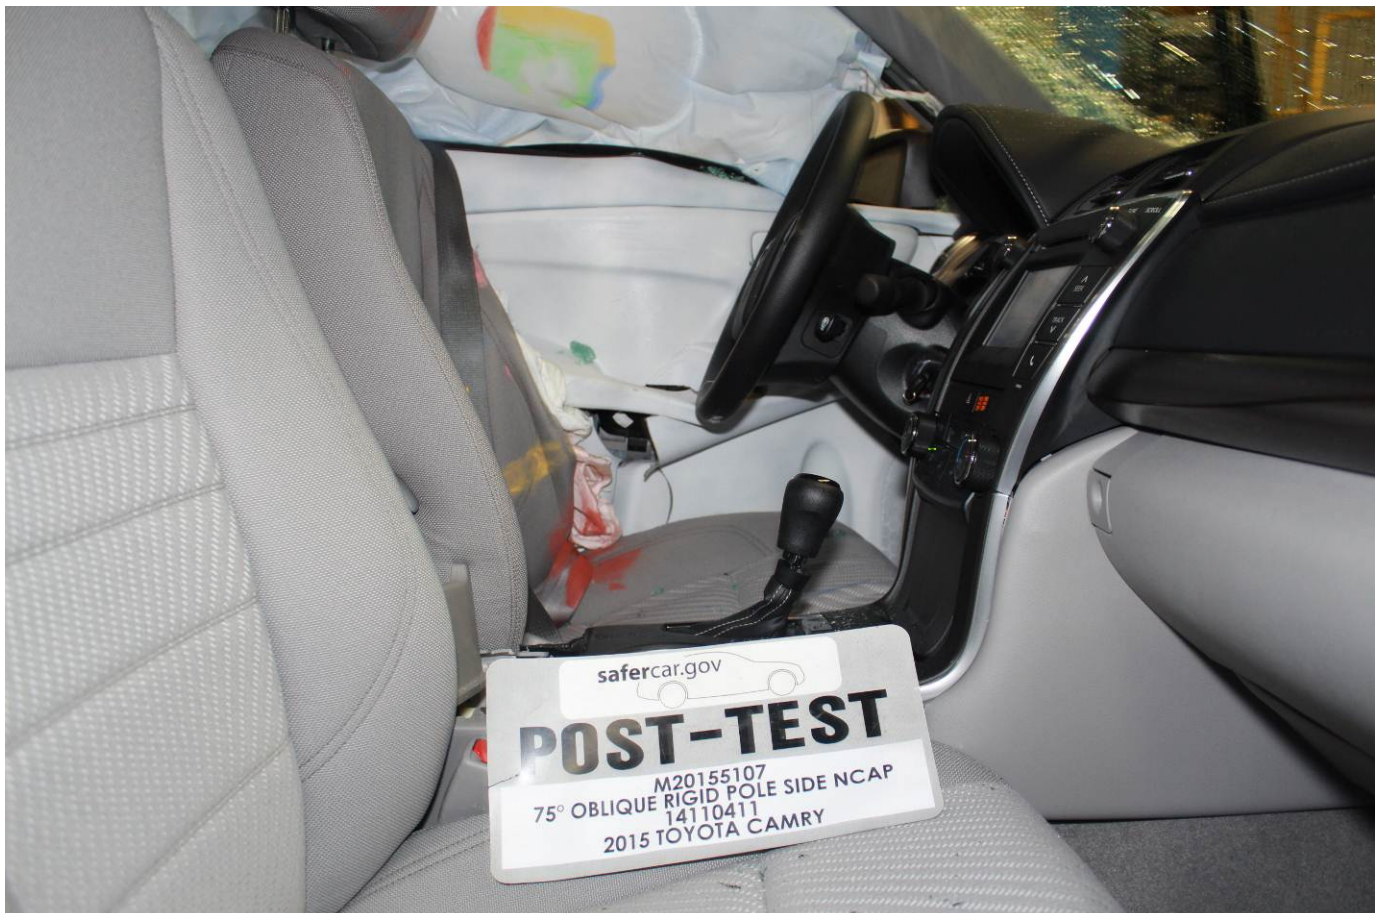
Post-Test View of Shattered Vehicle Inner Door Panel

| Critical Areas of Performance | Observations and Conclusions |
|---|---|
| Side Window Damage | Left Front Window Broken |
