REPORT NUMBER: NCAP-KAR-15-014

**NEW CAR ASSESSMENT PROGRAM (NCAP)
FRONTAL BARRIER IMPACT TEST**

**BAYERISCHE MOTOREN WERKE AG
2015 BMW X5 xDRIVE35i 5-DOOR MPV**

**PREPARED BY:
KARCO ENGINEERING, LLC.
9270 HOLLY ROAD
ADELANTO, CA 92301**

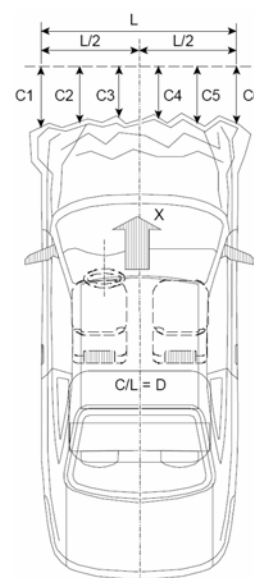
Collision Deformation Classification: 12FDEW2
 Midpoint of Damage: Vehicle Centerline
 Damage Region Length (mm): 1684
 Impact Mode: Full Frontal

No.	Measurement Description	Units	Pre-Test	Post-Test	Difference
C1	Crush Zone 1 at Left Side	mm	260	400	140
C2	Crush Zone 2 at Left Side	mm	66	437	371
C3	Crush Zone 3 at Left Side	mm	10	459	449
C4	Crush Zone 4 at Right Side	mm	10	467	457
C5	Crush Zone 5 at Right Side	mm	66	440	374
C6	Crush Zone 6 at Right Side	mm	260	330	70
L	C1 to C6	mm	1684

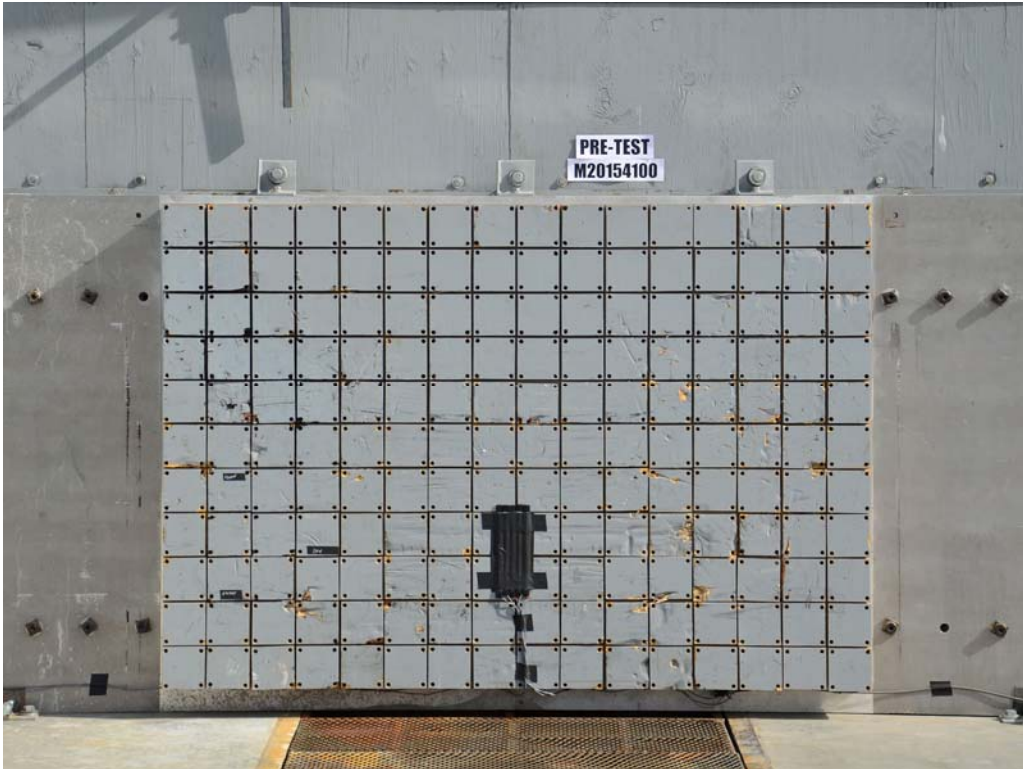
FIGURE 2. Load Cell Wall

A load cell barrier consisting of 176 load cells was impacted by a 2015 BMW X5 xDrive35i 5-door MPV at a velocity of 56.14 km/h. The test was performed at KARCO Engineering, LLC. on November 13, 2014. Pre- and post-test photographs of the vehicle and dummies can be found in Appendix A of this report.

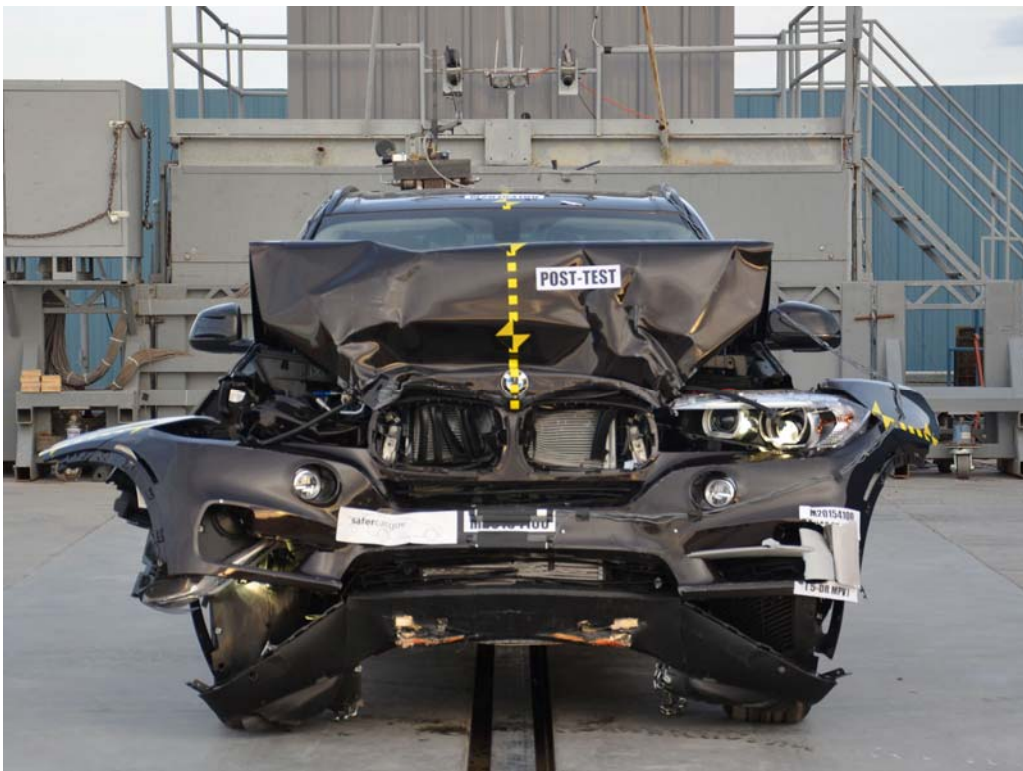
FIGURE 8. Post-Test Front View of Test Vehicle

Critical Areas of Performance	Observations and Conclusions
Windshield Damage	Broken
Window Damage	None
Other Notable Effects	None

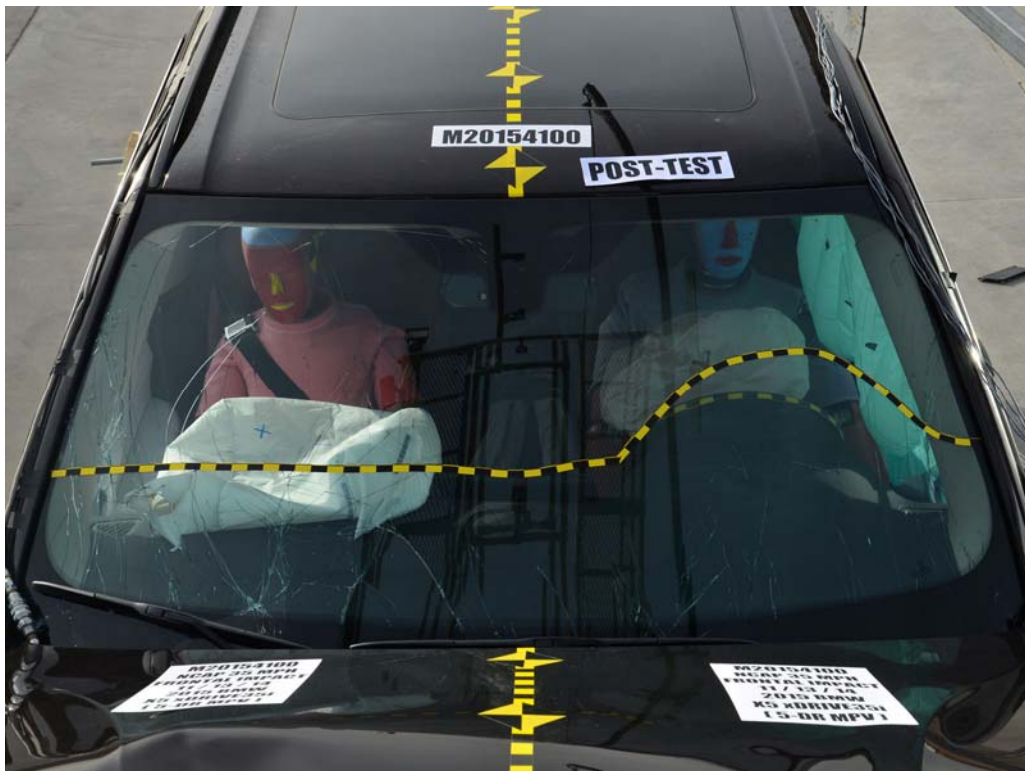
FIGURE 18. Post-Test Windshield View

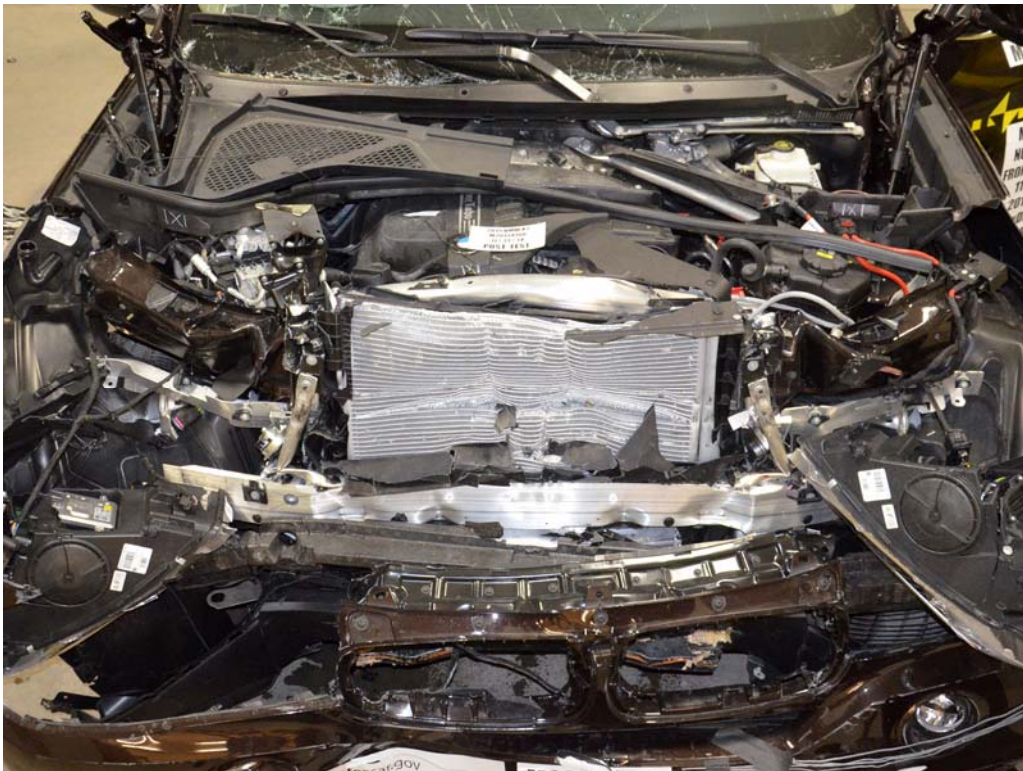
FIGURE 20. Post-Test Engine Compartment View

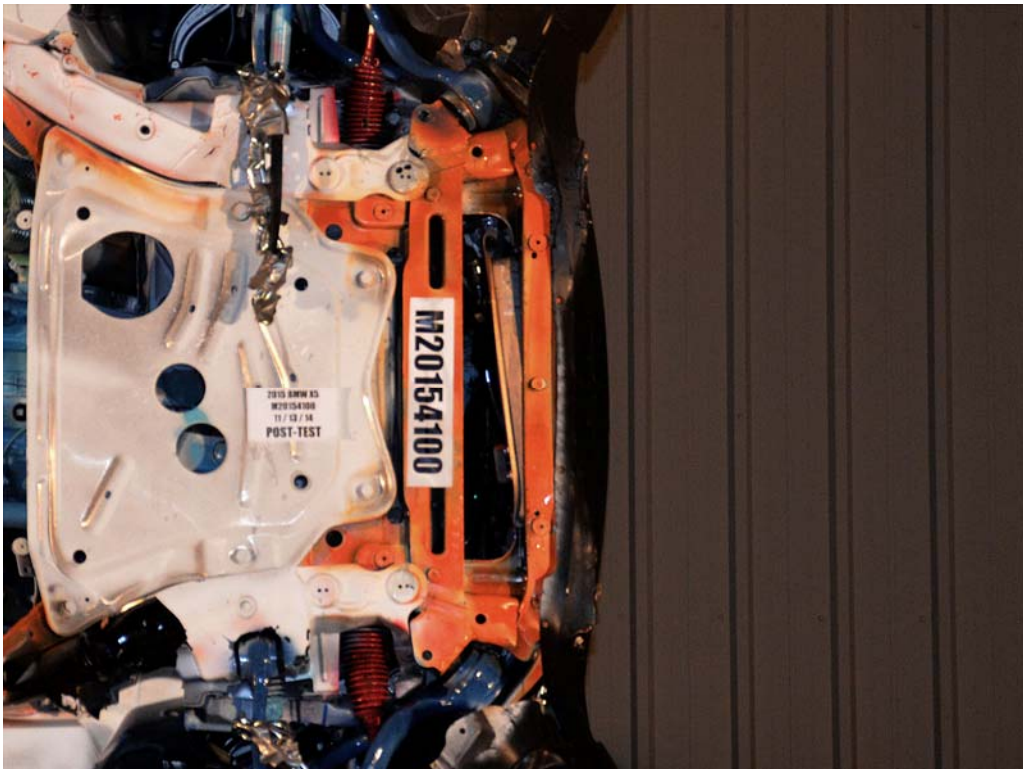
FIGURE 24. Post-Test Front Underbody View

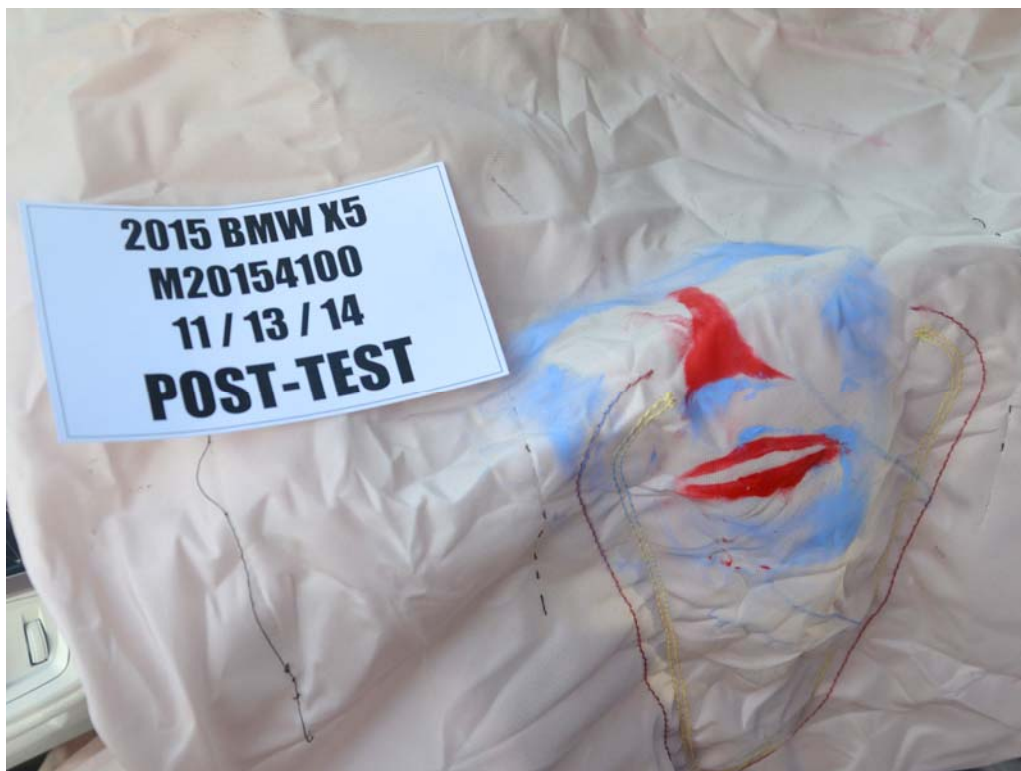
FIGURE 46. Post-Test Driver Dummy Contact with Airbag

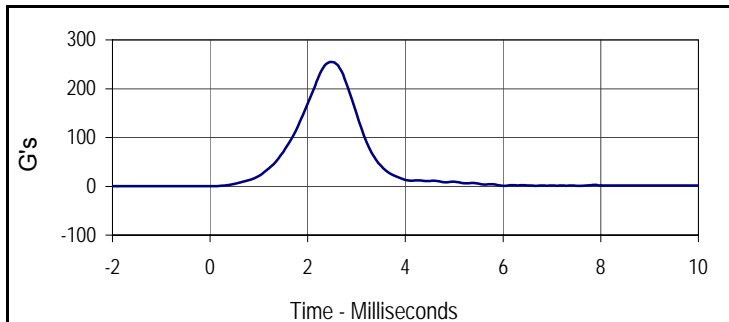
Curve Description			
Head Resultant			
Plot No.	Type	SAE Class	Units
001	RES	1000	G's
Max	Time	Min	Time
255.0	2.5	0.1	-1.8

Tested Parameter	Units	Specification	Result	Pass/Fail
Head Assembly Soak Time	Minutes	≥240	317	Pass
Temperature During Soak	Max	18.9 to 25.6	21.2	Pass
	Min		21.1	Pass
Humidity During Soak	Max	10.0 to 70.0	41.0	Pass
	Min		40.9	Pass
Laboratory Temperature During Test	°C	18.9 to 25.6	21.1	Pass
Laboratory Humidity During Test	%	10.0 to 70.0	41.0	Pass
Peak Resultant Acceleration	G's	225.0 to 275.0	255.0	Pass
Peak Lateral Acceleration	G's	≤15.0	7.6	Pass
Oscillations After Main Pulse	%	<10% of peak Res. Acceleration	5.0	Pass
Is Acceleration Unimodal?	Yes/No	Yes	Yes	Pass
Overall Test Results				Pass

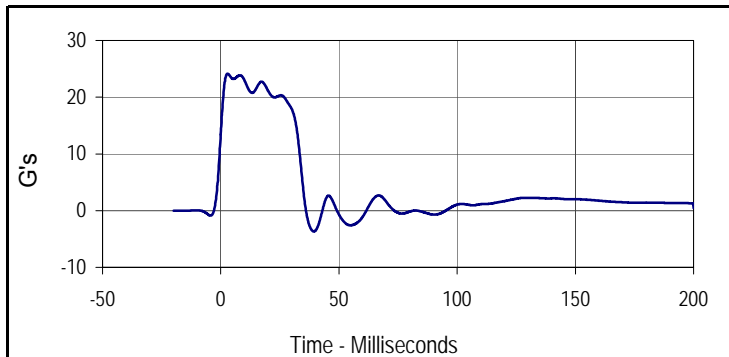
Curve Description			
Pendulum Deceleration			
Plot No.	Type	SAE Class	Units
001	FIL	60	G's
Max	Time	Min	Time
24.1	2.9	-3.7	39.4

Tested Parameter	Units	Specification	Result	Pass/Fail	
Neck Assembly Soak Time	Minutes	≥240	362	Pass	
Temperature During Soak	Max	20.6 to 22.2	21.2	Pass	
	Min		21.1	Pass	
Humidity During Soak	Max	10.0 to 70.0	41.0	Pass	
	Min		40.9	Pass	
Laboratory Temperature During Test	°C	20.6 to 22.2	21.1	Pass	
Laboratory Humidity During Test	%	10.0 to 70.0	41.0	Pass	
Pendulum Velocity	m/s	6.89 to 7.13	6.94	Pass	
Pendulum Deceleration	10 Msec.	G's	22.5 to 27.5	23.0	Pass
	20 Msec.	G's	17.6 to 22.6	21.1	Pass
	30 Msec.	G's	12.5 to 18.5	17.9	Pass
Peak Pendulum Decel. after 30 Msec.	G's	≤ 29.0	17.9	Pass	
Deceleration Decay, Time to Cross 5 G's	Msec.	34.0 to 42.0	34.6	Pass	
Maximum "D" Plane Rotation	Max	Degrees	64.0 to 78.0	75.1	Pass
	Time	Msec.	57.0 to 64.0	57.8	Pass
"D" Plane Rotation Decay, Time To Zero Crossing	Msec.	113.0 to 128.0	113.9	Pass	
Moment About Occ. Condyle	Max	Nm	88.1 to 108.5	100.2	Pass
	Time	Msec.	47.0 to 58.0	47.4	Pass

Positive Moment Decay, Time To Zero Crossing	Msec.	97.0 to 107.0	97.2	Pass	
Overall Test Results				Pass

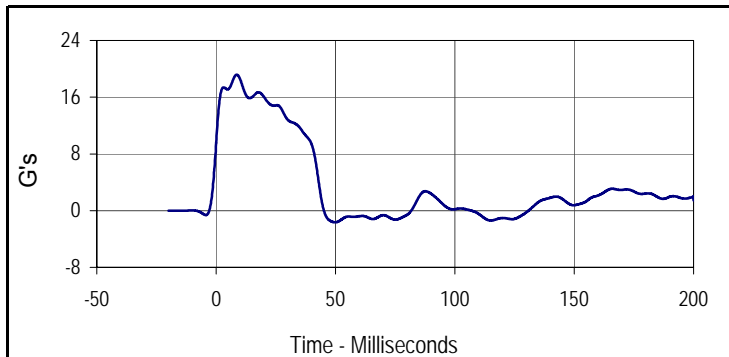
Curve Description			
Pendulum Deceleration			
Plot No.	Type	SAE Class	Units
001	FIL	60	G's
Max	Time	Min	Time
19.2	8.6	-1.6	49.8

Tested Parameter	Units	Specification	Result	Pass/Fail	
Neck Assembly Soak Time	Minutes	≥240	417	Pass	
Temperature During Soak	Max	20.6 to 22.2	21.2	Pass	
	Min		21.1	Pass	
Humidity During Soak	Max	10.0 to 70.0	41.0	Pass	
	Min		40.9	Pass	
Laboratory Temperature During Test	°C	20.6 to 22.2	21.1	Pass	
Laboratory Humidity During Test	%	10.0 to 70.0	41.0	Pass	
Pendulum Velocity	m/s	5.94 to 6.19	5.95	Pass	
Pendulum Deceleration	10 Msec.	G's	17.2 to 21.2	18.6	Pass
	20 Msec.	G's	14.0 to 19.0	16.1	Pass
	30 Msec.	G's	11.0 to 16.0	12.8	Pass
Peak Pendulum Decel. after 30 Msec.	G's	≤ 22.0	12.8	Pass	
Deceleration Decay, Time to Cross 5 G's	Msec.	38.0 to 46.0	42.6	Pass	
Maximum "D" Plane Rotation	Max	Degrees	81.0 to 106.0	93.2	Pass
	Time	Msec.	72.0 to 82.0	75.1	Pass
"D" Plane Rotation Decay, Time To Zero Crossing	Msec.	147.0 to 174.0	152.1	Pass	
Moment About Occ. Condyle	Max	Nm	-52.9 to -79.9	-69.5	Pass
	Time	Msec.	65.0 to 79.0	72.5	Pass

Positive Moment Decay, Time To Zero Crossing	Msec.	120.0 to 148.0	138.8	Pass	
Overall Test Results				Pass

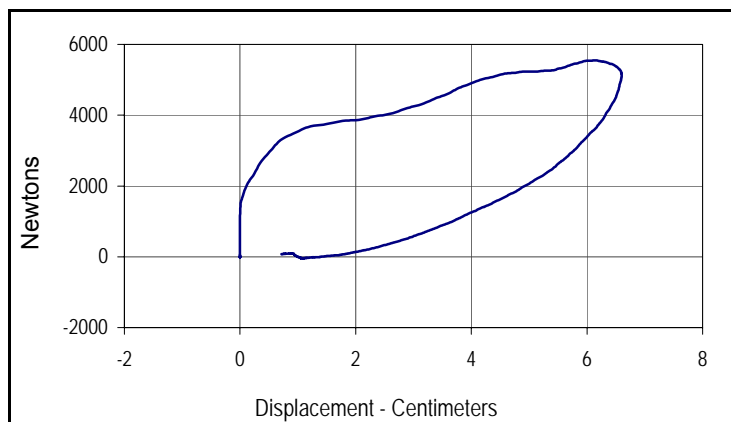
Curve Description			
Probe Force vs. Chest Deflection			
Plot No.	Type	SAE Class	Hysteresis
001	FIL	180	72.3
Peak Probe Force		Peak Chest Deflection	
5549		6.60

Tested Parameter	Units	Specification	Result	Pass/Fail
Dummy Soak Time	Minutes	≥240	492	Pass
Temperature During Soak	Max	20.6 to 22.2	21.2	Pass
	Min		21.1	Pass
Humidity During Soak	Max	10.0 to 70.0	41.0	Pass
	Min		40.9	Pass
Laboratory Temperature During Test	°C	20.6 to 22.2	21.1	Pass
Laboratory Humidity During Test	%	10.0 to 70.0	41.0	Pass
Probe Velocity	m/s	6.58 to 6.82	6.74	Pass
Peak Probe Force	Newtons	5159 to 5893	5549	Pass
Peak Sternum Deflection	CM	6.35 to 7.26	6.60	Pass
Internal Hysteresis	%	69 to 85	72.3	Pass
Overall Test Results				Pass

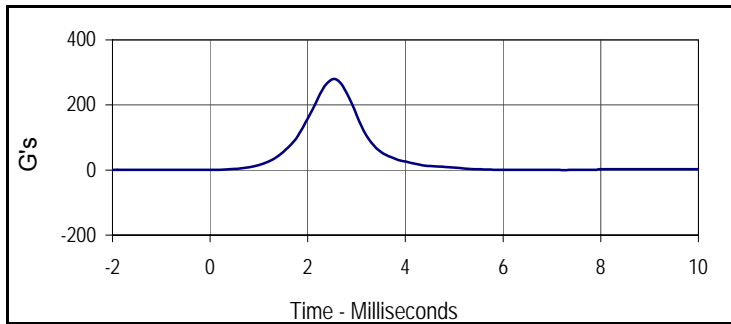
Curve Description			
Head Resultant			
Plot No.	Type	SAE Class	Units
001	RES	1000	G's
Max	Time	Min	Time
278.6	2.5	0.3	0.1

Tested Parameter	Units	Specification	Result	Pass/Fail
Head Assembly Soak Time	Minutes	≥240	312	Pass
Temperature During Soak	Max	18.9 to 25.6	21.1	Pass
	Min		21.1	Pass
Humidity During Soak	Max	10.0 to 70.0	40.9	Pass
	Min		40.6	Pass
Laboratory Temperature During Test	°C	18.9 to 25.6	21.1	Pass
Laboratory Humidity During Test	%	10.0 to 70.0	40.6	Pass
Peak Resultant Acceleration	G's	250.0 to 300.0	278.6	Pass
Peak Lateral Acceleration	G's	≤15.0	3.9	Pass
Oscillations After Main Pulse	%	<10% of peak Res. Acceleration	0.2	Pass
Is Acceleration Unimodal?	Yes/No	Yes	Yes	Pass
Overall Test Results				Pass

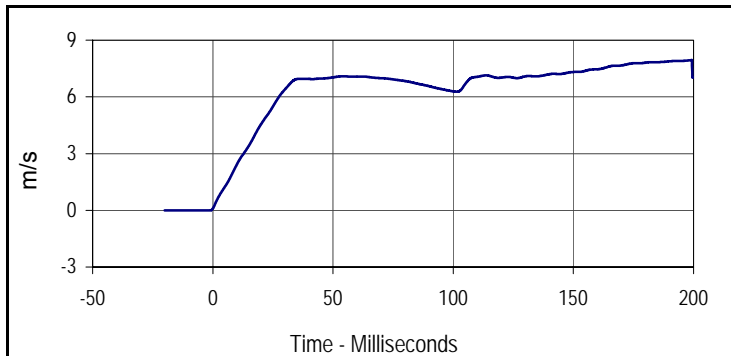
Curve Description			
Pendulum Velocity			
Plot No.	Type	SAE Class	Units
001	FIL	180	m/s
Max	Time	Min	Time
7.9	199.4	0.0	-1.3

Tested Parameter	Units	Specification	Result	Pass/Fail	
Neck Assembly Soak Time	Minutes	≥240	357	Pass	
Temperature During Soak	Max	20.6 to 22.2	21.1	Pass	
	Min		21.1	Pass	
Humidity During Soak	Max	10.0 to 70.0	40.9	Pass	
	Min		40.6	Pass	
Laboratory Temperature During Test	°C	20.6 to 22.2	21.1	Pass	
Laboratory Humidity During Test	%	10.0 to 70.0	40.8	Pass	
Pendulum Velocity	m/s	6.89 to 7.13	7.11	Pass	
Pendulum Deceleration	10 Msec.	m/s	2.1 to 2.5	2.4	Pass
	20 Msec.	m/s	4.0 to 5.0	4.5	Pass
	30 Msec.	m/s	5.8 to 7.0	6.4	Pass
"D" Plane Rotation	Max	Degrees	77.0 to 91.0	87.6	Pass
Peak Moment in Rotation	Max	Nm	69.0 to 83.0	73.2	Pass
Positive Moment Decay, Time To 10 Nm	Msec.	80.0 to 100.0	91.0	Pass	
Overall Test Results				Pass

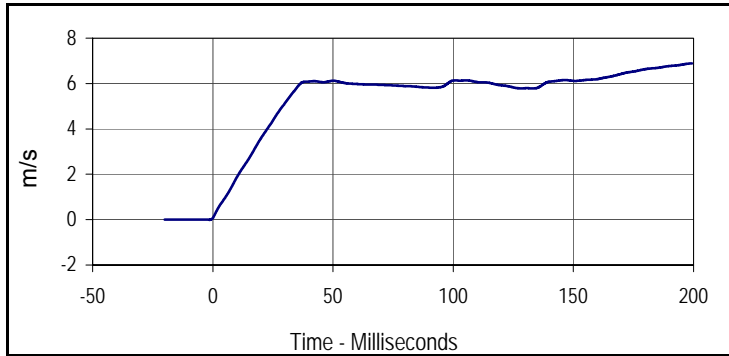
Curve Description			
Pendulum Velocity			
Plot No.	Type	SAE Class	Units
001	FIL	180	m/s
Max	Time	Min	Time
6.9	199.4	0.0	-1.3

Tested Parameter	Units	Specification	Result	Pass/Fail	
Neck Assembly Soak Time	Minutes	≥240	412	Pass	
Temperature During Soak	Max	20.6 to 22.2	21.1	Pass	
	Min		21.1	Pass	
Humidity During Soak	Max	10.0 to 70.0	40.9	Pass	
	Min		40.6	Pass	
Laboratory Temperature During Test	°C	20.6 to 22.2	21.1	Pass	
Laboratory Humidity During Test	%	10.0 to 70.0	40.9	Pass	
Pendulum Velocity	m/s	5.95 to 6.19	6.11	Pass	
Pendulum Deceleration	10 Msec.	m/s	1.5 to 1.9	1.9	Pass
	20 Msec.	m/s	3.1 to 3.9	3.6	Pass
	30 Msec.	m/s	4.6 to 5.6	5.1	Pass
"D" Plane Rotation	Max	Degrees	99.0 to 114.0	111.1	Pass
Peak Moment in Rotation	Max	Nm	-53.0 to -65.0	-57.8	Pass
Positive Moment Decay, Time To -10 Nm	Msec.	94.0 to 114.0	103.8	Pass	
Overall Test Results				Pass

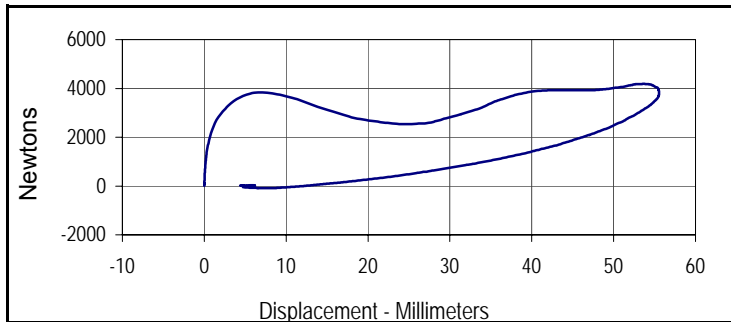
Curve Description			
Probe Force vs. Chest Deflection			
Plot No.	Type	SAE Class	Hysteresis
001	FIL	180	72.2
Peak Probe Force		Peak Chest Deflection	
4184.8		55.6

Tested Parameter	Units	Specification	Result	Pass/Fail
Dummy Soak Time	Minutes	≥240	477	Pass
Temperature During Soak	Max	20.6 to 22.2	21.1	Pass
	Min		21.1	Pass
Humidity During Soak	Max	10.0 to 70.0	40.9	Pass
	Min		40.6	Pass
Laboratory Temperature During Test	°C	20.6 to 22.2	21.1	Pass
Laboratory Humidity During Test	%	10.0 to 70.0	40.7	Pass
Probe Velocity	m/s	6.59 to 6.83	6.73	Pass
Peak Chest Deflection	mm	50.0 to 58.0	55.6	Pass
Peak Force Between 50 and 58 MM	Newtons	3900 to 4400	4016	Pass
Peak Force Between 18 and 50 MM	Newtons	≤4600	4185	Pass
Internal Hysteresis	%	69 to 85	72.2	Pass
Overall Test Results				Pass

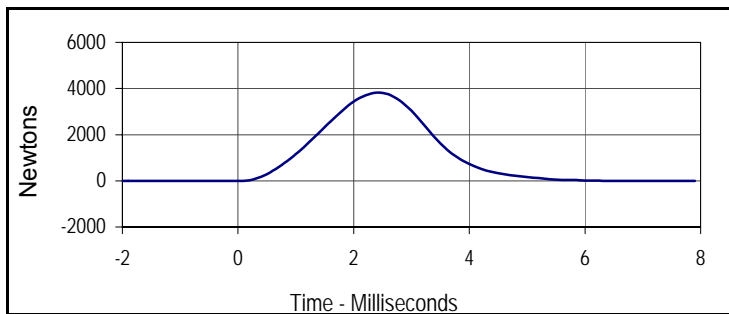
Curve Description			
Left Knee Probe Force			
Plot No.	Type	SAE Class	Units
001	FIL	600	Newtons
Max	Time	Min	Time
3819.3	2.4	-8.2	0.0

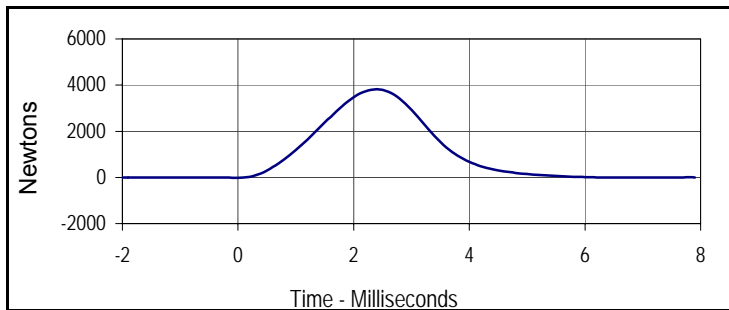
Curve Description			
Right Knee Probe Force			
Plot No.	Type	SAE Class	Units
003	FIL	600	Newtons
Max	Time	Min	Time
3822.9	2.4	-11.3	-0.1

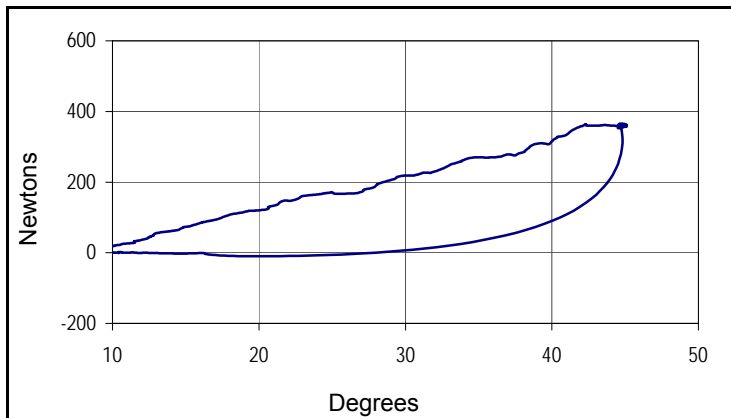
Curve Description		
Force vs Torso Rotation		
Plot No.	Type	Filter Freq
001	FIL	1 Hz
Peak Force		Peak Rotation
365.3		45.1

Tested Parameter		Units	Specification	Result	Pass/Fail
Dummy Soak Time		Minutes	≥240	609	Pass
Temperature During Soak	Max	°C	18.9 to 25.6	21.1	Pass
	Min	°C		21.1	Pass
Humidity During Soak	Max	%	10.0 to 70.0	40.9	Pass
	Min	%		40.6	Pass
Laboratory Temperature During Test		°C	18.9 to 25.6	21.1	Pass
Laboratory Humidity During Test		%	10.0 to 70.0	40.8	Pass
Initial Reference Plane Angle		Degrees	≤ 20	7.1	Pass
Peak Force at 45° +/-0.5°		Newtons	320.0 to 390.0	365.3	Pass
Torso Rotation Rate		deg/sec	0.5 to 1.5	1.0	Pass
Final Reference Plane Angle		Degrees	+/-8	7.2	Pass
Overall Test Results					Pass

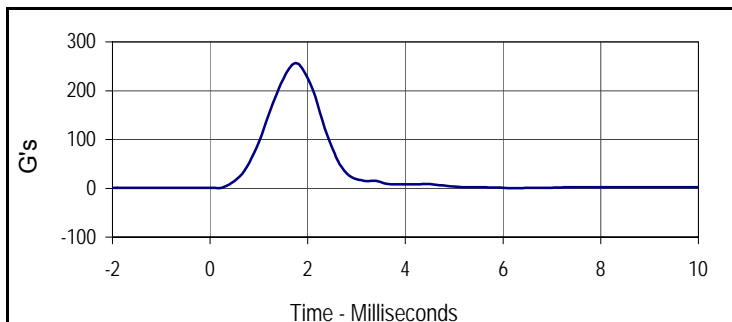
Curve Description			
Head Resultant			
Plot No.	Type	SAE Class	Units
001	RES	1000	G's
Max	Time	Min	Time
255.2	1.8	0.2	0.2

Tested Parameter	Units	Specification	Result	Pass/Fail
Head Assembly Soak Time	Minutes	≥240	300	Pass
Temperature During Soak	Max	18.9 to 25.6	22.2	Pass
	Min		21.7	Pass
Humidity During Soak	Max	10.0 to 70.0	38.4	Pass
	Min		23.1	Pass
Laboratory Temperature During Test	°C	18.9 to 25.6	22.2	Pass
Laboratory Humidity During Test	%	10.0 to 70.0	38.4	Pass
Peak Resultant Acceleration	G's	225.0 to 275.0	255.2	Pass
Peak Lateral Acceleration	G's	≤15.0	4.7	Pass
Oscillations After Main Pulse	%	<10% of peak Res. Acceleration	3.4	Pass
Is Acceleration Unimodal?	Yes/No	Yes	Yes	Pass
Overall Test Results				Pass

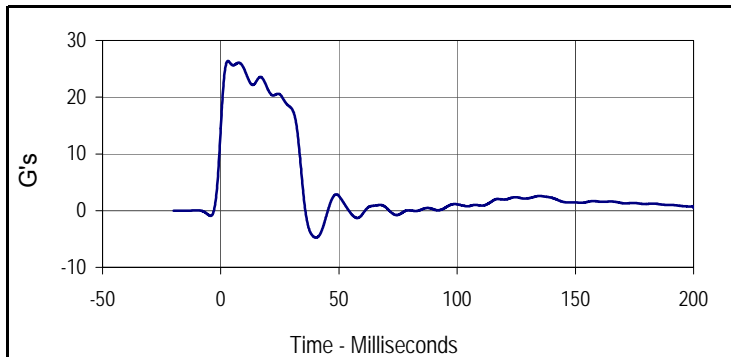
Curve Description			
Pendulum Deceleration			
Plot No.	Type	SAE Class	Units
001	FIL	60	G's
Max	Time	Min	Time
26.4	3.0	-4.7	40.3

Tested Parameter	Units	Specification	Result	Pass/Fail	
Neck Assembly Soak Time	Minutes	≥240	365	Pass	
Temperature During Soak	Max	20.6 to 22.2	22.2	Pass	
	Min		21.7	Pass	
Humidity During Soak	Max	10.0 to 70.0	38.4	Pass	
	Min		23.1	Pass	
Laboratory Temperature During Test	°C	20.6 to 22.2	22.2	Pass	
Laboratory Humidity During Test	%	10.0 to 70.0	37.7	Pass	
Pendulum Velocity	m/s	6.89 to 7.13	6.96	Pass	
Pendulum Deceleration	10 Msec.	G's	22.5 to 27.5	24.9	Pass
	20 Msec.	G's	17.6 to 22.6	21.3	Pass
	30 Msec.	G's	12.5 to 18.5	18.0	Pass
Peak Pendulum Decel. after 30 Msec.	G's	≤ 29.0	18.0	Pass	
Deceleration Decay, Time to Cross 5 G's	Msec.	34.0 to 42.0	34.5	Pass	
Maximum "D" Plane Rotation	Max	Degrees	64.0 to 78.0	75.6	Pass
	Time	Msec.	57.0 to 64.0	57.7	Pass
"D" Plane Rotation Decay, Time To Zero Crossing	Msec.	113.0 to 128.0	113.2	Pass	
Moment About Occ. Condyle	Max	Nm	88.1 to 108.5	103.5	Pass
	Time	Msec.	47.0 to 58.0	47.0	Pass

Positive Moment Decay, Time To Zero Crossing	Msec.	97.0 to 107.0	99.9	Pass	
Overall Test Results				Pass

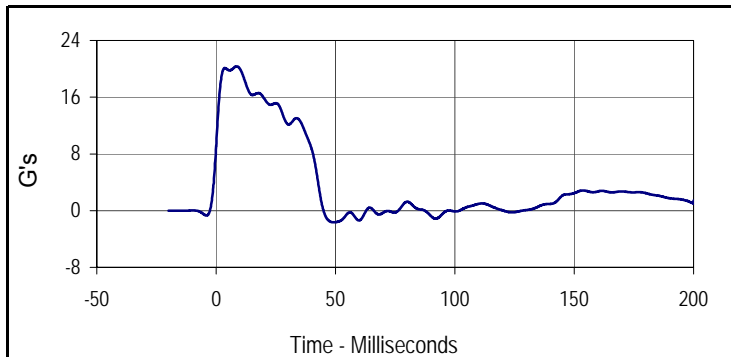
Curve Description			
Pendulum Deceleration			
Plot No.	Type	SAE Class	Units
001	FIL	60	G's
Max	Time	Min	Time
20.3	8.6	-1.7	49.2

Tested Parameter	Units	Specification	Result	Pass/Fail	
Neck Assembly Soak Time	Minutes	≥240	410	Pass	
Temperature During Soak	Max	20.6 to 22.2	22.2	Pass	
	Min		21.7	Pass	
Humidity During Soak	Max	10.0 to 70.0	38.4	Pass	
	Min		23.1	Pass	
Laboratory Temperature During Test	°C	20.6 to 22.2	22.1	Pass	
Laboratory Humidity During Test	%	10.0 to 70.0	37.8	Pass	
Pendulum Velocity	m/s	5.94 to 6.19	6.12	Pass	
Pendulum Deceleration	10 Msec.	G's	17.2 to 21.2	20.0	Pass
	20 Msec.	G's	14.0 to 19.0	15.9	Pass
	30 Msec.	G's	11.0 to 16.0	12.2	Pass
Peak Pendulum Decel. after 30 Msec.	G's	≤ 22.0	13.1	Pass	
Deceleration Decay, Time to Cross 5 G's	Msec.	38.0 to 46.0	42.3	Pass	
Maximum "D" Plane Rotation	Max	Degrees	81.0 to 106.0	93.3	Pass
	Time	Msec.	72.0 to 82.0	74.6	Pass
"D" Plane Rotation Decay, Time To Zero Crossing	Msec.	147.0 to 174.0	152	Pass	
Moment About Occ. Condyle	Max	Nm	-52.9 to -79.9	-68.0	Pass
	Time	Msec.	65.0 to 79.0	66.2	Pass

Positive Moment Decay, Time To Zero Crossing	Msec.	120.0 to 148.0	122.0	Pass	
Overall Test Results				Pass

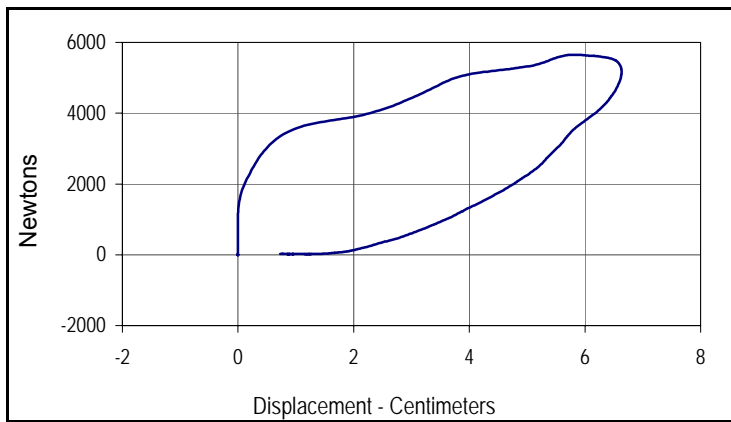
Curve Description			
Probe Force vs. Chest Deflection			
Plot No.	Type	SAE Class	Hysteresis
001	FIL	180	70.4
Peak Probe Force		Peak Chest Deflection	
5650		6.63

Tested Parameter		Units	Specification	Result	Pass/Fail
Dummy Soak Time		Minutes	≥240	485	Pass
Temperature During Soak	Max	°C	20.6 to 22.2	22.2	Pass
	Min	°C		21.7	Pass
Humidity During Soak	Max	%	10.0 to 70.0	38.4	Pass
	Min	%		23.1	Pass
Laboratory Temperature During Test		°C	20.6 to 22.2	22.1	Pass
Laboratory Humidity During Test		%	10.0 to 70.0	37.8	Pass
Probe Velocity		m/s	6.58 to 6.82	6.67	Pass
Peak Probe Force		Newtons	5159 to 5893	5650	Pass
Peak Sternum Deflection		CM	6.35 to 7.26	6.63	Pass
Internal Hysteresis		%	69 to 85	70.4	Pass
Overall Test Results					Pass

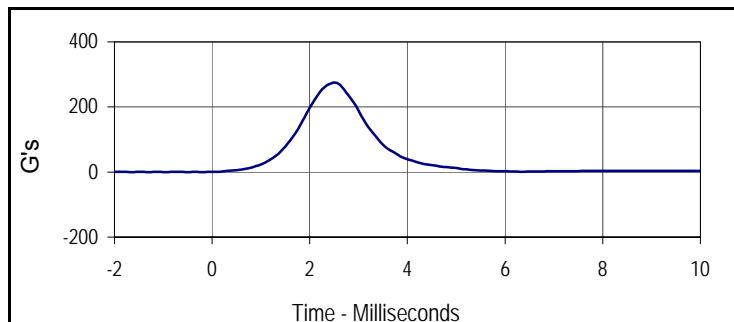
Curve Description			
Head Resultant			
Plot No.	Type	SAE Class	Units
001	RES	1000	G's
Max	Time	Min	Time
274.9	2.5	0.0	-0.2

Tested Parameter	Units	Specification	Result	Pass/Fail
Head Assembly Soak Time	Minutes	≥240	400	Pass
Temperature During Soak	Max	18.9 to 25.6	21.7	Pass
	Min		21.4	Pass
Humidity During Soak	Max	10.0 to 70.0	38.2	Pass
	Min		37.7	Pass
Laboratory Temperature During Test	°C	18.9 to 25.6	21.7	Pass
Laboratory Humidity During Test	%	10.0 to 70.0	38.0	Pass
Peak Resultant Acceleration	G's	250.0 to 300.0	274.9	Pass
Peak Lateral Acceleration	G's	≤15.0	4.3	Pass
Oscillations After Main Pulse	%	<10% of peak Res. Acceleration	1.3	Pass
Is Acceleration Unimodal?	Yes/No	Yes	Yes	Pass
Overall Test Results				Pass

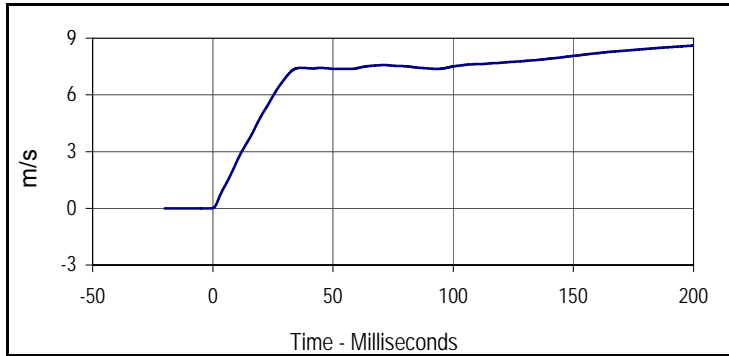
Curve Description			
Pendulum Velocity			
Plot No.	Type	SAE Class	Units
001	FIL	180	m/s
Max	Time	Min	Time
8.6	199.4	0.0	-1.1

Tested Parameter	Units	Specification	Result	Pass/Fail	
Neck Assembly Soak Time	Minutes	≥240	351	Pass	
Temperature During Soak	Max	20.6 to 22.2	21.7	Pass	
	Min		21.4	Pass	
Humidity During Soak	Max	10.0 to 70.0	38.2	Pass	
	Min		37.7	Pass	
Laboratory Temperature During Test	°C	20.6 to 22.2	21.6	Pass	
Laboratory Humidity During Test	%	10.0 to 70.0	37.9	Pass	
Pendulum Velocity	m/s	6.89 to 7.13	7.01	Pass	
Pendulum Deceleration	10 Msec.	m/s	2.1 to 2.5	2.5	Pass
	20 Msec.	m/s	4.0 to 5.0	4.9	Pass
	30 Msec.	m/s	5.8 to 7.0	6.9	Pass
"D" Plane Rotation	Max	Degrees	77.0 to 91.0	84.3	Pass
Peak Moment in Rotation	Max	Nm	69.0 to 83.0	82.3	Pass
Positive Moment Decay, Time To 10 Nm	Msec.	80.0 to 100.0	83.0	Pass	
Overall Test Results				Pass

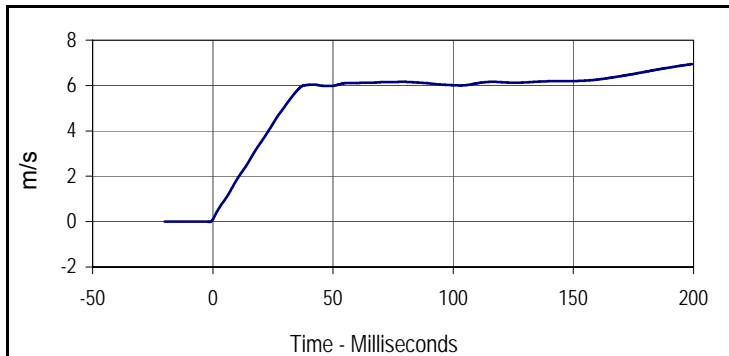
Curve Description			
Pendulum Velocity			
Plot No.	Type	SAE Class	Units
001	FIL	180	m/s
Max	Time	Min	Time
6.9	199.4	0.0	-1.5

Tested Parameter	Units	Specification	Result	Pass/Fail	
Neck Assembly Soak Time	Minutes	≥240	386	Pass	
Temperature During Soak	Max	20.6 to 22.2	21.7	Pass	
	Min		21.4	Pass	
Humidity During Soak	Max	10.0 to 70.0	38.2	Pass	
	Min		37.7	Pass	
Laboratory Temperature During Test	°C	20.6 to 22.2	21.5	Pass	
Laboratory Humidity During Test	%	10.0 to 70.0	37.7	Pass	
Pendulum Velocity	m/s	5.95 to 6.19	6.01	Pass	
Pendulum Deceleration	10 Msec.	m/s	1.5 to 1.9	1.9	Pass
	20 Msec.	m/s	3.1 to 3.9	3.5	Pass
	30 Msec.	m/s	4.6 to 5.6	5.1	Pass
"D" Plane Rotation	Max	Degrees	99.0 to 114.0	110.1	Pass
Peak Moment in Rotation	Max	Nm	-53.0 to -65.0	-63.3	Pass
Positive Moment Decay, Time To -10 Nm	Msec.	94.0 to 114.0	98.6	Pass	
Overall Test Results				Pass

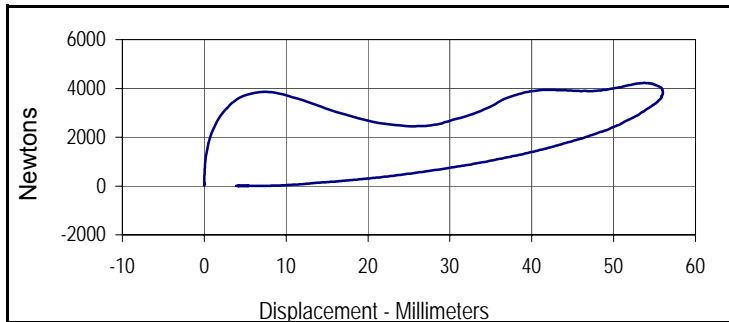
Curve Description			
Probe Force vs. Chest Deflection			
Plot No.	Type	SAE Class	Hysteresis
001	FIL	180	71.3
Peak Probe Force		Peak Chest Deflection	
4223.4		56.0

Tested Parameter	Units	Specification	Result	Pass/Fail
Dummy Soak Time	Minutes	≥240	436	Pass
Temperature During Soak	Max	20.6 to 22.2	21.7	Pass
	Min		21.4	Pass
Humidity During Soak	Max	10.0 to 70.0	38.2	Pass
	Min		37.7	Pass
Laboratory Temperature During Test	°C	20.6 to 22.2	21.5	Pass
Laboratory Humidity During Test	%	10.0 to 70.0	38.1	Pass
Probe Velocity	m/s	6.59 to 6.83	6.72	Pass
Peak Chest Deflection	mm	50.0 to 58.0	56.0	Pass
Peak Force Between 50 and 58 MM	Newtons	3900 to 4400	4005	Pass
Peak Force Between 18 and 50 MM	Newtons	≤4600	4223	Pass
Internal Hysteresis	%	69 to 85	71.3	Pass
Overall Test Results				Pass

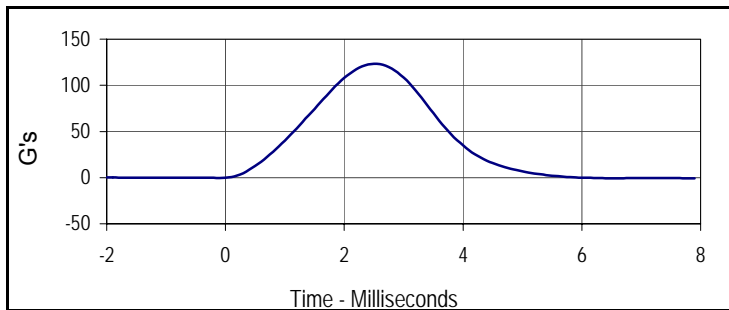
Curve Description			
Left Knee Acceleration			
Plot No.	Type	SAE Class	Units
002	FIL	600	G's
Max	Time	Min	Time
123.5	2.5	-1.2	0.0

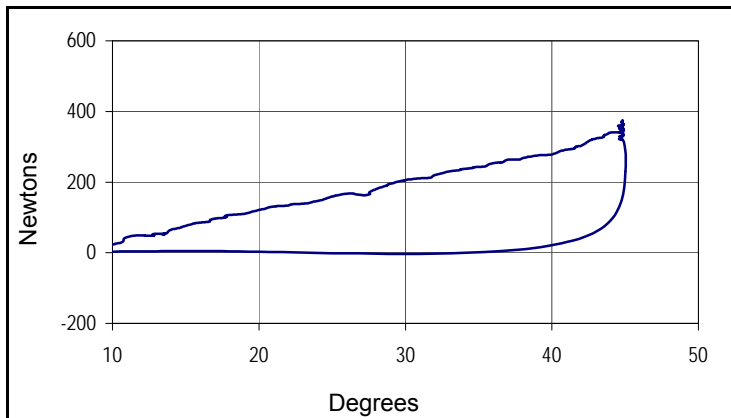
Curve Description		
Force vs Torso Rotation		
Plot No.	Type	Filter Freq
001	FIL	1 Hz
Peak Force		Peak Rotation
374.6		45.0

Tested Parameter		Units	Specification	Result	Pass/Fail
Dummy Soak Time		Minutes	≥240	591	Pass
Temperature During Soak	Max	°C	18.9 to 25.6	21.7	Pass
	Min	°C		21.4	Pass
Humidity During Soak	Max	%	10.0 to 70.0	38.2	Pass
	Min	%		37.7	Pass
Laboratory Temperature During Test		°C	18.9 to 25.6	21.4	Pass
Laboratory Humidity During Test		%	10.0 to 70.0	38.2	Pass
Initial Reference Plane Angle		Degrees	≤ 20	8.3	Pass
Peak Force at 45° +/-0.5°		Newtons	320.0 to 390.0	374.6	Pass
Torso Rotation Rate		deg/sec	0.5 to 1.5	1.0	Pass
Final Reference Plane Angle		Degrees	+/-8	2.9	Pass
Overall Test Results					Pass
