REPORT NUMBER: SINCAP-KAR-15-017

**NEW CAR ASSESSMENT PROGRAM (NCAP)
MOVING DEFORMABLE BARRIER SIDE IMPACT TEST**

**CHRYSLER GROUP LLC
2015 DODGE CHALLENGER SXT 2-DOOR COUPE**

NHTSA No: M20150302

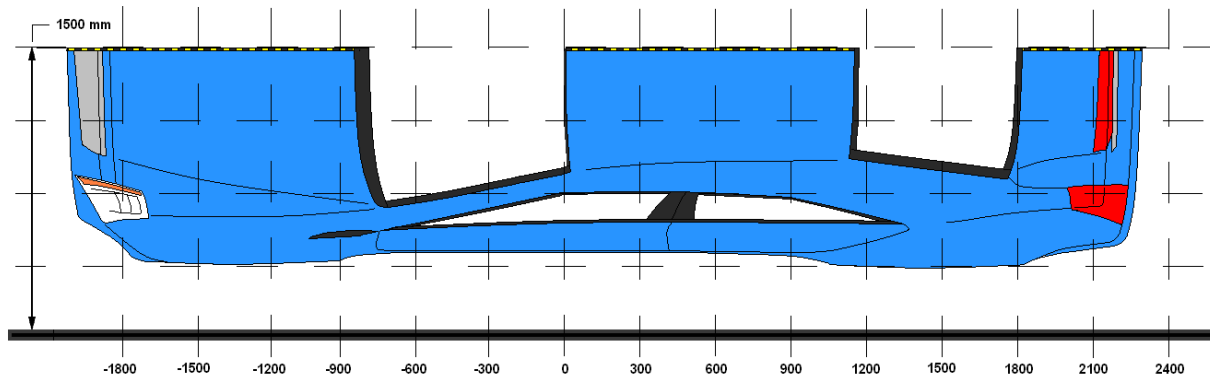
VEHICLE AND MDB DAMAGE PROFILE DISTANCES

VEHICLE DAMAGE PROFILE DISTANCES

MDB DAMAGE PROFILE DISTANCES

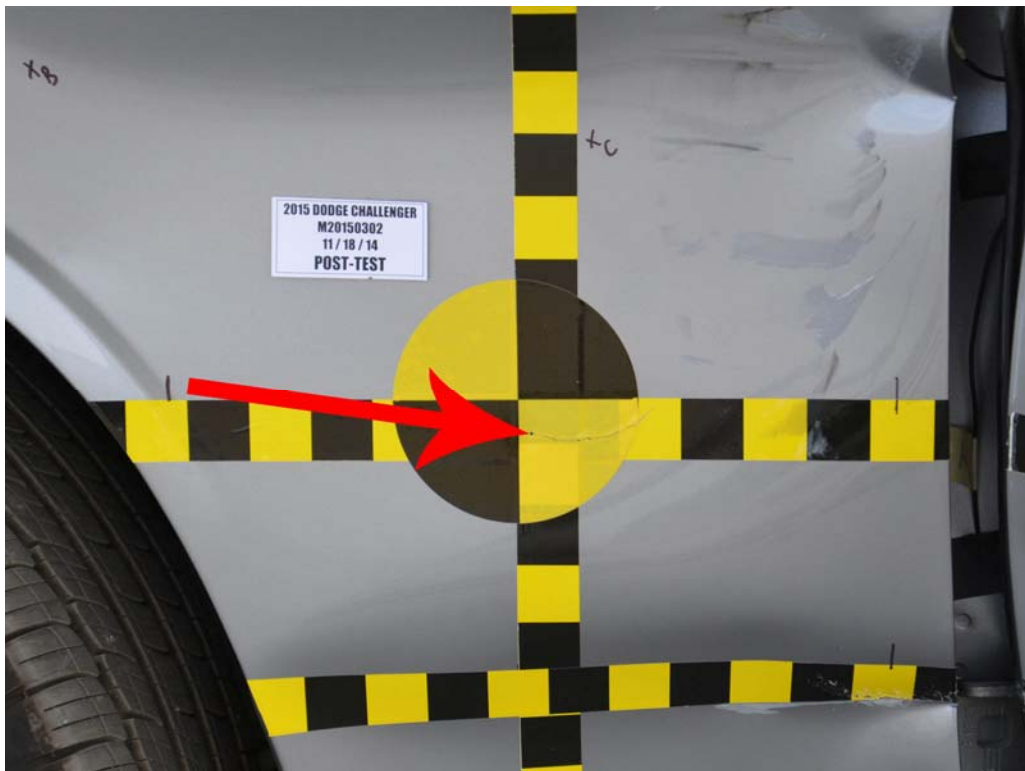
FIGURE 20. Post-Test Close-Up View of Impact Point Target

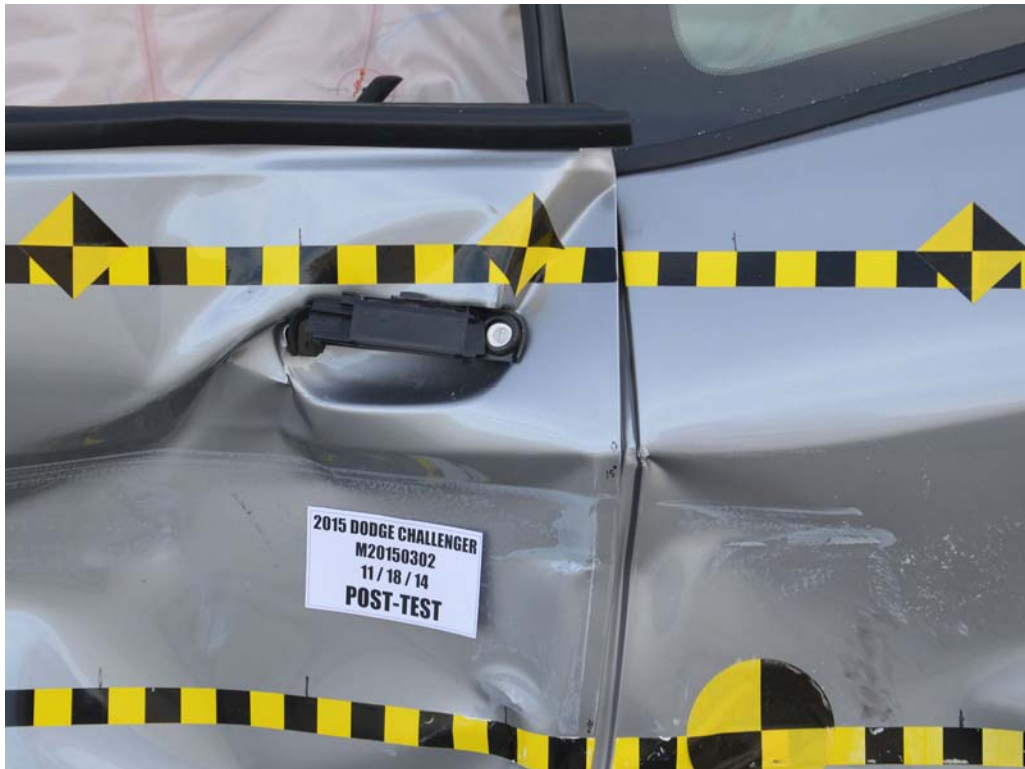
FIGURE 22. Post-Test Left Front Door Latch Close-Up

The door on the struck side of the vehicle did not separate from the body at the hinges or latch. The opposite side door did not open during the side impact event.

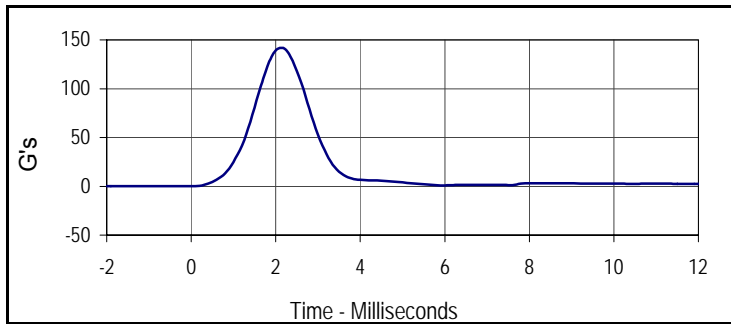
Curve Description			
Head Resultant			
Plot No.	Type	SAE Class	Units
001	RES	1000	G's
Max	Time	Min	Time
141.9	2.1	0.1	-1.6

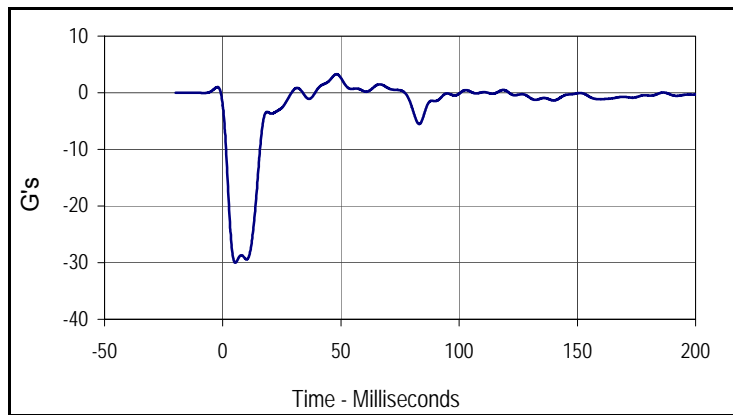
Curve Description			
Pendulum Deceleration			
Plot No.	Type	SAE Class	Units
001	FIL	60	G's
Max	Time	Min	Time
3.3	48.1	-30.0	5.3

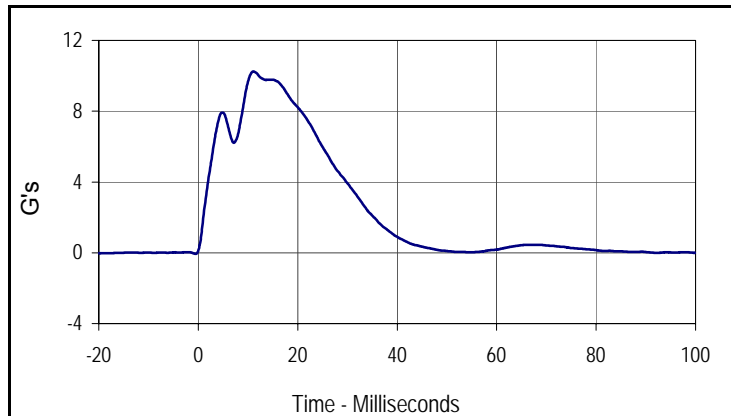
Curve Description			
Impactor Acceleration			
Plot No.	Type	SAE Class	Units
001	FIL	180	G's
Max	Time	Min	Time
10.2	11.0	-0.1	-0.6

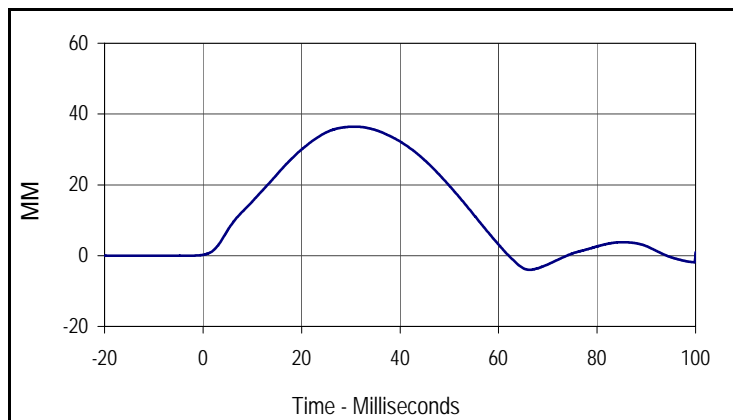
Curve Description			
Upper Rib Deflection (459 mm Drop Height)			
Plot No.	Type	SAE Class	Units
001	FIL	180	MM
Max	Time	Min	Time
36.4	30.7	-4.0	66.3

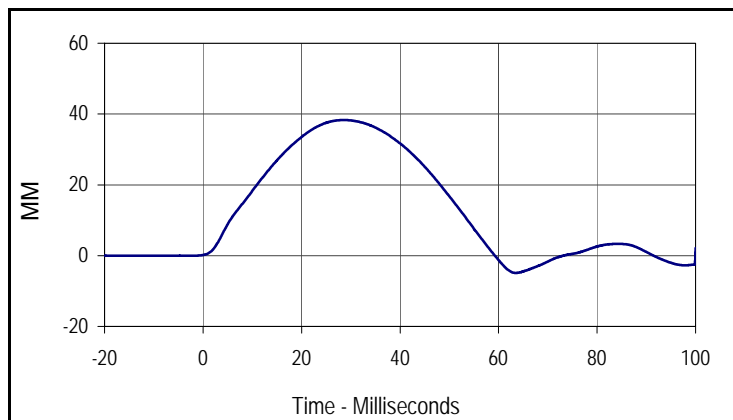
Curve Description			
Middle Rib Deflection (459 mm Drop Height)			
Plot No.	Type	SAE Class	Units
001	FIL	180	MM
Max	Time	Min	Time
38.3	28.6	-4.9	63.5

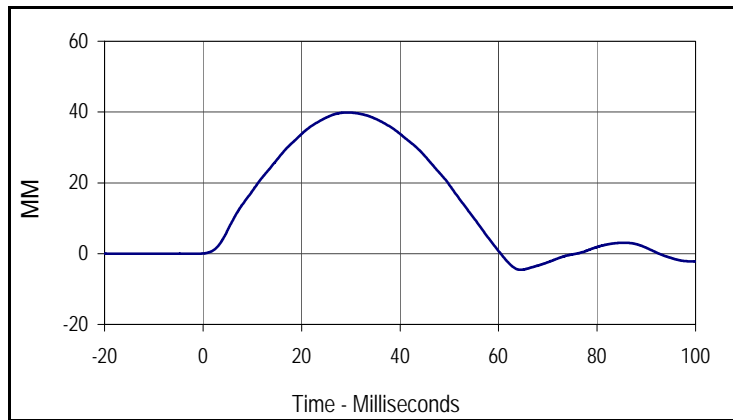
Curve Description			
Lower Rib Deflection (459 mm Drop Height)			
Plot No.	Type	SAE Class	Units
001	FIL	180	MM
Max	Time	Min	Time
39.9	29.3	-4.6	64.5

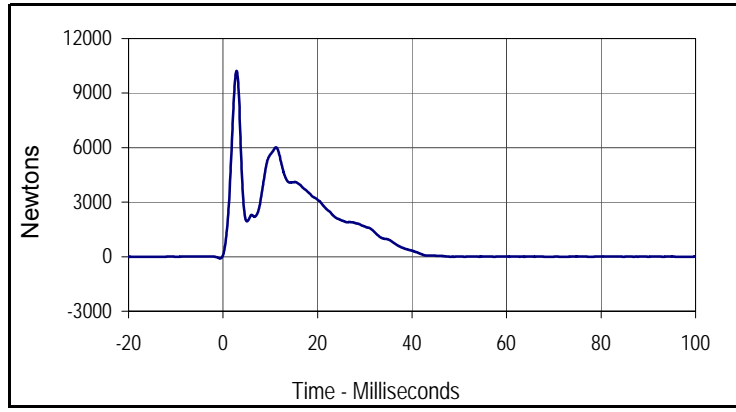
Curve Description			
Impactor Force			
Plot No.	Type	SAE Class	Units
001	FIL	180	Newtons
Max	Time	Min	Time
10223.1	2.9	-90.7	-0.6

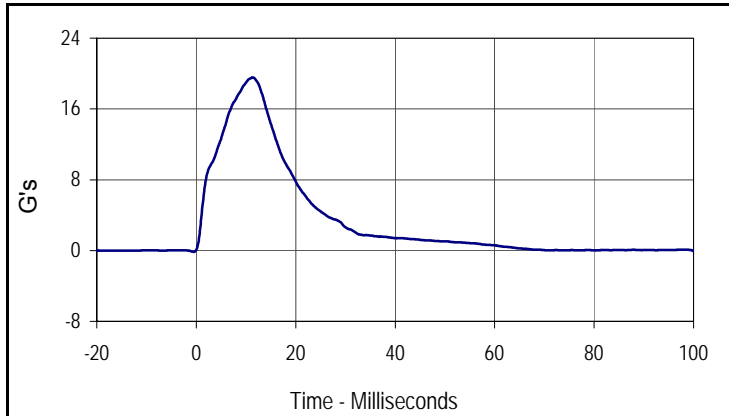
Curve Description			
Impactor Acceleration			
Plot No.	Type	SAE Class	Units
001	FIL	180	G's
Max	Time	Min	Time
19.6	11.4	-0.1	-0.5

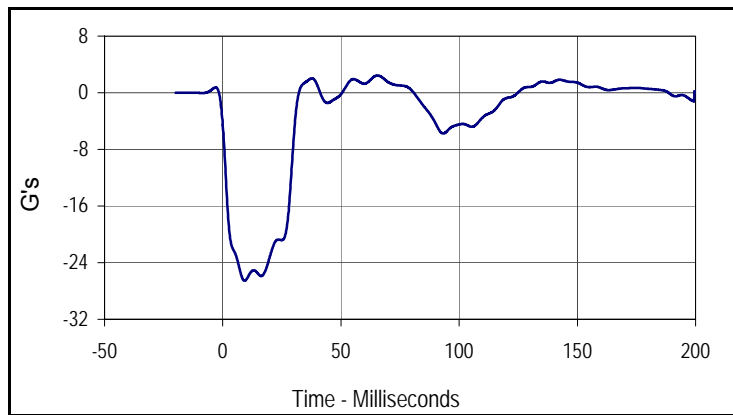
Curve Description			
Pendulum Deceleration			
Plot No.	Type	SAE Class	Units
001	FIL	60	G's
Max	Time	Min	Time
2.4	66.1	-26.6	9.8

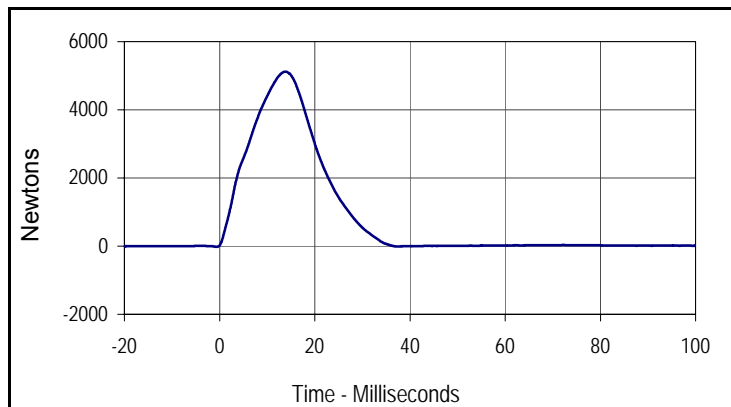
Curve Description			
Impactor Force			
Plot No.	Type	SAE Class	Units
001	FIL	180	Newtons
Max	Time	Min	Time
5121.5	13.8	-19.6	-0.7

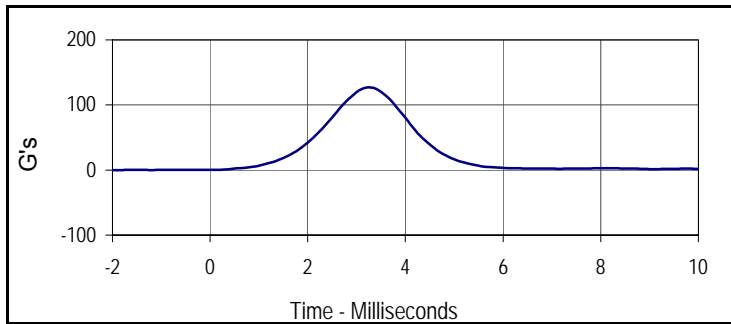
Curve Description			
Head Resultant			
Plot No.	Type	SAE Class	Units
001	RES	1000	G's
Max	Time	Min	Time
126.9	3.3	0.1	-2.0

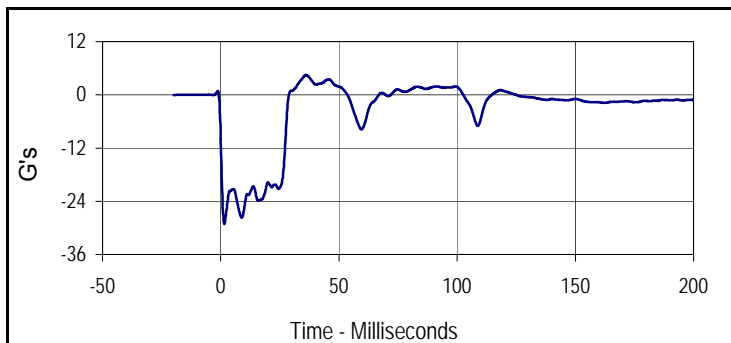
Curve Description			
Pendulum Deceleration			
Plot No.	Type	SAE Class	Units
001	FIL	180	G's
Max	Time	Min	Time
4.5	0.0	-29.1	0.0

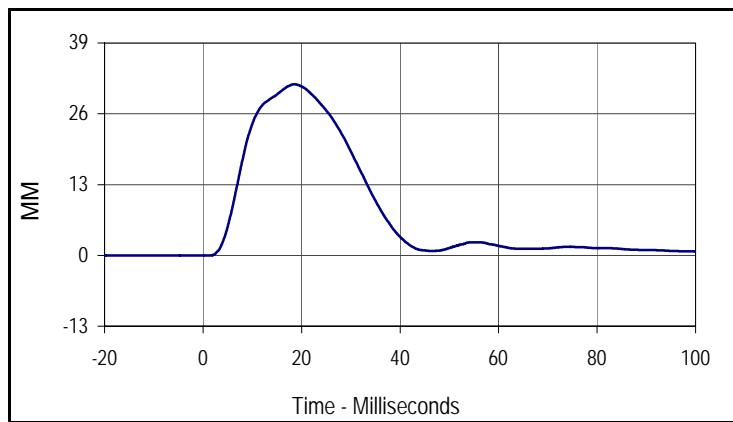
Curve Description			
Shoulder Deflection			
Plot No.	Type	SAE Class	Units
001	FIL	600	MM
Max	Time	Min	Time
31.4	18.5	0.0	1.2

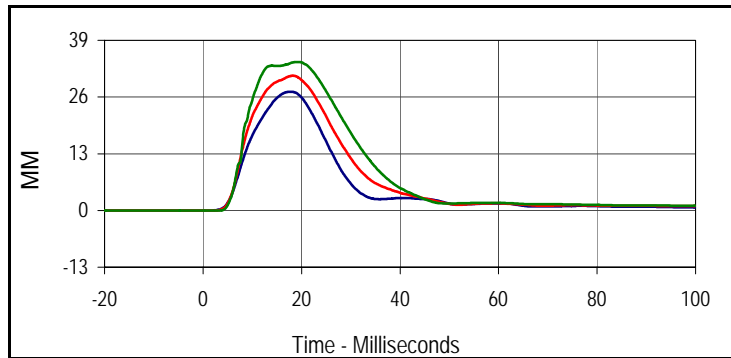
Curve Description			
Upper Thorax Deflection			
Plot No.	Type	SAE Class	Units
001	FIL	600	MM
Max	Time	Min	Time
27.2	17.6	0.0	-8.4
Middle Thorax Deflection			
Max	Time	Min	Time
30.9	18.2	0.0	-4.4
Lower Thorax Deflection			
Max	Time	Min	Time
34.0	18.9	0.0	-9.8

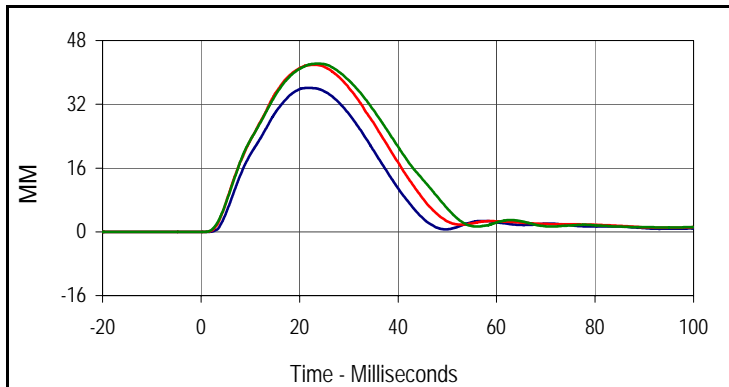
Curve Description			
Upper Thorax Deflection			
Plot No.	Type	SAE Class	Units
001	FIL	600	MM
Max	Time	Min	Time
36.1	21.9	0.0	-15.1
Middle Thorax Deflection			
Max	Time	Min	Time
41.9	23.1	0.0	-10.3
Lower Thorax Deflection			
Max	Time	Min	Time
42.2	23.7	0.0	-13.4

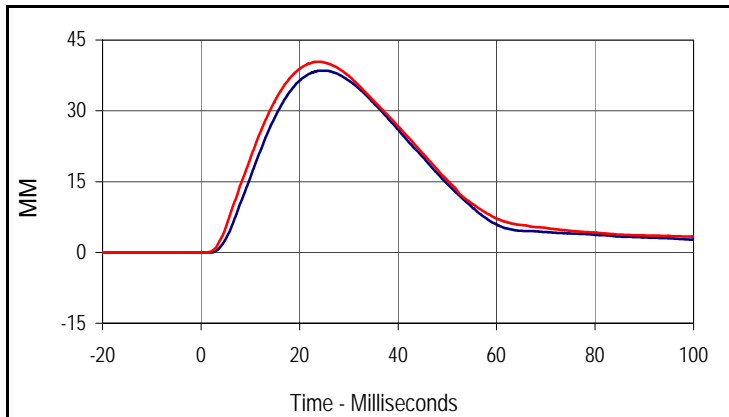
Curve Description			
Upper Abdominal Rib Deflection			
Plot No.	Type	SAE Class	Units
001	FIL	600	MM
Max	Time	Min	Time
38.5	25.0	0.0	-3.7
Curve Description			
Lower Abdominal Rib Deflection			
Plot No.	Type	SAE Class	Units
002	FIL	600	MM
Max	Time	Min	Time
40.4	23.8	0.0	-8.7

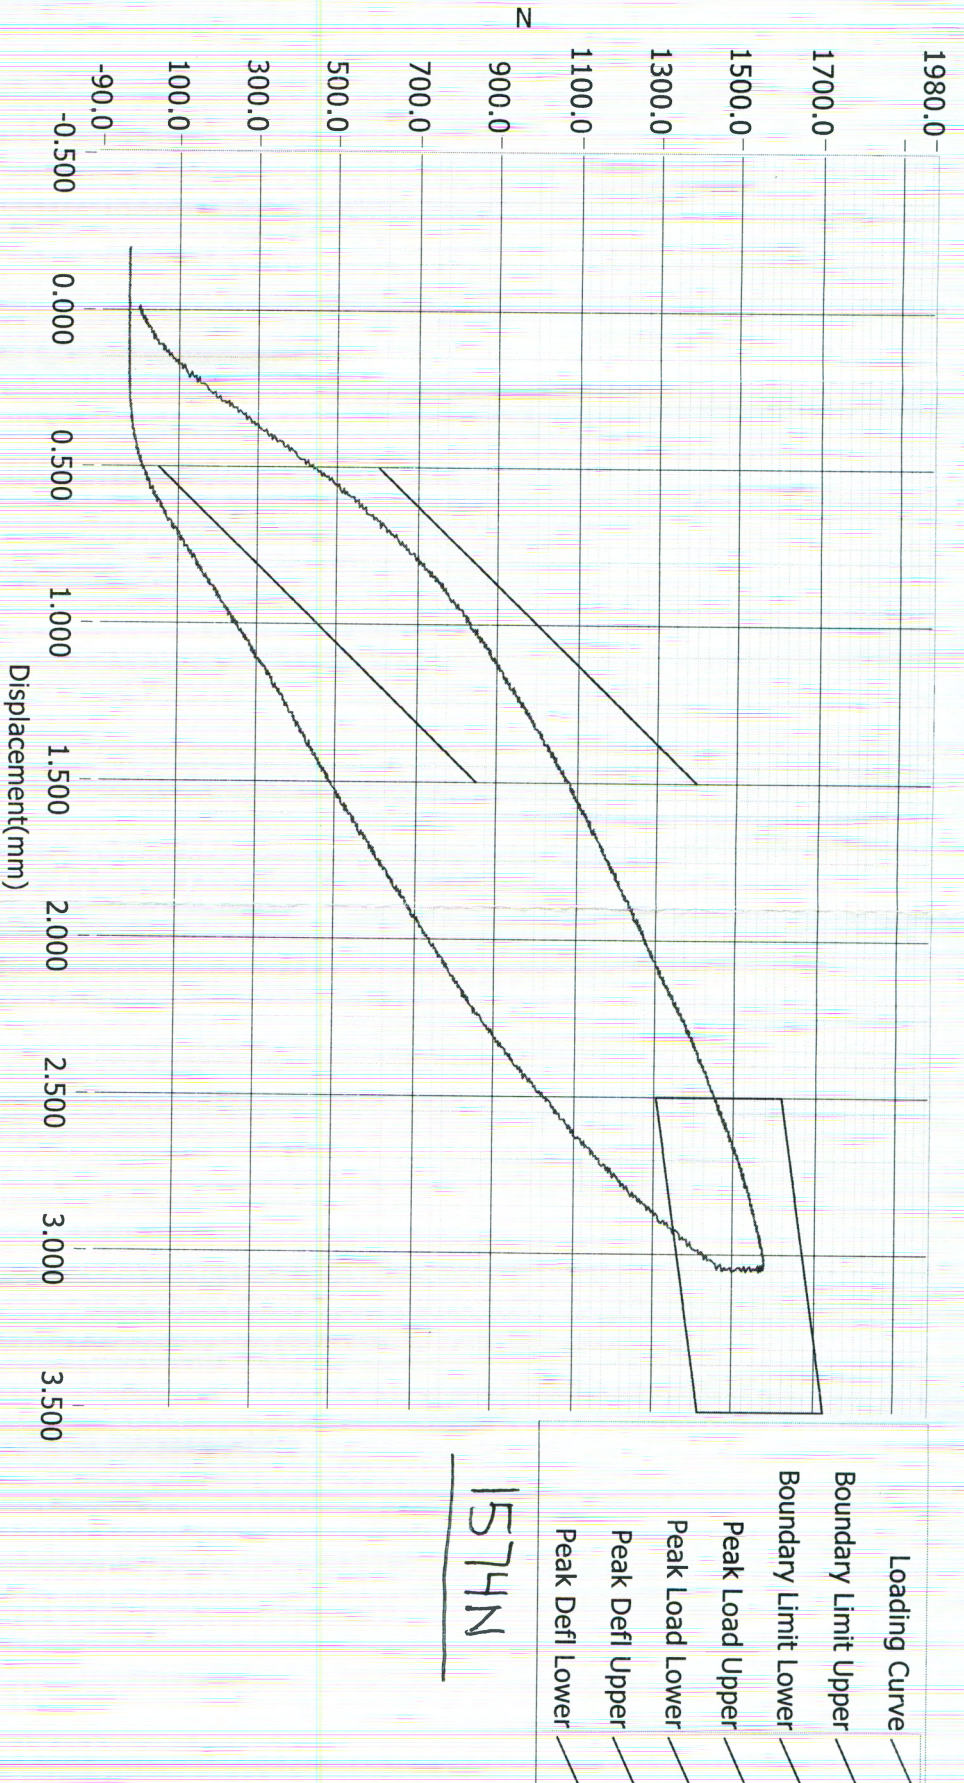
Resultant Data - SIDIIS Plug Compression

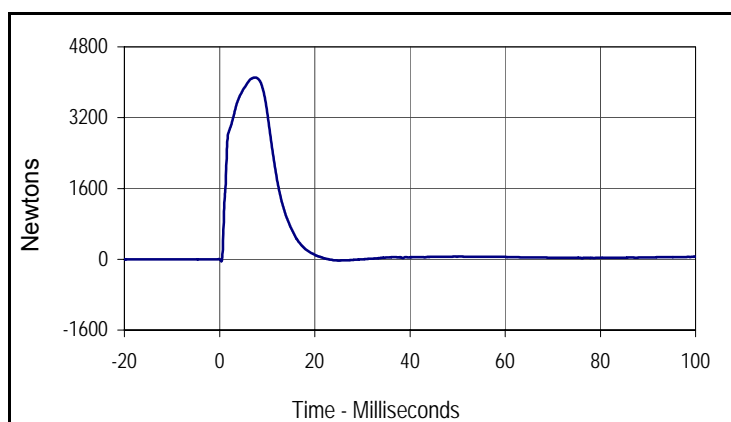
Curve Description			
Pelvis Acetabulum Force			
Plot No.	Type	SAE Class	Units
001	FIL	600	Newtons
Max	Time	Min	Time
4104.9	7.6	-42.5	0.4

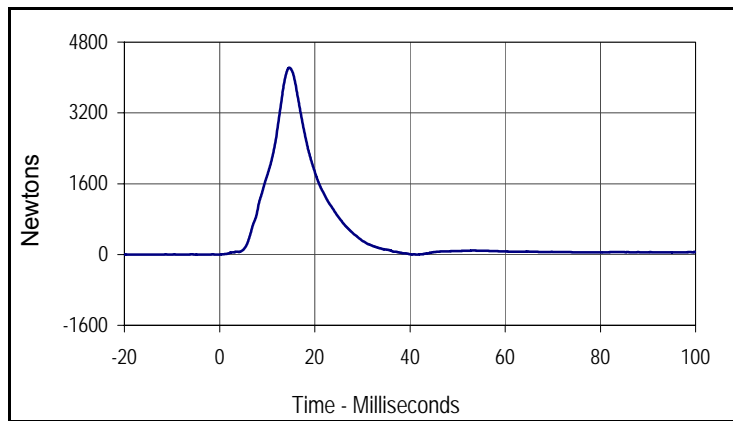
Curve Description			
Pelvis Iliac Force			
Plot No.	Type	SAE Class	Units
001	FIL	600	Newtons
Max	Time	Min	Time
4222.8	14.7	-2.4	-19.1

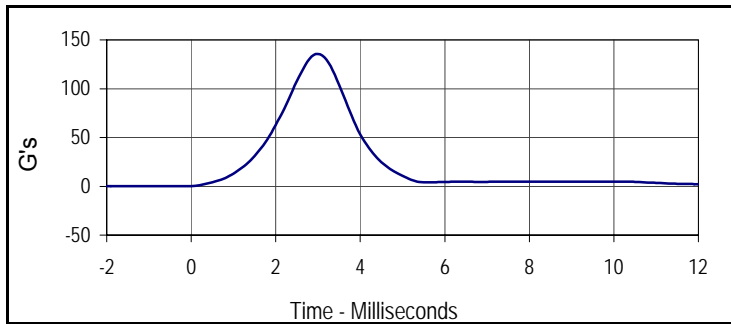
Curve Description			
Head Resultant			
Plot No.	Type	SAE Class	Units
001	RES	1000	G's
Max	Time	Min	Time
135.6	3.0	0.0	-0.5

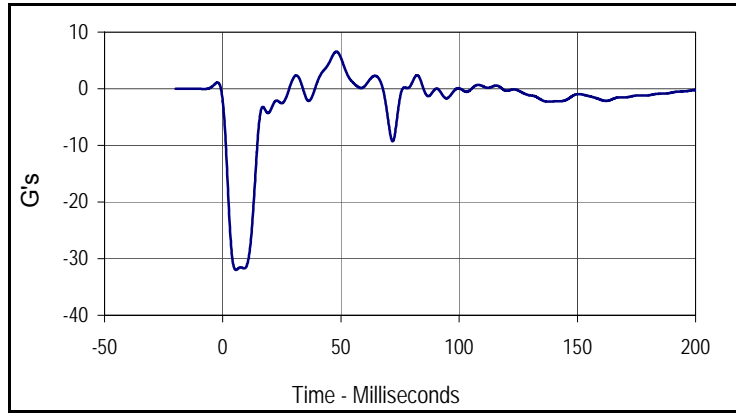
Curve Description			
Pendulum Deceleration			
Plot No.	Type	SAE Class	Units
001	FIL	60	G's
Max	Time	Min	Time
6.5	48.1	-32.0	5.6

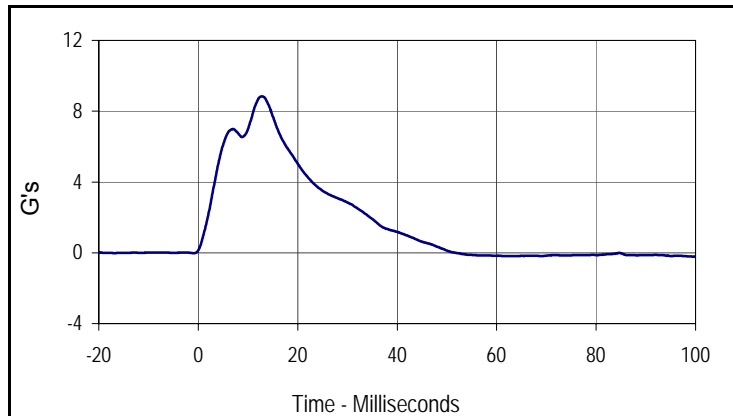
Curve Description			
Impactor Acceleration			
Plot No.	Type	SAE Class	Units
001	FIL	180	G's
Max	Time	Min	Time
8.8	12.8	-0.2	99.6

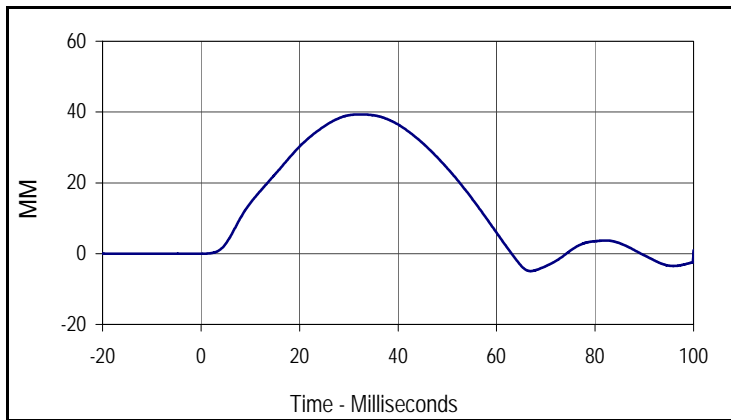
Curve Description			
Upper Rib Deflection (459 mm Drop Height)			
Plot No.	Type	SAE Class	Units
001	FIL	180	MM
Max	Time	Min	Time
39.3	32.4	-5.0	66.9

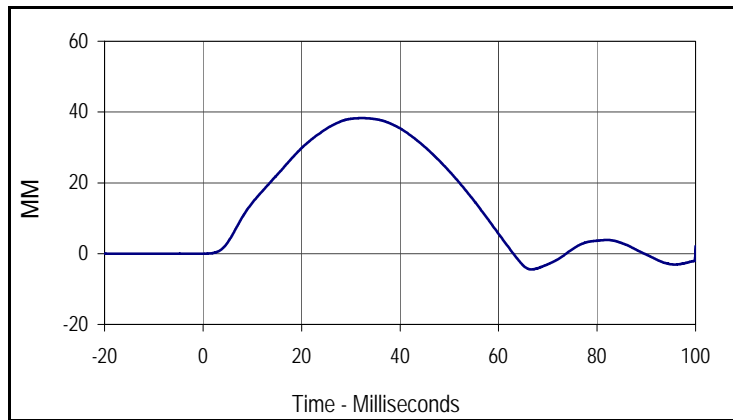
Curve Description			
Middle Rib Deflection (459 mm Drop Height)			
Plot No.	Type	SAE Class	Units
001	FIL	180	MM
Max	Time	Min	Time
38.3	32.2	-4.5	66.7

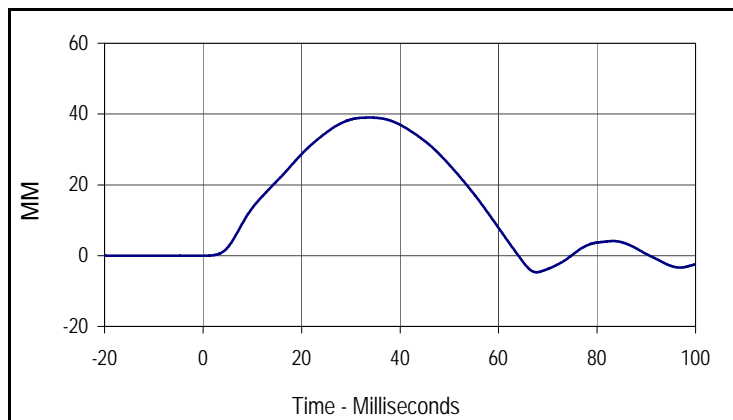
Curve Description			
Lower Rib Deflection (459 mm Drop Height)			
Plot No.	Type	SAE Class	Units
001	FIL	180	MM
Max	Time	Min	Time
39.0	34.0	-4.7	67.7

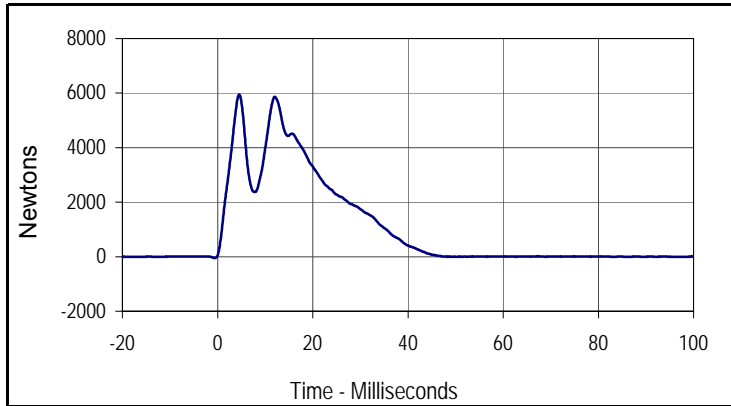
Curve Description			
Impactor Force			
Plot No.	Type	SAE Class	Units
001	FIL	180	Newtons
Max	Time	Min	Time
5947.7	4.6	-50.0	-0.6

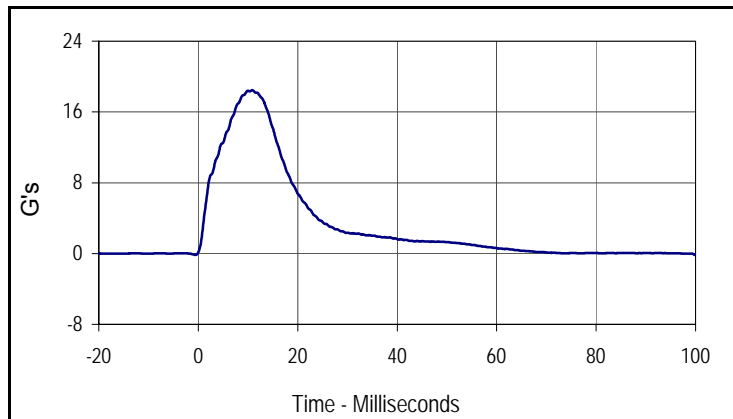
Curve Description			
Impactor Acceleration			
Plot No.	Type	SAE Class	Units
001	FIL	180	G's
Max	Time	Min	Time
18.5	10.9	-0.1	-0.6

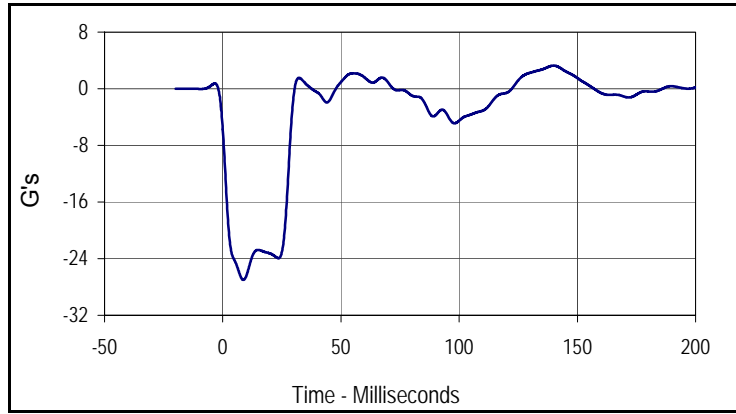
Curve Description			
Pendulum Deceleration			
Plot No.	Type	SAE Class	Units
001	FIL	60	G's
Max	Time	Min	Time
3.3	140.5	-27.0	9.3

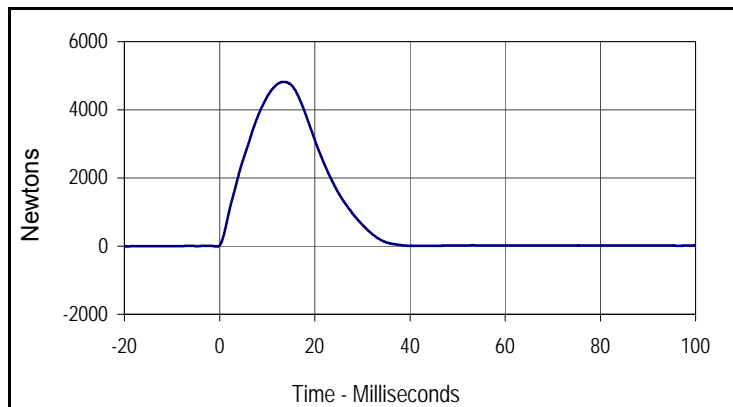
Curve Description			
Impactor Force			
Plot No.	Type	SAE Class	Units
001	FIL	180	Newtons
Max	Time	Min	Time
4820.2	13.5	-10.2	-0.6

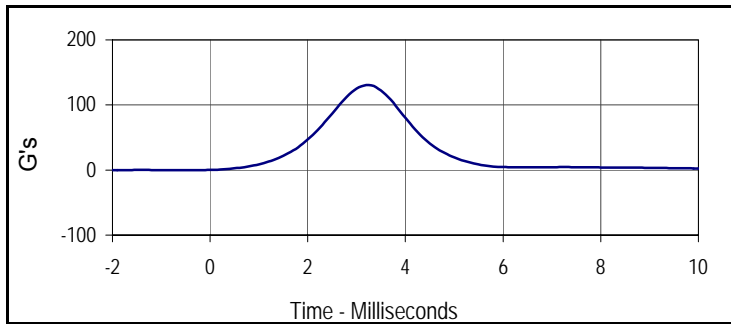
Curve Description			
Head Resultant			
Plot No.	Type	SAE Class	Units
001	RES	1000	G's
Max	Time	Min	Time
130.5	3.2	0.0	-0.5

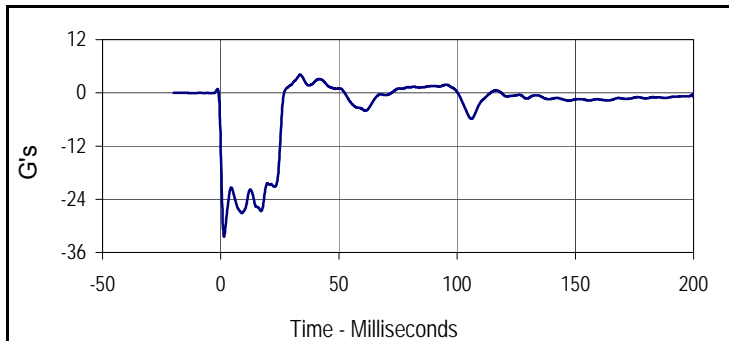
Curve Description			
Pendulum Deceleration			
Plot No.	Type	SAE Class	Units
001	FIL	180	G's
Max	Time	Min	Time
4.1	0.0	-32.4	0.0

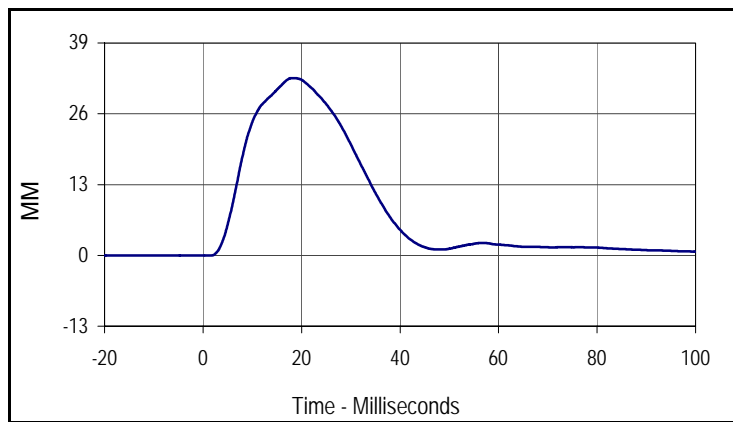
Curve Description			
Shoulder Deflection			
Plot No.	Type	SAE Class	Units
001	FIL	600	MM
Max	Time	Min	Time
32.5	18.7	0.0	-9.5

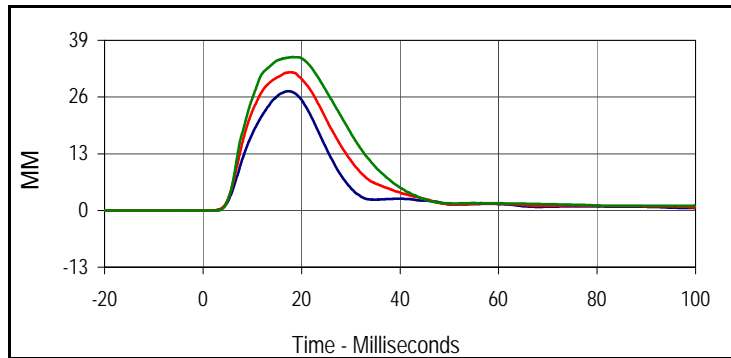
Curve Description			
Upper Thorax Deflection			
Plot No.	Type	SAE Class	Units
001	FIL	600	MM
Max	Time	Min	Time
27.3	17.3	0.0	-10.8
Middle Thorax Deflection			
Max	Time	Min	Time
31.7	17.8	0.0	-12.5
Lower Thorax Deflection			
Max	Time	Min	Time
35.2	18.2	0.0	-11.0

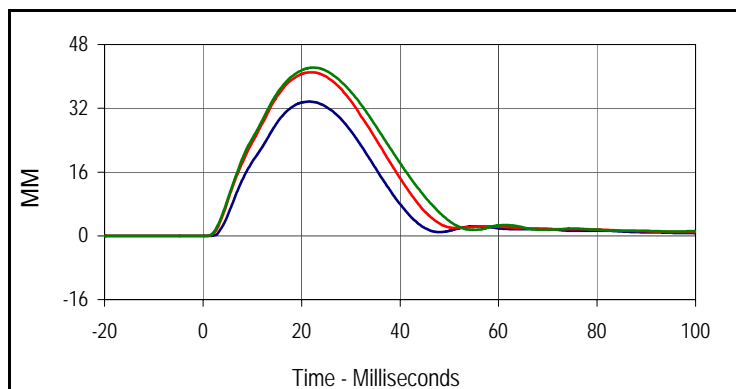
Curve Description			
Upper Thorax Deflection			
Plot No.	Type	SAE Class	Units
001	FIL	600	MM
Max	Time	Min	Time
33.7	21.6	0.0	-4.3
Middle Thorax Deflection			
Max	Time	Min	Time
41.0	22.0	0.0	-6.9
Lower Thorax Deflection			
Max	Time	Min	Time
42.2	22.4	0.0	-7.9

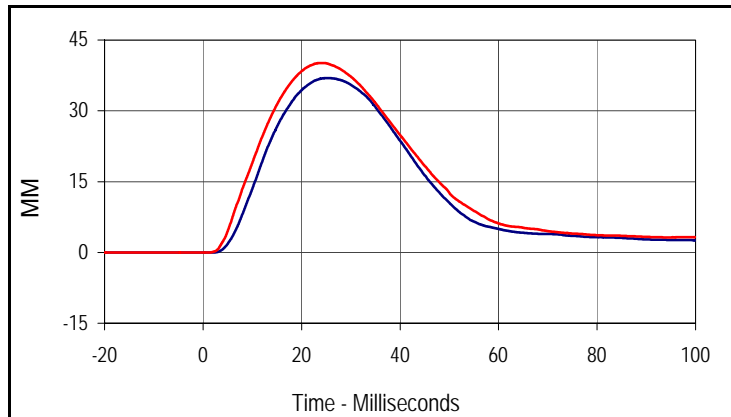
Curve Description			
Upper Abdominal Rib Deflection			
Plot No.	Type	SAE Class	Units
001	FIL	600	MM
Max	Time	Min	Time
36.9	25.2	0.0	-11.6
Curve Description			
Lower Abdominal Rib Deflection			
Plot No.	Type	SAE Class	Units
002	FIL	600	MM
Max	Time	Min	Time
40.1	24.0	0.0	-5.2

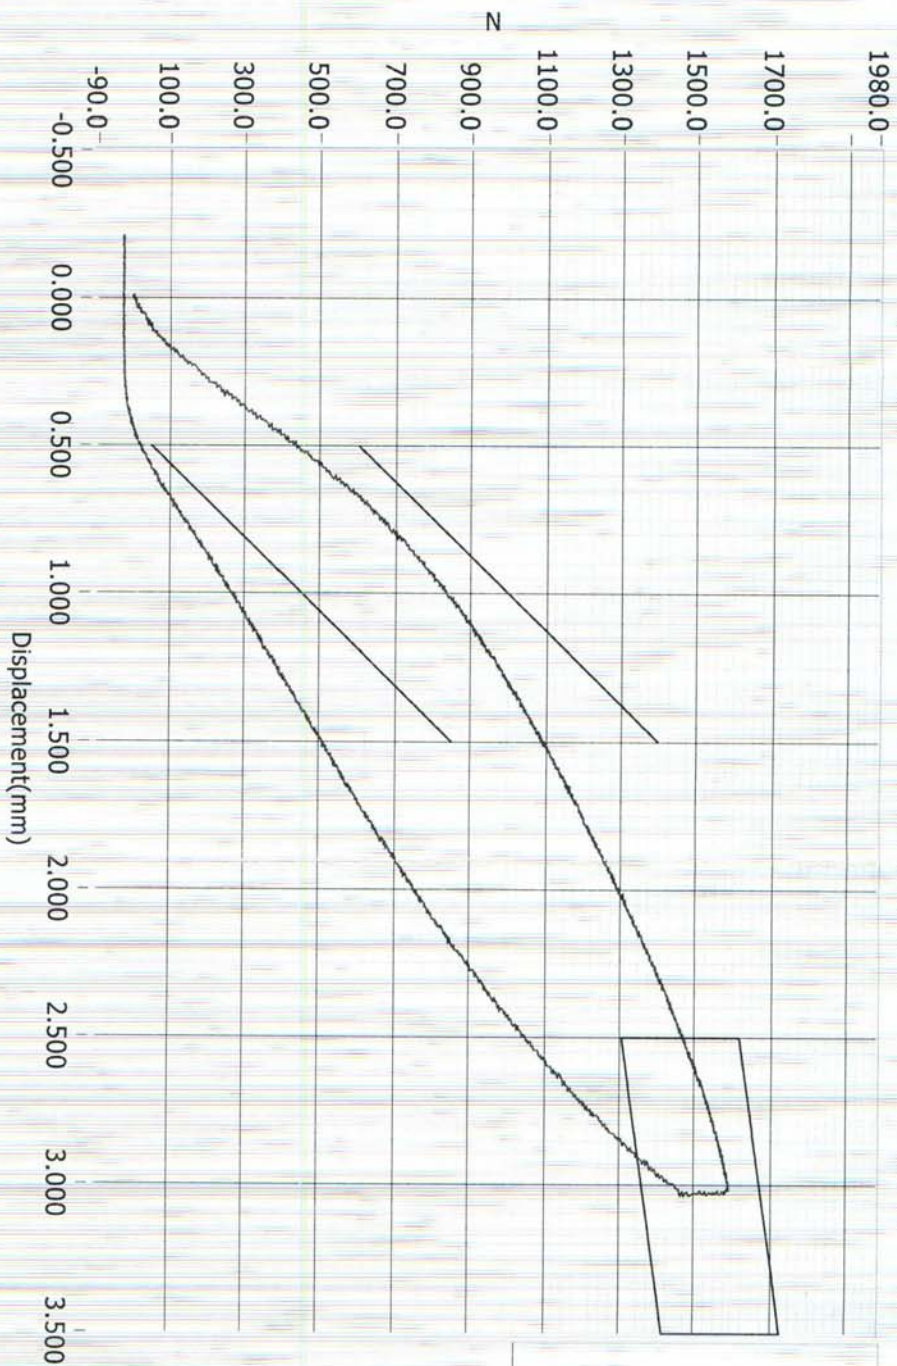
Resultant Data - SIDIIs Plug Compression

- Loading Curve
- Boundary Limit Upper
- Boundary Limit Lower
- Peak Load Upper
- Peak Load Lower
- Peak Defl Upper
- Peak Defl Lower

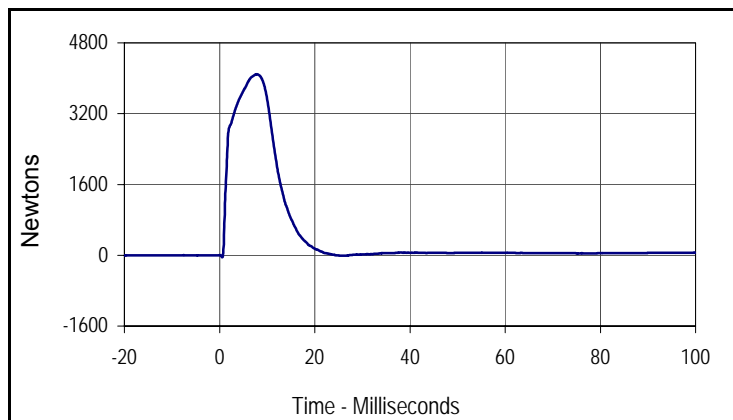
Curve Description			
Pelvis Acetabulum Force			
Plot No.	Type	SAE Class	Units
001	FIL	600	Newtons
Max	Time	Min	Time
4089.2	7.8	-44.7	0.6

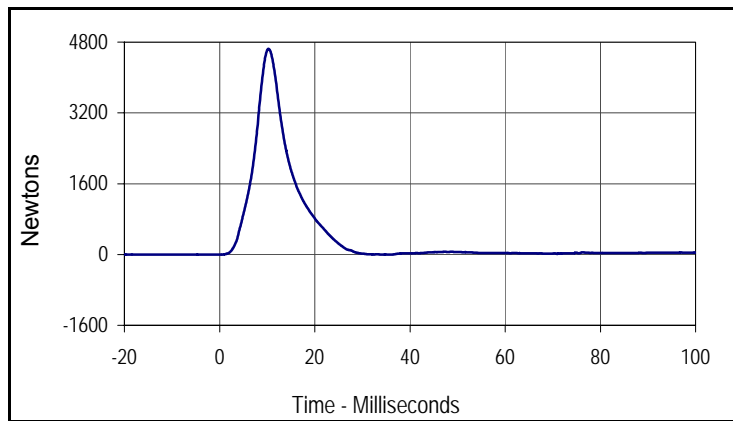
Curve Description			
Pelvis Iliac Force			
Plot No.	Type	SAE Class	Units
001	FIL	600	Newtons
Max	Time	Min	Time
4647.7	10.3	-3.0	35.4
