**REPORT NUMBER: SPNCAP-MGA-2015-032**

**NEW CAR ASSESSMENT PROGRAM (NCAP)  
Side Impact Pole Test**

**TOYOTA MOTOR MANUFACTURING, INDIANA, INC.  
2015 Toyota Sienna L Minivan  
NHTSA No.: O20155104**

**FINAL REPORT**

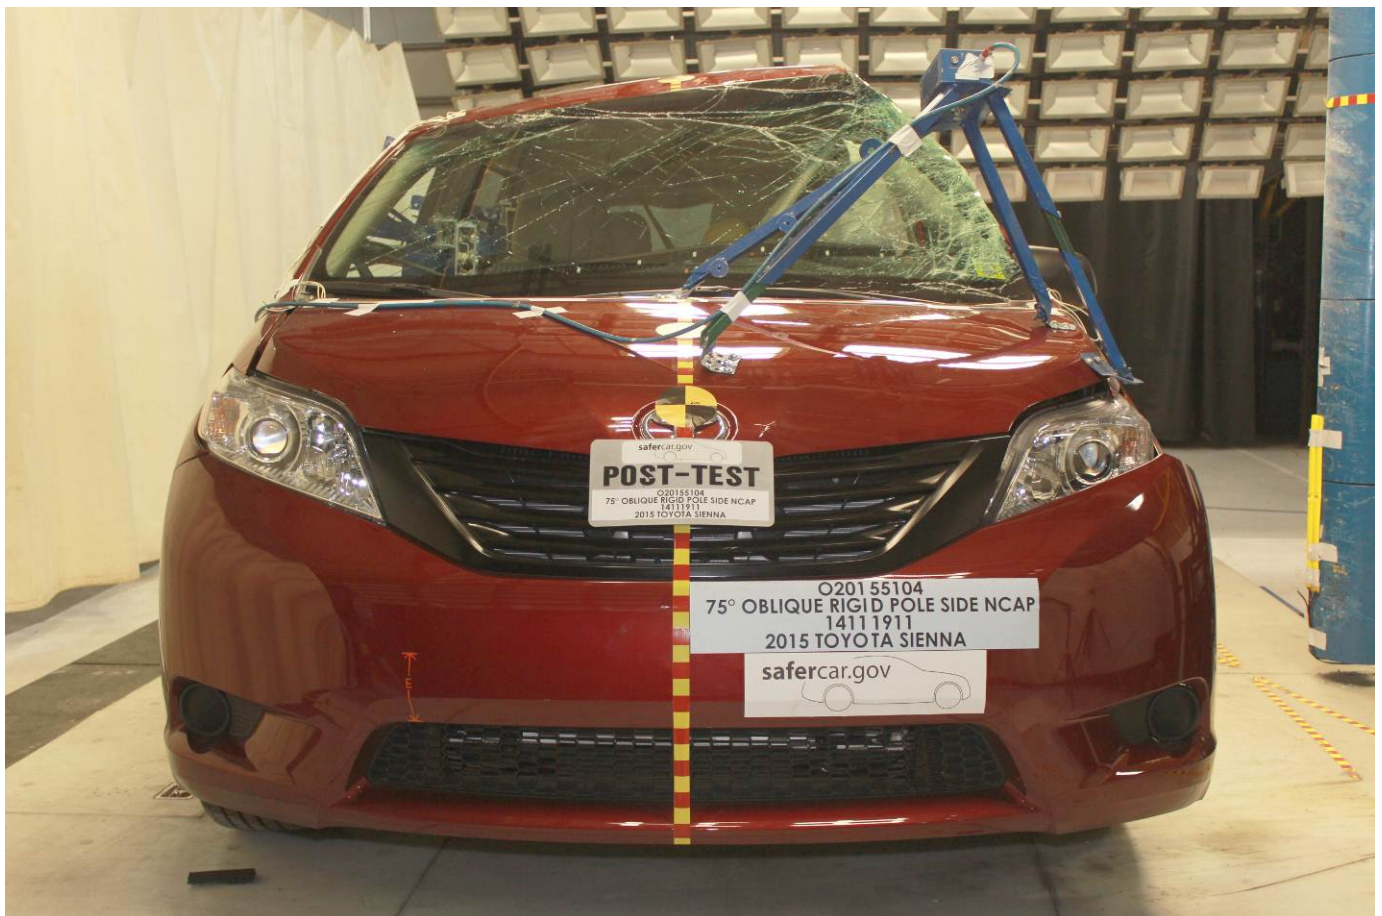
Post-Test Frontal View of Test Vehicle

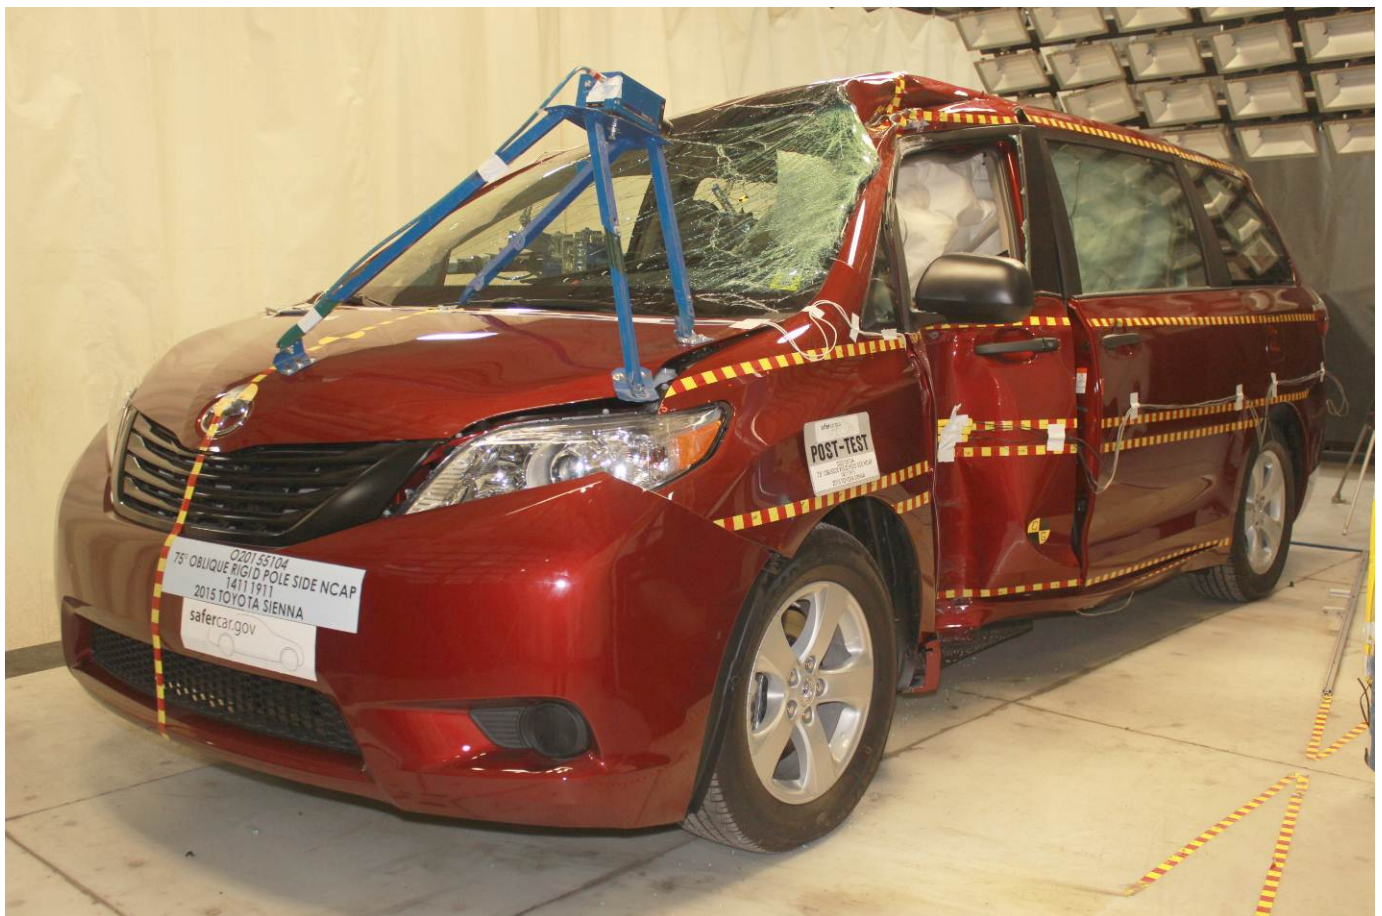
Post-Test Left Front  $\frac{3}{4}$  View of Test Vehicle

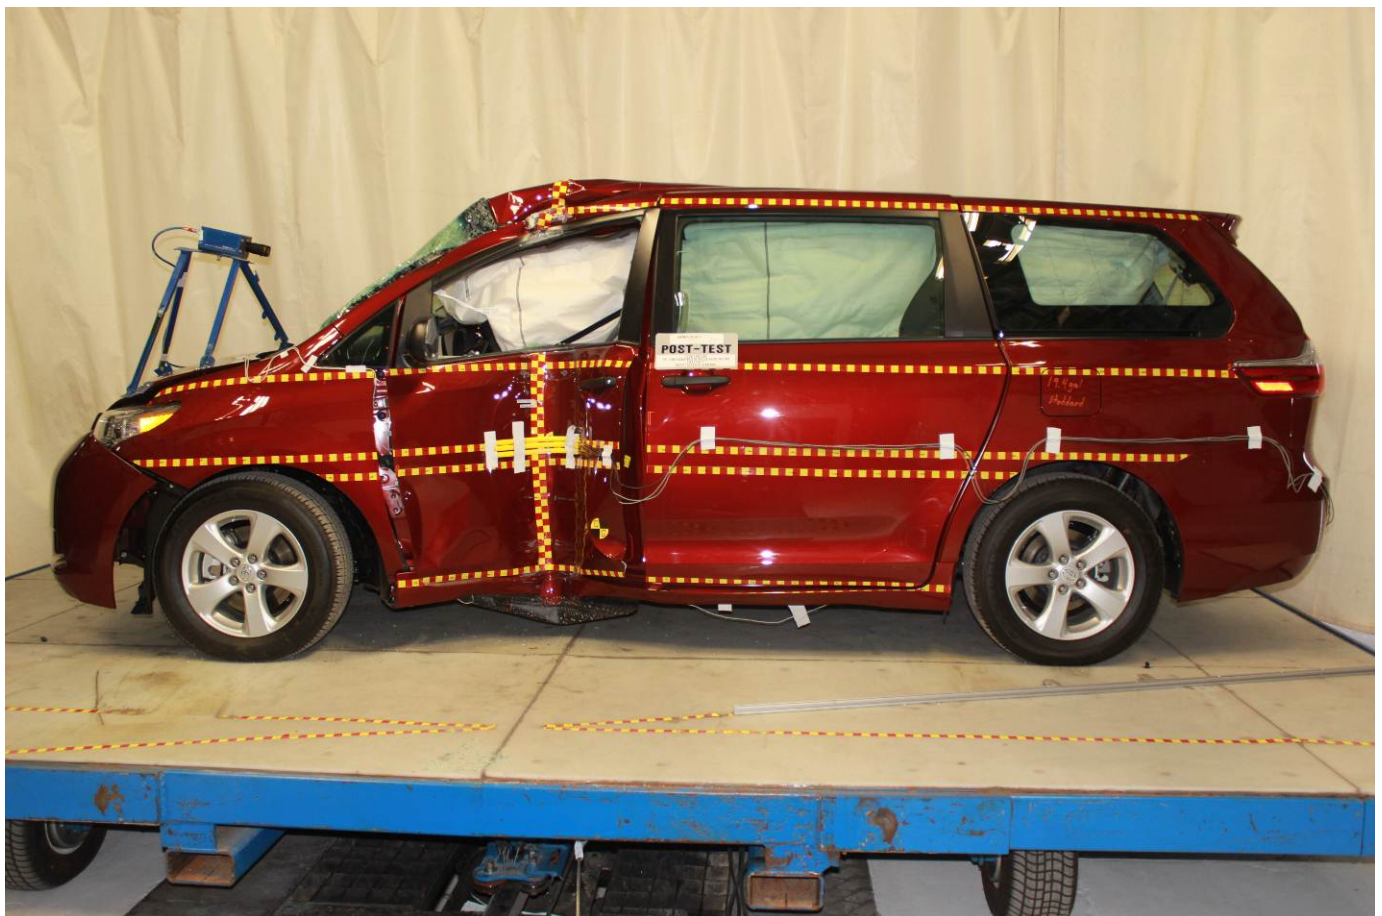
Post-Test Left Side View of Test Vehicle

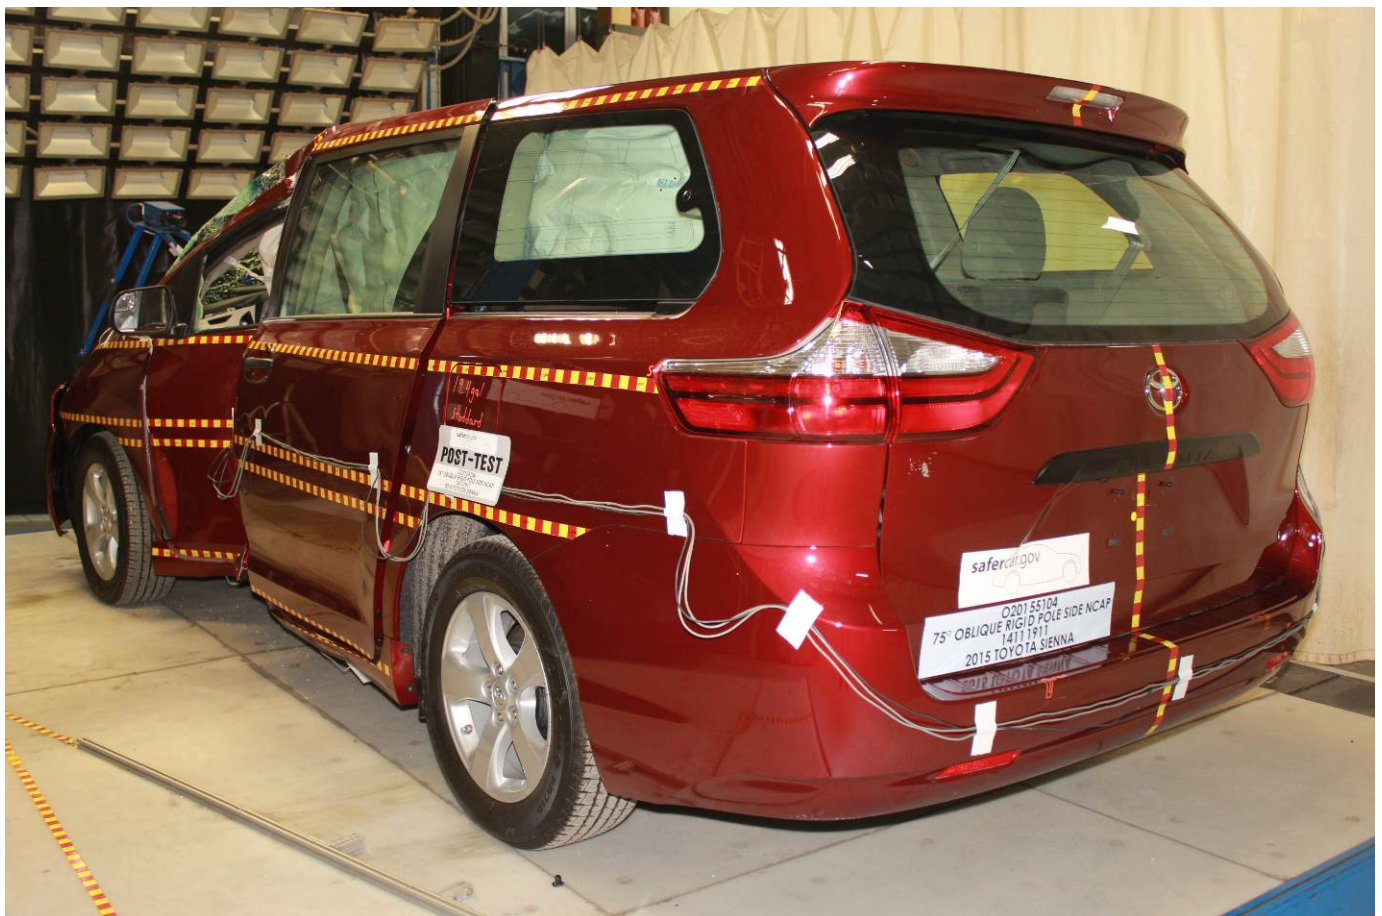
Post-Test Left Rear  $\frac{3}{4}$  View of Test Vehicle

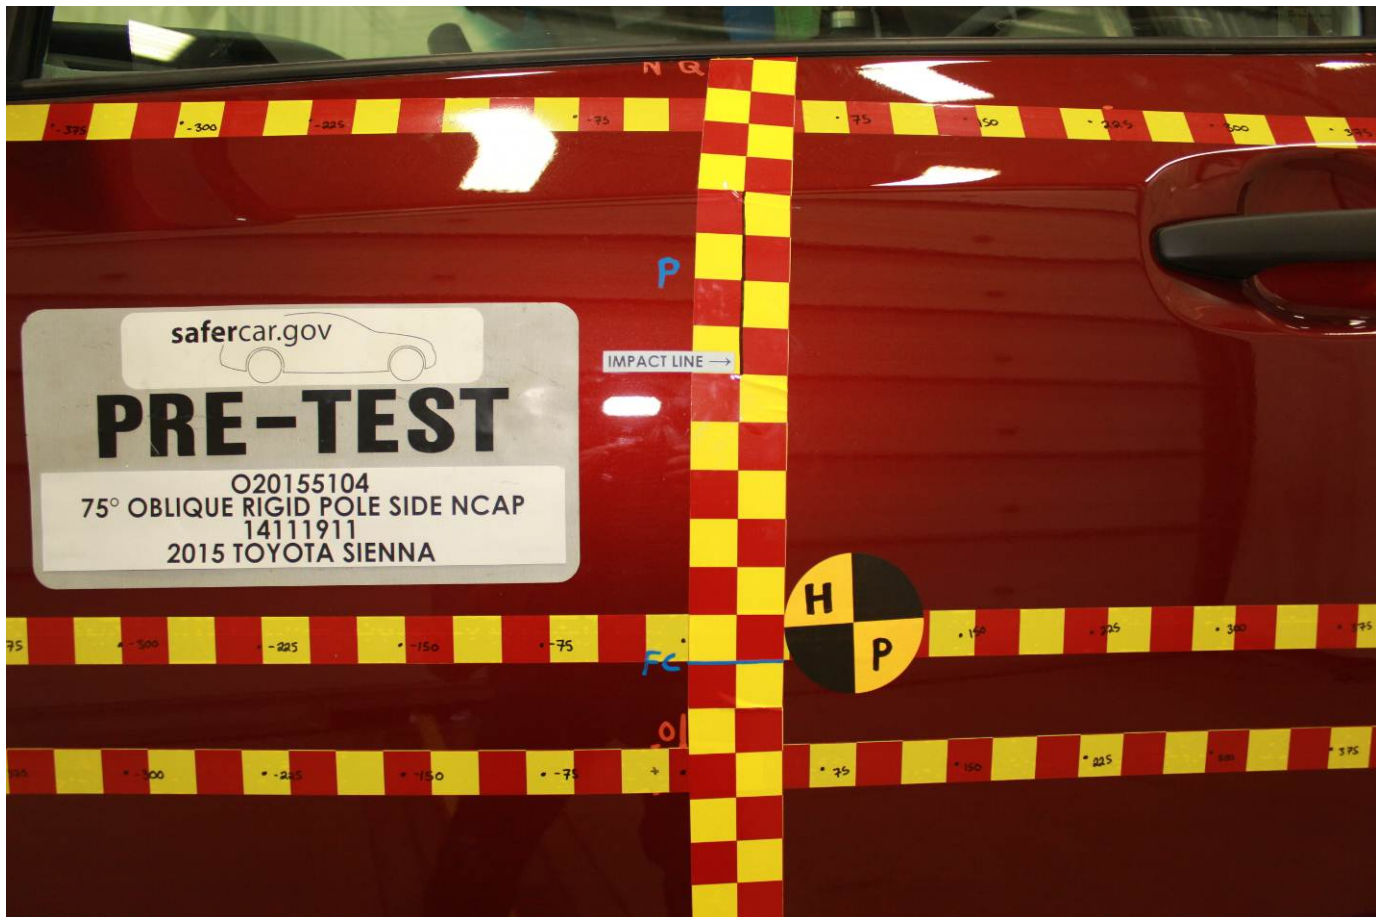
Pre-Test Close-Up View of Impact Point Target

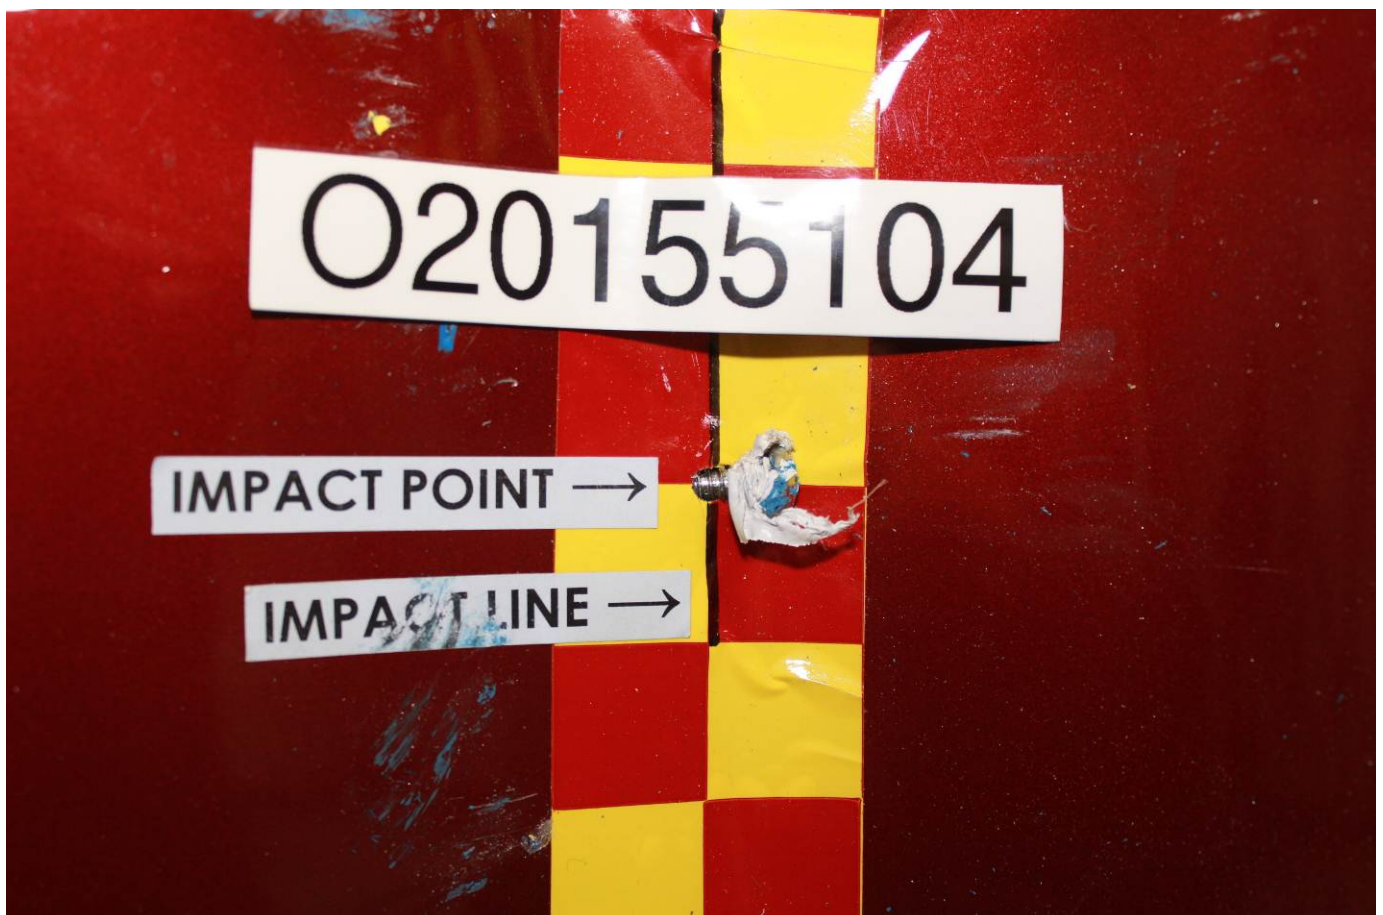
Post-Test Close-Up View of Impact Point Target Showing Impact Location

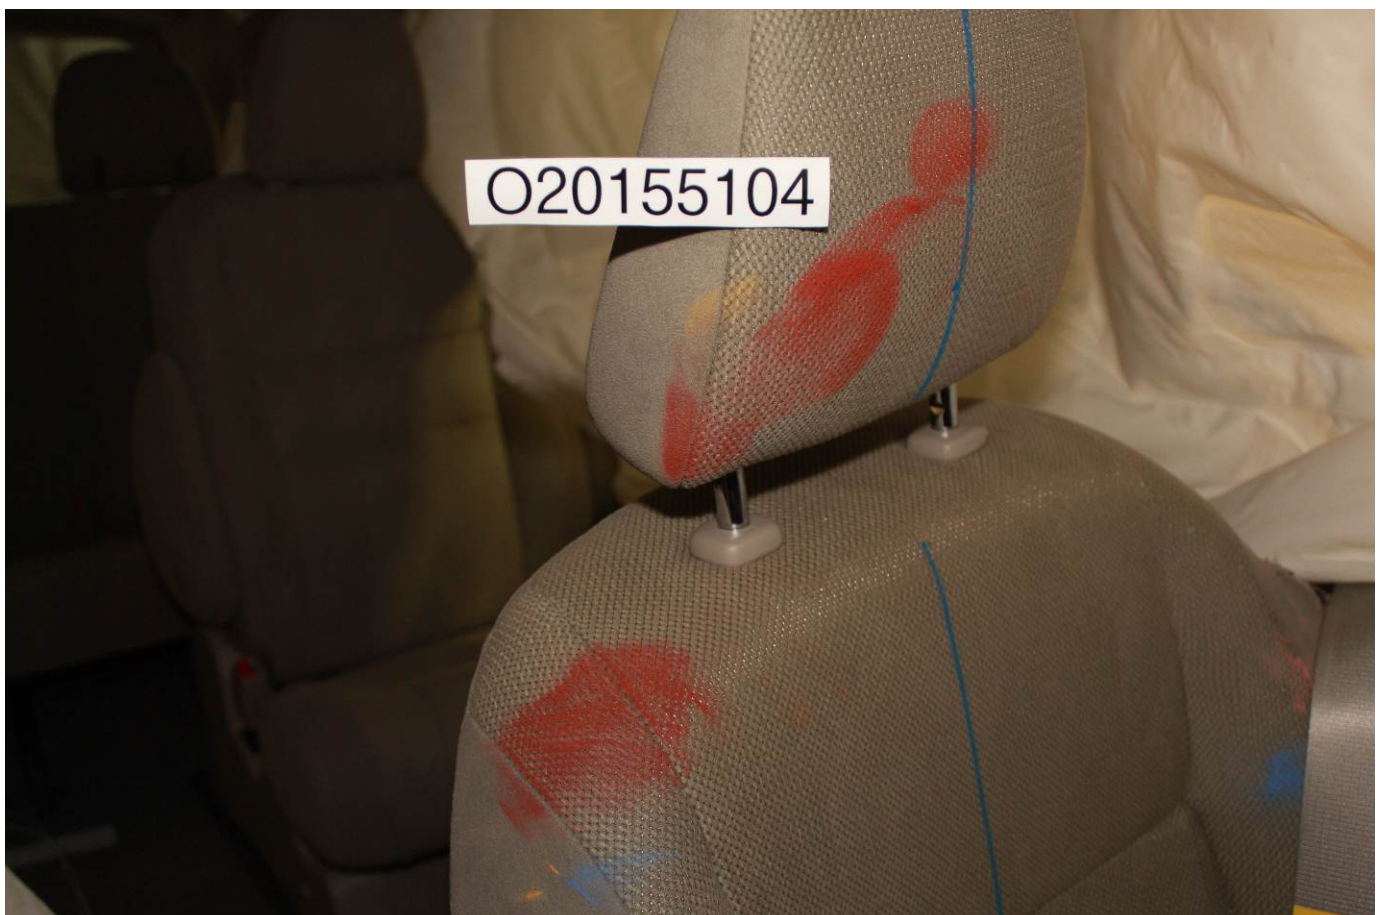
Post-Test Dummy Close-Up Head Contact with Vehicle Interior View

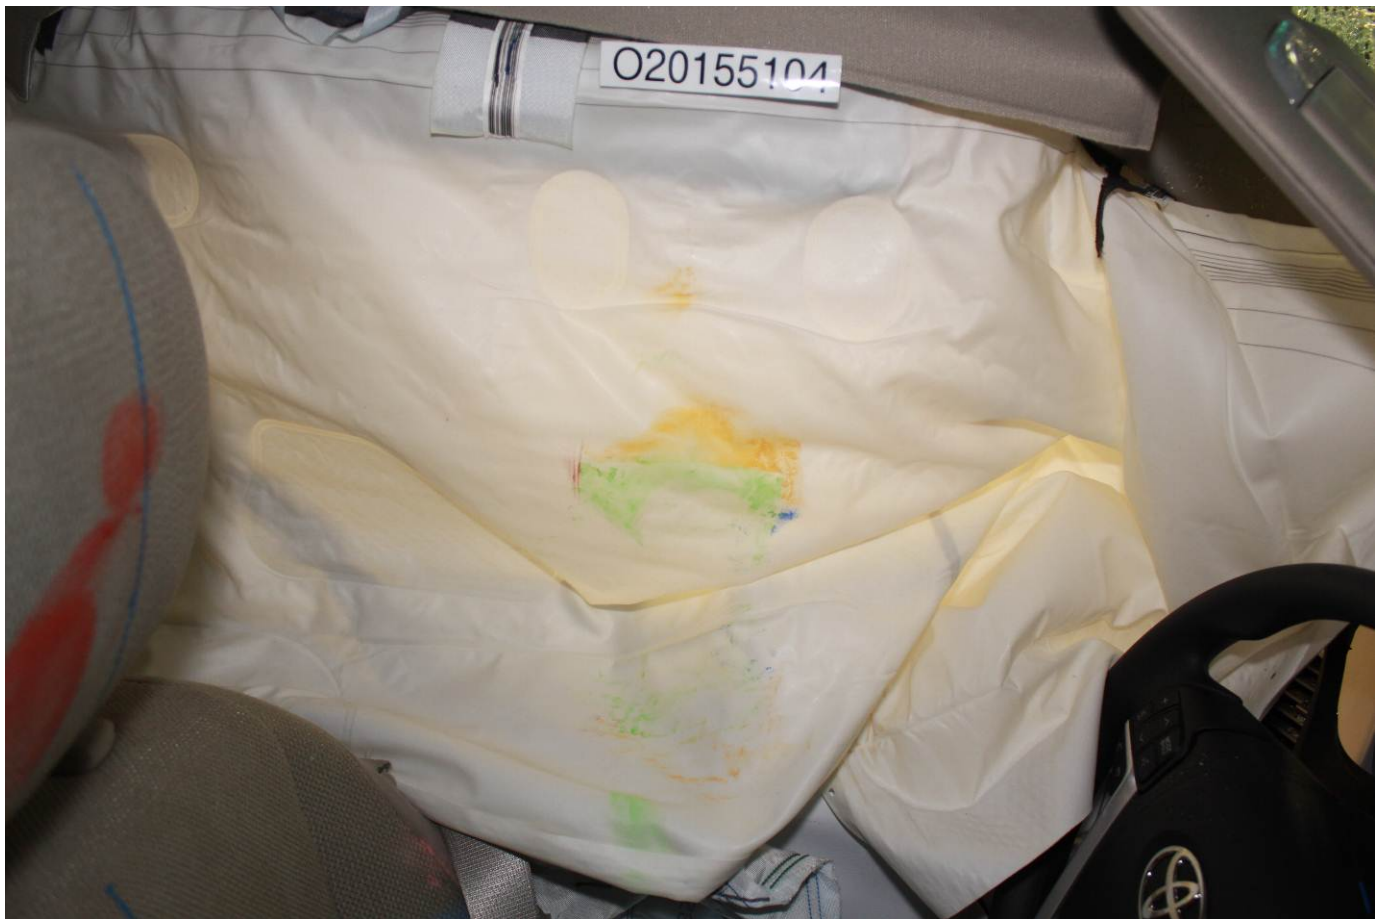
Post-Test Dummy Close-Up Head Contact with Side Air Bag View

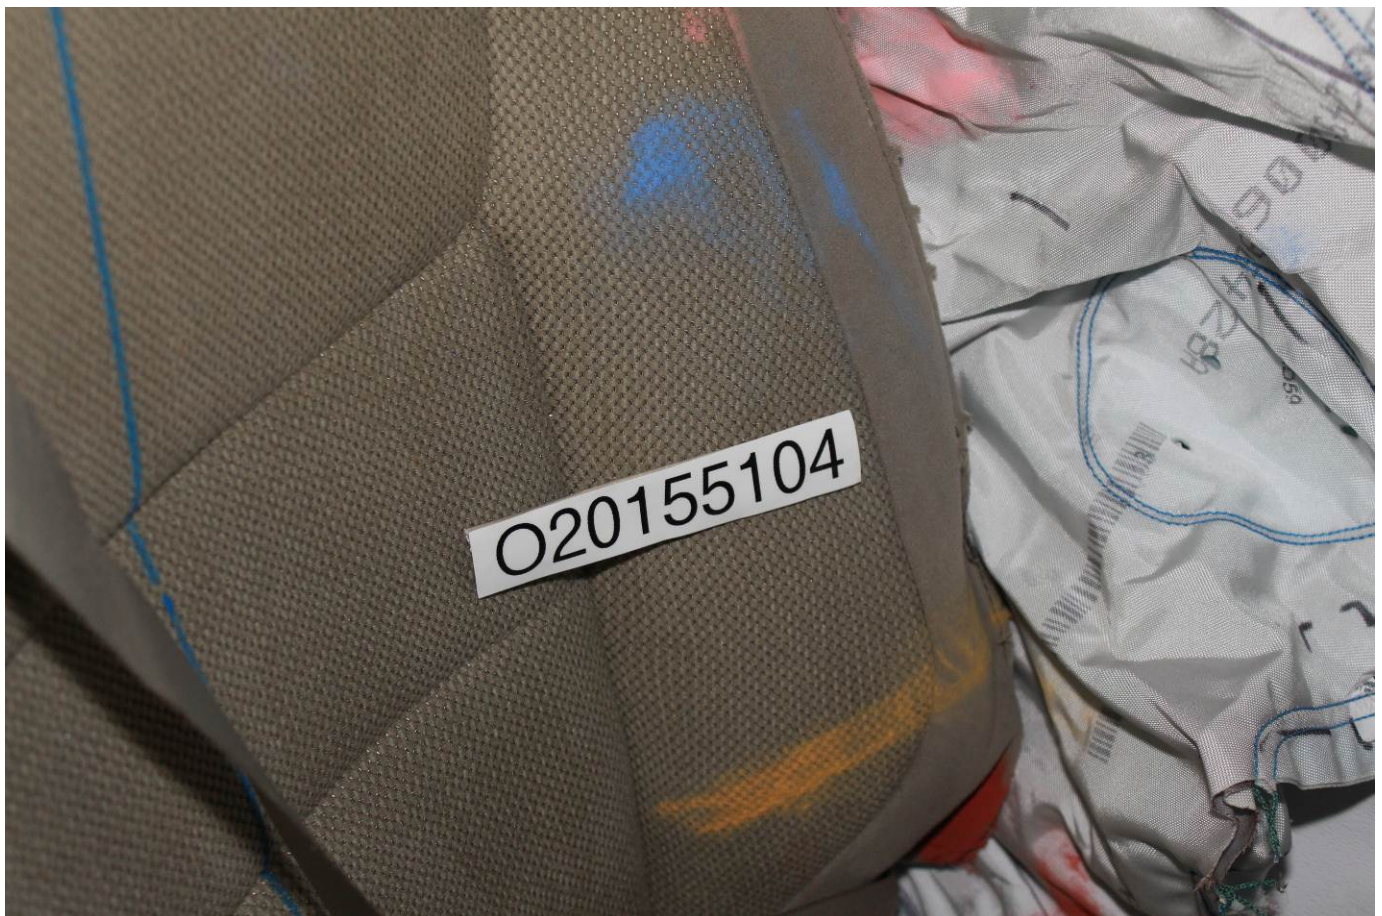
Post-Test Dummy Close-Up Torso Contact with Vehicle Interior View

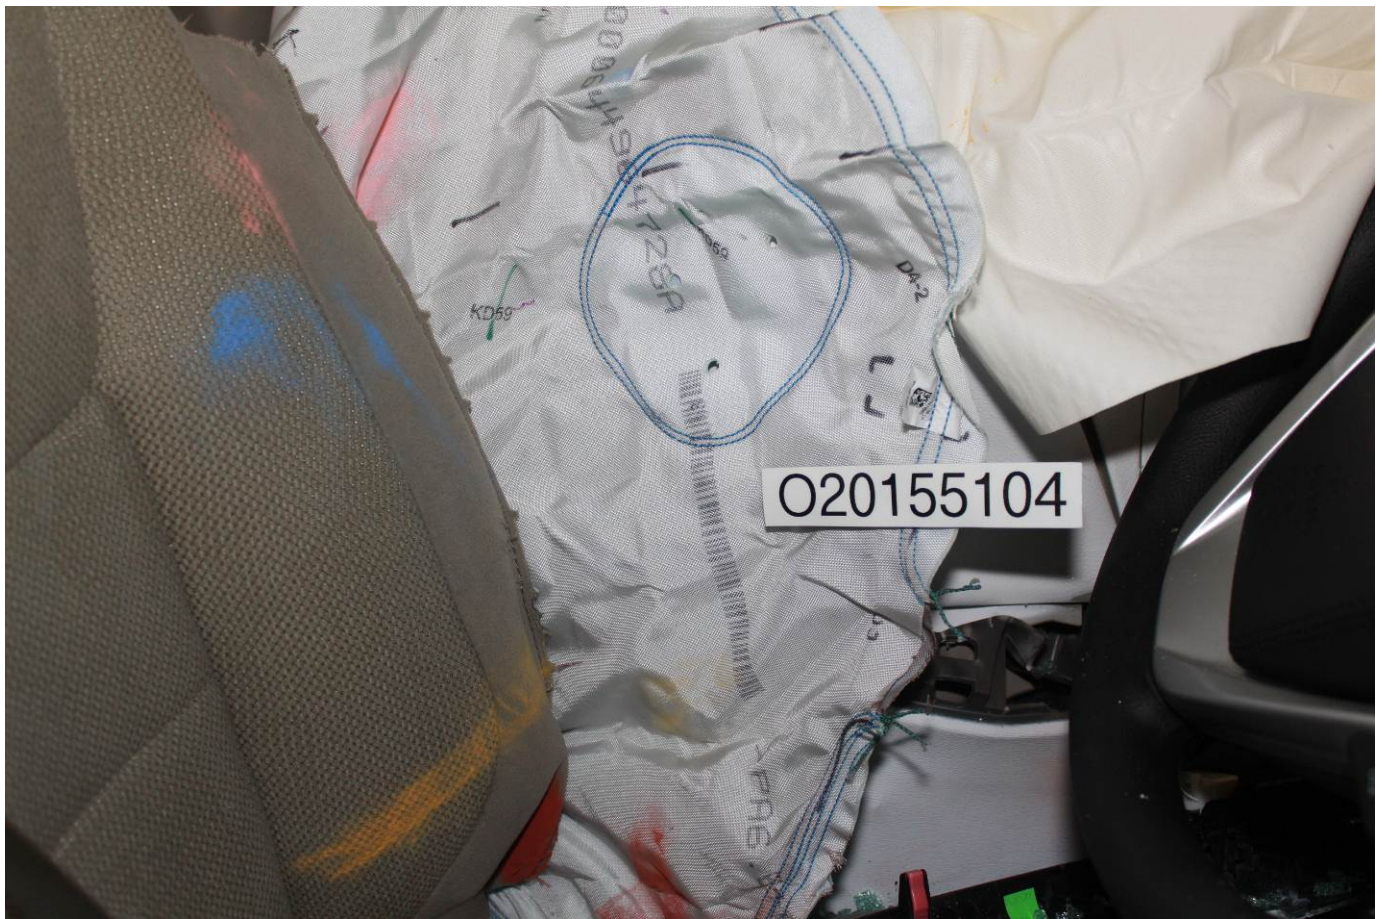
Post-Test Dummy Close-Up Torso Contact with Side Air Bag View

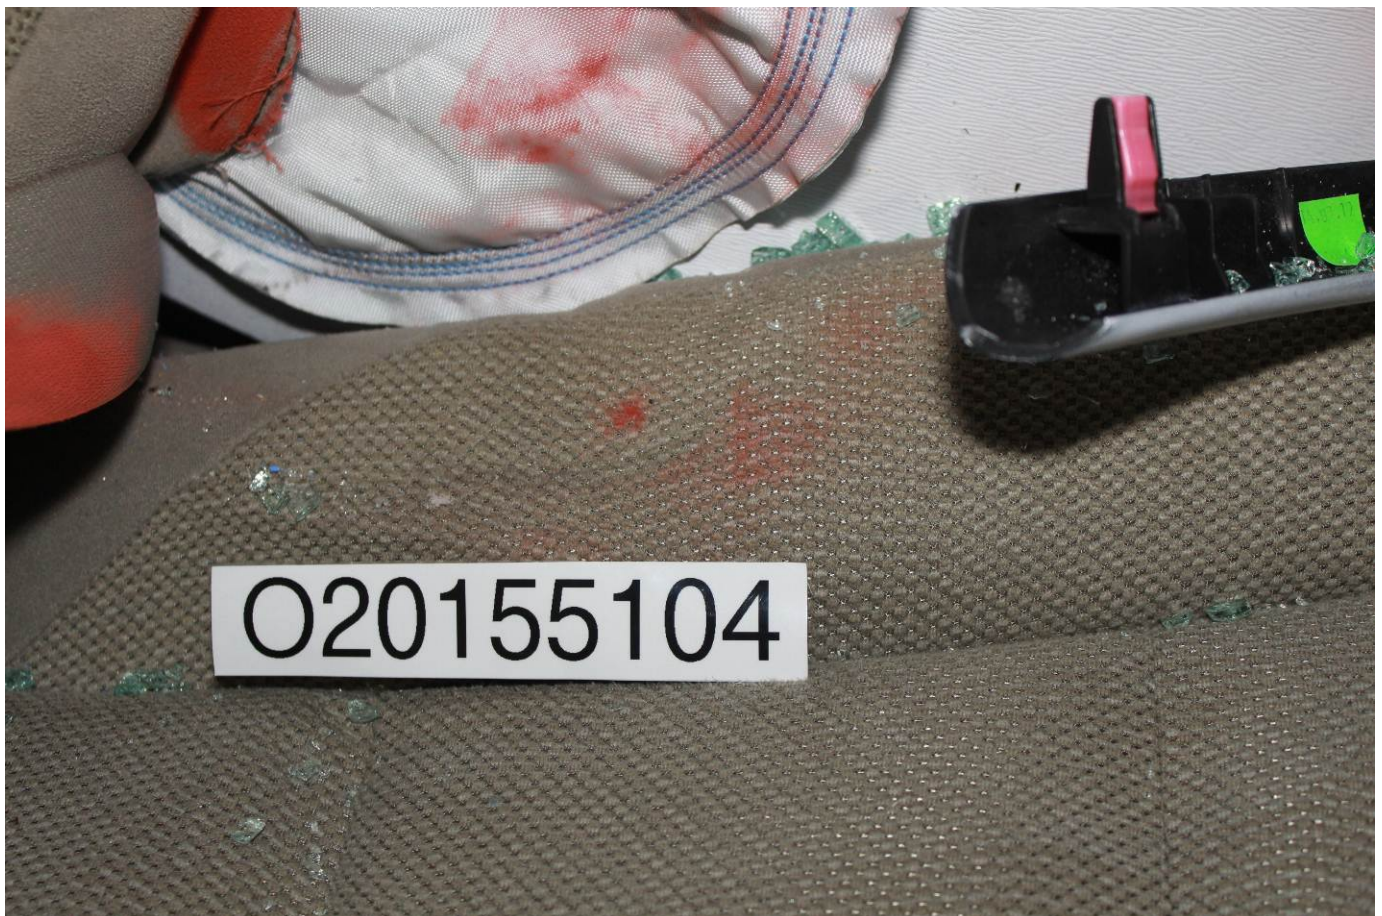
Post-Test Dummy Close-Up Pelvis Contact with Vehicle Interior View

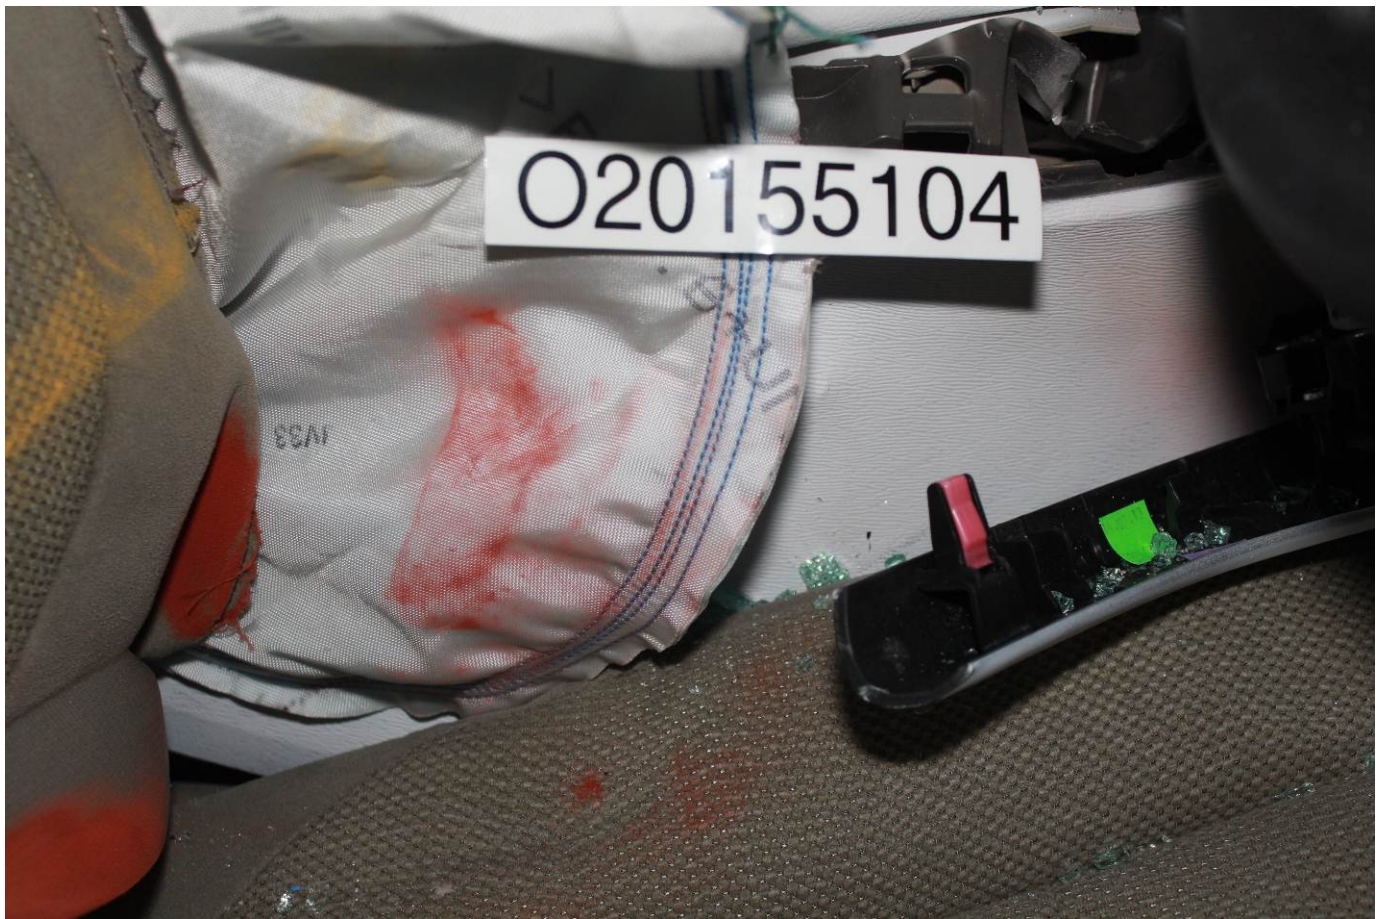
Post-Test Dummy Close-Up Pelvis Contact with Side Air Bag View

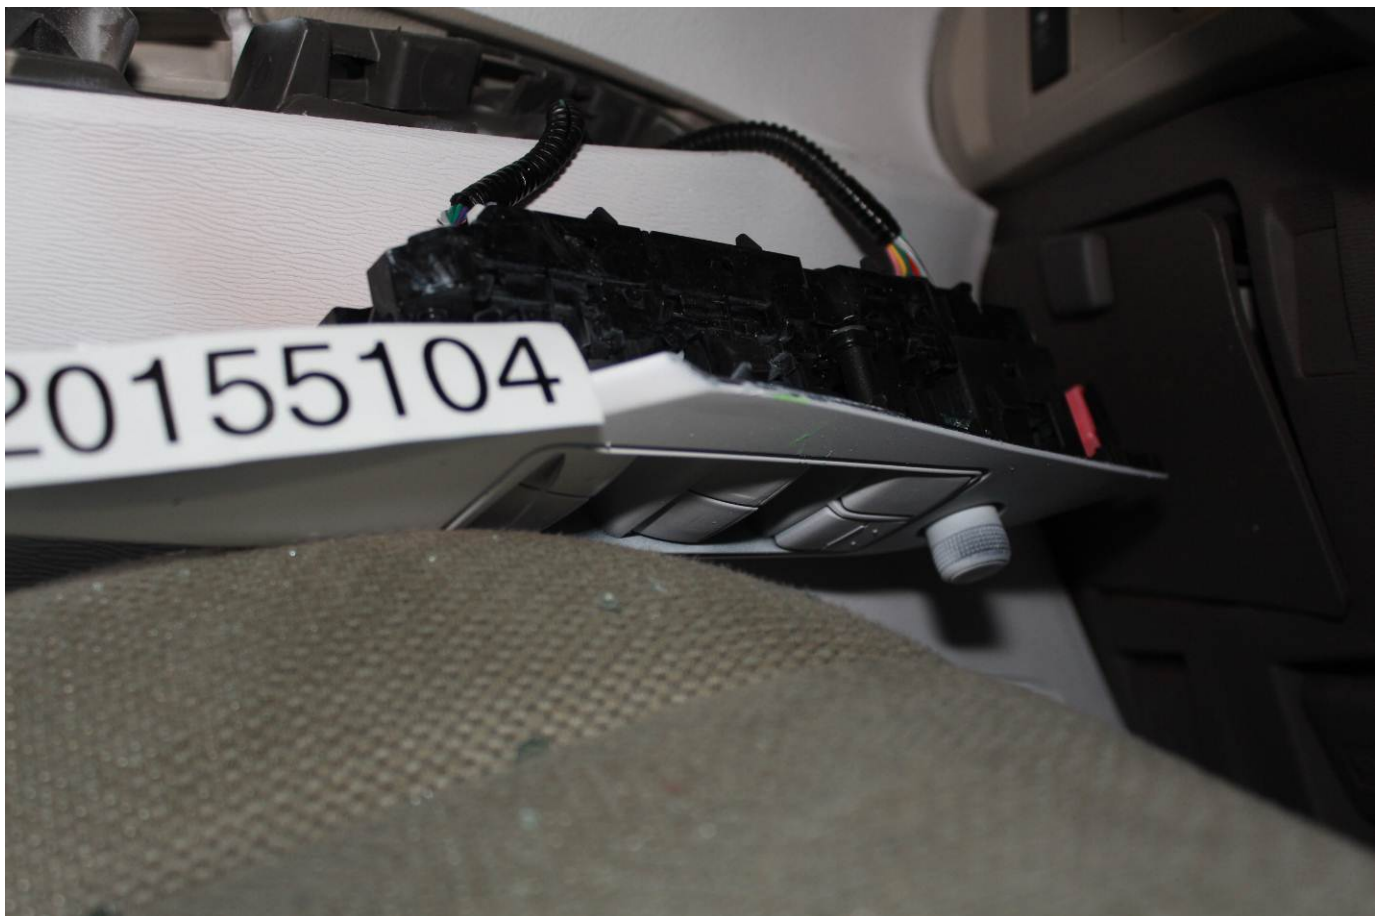
Post-Test Dummy Close-Up Knee Contact with Vehicle Interior View
