**REPORT NUMBER: SINCAP-MGA-2015-033**

**NEW CAR ASSESSMENT PROGRAM (NCAP)  
Moving Deformable Barrier Side Impact Test**

**TOYOTA MOTOR MANUFACTURING, INDIANA, INC.  
2015 Toyota Sienna L Minivan  
NHTSA No.: O20155105**

**FINAL REPORT**

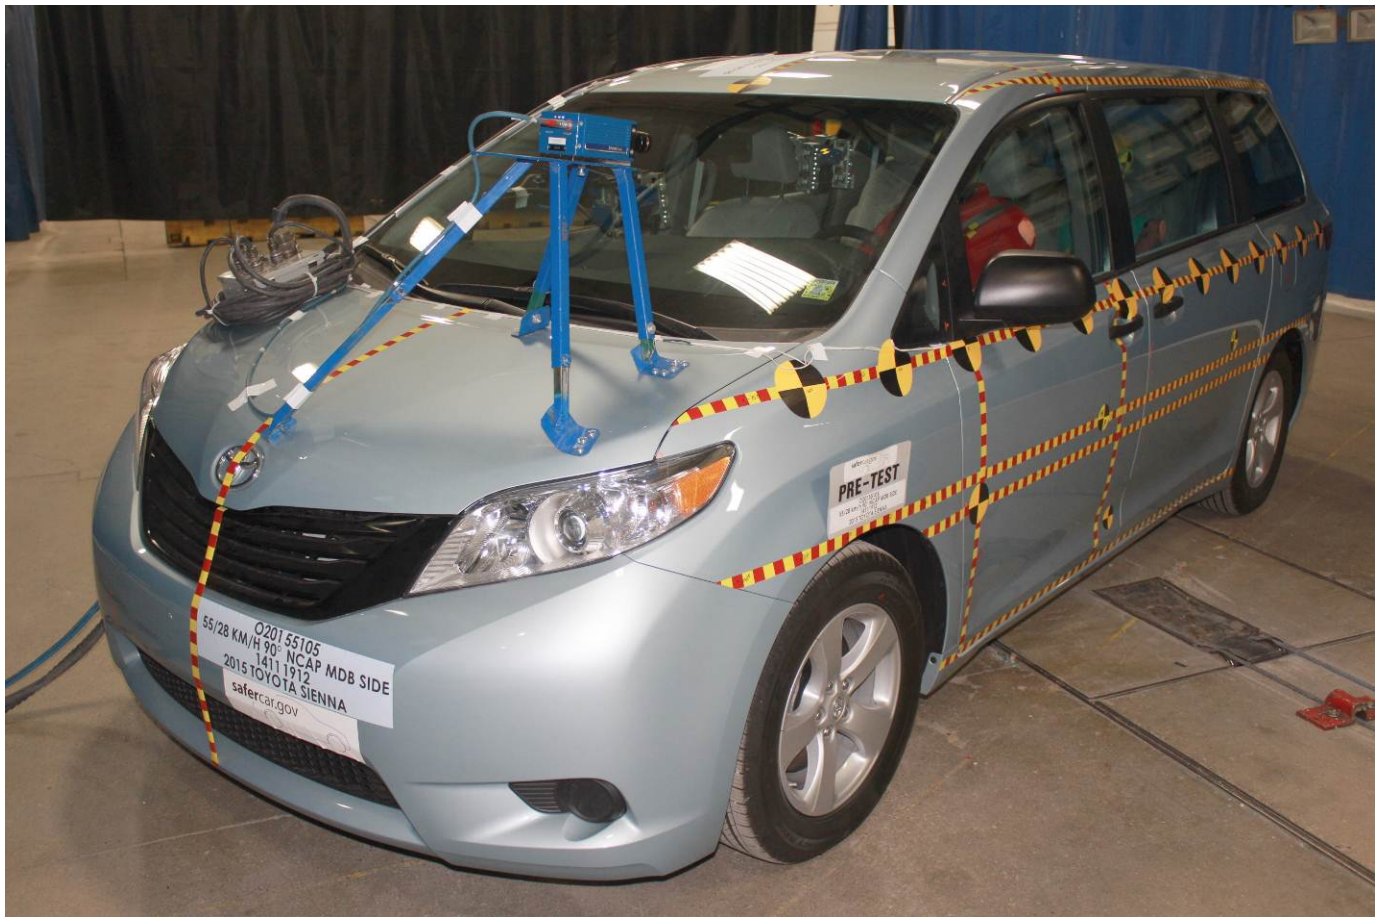
Post-Test Frontal View of Test Vehicle

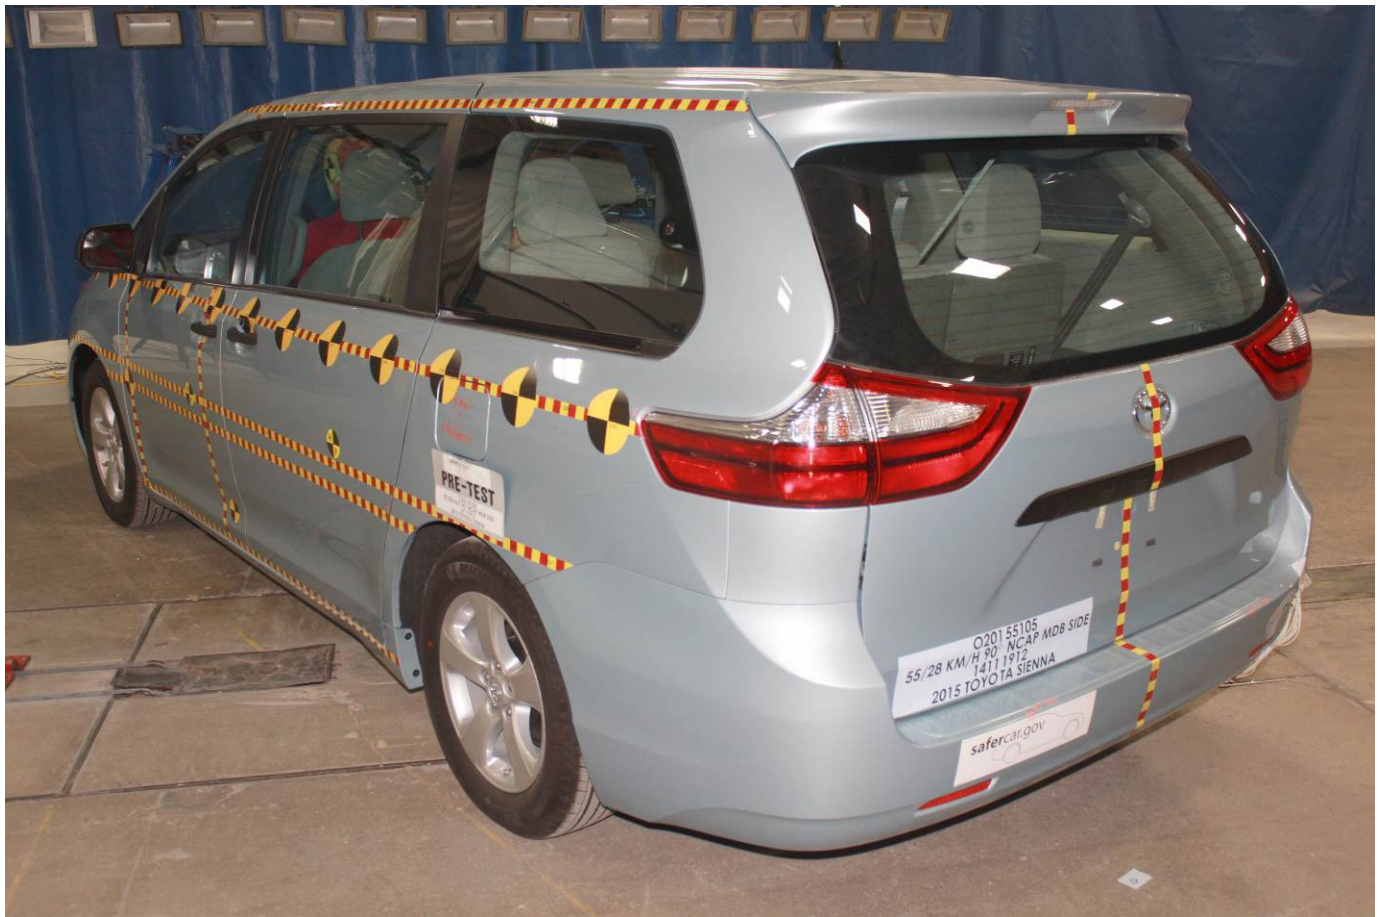
Post-Test Left Side View of Test Vehicle

| Critical Areas of Performance | Observations and Conclusions |
|---|---|
| Side Window Damage | Third Row Window Broken |

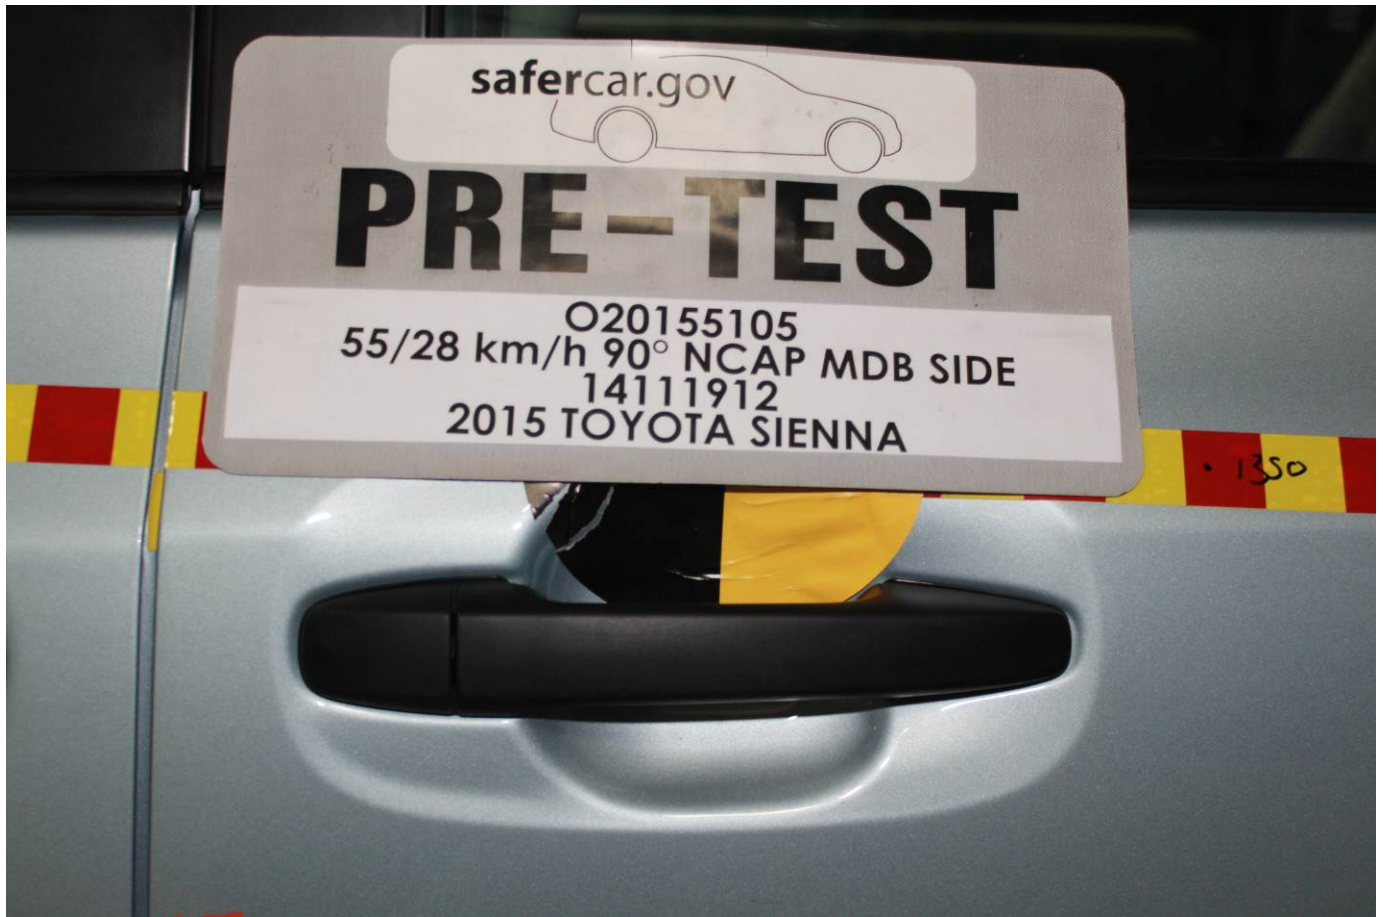
Post-Test Left Front Door Latch Close-Up

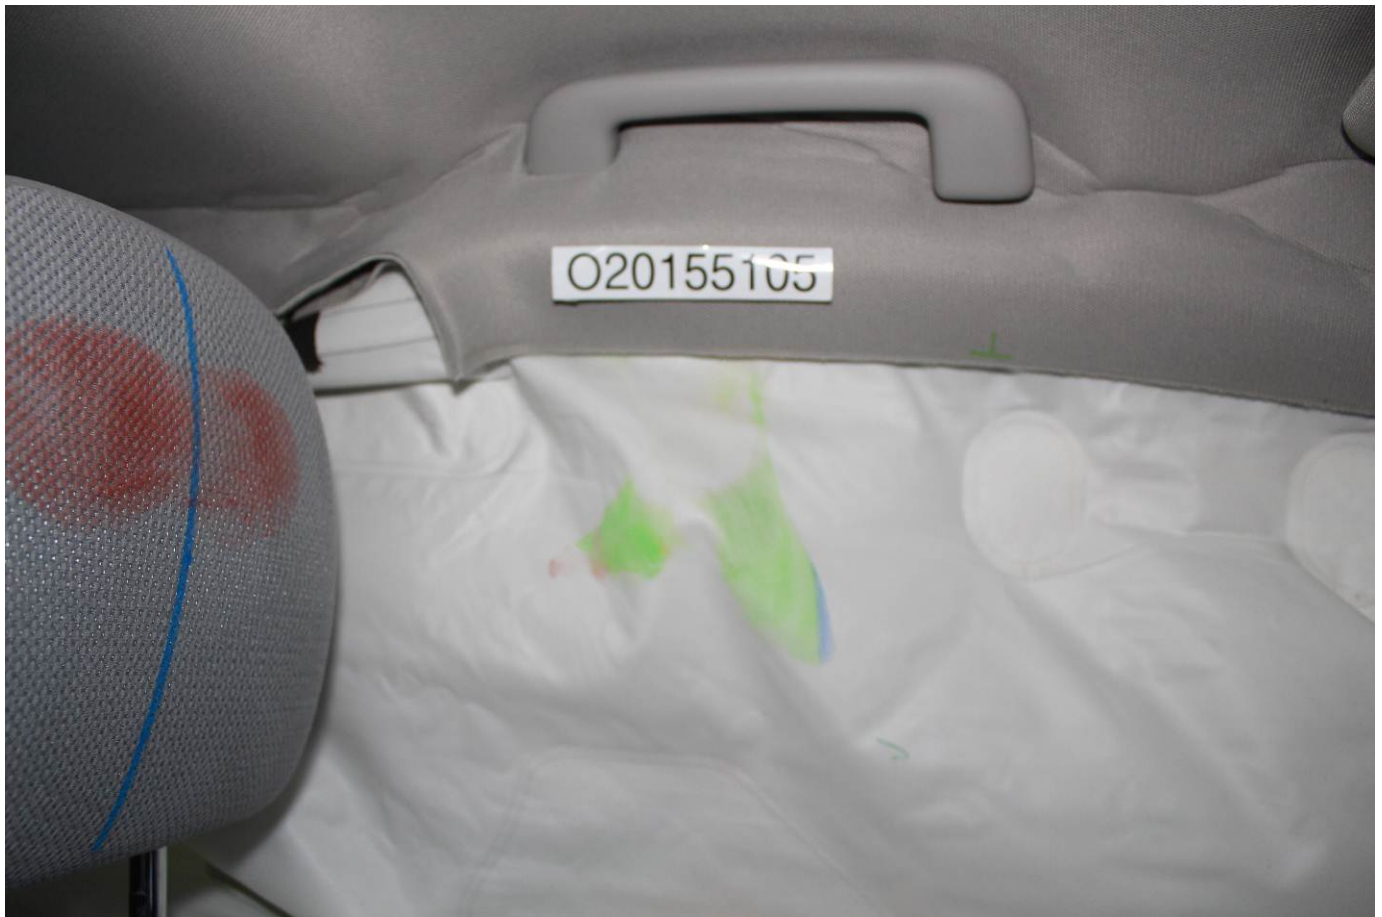
Post-Test Driver Dummy Close-up Head Contact with Vehicle Interior View

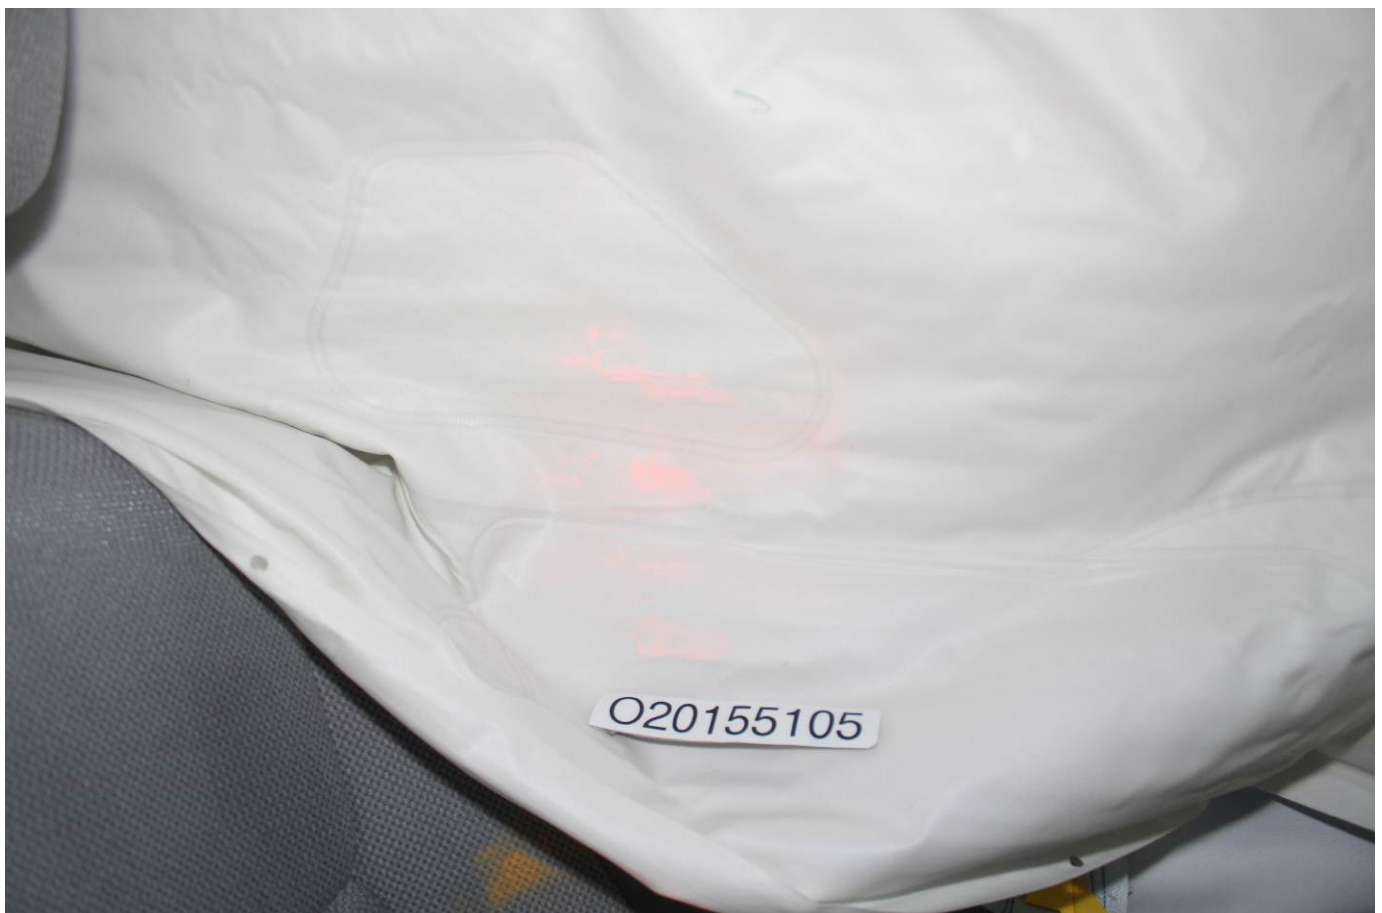
Post-Test Driver Dummy Close-up Head Contact with Side Airbag View

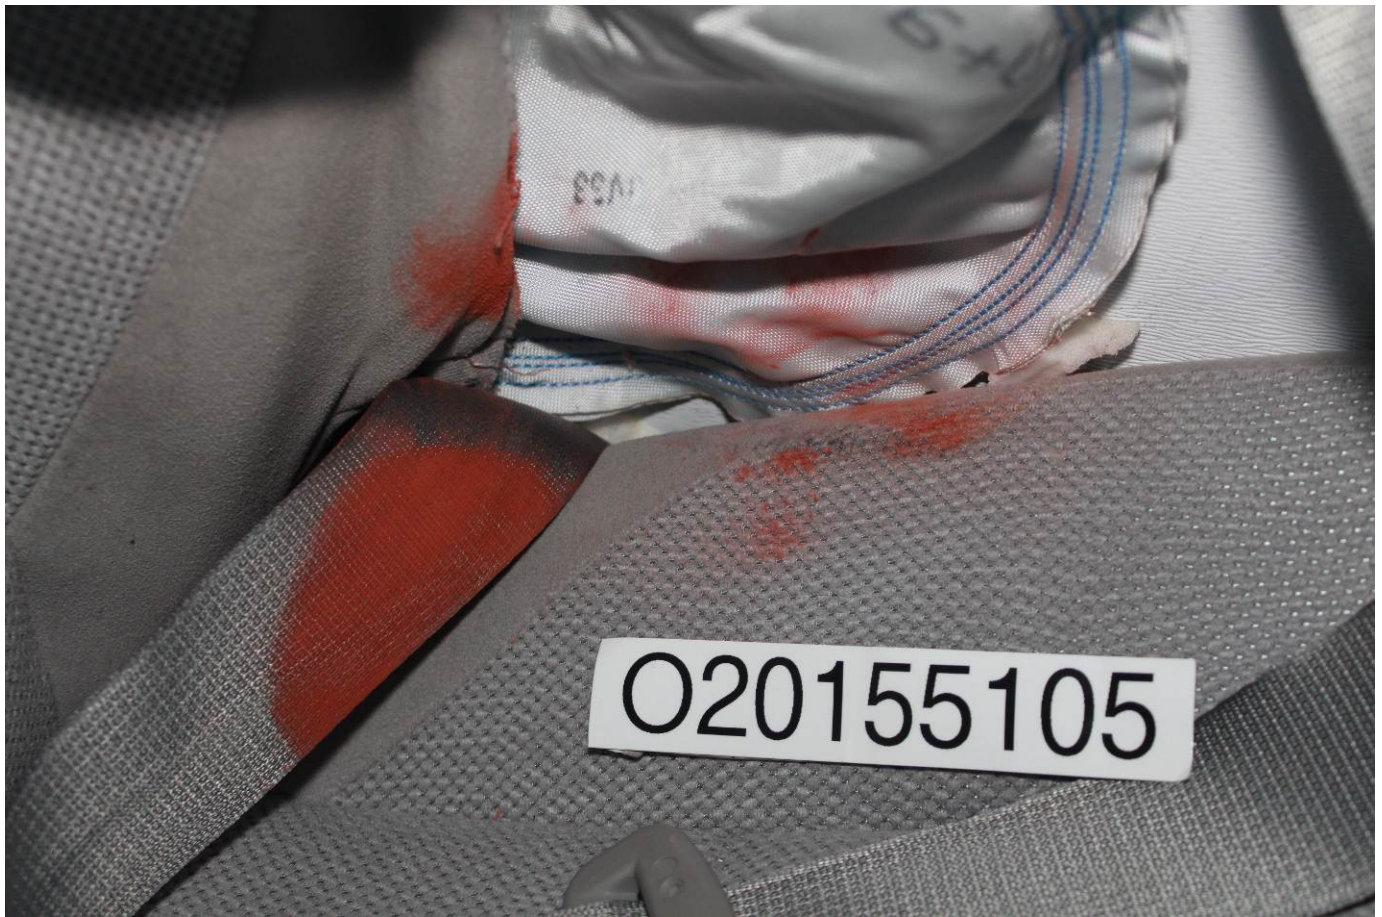
Post-Test Driver Dummy Close-up Torso Contact with Side Airbag View

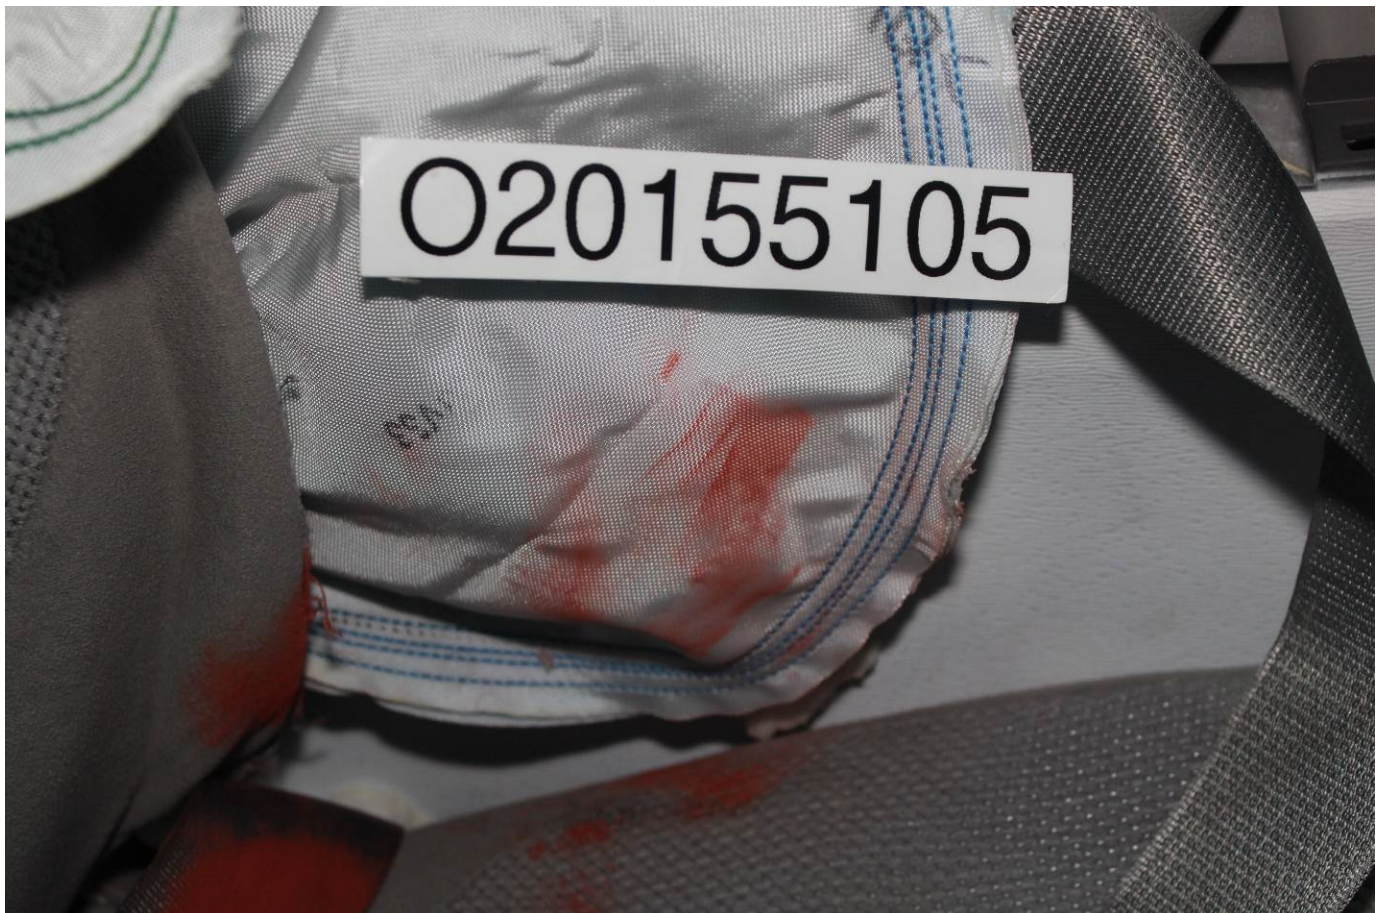
Post-Test Driver Dummy Close-up Pelvis Contact with Vehicle Interior View
