REPORT NUMBER: SPNCAP-KAR-15-018

**NEW CAR ASSESSMENT PROGRAM (NCAP)
SIDE IMPACT POLE TEST**

**CHRYSLER GROUP LLC
2015 DODGE CHALLENGER SXT 2-DOOR COUPE**

**PREPARED BY:
KARCO ENGINEERING, LLC.
9270 HOLLY ROAD
ADELANTO, CA 92301**

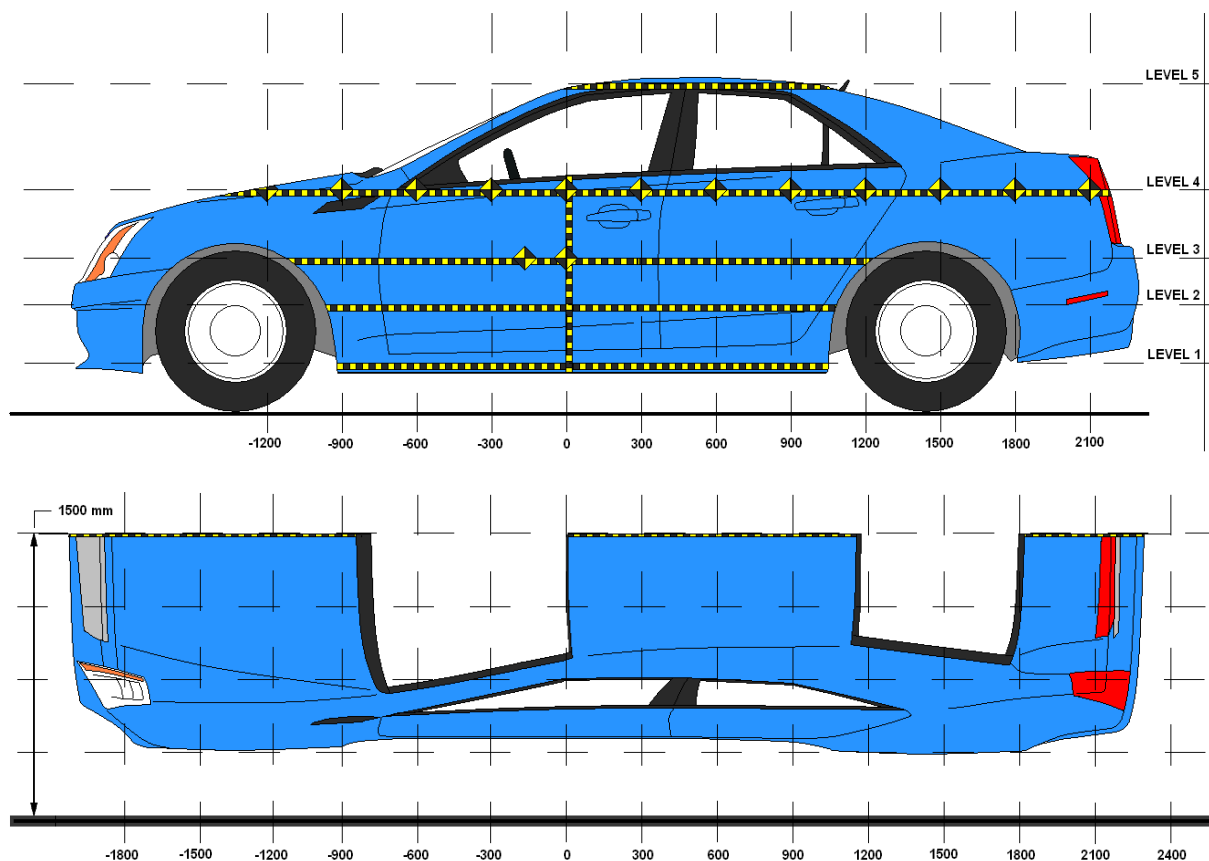
NOTE: All measurements in mm with tolerance of $\pm 3\text{mm}$

MAXIMUM EXTERIOR CRUSH MEASUREMENTS

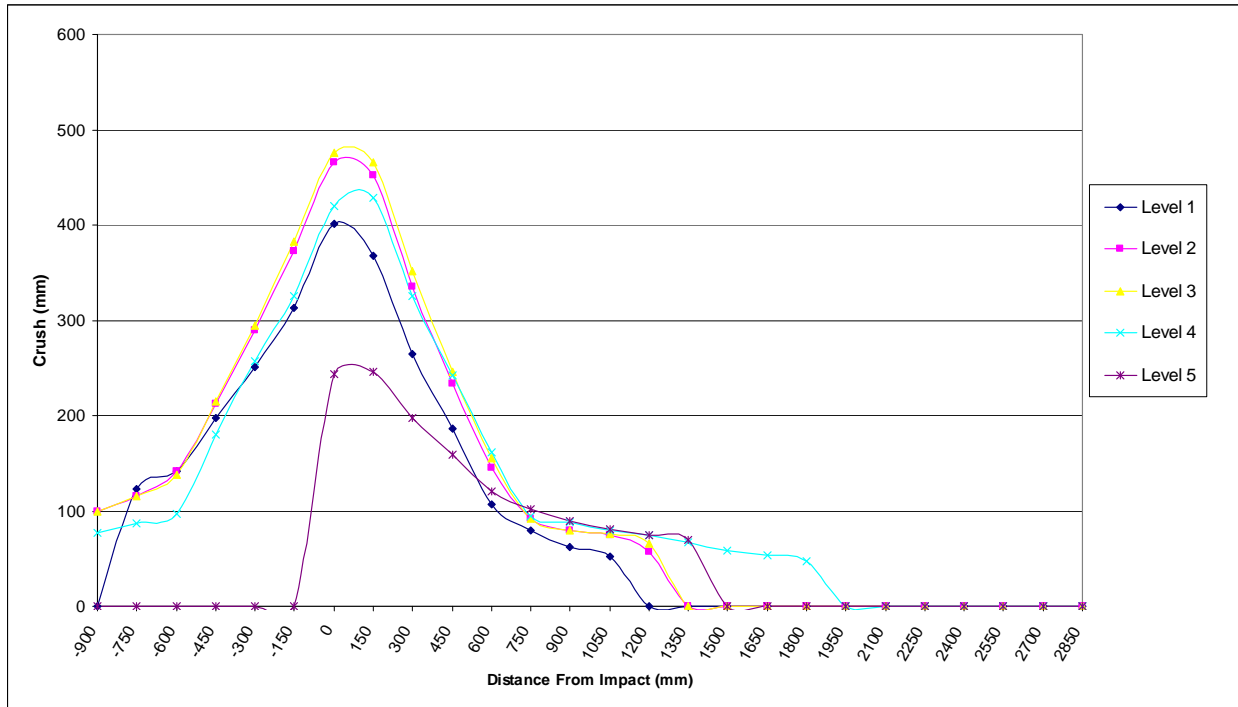
VEHICLE DAMAGE PROFILE DISTANCES

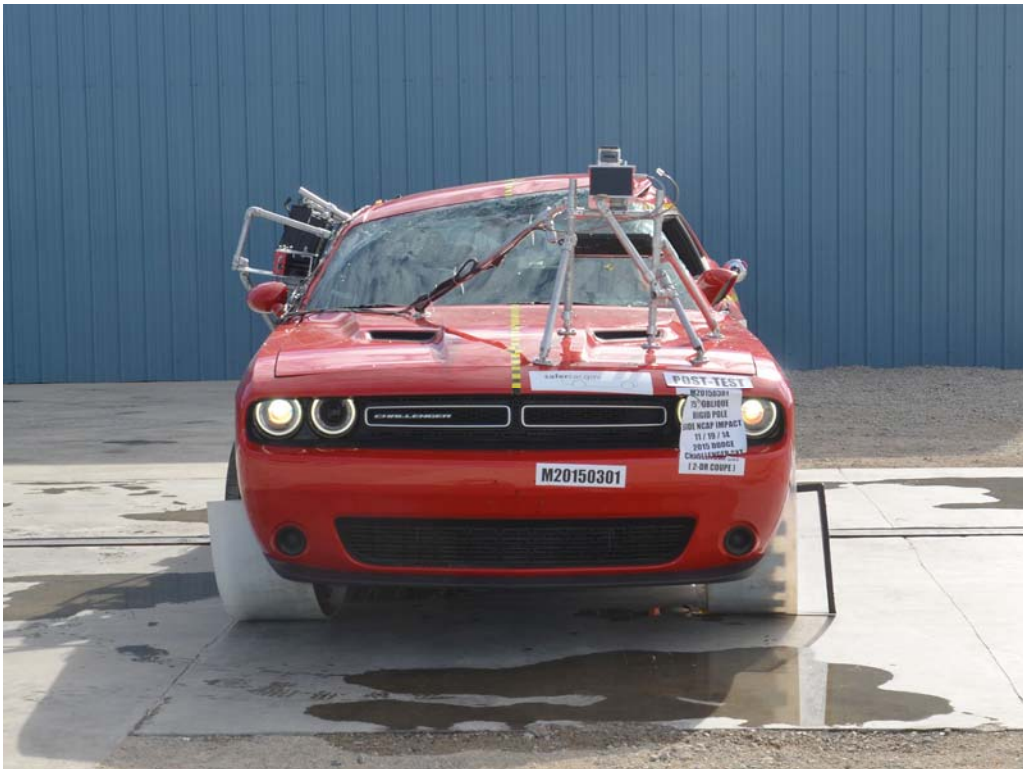
FIGURE 4. Post-Test Frontal View of Test Vehicle

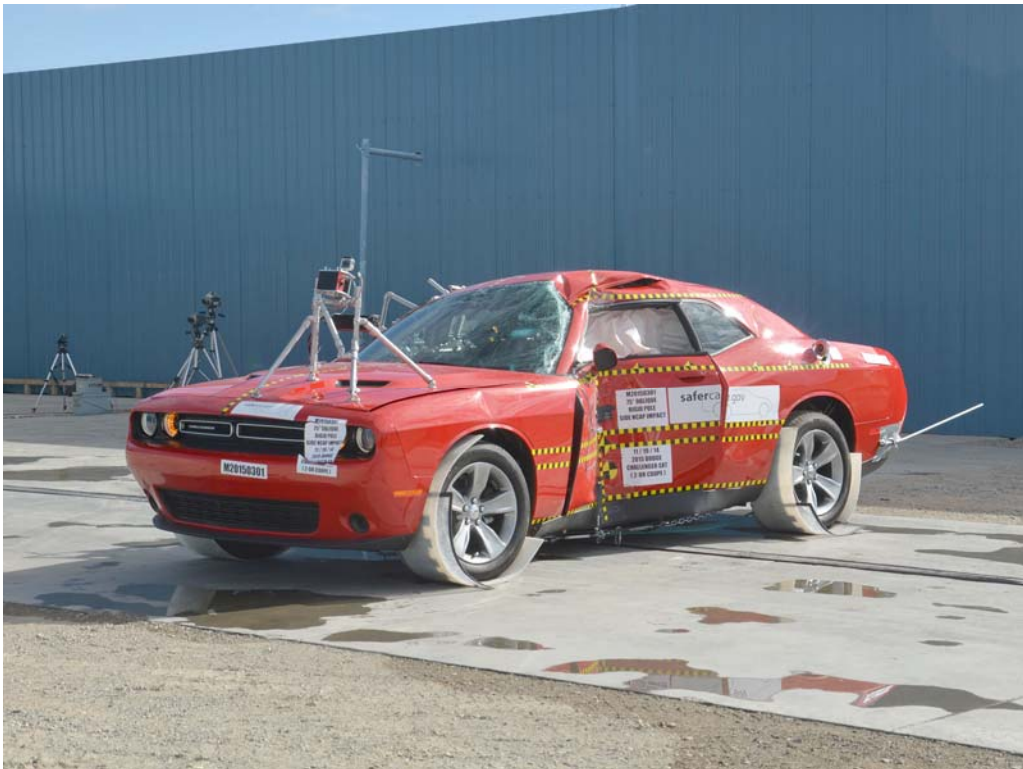
FIGURE 6. Post-Test Left Front $\frac{3}{4}$ View of Test Vehicle

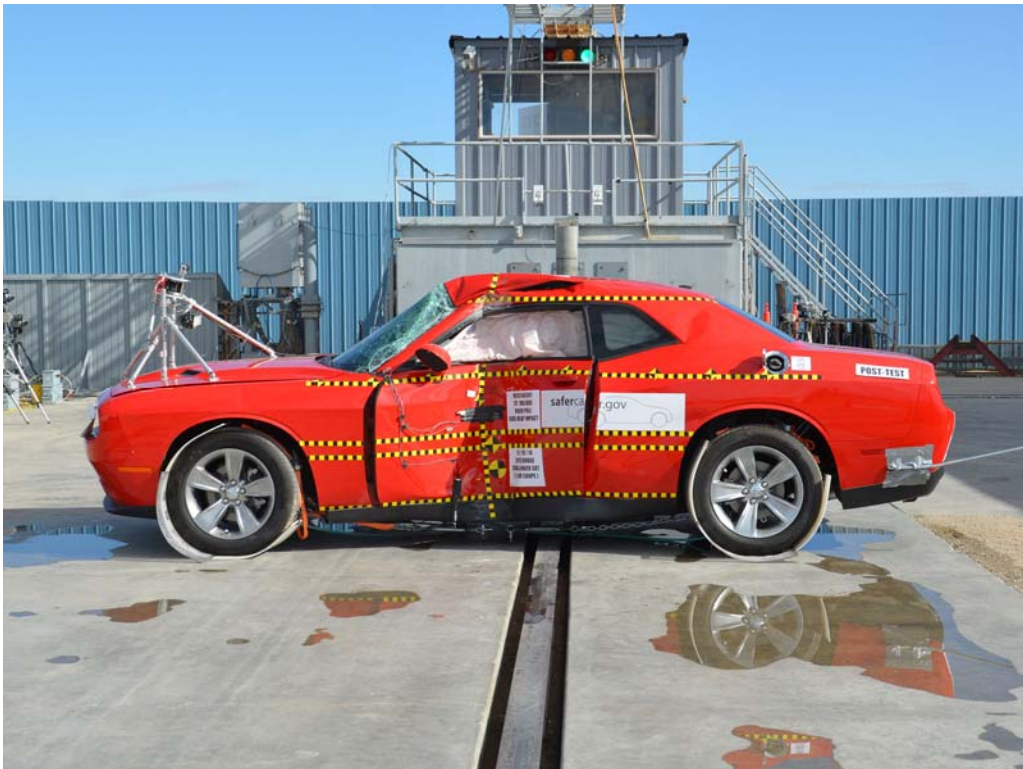
FIGURE 8. Post-Test Left Side View of Test Vehicle

Critical Areas of Performance	Observations and Conclusions
Pillar Performance	No separation occurred
Sill Separation	No separation occurred
Windshield Damage	Broken
Side Window Damage	Left front window broken
Other Notable Effects	Roof skin separated from sill

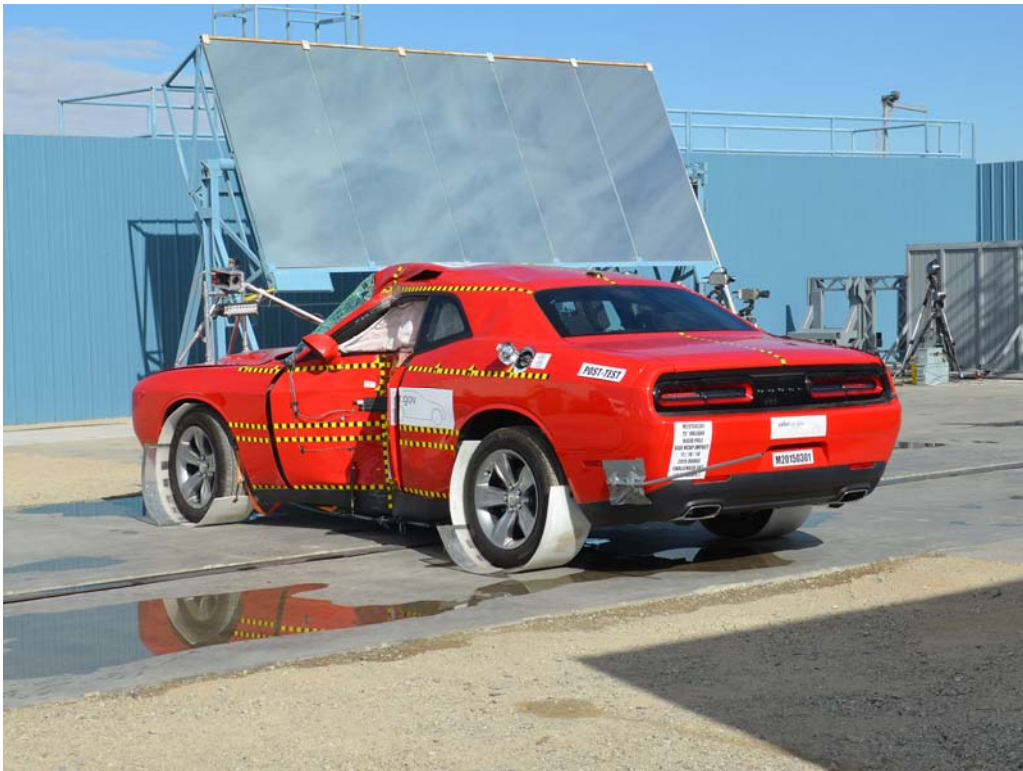
FIGURE 10. Post-Test Left Rear $\frac{3}{4}$ View of Test Vehicle

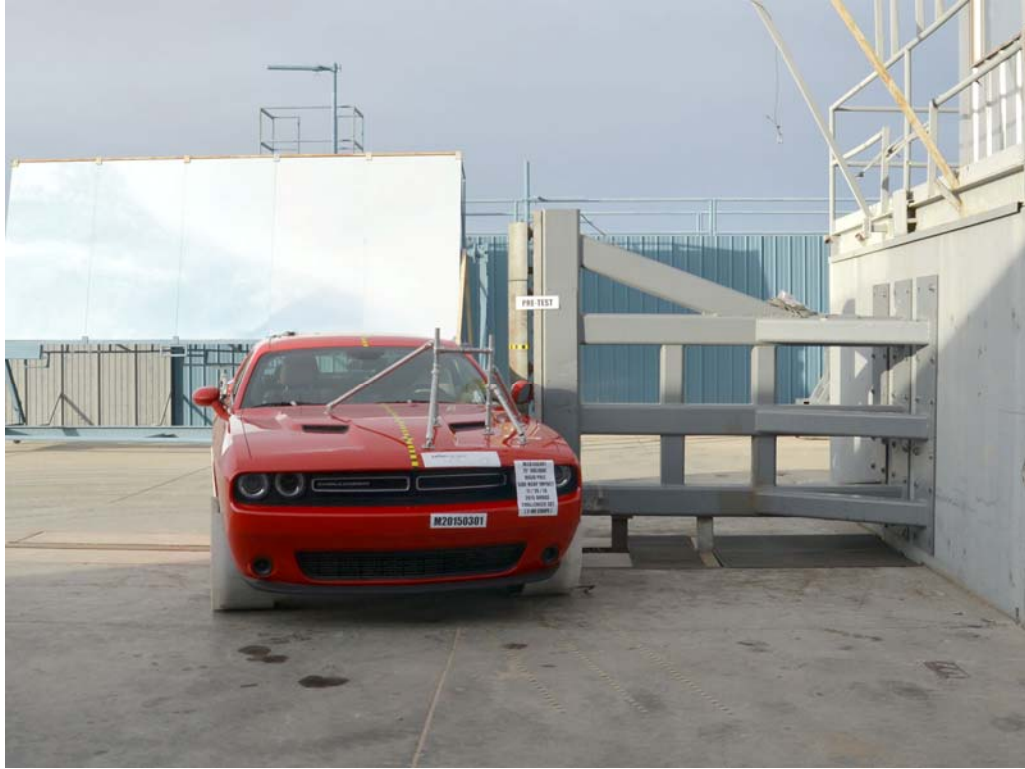
FIGURE 17. Pre-Test Left Side View of Pole
Positioned Against Side of Vehicle

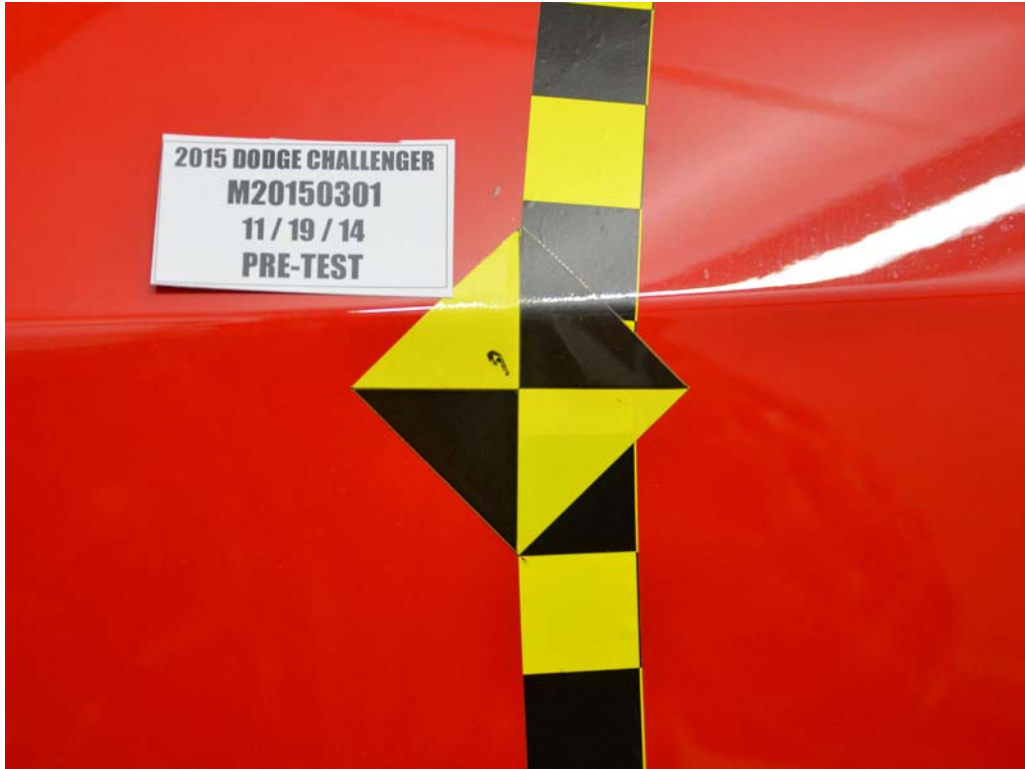
FIGURE 19. Pre-Test Close-Up View of Impact Point Target

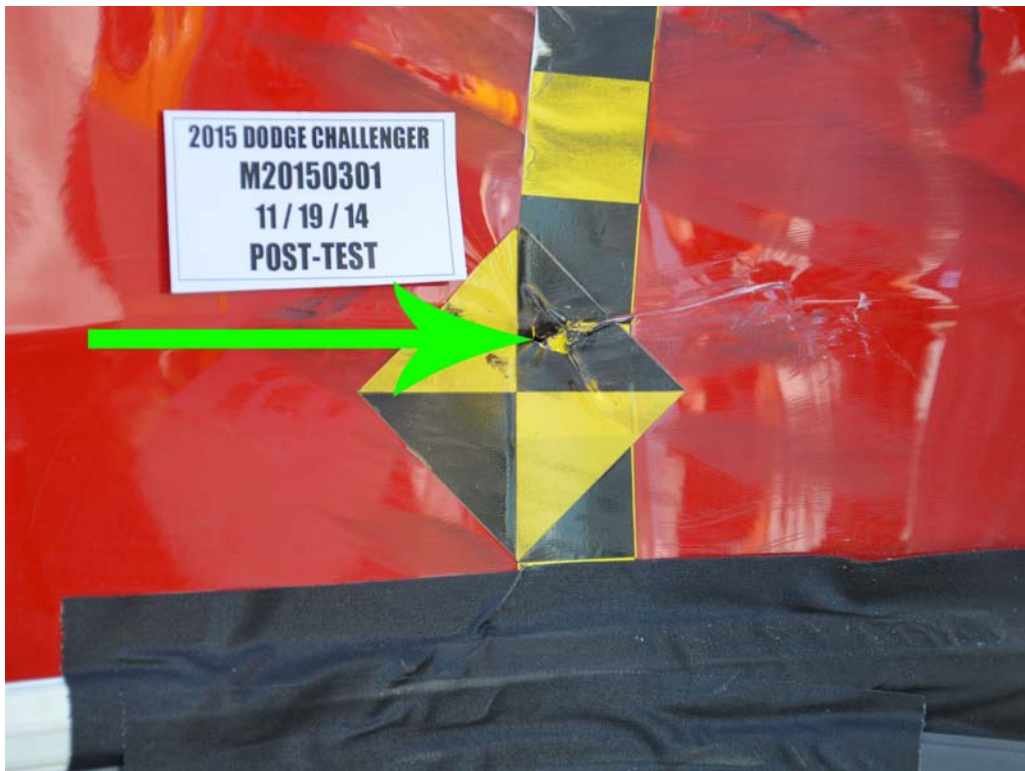
FIGURE 20. Post-Test Close-Up View of Impact Point Target
Showing Impact Location

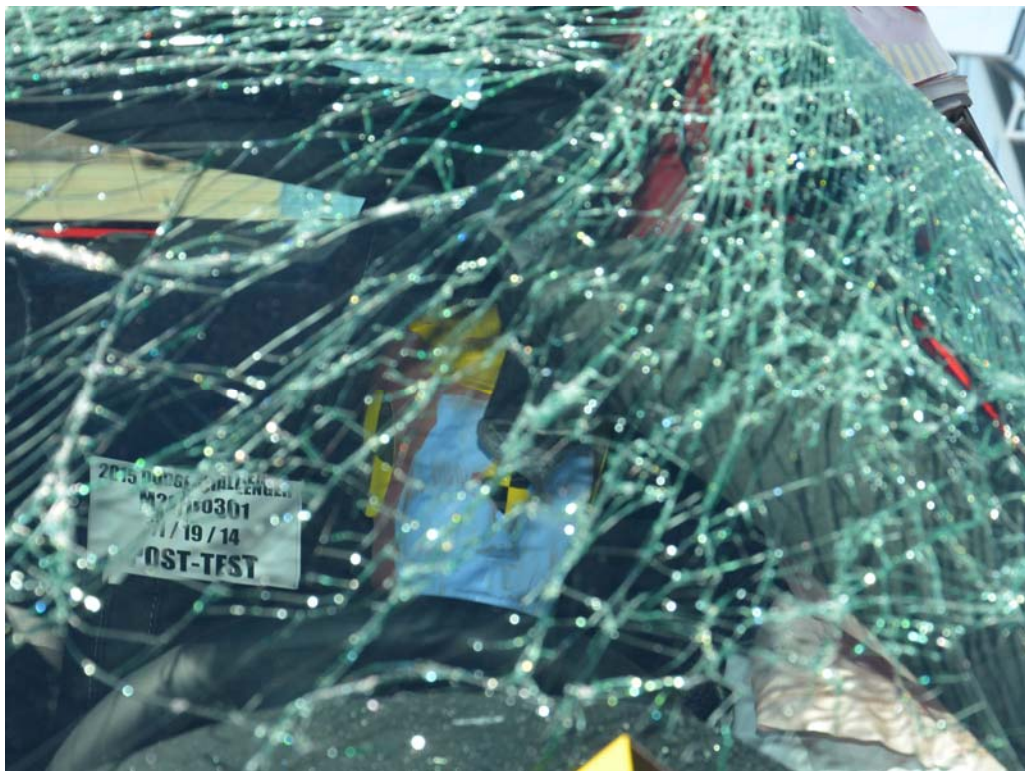
FIGURE 22. Post-Test Front Close-Up View of Dummy

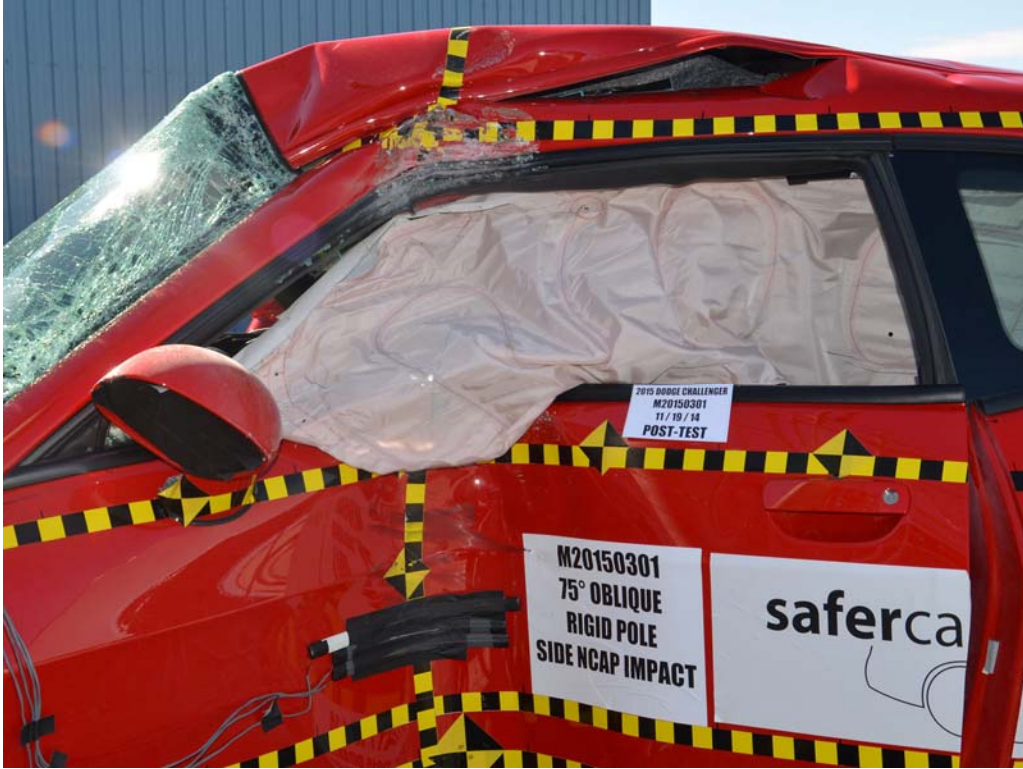
FIGURE 25. Post-Test Left Side View of Dummy Shoulder and Door Top View

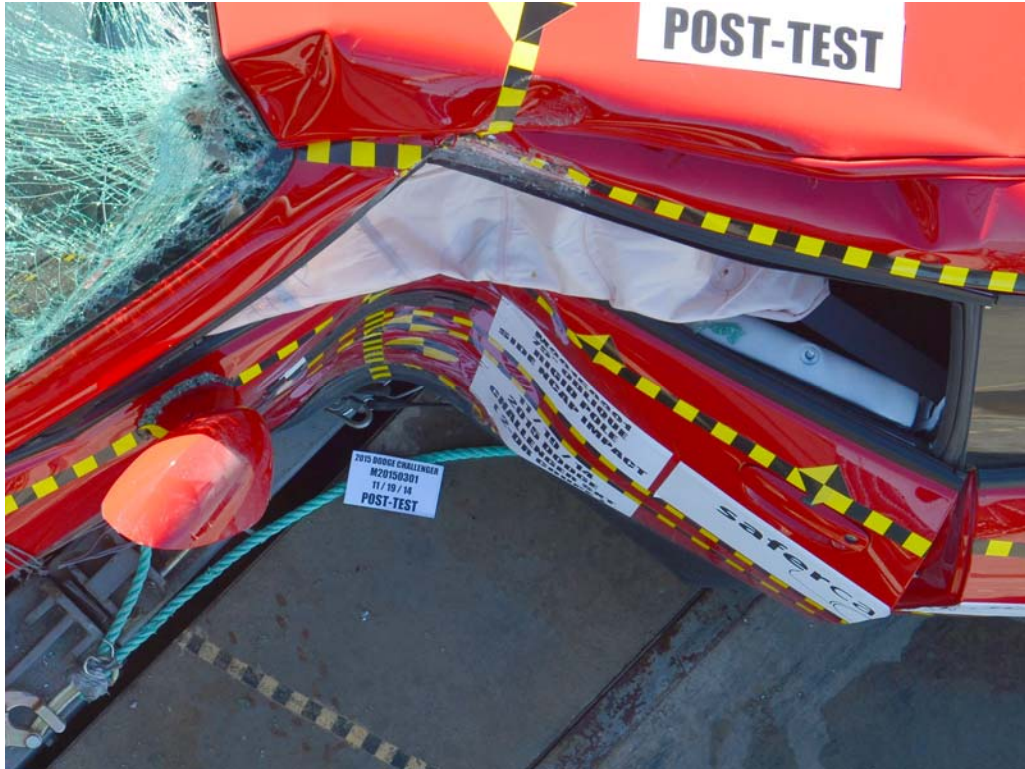
FIGURE 41. Post-Test Dummy and Door Clearance View

The door on the struck side of the vehicle remained closed and latched. There was no separation at the hinges or latches. The door on the non-struck side remained closed and latched. There was no ATD injury value that exceeded its limit.

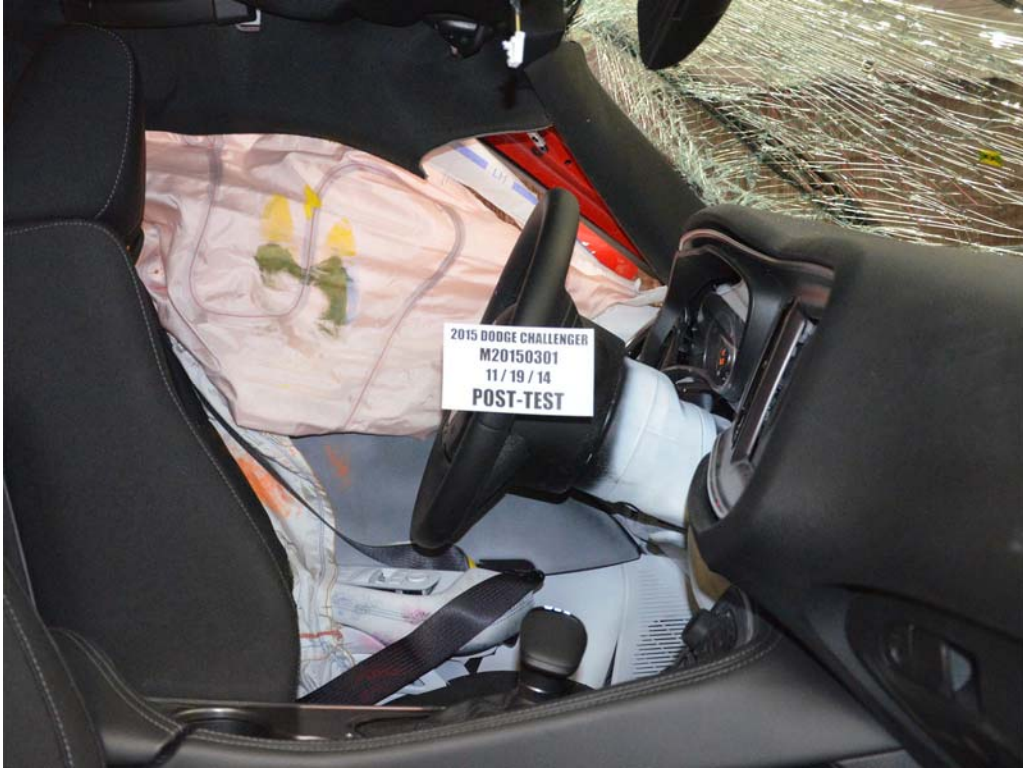
FIGURE 45. Post-Test Inner Door Panel View
Showing Dummy Contact Locations

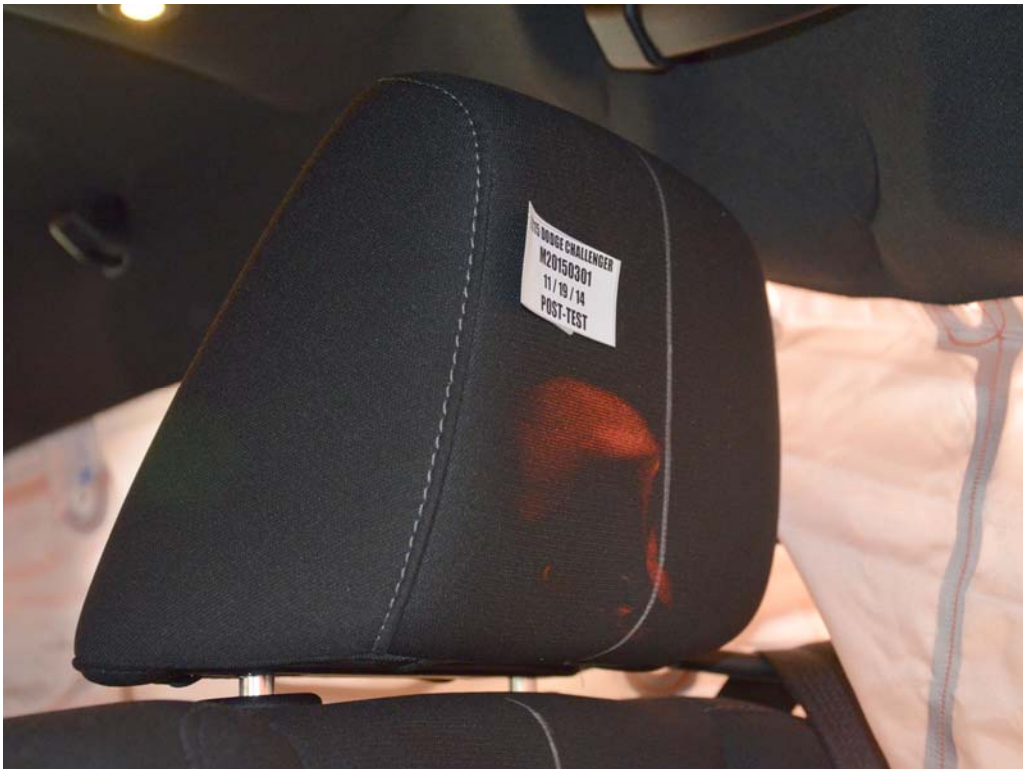
FIGURE 46. Post-Test Dummy Close-Up Head Contact with Vehicle Interior View

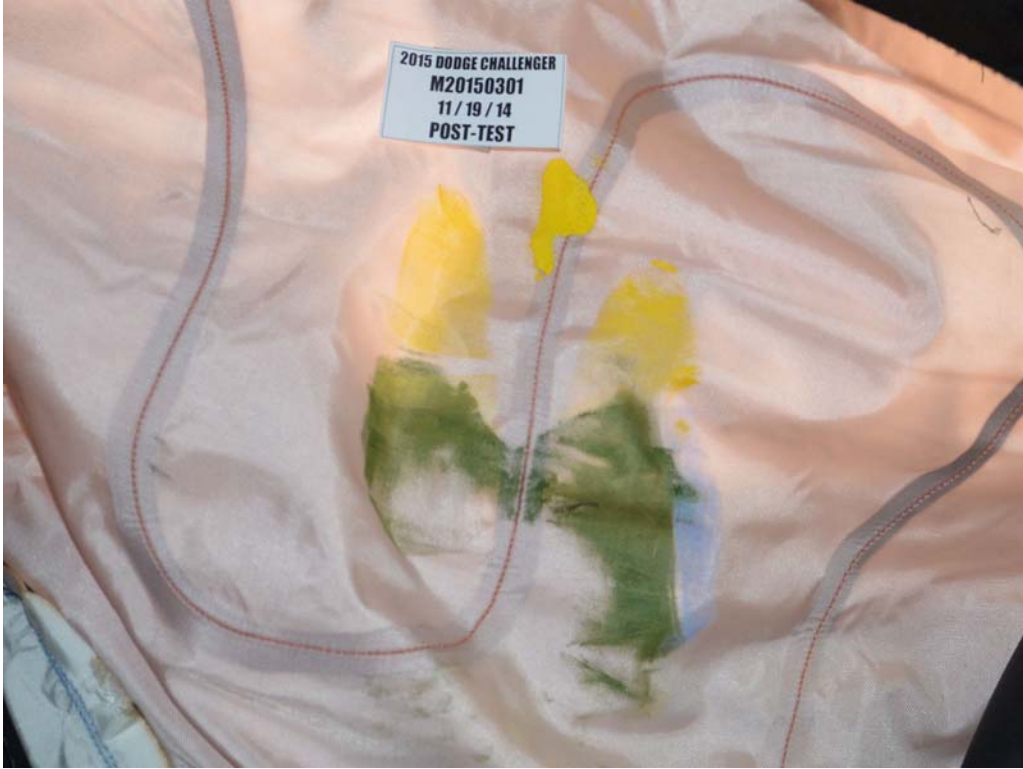
FIGURE 47. Post-Test Dummy Close-Up Head Contact With Side Airbag View

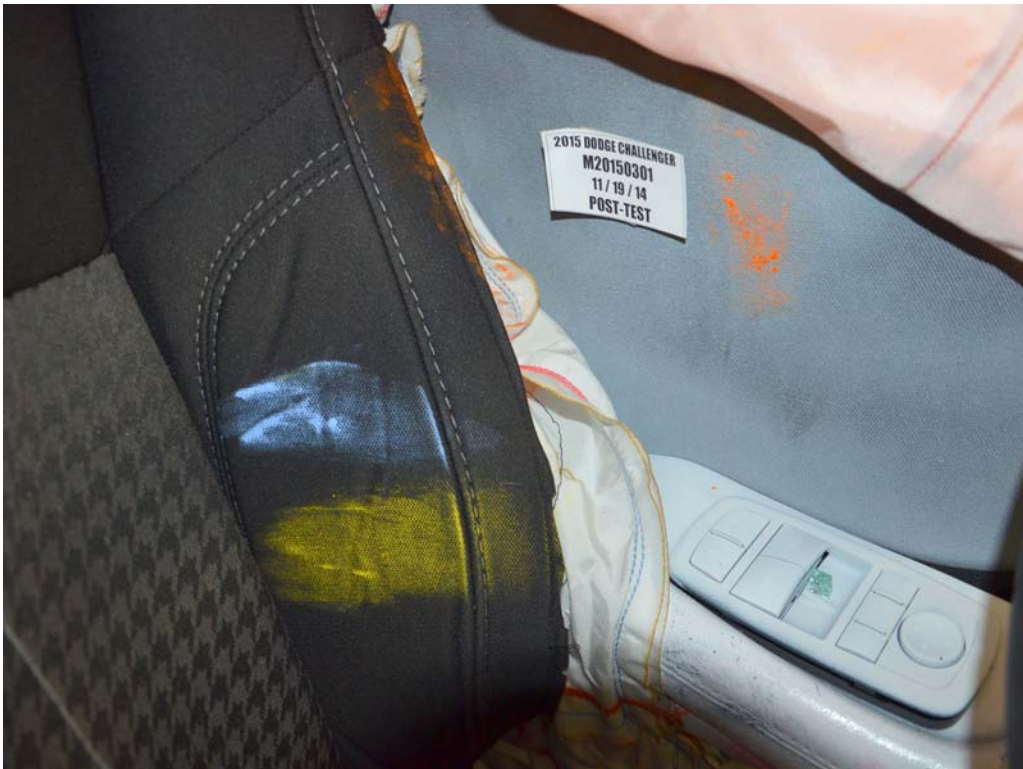
FIGURE 48. Post-Test Dummy Close-Up Torso Contact With Vehicle Interior View

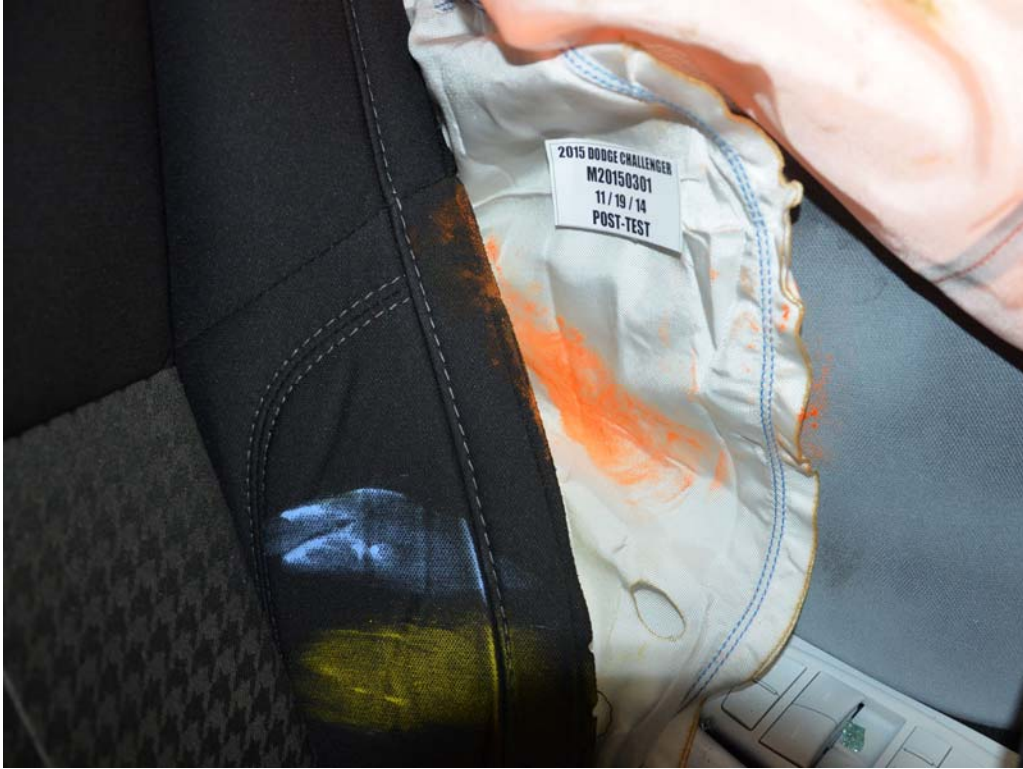
FIGURE 49. Post-Test Dummy Close-Up Torso Contact With Side Airbag View

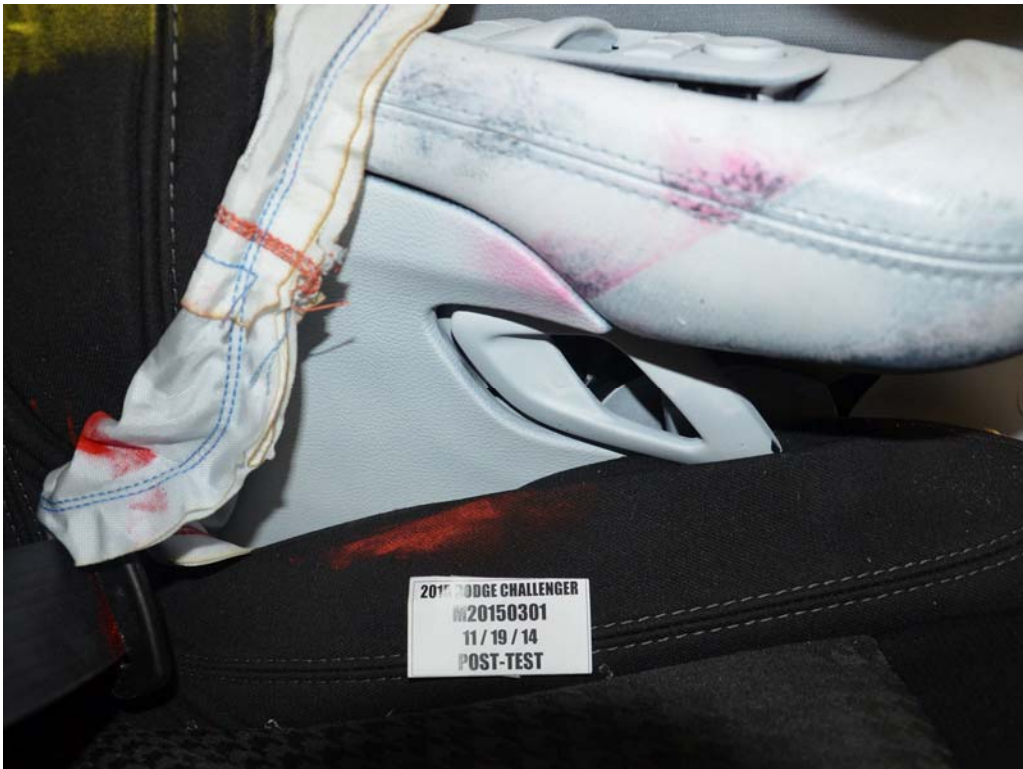
FIGURE 50. Post-Test Dummy Close-Up Pelvis Contact With Vehicle Interior View

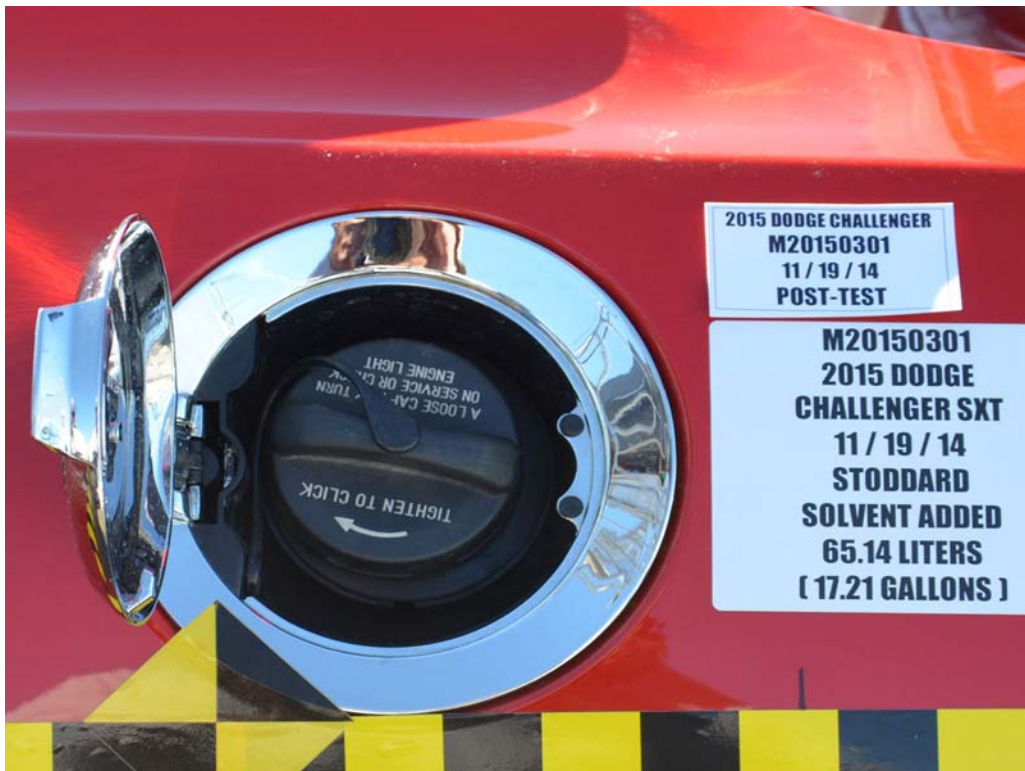
FIGURE 54. Post-Test View of Fuel Filler Cap or Fuel Filler Neck

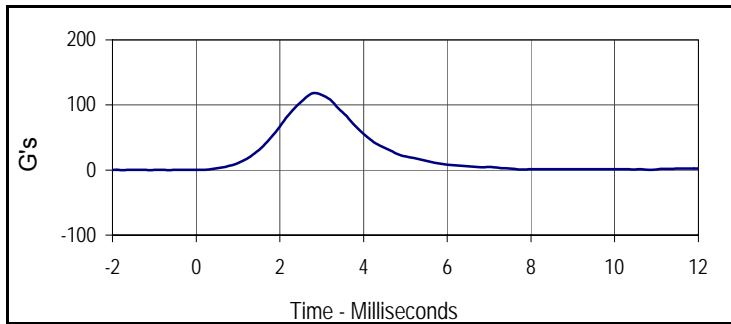
Curve Description			
Head Resultant			
Plot No.	Type	SAE Class	Units
001	RES	1000	G's
Max	Time	Min	Time
118.2	2.8	0.0	-1.7

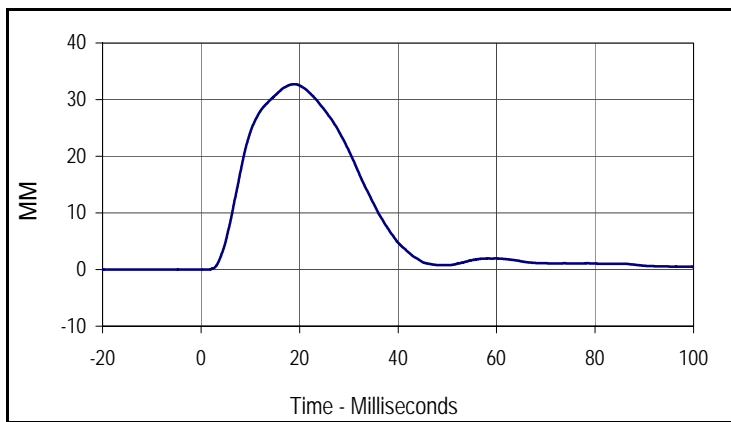
Curve Description			
Shoulder Deflection			
Plot No.	Type	SAE Class	Units
001	FIL	600	MM
Max	Time	Min	Time
32.7	19.1	0.0	-0.4

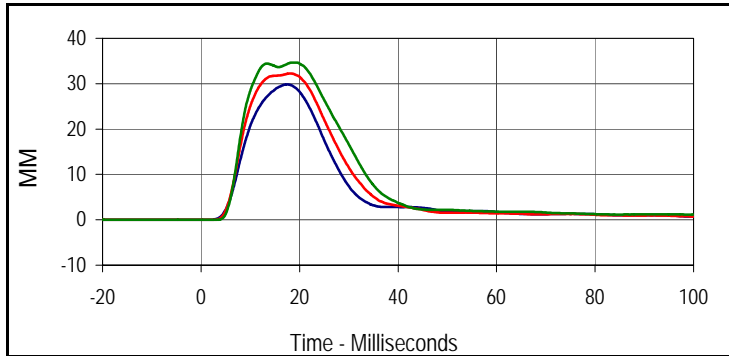
Curve Description			
Upper Thorax Deflection			
Plot No.	Type	SAE Class	Units
001	FIL	600	MM
Max	Time	Min	Time
29.8	17.5	0.0	-4.9
Middle Thorax Deflection			
Max	Time	Min	Time
32.2	18.0	0.0	-10.8
Lower Thorax Deflection			
Max	Time	Min	Time
34.6	18.4	0.0	-11.1

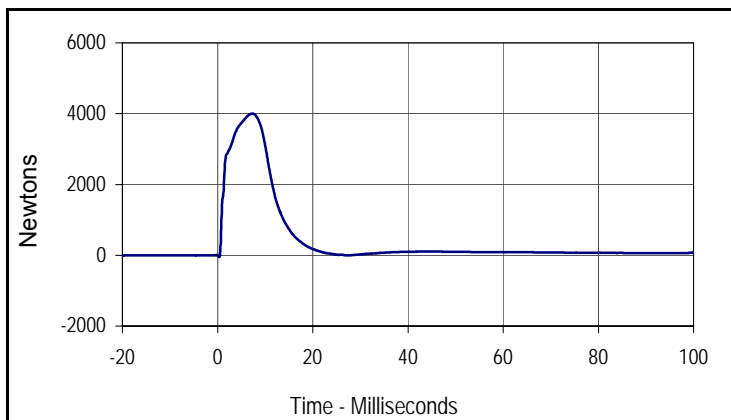
Curve Description			
Pelvis Acetabulum Force			
Plot No.	Type	SAE Class	Units
001	FIL	600	Newtons
Max	Time	Min	Time
3999.1	7.3	-45.9	0.4

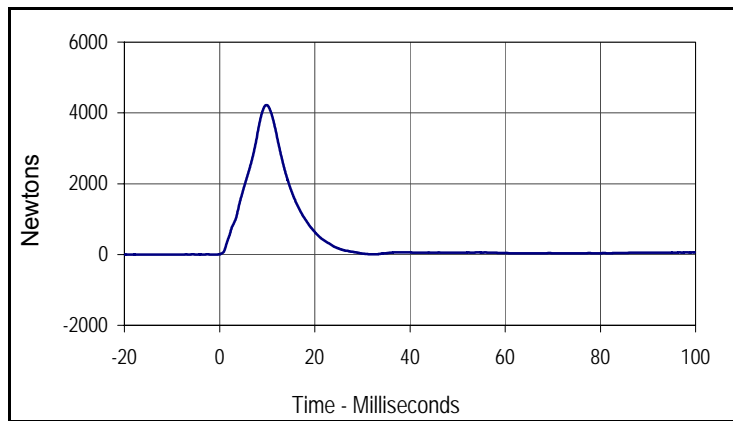
Curve Description			
Pelvis Iliac Force			
Plot No.	Type	SAE Class	Units
001	FIL	600	Newtons
Max	Time	Min	Time
4223.5	9.8	-3.6	-13.2
