**REPORT NUMBER: NCAP-MGA-2015-034**

**NEW CAR ASSESSMENT PROGRAM (NCAP)  
Frontal Barrier Impact Test**

**TOYOTA MOTOR MANUFACTURING, TEXAS, INC.  
2015 Toyota Tundra 4x4 SR5 CrewMax  
NHTSA No.: O20155106**

**FINAL REPORT**

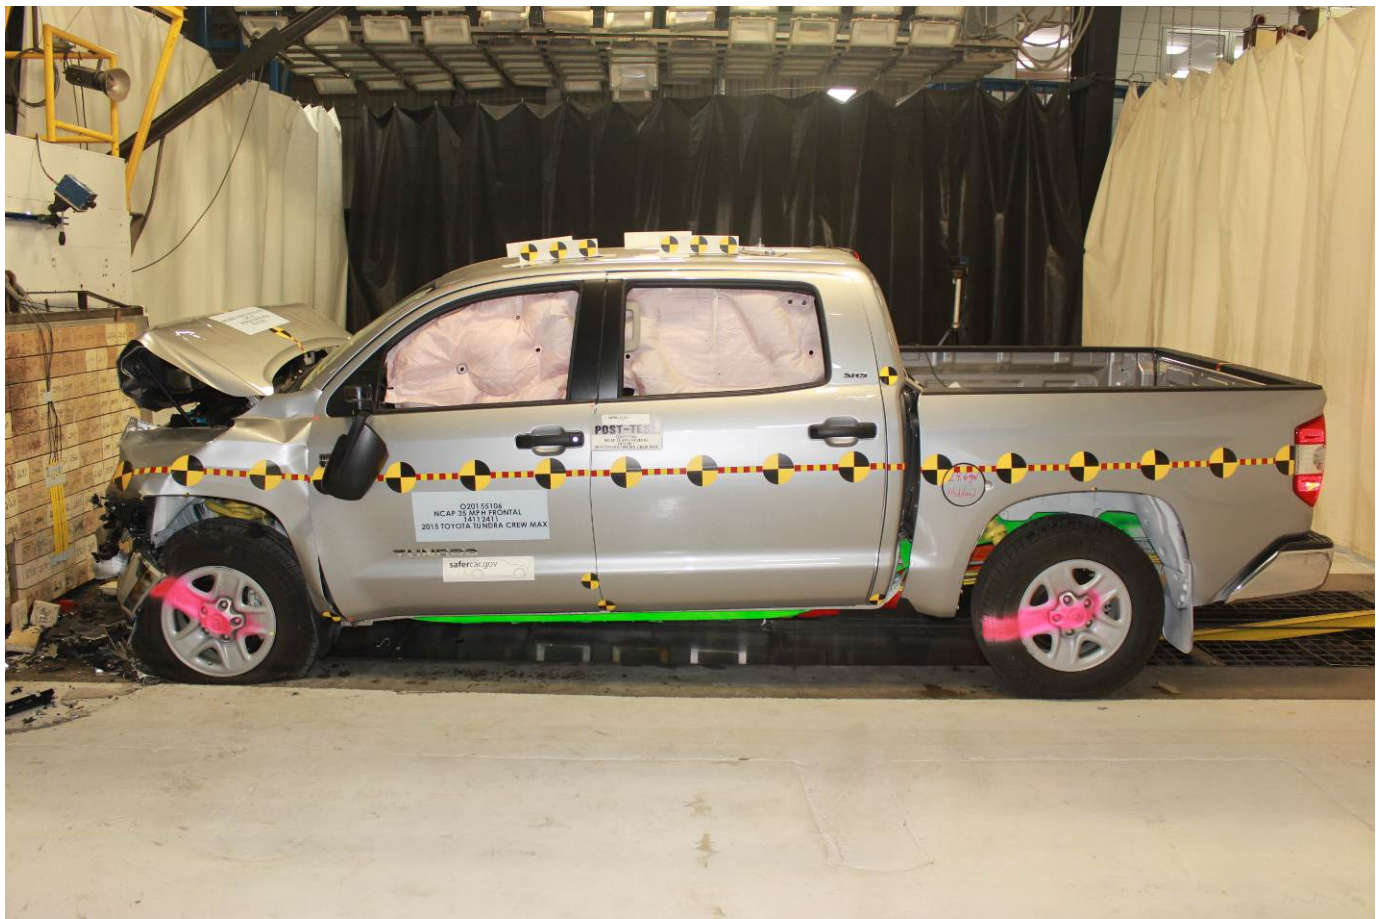
Post-Test Left View of Test Vehicle

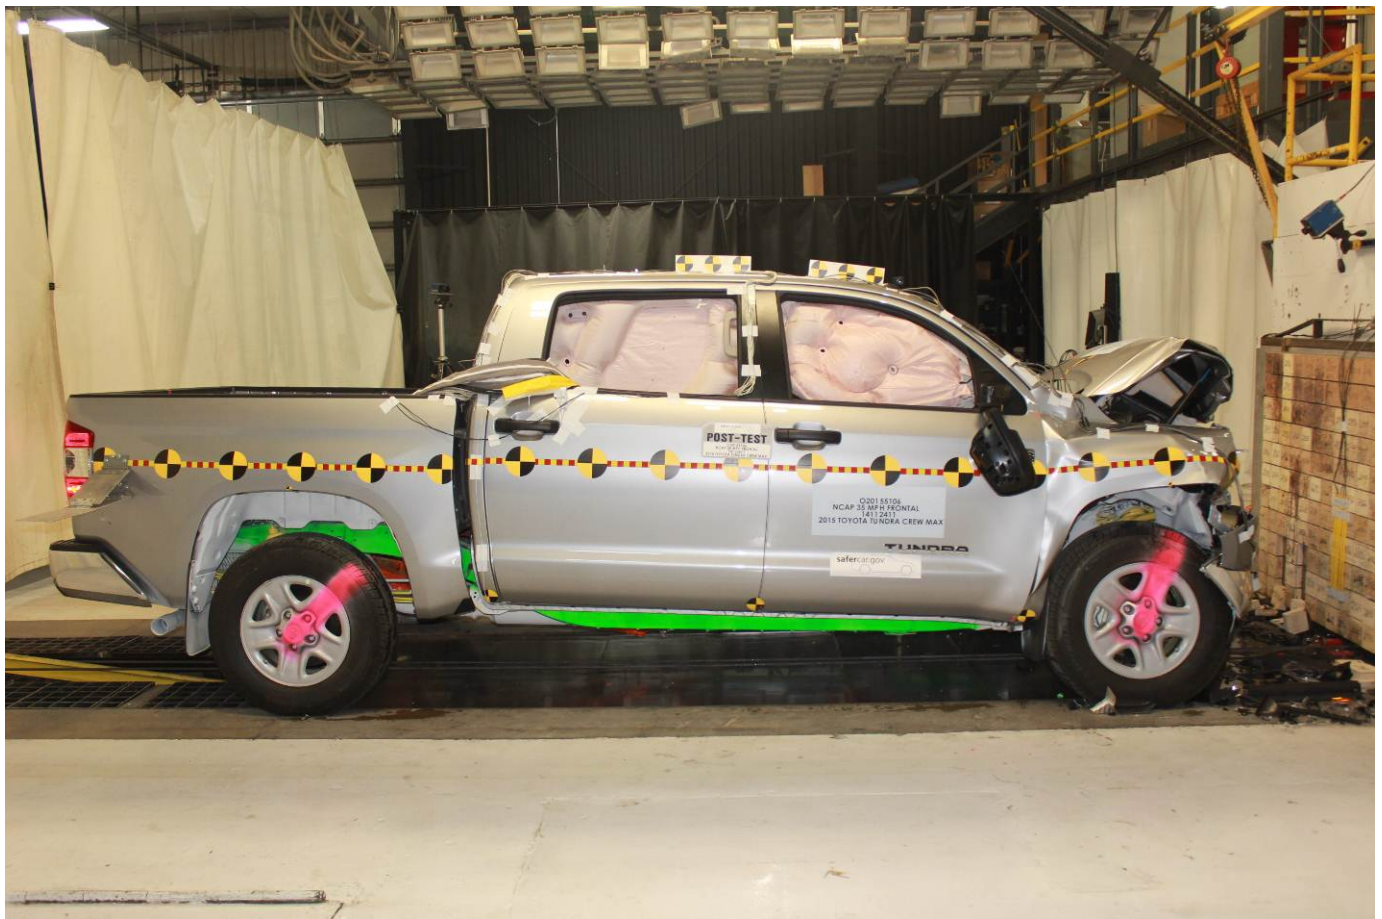
Post-Test Right View of Test Vehicle

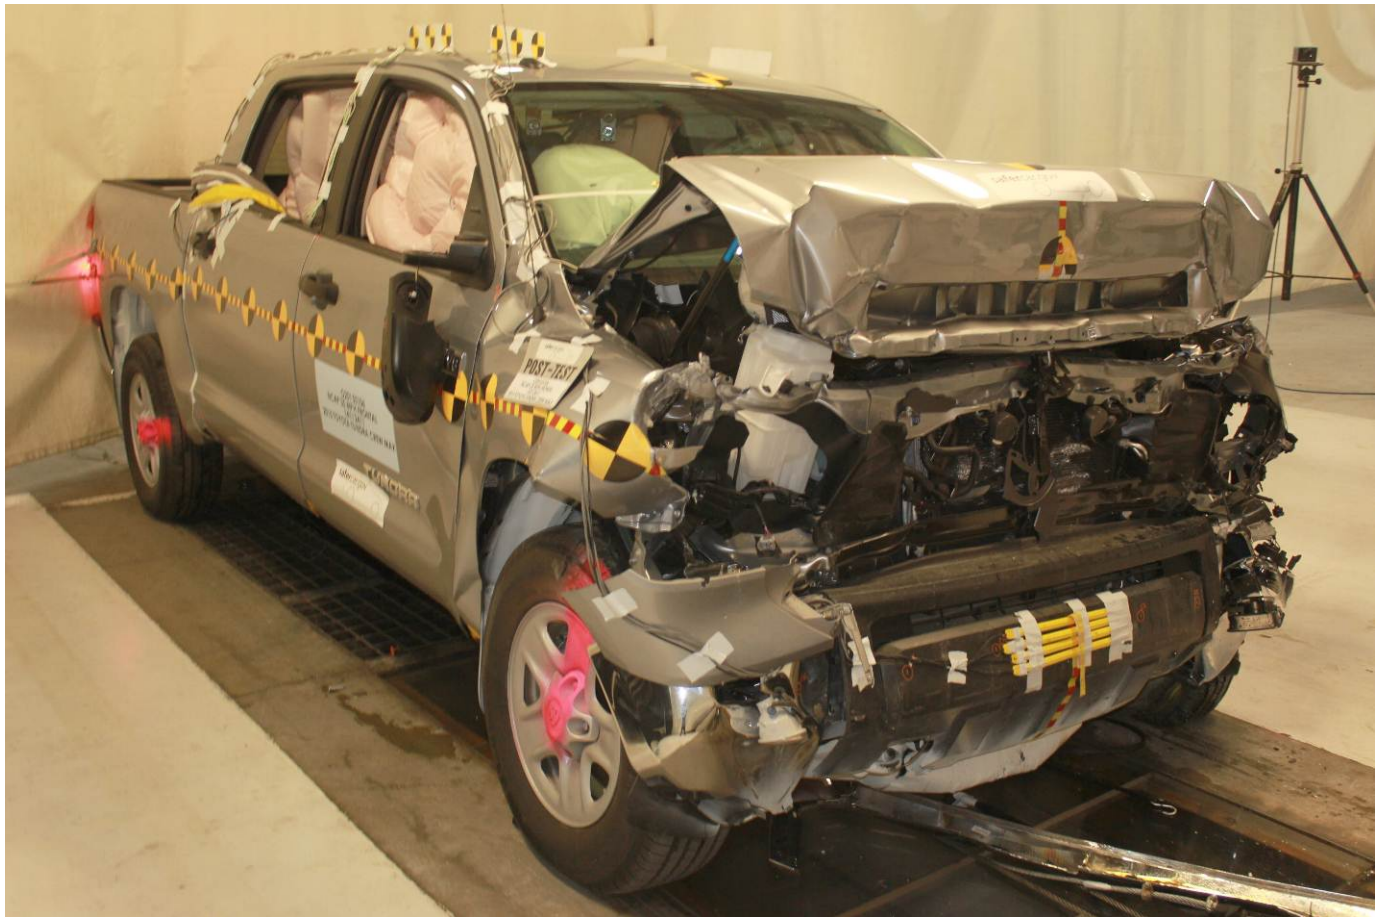
Post-Test Right Front 3-4 View

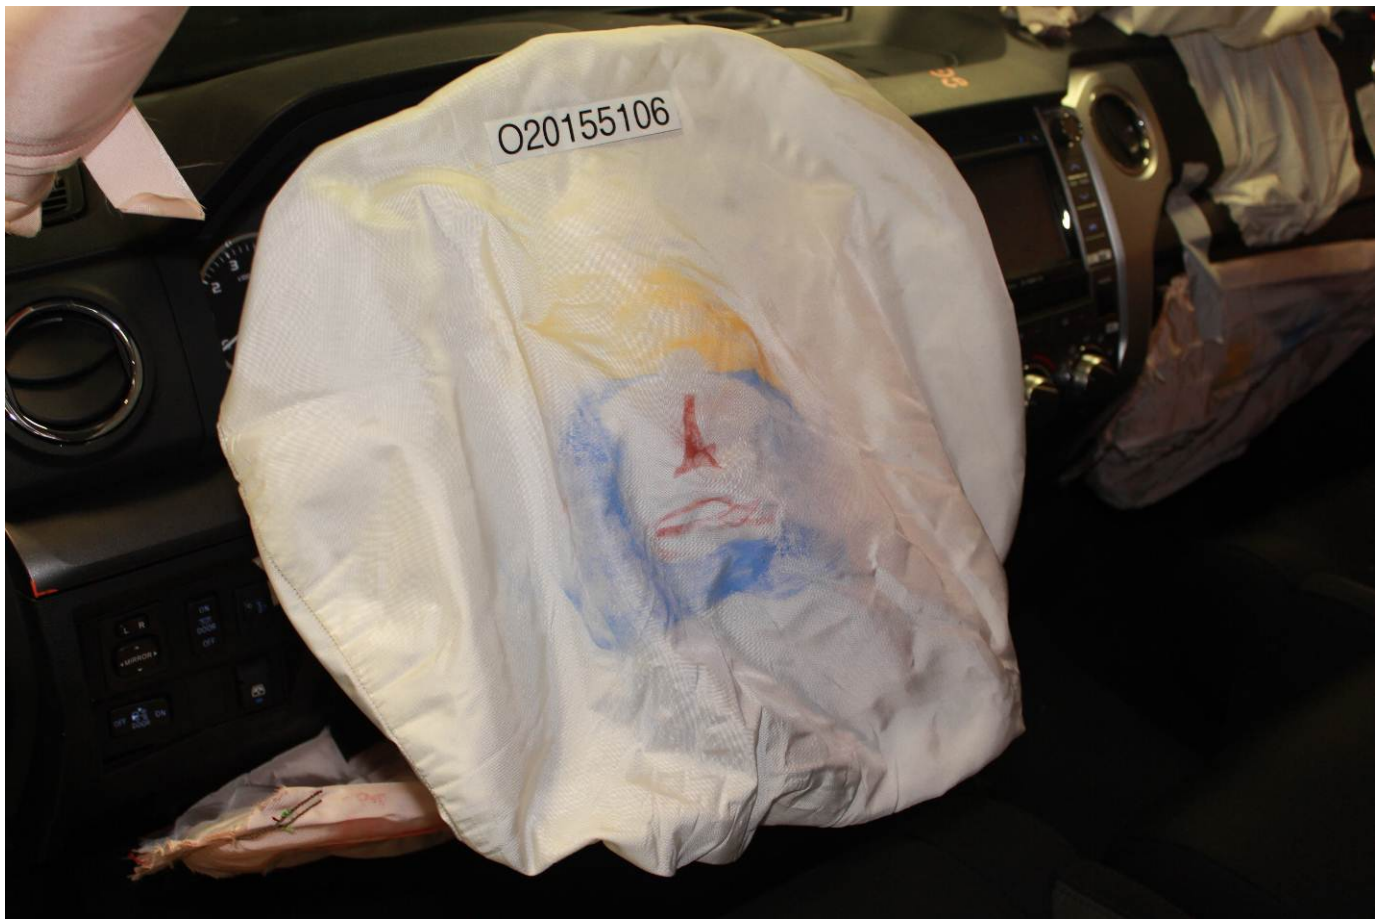
Post-Test Driver Dummy Contact with Airbag

The driver's visible contact points were as follows: The driver's head and chest contacted the airbag. The driver's head also contacted the curtain airbag and headliner. The driver's knees contacted the knee airbag. The passenger's visible contact points were as follows: The passenger's head and chest contacted the airbag. The passenger's head also contacted the headrest. The passenger's knees contacted the knee airbag.

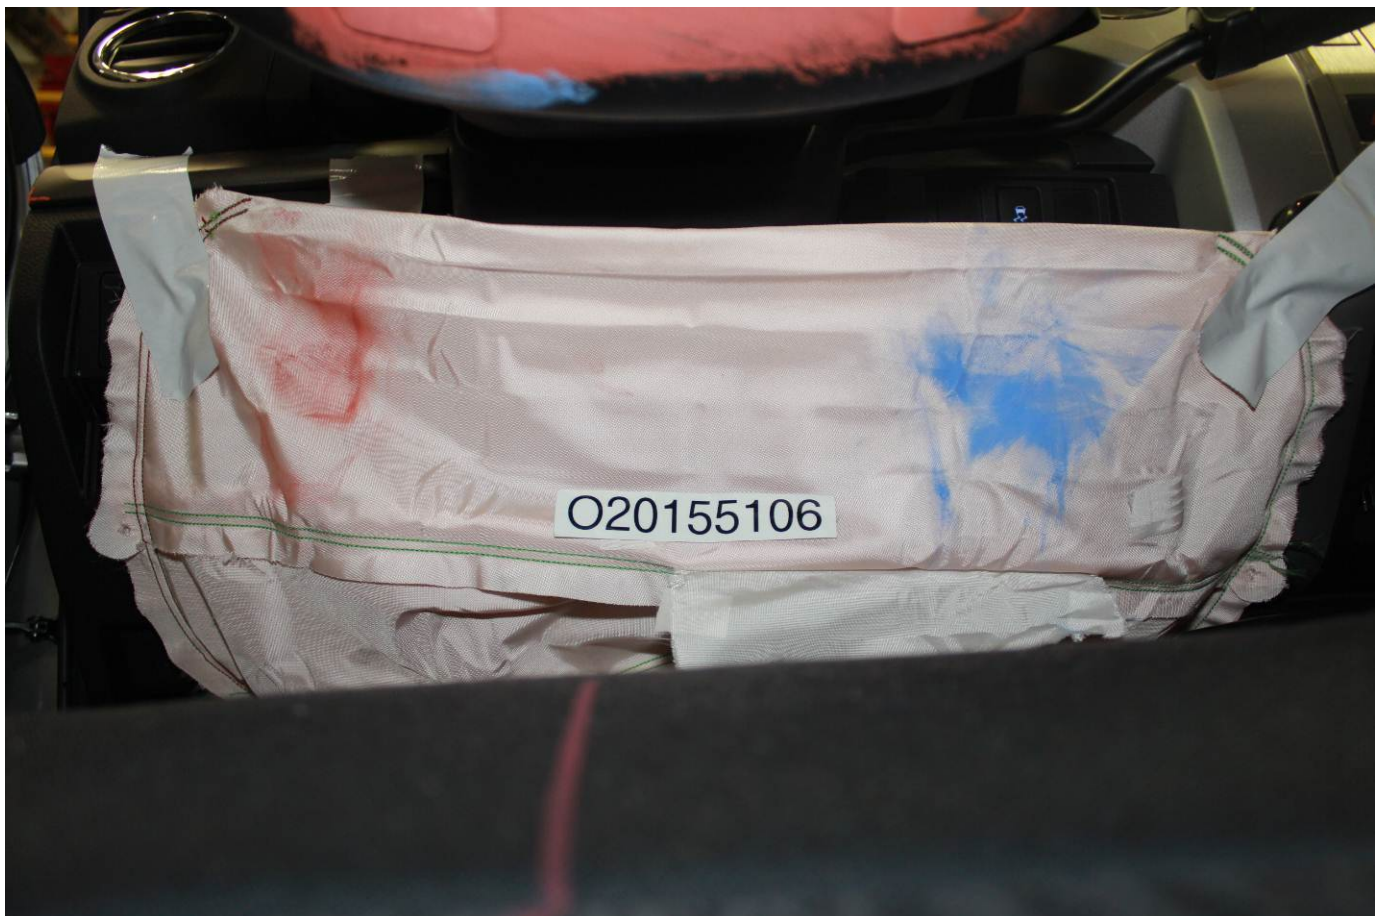
Post-Test Driver Dummy Contact with Knee Airbag

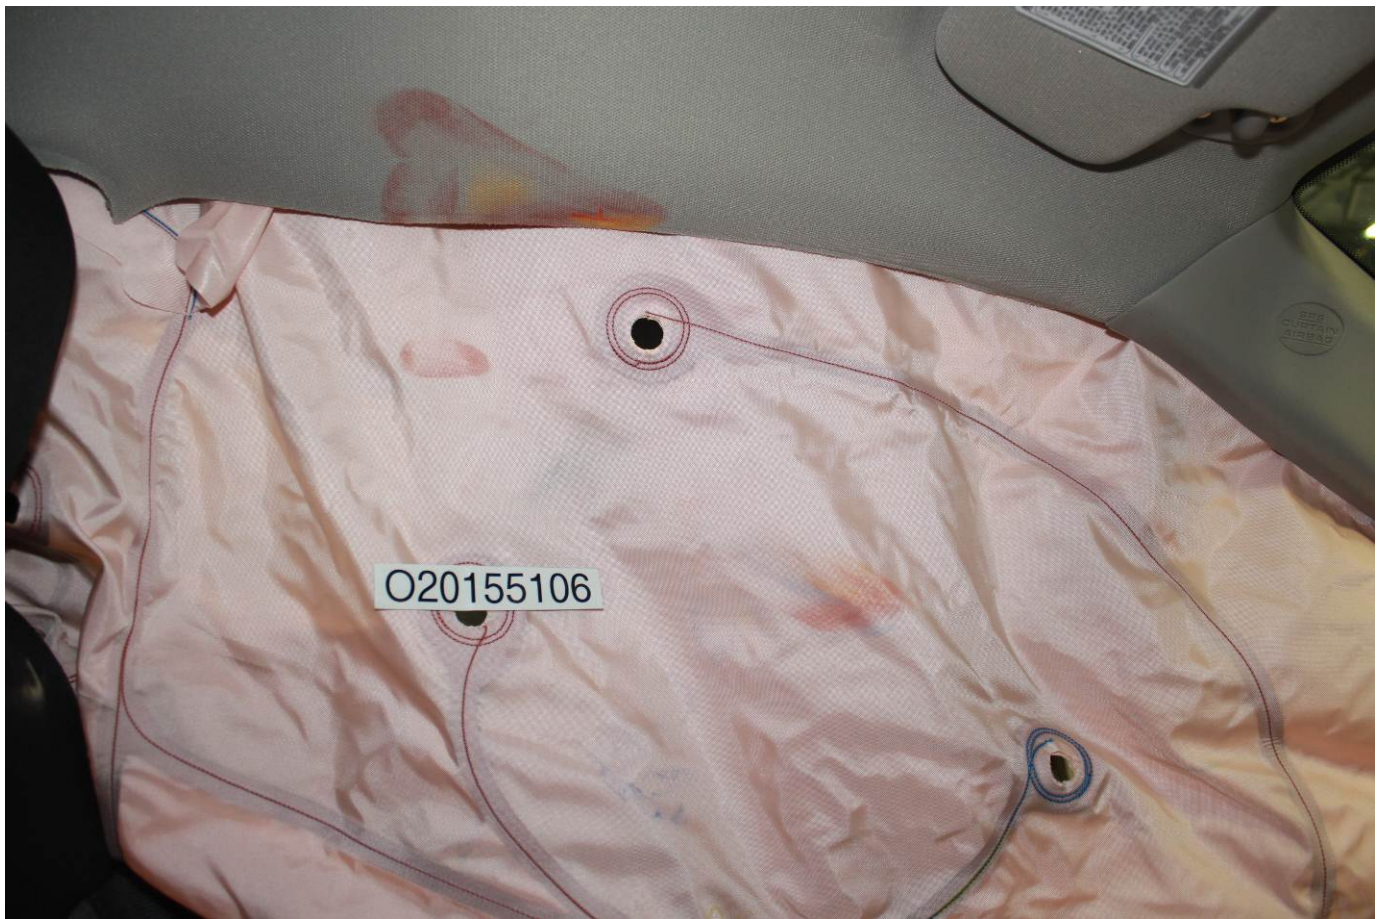
Post-Test Driver Dummy Contact with Curtain Airbag/Headliner

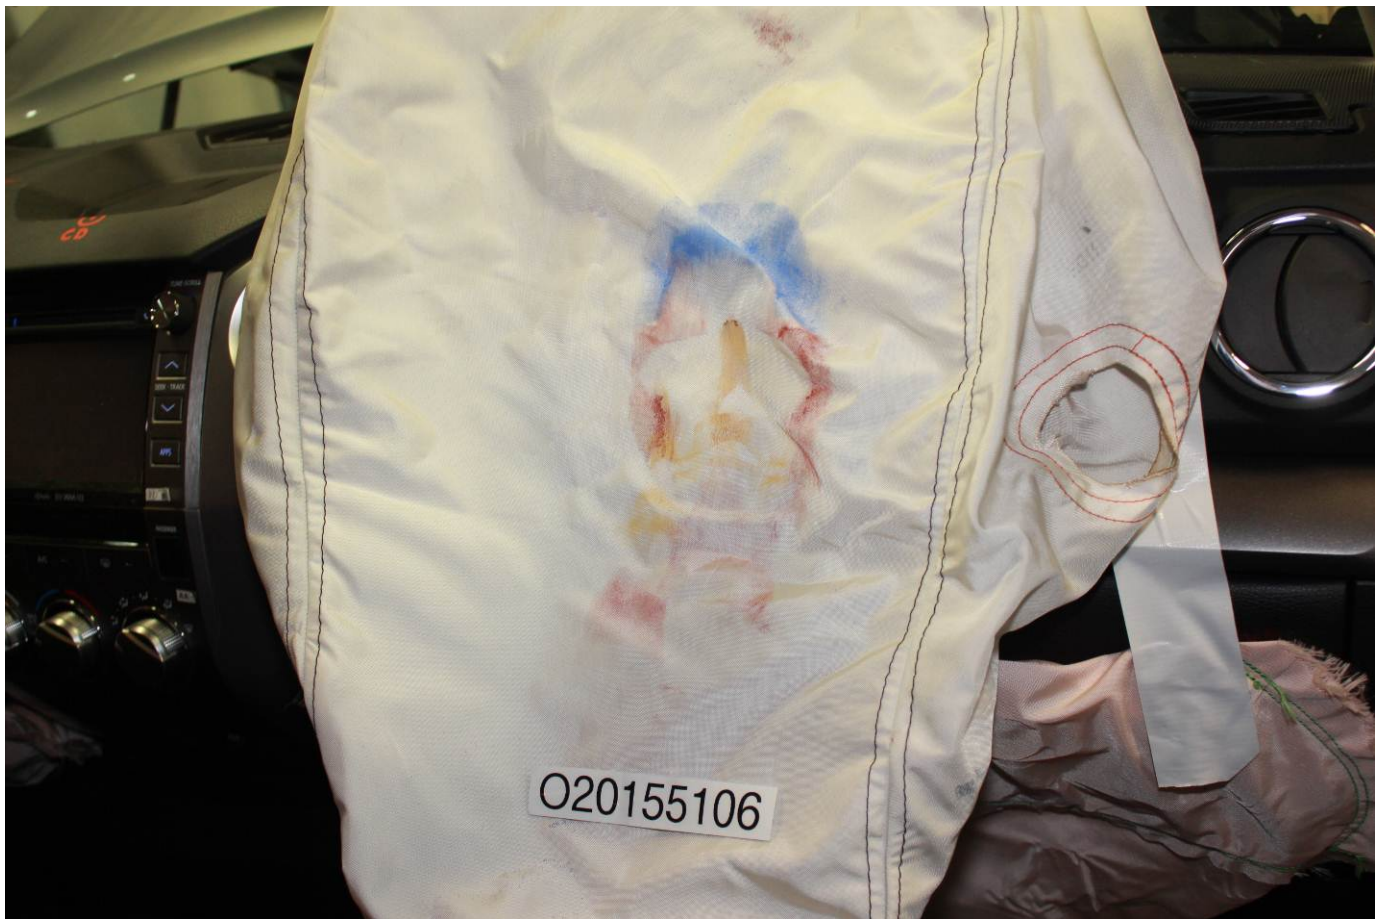
Post-Test Passenger Dummy Contact with Airbag

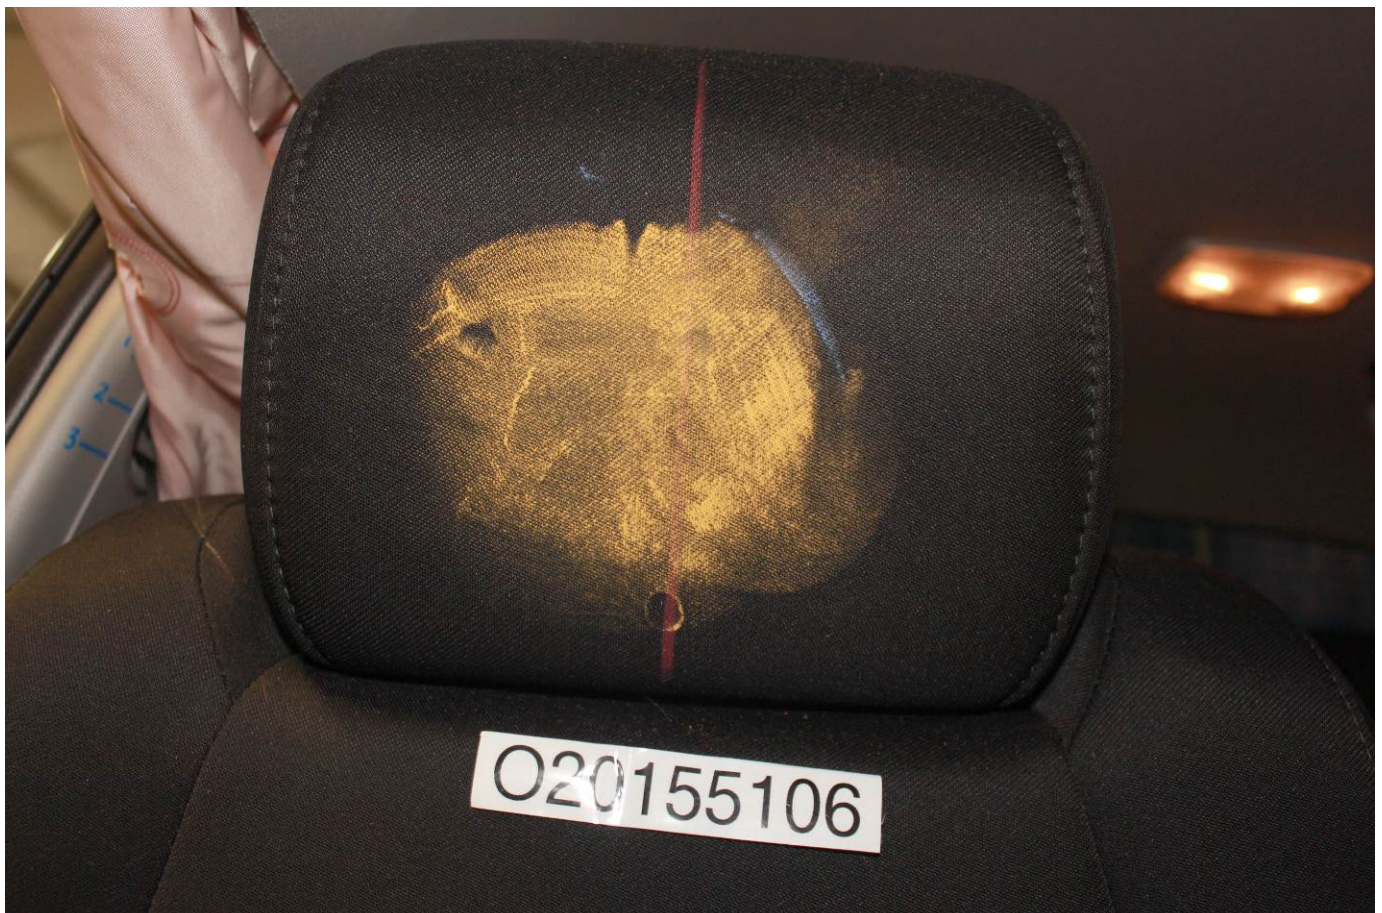
Post-Test Passenger Dummy Contact with Headrest

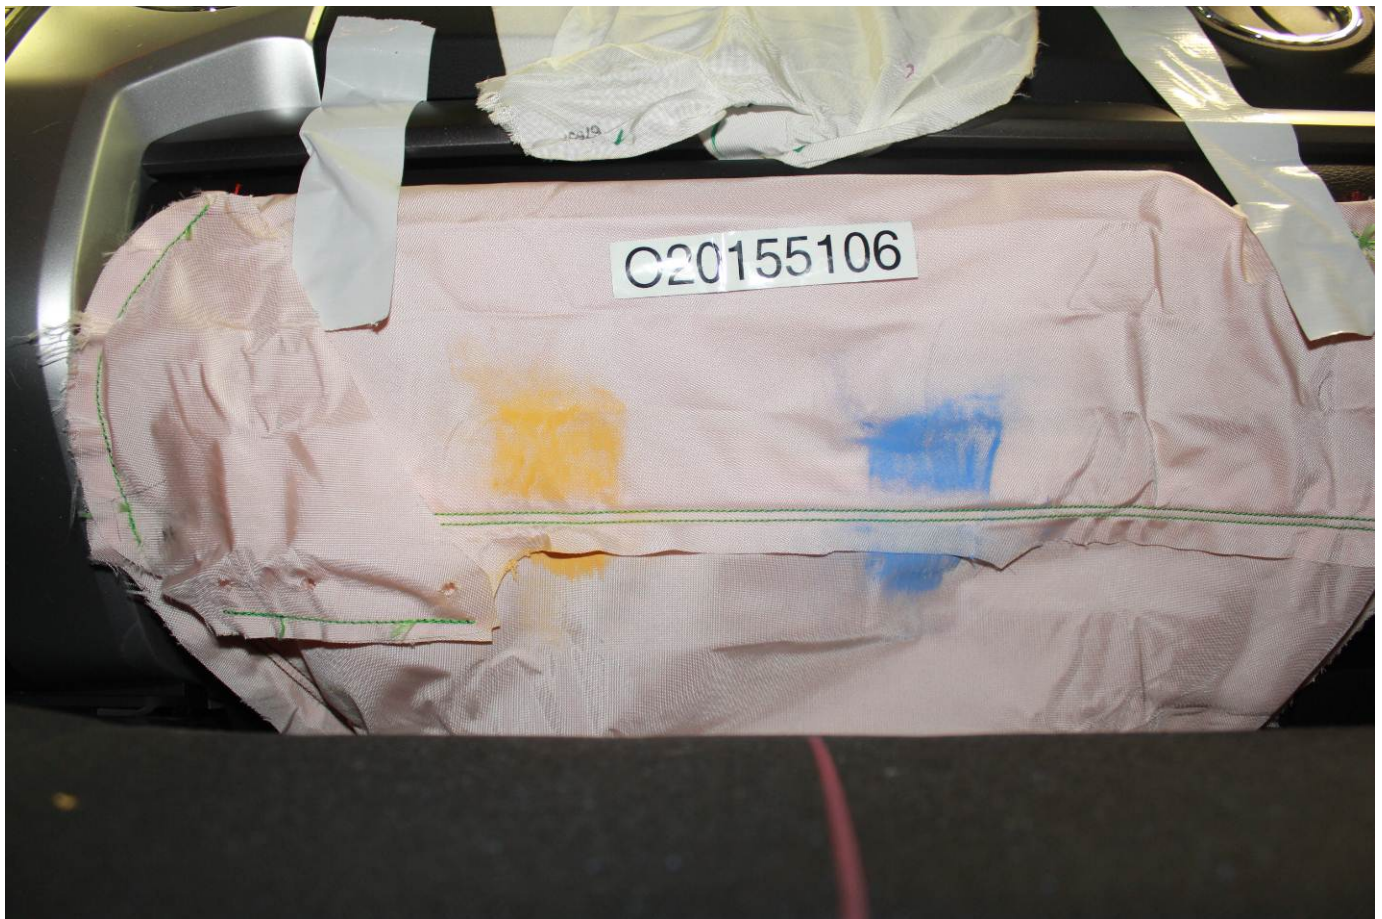
Post-Test Passenger Dummy Contact with Knee Airbag

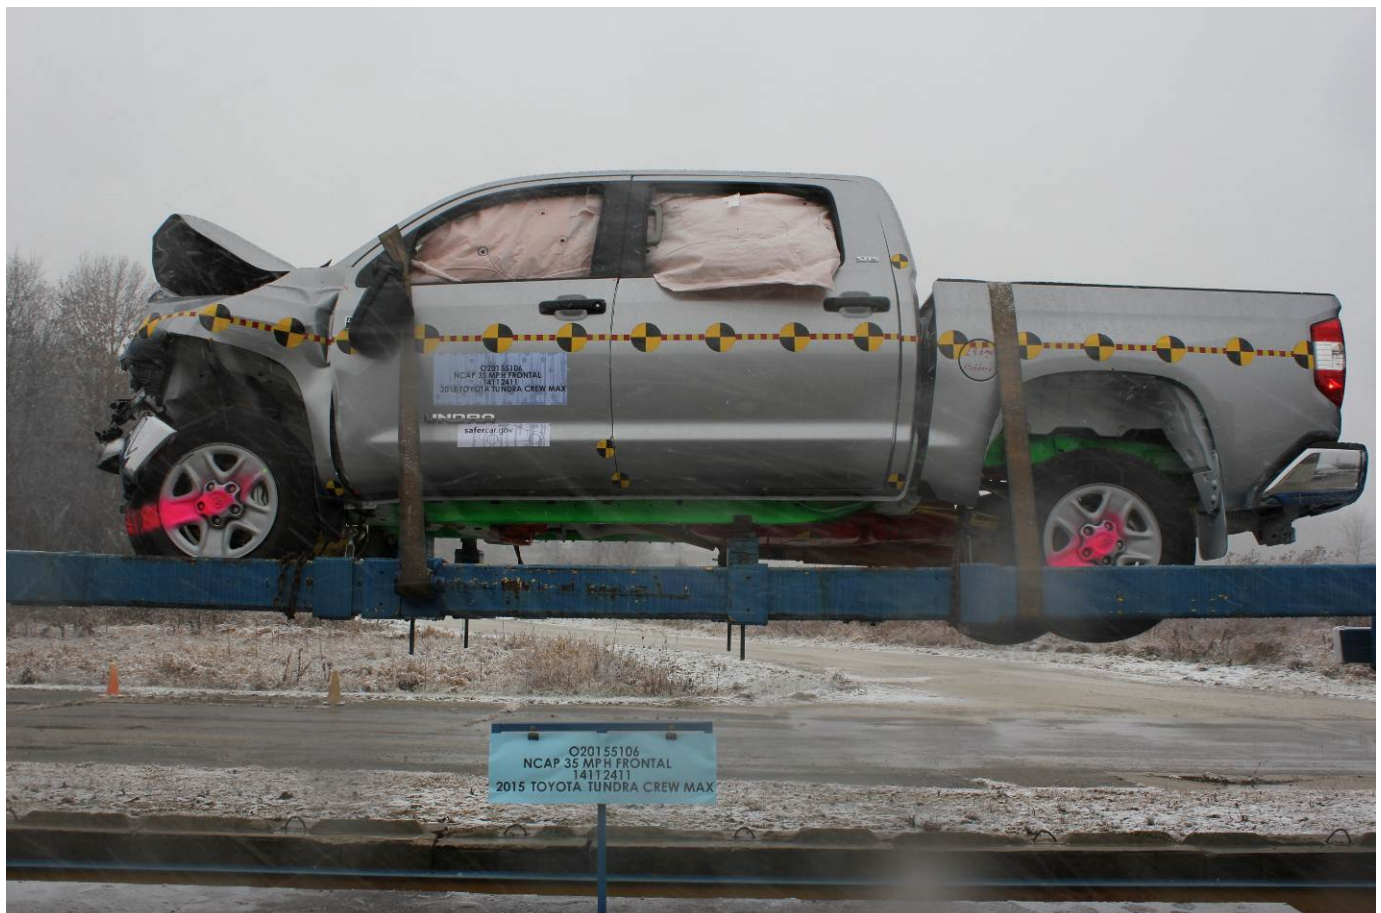
Vehicle at 0 Degree on Static Rollover Device

There was 100 percent windshield retention and no intrusion into the protected zone of the windshield during the event. There was no Stoddard Solvent leakage after the event or during any phase of the static rollover.

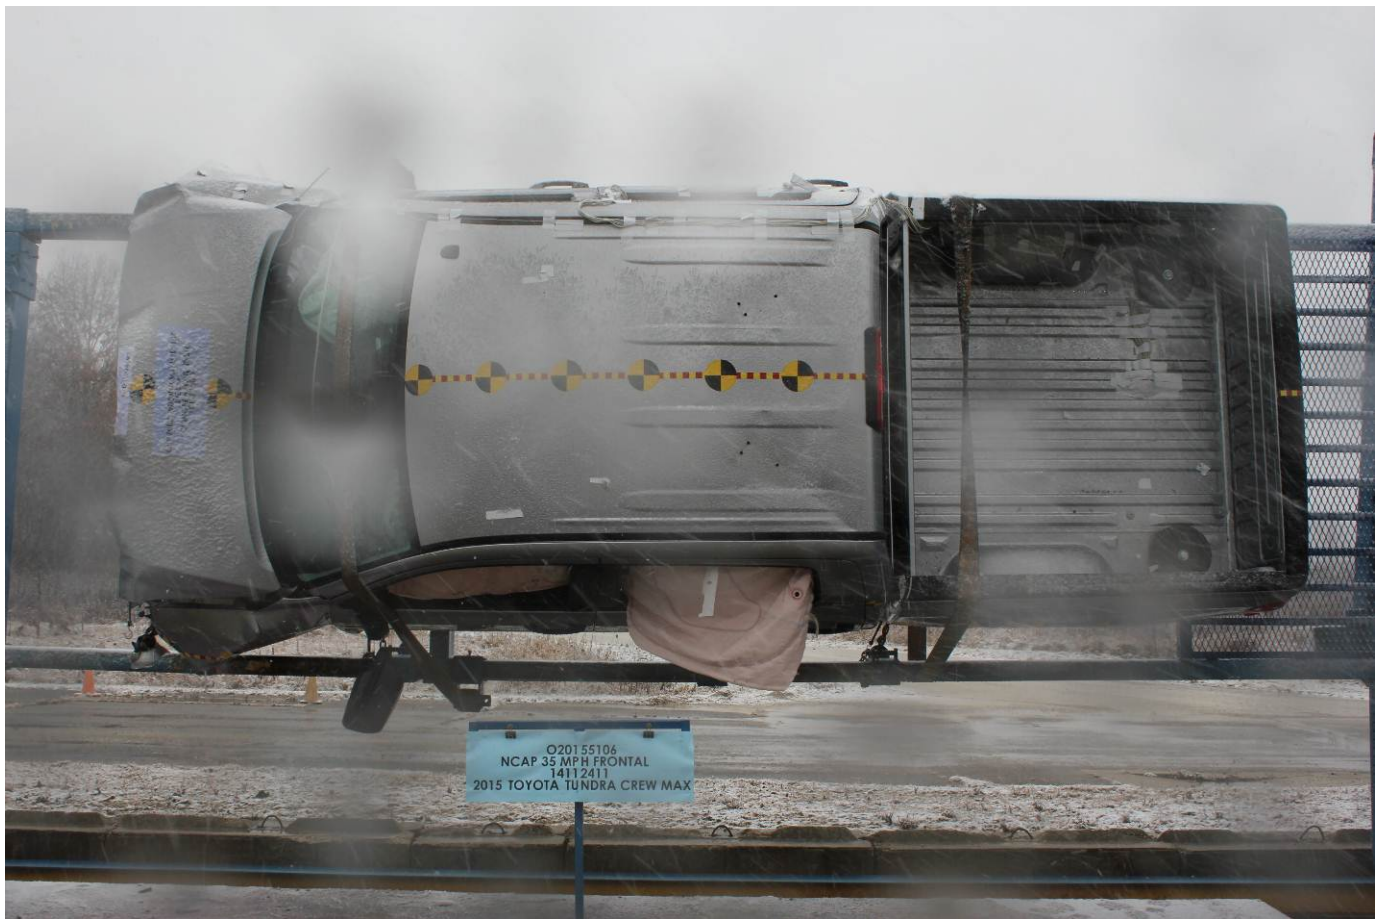
Vehicle at 90 Degrees on Static Rollover Device

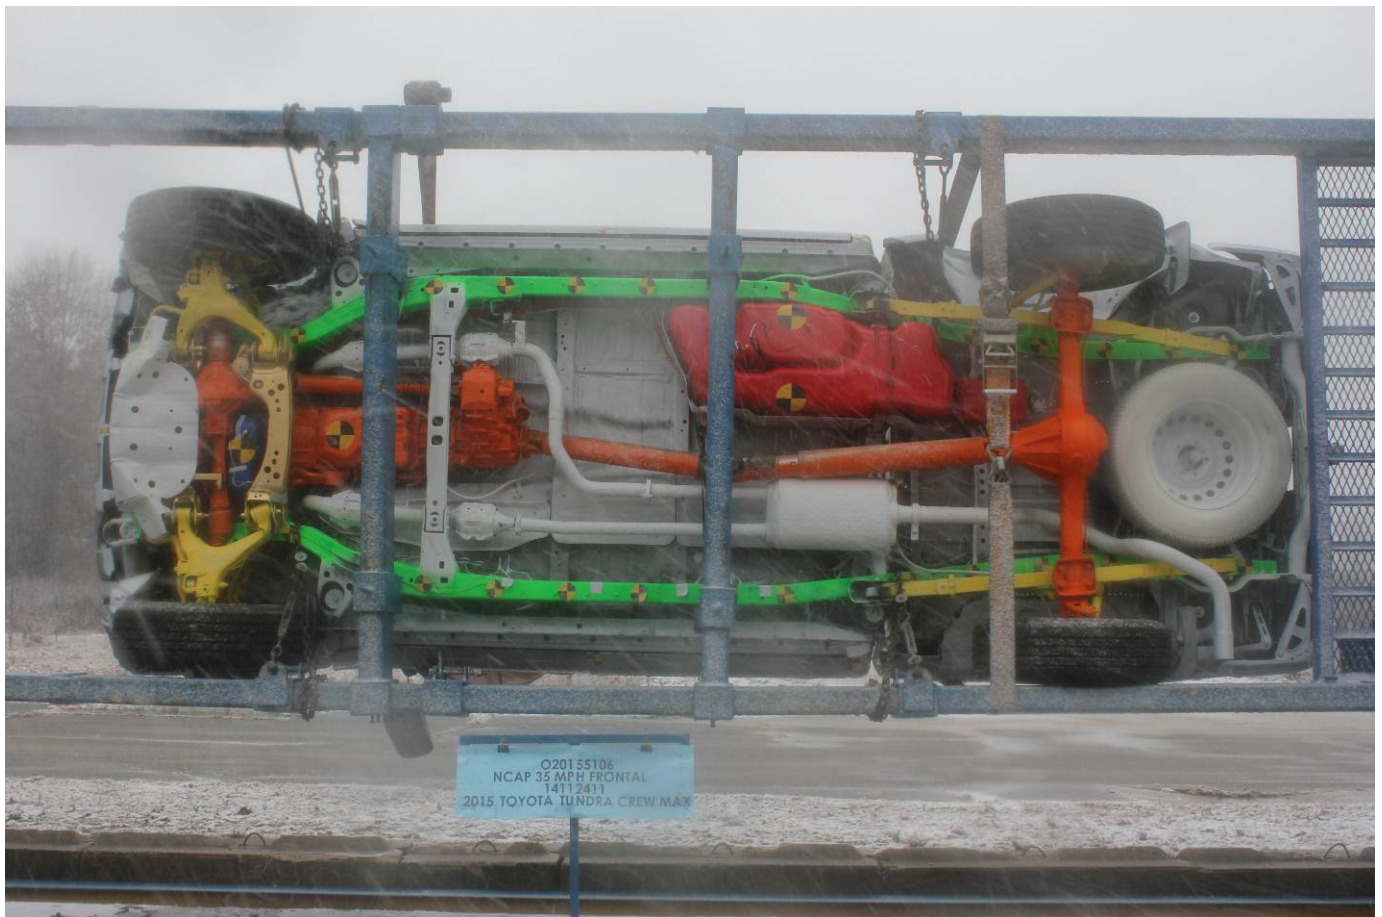
Vehicle at 270 Degrees on Static Rollover Device

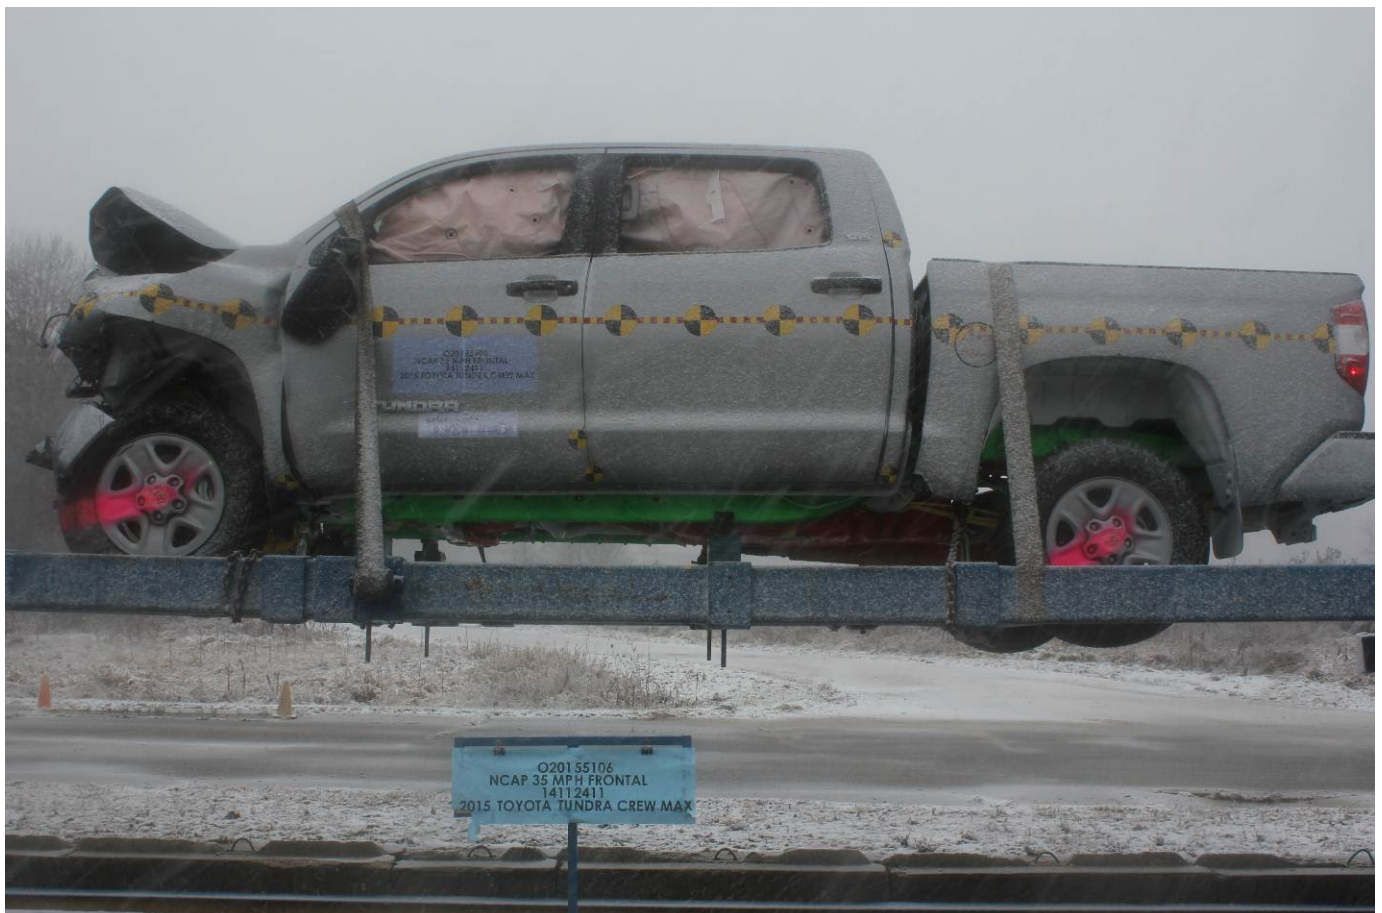
Vehicle at 360 Degrees on Static Rollover Device
