**REPORT NUMBER: SINCAP-MGA-2015-037**

**NEW CAR ASSESSMENT PROGRAM (NCAP)  
Moving Deformable Barrier Side Impact Test**

**MITSUBISHI MOTORS (THAILAND) CO., LTD.  
2015 Mitsubishi Mirage DE 5-Dr Hatchback  
NHTSA No.: M20155602**

**FINAL REPORT**

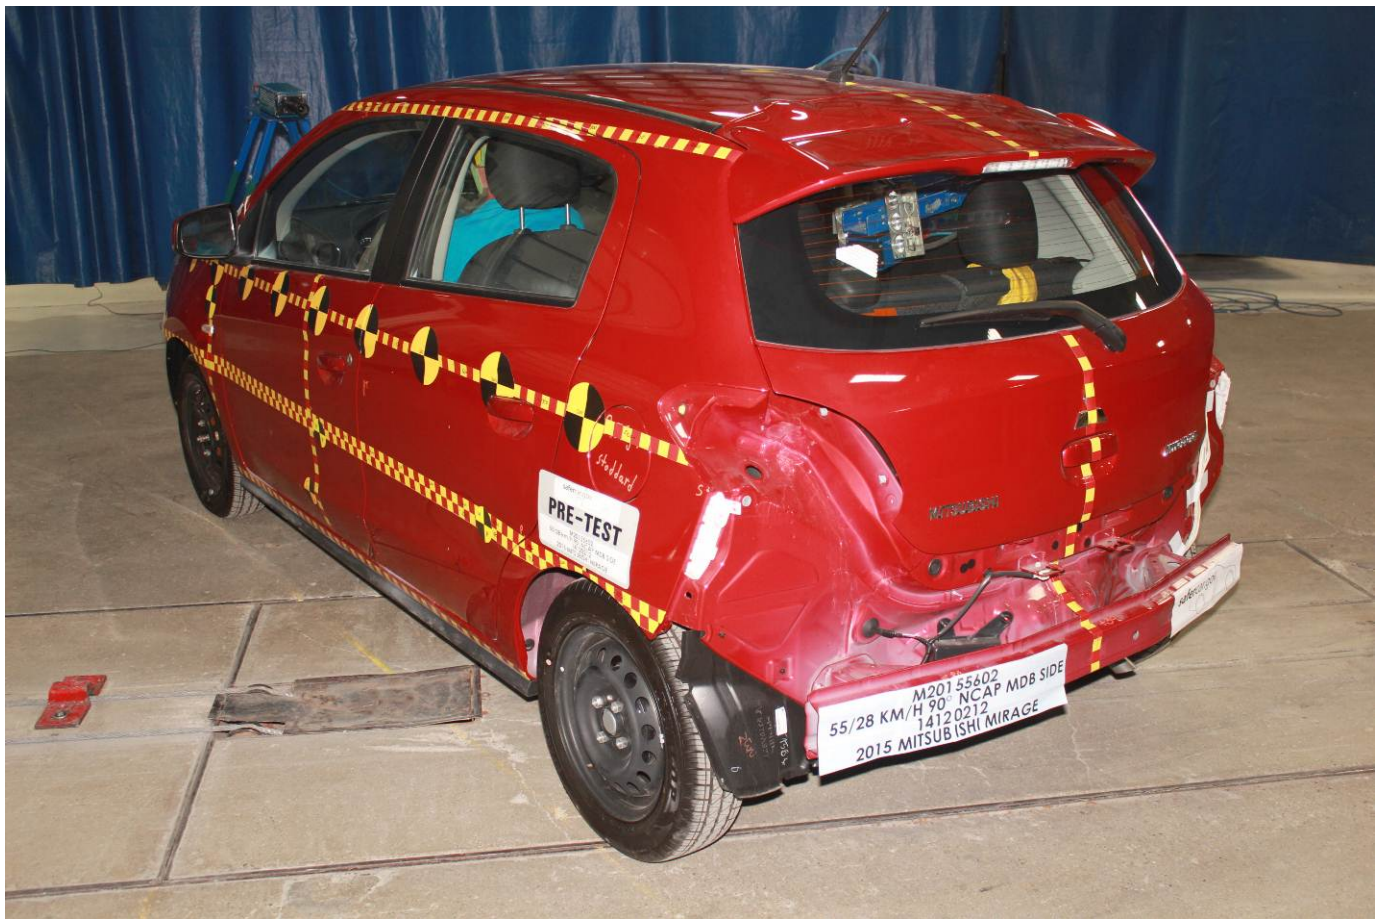
Post-Test Left Side View of Test Vehicle

| Critical Areas of Performance | Observations and Conclusions |
|---|---|
| Side Window Damage | Left Front and Left Rear Windows Broken |

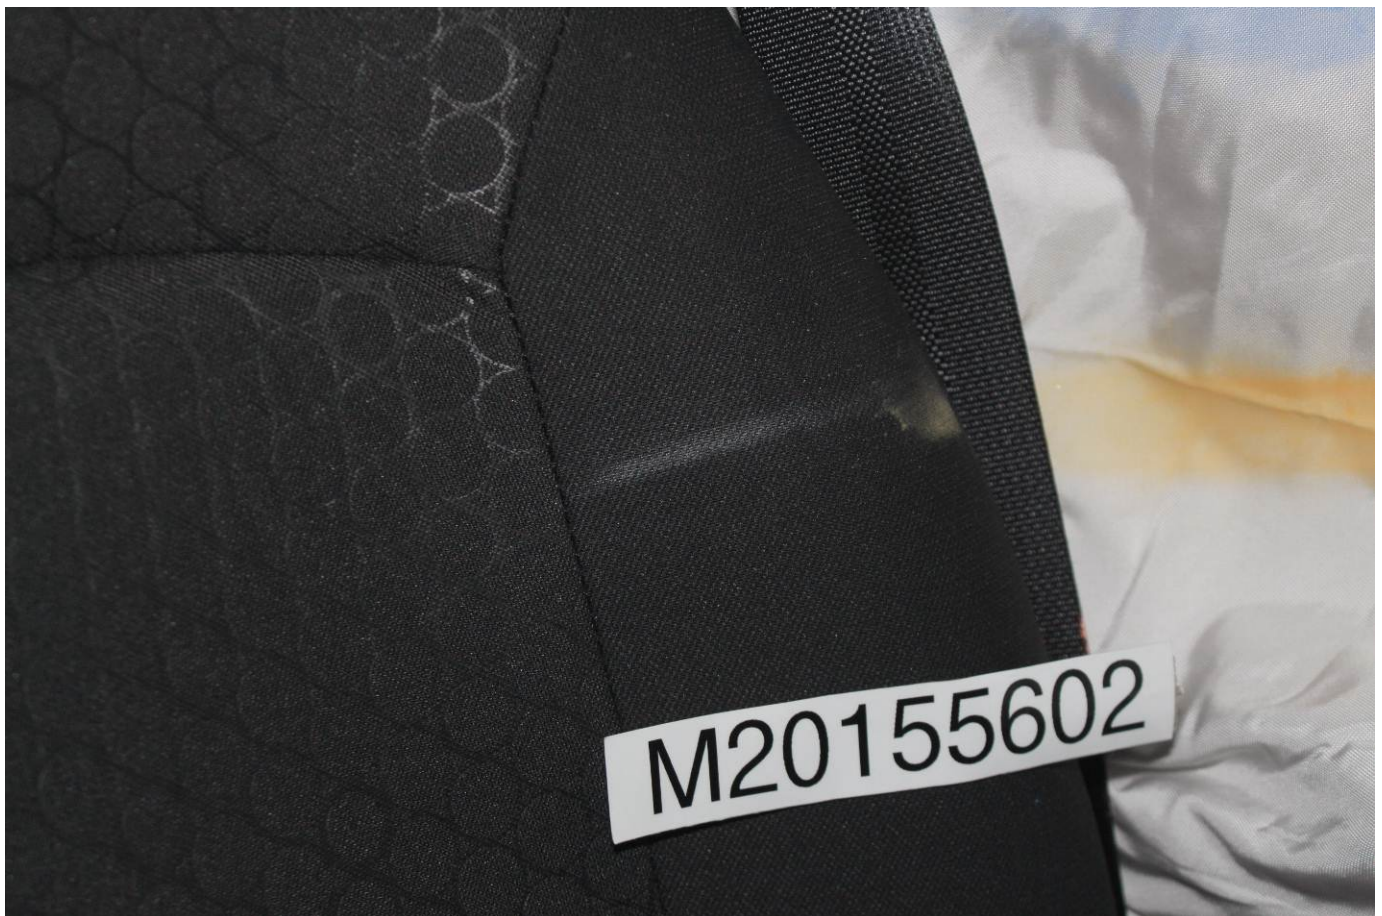
Post-Test Driver Dummy Close-up Head Contact with Side Airbag View

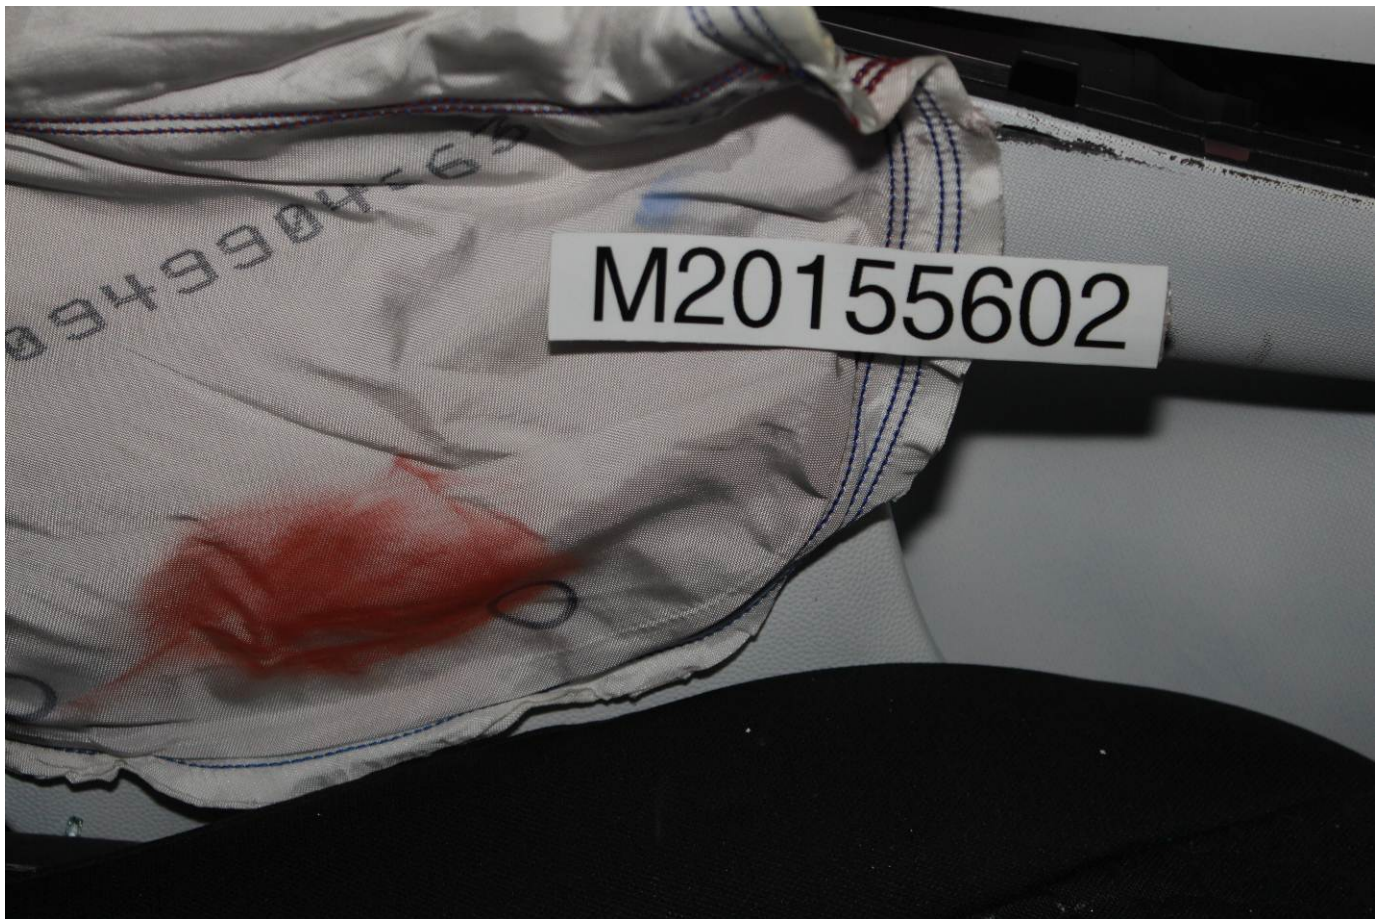
Post-Test Driver Dummy Close-up Pelvis Contact with Vehicle Interior View

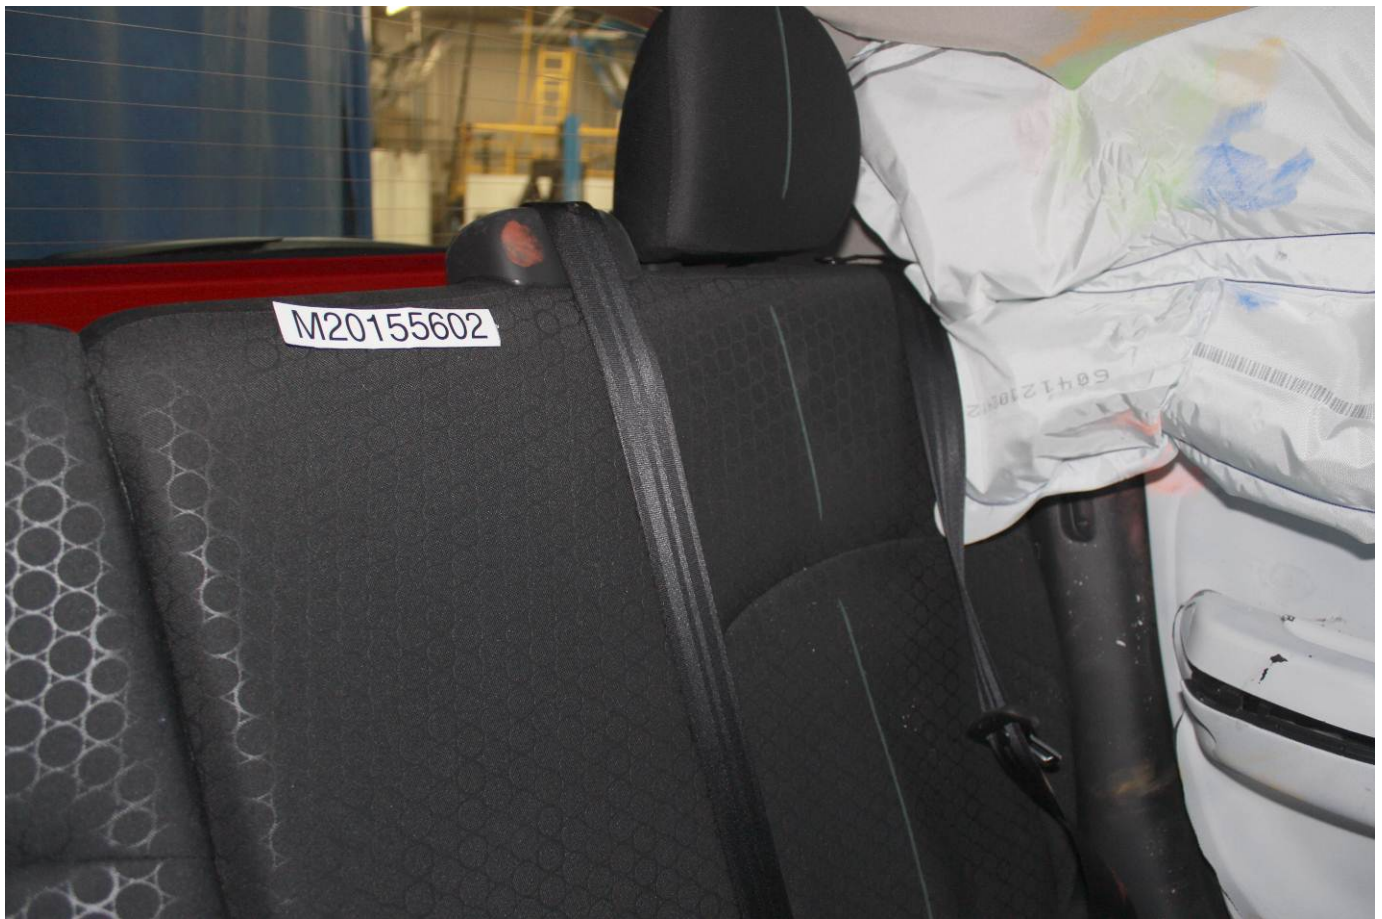
Post-Test Rear Passenger Inner Door Panel View

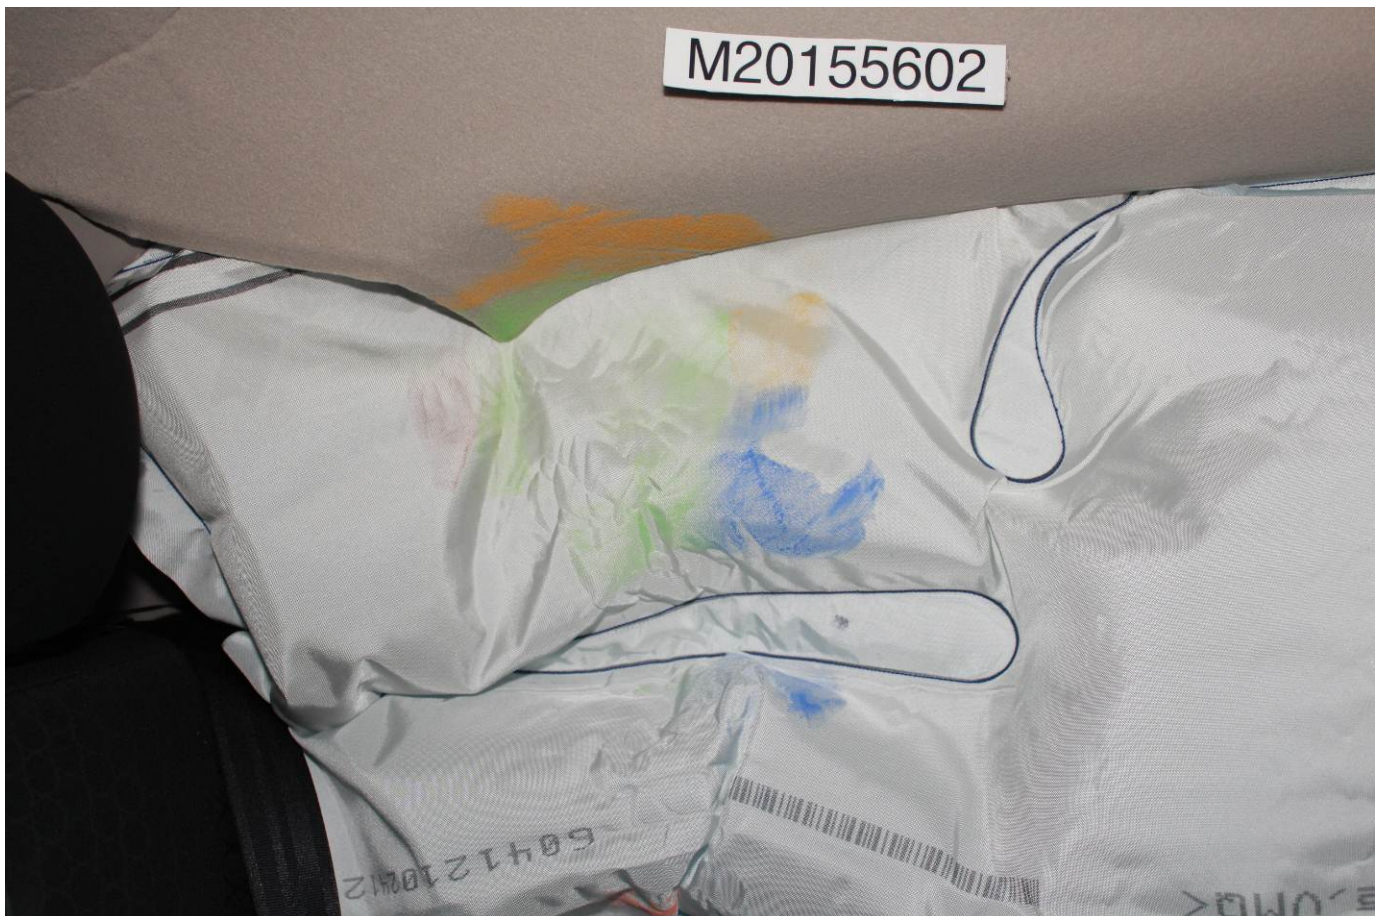
Post-Test Rear Passenger Dummy Close-up Head Contact with Vehicle Interior View

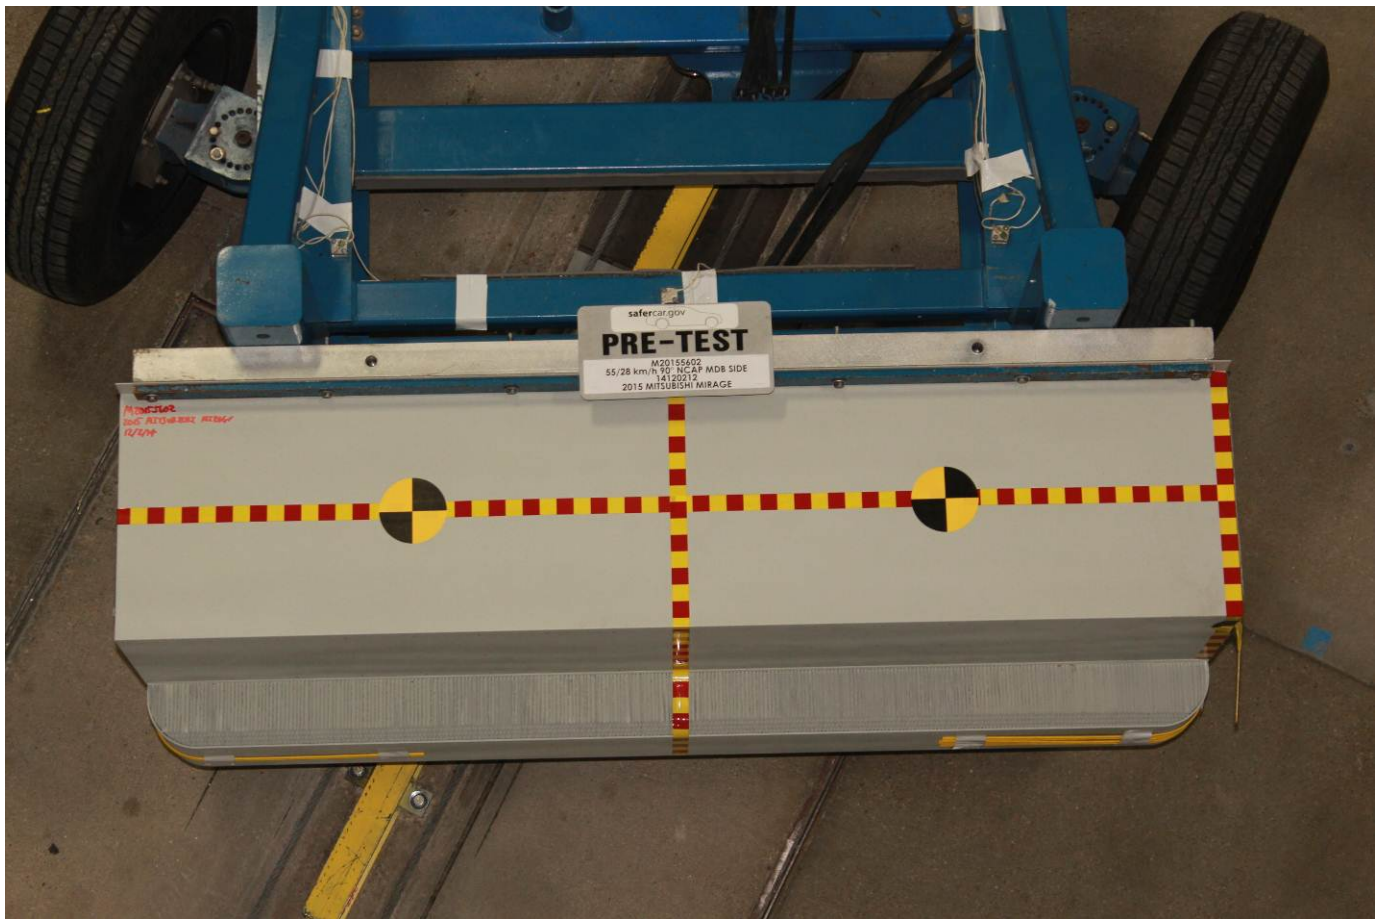
Post-Test Front View of MDB Impactor Face

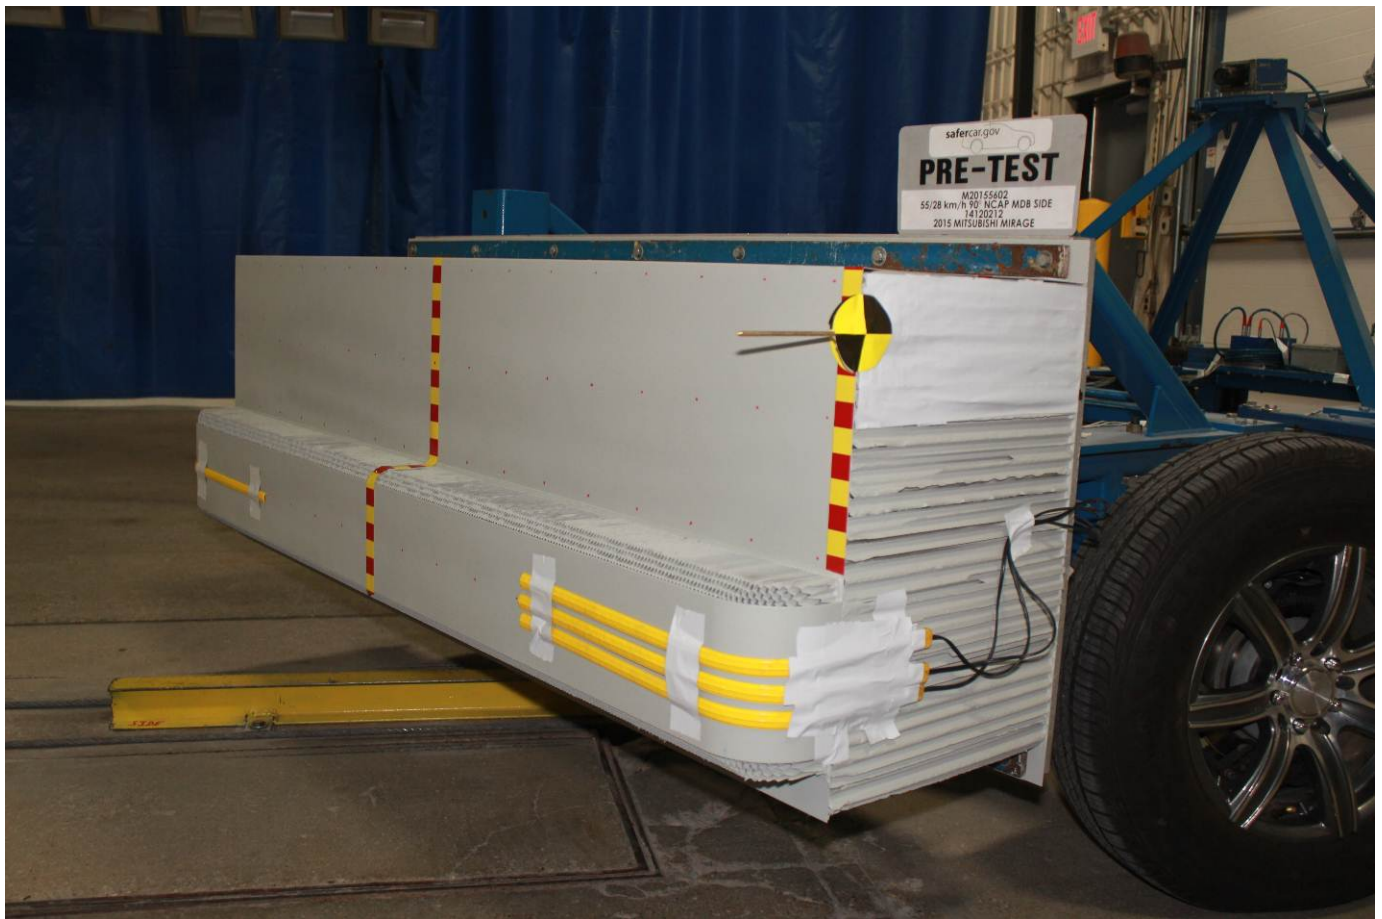
Post-Test Top View of MDB Impactor Face
