**REPORT NUMBER: NCAP-CAL-15-001**

**NEW CAR ASSESSMENT PROGRAM (NCAP)  
FRONTAL BARRIER IMPACT TEST**

**Honda De Mexico S.A. De C.V  
2015 Honda Fit  
Five Door Hatchback**

**NHTSA No: M20155318**

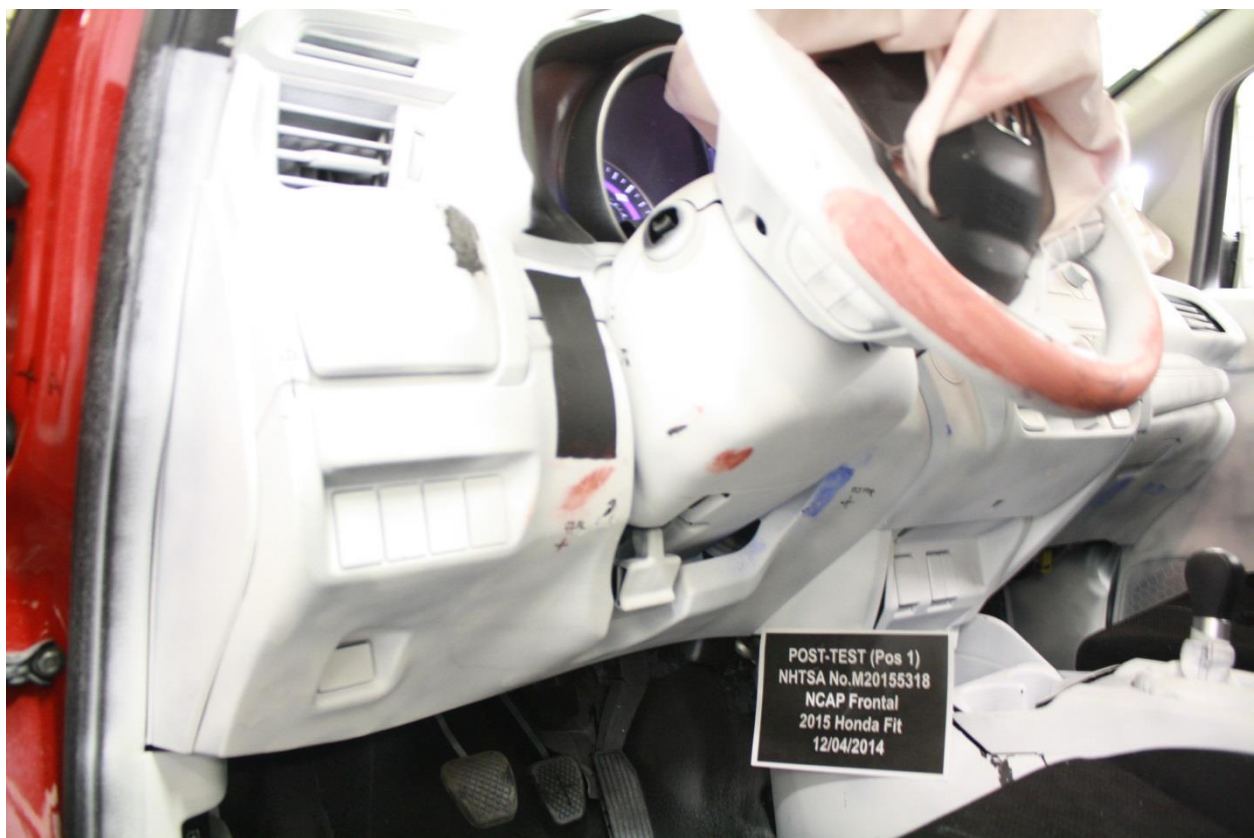
**Figure A-42: Post-Test Driver's Side Knee Bolster**

The driver's visible contact points were as follows: The driver's head contacted the frontal airbag and then the head restraint. The upper torso contacted the frontal airbag. Both knees contacted the knee bolster.

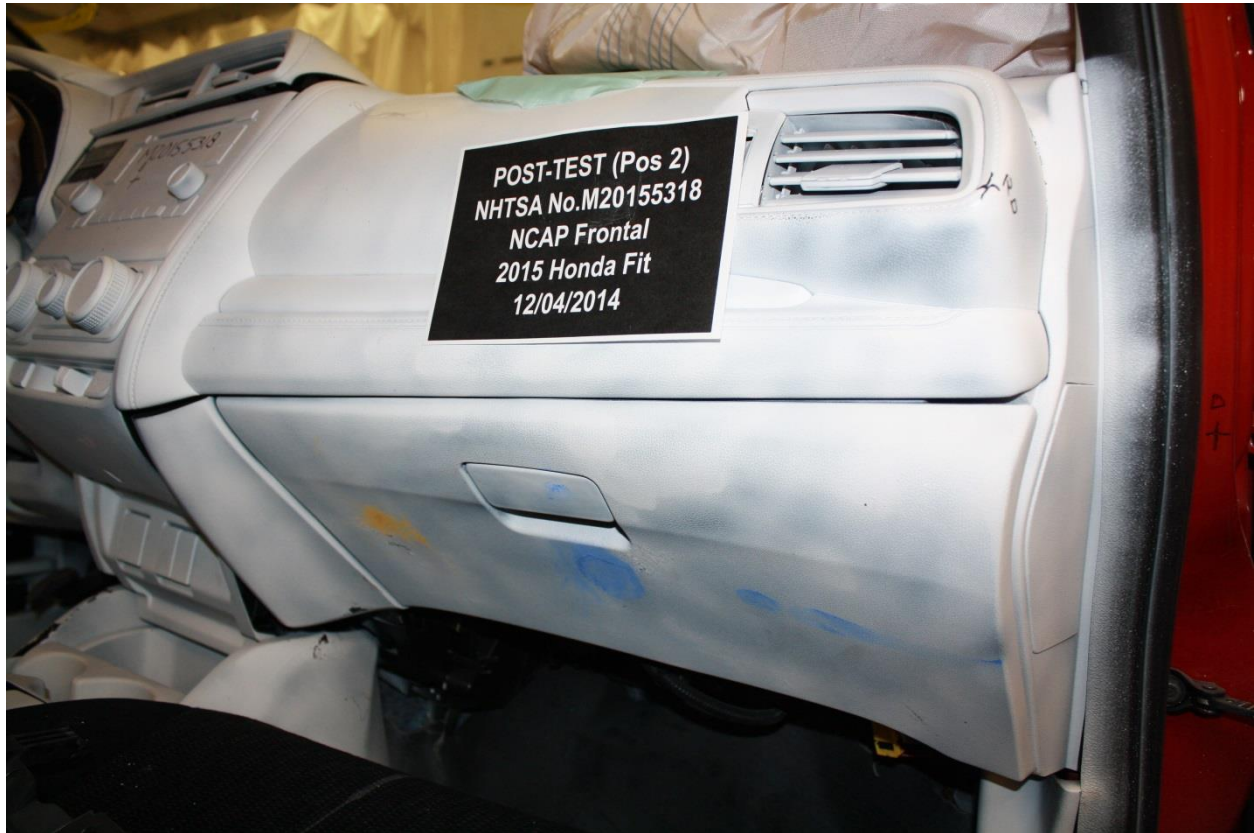
**Figure A-63: Post-Test Passenger's Side Knee Bolster**

The passenger's visible contact points were as follows: The passenger's head contacted the frontal airbag and then the head restraint. The upper torso contacted the frontal airbag. Both knees contacted the glove box.
