**REPORT NUMBER: TWG-MGA-2015-002**

**SIDE AIRBAG OUT-OF-POSITION INJURY  
TECHNICAL WORKING GROUP**

**GENERAL MOTORS LLC  
2015 Cadillac ATS 4-Dr Sedan  
NHTSA No.: M20150115TWG2**

**FINAL REPORT**

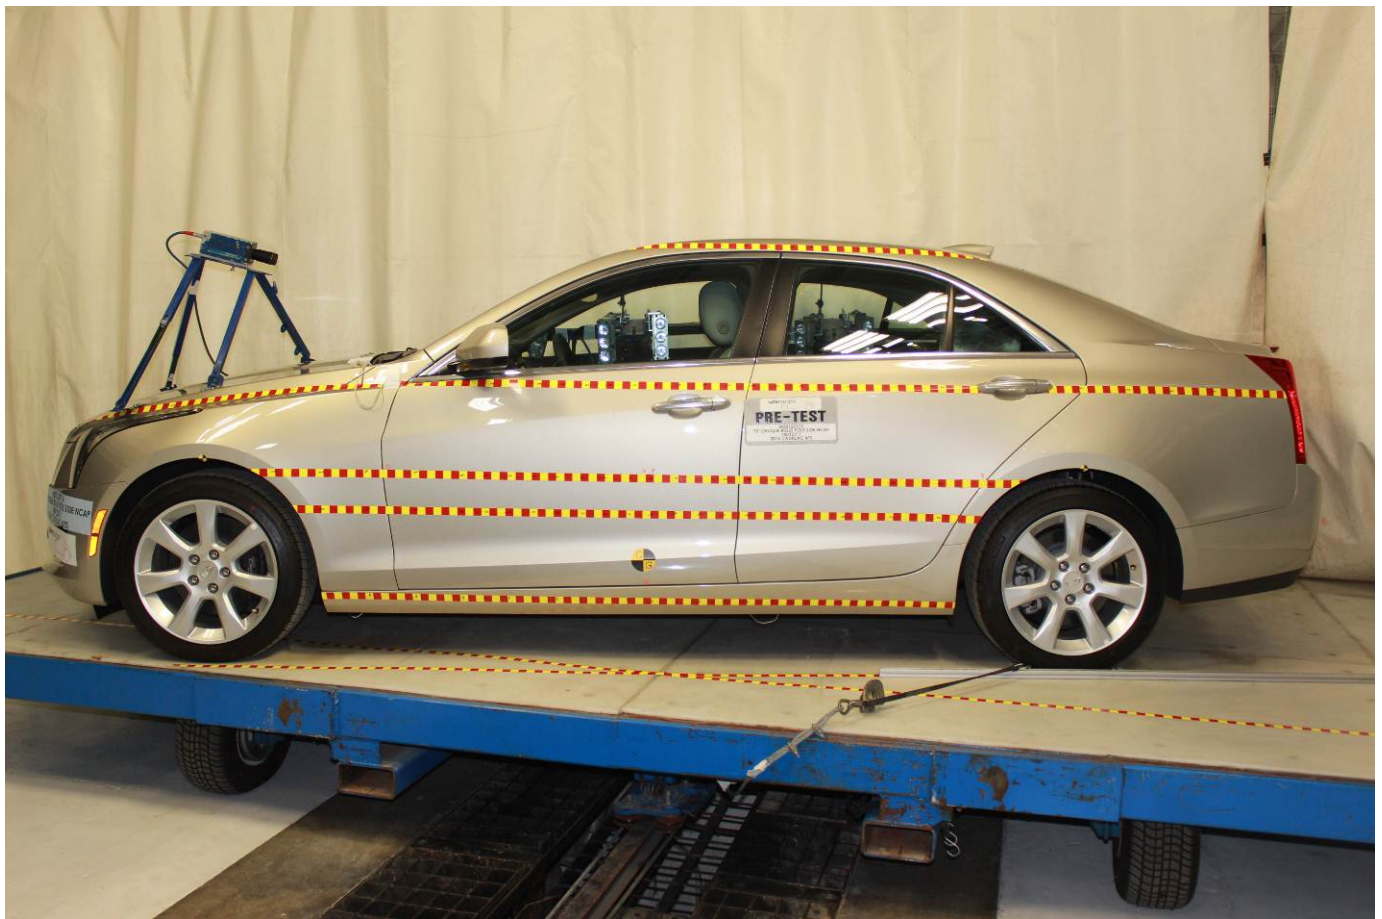
Pre-Test Vehicle Left Side View

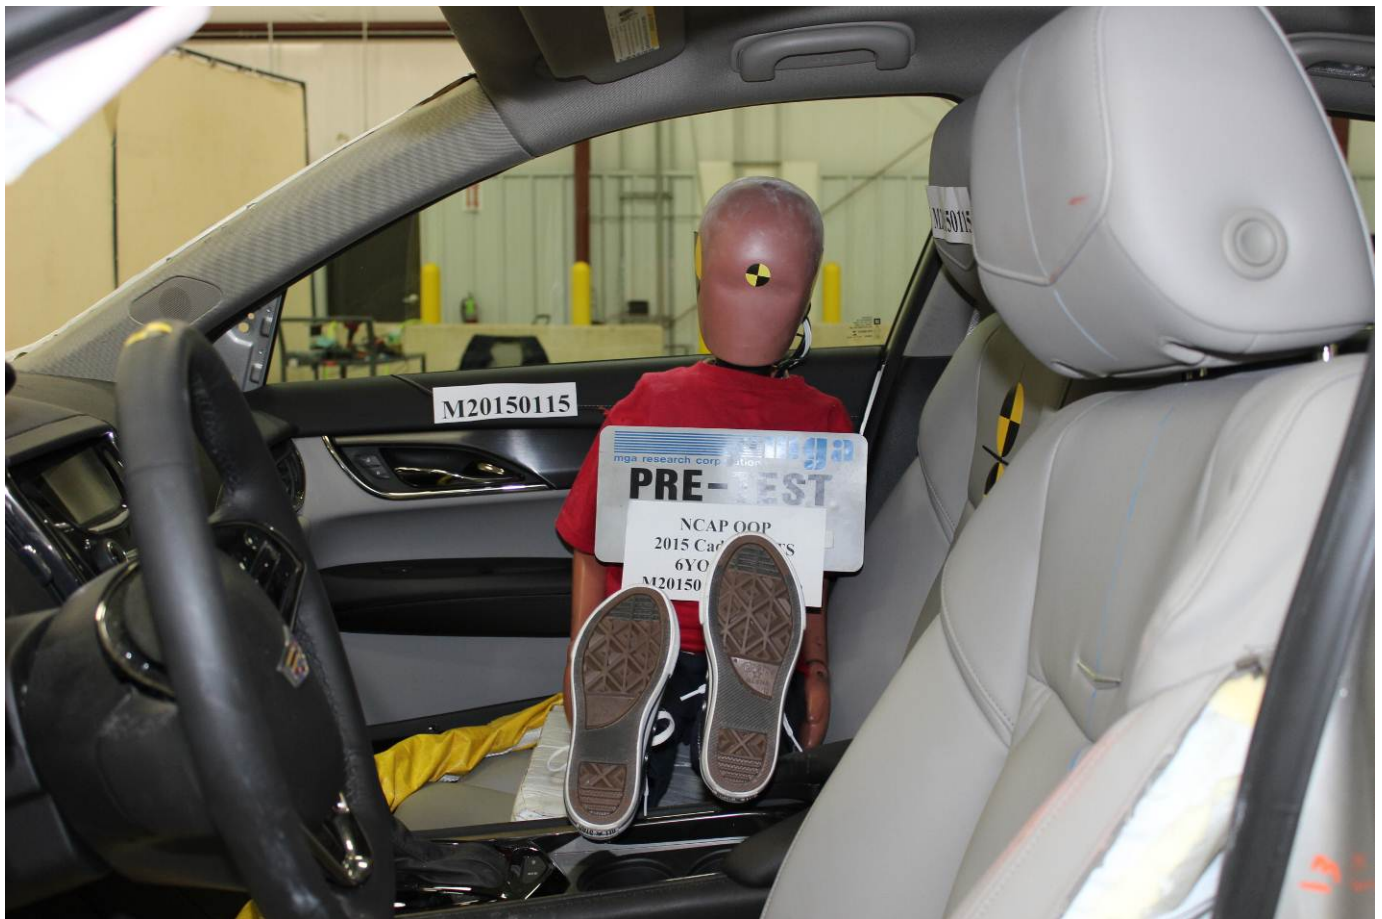
Pre-Test 6-Year-Old Child Dummy Left Side View

The Hybrid III 6-Year-Old child dummy was placed in the right front passenger seat along the outboard edge of the foam block, facing inboard with its legs extended and arms hanging at its sides. The seat track was positioned forward to maximize the cushion to head interaction. The dummy's pelvis was slid outboard until the dummy's back contacted the door trim panel or armrest and the center of gravity of the head was centered in the deployment trajectory of the airbag. The head remained in its neutral orientation. A vertical plane through the centerline of the dummy's shoulder bolts was parallel to the vehicle centerline. The dummy's arms were bent at the elbow until the fingertips contacted the foam block.

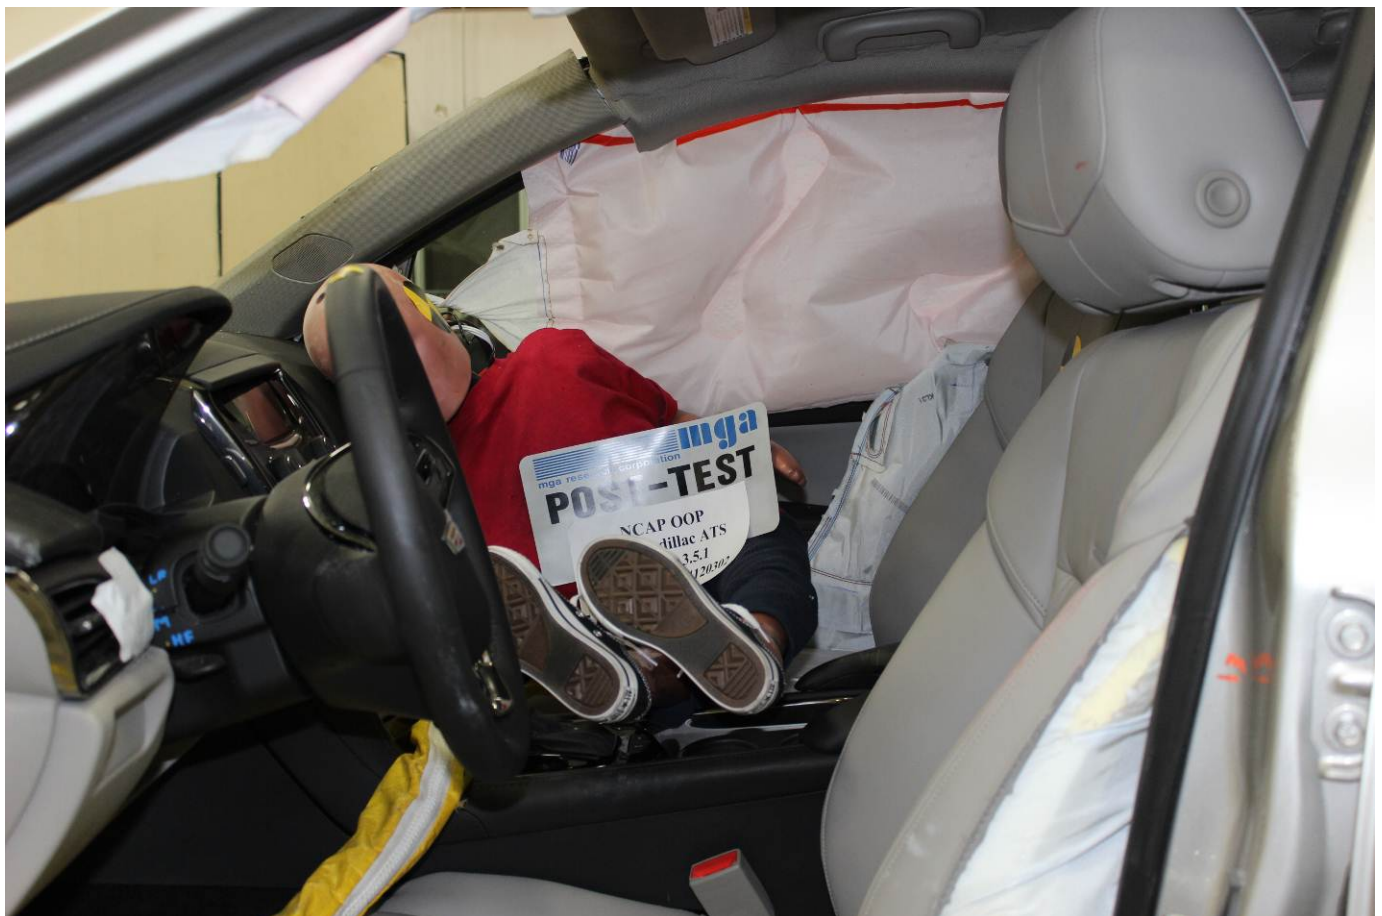
Post-Test 6-Year-Old Child Dummy Left Side View

- Curtain airbag to top and back of head
- Torso bag to left side of shoulder, torso and pelvis

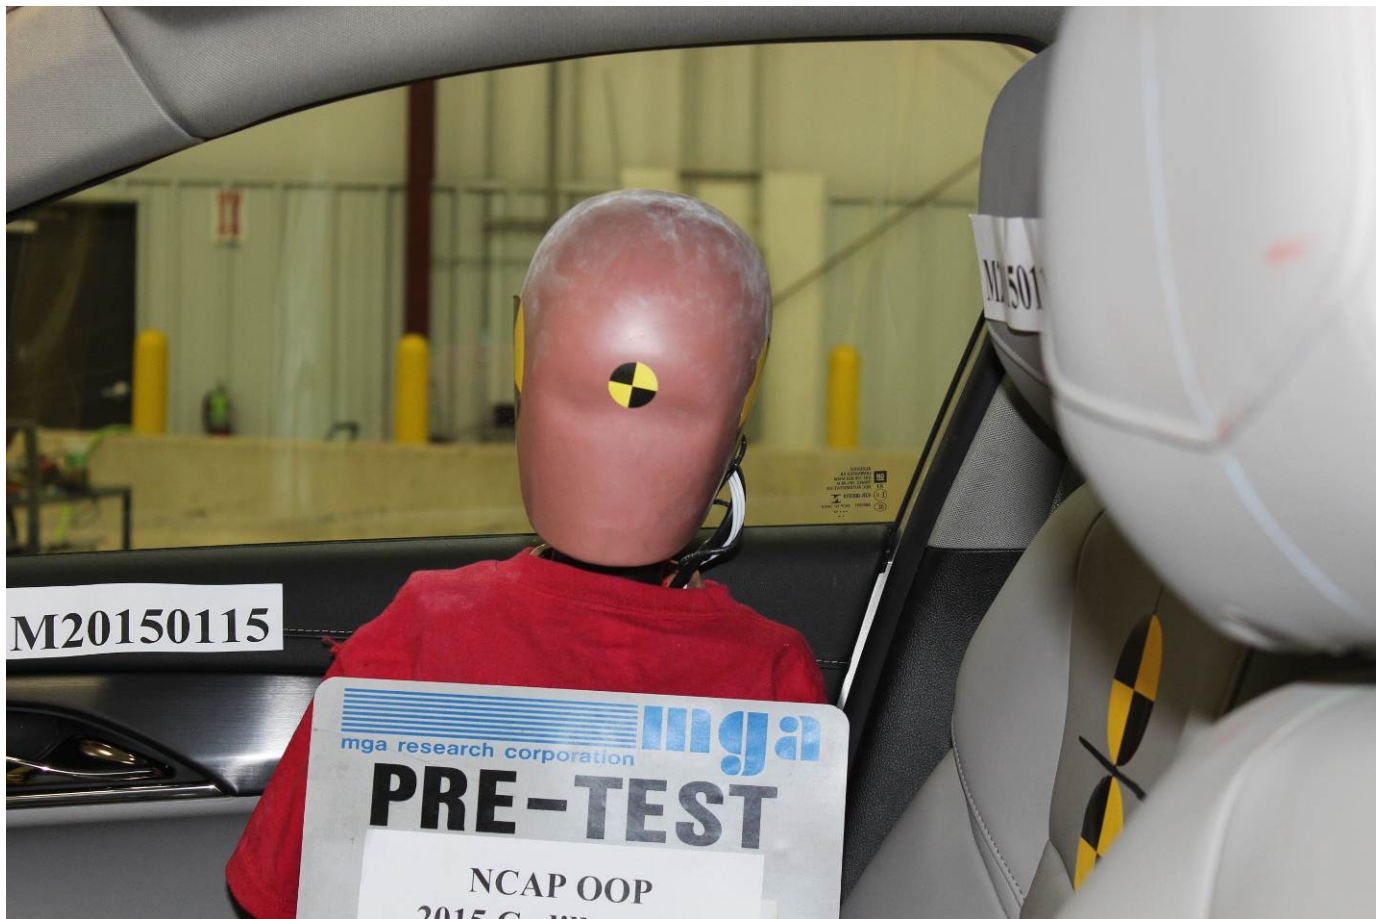
Pre-Test 6-Year-Old Child Dummy Left Side Closeup View

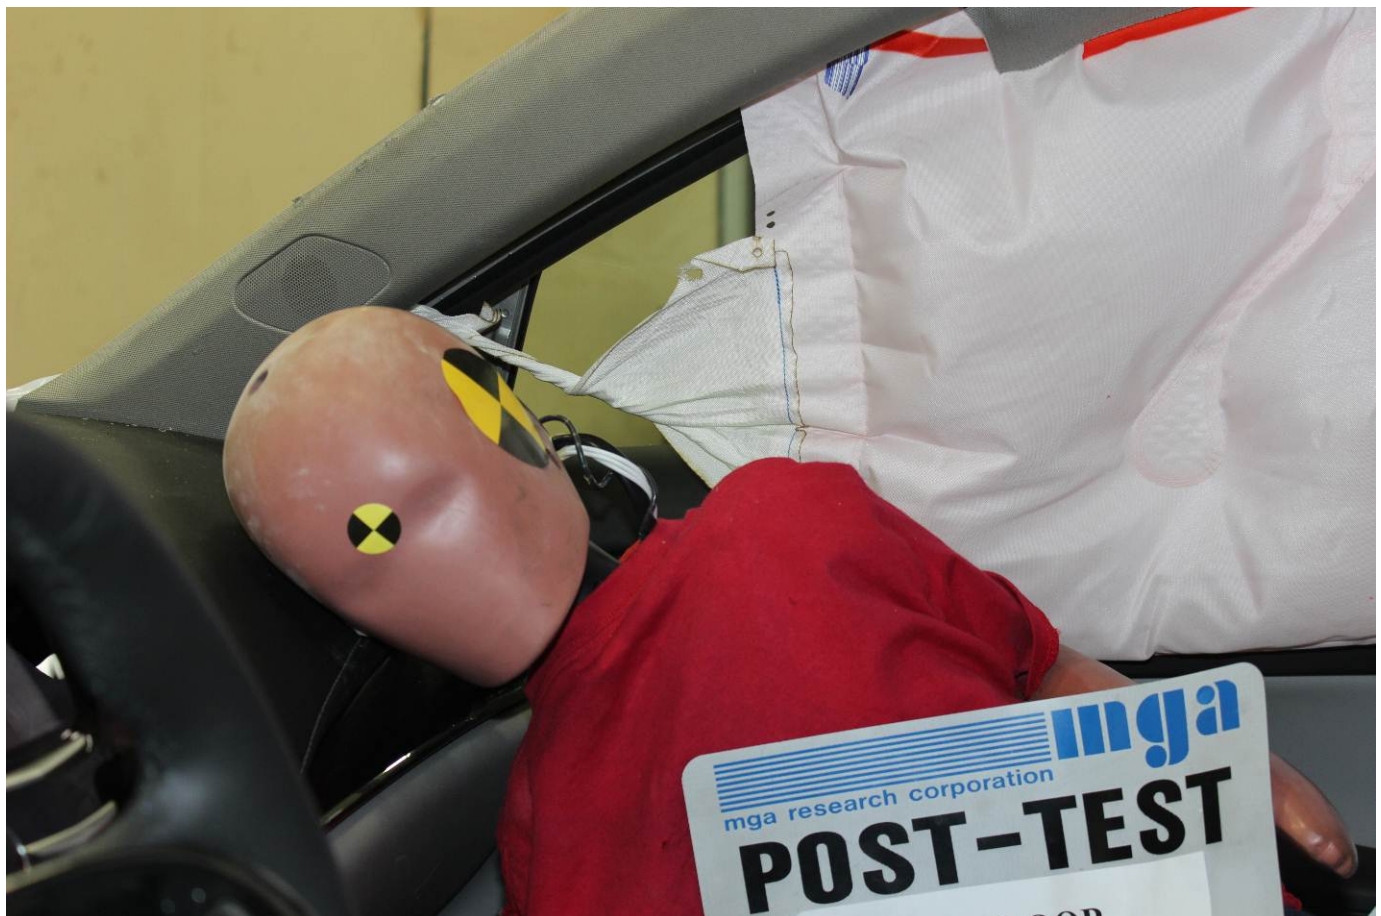
Post-Test 6-Year-Old Child Dummy Left Side Closeup View

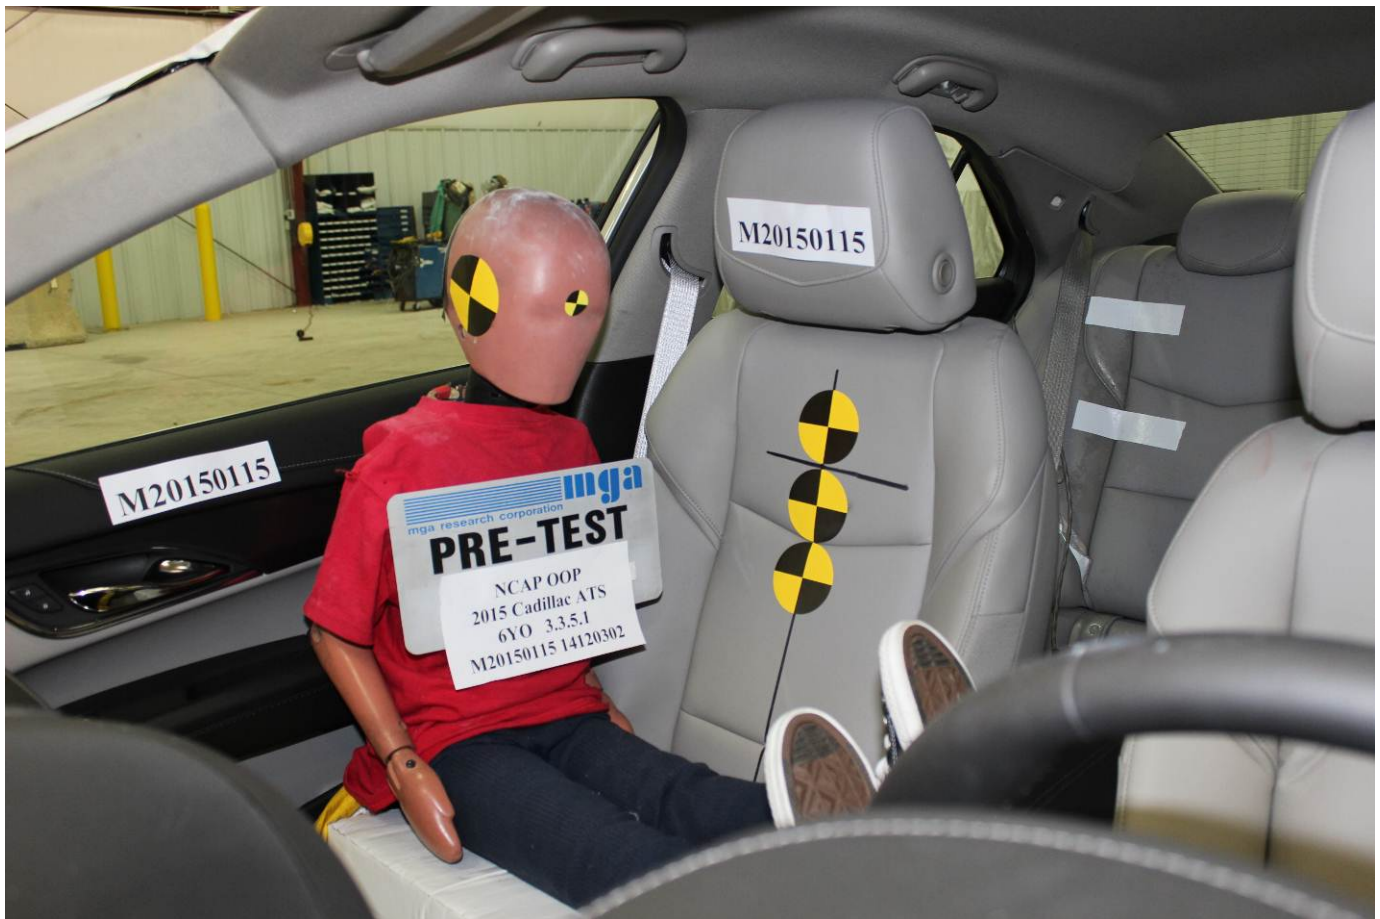
Pre-Test 6-Year-Old Child Dummy Left 3/4 Front View

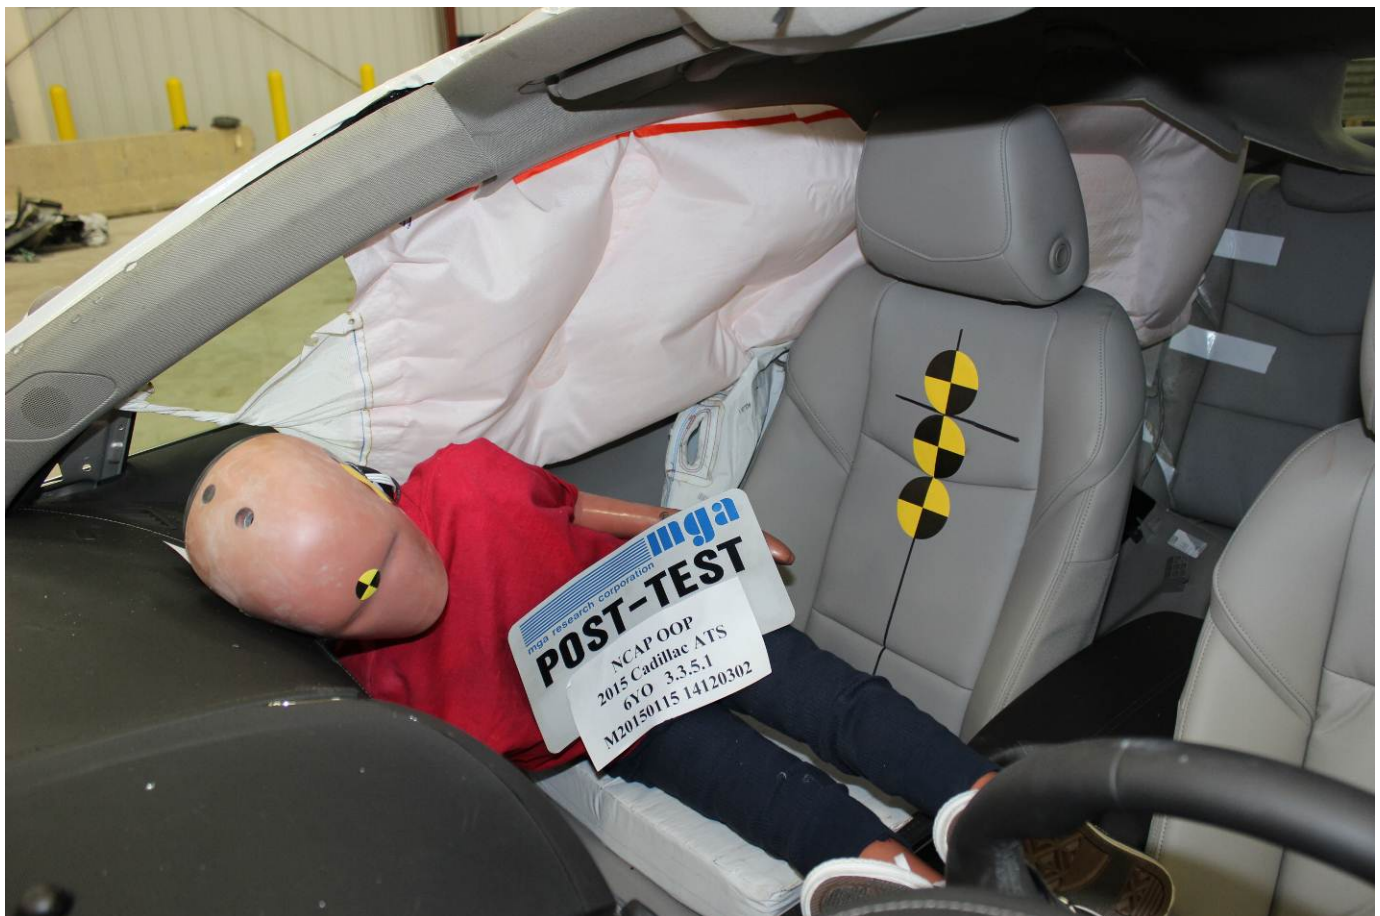
Post-Test 6-Year-Old Child Dummy Left 3/4 Front View

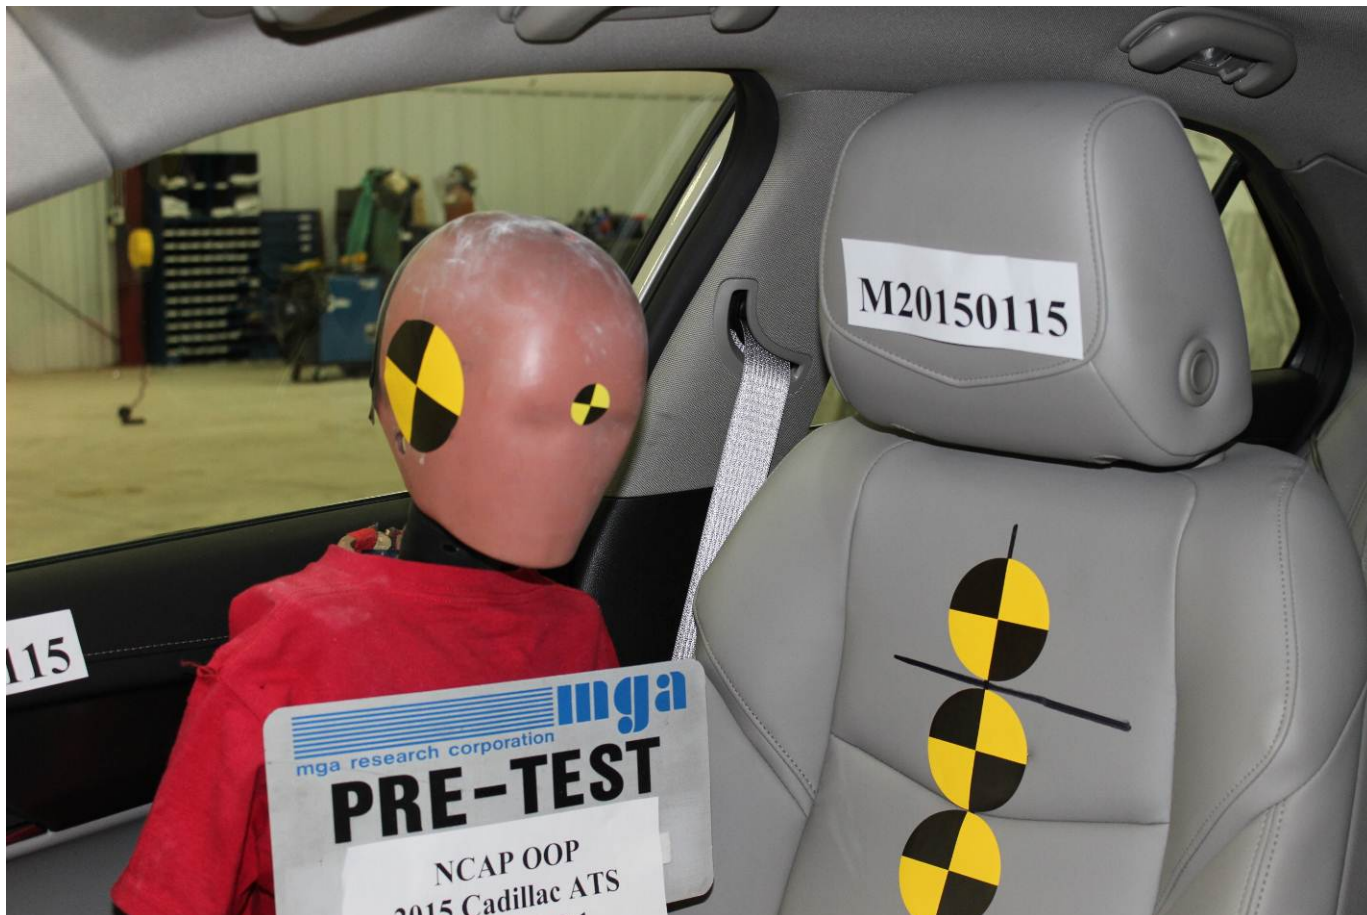
Pre-Test 6-Year-Old Child Dummy Left  $\frac{3}{4}$  Front Closeup View

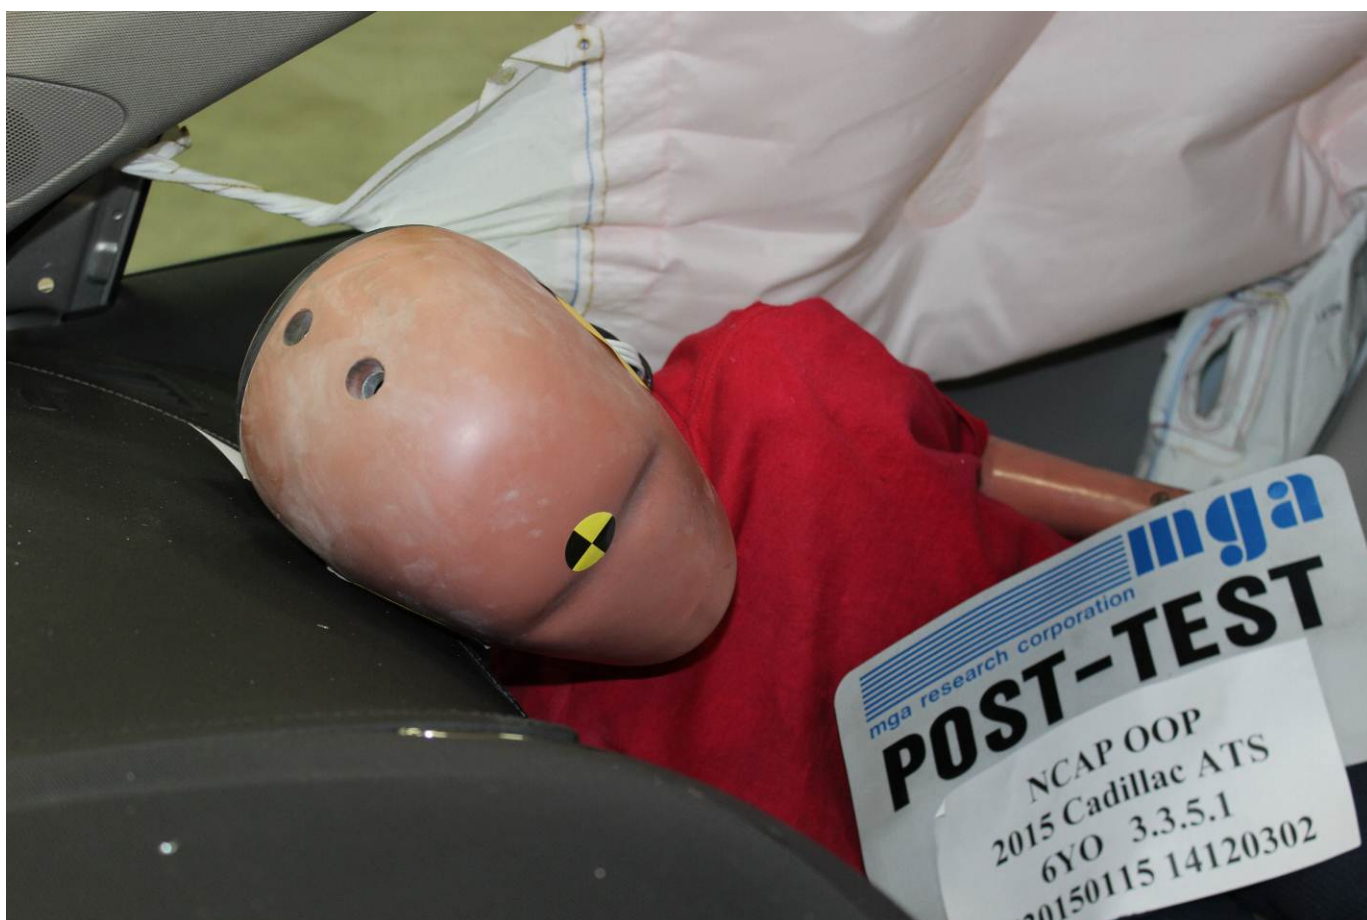
Post-Test 6-Year-Old Child Dummy Left  $\frac{3}{4}$  Front Closeup View

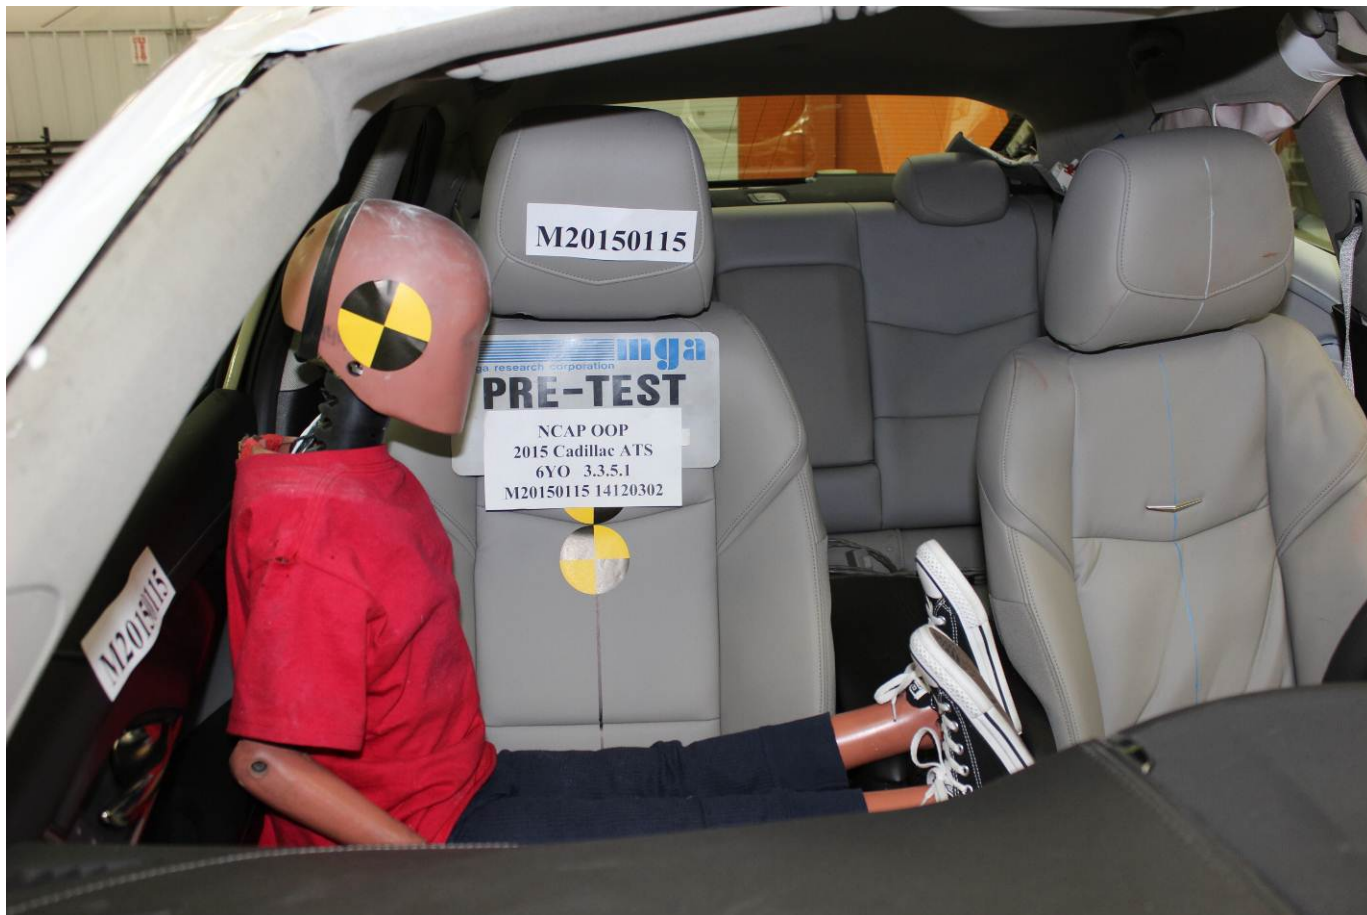
Pre-Test 6-Year-Old Child Dummy Front View

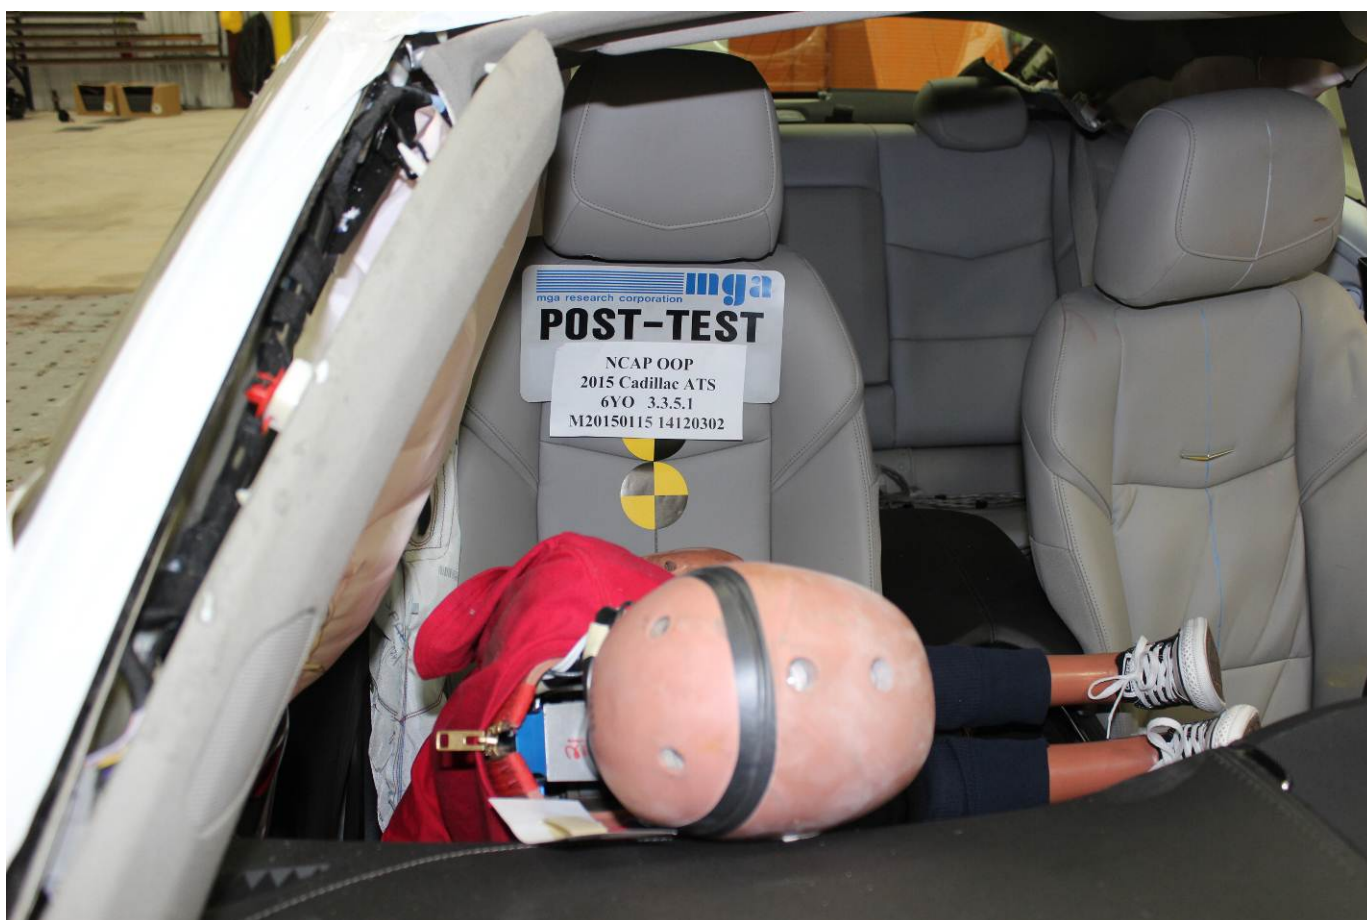
Post-Test 6-Year-Old Child Dummy Front View

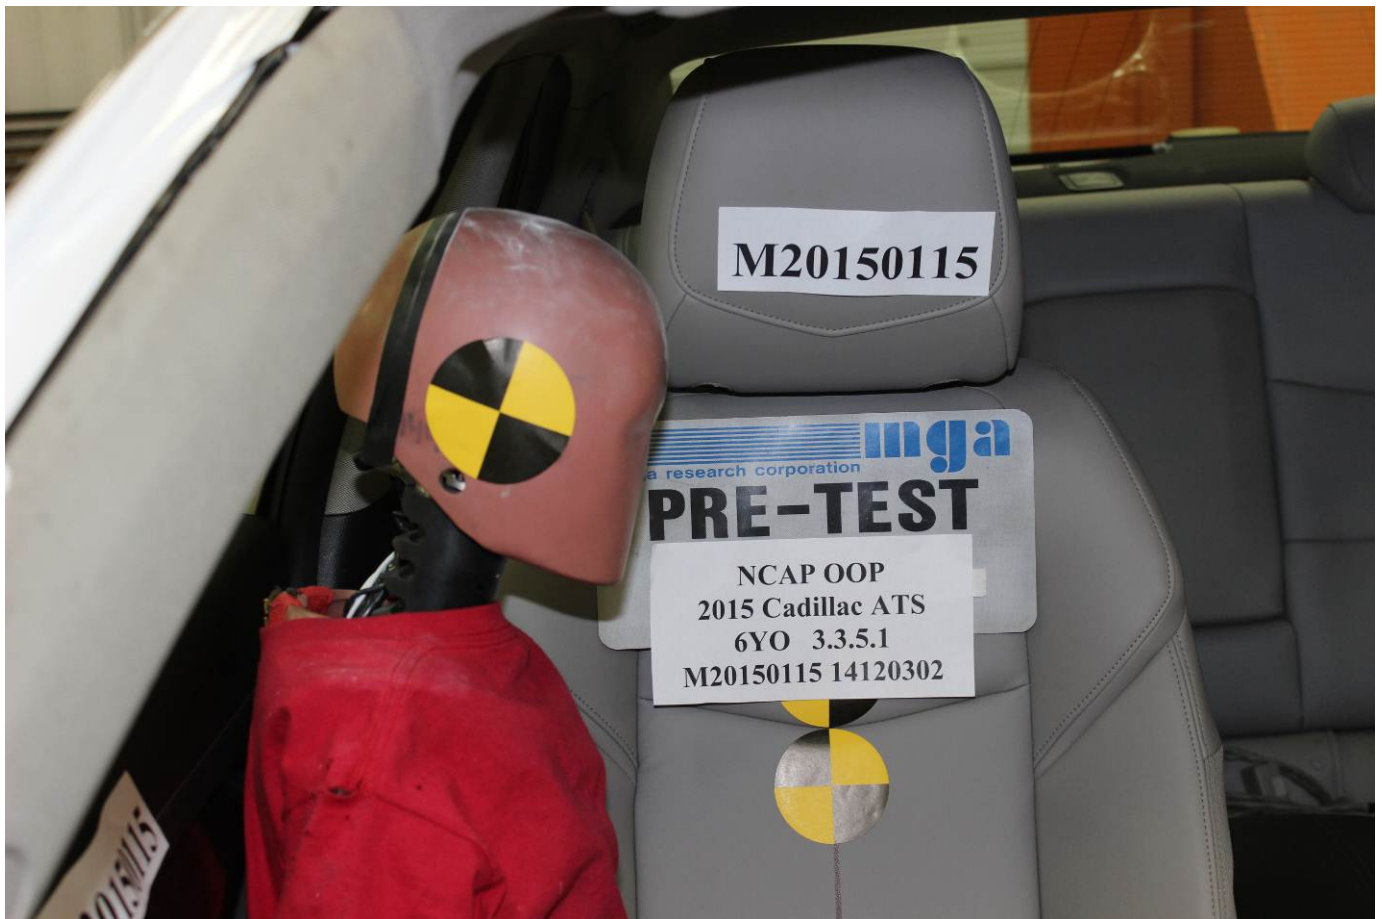
Pre-Test 6-Year-Old Child Dummy Front Closeup View

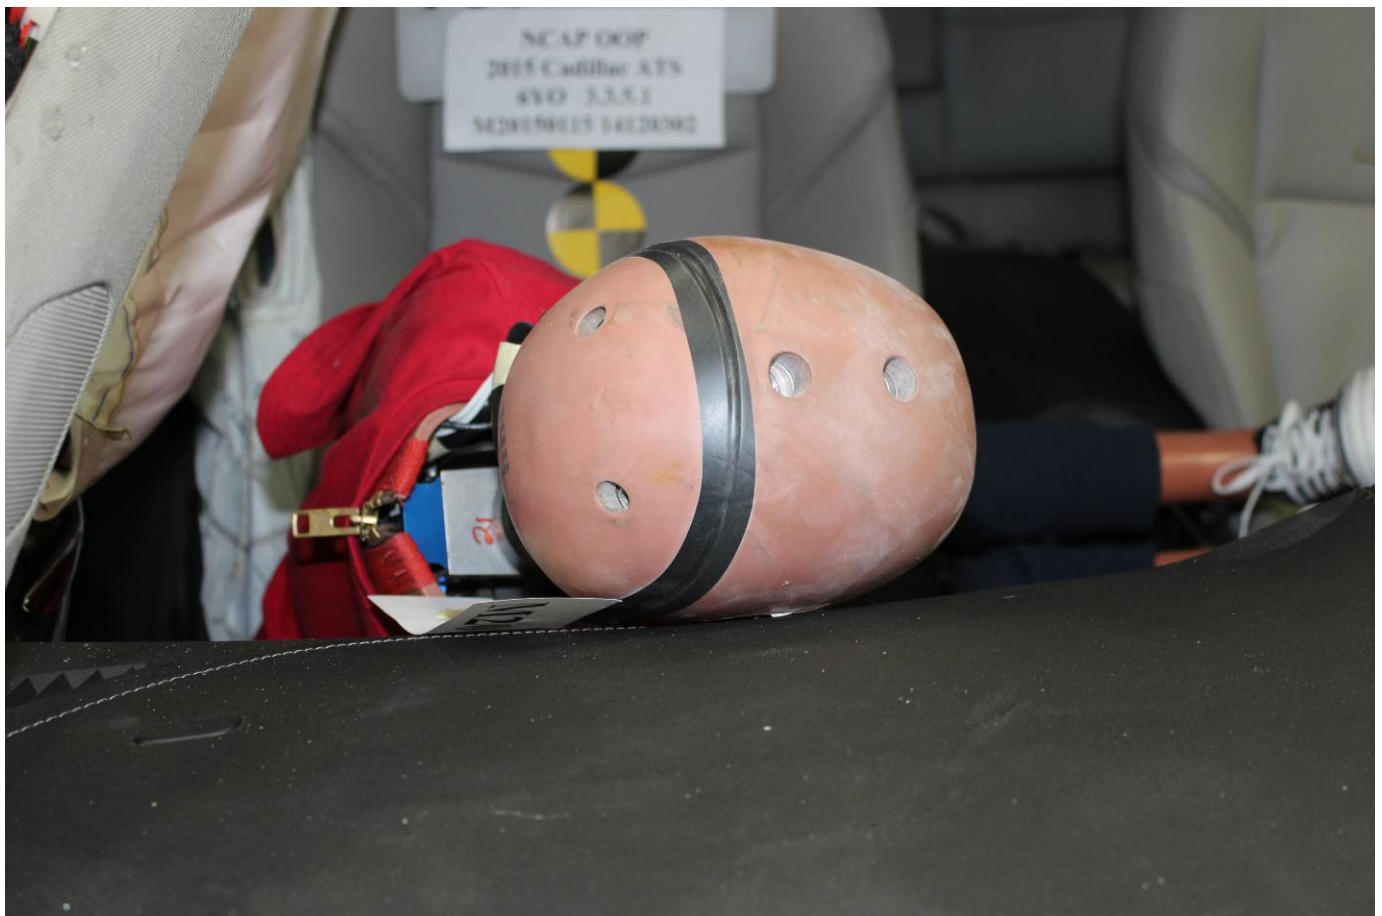
Post-Test 6-Year-Old Child Dummy Front Closeup View

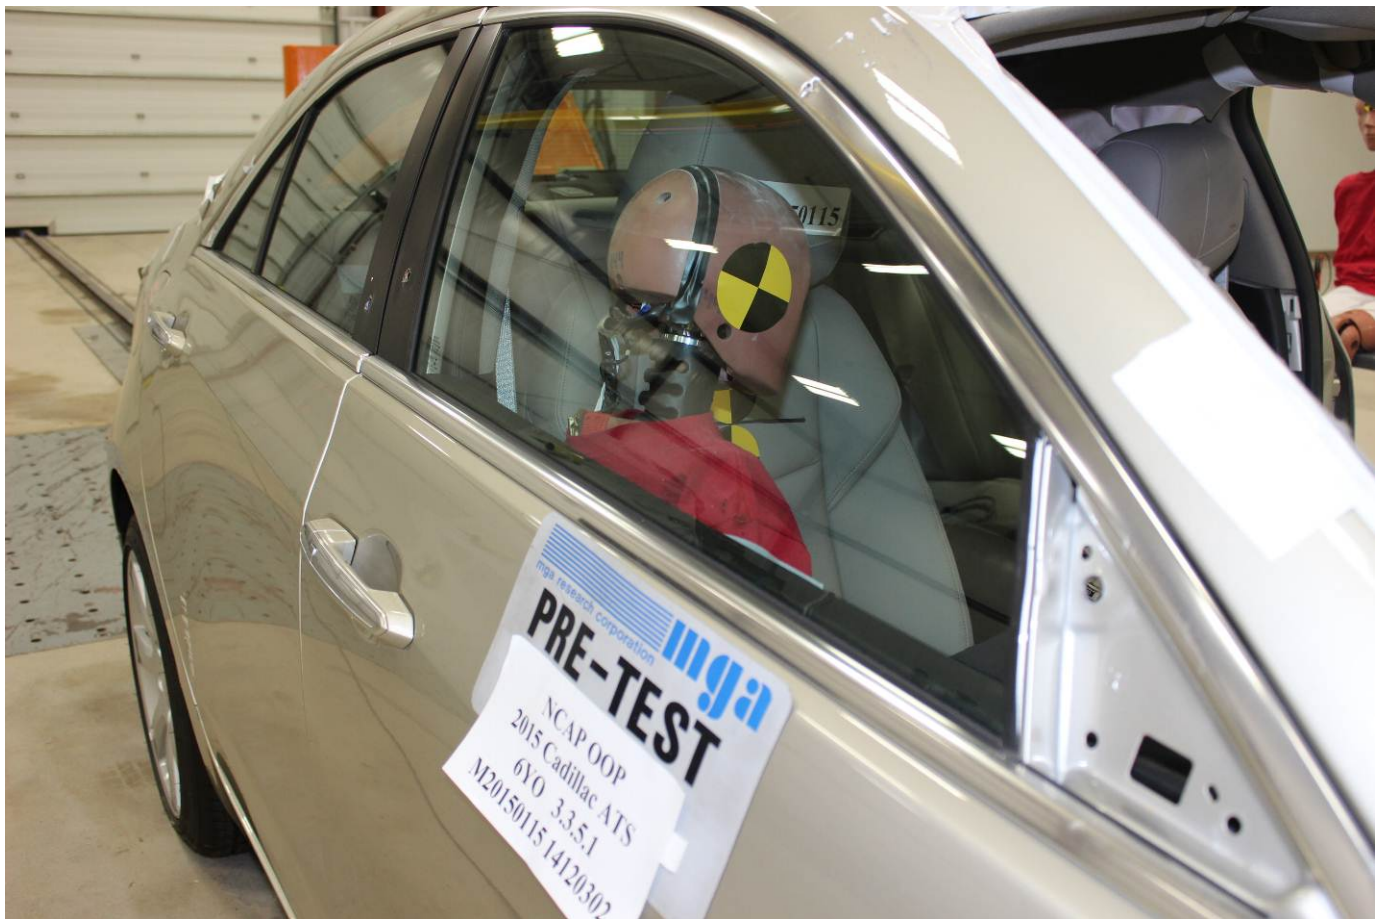
Pre-Test 6-Year-Old Child Dummy Right  $\frac{3}{4}$  Front View

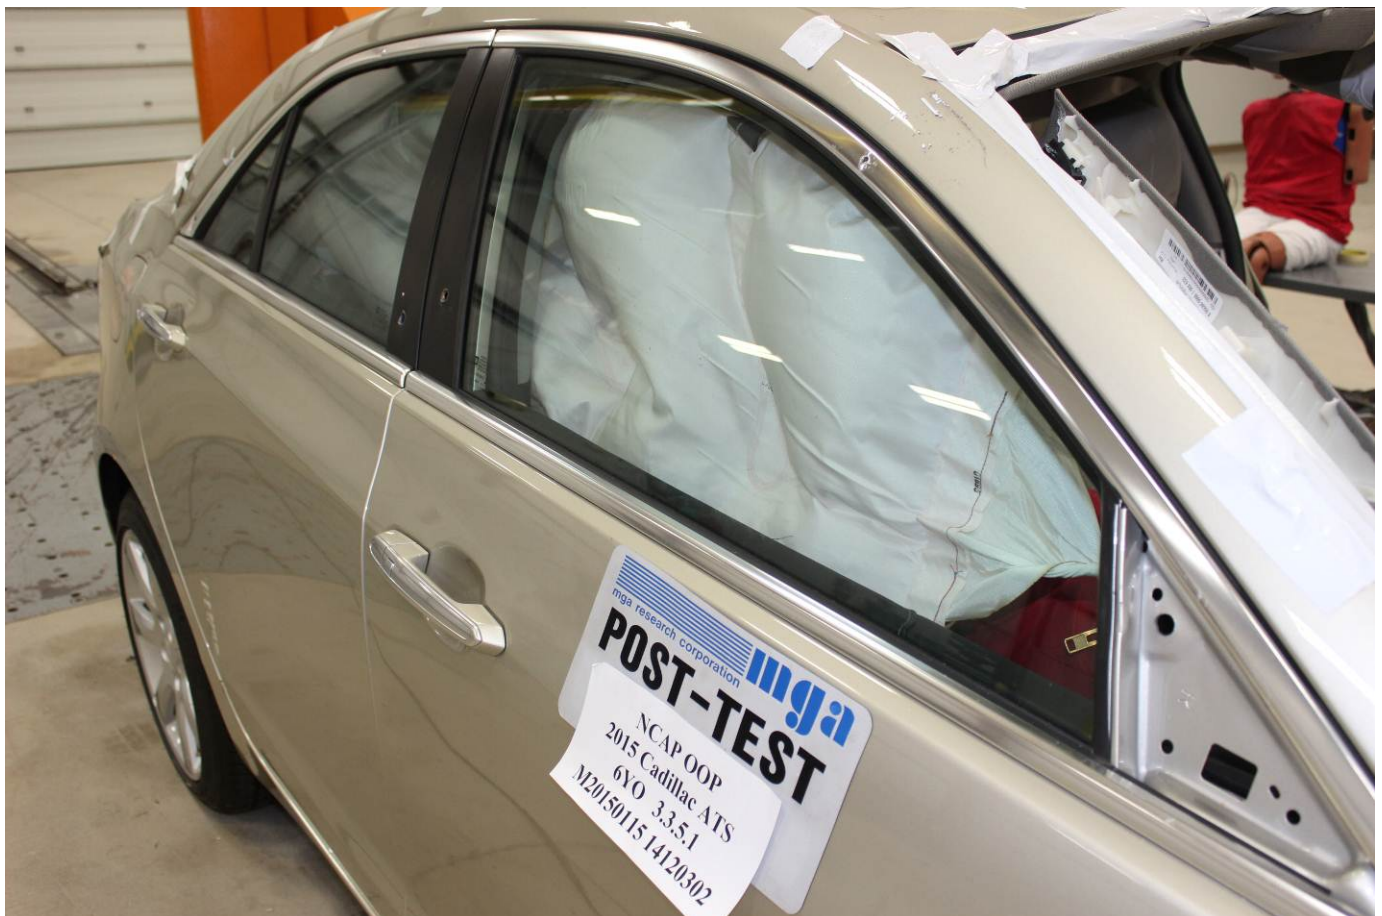
Post-Test 6-Year-Old Child Dummy Right  $\frac{3}{4}$  Front View

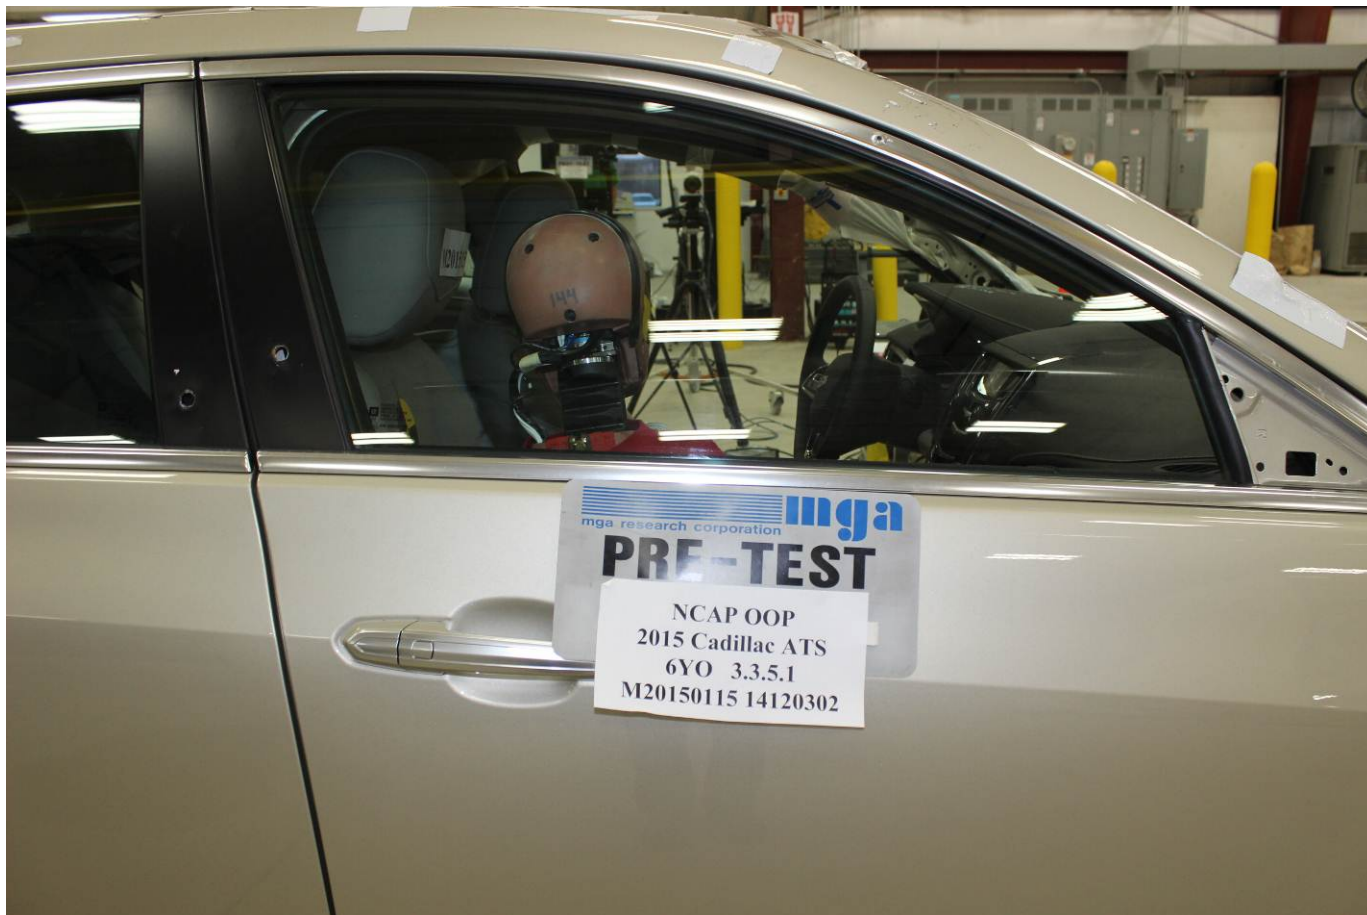
Pre-Test 6-Year-Old Child Dummy Right Side View

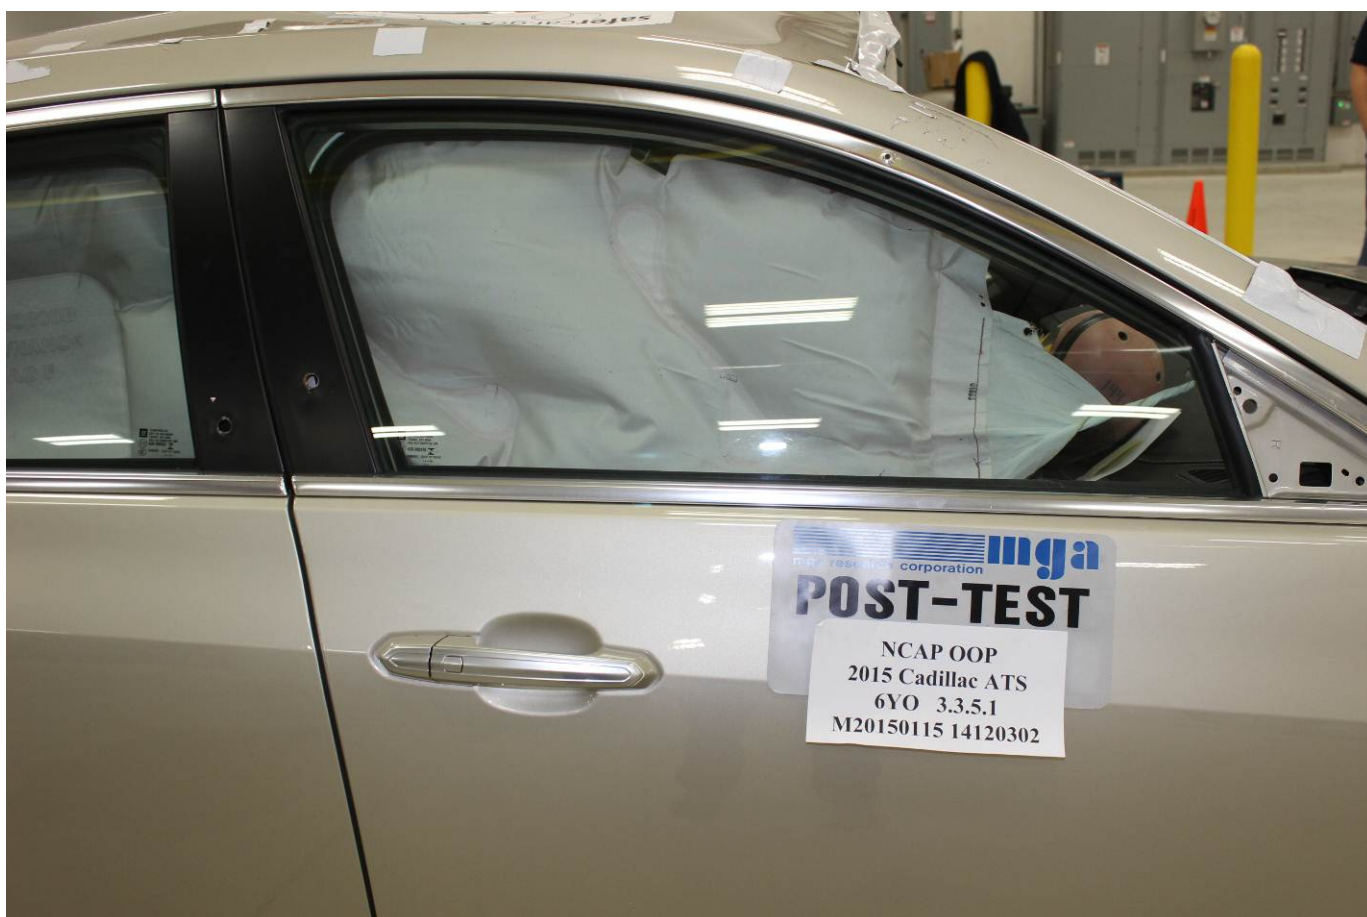
Post-Test 6-Year-Old Child Dummy Right Side View

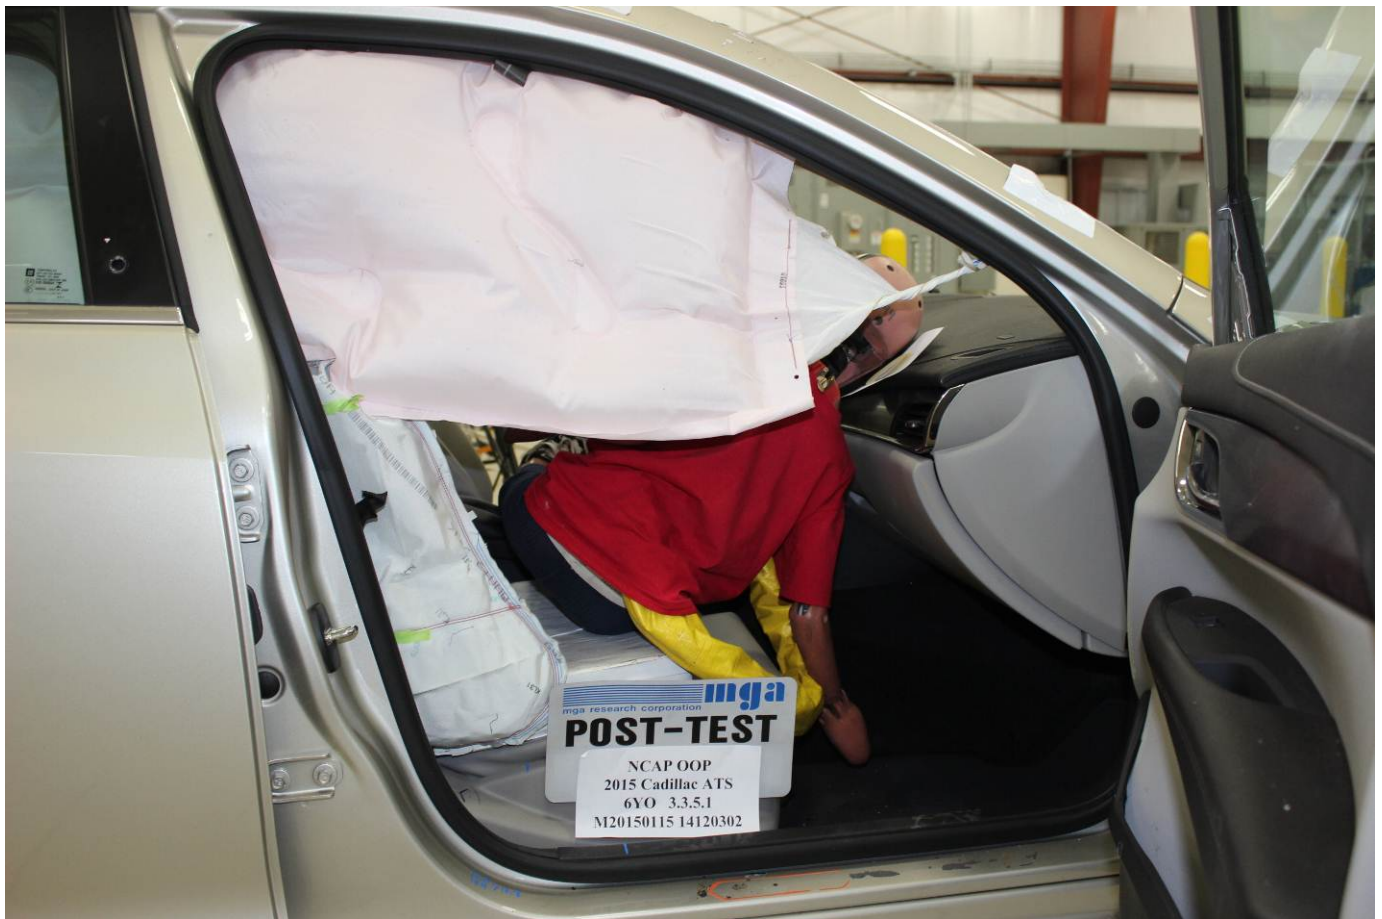
Post-Test 6-Year-Old Child Dummy Right Side View (Door Open)
