**REPORT NUMBER: TWG-MGA-2015-002**

**SIDE AIRBAG OUT-OF-POSITION INJURY  
TECHNICAL WORKING GROUP**

**GENERAL MOTORS LLC  
2015 Cadillac ATS 4-Dr Sedan  
NHTSA No.: M20150115TWG2**

**FINAL REPORT**

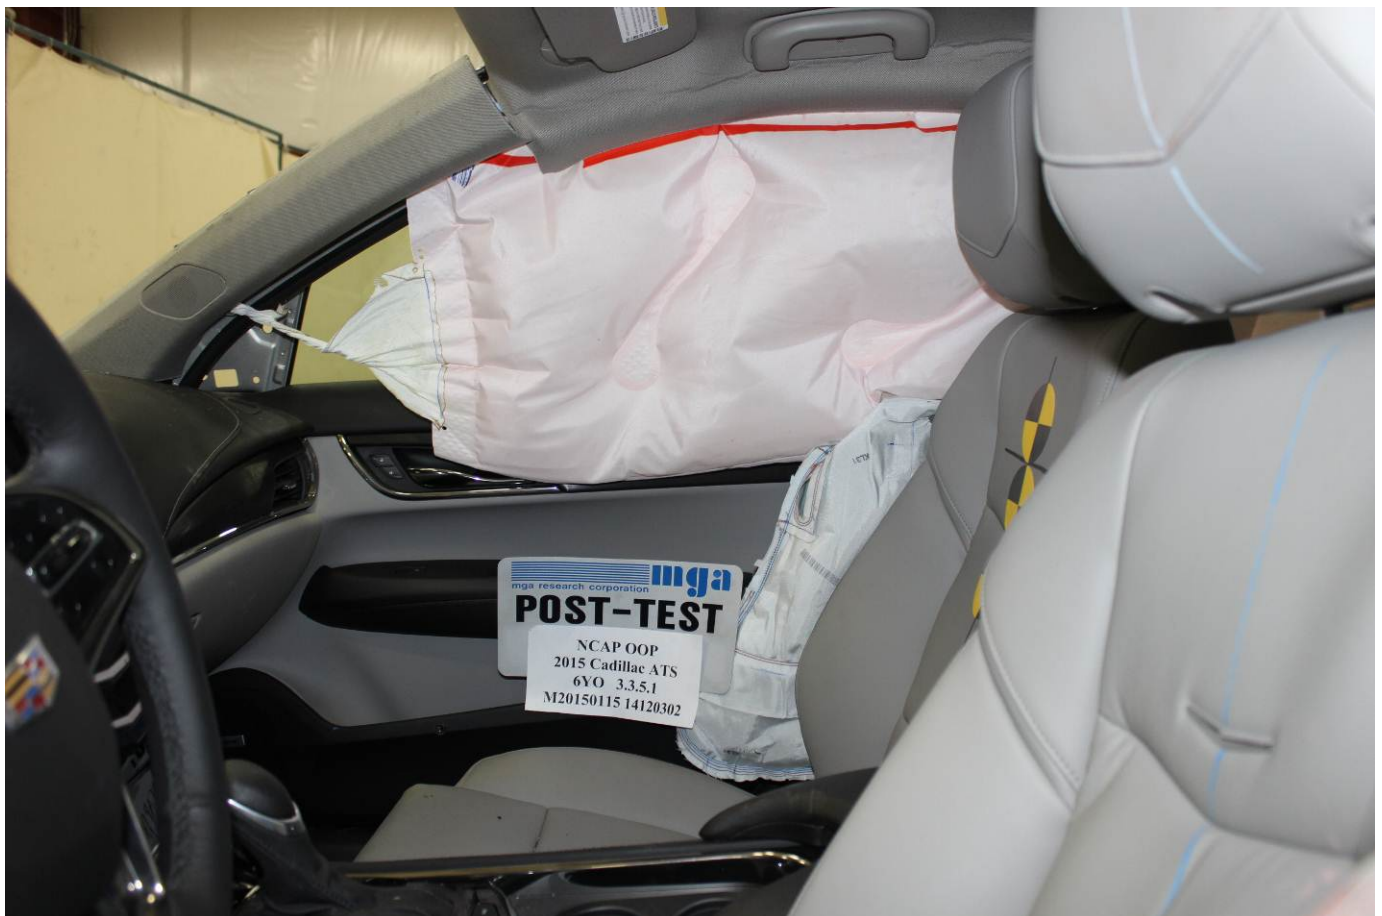
Post-Test Curtain Airbag Left Side View

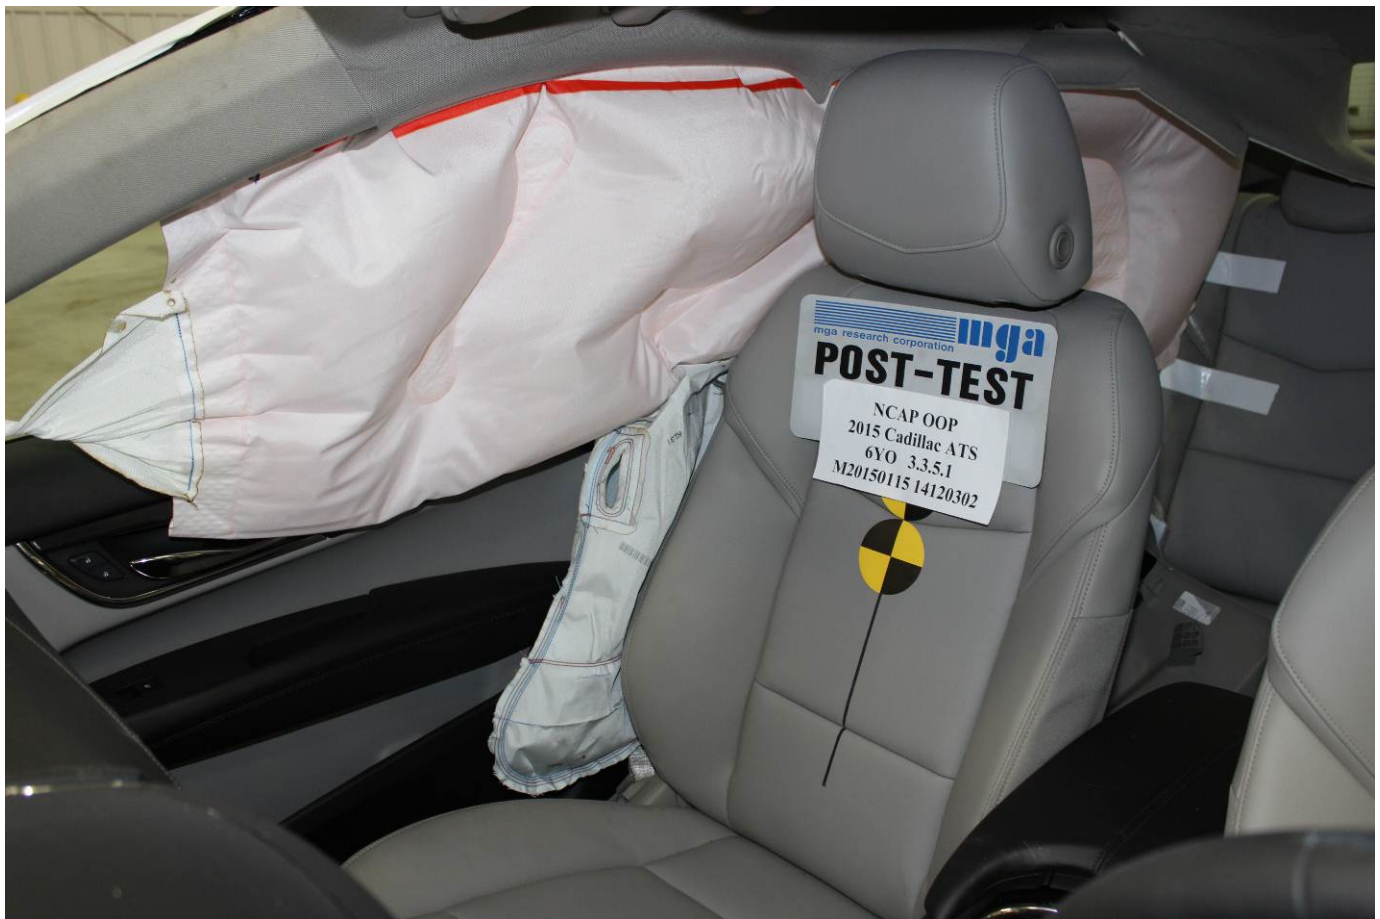
Post-Test Curtain Airbag Left 3/4 Front View

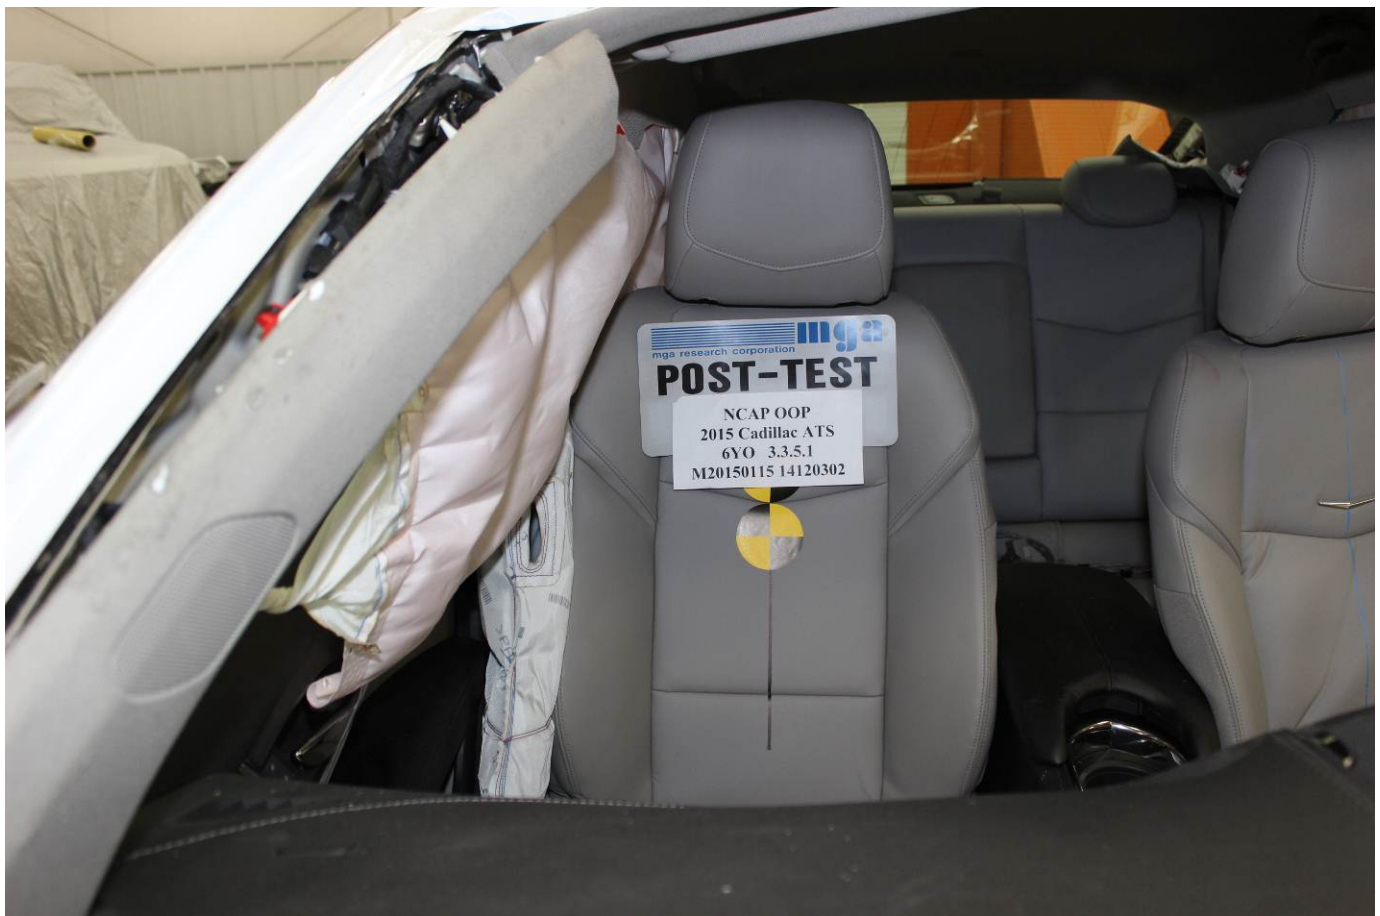
Post-Test Curtain Airbag Front View

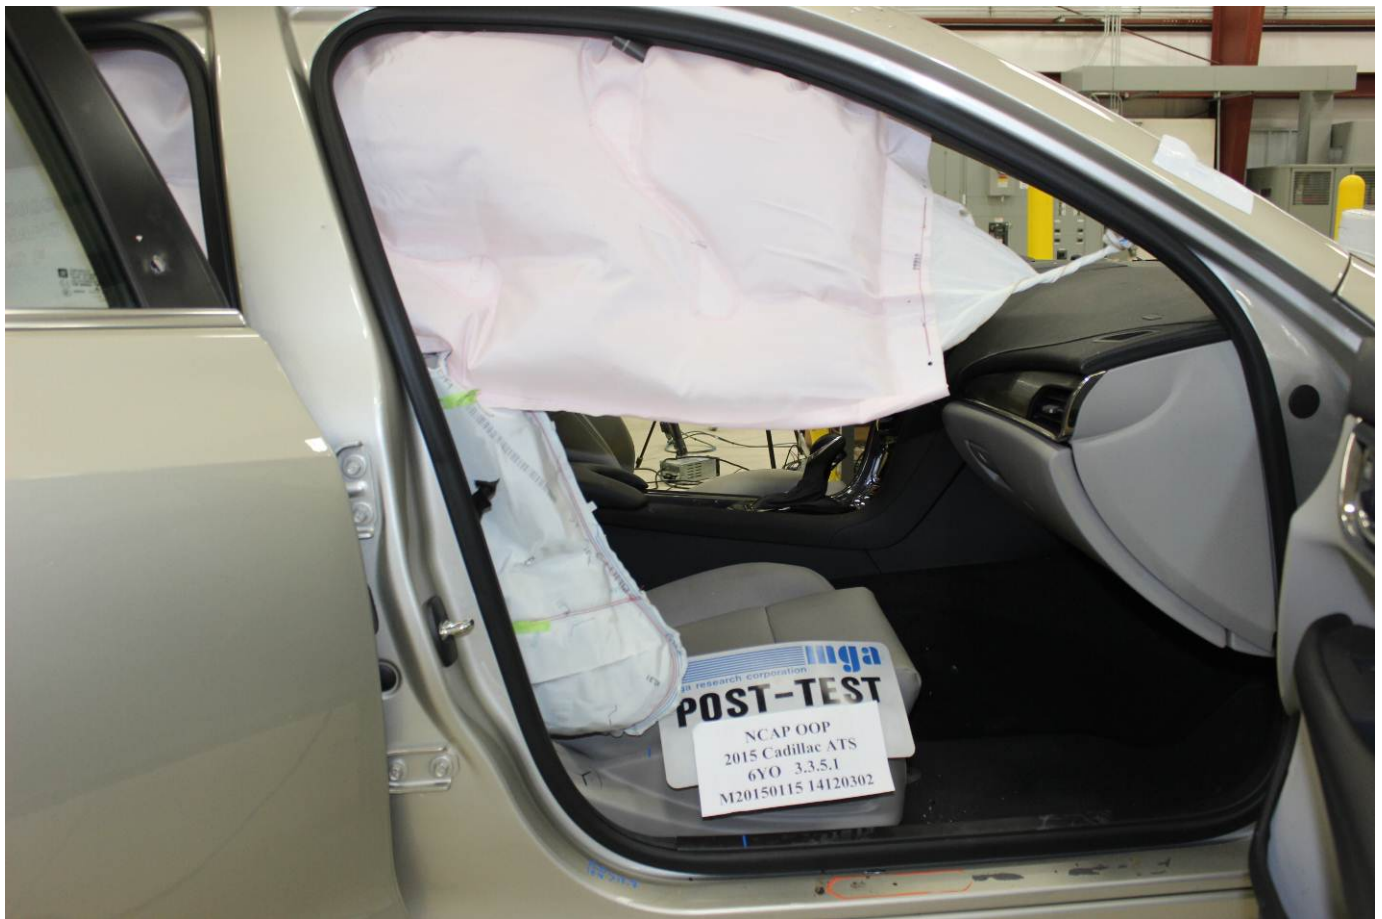
Post-Test Curtain Airbag Right Side View (Door Open)

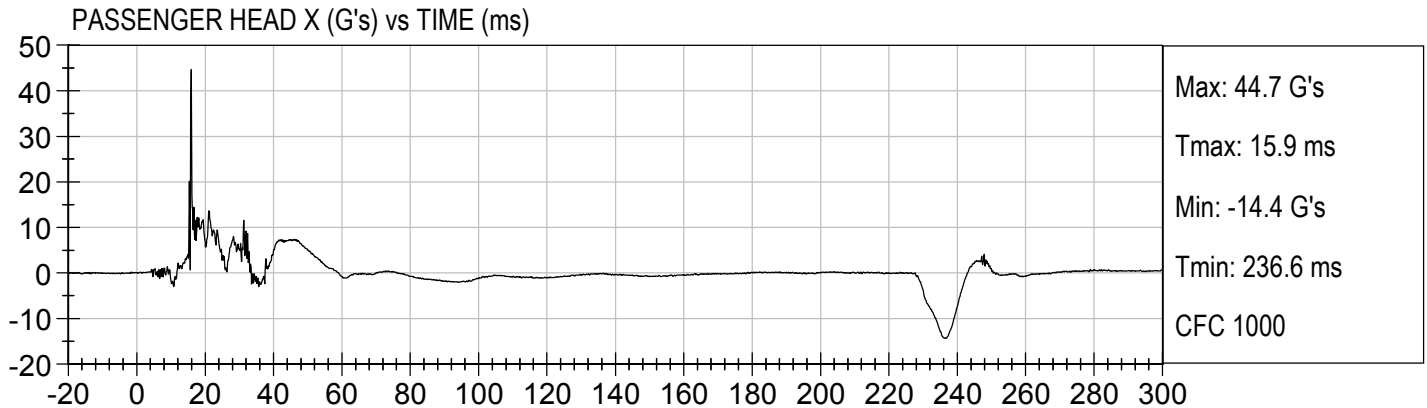
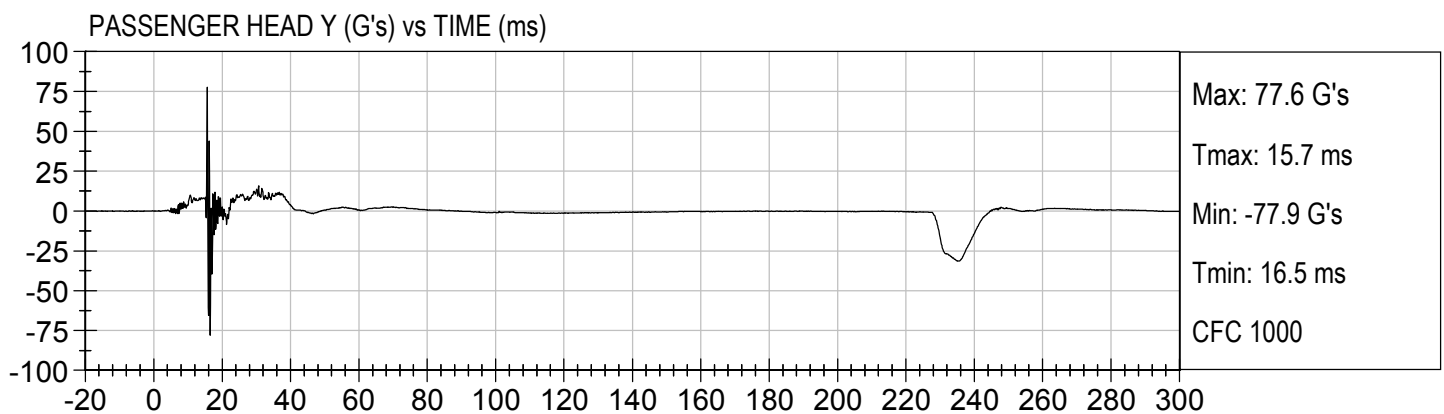
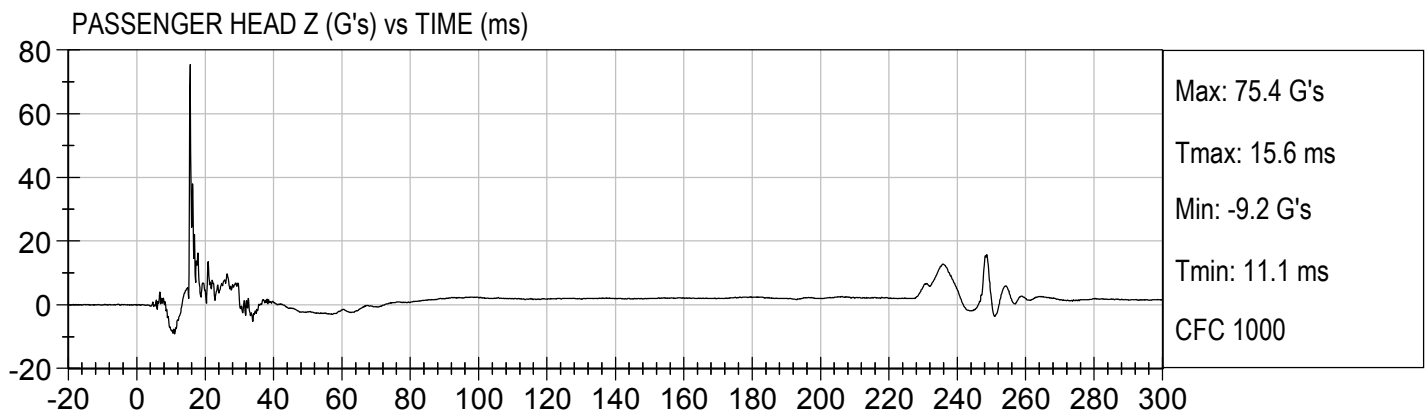
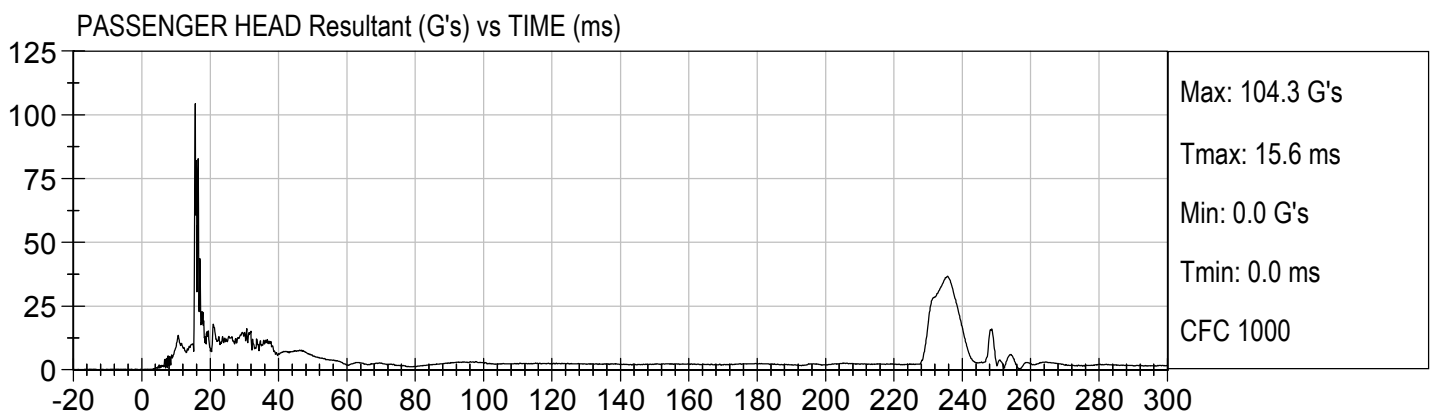
| | <u>Page No.</u> |
|---|---|
| Figure No. 1. Passenger Head X Acceleration vs. Time | 23 |
| Figure No. 2. Passenger Head Y Acceleration vs. Time | 23 |
| Figure No. 3. Passenger Head Z Acceleration vs. Time | 23 |
| Figure No. 4. Passenger Head Resultant Acceleration vs. Time | 23 |

| | | MAXIMUM VALUE | | | |
|---|---|---|---|---|---|
| Head X | g | 44.7 | 15.9 | -14.4 | 236.6 |
| Head Y | g | 77.6 | 15.7 | -77.9 | 16.5 |
| Head Z | g | 75.4 | 15.6 | -9.2 | 11.1 |
| Head Resultant | g | 104.3 | 15.6 | | |

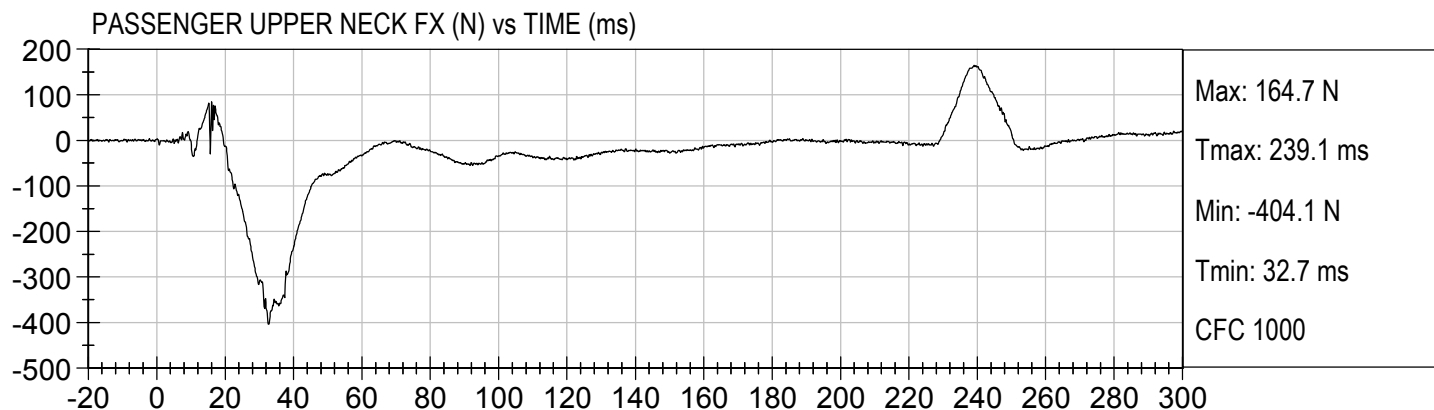
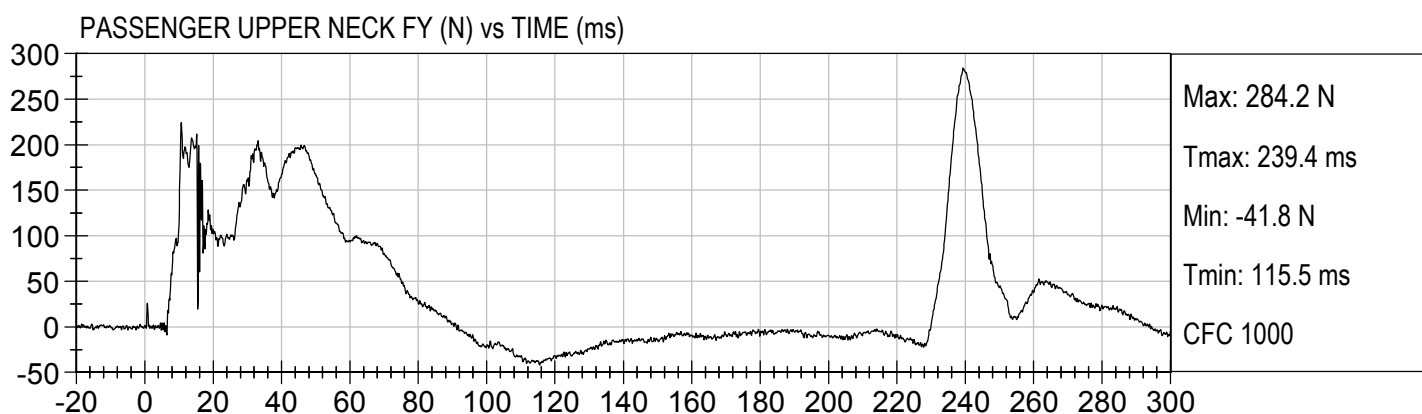
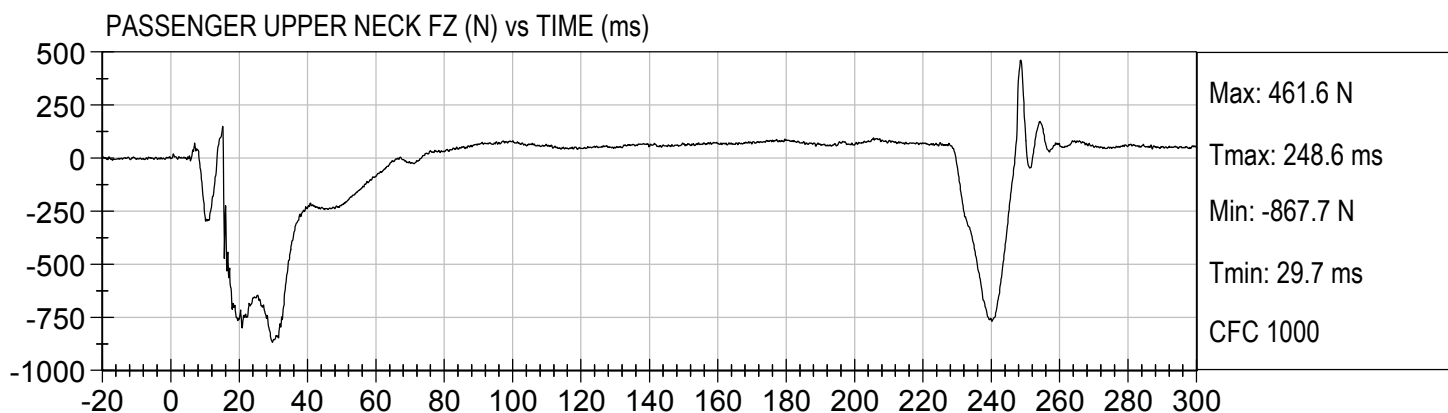
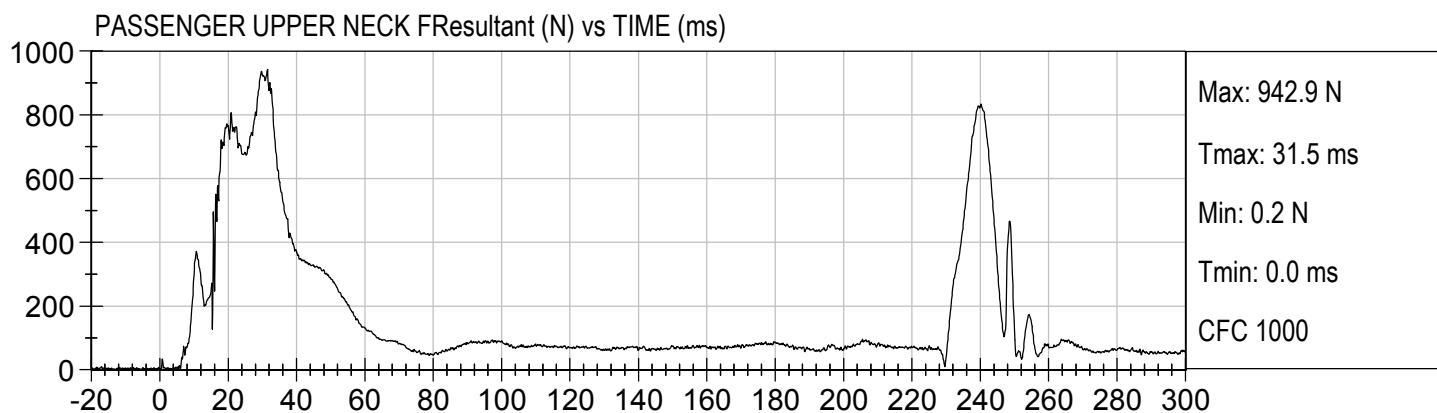
| | <u>Page No.</u> |
|---|---|
| Figure No. 5. Passenger Upper Neck X Force vs. Time | 24 |
| Figure No. 6. Passenger Upper Neck Y Force vs. Time | 24 |
| Figure No. 7. Passenger Upper Neck Z Force vs. Time | 24 |
| Figure No. 8. Passenger Upper Neck Resultant Force vs. Time | 24 |

| | | MAXIMUM VALUE | | | |
|---|---|---|---|---|---|
| Upper Neck Fx | N | 164.7 | 239.1 | -404.1 | 32.7 |
| Upper Neck Fy | N | 284.2 | 239.4 | -41.8 | 115.5 |
| Upper Neck Fz | N | 461.6 | 248.6 | -867.7 | 29.7 |
| Upper Neck F Resultant | N | 942.9 | 31.5 | | |

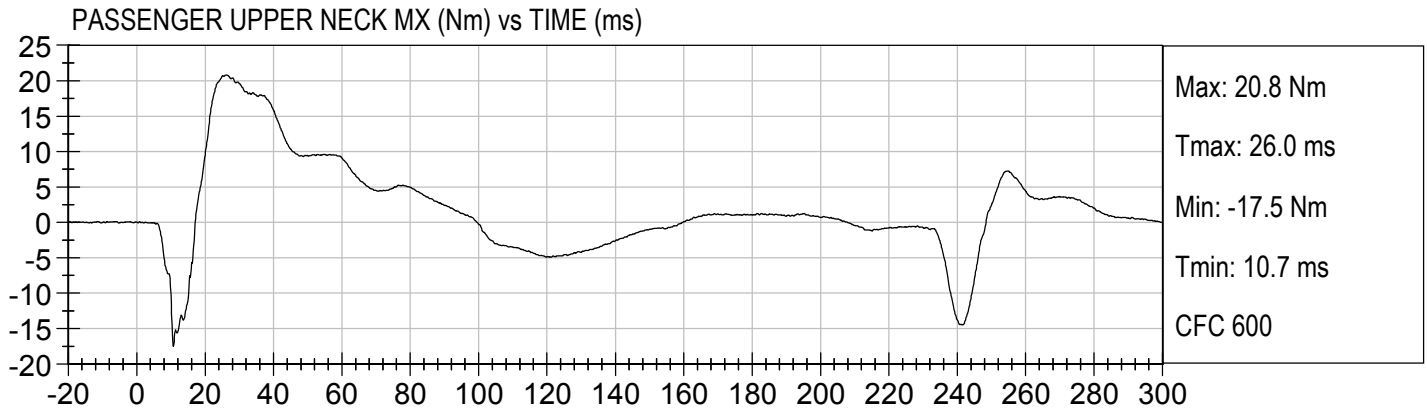
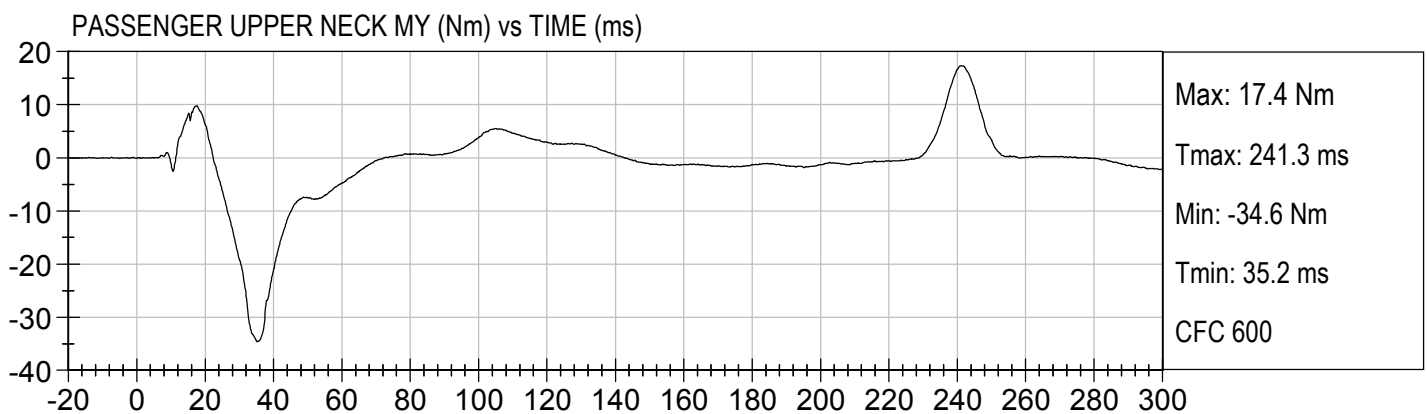
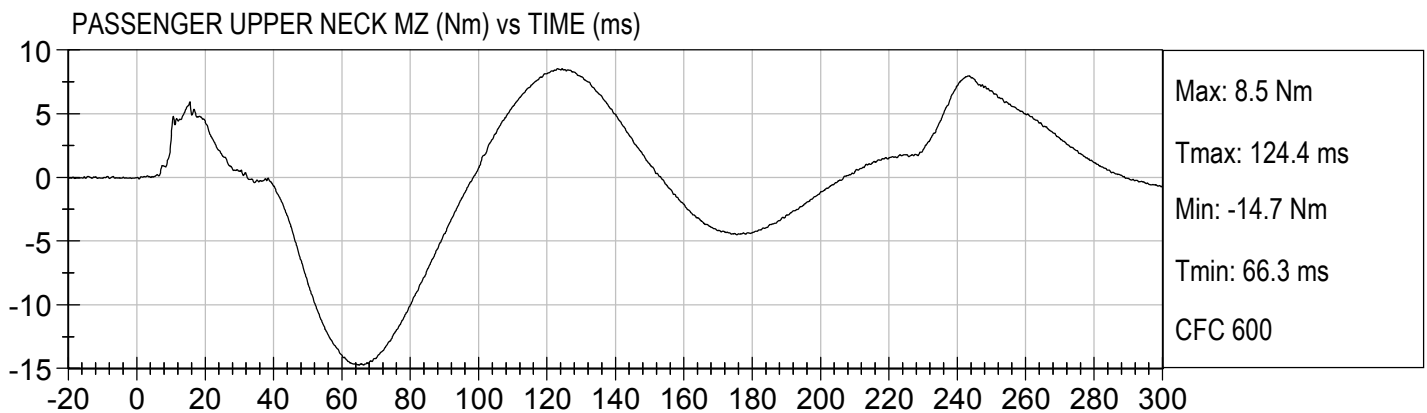
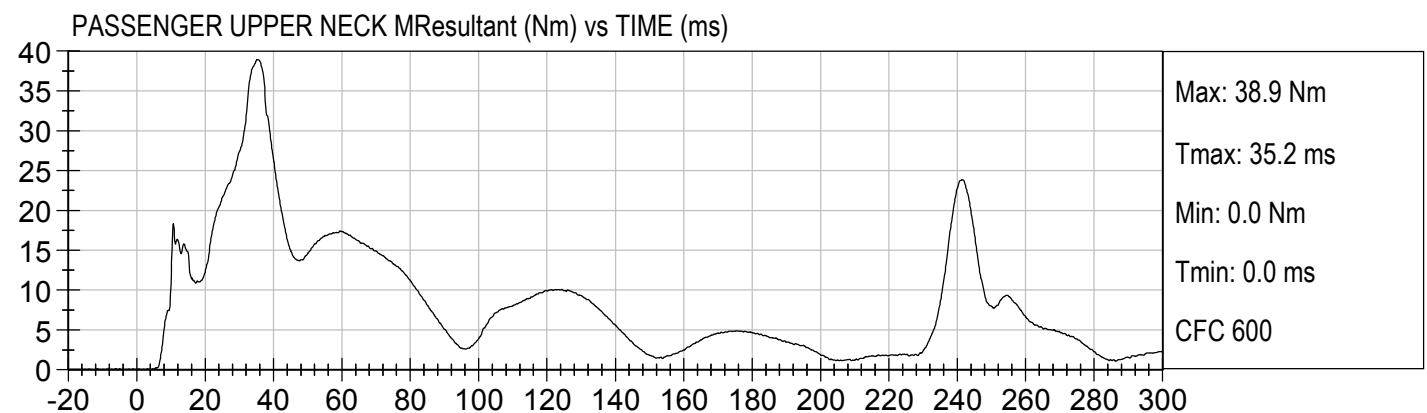
| | <u>Page No.</u> |
|---|---|
| Figure No. 9. Passenger Upper Neck X Moment vs. Time | 25 |
| Figure No. 10. Passenger Upper Neck Y Moment vs. Time | 25 |
| Figure No. 11. Passenger Upper Neck Z Moment vs. Time | 25 |
| Figure No. 12. Passenger Upper Neck Resultant Moment vs. Time | 25 |

| | | MAXIMUM VALUE | | | |
|---|---|---|---|---|---|
| Upper Neck Mx | Nm | 20.8 | 26.0 | -17.5 | 10.7 |
| Upper Neck My | Nm | 17.4 | 241.3 | -34.6 | 35.2 |
| Upper Neck Mz | Nm | 8.5 | 124.4 | -14.7 | 66.3 |
| Upper Neck M Resultant | Nm | 38.9 | 35.2 | | |

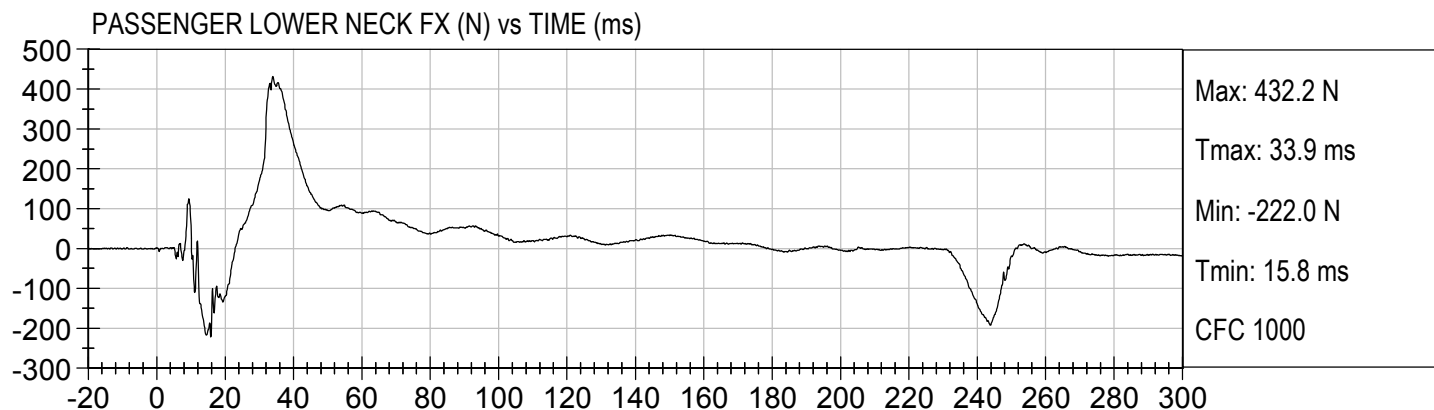
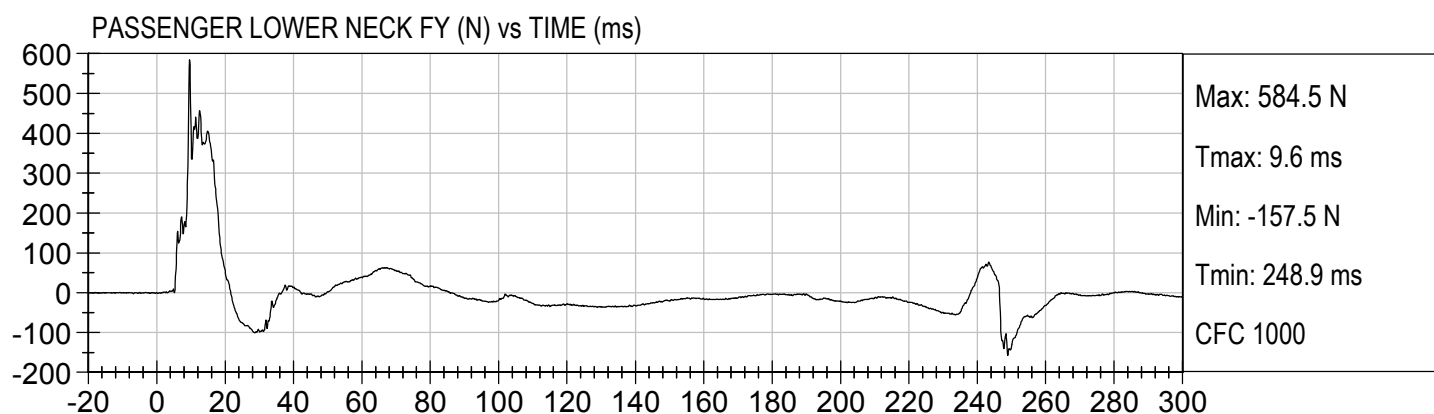
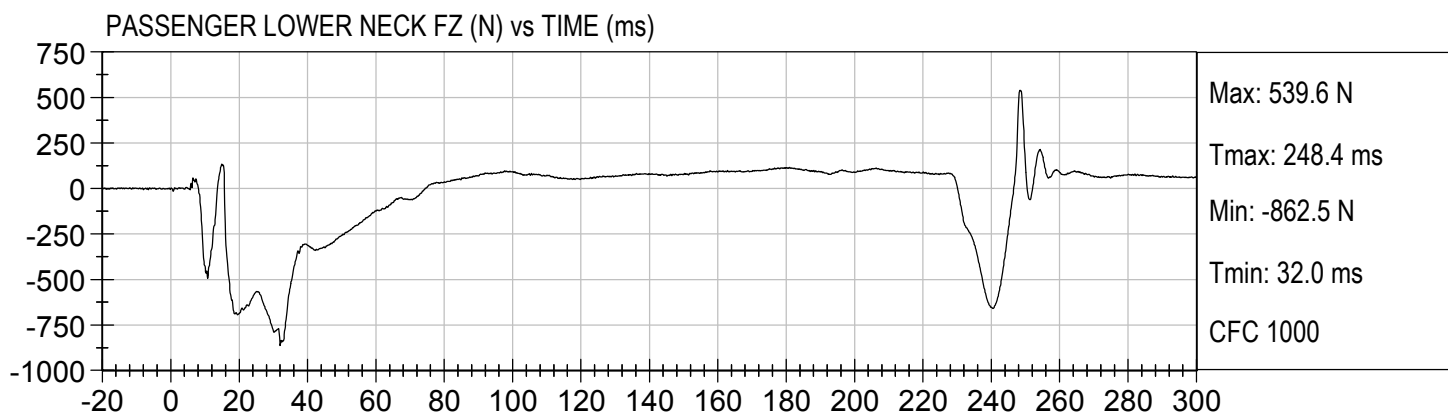
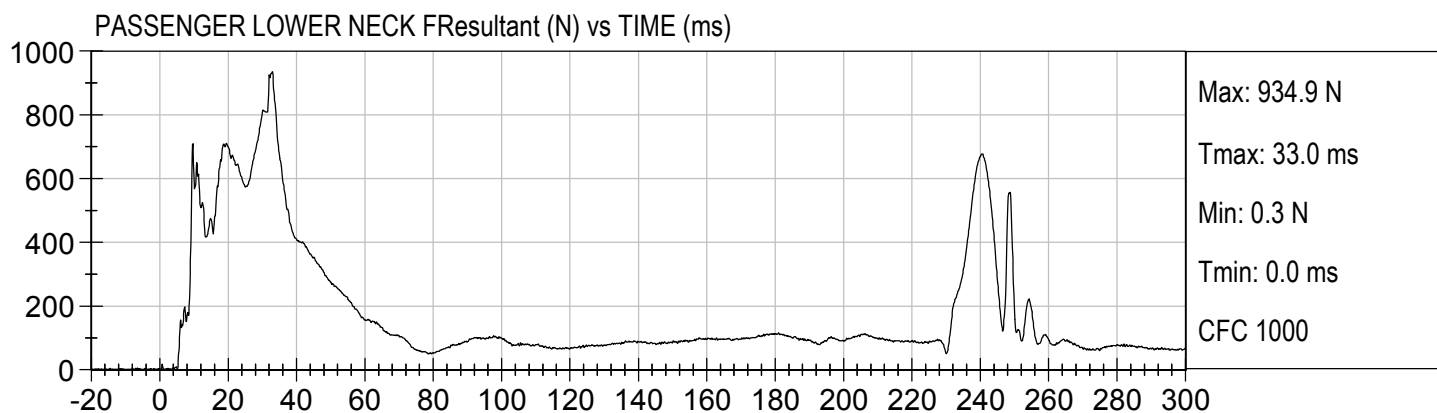
| | <u>Page No.</u> |
|---|---|
| Figure No. 13. Passenger Lower Neck X Force vs. Time | 26 |
| Figure No. 14. Passenger Lower Neck Y Force vs. Time | 26 |
| Figure No. 15. Passenger Lower Neck Z Force vs. Time | 26 |
| Figure No. 16. Passenger Lower Neck Resultant Force vs. Time | 26 |

| | | MAXIMUM VALUE | | | |
|---|---|---|---|---|---|
| Lower Neck Fx | N | 432.2 | 33.9 | -222.0 | 15.8 |
| Lower Neck Fy | N | 584.5 | 9.6 | -157.5 | 248.9 |
| Lower Neck Fz | N | 539.6 | 248.4 | -862.5 | 32.0 |
| Lower Neck F Resultant | N | 934.9 | 33.0 | | |

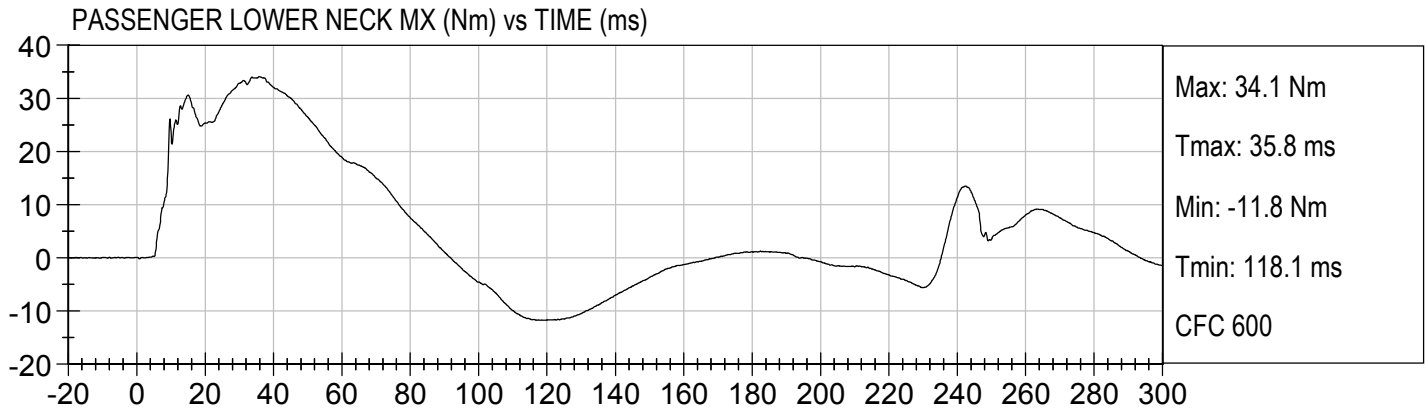
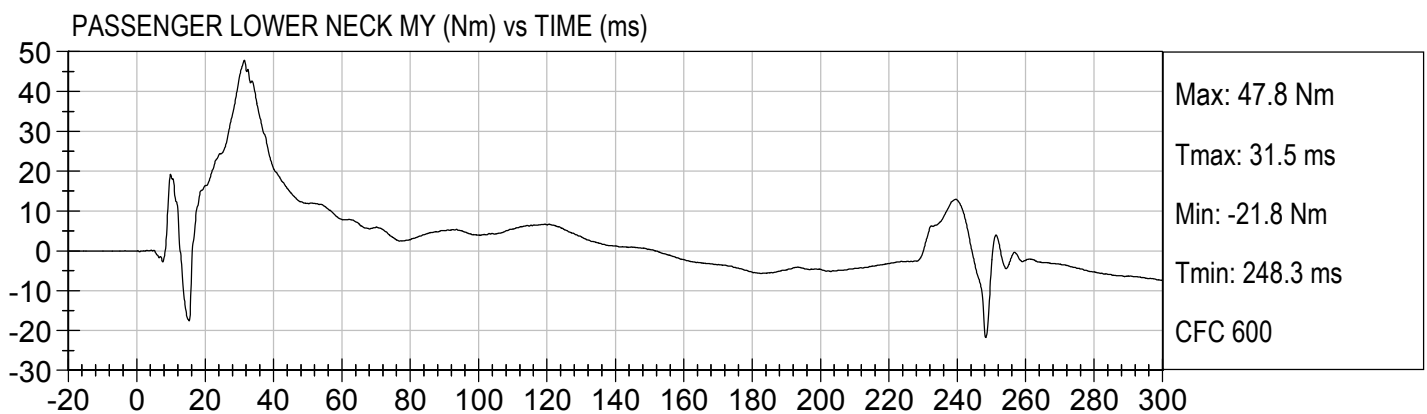
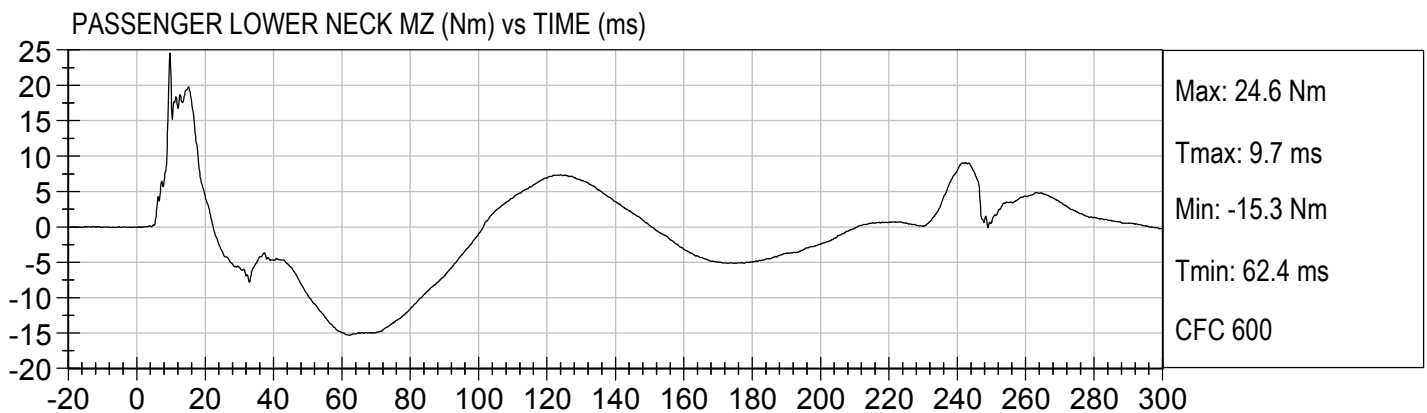
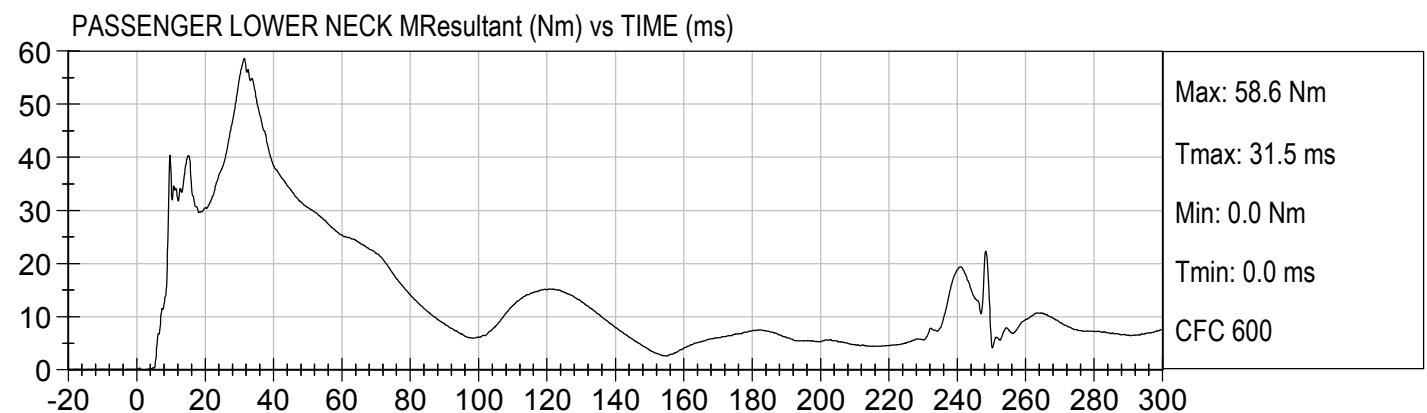
| | <u>Page No.</u> |
|---|---|
| Figure No. 17. Passenger Lower Neck X Moment vs. Time | 27 |
| Figure No. 18. Passenger Lower Neck Y Moment vs. Time | 27 |
| Figure No. 19. Passenger Lower Neck Z Moment vs. Time | 27 |
| Figure No. 20. Passenger Lower Neck Resultant Moment vs. Time | 27 |

| | | MAXIMUM VALUE | | | |
|---|---|---|---|---|---|
| Lower Neck Mx | Nm | 34.1 | 35.8 | -11.8 | 118.1 |
| Lower Neck My | Nm | 47.8 | 31.5 | -21.8 | 248.3 |
| Lower Neck Mz | Nm | 24.6 | 9.7 | -15.3 | 62.4 |
| Lower Neck M Resultant | Nm | 58.6 | 31.5 | | |

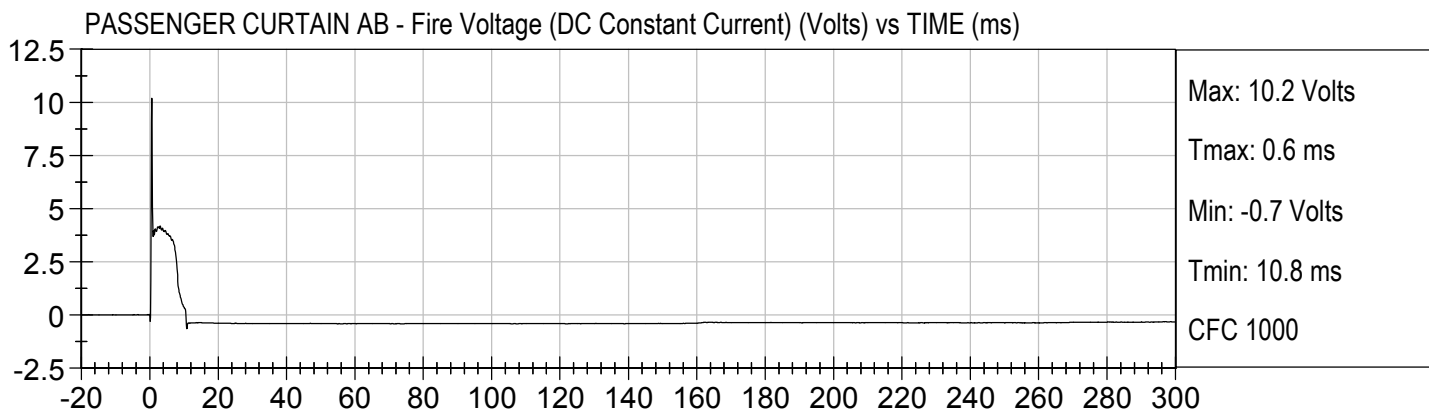
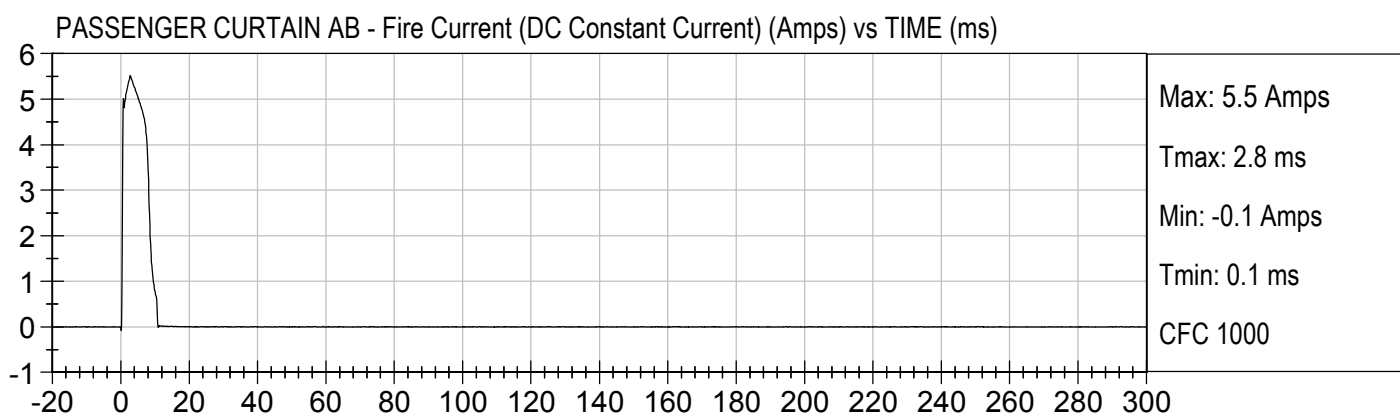
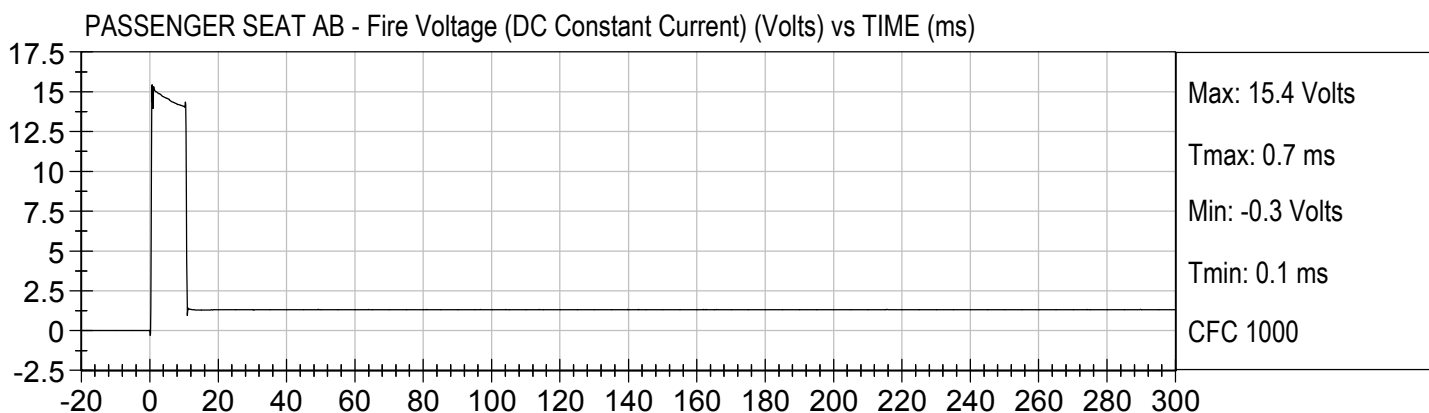
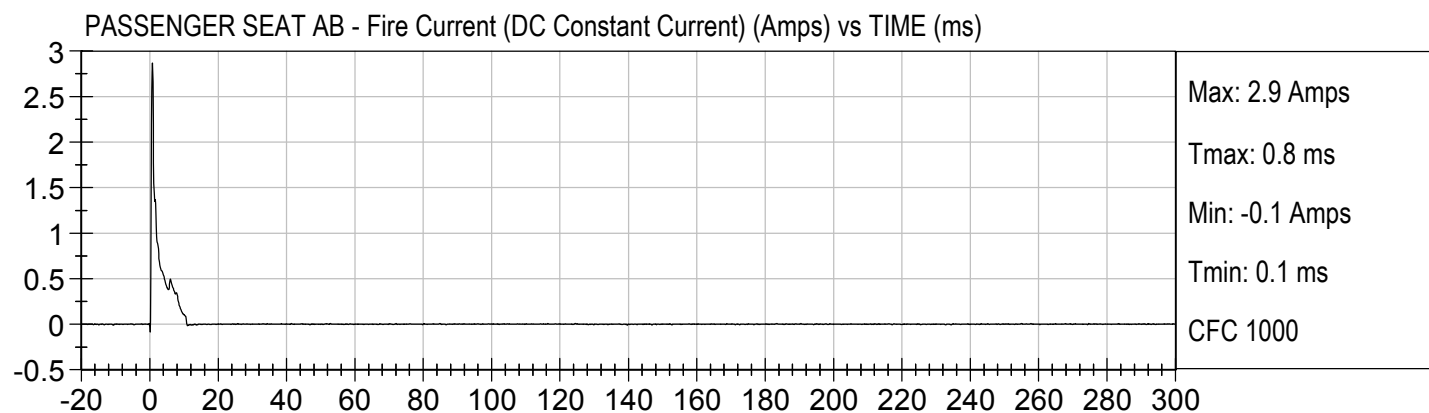
| | <u>Page No.</u> |
|---|---|
| Figure No. 21. Passenger Curtain Airbag – Fire Voltage vs. Time | 28 |
| Figure No. 22. Passenger Curtain Airbag – Fire Current vs. Time | 28 |
| Figure No. 23. Passenger Seat Airbag – Fire Voltage vs. Time | 28 |
| Figure No. 24. Passenger Seat Airbag – Fire Current vs. Time | 28 |
