**REPORT NUMBER: NCAP-KAR-15-021**

**NEW CAR ASSESSMENT PROGRAM (NCAP)  
FRONTAL BARRIER IMPACT TEST**

**BAYERISCHE MOTOREN WERKE AG  
2015 BMW X3 XDRIVE28i 5-DOOR MPV**

**NHTSA NUMBER: M20154104**

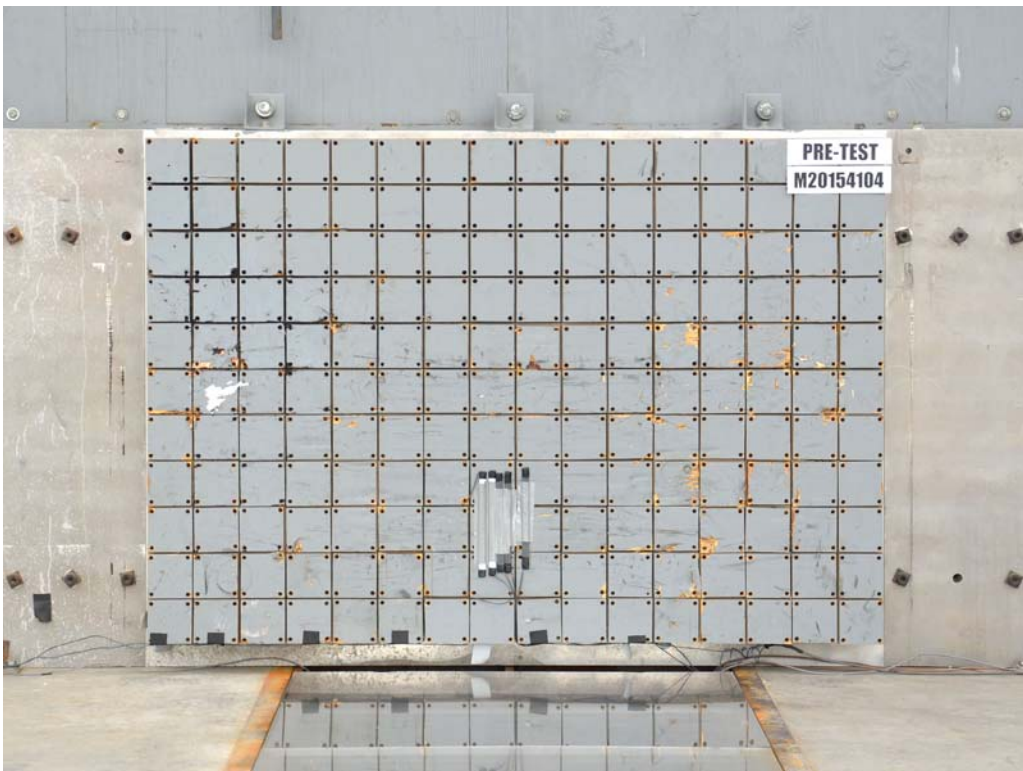
FIGURE 2. Load Cell Wall

A load cell barrier consisting of 176 load cells was impacted by a 2015 BMW X3 xDrive28i 5-door MPV at a velocity of 55.74 km/h. The test was performed at KARCO Engineering, LLC. on December 11, 2014. Pre- and post-test photographs of the vehicle and dummies can be found in Appendix A of this report.

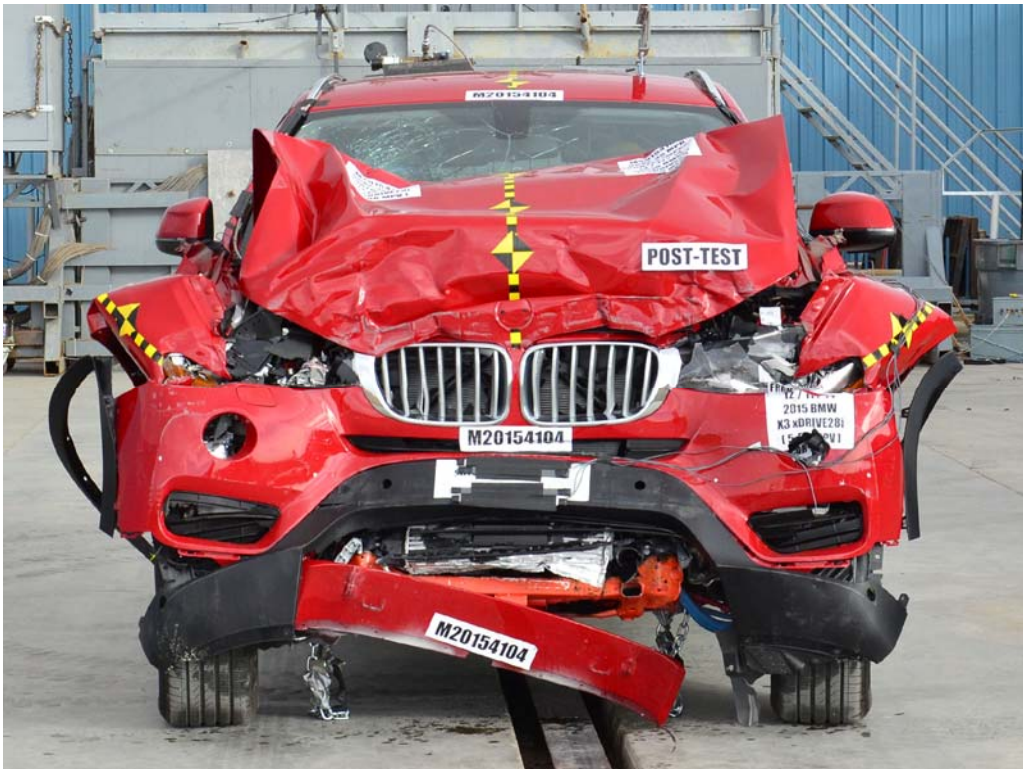
FIGURE 8. Post-Test Front View of Test Vehicle

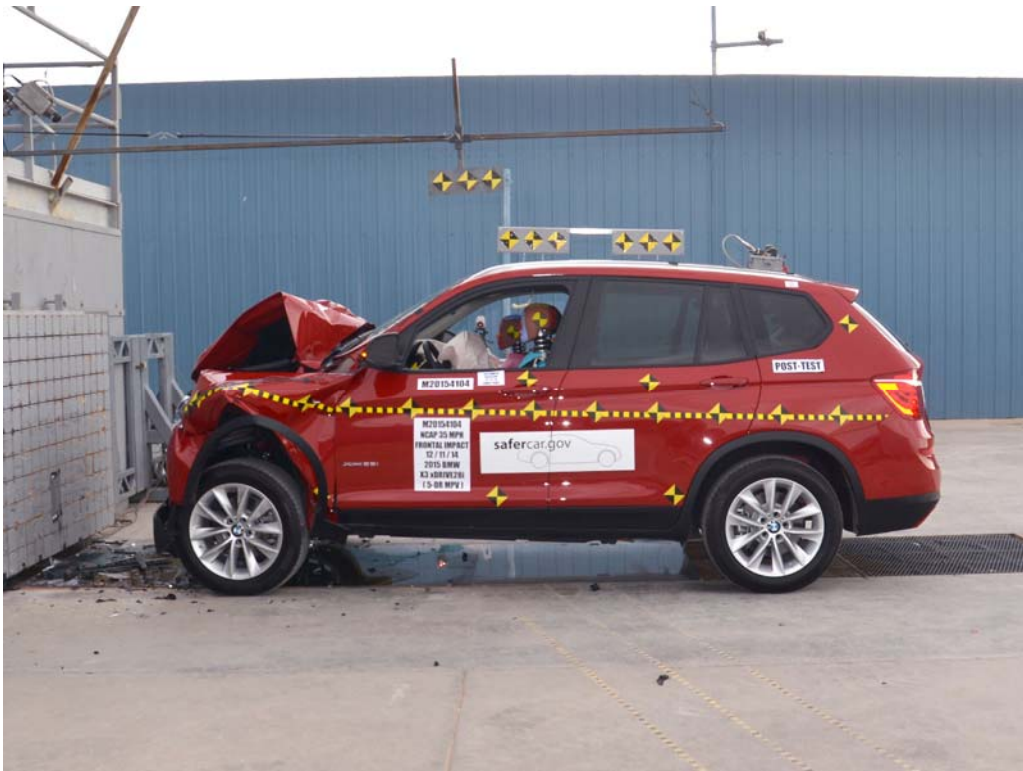
FIGURE 10. Post-Test Left View of Test Vehicle

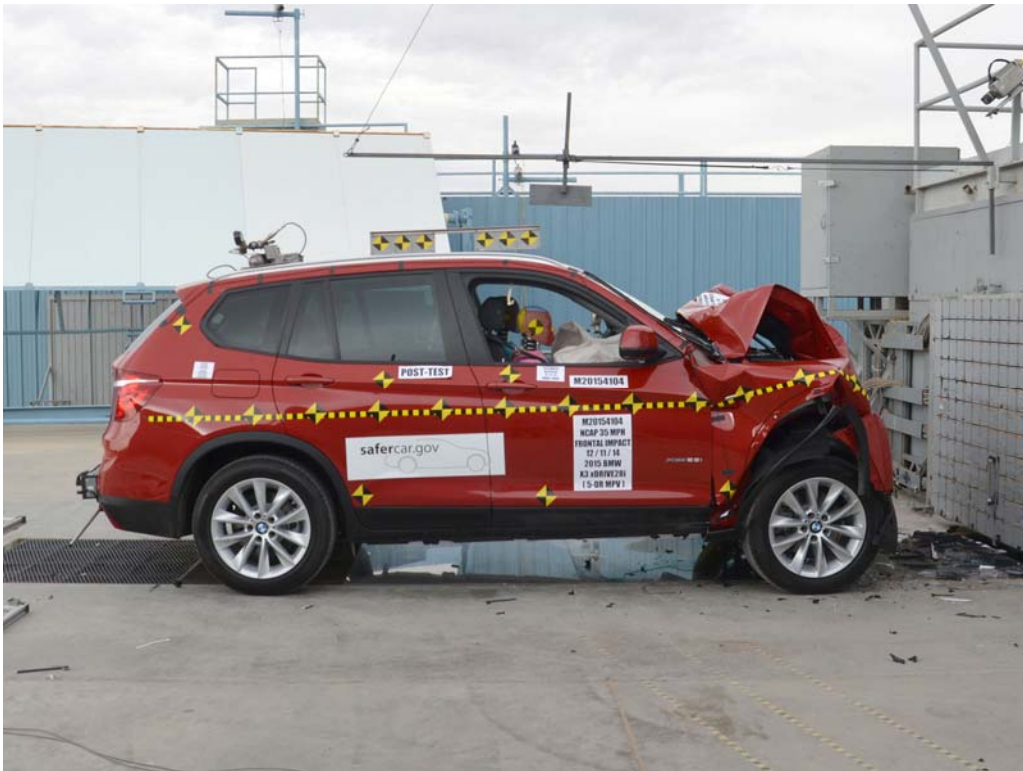
FIGURE 12. Post-Test Right View of Test Vehicle

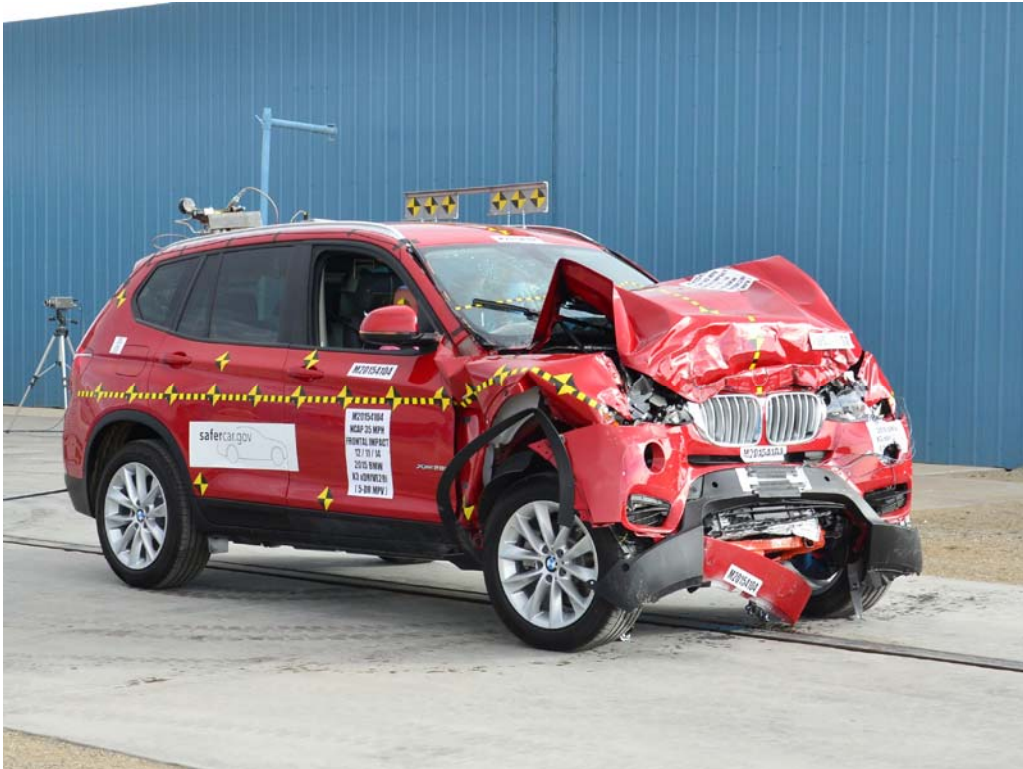
FIGURE 14. Post-Test Right Front  $\frac{3}{4}$  View

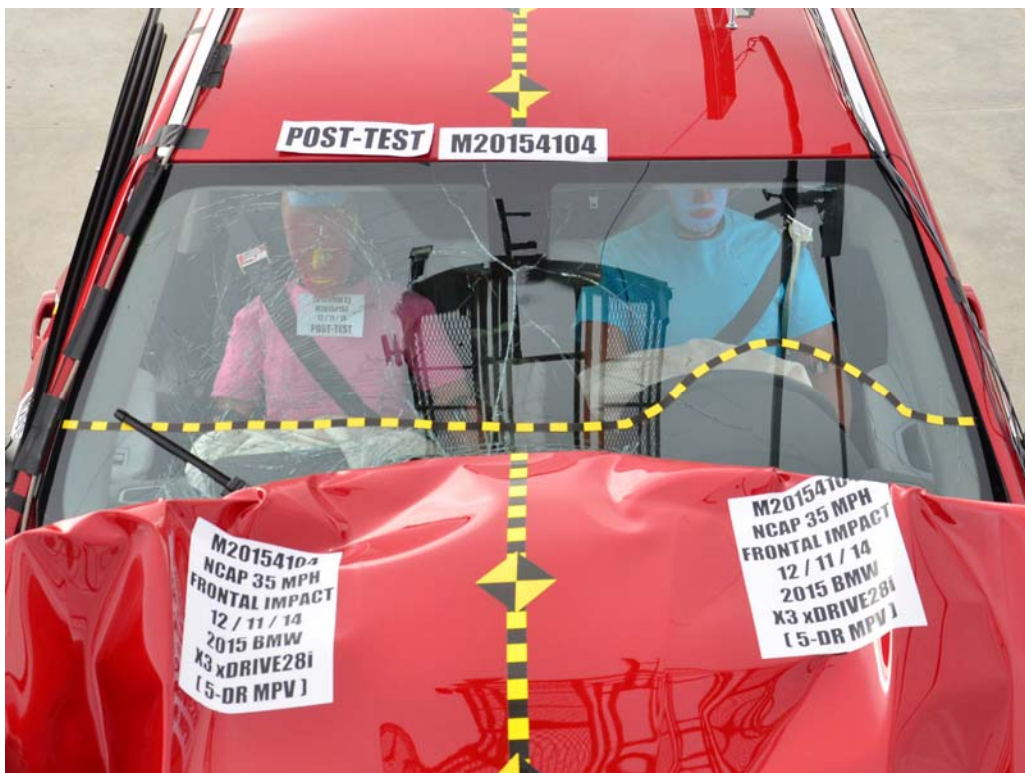
FIGURE 18. Post-Test Windshield View

There was 100% windshield retention and no intrusion into the protected zone of the windshield during the event.

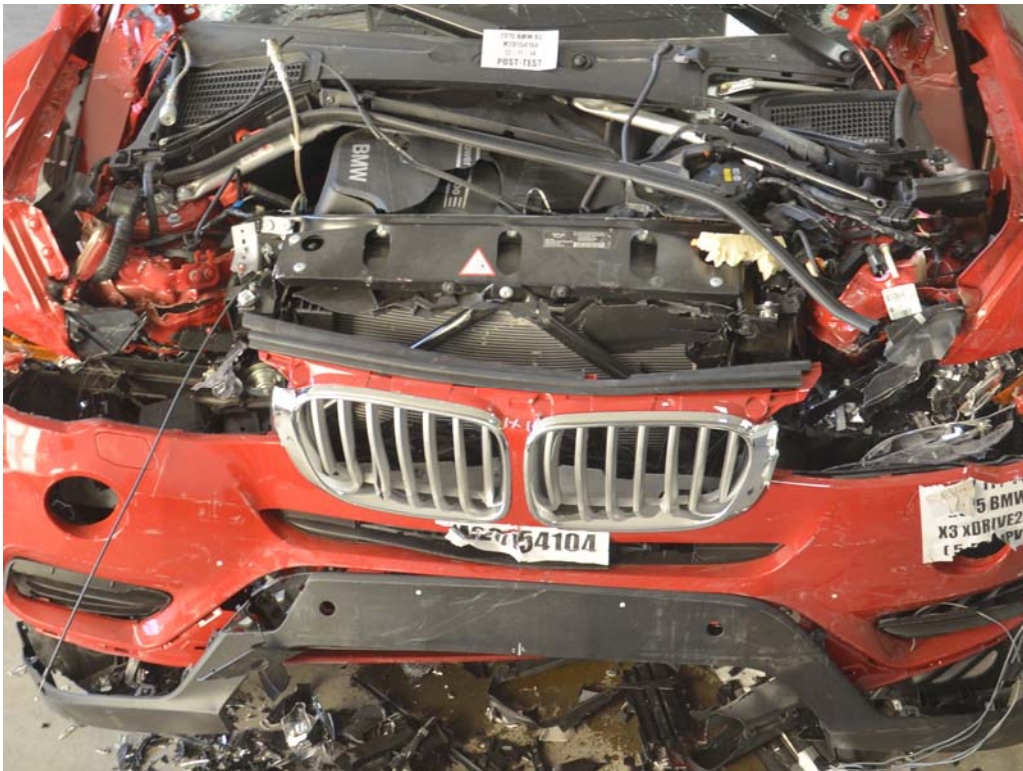
FIGURE 20. Post-Test Engine Compartment View

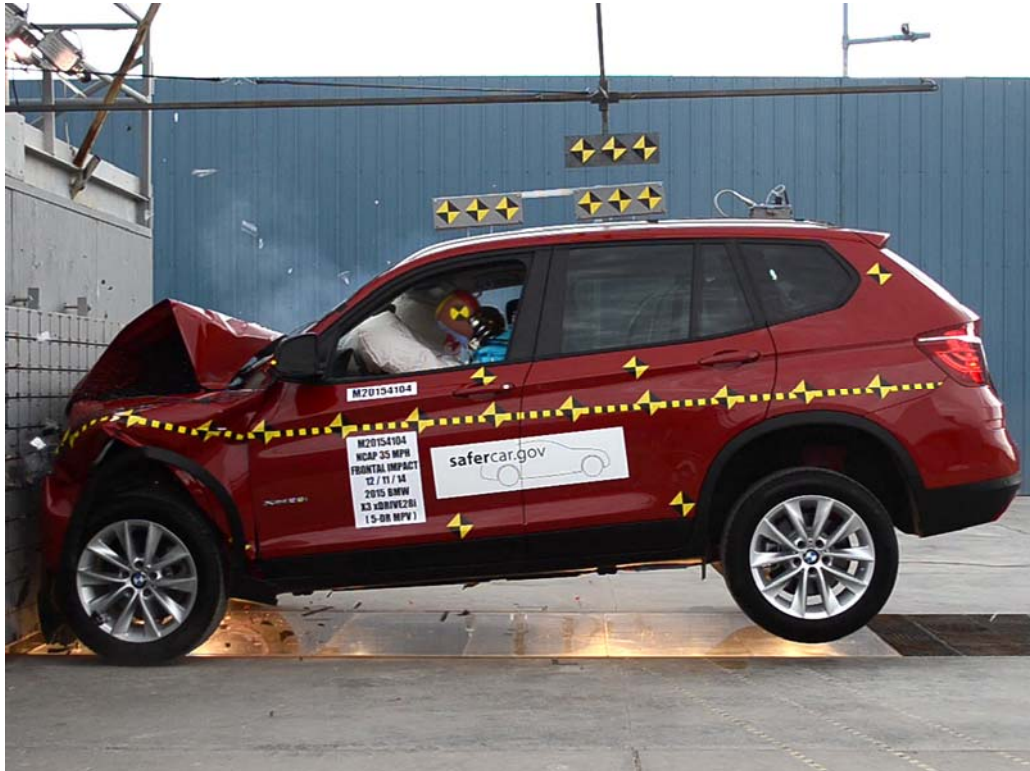
FIGURE 77. 2015 BMW X3 Frontal Impact Event
