**REPORT NUMBER: NCAP-CAL-15-002**

**NEW CAR ASSESSMENT PROGRAM (NCAP)  
FRONTAL BARRIER IMPACT TEST**

**Honda of America MFG., INC  
2015 Honda CR-V  
SUV**

**FINAL REPORT**

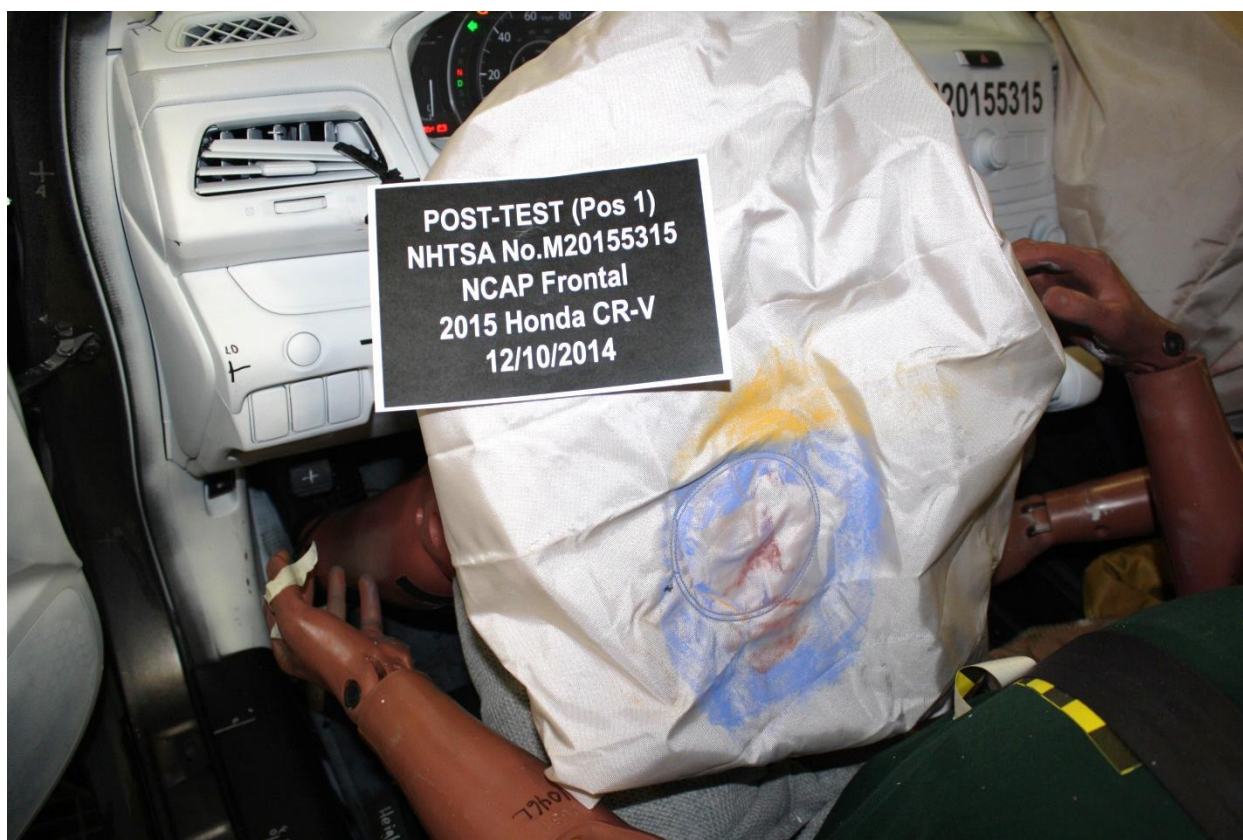
**Figure A-46: Post-Test Driver Dummy Contact With Airbag**

The driver's visible contact points were as follows: The driver's head contacted the frontal airbag and then the head restraint. The upper torso contacted the frontal airbag. Both knees contacted the knee bolster.

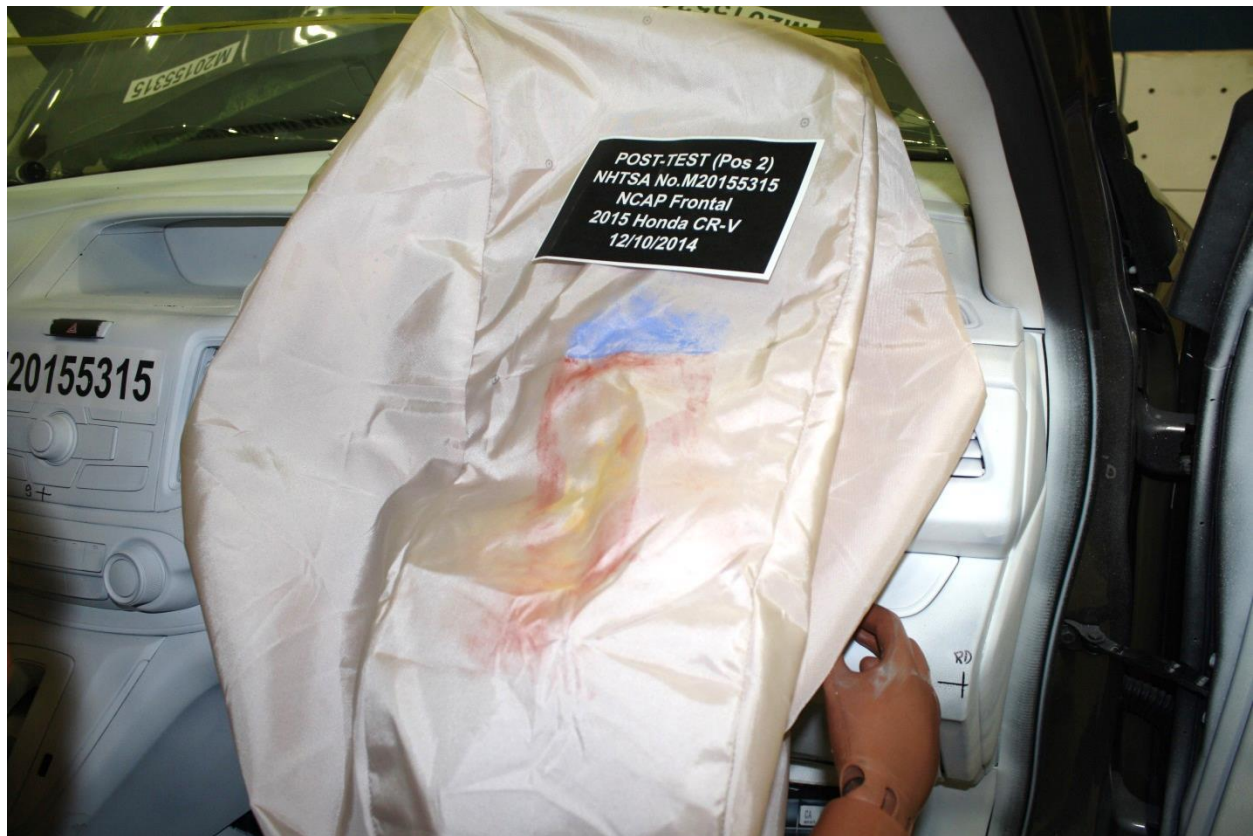
**Figure A-67: Post-Test Passenger Dummy Contact With Airbag**

The passenger's visible contact points were as follows: The passenger's head contacted the frontal airbag and then the head restraint and seat back. The upper torso contacted the frontal airbag. Both knees contacted the glove box.
