**REPORT NUMBER: SINCAP-CAL-15-002**

**NEW CAR ASSESSMENT PROGRAM (NCAP)  
MOVING DEFORMABLE BARRIER SIDE IMPACT TEST**

**MFD in Canada by Honda of Canada MFG.,  
A Division of Honda Canada INC.  
2015 Honda CR-V  
SUV**

**FINAL REPORT**

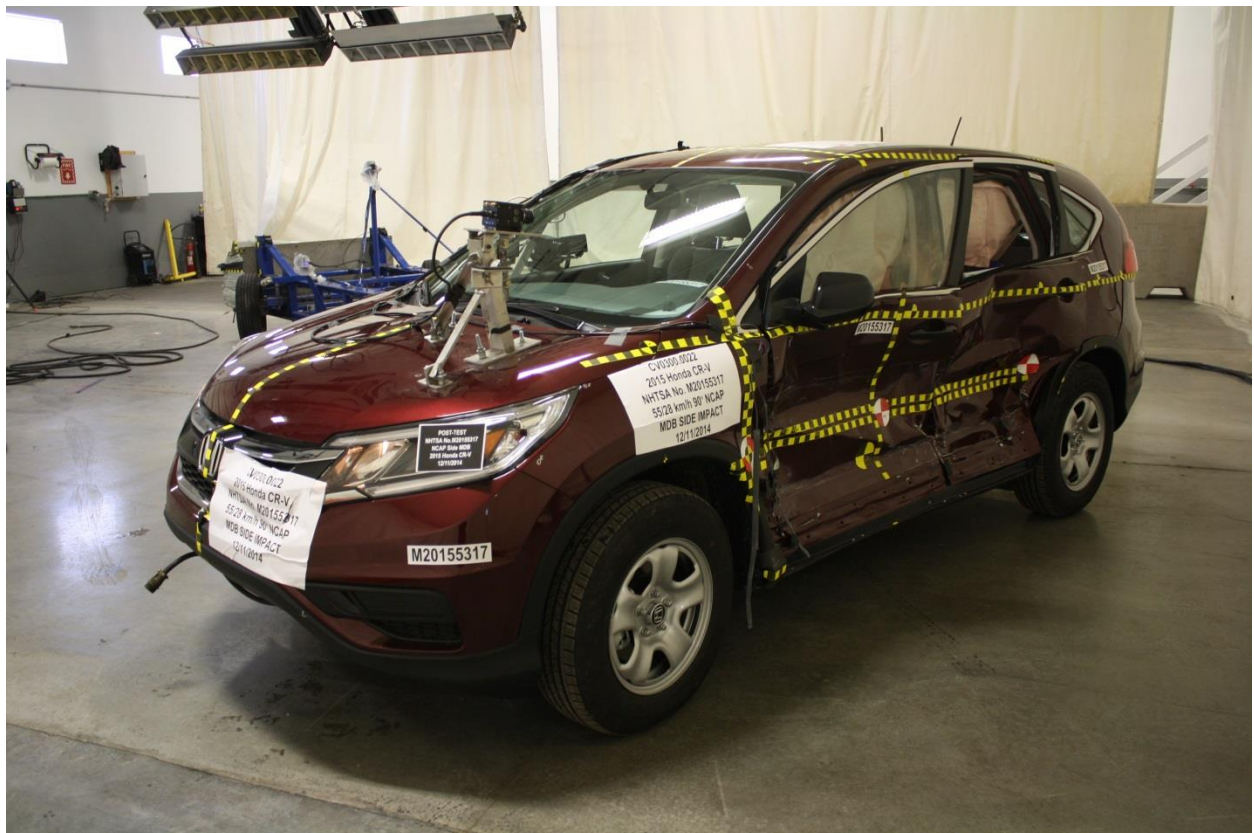
**Figure A-6: Post-Test Left Front  $\frac{3}{4}$  View of Test Vehicle**

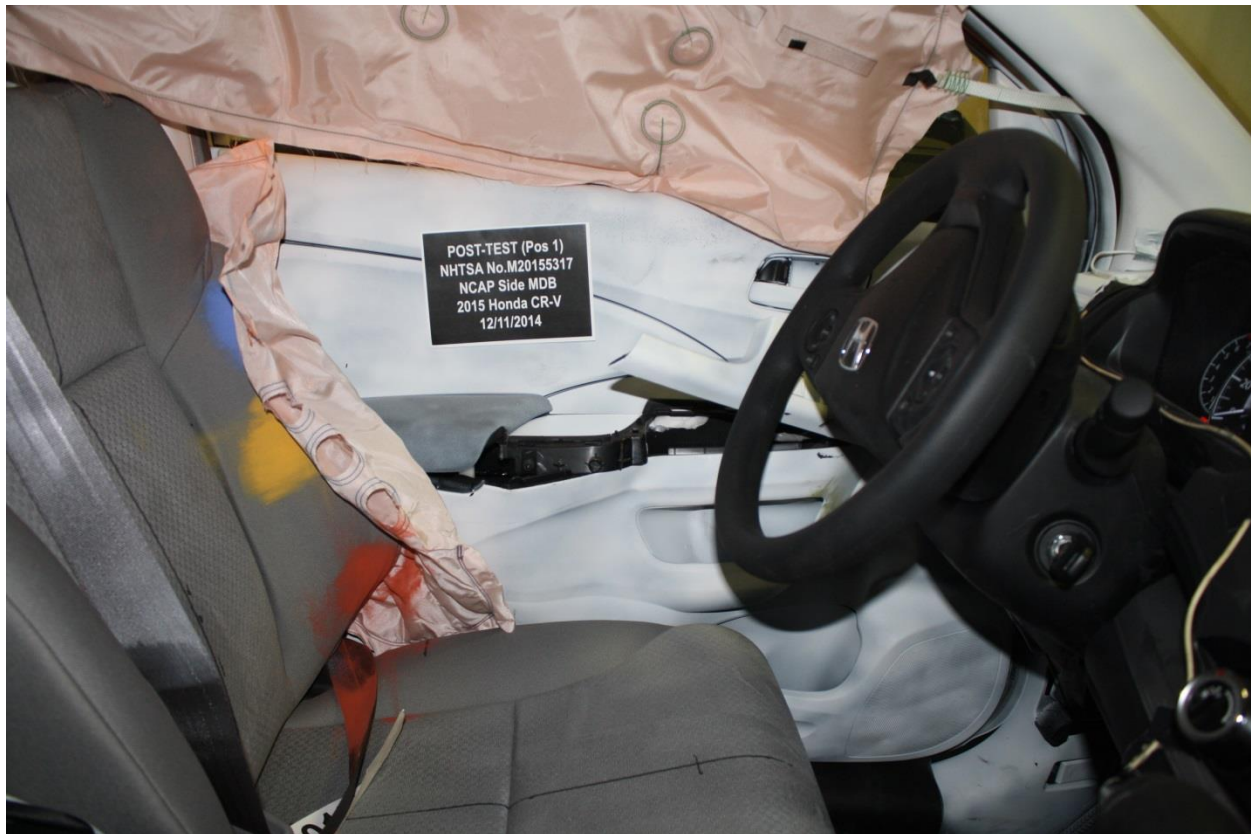
**Figure A-47: Post-Test Driver Inner Door Panel View**

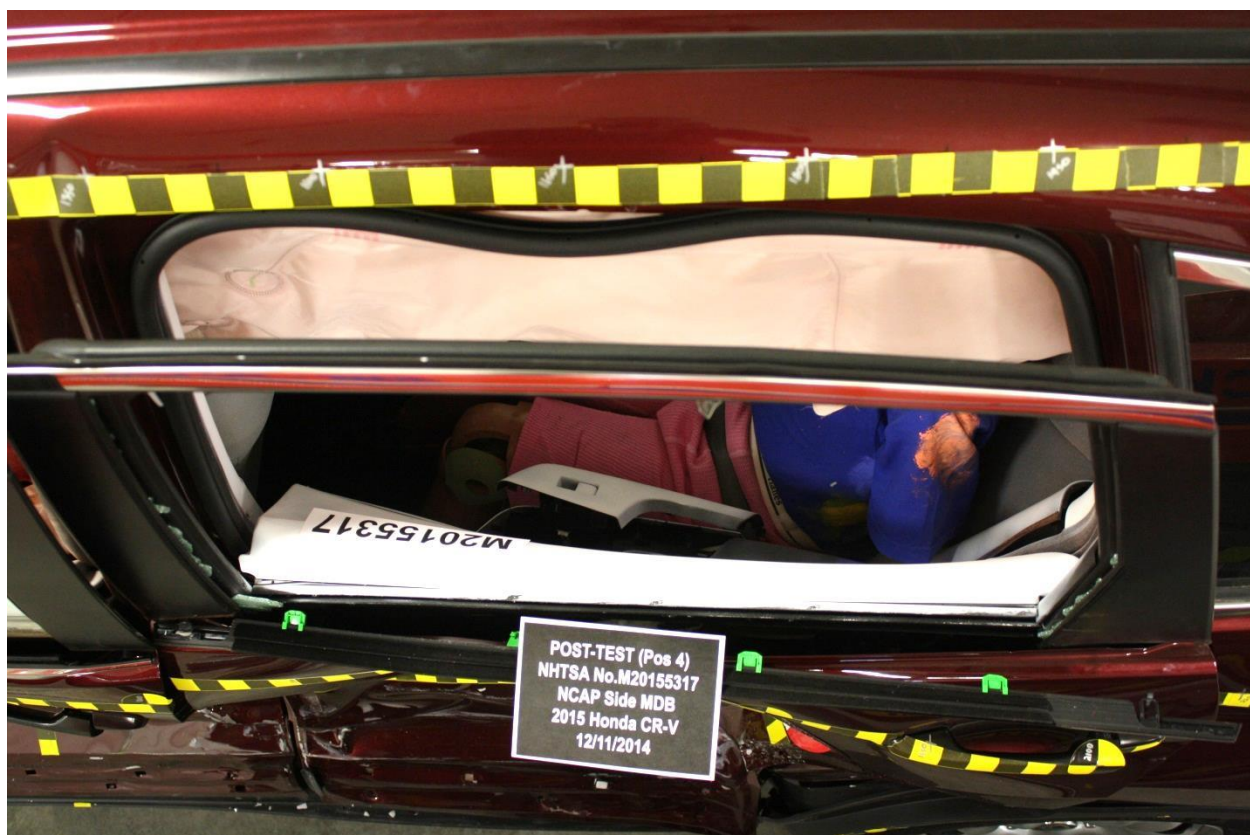
**Figure A-70: Post-Test Passenger Dummy and Door Clearance View**

| Critical Areas of Performance | Observations and Conclusions |
|---|---|
| Side Window Damage | Left Side Rear Passenger Window Shattered |

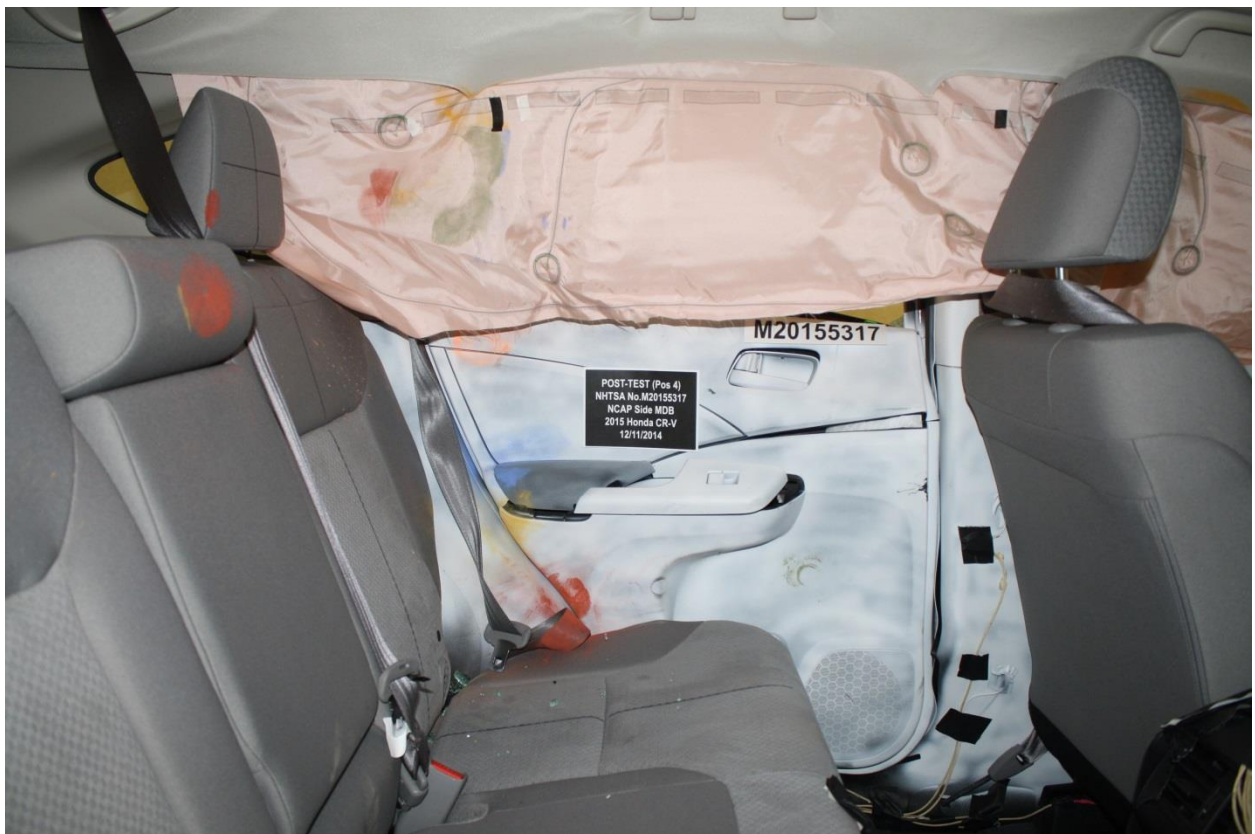
**Figure A-74: Post-Test Passenger Inner Door Panel View**

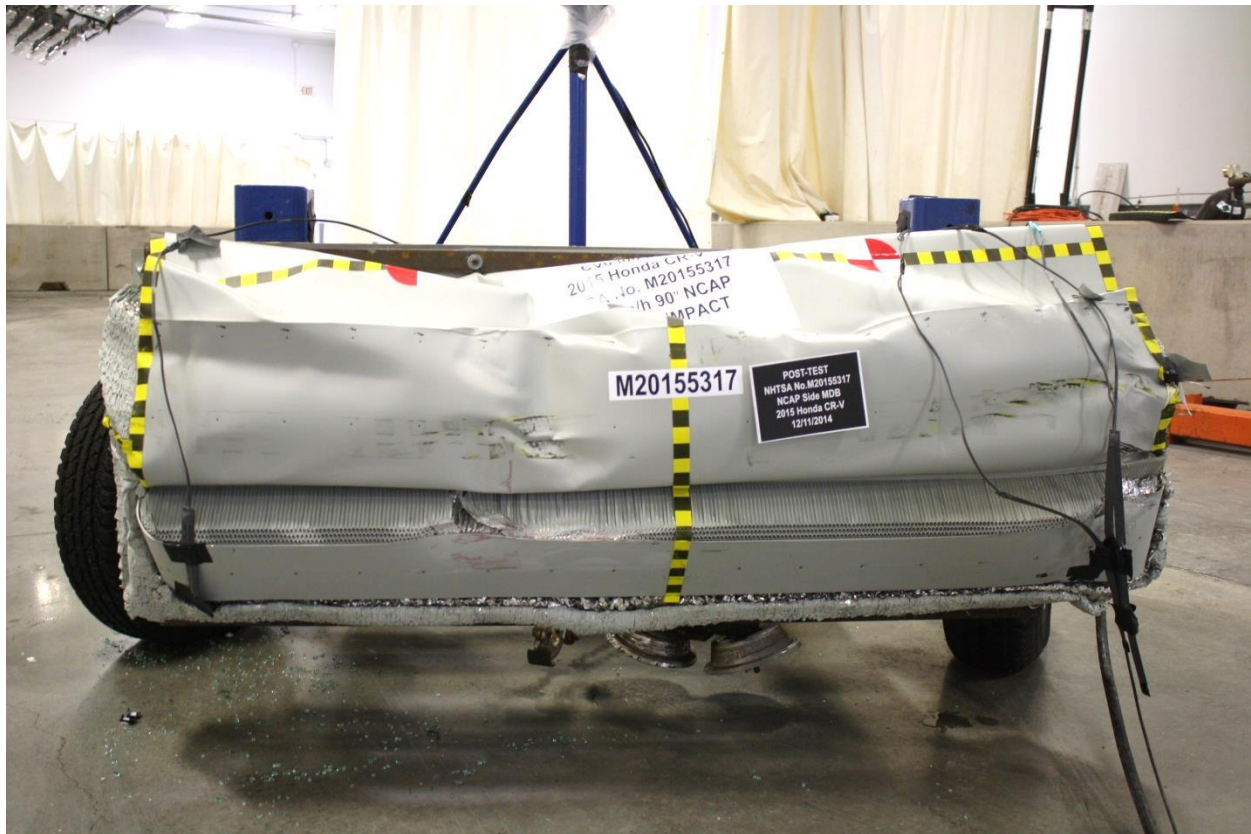
Figure A-85: Post-Test Front View of MDB Impactor Face

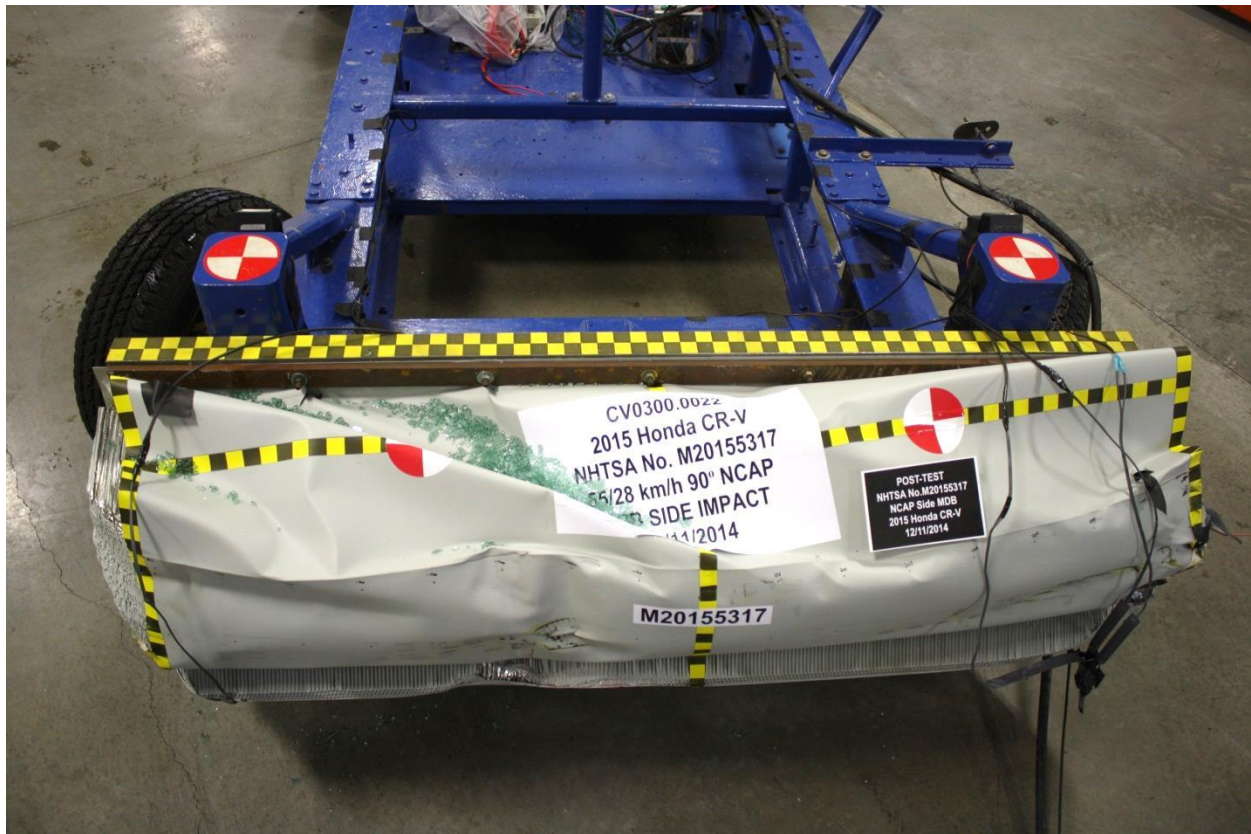
Figure A-87: Post-Test Top View of MDB Impactor Face

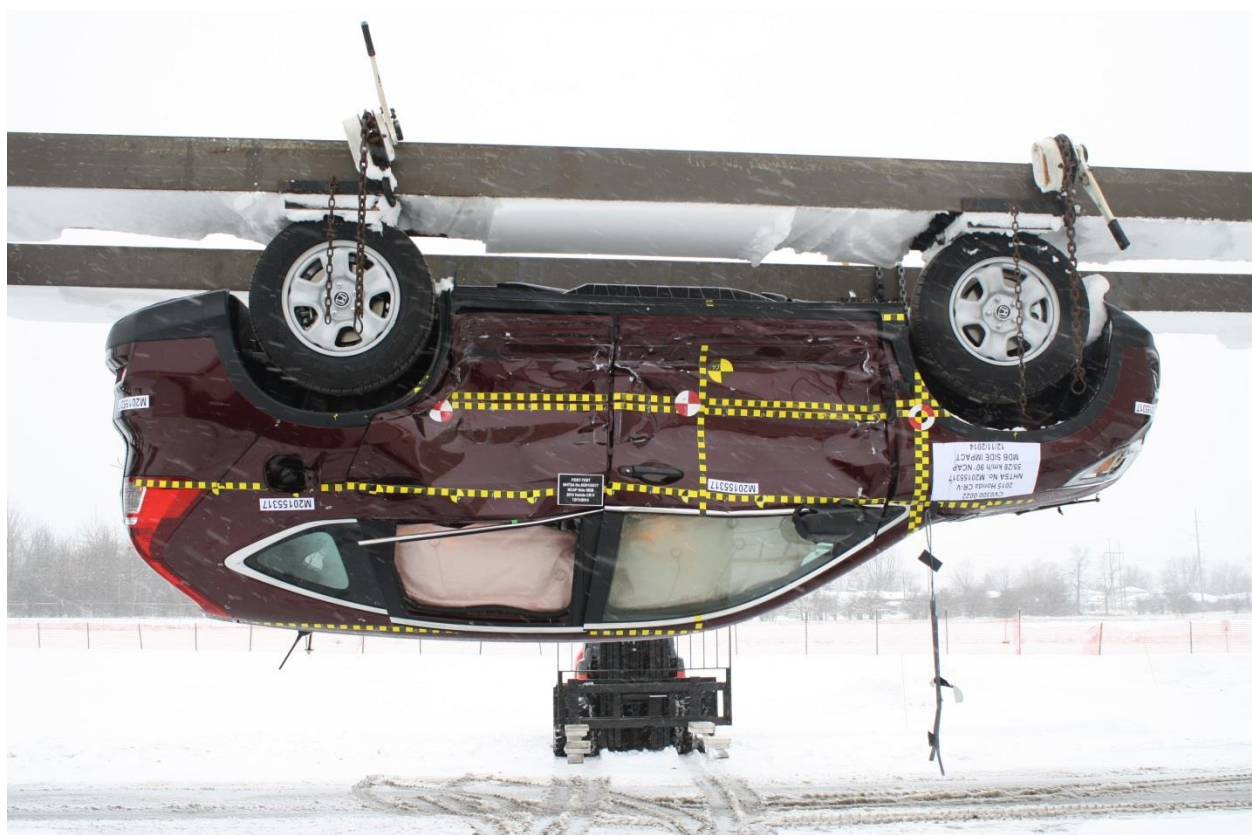
**Figure A-98: FMVSS No. 301 Static Rollover 180 Degrees**
