**REPORT NUMBER: SPNCAP-MGA-2015-044**

**NEW CAR ASSESSMENT PROGRAM (NCAP)  
Side Impact Pole Test**

**GM KOREA COMPANY  
2015 Buick Encore SUV  
NHTSA No.: O20150100**

**FINAL REPORT**

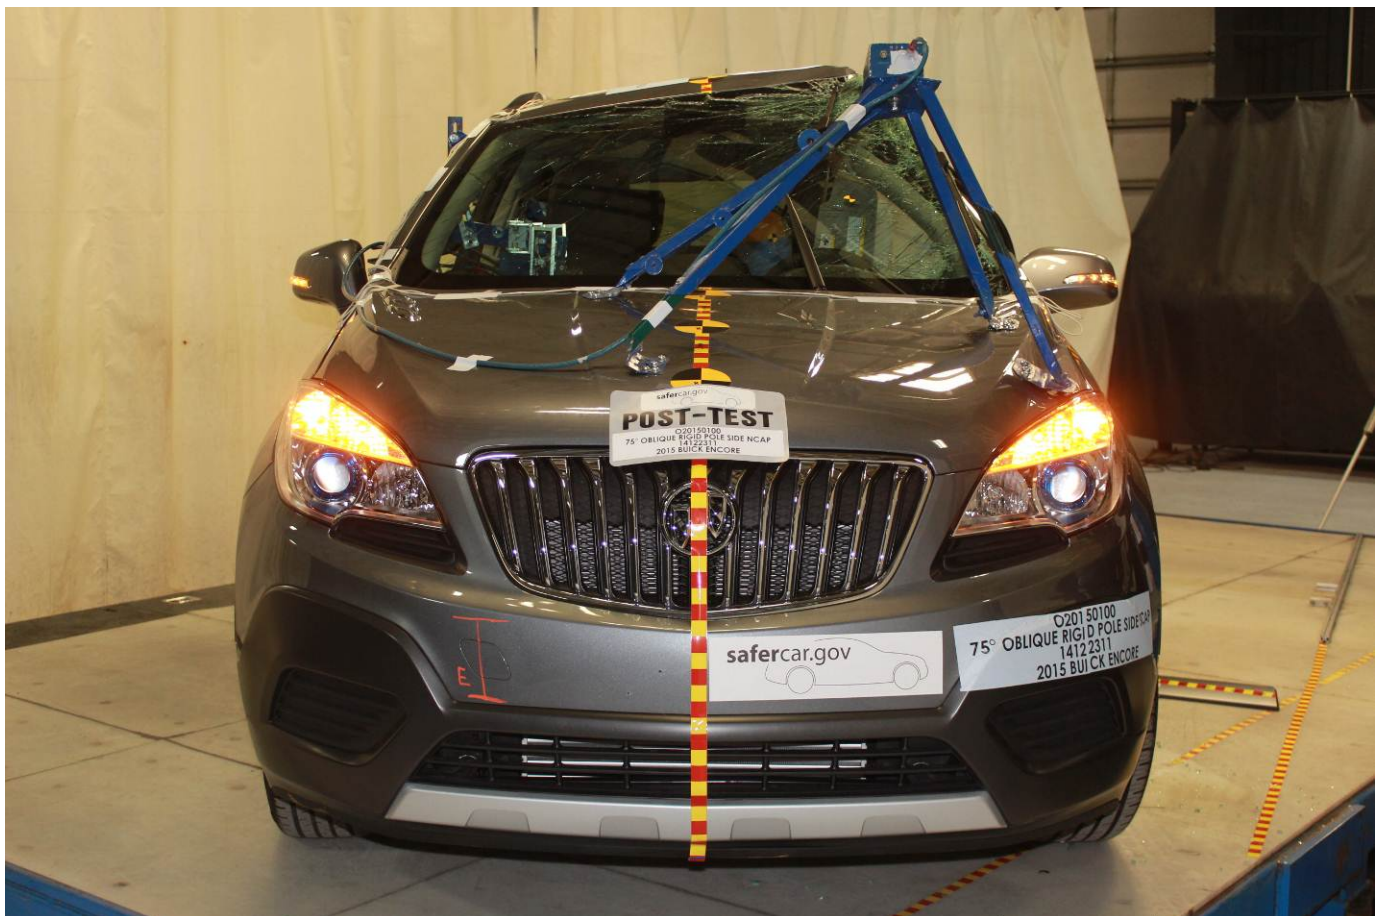
Post-Test Frontal View of Test Vehicle

| Critical Areas of Performance | Observations and Conclusions |
|---|---|
| Windshield Damage | Cracked |

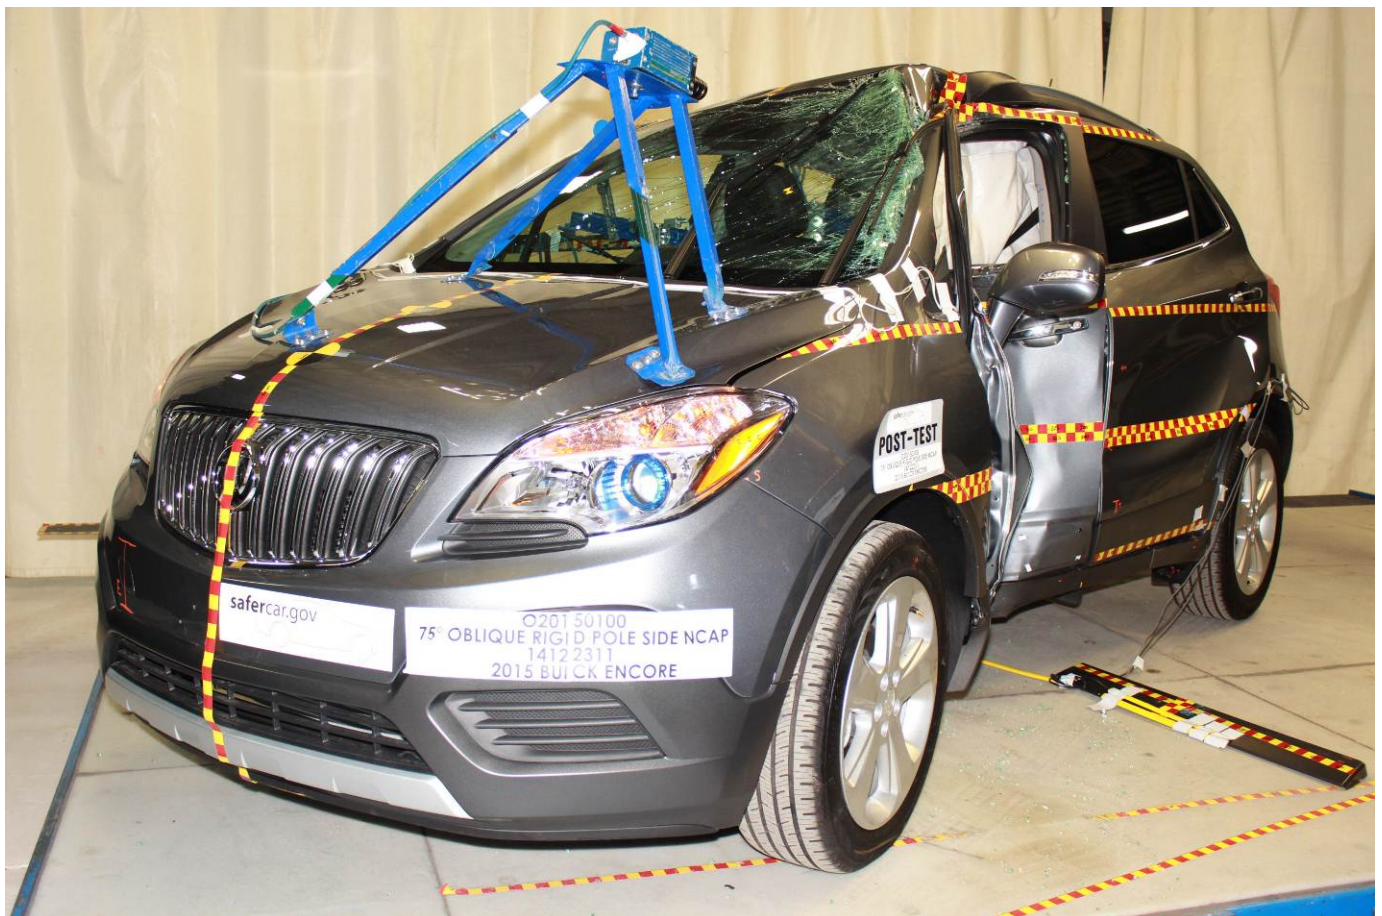
Post-Test Left Front  $\frac{3}{4}$  View of Test Vehicle

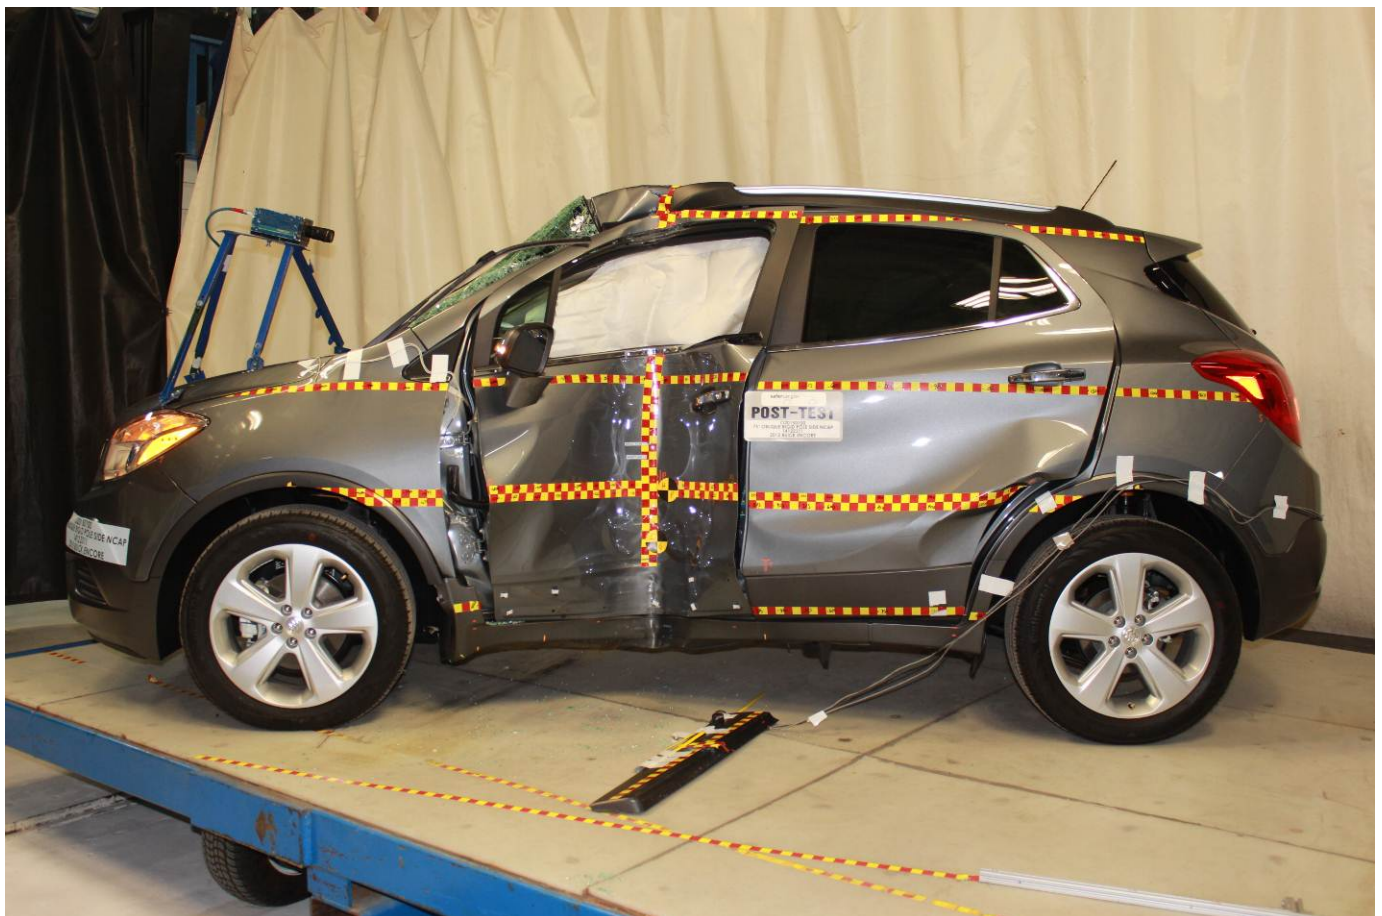
Post-Test Left Side View of Test Vehicle

| Critical Areas of Performance | Observations and Conclusions |
|---|---|
| Side Window Damage | Left Front Window Broken |

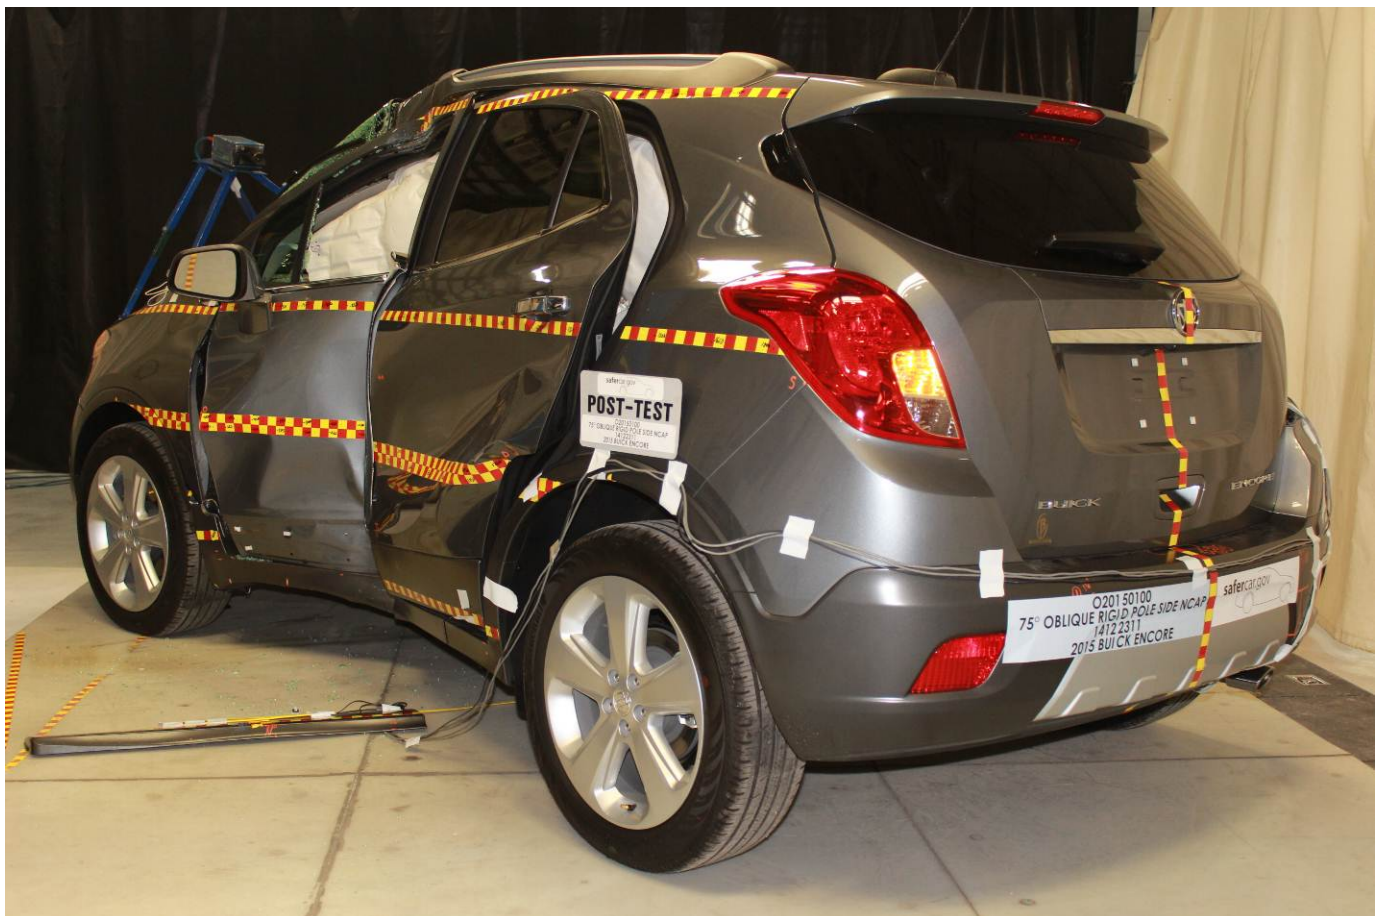
Post-Test Left Rear  $\frac{3}{4}$  View of Test Vehicle

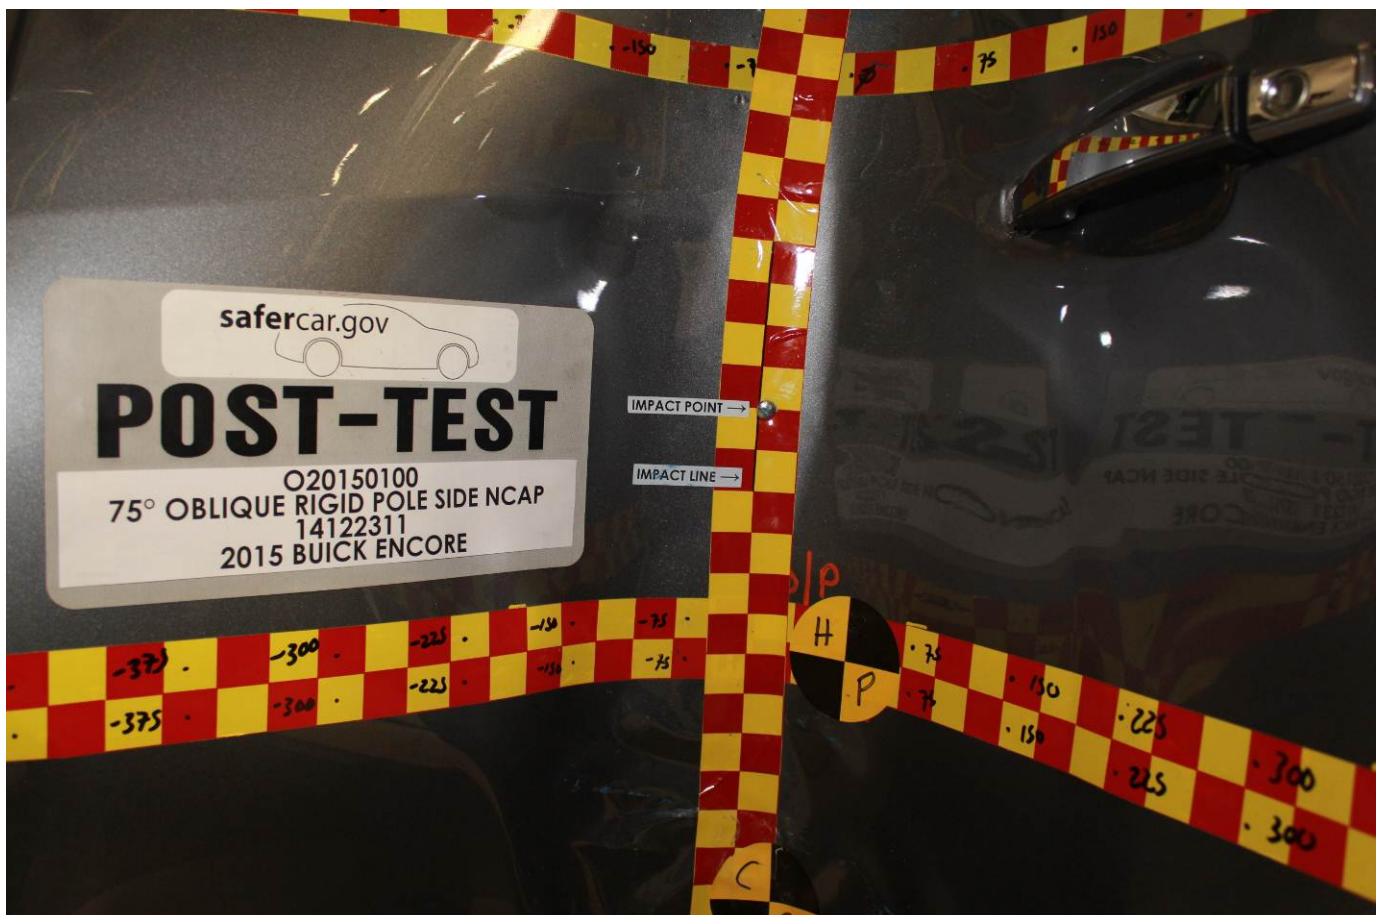
Post-Test Close-Up View of Impact Point Target Showing Impact Location

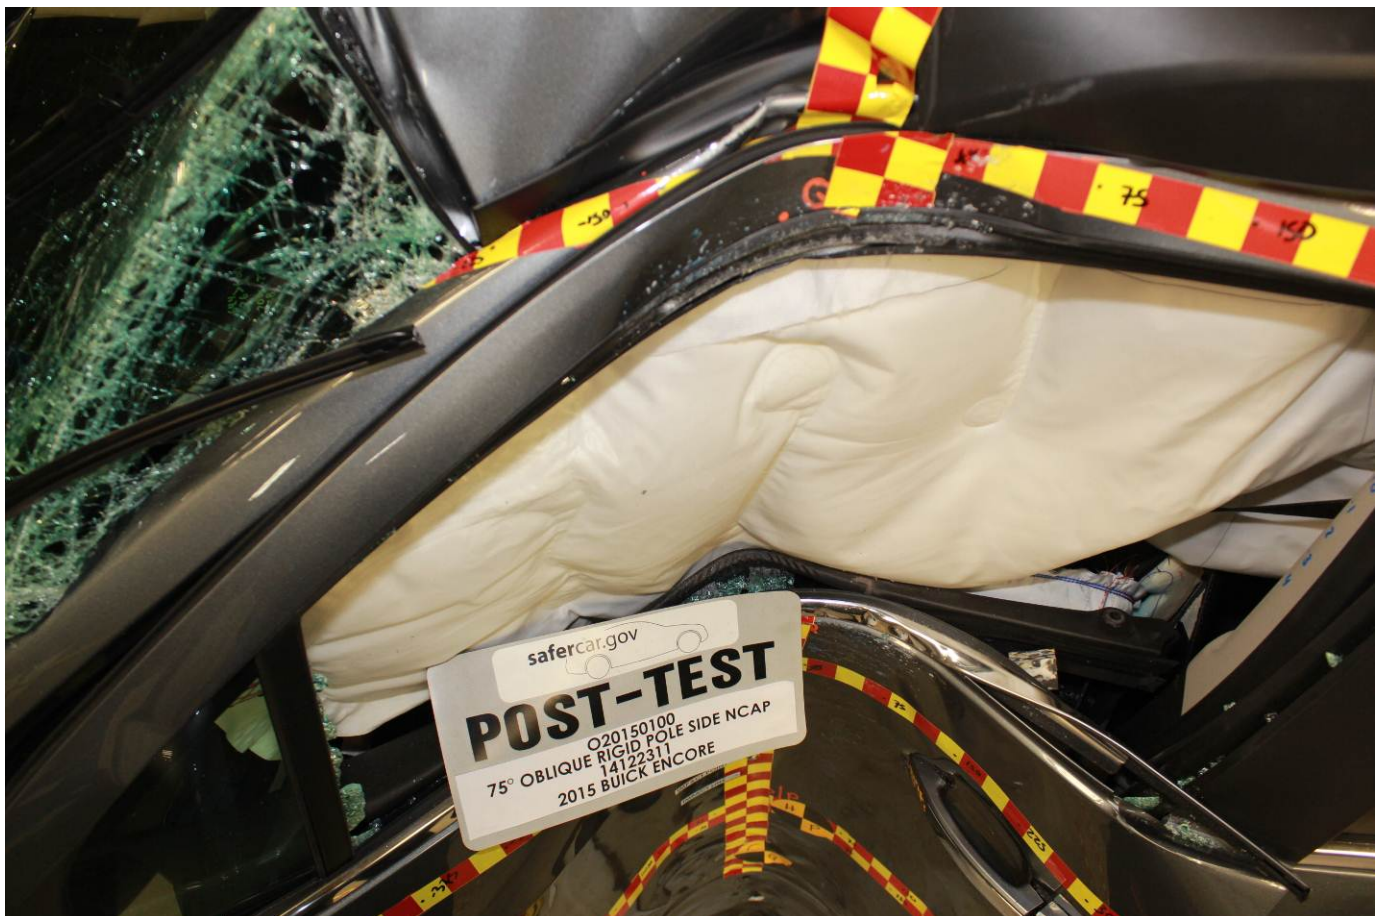
Post-Test Dummy and Door Clearance View

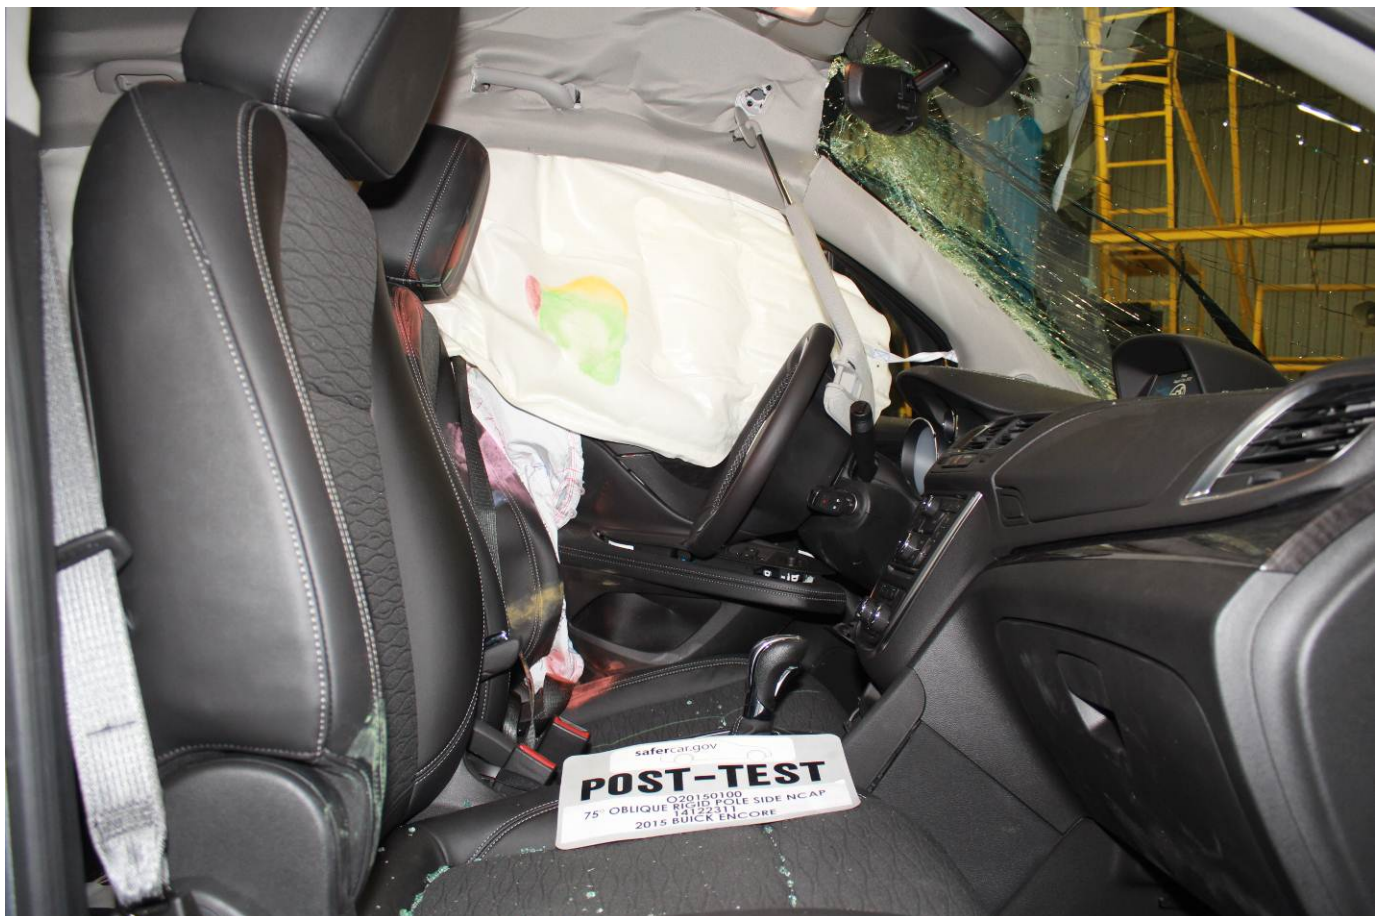
Post-Test Inner Door Panel View Showing Dummy Contact Location

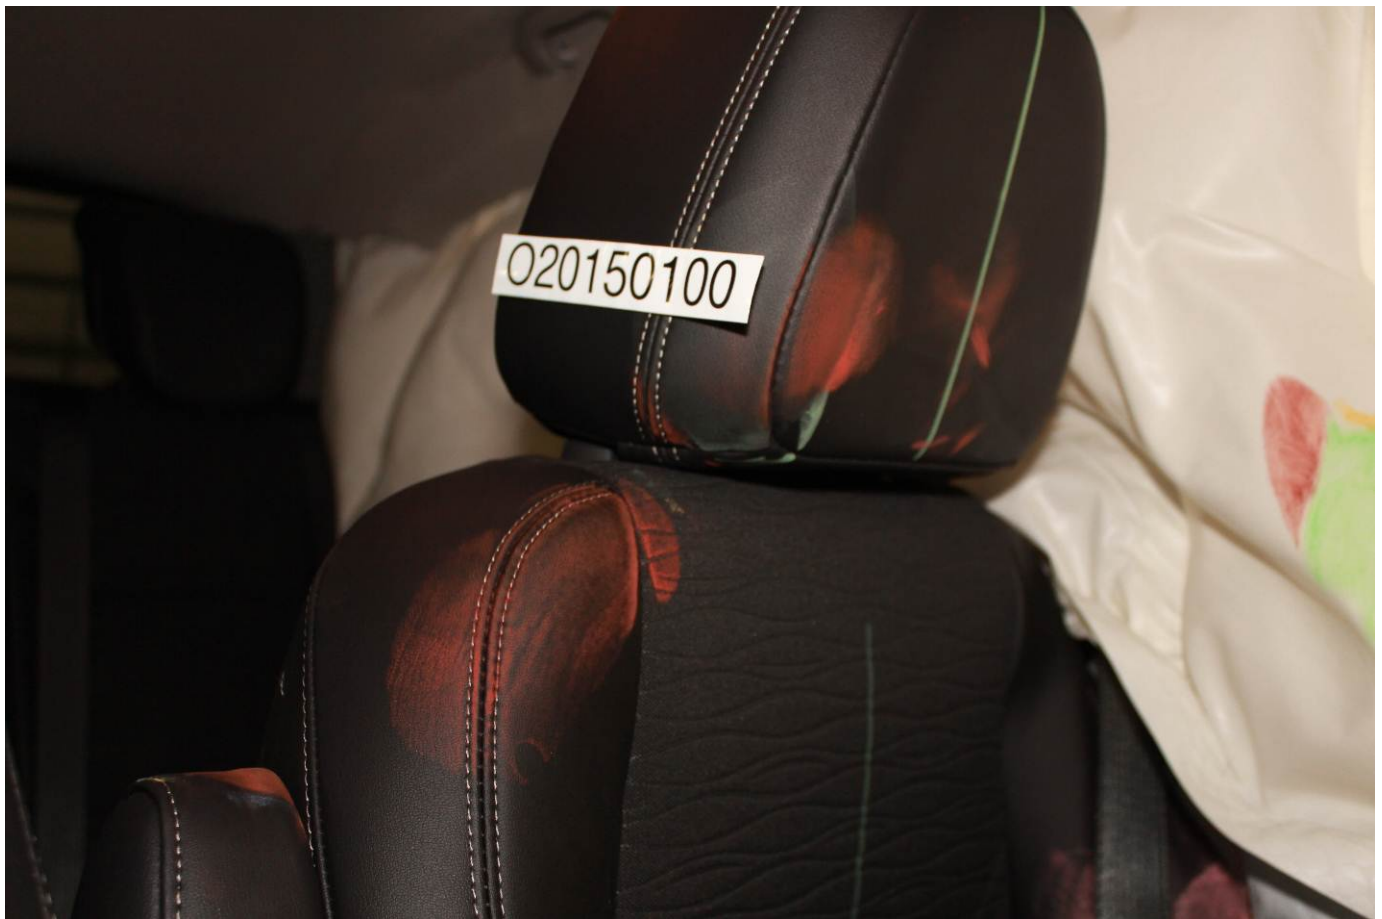
Post-Test Dummy Close-Up Head Contact with Vehicle Interior View

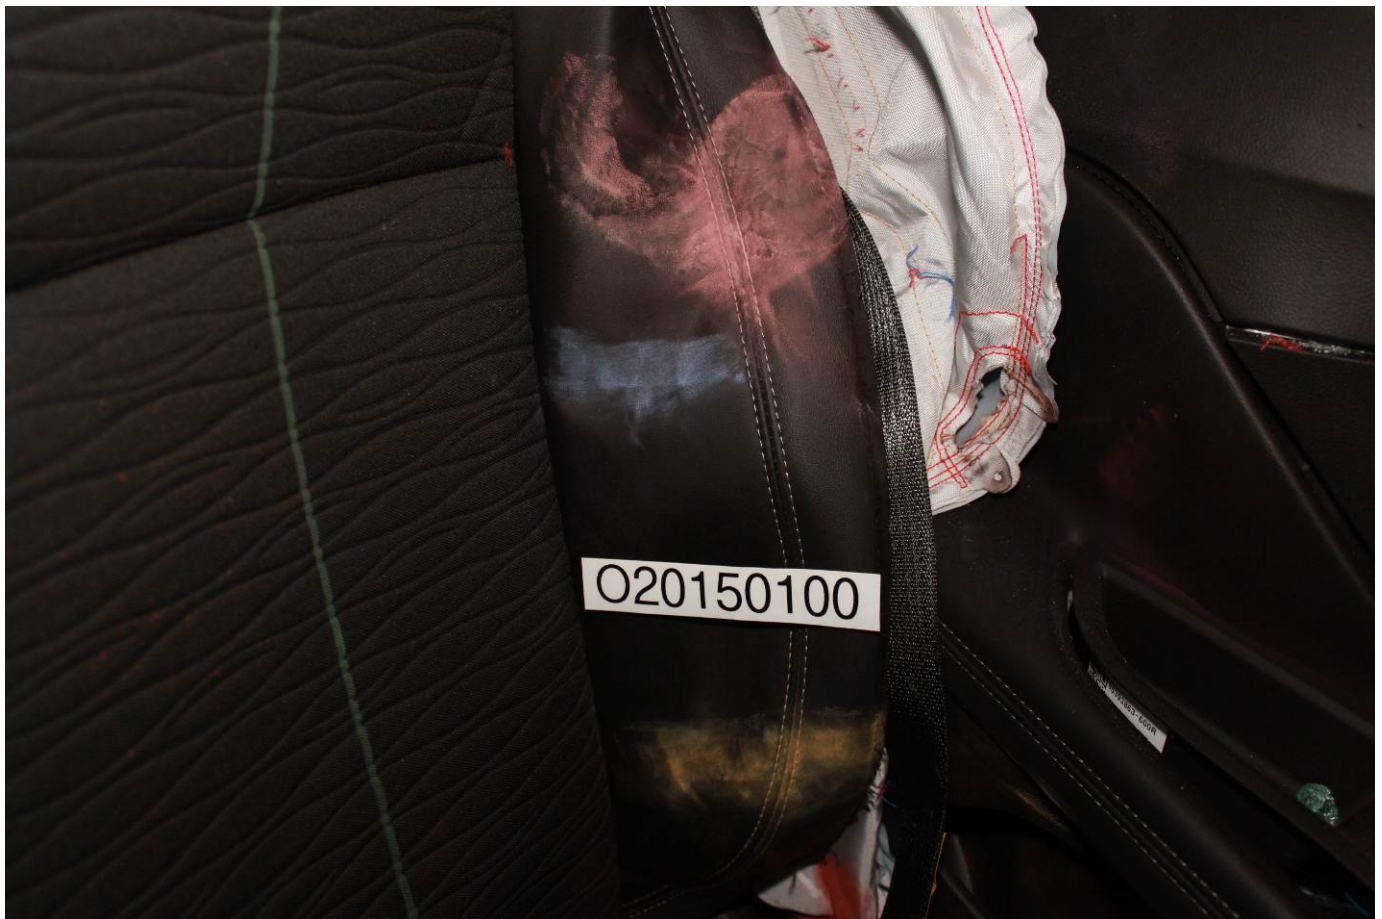
Post-Test Dummy Close-Up Torso Contact with Vehicle Interior View

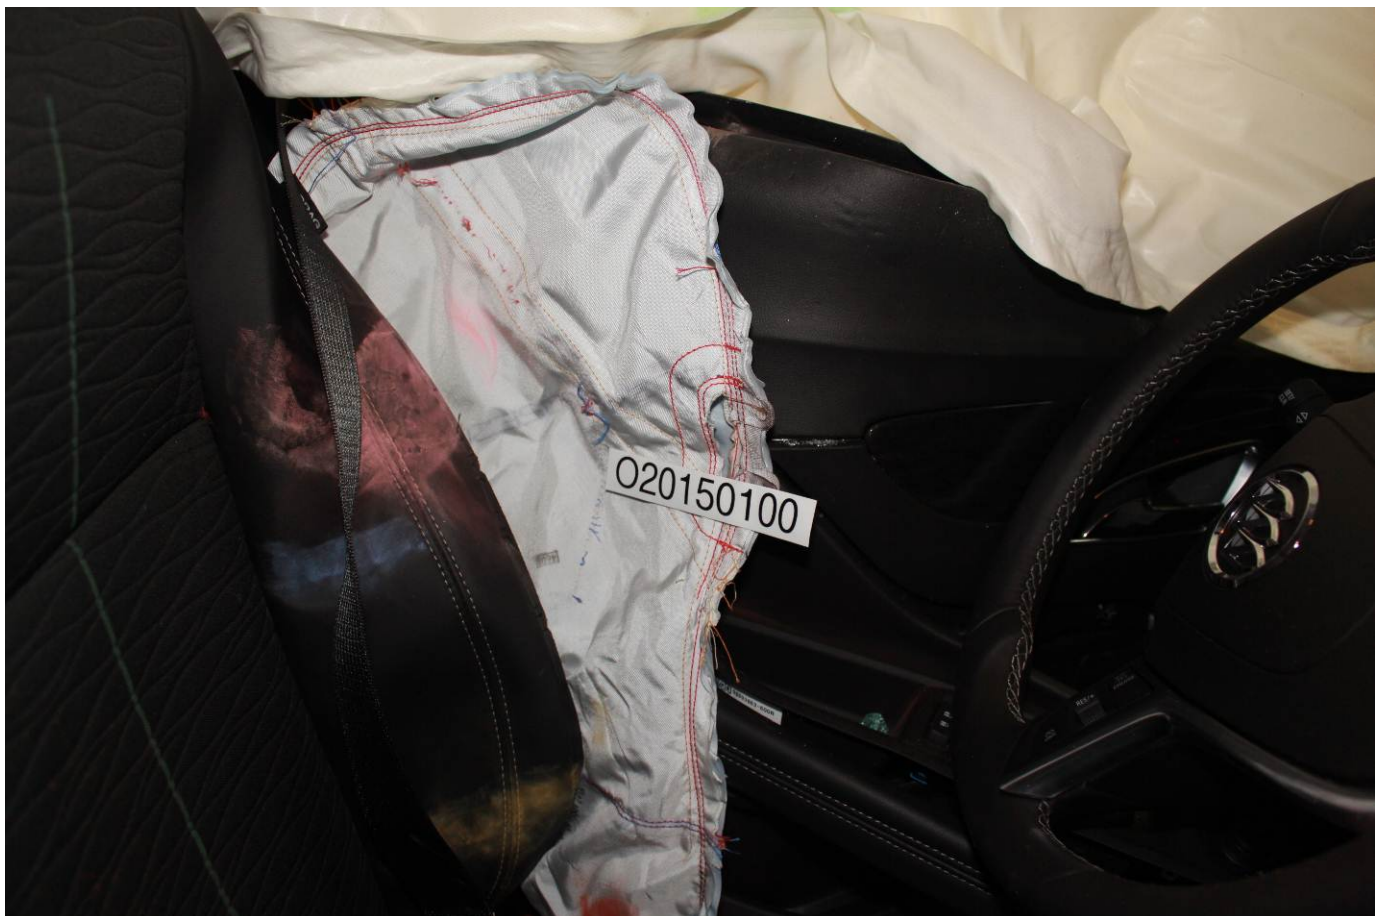
Post-Test Dummy Close-Up Torso Contact with Side Air Bag View

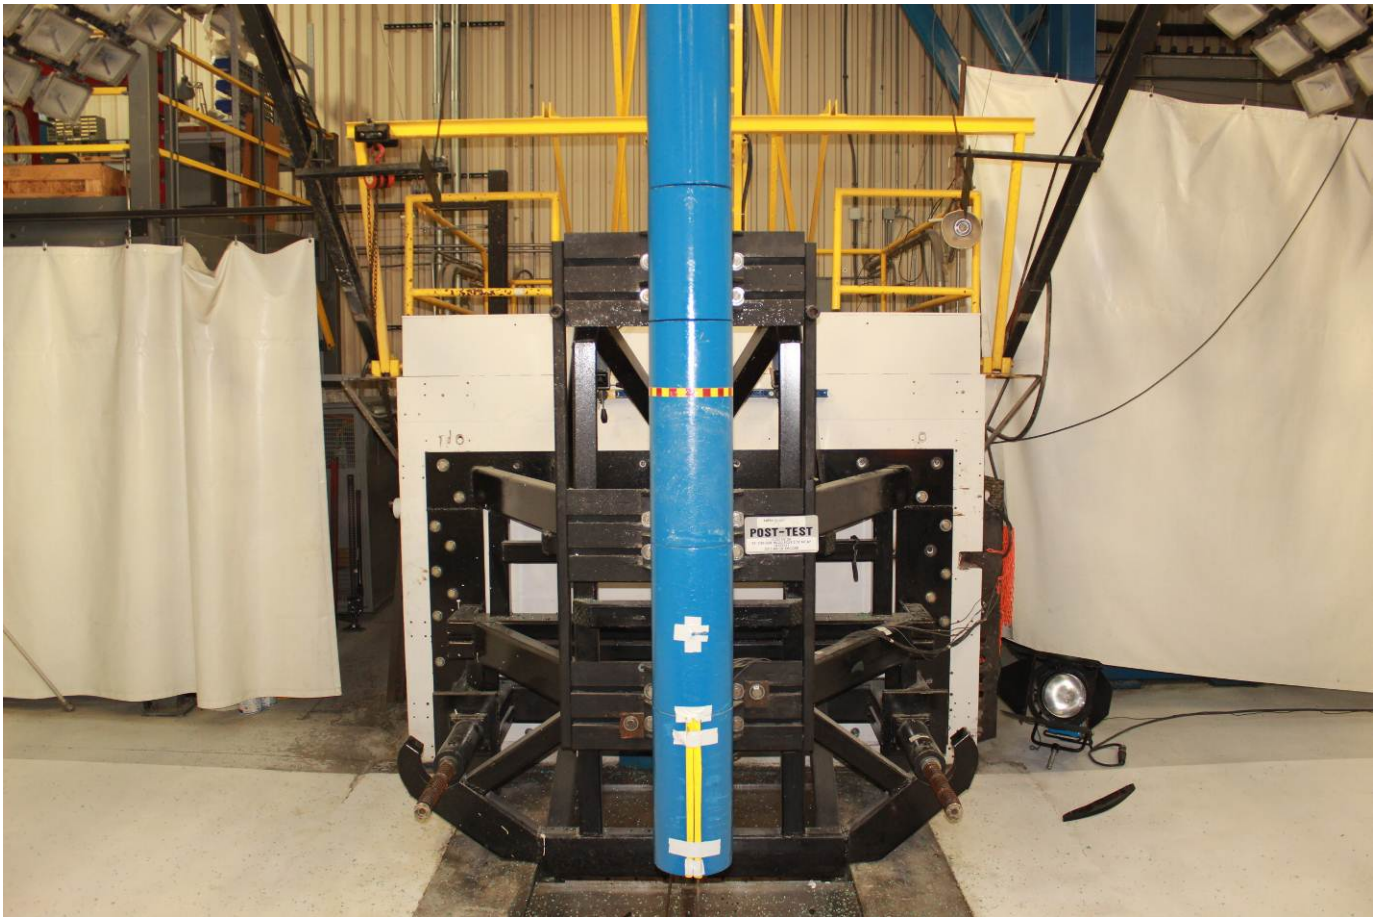
Post-Test Pole Barrier Front View

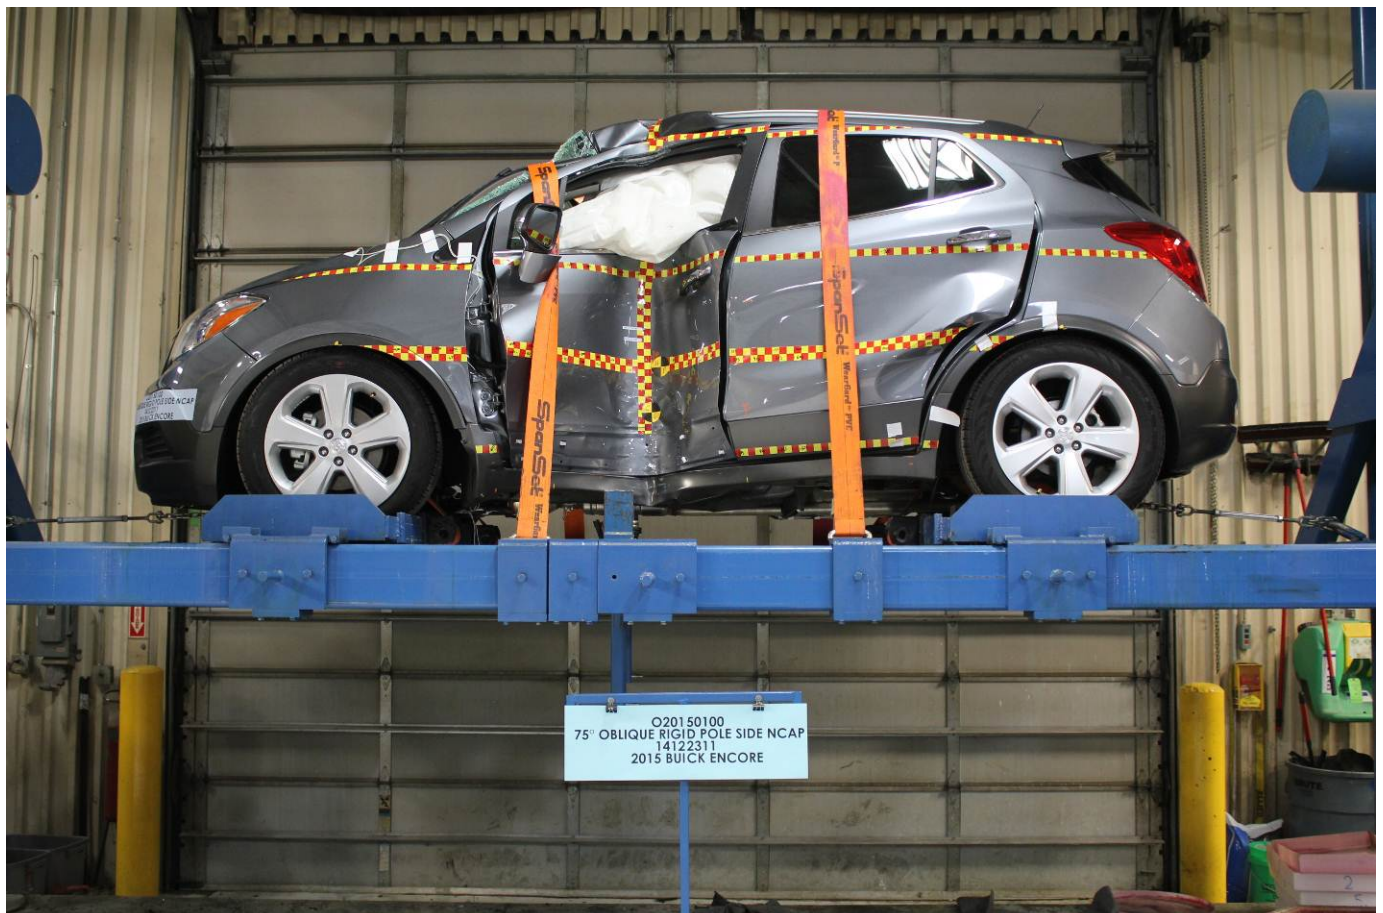
FMVSS No. 301 Static Rollover 0 Degrees

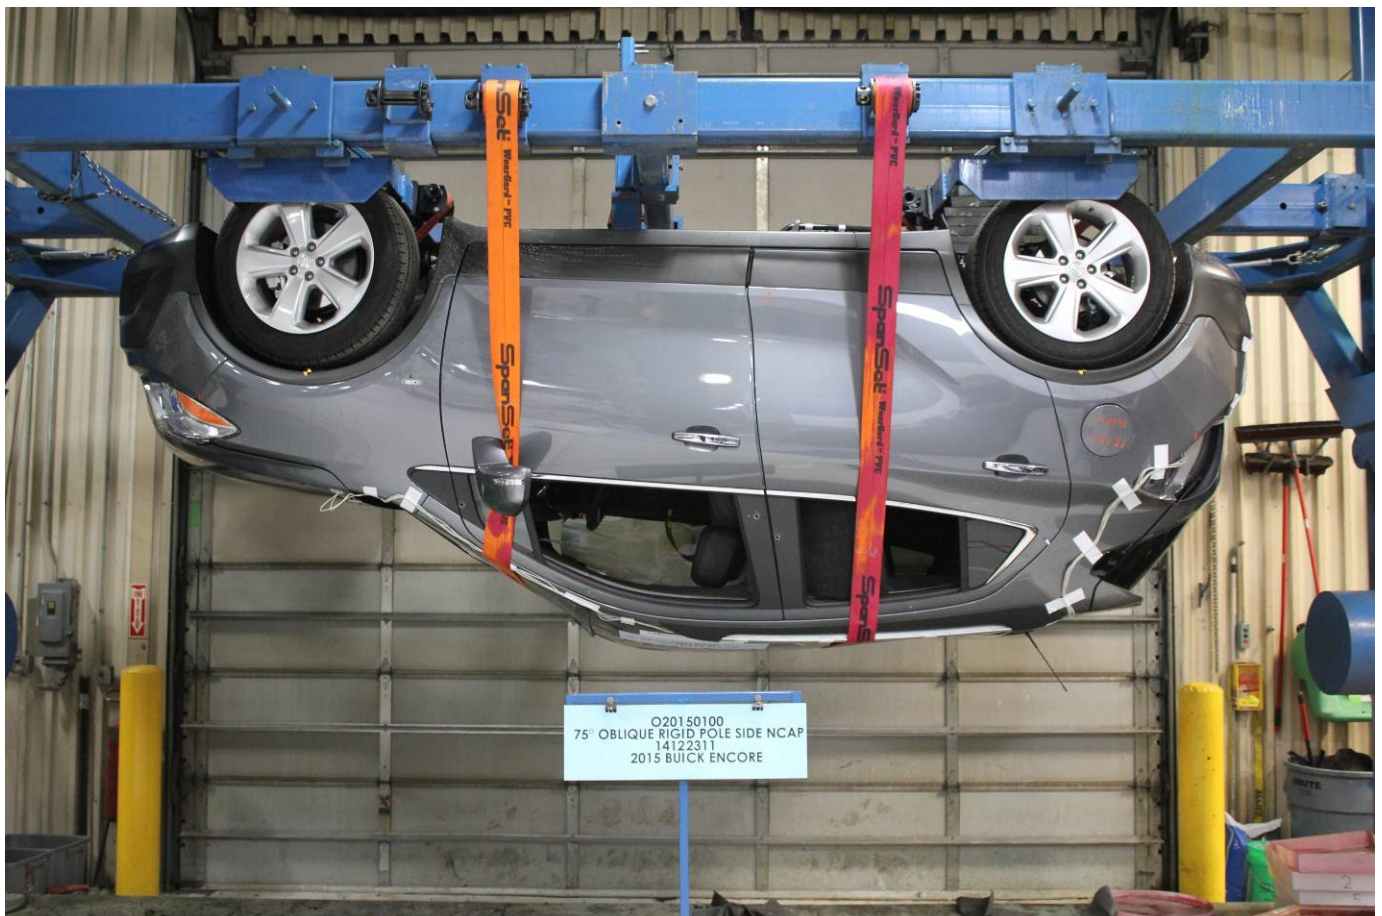
FMVSS No. 301 Static Rollover 180 Degrees

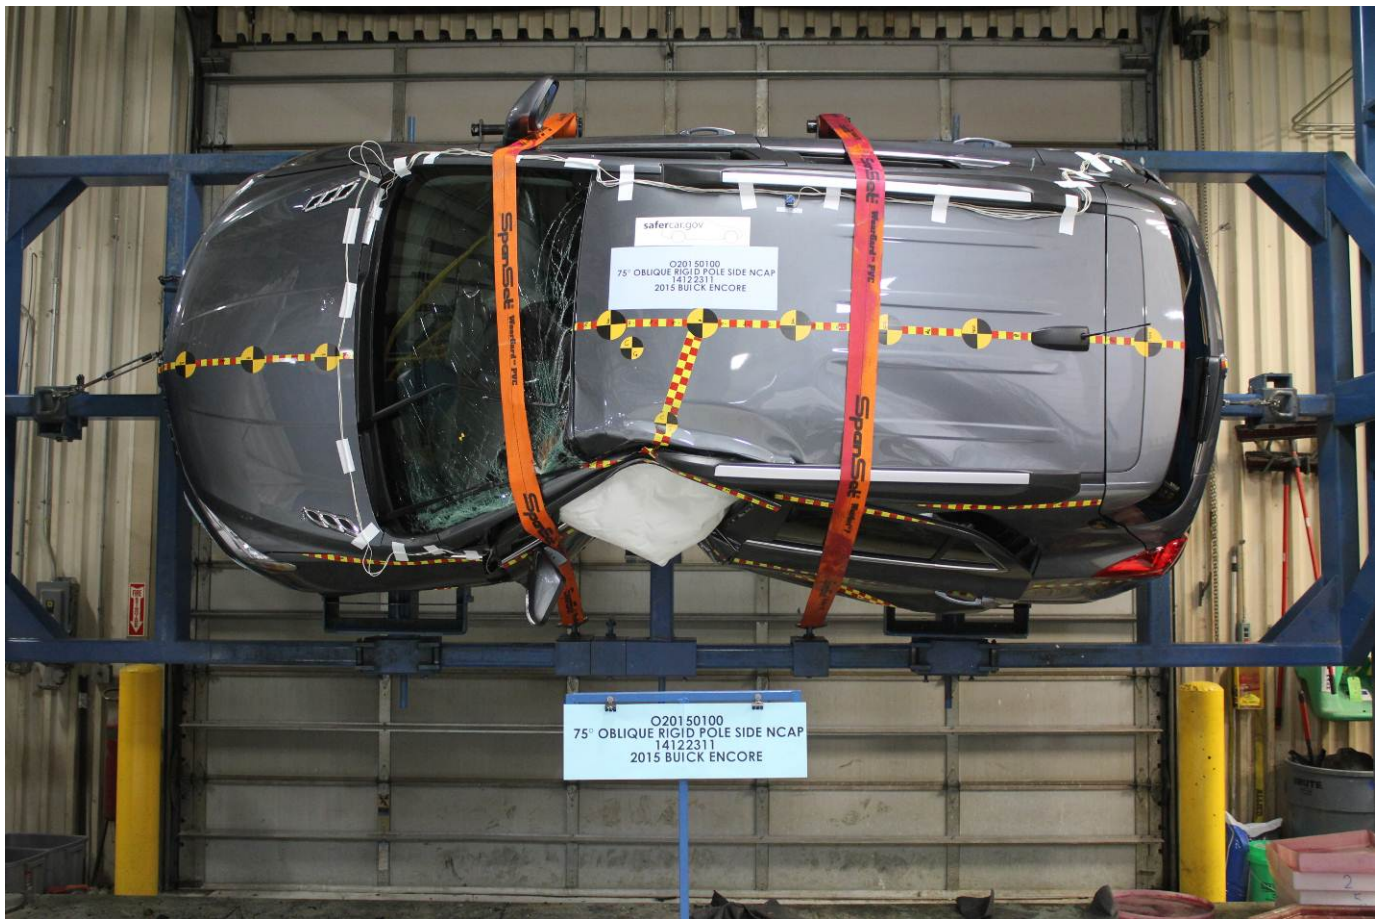
FMVSS No. 301 Static Rollover 270 Degrees

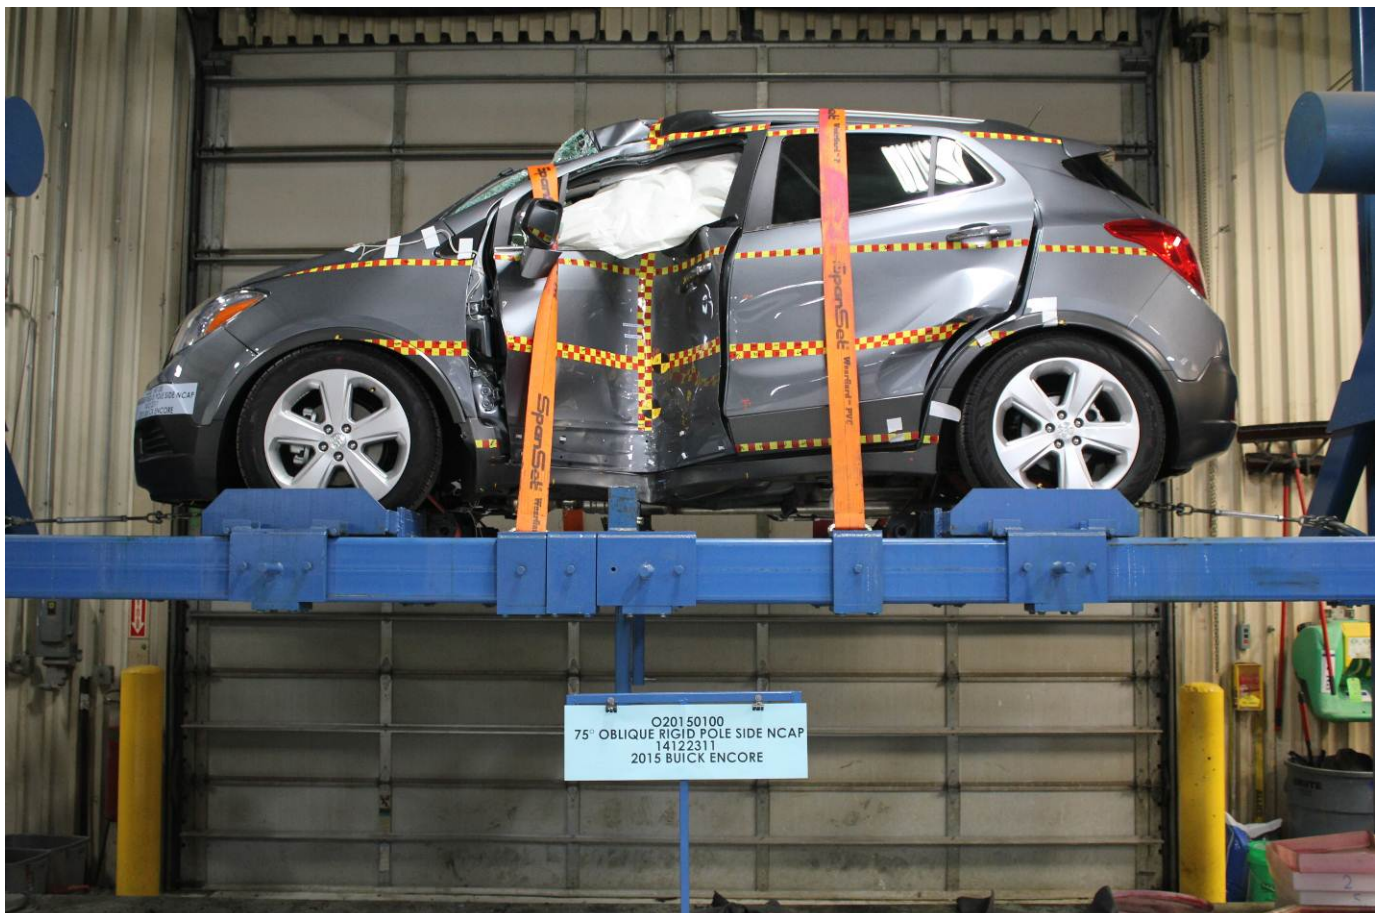
FMVSS No. 301 Static Rollover 360 Degrees
