**REPORT NUMBER: SINCAP-MGA-2015-045**

**NEW CAR ASSESSMENT PROGRAM (NCAP)  
Moving Deformable Barrier Side Impact Test**

**GM KOREA COMPANY  
2015 Buick Encore SUV  
NHTSA No.: O20150101**

**MGA RESEARCH CORPORATION  
5000 Warren Road  
Burlington, WI 53105**

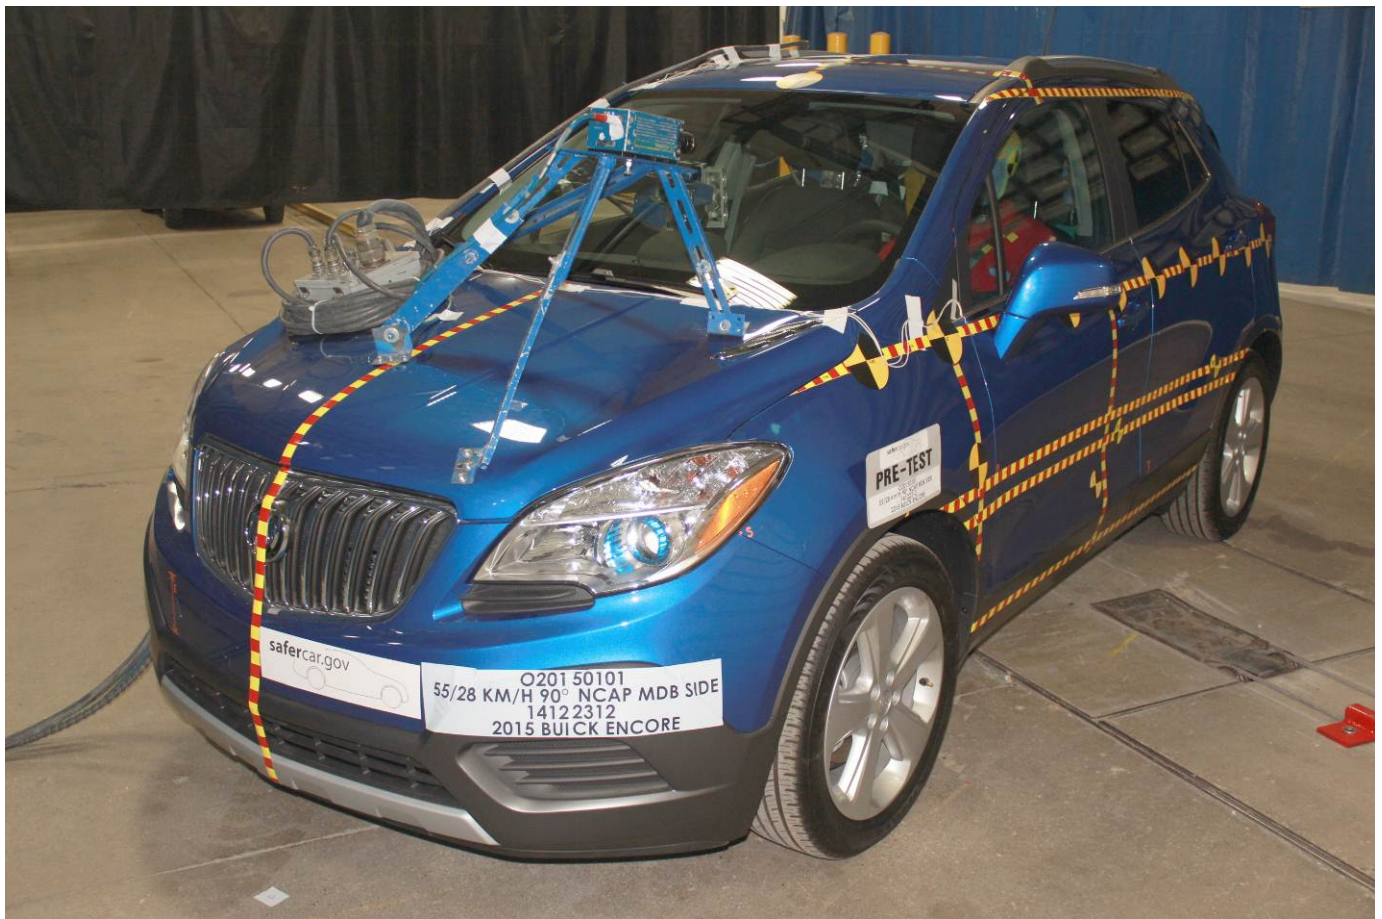
Post-Test Frontal View of Test Vehicle

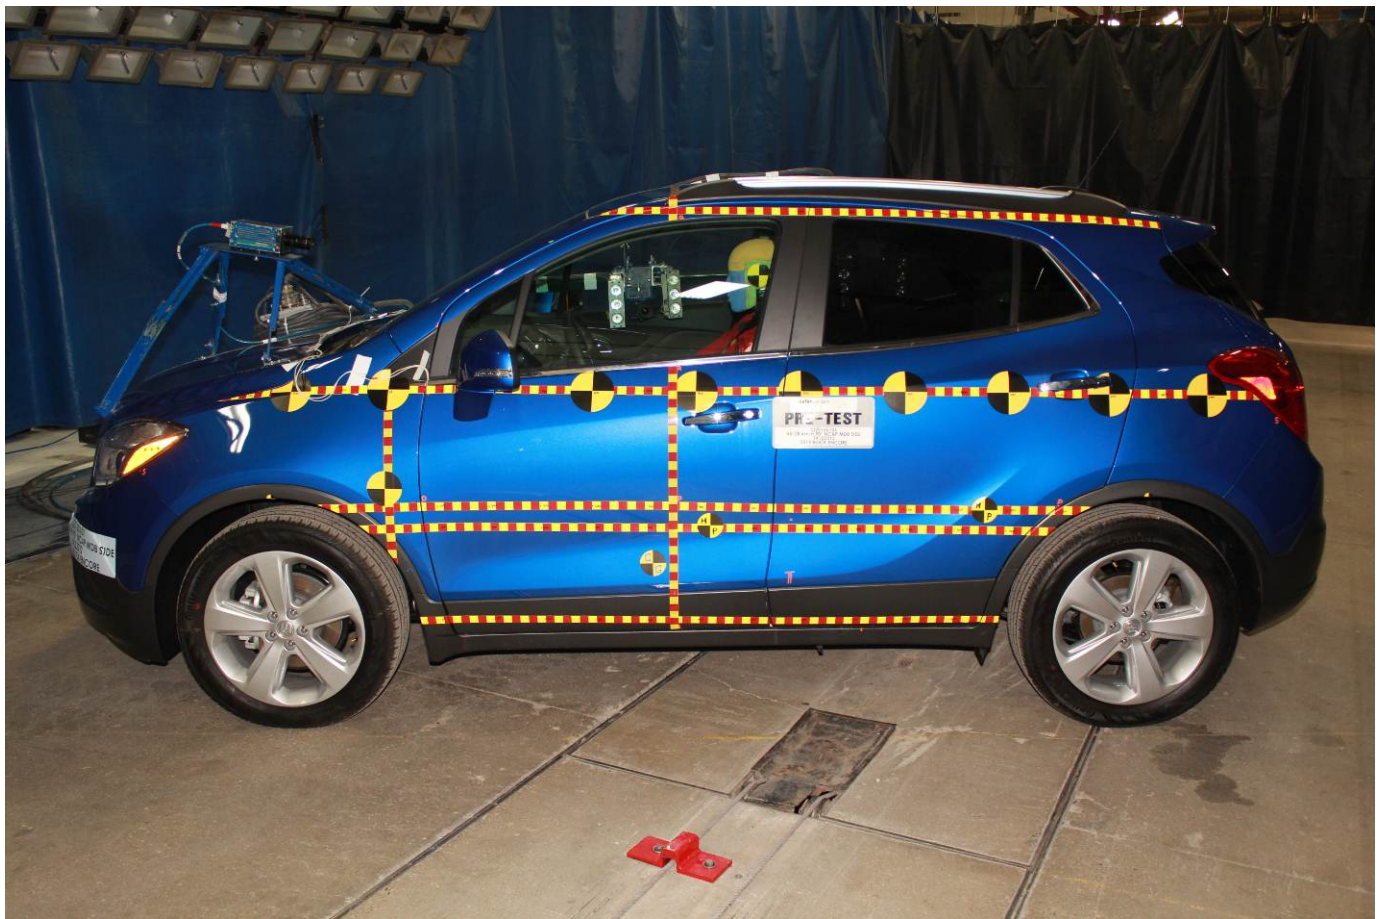
Post-Test Left Front Three-Quarter View of Test Vehicle

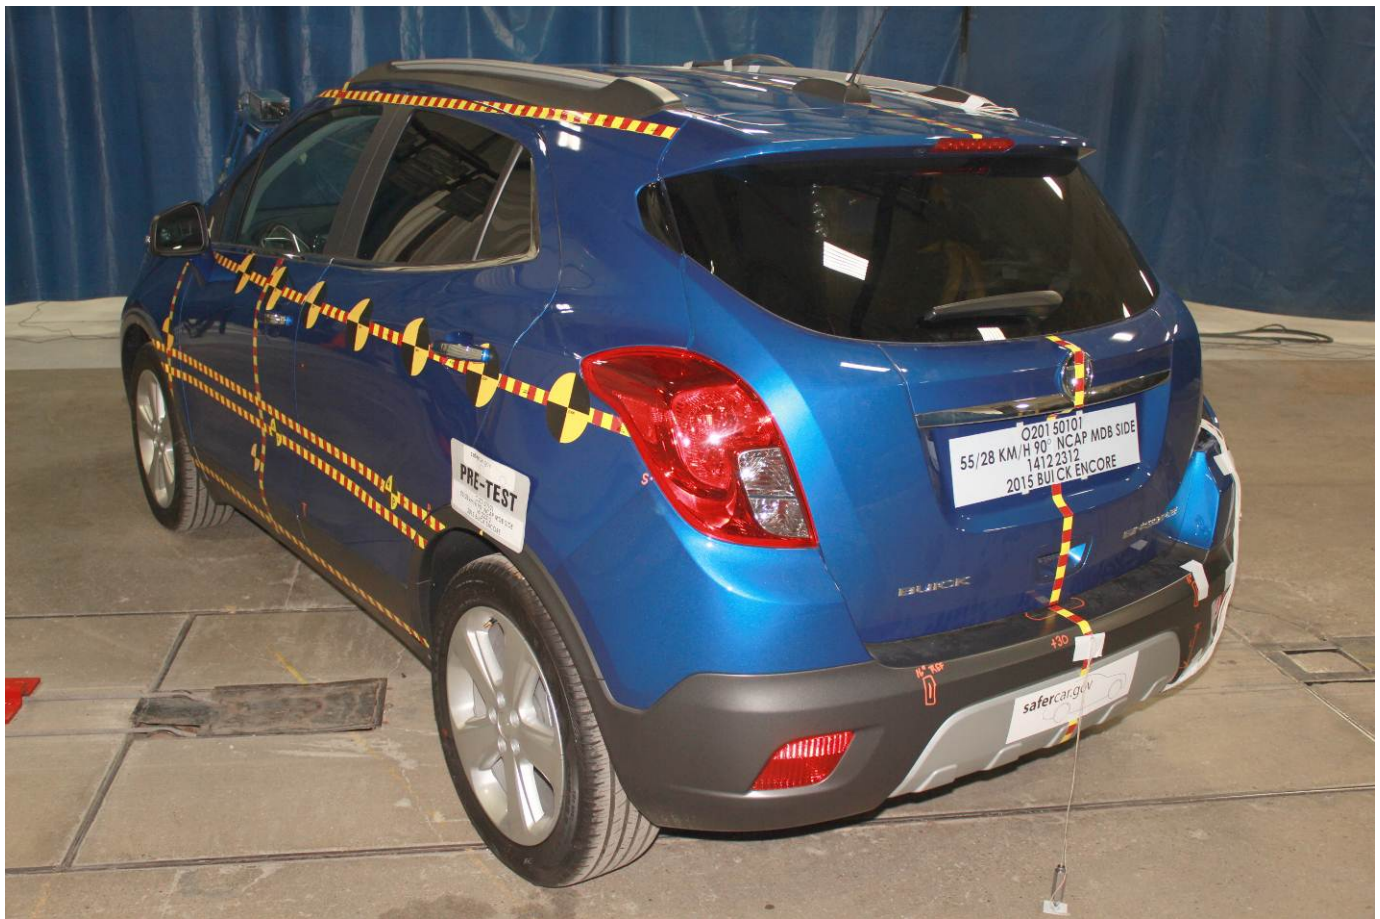
Post-Test Left Side View of Test Vehicle

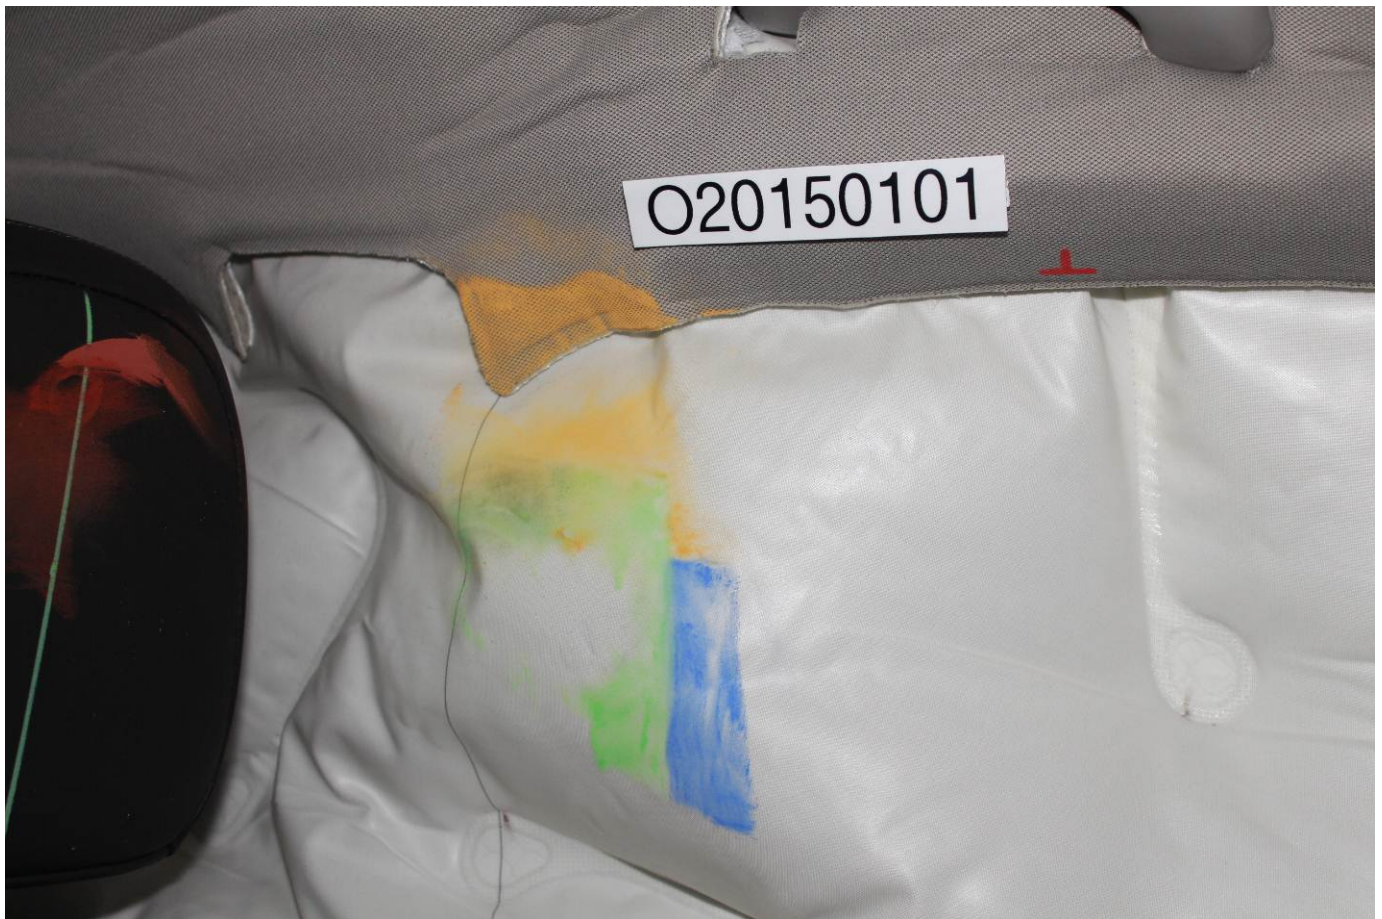
Post-Test Driver Dummy Close-up Head Contact with Vehicle Interior View

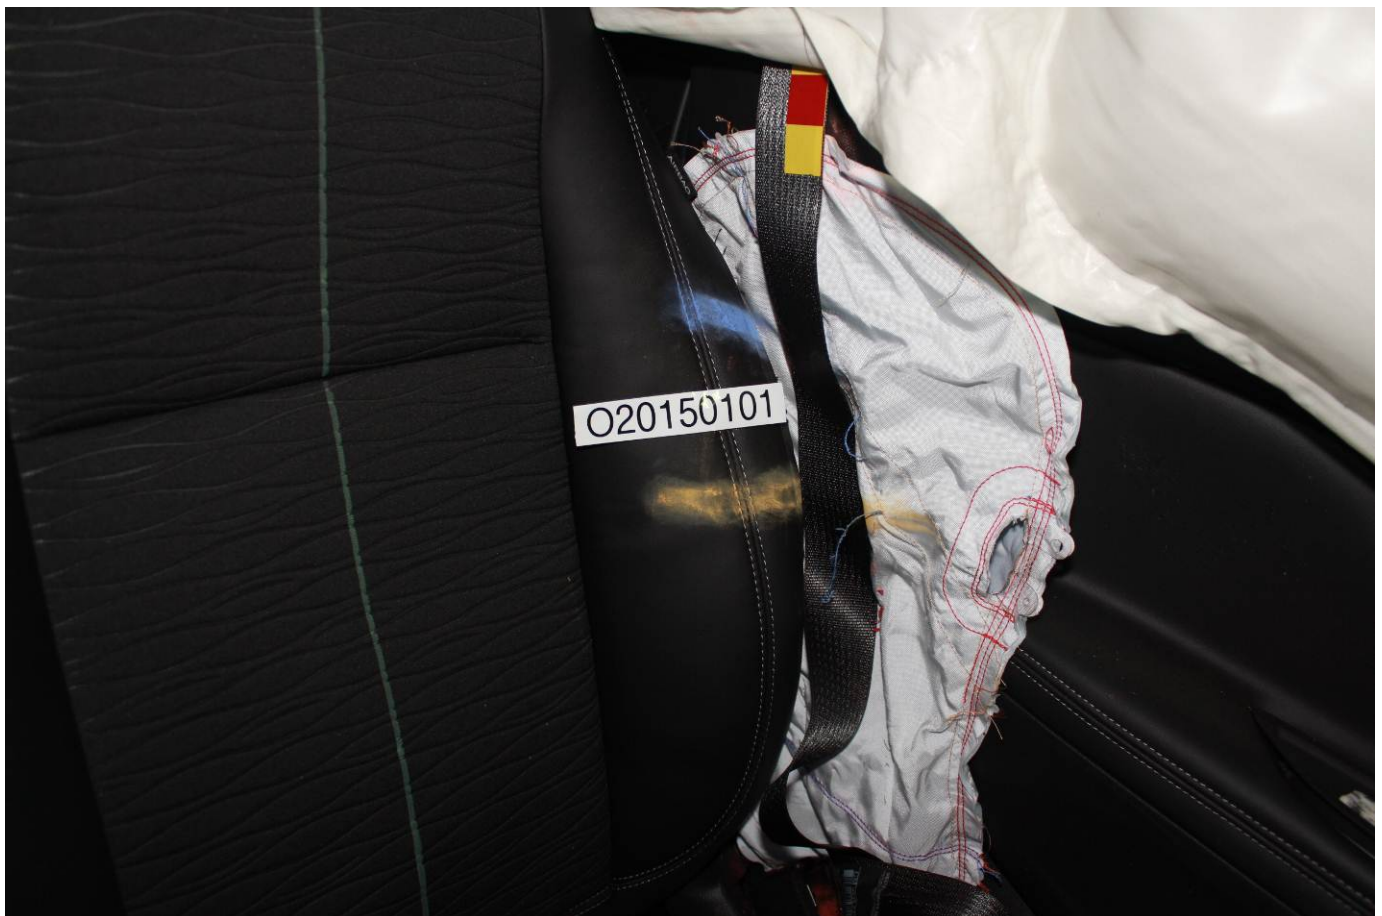
Post-Test Driver Dummy Close-up Head Contact with Side Airbag View

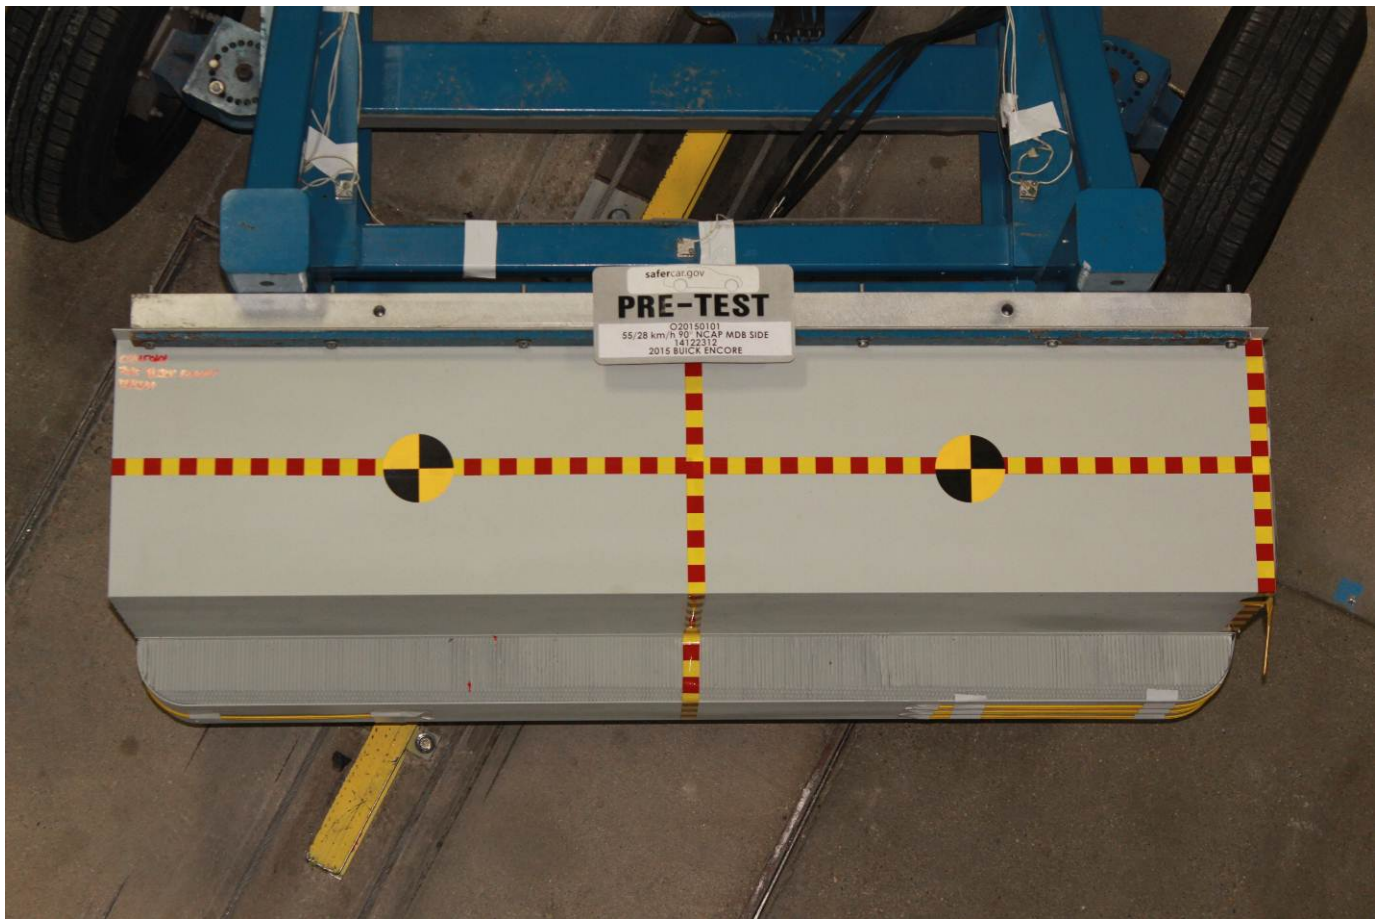
Post-Test Front View of MDB Impactor Face

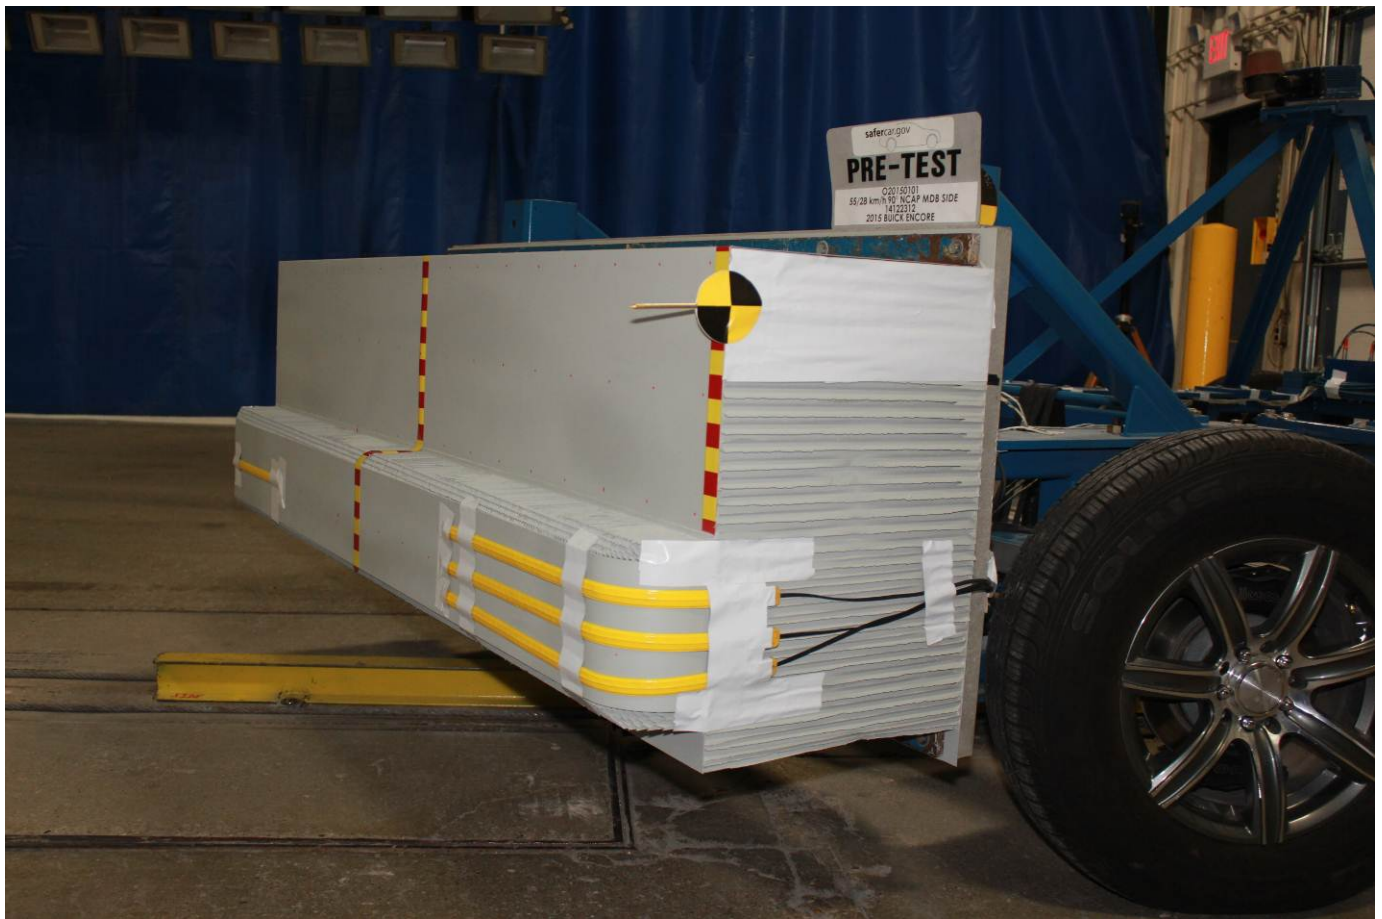
Post-Test Top View of MDB Impactor Face
