**REPORT NUMBER: SPNCAP-KAR-15-025**

**NEW CAR ASSESSMENT PROGRAM (NCAP)  
SIDE IMPACT POLE TEST**

**BAYERISCHE MOTOREN WERKE AG  
2015 MINI COOPER HARDTOP 3-DOOR HATCHBACK**

**NHTSA No: M20154107**

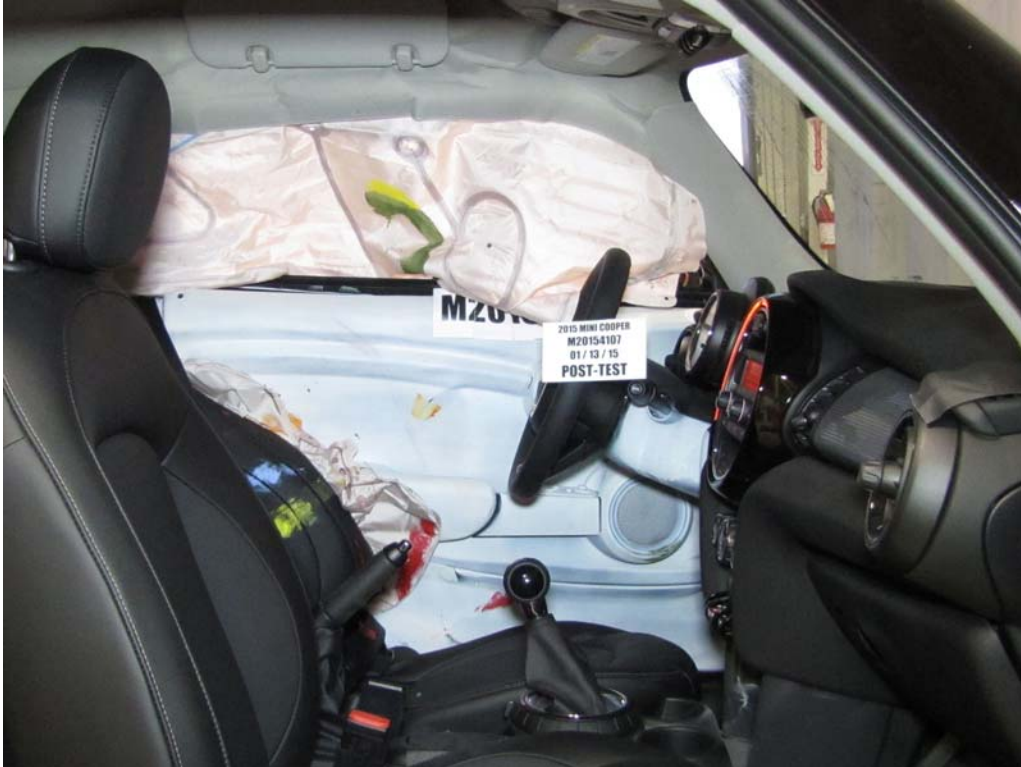
FIGURE 45. Post-Test Inner Door Panel View  
Showing Dummy Contact Locations

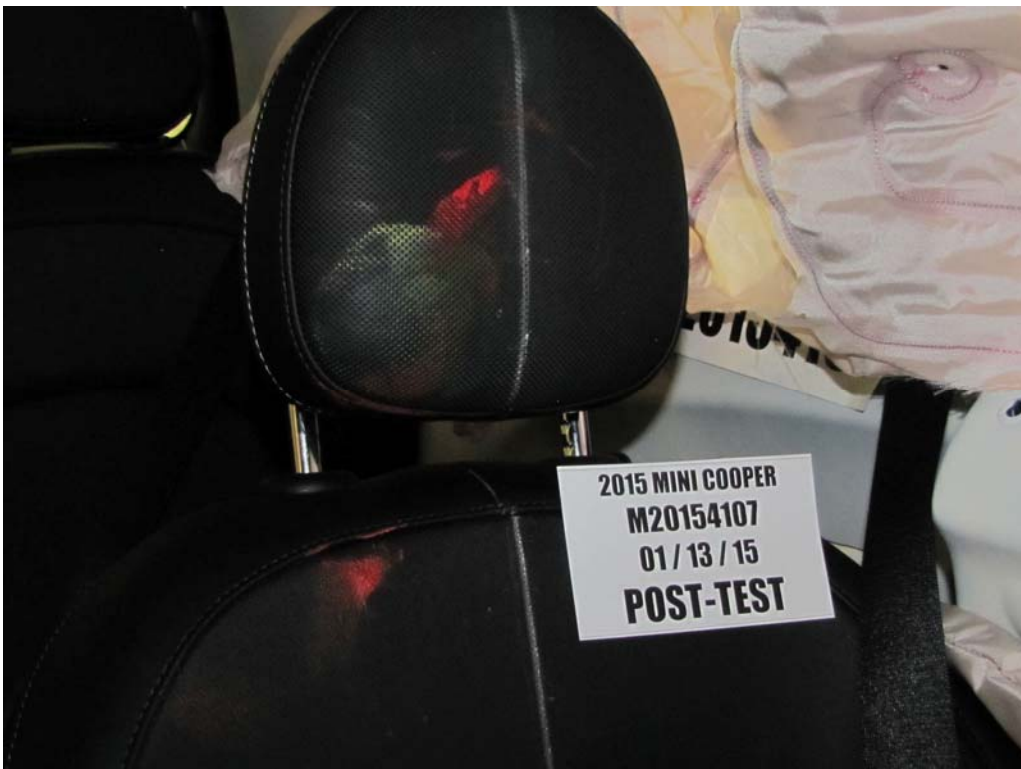
FIGURE 46. Post-Test Dummy Close-Up Head Contact with Vehicle Interior View

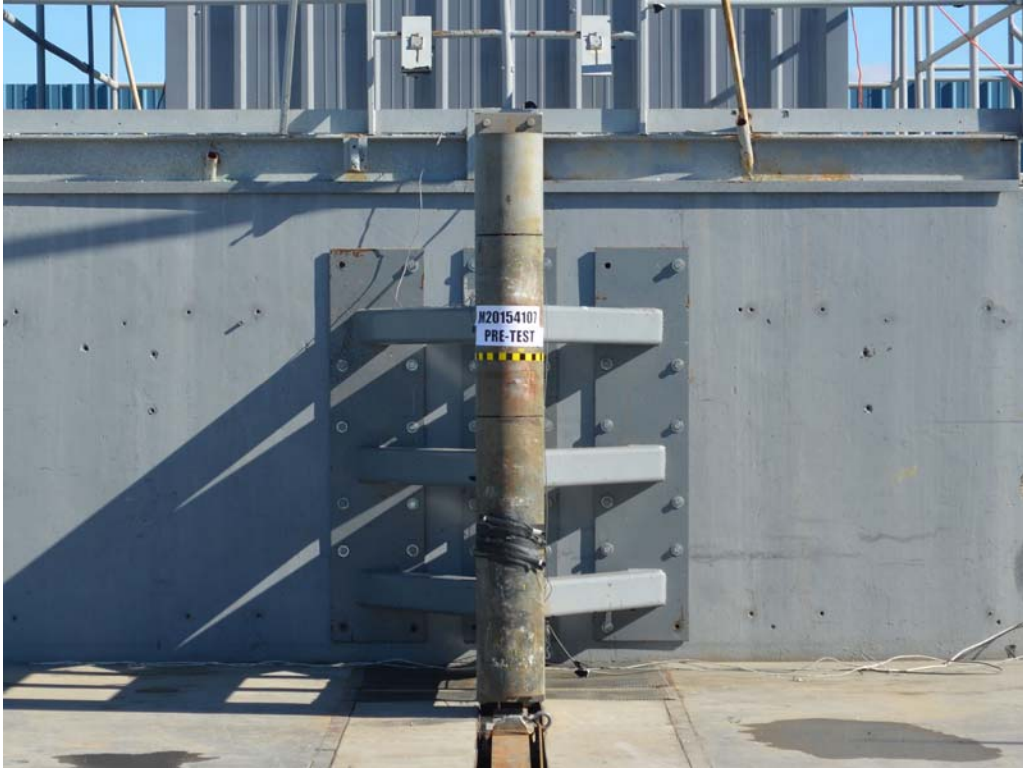
FIGURE 57. Pre-Test Pole Barrier Front View

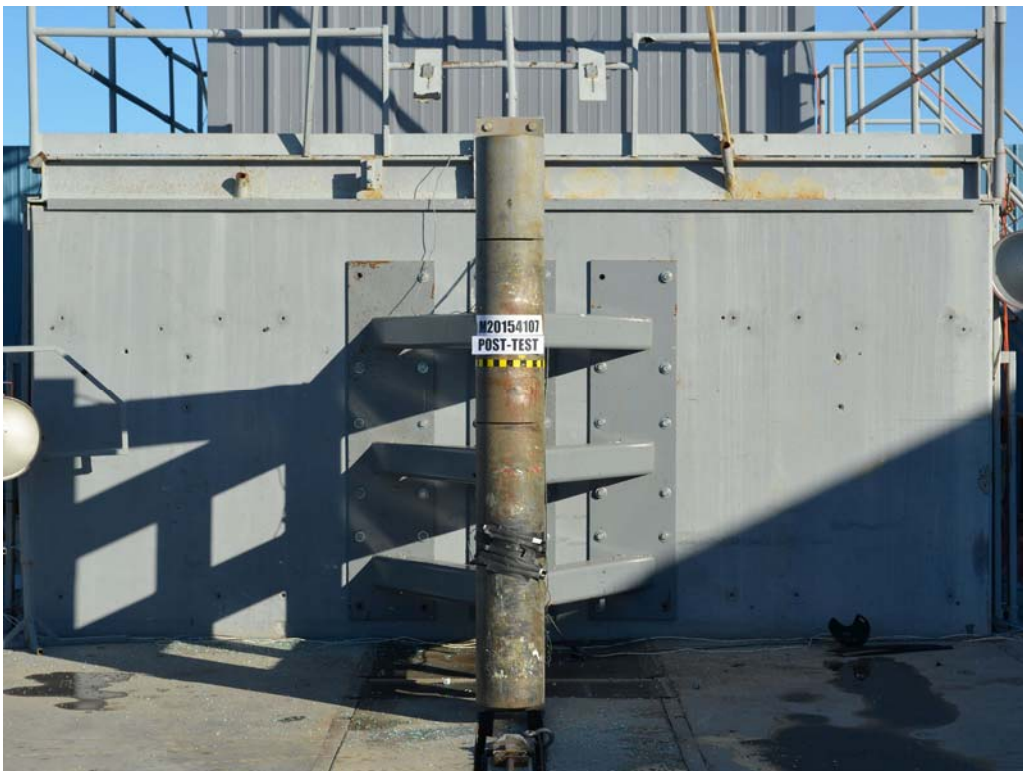
FIGURE 58. Post-Test Pole Barrier Front View
