**REPORT NUMBER: SINCAP-MGA-2015-046**

**NEW CAR ASSESSMENT PROGRAM (NCAP)  
Moving Deformable Barrier Side Impact Test**

**FORD MOTOR COMPANY  
2015 Lincoln MKC SUV  
NHTSA No.: O20150200**

**FINAL REPORT**

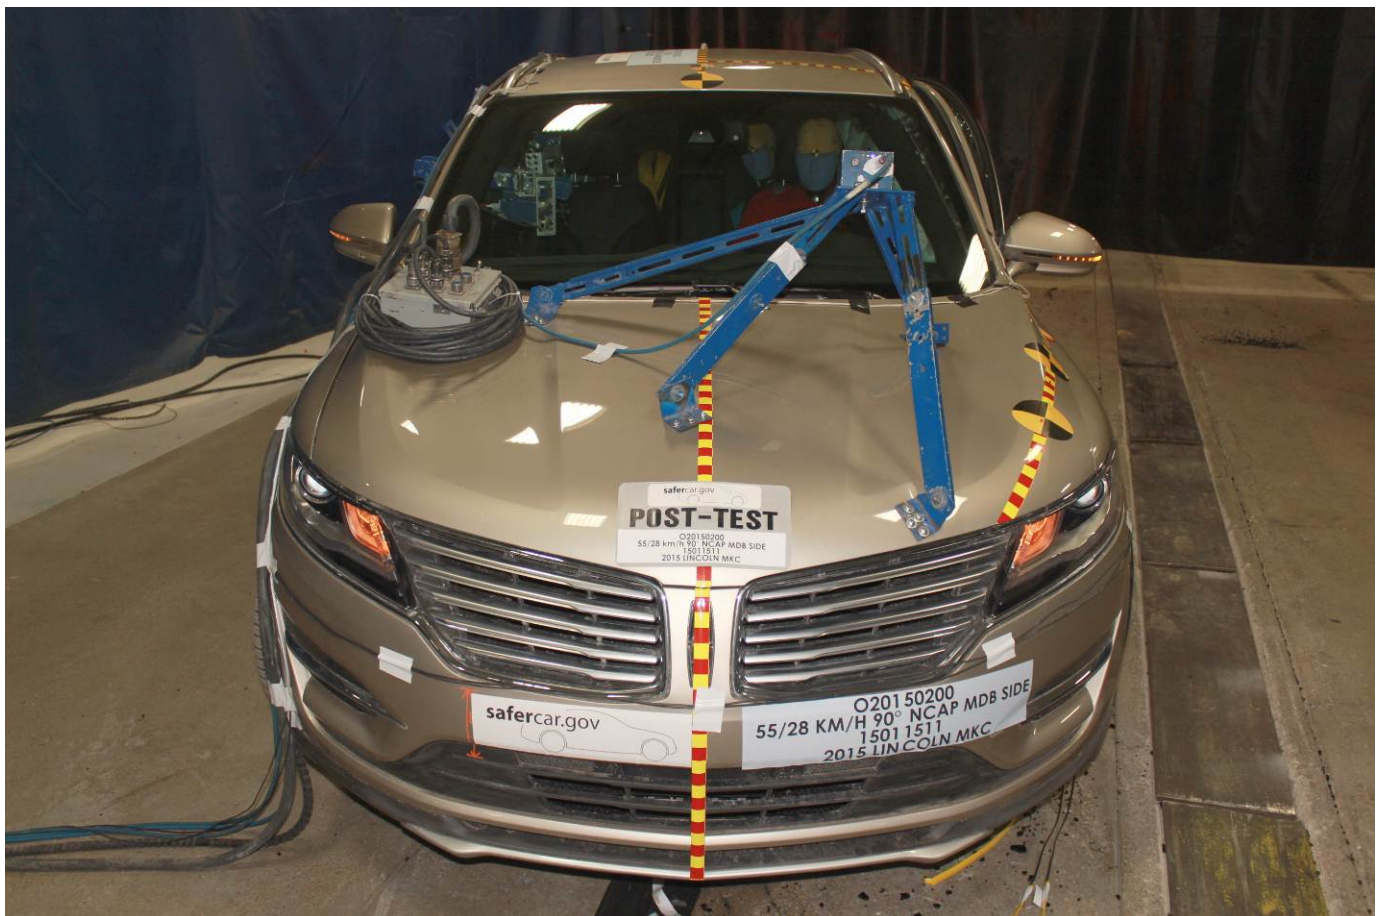
Post-Test Frontal View of Test Vehicle

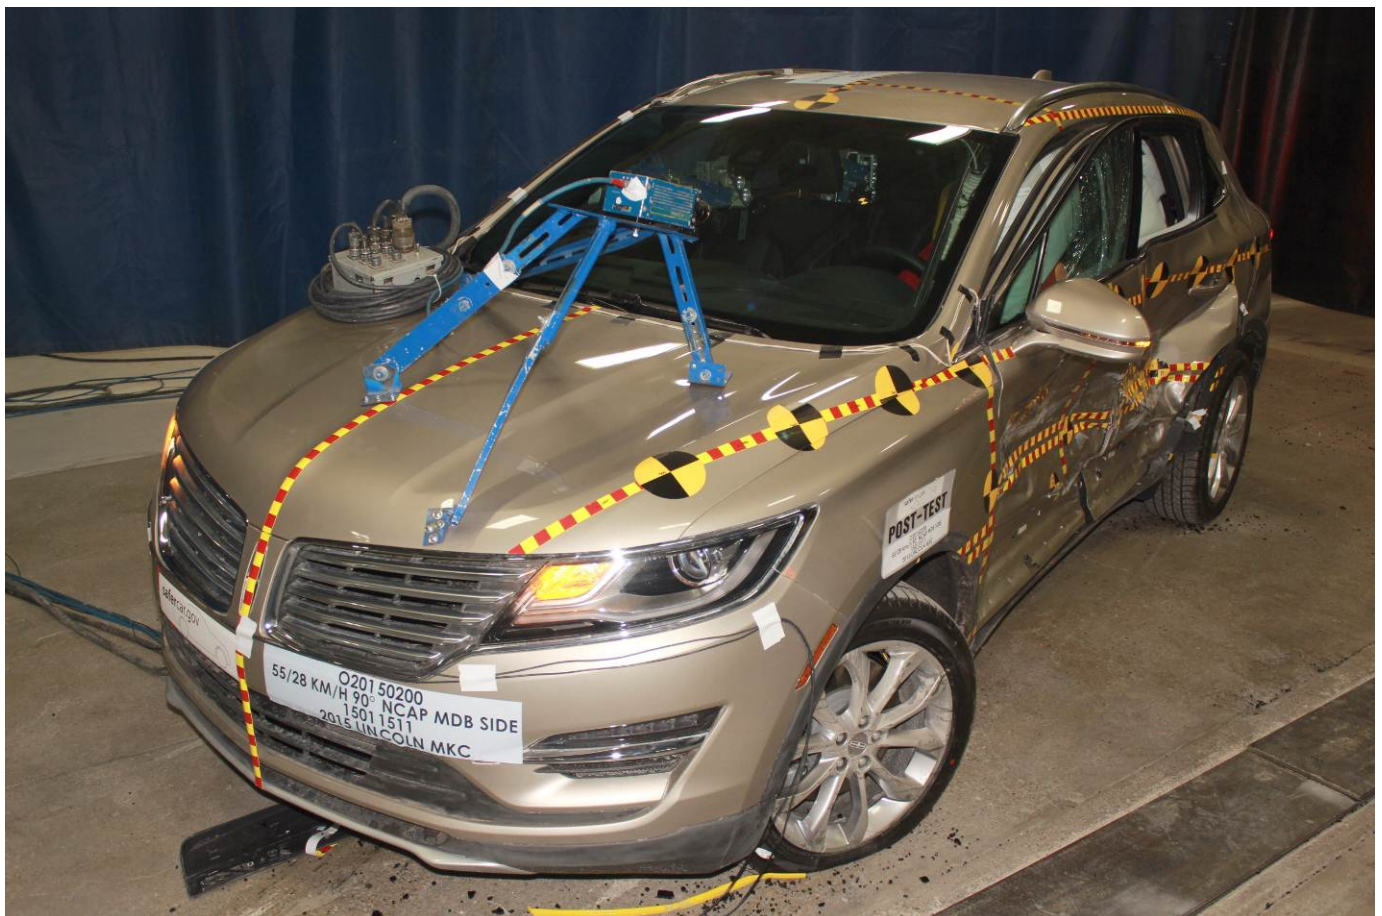
Post-Test Left Front Three-Quarter View of Test Vehicle

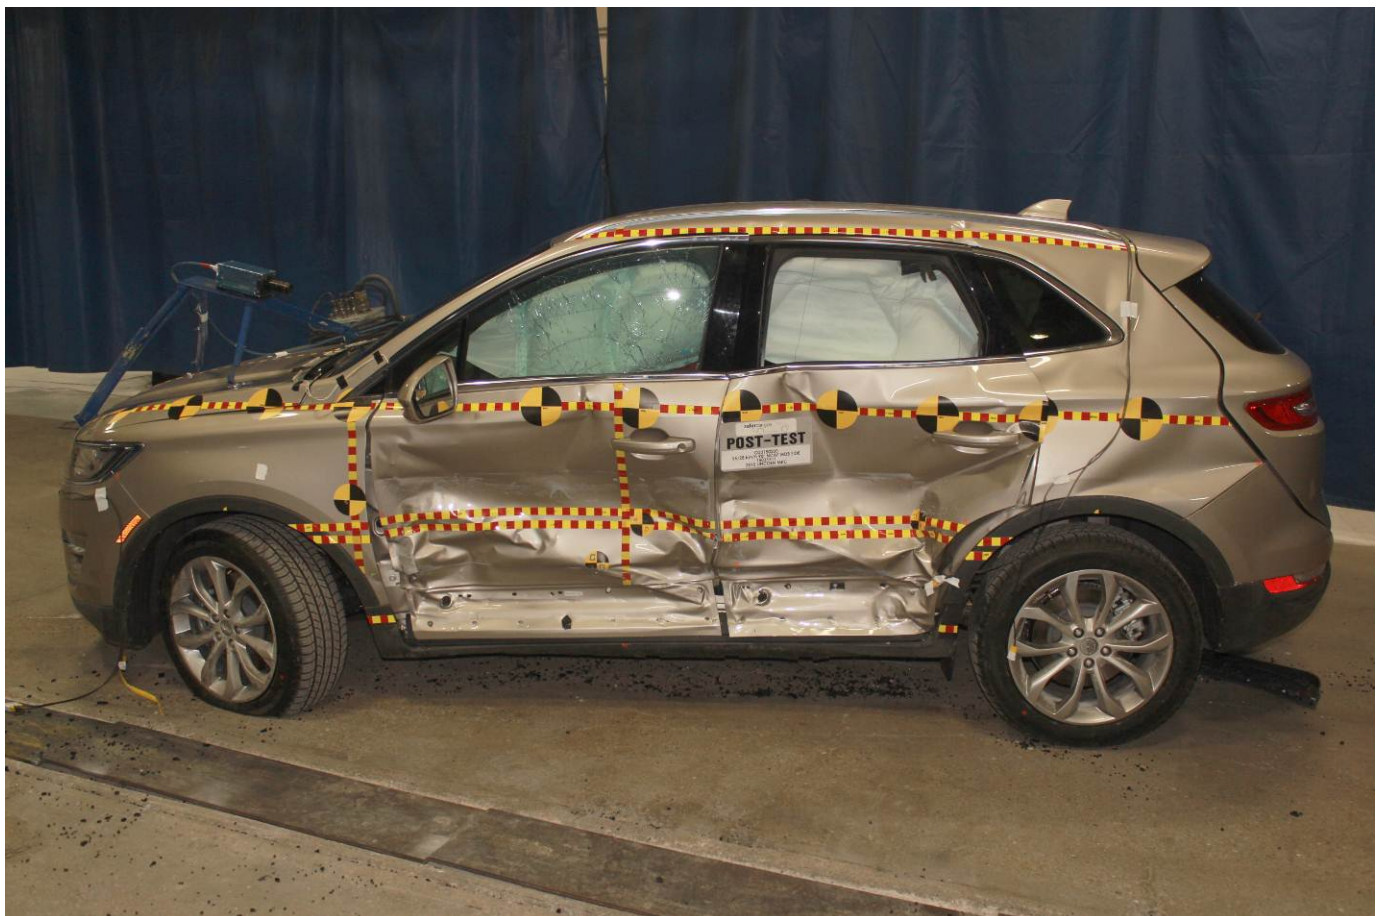
Post-Test Left Side View of Test Vehicle

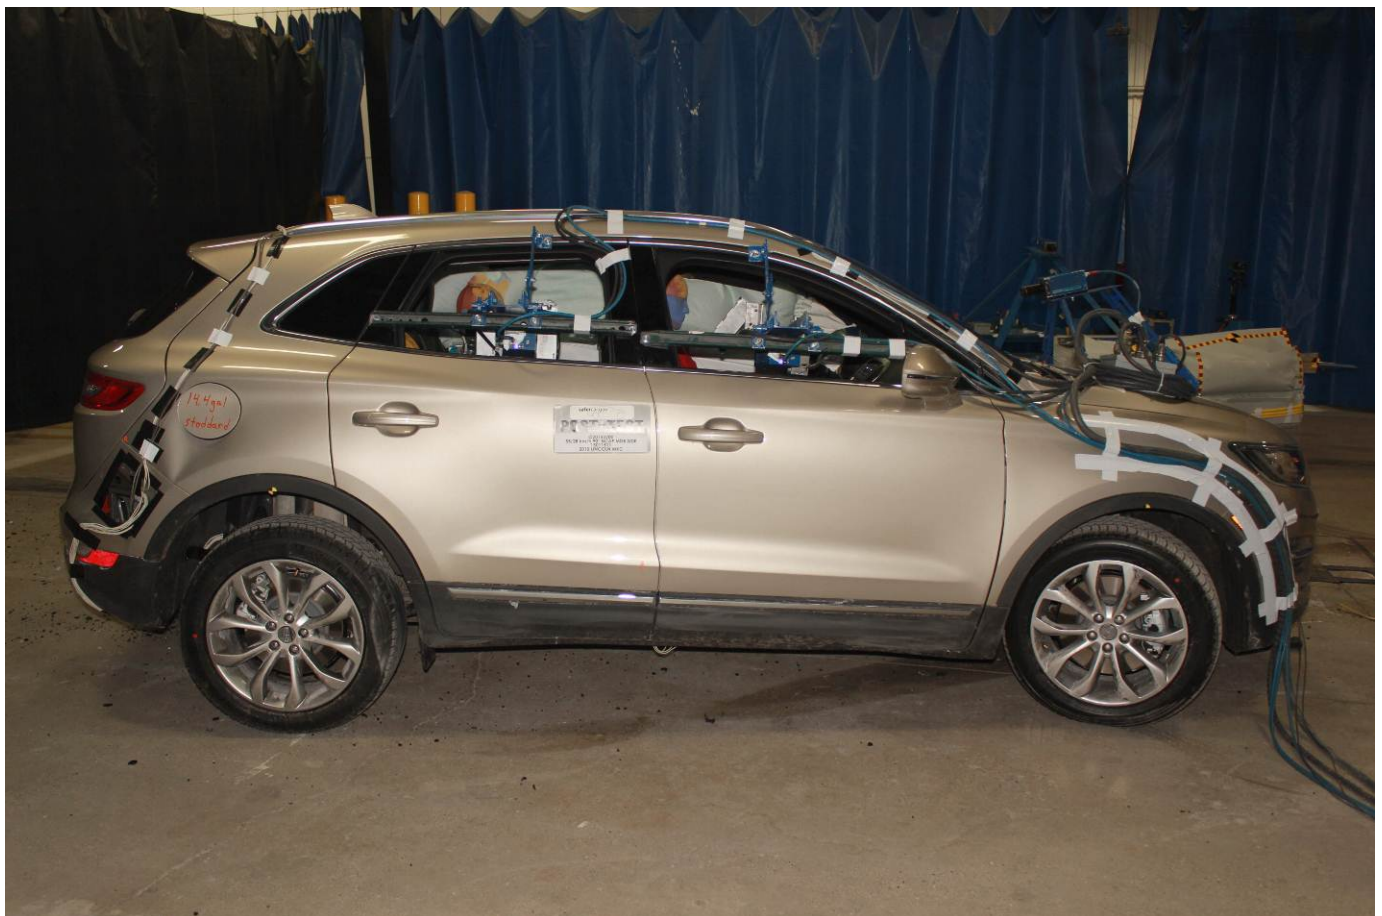
Post-Test Right Side View of Test Vehicle

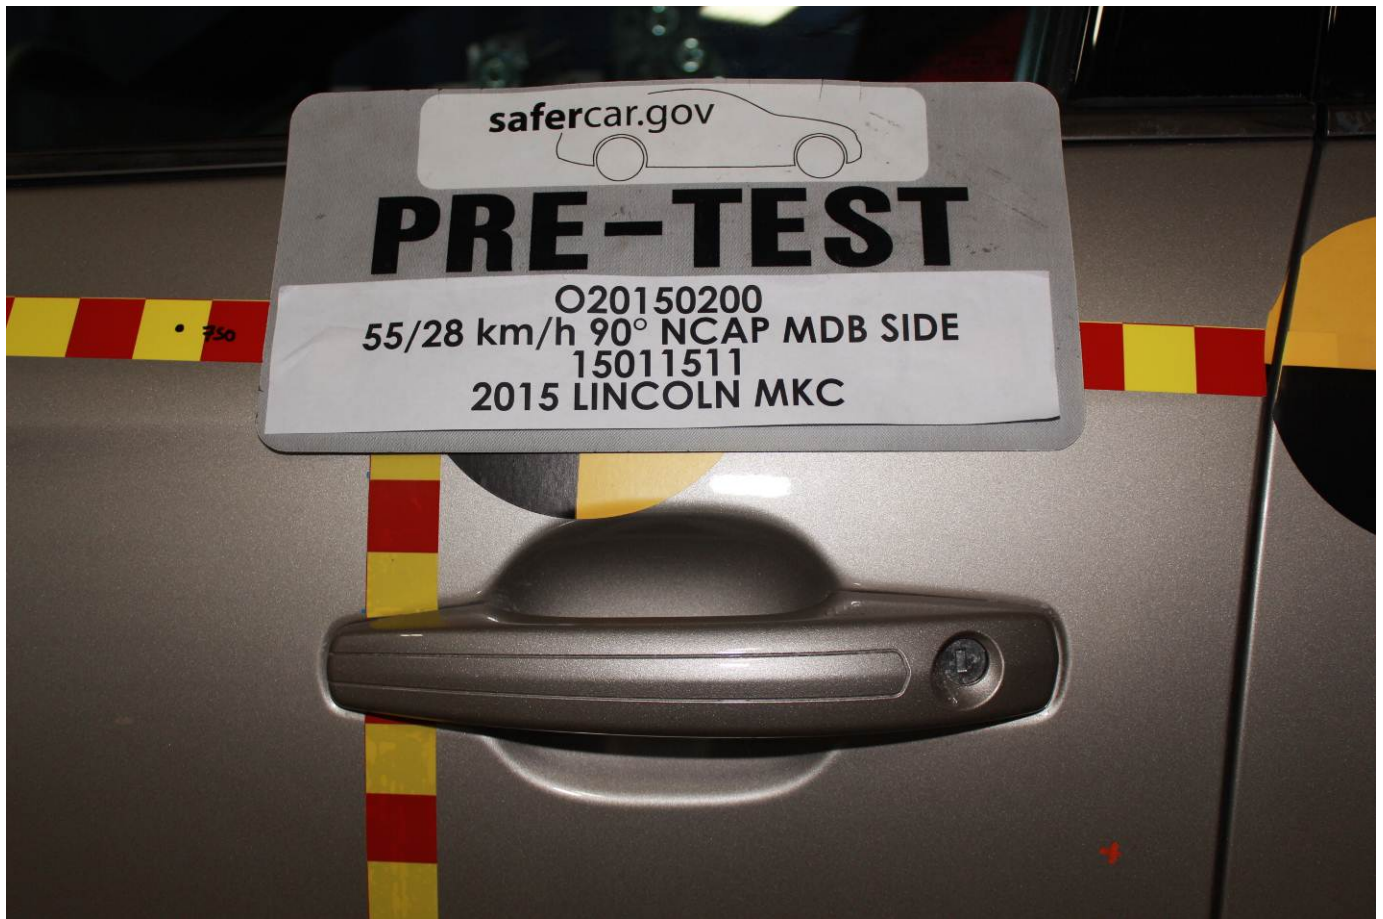
Pre-Test Left Front Door Latch Close-Up

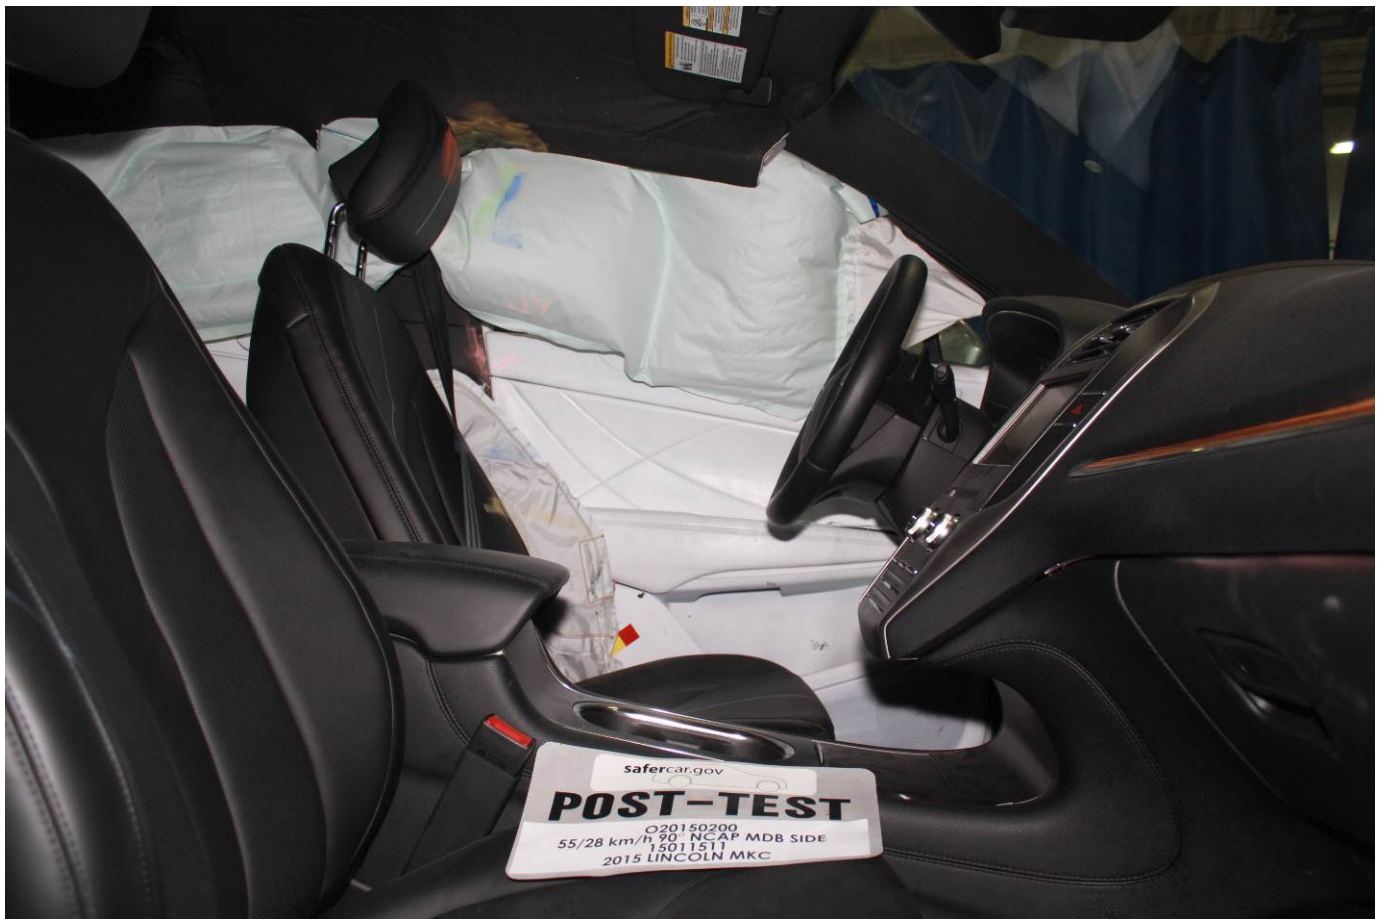
Post-Test Driver Inner Door Panel View

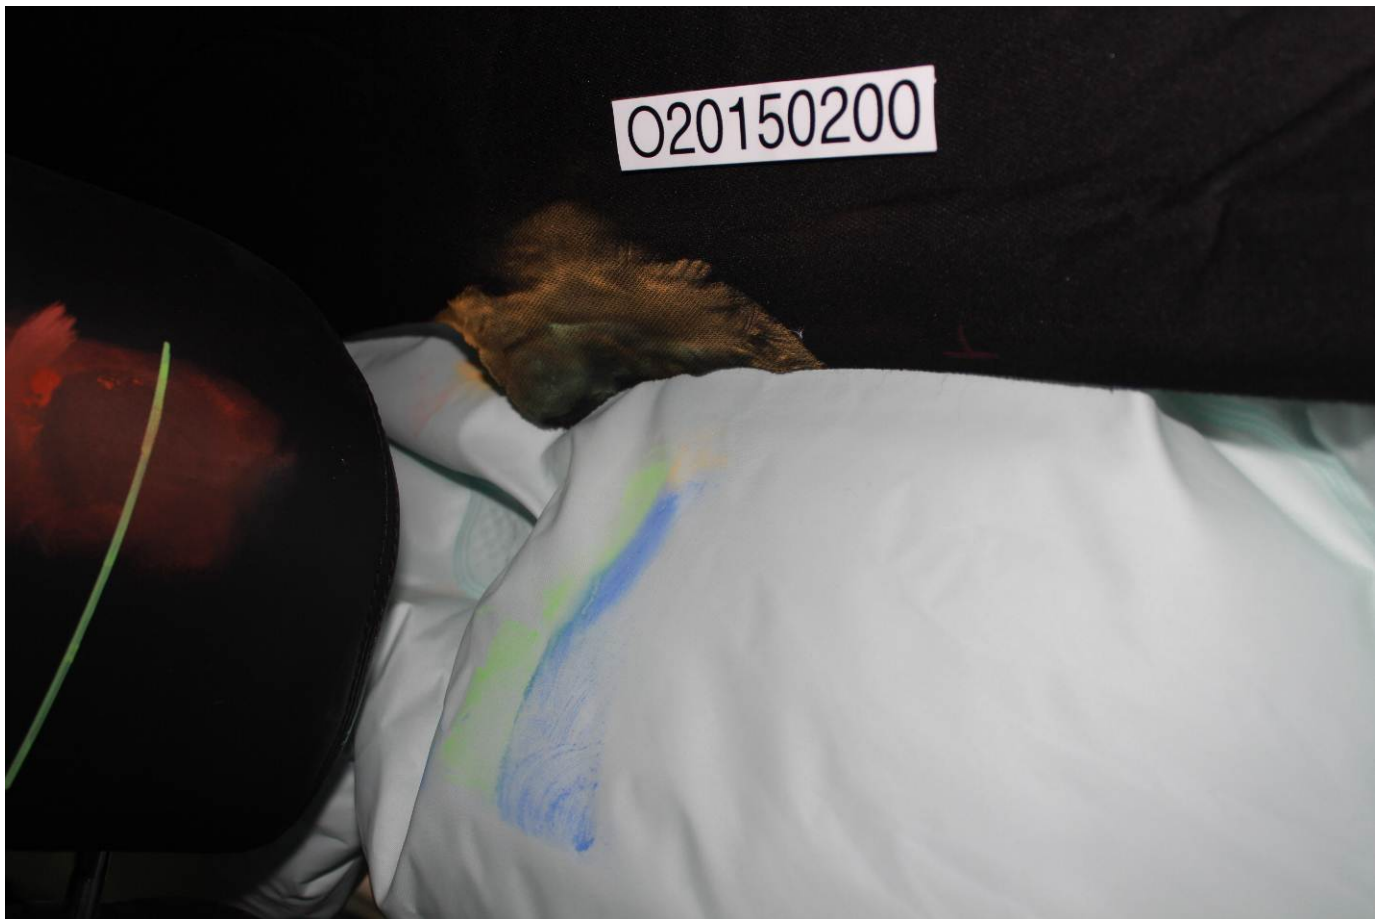
Post-Test Driver Dummy Close-up Head Contact with Side Airbag View

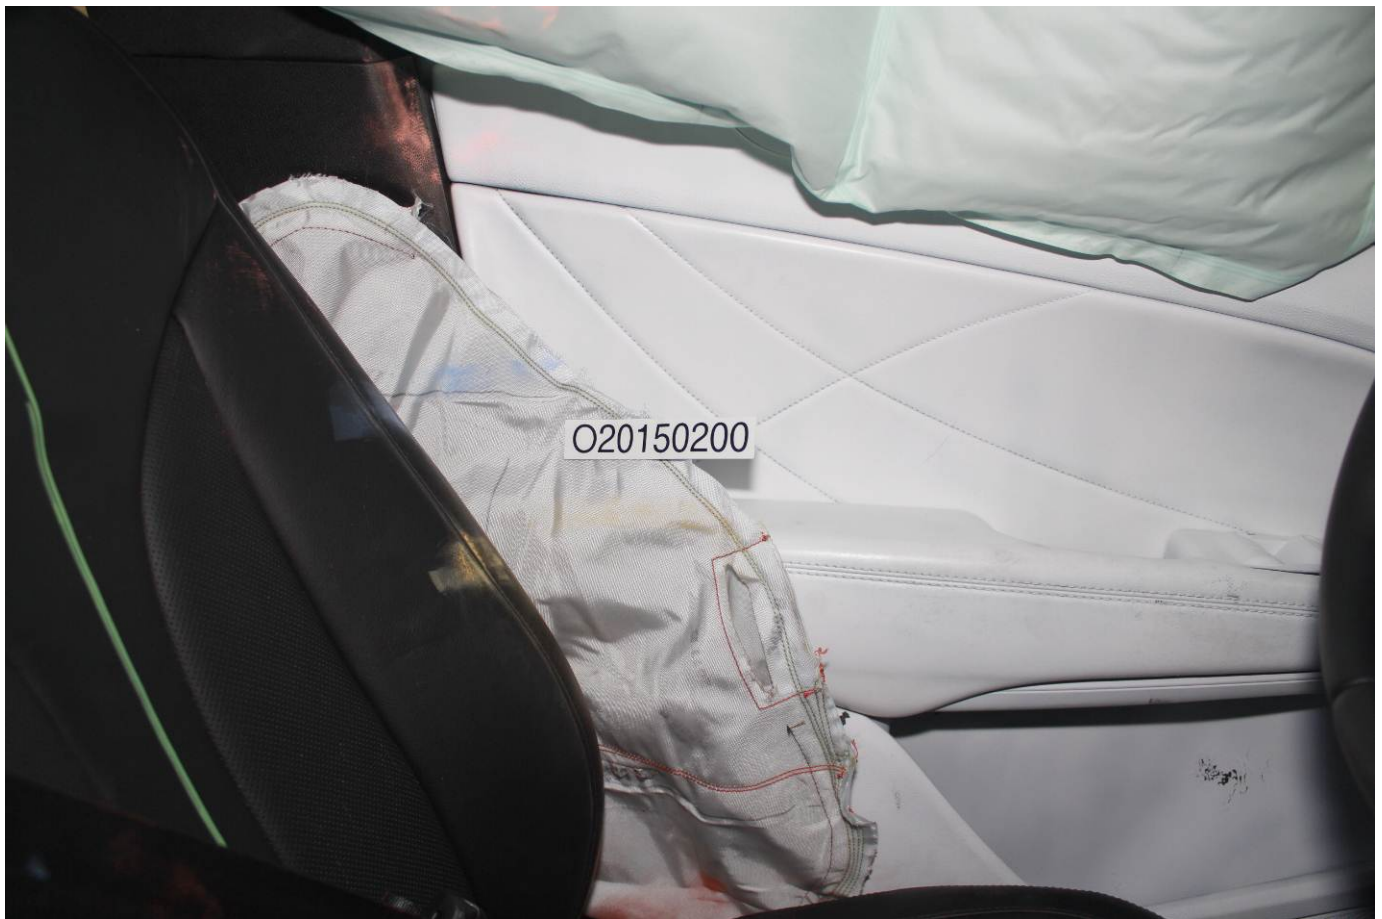
Post-Test Driver Dummy Close-up Torso Contact with Side Airbag View

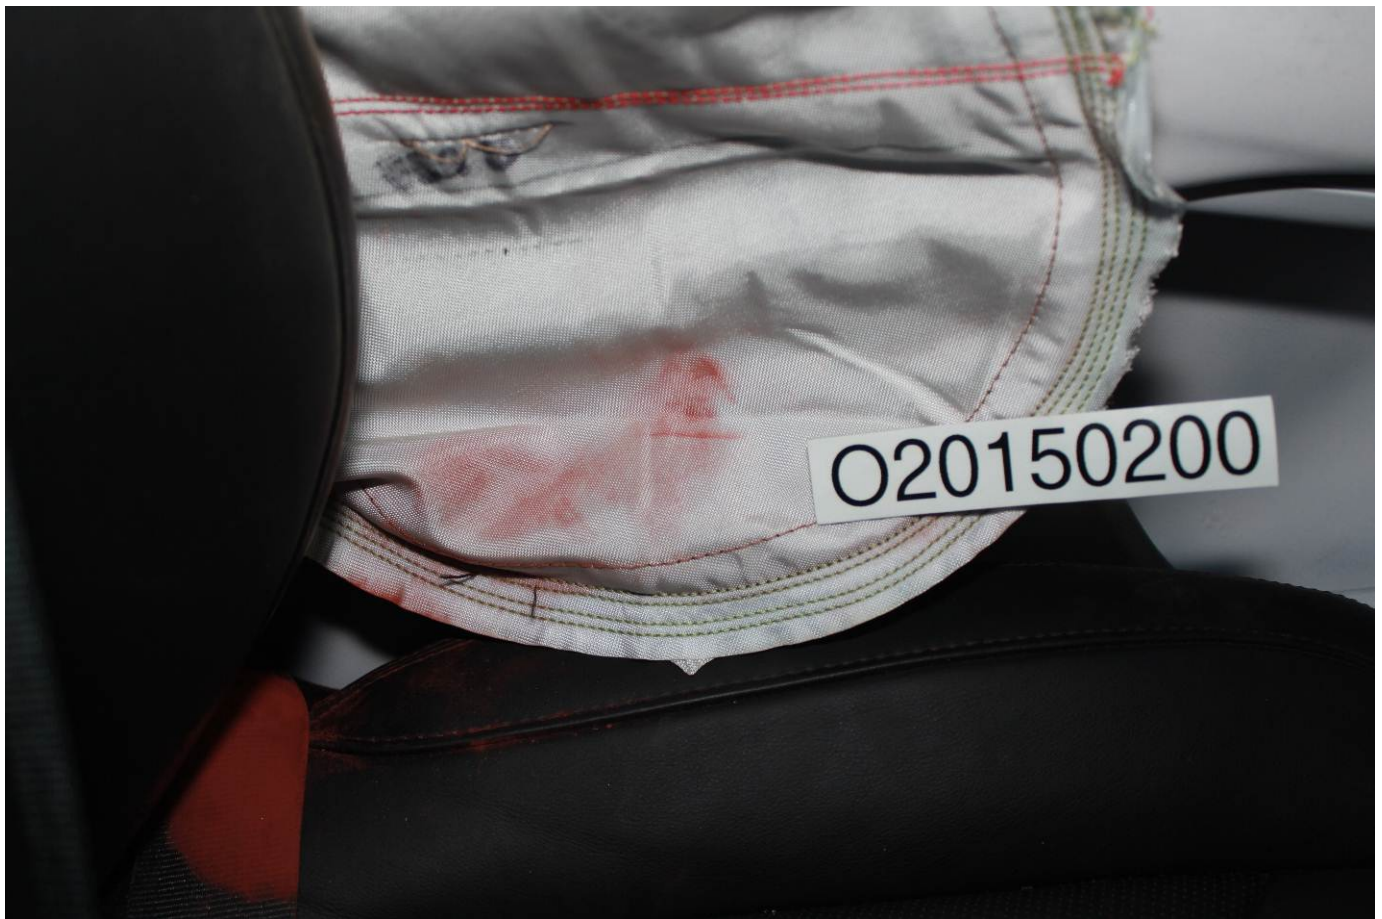
Post-Test Driver Dummy Close-up Pelvis Contact with Side Airbag View

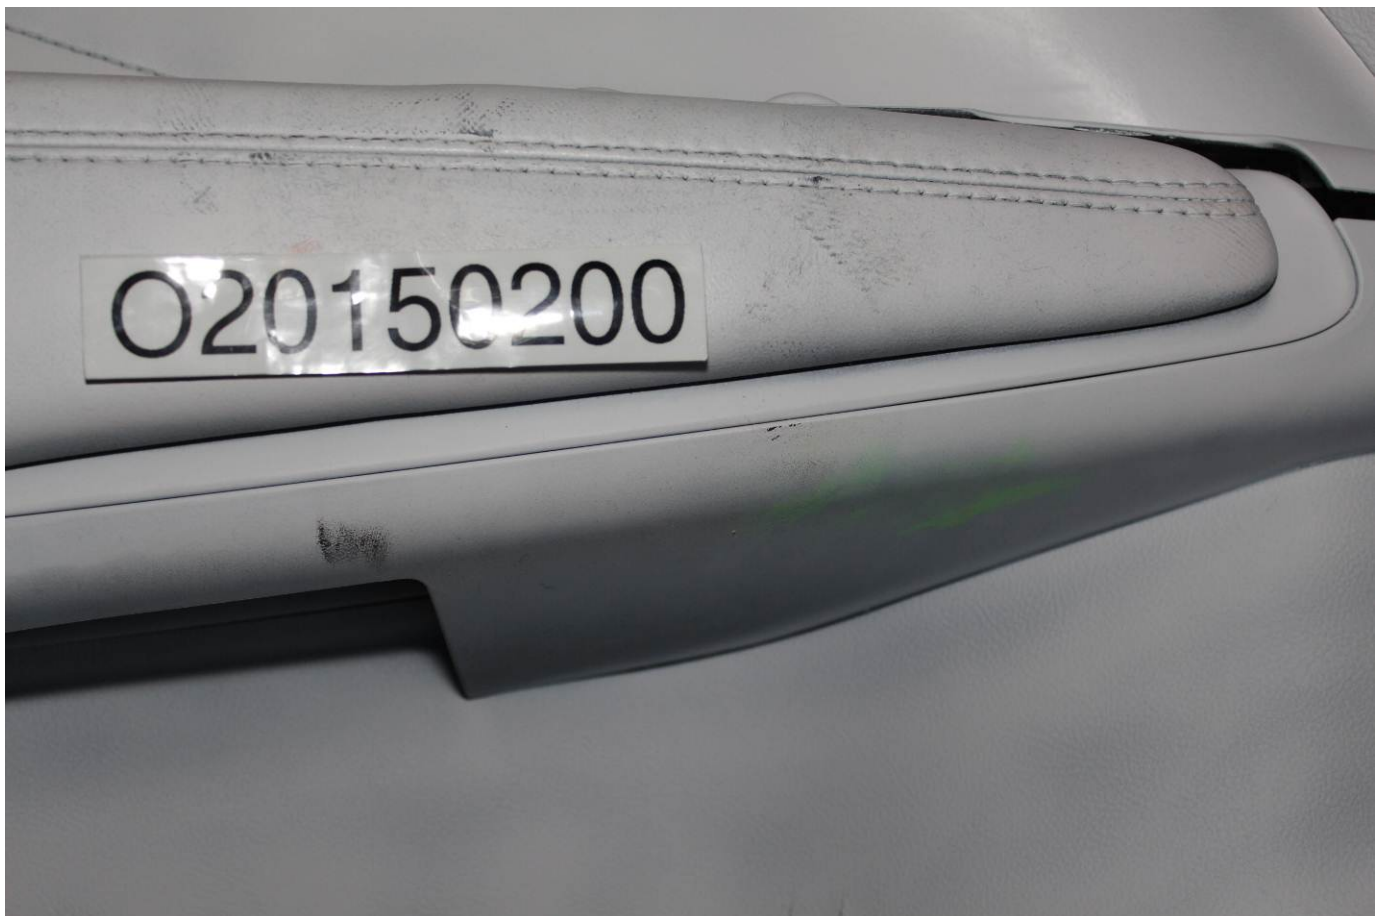
Post-Test Driver Dummy Close-up Knee Contact View

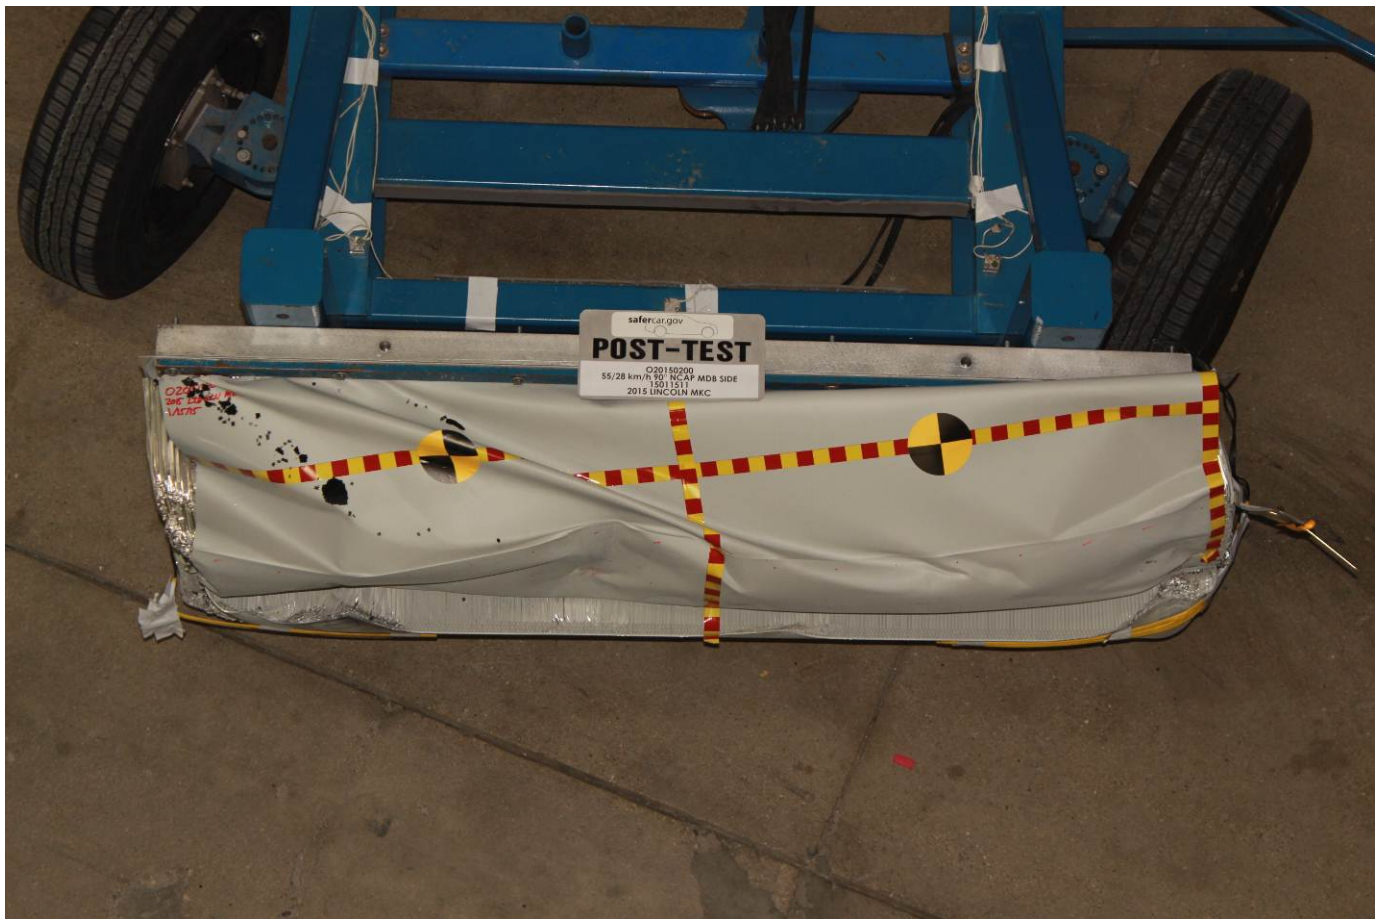
Post-Test Top View of MDB Impactor Face
