**REPORT NUMBER: NCAP-MGA-2015-049**

**NEW CAR ASSESSMENT PROGRAM (NCAP)  
Frontal Barrier Impact Test**

**HONDA OF AMERICA MFG., INC.  
2015 Acura TLX AWD 4-Dr Sedan  
NHTSA No.: M20155312**

**FINAL REPORT**

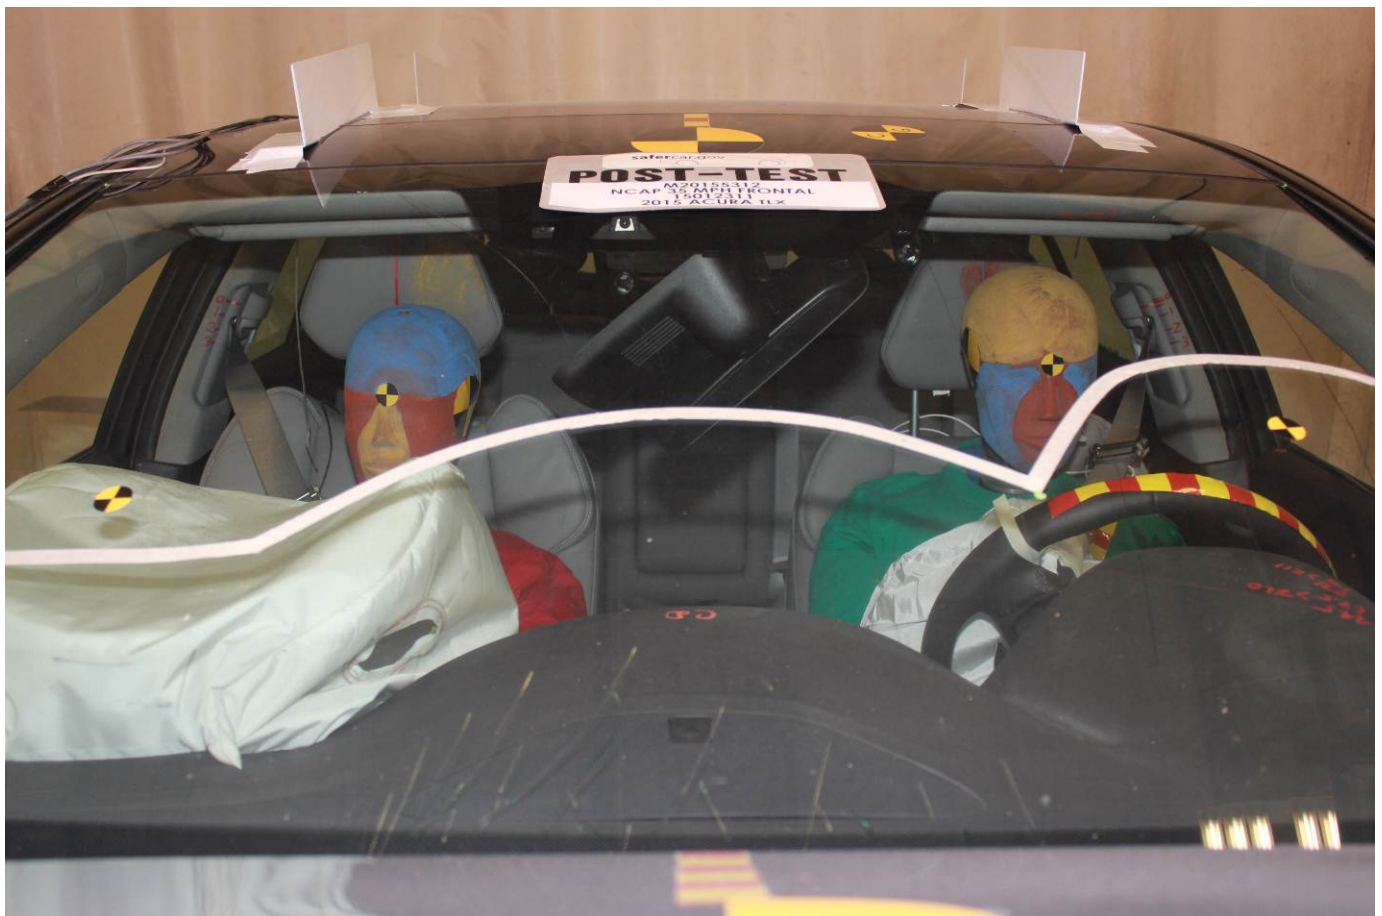
Post-Test Windshield View

There was 100 percent windshield retention and no intrusion into the protected zone of the windshield during the event. There was no Stoddard Solvent leakage after the event or during any phase of the static rollover.

| Critical Areas of Performance | Observations and Conclusions |
|---|---|
| Windshield Damage | Cracked |

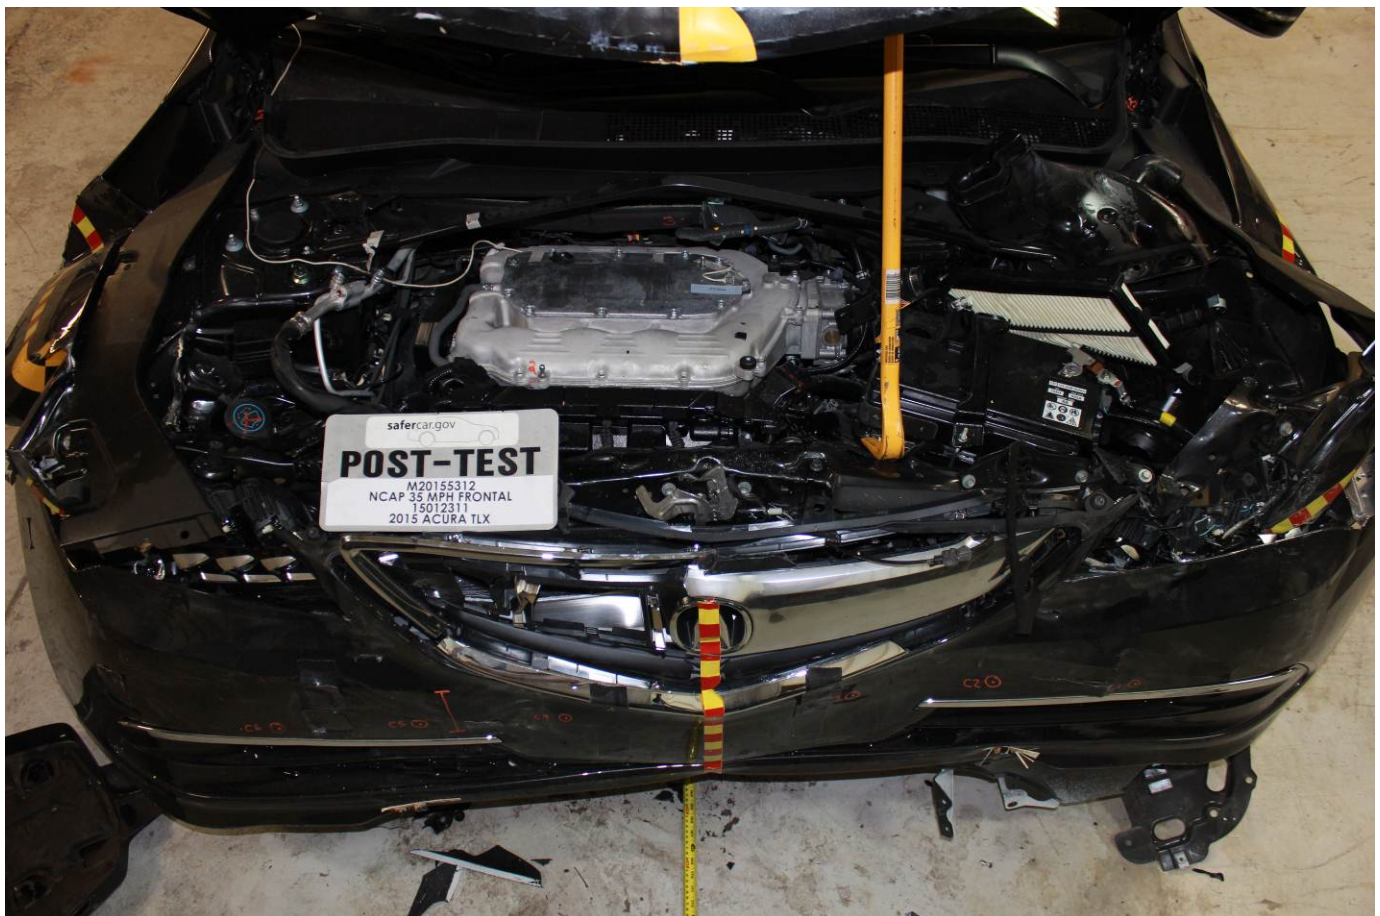
Post-Test Engine Compartment View

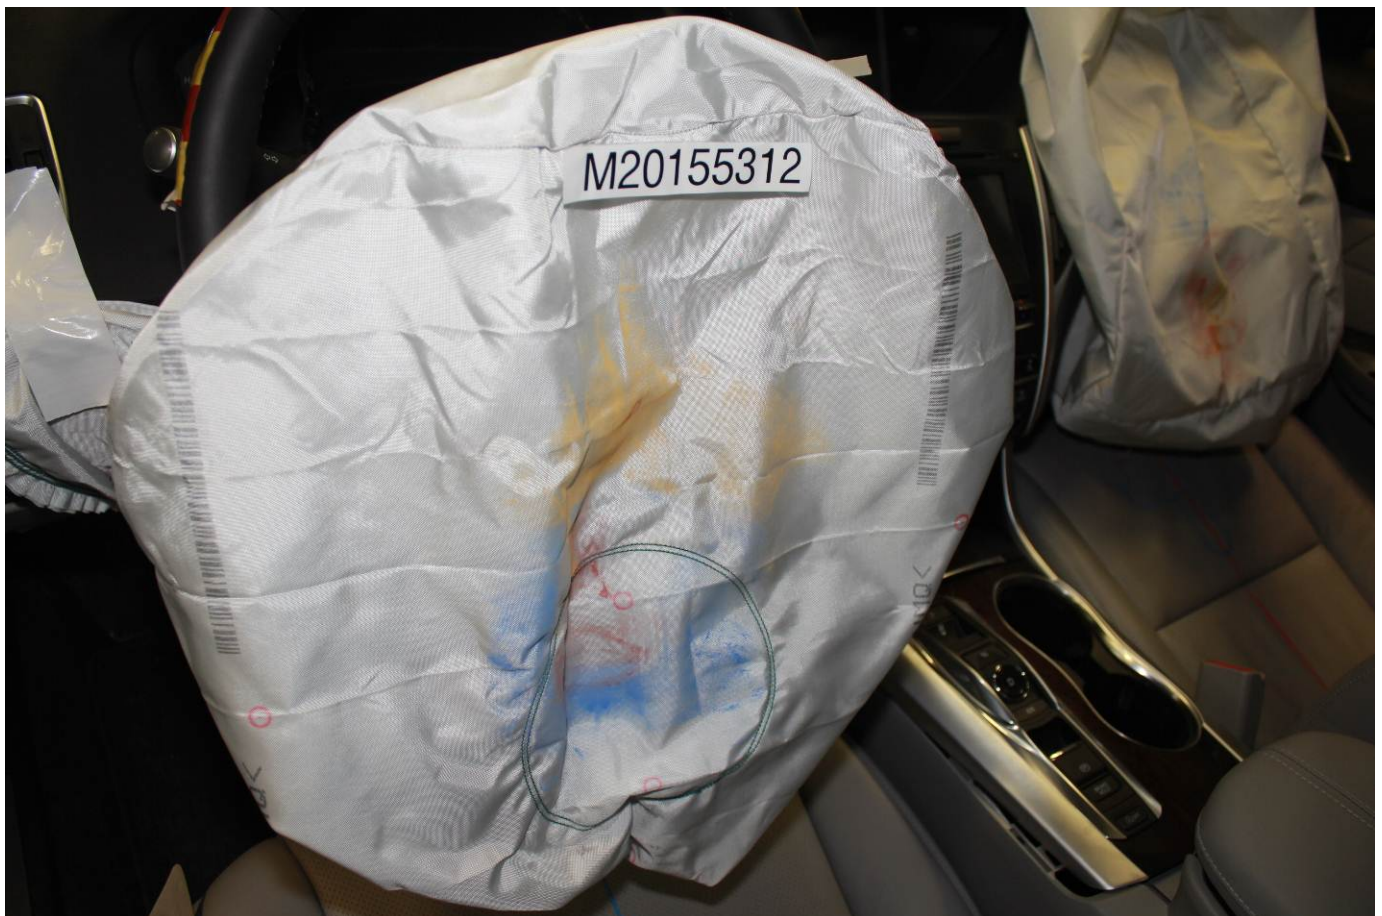
Post-Test Driver Dummy Contact with Airbag

The driver's visible contact points were as follows: The driver's head and chest contacted the airbag. The driver's head also contacted the headrest. The driver's knees contacted the knee airbag. The passenger's visible contact points were as follows: The passenger's head and chest contacted the airbag. The passenger's head also contacted the headrest. The passenger's knees contacted the glovebox.

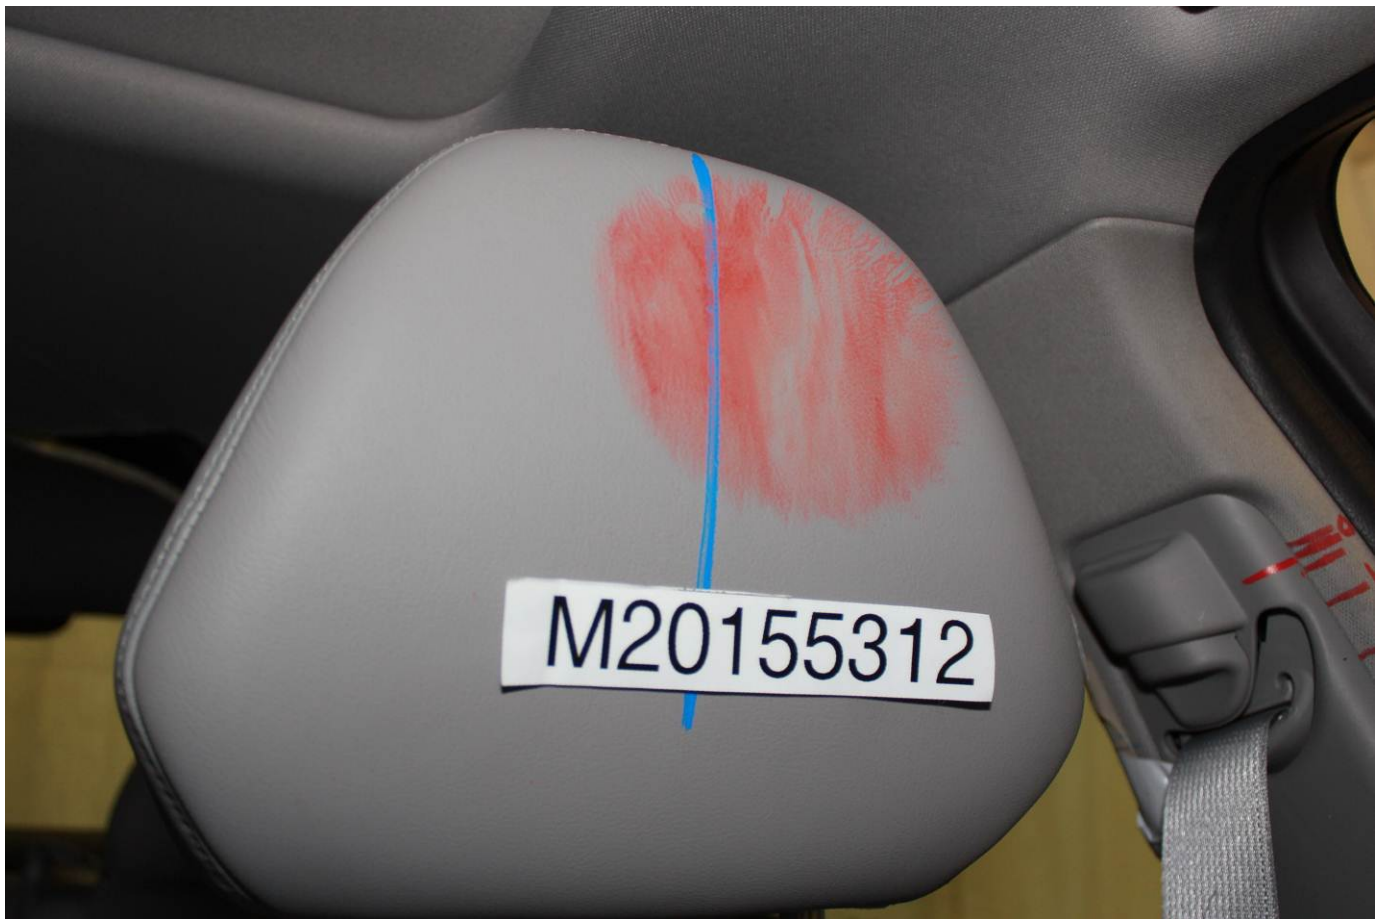
Post-Test Driver Dummy Contact with Headrest

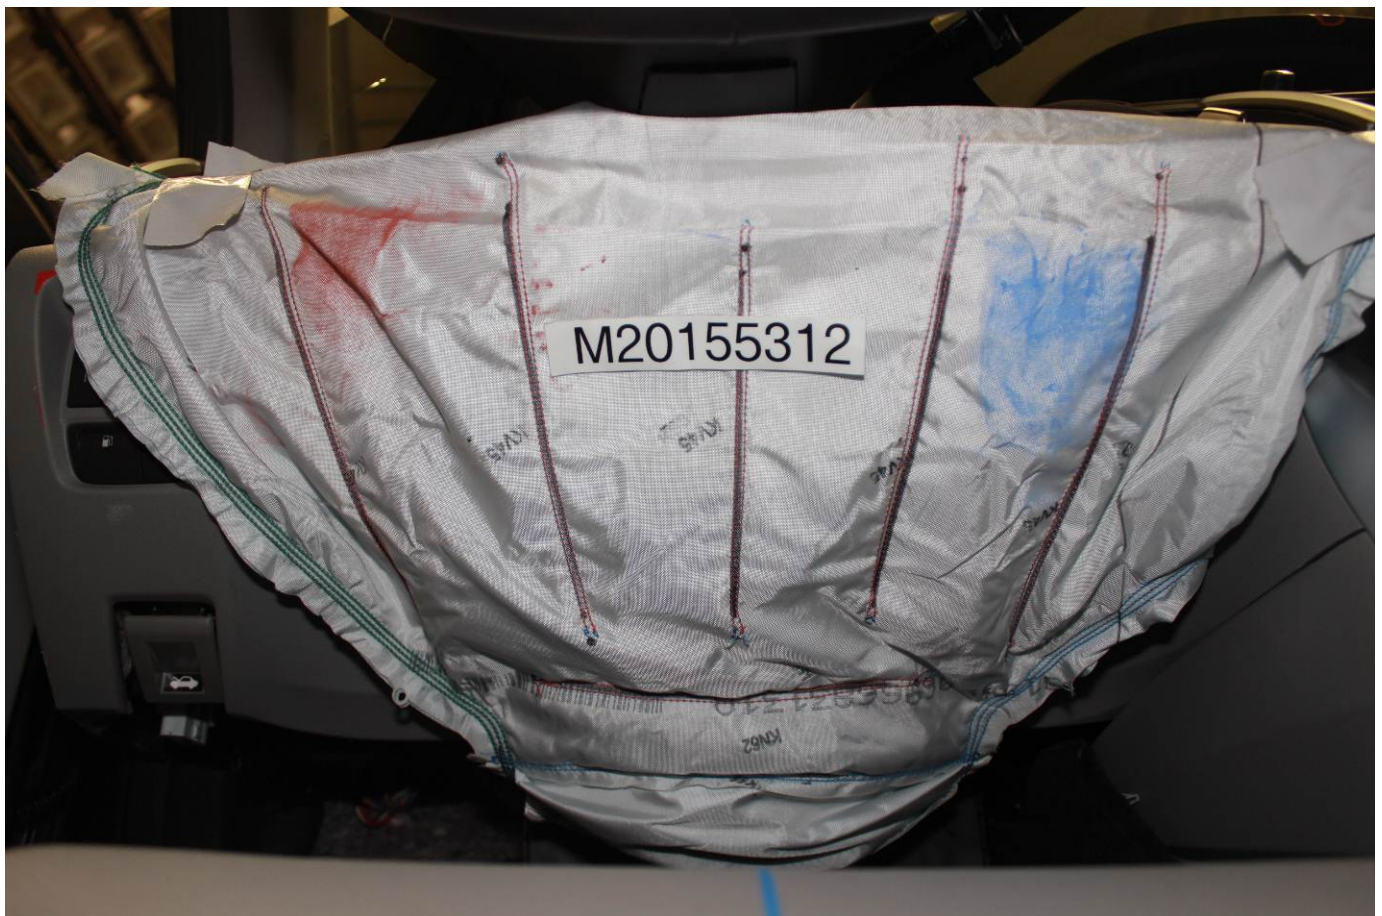
Post-Test Driver Dummy Contact with Knee Airbag

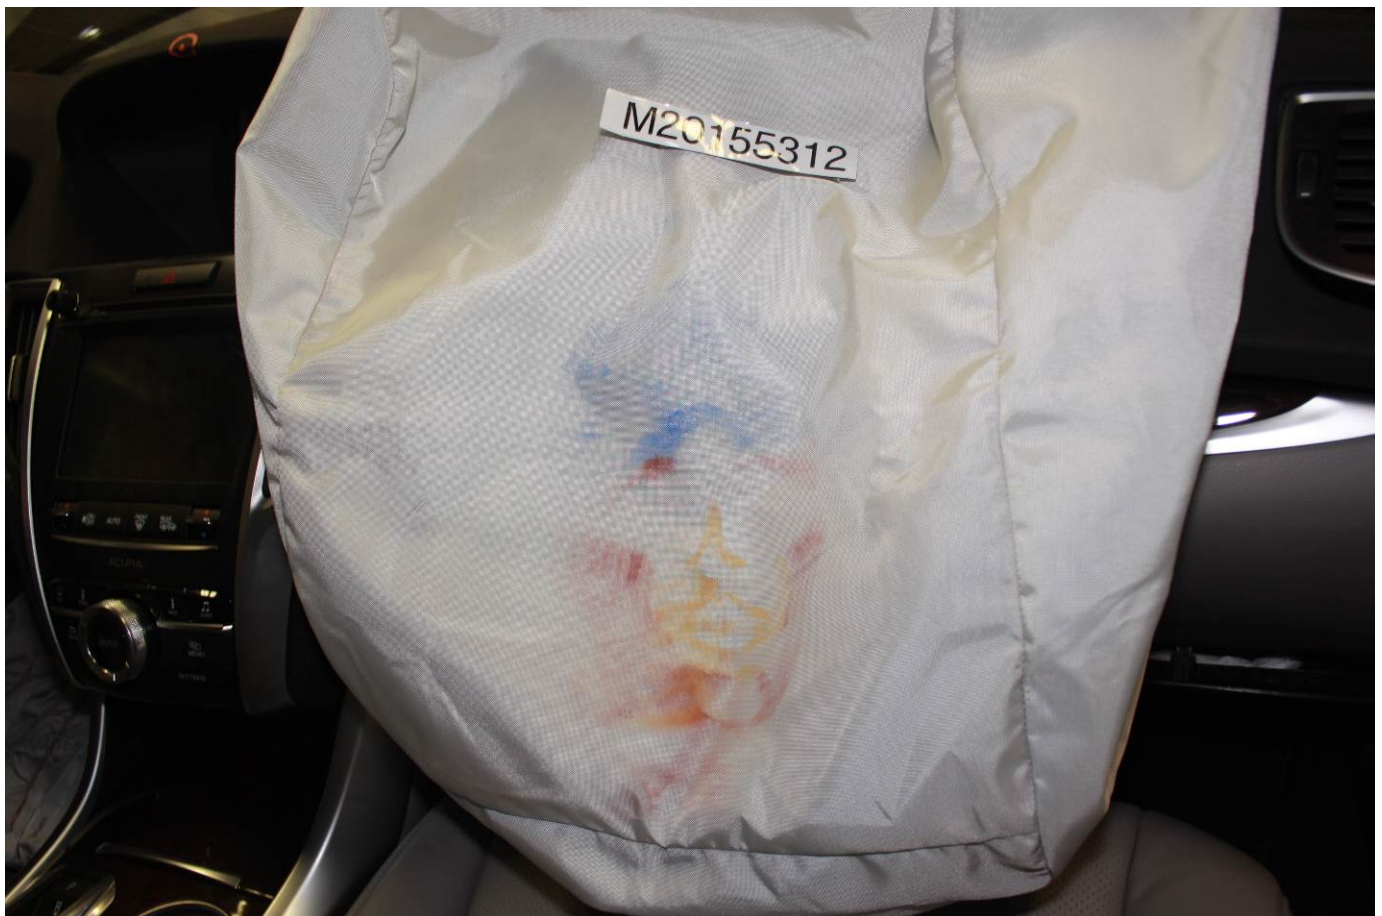
Post-Test Passenger Dummy Contact with Airbag

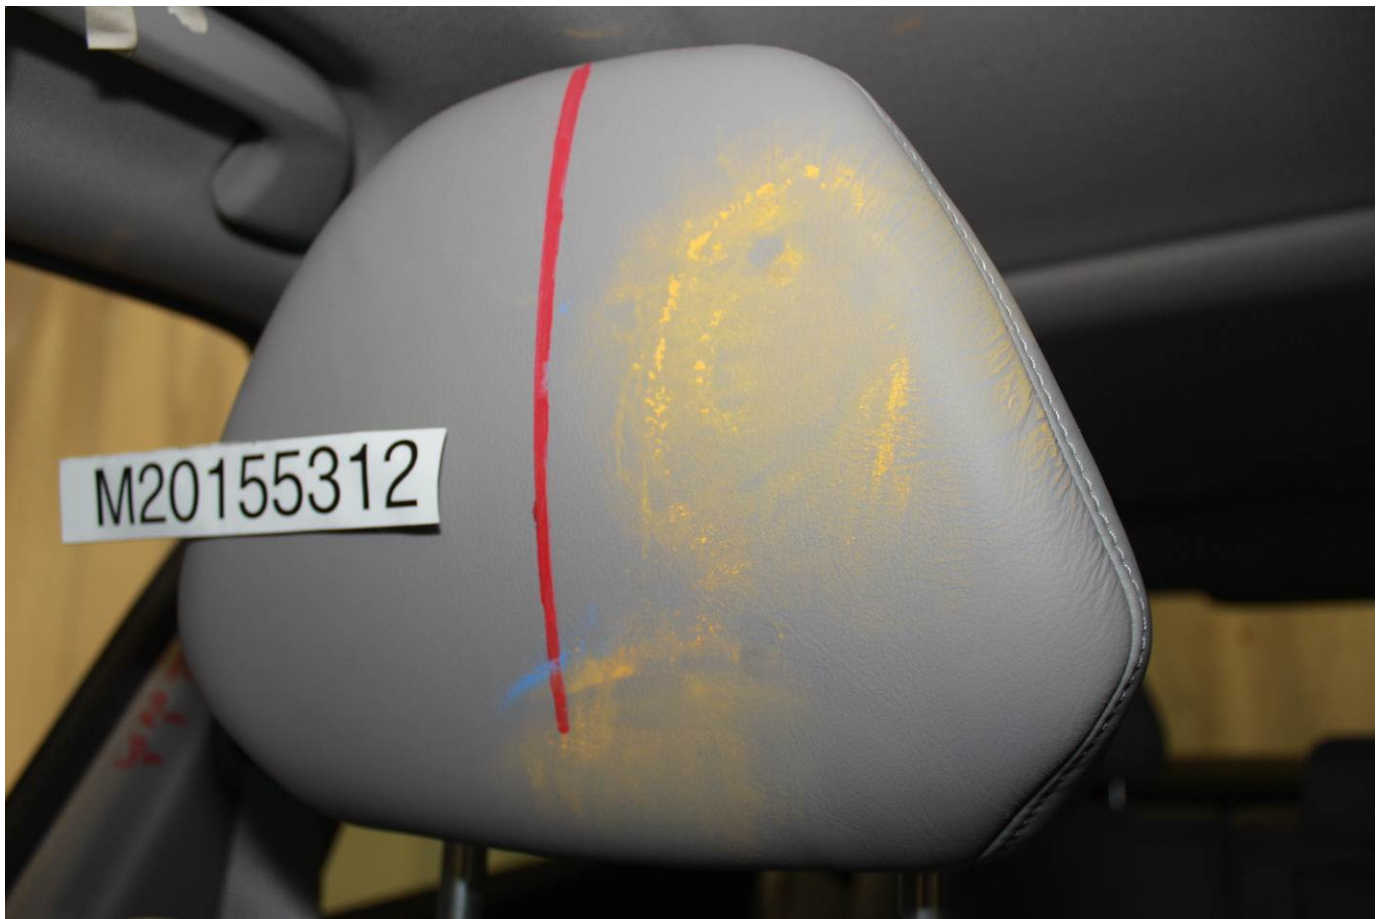
Post-Test Passenger Dummy Contact with Headrest

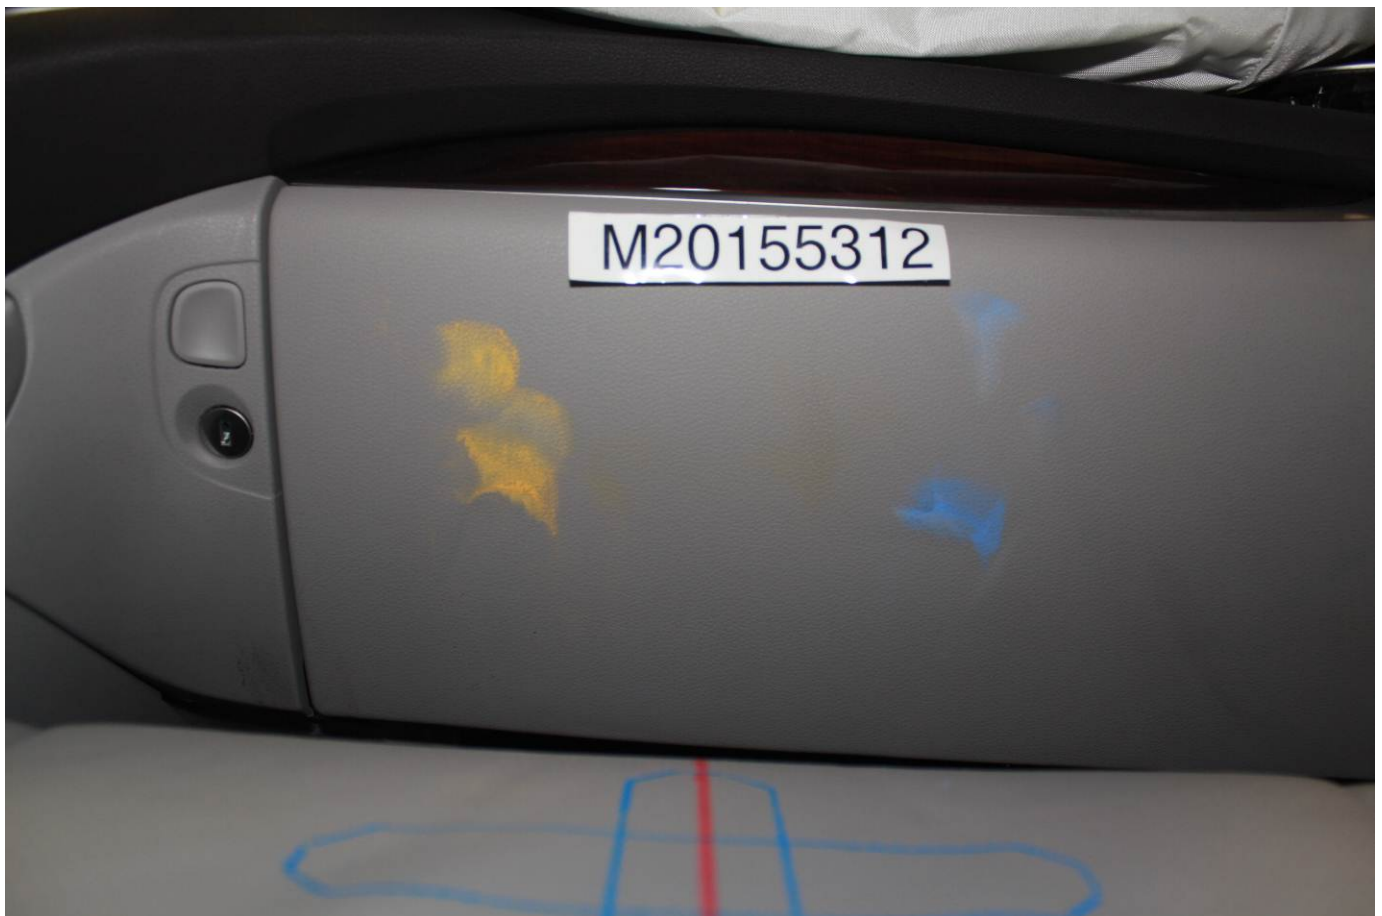
Post-Test Passenger Dummy Contact with Glovebox

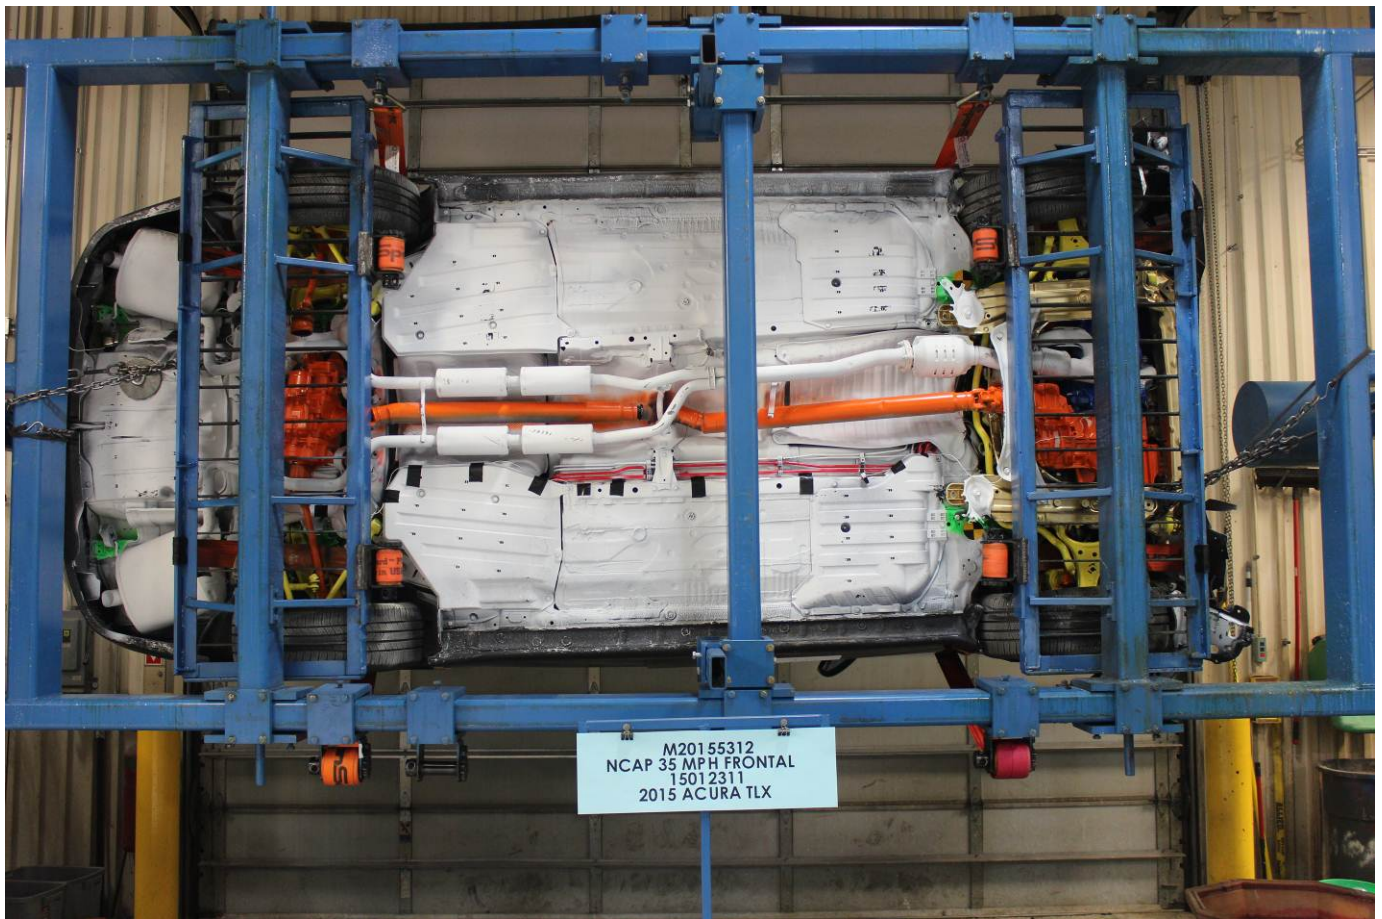
Vehicle at 90 Degrees on Static Rollover Device

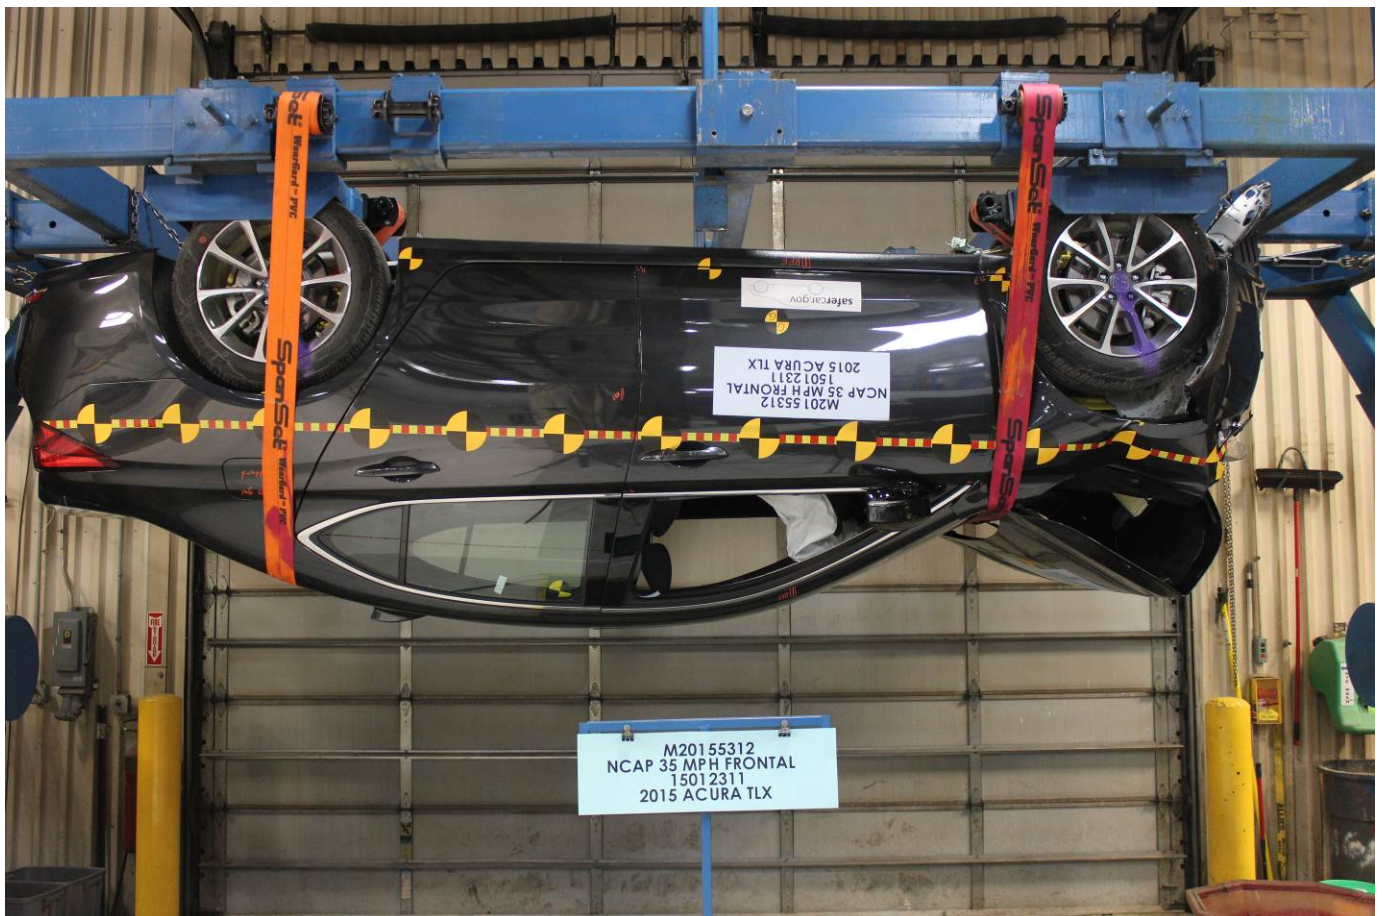
Vehicle at 180 Degrees on Static Rollover Device
