**REPORT NUMBER: NCAP-MGA-2015-050**

**NEW CAR ASSESSMENT PROGRAM (NCAP)  
Frontal Barrier Impact Test**

**TOYOTA MOTOR CORPORATION  
2015 Lexus NX 200t 5-Dr SUV  
NHTSA No.: O20155100**

**FINAL REPORT**

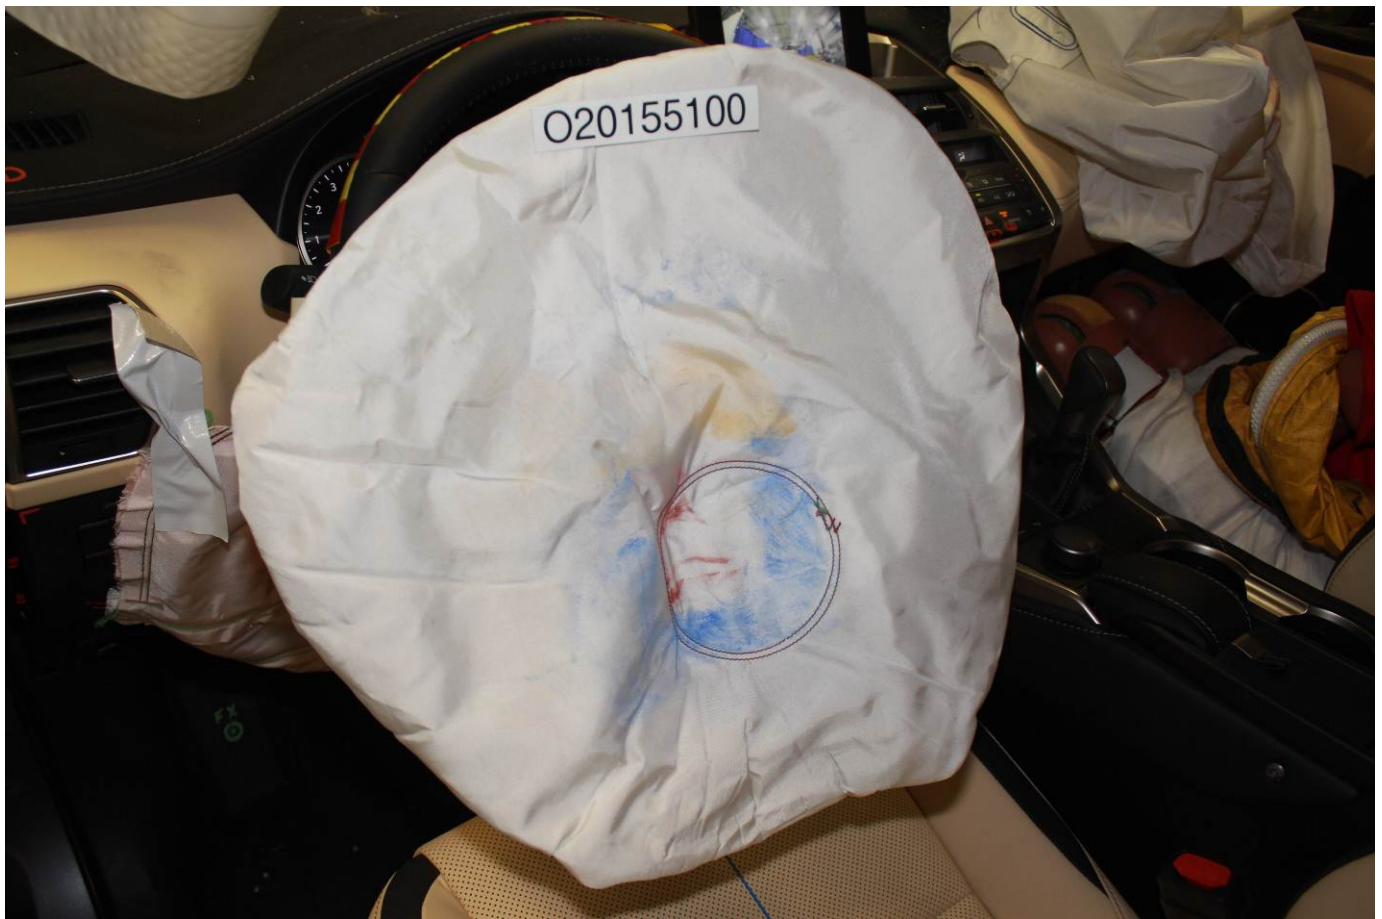
Post-Test Driver Dummy Contact with Airbag

The driver's visible contact points were as follows: The driver's head and chest contacted the airbag. The driver's head also contacted the curtain airbag. The driver's knees contacted the knee airbag. The passenger's visible contact points were as follows: The passenger's head and chest contacted the airbag. The passenger's head also contacted the curtain airbag and headrest. The passenger's knees contacted the glovebox and frontal airbag.

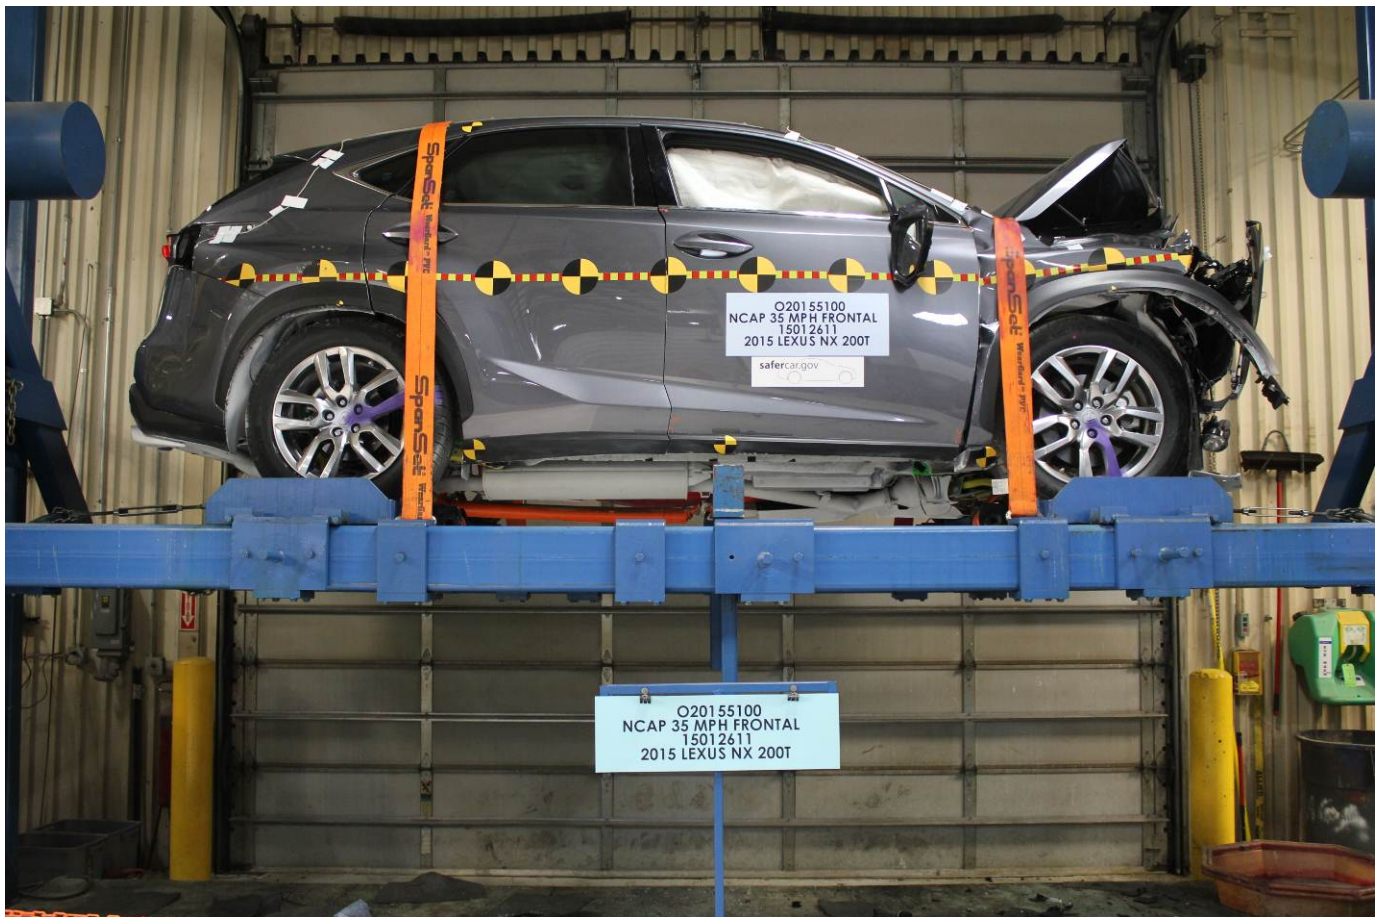
Vehicle at 0 Degree on Static Rollover Device

There was 100 percent windshield retention and no intrusion into the protected zone of the windshield during the event. There was no Stoddard Solvent leakage after the event or during any phase of the static rollover.
