**REPORT NUMBER: SPNCAP-CAL-15-003**

**NEW CAR ASSESSMENT PROGRAM (NCAP)  
SIDE IMPACT POLE TEST**

**Toyota Motor Corporation  
2015 Toyota RAV-4  
SUV**

**FINAL REPORT**

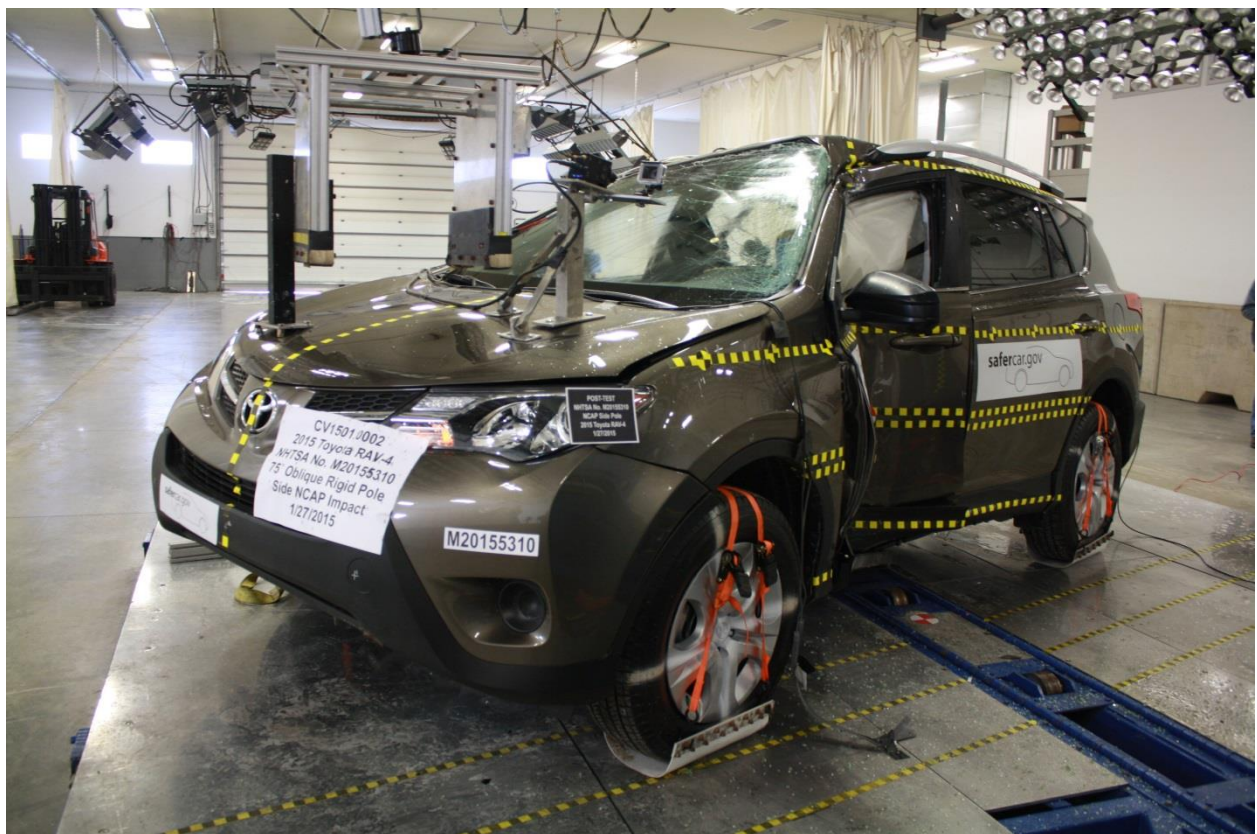
**Figure A-6: Post-Test Left Front  $\frac{3}{4}$  View of Test Vehicle**

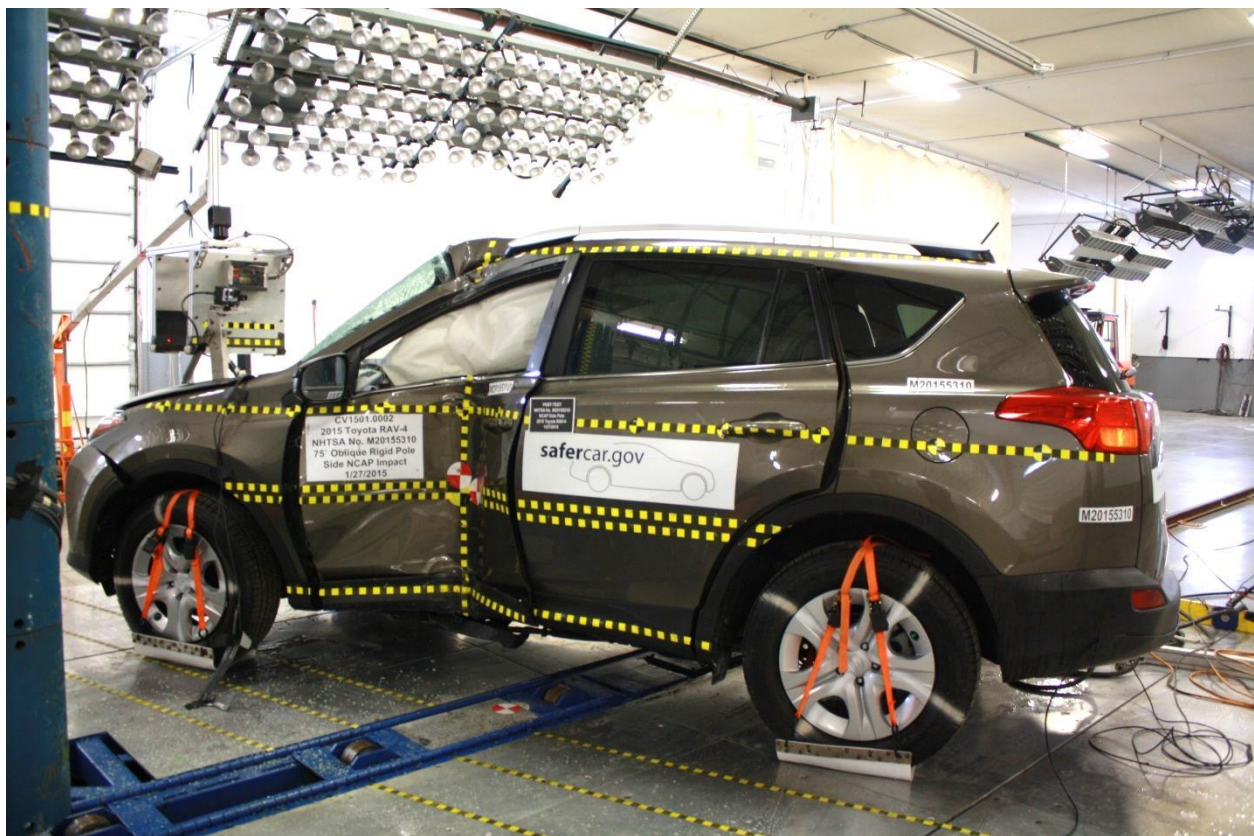
**Figure A-8: Post-Test Left Side View of Test Vehicle**

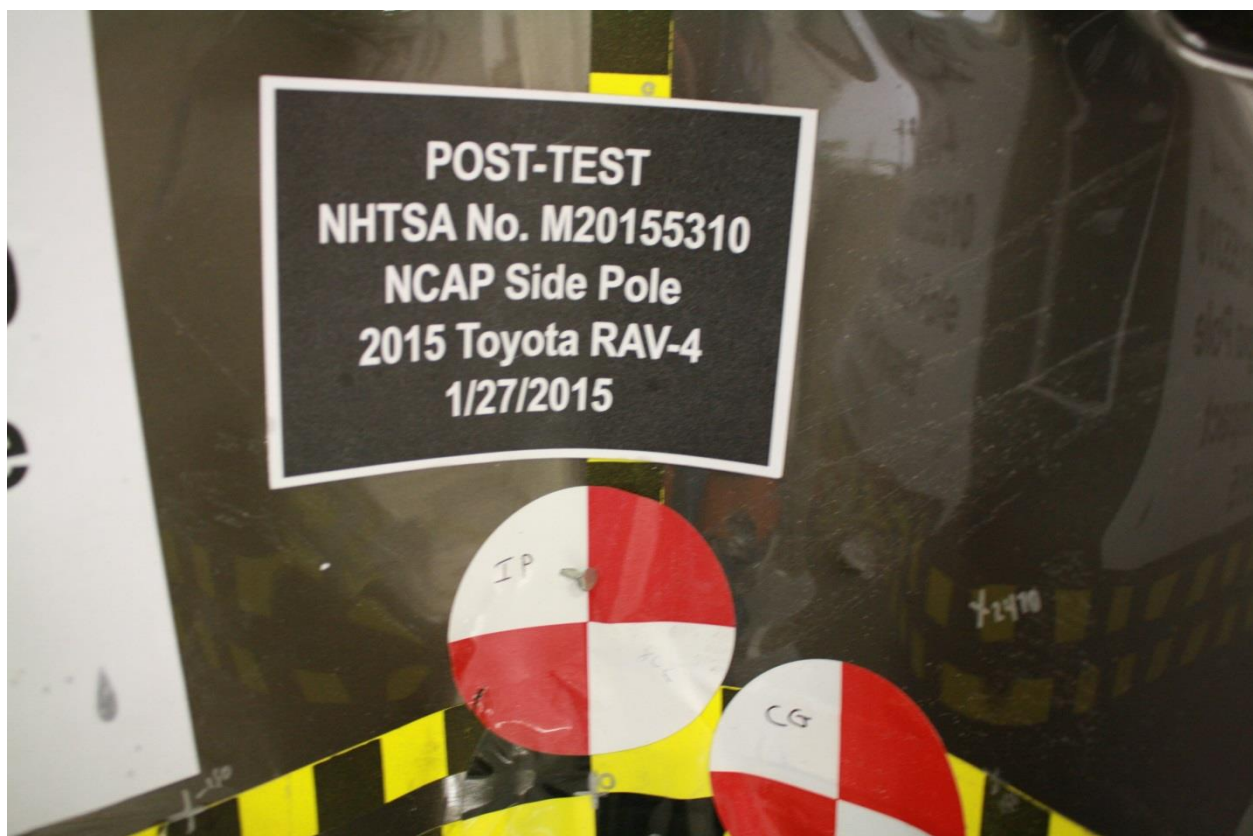
Figure A-20: Post-Test Close-Up View of Impact Point Target Showing Impact Location

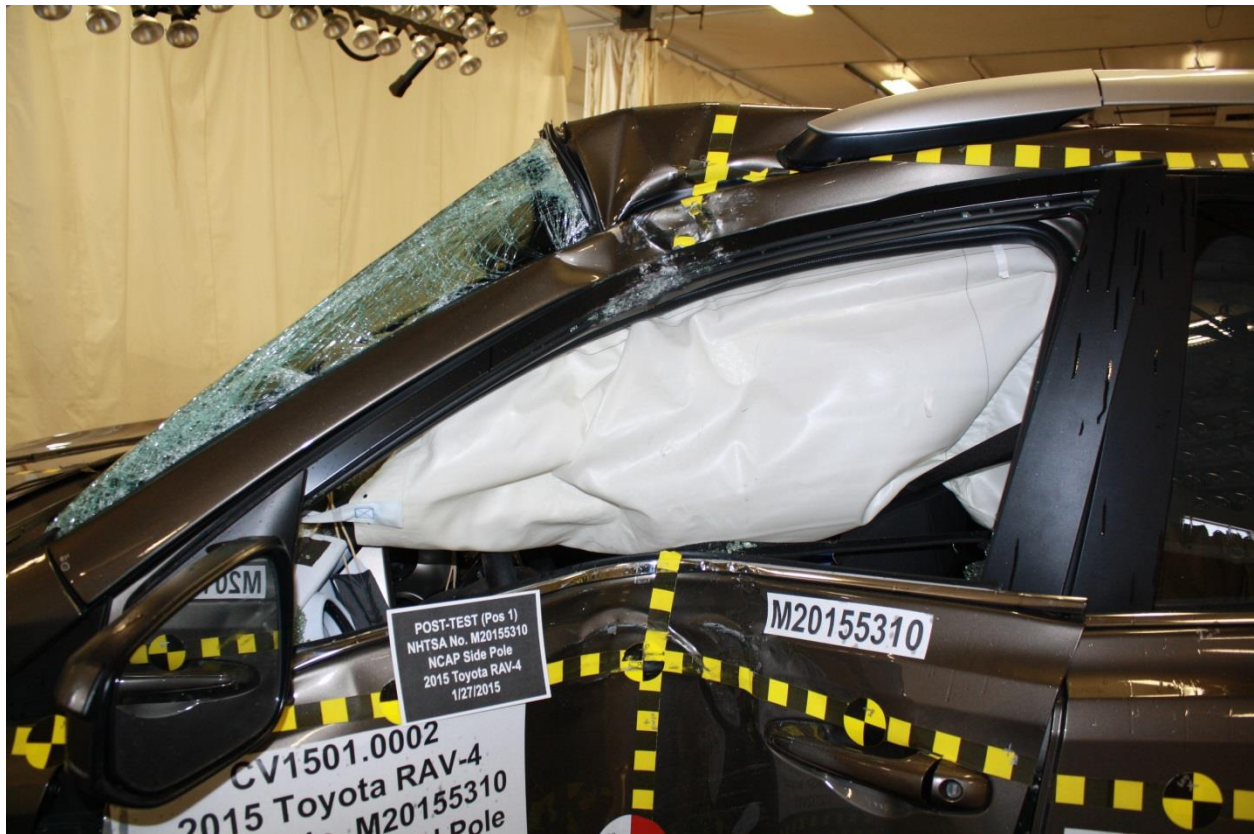
**Figure A-25: Post-Test Left Side View of Dummy Shoulder and Door Top View**

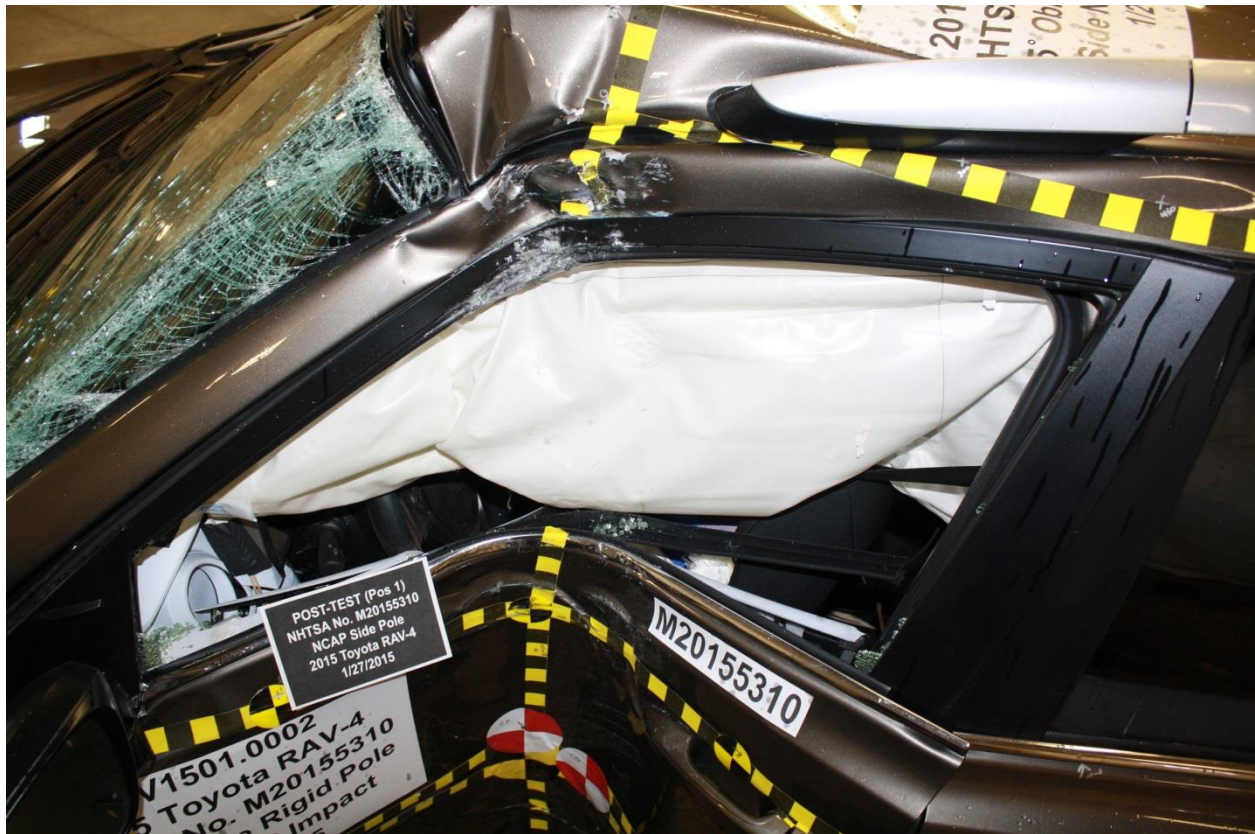
**Figure A-41: Post-Test Dummy and Door Clearance View**

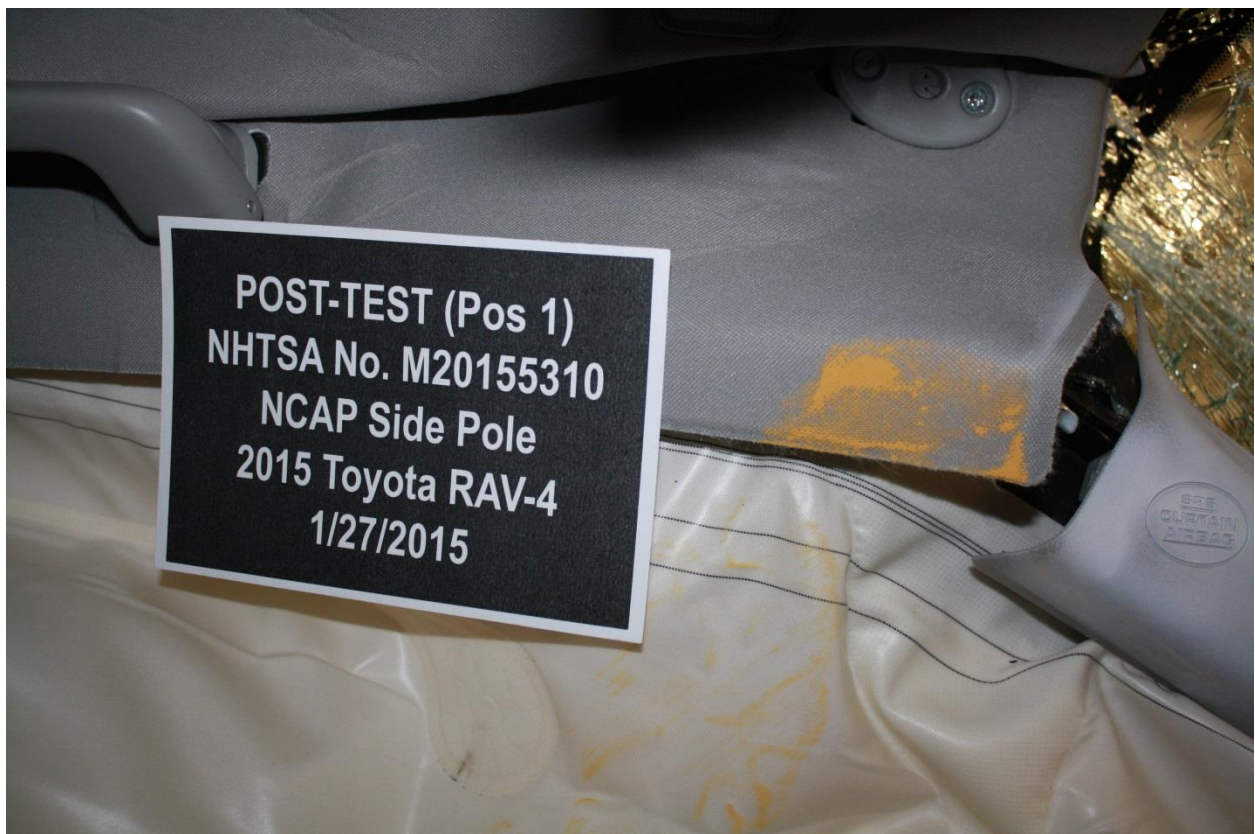
**Figure A-46: Post-Test Dummy Close-Up Head Contact with Vehicle Interior View**

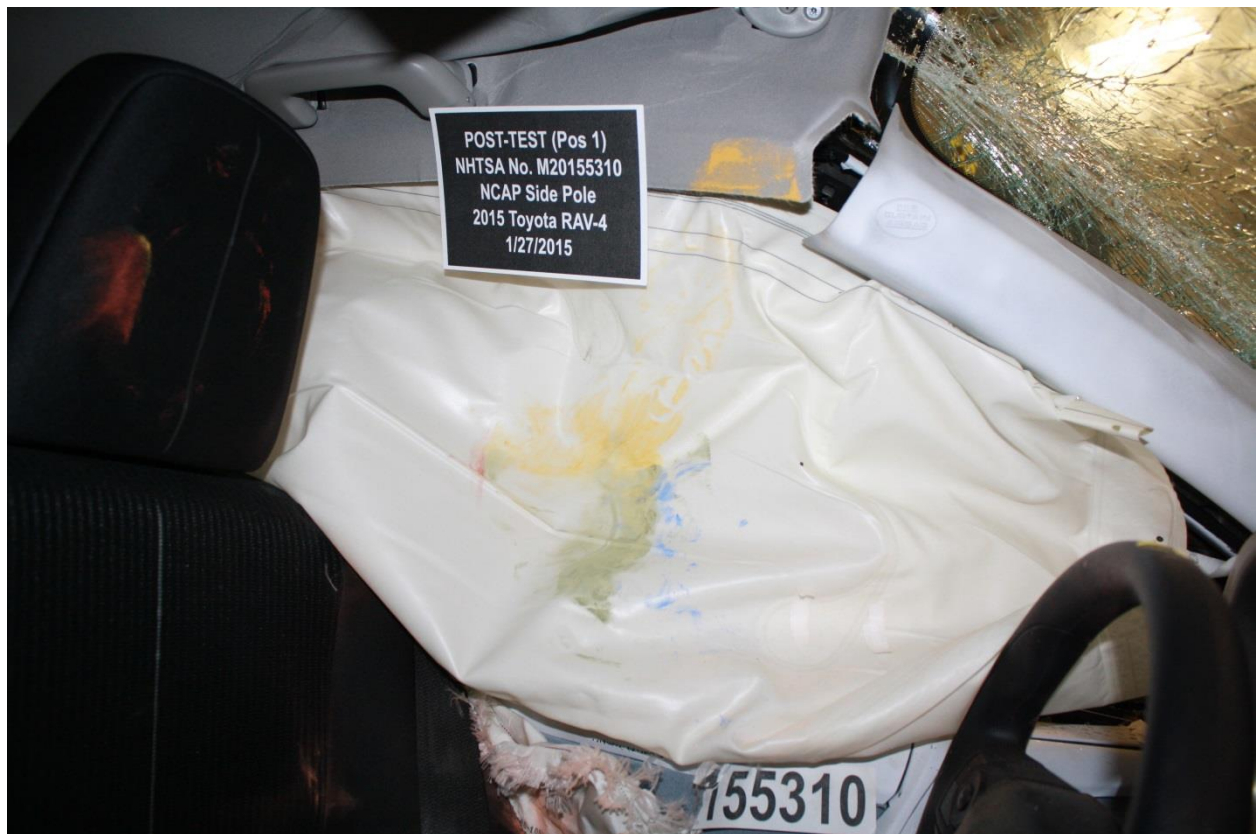
**Figure A-47: Post-Test Dummy Close-Up Head Contact with Side Airbag View**

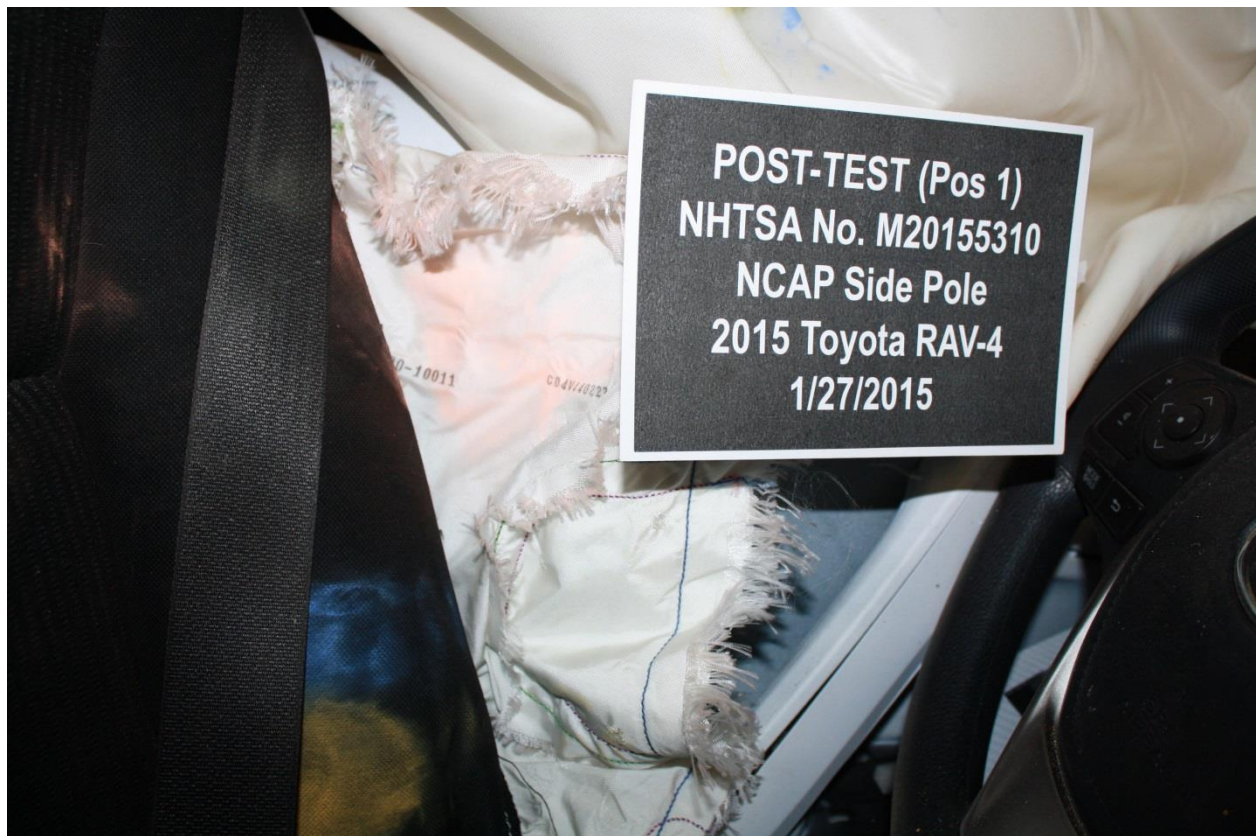
**Figure A-49: Post-Test Dummy Close-Up Torso Contact with Side Airbag View**

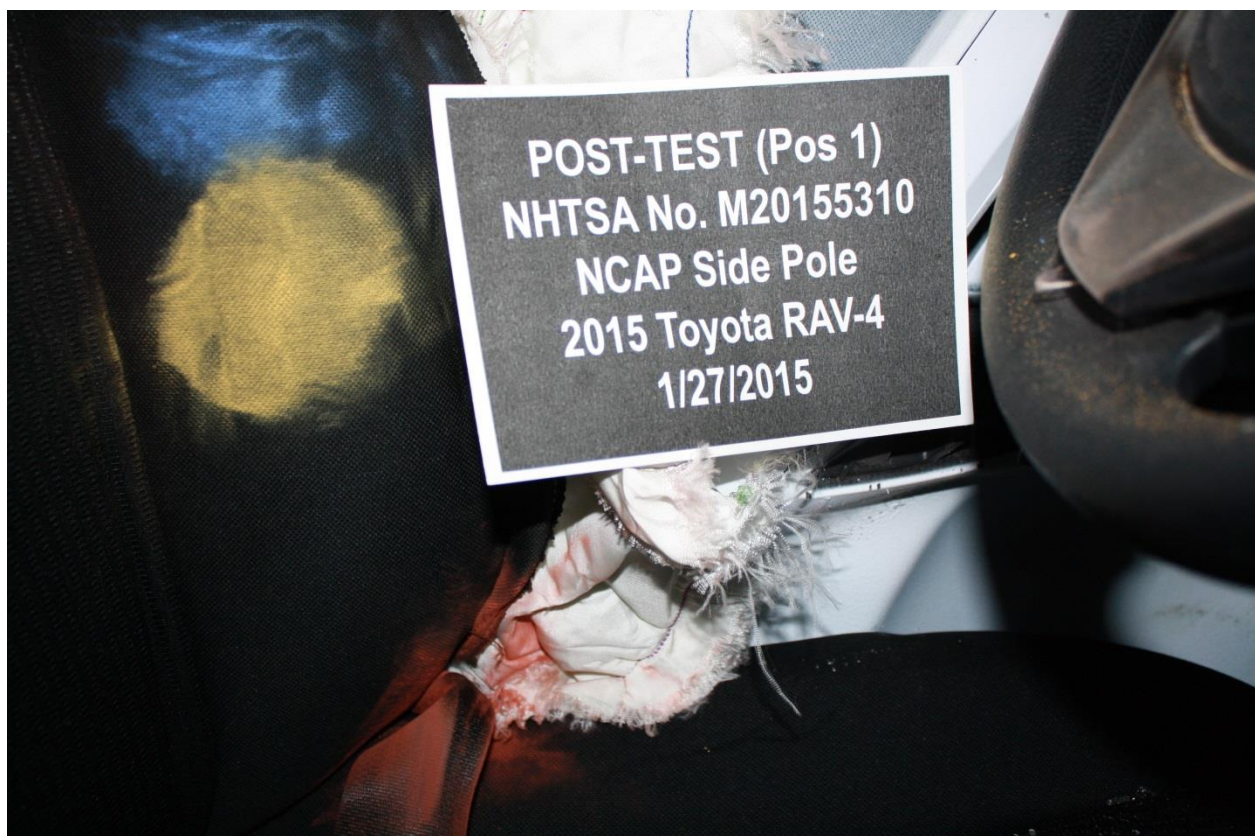
**Figure A-50: Post-Test Dummy Close-Up Pelvis Contact with Vehicle Interior View**

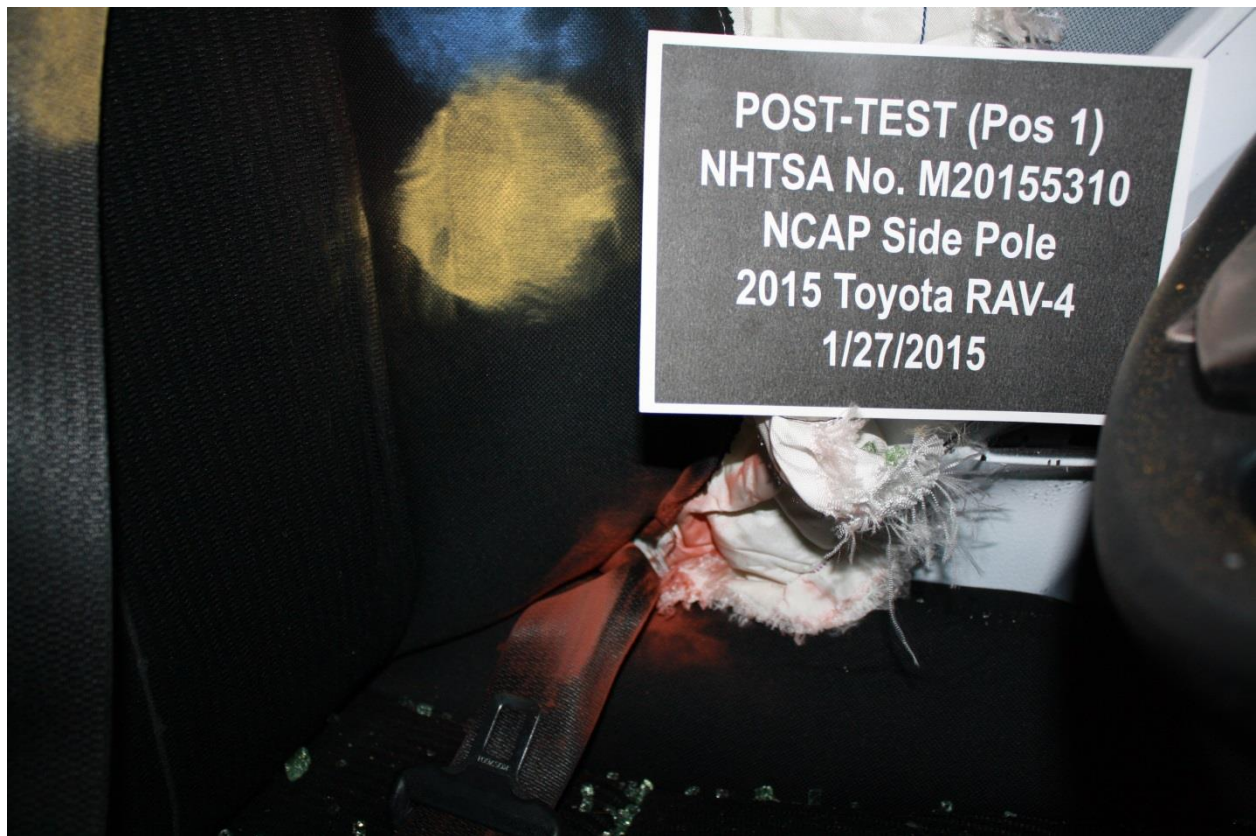
**Figure A-51: Post-Test Dummy Close-Up Pelvis Contact with Side Airbag View**

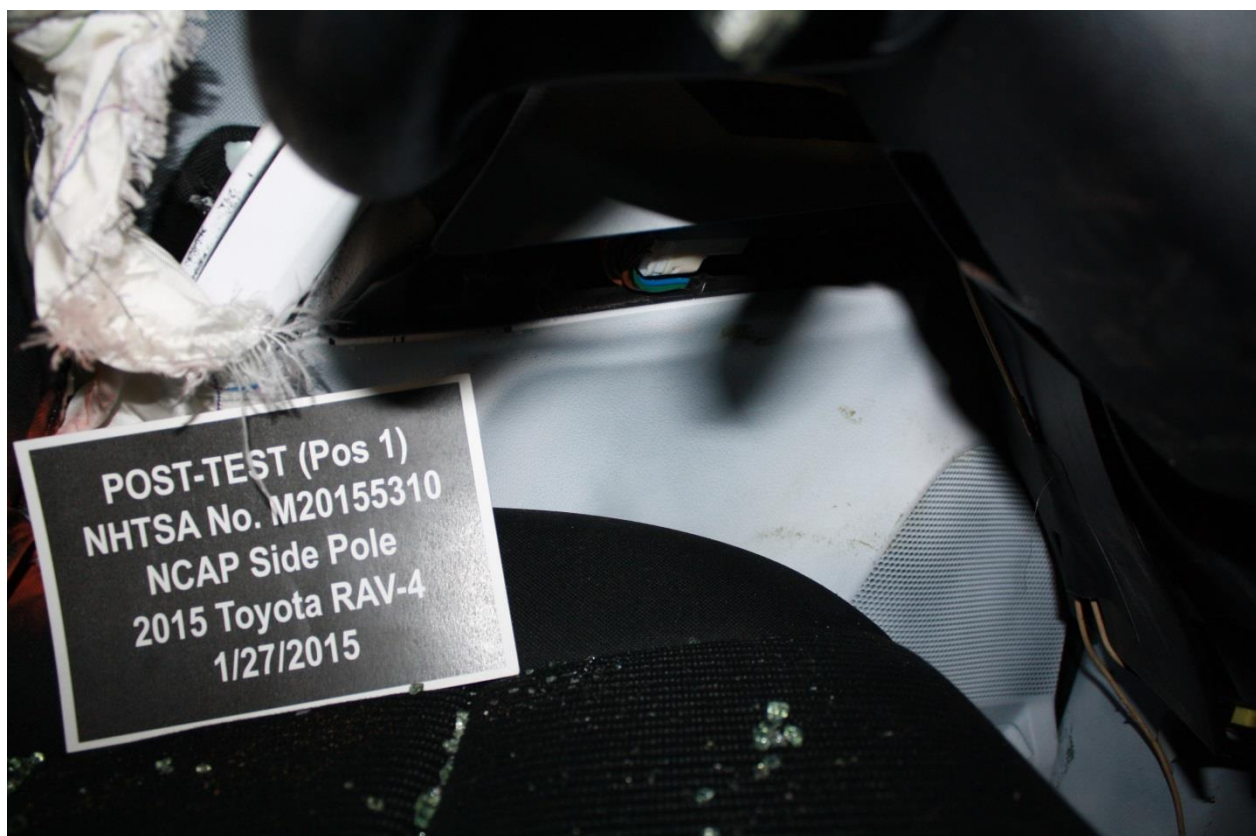
**Figure A-52: Post-Test Dummy Close-Up Knee Contact with Vehicle Interior View**

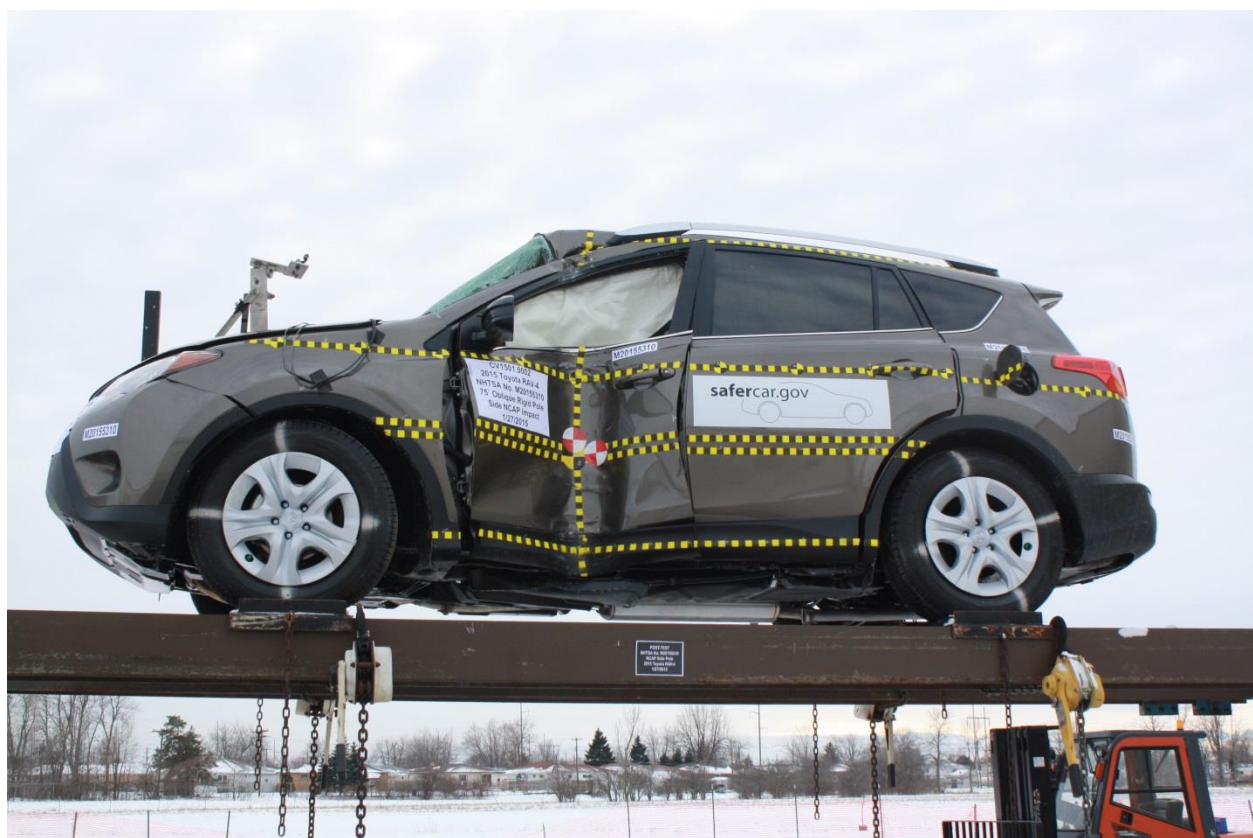
Figure A-63: FMVSS No. 301 Static Rollover 0 Degrees

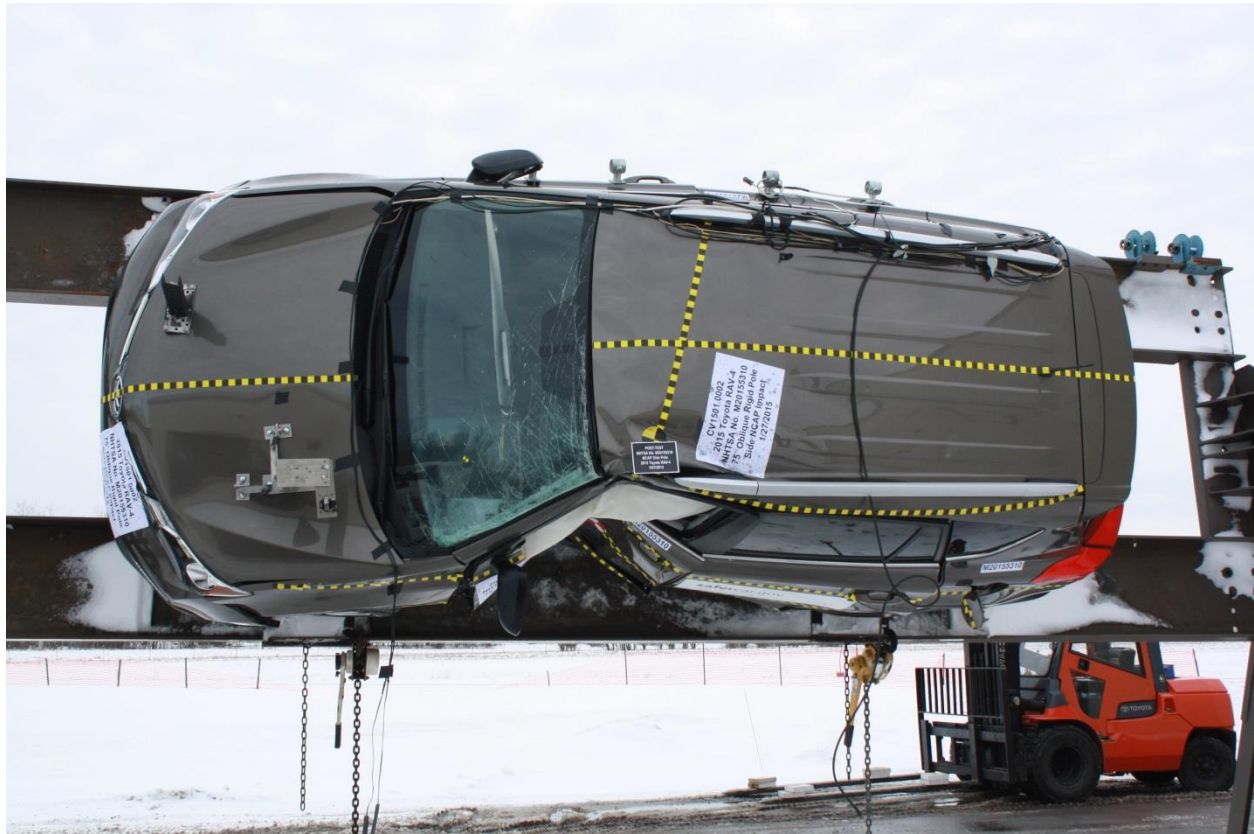
**Figure A-64: FMVSS No. 301 Static Rollover 90 Degrees**

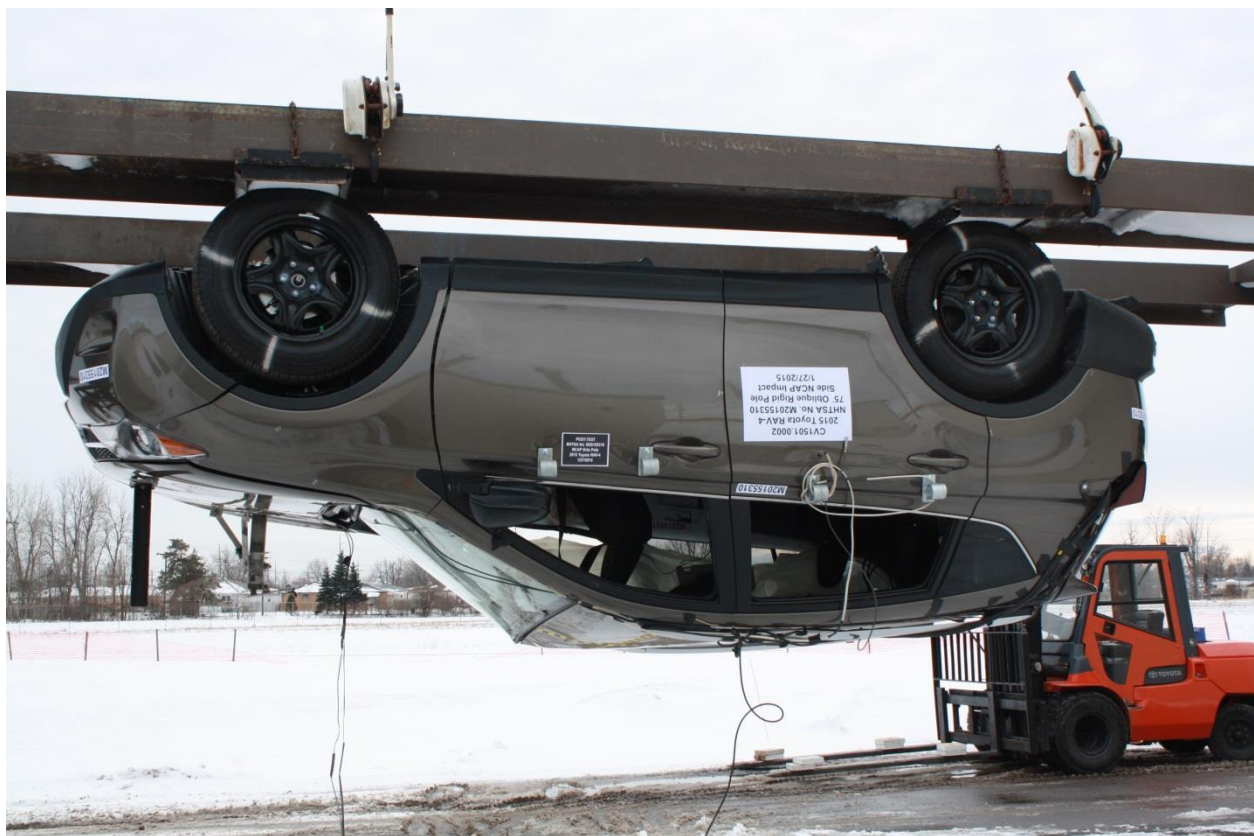
**Figure A-65: FMVSS No. 301 Static Rollover 180 Degrees**

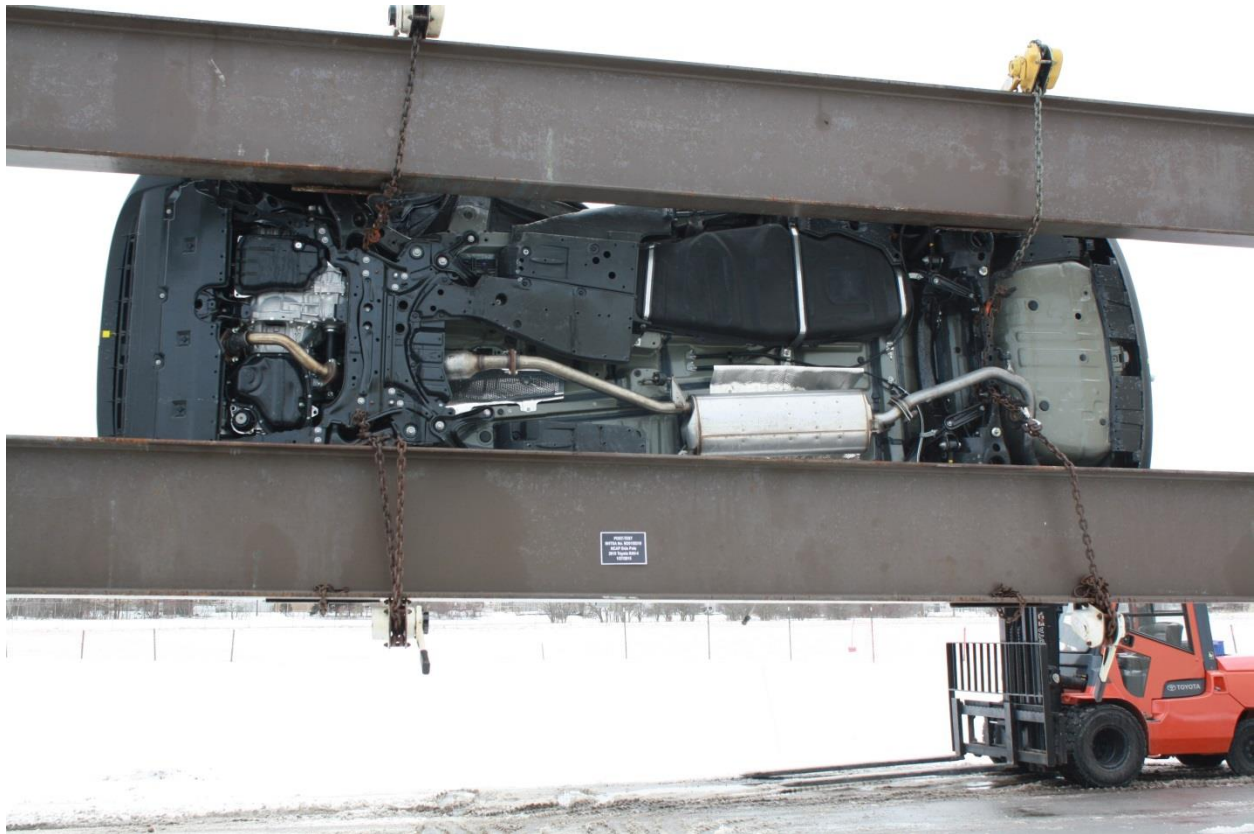
**Figure A-66: FMVSS No. 301 Static Rollover 270 Degrees**

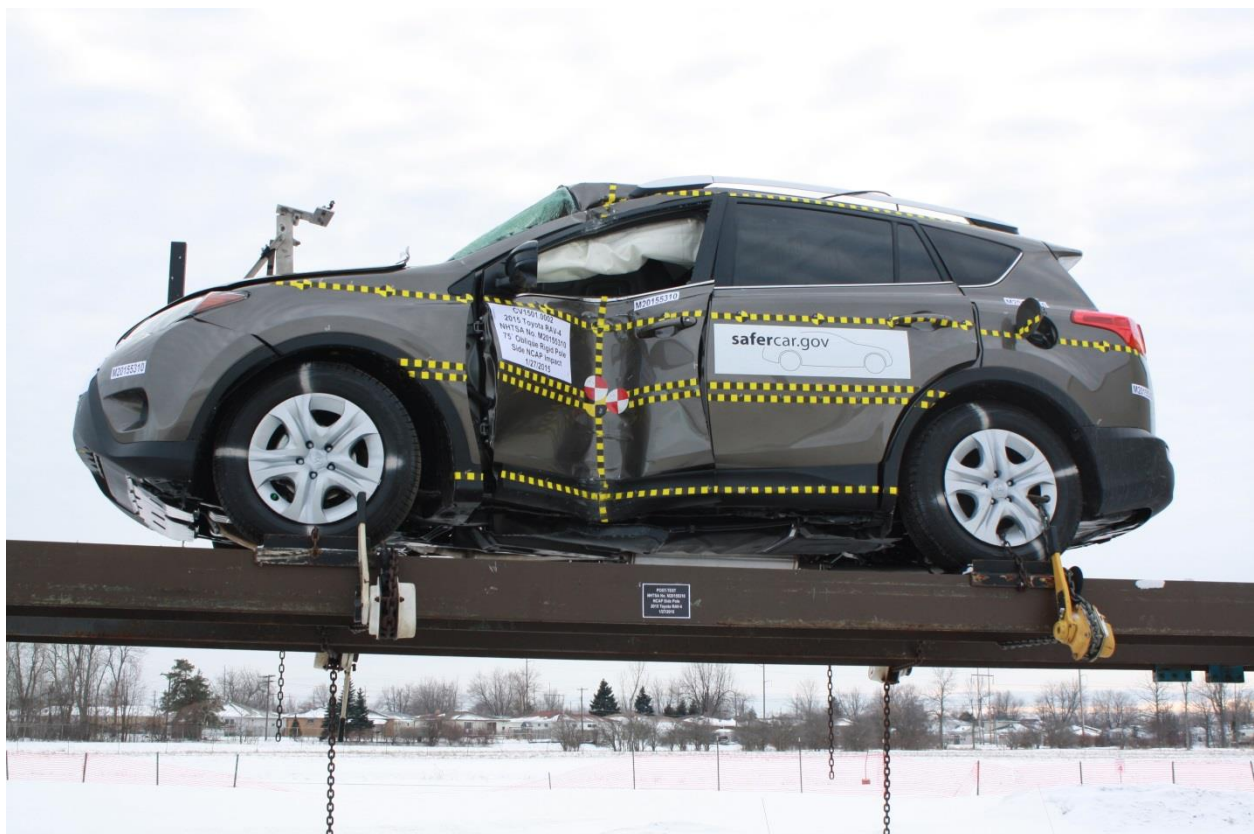
**Figure A-67: FMVSS No. 301 Static Rollover 360 Degrees**

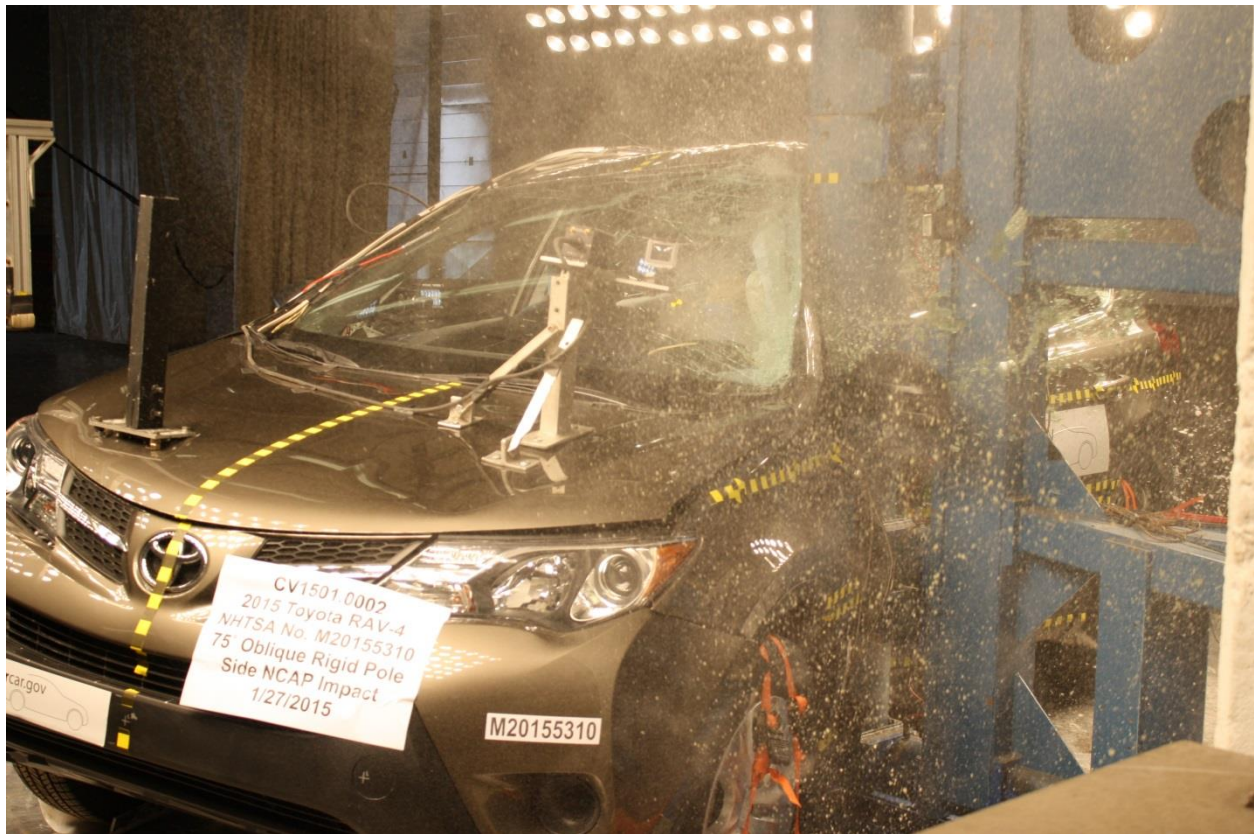
Figure A-68: Impact Event
