**REPORT NUMBER: SPNCAP-MGA-2015-051**

**NEW CAR ASSESSMENT PROGRAM (NCAP)  
Side Impact Pole Test**

**TOYOTA MOTOR CORPORATION  
2015 Lexus NX 200t F Sport 5-Dr SUV  
NHTSA No.: O20155101**

**FINAL REPORT**

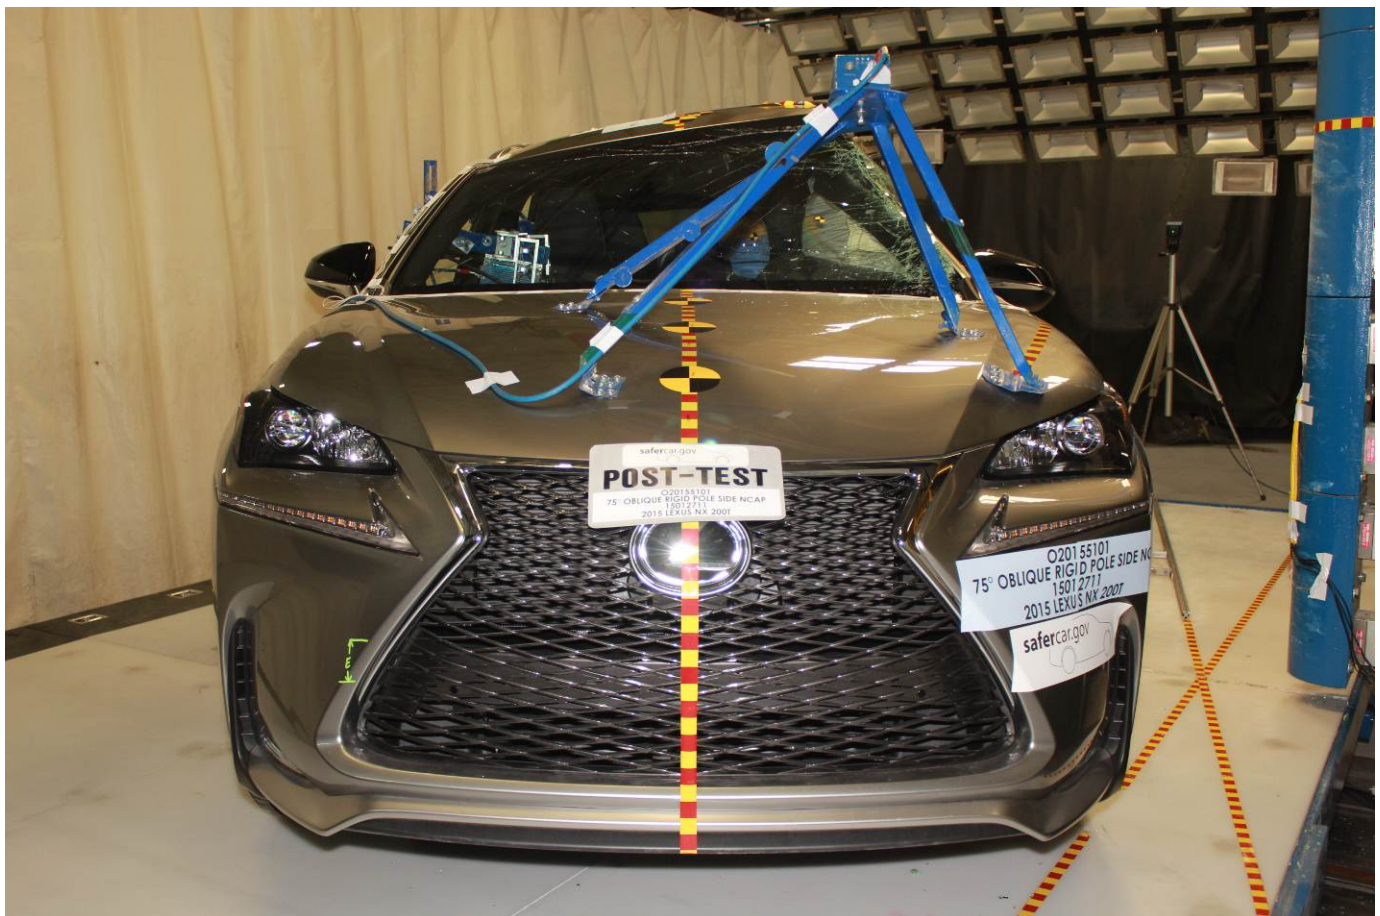
Post-Test Frontal View of Test Vehicle

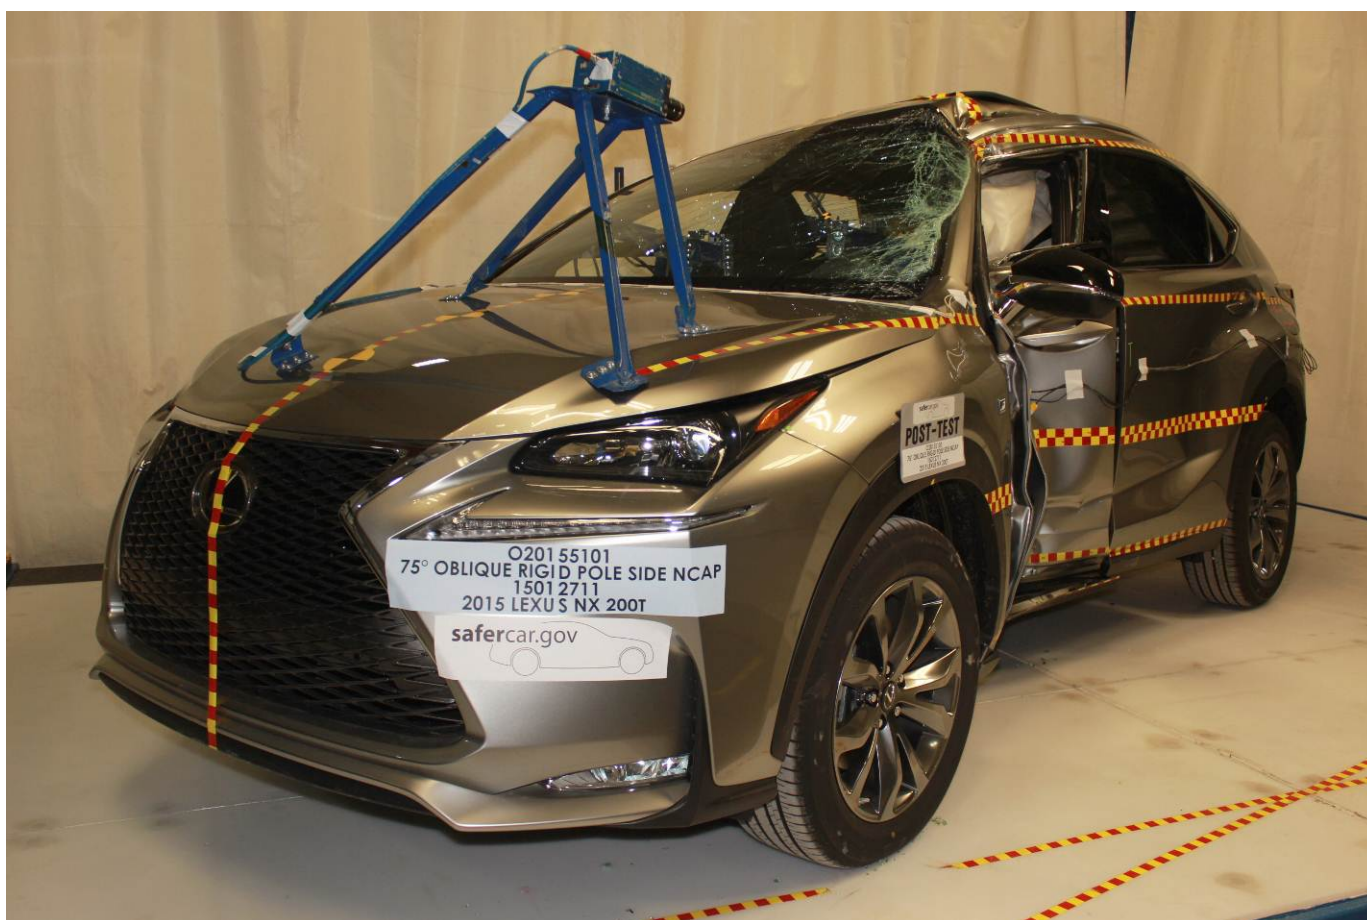
Post-Test Left Front  $\frac{3}{4}$  View of Test Vehicle

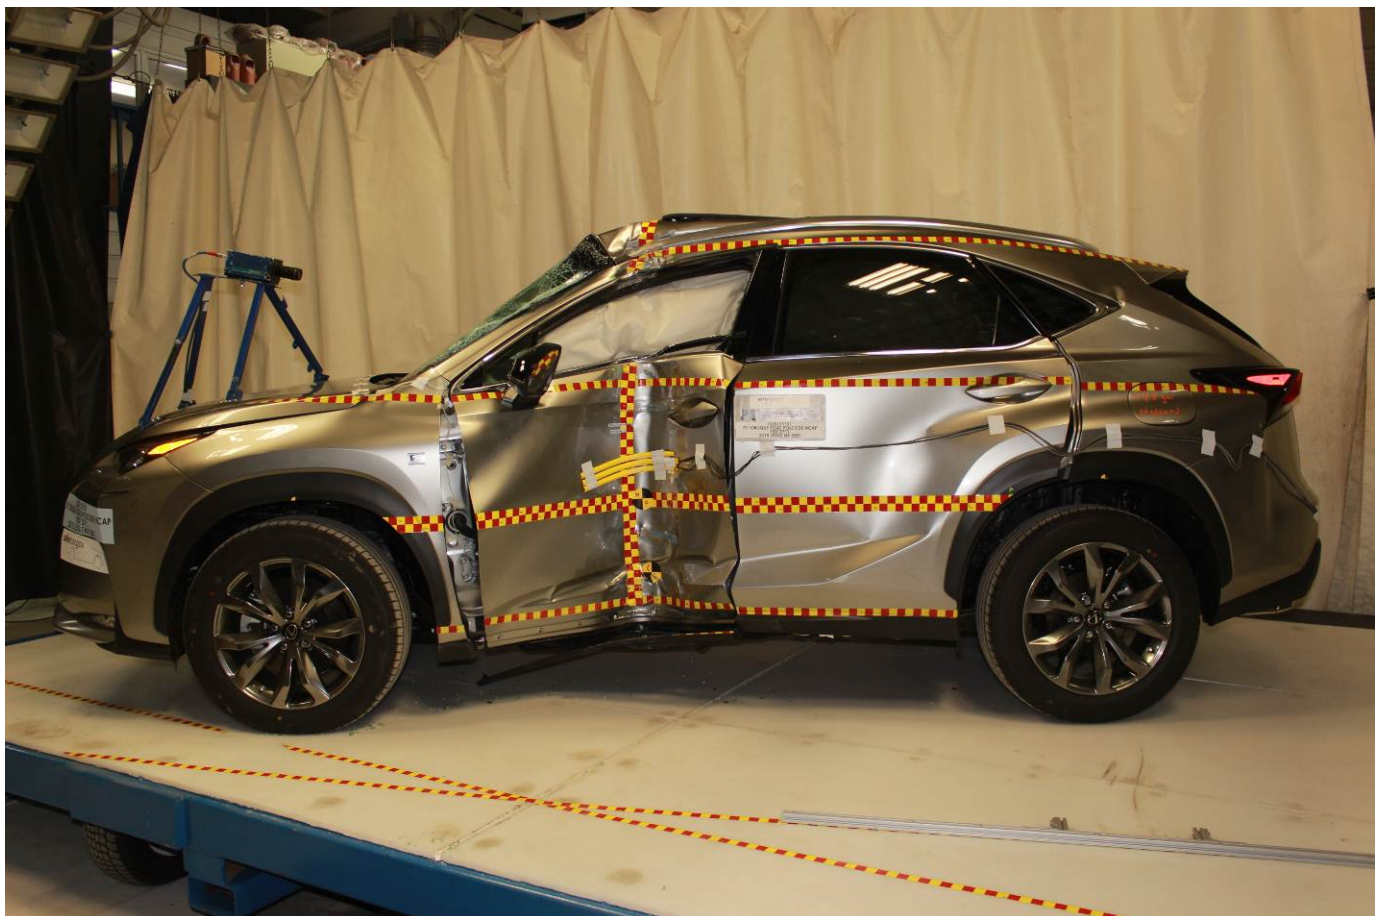
Post-Test Left Side View of Test Vehicle

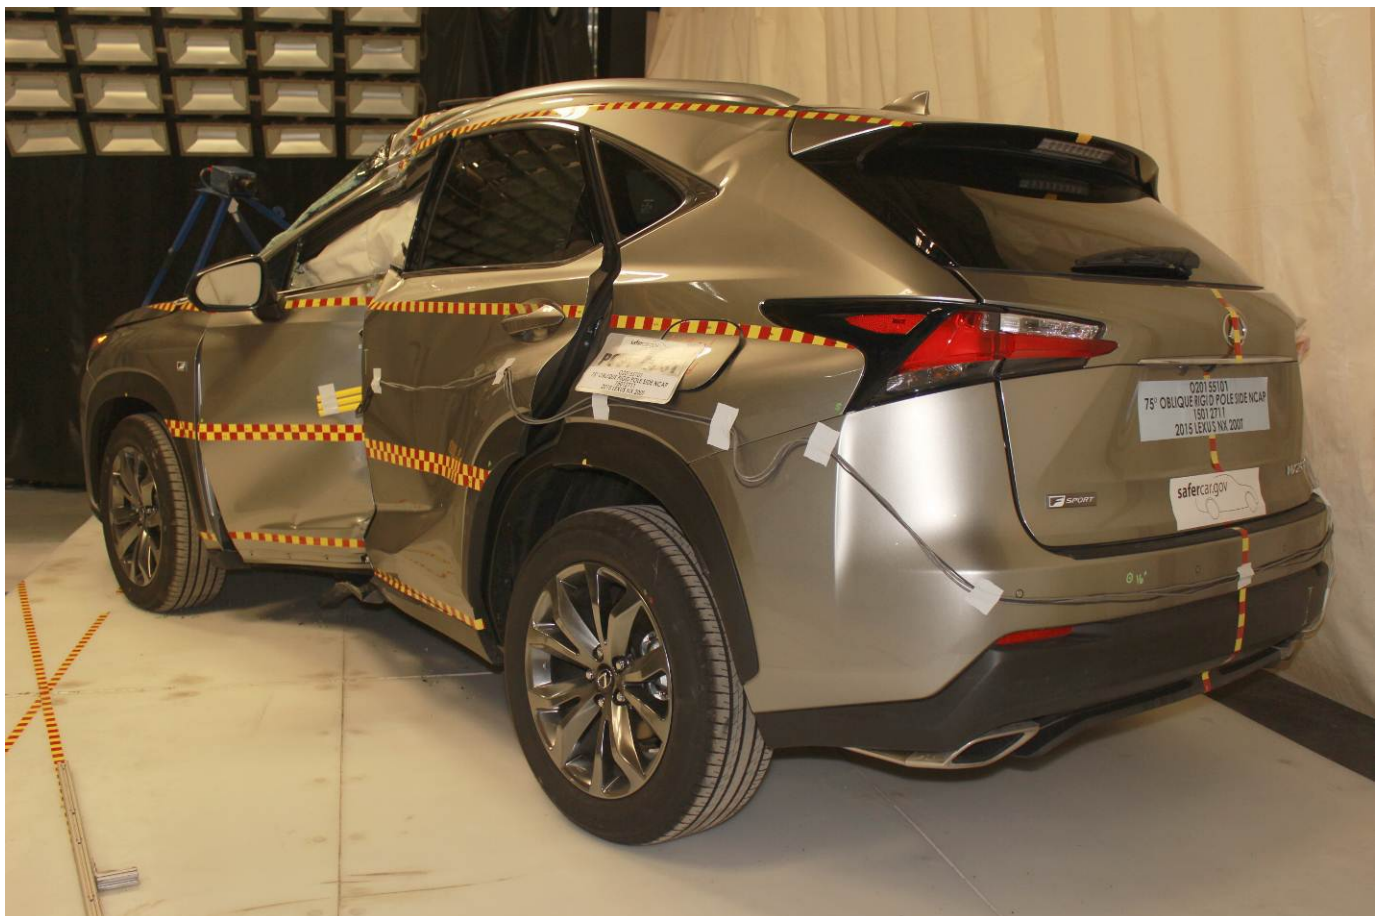
Post-Test Left Rear  $\frac{3}{4}$  View of Test Vehicle

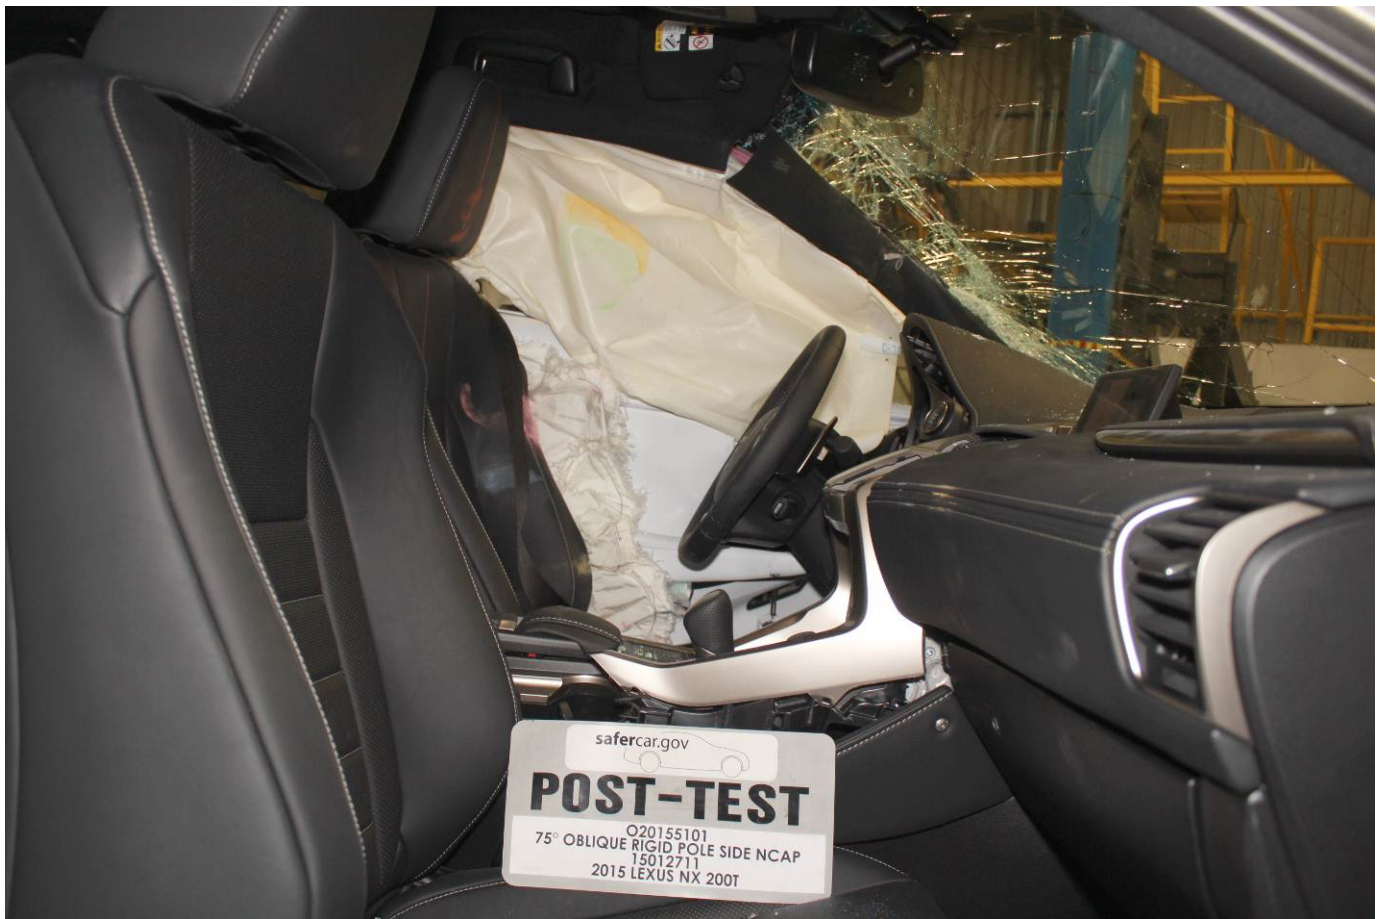
Post-Test Inner Door Panel View Showing Dummy Contact Location

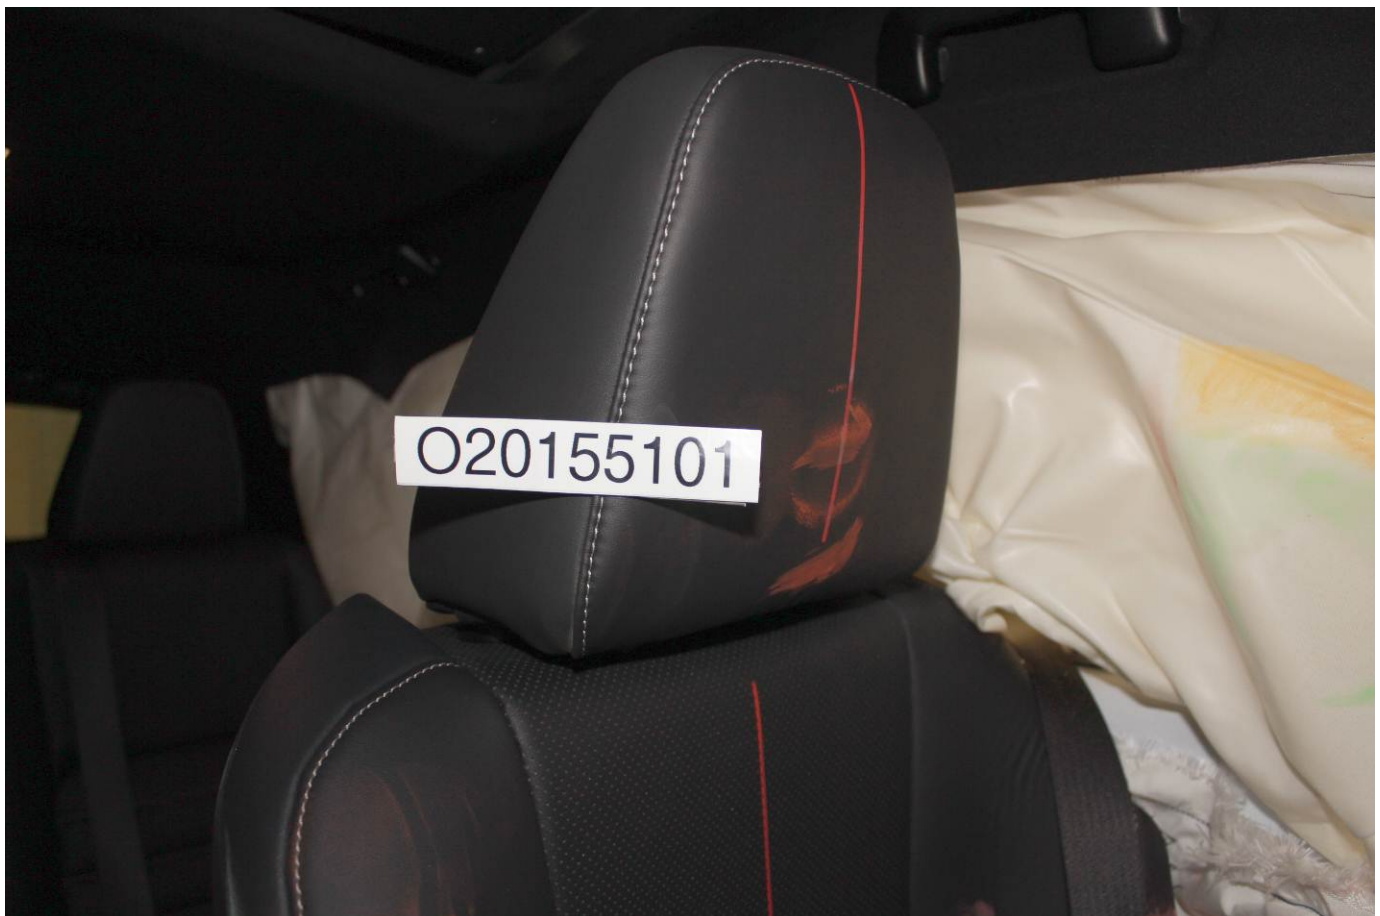
Post-Test Dummy Close-Up Head Contact with Vehicle Interior View

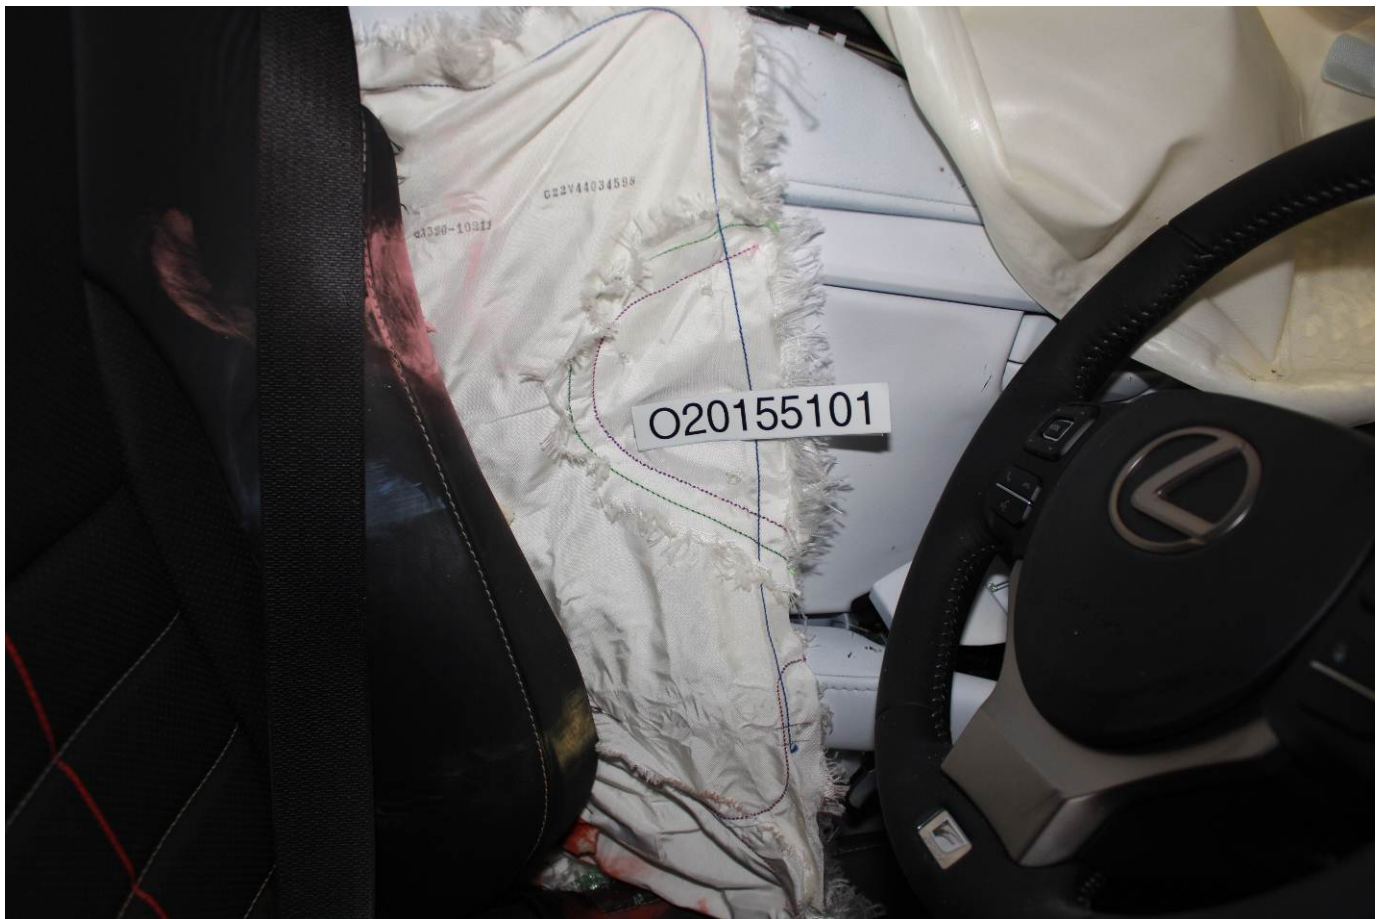
Post-Test Dummy Close-Up Torso Contact with Side Air Bag View

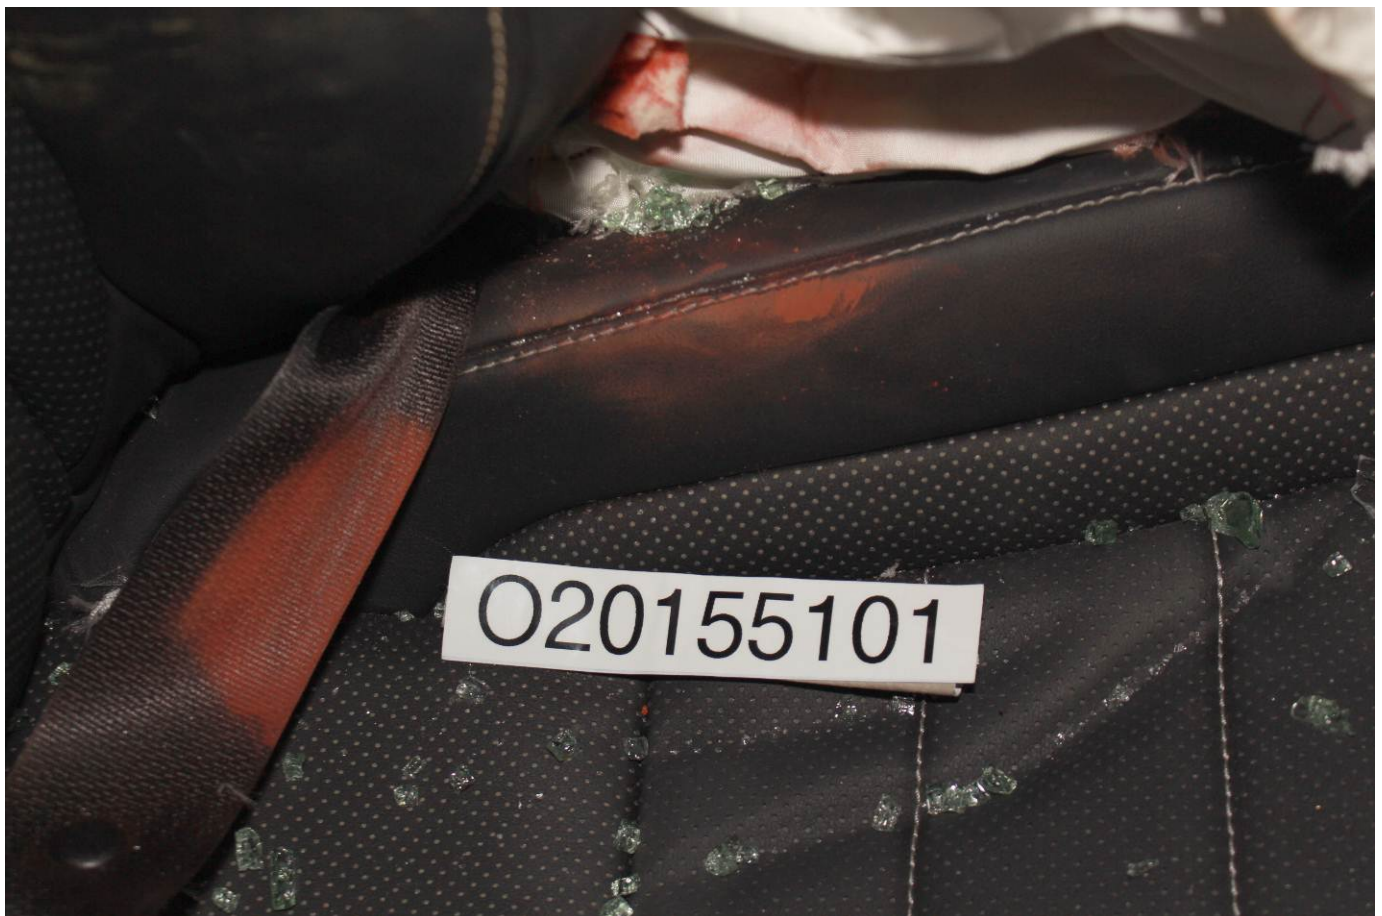
Post-Test Dummy Close-Up Pelvis Contact with Vehicle Interior View

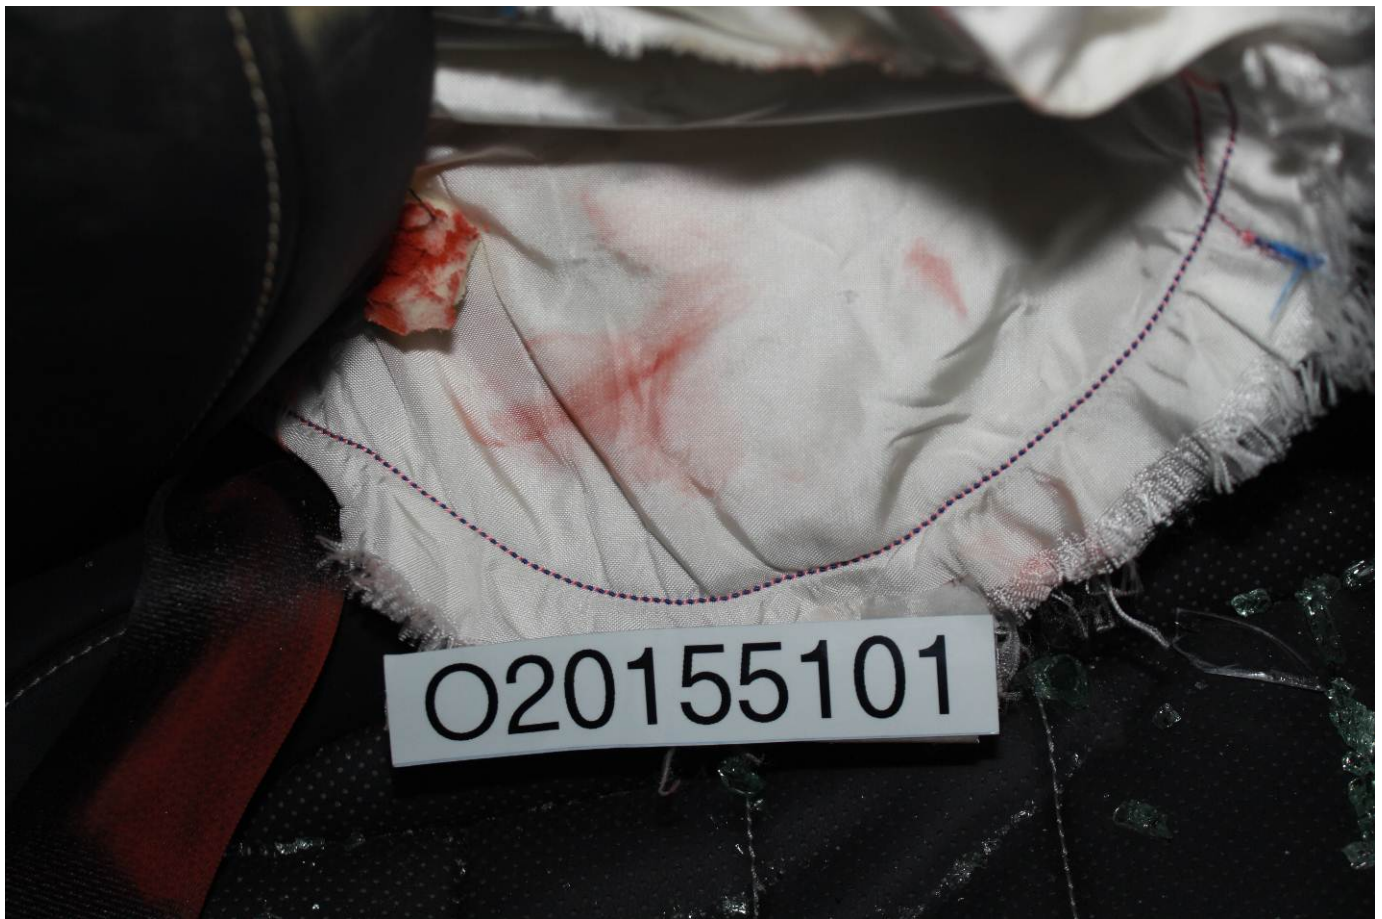
Post-Test Dummy Close-Up Pelvis Contact with Side Air Bag View

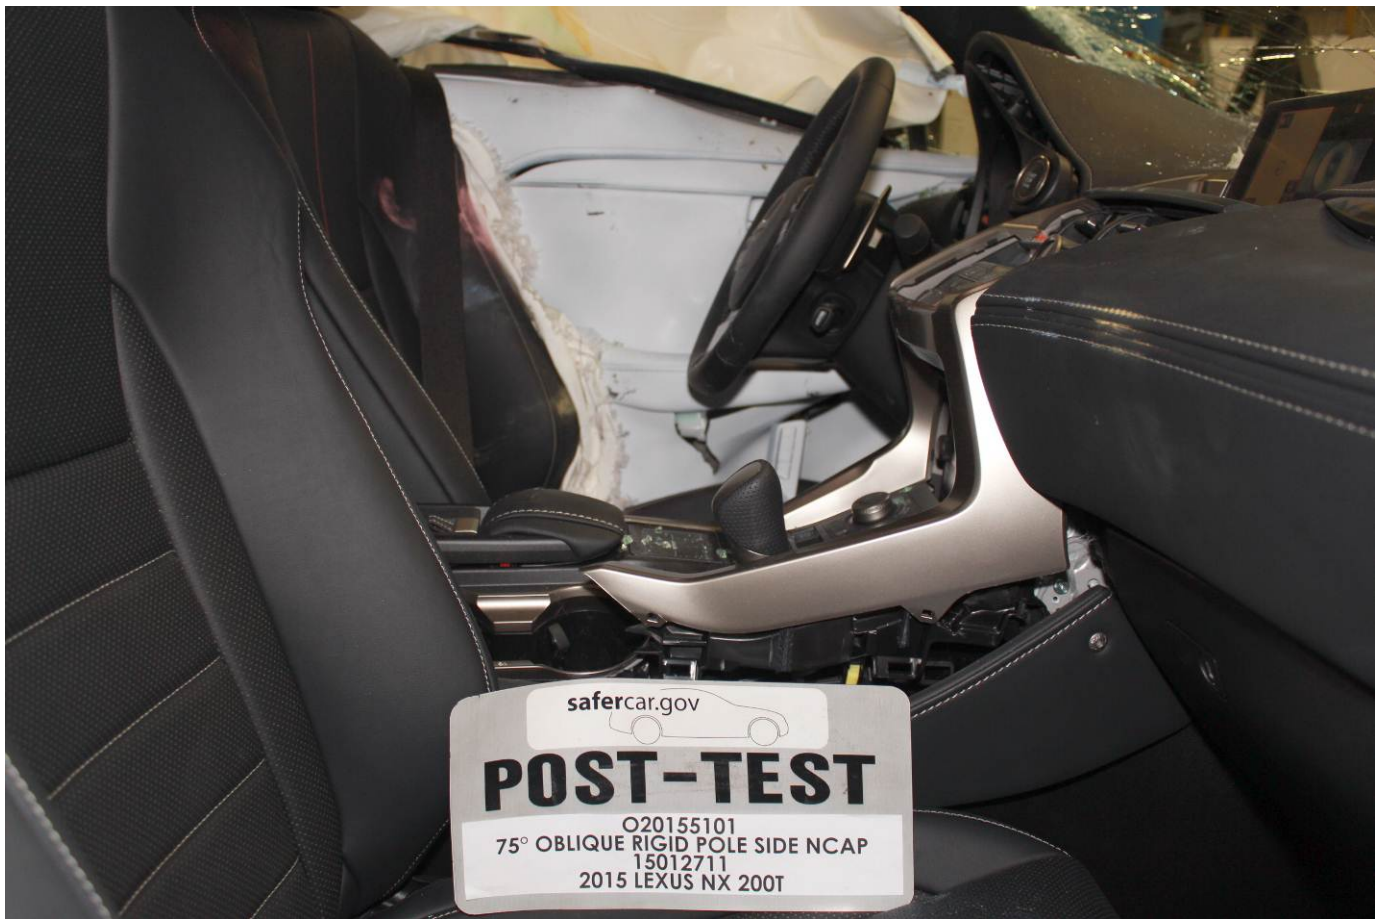
Post-Test View of Shattered Vehicle Inner Door Panel
