REPORT NUMBER: NCAP-MGA-2015-055

**NEW CAR ASSESSMENT PROGRAM (NCAP)
Frontal Barrier Impact Test**

**VOLKSWAGEN DE MEXICO S.A. DE C.V. MEXICO
2015 Volkswagen Golf 3-Dr Hatchback
NHTSA No.: O20155803**

**MGA RESEARCH CORPORATION
5000 Warren Road
Burlington, WI 53105**

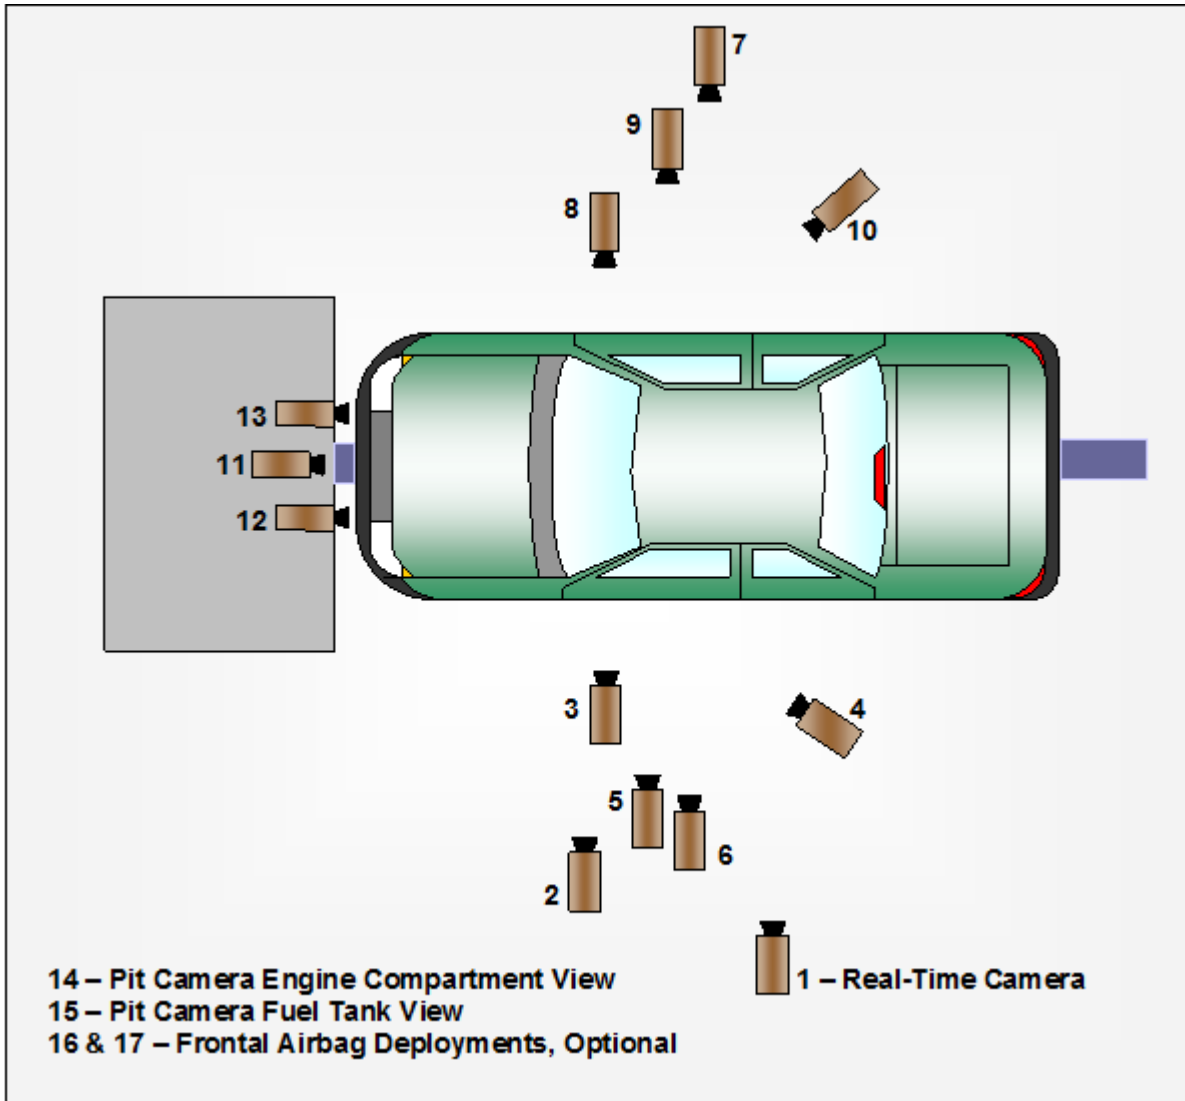
CAMERA POSITIONS FOR FRONTAL IMPACTS

Two (2) real-time cameras and fourteen (14) high-speed cameras were used to document the frontal barrier impact event. Camera locations and other pertinent camera information can be found in this report.

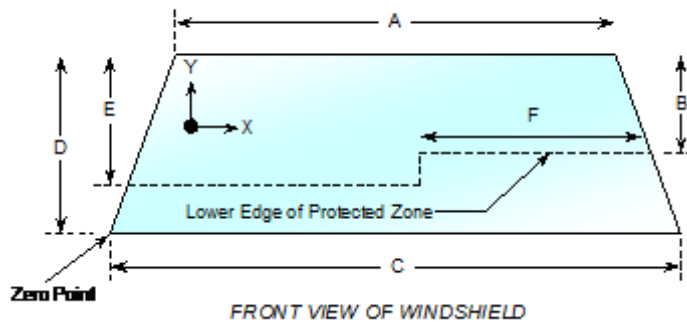
WINDSHIELD PERIPHERY MEASUREMENTS

Measurement	Pre-Test (mm)	Post-Test (mm)	% of Retention
Left Side	2138	2138	100
Right Side	2138	2138	100
Total	4276	4276	100

Item	Units	Value
A	mm	1146
B	mm	416
C	mm	1482
D	mm	824
E	mm	484
F	mm	486

AREA OF PROTECTED ZONE FAILURES - NONE

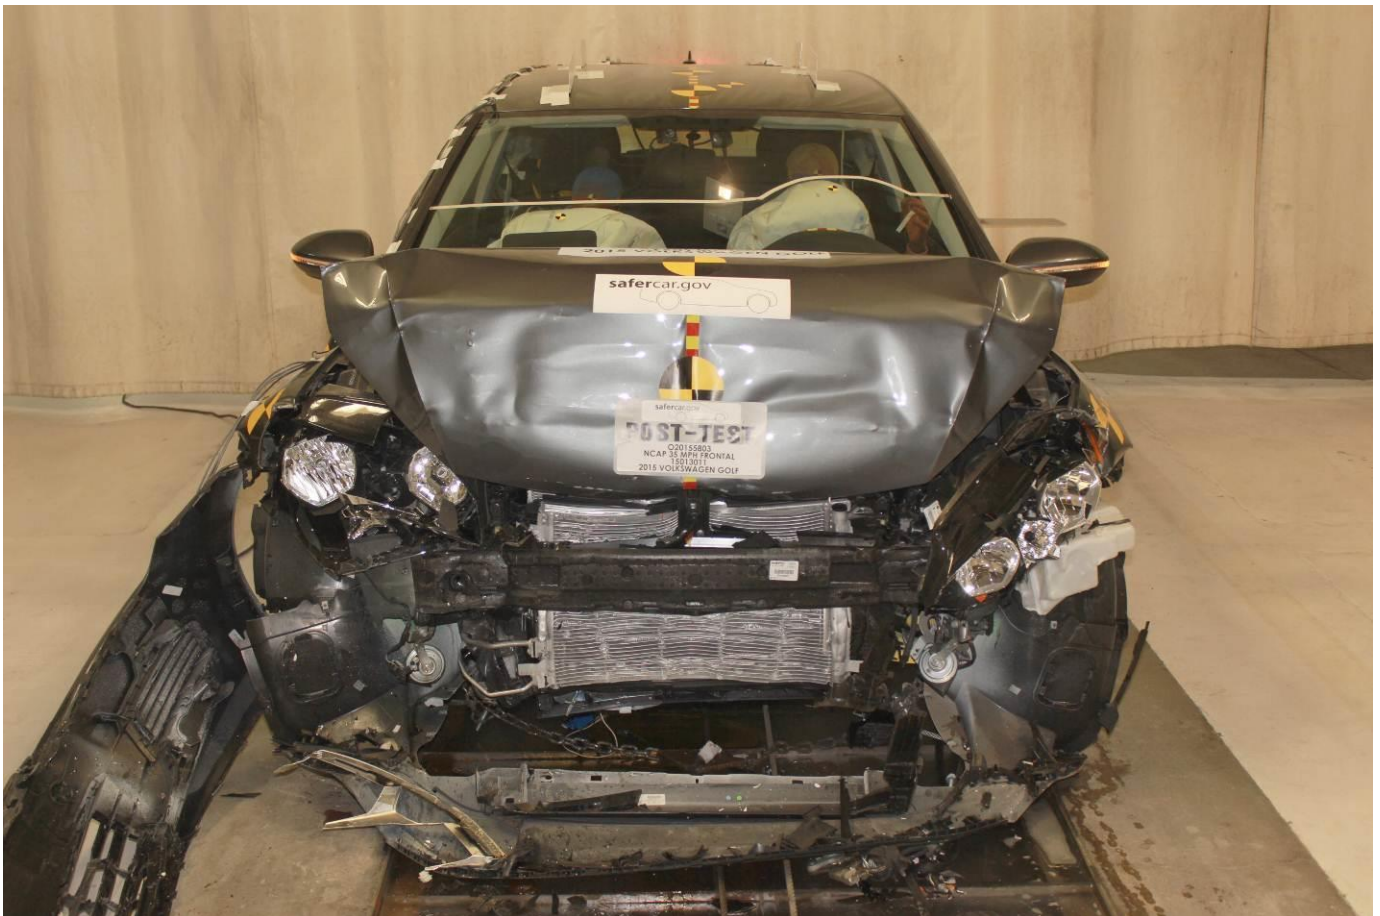
The maximum static crush of the vehicle was 356 mm and both the driver and passenger side doors remained closed during the impact event and were operable after the impact.

Post-Test Front View of Test Vehicle

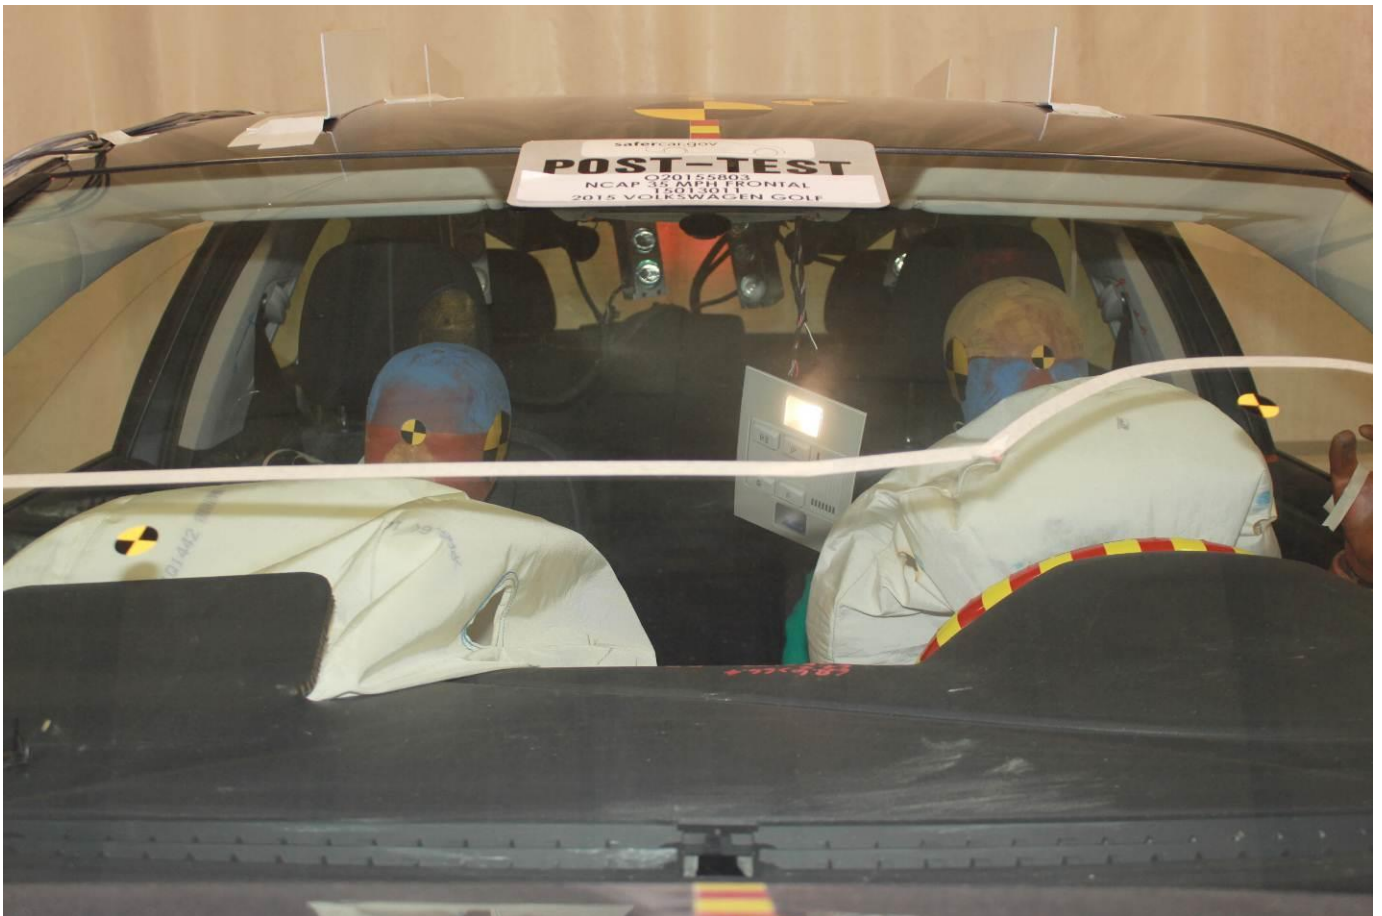
There was 100 percent windshield retention and no intrusion into the protected zone of the windshield during the event. There was no Stoddard Solvent leakage after the event or during any phase of the static rollover.

Post-Test Windshield View

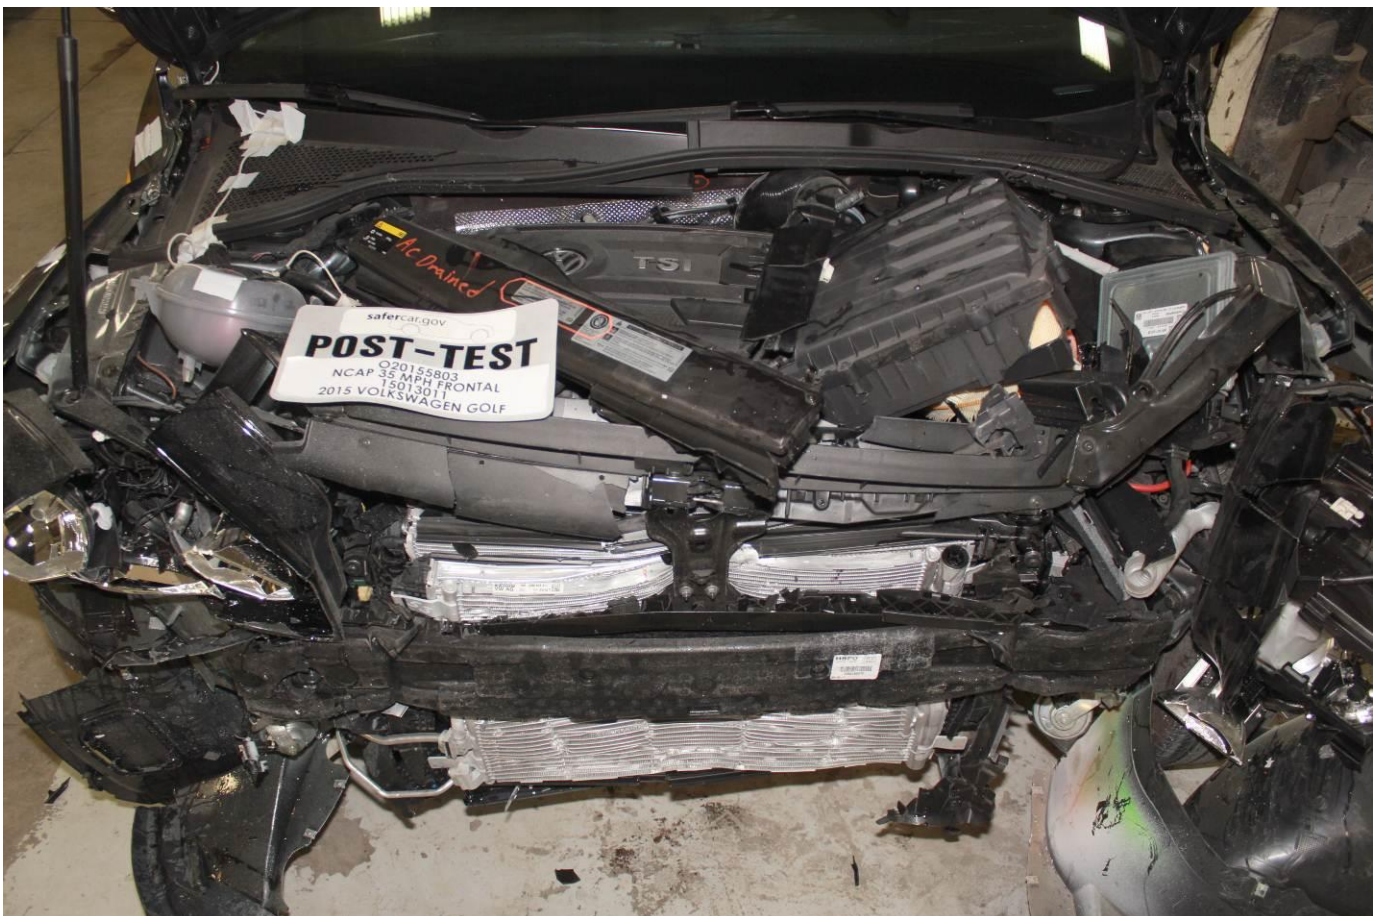
Post-Test Engine Compartment View

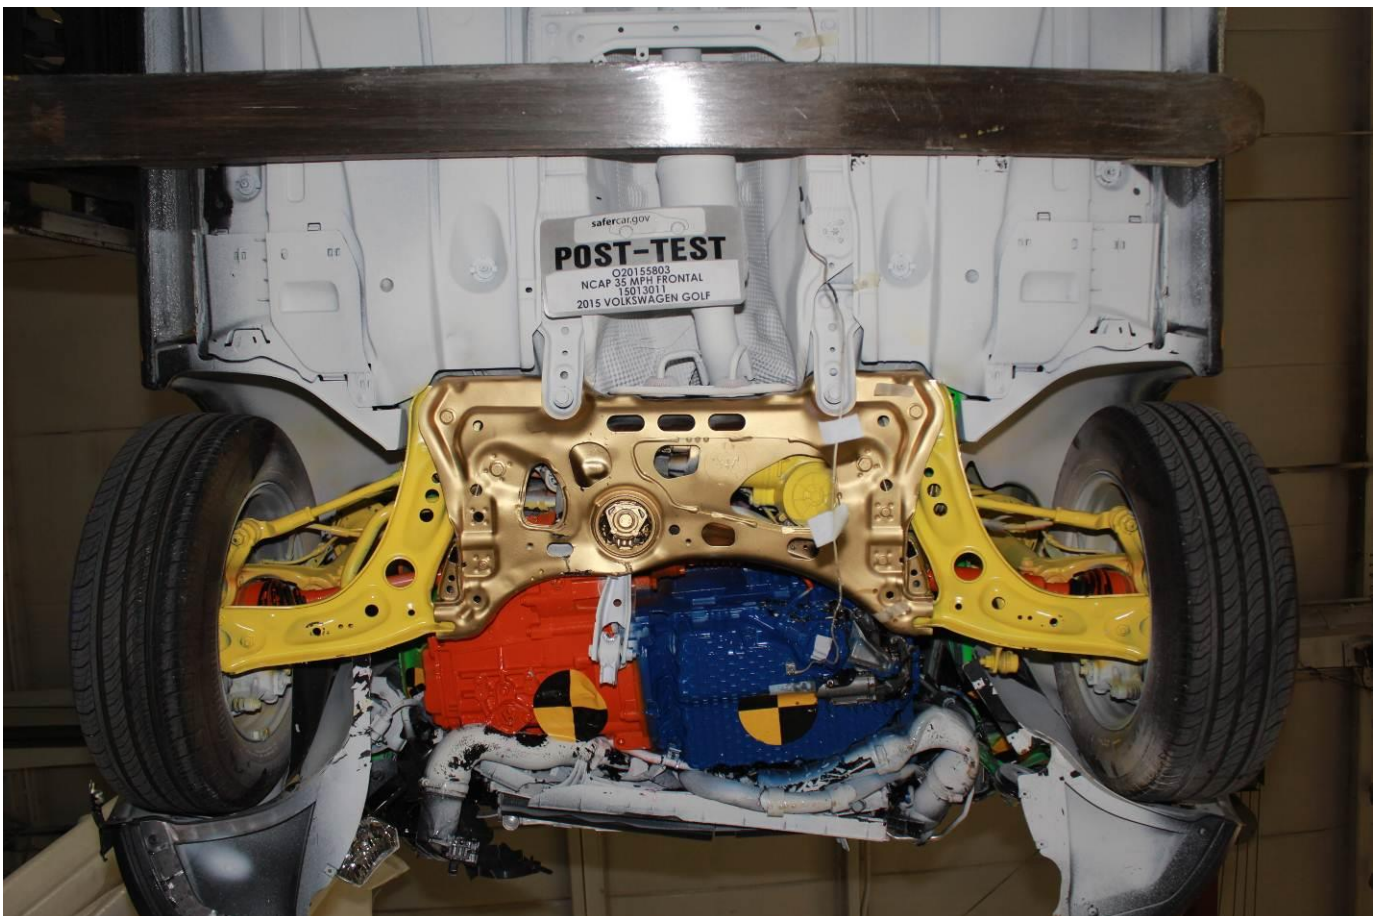
Post-Test Front Underbody View

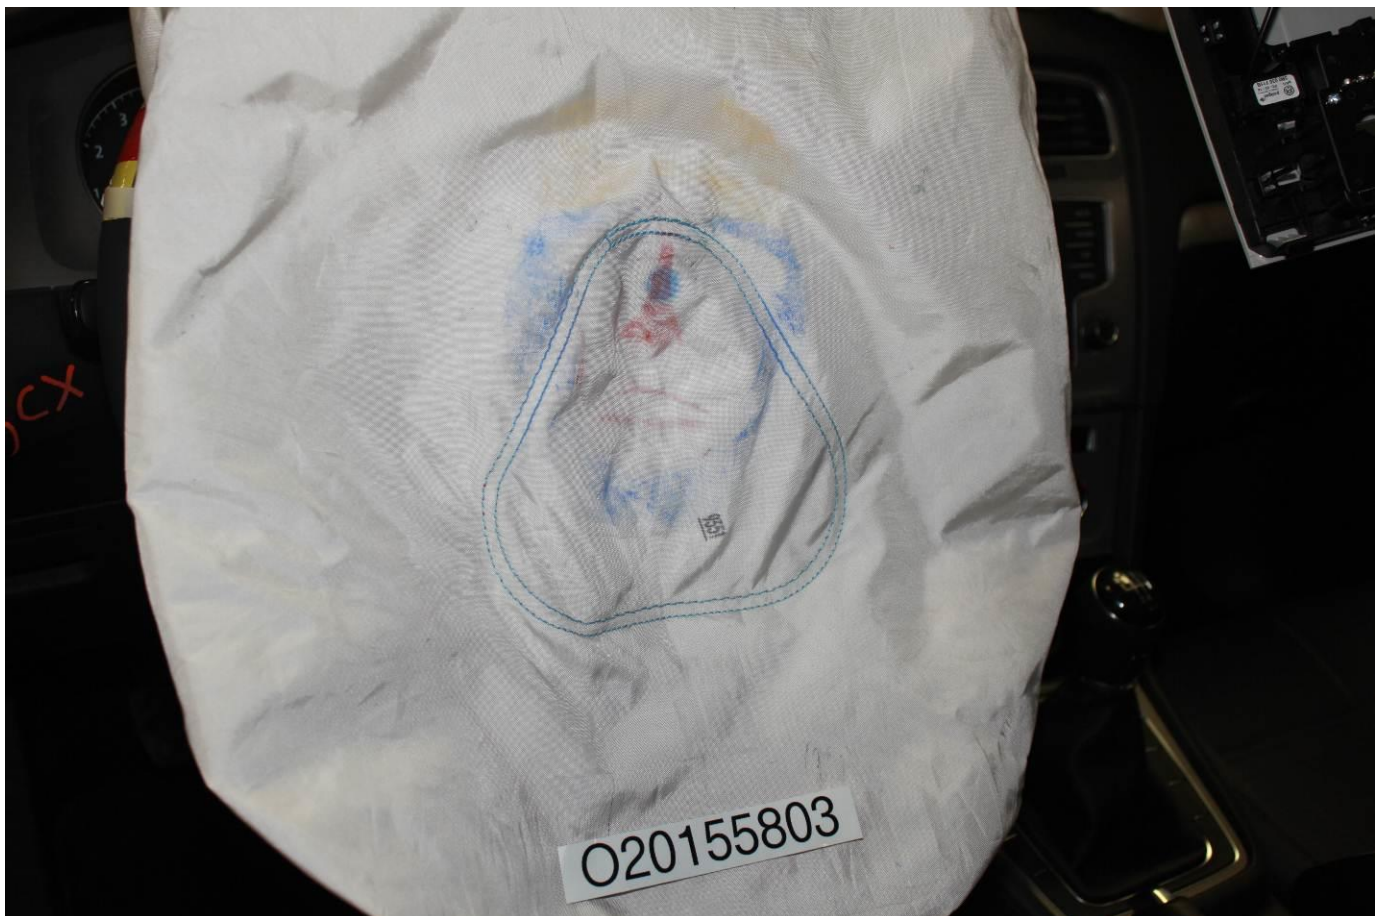
The driver's visible contact points were as follows: The driver's head and chest contacted the airbag. The driver's head also contacted the headrest. The driver's knees contacted the knee bolster and steering wheel. The passenger's visible contact points were as follows: The passenger's head and chest contacted the airbag. The passenger's head also contacted the headrest. The passenger's knees contacted the glovebox.

Post-Test Driver Dummy Contact with Airbag

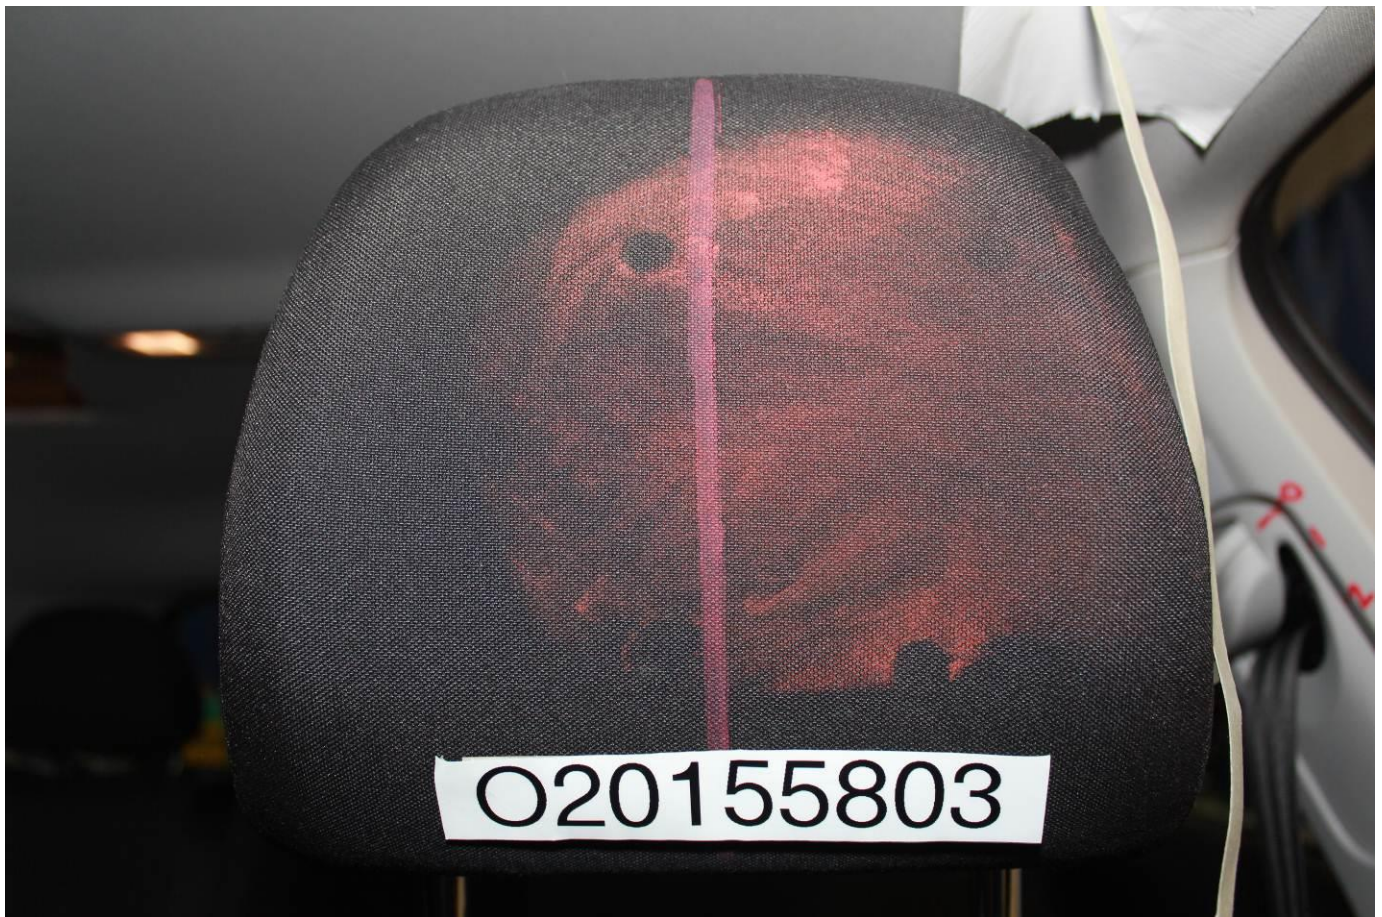
Post-Test Driver Dummy Contact with Headrest

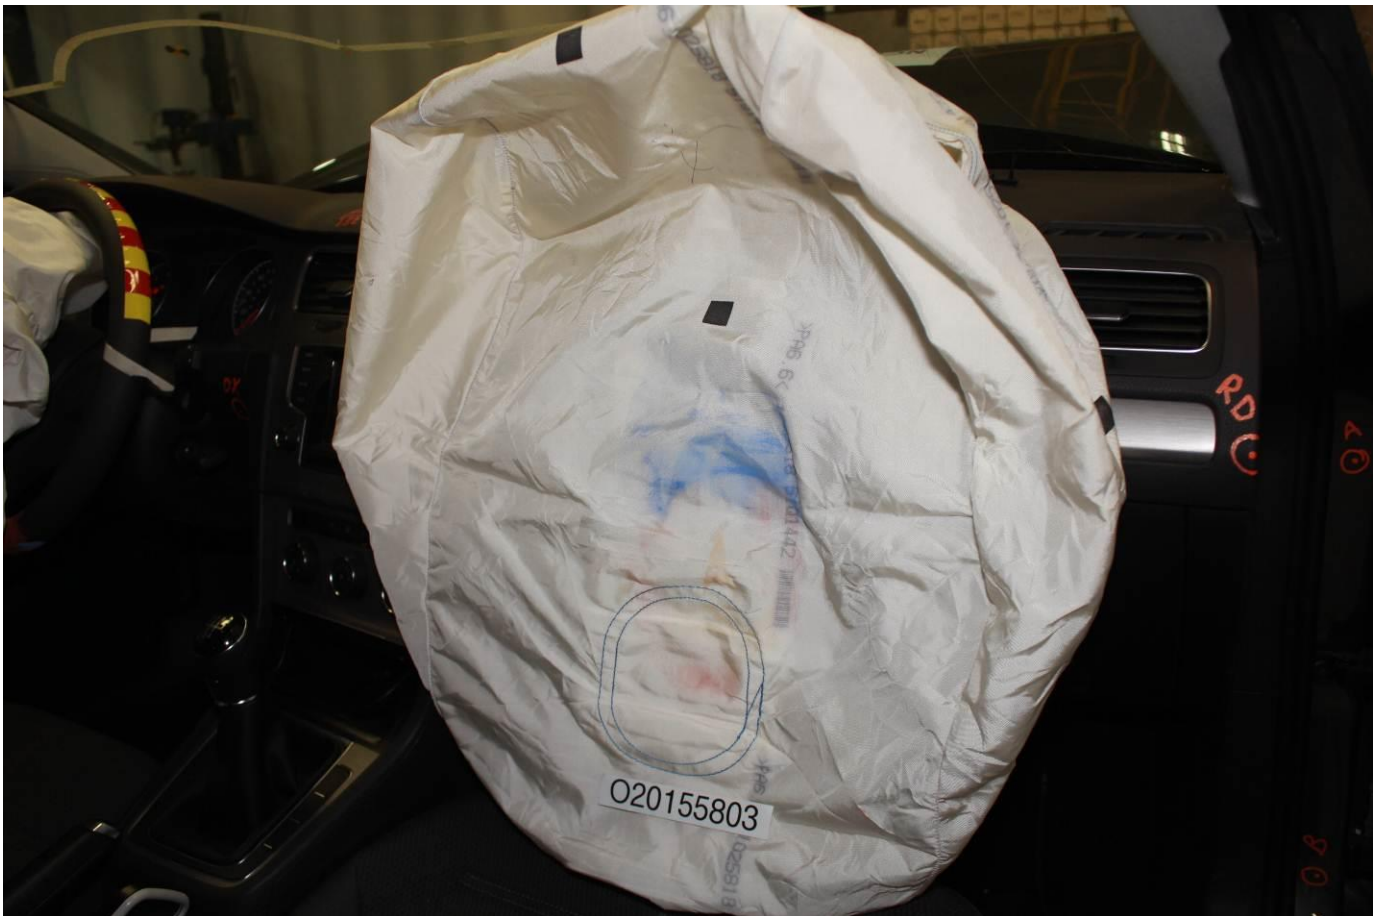
Post-Test Passenger Dummy Contact with Airbag

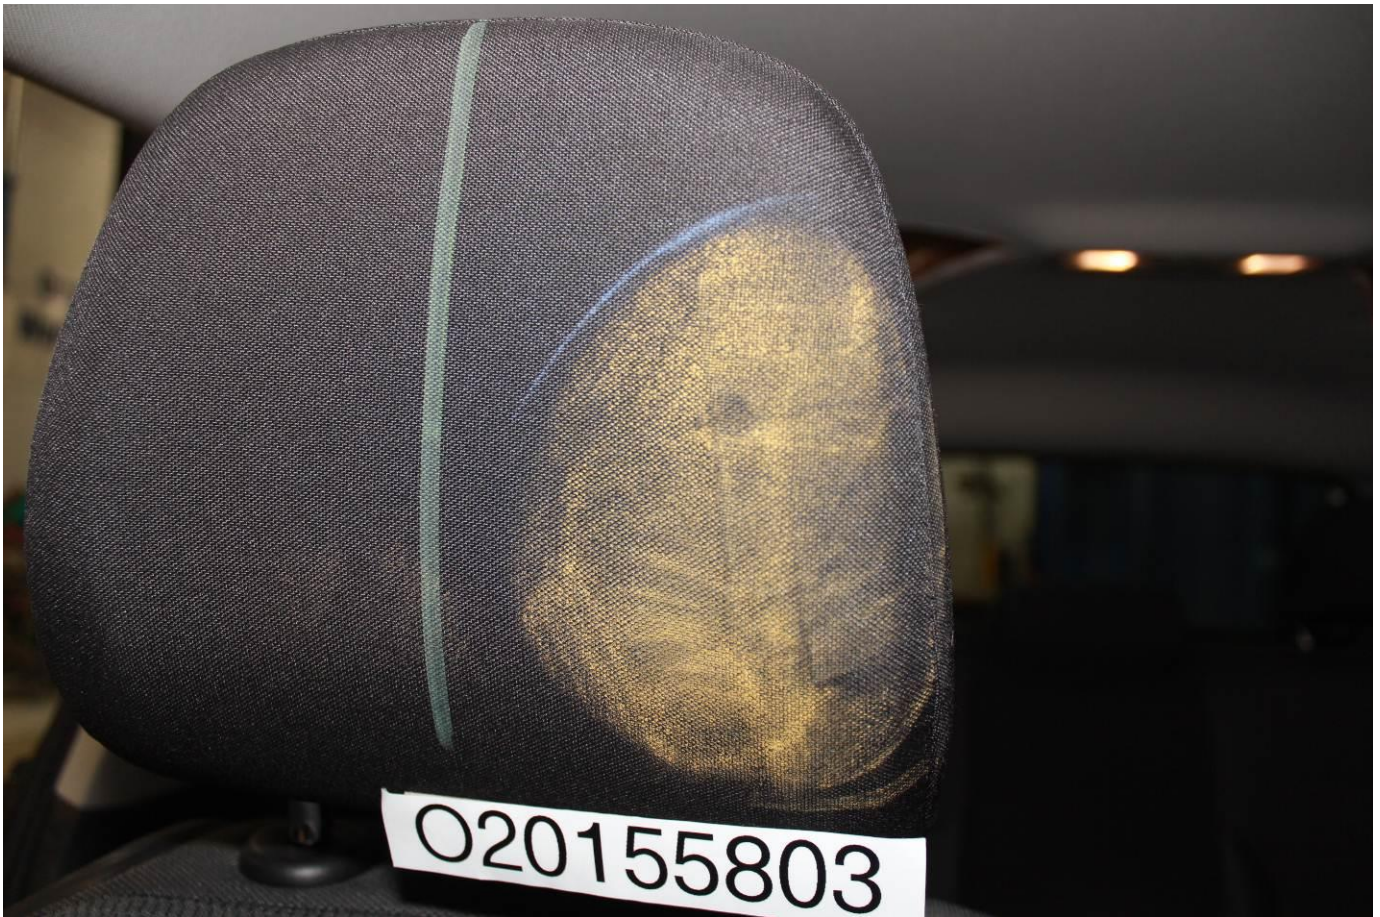
Post-Test Passenger Dummy Contact with Headrest
