REPORT NUMBER: NCAP-CAL-15-004

**NEW CAR ASSESSMENT PROGRAM (NCAP)
FRONTAL BARRIER IMPACT TEST**

**Nissan Motor Co., LTD
2015 Nissan Sentra
Four Door Sedan**

NHTSA No: M20155205

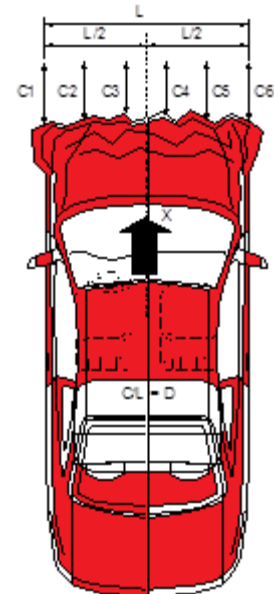
CRUSH PROFILE

Collision Deformation Classification: 12FDEW03
Midpoint of Damage: Vehicle Centerline
Damage Region Length (mm): 1471
Impact Mode: Frontal
