**REPORT NUMBER: NCAP-CAL-15-005**

**NEW CAR ASSESSMENT PROGRAM (NCAP)  
FRONTAL BARRIER IMPACT TEST**

**General Motors LLC  
2015 Chevrolet Colorado  
Pick Up / Extended Cab**

**NHTSA No: M20150112**

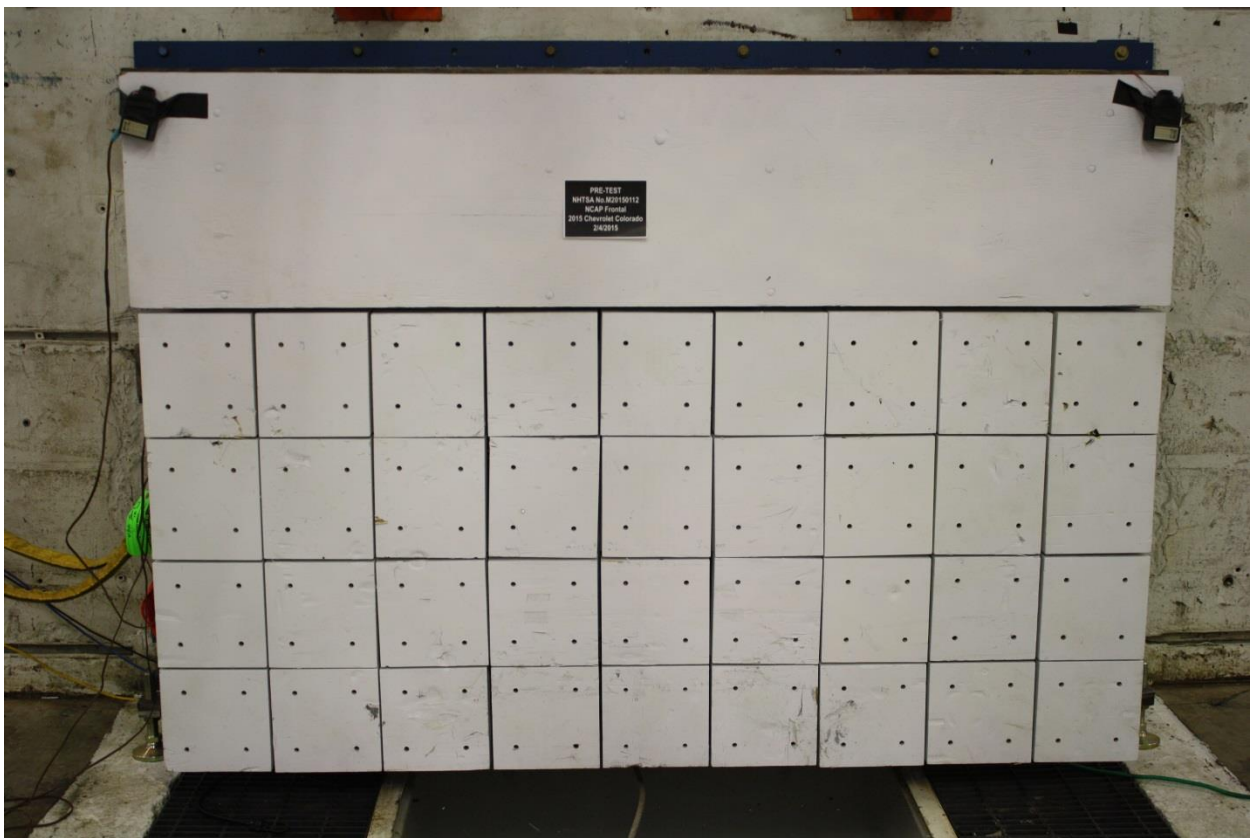
Figure A-2: Load Cell Wall

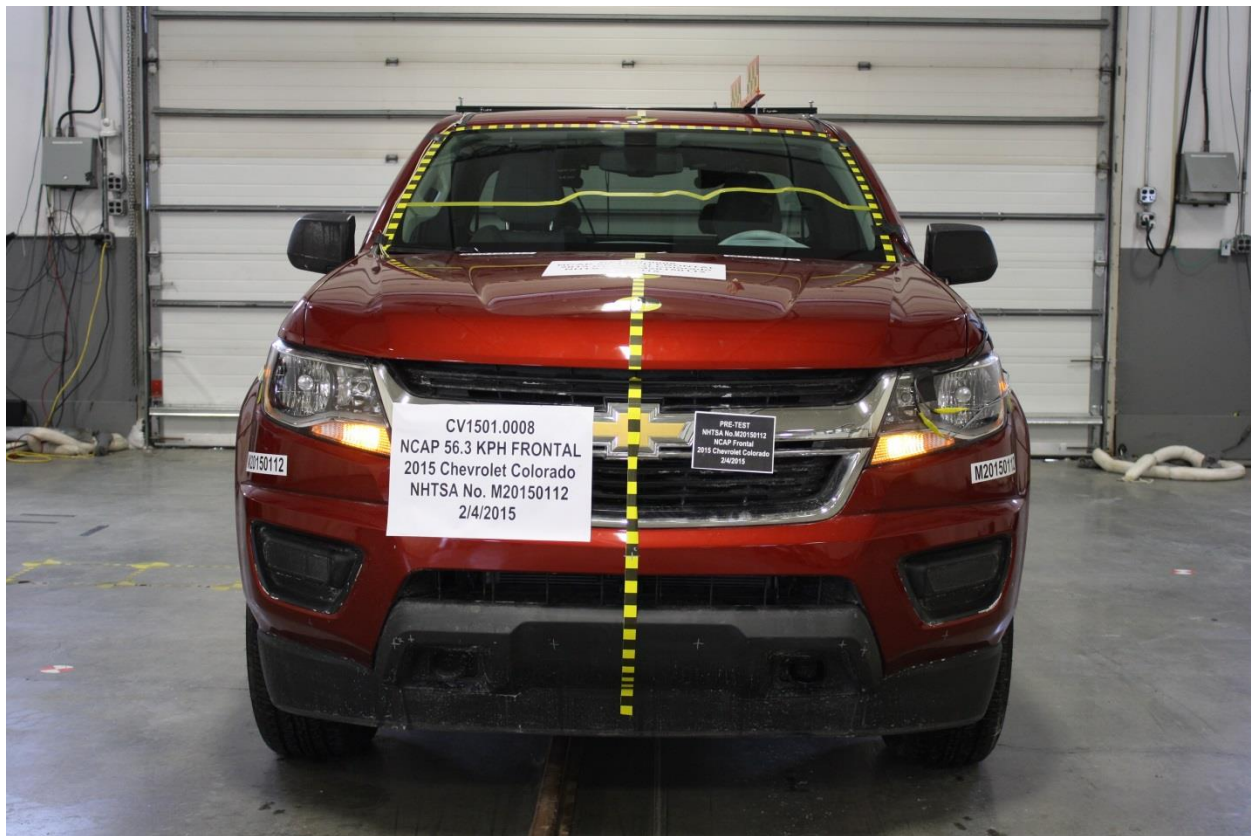
**Figure A-7: Pre-Test Front View of Test Vehicle**

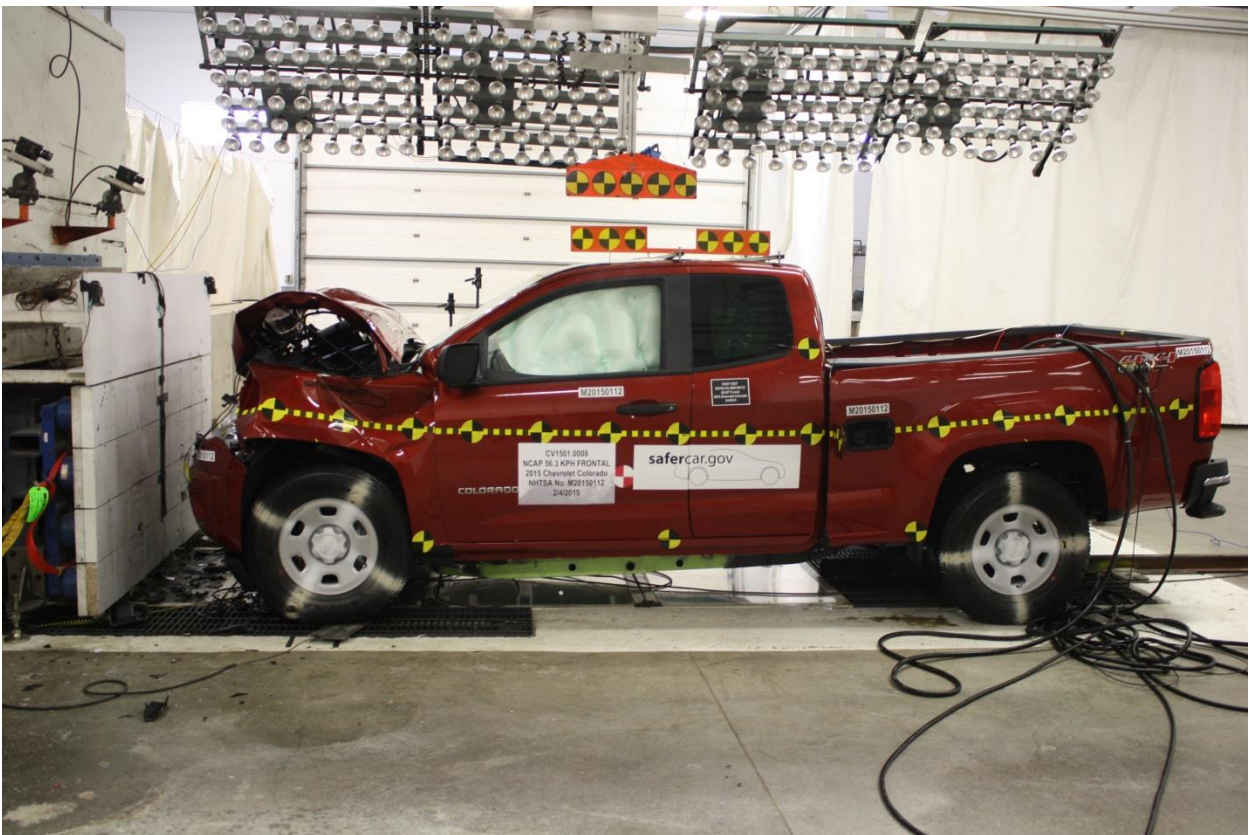
**Figure A-10: Post-Test Left View of Test Vehicle**

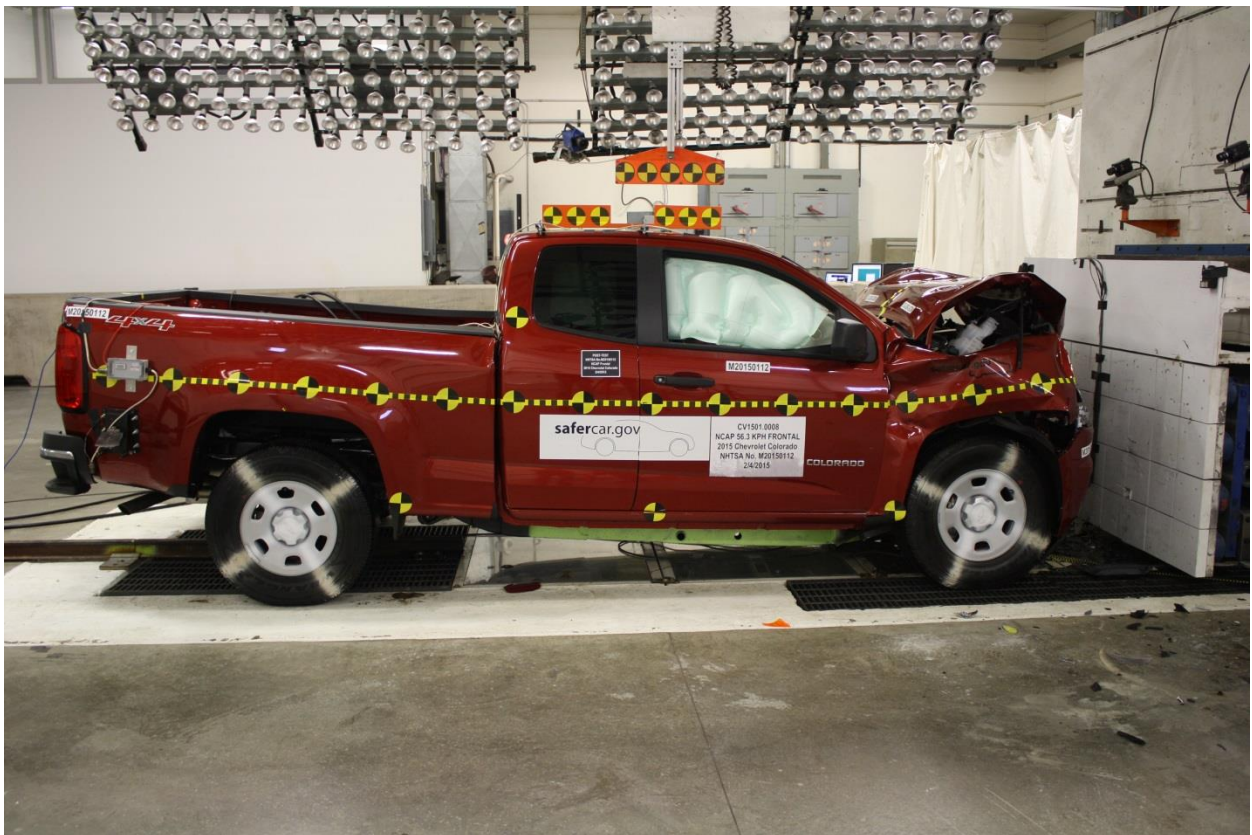
Figure A-12: Post-Test Right View of Test Vehicle

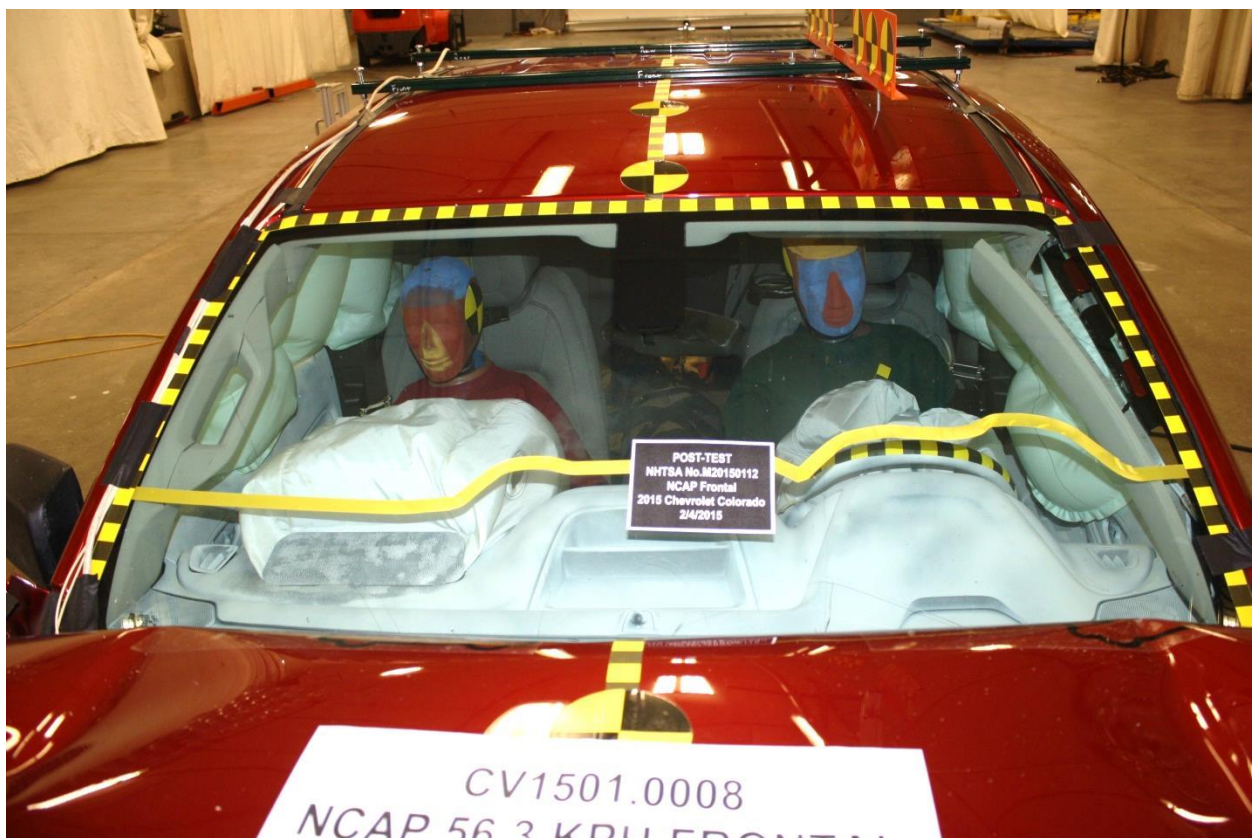
Figure A-18: Post-Test Windshield View

There was 100 percent windshield retention and no intrusion into the protected zone of the windshield during the event. There was a total of 0.0 grams of stoddard solvent leakage after the event and including all phases of the static rollover. The maximum static crush of the test vehicle was 408 mm at the vehicles centerline. During and after the impact event, the driver's and passenger's side doors were closed and operational.

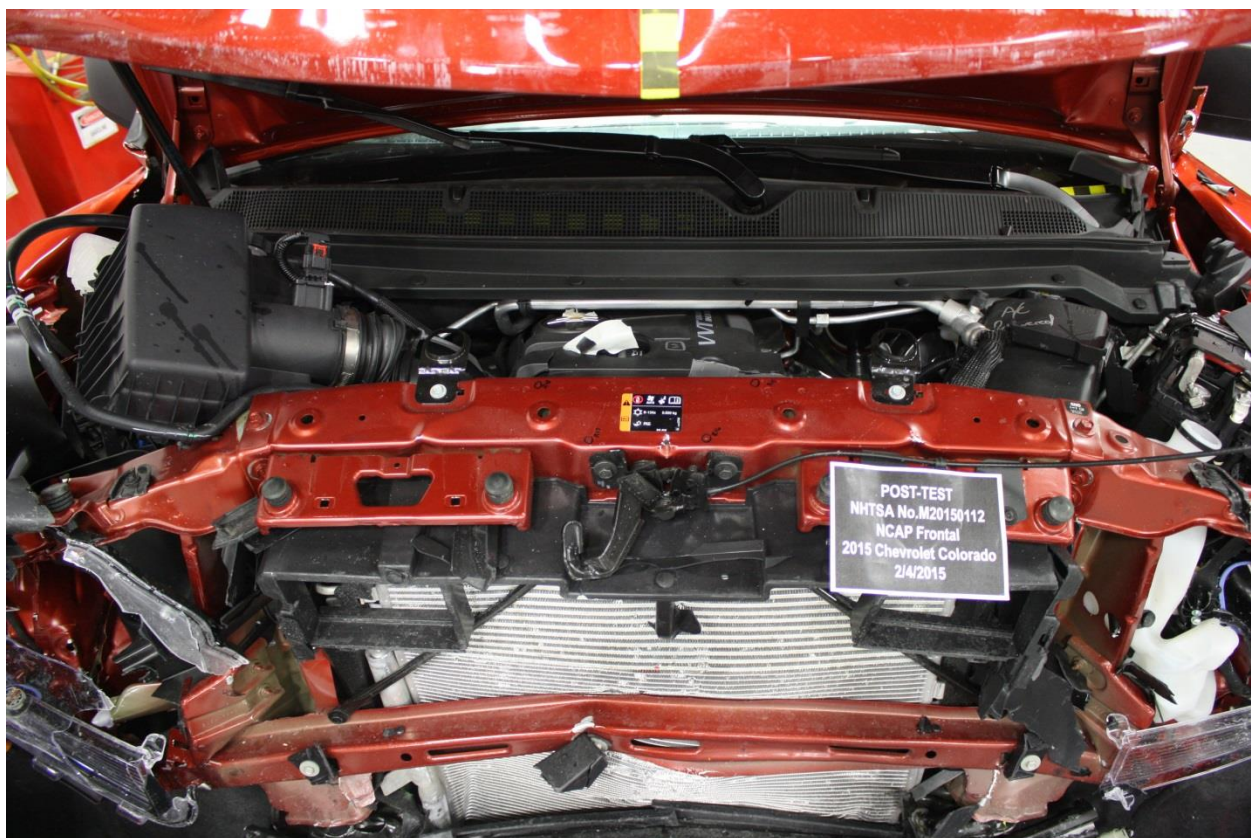
**Figure A-20: Post-Test Engine Compartment View**

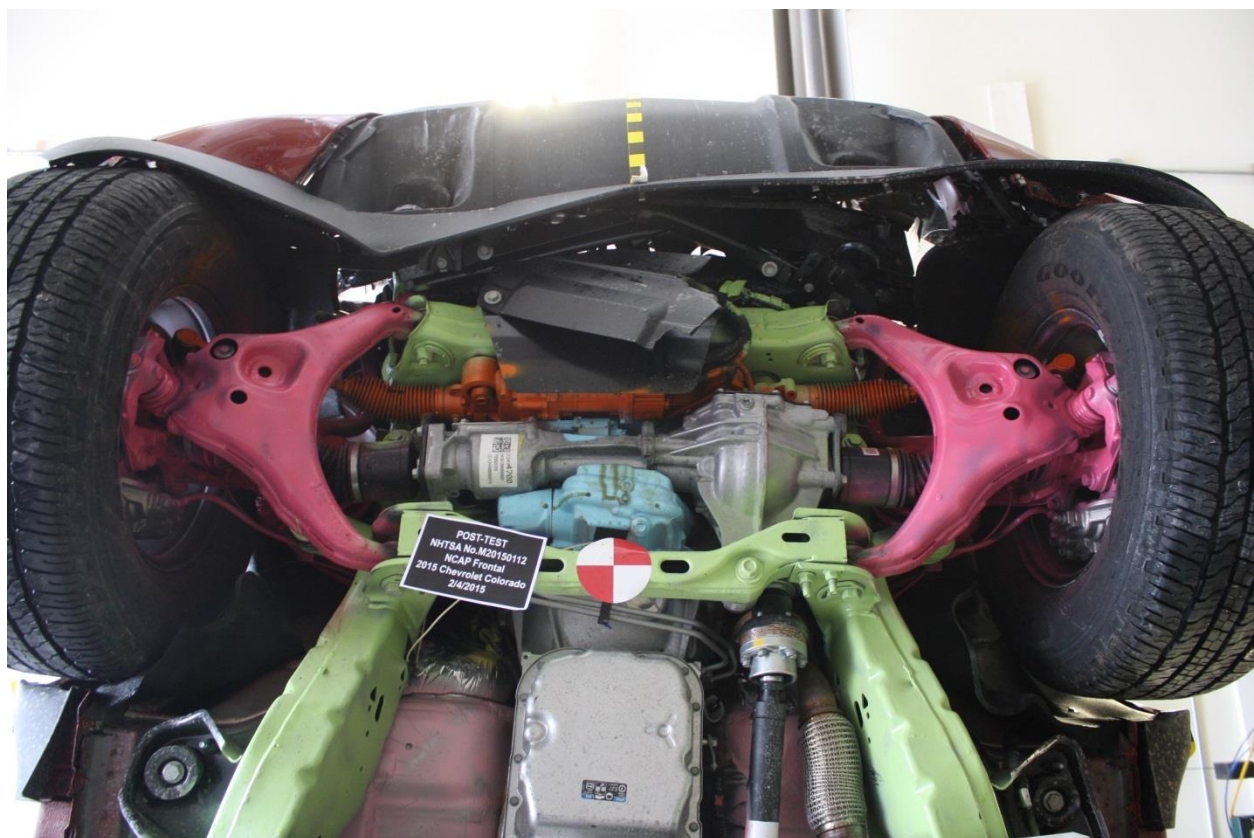
**Figure A-24: Post-Test Front Underbody View**

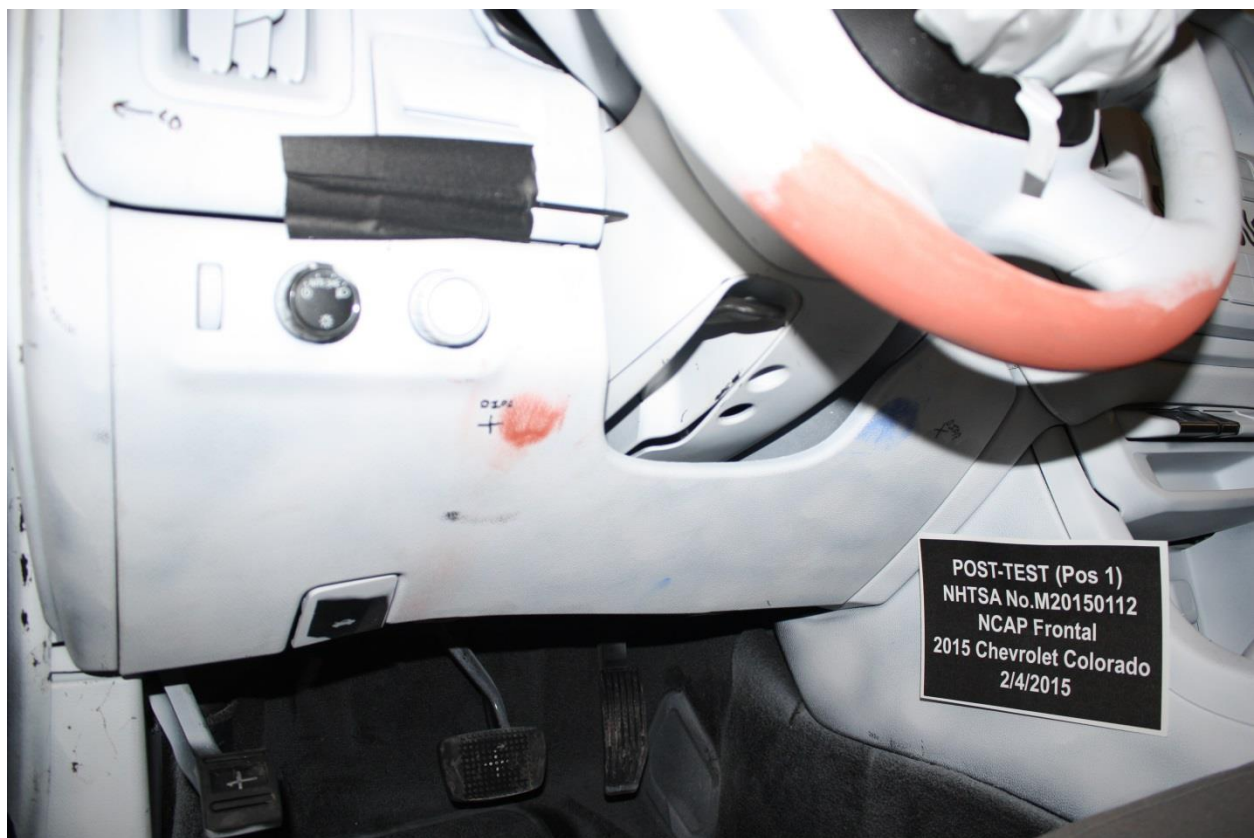
**Figure A-42: Post-Test Driver's Side Knee Bolster**

The driver's visible contact points were as follows: The driver's head contacted the frontal airbag and then the head restraint. The upper torso contacted the frontal airbag. Both knees contacted the knee bolster.

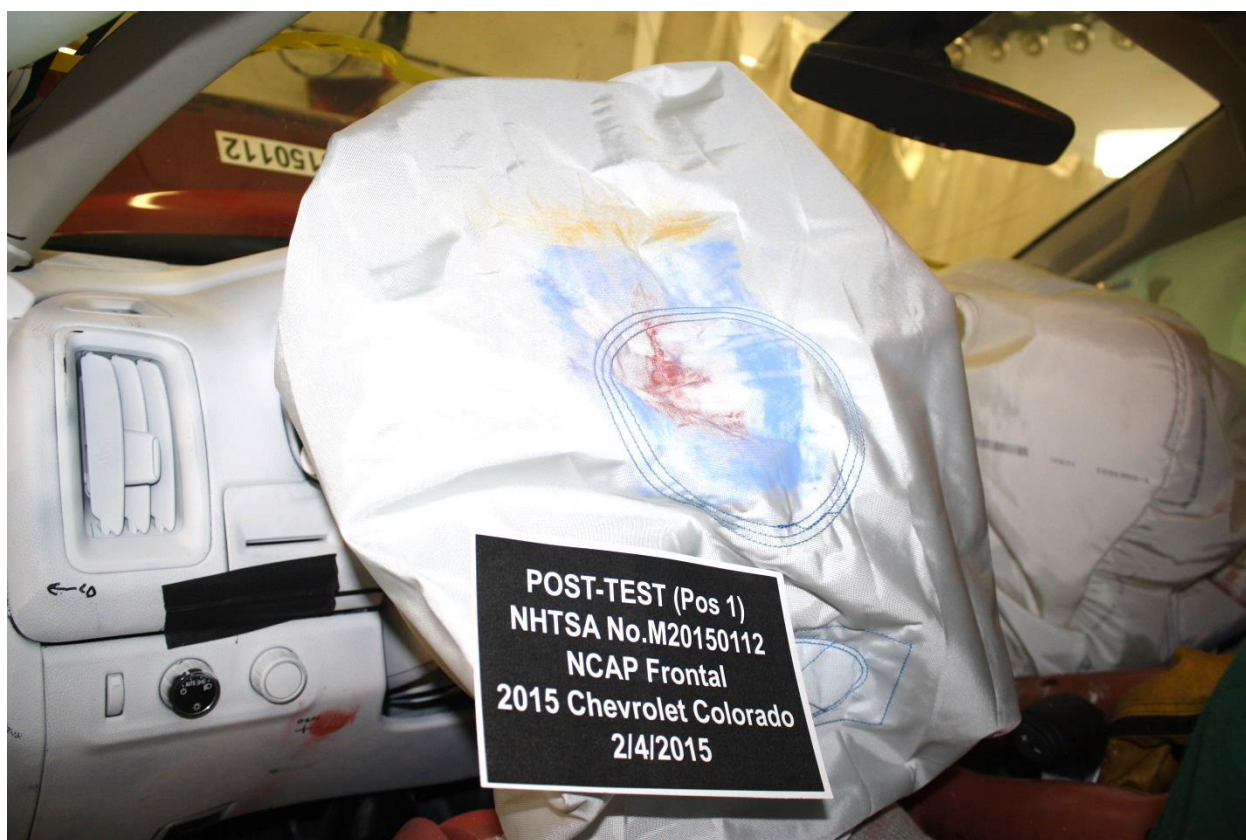
**Figure A-46: Post-Test Driver Dummy Contact With Airbag**

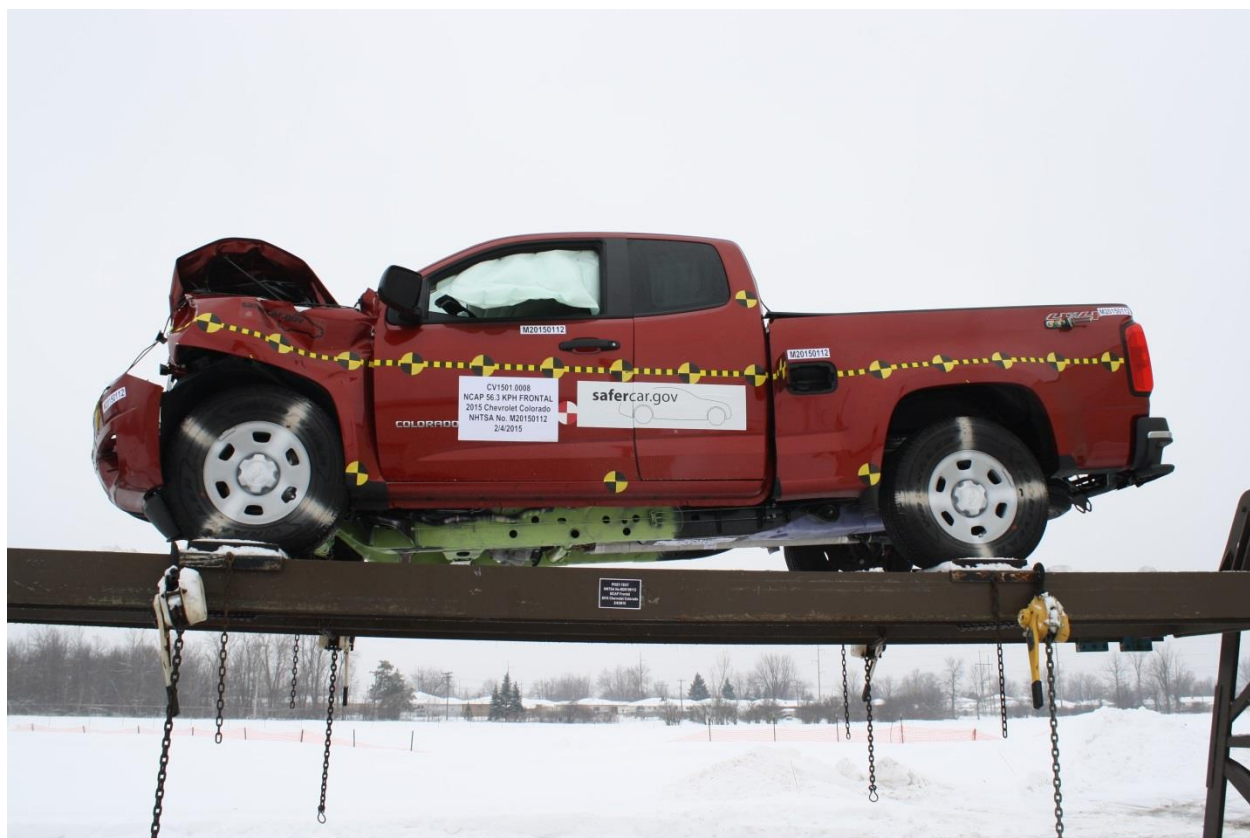
Figure A-72: Vehicle at 0° on Static Rollover Device

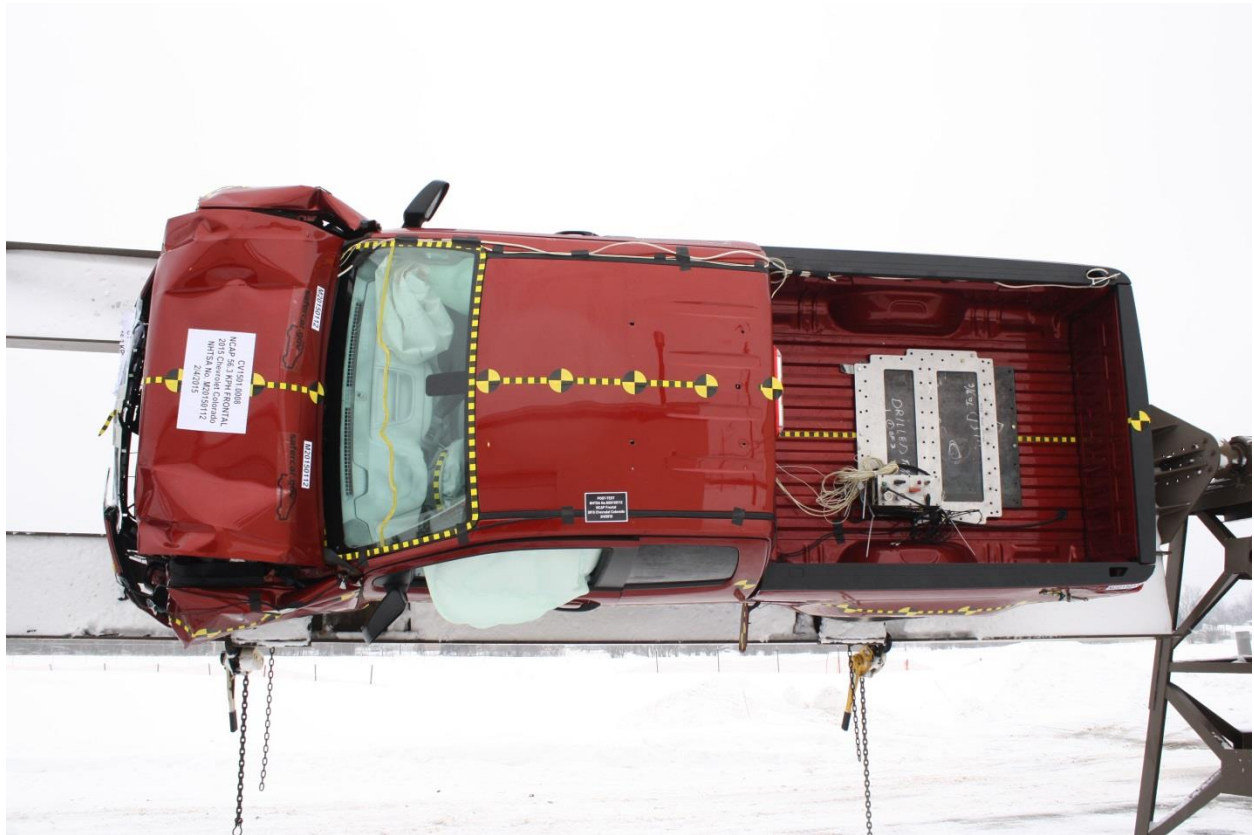
**Figure A-73: Vehicle at 90° on Static Rollover Device**

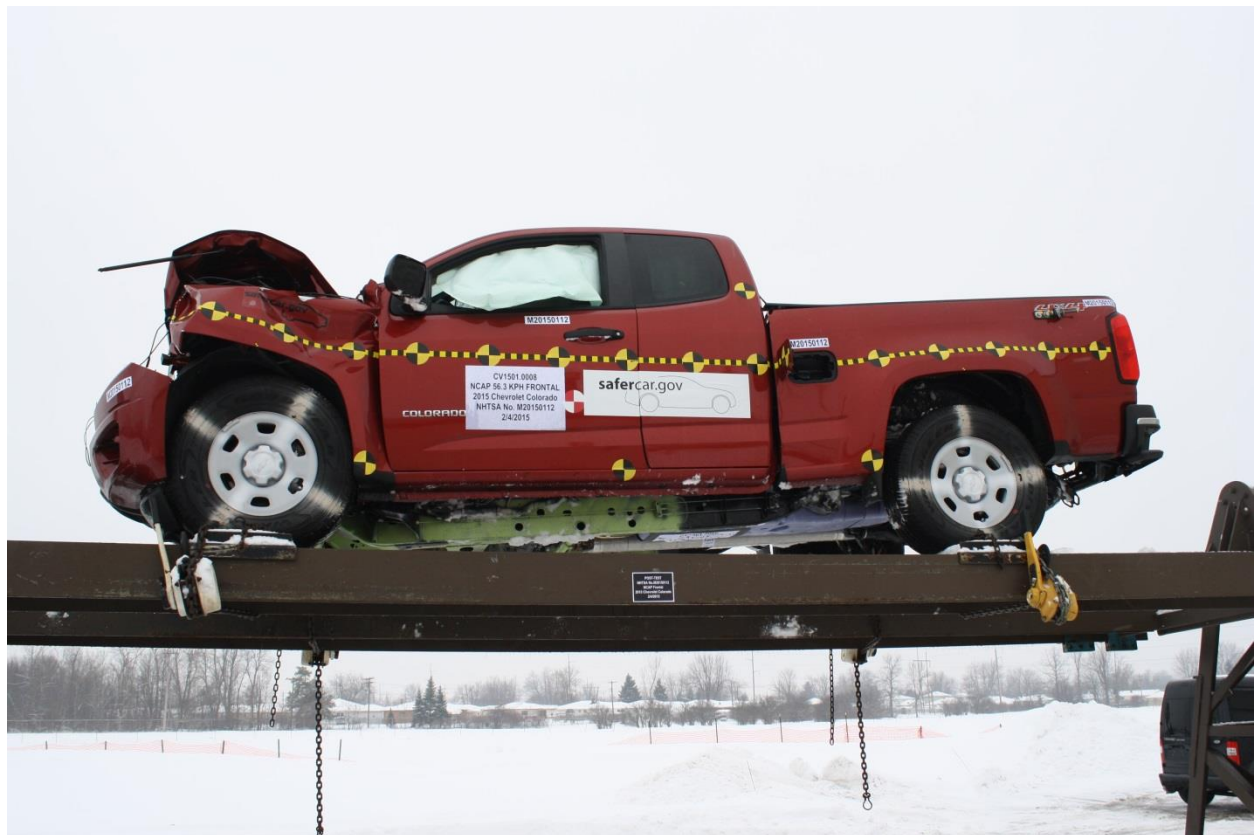
**Figure A-76: Vehicle at 360° on Static Rollover Device**

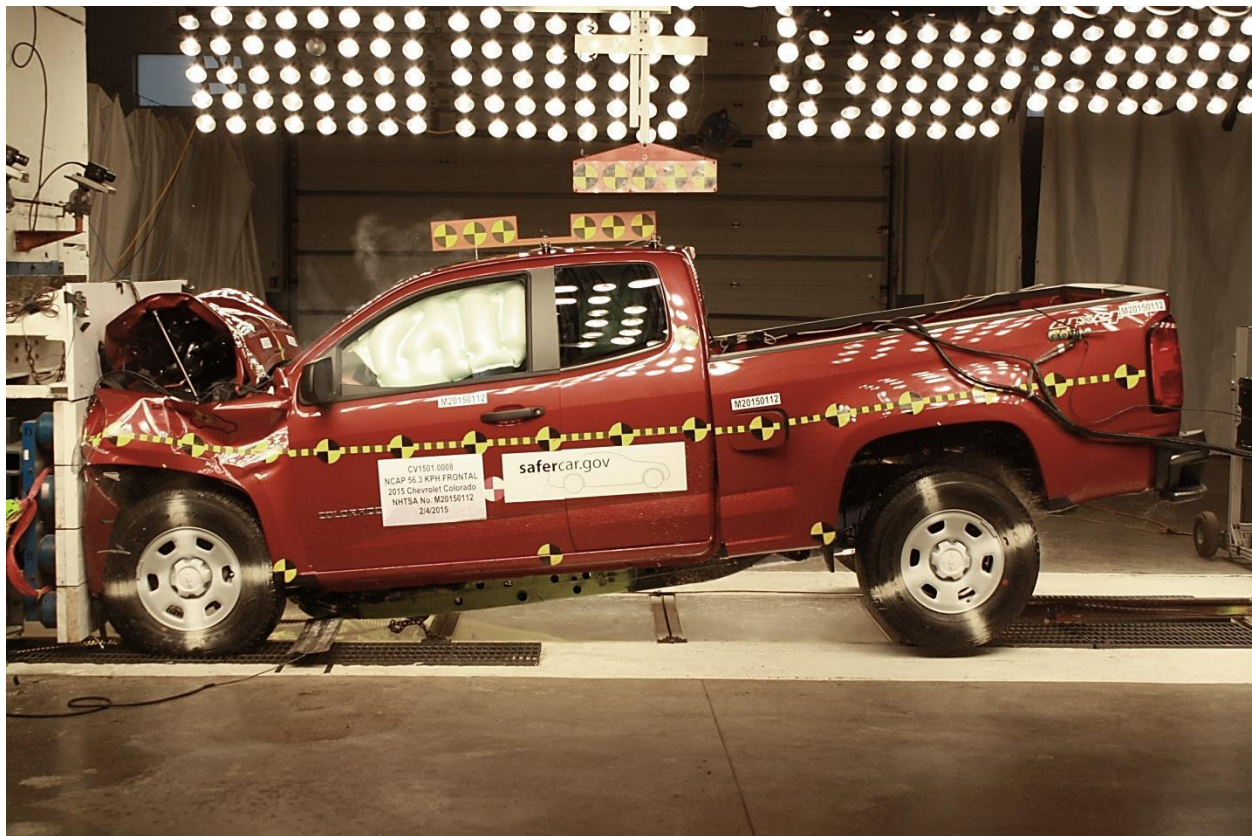
Figure A-77: 2015 Chevrolet Colorado Frontal Impact Event

A ridged fixed barrier was impacted by a 2015 Chevrolet Colorado Extended Cab Pick Up at a velocity of 56.81 km/h. The test was performed at Calspan Corporation's Transportation Test Operations facility in Buffalo, New York on February 4, 2015. Pre- and post-test photographs of the vehicle and dummies to document the test can be found in Appendix A. One real-time camera and 14 high-speed cameras were used to document the frontal barrier impact event. Camera locations and other pertinent camera information can be found in Data Sheet 6 of this report.
