**REPORT NUMBER: SPNCAP-CAL-15-004**

**NEW CAR ASSESSMENT PROGRAM (NCAP)  
SIDE IMPACT POLE TEST**

**General Motors LLC  
2015 Chevrolet Colorado  
Pick Up / Extended Cab**

**FINAL REPORT**

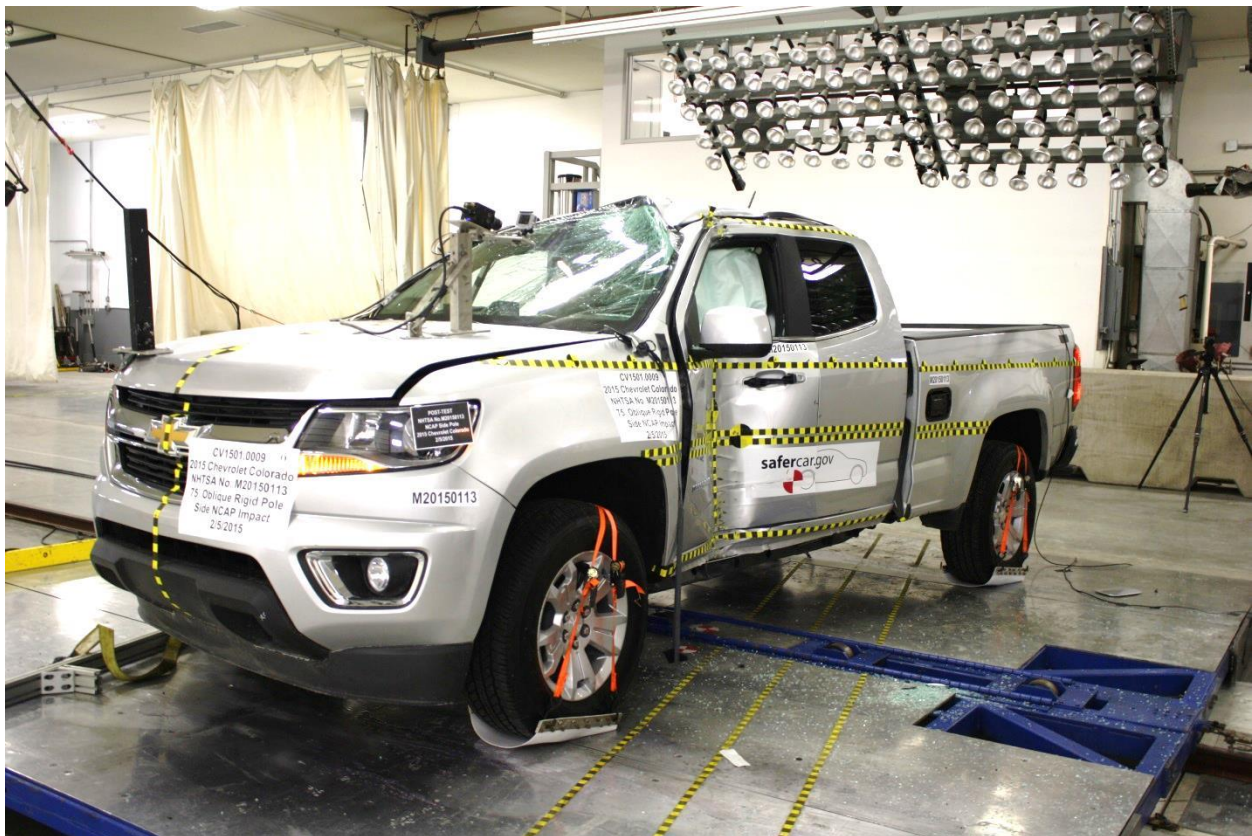
**Figure A-6: Post-Test Left Front  $\frac{3}{4}$  View of Test Vehicle**

| Critical Areas of Performance | Observations and Conclusions |
|---|---|
| Windshield Damage | Separation along driver's A-Pillar |

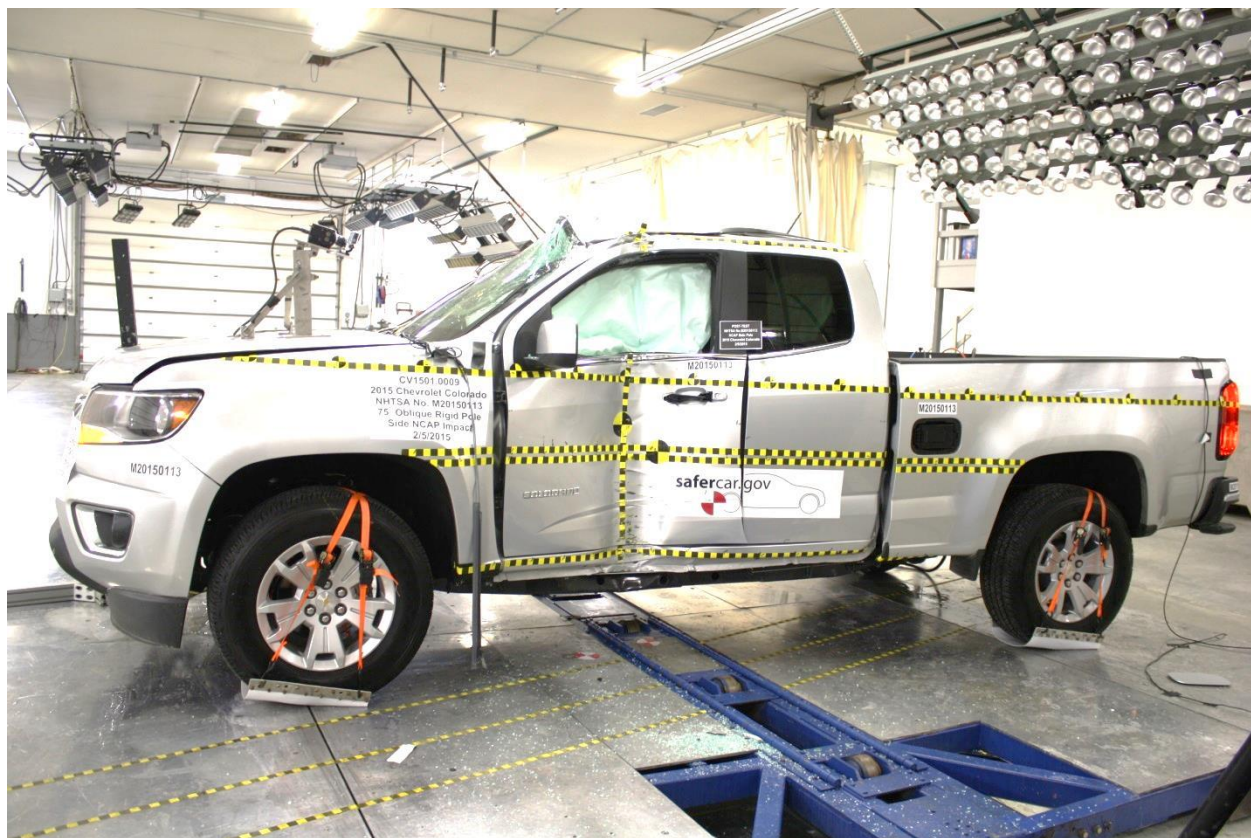
**Figure A-8: Post-Test Left Side View of Test Vehicle**

| Critical Areas of Performance | Observations and Conclusions |
|---|---|
| Side Window Damage | Driver's window shattered during impact event |

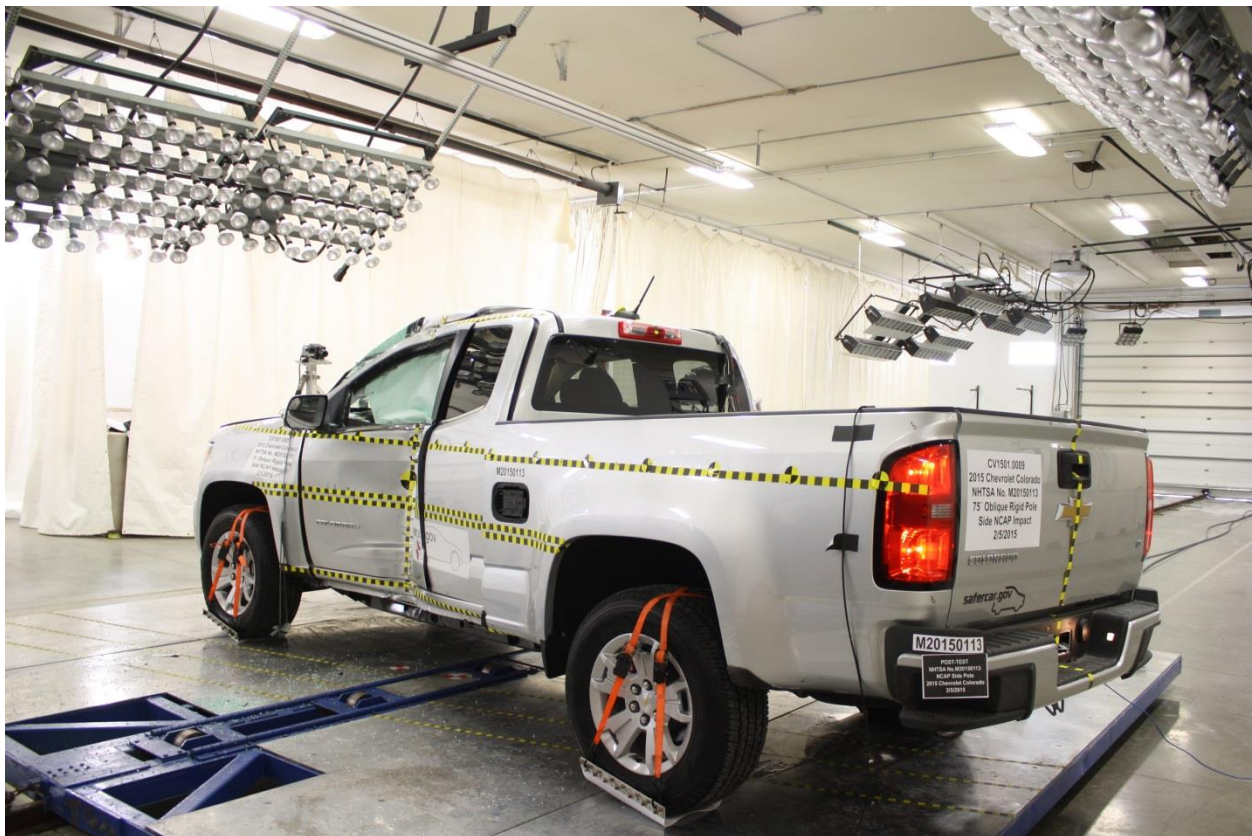
**Figure A-10: Post-Test Left Rear  $\frac{3}{4}$  View of Test Vehicle**

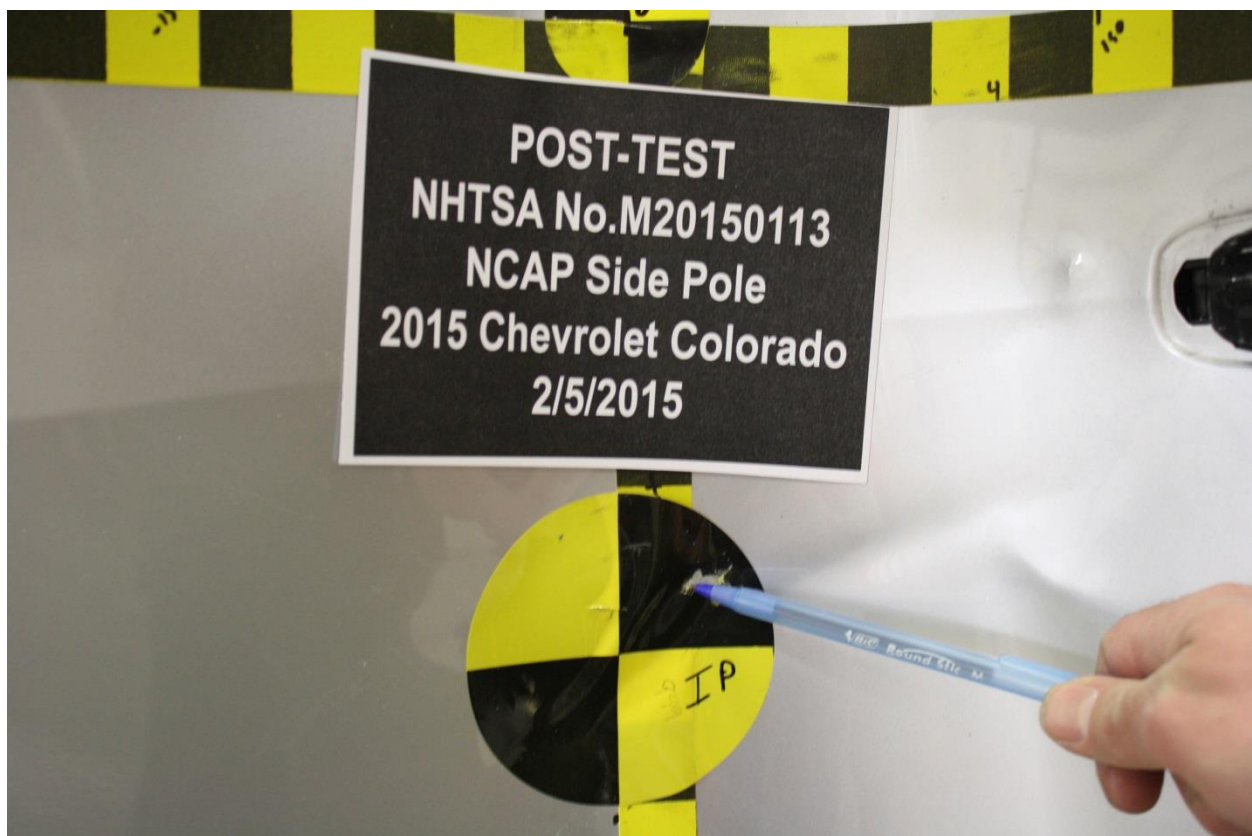
**Figure A-20: Post-Test Close-Up View of Impact Point Target Showing Impact Location**

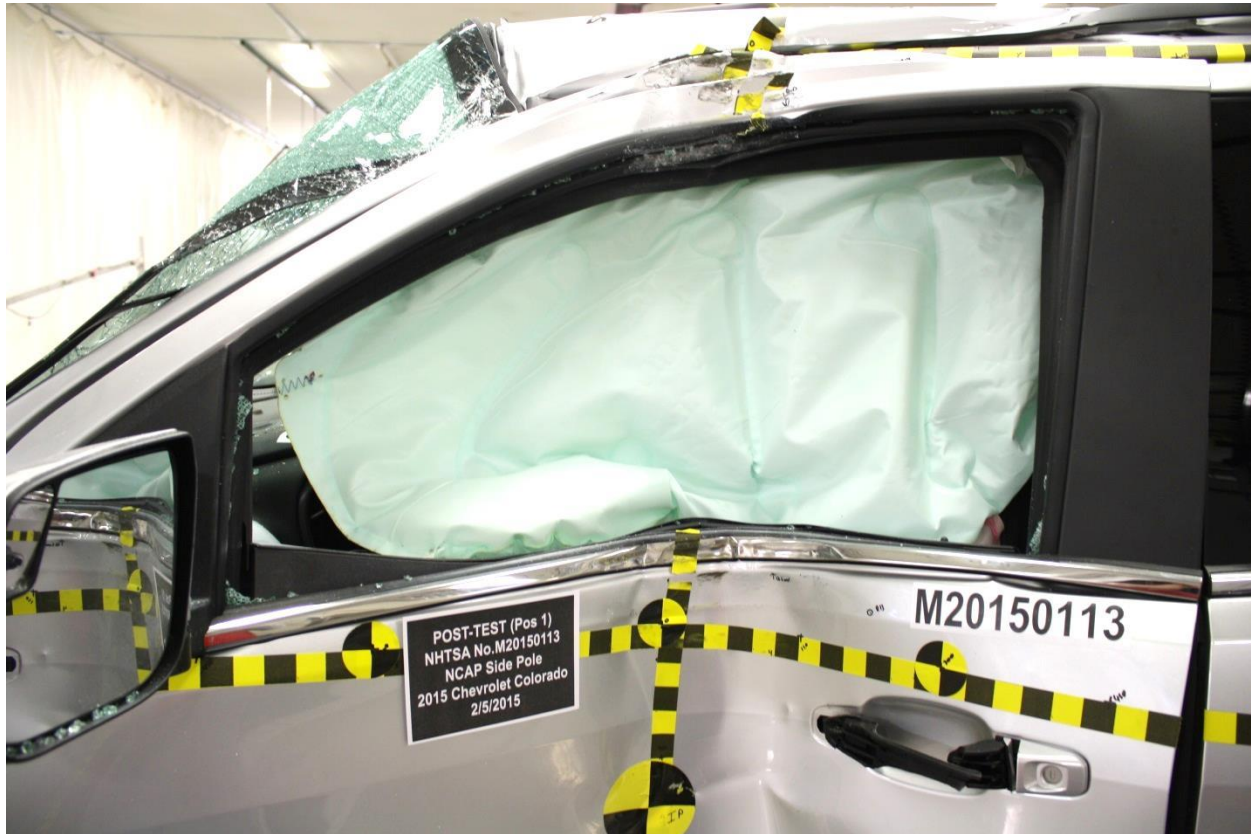
**Figure A-25: Post-Test Left Side View of Dummy Shoulder and Door Top View**

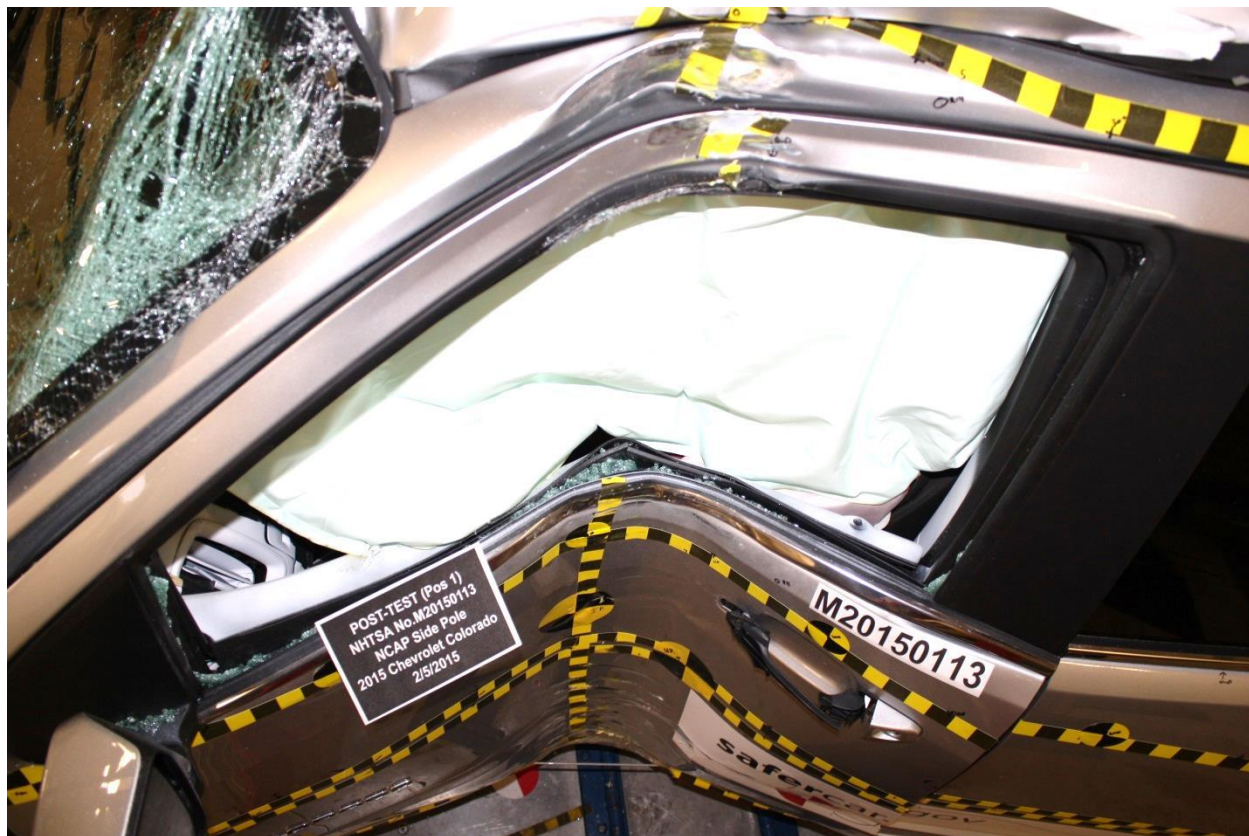
**Figure A-41: Post-Test Dummy and Door Clearance View**

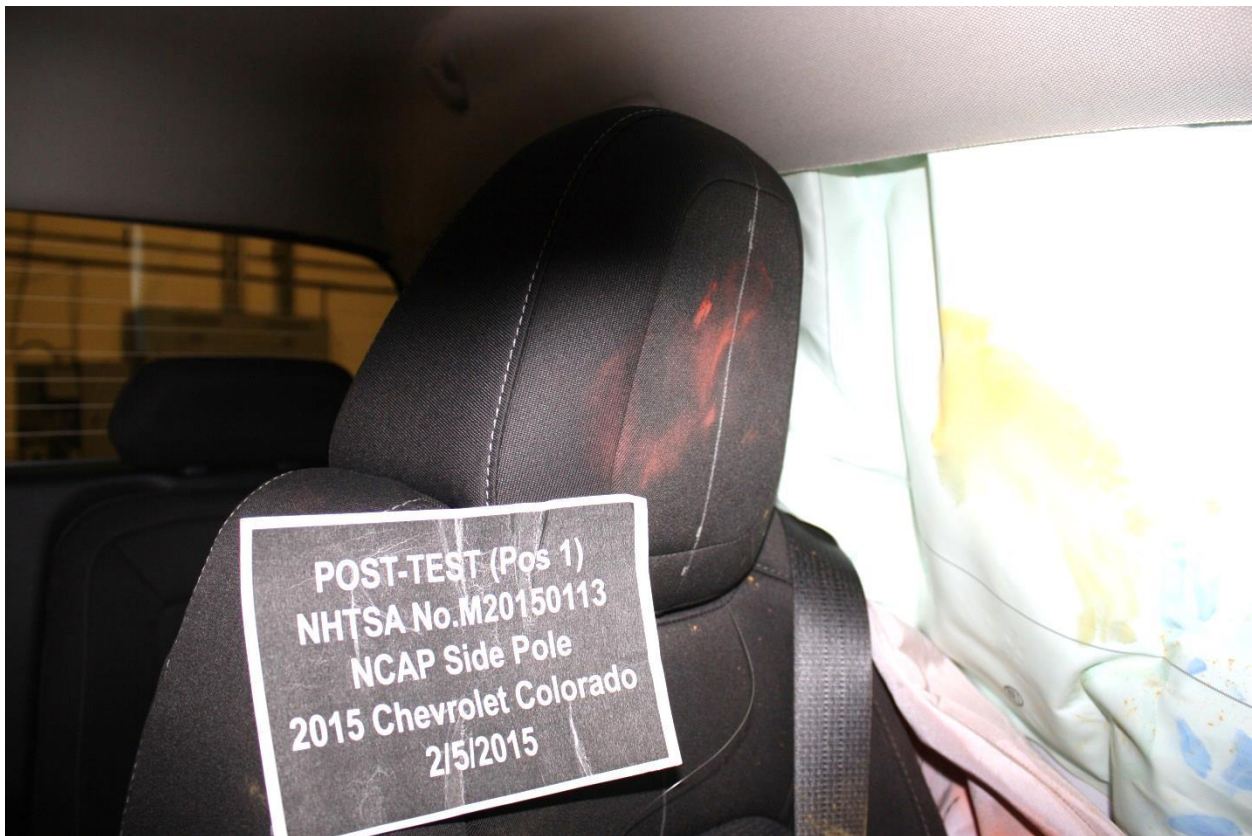
**Figure A-46: Post-Test Dummy Close-Up Head Contact with Vehicle Interior View**

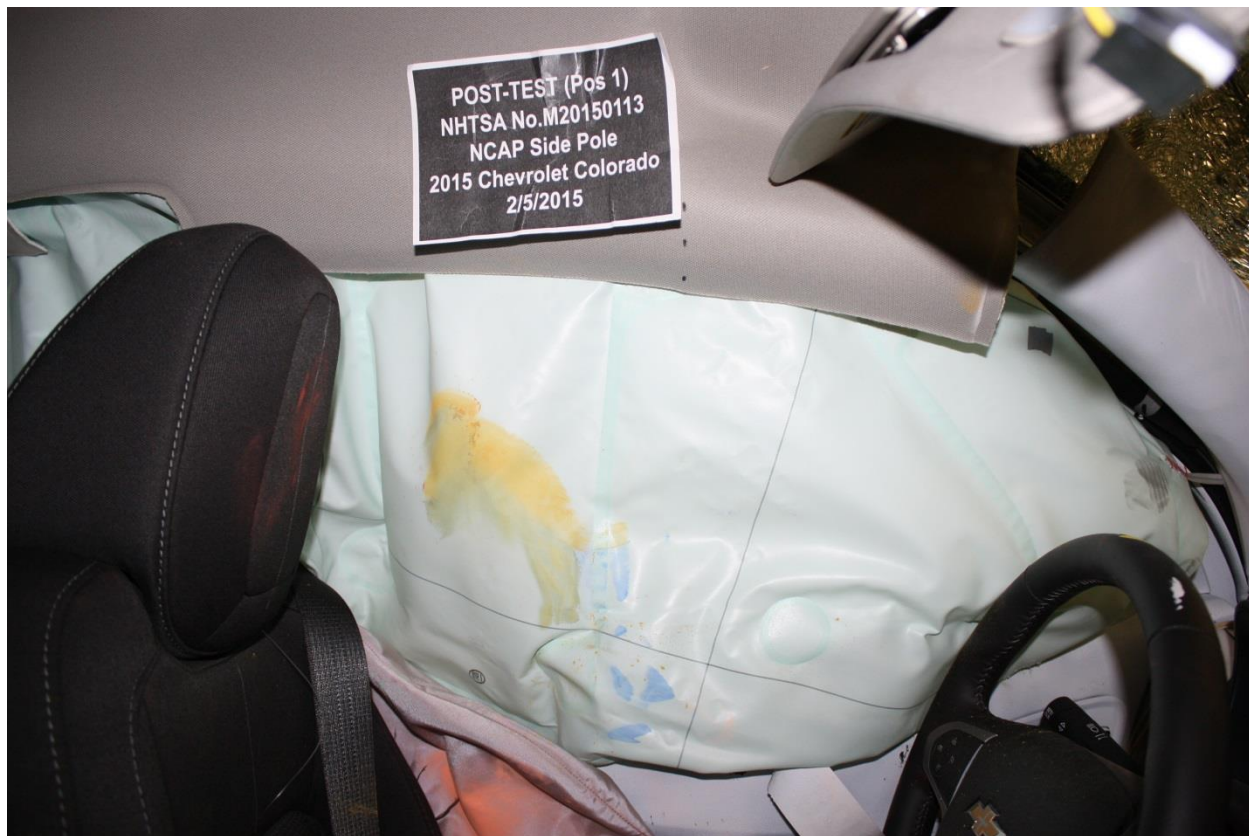
**Figure A-47: Post-Test Dummy Close-Up Head Contact with Side Airbag View**

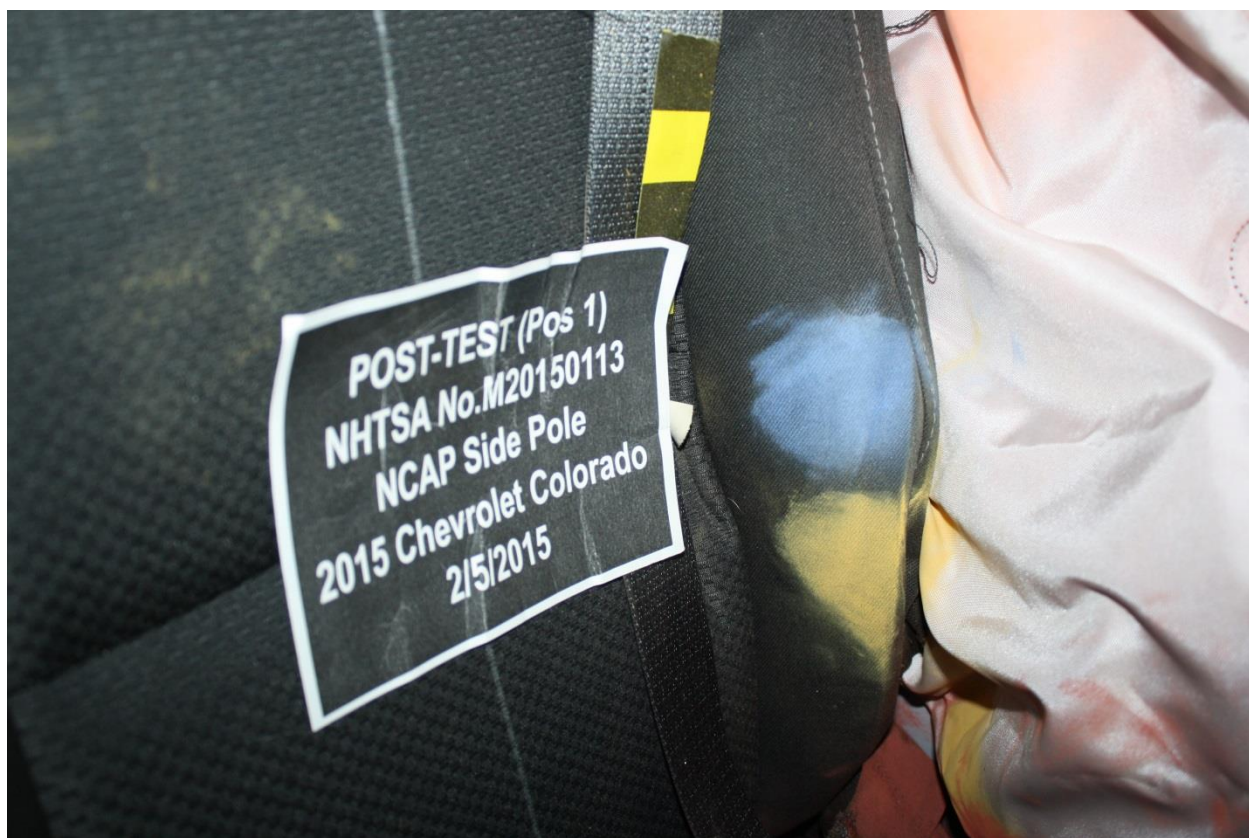
**Figure A-48: Post-Test Dummy Close-Up Torso Contact with Vehicle Interior View**

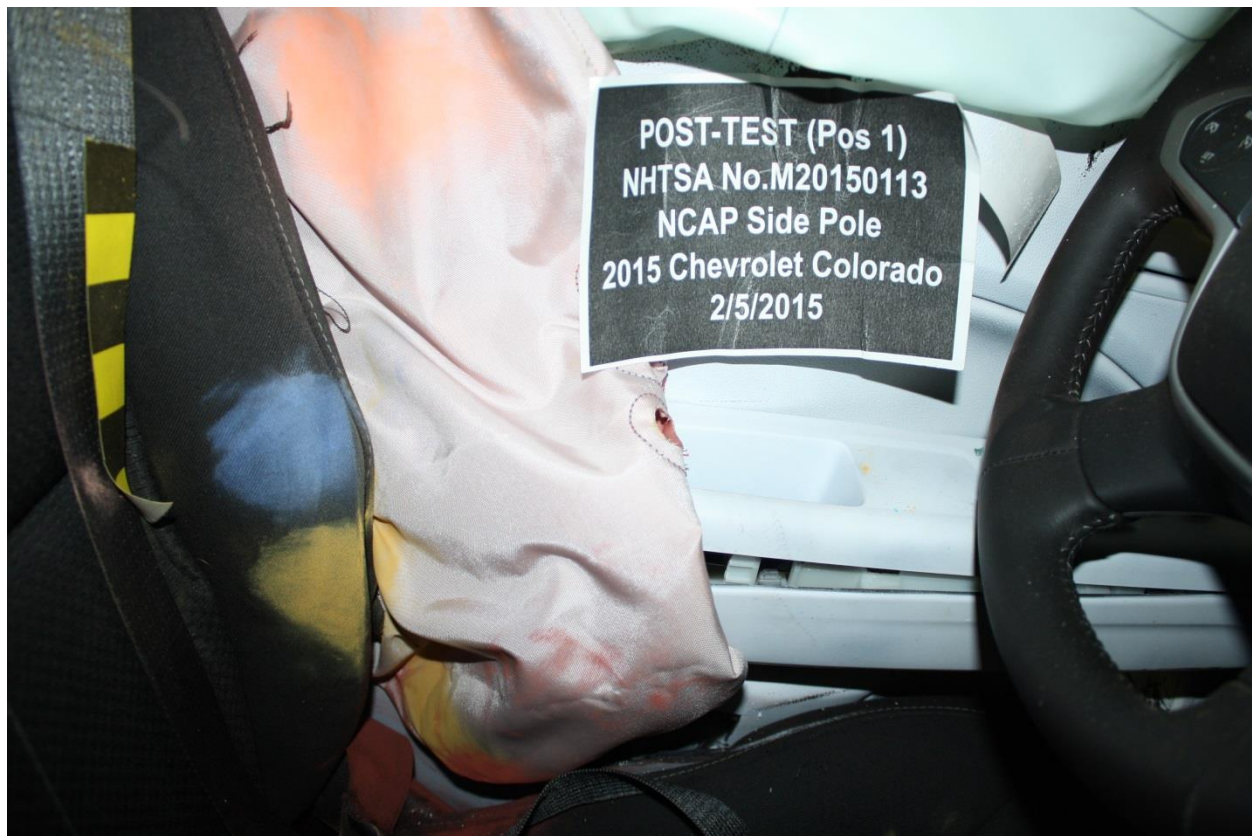
**Figure A-49: Post-Test Dummy Close-Up Torso Contact with Side Airbag View**

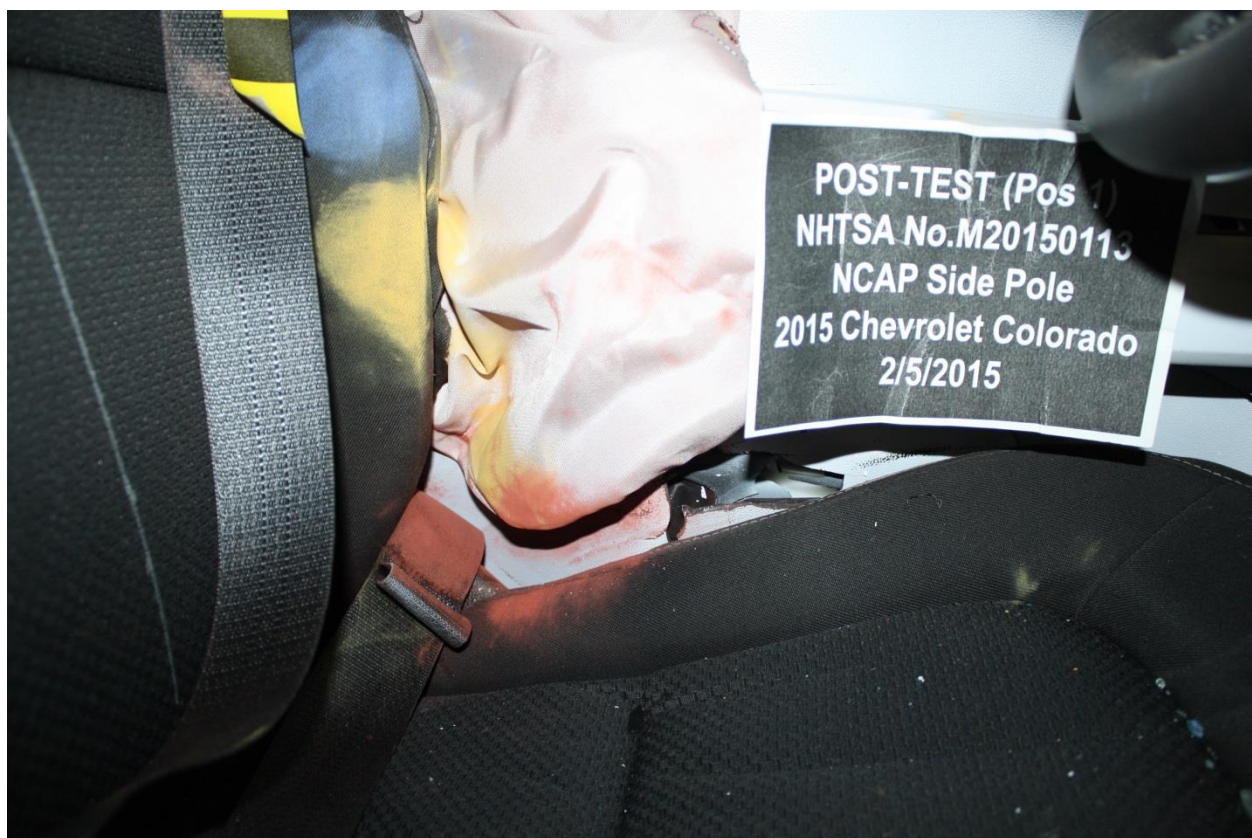
**Figure A-50: Post-Test Dummy Close-Up Pelvis Contact with Vehicle Interior View**

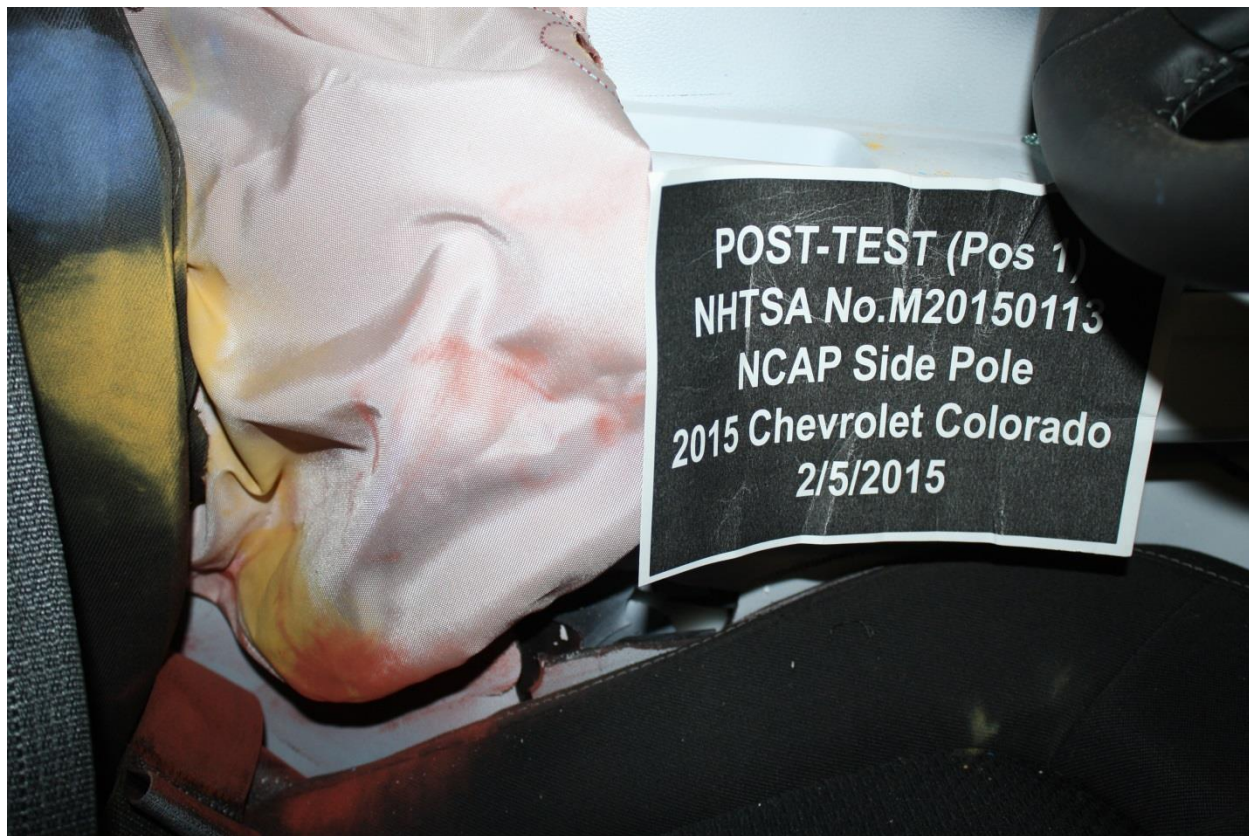
**Figure A-51: Post-Test Dummy Close-Up Pelvis Contact with Side Airbag View**

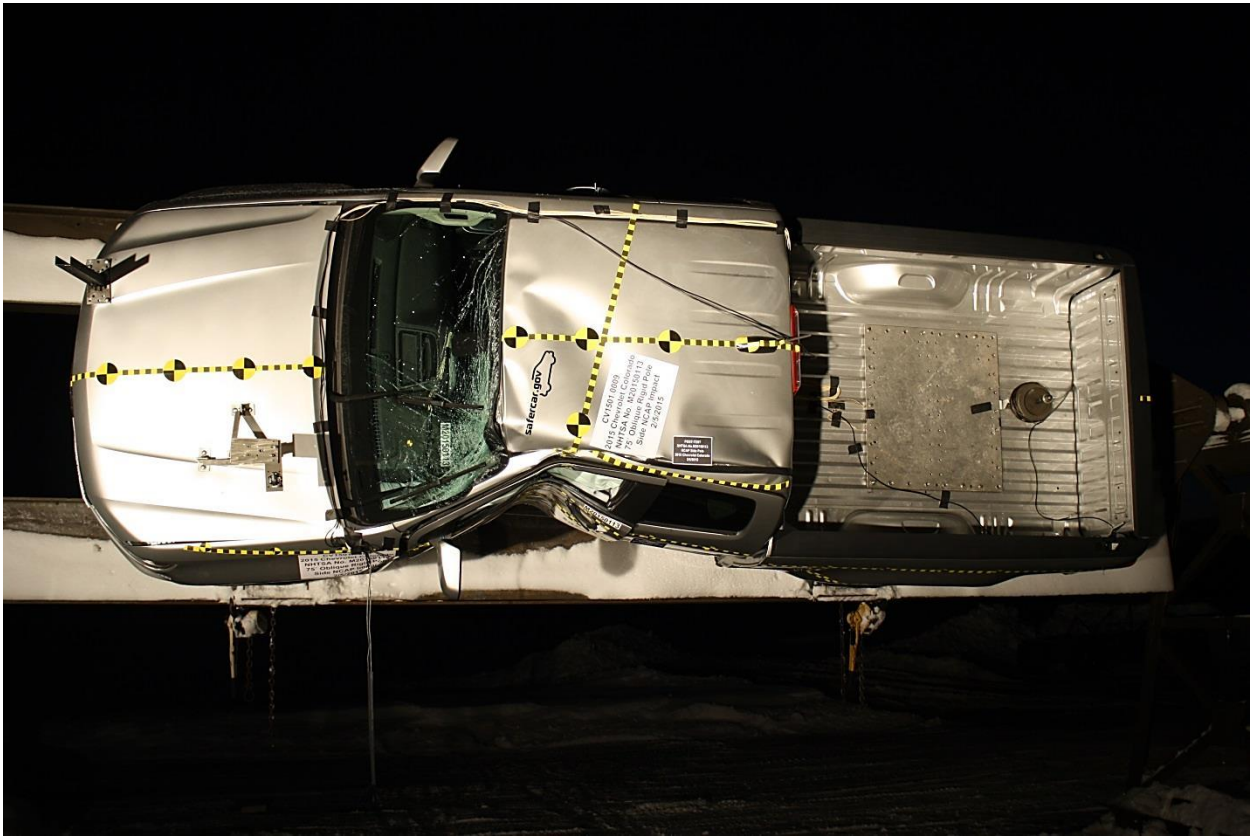
**Figure A-64: FMVSS No. 301 Static Rollover 90 Degrees**

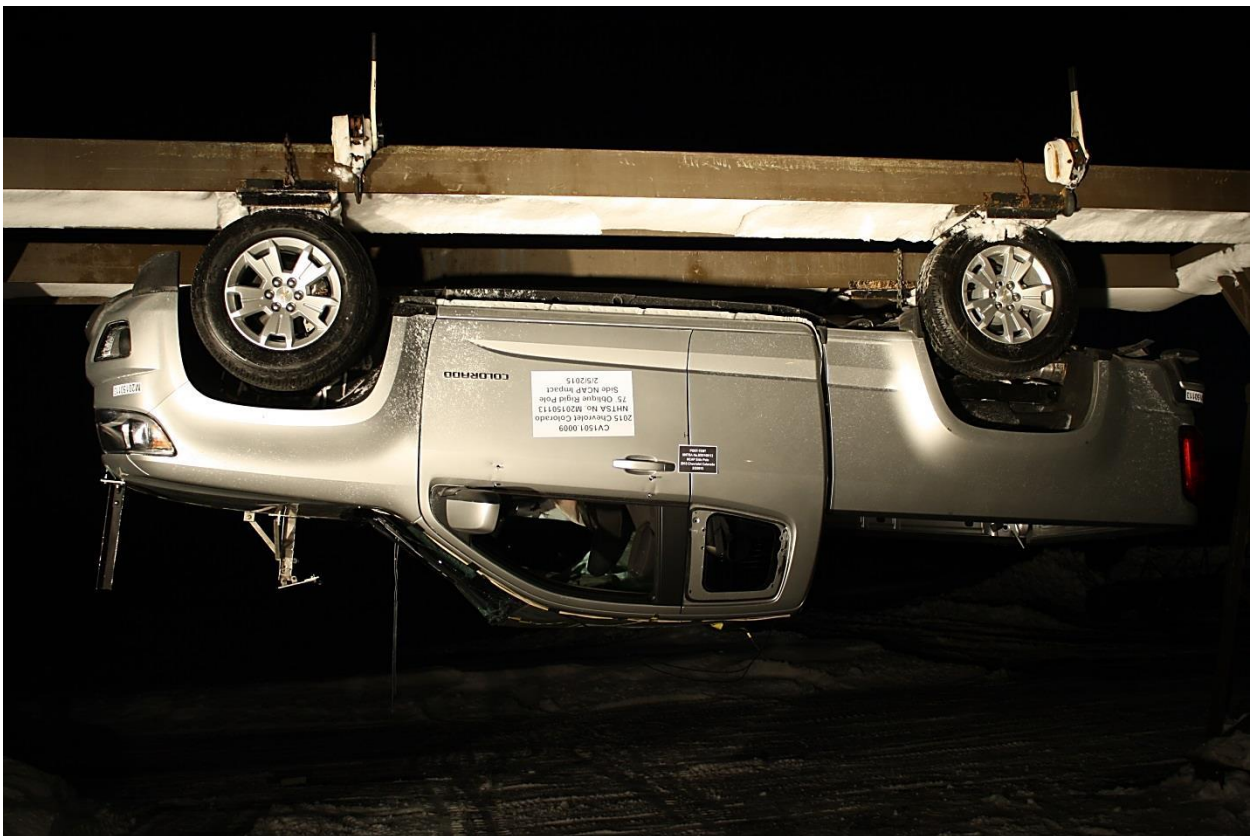
**Figure A-65: FMVSS No. 301 Static Rollover 180 Degrees**
