REPORT NUMBER: SPNCAP-MGA-2015-057

**NEW CAR ASSESSMENT PROGRAM (NCAP)
Side Impact Pole Test**

**FORD MOTOR CO.
2015 Ford F-150 SuperCrew XL Truck
NHTSA No.: M20150217**

FINAL REPORT

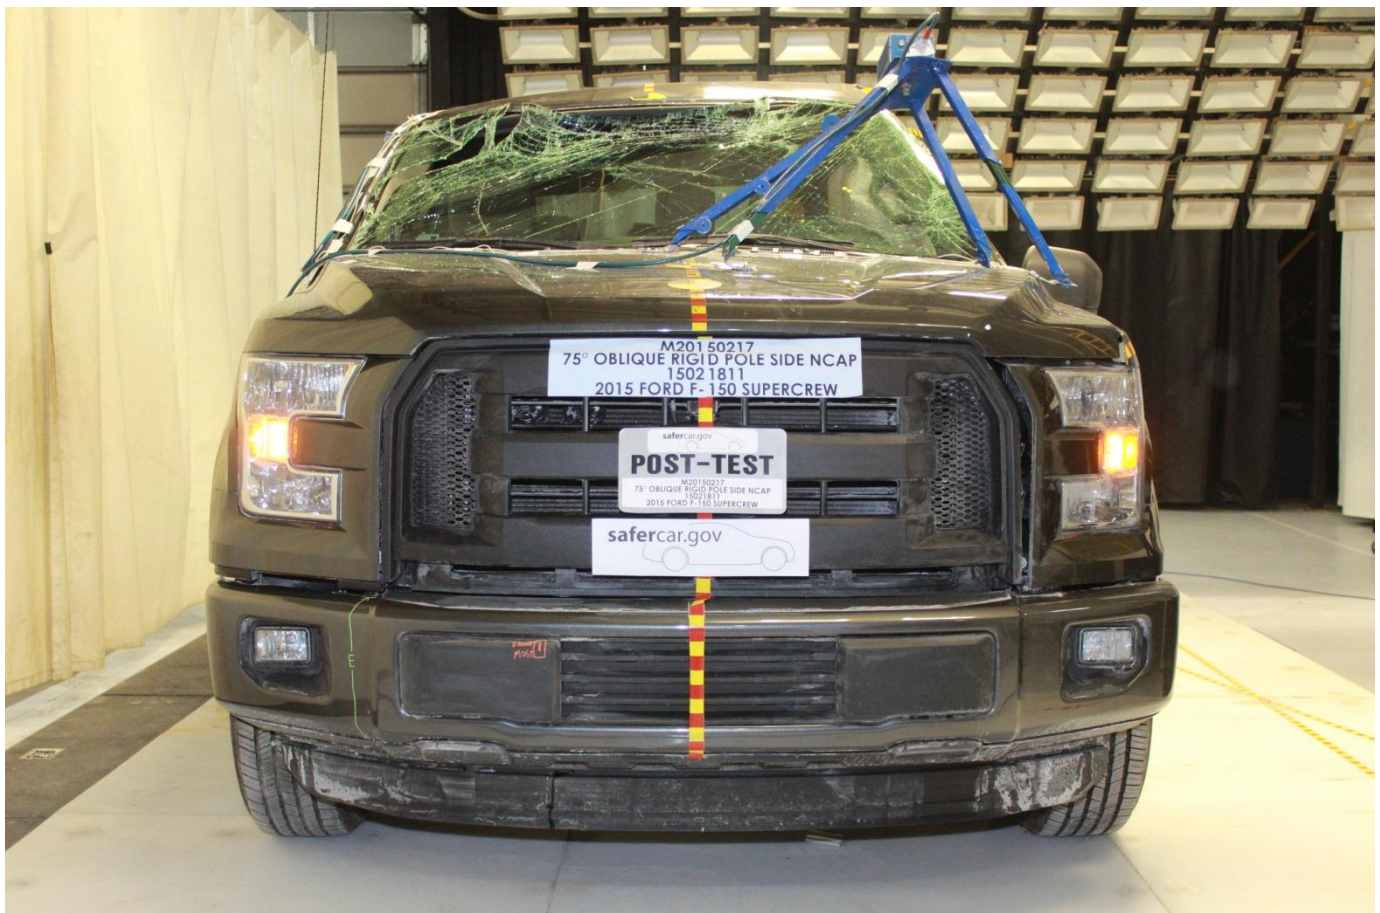
Post-Test Frontal View of Test Vehicle

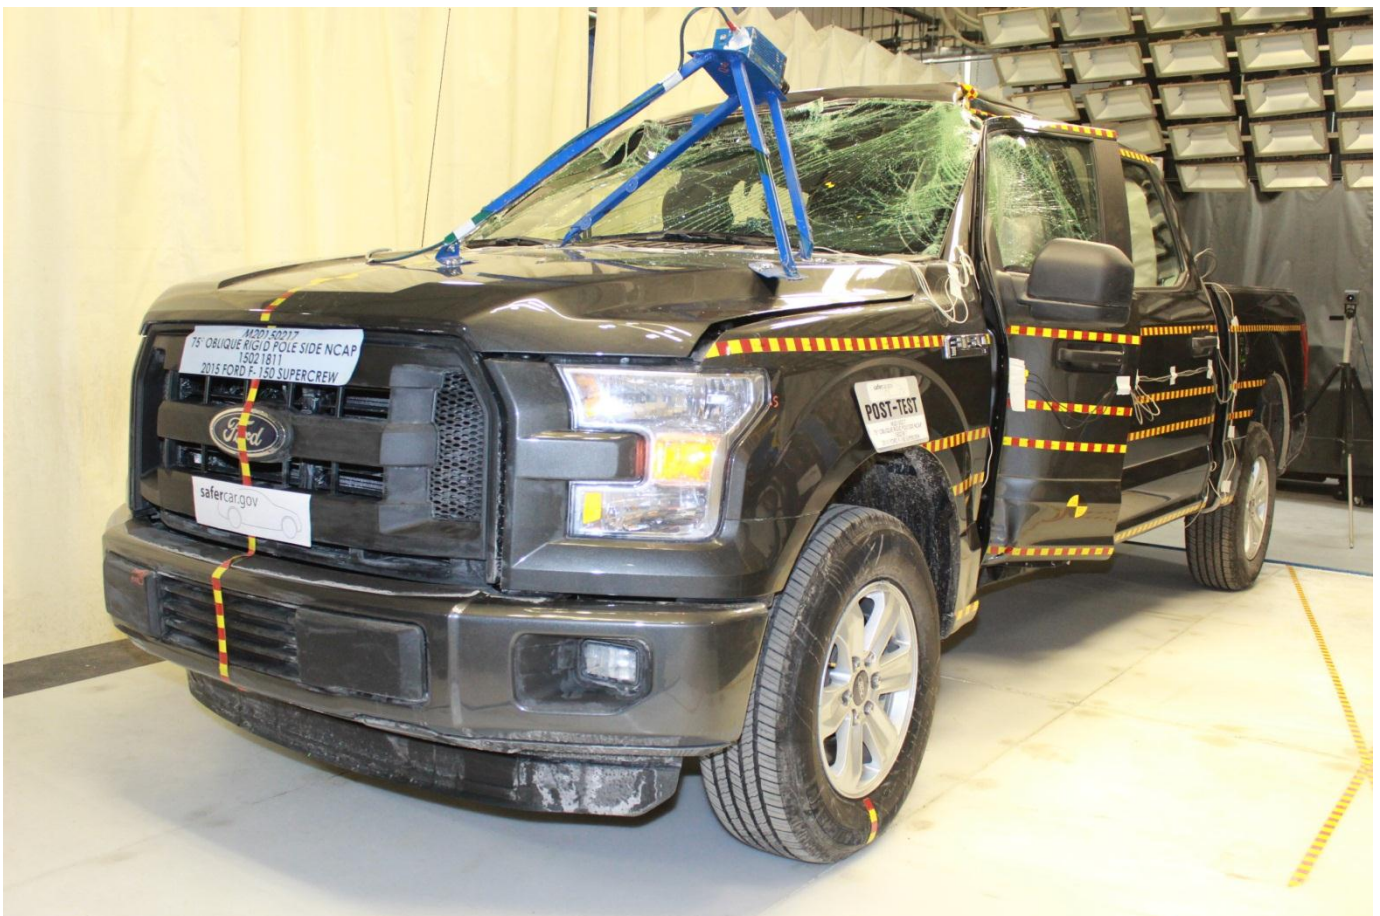
Post-Test Left Front ¾ View of Test Vehicle

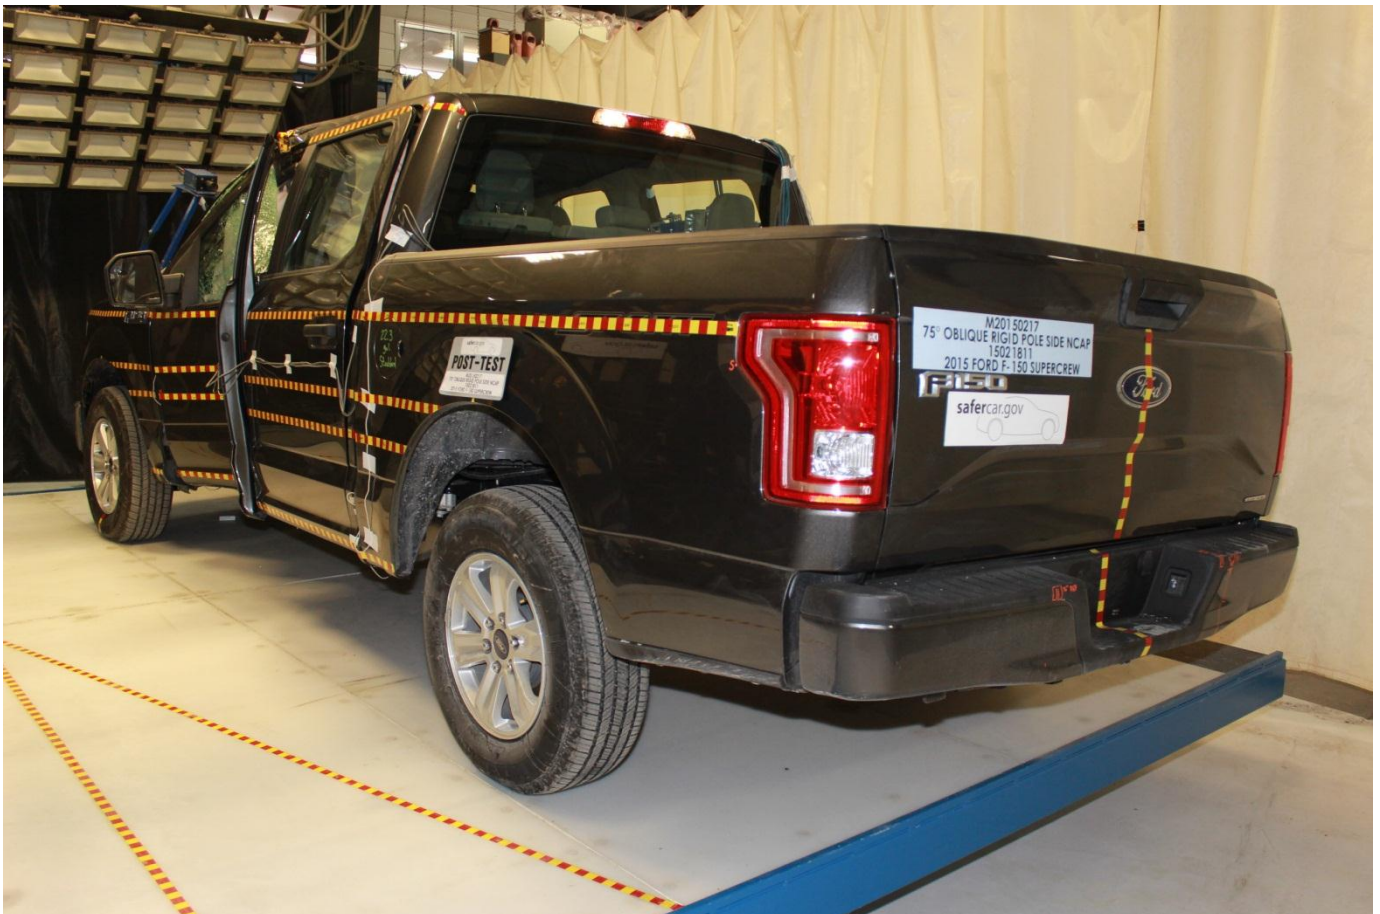
Post-Test Left Rear $\frac{3}{4}$ View of Test Vehicle

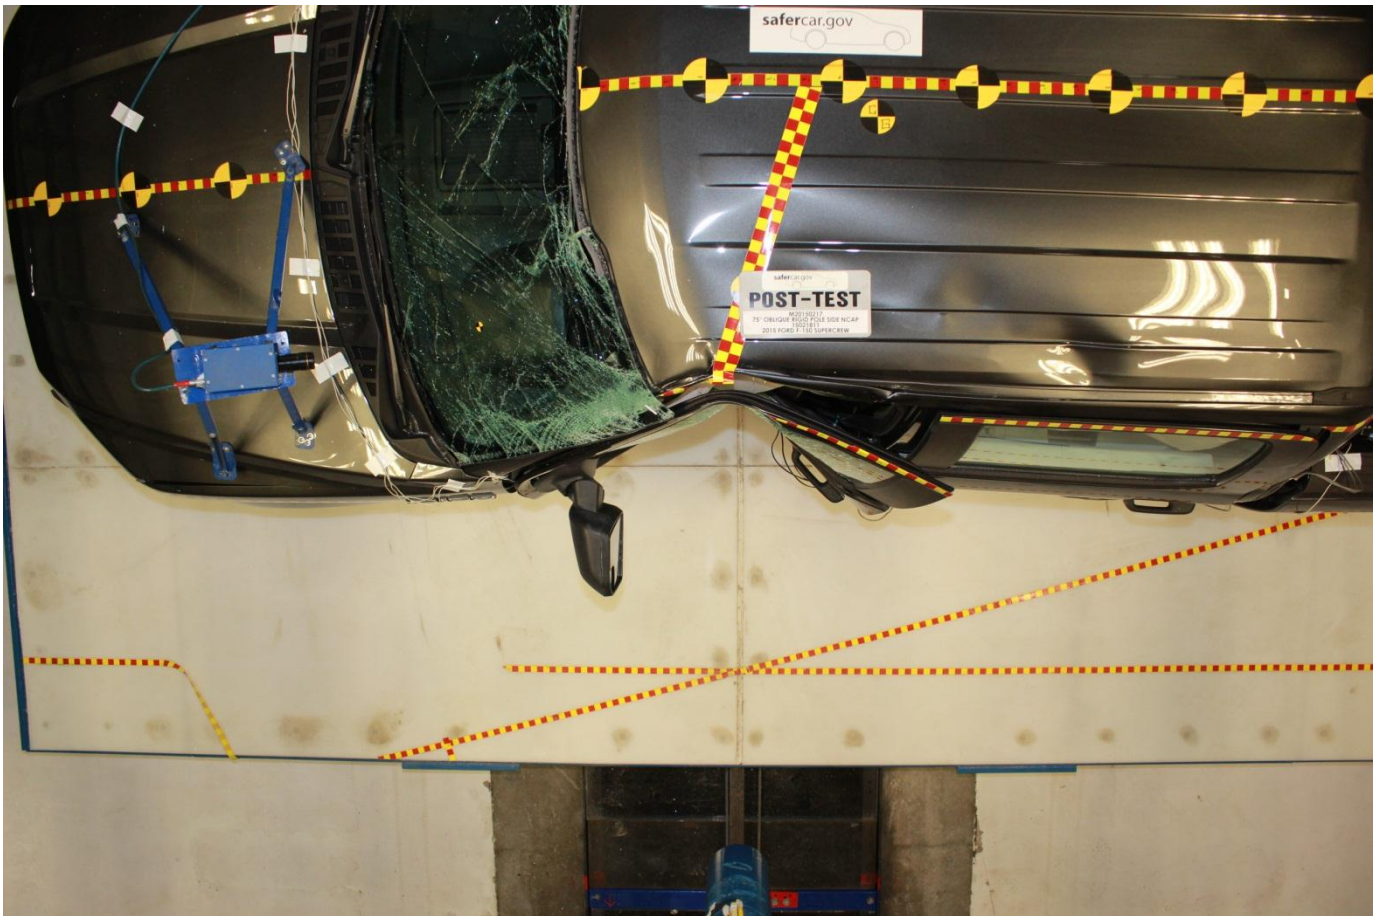
Post-Test Overhead View of Test Area

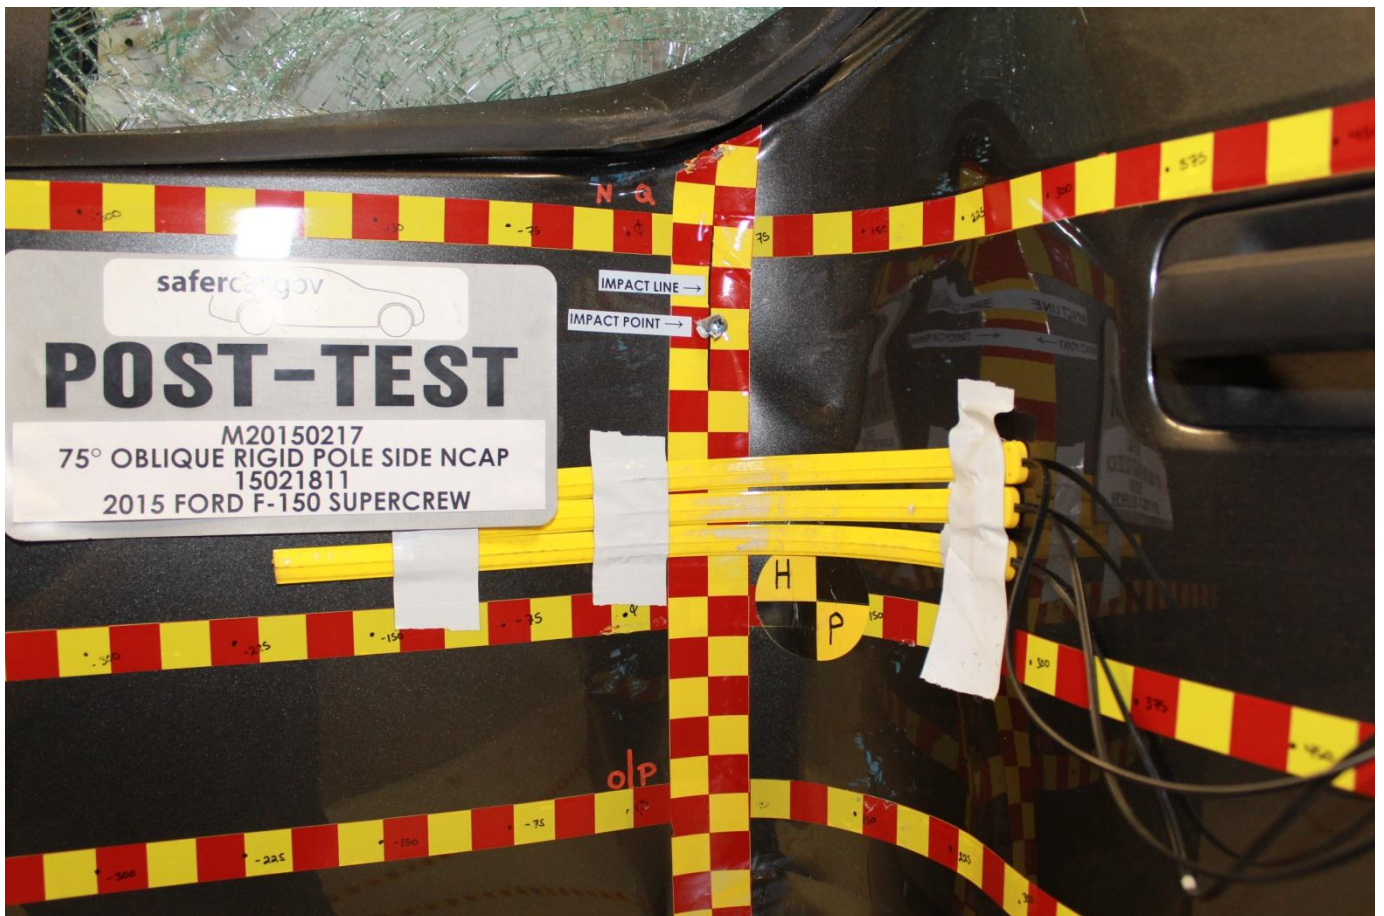
Post-Test Close-Up View of Impact Point Target Showing Impact Location

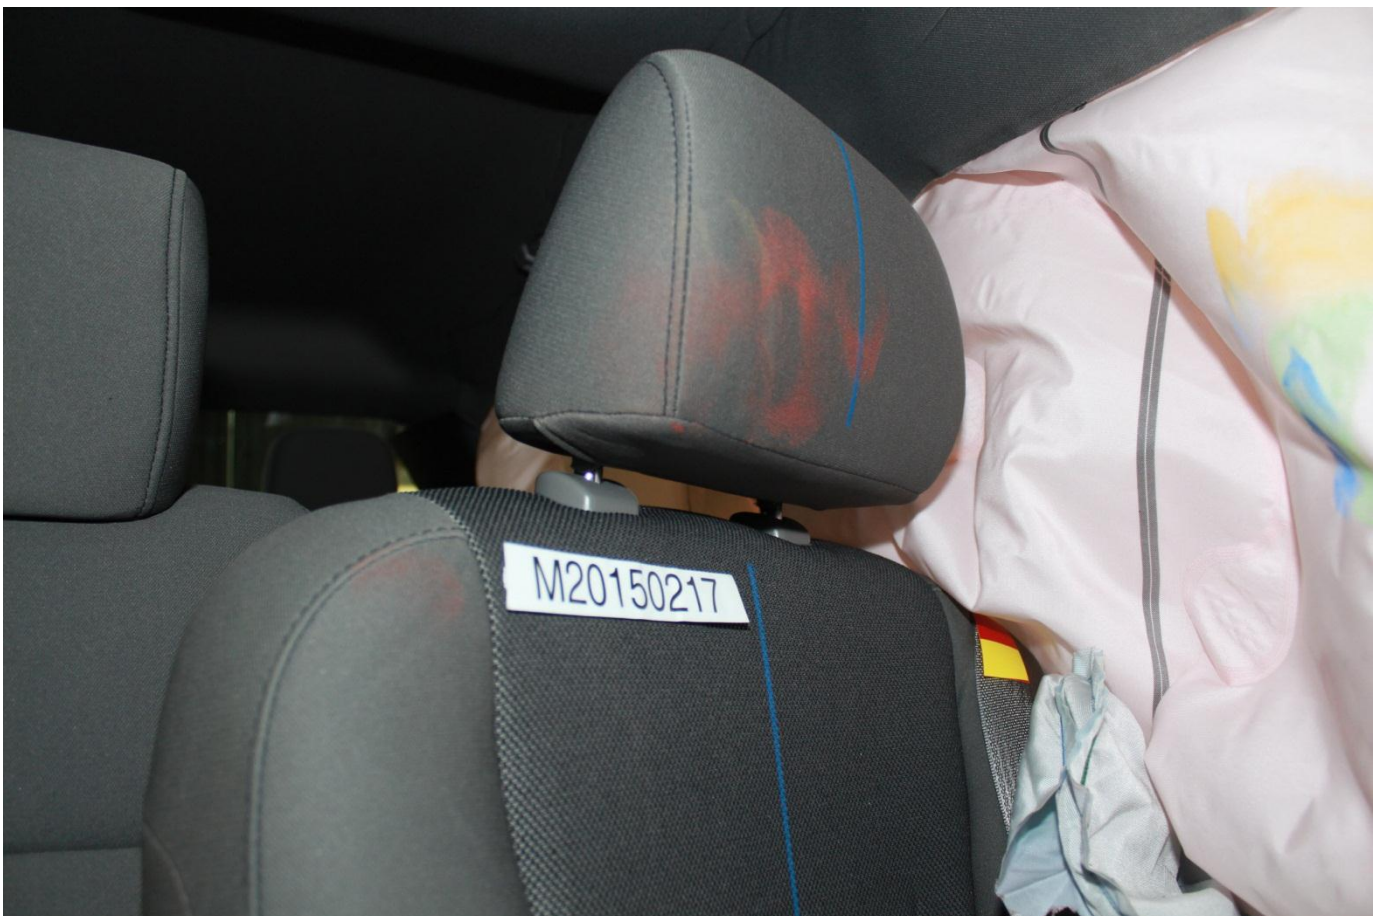
Post-Test Dummy Close-Up Head Contact with Vehicle Interior View

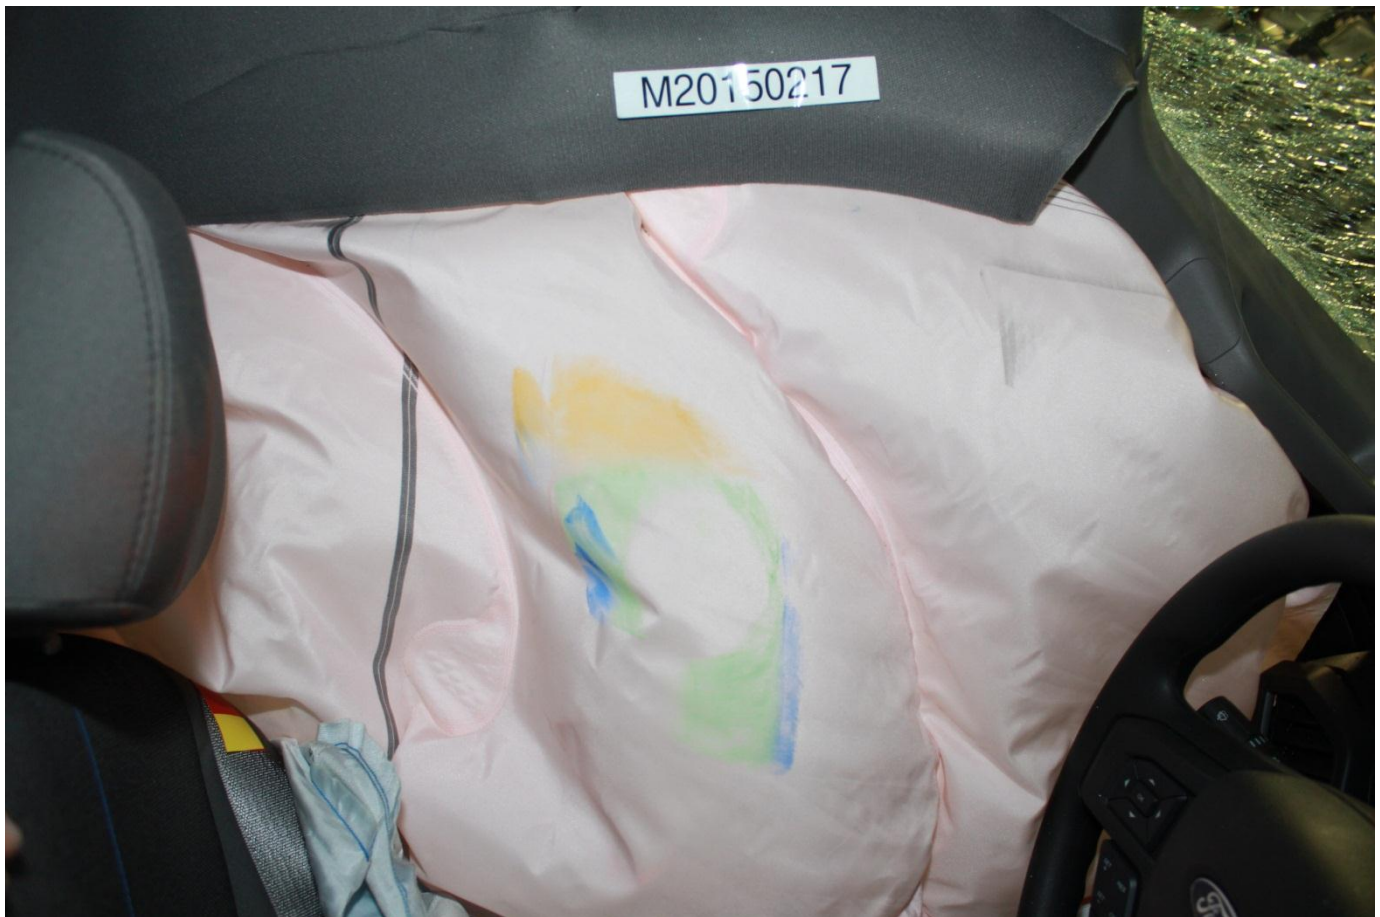
Post-Test Dummy Close-Up Head Contact with Side Air Bag View

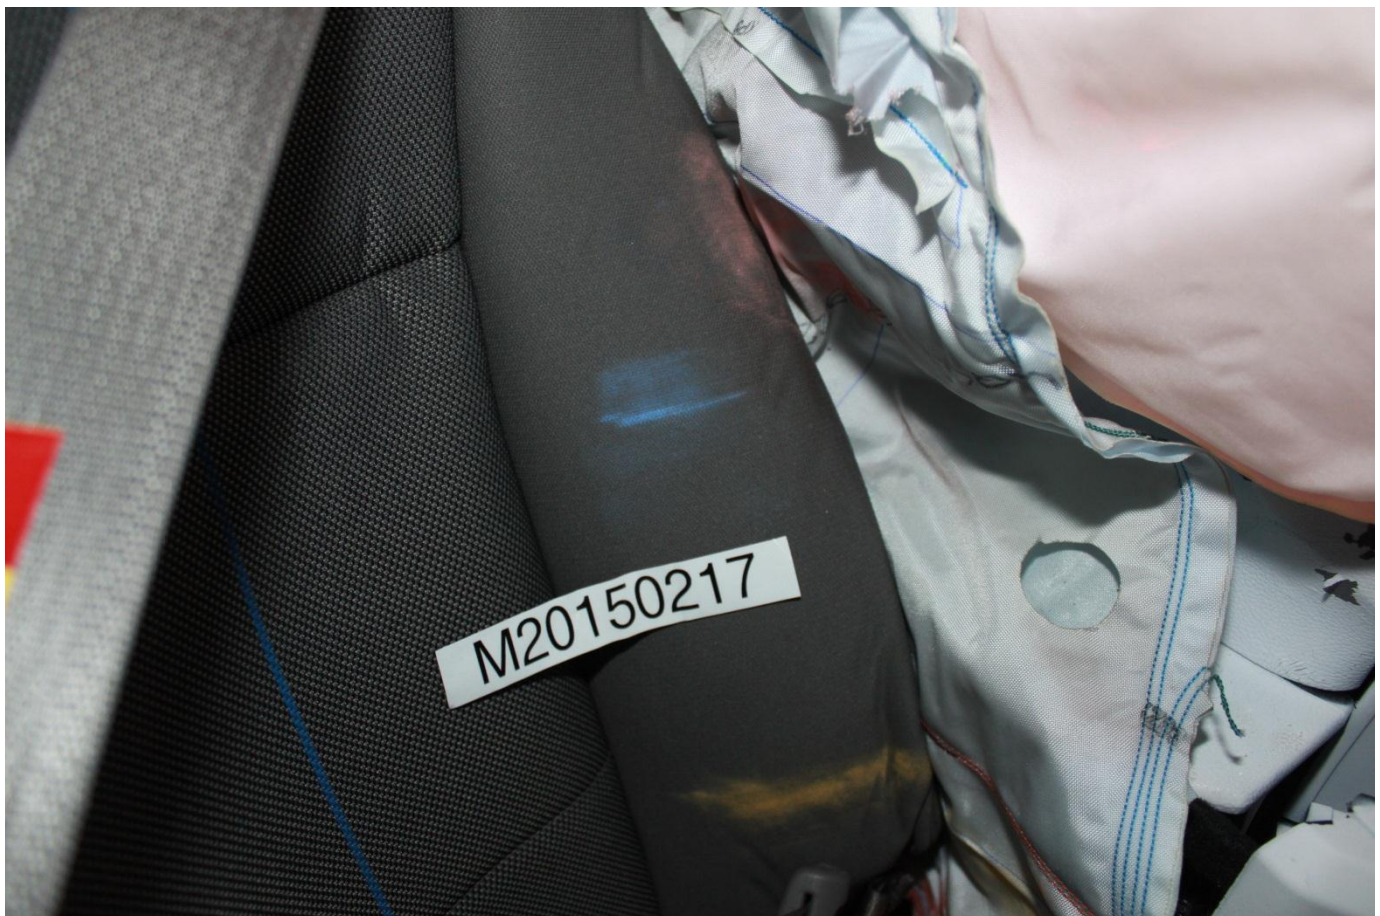
Post-Test Dummy Close-Up Torso Contact with Vehicle Interior View

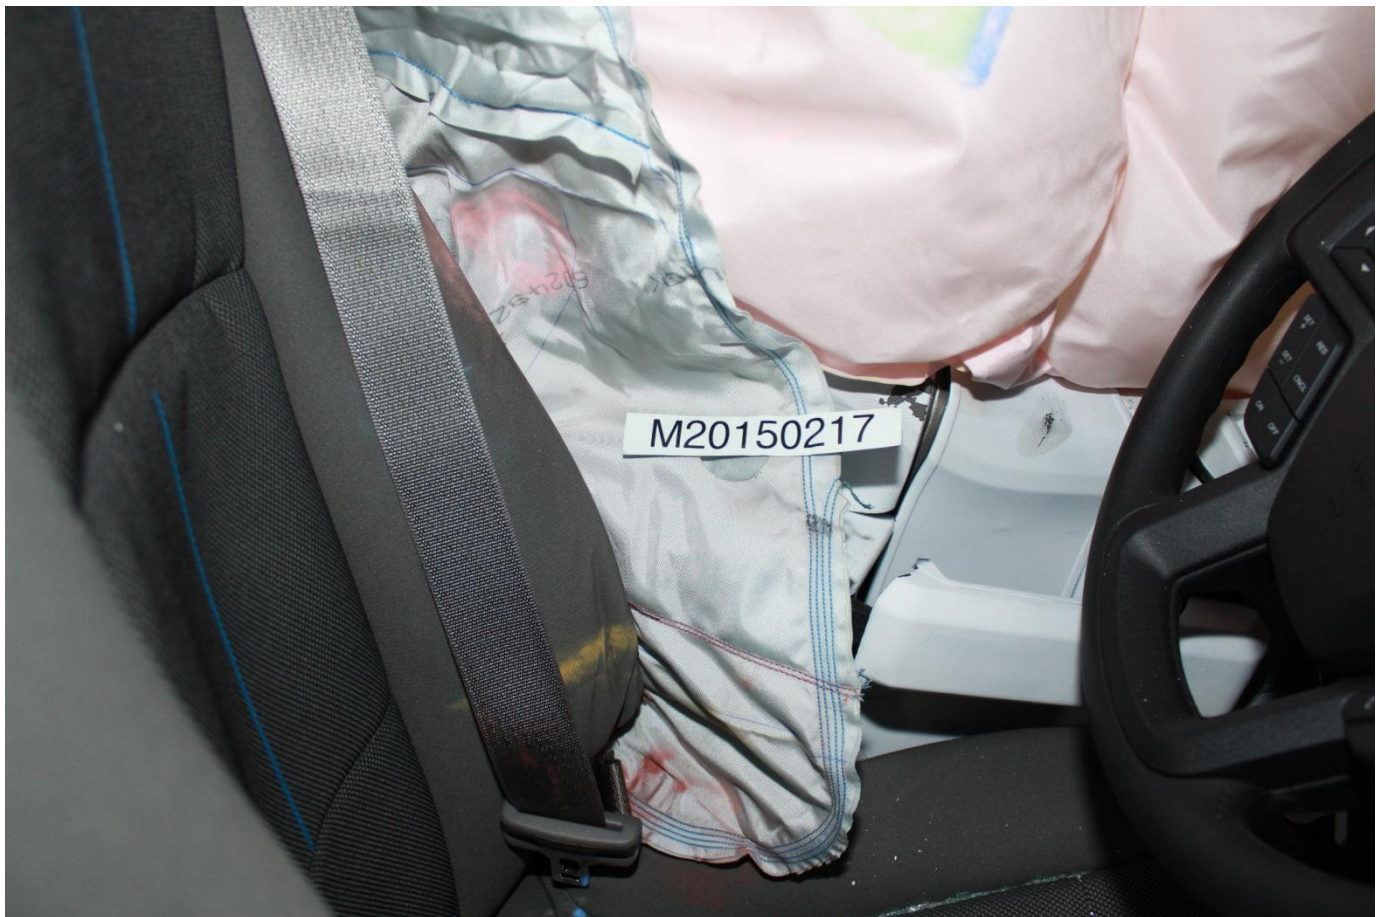
Post-Test Dummy Close-Up Torso Contact with Side Air Bag View

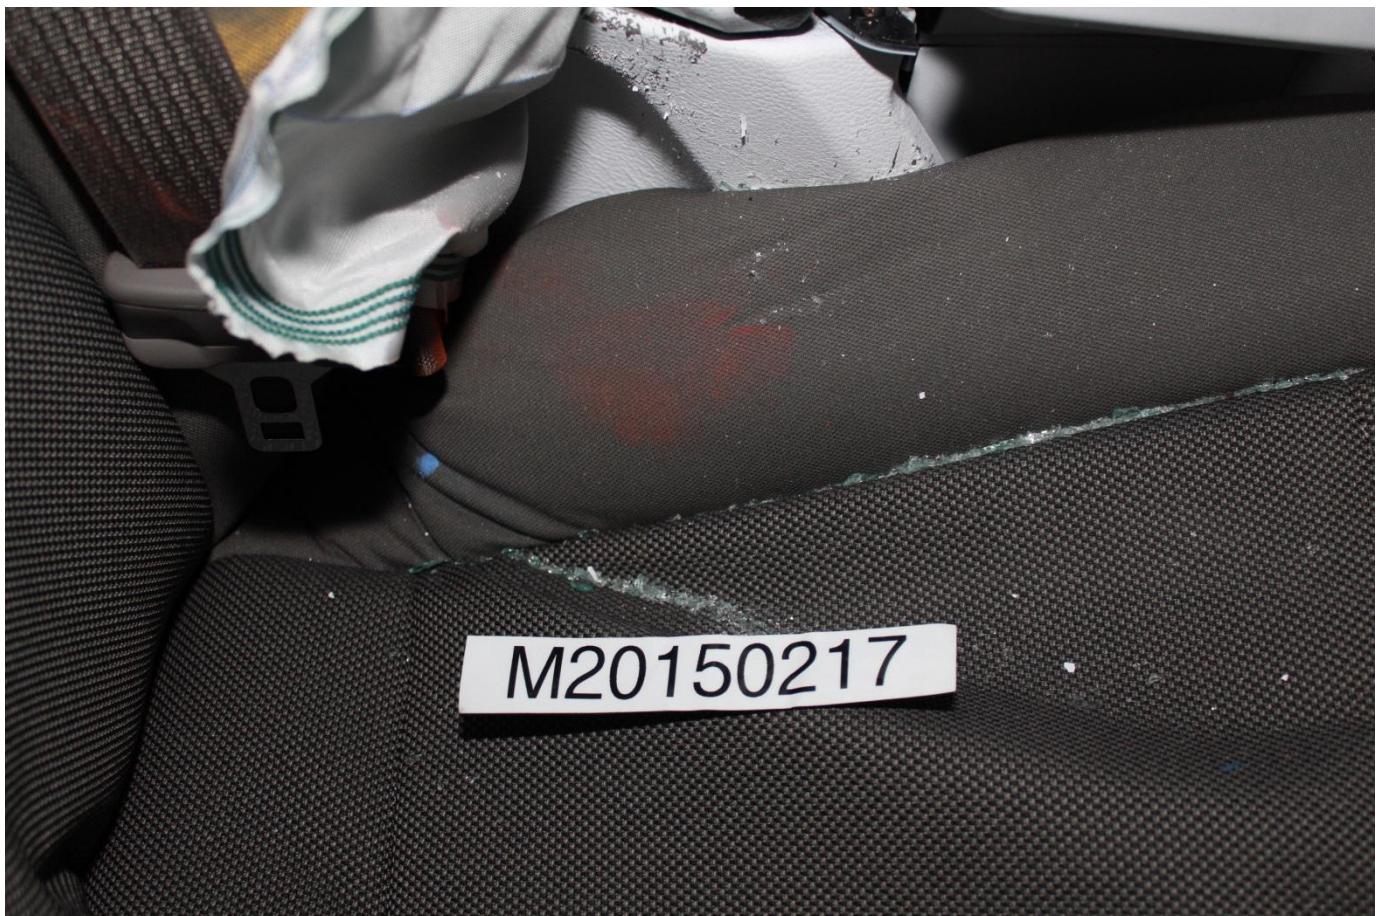
Post-Test Dummy Close-Up Pelvis Contact with Vehicle Interior View

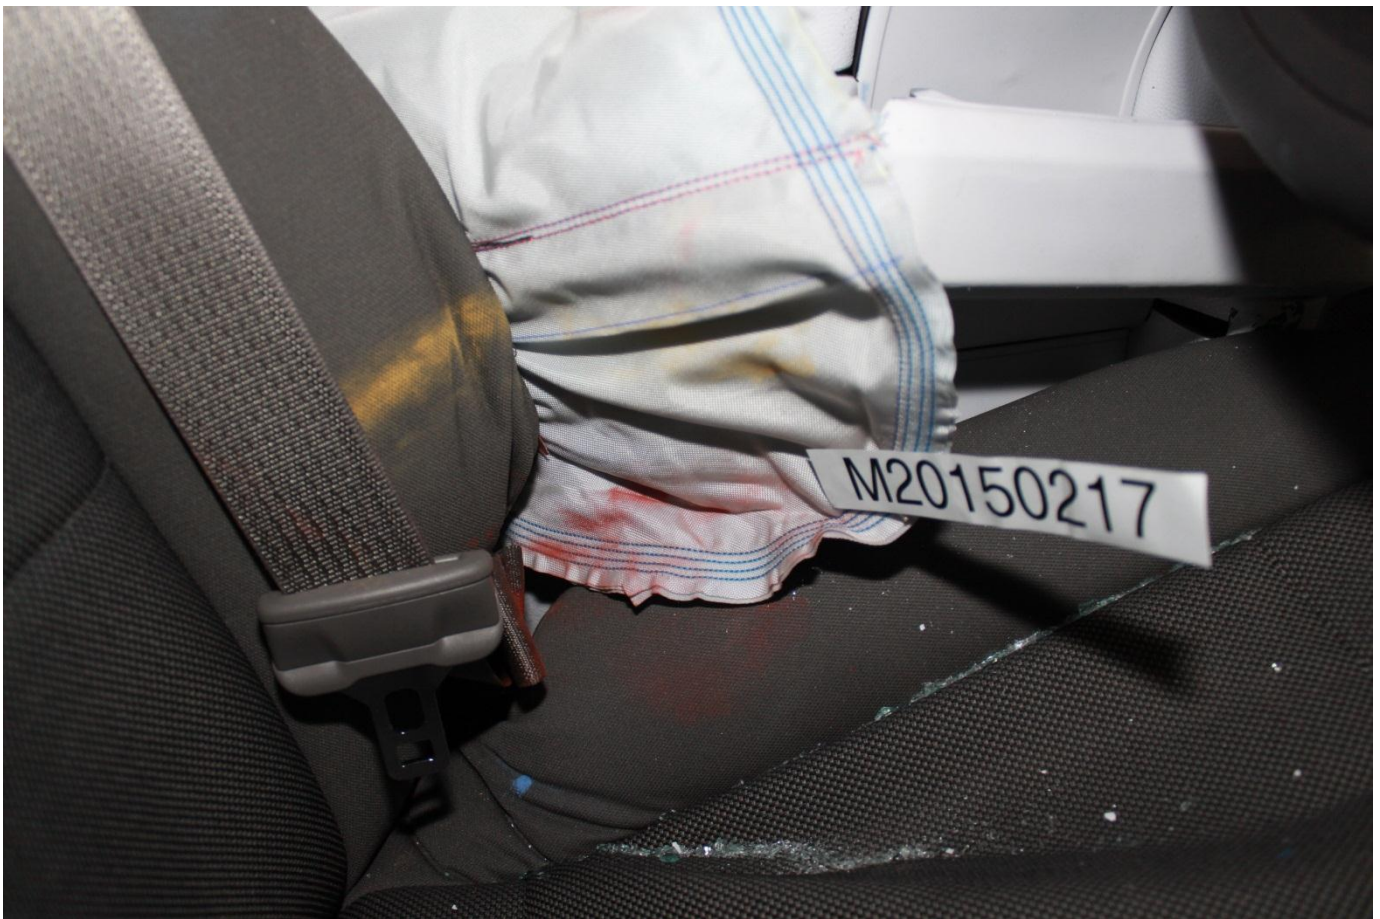
Post-Test Dummy Close-Up Pelvis Contact with Side Air Bag View

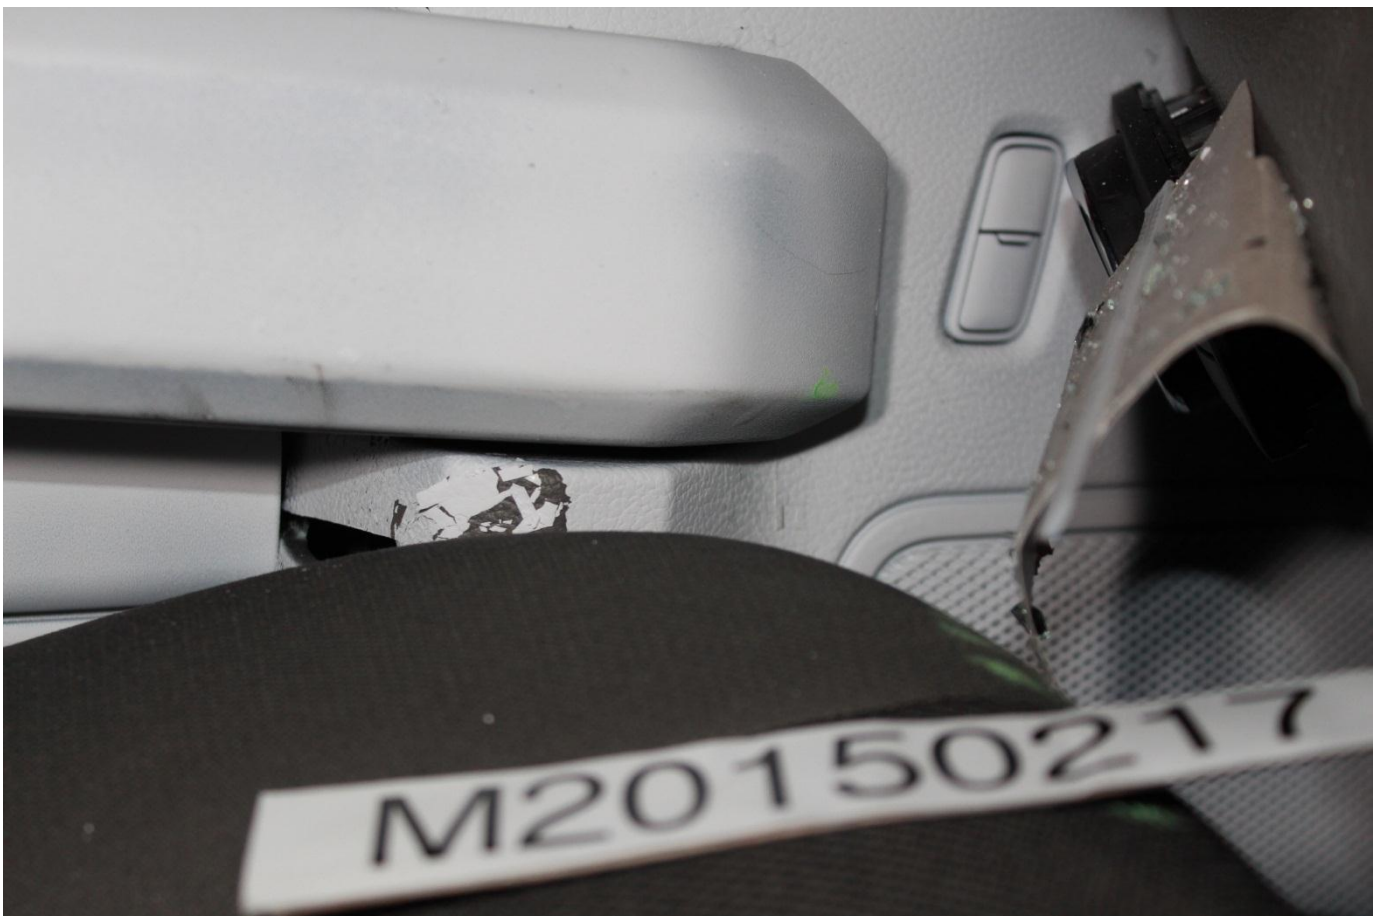
Post-Test Dummy Close-Up Knee Contact with Vehicle Interior View

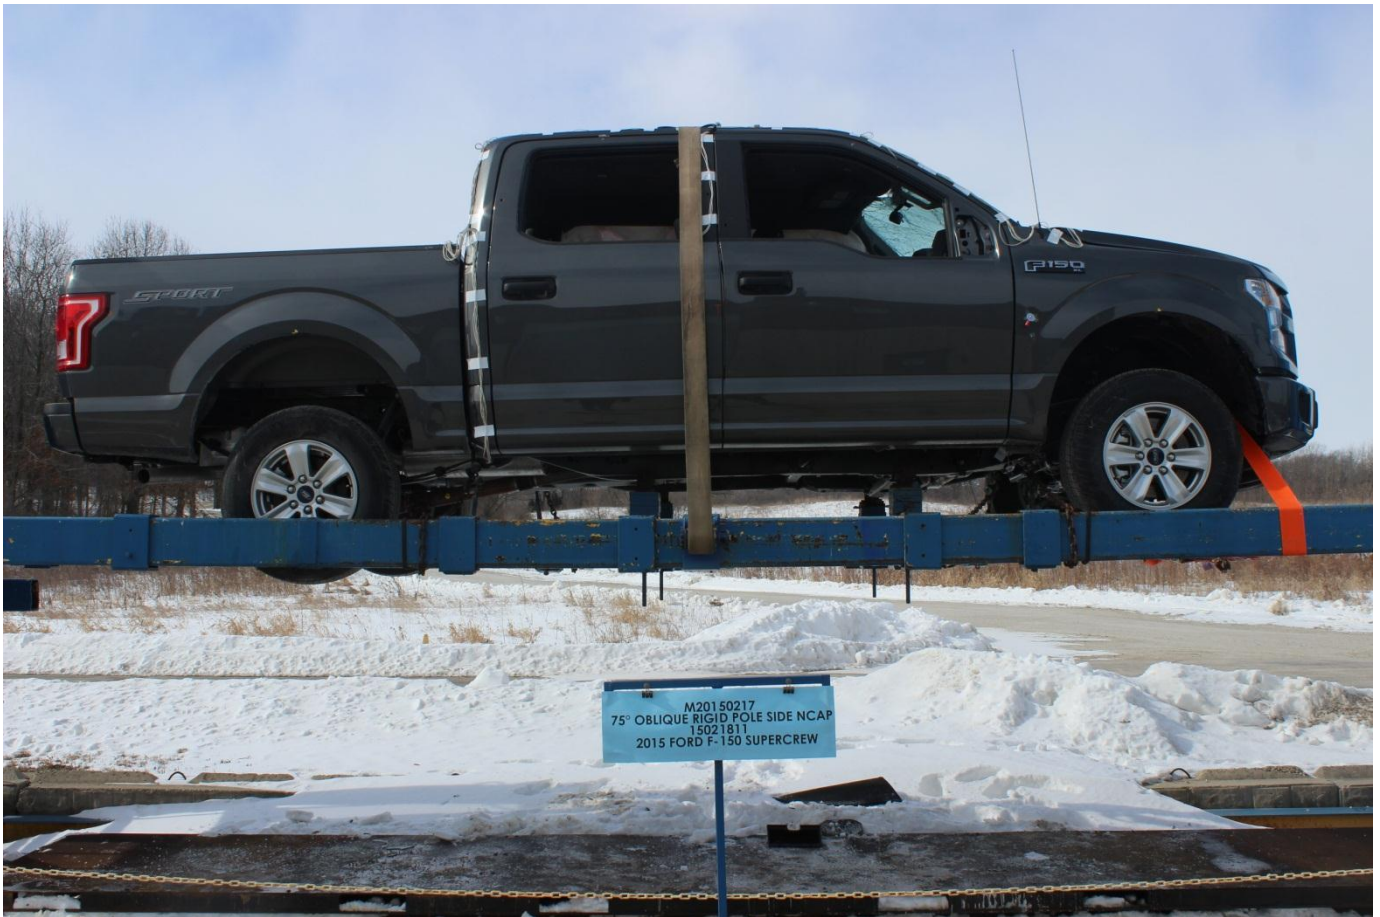
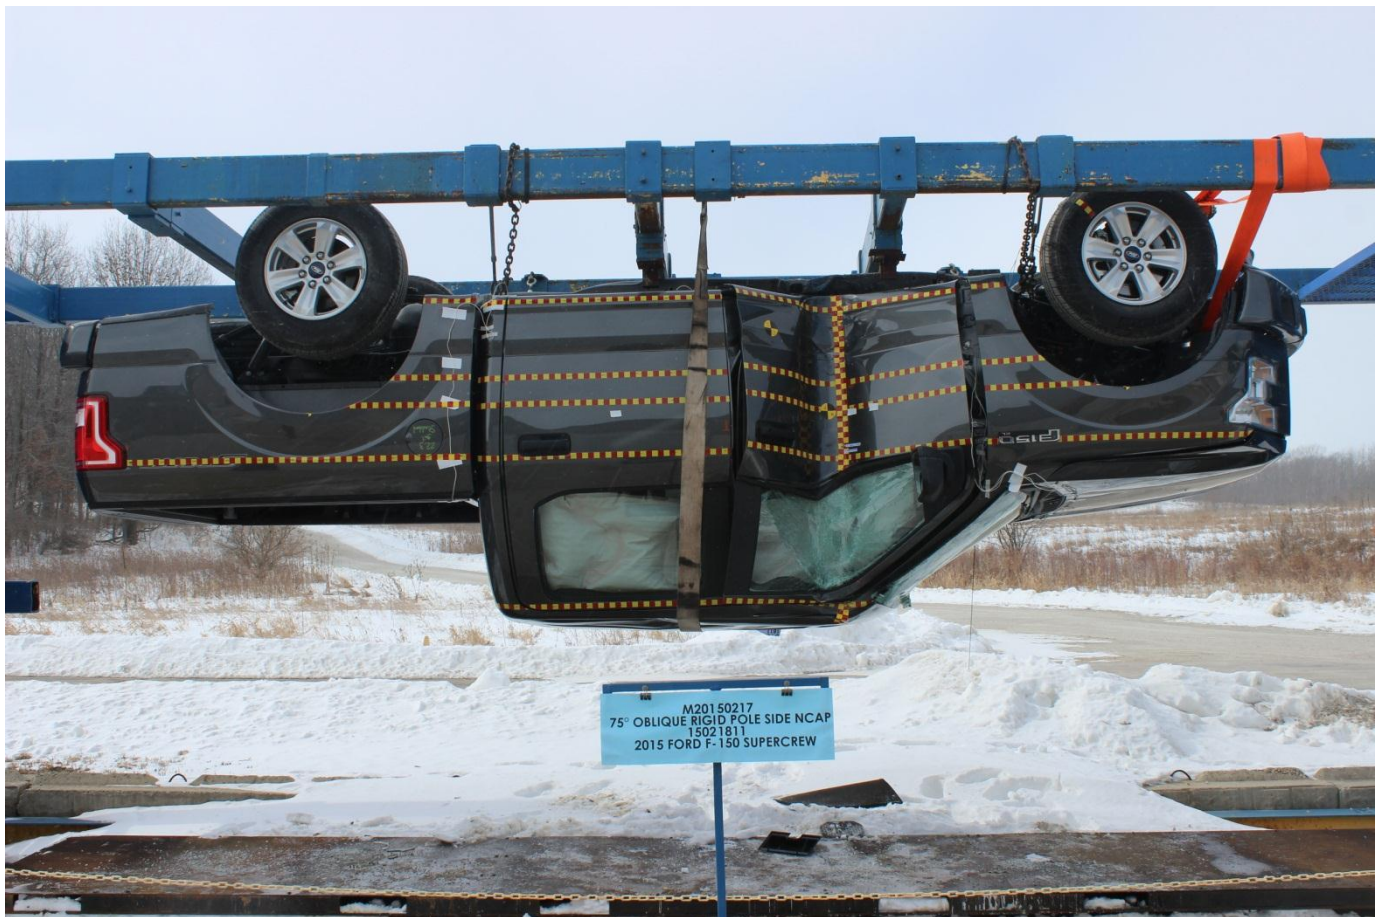
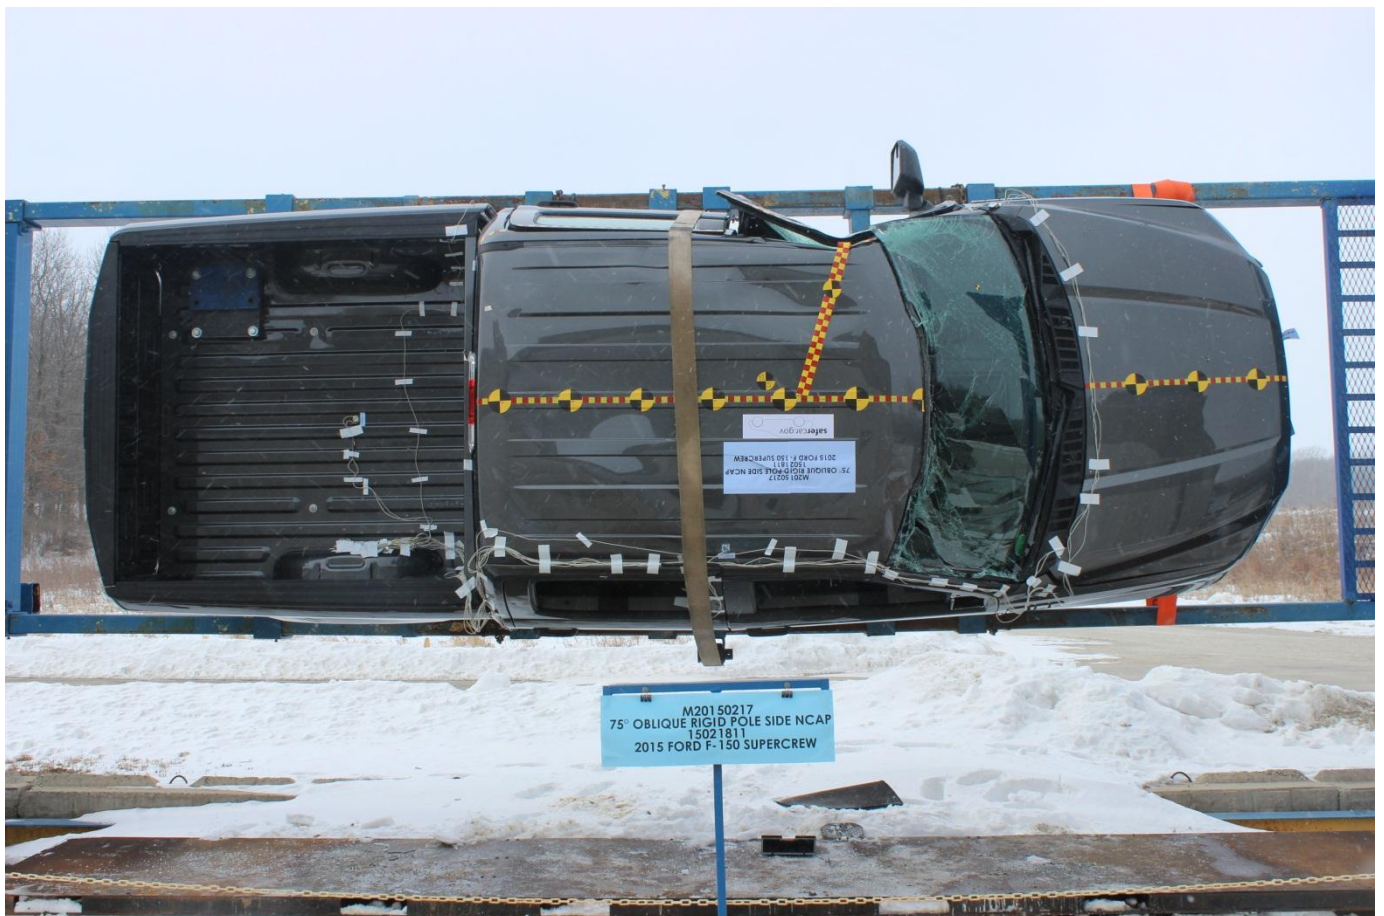
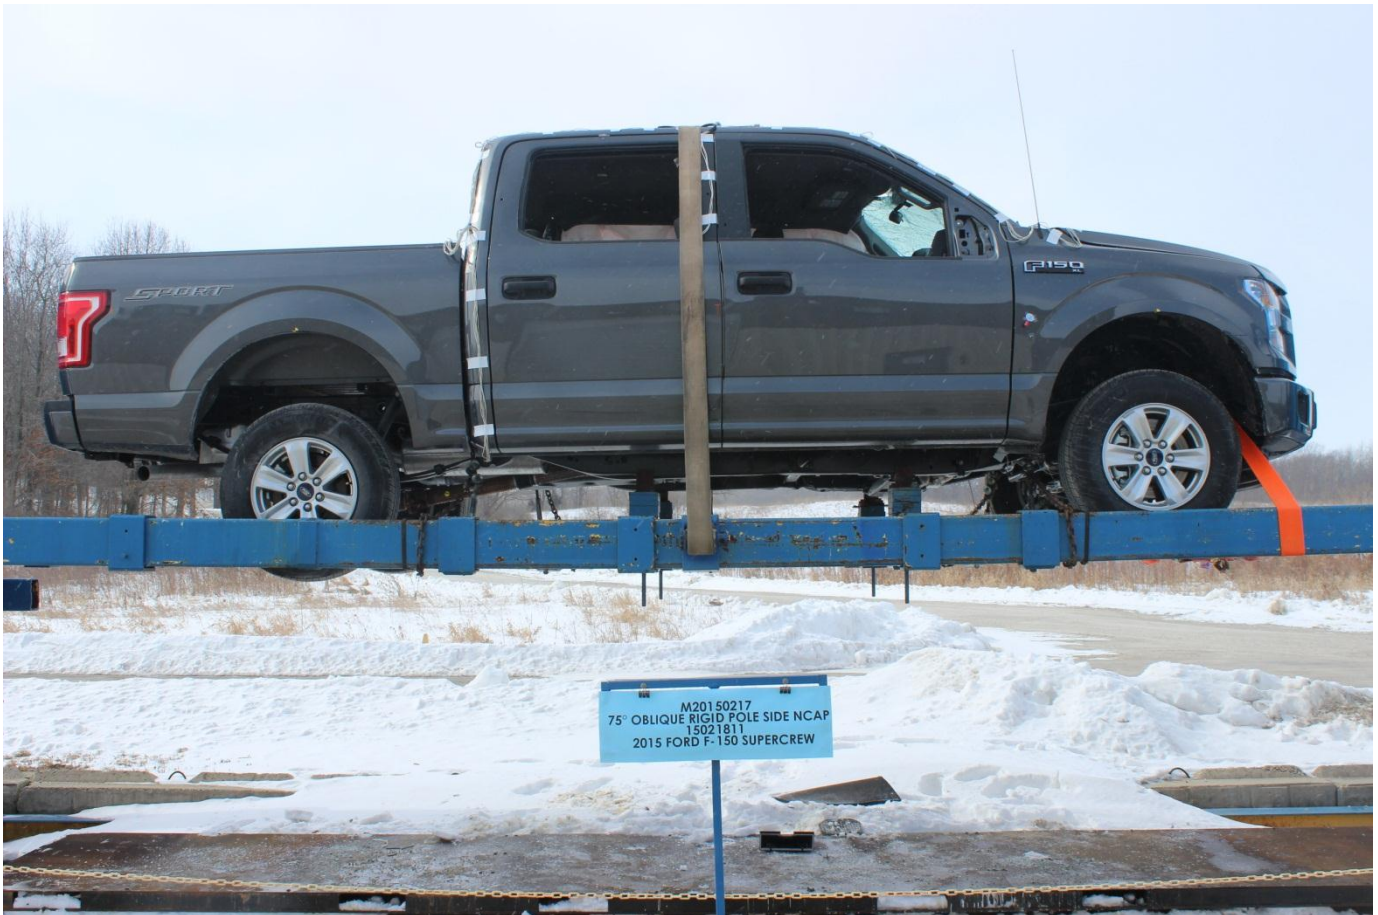
FMVSS No. 301 Static Rollover 0 Degrees

FMVSS No. 301 Static Rollover 90 Degrees

FMVSS No. 301 Static Rollover 180 Degrees

FMVSS No. 301 Static Rollover 270 Degrees

FMVSS No. 301 Static Rollover 360 Degrees

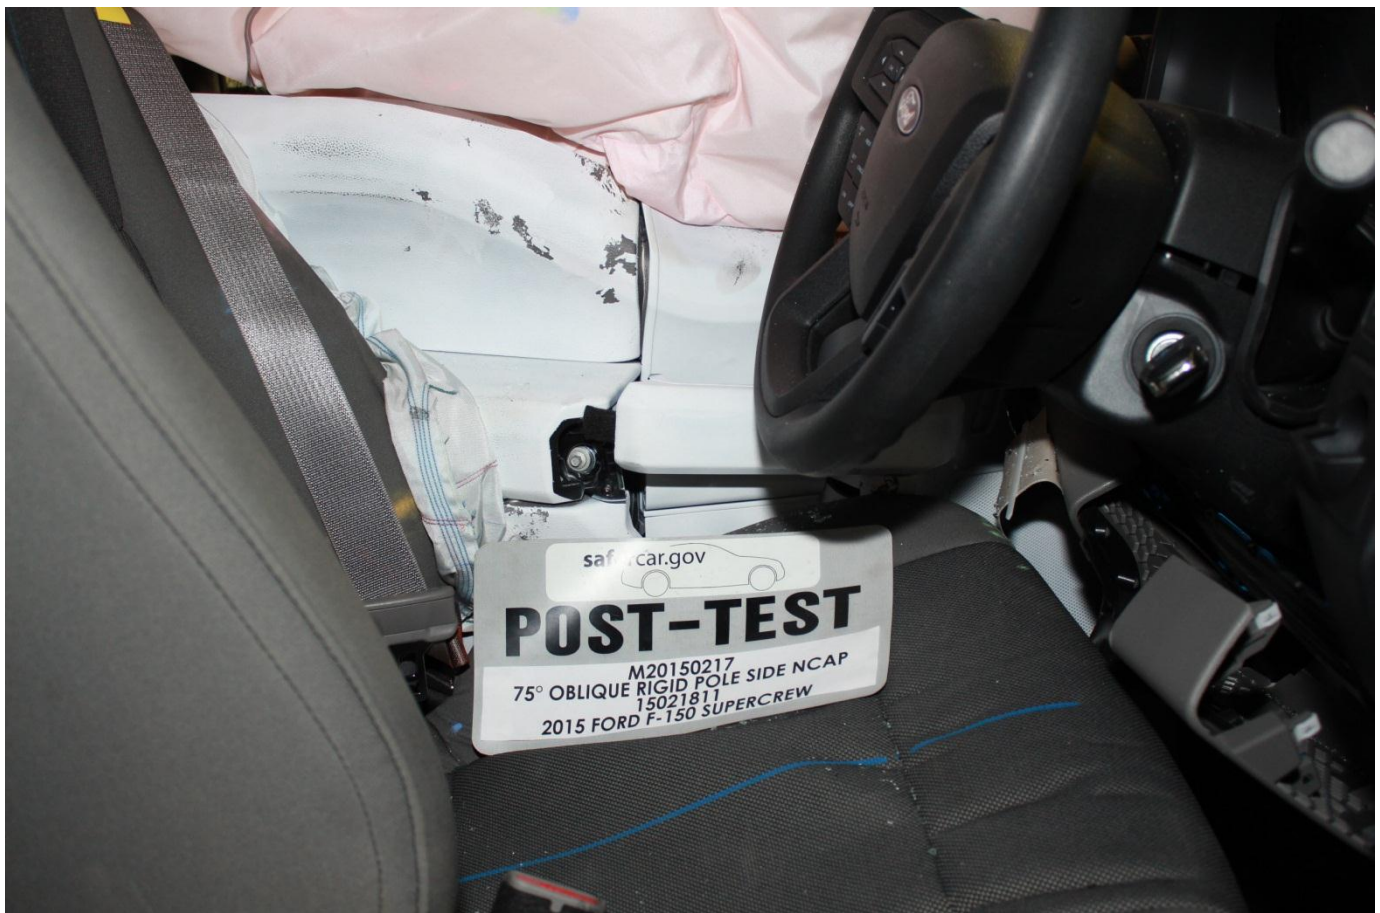
Post-Test View of Shattered Vehicle Inner Door Panel

| | <u>Page No.</u> |
|--|---|
| Photo No. 71. Post-Test View of Shattered Vehicle Inner Door Panel | A-36 |
