**REPORT NUMBER: SINCAP-MGA-2015-059**

**NEW CAR ASSESSMENT PROGRAM (NCAP)  
Moving Deformable Barrier Side Impact Test**

**FORD MOTOR CO.  
2015 Ford F-150 SuperCab XL Truck  
NHTSA No.: M20150215**

**MGA RESEARCH CORPORATION  
5000 Warren Road  
Burlington, WI 53105**

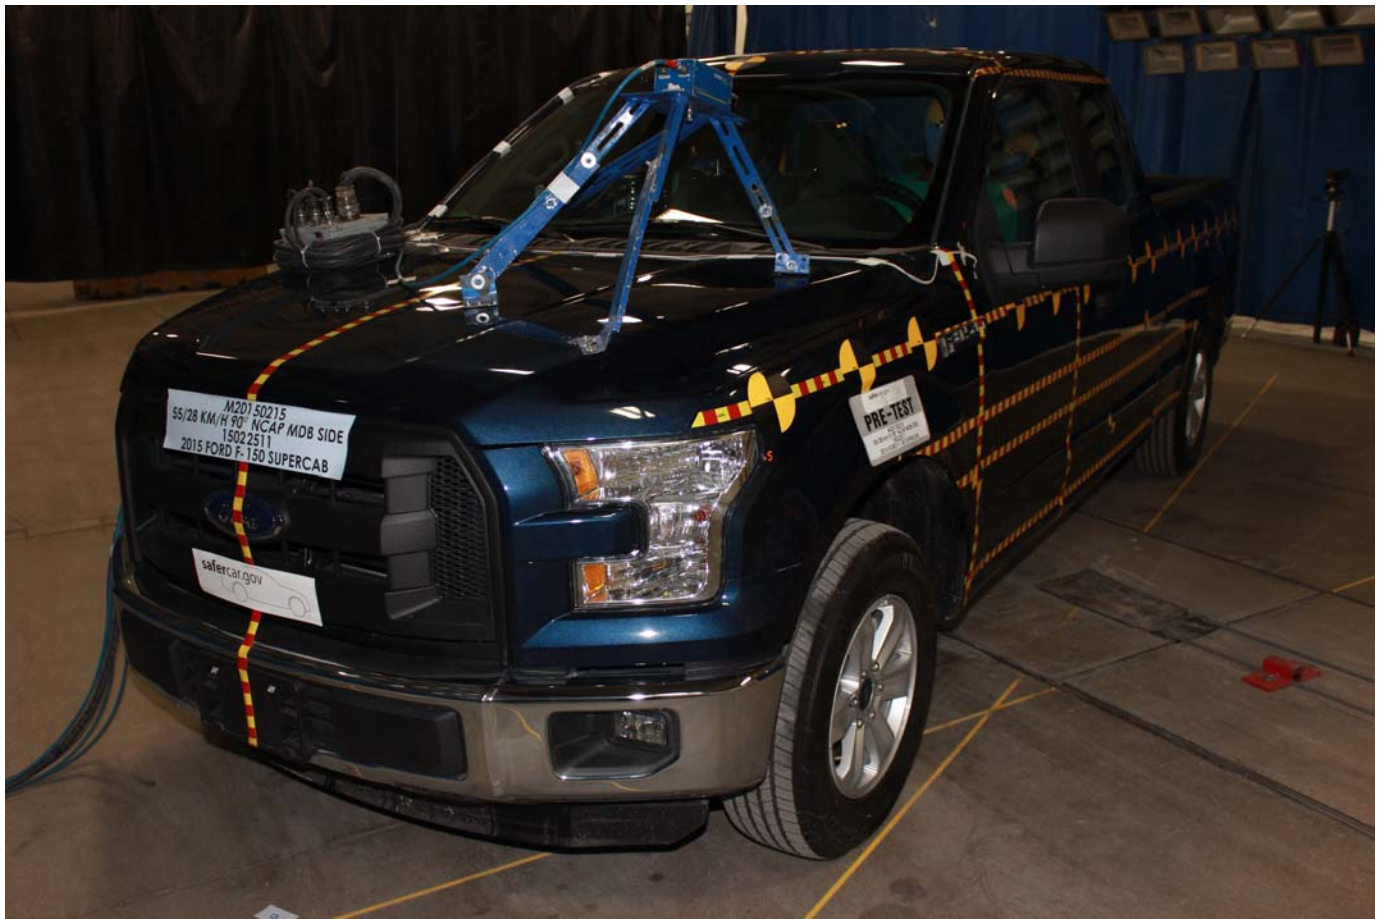
No. 005 Pre-Test Left Front Three-Quarter View of Test Vehicle

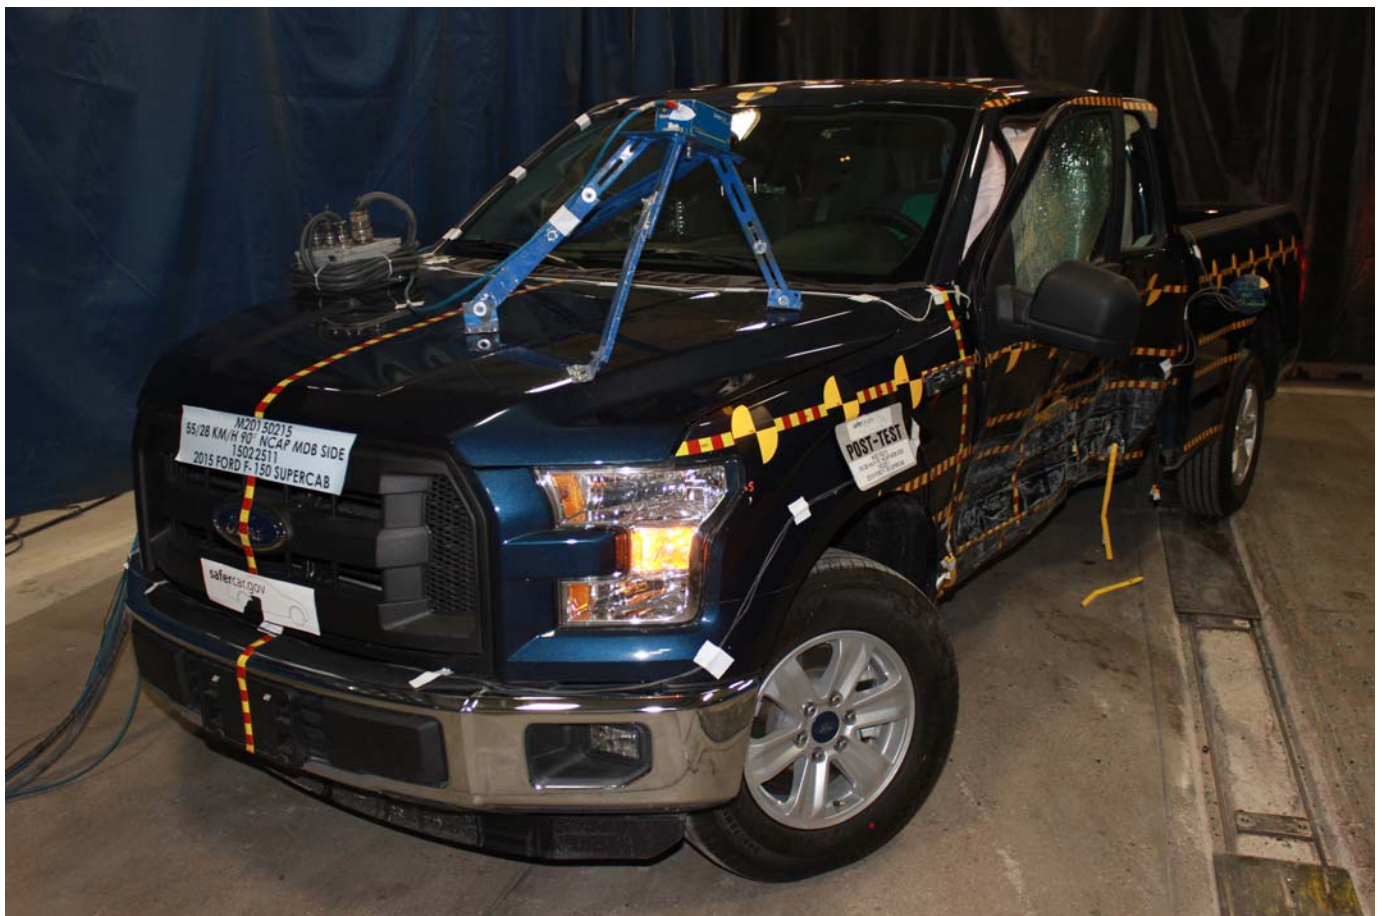
No. 006 Post-Test Left Front Three-Quarter View of Test Vehicle

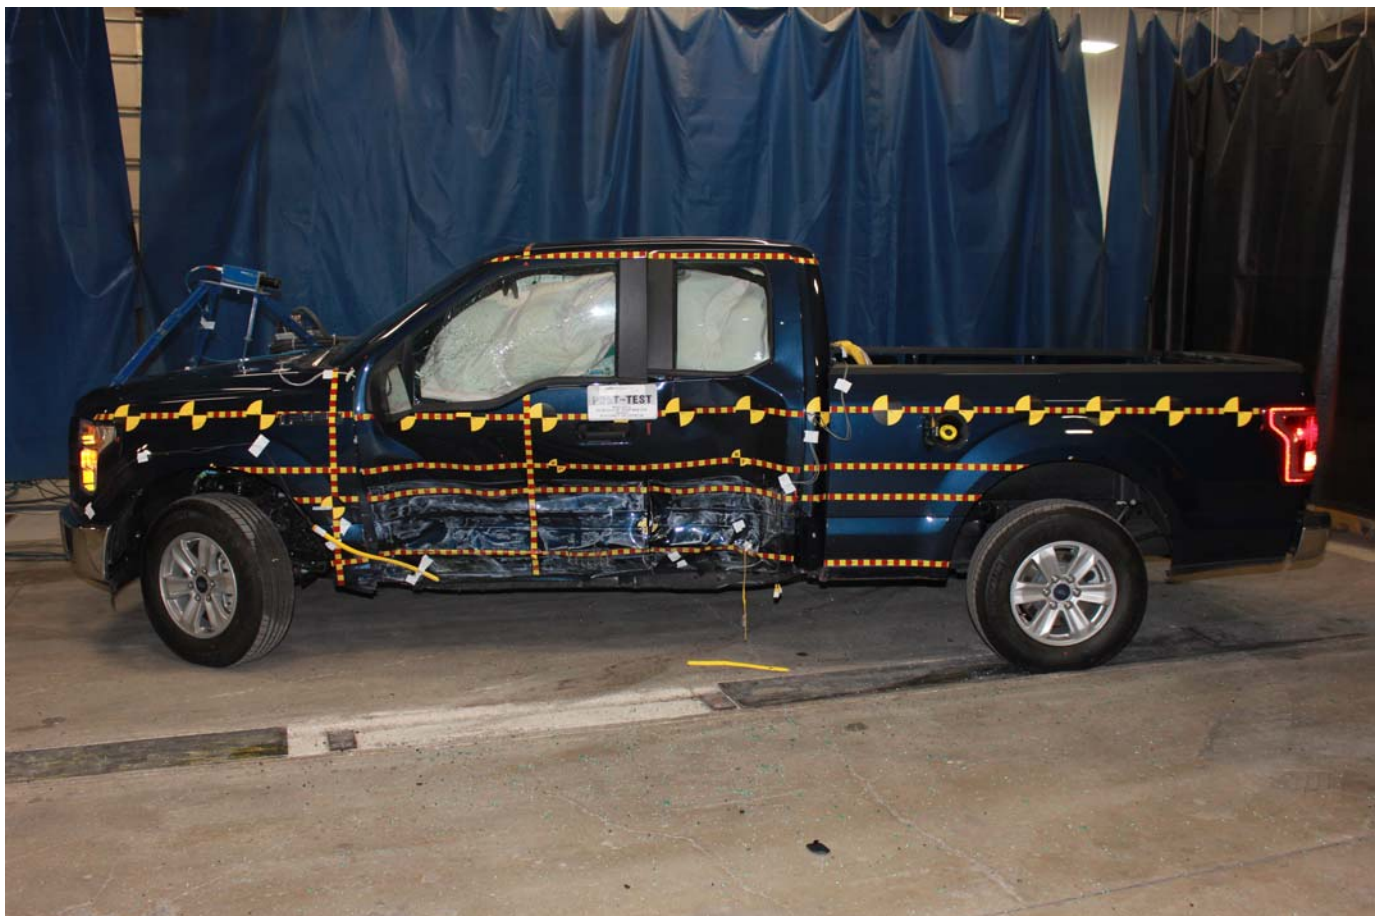
No. 008 Post-Test Left Side View of Test Vehicle

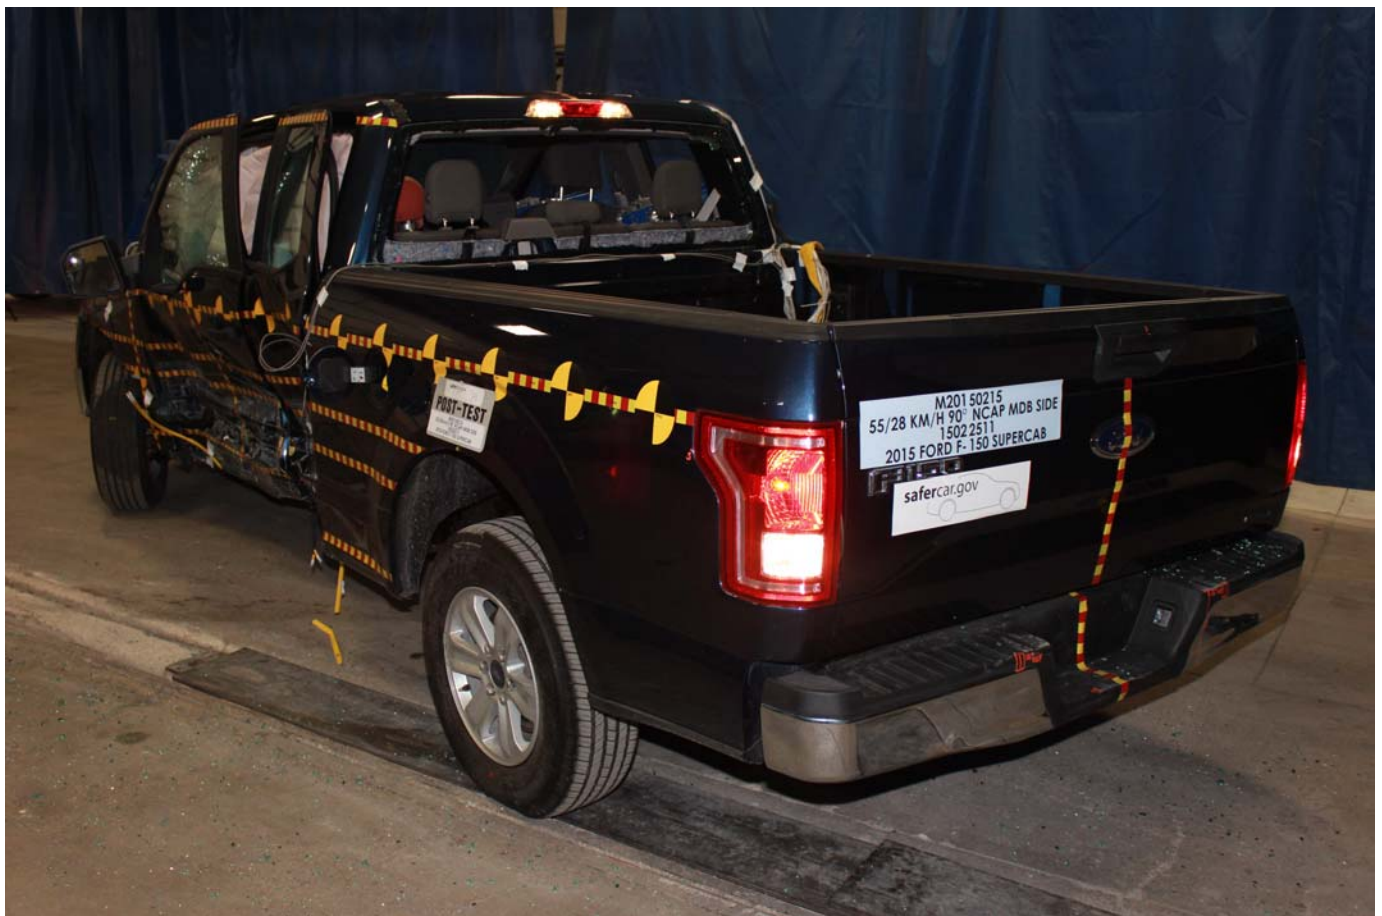
No. 010 Post-Test Left Three-Quarter Rear View of Test Vehicle

| Critical Areas of Performance | Observations and Conclusions |
|---|---|
| Other Notable Effects | Rear Window Broken |

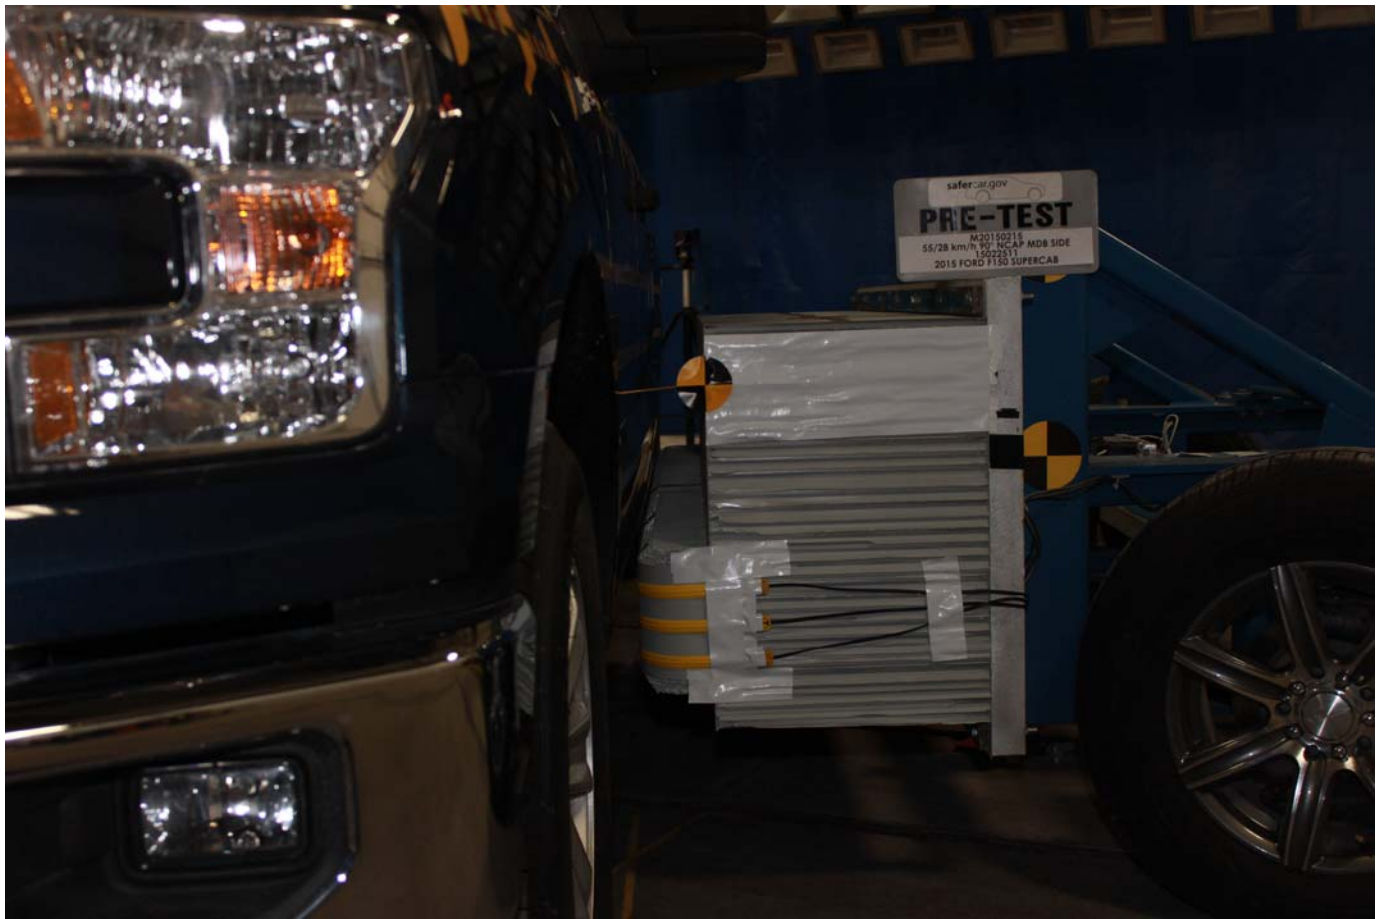
No. 017 Pre-Test Left Side View of MDB Positioned Against Side of Test Vehicle

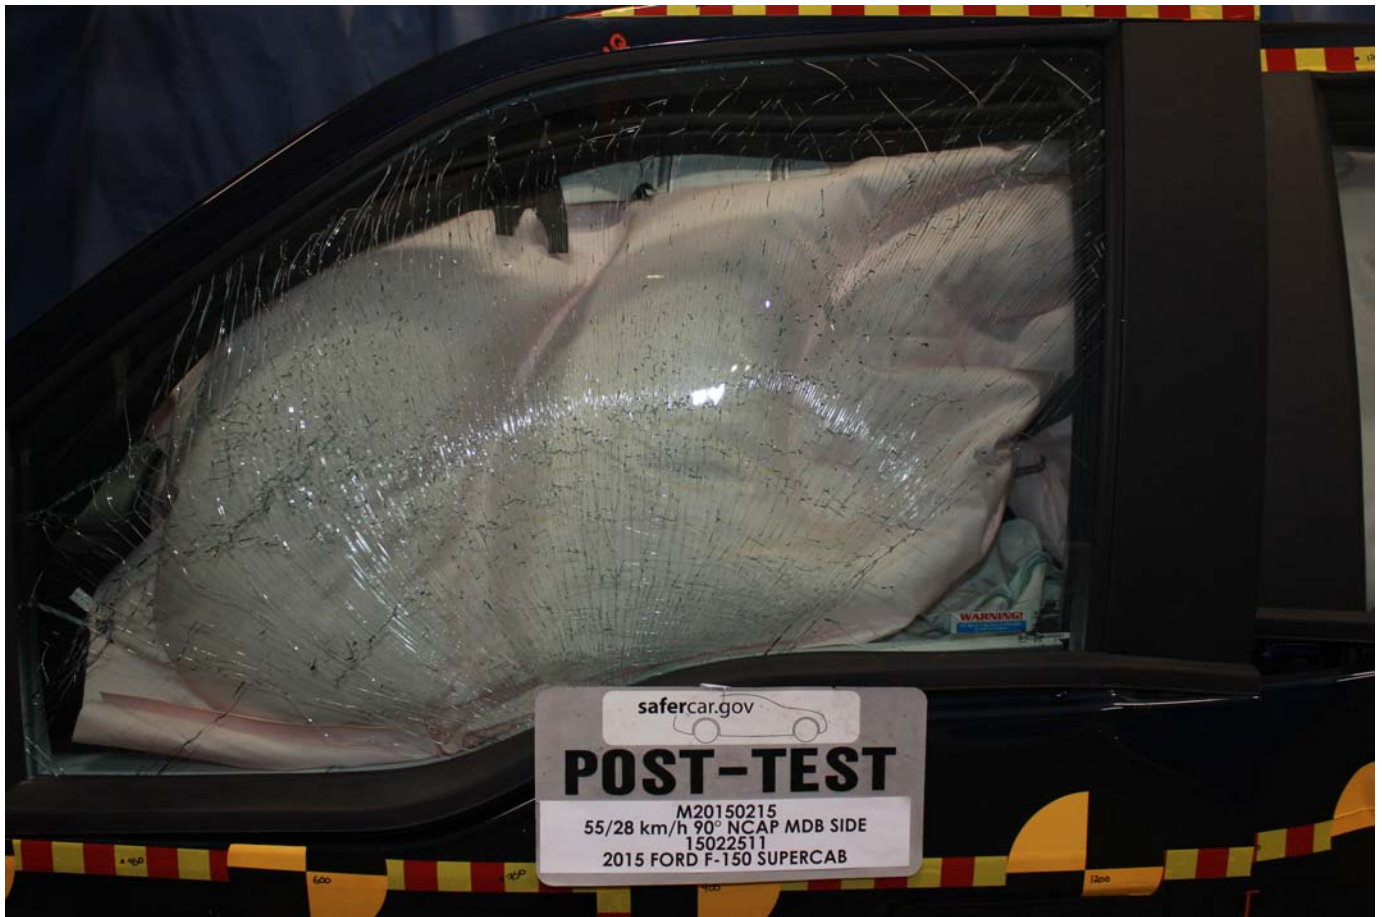
No. 029 Post-Test Left Side View of Driver Dummy Shoulder and Door Top View

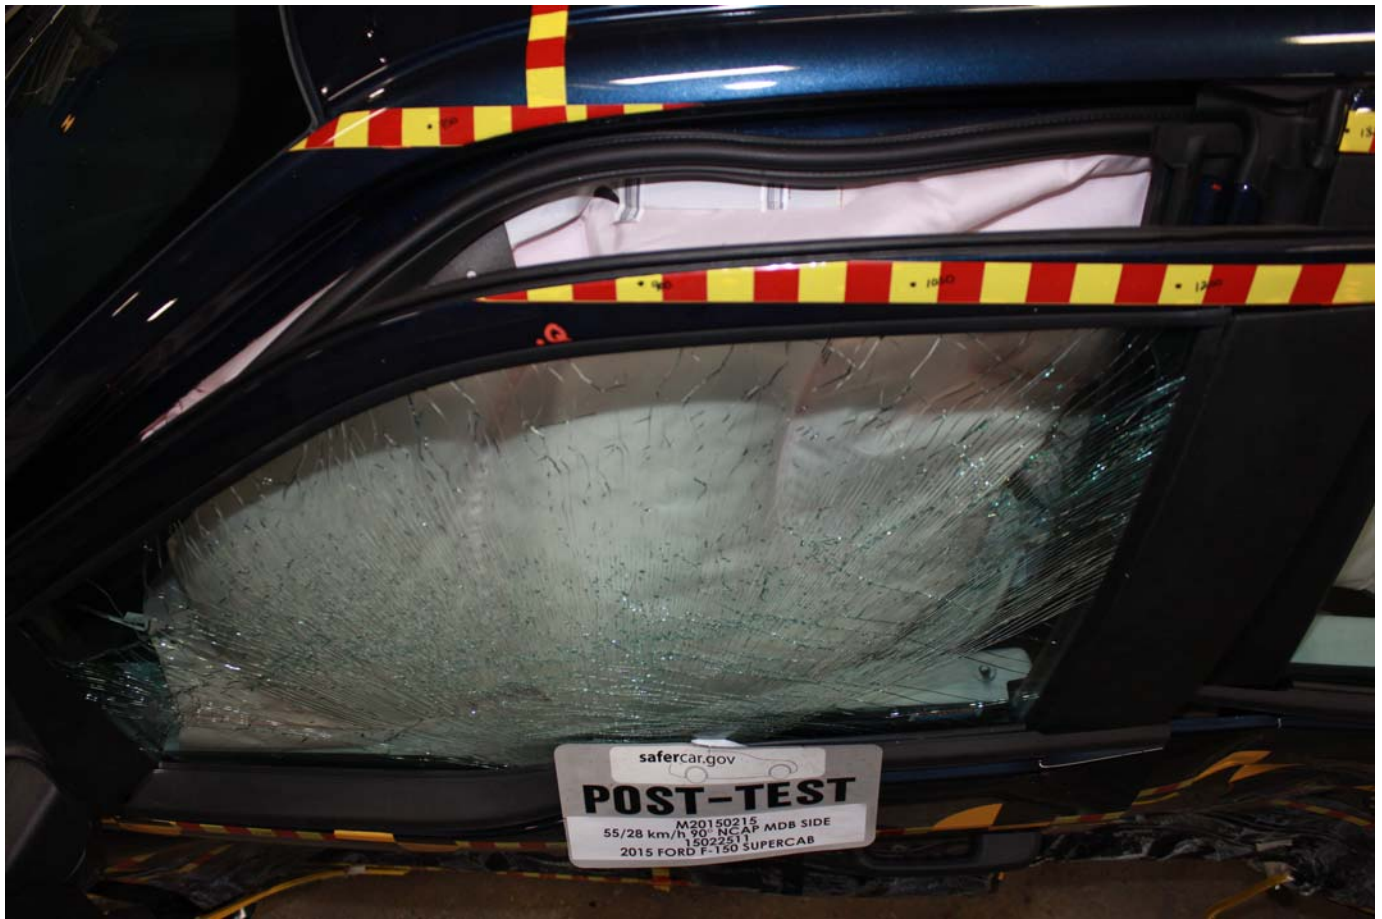
No. 043 Post-Test Driver Dummy and Door Clearance View

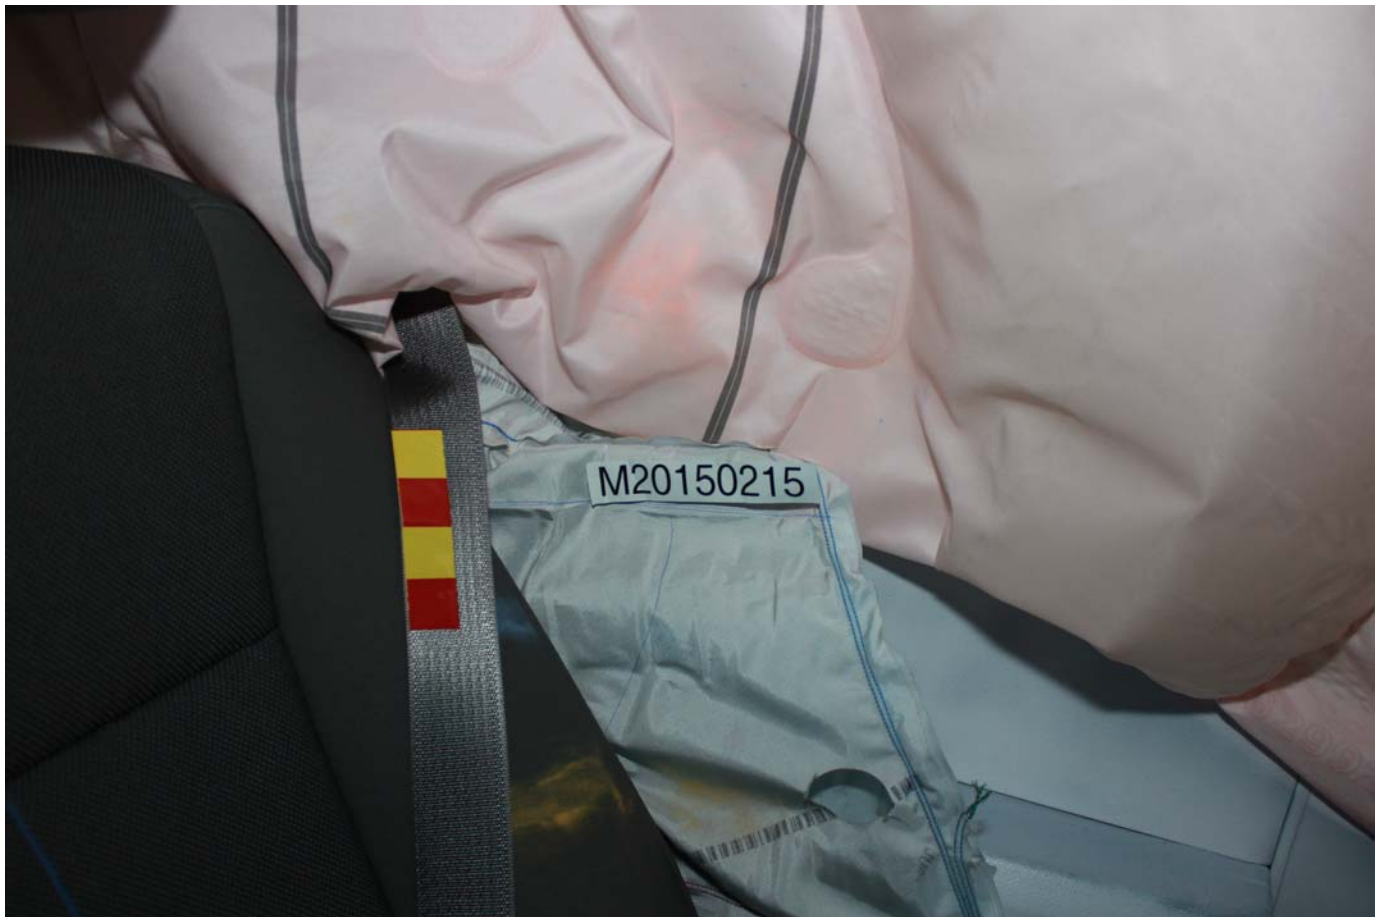
No. 051 Post-Test Driver Dummy Close-up Torso Contact with Side Airbag View

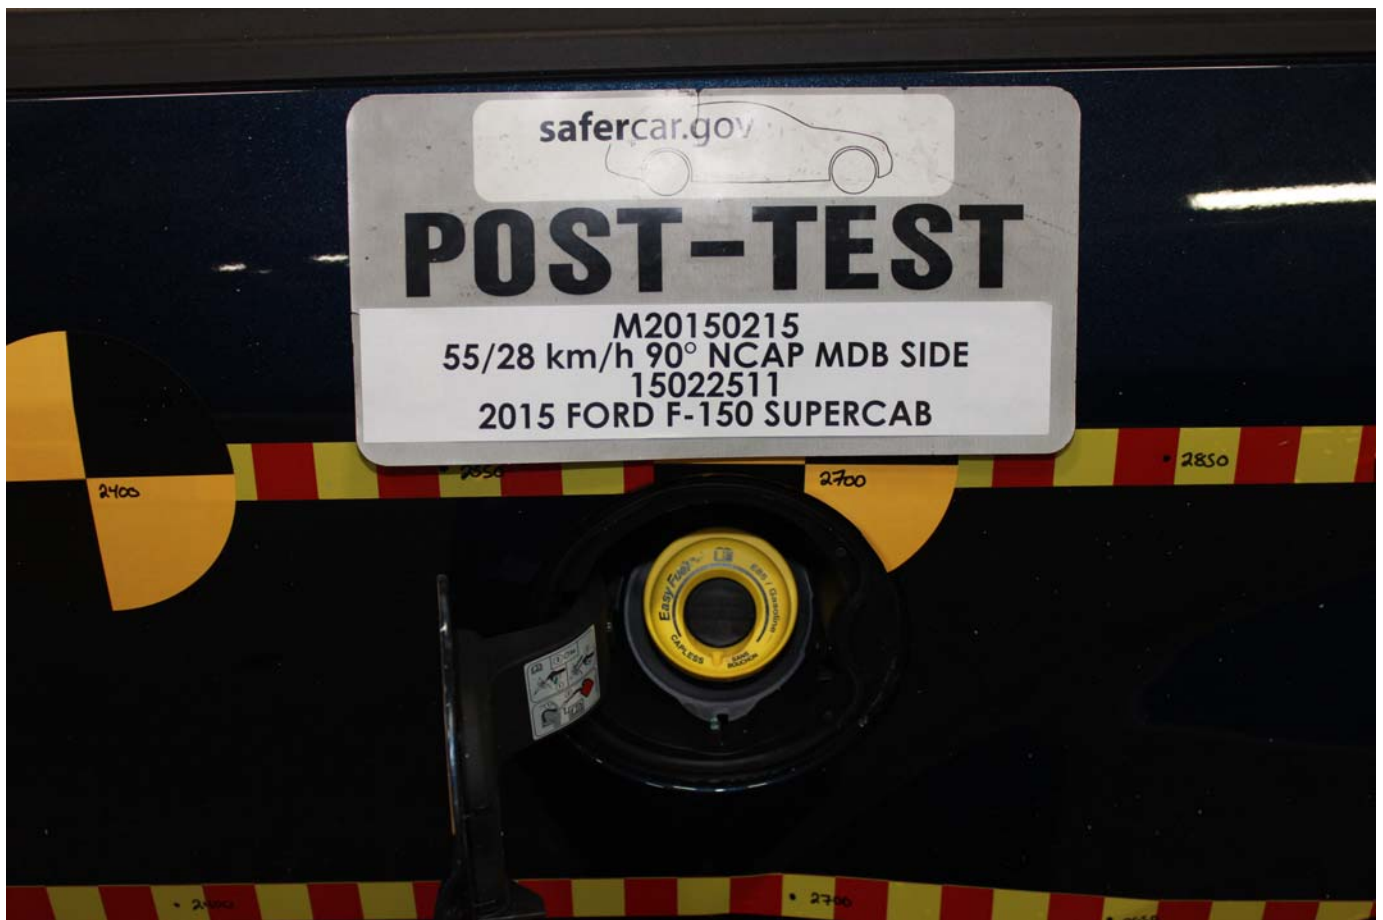
No. 083 Post-Test View of Fuel Filler Cap or Fuel Filler Neck

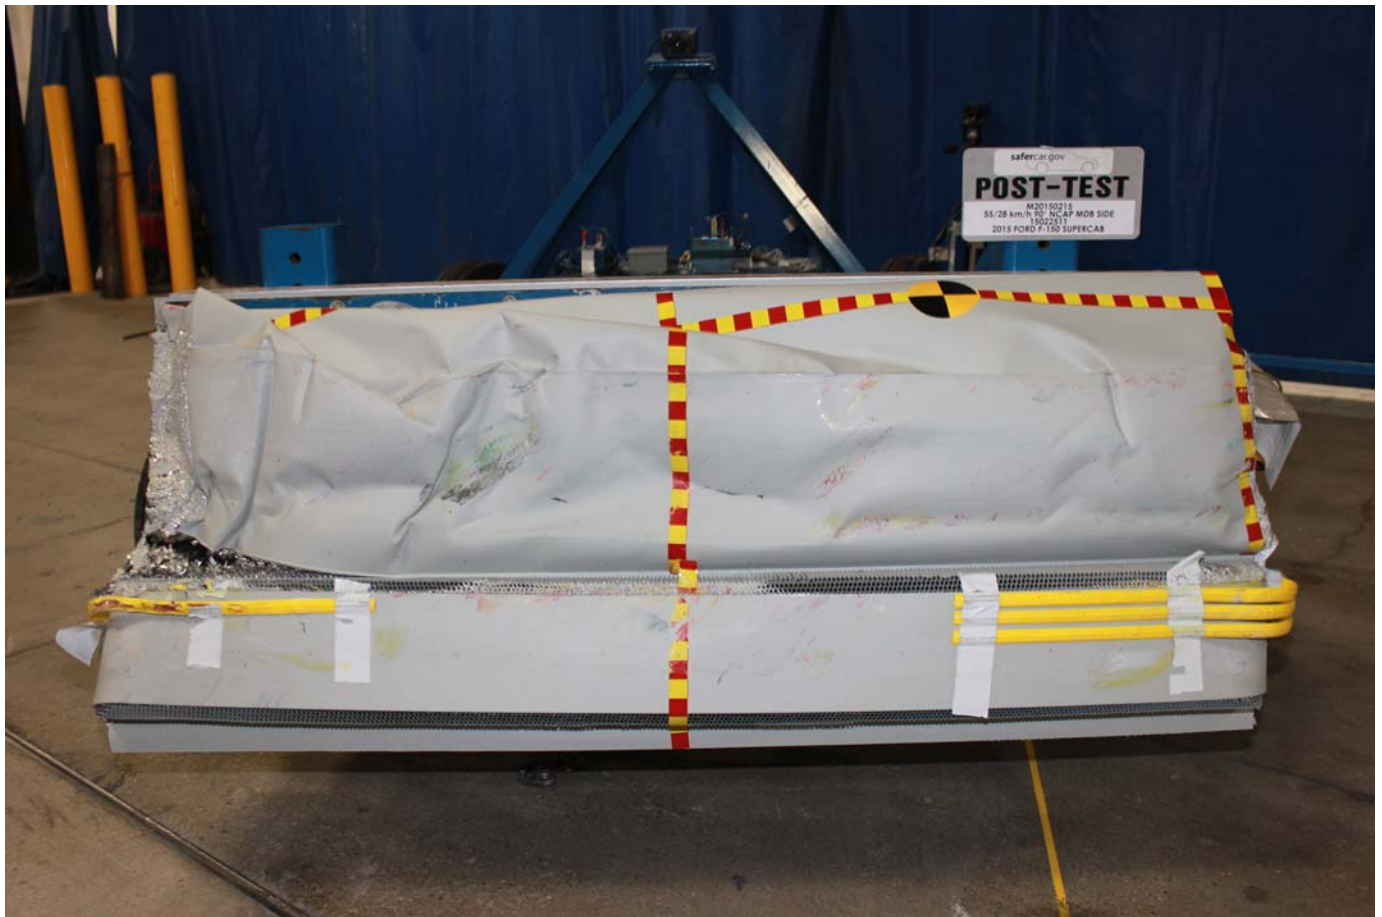
No. 085 Post-Test Front View of MDB Impactor Face
